PAVEMENT DATA REPORT

LAK-84-0.79 (PID 112506)

SR-84 (BISHOP ROAD/RIDGE ROAD), WICKLIFFE, OHIO

SME Project Number: 092062.14

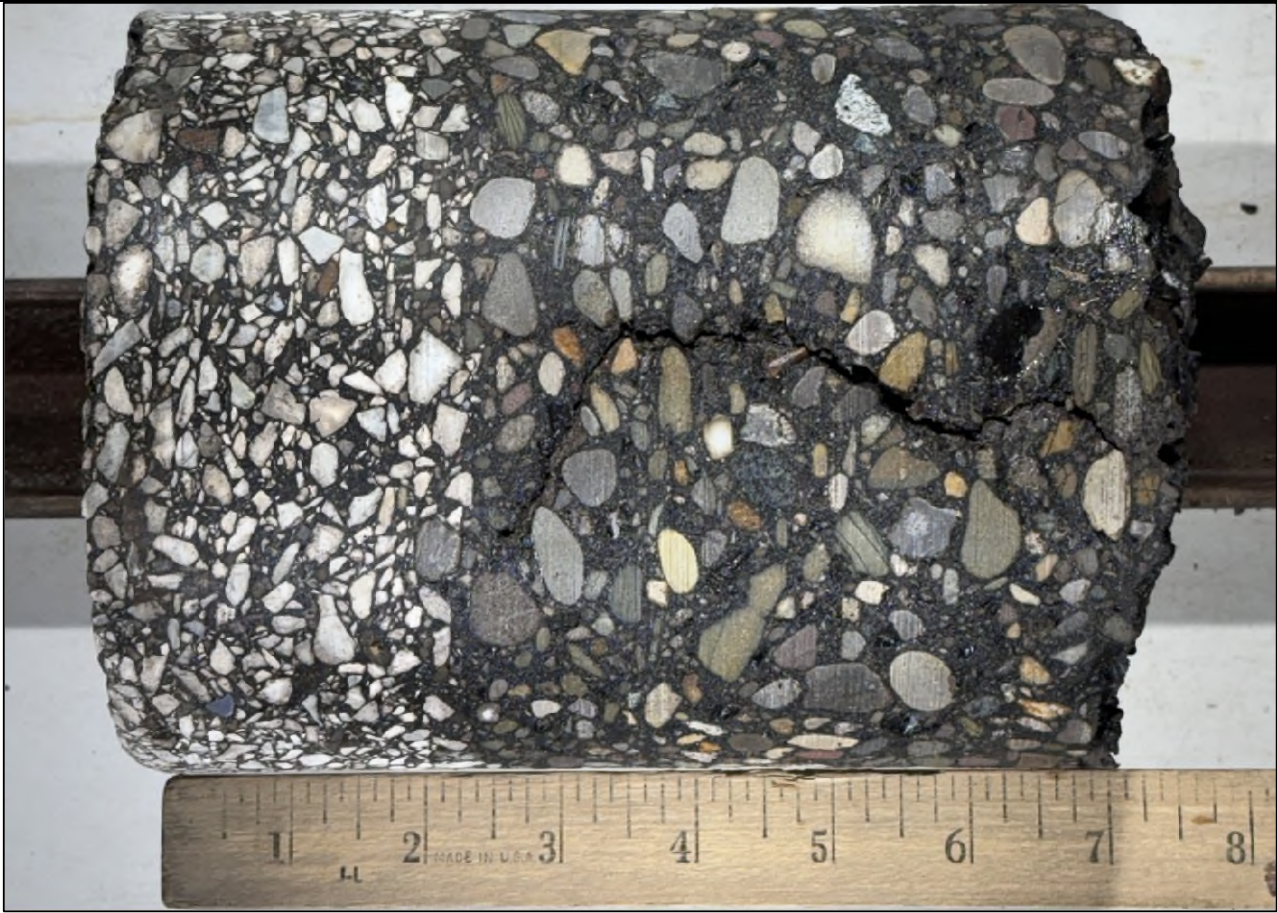
X-001-0-24

Layer Thickness, in.	Description	Comments
2	ASPHALT: Surface Course	- 7 inches of pavement total - Core observed to be intact
5	ASPHALT: Intermediate Course	- Shallow vertical crack observed through intermediate layer
3½	AGGREGATE BASE: Crushed Limestone and Pea Gravel

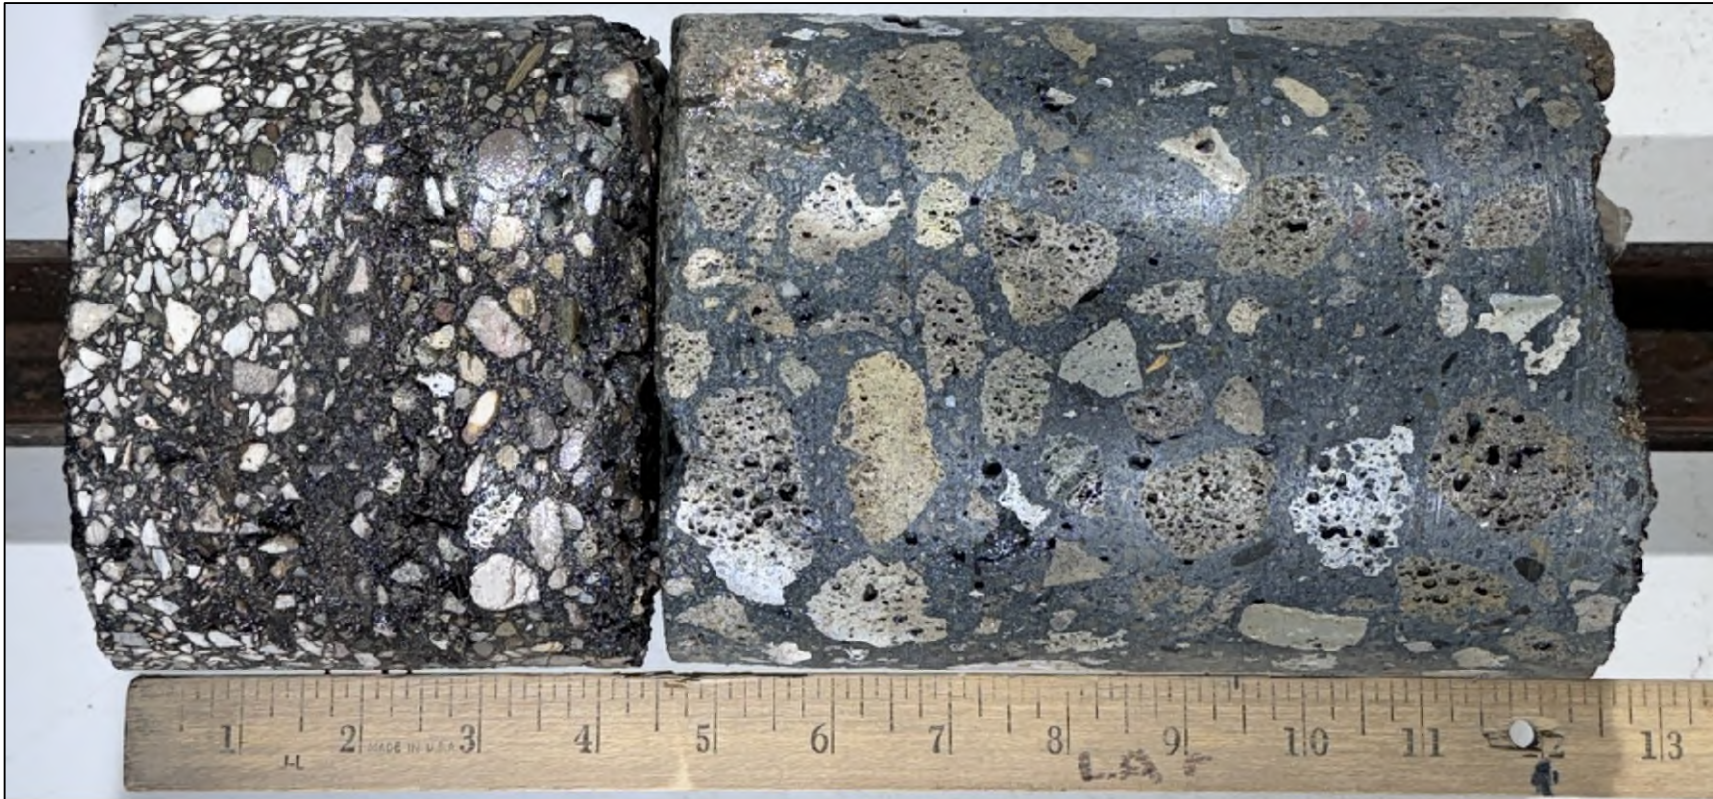
X-002-0-24

Layer Thickness, in.	Description	Comments
2	ASPHALT: Surface Course	- 12½ inches of pavement total - Asphalt and concrete sections observed to be intact
2½	ASPHALT: Intermediate Course	- Slight deterioration in layer - Delaminated from concrete section
8	UNREINFORCED CONCRETE	
--	NO AGGREGATE BASE ENCOUNTERED

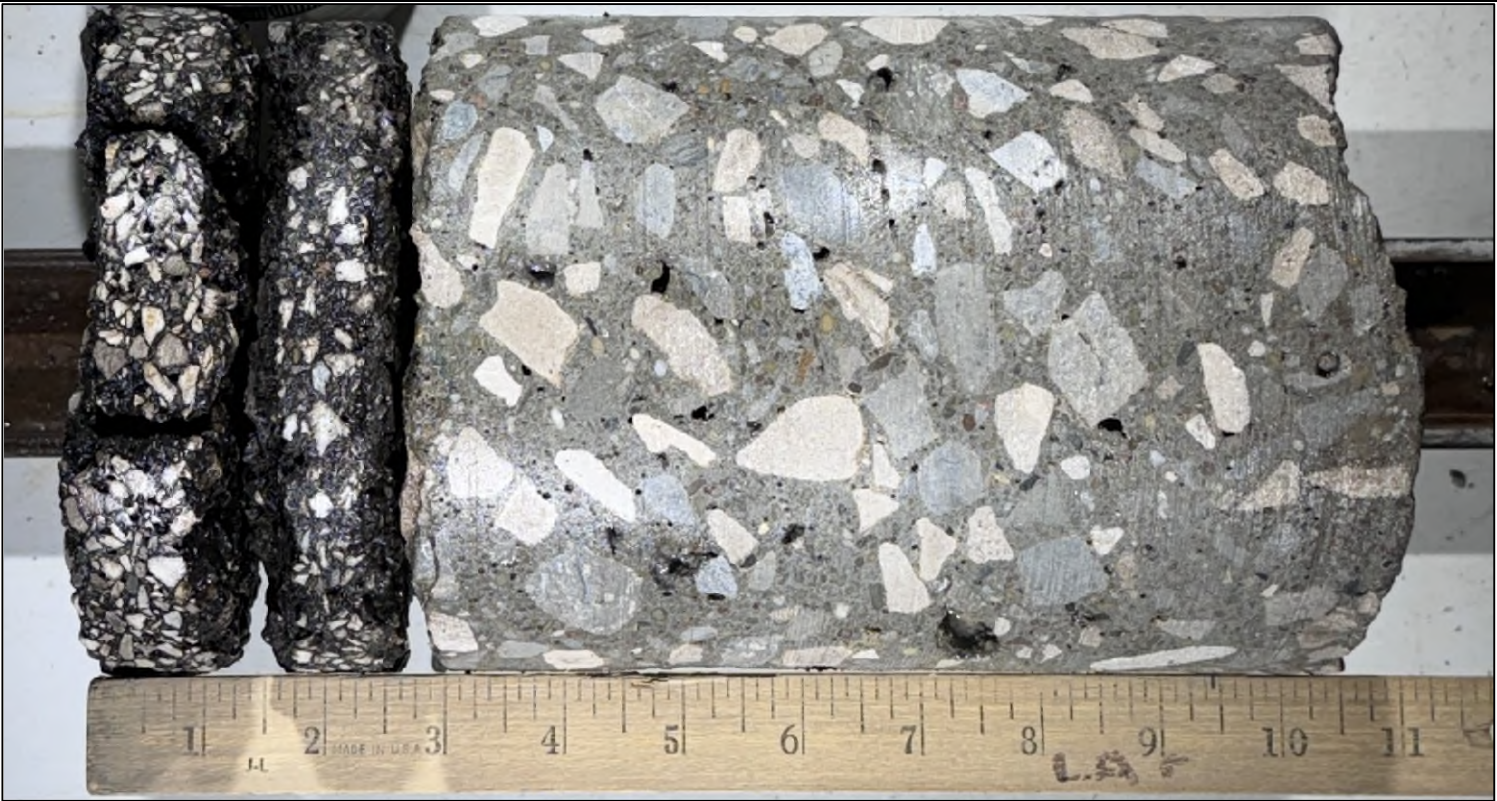
X-003-0-24

Layer Thickness, in.	Description	Comments
1½	ASPHALT: Surface Course	- 10½ inches of pavement total - Asphalt broken/deteriorated
1¼	ASPHALT: Intermediate Course	- Delaminated from concrete section
7¾	UNREINFORCED CONCRETE	- Concrete section observed to be intact
5½	AGGREGATE BASE: Crushed Limestone and Slag

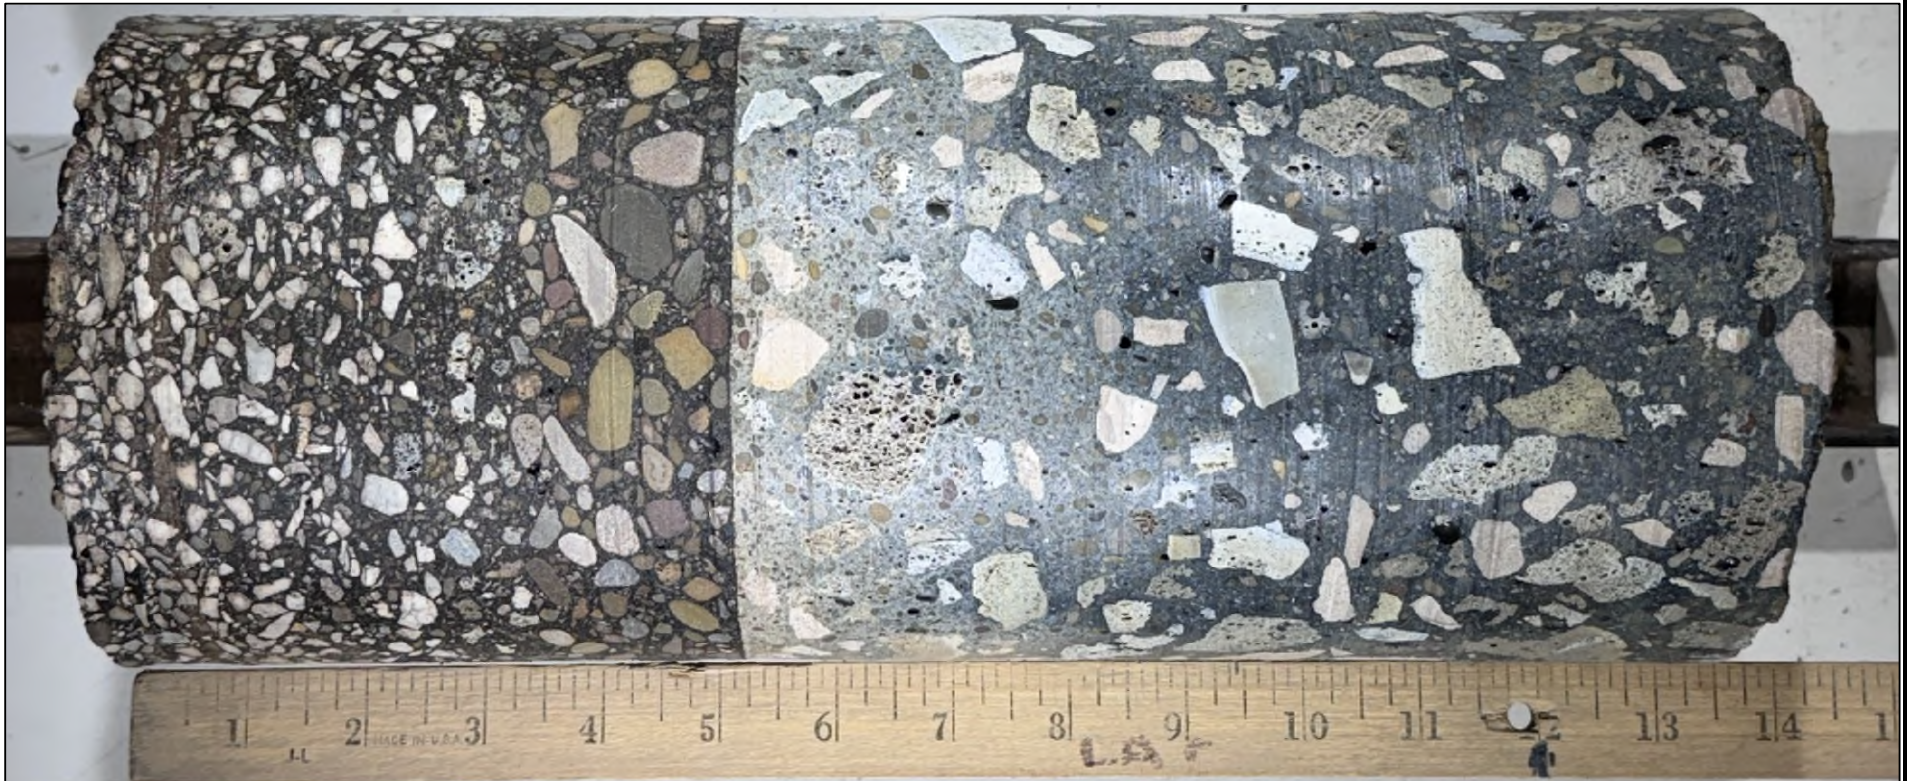
X-004-0-24

Layer Thickness, in.	Description	Comments
3½	ASPHALT: Surface Course	- 13½ inches of pavement total - Asphalt and concrete sections observed to be intact
1¾	ASPHALT: Intermediate Course	
8¼	UNREINFORCED CONCRETE	
--	NO AGGREGATE BASE ENCOUNTERED

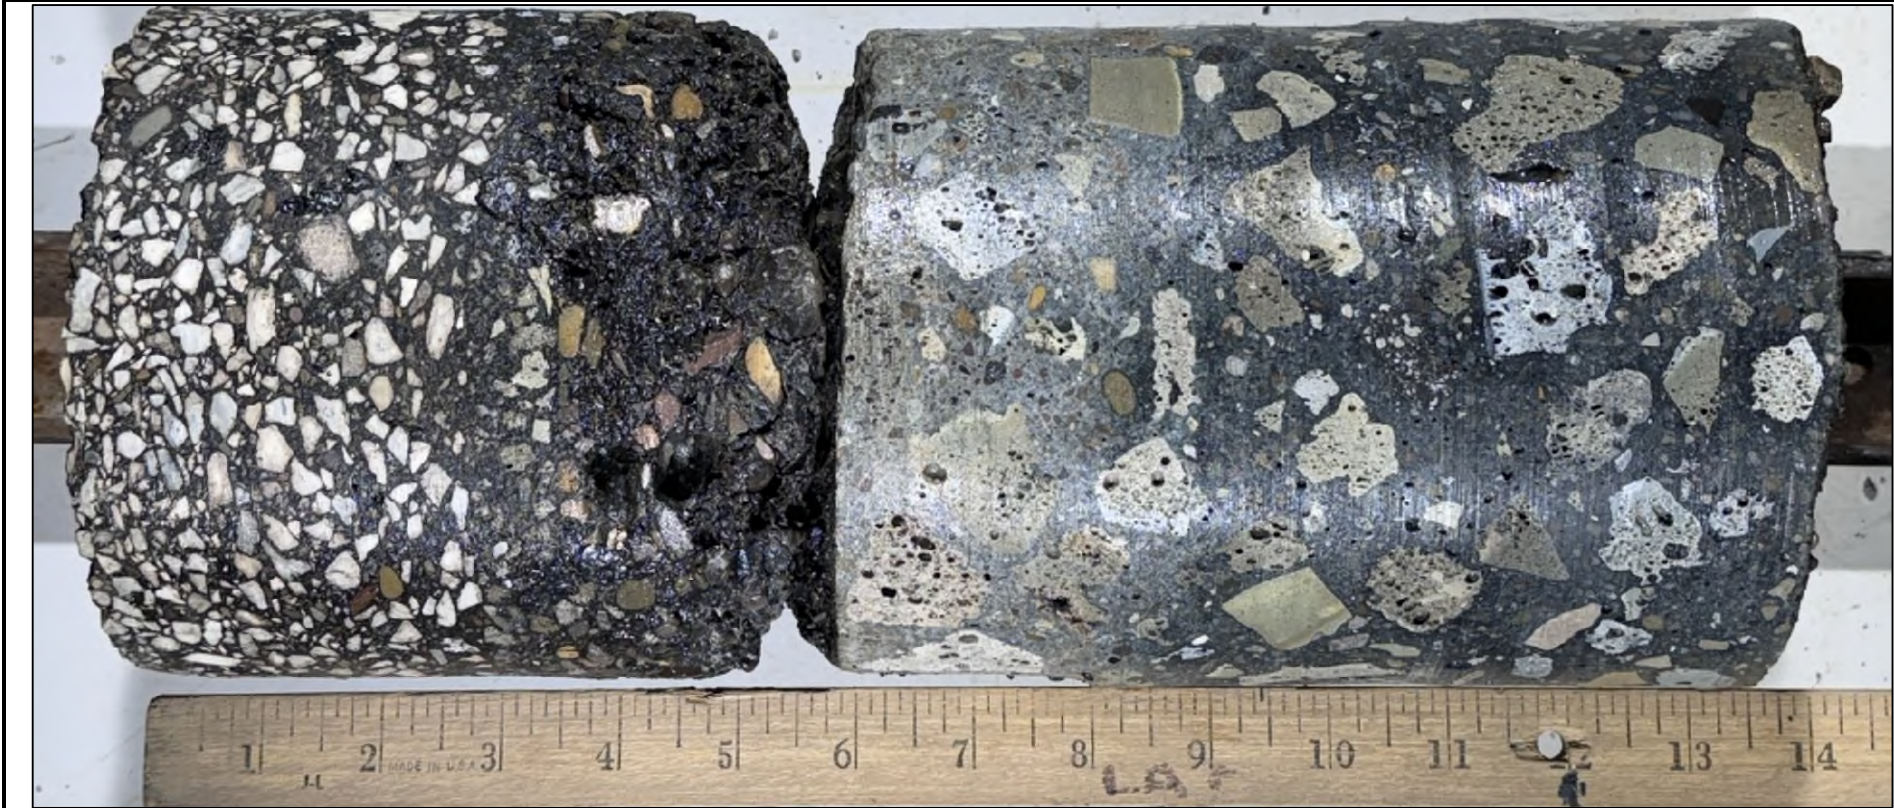
X-005-0-24

Layer Thickness, in.	Description	Comments
3	ASPHALT: Surface Course	- 13½ inches of pavement total
2½	ASPHALT: Intermediate Course	- Moderate deterioration in layer - Delaminated from concrete section
8	UNREINFORCED CONCRETE	- Concrete section observed to be intact
--	NO AGGREGATE BASE ENCOUNTERED

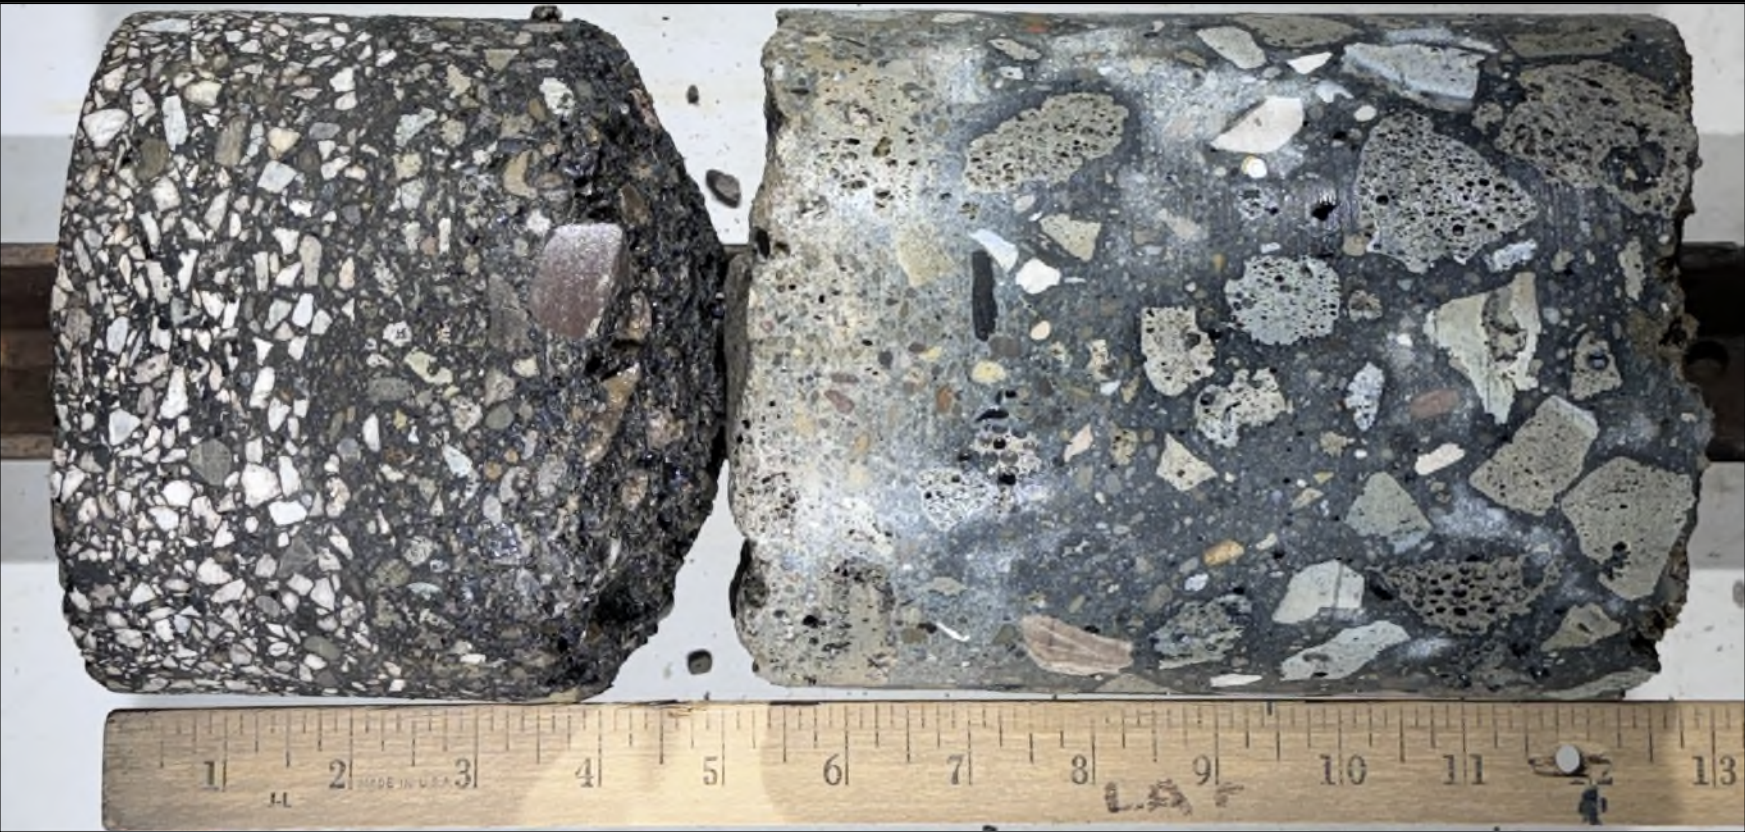
X-006-0-24

Layer Thickness, in.	Description	Comments
2½	ASPHALT: Surface Course	- 12½ inches of pavement total
2½	ASPHALT: Intermediate Course	- Moderate deterioration in intermediate layer - Delaminated from concrete section
7½	UNREINFORCED CONCRETE	- Concrete section observed to be intact
--	NO AGGREGATE BASE ENCOUNTERED

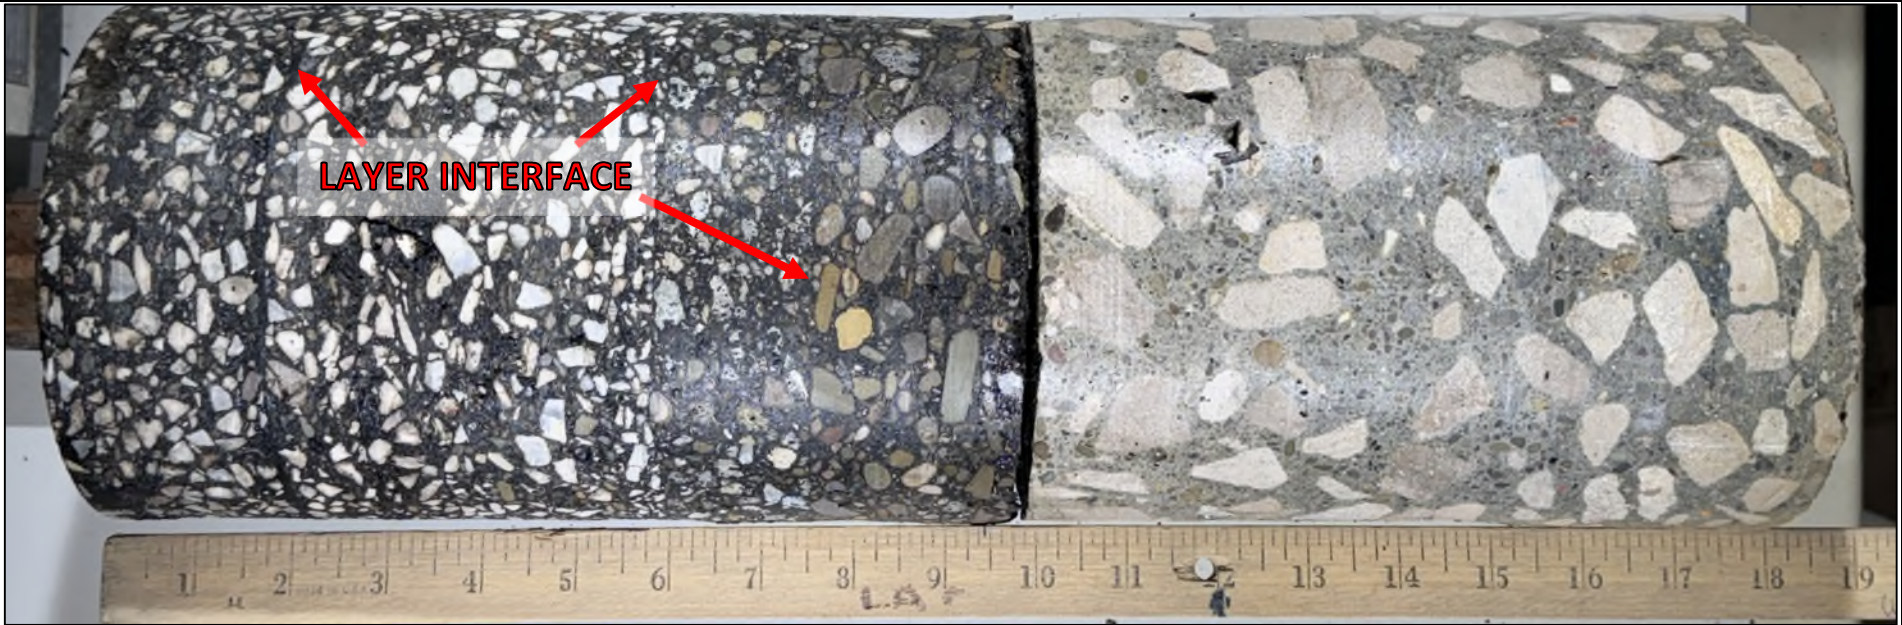
X-007-0-24

Layer Thickness, in.	Description	Comments
2	ASPHALT: Surface Course	- 18 inches of pavement total - Asphalt and concrete sections observed to be intact
4	ASPHALT: Surface Course	
1½	ASPHALT: Surface Course	
2¼	ASPHALT: Intermediate Course	- Delaminated from concrete section
8¼	UNREINFORCED CONCRETE	
--	NO AGGREGATE BASE ENCOUNTERED

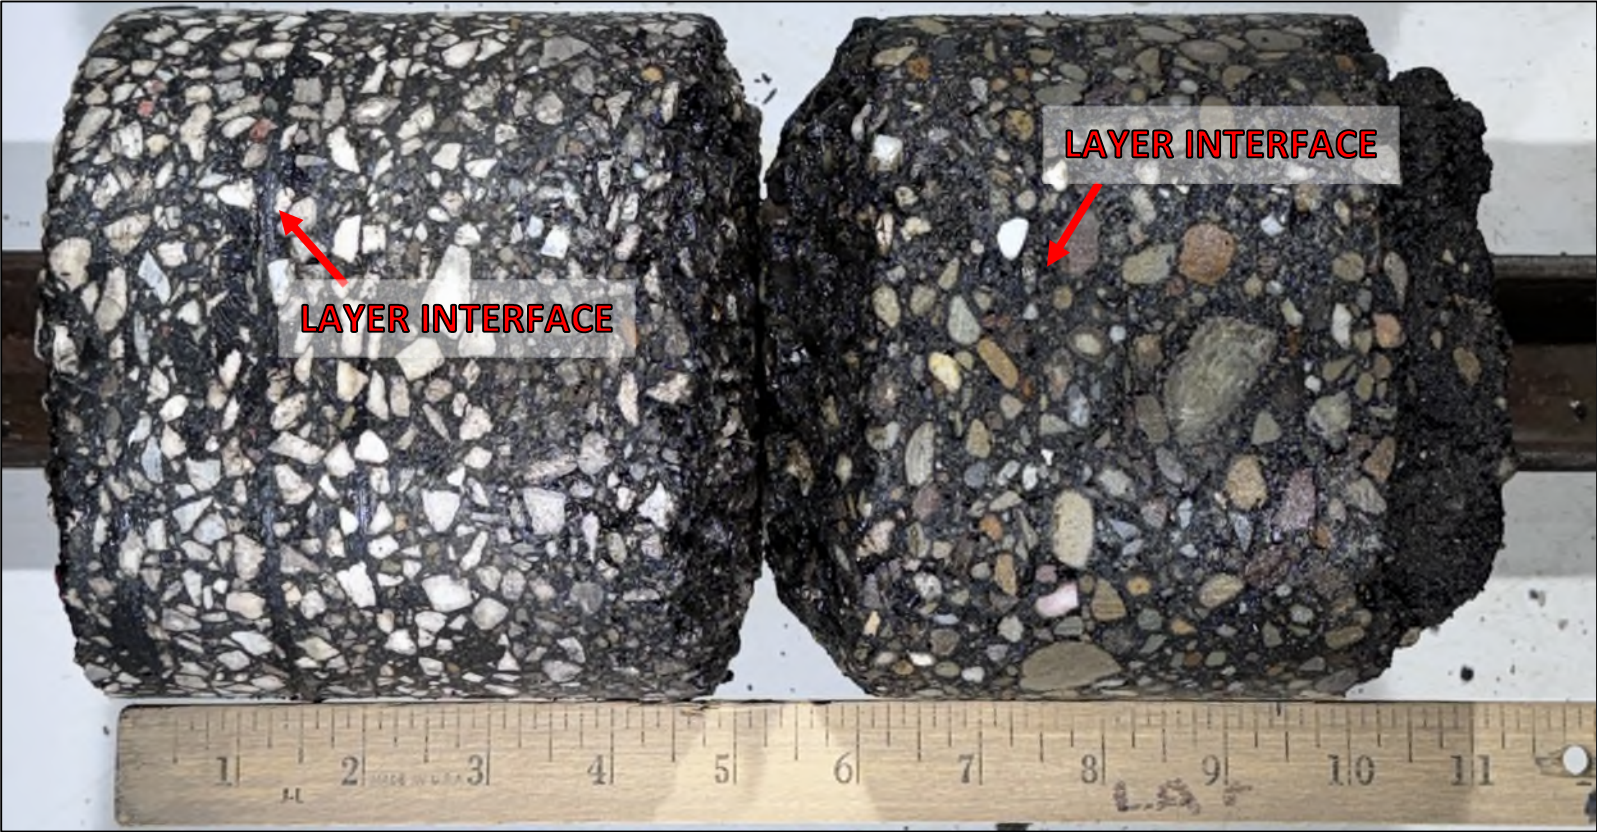
X-008-0-24

Layer Thickness, in.	Description	Comments
1½	ASPHALT: Surface Course	- 10½ inches of pavement total
4	ASPHALT: Surface Course	
2	ASPHALT: Intermediate Course	- Deteriorated at interface of surface and intermediate layers
3	ASPHALT: Intermediate Course	
7	AGGREGATE BASE: Crushed Limestone, Sandstone, and Pea Gravel
