Structure Number: 8502129
 Facility Carried: NEW USR 30

Ohio Bridge Inspection Summary Report

WAY-00030-1484 (8502129)

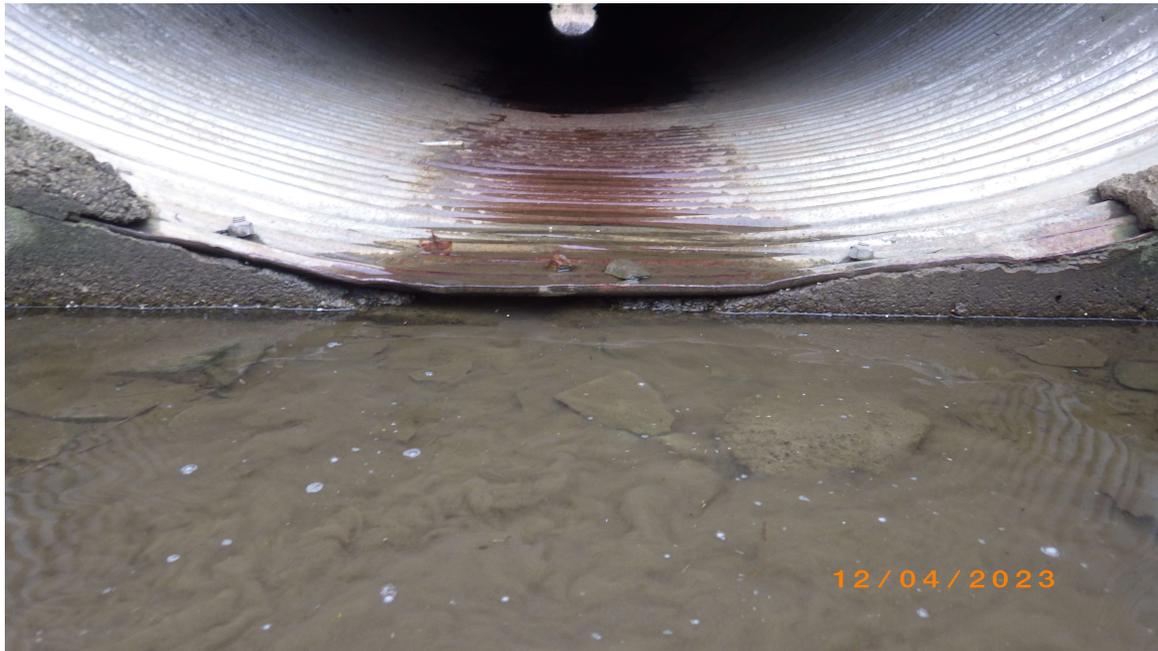
PHOTO 1

Environment	Total Quantity	Units	Condition State 1	Condition State 2	Condition State 3	Condition State 4
240-Steel Culvert	3 - Mod.	225	ft.	133	41	51	0
	CS2- 2020: Light rust developing throughout entire pipe (one tiny area w/ effl.). Minor silt in LT-half w/ 6"-10"+/- standing water. CS3- 2021: 30% of pipe has scattered rust holes & perforations throughout complete pipe ('23-photos). 2016: Scattered rust holes / perforations in invert (Visible in RT-half of pipe - low water, '23-photos) plus a couple small areas bulging upward. Unevenness throughout w/ hollow sounding areas (top & bottom) entire length w/ gaps @ joints & filter fabric visible.						
835-Culvert End Treatment	3 - Mod.	2	each	1	1	0	0
	CS2- 2023: Piping under Inlet (1/2", photo). 2020: Inlet (RT): gap along bottom & sides @ jct. w/ pipe (hollow sounding w/ piping, '23-photo). Ground hog hole & loss of material behind wingwall @ FWD-RT corner next to pipe & embankment. See photo(s): 1

Inlet (RT): 1st ('23-photo) & 2nd sections of pipe w/ significant piping (large hollow sounding areas along invert).

Description Piping-RT
