**PHYSICAL CONDITION REPORT  
FOR THE 2022 ROUTINE ELEMENT LEVEL INSPECTION**

**LORAIN ROAD OVER ROCKY RIVER  
BRIDGE NO. CUY-10-0869  
SFN: 1801325**

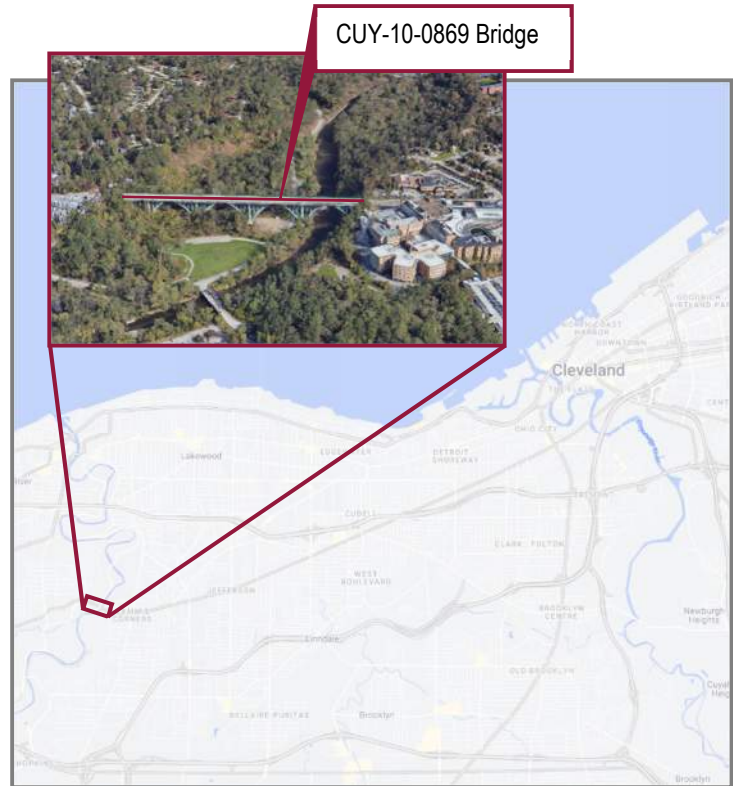
All structure component nomenclature follows previous inspection reports for consistency and in accordance with current ODOT standards. Therefore, in this report, "left" is north, "right" is south, "rear" is west, and "forward" is east. Substructure units and spans are labeled from west to east, and beams and stringers are labeled 1 through 13 from north to south. Jack arches are considered part of the arch element but are labelled with the beams to remain consistent with previous inspection reports. The interior bays of the arch ribs are numbered from west to east. Note that in the original plans and rehabilitation plans, the spans are labeled from east to west.

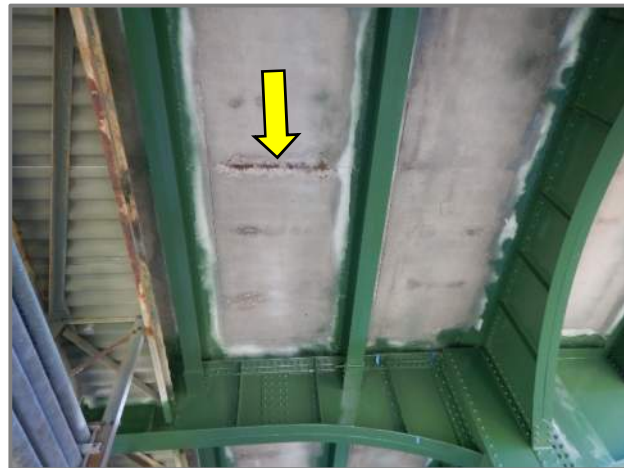
Photo 1 – Isolated spall with exposed reinforcement and adjacent typical hairline transverse cracks in the deck underside (looking up and east at the right forward end of Span 8).

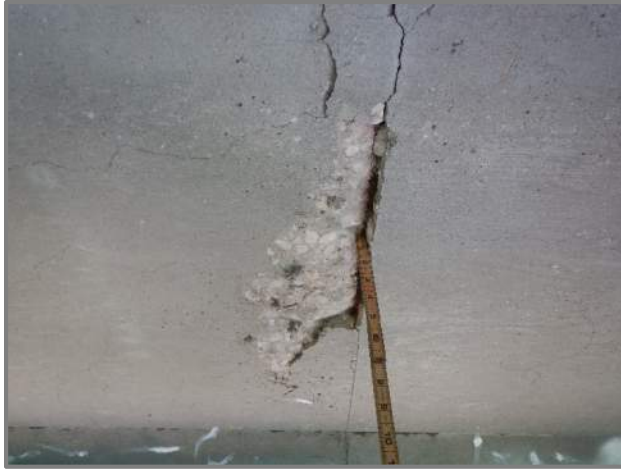
Photo 2 – Spall in the deck underside at the right forward end of Span 7 (looking up and south between Floorbeams 11 and 12).

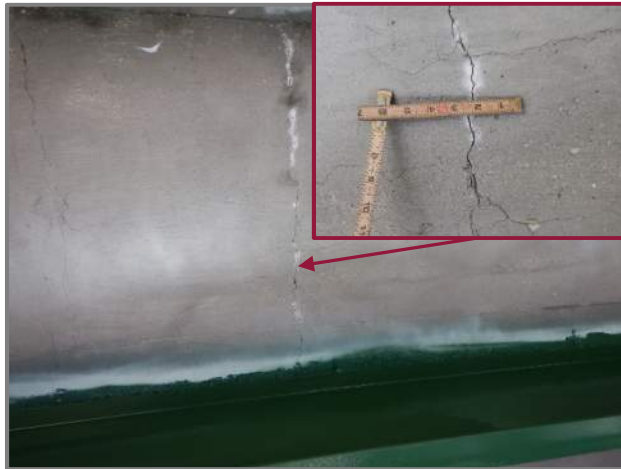
Photo 3 – Isolated 1/16" wide transverse crack in the deck underside (looking up and north between Floorbeams 8 and 9 in Span 7).

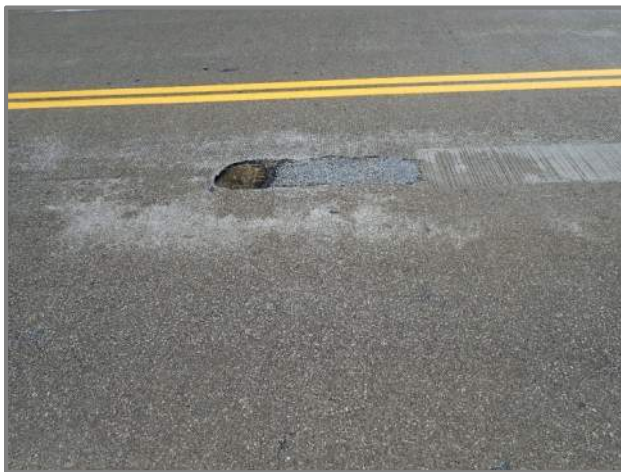
Photo 4 – 1 1/2" deep spall in the wearing surface with water ponding at a failing asphalt patch (looking south at the forward end of Span 9).

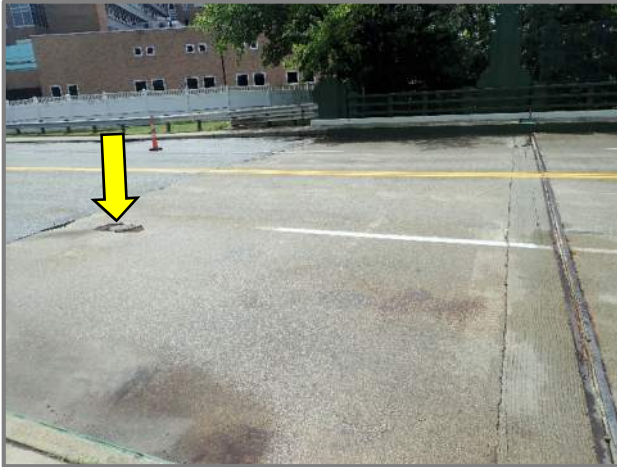
Photo 5 – Overall view of the Forward Abutment slab wearing surface with a 2' diameter spall at a failing asphalt patch (looking south).

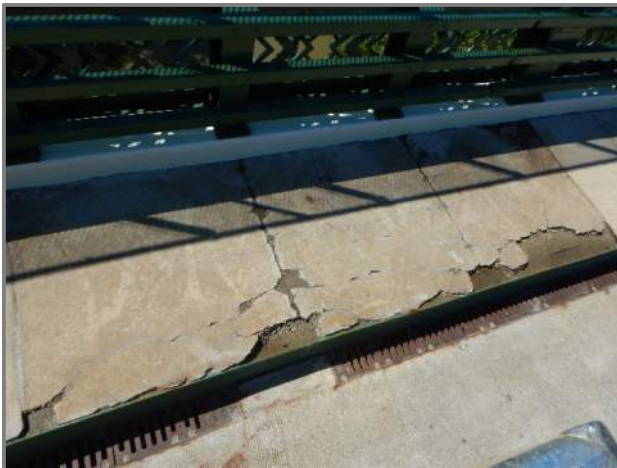
Photo 6 – Spalls with exposed reinforcement in the right sidewalk with water ponding (looking south near midspan of Span 8).

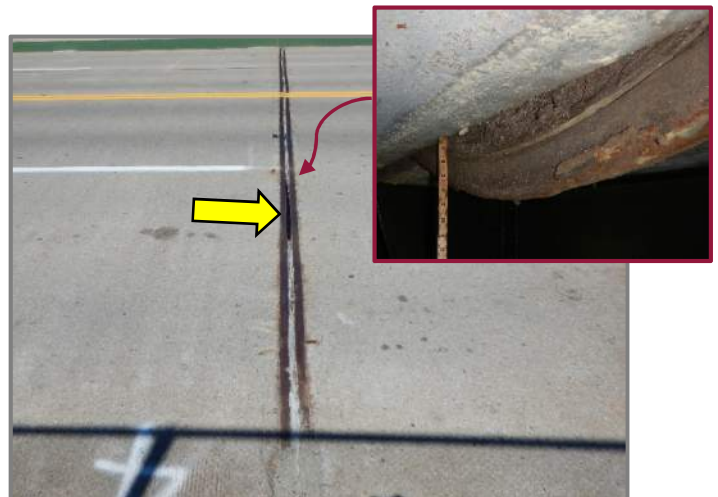
Photo 7 – Elastomeric strip seal failure at the Pier 4 expansion joint (looking north). Inset: Looking southwest at the joint underside from within the Pier 4 cap.

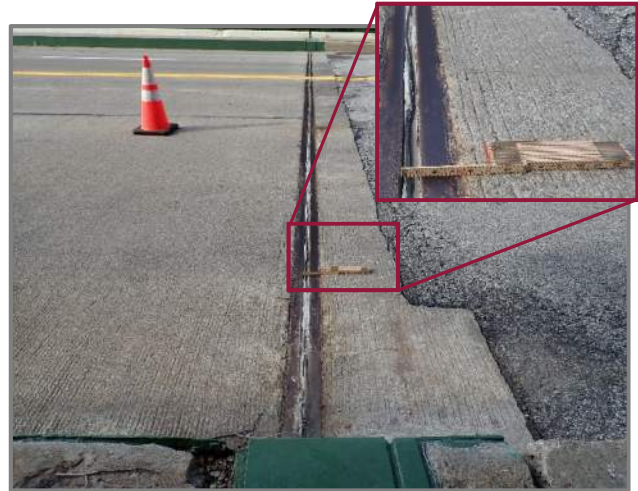
Photo 8 – Rear Abutment expansion joint with failing strip seal, longitudinal cracks in the joint header, and surface corrosion on the joint armor (looking south).

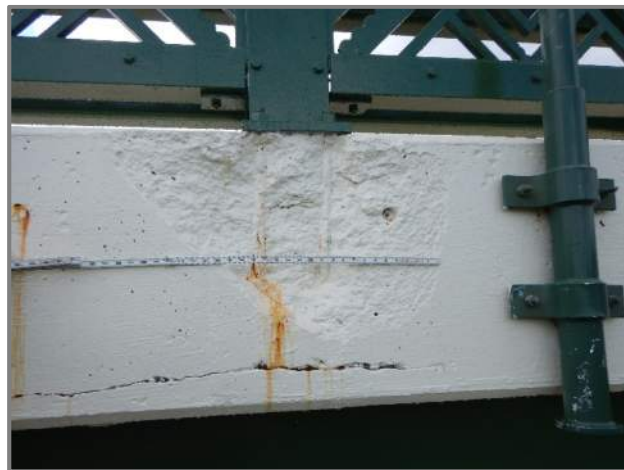
Photo 9 – Typical spall in the concrete portion of the railings with exposed railing post anchor bolts (looking south near midspan of Span 7).

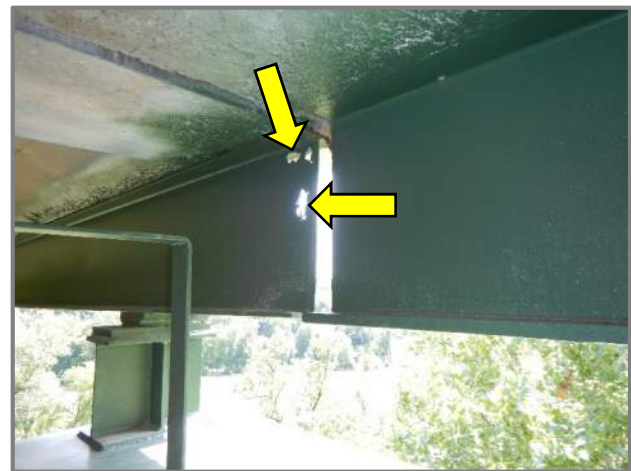
Photo 10 – 100% section loss in the right railing fascia stringer web (looking southeast at Stringer 11 at Pier 4).

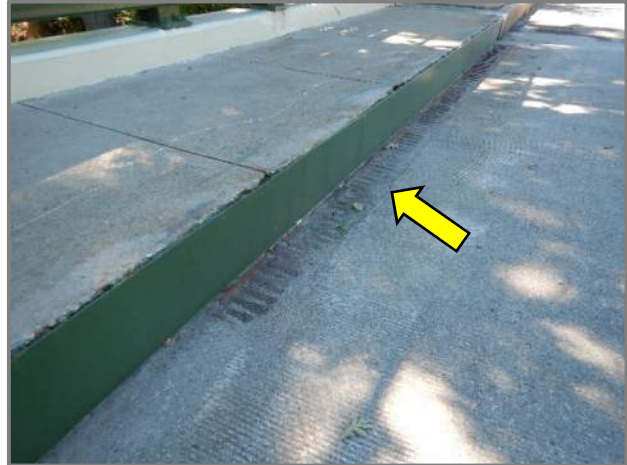
Photo 11 – Scuppers at the right rear end of Span 1 full of debris (looking southwest).

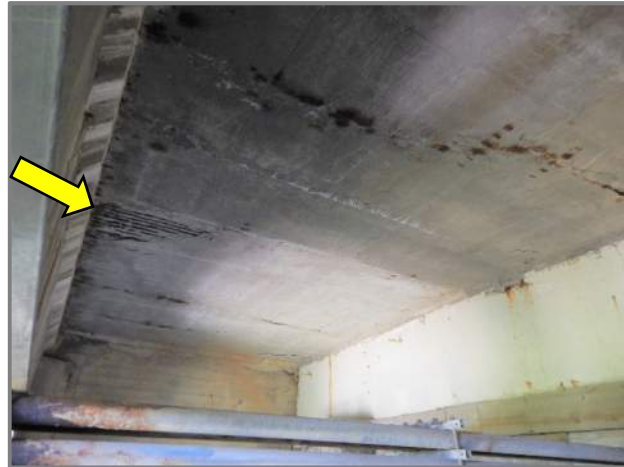
Photo 14 – Forward Abutment slab underside with full length longitudinal cracks and a spall with exposed reinforcement at the left rear end (looking north).

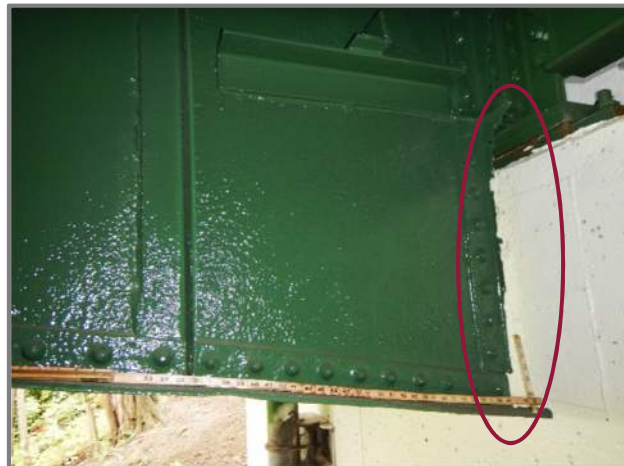
Photo 15 – Beam 11 at the Rear Abutment with 100% section loss in the transverse stiffener and painted over pitting throughout the web and flanges (looking south).

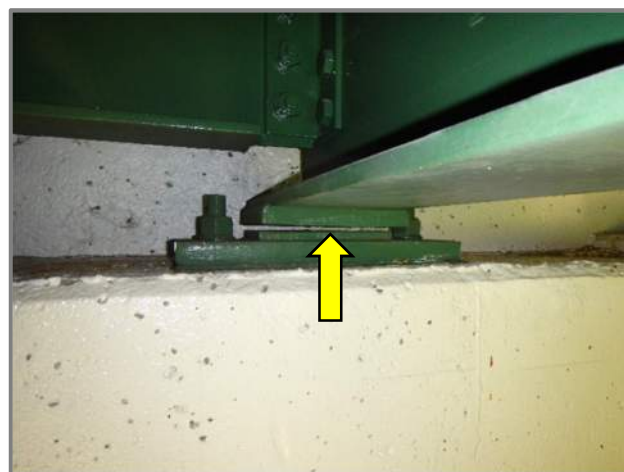
Photo 16 – Beam 10 floating at the Rear Abutment due to a missing shim plate (looking west).

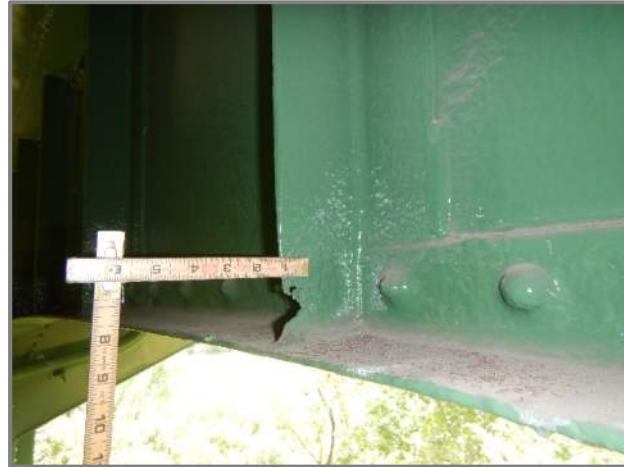
Photo 17 – Beam 3 transverse stiffener with 100% section loss at the bottom 3" (looking southeast at midspan of Span 4).

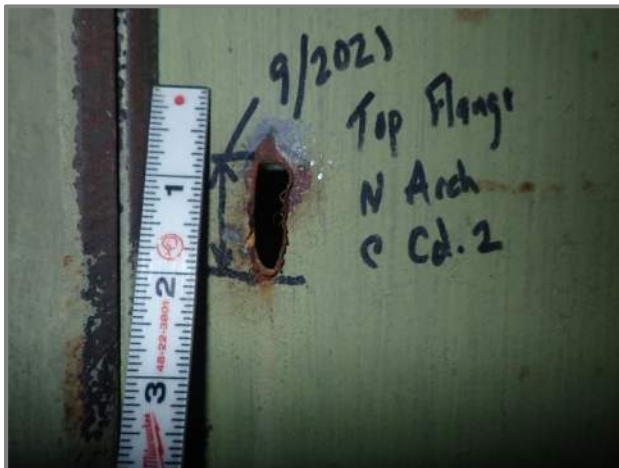
Photo 22 – Corrosion hole in the Span 8 left arch top flange plate at Column 2 (looking west at the interior).

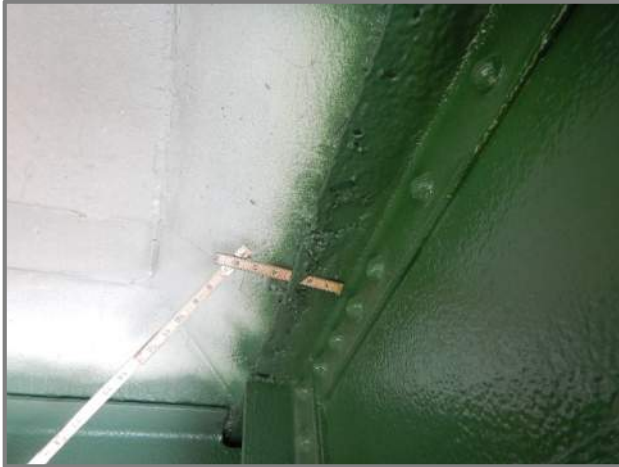
Photo 23 – 100% section loss in the top flange angle of the Span 7 right jack arch (looking east near Pier 7).

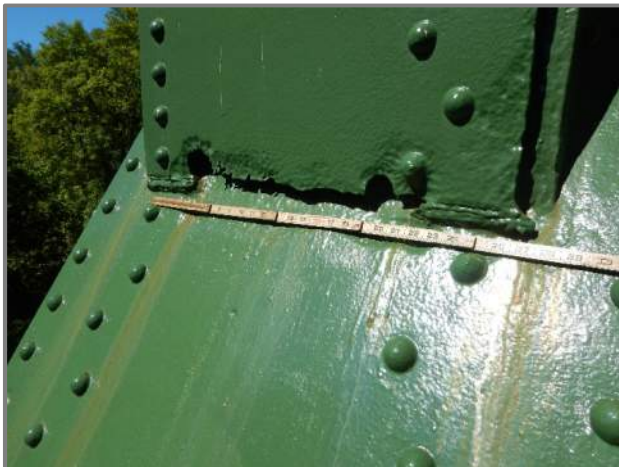
Photo 24 – Typical poor quality welds between the spandrel column web plates and the arch top flange and 100% section loss in the column web plate (looking west at the forward web plate of Column 11 at the top flange of the right arch in Span 5).

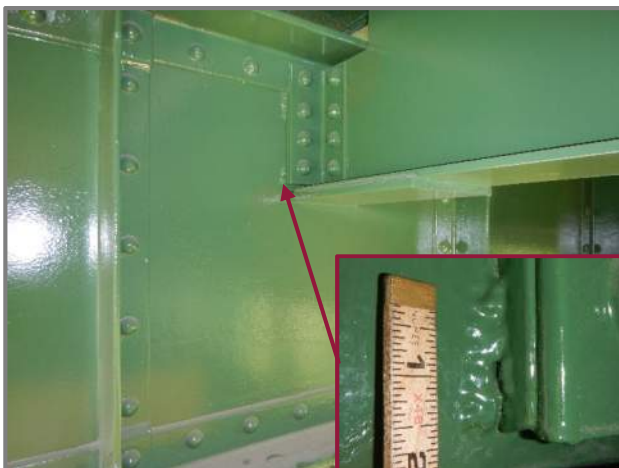
Photo 25 – Cracked tack weld at Floorbeam 4 at the Stringer 6 connection angle fill plate in Span 6 (looking southeast).

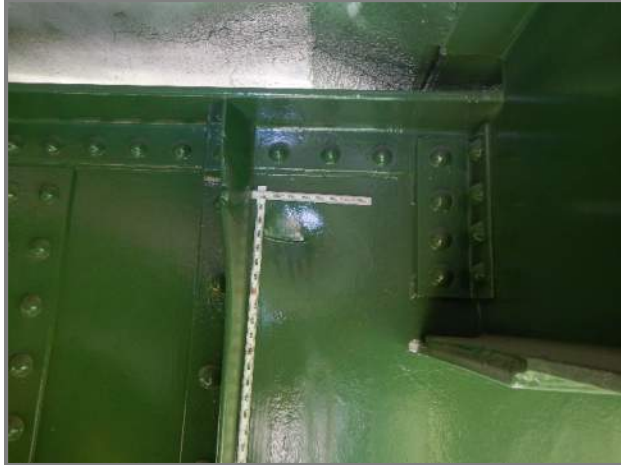
Photo 26 – Construction damage in the web of Floorbeam 3 in Span 6 (looking east at the rear face between Stringers 7 and 8).

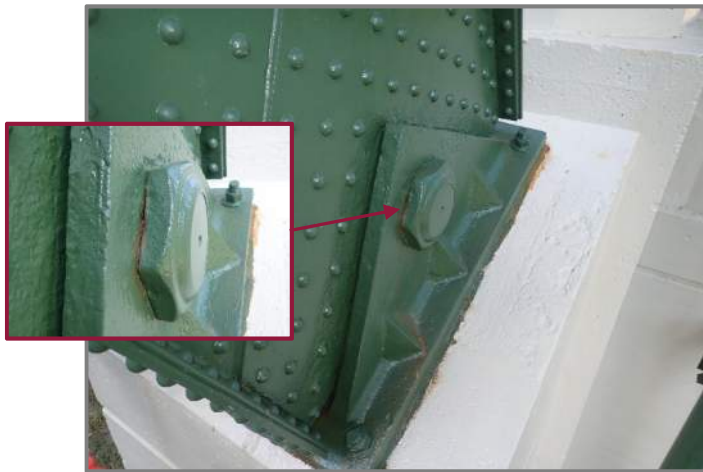
Photo 27 – Active pack rust at the Span 8 right arch pin nut (looking southwest at the Pier 7 bearing). Note the typical pitting in the exterior face of the pin plate and bearing casting.

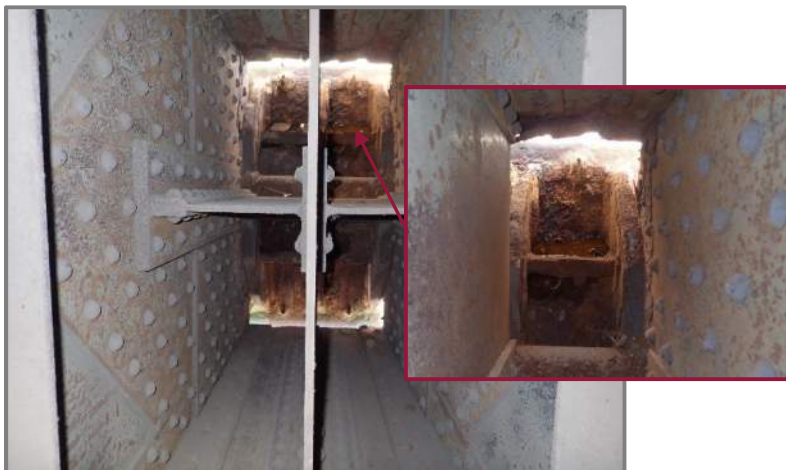
Photo 28 – Moderate laminate corrosion on the web plates and stiffeners at the Span 5 left arch bearing (looking east at the Pier 5 bearing). Note the anchor bolt nut with up to 100% loss on the uphill side.

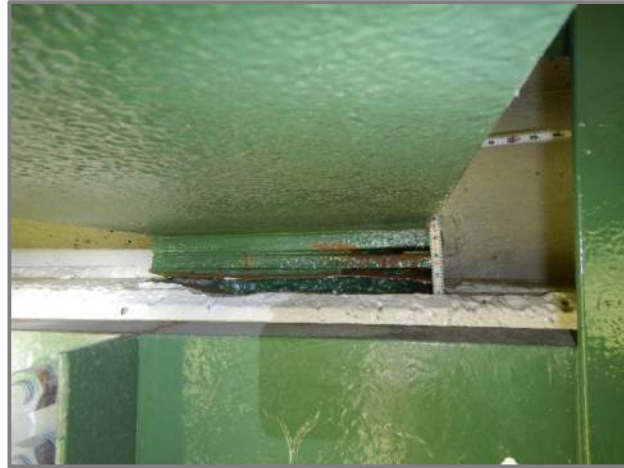
Photo 29 – Gaps up to 3/8" high between the right edge of the shim plates at the Forward Abutment fixed bearings (looking east at the Beam 8 Forward Abutment bearing).

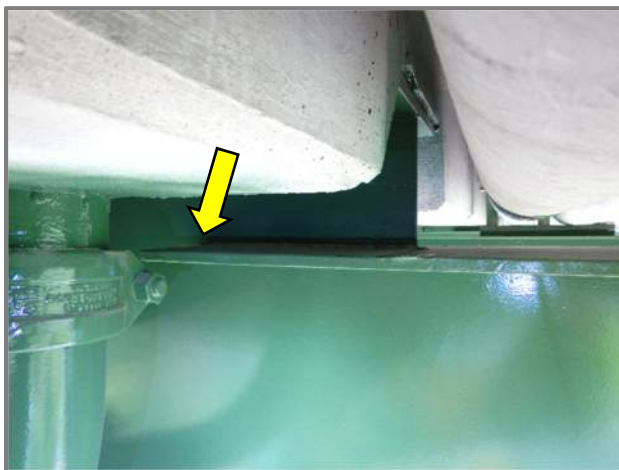
Photo 31 – Longitudinal stiffener to web weld termination with no transition radius (looking west at the Span 7 Floorbeam 12 left cantilever).

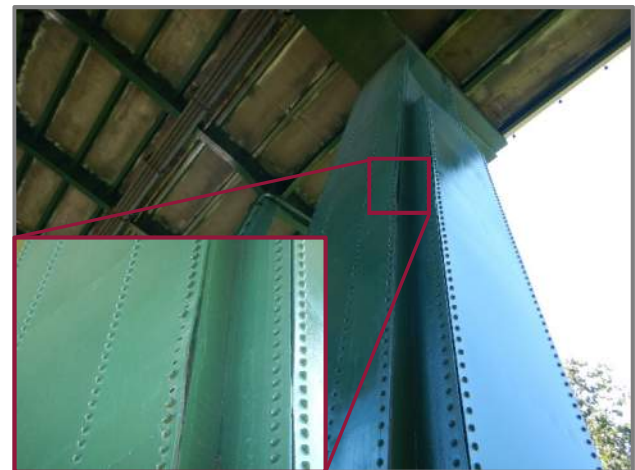
Photo 35 – Missing fasteners at the left rear corner of the Pier 5 right column (looking up and southeast).

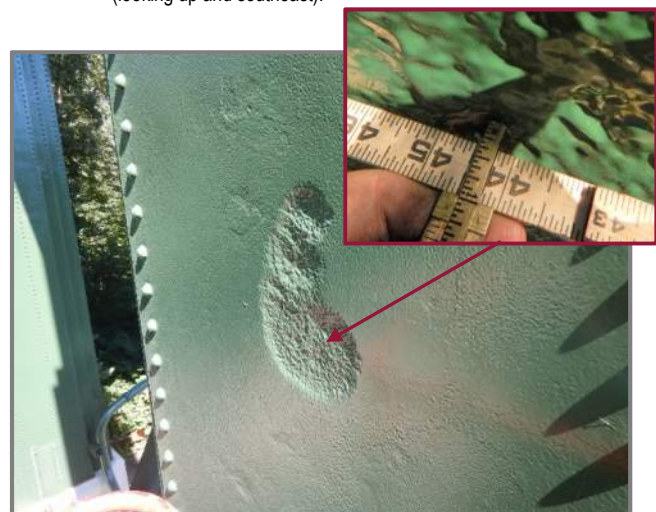
Photo 36 – Pier 6 right column exterior with 3/8" deep pitting in the rear web plate (looking northeast).

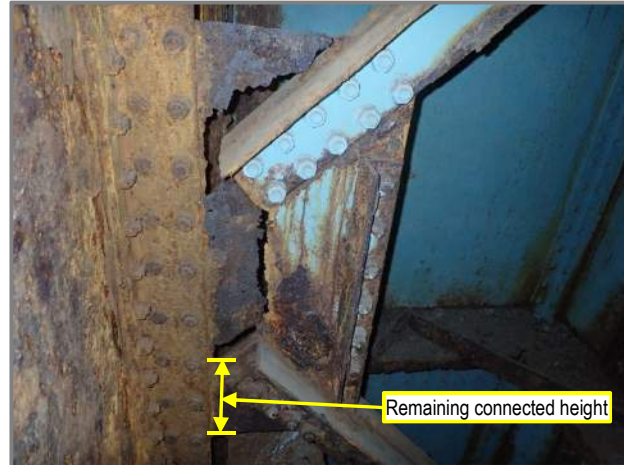
Photo 37 – Pier 7 left column interior with only up to 10 1/2" high remaining section (41 1/2" nominal height) at a diagonal bracing connection plate (looking south in the upper half of the column).

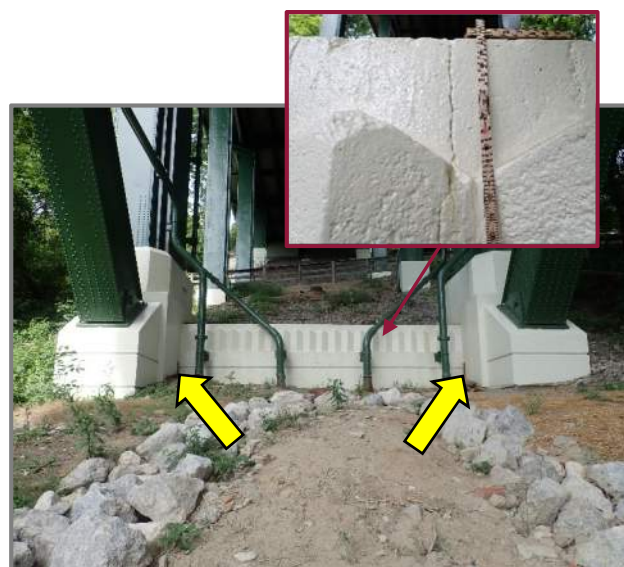
Photo 38 – Pier 4 reinforced concrete pier wall with a typical sealed vertical crack and minor rust staining below the column drainage holes (looking west).

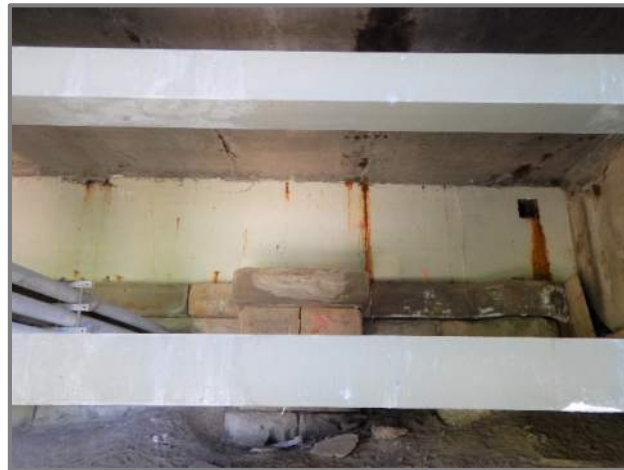
Photo 39 – Vertical hairline cracks and rust staining on the reinforced concrete portion of the forward wall at the Forward Abutment (looking east).

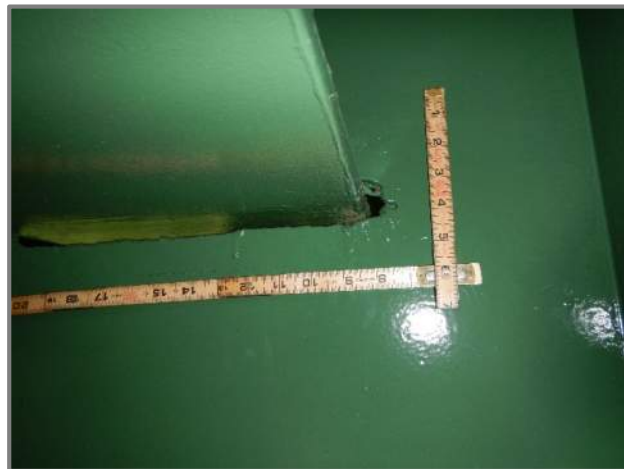
Photo 40 – 1/4" long overcut in the rear face of the Pier 3 web at the Beam 6 bottom flange (looking east).

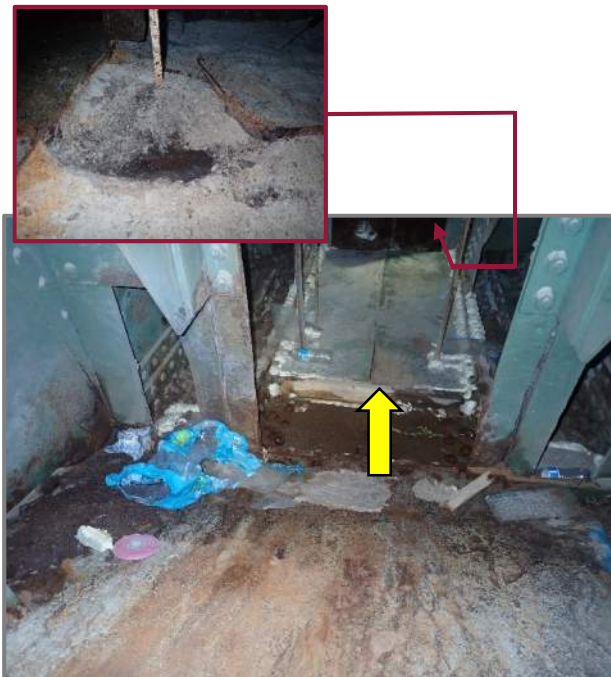
Photo 41 – Debris and water ponding in the south side of the Pier 6 cap with access to the column blocked by painting containment plywood (looking north). Inset: Looking east at blasting debris in the north half of the cap and 100% section loss in the bottom flange longitudinal stiffener.

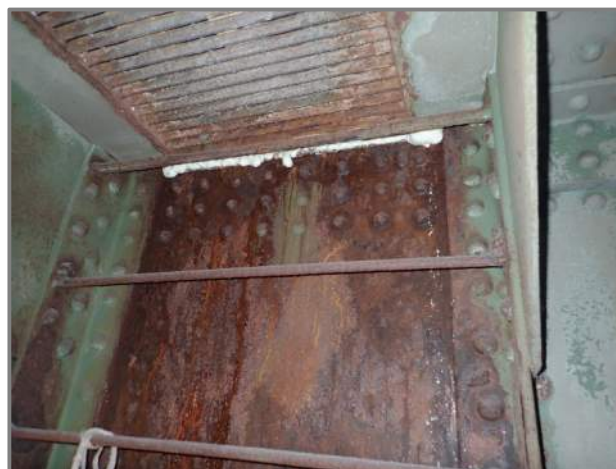
Photo 42 – Laminated corrosion at the top of the Pier 6 right column below the painting containment (looking up and south).

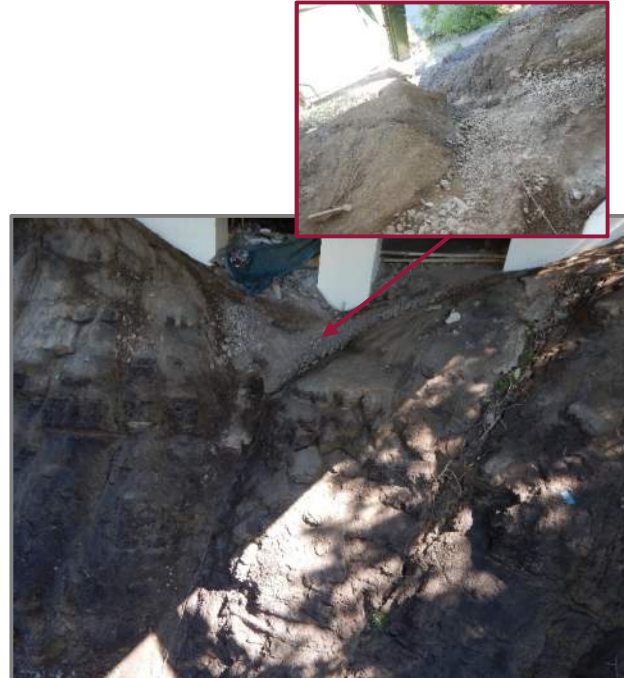
Photo 43 – Erosion channel at the Forward Abutment (looking east).

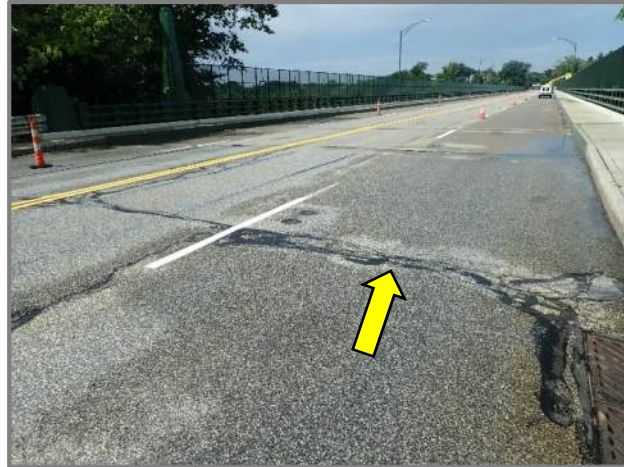
Photo 45 – Forward approach slab with transverse map cracking along the forward edge (looking west).

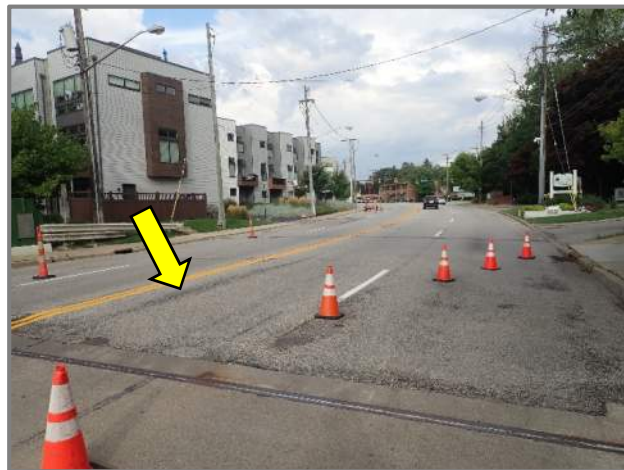
Photo 46 – Full length longitudinal cracks and deteriorating asphalt patches in the rear approach wearing surface (looking west).

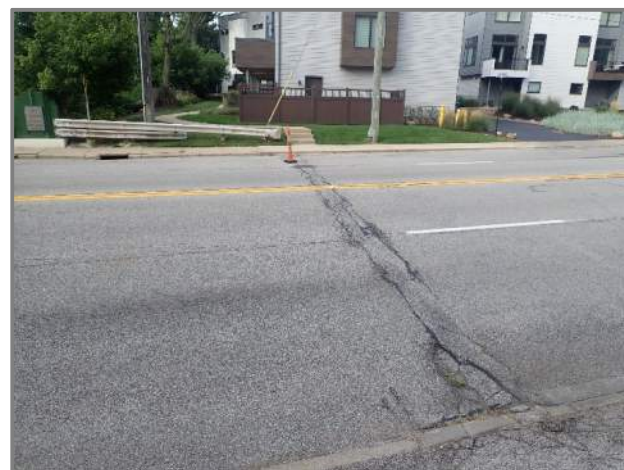
Photo 47 – Overall view of the rear approach relief joint which is heaved upwards (looking south).

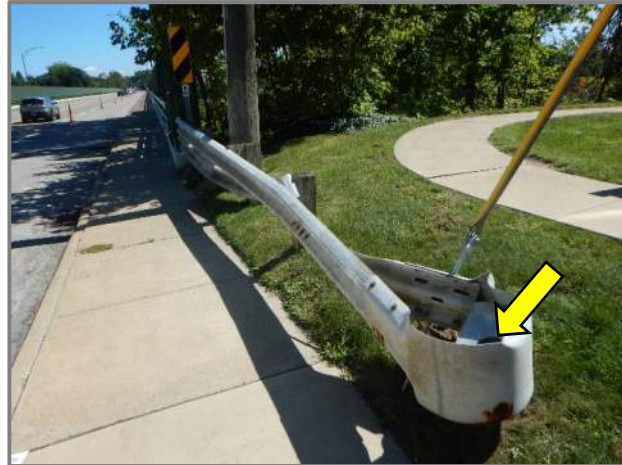
Photo 48 – Impact damage to the left rear guardrail; note the broken and missing end post (looking east).

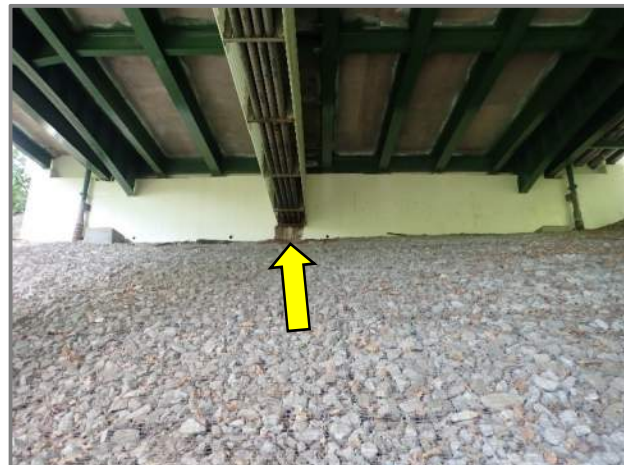
Photo 49 – The conduit at the Rear Abutment with 100% section loss in the underside of the conduit and minor water staining on the abutment wall below (looking west).

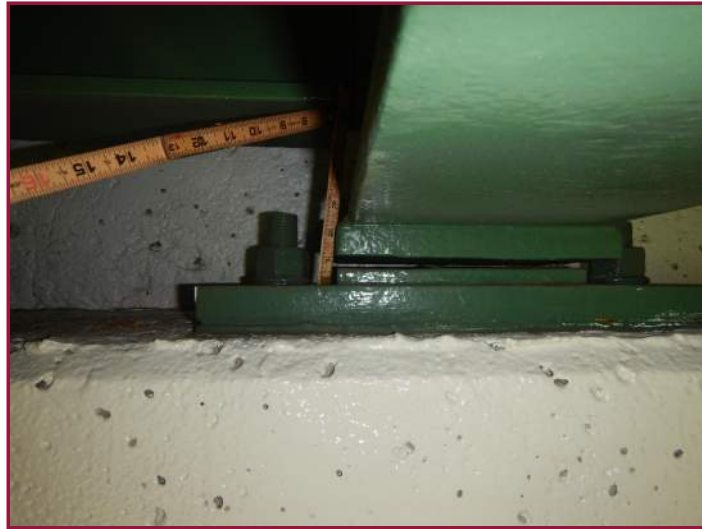
Missing shim plate with a 1/4" gap between the sole plate and the masonry plate (looking west).

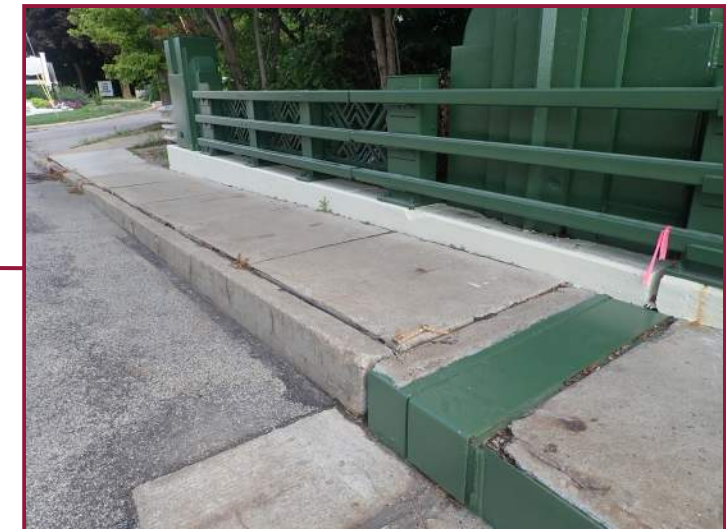
2" vertical misalignment between the left rear approach sidewalk and the bridge (looking northwest).

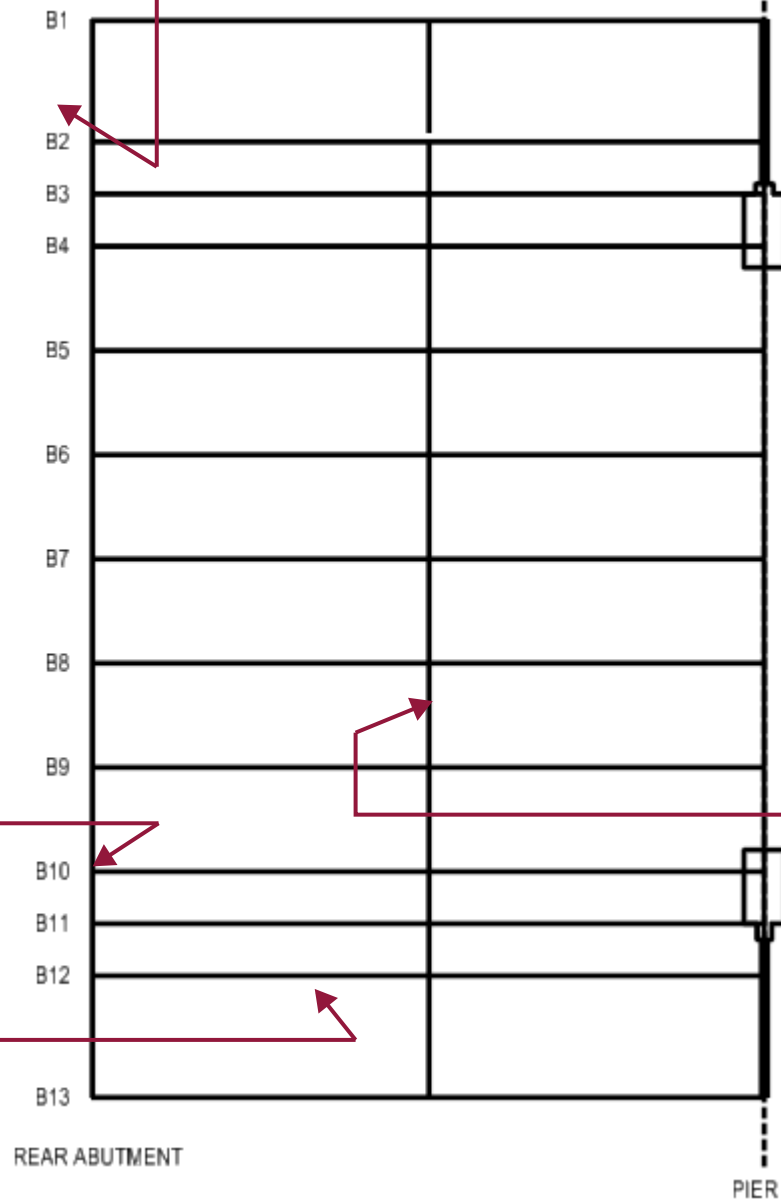
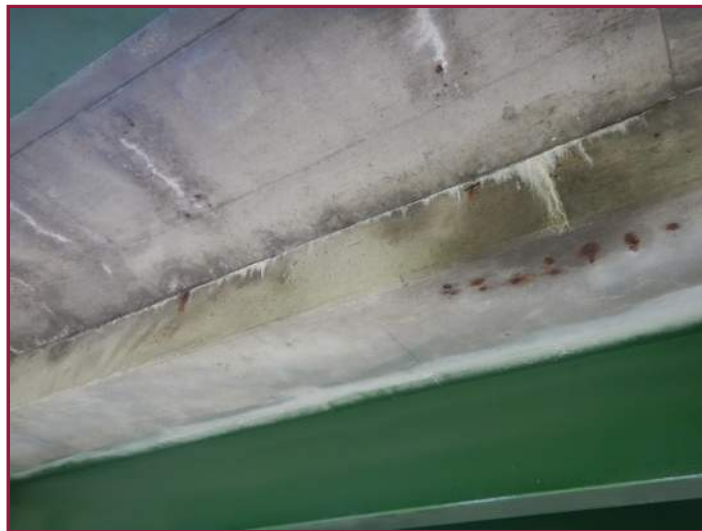
Hairline transverse cracks with efflorescence in the sidewalk underside and efflorescence at the joint with the deck (looking northwest).

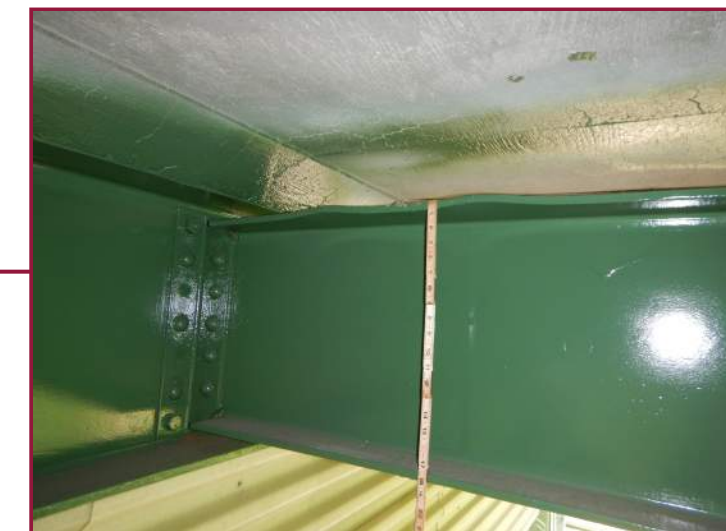
Diaphragm top flange bent up 1/2" over 9" in two locations (looking east).

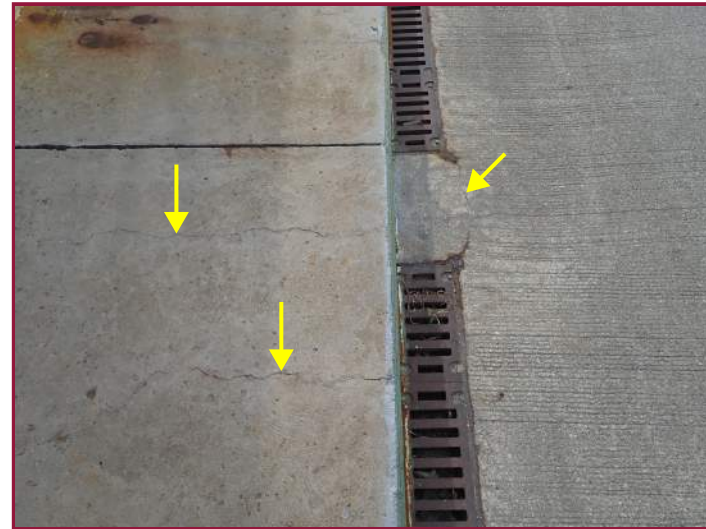
Transverse cracks in the sidewalk and a longitudinal crack in the wearing surface between scuppers (looking east).

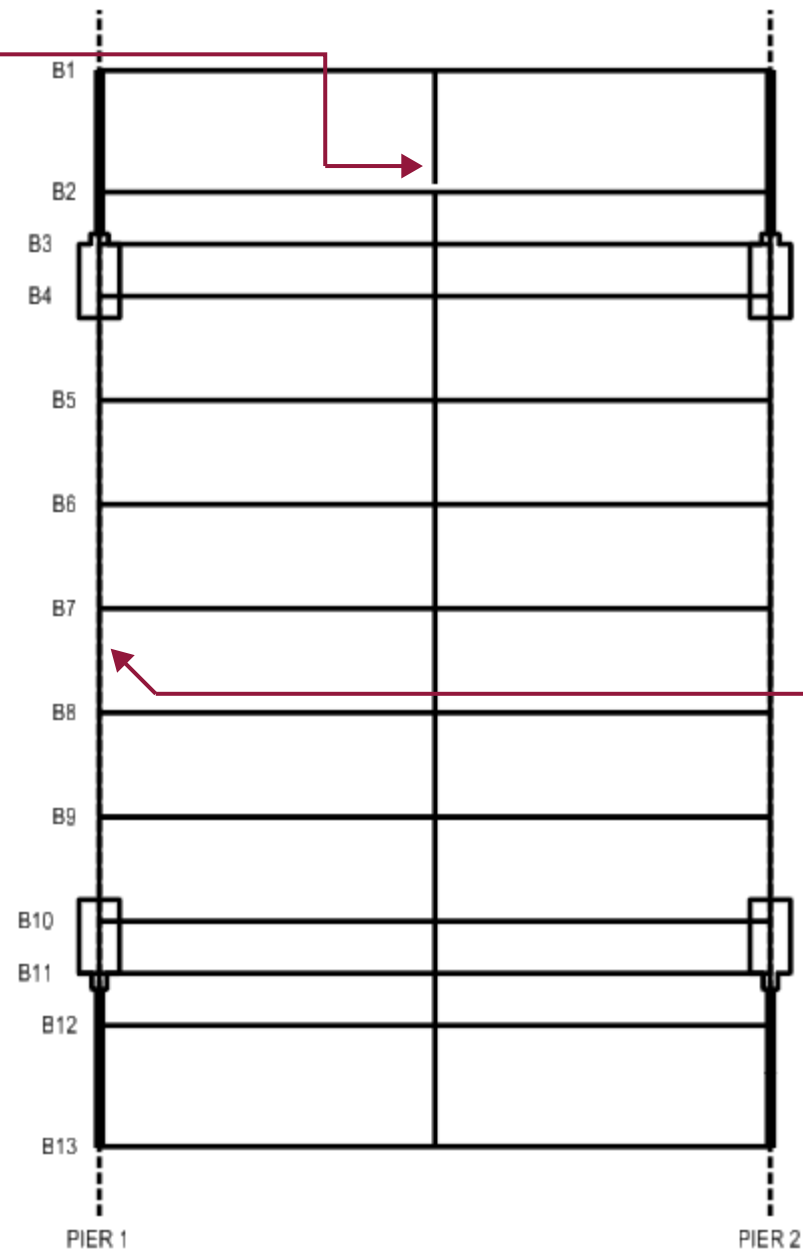
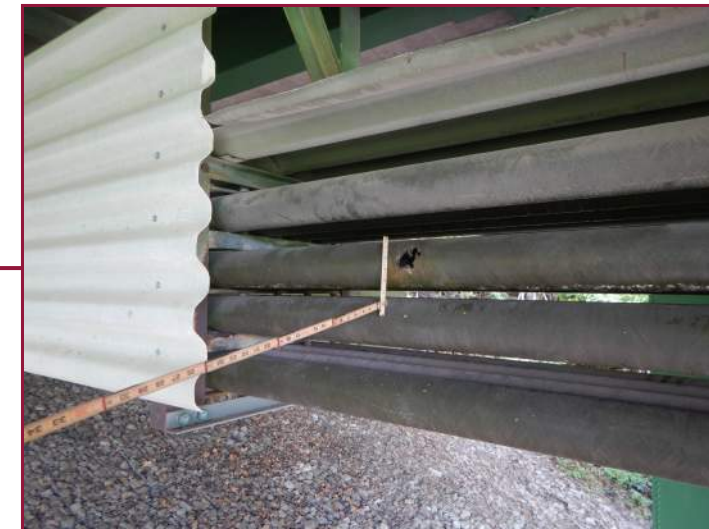
3" diameter hole in the utility conduit below Pier 1 (looking northwest).

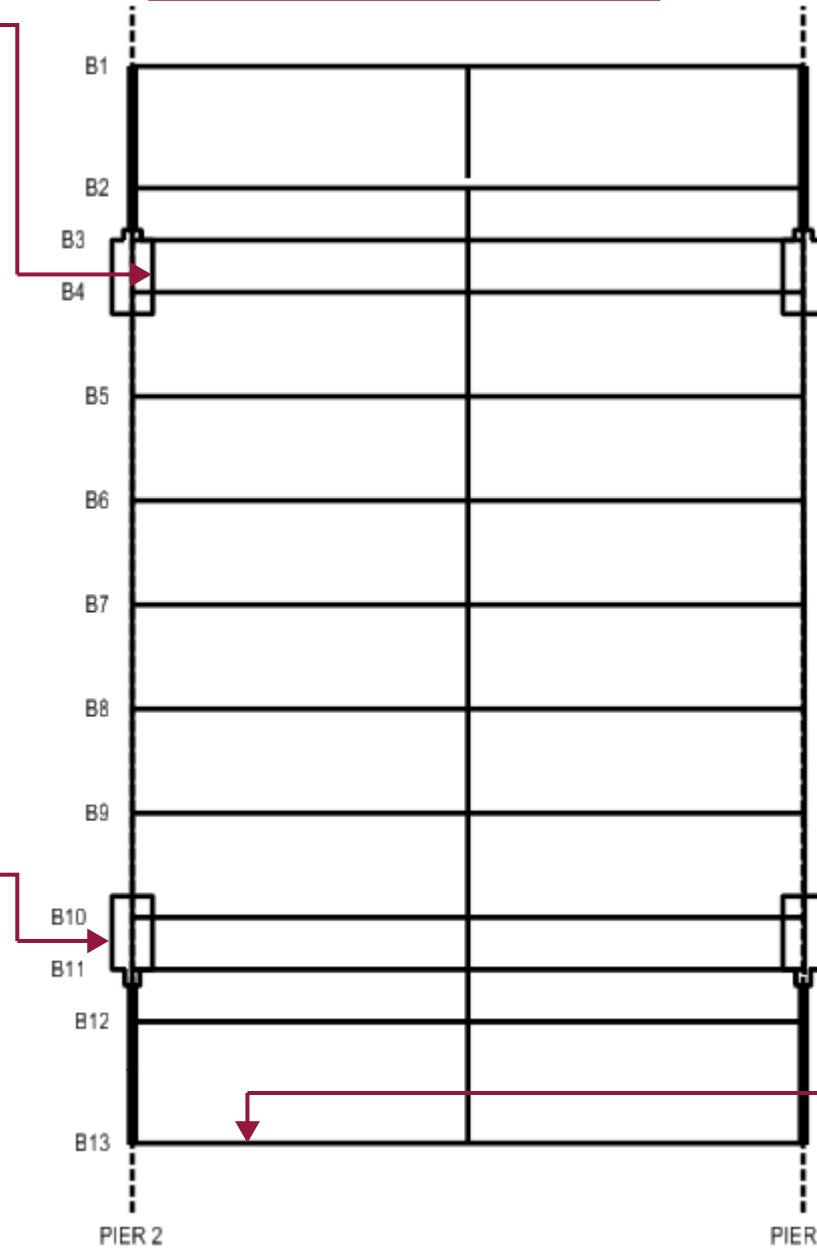
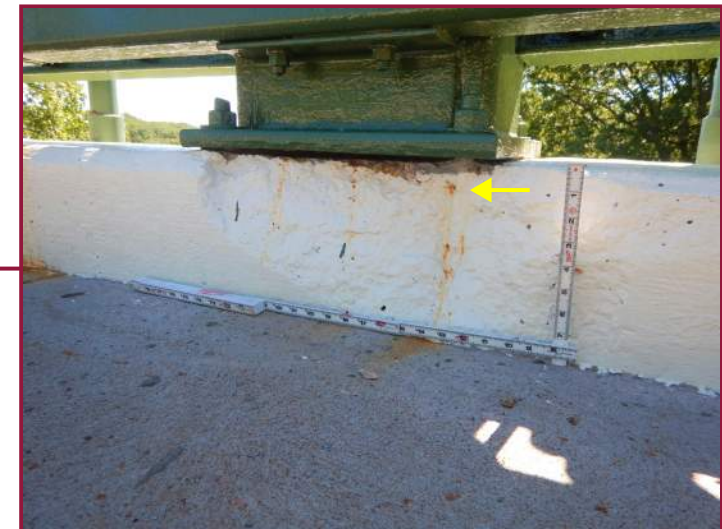
Typical sealed spall in the concrete portion of the railing with an exposed metal railing anchor bolt (looking south).

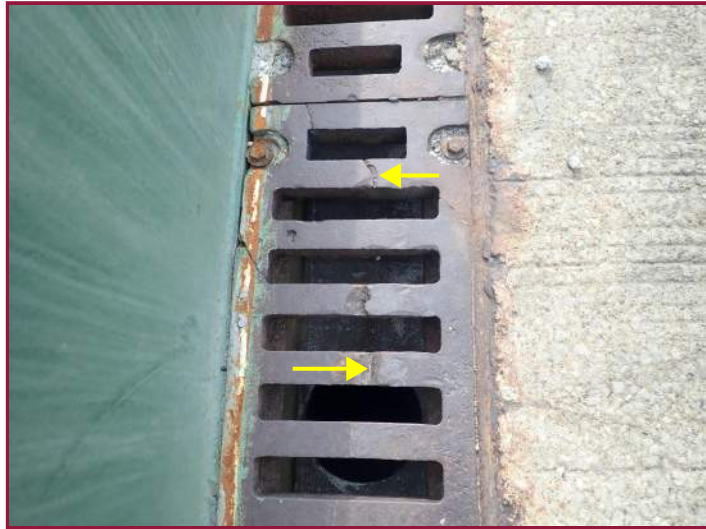
Scupper grate with full depth cracks in five of the bars (looking east near the left curb).

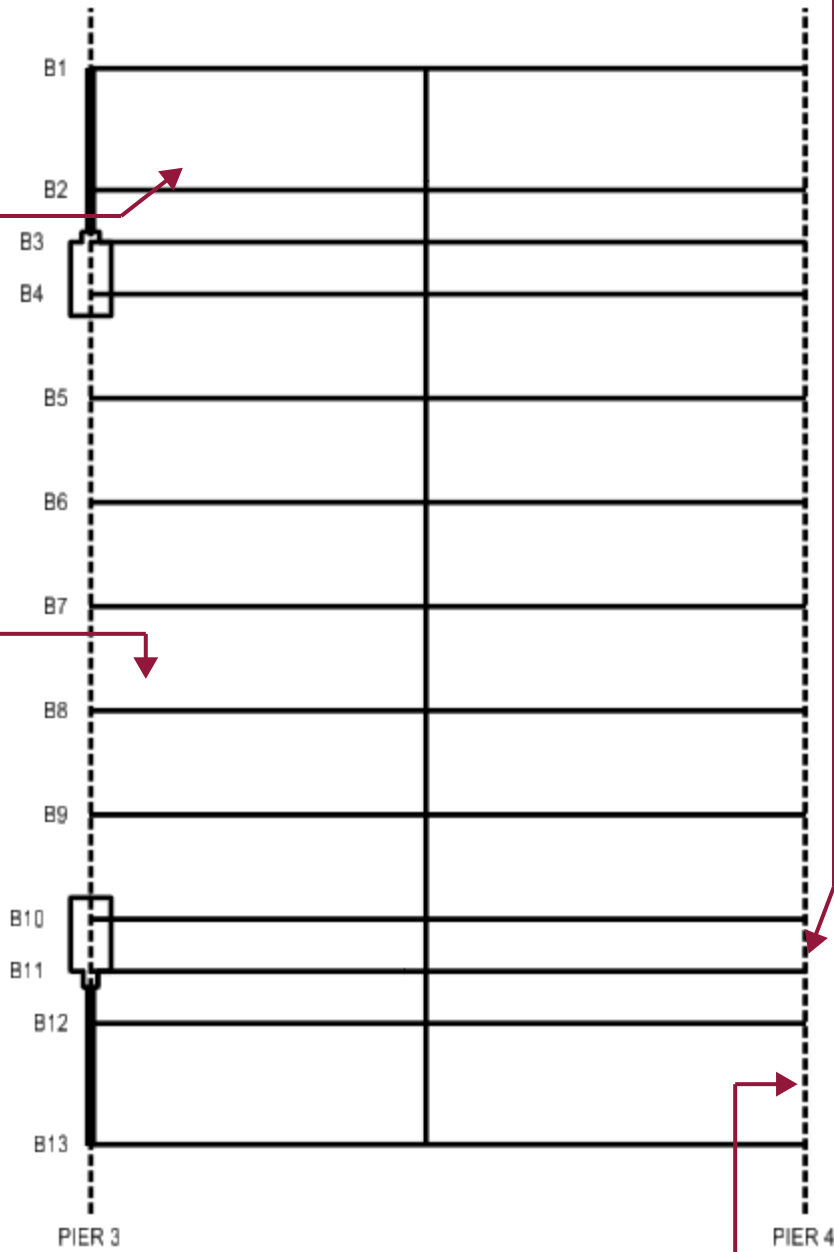
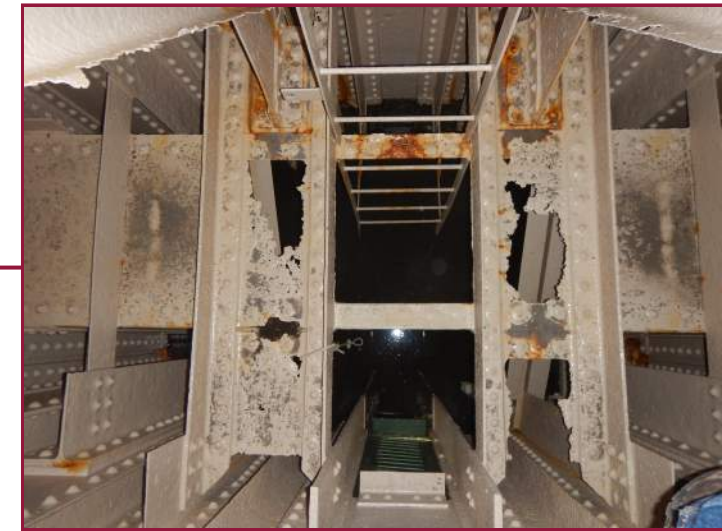
Painted over 100% section loss in the column interior diaphragms (looking down and south near the base). Note the water ponding at the bottom of the column due to the clogged drainage pipe.

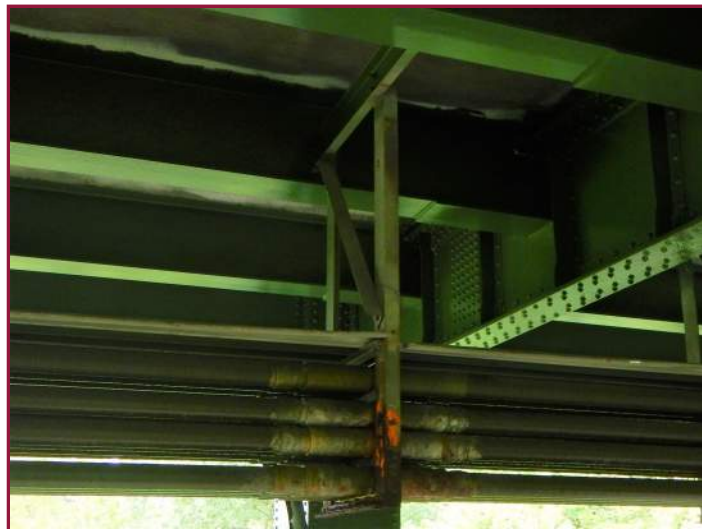
Corrosion at the bottom of the utility hanger (looking southwest).

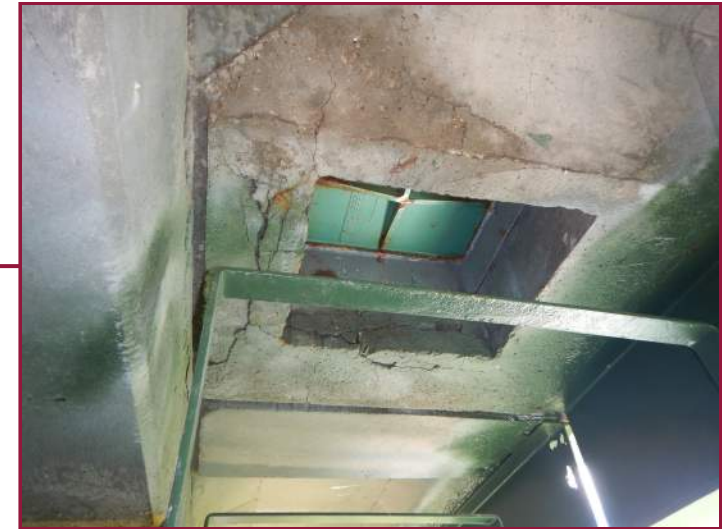
Delaminations and minor water staining in the underside of the sidewalk at the pier cap access hatch (looking east).

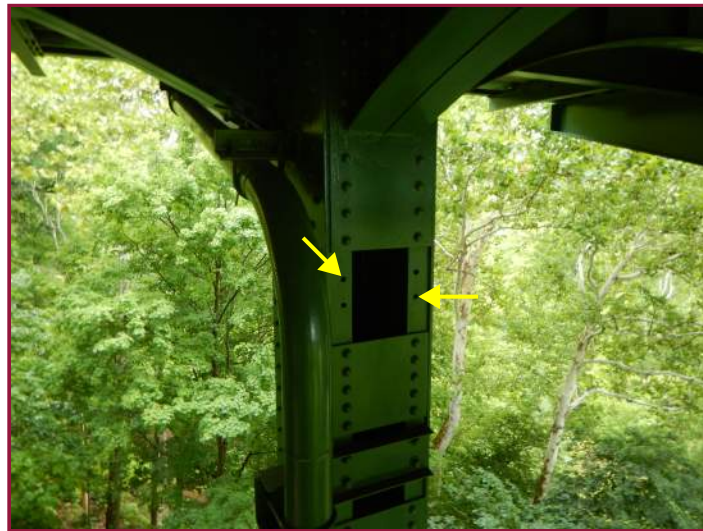
Four open holes in the south column angles of Column 1 (looking northeast).
