**PHYSICAL CONDITION REPORT  
FOR THE 2022 ROUTINE ELEMENT LEVEL INSPECTION**

**LORAIN ROAD OVER ROCKY RIVER  
BRIDGE NO. CUY-10-0869  
SFN: 1801325**

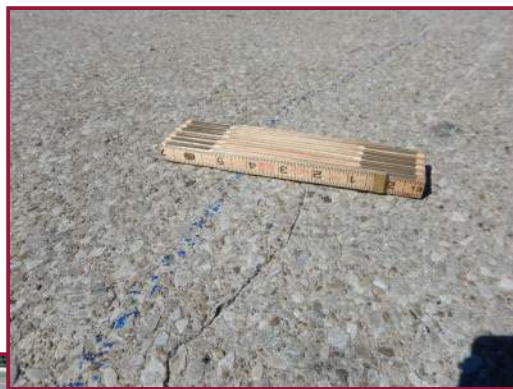
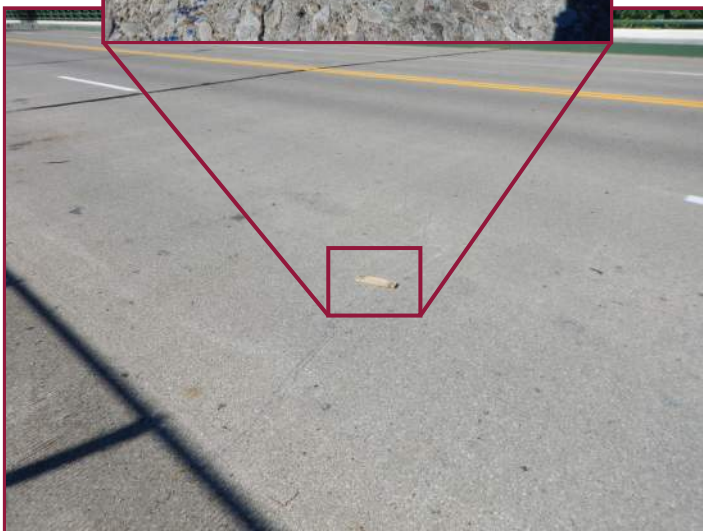
Hairline diagonal and transverse cracks in the wearing surface (looking northwest).

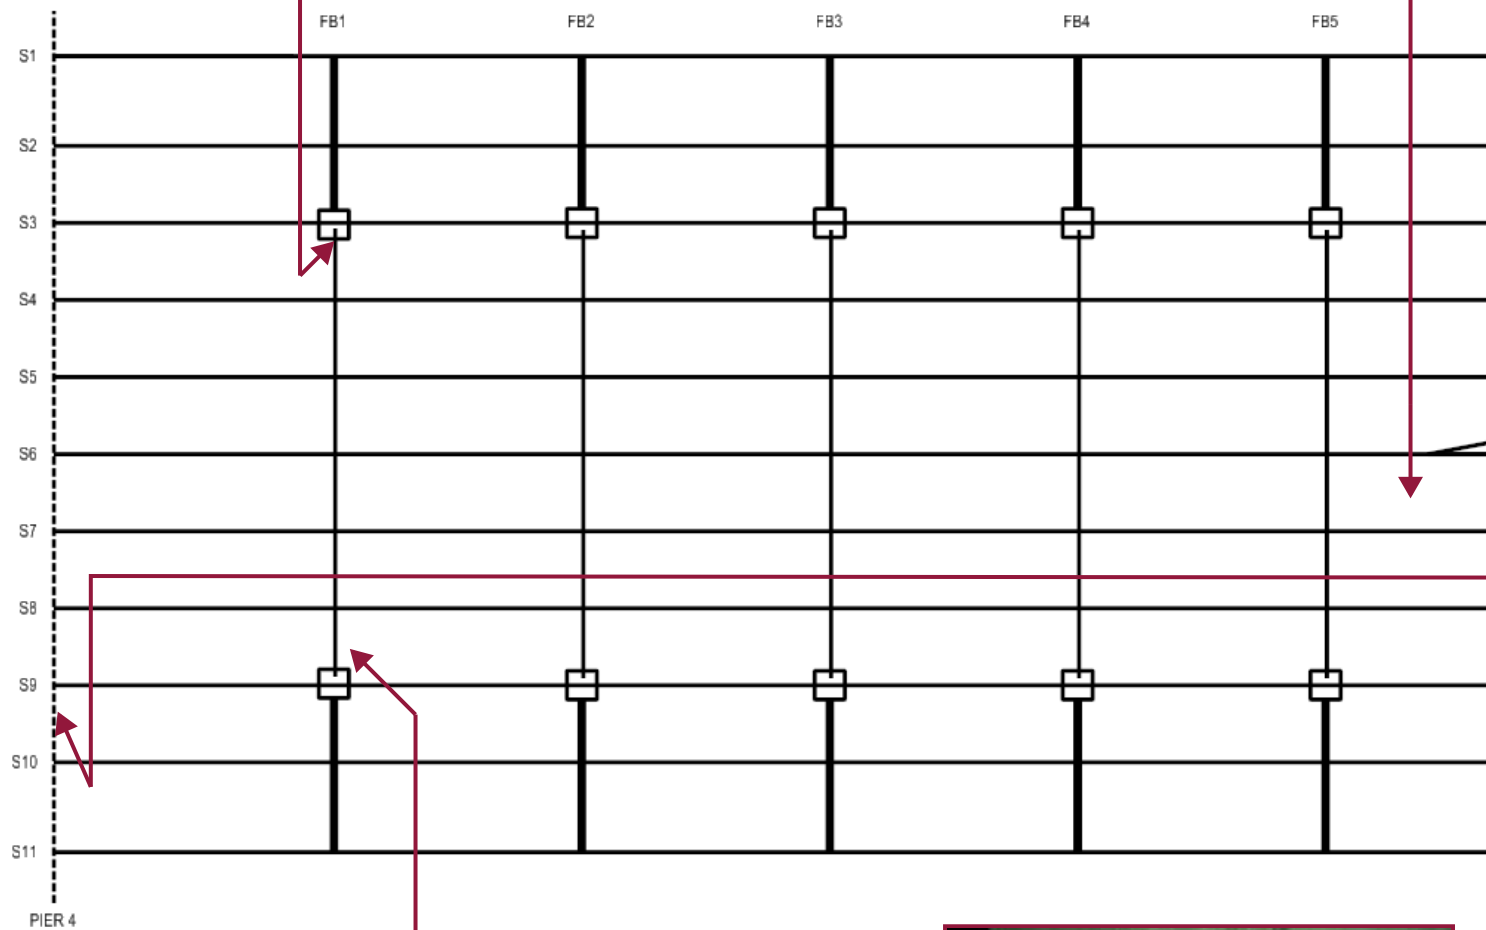
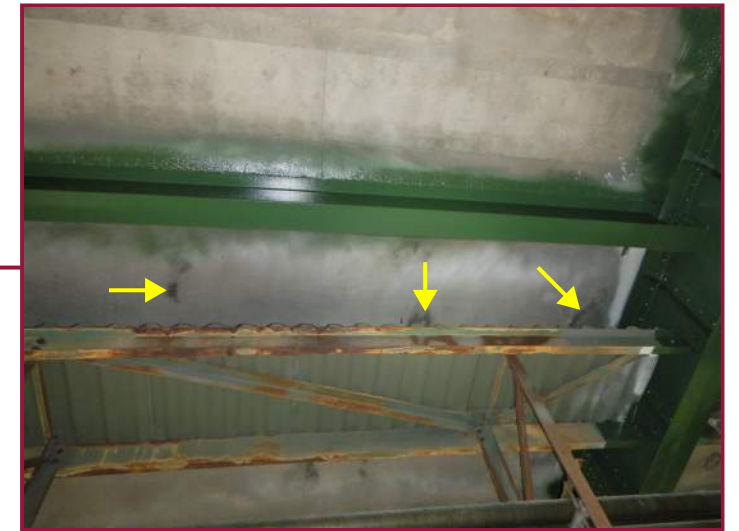
Minor delaminations and water staining in the deck underside above the utilities (looking up and south). Note the corrosion on the utility supports.

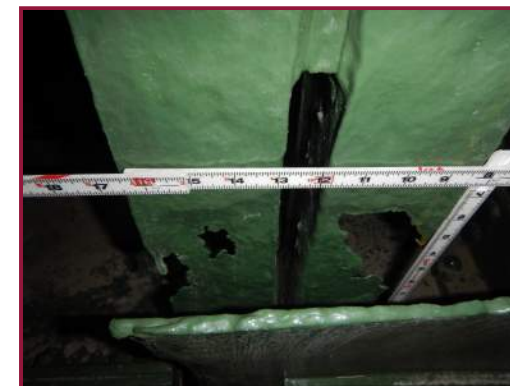
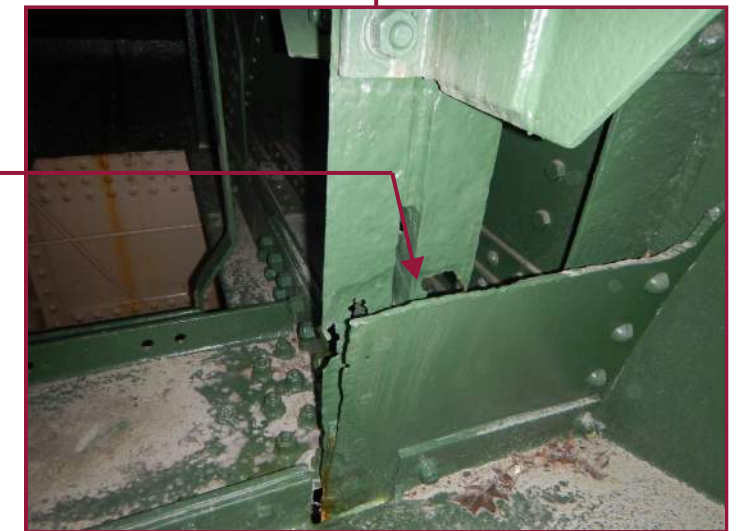
Painted over 100% section loss in the pier cap interior stiffener angles (looking northeast near the south end of the pier cap).

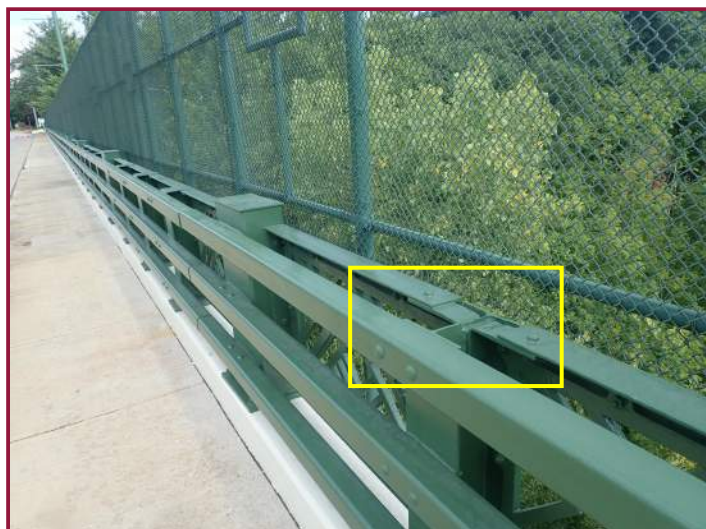
Missing railing post cap plate with minor section loss in the top of the post (looking west).

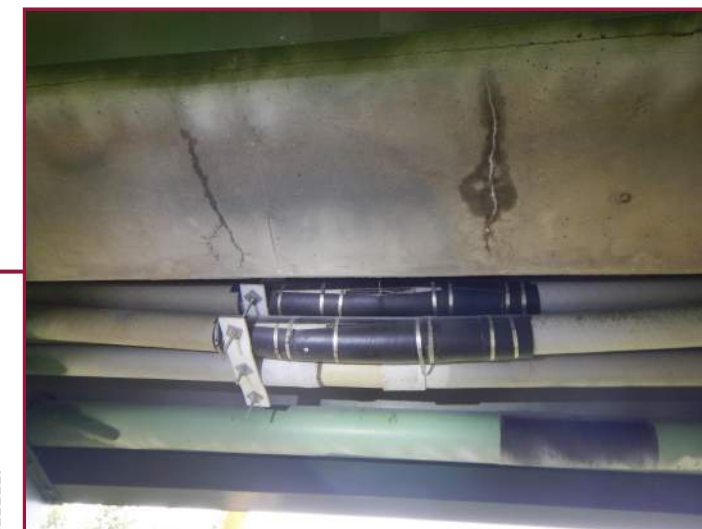
Hairline transverse cracks with minor efflorescence in the edge of the deck underside (looking north). Note the misalignment and sag of the utilities.

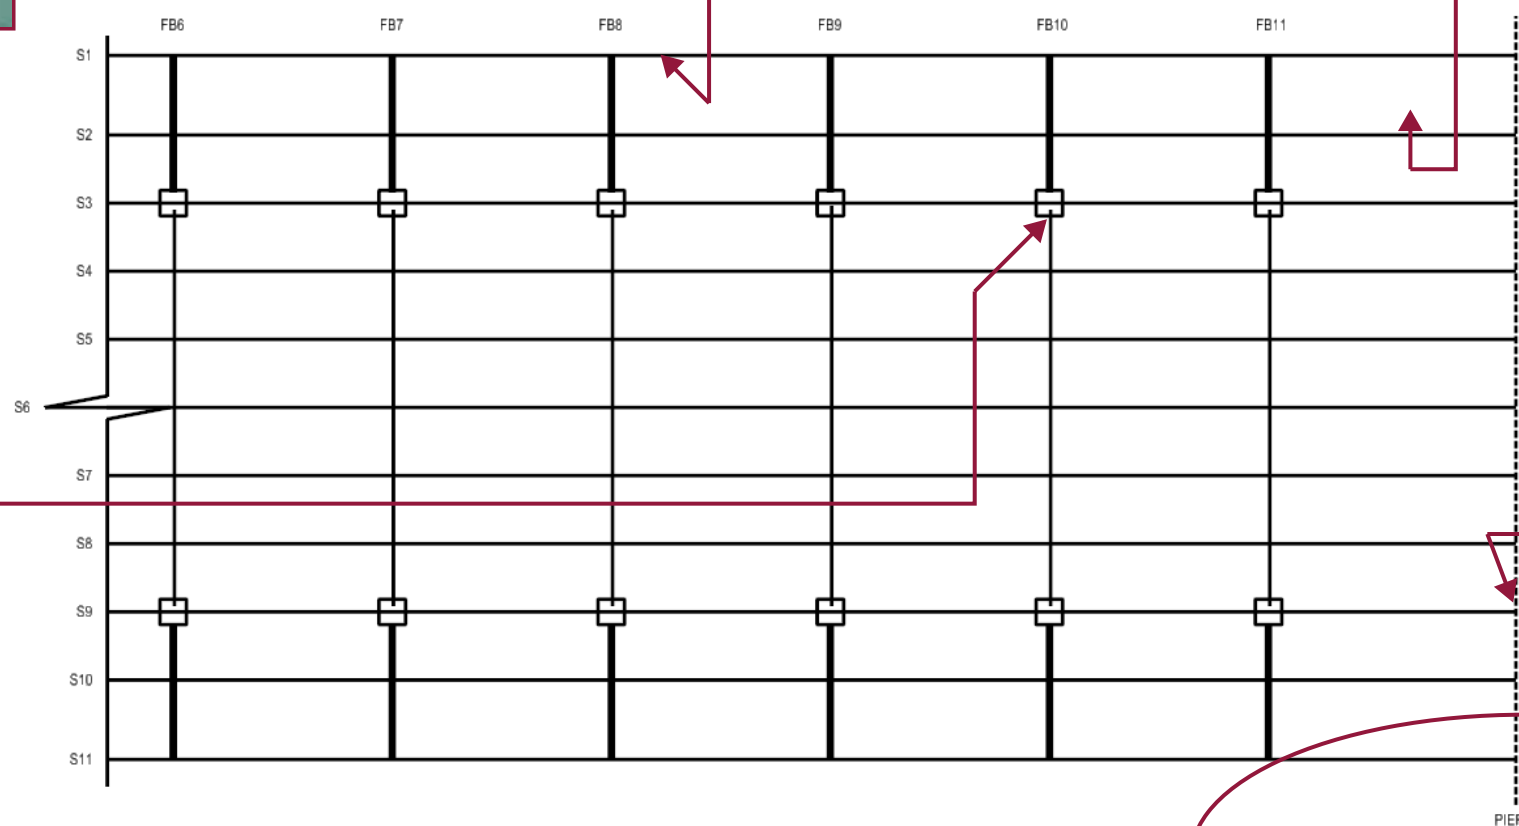
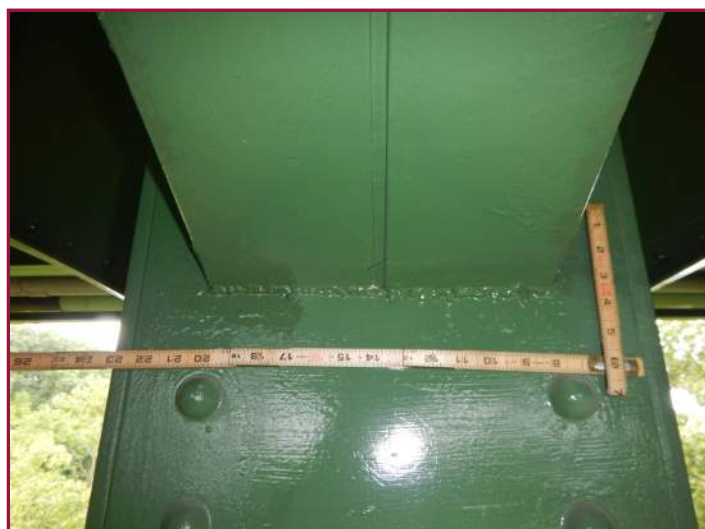
Poor quality weld between the floorbeam bottom flange and the spandrel column (looking north).

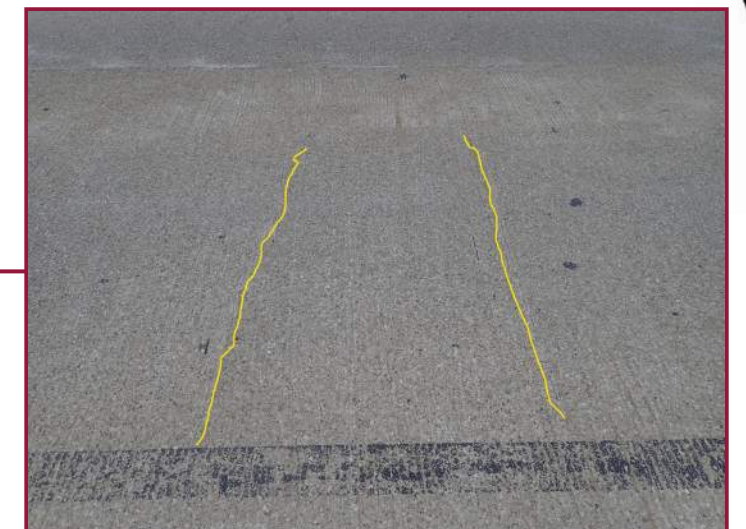
Transverse hairline cracks in the wearing surface (looking south). Cracks outlined in yellow.

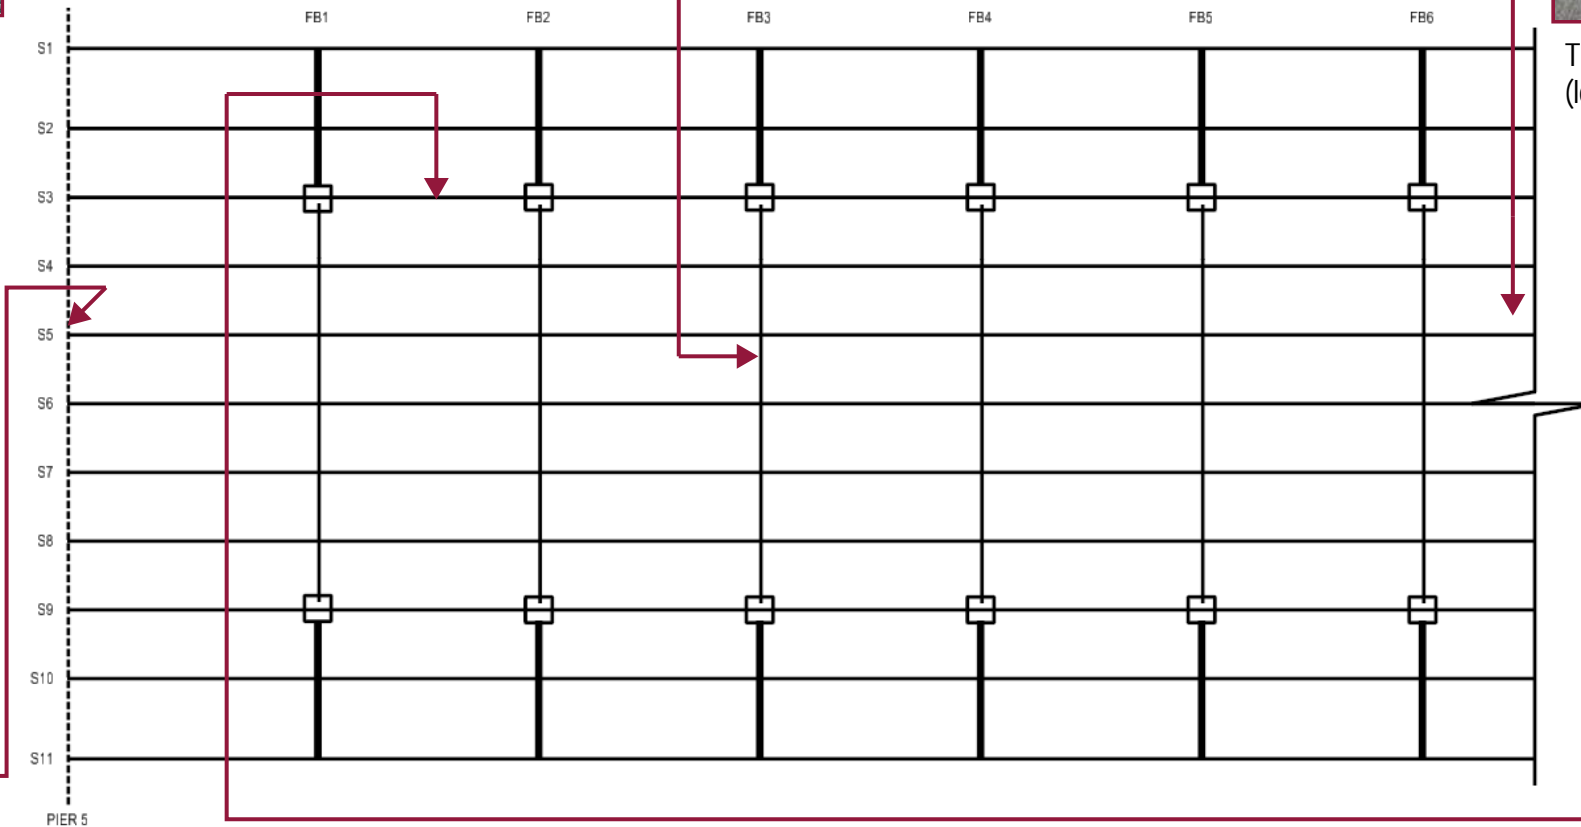
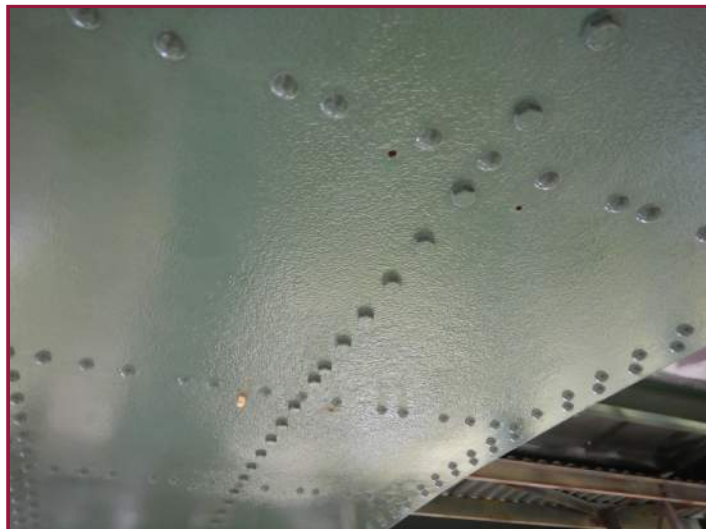
1/16" deep pitting throughout the underside of the pier cap (looking south).

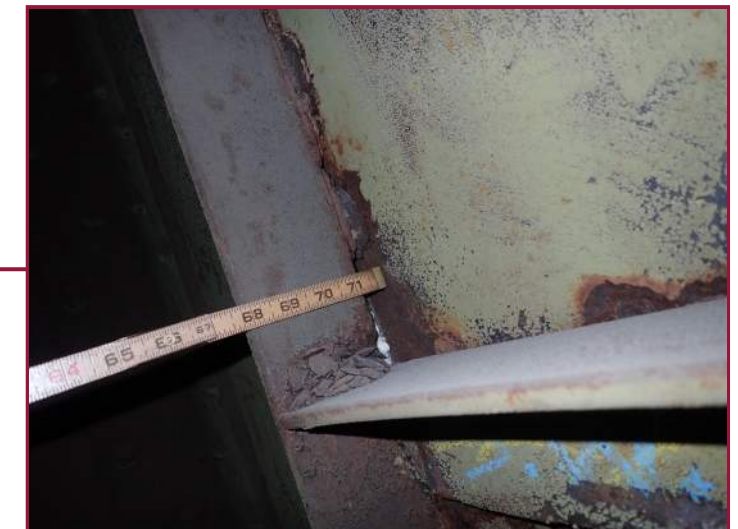
Up to 3/4" thick pack rust between the south web and the intermediate hatch door (looking southeast in Bay 12 of the arch interior).

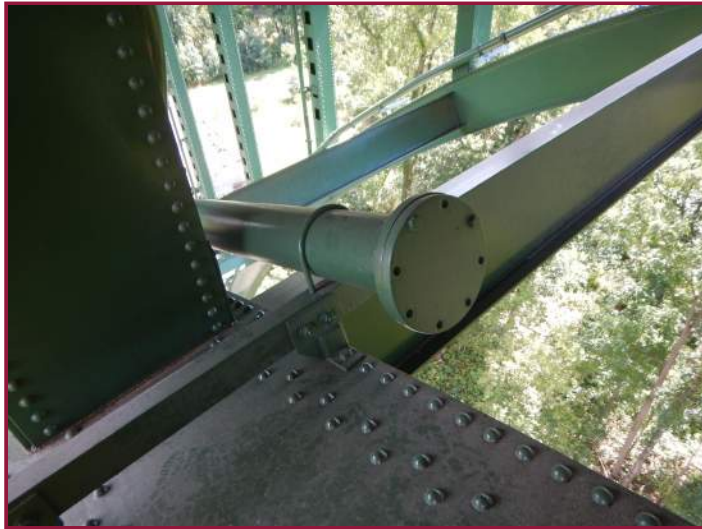
Only 2 of 8 bolts in place at the drainage cover plate (looking southeast).

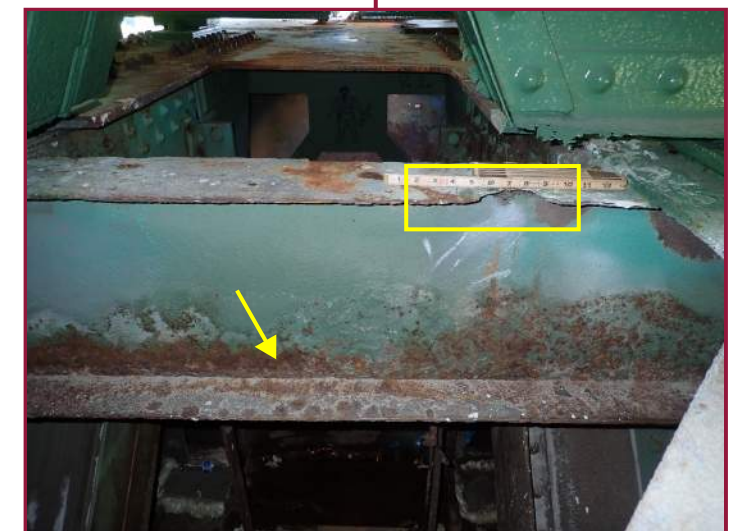
100% section loss in the top flange of the pier cap strut (looking south near Stringer 9). Note the typical corrosion in the pier cap.

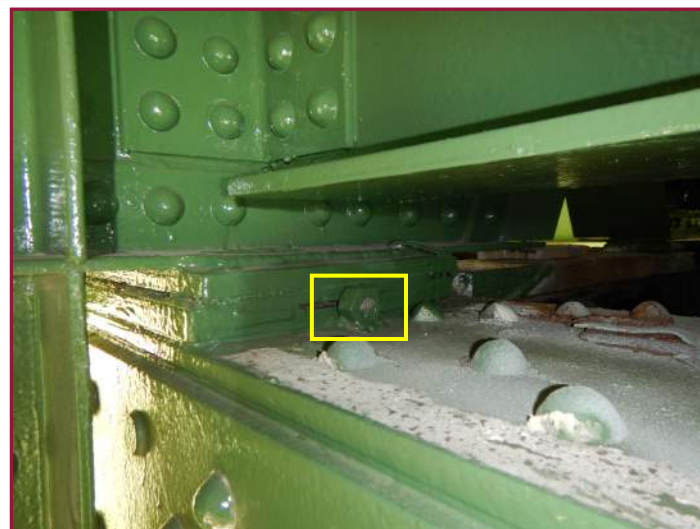
Nut painted to the top flange of the pier cap (looking northeast).

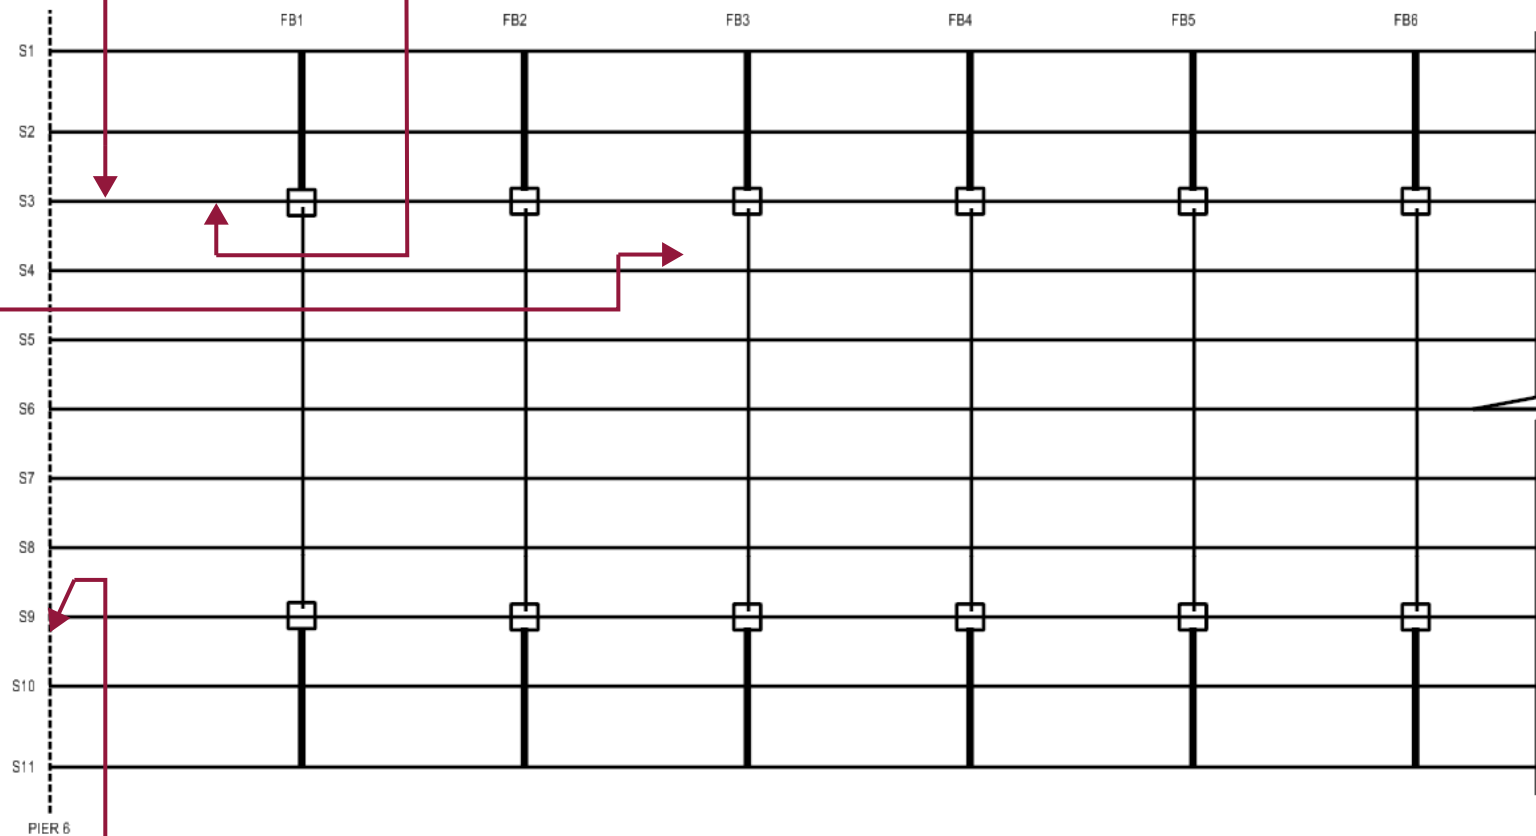
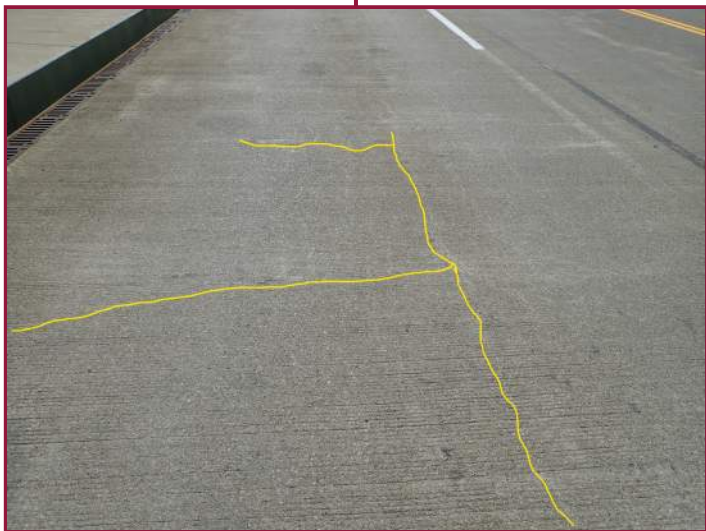
Longitudinal and transverse cracks up to 0.06" wide in the wearing surface (looking east).

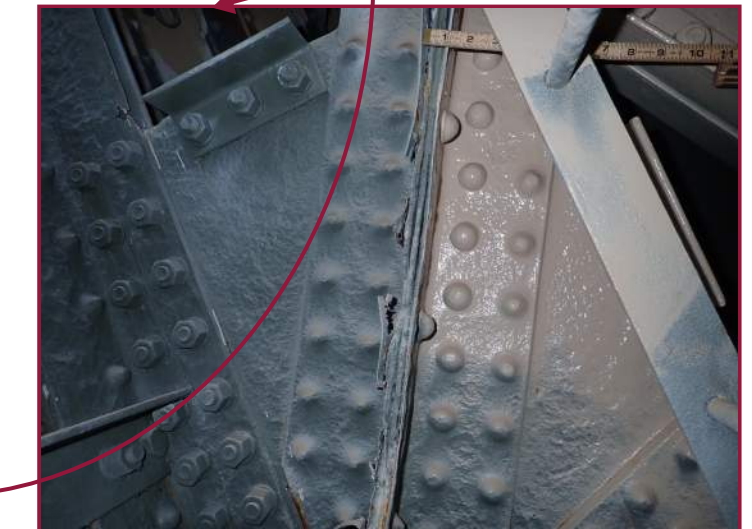
South column diagonal bracing and connection plate with advanced section loss and painted pack rust 1" thick (looking west across from the pier strut). Inset: Looking south at the horizontal bracing with 100% section loss in the vertical leg between the south column wall and the ladder.

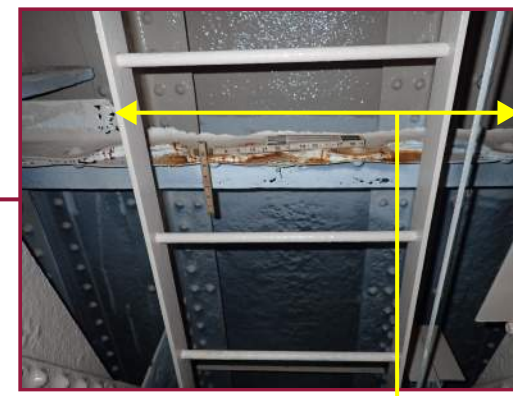
100% section loss in the vertical leg of the angle

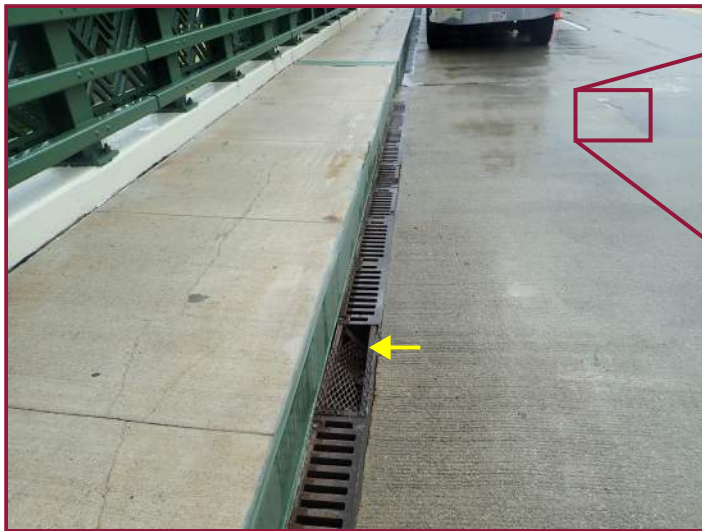
Scupper wire grate failed (looking east near the left curb). Note the wearing surface patch which is spalled along the left side.

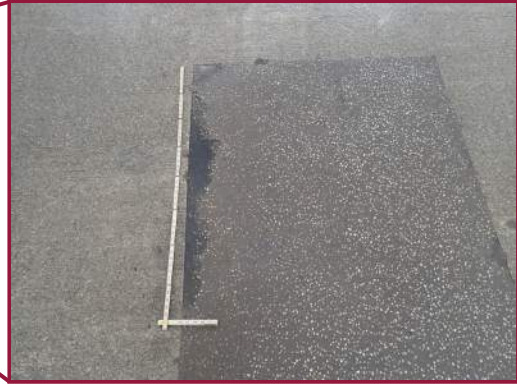
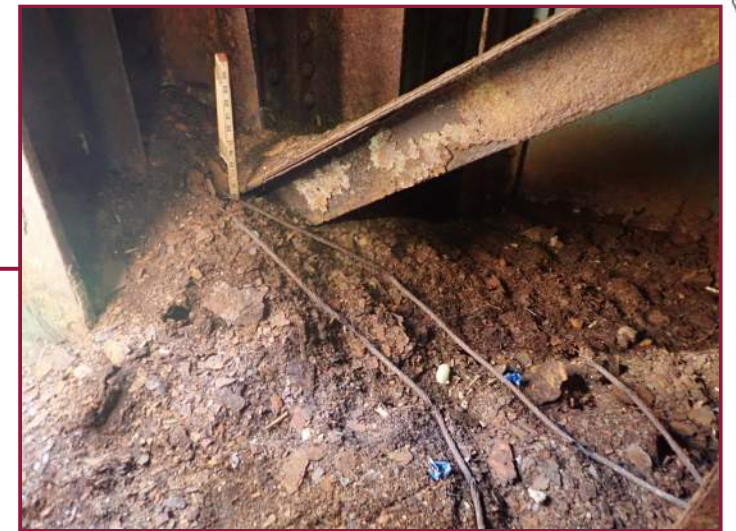
2' high rust and debris at the base of the Pier 7 left column (looking southwest).

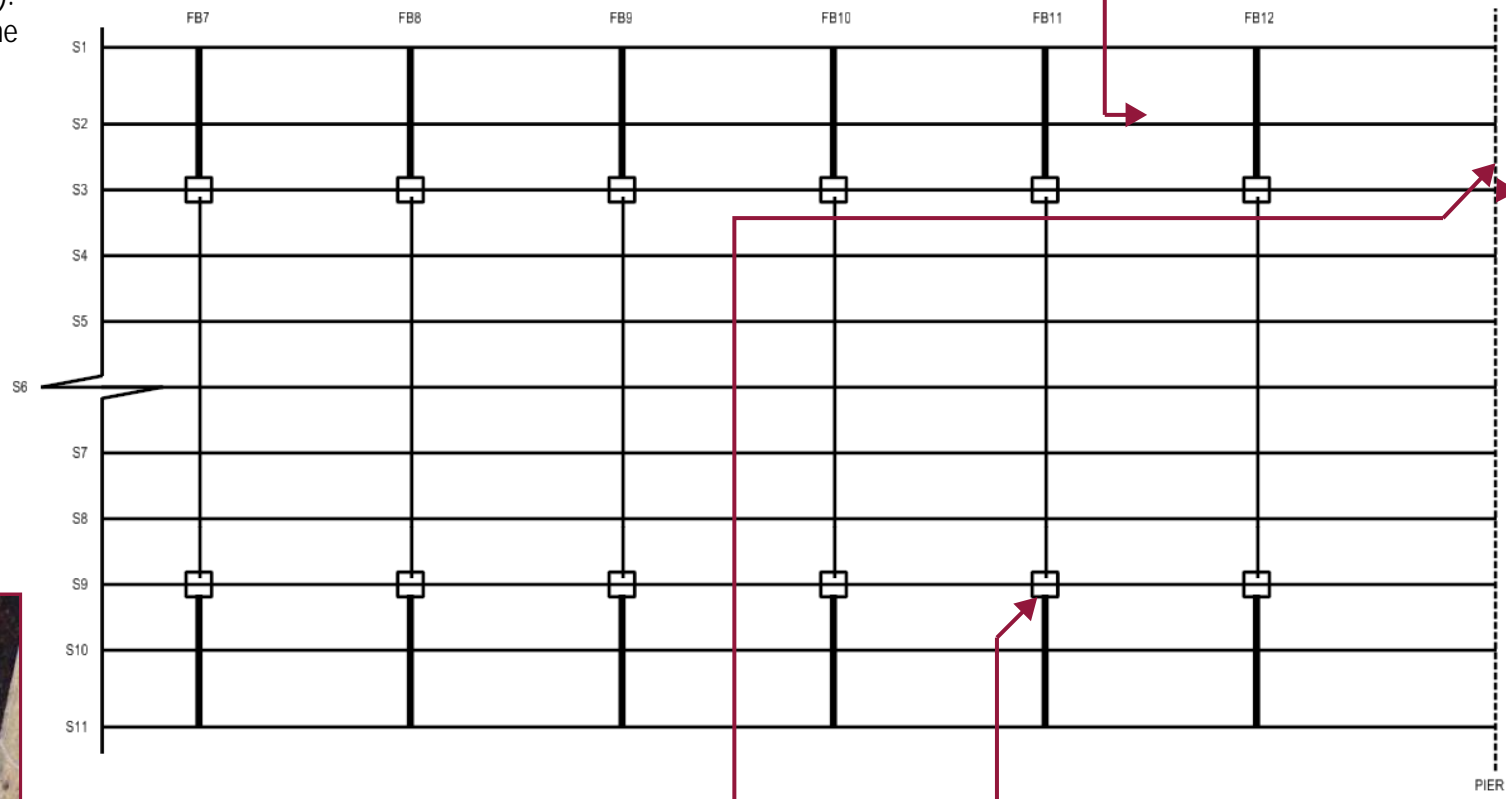
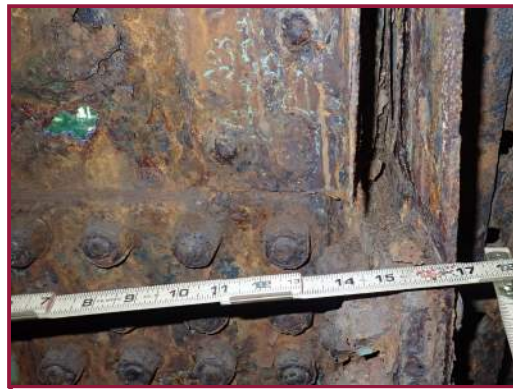
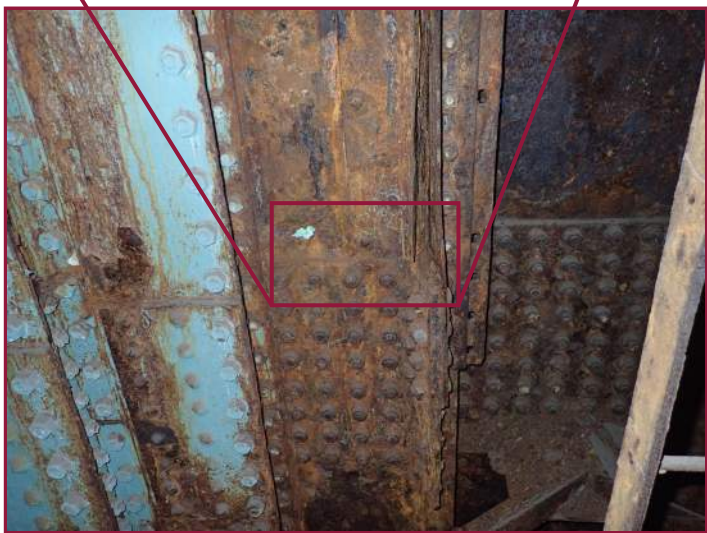
Corrosion hole in the north web plate and 2" thick pack rust between outstanding stiffener angle legs (looking north in the lower half of the Pier 7 left column).

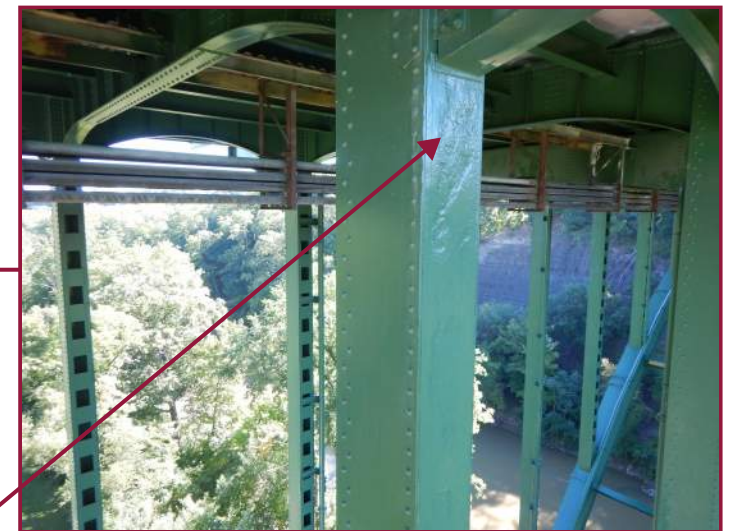
Typical 1/16" to 1/8" deep painted over pitting in a spandrel column (looking northeast).

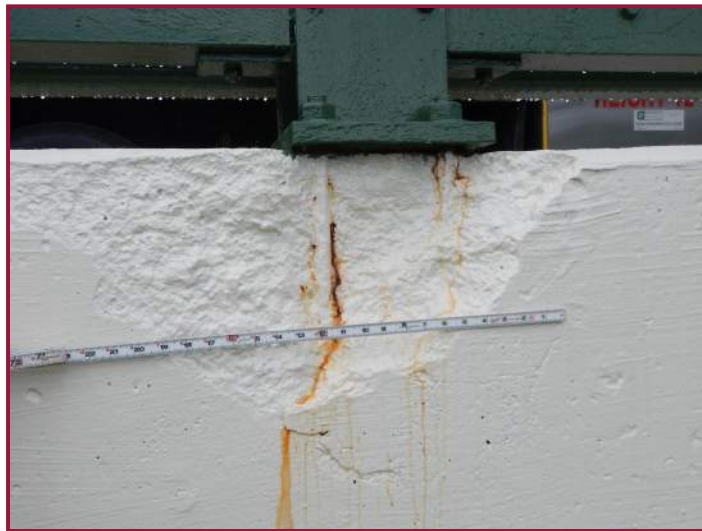
Spall with exposed railing post anchor bolts with minor rust staining in the concrete portion of the left railing (looking south).

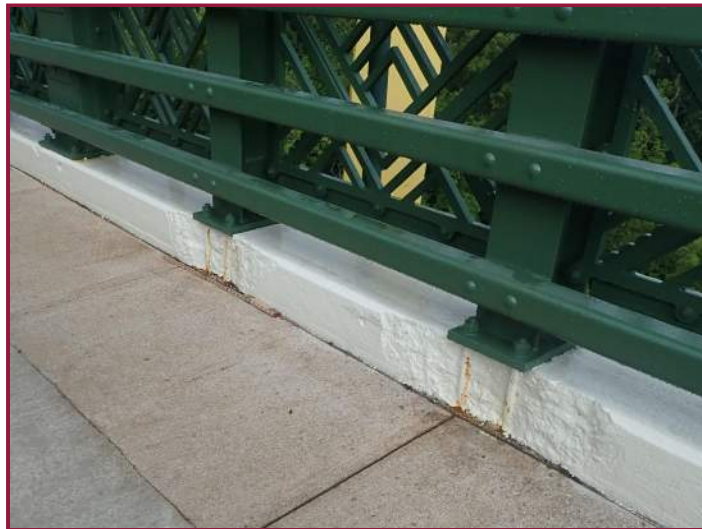
Spalls with exposed railing post anchor bolts in the concrete portion of the left railing (looking northwest).

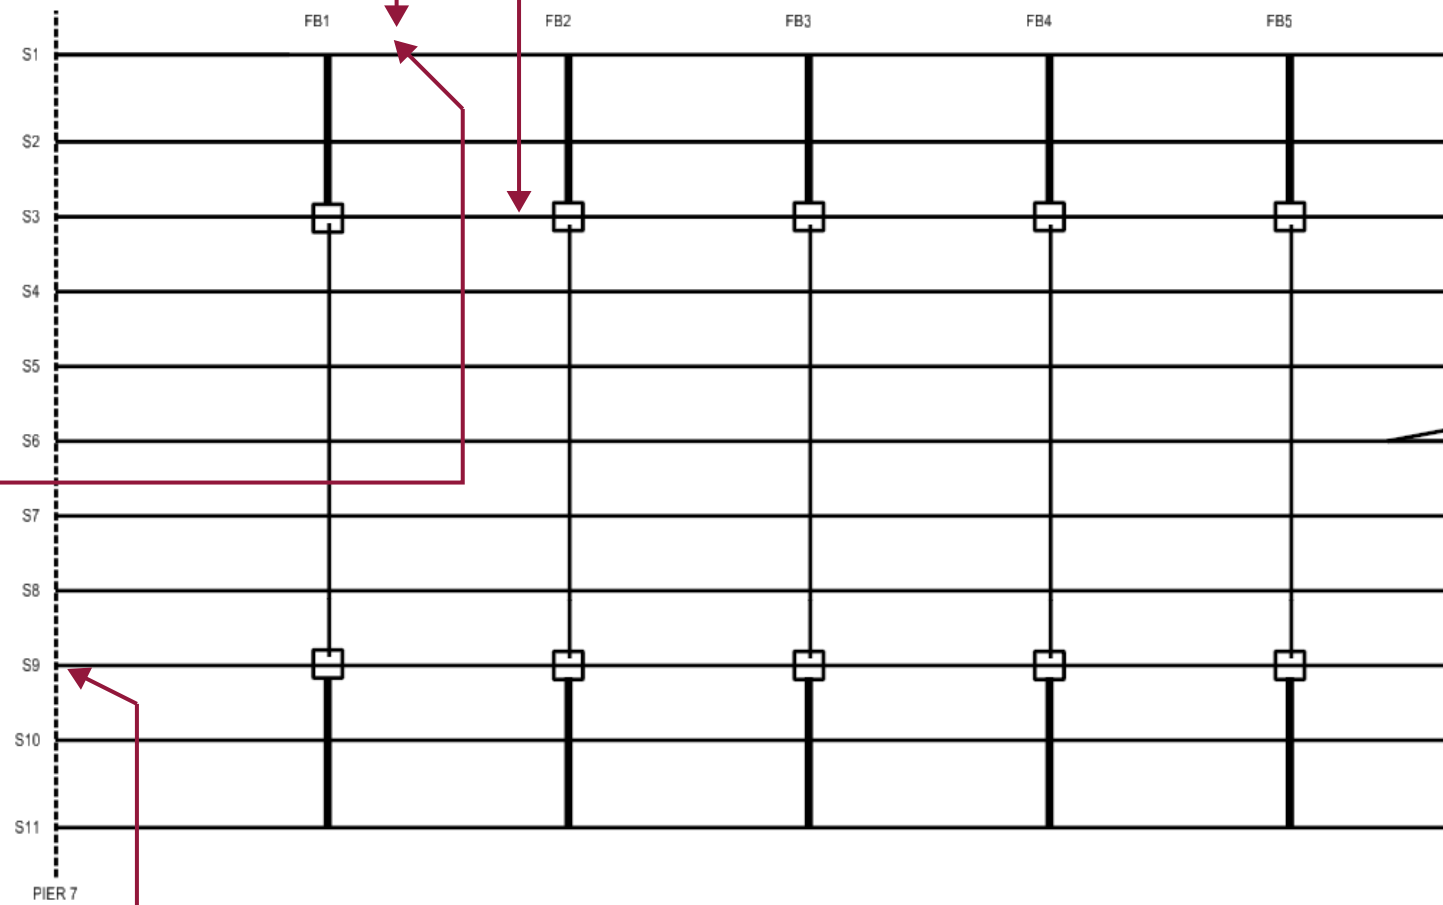
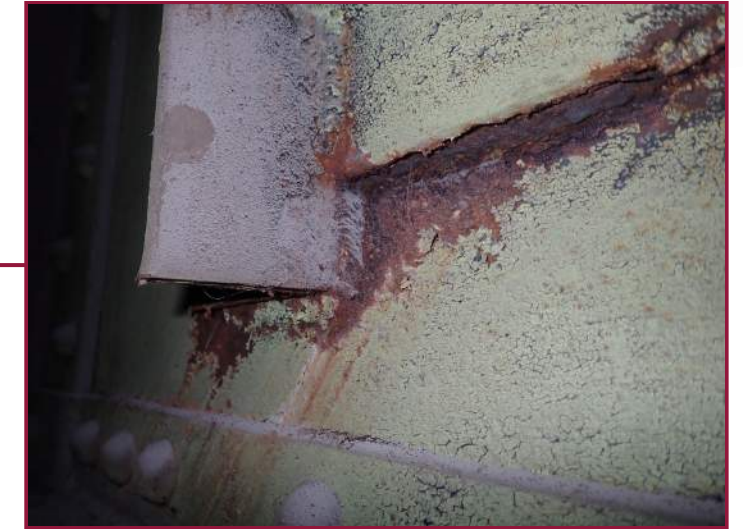
Pack rust at the interior of the arch between an access hatch and the south web (looking southeast).

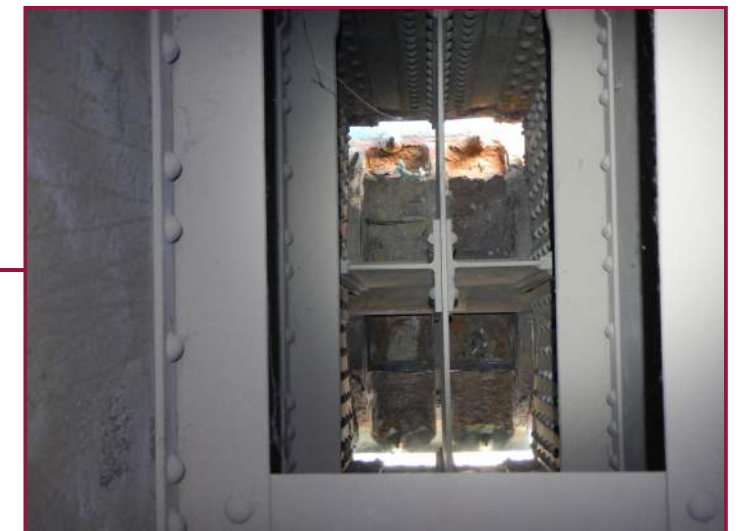
Typical laminate corrosion and bearing anchor bolt and nut section loss at the arch pins (looking west).

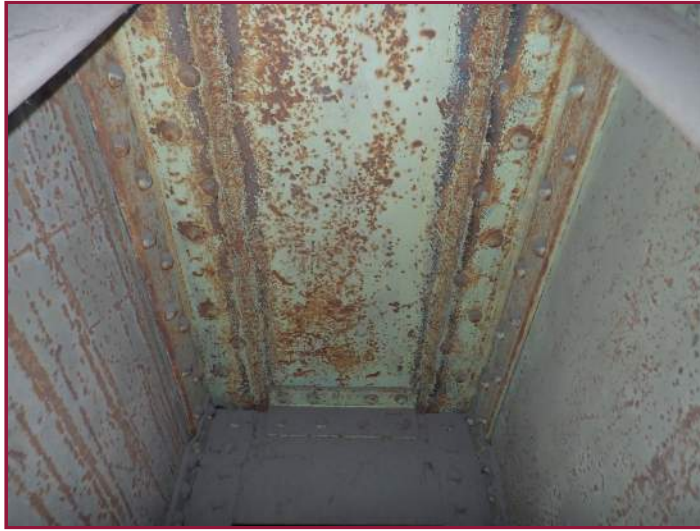
Typical minor surface corrosion at the interior of the arch (looking east).

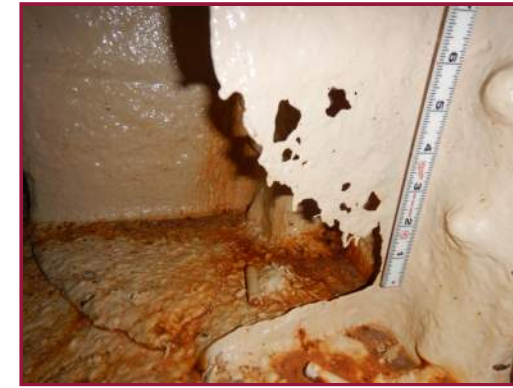
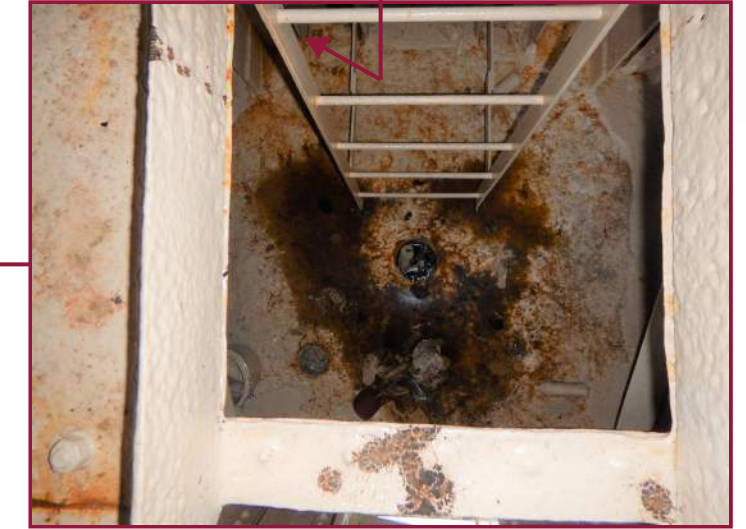
Clogged drainage pipe at the bottom of the column and 100% section loss at the bottom 4" of a north web stiffener angle (looking down and north). Inset: Looking northwest.

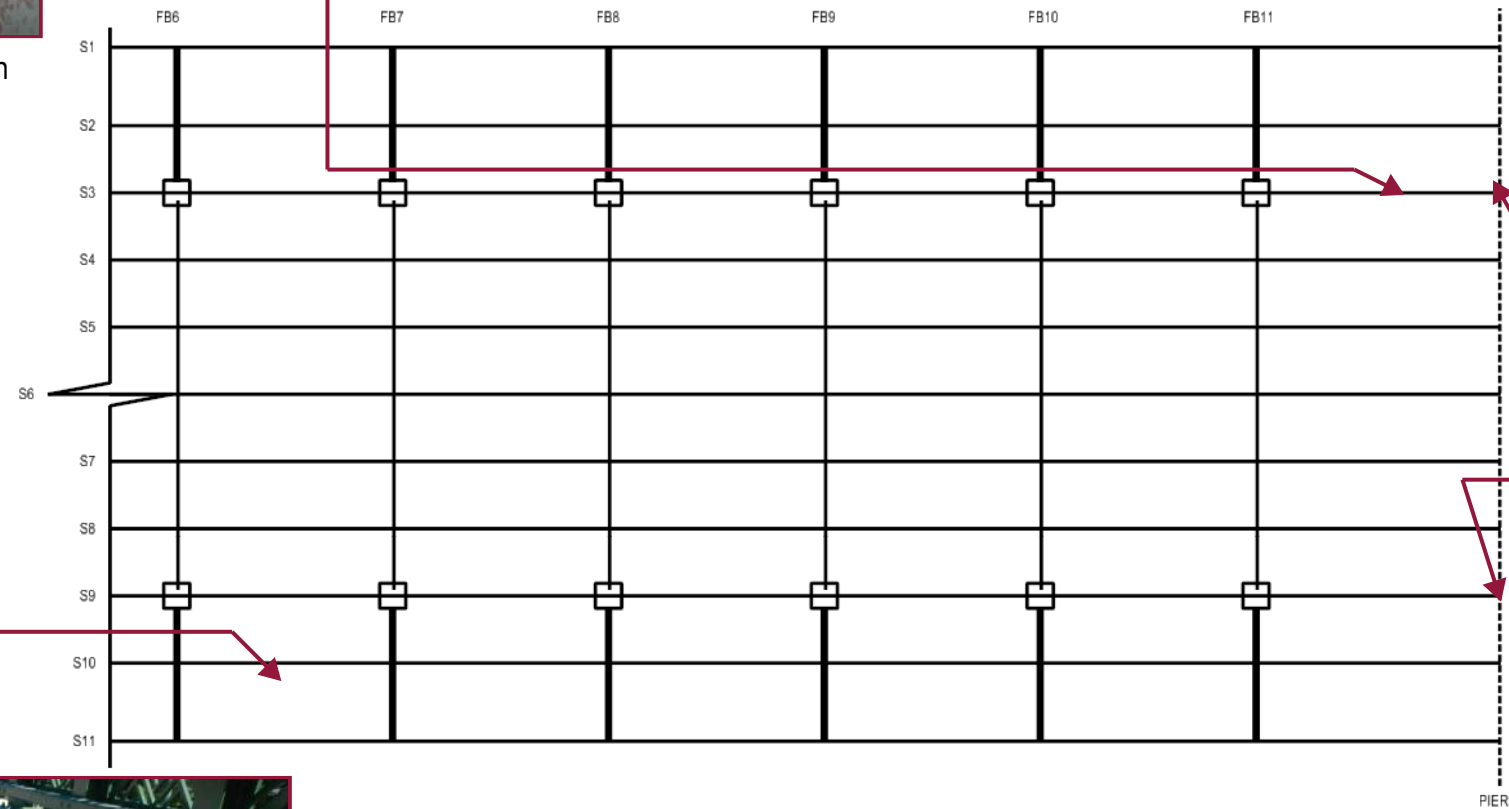
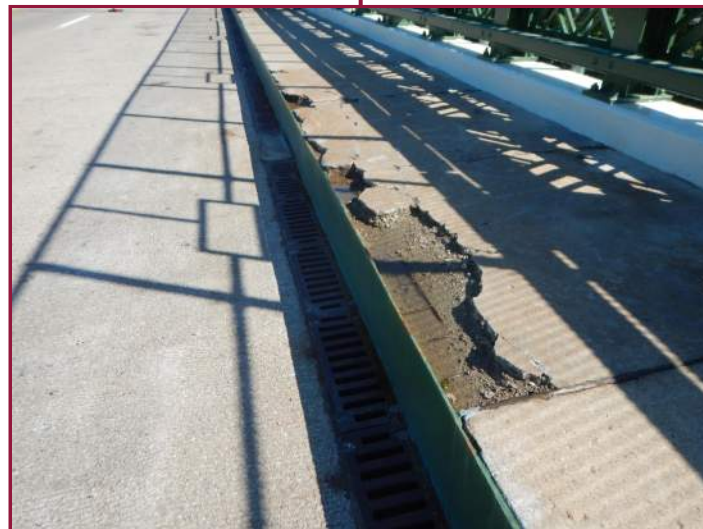
Spalls with exposed reinforcement and water ponding in the right sidewalk (looking east).

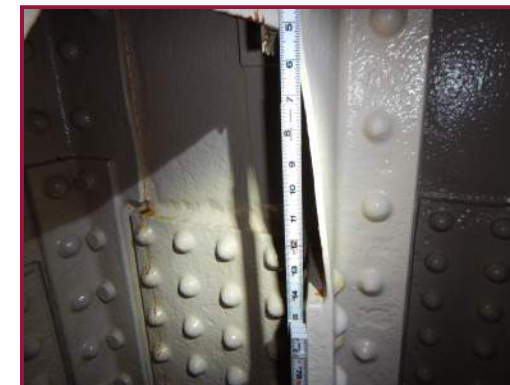
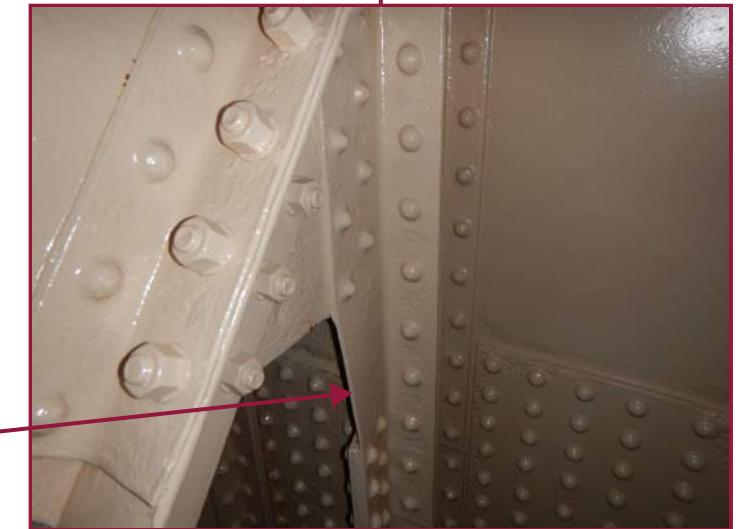
Column stiffener outstanding leg bowed up to 2" to the west (looking southeast in the bay below the pier cap).

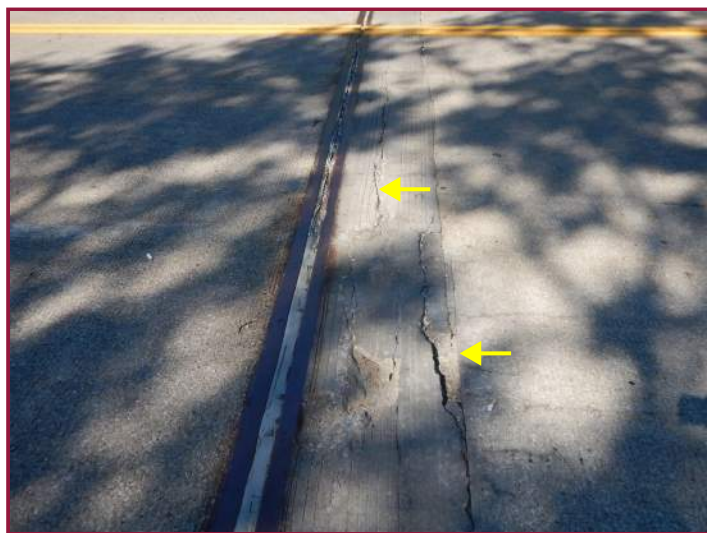
Spalls and transverse cracks in the joint header (looking north).

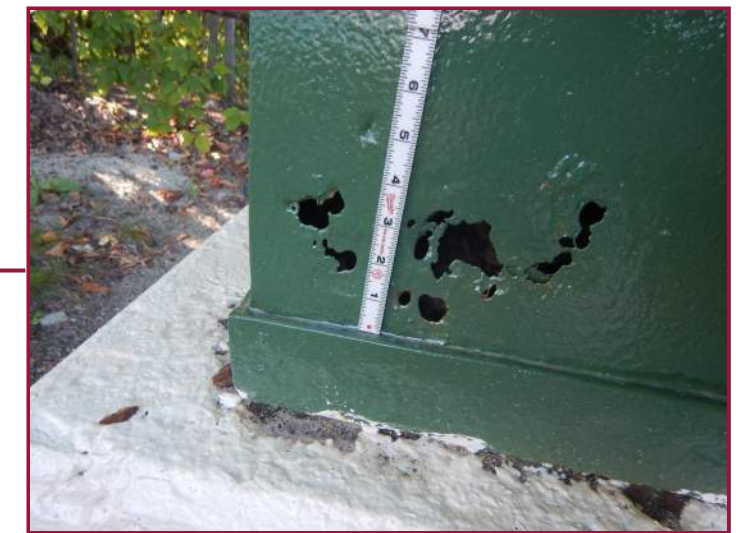
100% section loss near the base of the decorative railing obelisk (looking south).
