**PHYSICAL CONDITION REPORT  
FOR THE 2022 ROUTINE ELEMENT LEVEL INSPECTION**

**LORAIN ROAD OVER ROCKY RIVER  
BRIDGE NO. CUY-10-0869  
SFN: 1801325**

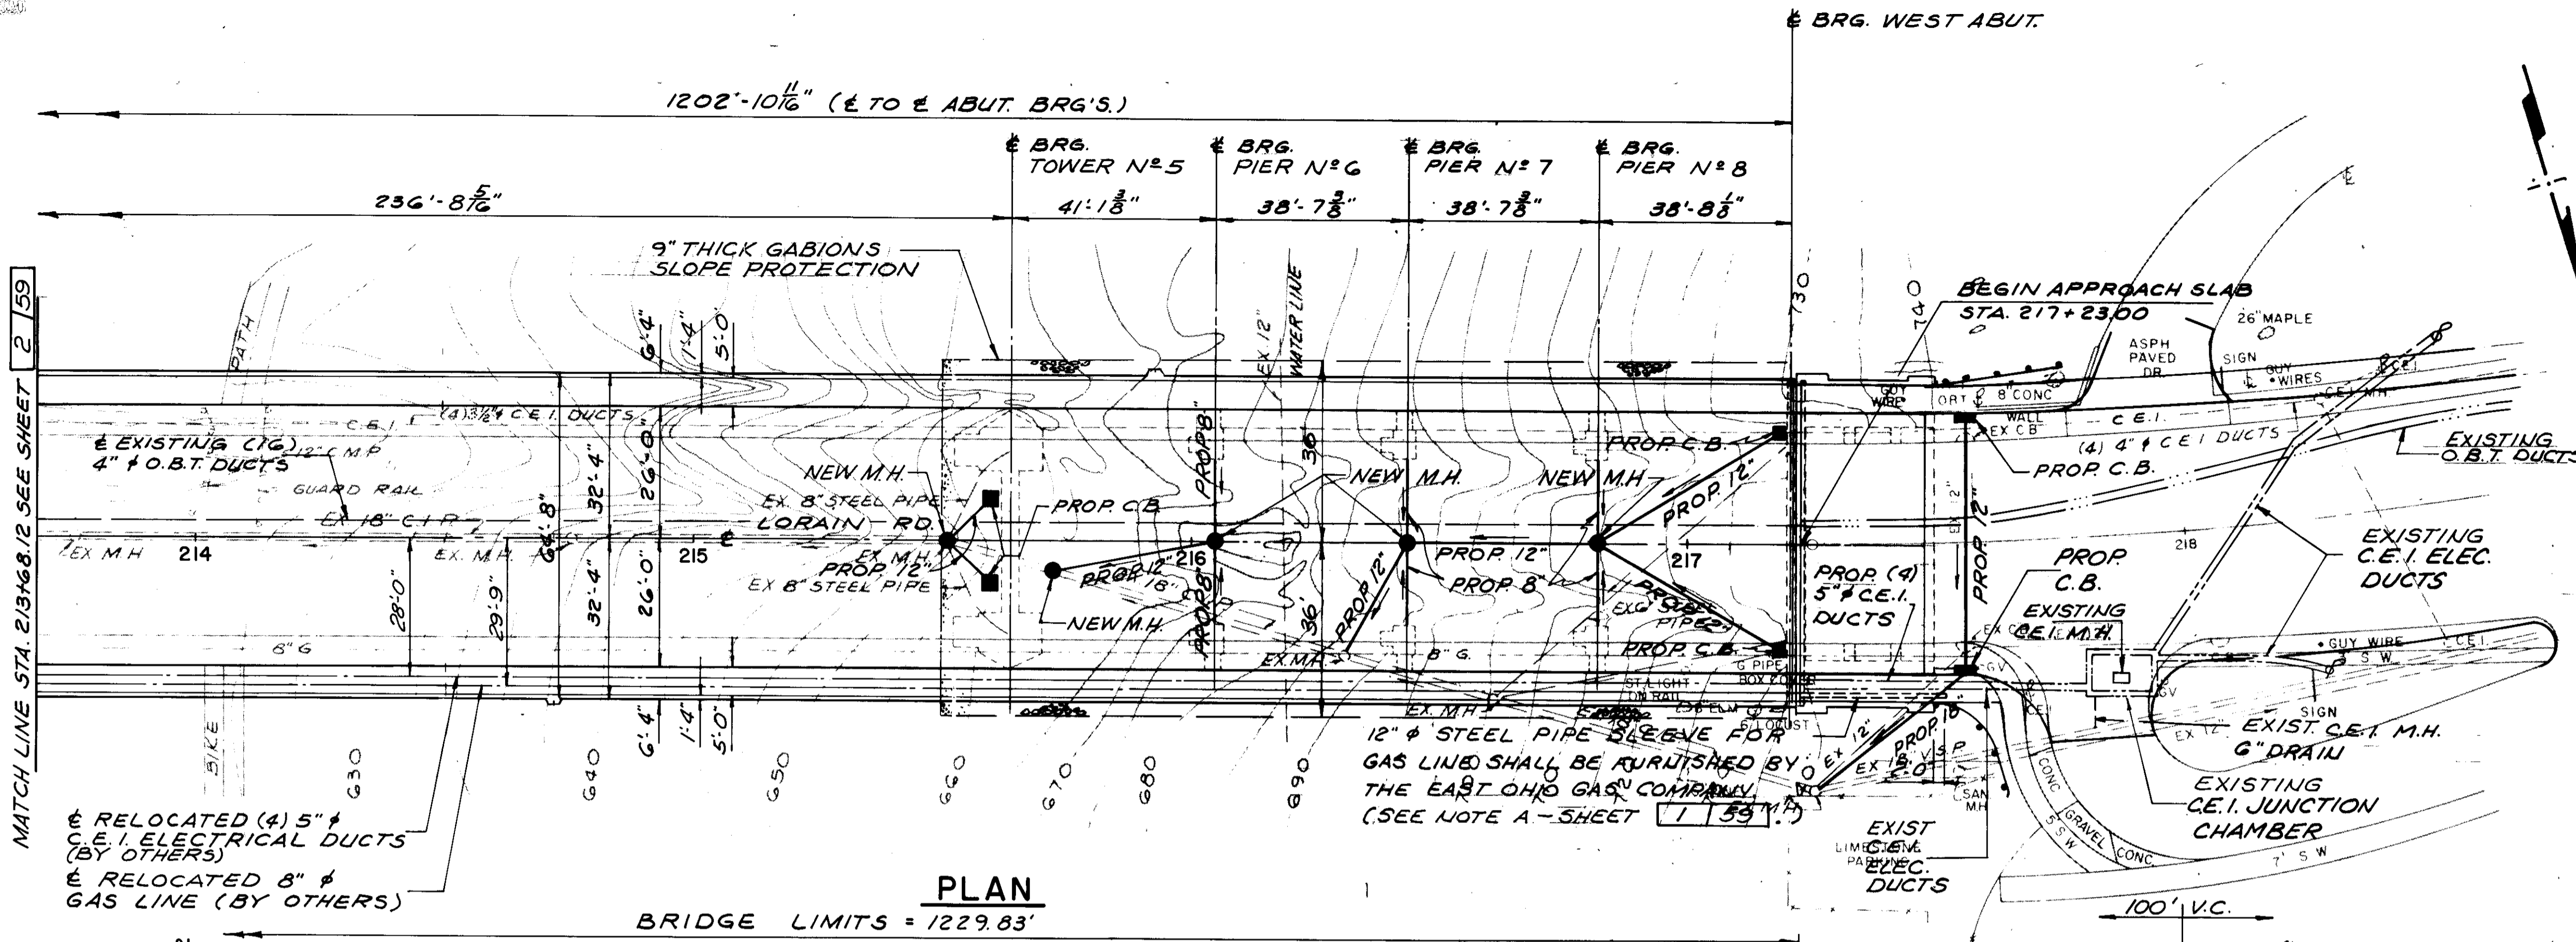
NOTE: FOR VERTICAL LOCATIONS OF EXISTING UTILITIES, SANITARY AND STORM SEWERS SEE SHEETS 18, 28 THRU 33.

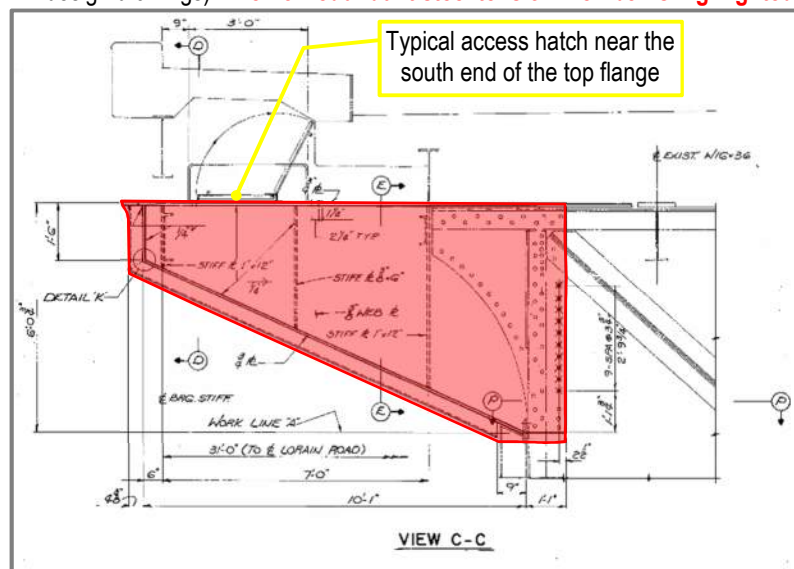
Figure 5 – Built-up steel tower pier cap cantilever elevation (taken from the major rehabilitation drawings). **The nonredundant steel tension member is highlighted red.**

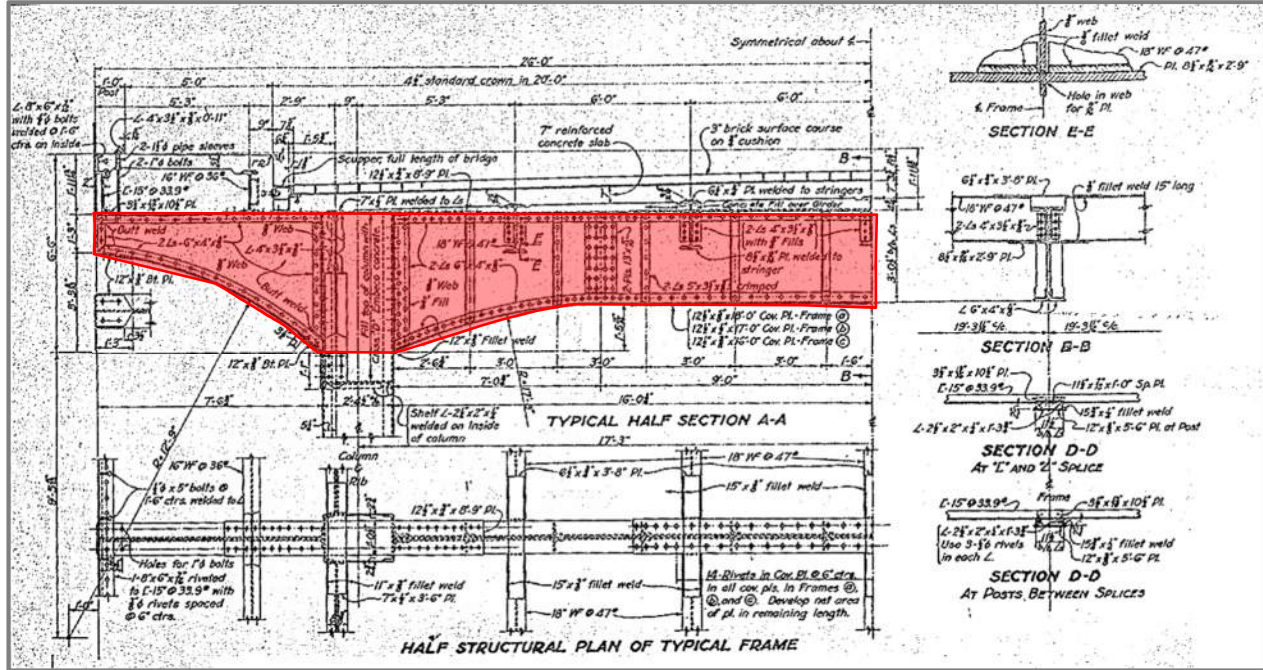
Figure 6 – Built-up steel pier caps at Piers 1 through 3 and built-up steel arch span floorbeams half elevation (taken from the original design drawings). **The nonredundant steel tension member is highlighted red.**

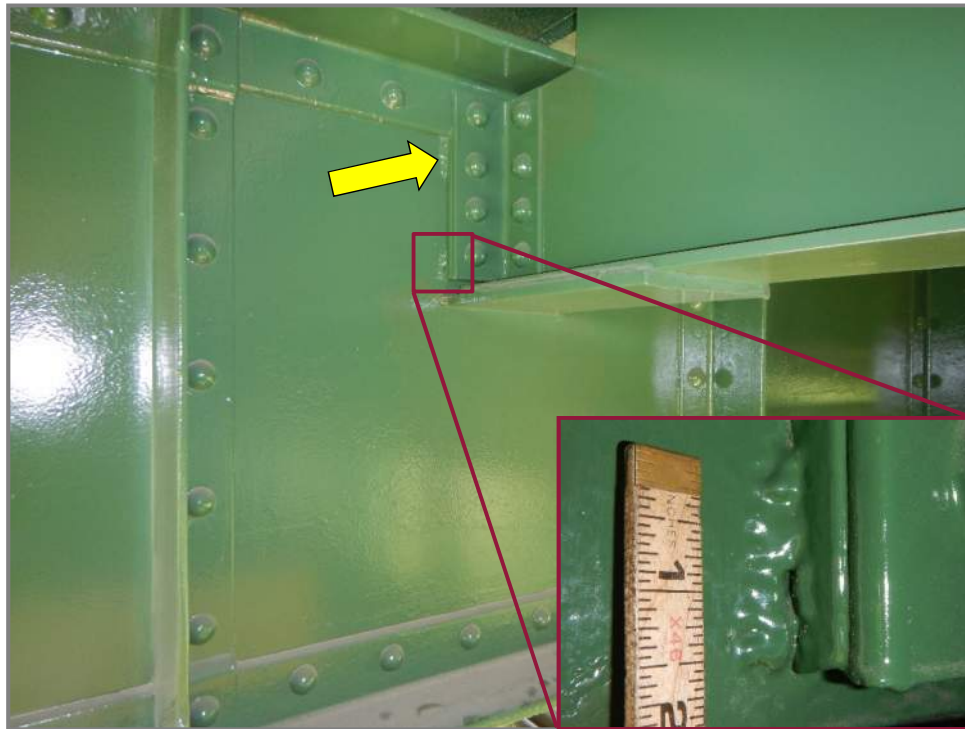
Photo 4 – Base metal of the floorbeams and pier caps at tack welds (**Problematic Detail**) (looking southeast at the north face of Floorbeam 4 in Span 6 at the Stringer 6 connection angle fill plate tack weld with a 3/4" long crack).
