## LAK-283-14.34 BRIDGE REPLACEMENT PID: 111005 LAKE COUNTY, OHIO

# DRAFT STRUCTURE FOUNDATION EXPLORATION REPORT

Rii Project No. N-20-011

December 2021

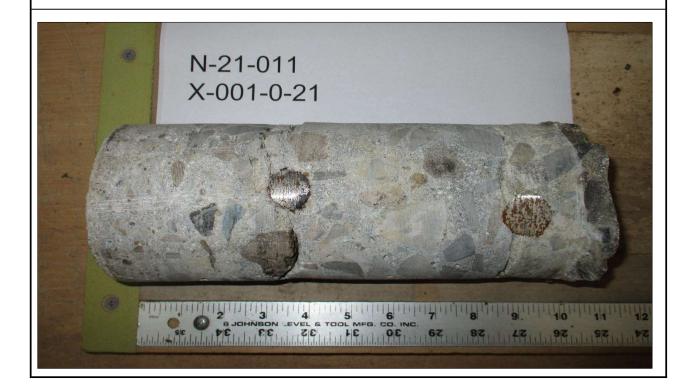
X-001-0-21

| | Core Co | omp | osit | ion | | | | | | | Comments/Remarks |
|---|---|---|---|---|---|---|---|---|---|---|---|
| | | | Α | sph | alt | | Base | ( | Othe | er | - The core has horizontal breaks @ 3.25" & 8.00". |
| | | | der | Binder | | | | | | | - The core has 0.75" rebar @ 3.25" & 8.00". - The core has trace voids throughout. |

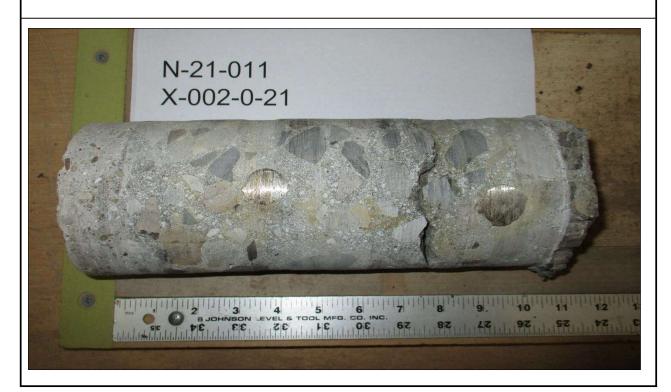
X-002-0-21

- The core has a horizontal break @ 7.00".

- The core has 0.75" rebar @ 3.50" & 8.00".
- The core has trace voids throughout.

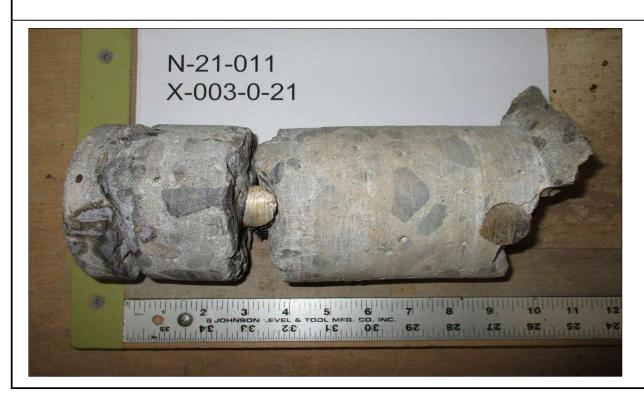
X-003-0-21

- The core has horizontal breaks @ 1.00" & 3.00" 4.00".
- Note: The core break @ 8.50" 9.75" occurred while removing the core from the barrel. The concrete had been intact.
- The core has 0.75" rebar @ 3.25" & 7.75".
- The core has trace voids throughout.

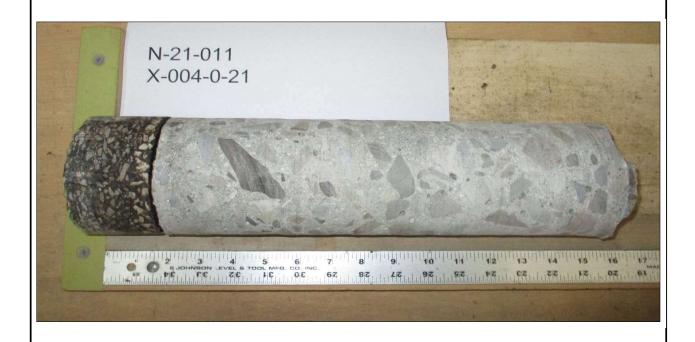
X-004-0-21

- The core has separated between the asphalt and concrete.
- The core has a small, vertical crack throughout the asphalt.
- The concrete has trace voids throughout.
