UNDERWATER BRIDGE INSPECTION REPORT

STRUCTURE NO. 7305796

SR-348 OVER SCIOTO RIVER

June 2024

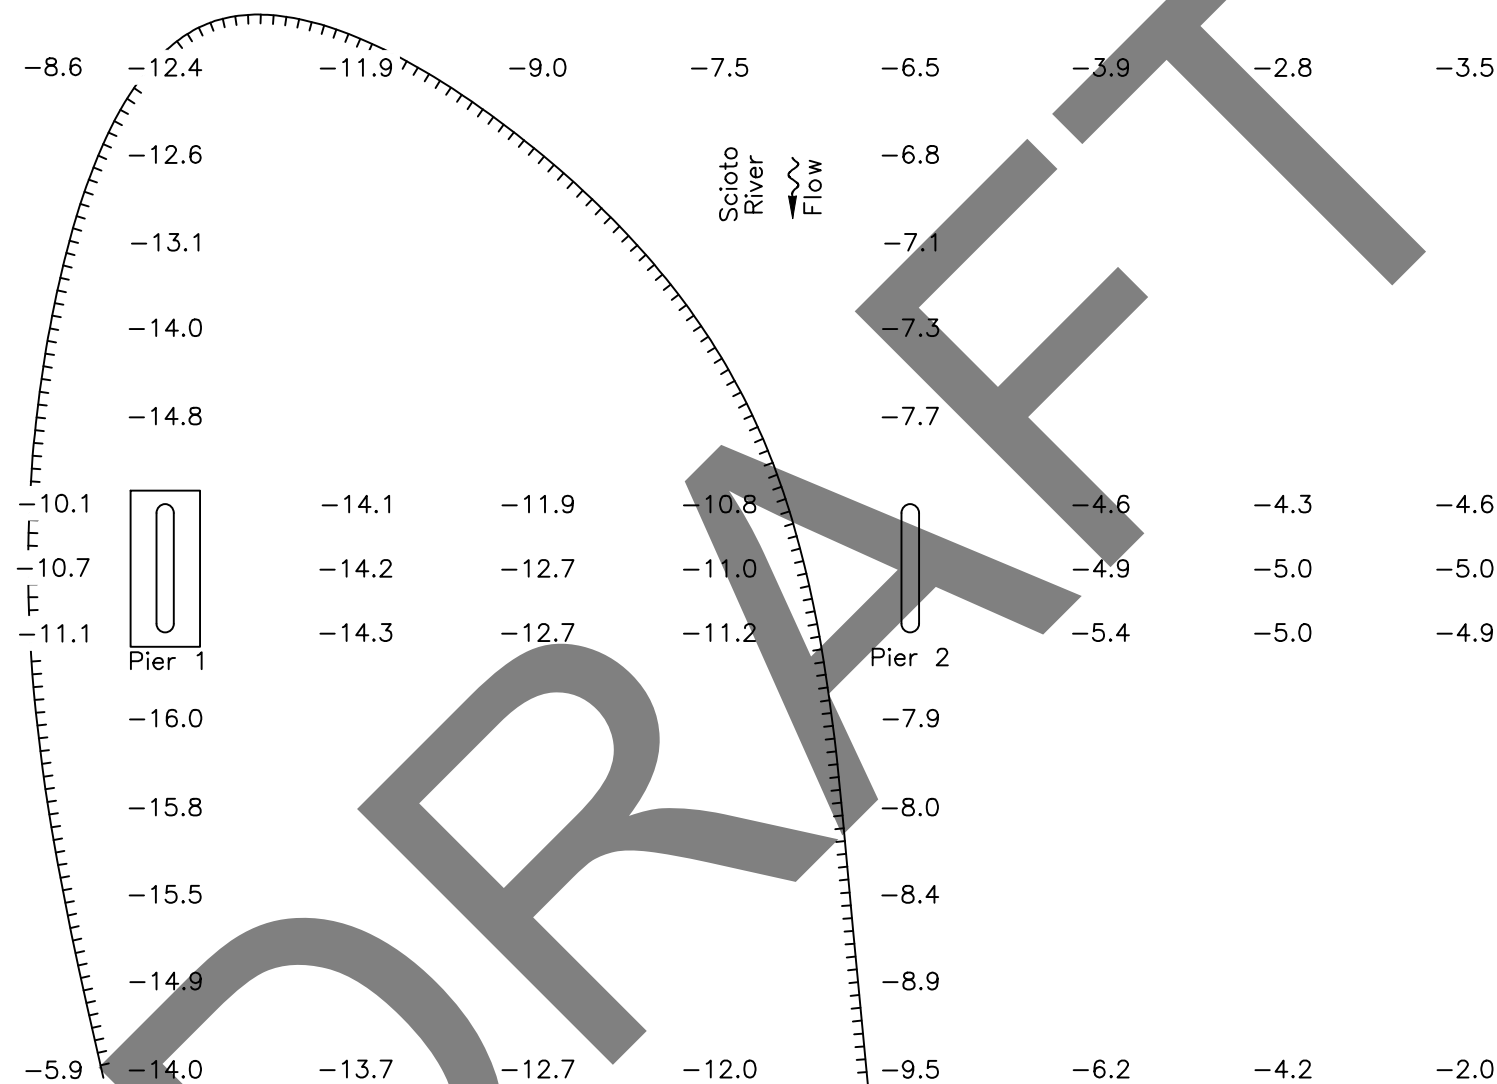
SR-348 OVER SCIOTO RIVER
STRUCTURE NO. 7305796
SOUNDING PLAN
SCIOTO COUNTY, OHIO

1. Piers 1 through 3 were inspected underwater.
2. At the time of inspection on June 6, 2024, the waterline was located approximately 24.0 ft below the bottom of the pier cap nose on Pier 3 at the downstream nose (EL. +532.59 ft). This corresponds with a waterline elevation of +508.59 ft.
3. Soundings indicate the water depth at the time of inspection and are measured in feet.
4. Soundings were taken parallel to the bridge at the upstream and downstream fascias, parallel to the bridge at 50 ft upstream and downstream, at quarter-point intervals between the substructure units, and at 10 ft intervals in-line with the piers upstream and downstream up to 50 ft.

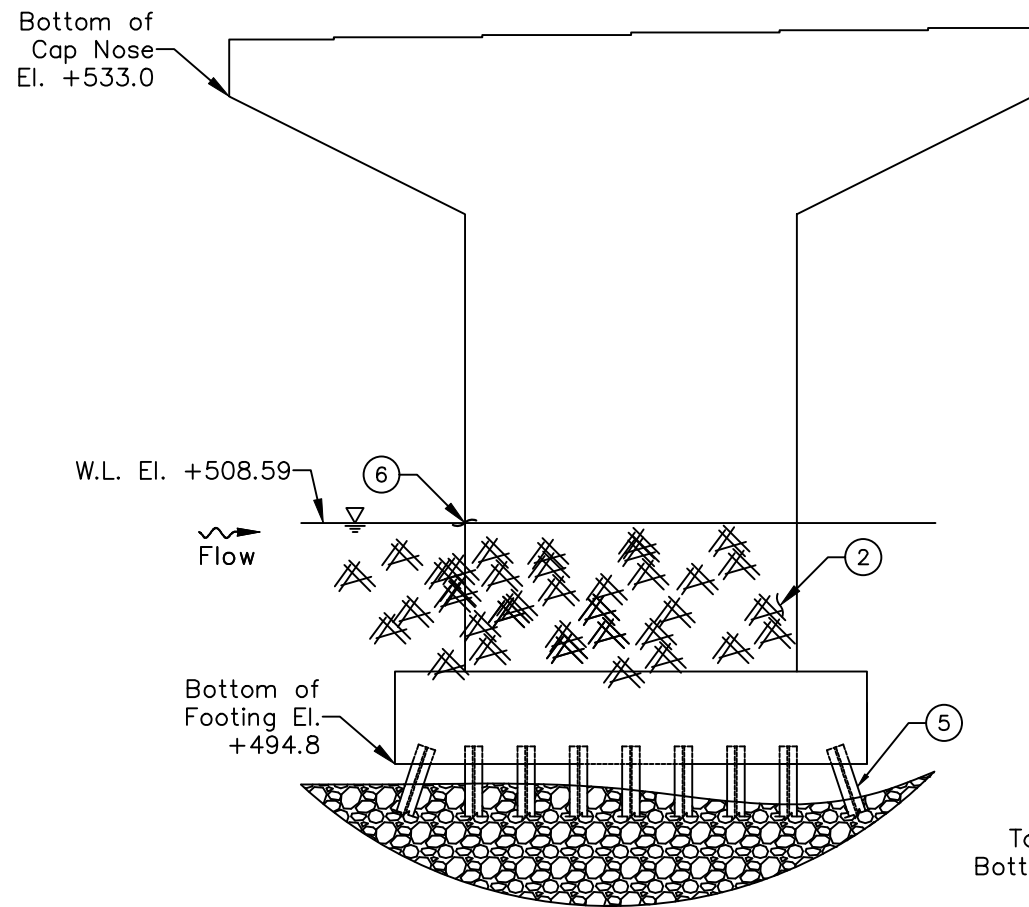
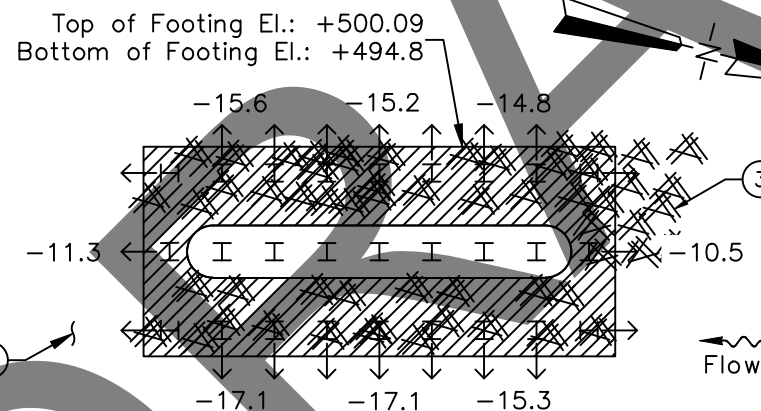
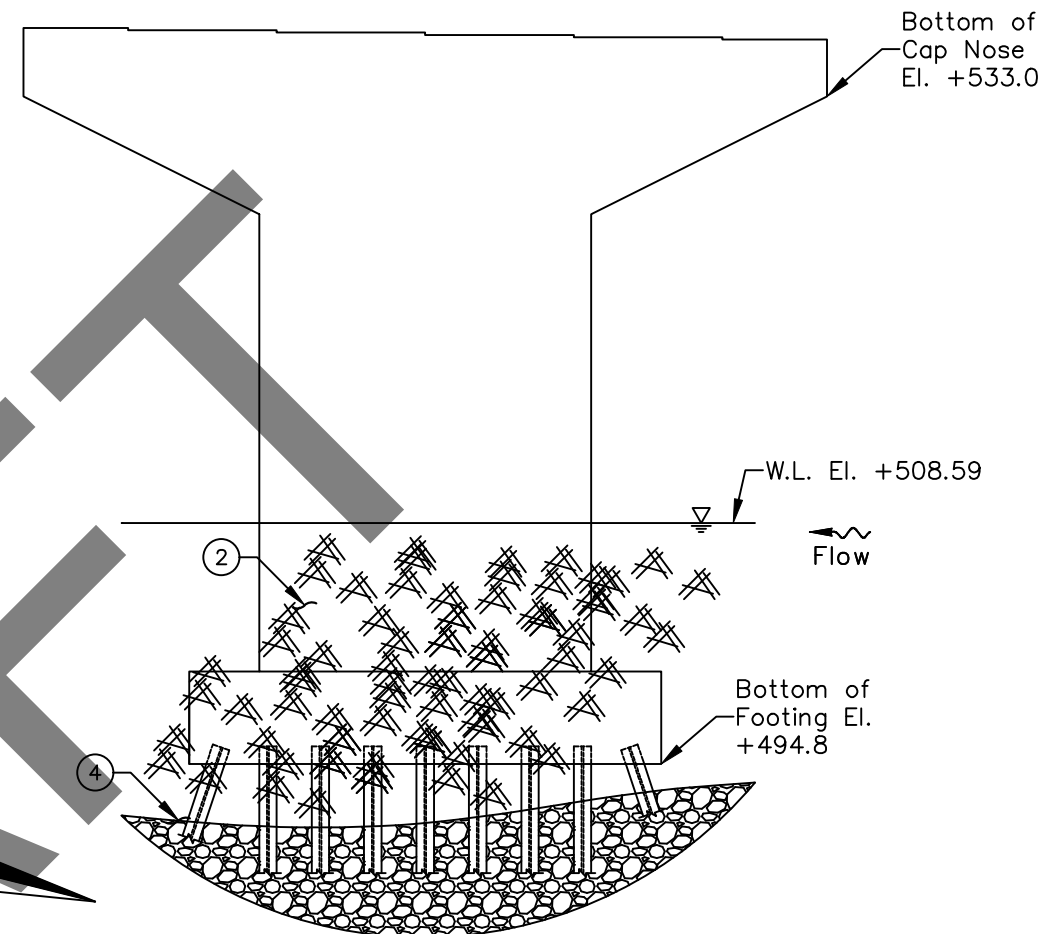
Undermining Measurements	
Location	Vertical Exposure (ft)
Northeast Corner	1.5
East Face	3.5
Southeast Corner	4.8
North Face	1.0
South Face	4.7
West Face	1.6

- ① The channel bottom material around Pier 1 consisted of boulders up to 6 in. diameter with sand in-fill and no probe rod penetration.
- ② The submerged portions of the pier exhibited light scaling up to 1/16 in. deep extending from the channel bottom to the waterline.

- ③ Heavy timber debris accumulation consisting of branches up to 3 in. diameter was observed along the entire west and east face of the pier. A timber log up to 2 ft diameter was observed wrapped around the upstream nose of the pier located approximately 3 ft below the waterline.

- ④ A scour depression with undermining up to 4.8 ft vertical was observed around the entire pier at Pier 1. The pier is pile supported, and the piles were adequately embedded in the channel bottom at the time of inspection.

- ⑤ The exposed steel H-piles typically exhibited rust nodules up to 1/2 in. diameter with up to 1/8 in. section loss.
- ⑥ The flow angle of attack was observed to be striking the northeast corner approximately 10 degrees off the upstream nose of Pier 1.

- Perform structural analysis to determine stability at Pier 1 due to undermining.
- Replace lost bearing material with backfill and place properly designed riprap around Pier 1.
- Consider river training devices such as spur dikes to reduce scour at Pier 1.
- Create a scour POA until the repairs have been completed.
- Remove timber debris at Piers 1 and 2.
- Monitor the channel bottom.

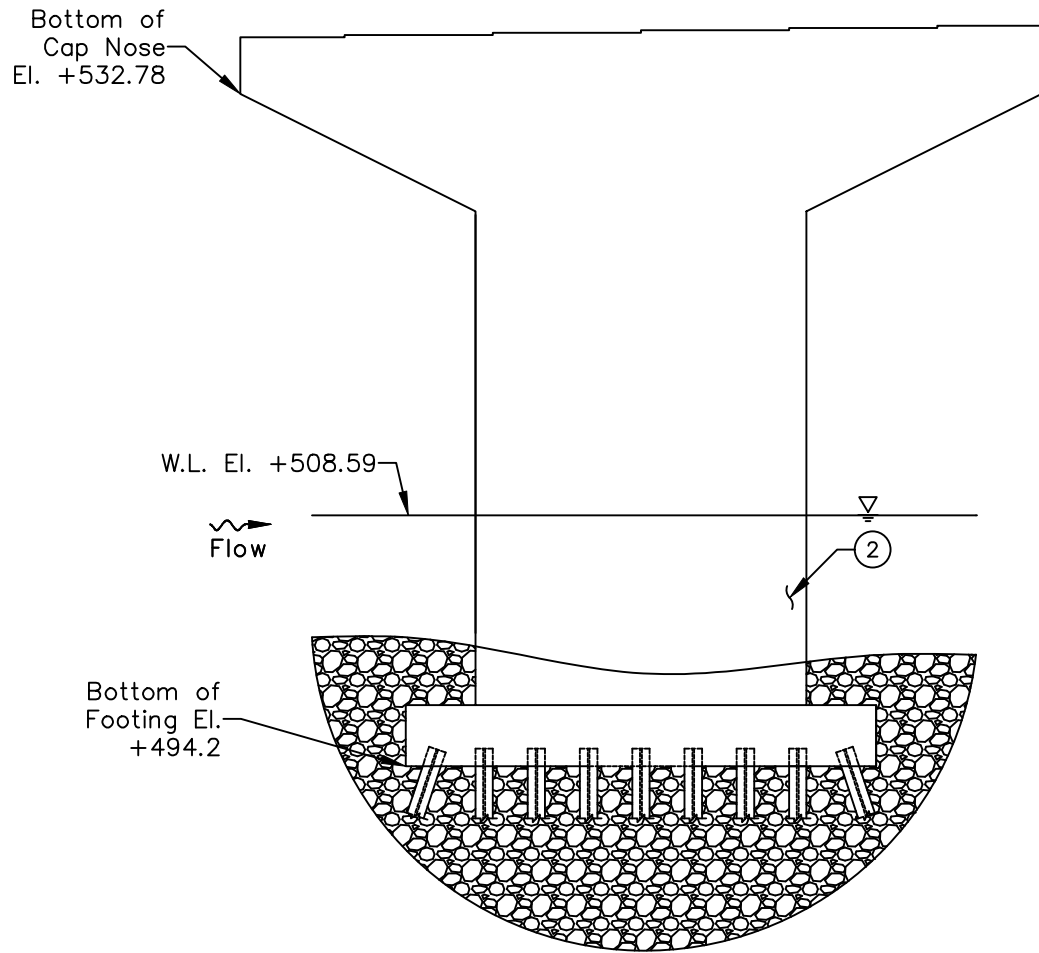
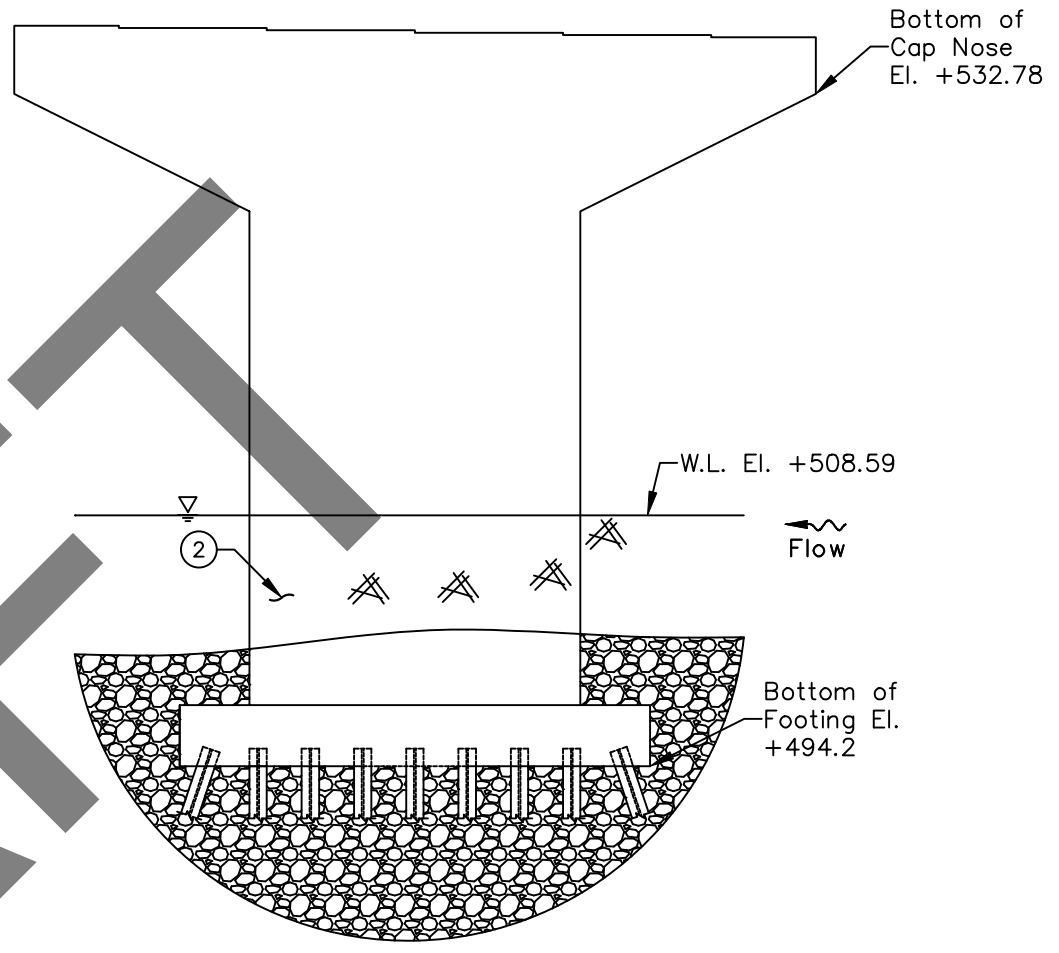
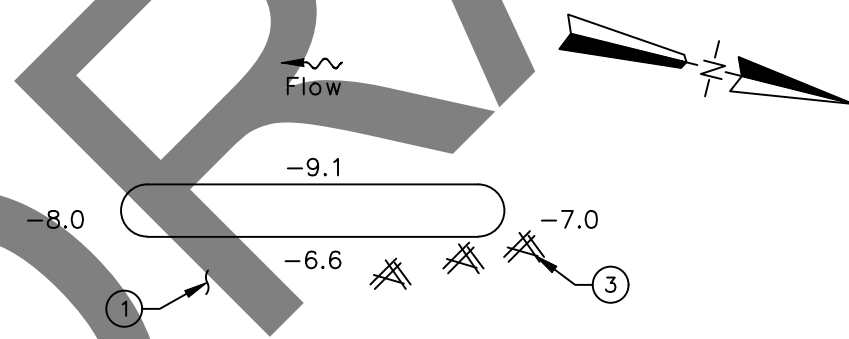
SR-348 OVER SCIOTO RIVER
STRUCTURE NO. 7305796
PIER 2
SCIOTO COUNTY, OHIO

- ① The channel bottom material around Pier 2 consisted of boulders up to 6 in. diameter with sand in-fill and no probe rod penetration.
- ② The submerged portions of the pier exhibited light scaling up to 1/16 in. deep extending from the channel bottom to the waterline.
- ③ A timber log up to 3 ft diameter was observed from the upstream nose along the east face of the pier.

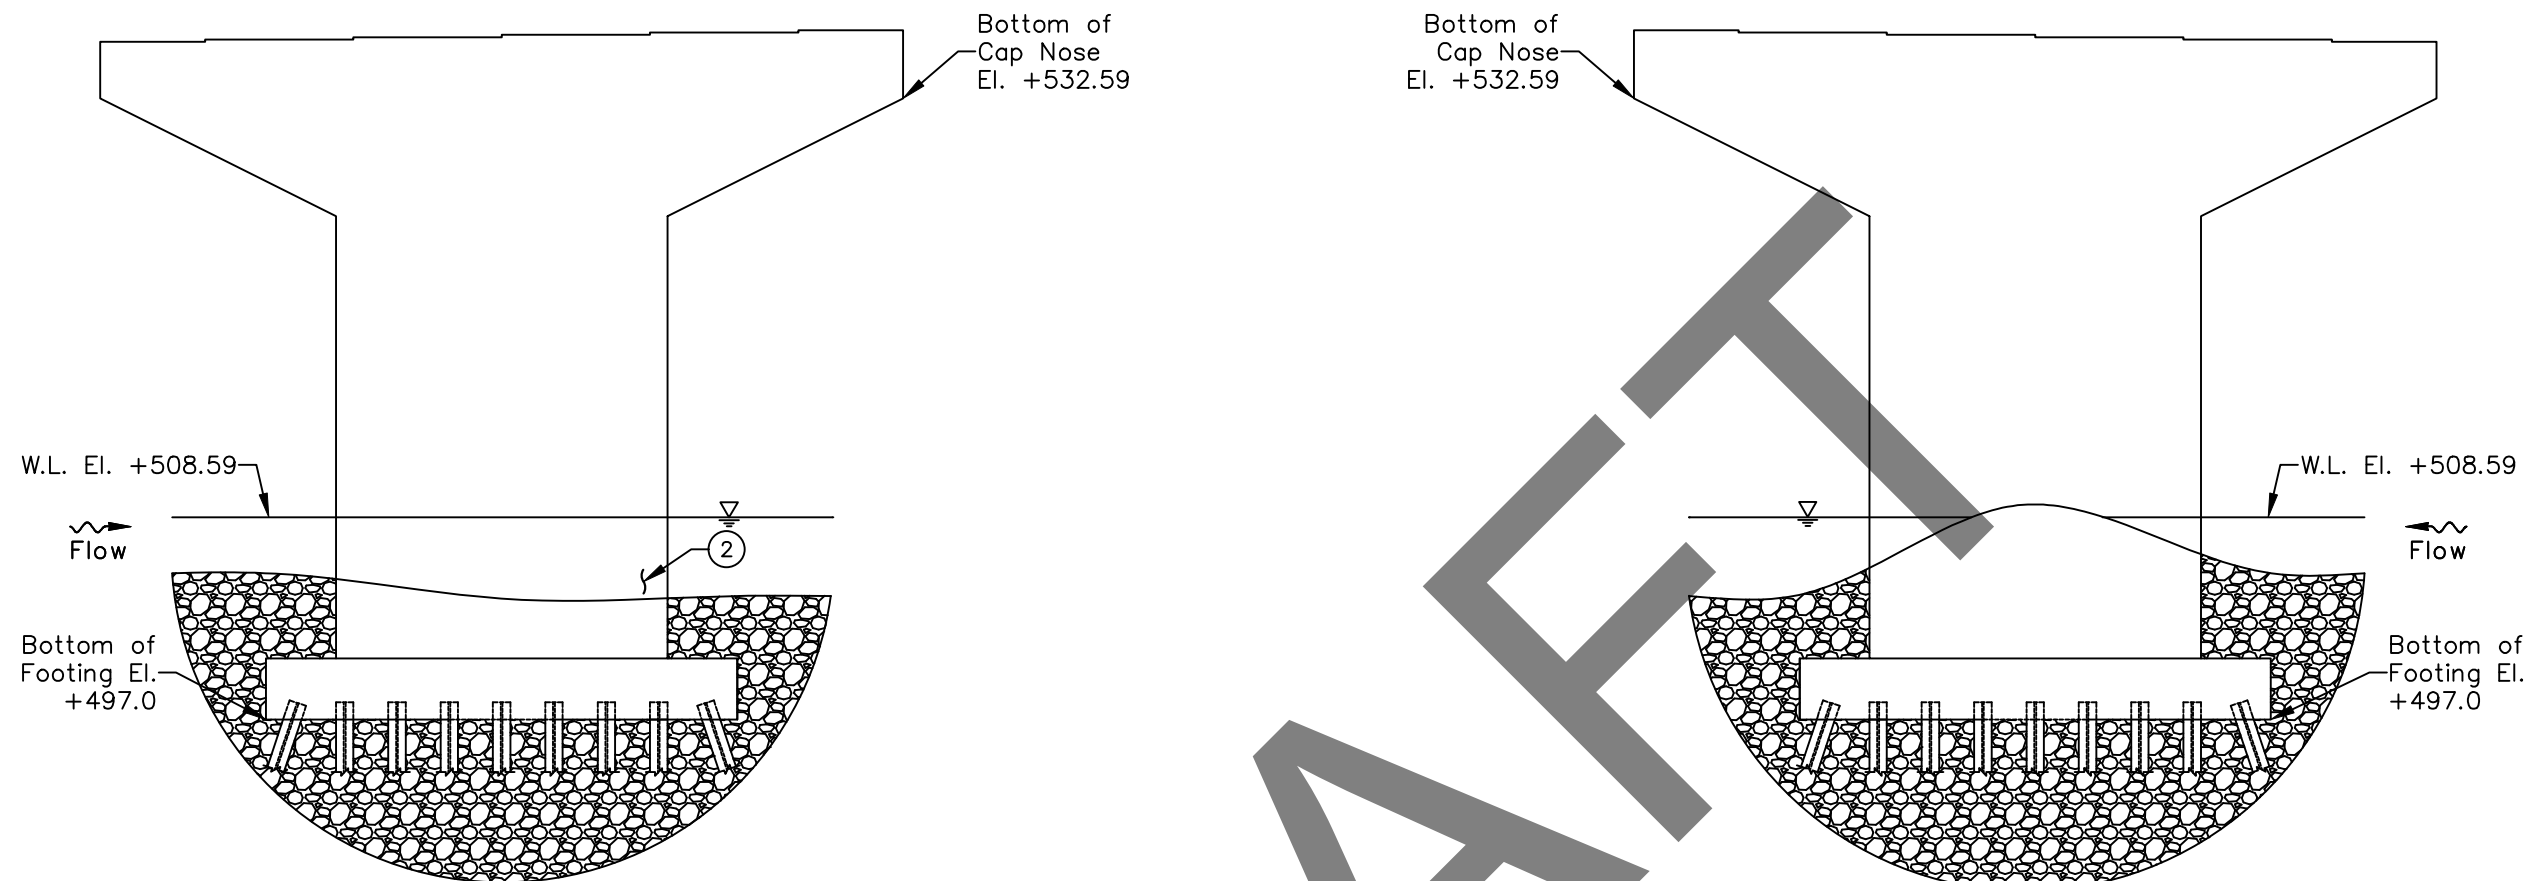
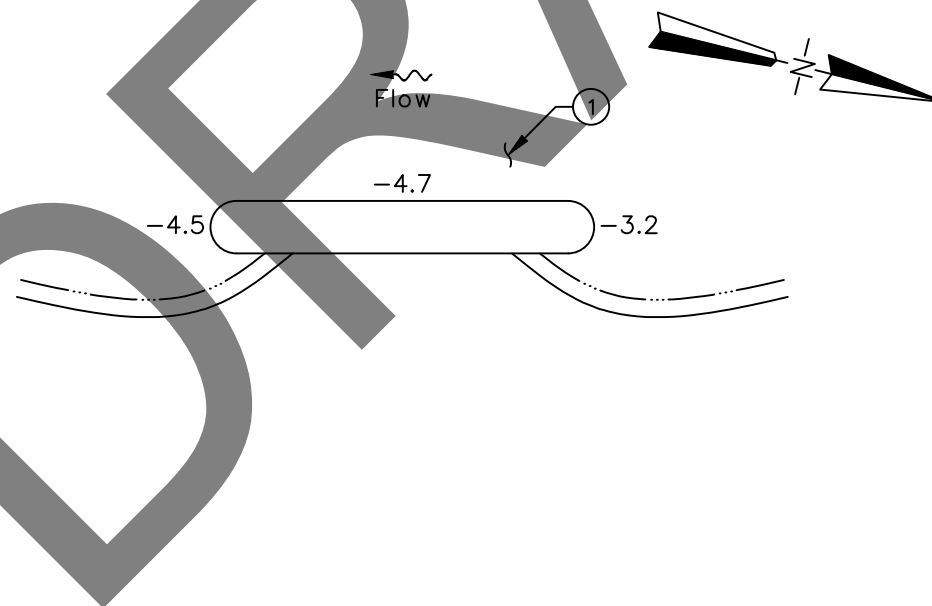
- ① The channel bottom material around Pier 3 consisted of boulders up to 6 in. diameter with sand in-fill and no probe rod penetration.
- ② The submerged portions of the pier exhibited light scaling up to 1/16 in. deep extending from the channel bottom to the waterline.

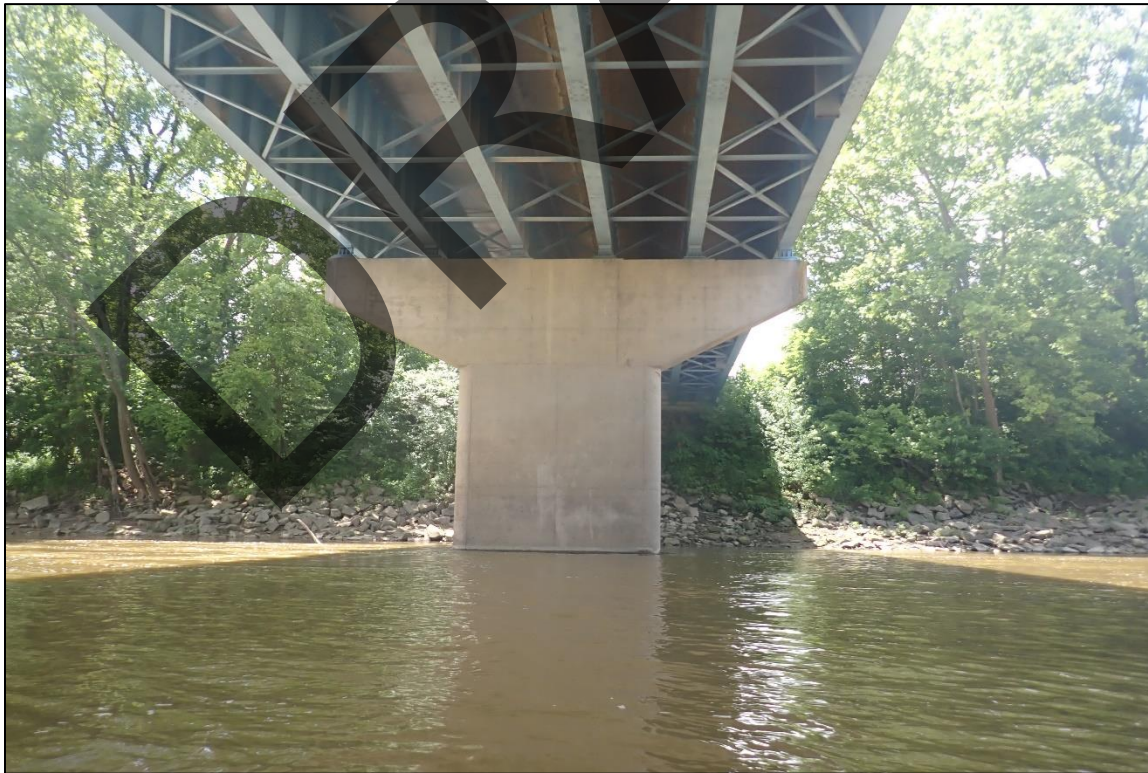
The channel bottom material around Pier 1 consisted of boulders up to 6 in. diameter with sand in-fill and no probe rod penetration. The submerged portions of the pier exhibited light scaling up to 1/16 in. deep extending from the channel bottom to the waterline. Heavy timber debris accumulation consisting of branches up to 3 in. diameter was observed along the entire west and east face of the pier, and a timber log up to 2 ft diameter was observed wrapped around the upstream nose of the pier located approximately 3 ft below the waterline. A scour depression with undermining up to 4.8 ft vertical was observed around the entire pier at Pier 1. The pier is pile supported, and the piles were adequately embedded in the channel bottom at the time of inspection. The exposed steel H-piles typically exhibited rust nodules up to 1/2 in. diameter with up to 1/8 in. section loss. Refer to Figure 7 in Exhibit 1 for detailed inspection notes of Pier 1. Refer to Photographs 14 through 16 in Exhibit 2 for views of Pier 1 and typical concrete condition below the waterline.

Photograph No. 14: View of the East Face of Pier 1, Looking West.

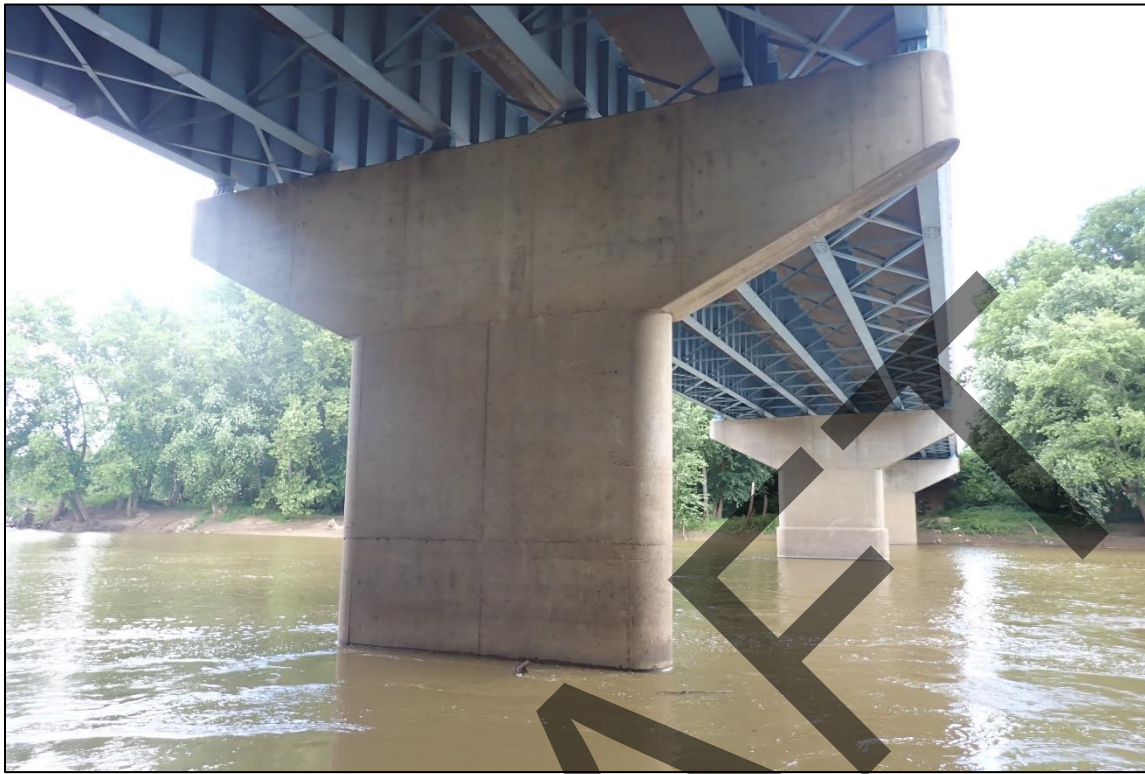
Photograph No. 15: View of the West Face of Pier 1, Looking Northeast.

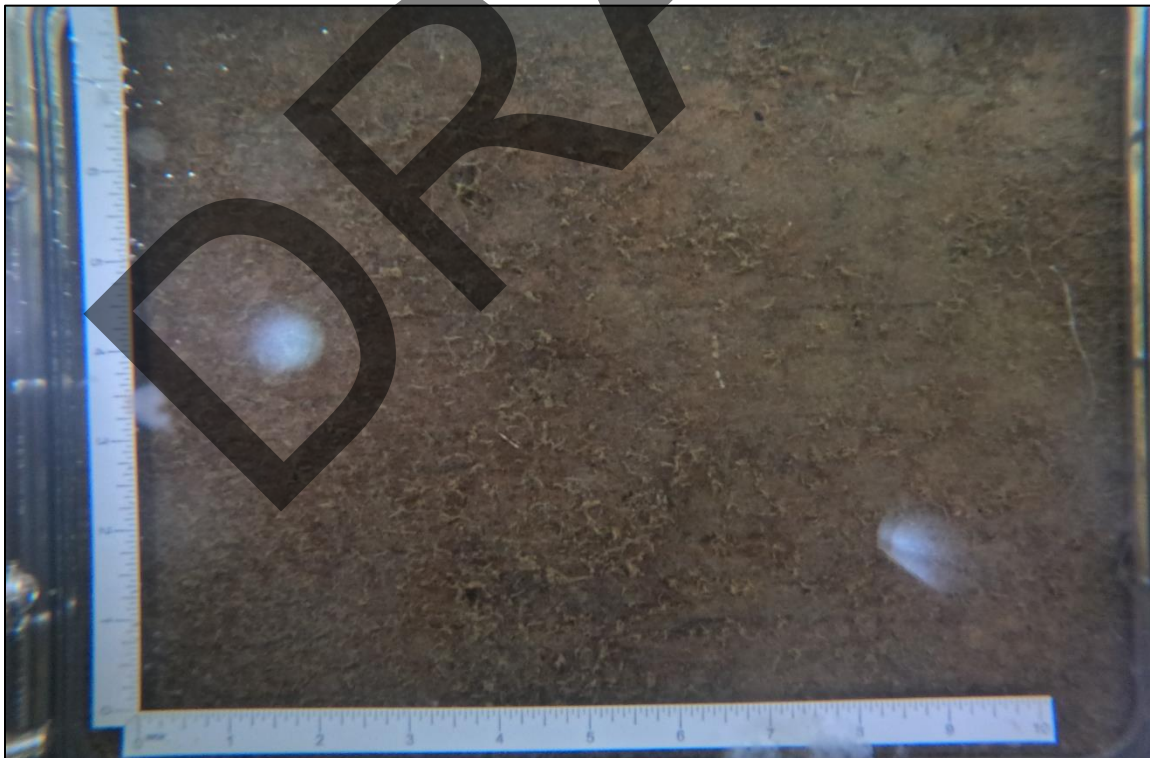
Photograph No. 16: View of the Typical Concrete Condition Below the Waterline, Looking East.

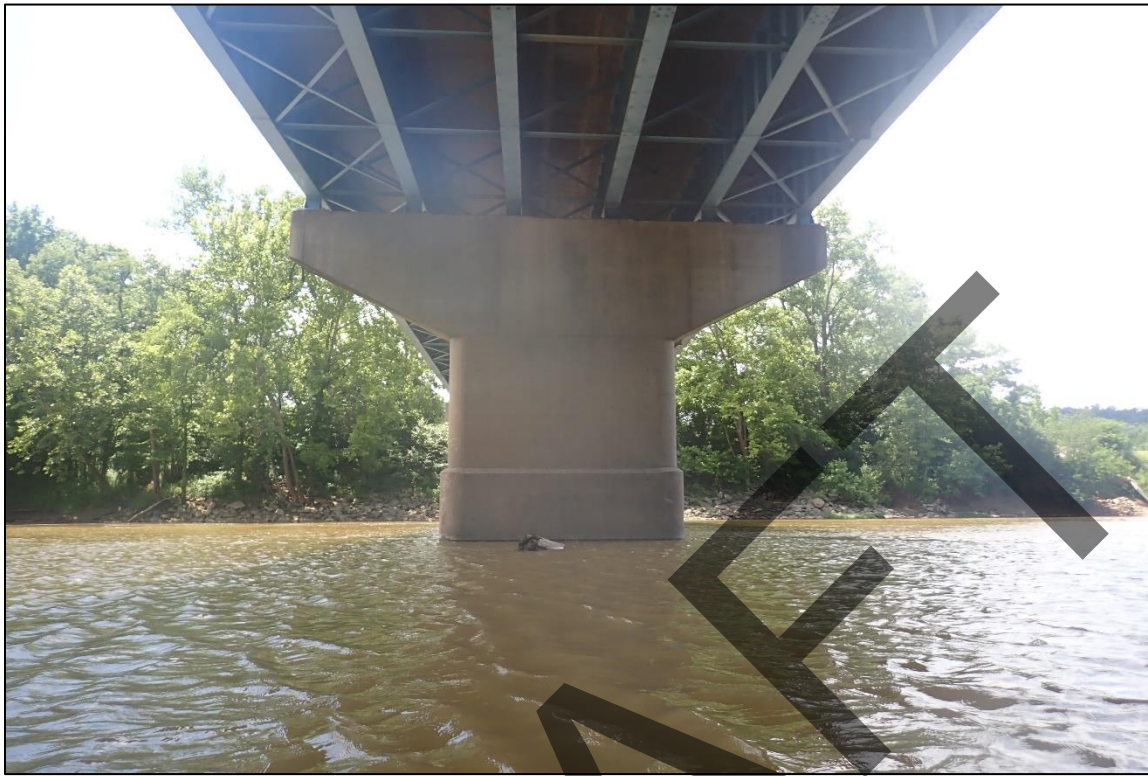
The channel bottom material around Pier 2 consisted of boulders up to 6 in. diameter with sand in-fill and no probe rod penetration. The submerged portions of the pier exhibited light scaling up to 1/16 in. deep extending from the channel bottom to the waterline. A timber log up to 3 ft diameter was observed from the upstream nose along the east face of the pier. Refer to Figure 8 in Exhibit 1 for detailed inspection notes of Pier 2. Refer to Photographs 17 and 18 in Exhibit 2 for views of Pier 2.

Photograph No. 17: View of the East Face of Pier 2, Looking West.

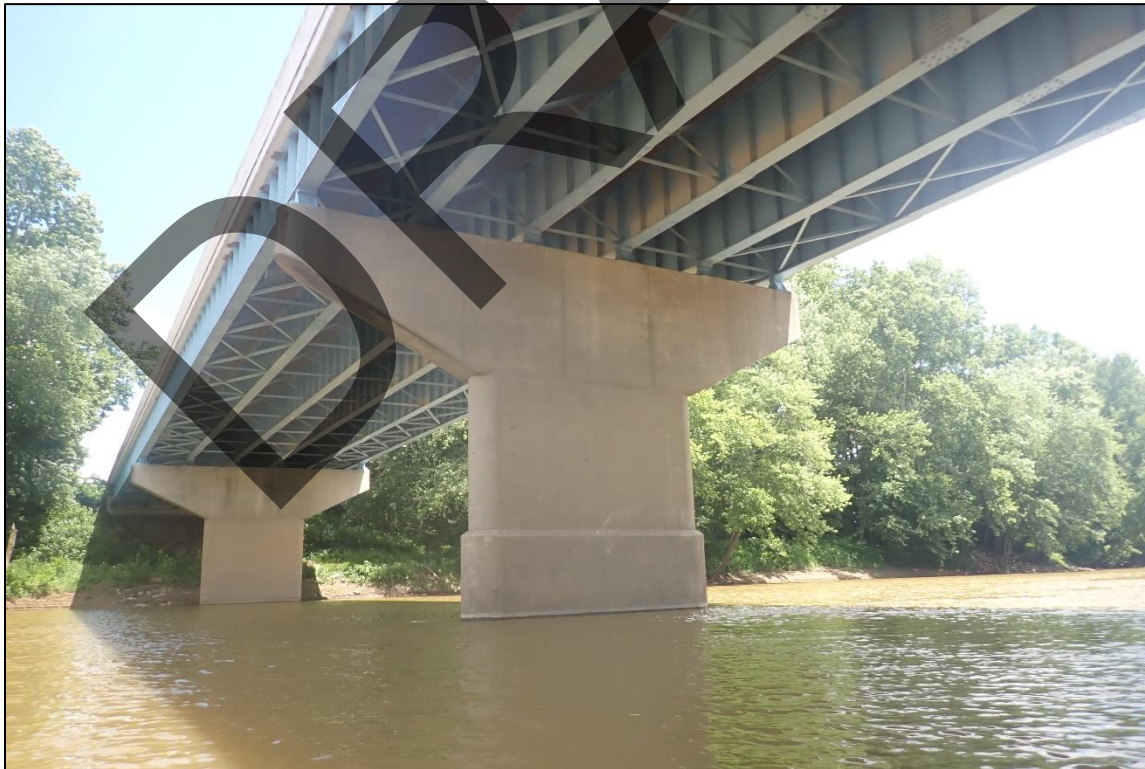
Photograph No. 18: View of the West Face of Pier 2, Looking Southeast.

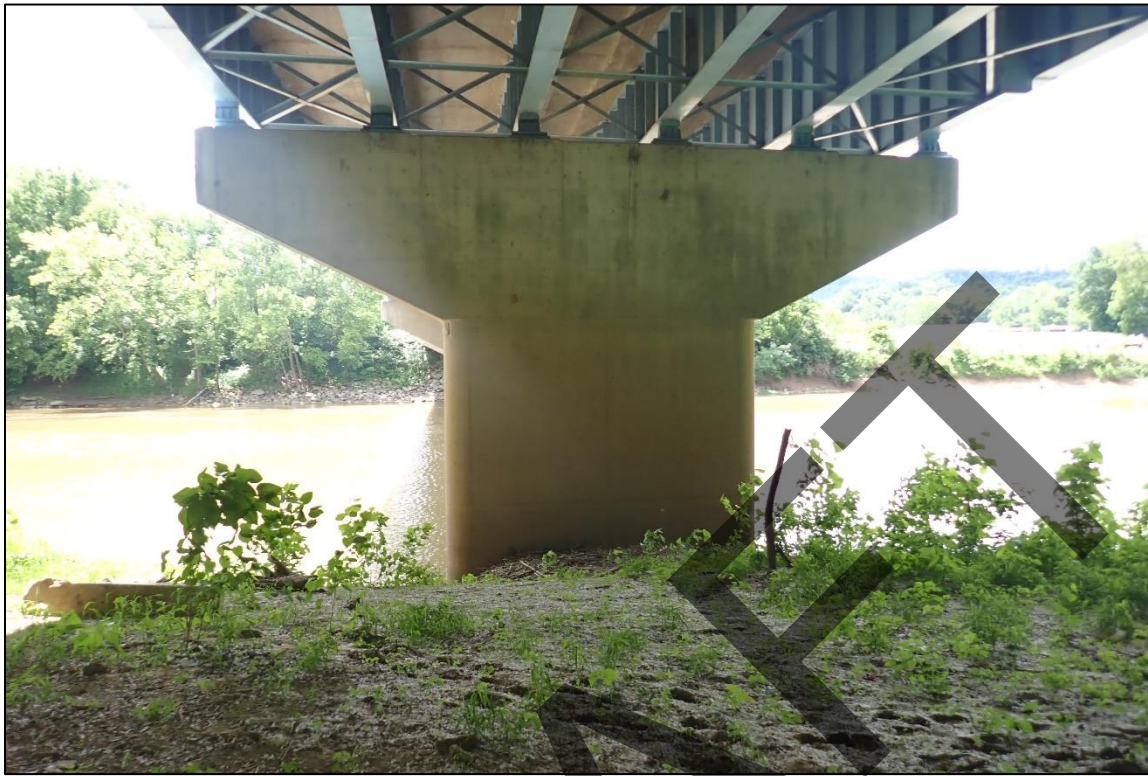
The channel bottom material around Pier 3 consisted of boulders up to 6 in. diameter with sand in-fill and no probe rod penetration. The submerged portions of the pier exhibited light scaling up to 1/16 in. deep extending from the channel bottom to the waterline. Refer to Figure 9 in Exhibit 1 for detailed inspection notes of Pier 3. Refer to Photographs 19 and 20 in Exhibit 2 for views of Pier 3.

Photograph No. 19: View of the East Face of Pier 3, Looking West.

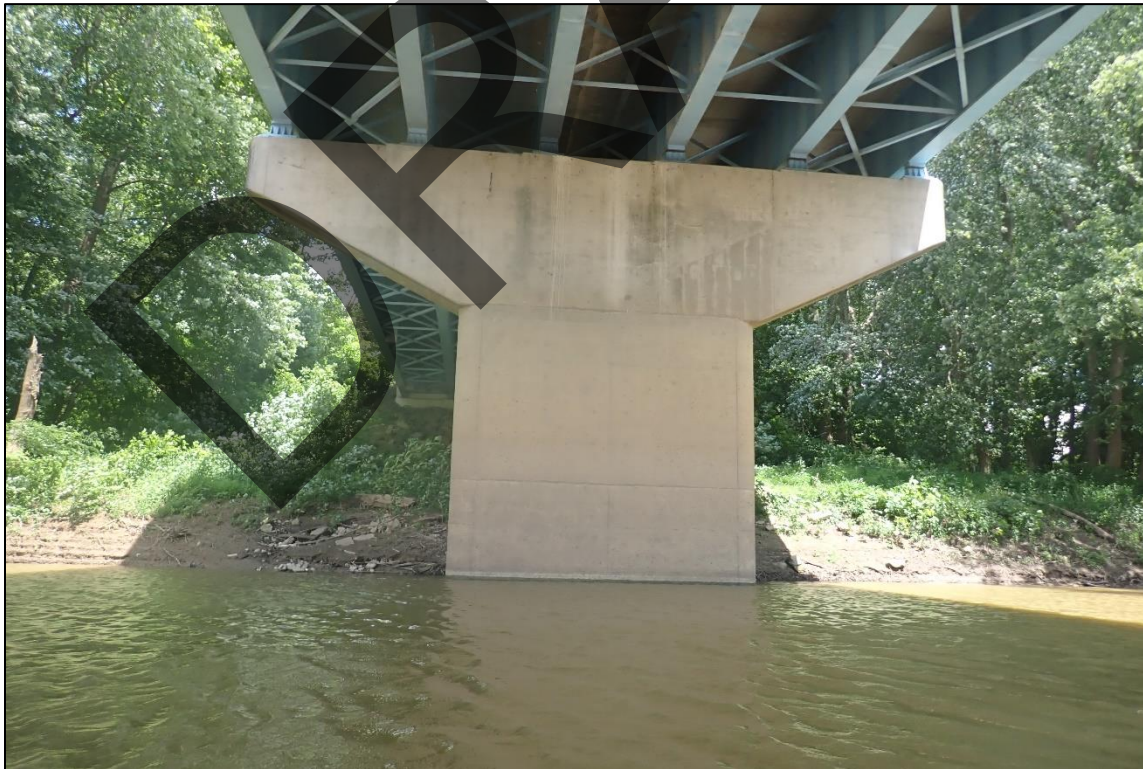
Photograph No. 20: View of the West Face of Pier 3, Looking East.
