**Baker Slope Stability Study Report
(Reference Document)**

**Innerbelt Bridge
Construction Contract Group 1 (CCG1)**

Slope Stability Evaluation Report of the West Bank

CUY-90-14.92
PID 77332

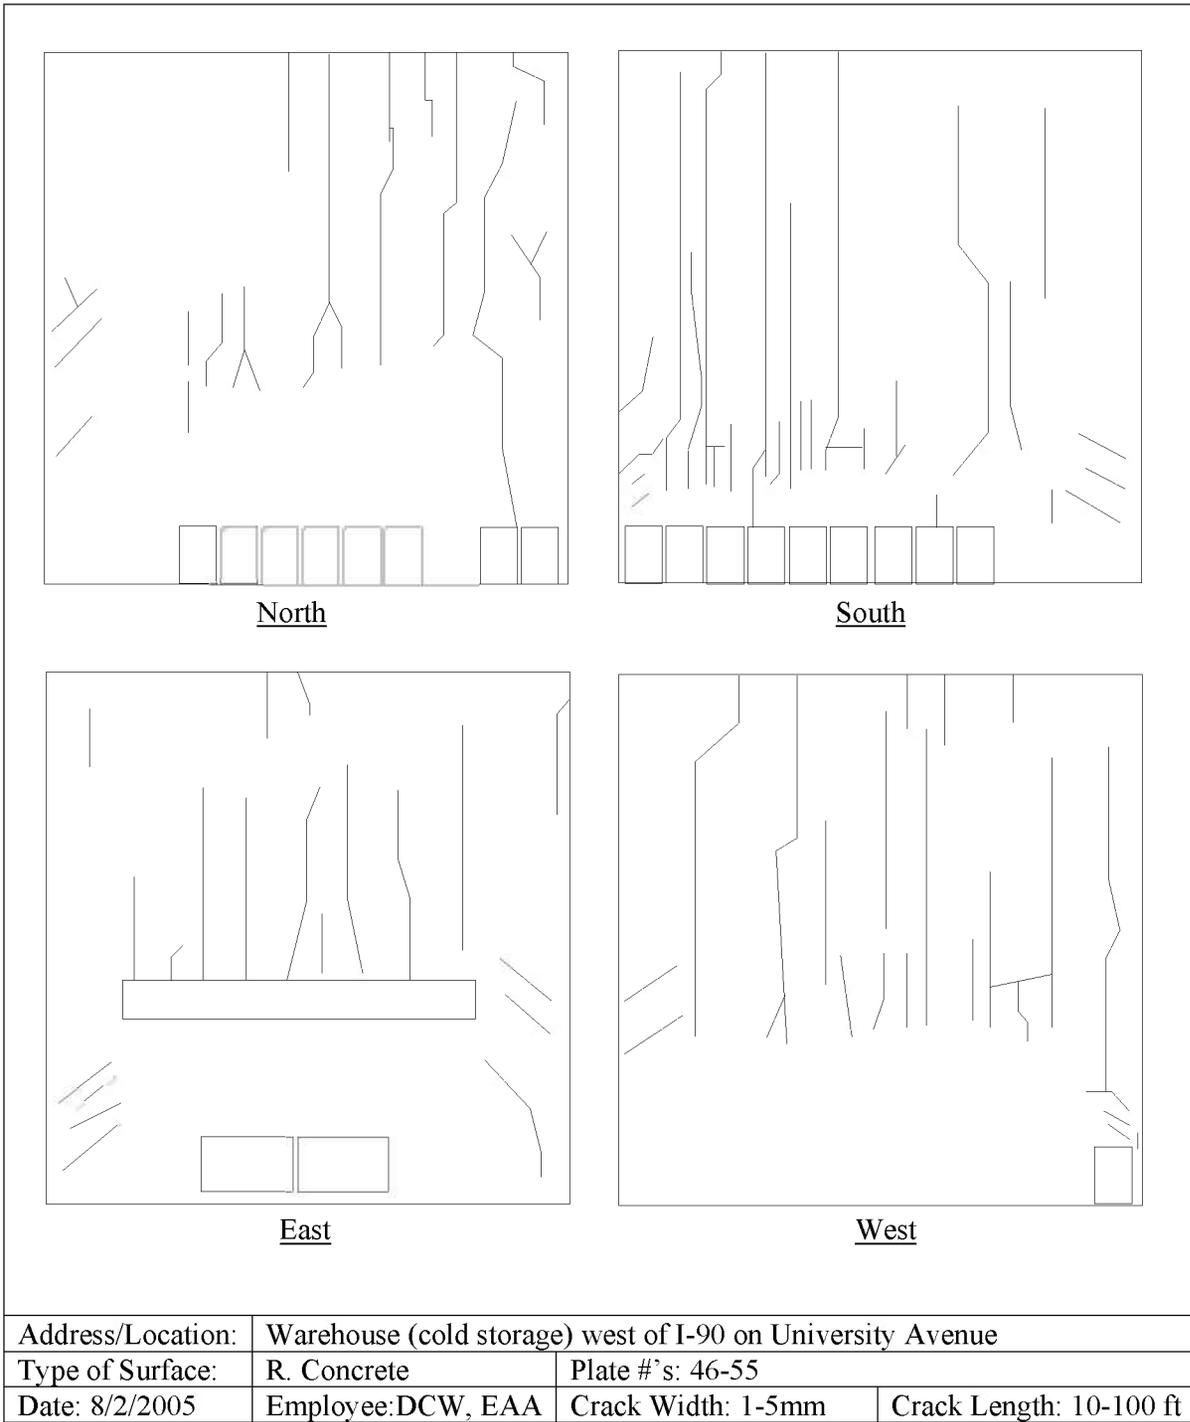
Figure 9: Crack mapping for the warehouse (cold storage) west of I-90 on University Avenue. The location and extent of the cracking is approximate only (BBCM, 2005b).

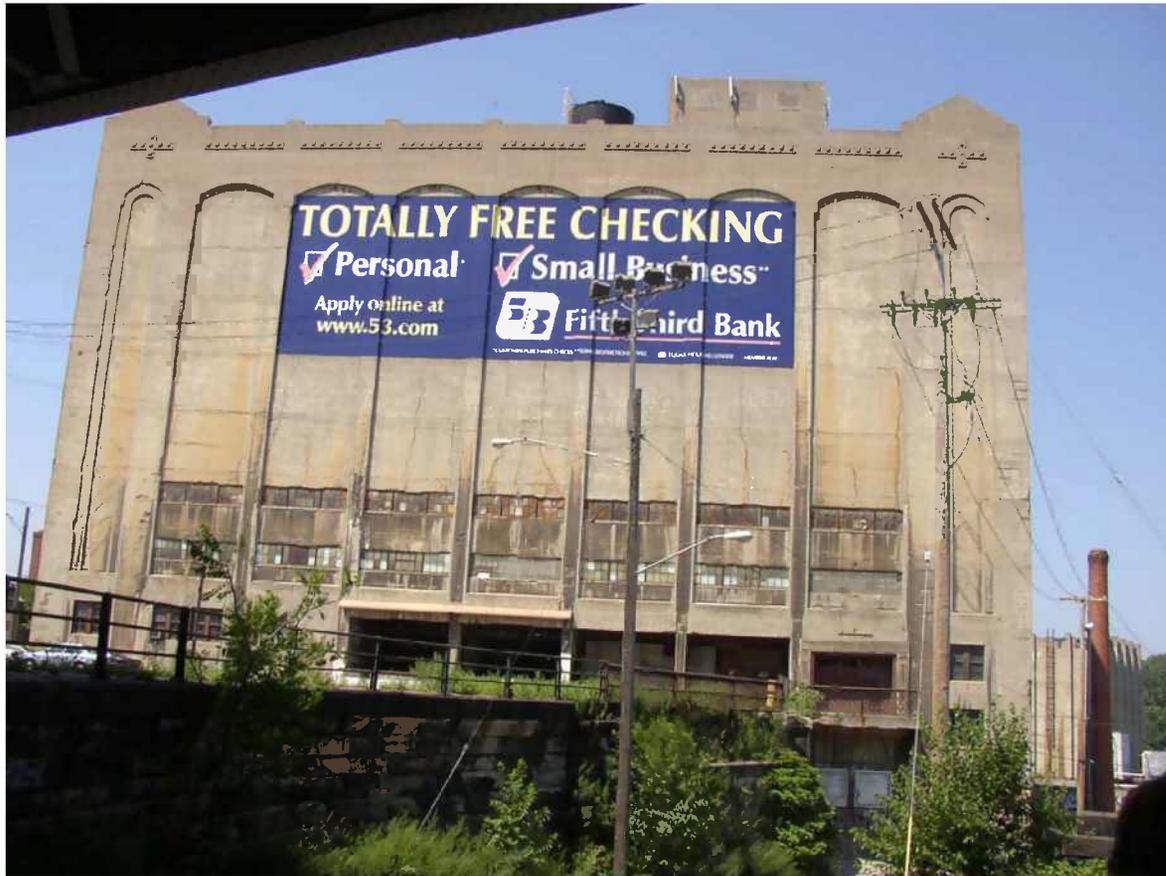
Figure 10: Warehouse (cold storage) west of I-90 on University Avenue. Photo is looking at the east wall of the warehouse (BBCM, 2005b).

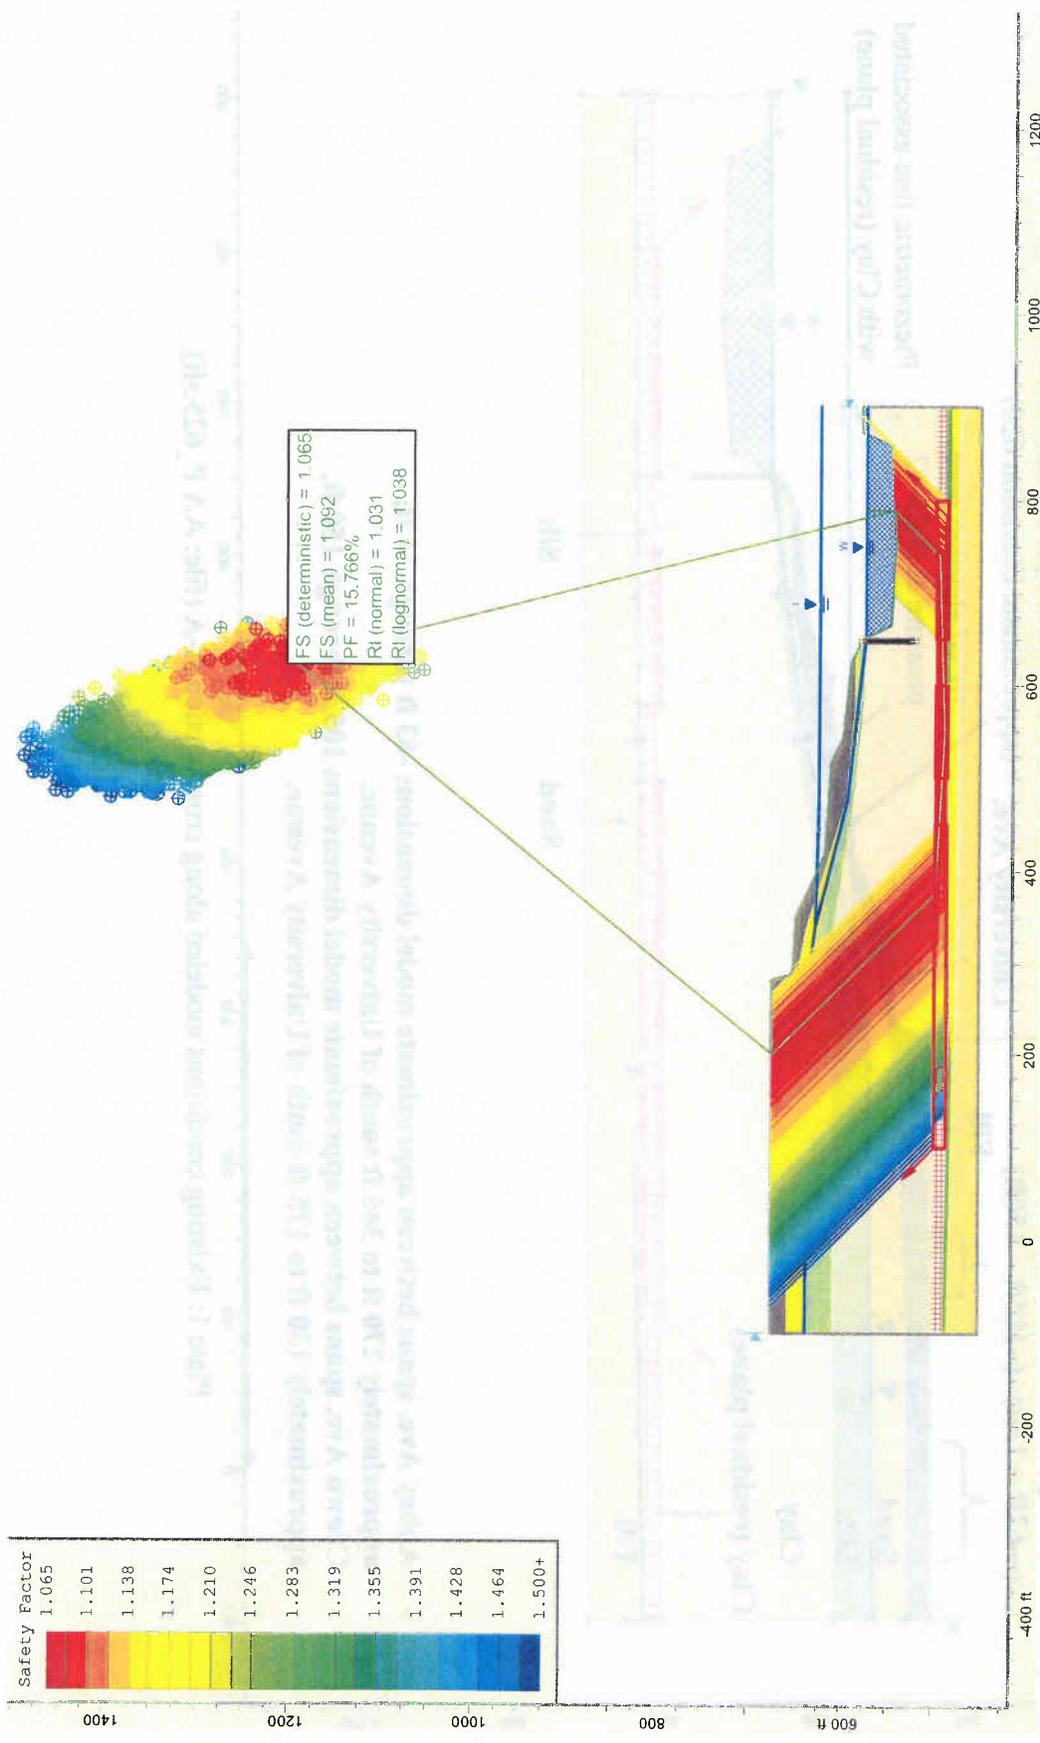
Plate 2: Results of the slope stability analysis within cross section A-A for the existing conditions (file: AA_P_625.sli). The minimum Factor of Safety equals 1.065. The estimated Factor of Safety along Abbey Ave. approximately ranges between 1.36 and 1.56.

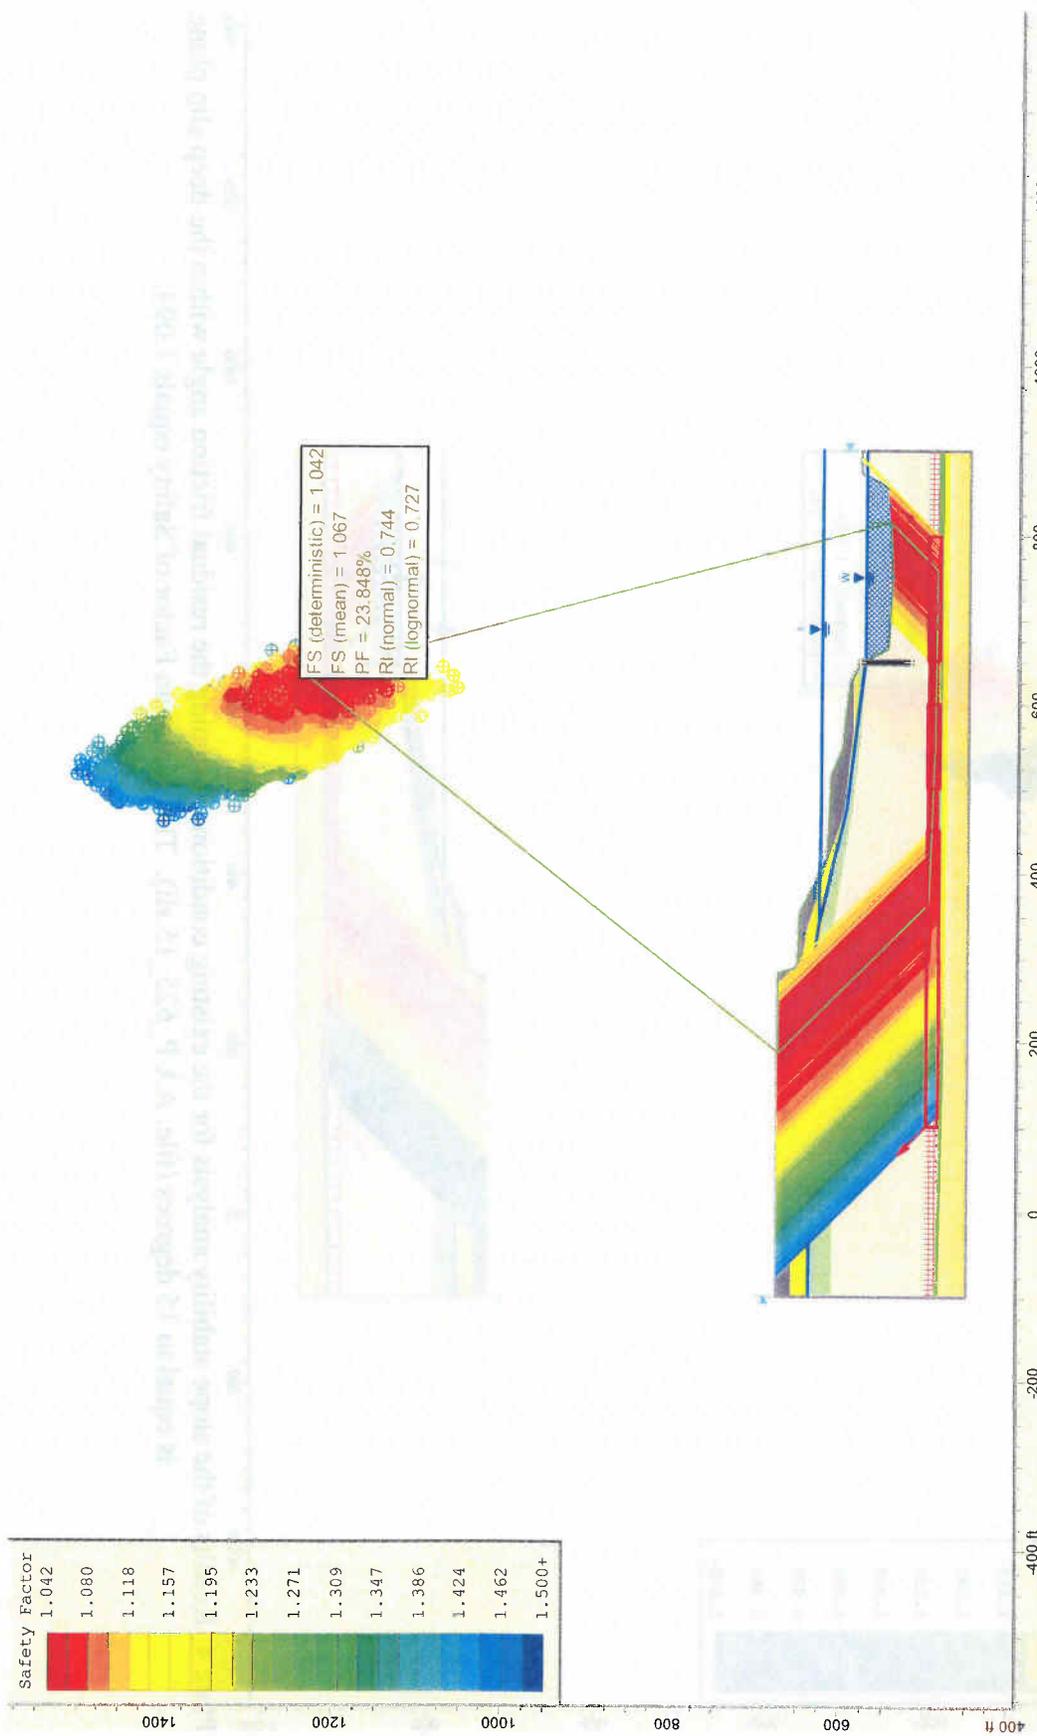
Plate 3: Results of the slope stability analysis within cross section A-A for the existing conditions assuming the residual friction angle within the deep slip plane is equal to 13 degrees (file: AA P_625_13.sli). The minimum Factor of Safety equals 1.042.

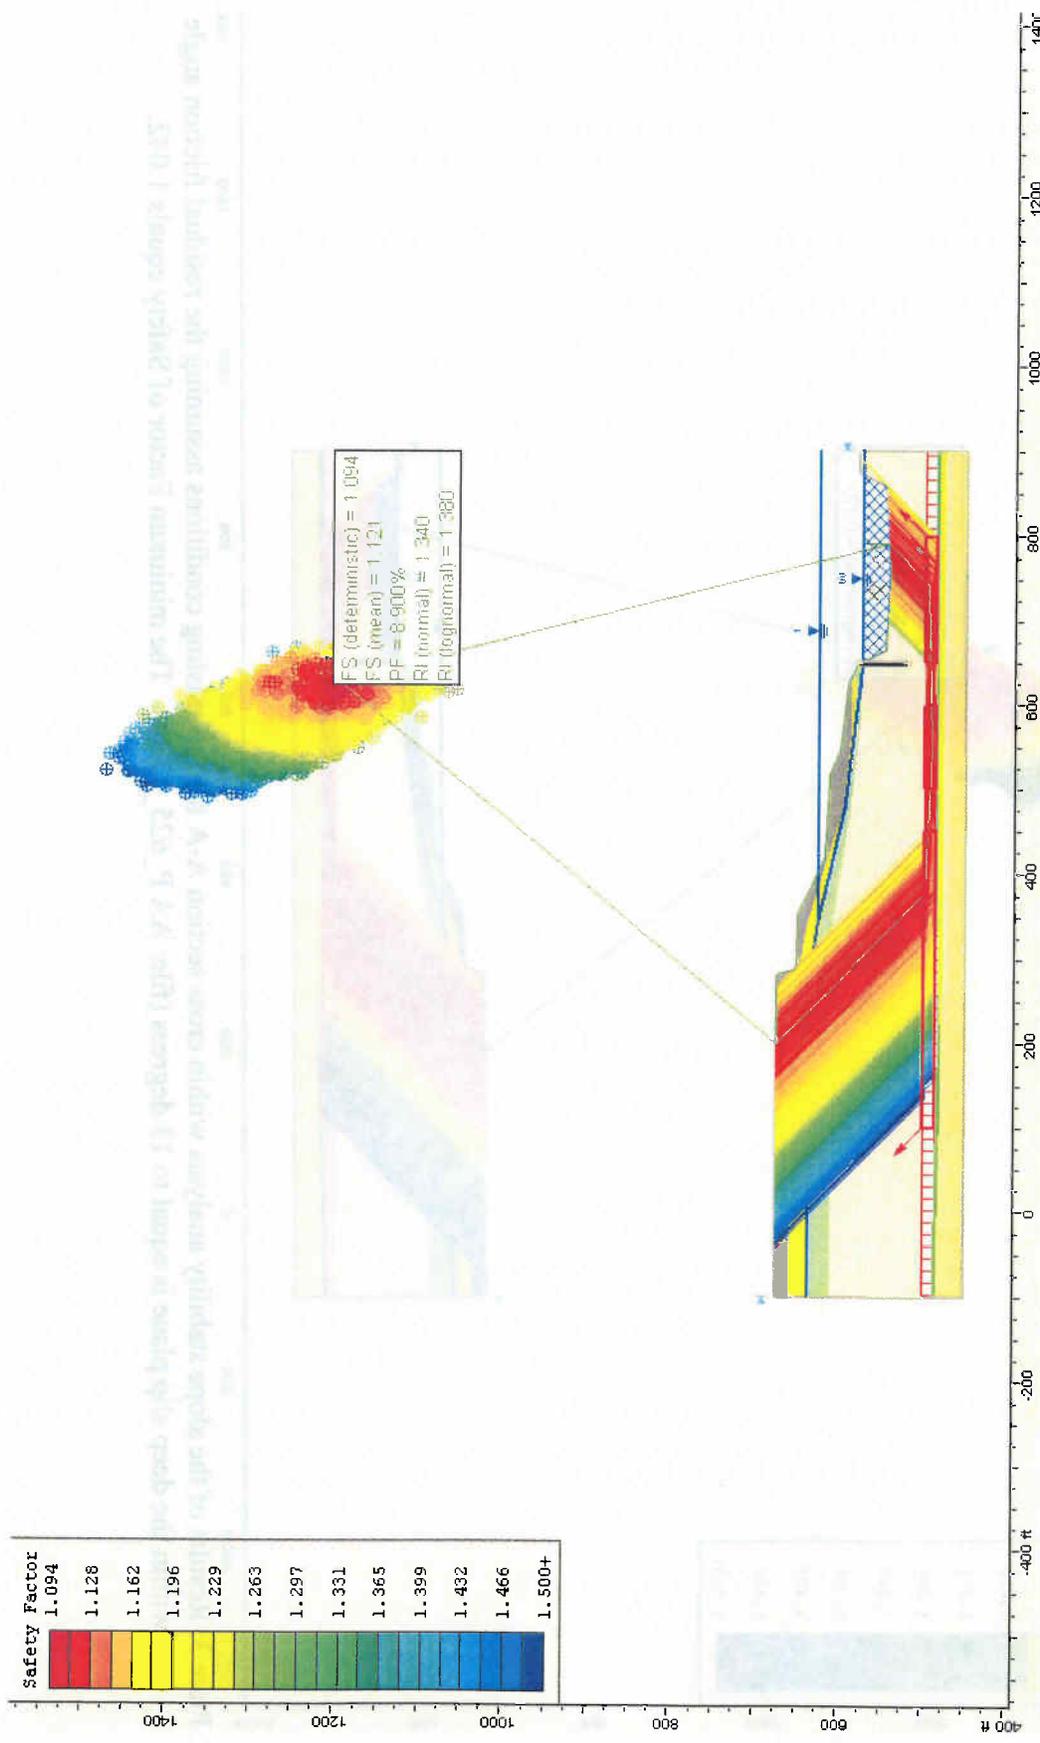
Plate 4: Results of the slope stability analysis for the existing conditions assuming the residual friction angle within the deep slip plane is equal to 15 degrees (file: AA P_625_15.sli). The minimum Factor of Safety equals 1.094.

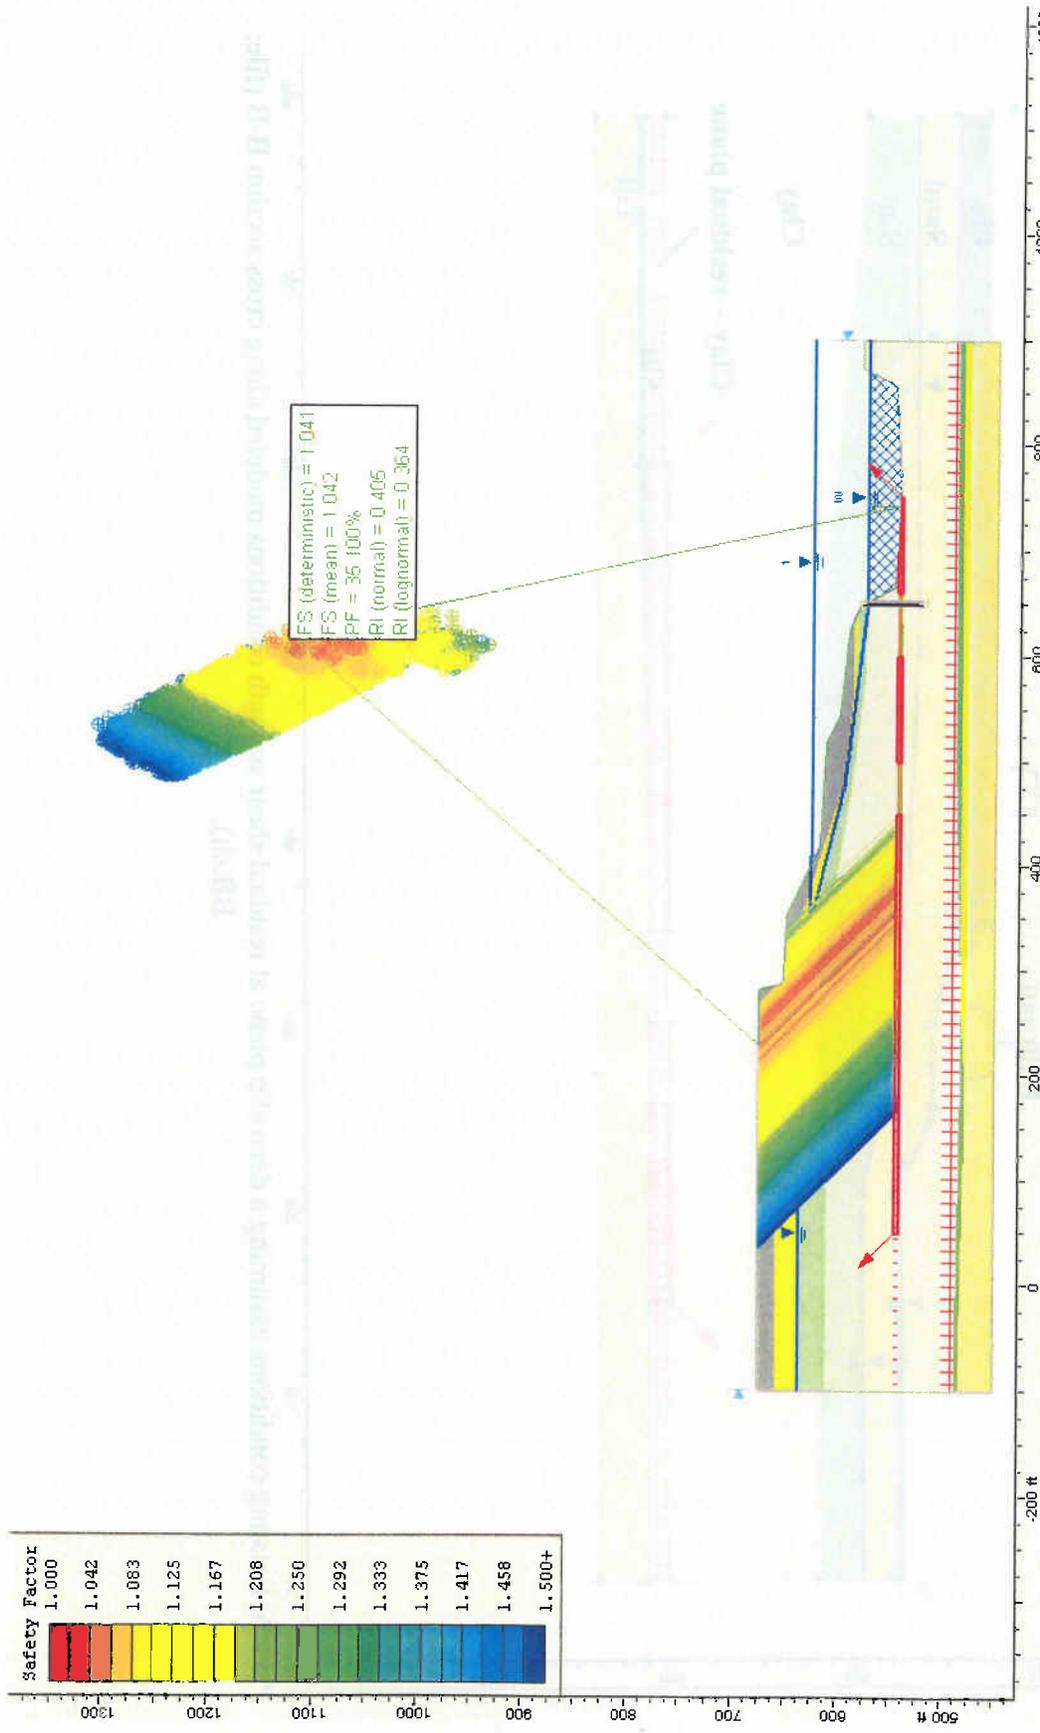
Plate 5: Results of the slope stability analysis for the existing conditions for a potential shallow slip plane (file: AA P_625SH.sli). The minimum Factor of Safety equals 1.041.

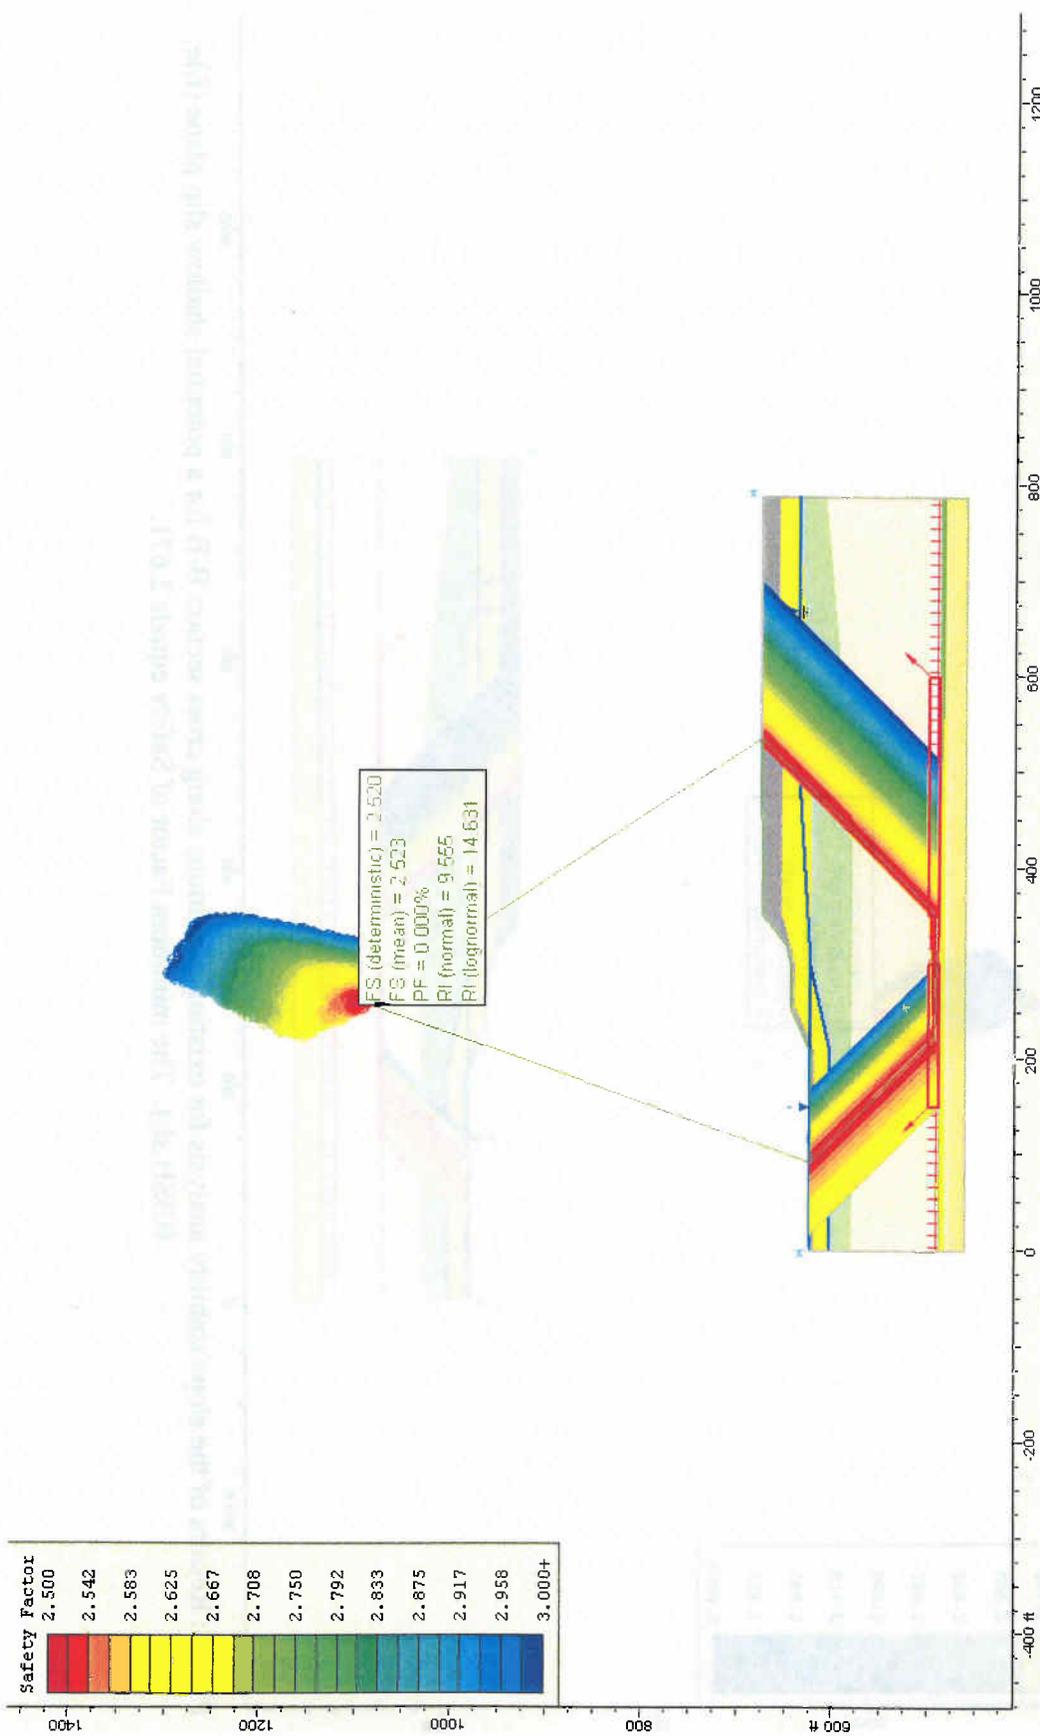
Plate 7: Results of the slope stability analyses for existing conditions along cross section B-B assuming a deep slip surface at residual shear strength conditions (file: BB.sli). The minimum Factor of Safety equals 2.52. The results presented were obtained by using the Simplified Janbu method instead of the Spencer method since the resulting Factor of Safety exceeds the allowable maximum Factor of Safety produced by the Spencer method.

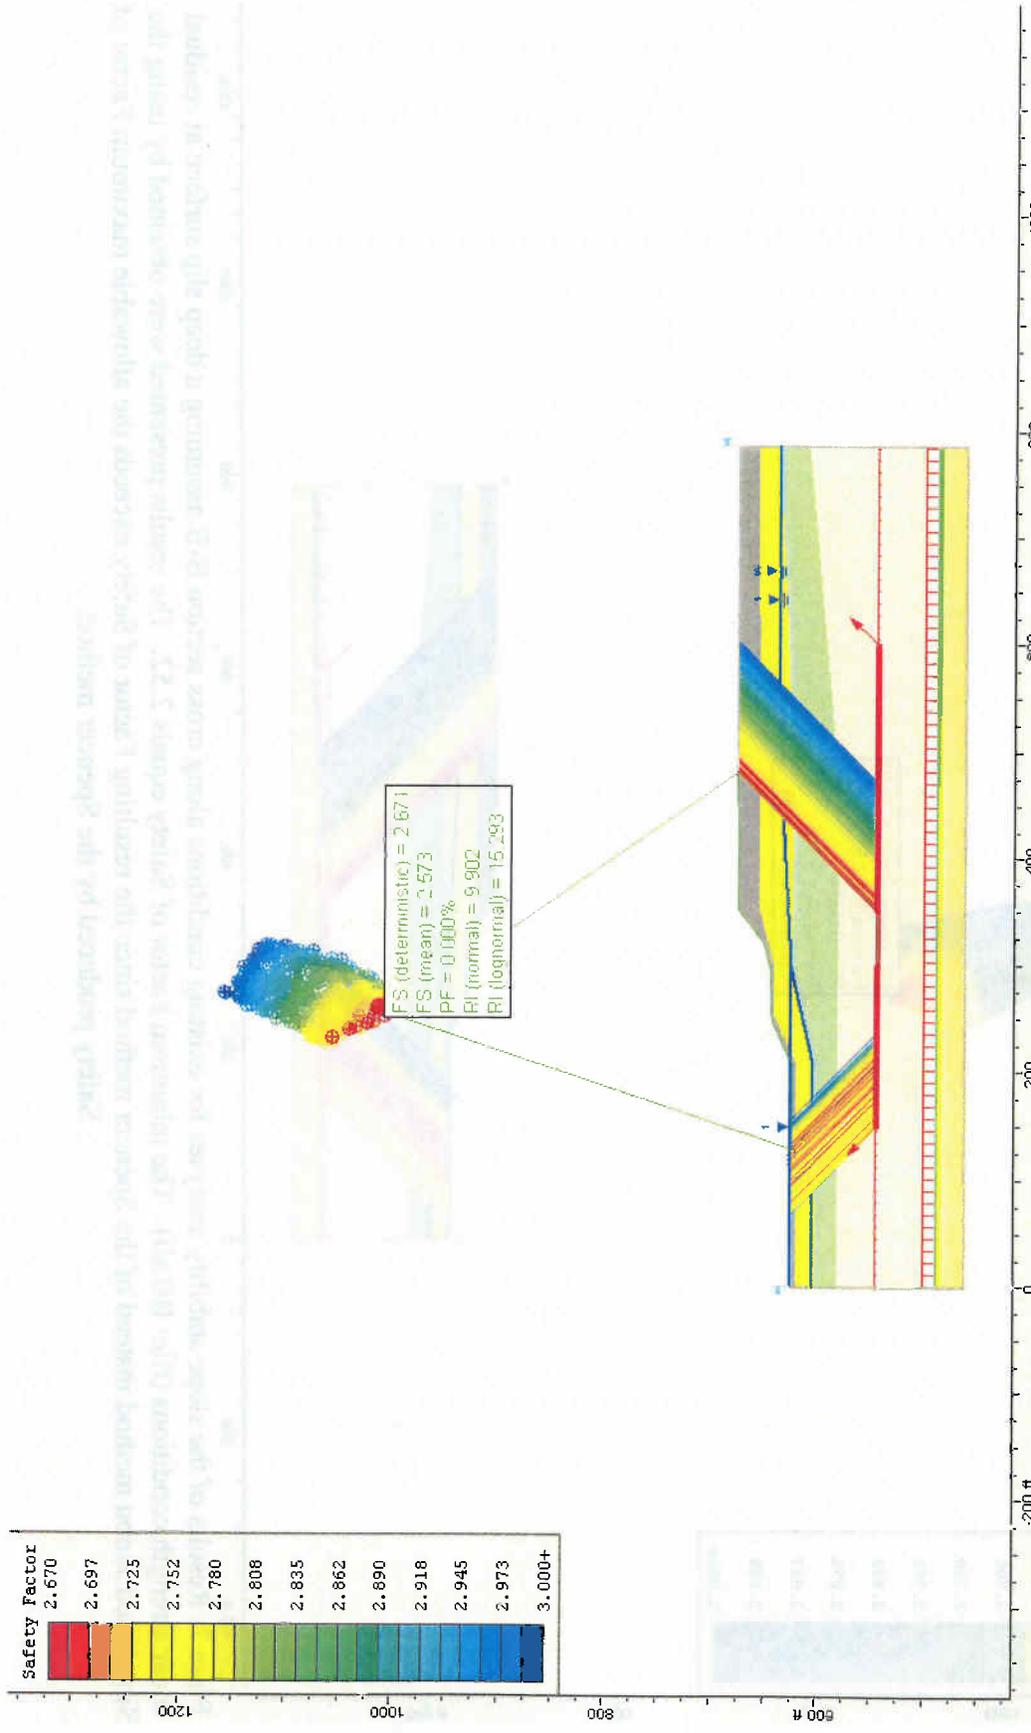
Plate 8: Results of the slope stability analysis for existing conditions along cross section B-B for a potential shallow slip plane (file: BBSH.sli). The minimum Factor of Safety equals 2.671.

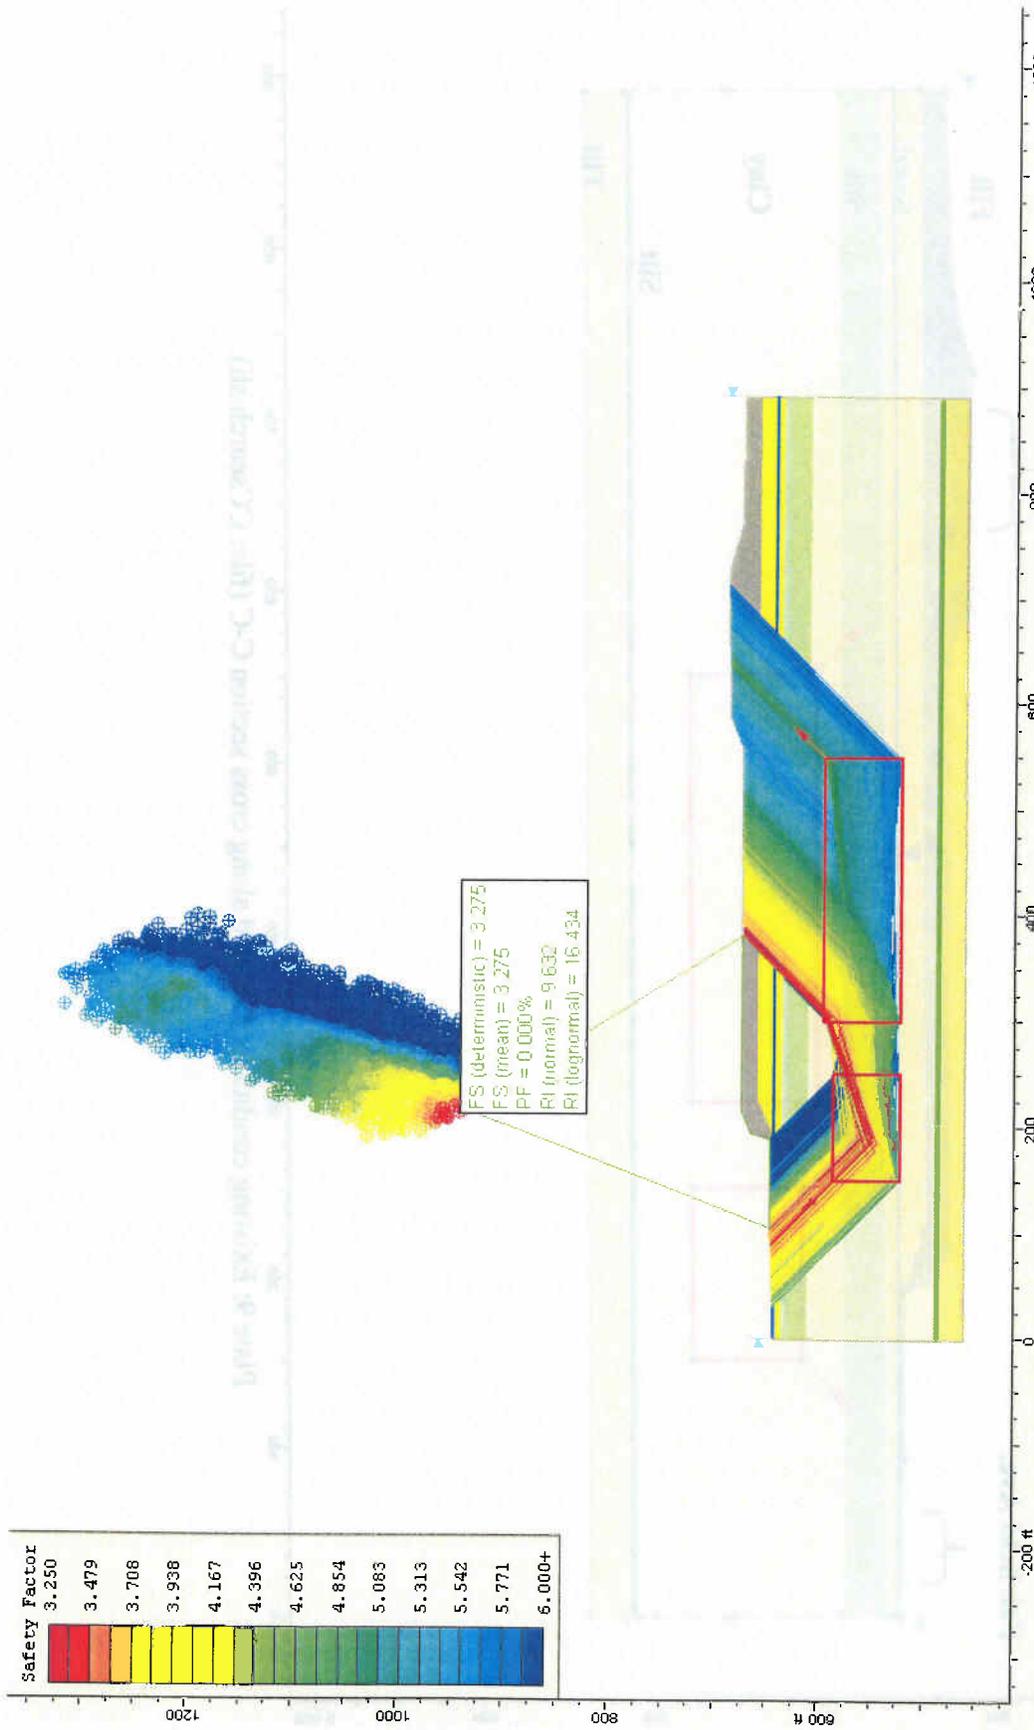
Plate 10: Results of the slope stability analyses for existing conditions along cross section C-C assuming a deep block slip surface (file: CCsearch.sli). The minimum Factor of Safety equals 3.275. The results presented were obtained by using the Simplified Janbu method instead of the Spencer method since the resulting Factor of Safety exceeds the allowable maximum Factor of Safety produced by the Spencer method.

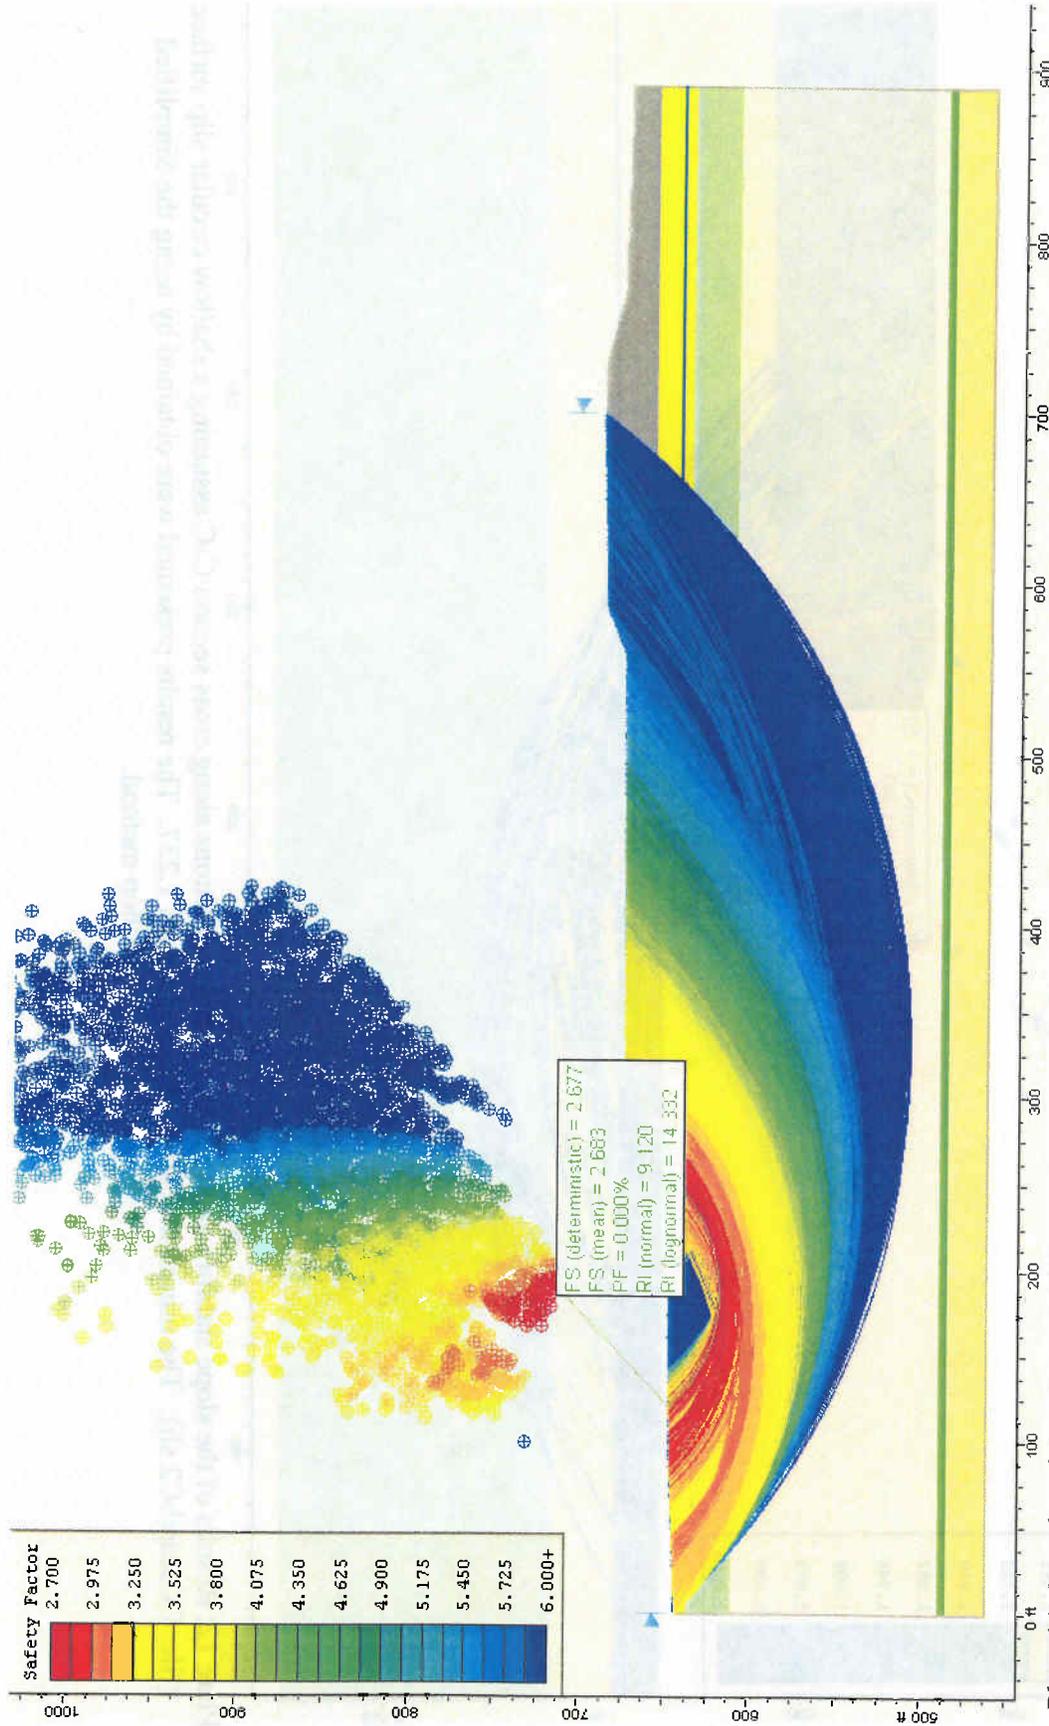
Plate 11: Results of the slope stability analyses for existing conditions along cross section C-C assuming a deep circular slip surface (file: CCsearchC.sli). The minimum Factor of Safety equals 2.677. The results presented were obtained by using the Simplified Bishop method.

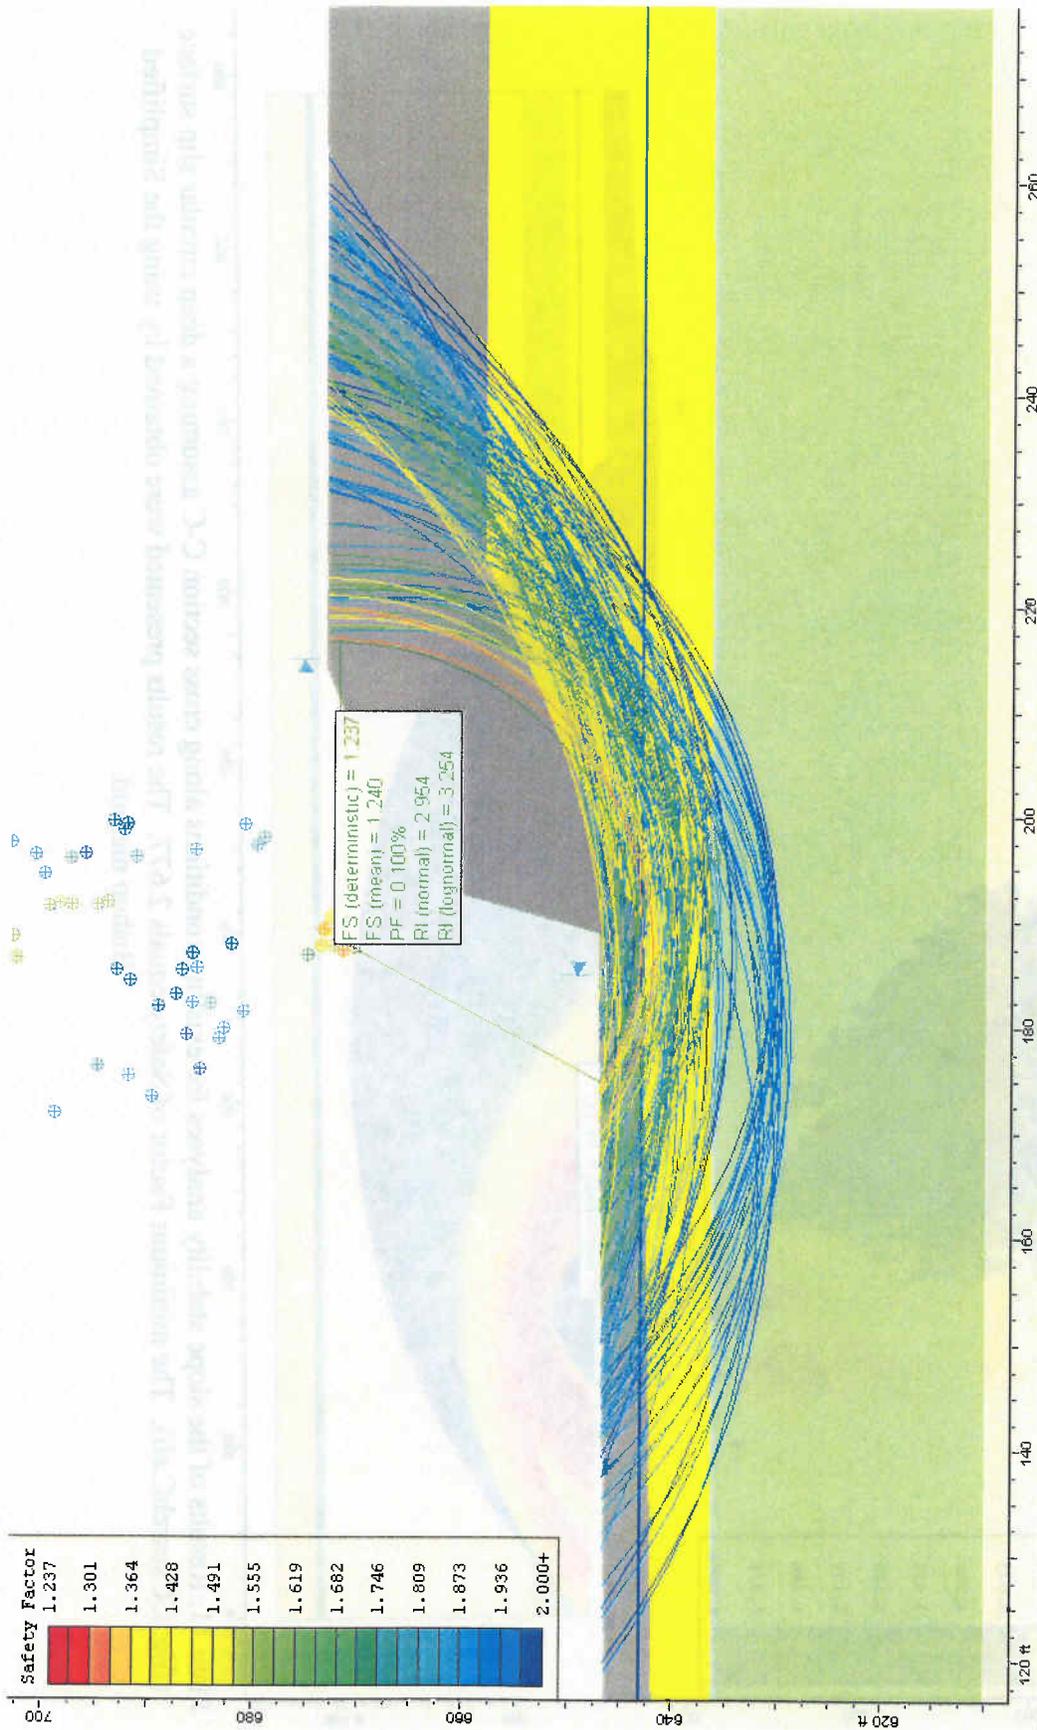
Plate 12: Results of the slope stability analyses for existing conditions along cross section C-C assuming a shallow circular slip surface (file: CCsearchC2.sli). The minimum Factor of Safety equals 1.237. The results presented were obtained by using the Simplified Bishop method.

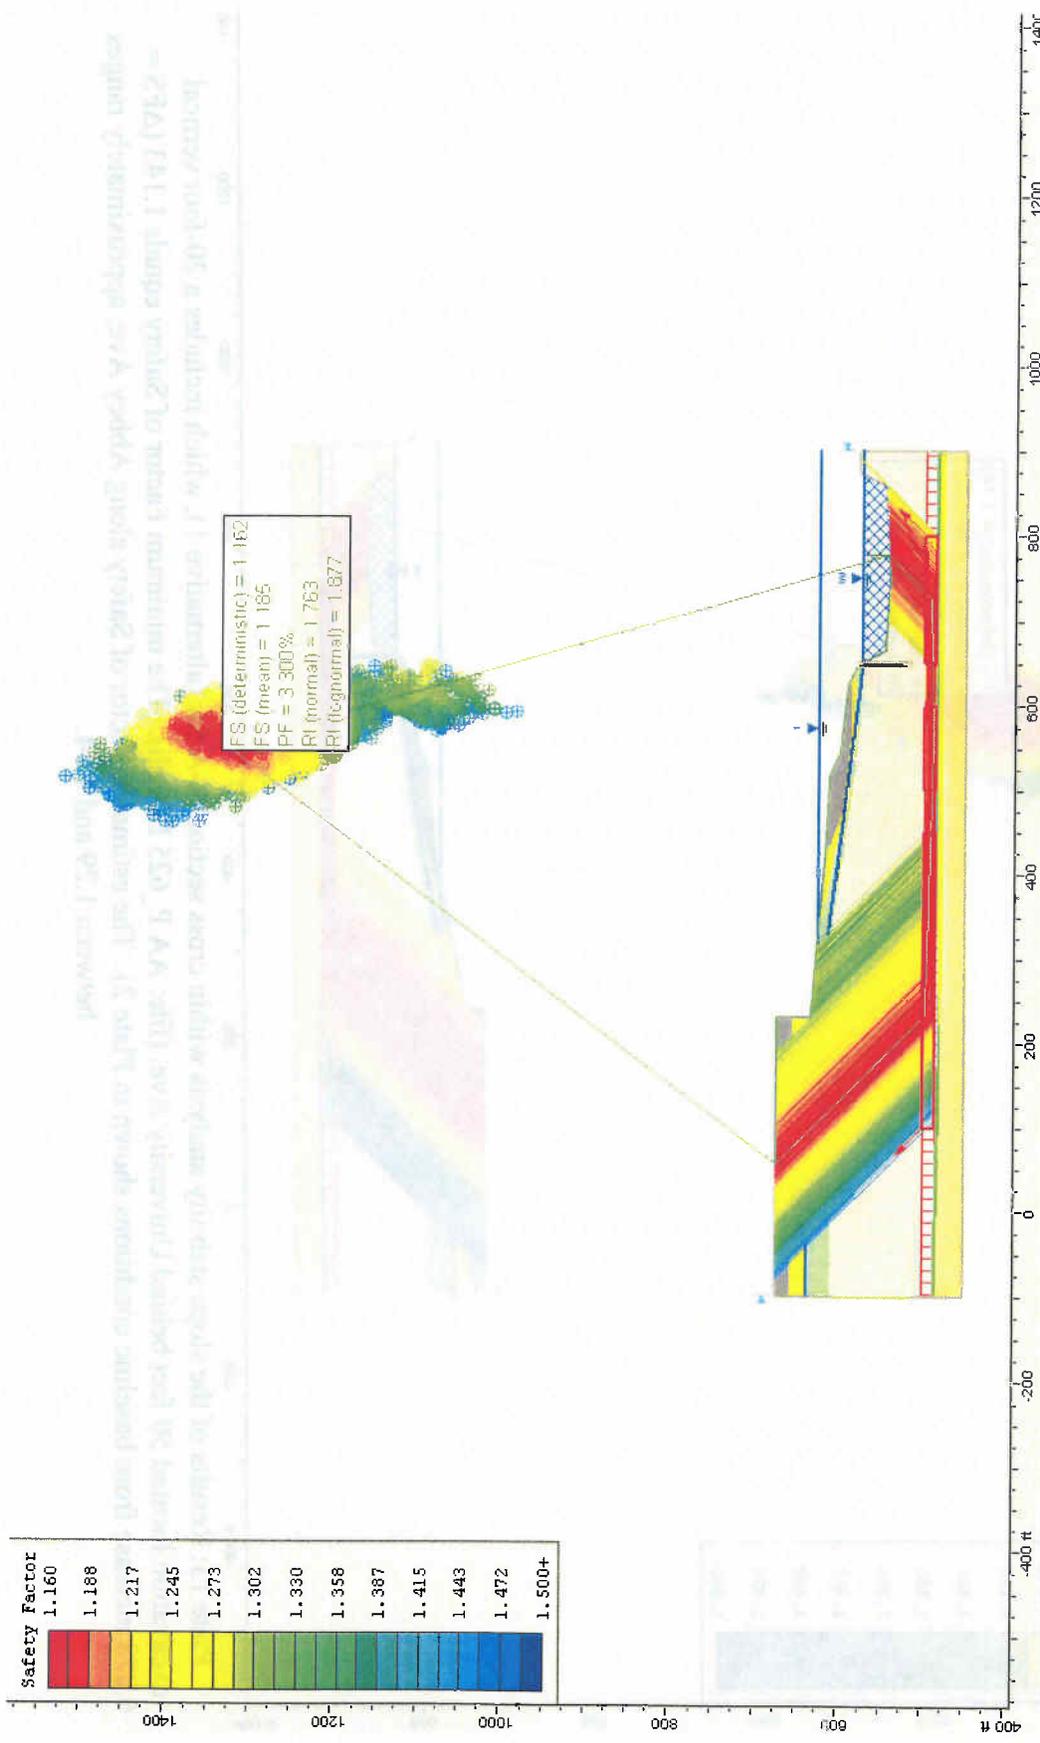
Plate 14: Results of the slope stability analysis within cross section A-A for (alternative 2), which includes a 30-foot vertical excavation located 50 feet behind University Ave. (file: AA_P_625_E30.sli). The minimum Factor of Safety equals 1.162 (Δ FS = 0.097 increase from baseline conditions shown in Plate 2). The estimated Factor of Safety along Abbey Ave. approximately ranges between 1.29 and 1.45.
