**Baker Slope Stability Study Report
(Reference Document)**

**Innerbelt Bridge
Construction Contract Group 1 (CCG1)**

Slope Stability Evaluation Report of the West Bank

CUY-90-14.92
PID 77332

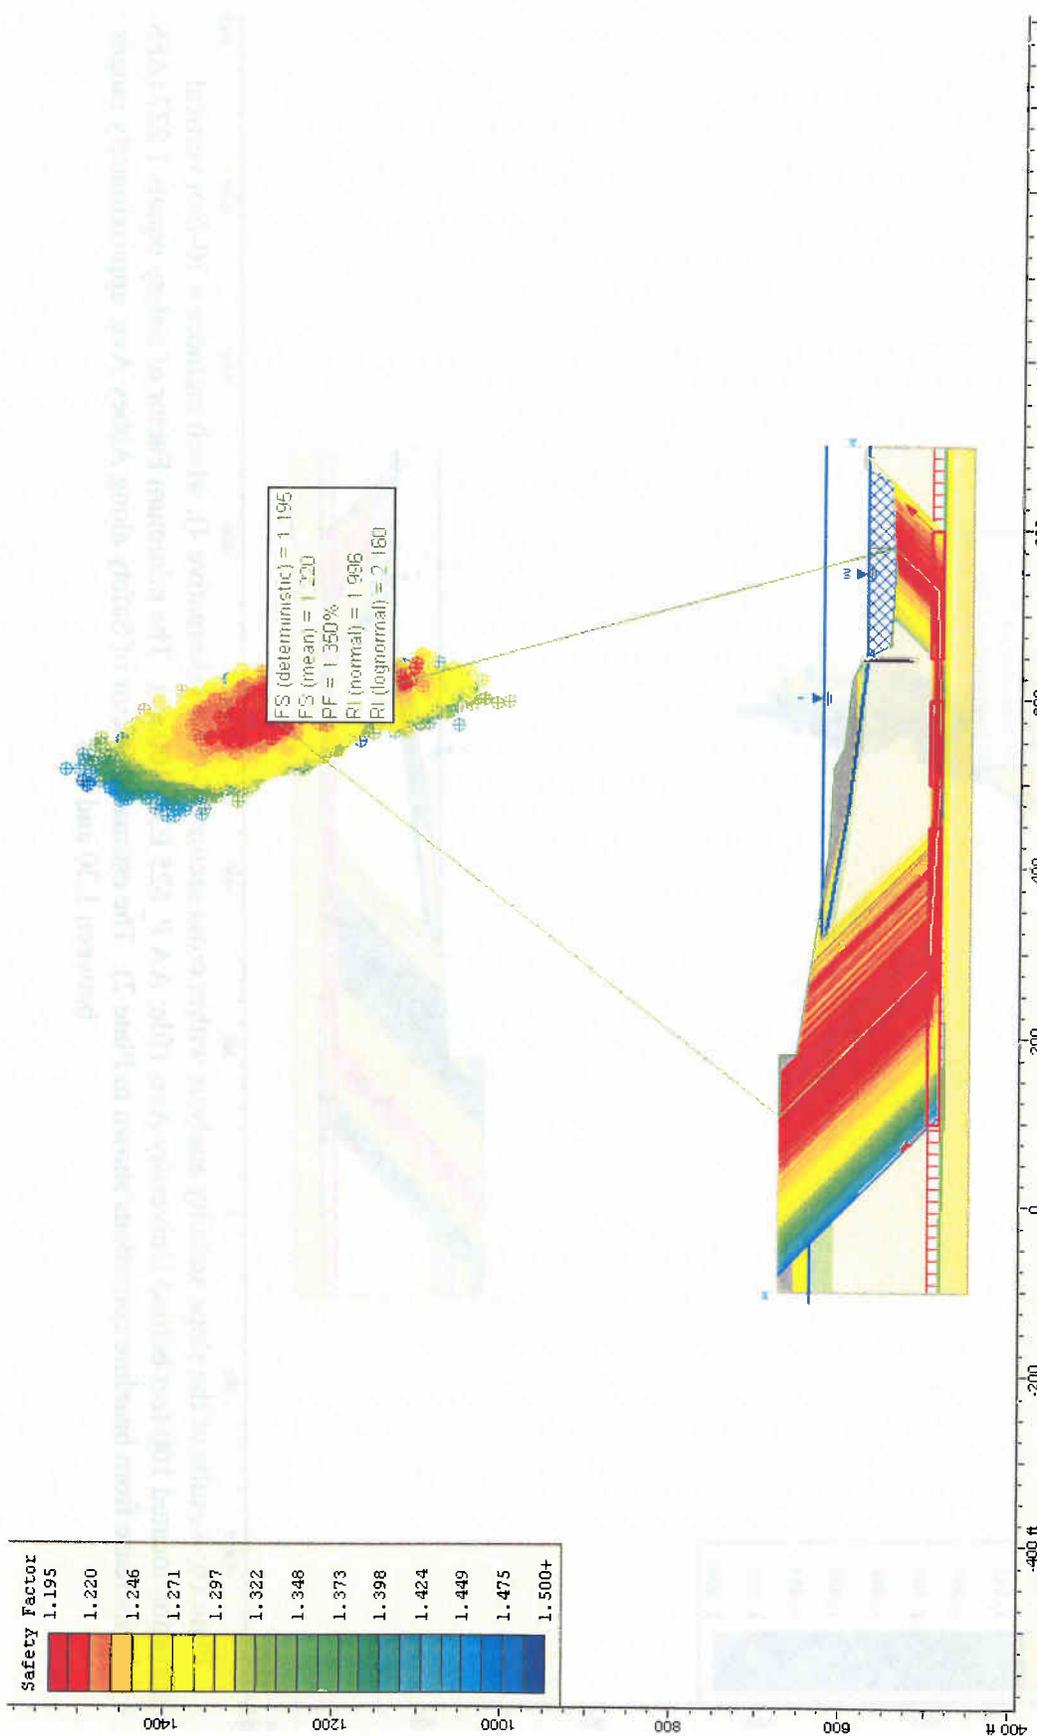
Plate 15: Results of the slope stability analysis within cross section A-A for (alternative 3), which includes a 20-foot vertical excavation located 100 feet behind University Ave. (file: AA_P_625 E20_100.sli). The minimum Factor of Safety equals 1.195 (Δ FS = 0.13 increase from baseline conditions shown in Plate 2). The estimated Factor of Safety along Abbey Ave. approximately ranges between 1.26 and 1.42.

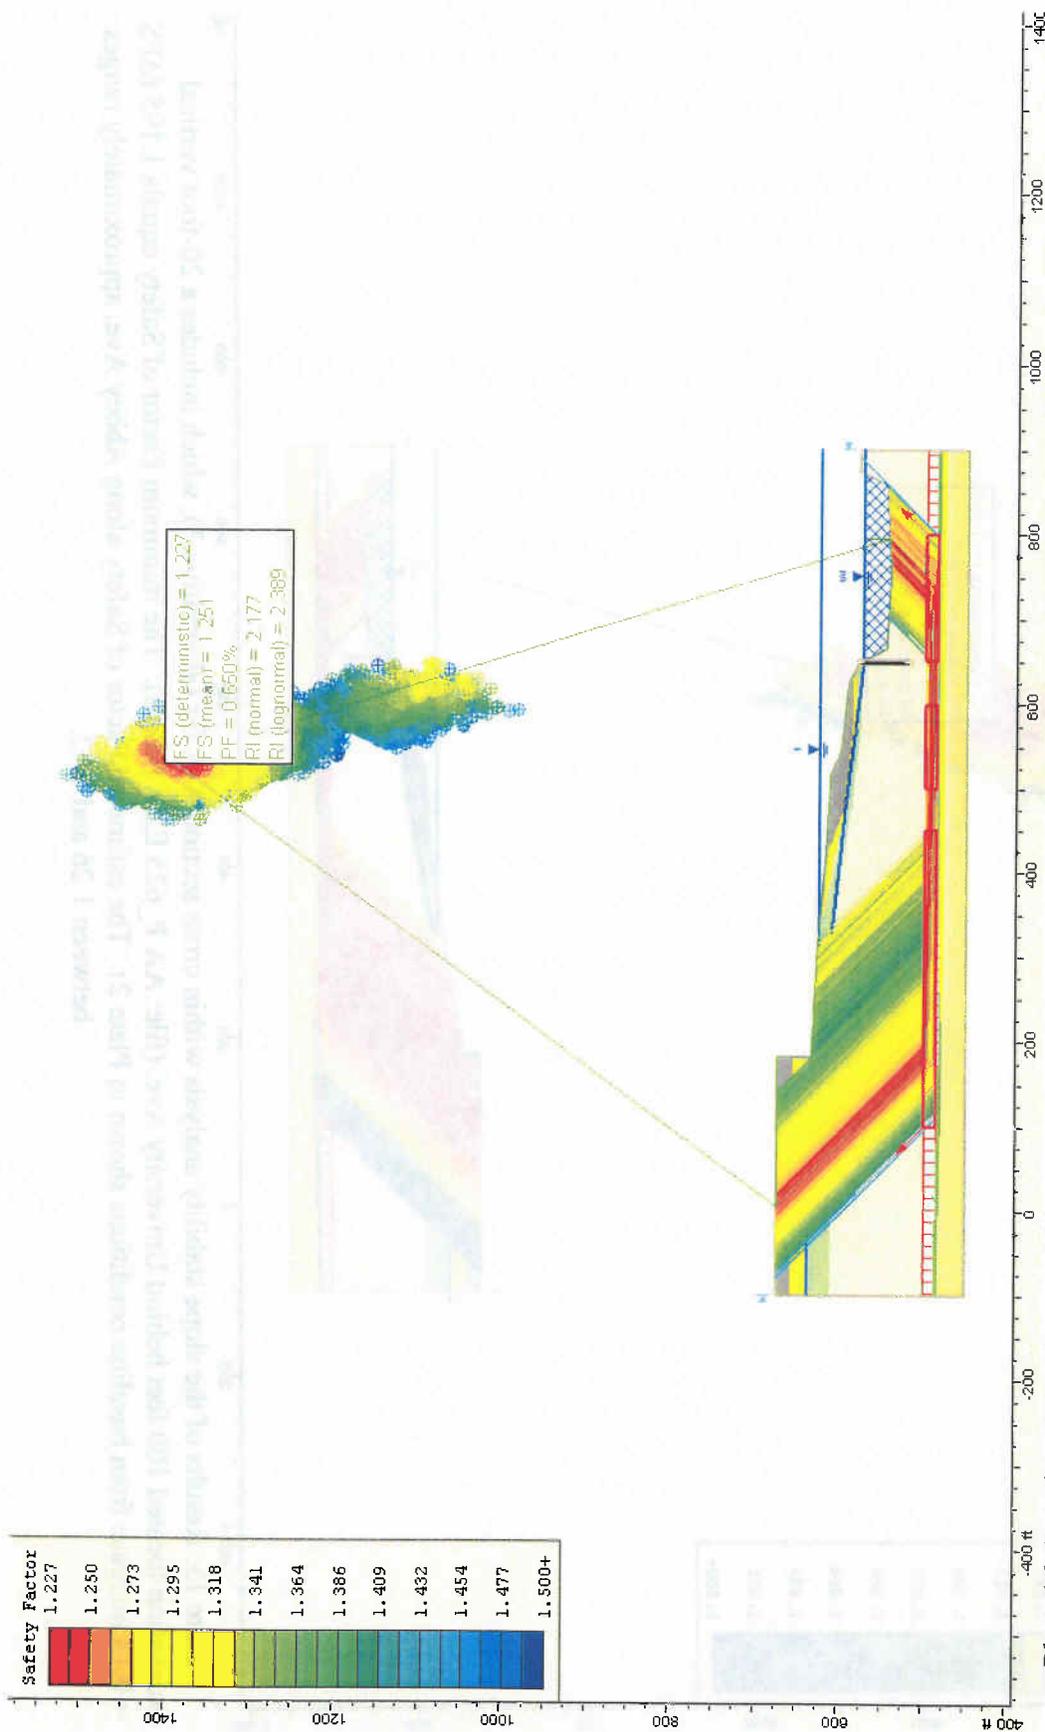
Plate 16: Results of the slope stability analysis within cross section A-A for (alternative 4), which includes a 30-foot vertical excavation located 100 feet behind University Ave. (file: AA_P_625_E30_100.sli). The minimum Factor of Safety equals 1.227 (Δ FS = 0.16 increase from baseline conditions shown in Plate 2). The estimated Factor of Safety along Abbey Ave. approximately ranges between 1.30 and 1.41.

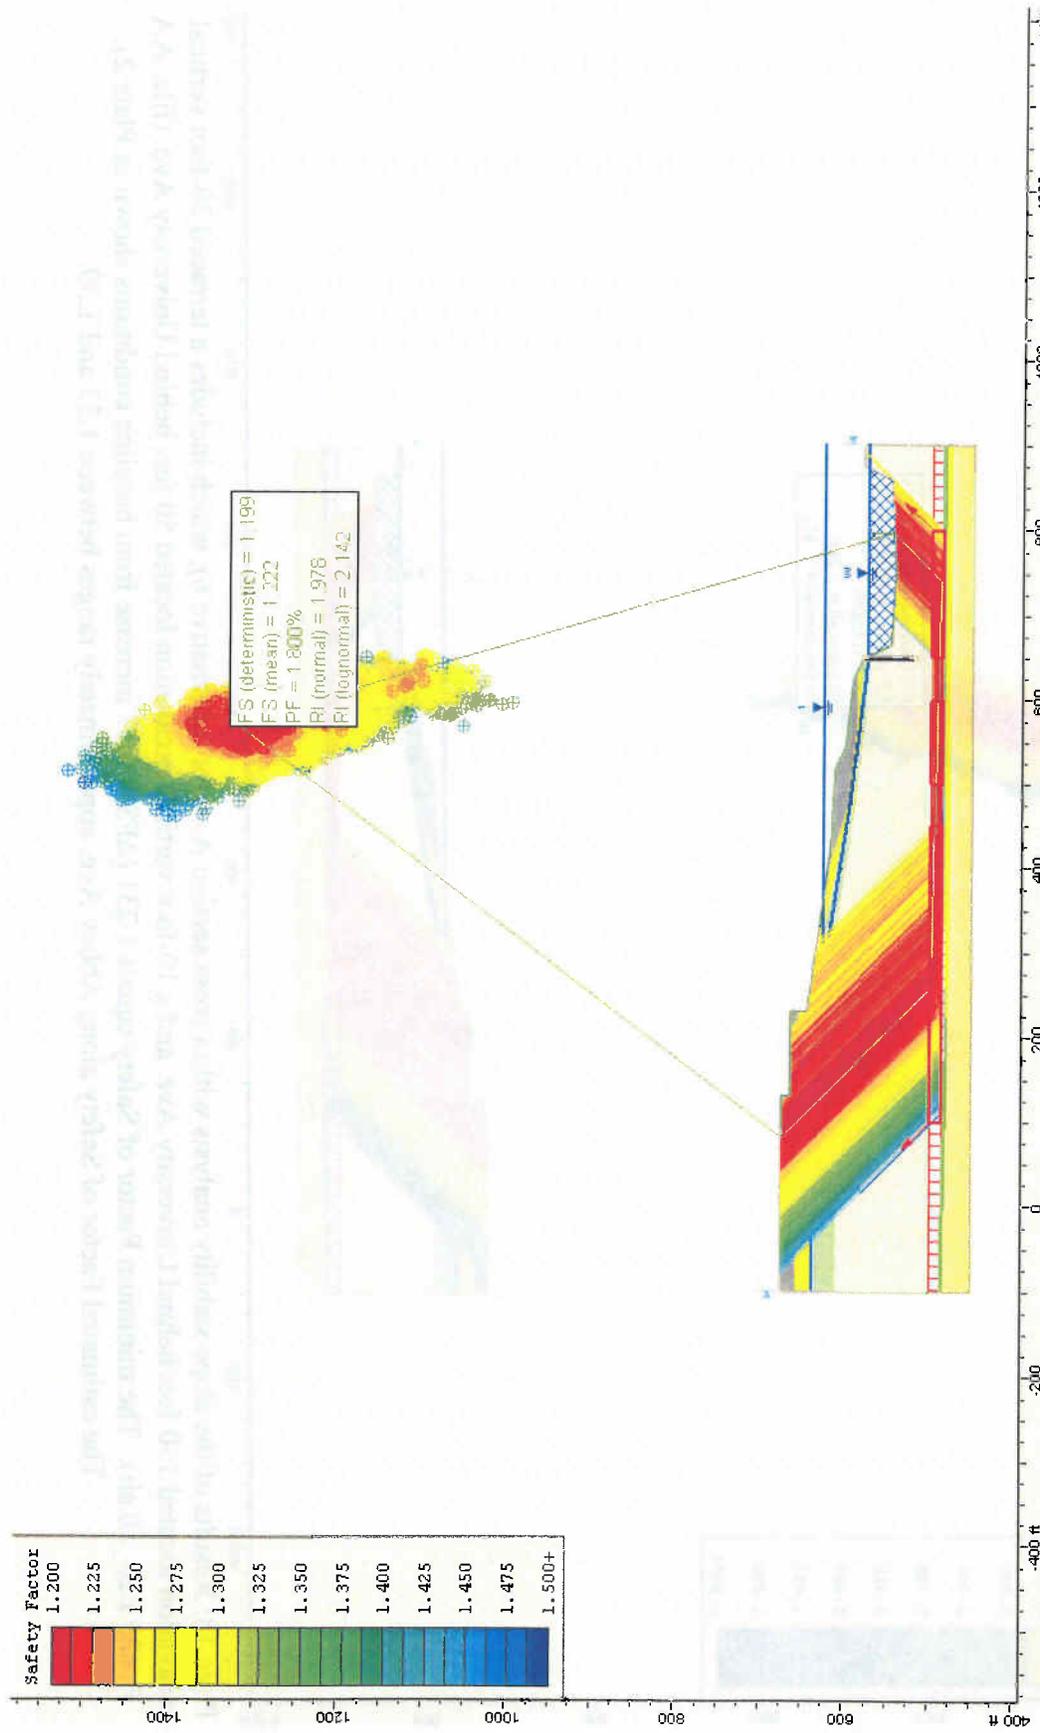
Plate 17: Results of the slope stability analysis within cross section A-A for (alternative 5), which includes a terraced 10-foot vertical excavation located 150 feet behind University Ave. and a 20-foot vertical excavation located 50 feet behind University Ave. (file: AA_P_625 E10_20.sli). The minimum Factor of Safety equals 1.199 (Δ FS = 0.13 increase from baseline conditions shown in Plate 2). The estimated Factor of Safety along Abbey Ave. approximately ranges between 1.32 and 1.41.

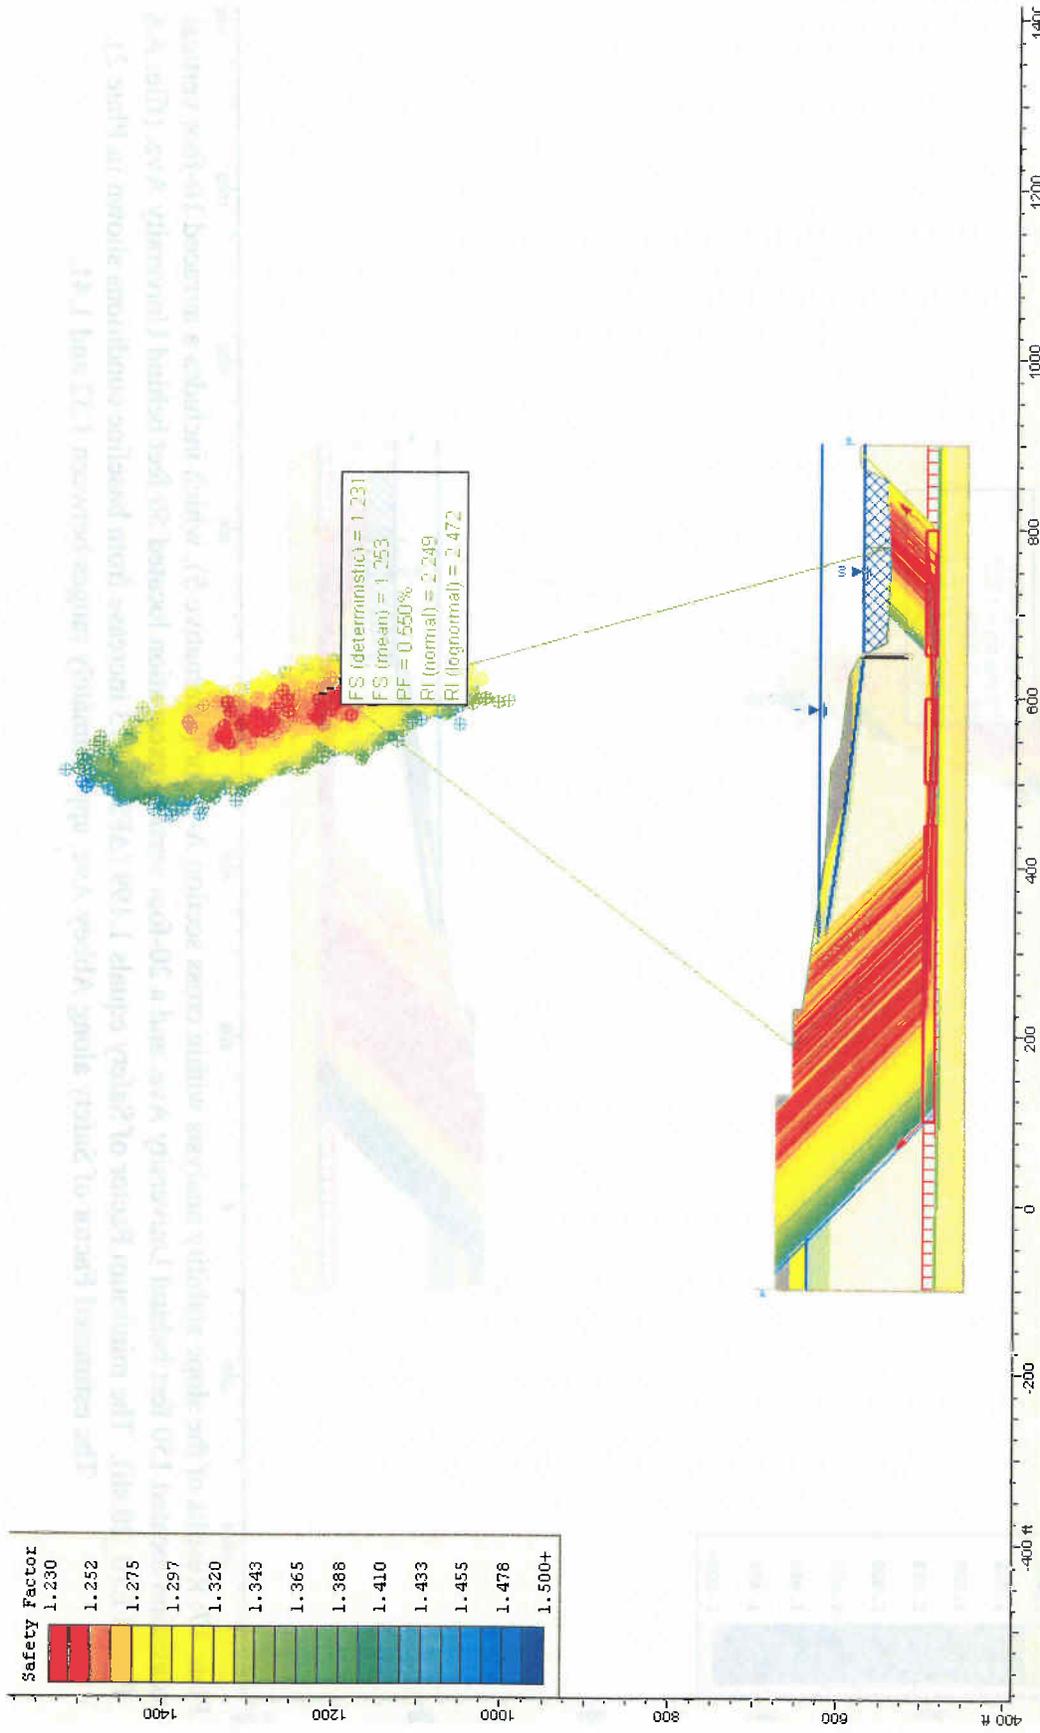
Plate 18: Results of the slope stability analysis within cross section A-A for (alternative 6), which includes a terraced 20-foot vertical excavation located 150 feet behind University Ave. and a 10-foot vertical excavation located 50 feet behind University Ave. (file: AA_P_625 E20_10.sli). The minimum Factor of Safety equals 1.231 ($\Delta FS = 0.17$ increase from baseline conditions shown in Plate 2). The estimated Factor of Safety along Abbey Ave. approximately ranges between 1.33 and 1.39.

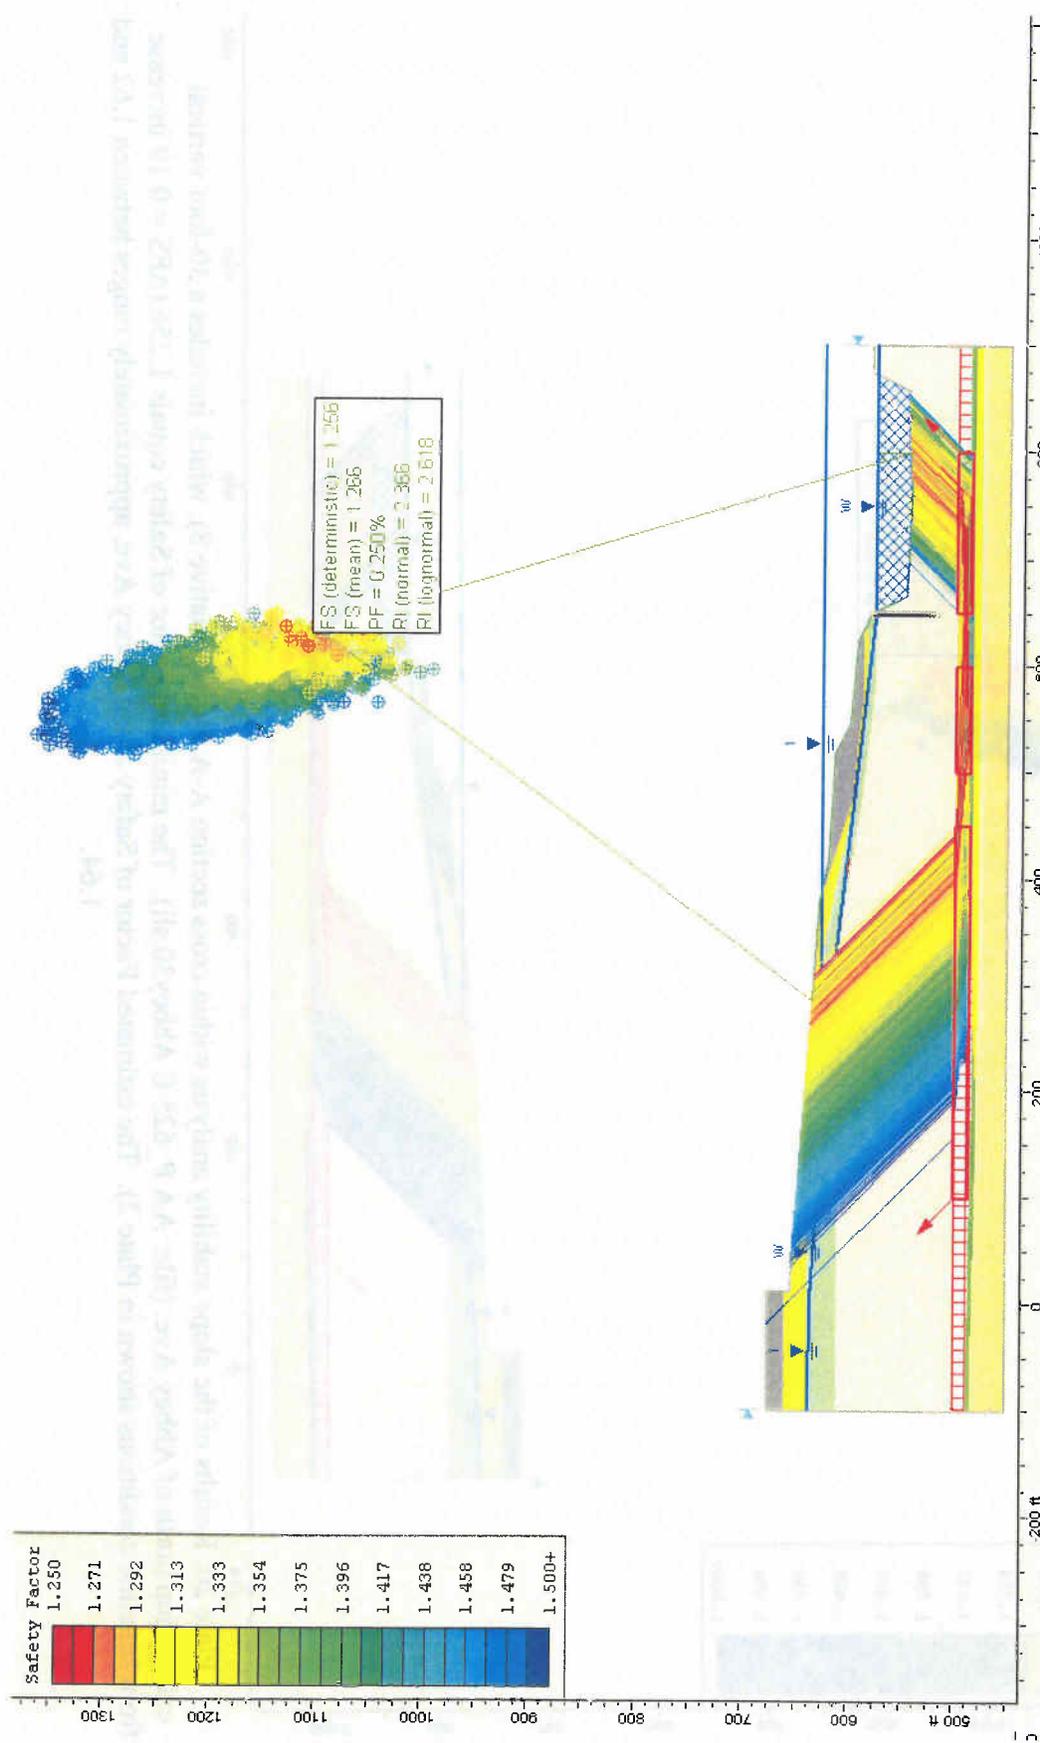
Plate 19: Results of the slope stability analysis within cross section A-A for (alternative 7), which includes a 20-foot vertical excavation north of Abbey Ave. (file: AA_P_625 E Abbey20.sli). The minimum Factor of Safety equals 1.256 ($\Delta FS = 0.19$ increase from baseline conditions shown in Plate 2). The estimated Factor of Safety along Abbey Ave. approximately ranges between 1.56 and 1.90.
