Geohazard Exploration Report (Final)
CUY-480-16.56 Landslide
Brooklyn Heights, Cuyahoga County, Ohio
S&ME Project No. 24170140E

Geohazard Exploration Report – Final (Task Order No. D12-04)

CUY-480-16.56 Landslide (PID 124096)
Brooklyn Heights, Cuyahoga County, Ohio
S&ME Project No. 24170140E

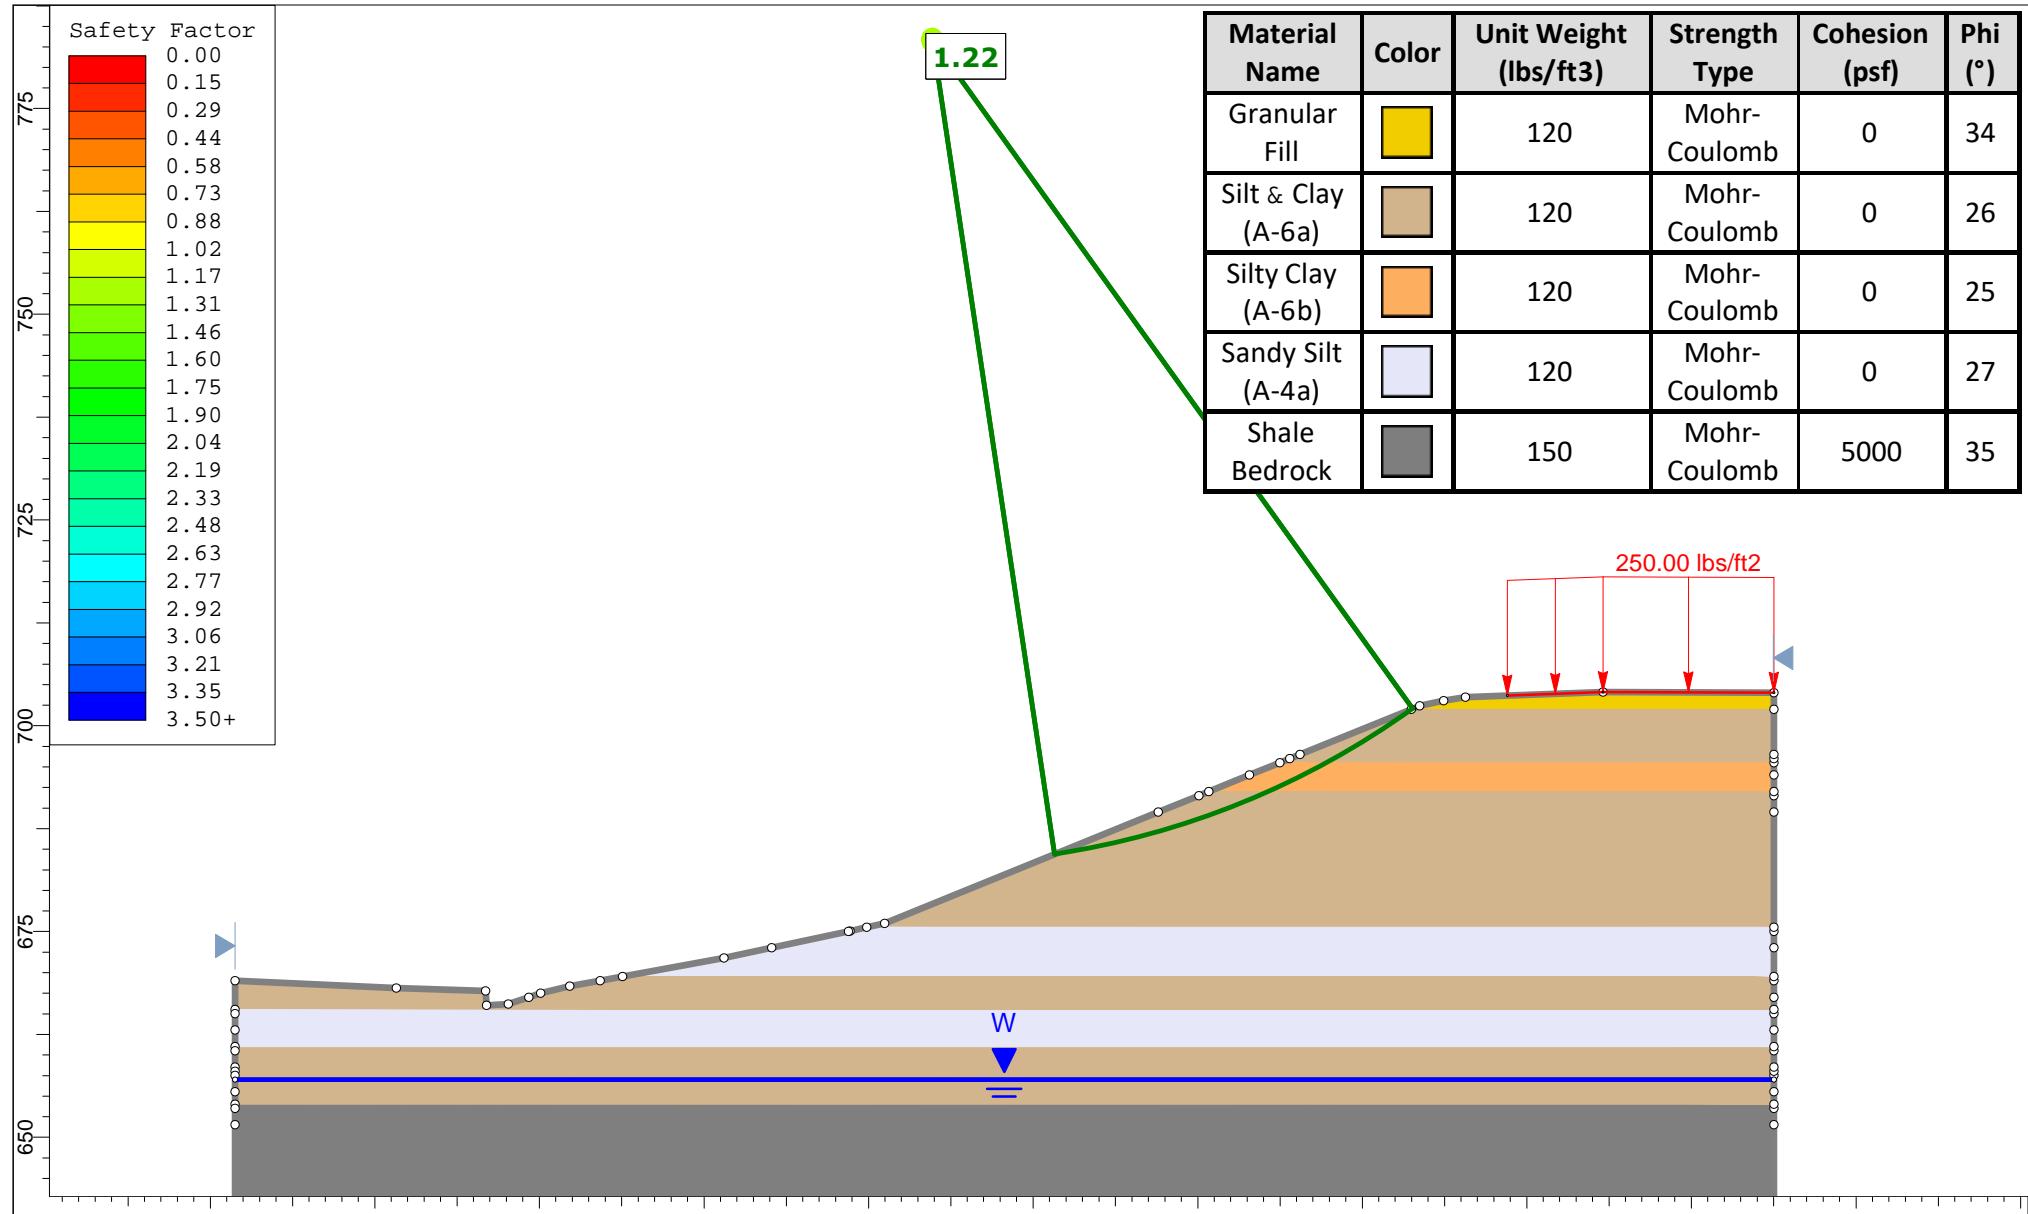
Global Stability Back-Analysis Results

S&ME evaluated the stability of the failed existing embankment at Sta. 896+25, Sta. 897+50, and Sta. 899+00. Using cross sections at these 3 locations provided by ODOT and CVE and the results of the field exploration and laboratory testing programs, S&ME back-analyzed the cross section models to develop a failure model which roughly reproduced the observed slope failure. For the purposes of our analyses, slope failure was considered to have occurred when the factor of safety calculated was approximately 1.0. We note that back-analyses performed at Sta. 896+25 resulted in a factor of safety near 1.2 due to the slightly flatter existing slope at that location.
