# Asbestos and Lead Paint Demolition Survey Report

**MRW-288-0.50**

**Bridge SFN: 5902827**

**June 10, 2025**

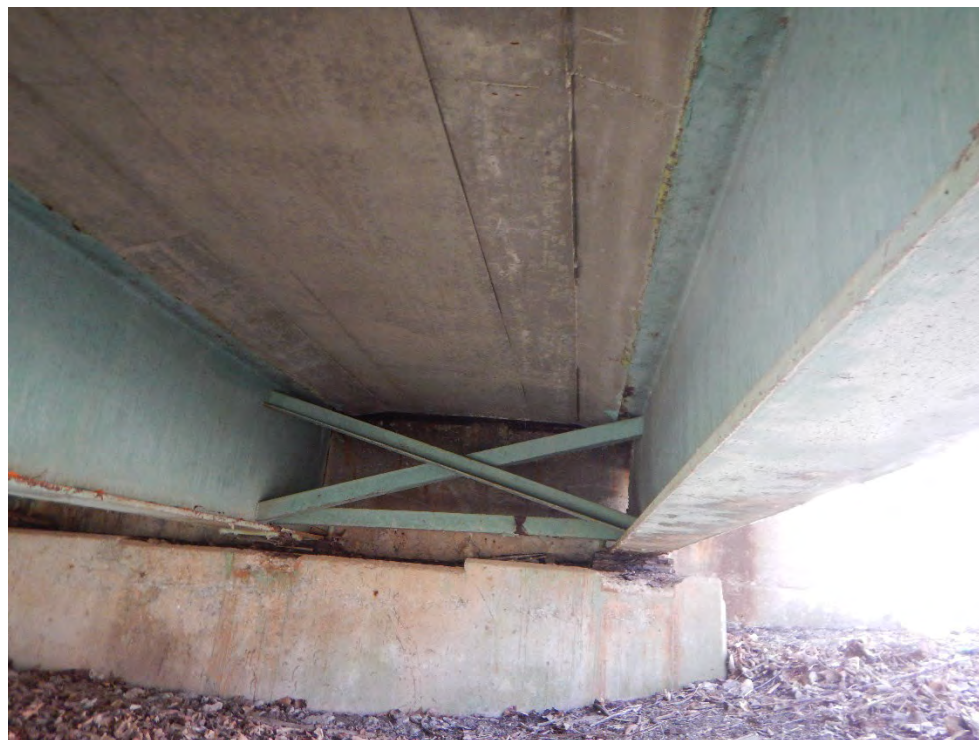
Photo 8:  
Underside view of the  
structure beams

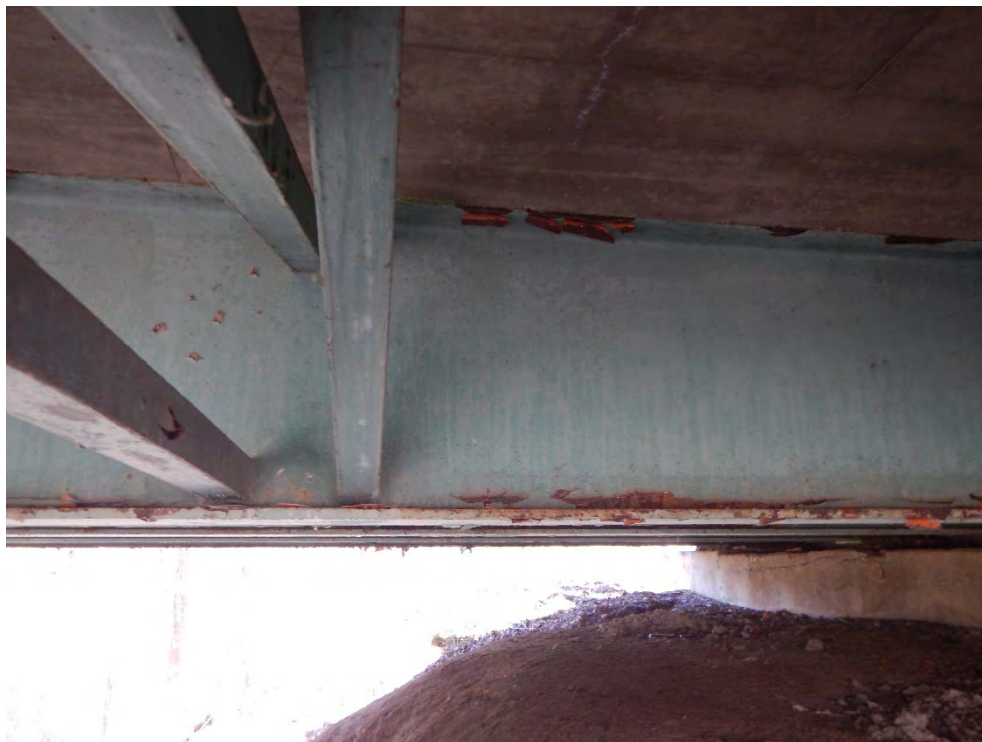
Photo 9:

Underside view of the structure beams

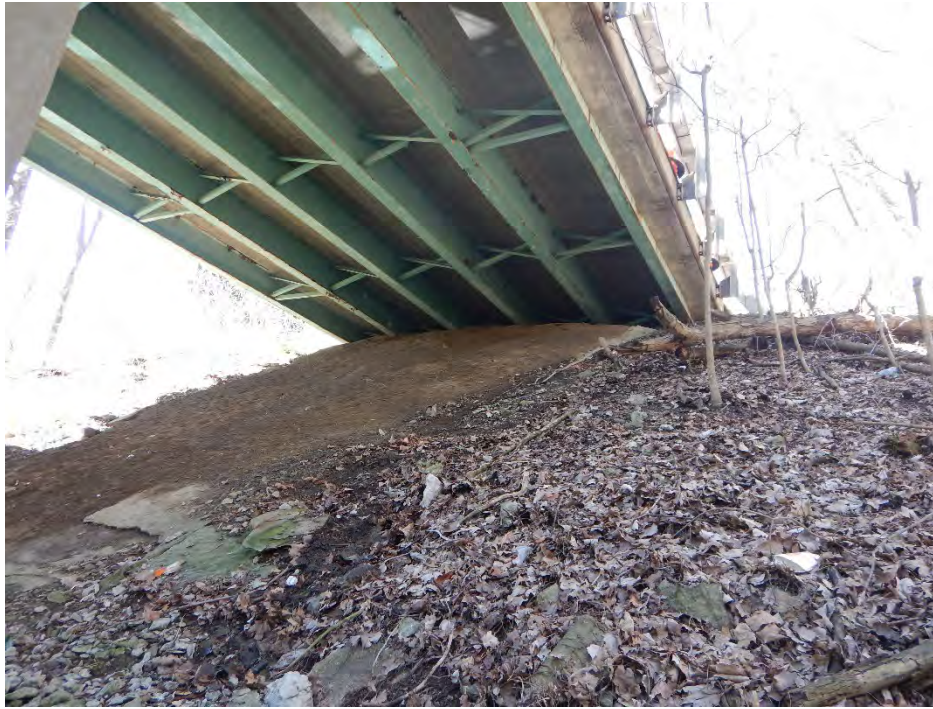
Photo 11:

Underside view of the structure beams

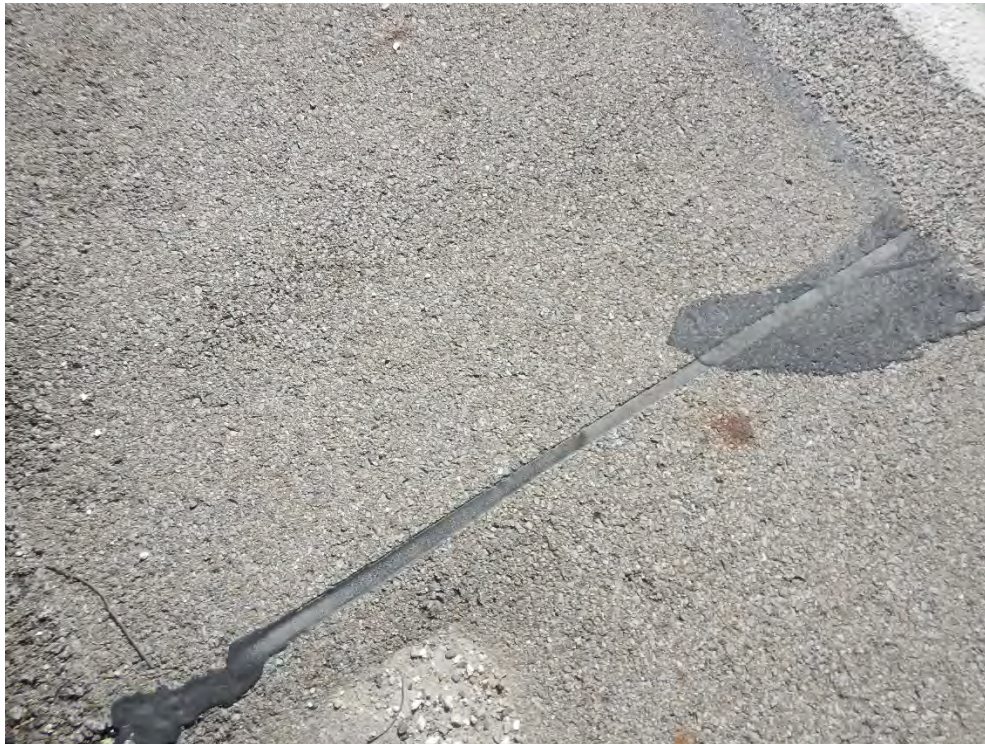
Photo 12:

Tar from the structure deck

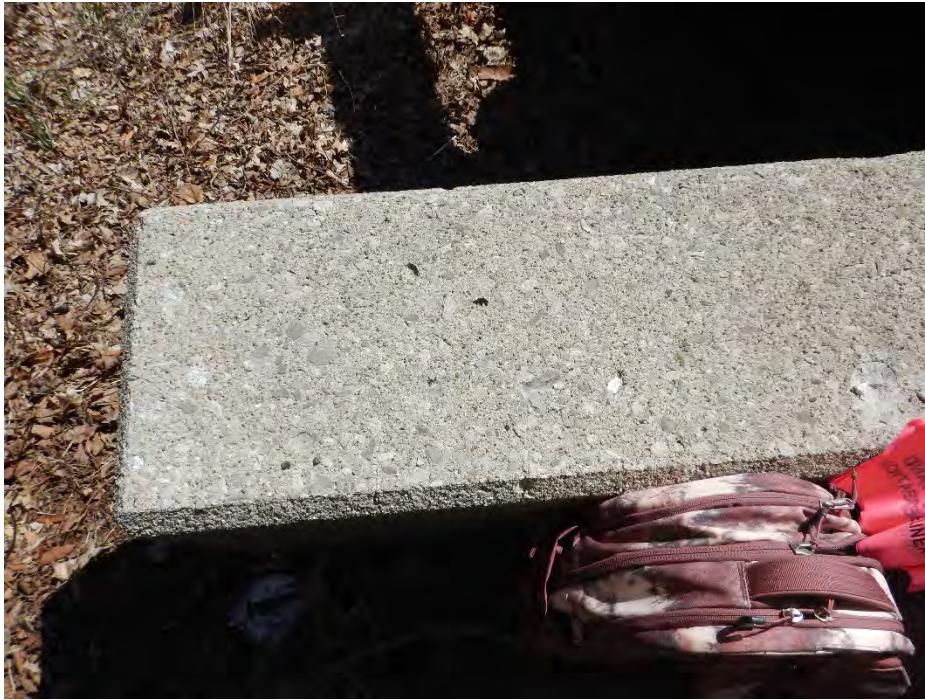
Photo 13:  
Concrete from the  
structure

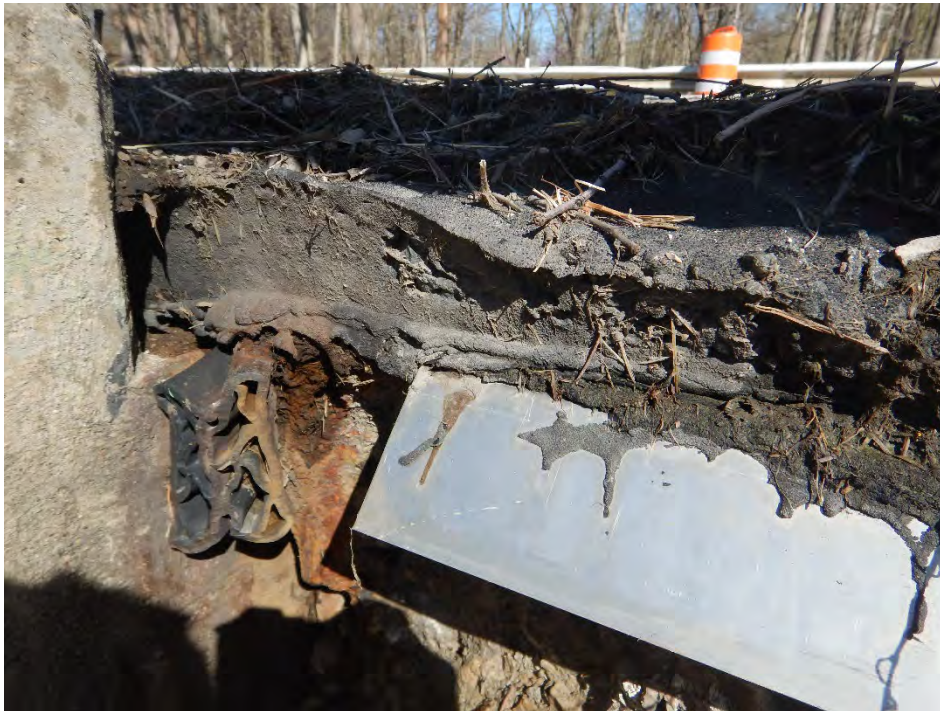
Photo 14:  
Tar from the guard  
rails of the structure

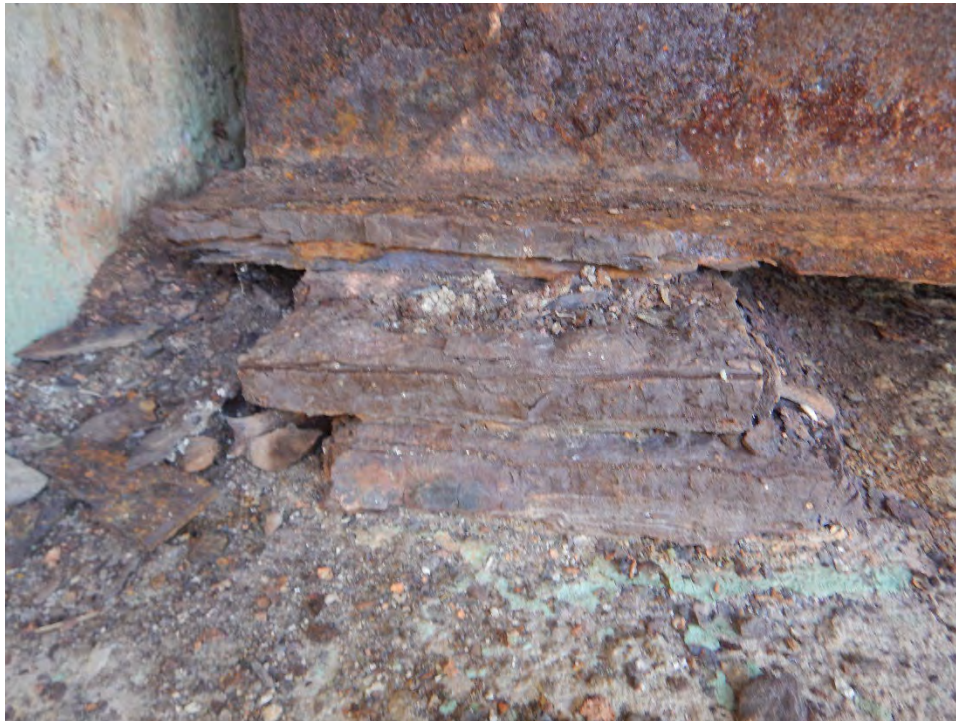
Photo 16:  
Rocker plate pads
