Pavement Core Summary

S&ME Project No.: 217525

Project Name: LOR-90-10.76

Client: ODOT District 3

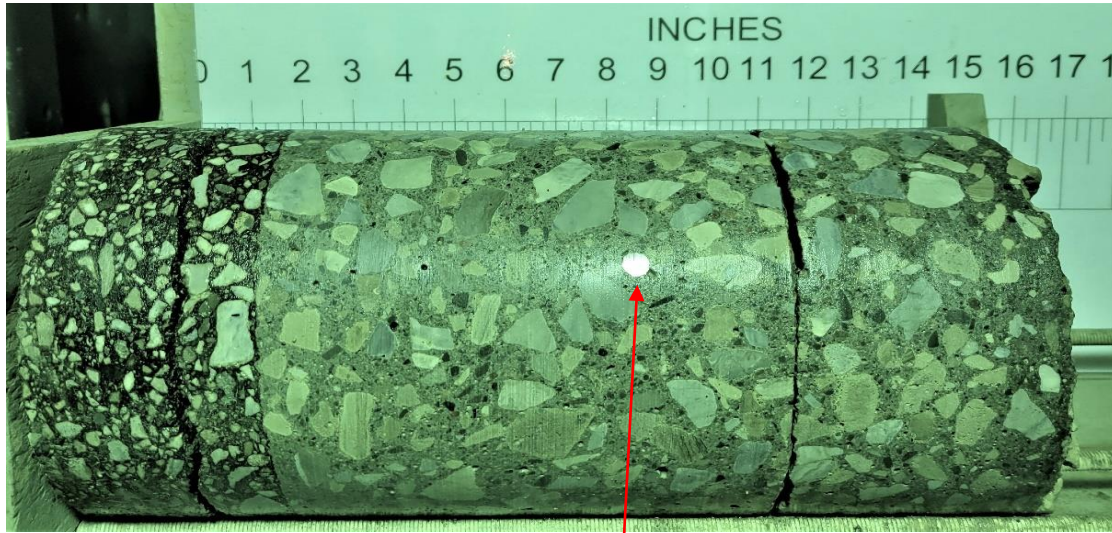
1	Core Number / Thickness	B-001-0-22 / Asphalt = 3" Concrete = 11¼"
	Remarks	Reinforcing steel observed 5" below the top of concrete.

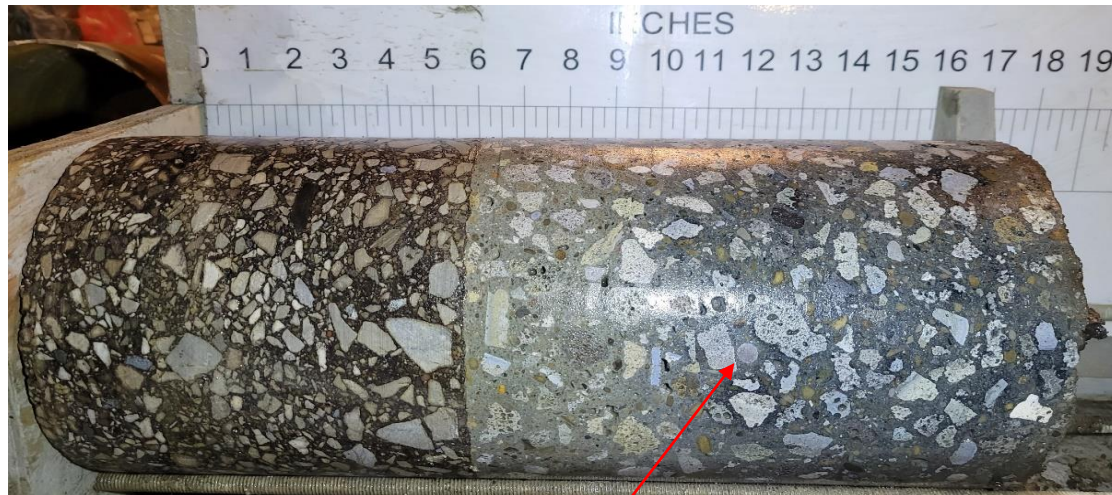
2	Core Number / Thickness	B-002-0-22 / Asphalt = 6½" Concrete = 9¼"
	Remarks	Reinforcing steel observed 3½" below the top of concrete. A color change was observed in the concrete about 3" from the top of concrete

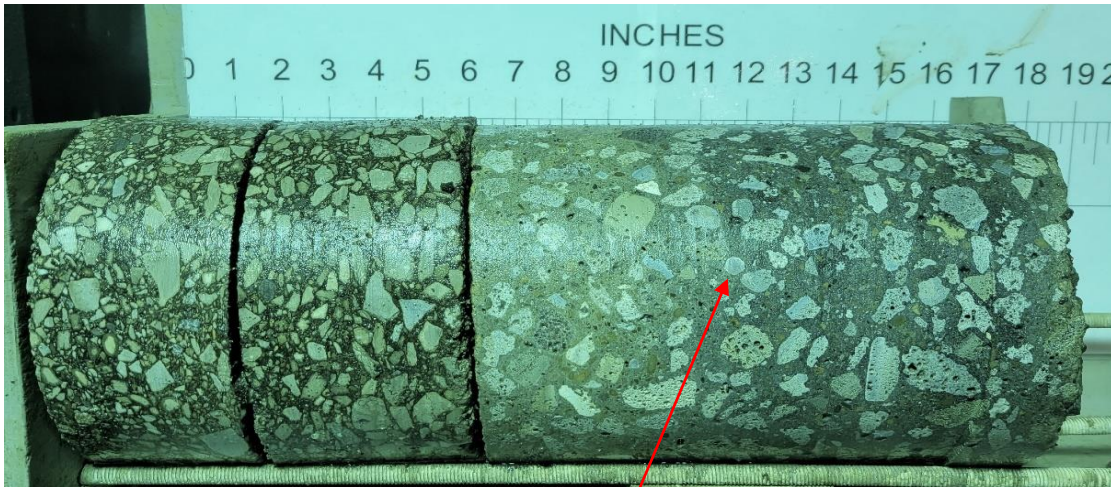
3	Core Number / Thickness	B-003-0-22 / Asphalt = 6" Concrete = 10¼"
	Remarks	Reinforcing steel observed 4" below the top of concrete.

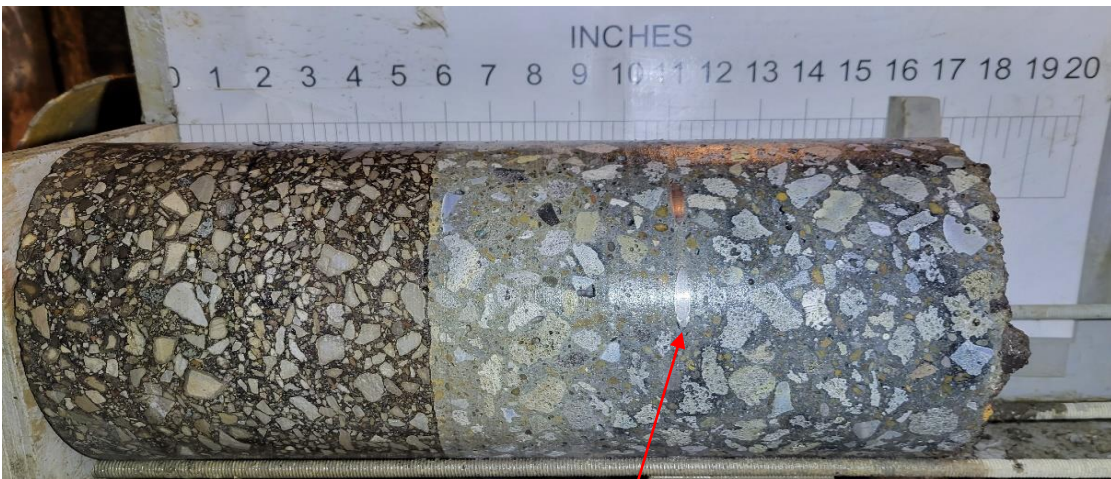
4	Core Number / Thickness	B-004-0-22 / Asphalt = 6½" Concrete = 9¼"
	Remarks	Reinforcing steel observed 3¾" below the top of concrete. A color change was observed in the concrete about 2½" from the top of concrete

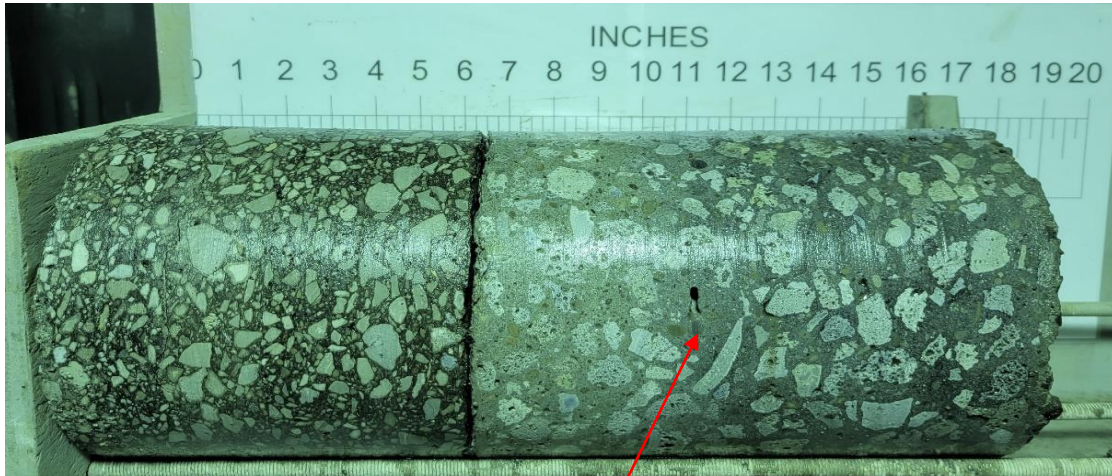
5	Core Number / Thickness	B-005-0-22 / Asphalt = 6½" Concrete = 9½"
	Remarks	Reinforcing steel observed 3½" below the top of concrete.

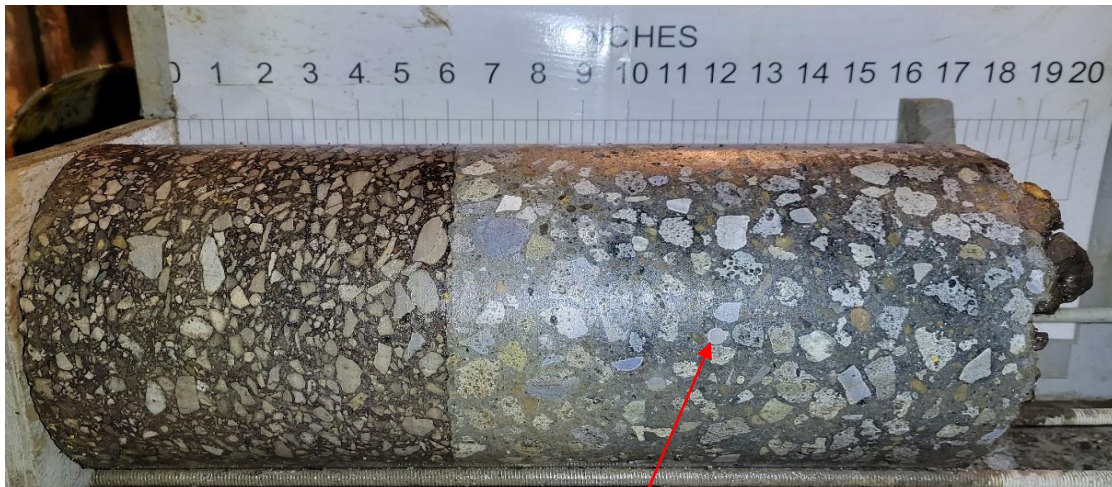
6	Core Number / Thickness	B-006-0-22 / Asphalt = 6½" Concrete = 9½"
	Remarks	Reinforcing steel observed 4" below the top of concrete. A color change was observed in the concrete about 2½" from the top of concrete

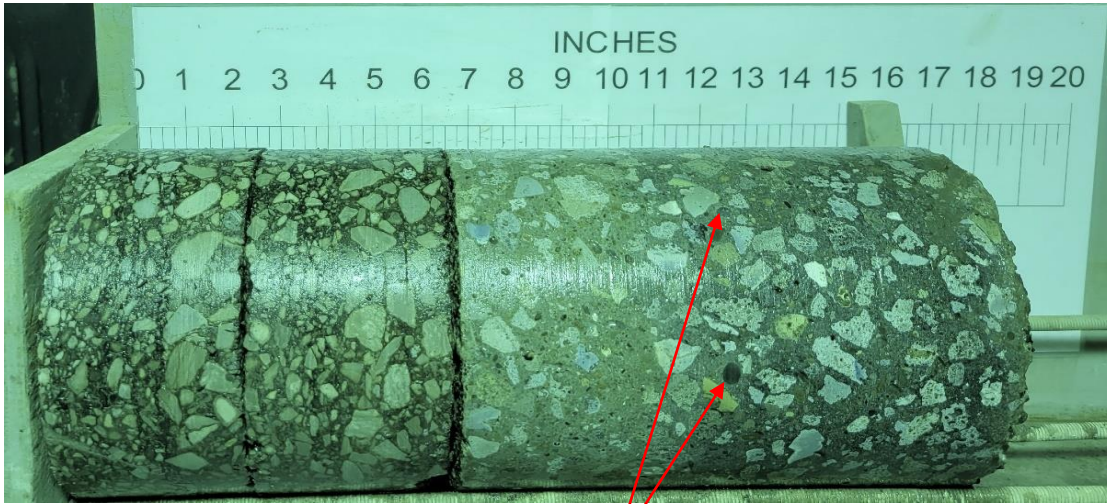
7	Core Number / Thickness	B-007-0-22 / Asphalt = 6¼" Concrete = 9"
	Remarks	Reinforcing steel observed 4" below the top of concrete.

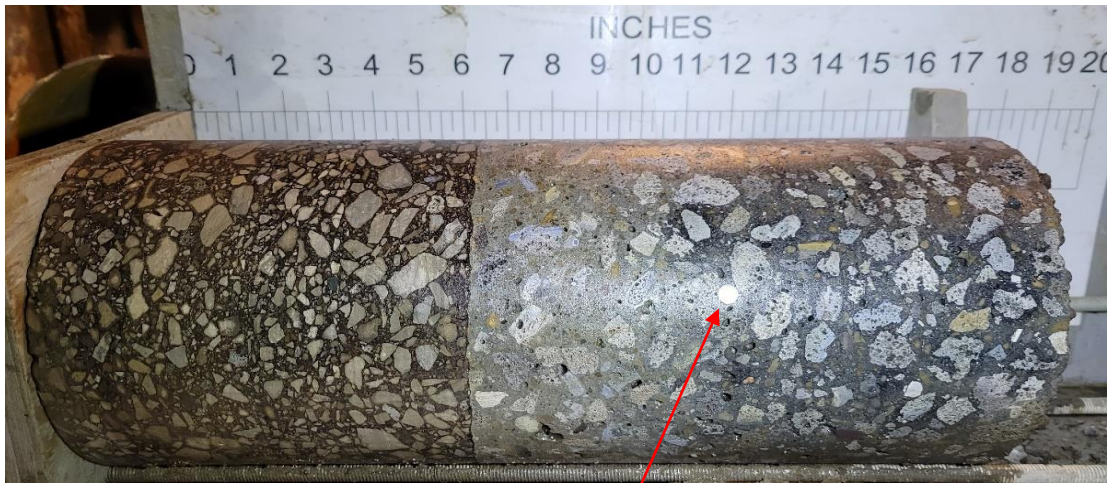
8	Core Number / Thickness	B-008-0-22 / Asphalt = 6¾" Concrete = 9¼"
	Remarks	Reinforcing steel observed 4" below the top of concrete. A color change was observed in the concrete about 3" from the top of concrete

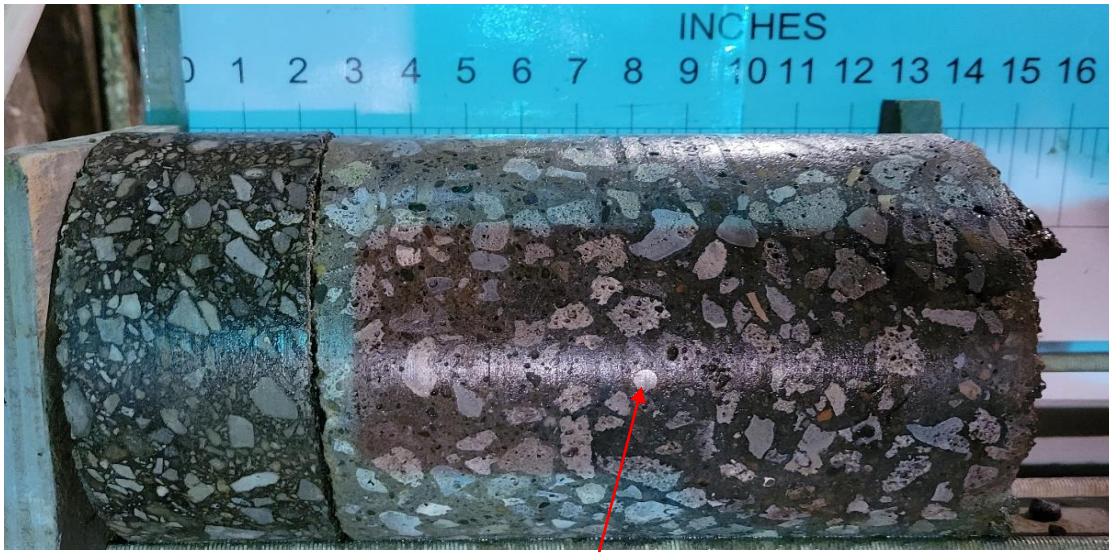
9	Core Number / Thickness	B-009-0-22 / Asphalt = 3" Concrete = 9½"
	Remarks	Reinforcing steel observed 4" below the top of concrete.

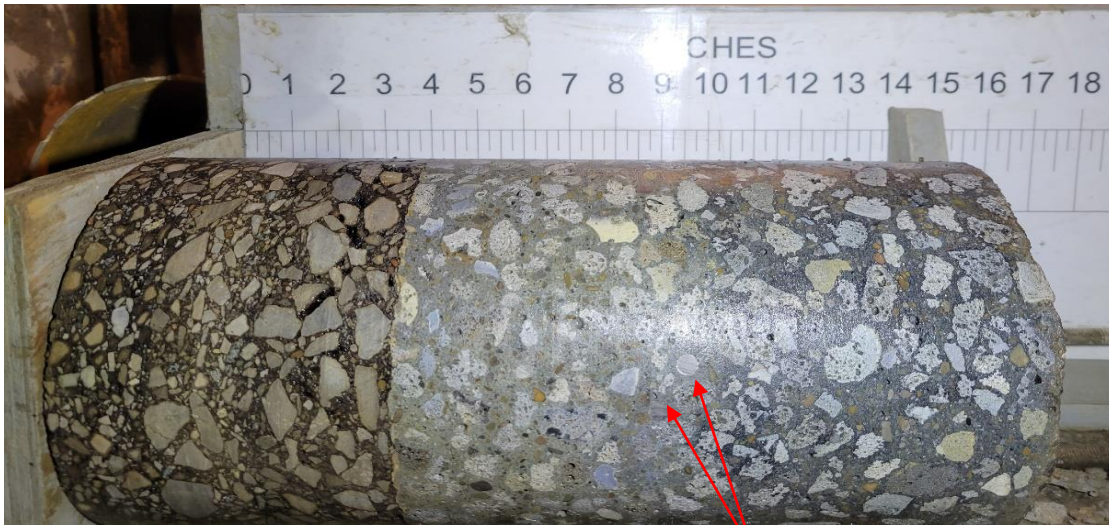
10	Core Number / Thickness	B-010-0-22 / Asphalt = 4½" Concrete = 9¼"
	Remarks	Reinforcing steel observed ¾" and 4" below the top of concrete. A color change was observed in the concrete about ½" from the top of concrete

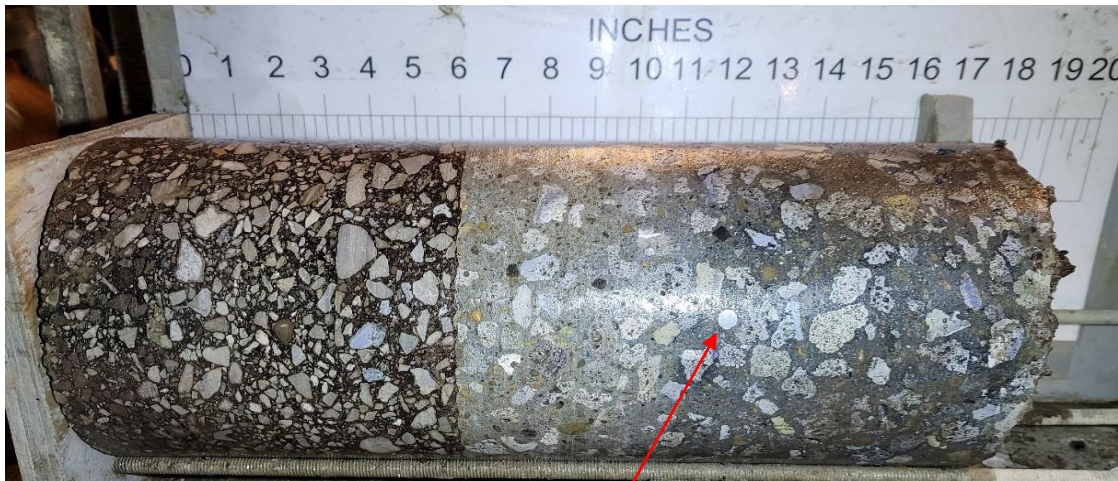
B-012-0-22 / Asphalt = 6½" Concrete = 9½"

Reinforcing steel observed 4½" below the top of concrete. A color change was observed in the concrete about 3" from the top of concrete

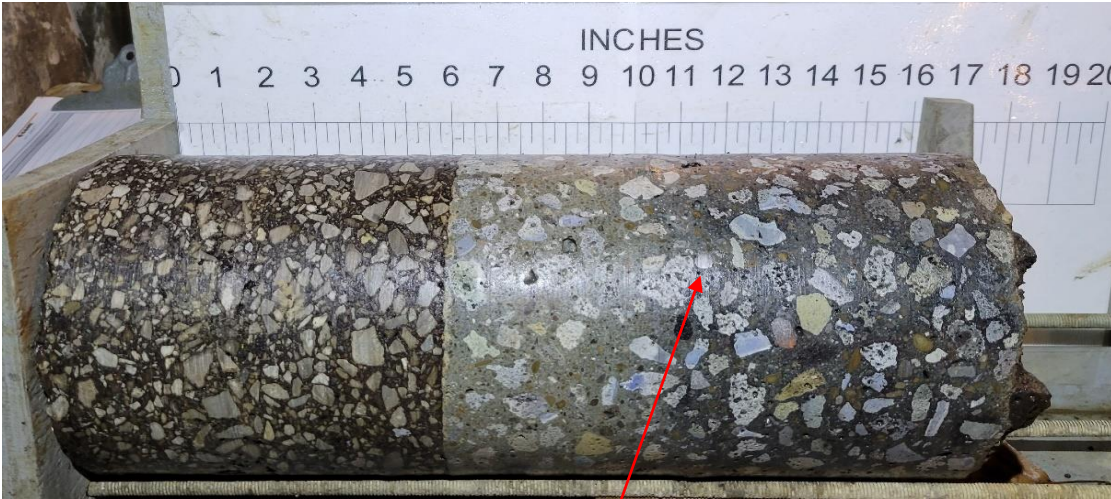
B-013-0-22 / Asphalt = 6½" Concrete = 9½"

Reinforcing steel observed 4" below the top of concrete.

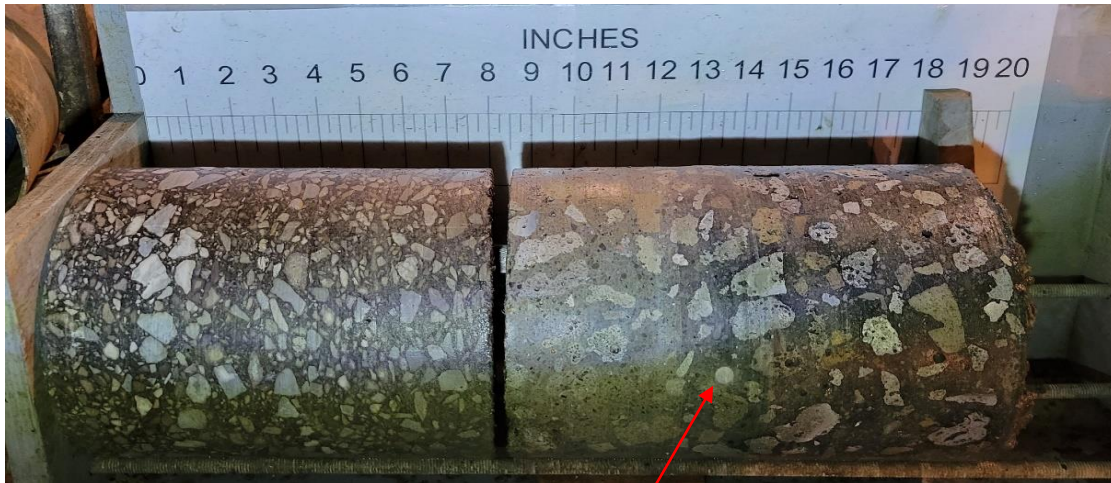
B-013-1-22 / Asphalt = 8¼" Concrete = 9½"

Reinforcing steel observed 4" below the top of concrete.

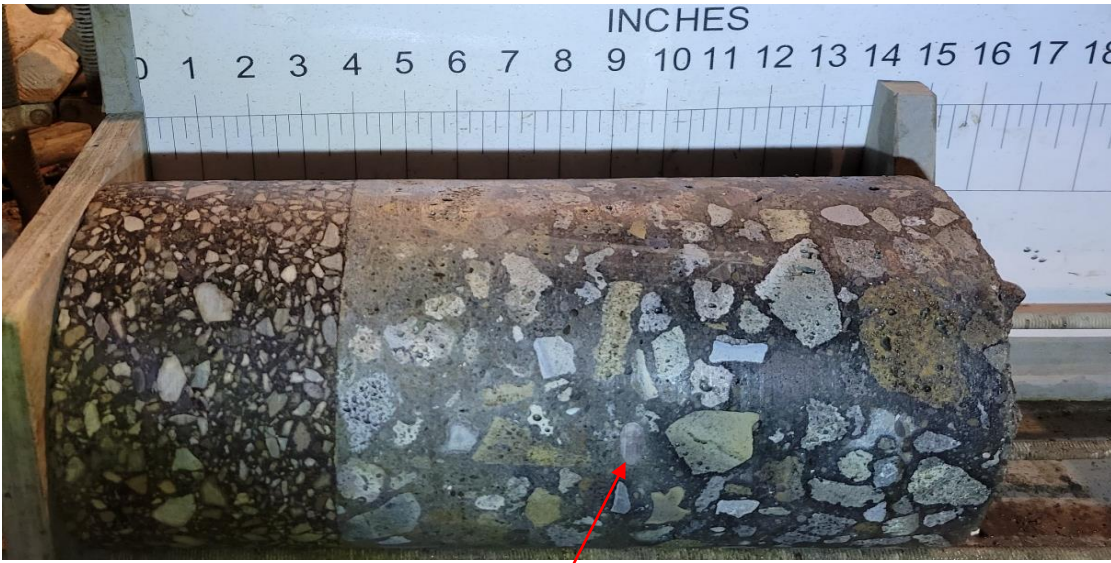
B-013-2-22 / Asphalt = 4 " Concrete = 9¾"

Reinforcing steel observed 4¼" below the top of concrete.

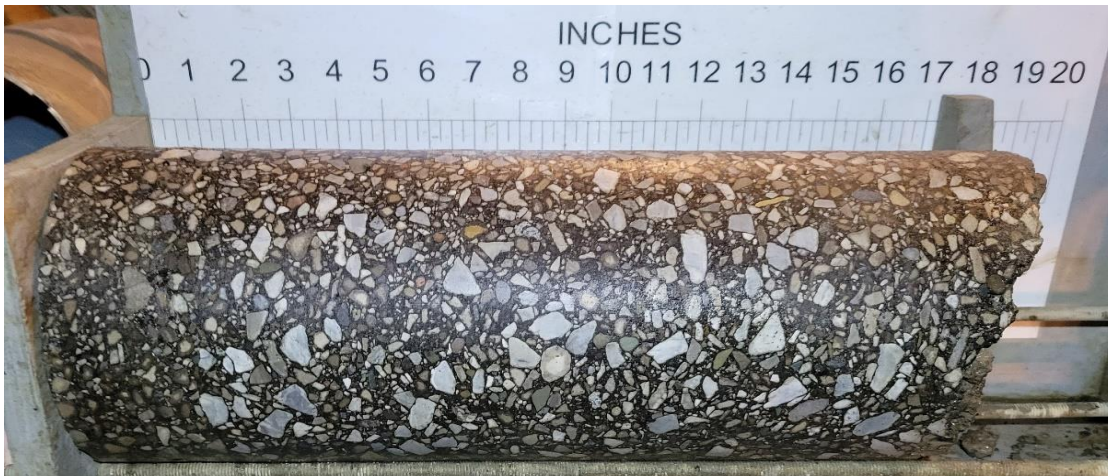
B-013-3-22 / Asphalt = 17¼"

Core length ranged from 15¾" to 17¼".

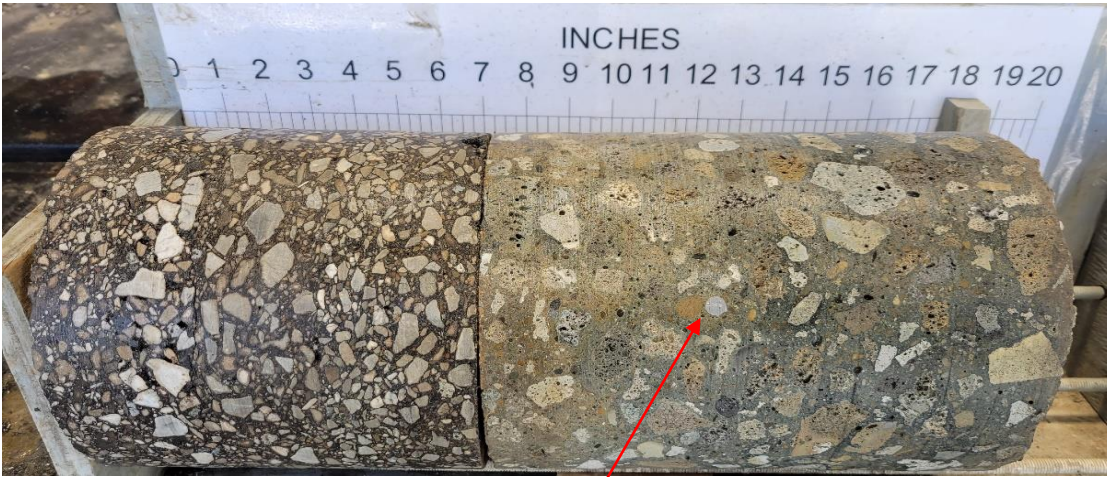
19	Core Number / Thickness	B-014-2-22 / Asphalt = 7¾" Concrete = 10 "
	Remarks	Reinforcing steel observed 4¼" below the top of concrete.

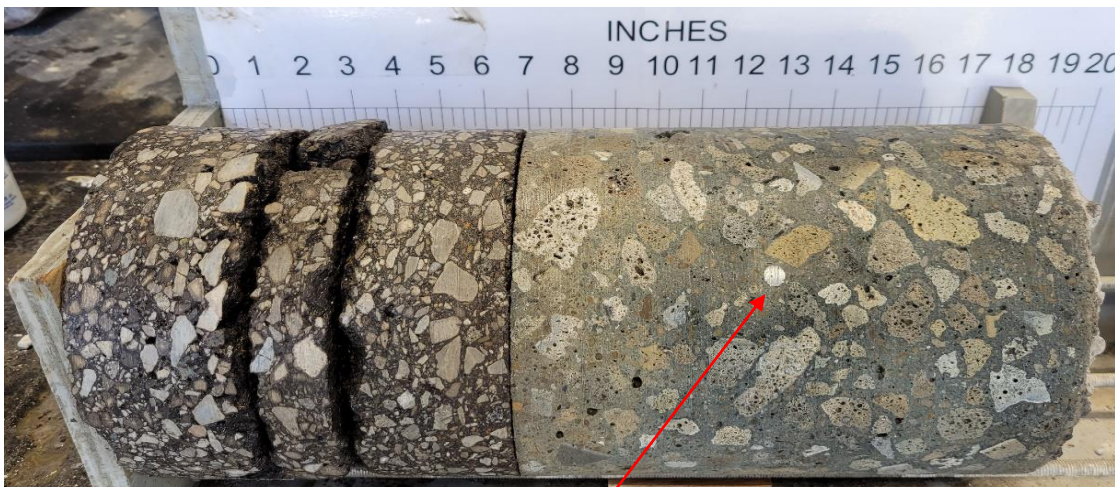
20	Core Number / Thickness	B-014-3-22 / Asphalt = 8 " Concrete = 9½"
	Remarks	Reinforcing steel observed 4½" below the top of concrete.

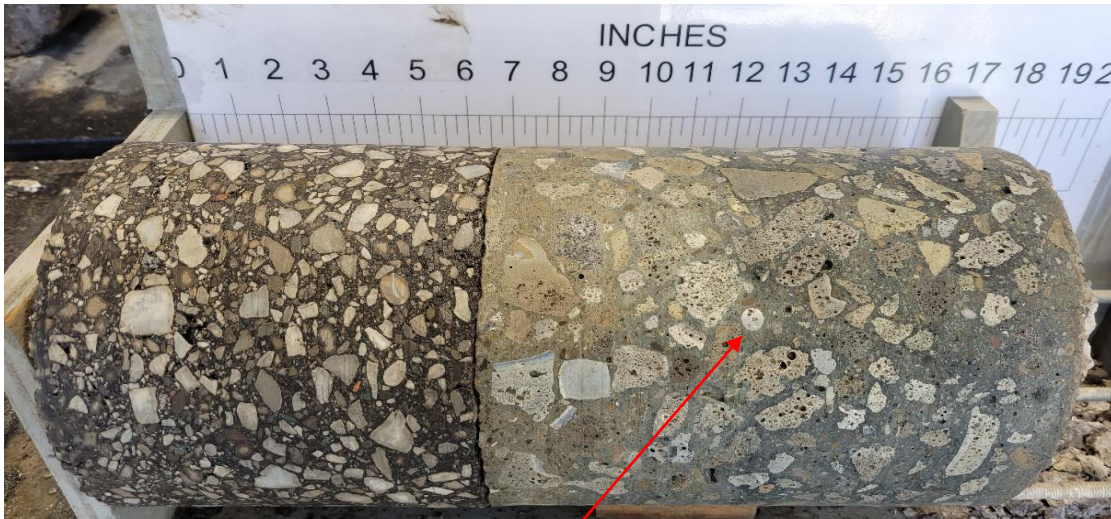
B-014-4-22 / Asphalt = 8 " Concrete = 8½"

Reinforcing steel observed 4¼" below the top of concrete.

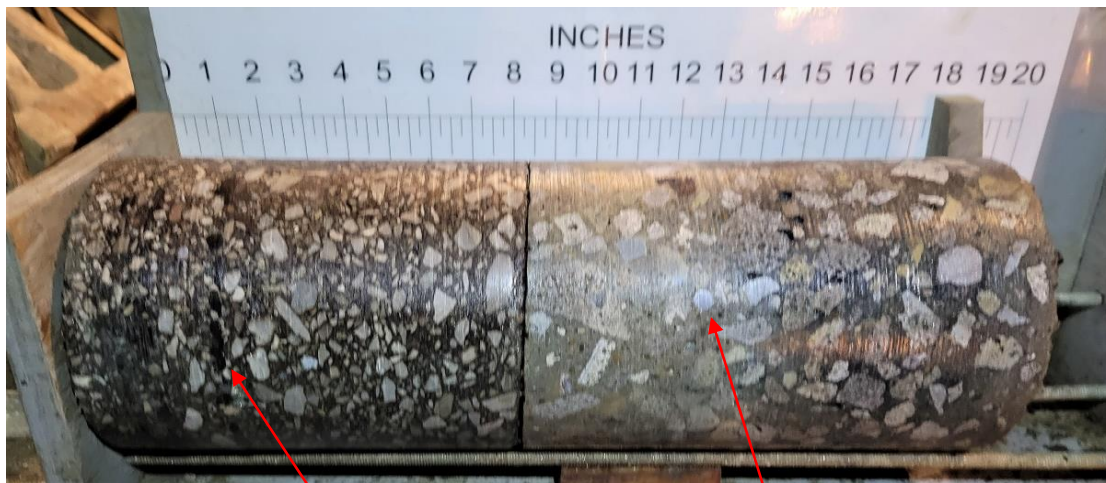
B-015-0-22 / Asphalt = 8 " Concrete = 9¾"

Reinforcing steel observed 3½" below the top of concrete. A layer with higher bitumen content observed about 3" below top of asphalt.

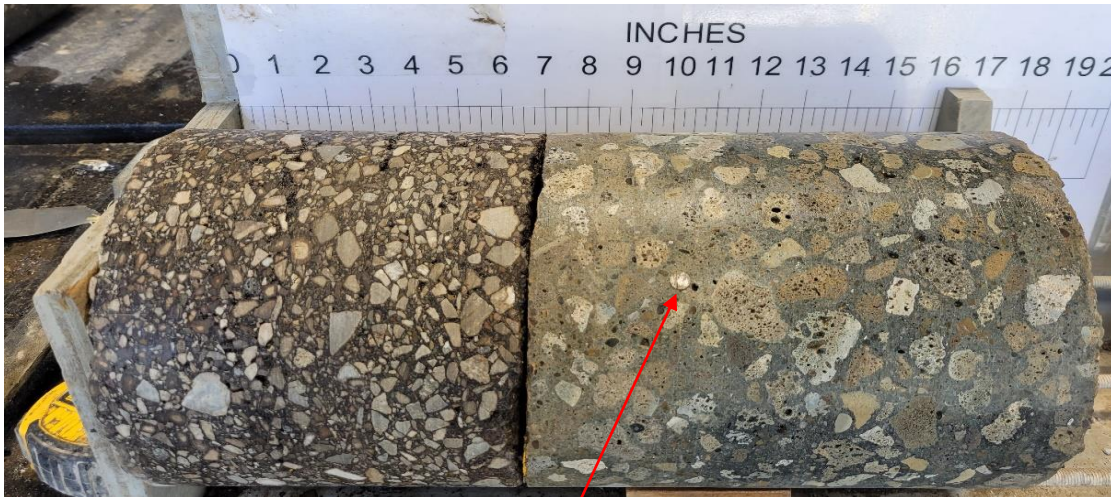
23	Core Number / Thickness	B-016-0-22 / Asphalt = 6¾" Concrete = 9½"
	Remarks	Reinforcing steel observed 2½" below the top of concrete.

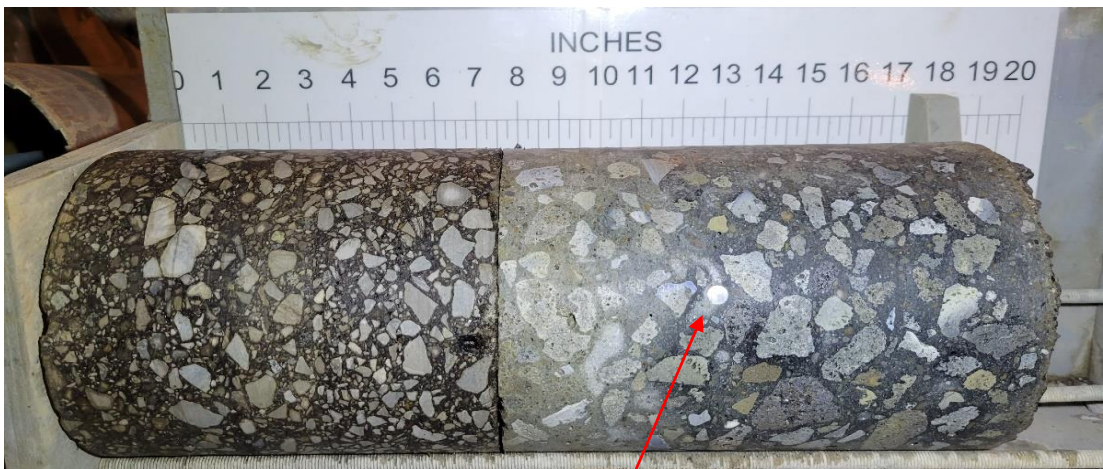
24	Core Number / Thickness	B-017-0-22 / Asphalt = 7¾" Concrete = 9½"
	Remarks	Reinforcing steel observed 3¾" below the top of concrete.

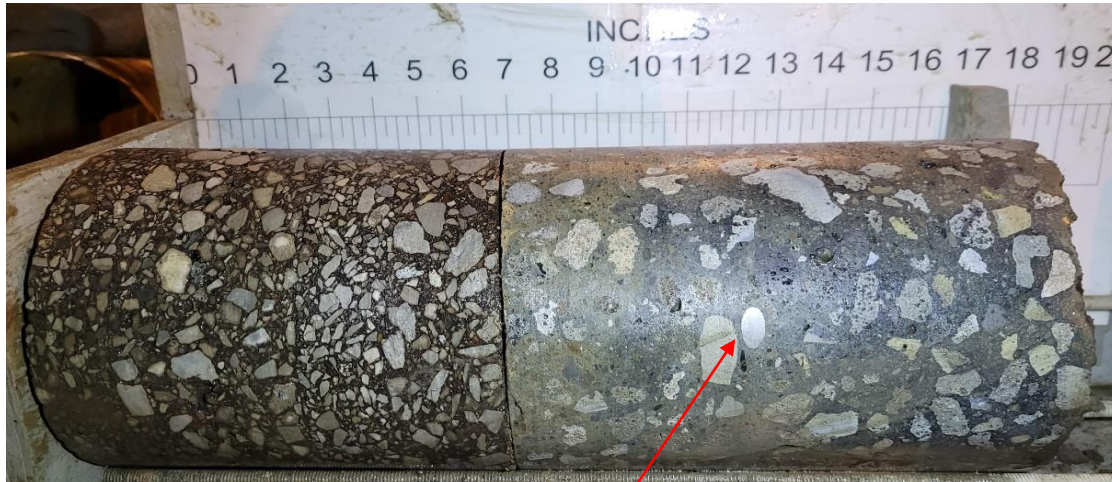
B-018-0-22 / Asphalt = 7 " Concrete = 9½"

Reinforcing steel observed 3½" below the top of concrete.

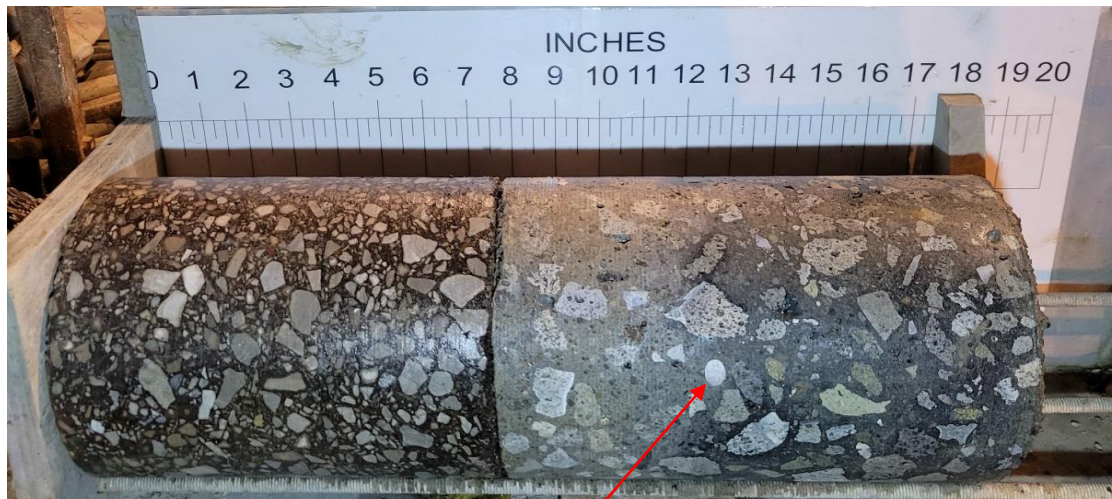
B-021-0-22 / Asphalt = 7¾" Concrete = 9¾"

Reinforcing steel observed 3¾" below the top of concrete. A color change was observed in the concrete about 3" from the top of concrete

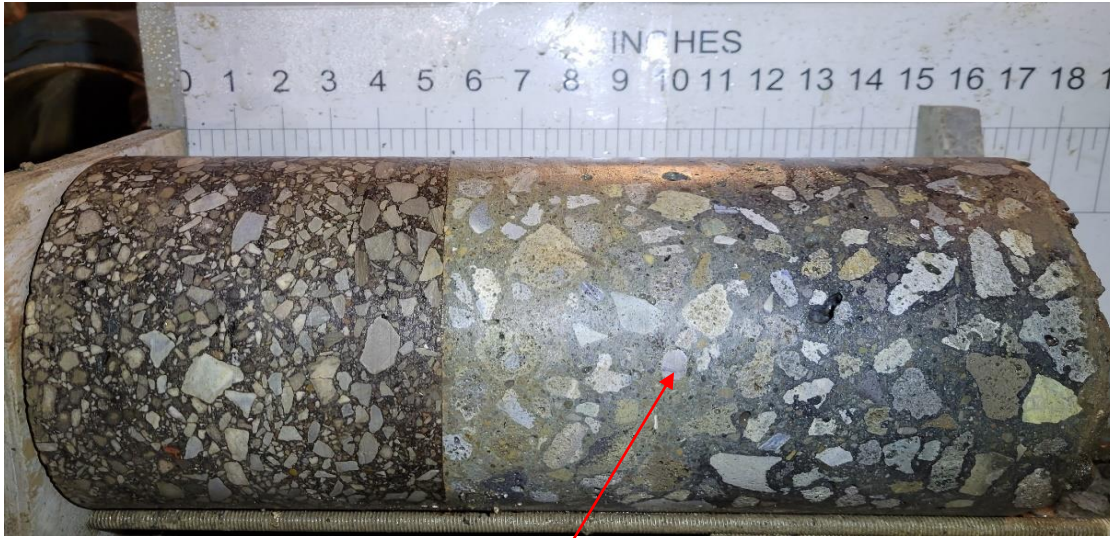
B-022-0-22 / Asphalt = 5¾" Concrete = 9¼"

Reinforcing steel observed 3¼" below the top of concrete.

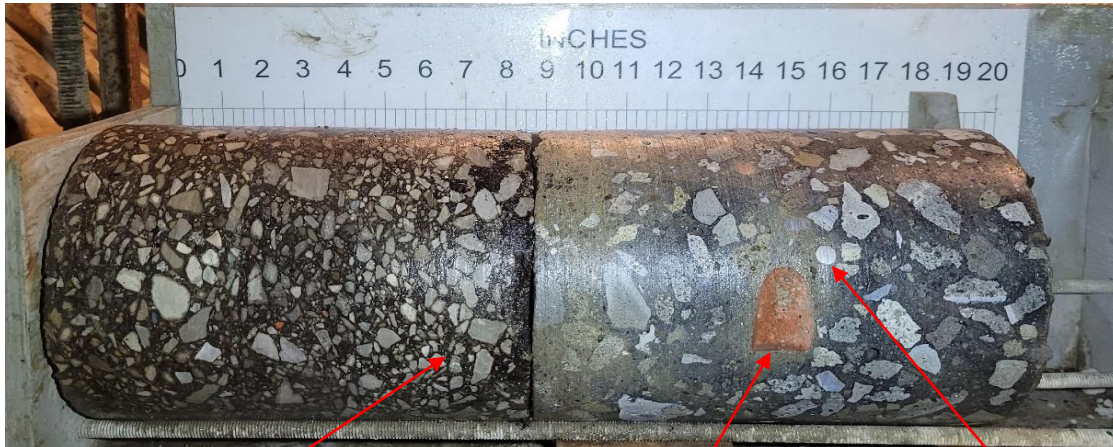
29	Core Number / Thickness	B-025-0-22 / Asphalt = 8¾" Concrete = 9¼"
	Remarks	A layer of higher bitumen content observed in the ½" from the bottom of the asphalt. Reinforcing steel observed 3¾", 4½", and 5" below the top of concrete. An indentation was observed about 4"-5" from the top of the concrete.

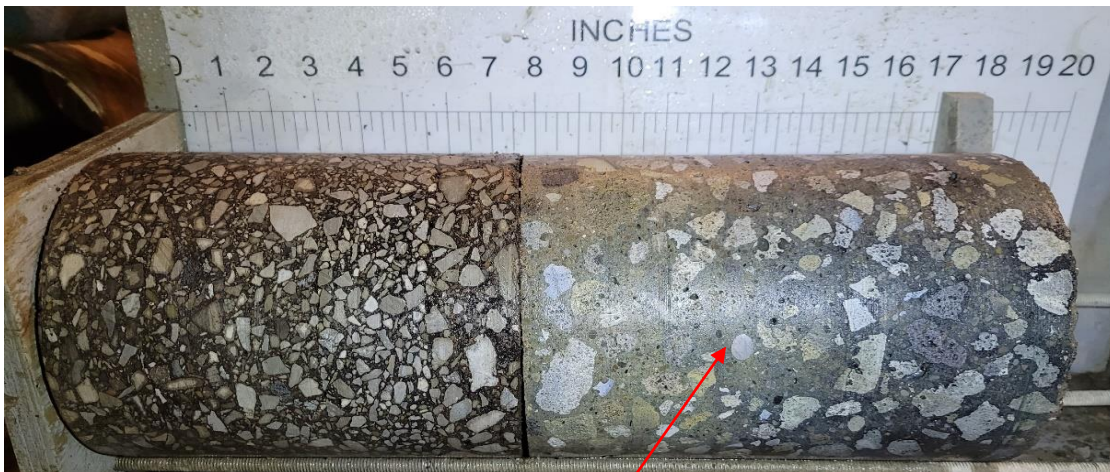
30	Core Number / Thickness	B-026-0-22 / Asphalt = 7¾" Concrete = 9¼"
	Remarks	Reinforcing steel observed 3½" below the top of concrete.

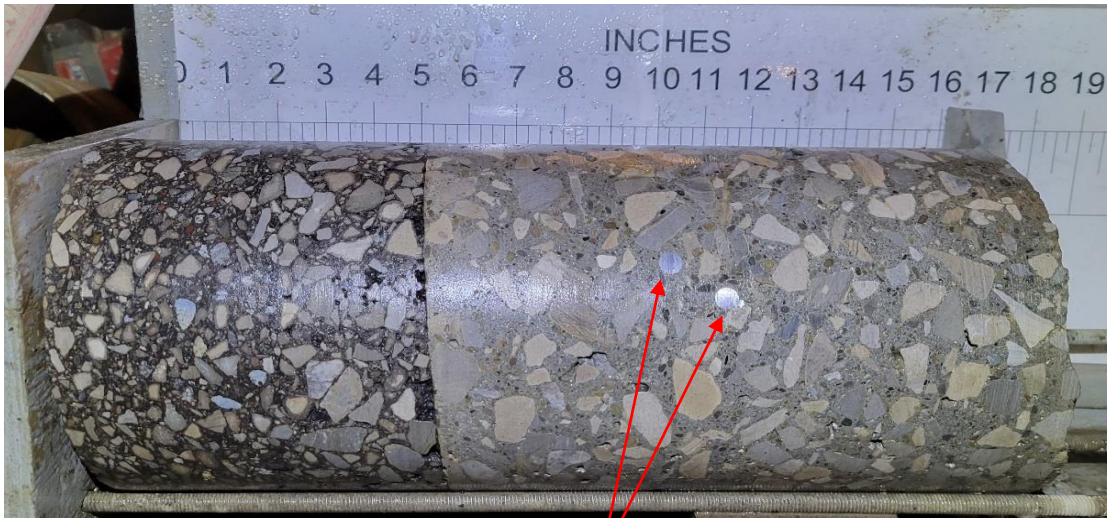
32	Core Number / Thickness	B-036-0-22 / Asphalt = 5½" Concrete = 10½"
	Remarks	Reinforcing steel was observed 3½" and 4" from the top of concrete.

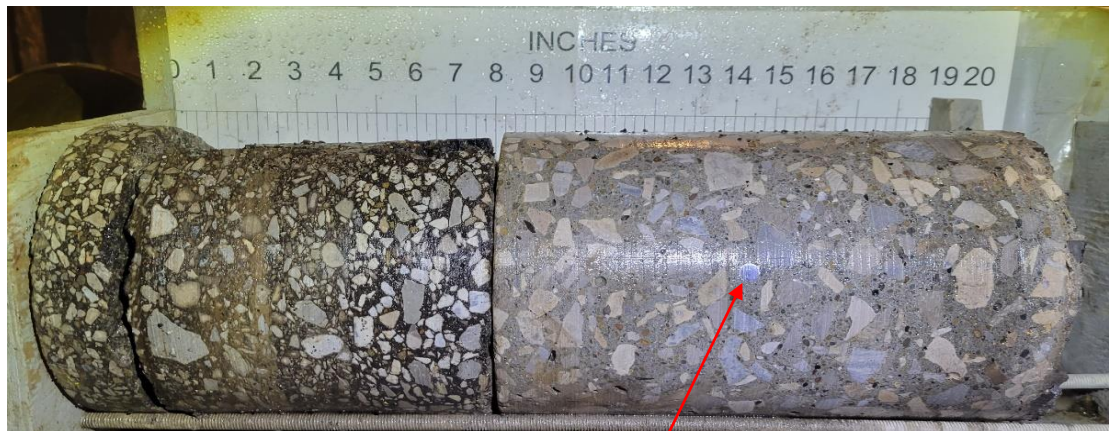
B-040-0-22 / Asphalt = 8 " Concrete = 10¾"

Reinforcing steel was observed 4¼" from the top of concrete.
Deterioration was observed in the lower ½" of the concrete.

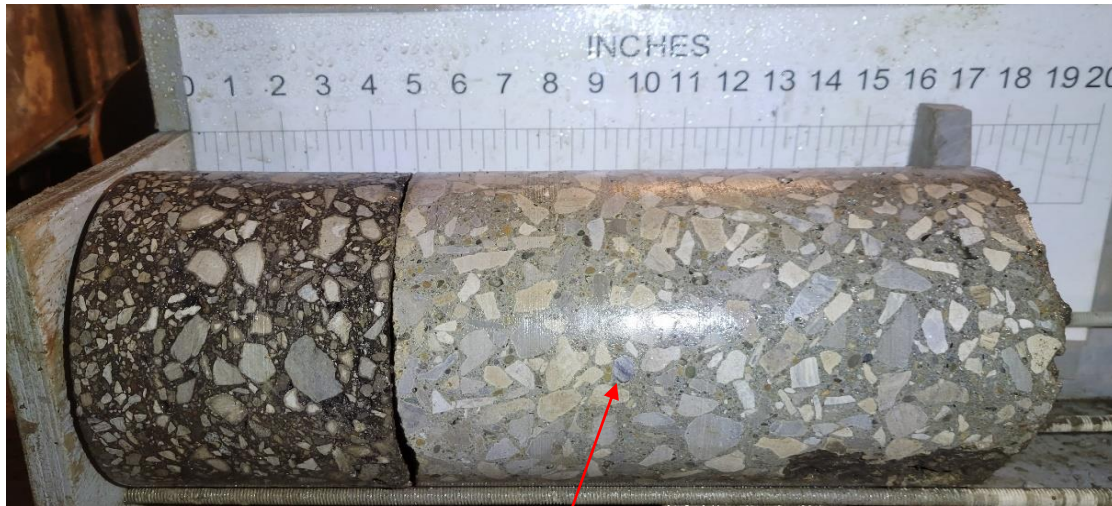
B-046-0-22 / Asphalt = 5 " Concrete = 11 "

Reinforcing steel was observed 3³/₄" from the top of concrete. A portion of the lower 3" of the concrete split away during coring.

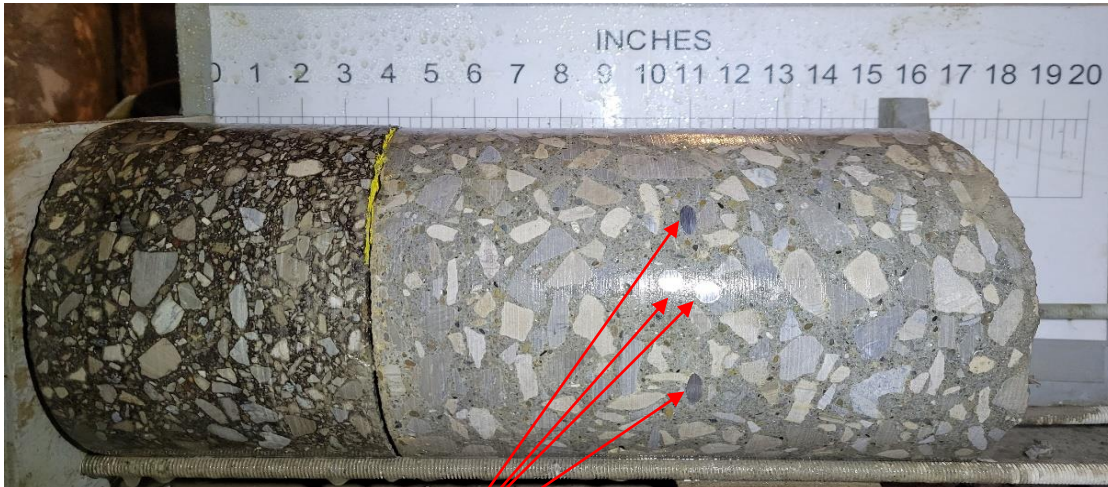
39	Core Number / Thickness	B-050-0-22 / Asphalt = 5 " Concrete = 10¼"
	Remarks	Reinforcing steel was observed 4½", 4¾, and 5" from the top of concrete.

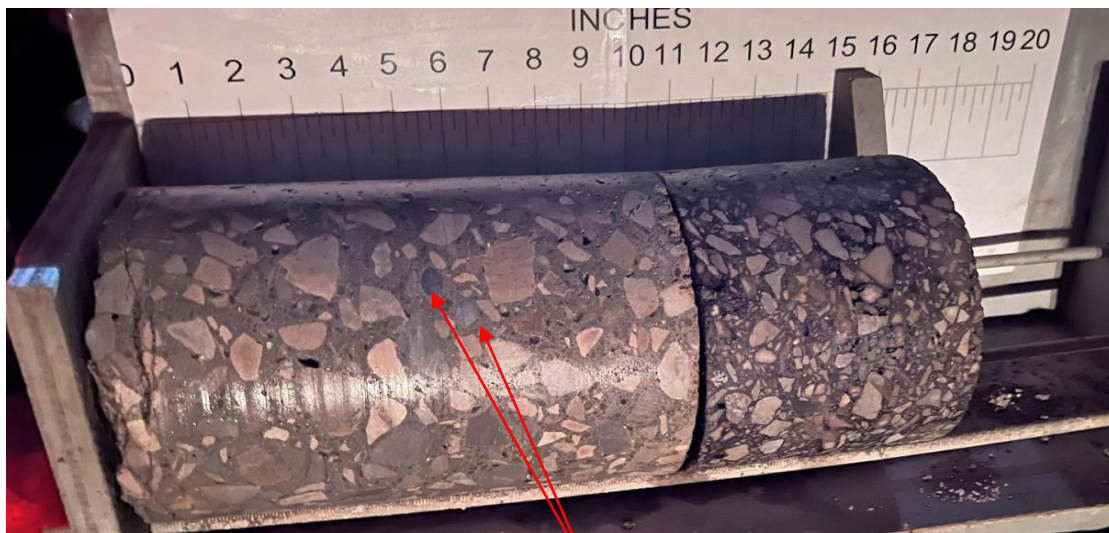
40	Core Number / Thickness	B-051-0-22 / Asphalt = 5 " Concrete = 9½"
	Remarks	Reinforcing steel was observed 4" and 4¼" from the top of concrete. Horizontal cracks were observed in the lower 1" - ½" of the concrete.

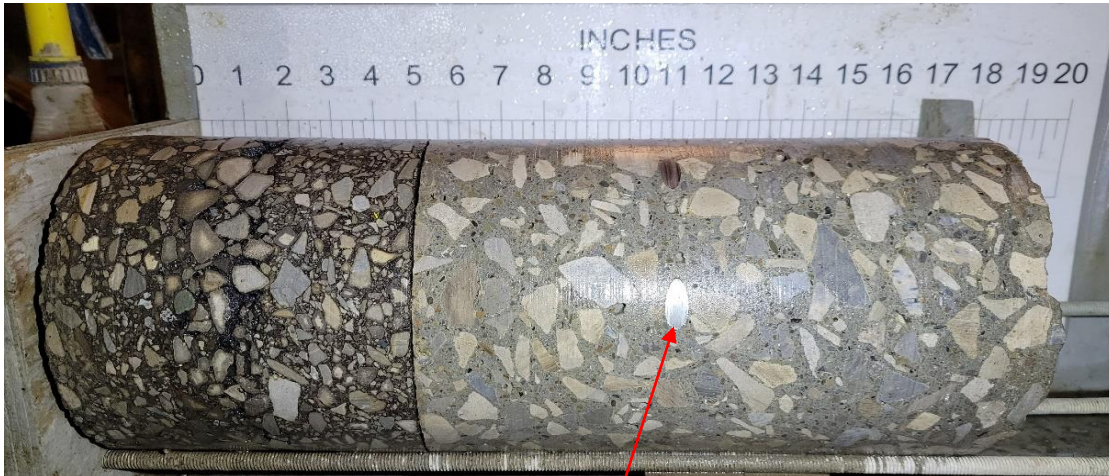
41	Core Number / Thickness	B-054-0-22 / Asphalt = 5 3/4" Concrete = 10 3/4"
	Remarks	Reinforcing steel was observed 4 1/4" from the top of concrete. Deterioration was observed in the lower 1/2" of the concrete.

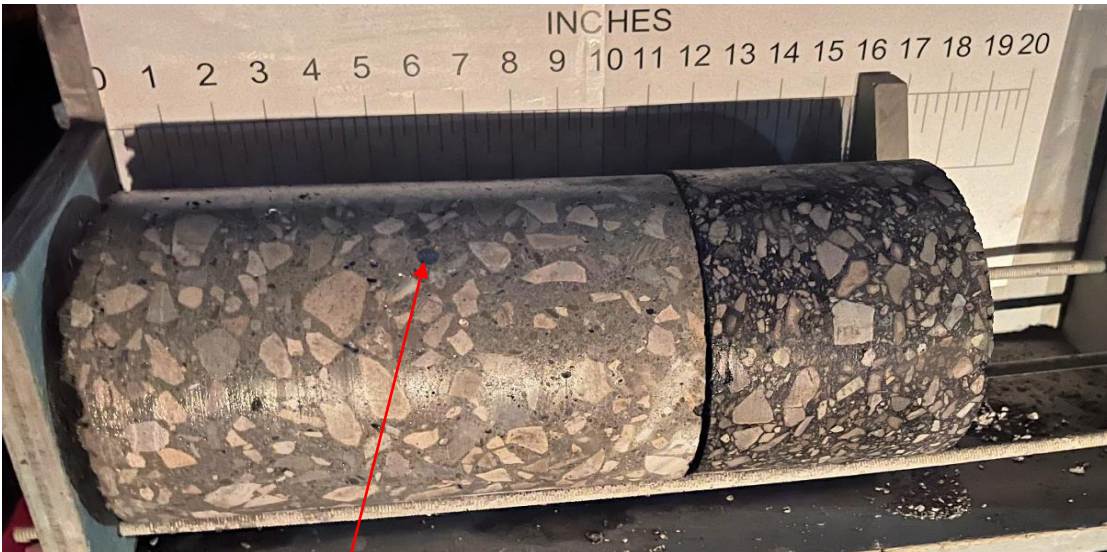
42	Core Number / Thickness	B-055-0-22 / Asphalt = 5 " Concrete = 10 "
	Remarks	Reinforcing steel was observed 4 1/2" from the top of concrete. Horizontal cracks were observed in the lower 1/2" of the concrete.

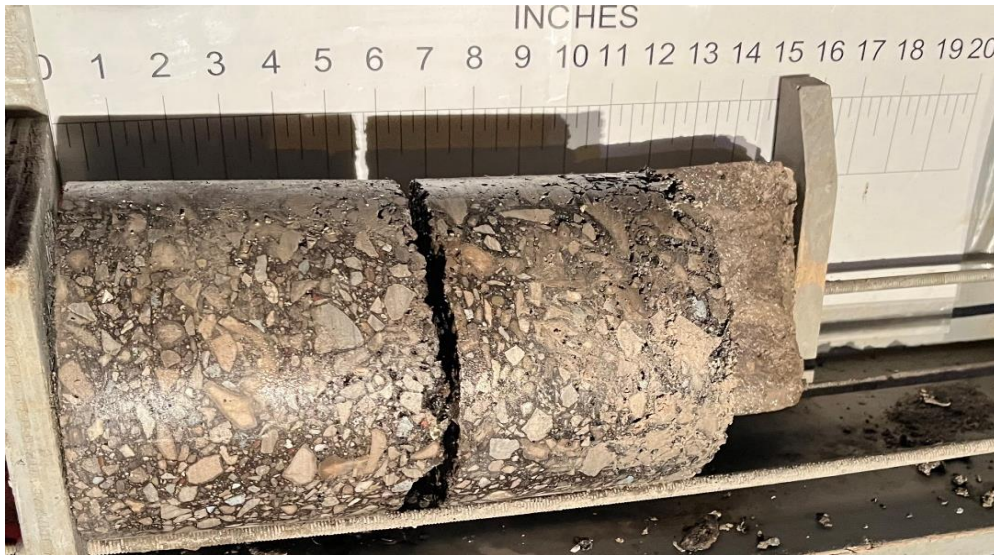
B-057-1-22 / Asphalt = 10½"

Cemented slag/base (4") based partially recovered below asphalt.

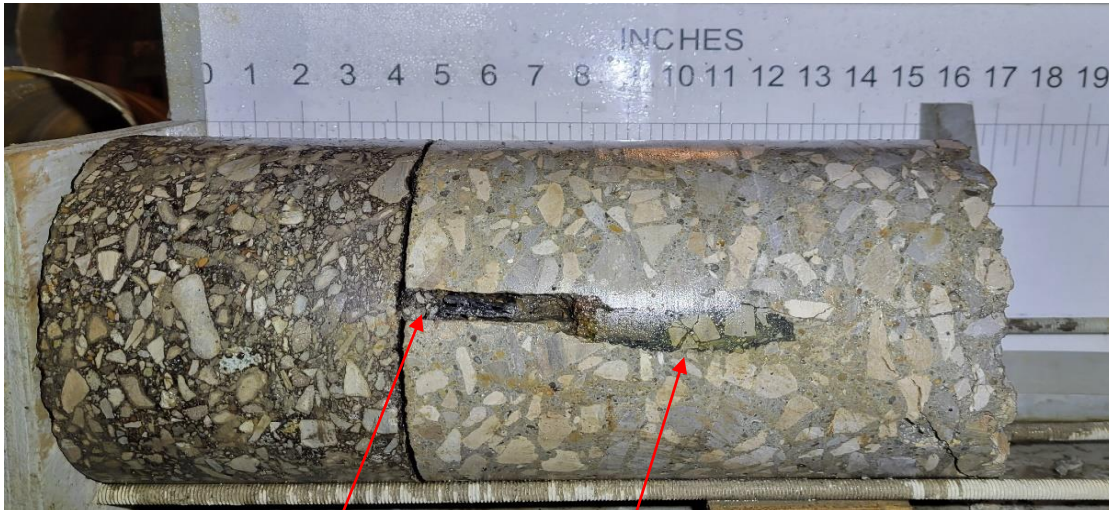
45	Core Number / Thickness	B-058-0-22 / Asphalt = 5" Concrete = 10¼"
	Remarks	An expansion joint, was observed in the upper 2½ of the concrete. A vertical crack, filled with a bituminous compound was observed in the upper 5¾" of the concrete. Horizontal cracks were observed in the lower 1" of the concrete.

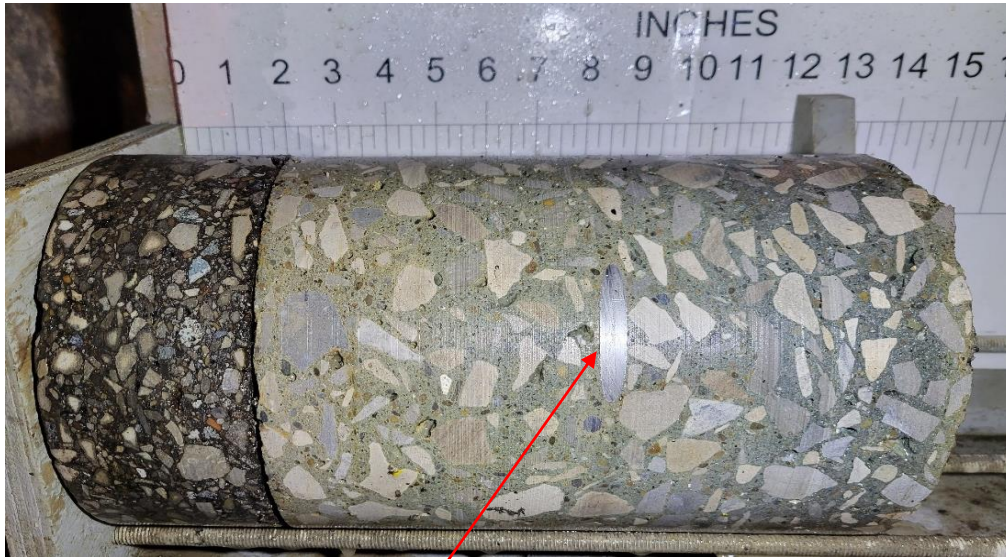
51	Core Number / Thickness	B-060-1-22 / Asphalt = 2¾" Concrete = 9¼"
	Remarks	Reinforcing steel was observed 4½" from the top of concrete.

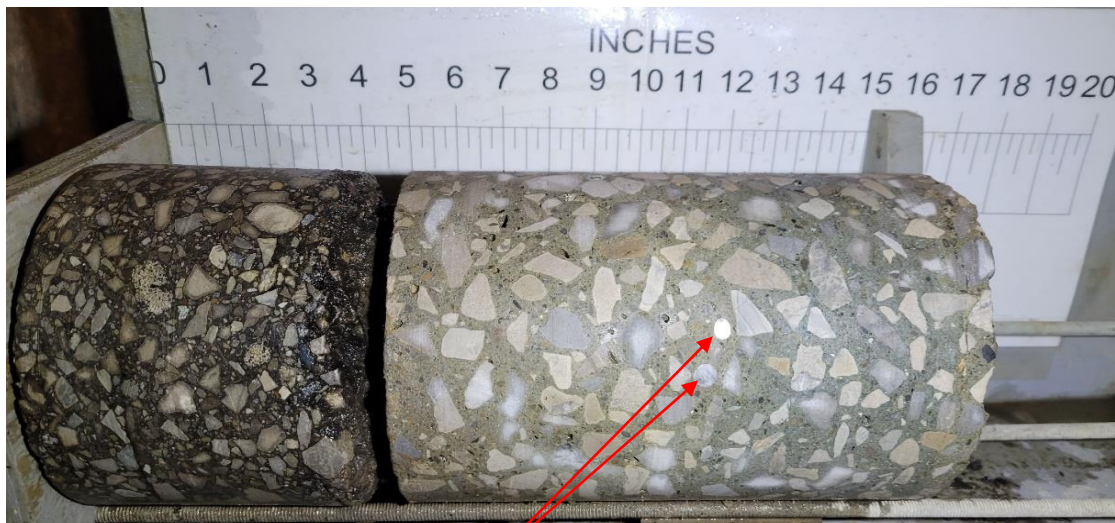
52	Core Number / Thickness	B-060-2-22 / Asphalt = 5½" Concrete = 9½"
	Remarks	Deterioration was observed in the lower 1" of the asphalt. Reinforcing steel was observed 4¾" and 5" from the top of concrete. Horizontal cracks were observed in the lower ½" of the concrete.

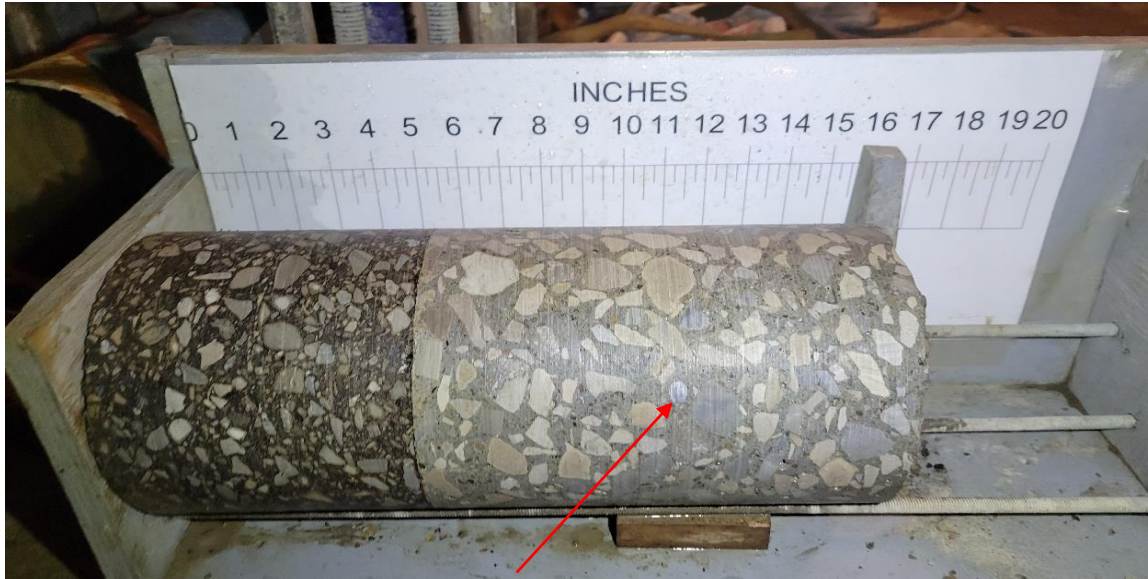
53	Core Number / Thickness	B-062-0-22 / Asphalt = 6 " Concrete = 9¼"
	Remarks	Reinforcing steel observed 4¾" below the top of concrete.
