Pavement Core Summary

S&ME Project No.: 217525

Project Name: LOR-90-10.76

Client: ODOT District 3

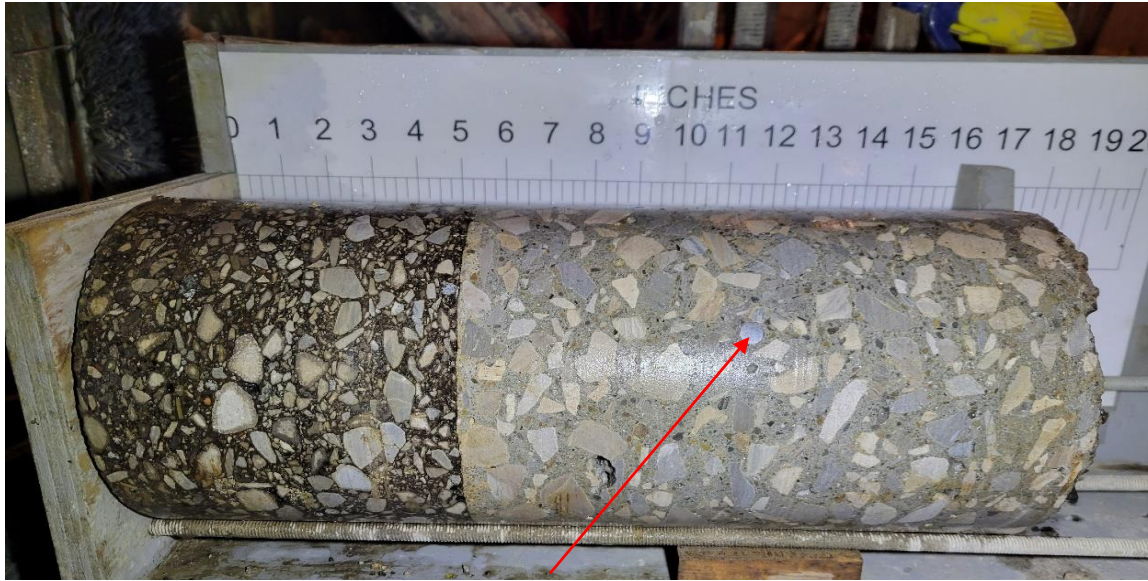
55	Core Number / Thickness	B-066-0-22 / Asphalt = 5¾" Concrete = 10¼"
	Remarks	Reinforcing steel observed 4½" below the top of concrete. Deterioration observed in the lower ½" of the concrete.

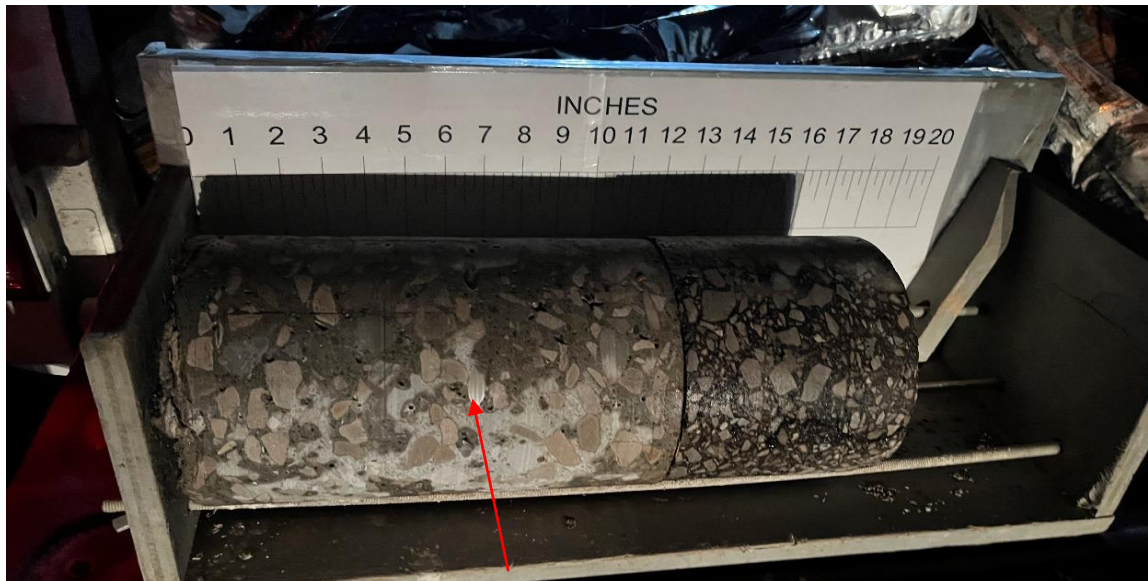
56	Core Number / Thickness	B-067-0-22 / Asphalt = 5¼" Concrete = 10½"
	Remarks	Reinforcing steel observed 4½" below the top of concrete.

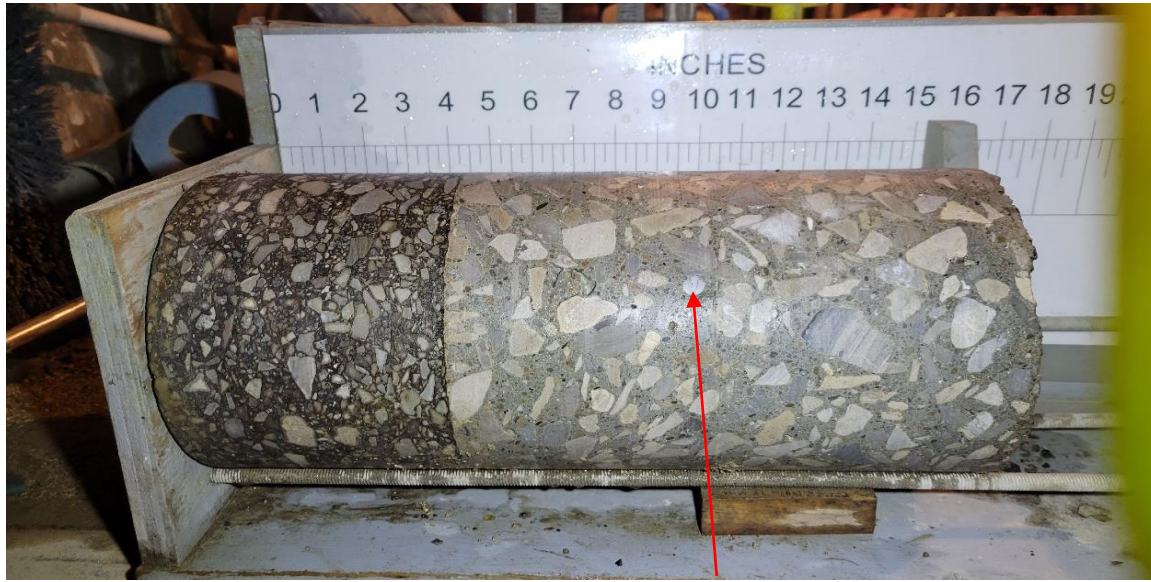
57	Core Number / Thickness	B-070-0-22 / Asphalt = 5 " Concrete = 10 "
	Remarks	Reinforcing steel observed 4¼" and 4½" below the top of concrete.

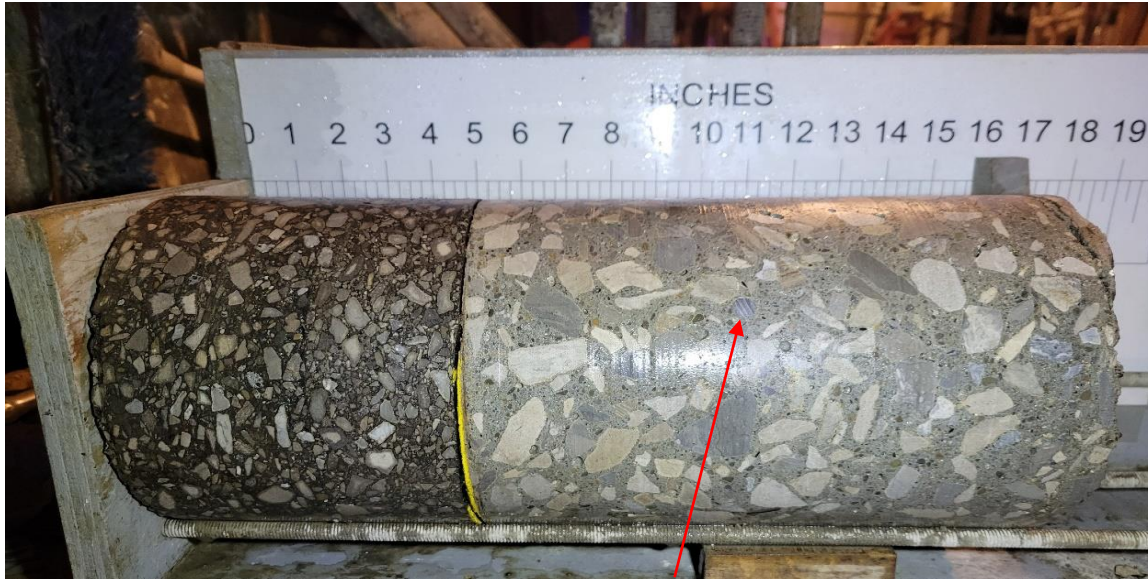
59	Core Number / Thickness	B-074-0-22 / Asphalt = 5¾" Concrete = 10¼"
	Remarks	Reinforcing steel observed 4¼" below the top of concrete. Horizontal cracks observed in the lower ½" of the concrete.

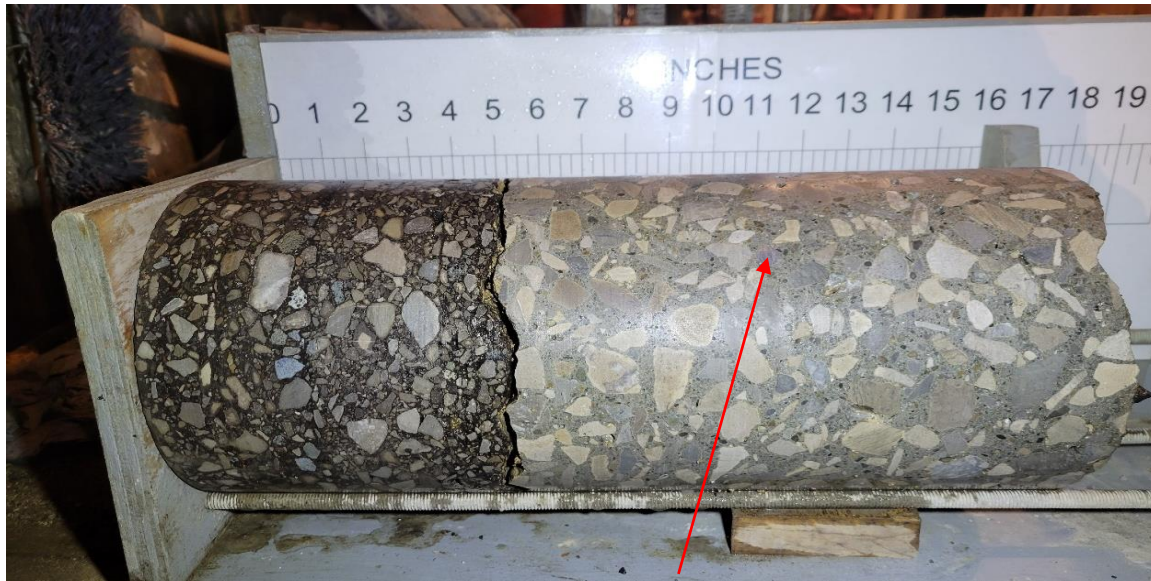
61	Core Number / Thickness	B-078-0-22 / Asphalt = 5¾" Concrete = 10¼"
	Remarks	Reinforcing steel observed 4½" below the top of concrete. Deterioration observed in the asphalt and concrete layers at their interface.

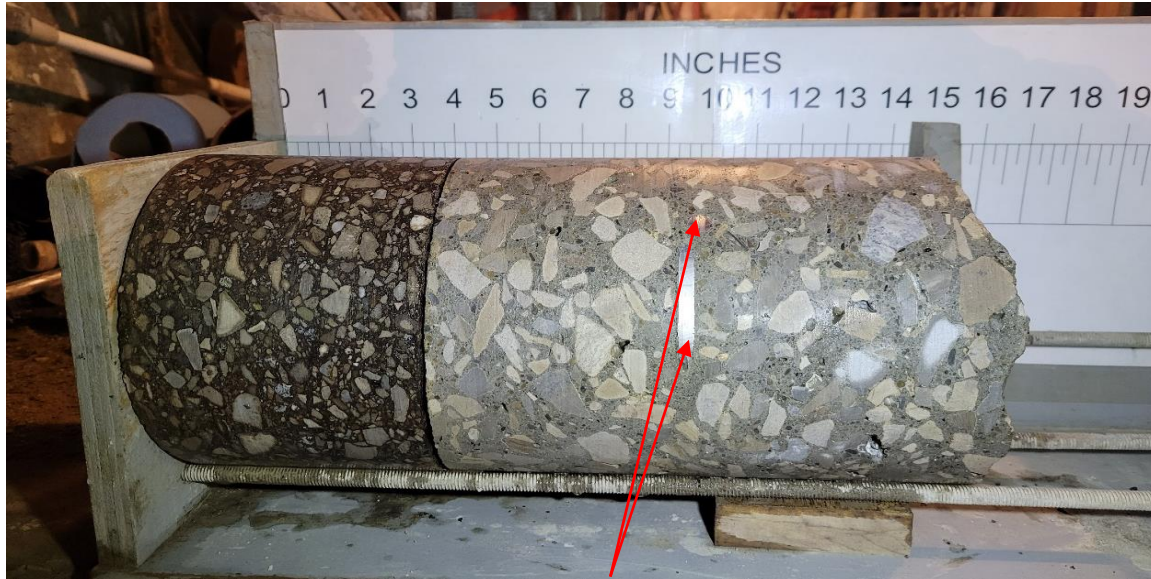
B-082-0-22 / Asphalt = 5" Concrete = 9¼"

Reinforcing steel observed 4" and 4¼" below the top of concrete.

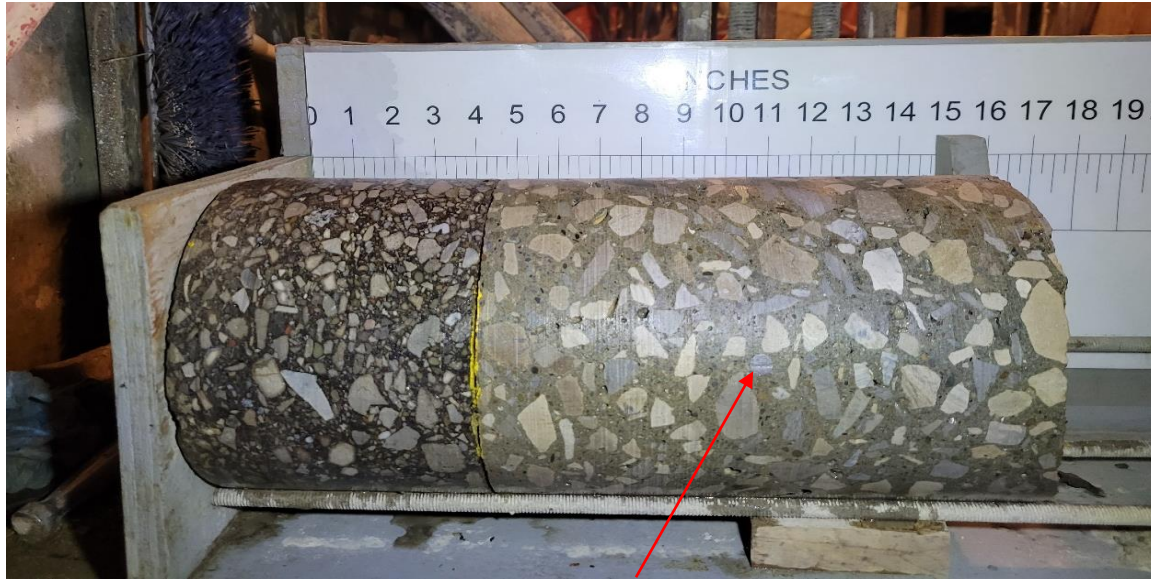
B-094-0-22 / Asphalt = 5 " Concrete = 9¾"

Reinforcing steel observed 4½" below the top of concrete.

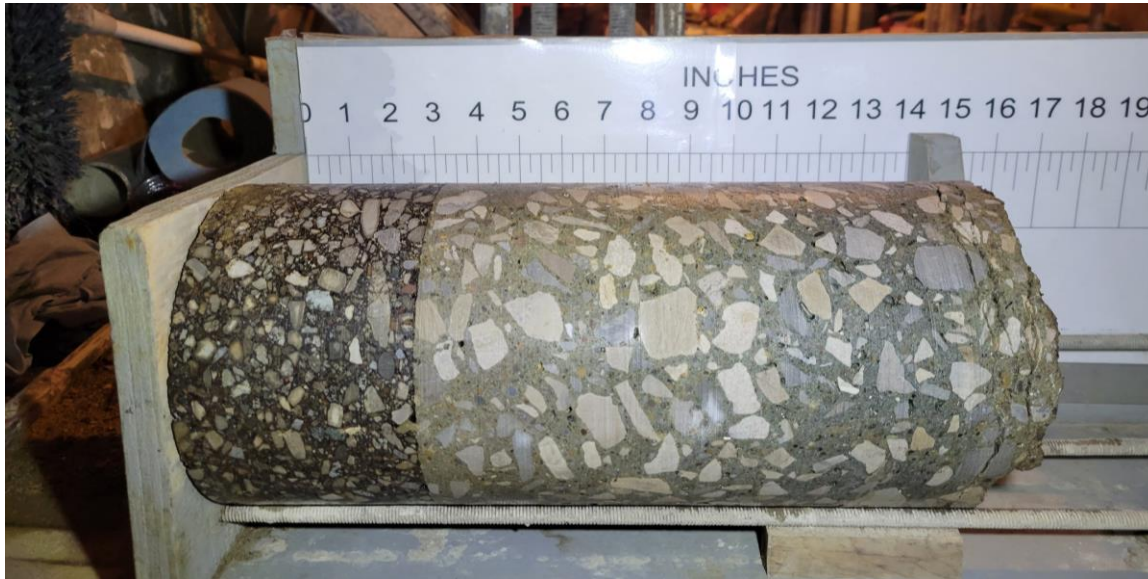
71	Core Number / Thickness	B-098-0-22 / Asphalt = 4 " Concrete = 10 "
	Remarks	Reinforcing steel observed 4½" below the top of concrete. Horizontal cracks observed in the lower 2" of the concrete.
