INTEROFFICE COMMUNICATION

To: Nikunj Kadakia, P.E., District Geotechnical Engineer, District 3
COPY: Steve A. Taliaferro, P.E., Office of Geotechnical Engineering
FROM: P. Paul Painter, Office of Geotechnical Engineering
DATE: November 16, 2023
SUBJECT: MUS-70-27.00 Field Reconnaissance for Geotechnical Exploration

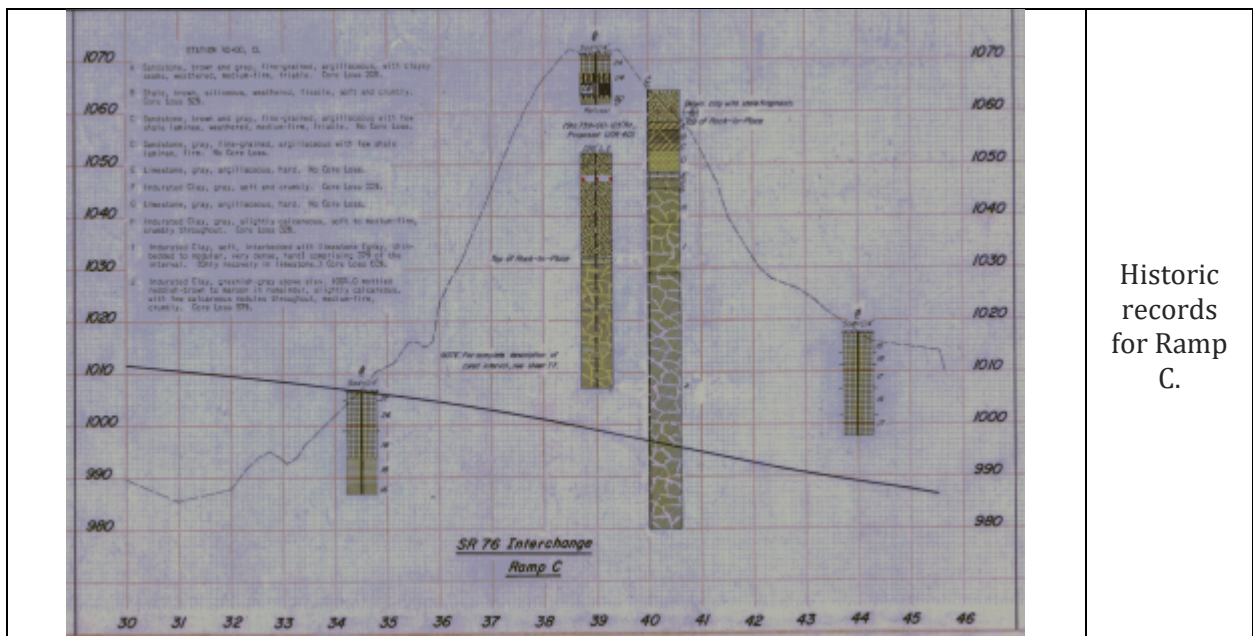
Historic records for Ramp C.

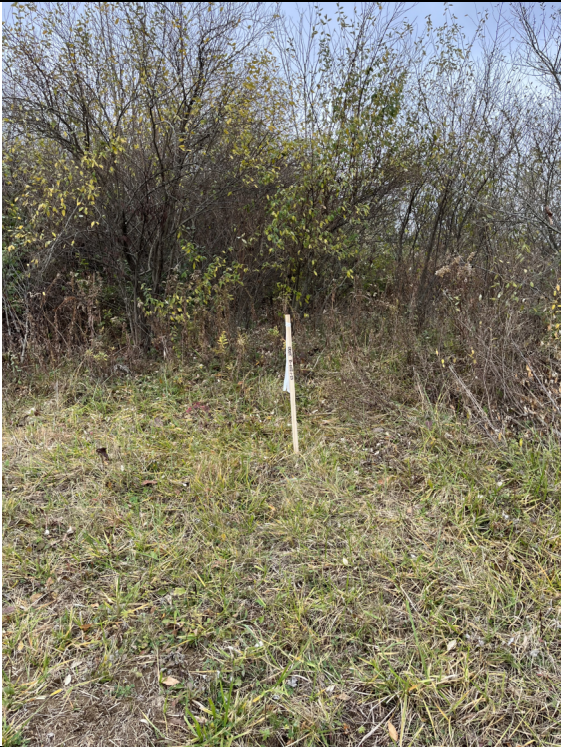
<p>Boring Location B-002-0- 23</p> <p>Clearing to B-001 is behind this location.</p>

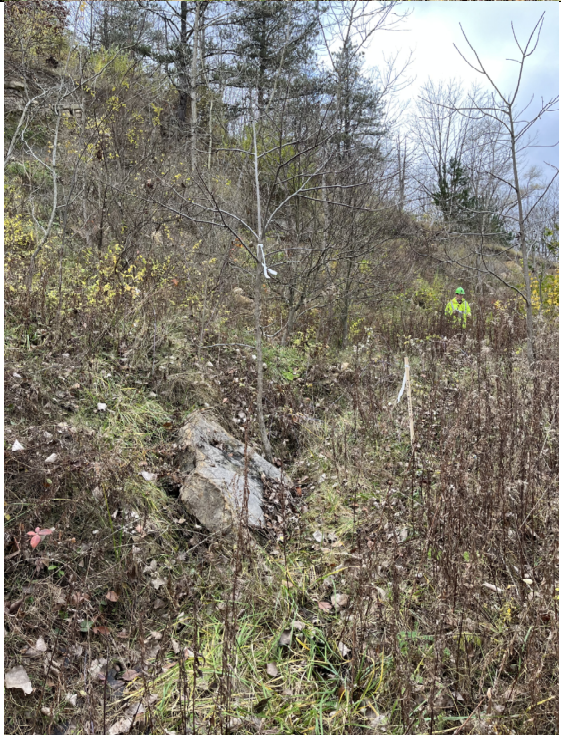
<p>Boring Location B-003-0- 23</p> <p>Clearing will be needed to access.</p>

from this jutting ledge. A relatively flat surface is located mid slope of the slide bench with deep depressions on either side. B-003-0-23 was staked at this location which will require minor access and clearing work. We plan to access this location from Ramp D, traversing across the lower slope. OGE recommends that an inclinometer be installed at this location to confirm the mode of slope instability. An additional boring, B-003-1-23, was staked at the top of the hillside which has been leveled off. This boring will be off right-of-way and will require a right of entry letter to be sent out. We plan on accessing this location via the field drive off SR-83. The right-of-way fence is present just outside of the head scarp face.

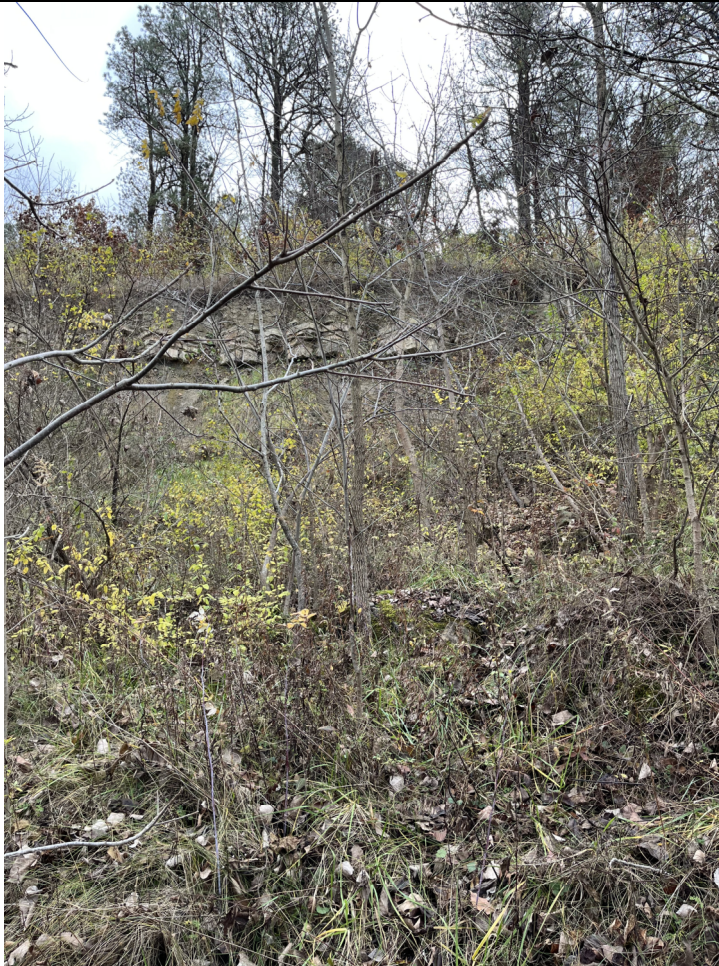
The eastbound on-ramp from SR-83 to IR-70 (Ramp D) previously experienced a large-scale slope failure. At the time of the failure, it was determined that grading to establish positive drainage off the slope and along the ramp was the best course of action due to the size of the slide. The slide mass has continued to move toward the ramp. The head scarp from the previous slide is present at the top of the cut section with the sandstone noted from the historical boring along Ramp C present jutting from the scarp face. Several rockfall blocks were noted on the slope surface which appear to have come

Sandstone
jutting
from head
scarp.
