Inspector: Hess,Derek
Inspection Date: 11/09/2022

Structure Number: 8758948
Facility Carried: BRIDGE STREET

Bridge Inspection Report

WOO-C463A-0001 (8758948)

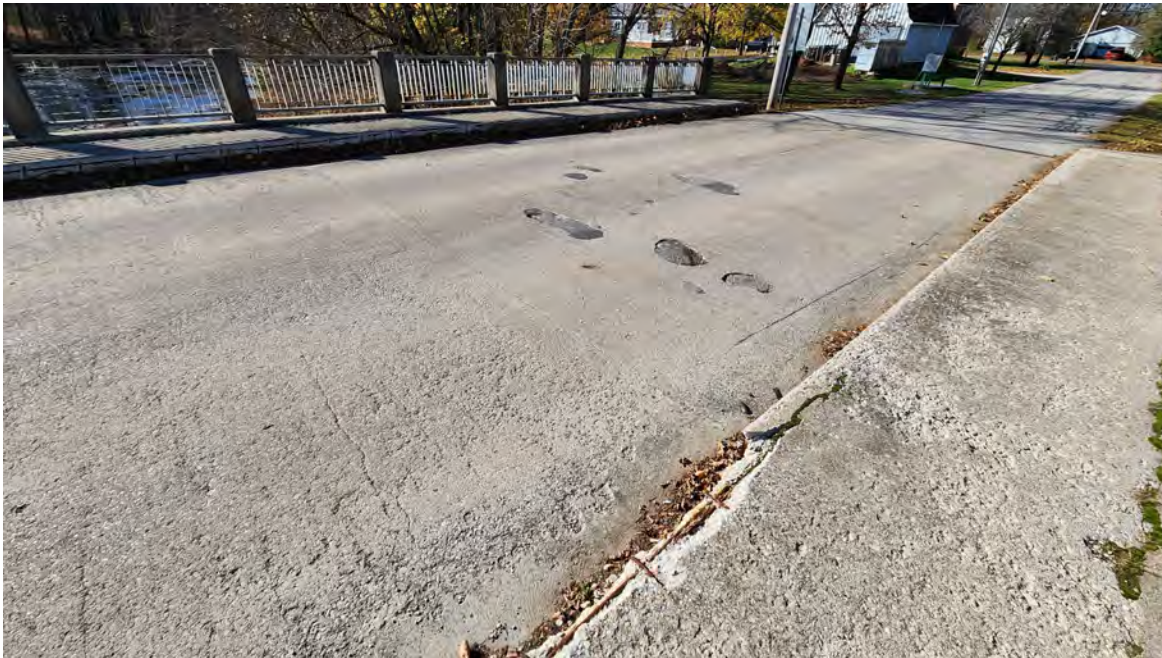
- Transverse cracking and scaling throughout.
- Span 1 has small potholes with some having been patched.
- Spot sounding has indicated approximately 25% of the wearing surface is delaminated. More prevalent in Span 1.

Description 8758948_Span 1 Surface

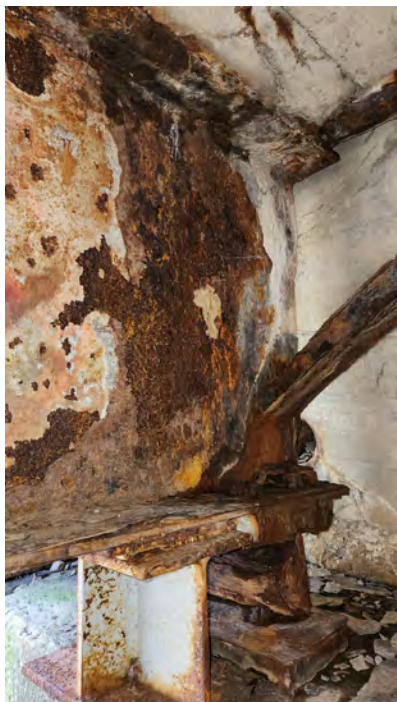
- Beams above fwd abutment have web section loss as follows: Beam 1 has 20% loss for full height. Beam 2 has 20% loss to web plate for bottom 8". Beam 6 has 20% loss for bottom 8" and 10% for remaining height to web plate. Beam 7 has 15% loss to bottom 4".

Description 8758948_Beam 1 @ FA_Corrosion

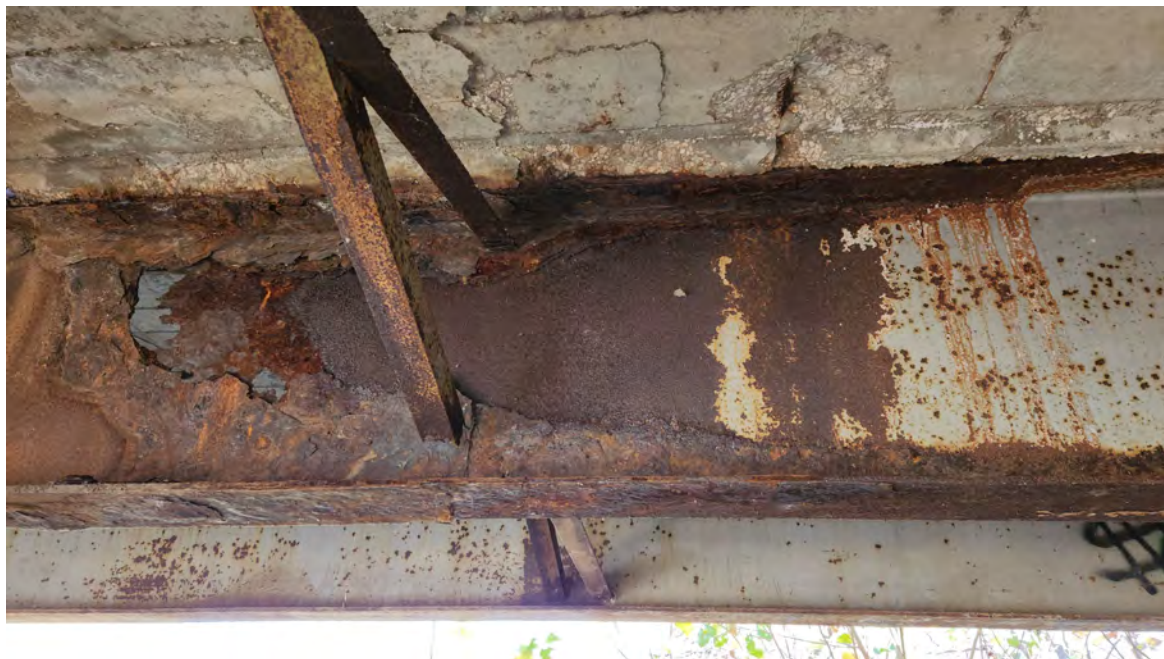
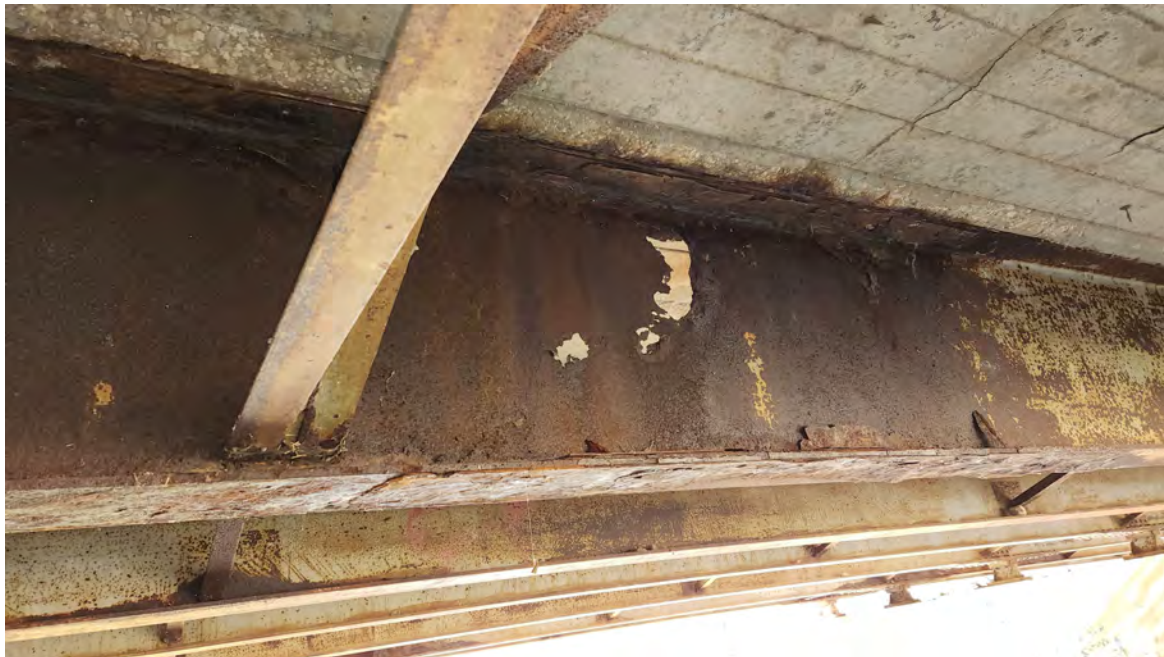
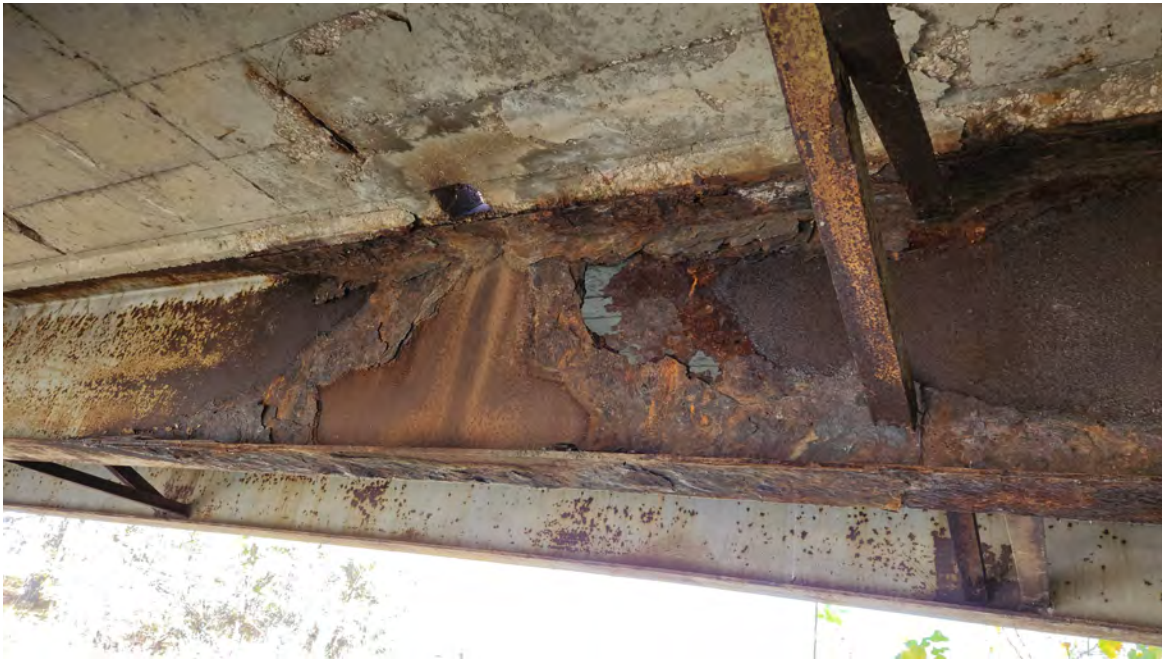
- Span 3 Beam 2 has a 2 foot long hole in web beneath scupper. Has shown noticeable increase in size from the 2021 inspection. **(Approximated at 50% of top flange, 50% to 90% of web, and 60% of bottom flange for a length of 10 feet)**

Description 8758948_Span 3 Beam 2_Section Loss (2)

Description 8758948_Span 3 Beam 2_Section Loss (3)

Description 8758948_Span 3 Beam 2_Section Loss

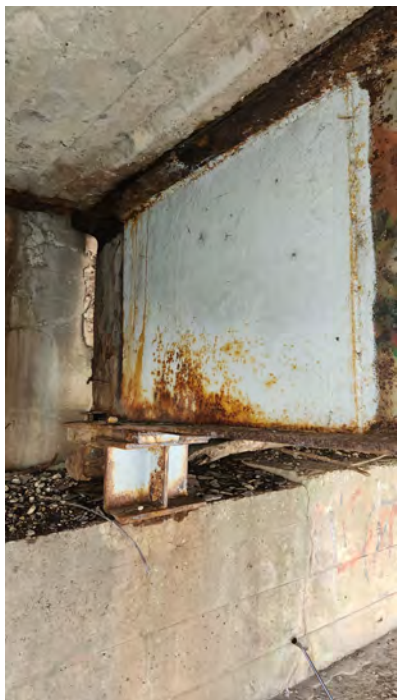
Description 8758948_Beam 2 @ FA_Corrosion

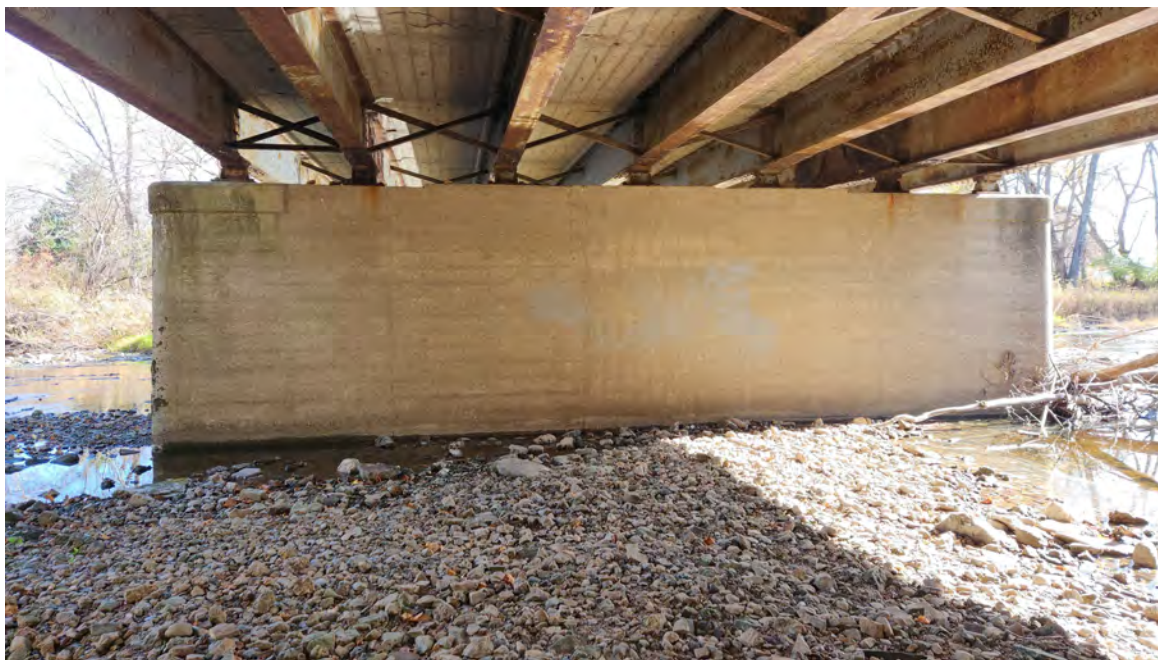
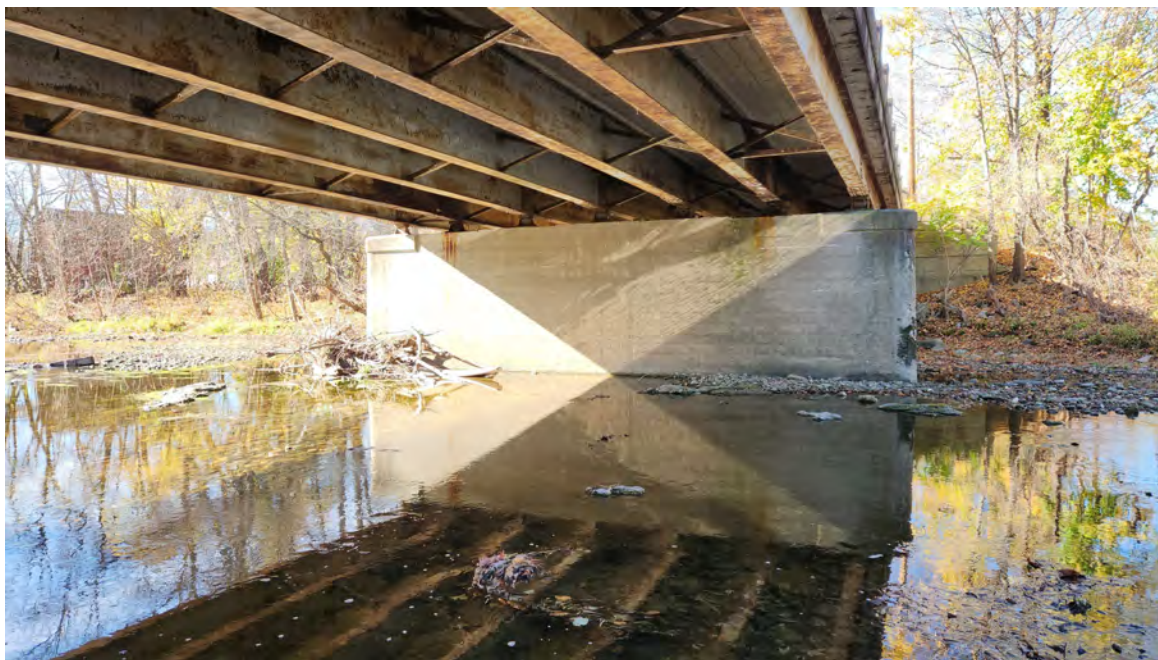
- Pier 1 has a 1/16" - 1/8" full height vertical crack under beams 3-4 through both faces.

Description 8758948_Pier 1 West Face

Description 8758948_Pier 1 East Face

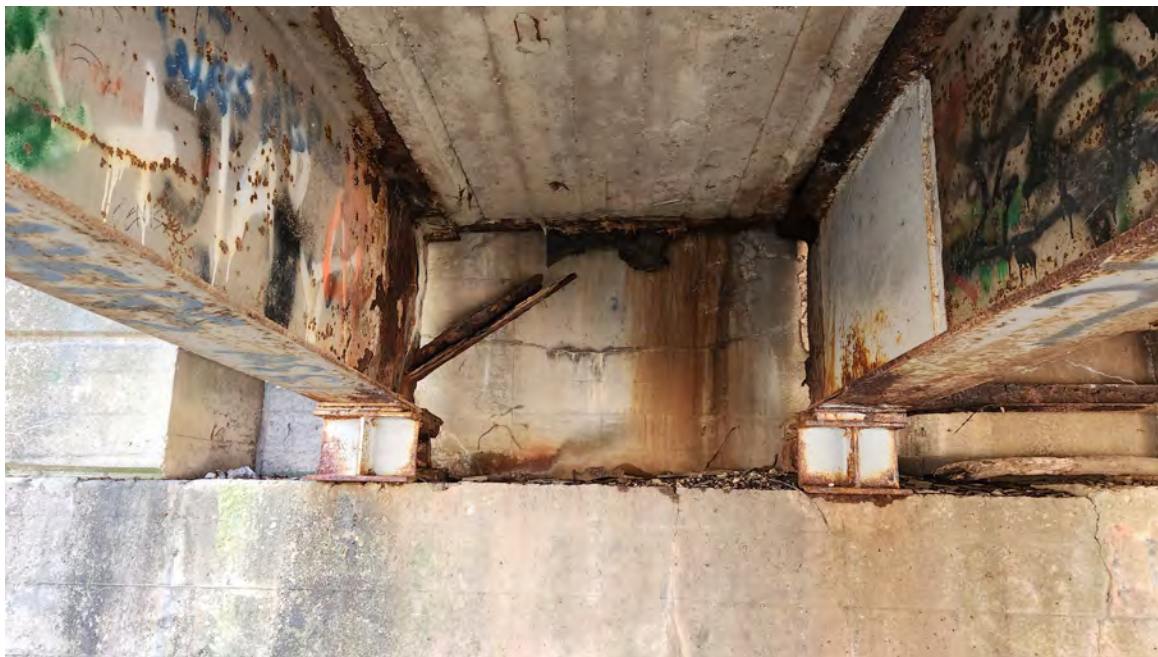
- The end cross frames of both abutments are heavily deteriorated with most having complete section loss.
- Forward abutment bays 1,2, 5 and 6 and Rear Abutment bays 1, 5, and 6 are non-functional.
- Intermediate cross frames in Bay 2 the first and last cross frame have complete section loss.
- Intermediate cross frames in Bay 6 the last cross frame has complete section loss.

Description 8758948_FA Bay 1_Broken X-frame

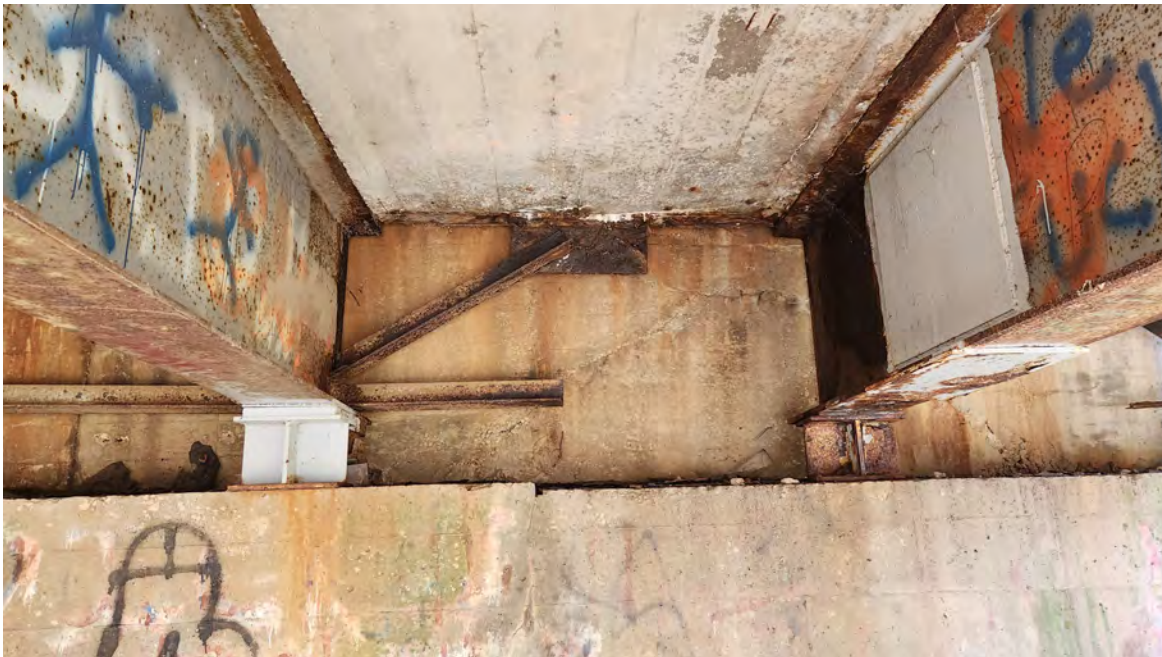
Description 8758948_FA Bay 5_Broken X-Frame

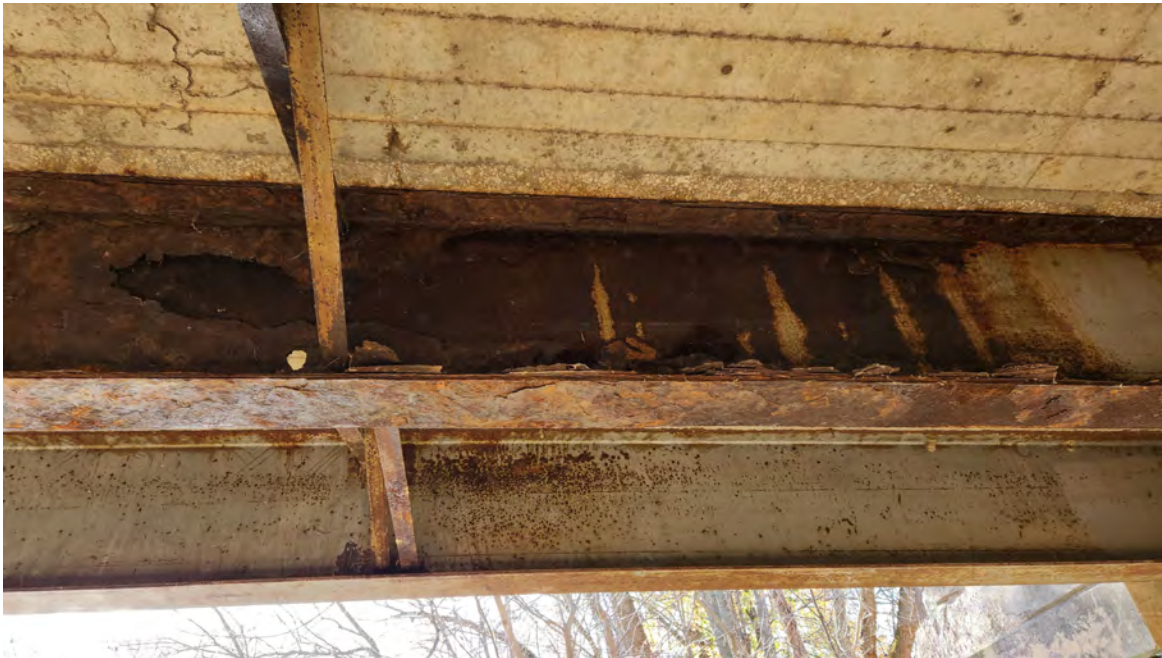
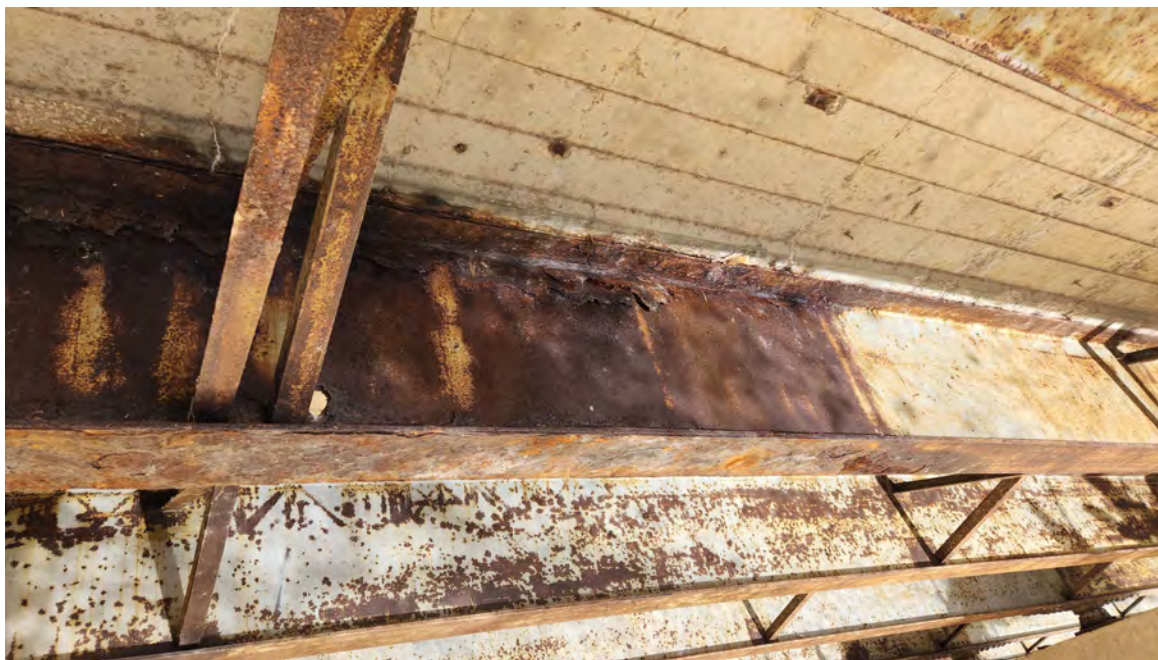
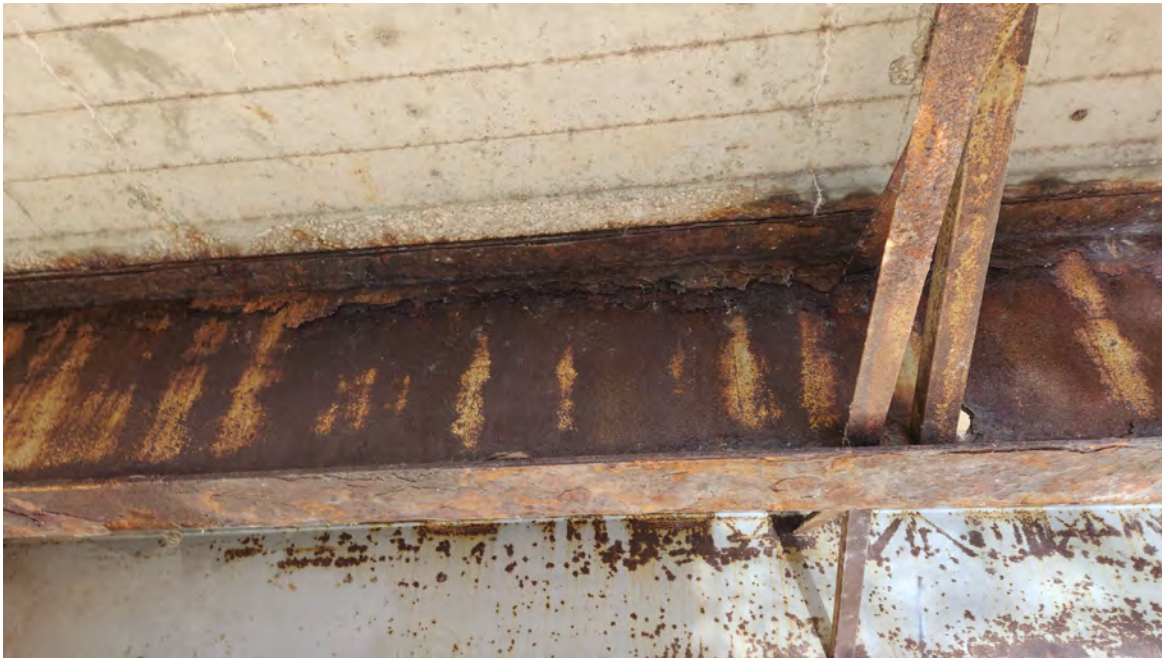
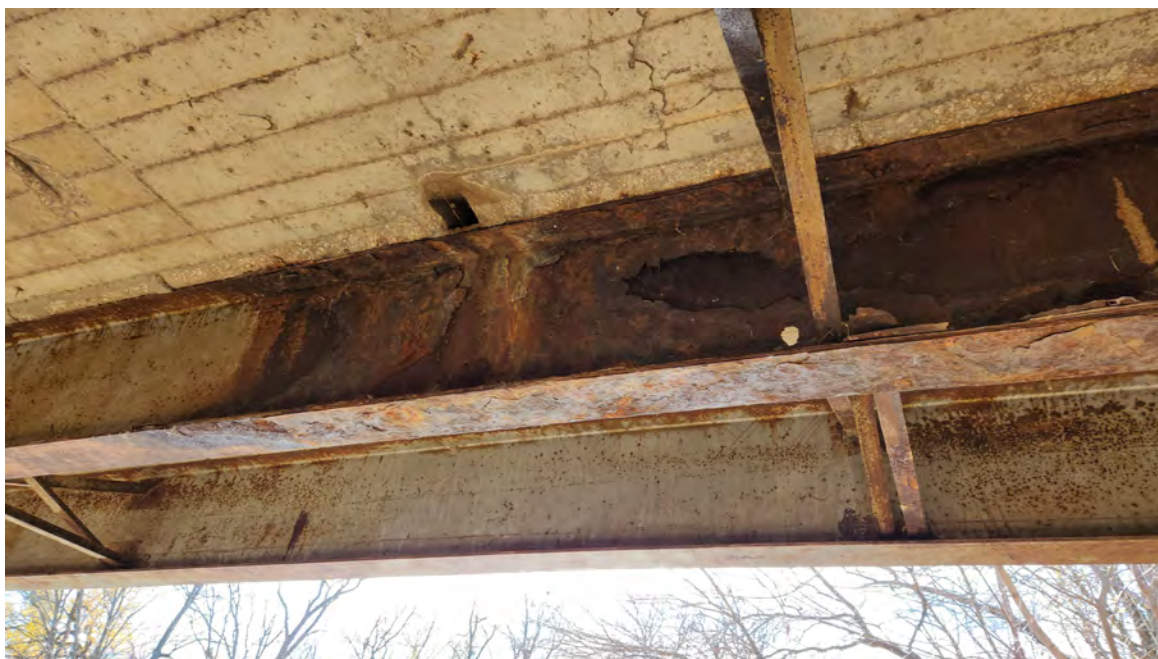
- Span 1 Beam 2 near scupper has an approximate section loss of 50% of top flange, 25% of web, 25% to 50% of bottom flange for a length of 12 feet.
- **Span 1 Beam 6 near scupper has an approximate section loss of 50% of top flange, 25% to 60% of web, 50% to 75% of bottom flange for a length of 17 feet. There is a 8" diameter hole in the web in this region.**

Description 8758948_Span 1 Beam 6_Corrosion (2)

Description 8758948_Span 1 Beam 6_Corrosion (3)

Description 8758948_Span 1 Beam 6_Corrosion (4)

Description 8758948_Span 1 Beam 6_Corrosion

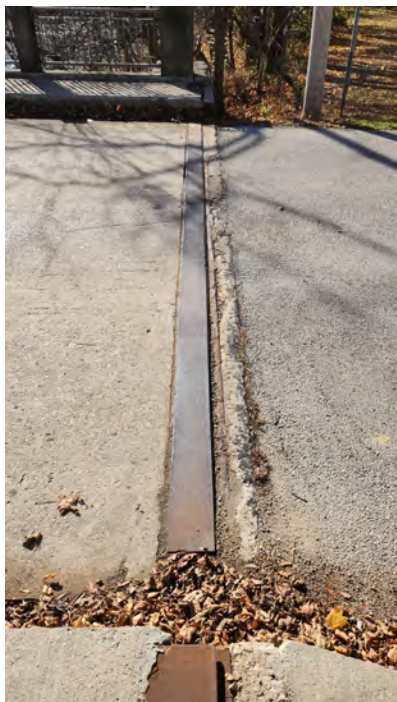
- The expansion joints are closed.
- Plates were welded on top of expansion joints in 2018.
- Some vertical movement under traffic with large impact force.

Description 8758948_Rear Joint

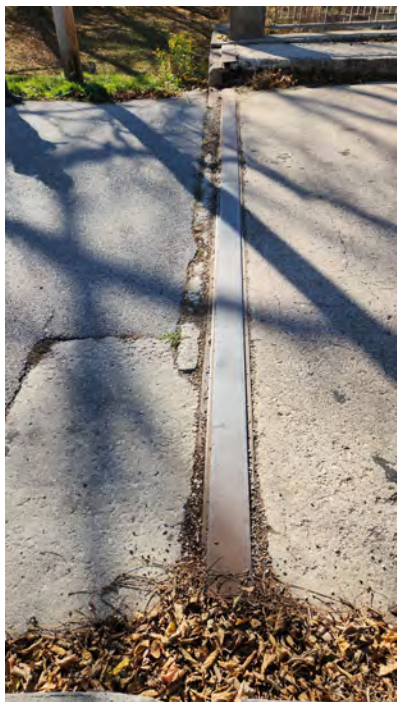
Description 8758948_Fwd Joint

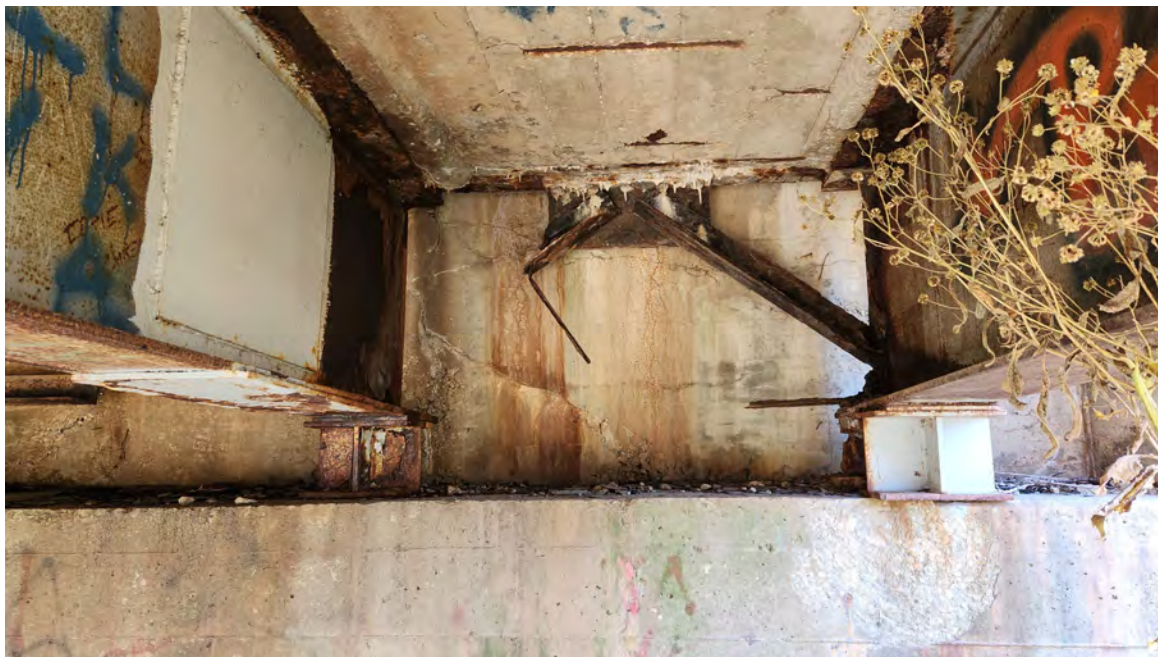
Description 8758948_FA Bay 6_Broken X-Frame

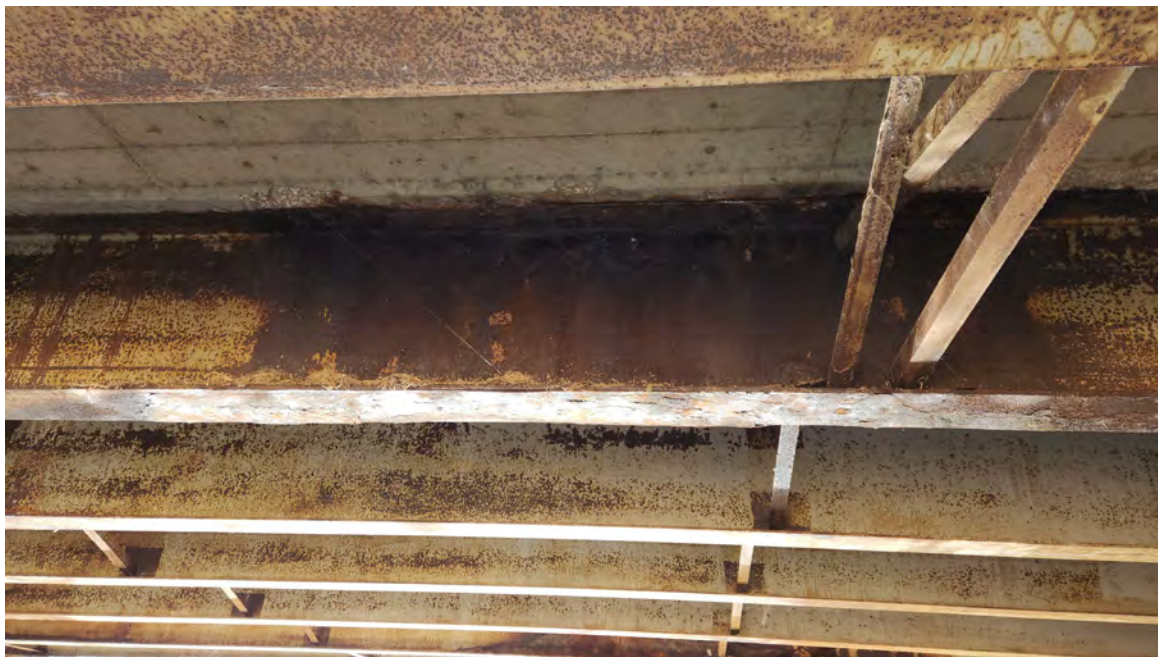
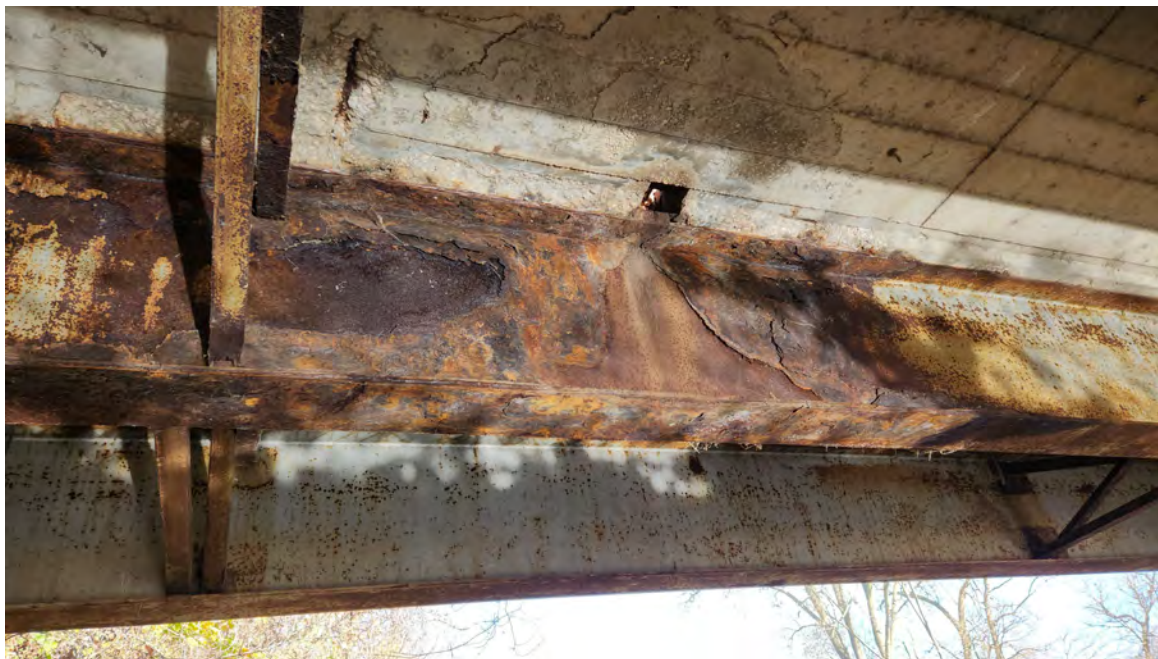
Description 8758948_Span 1 Beam 2_Corrosion (2)

Description 8758948_Span 1 Beam 2_Corrosion

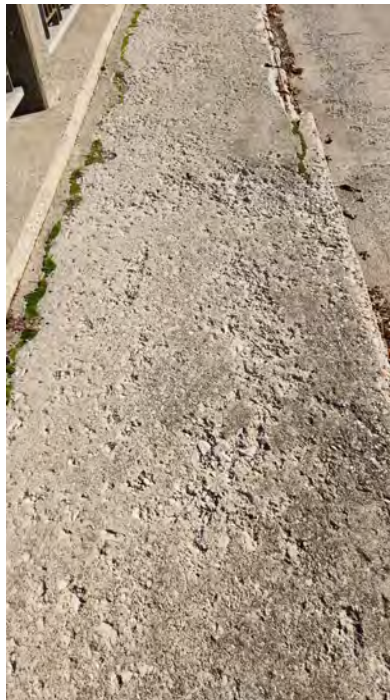
- Both sidewalks are heavily scaled.
- Curbs and sidewalks have shallow spalls with exposed reinforcing due to lack of concrete cover. More prevalent in the south sidewalk.
- The south sidewalk has considerable drop offs to the embankment as there are no approach sidewalks on this side..

Description 8758948_North Sidewalk_Scaling

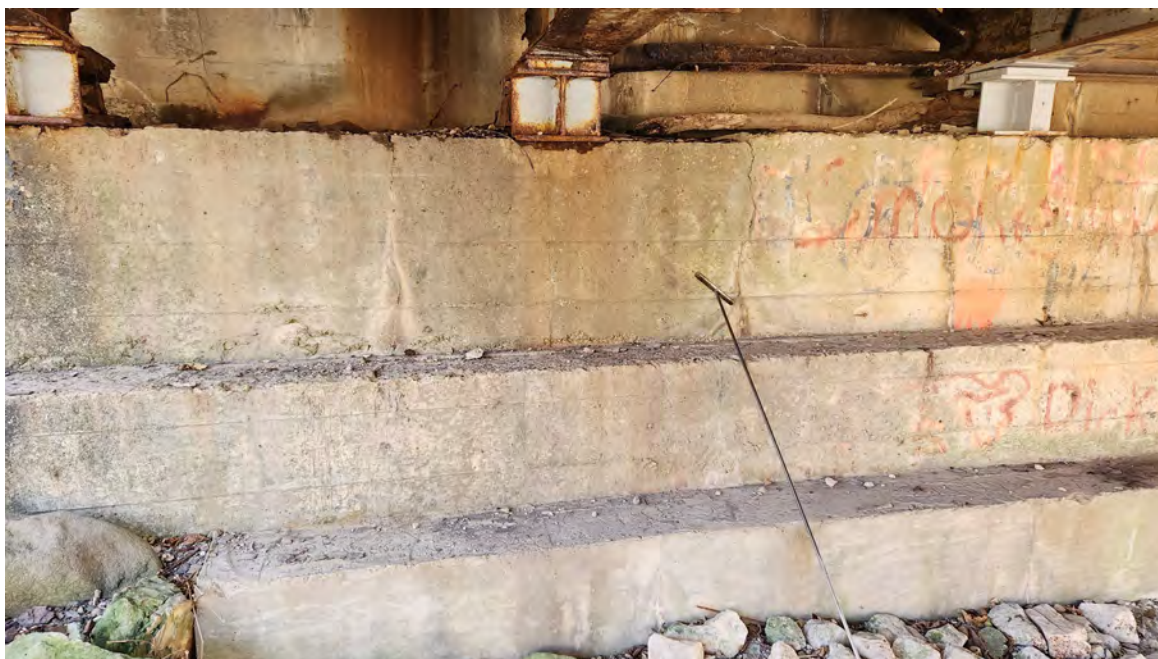
- There are moderate vertical cracks with leaking in both abutments

Description 8758948_FA_Vertical Cracks

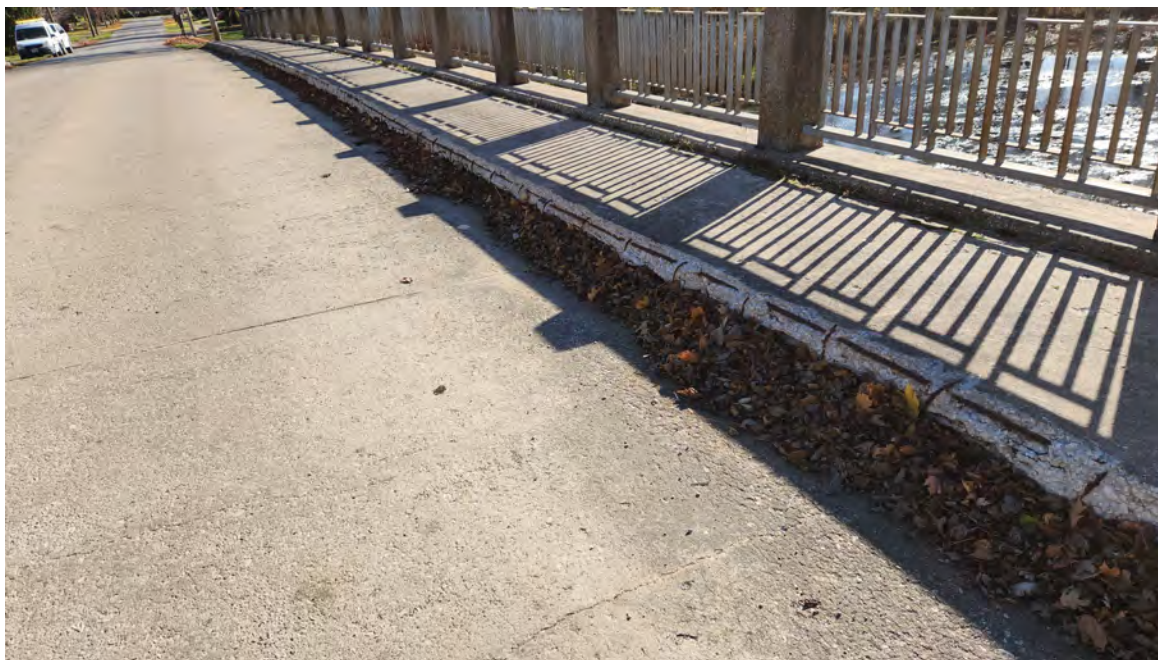
Description 8758948_South Curb_Spall

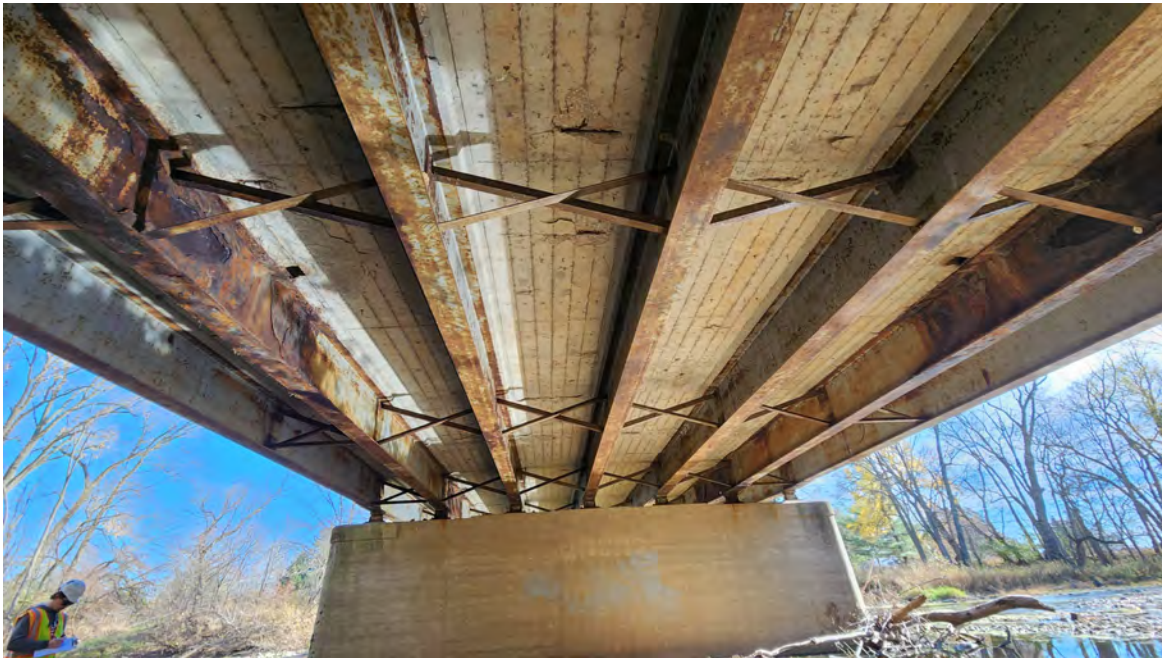
- There are numerous shallow spalls with exposed steel on the deck underside.
- Transverse cracks on underside.
- Span 1 has areas of saturation.
- Spalls and delams on deck near scuppers.

Description 8758948_Span 1 Underside

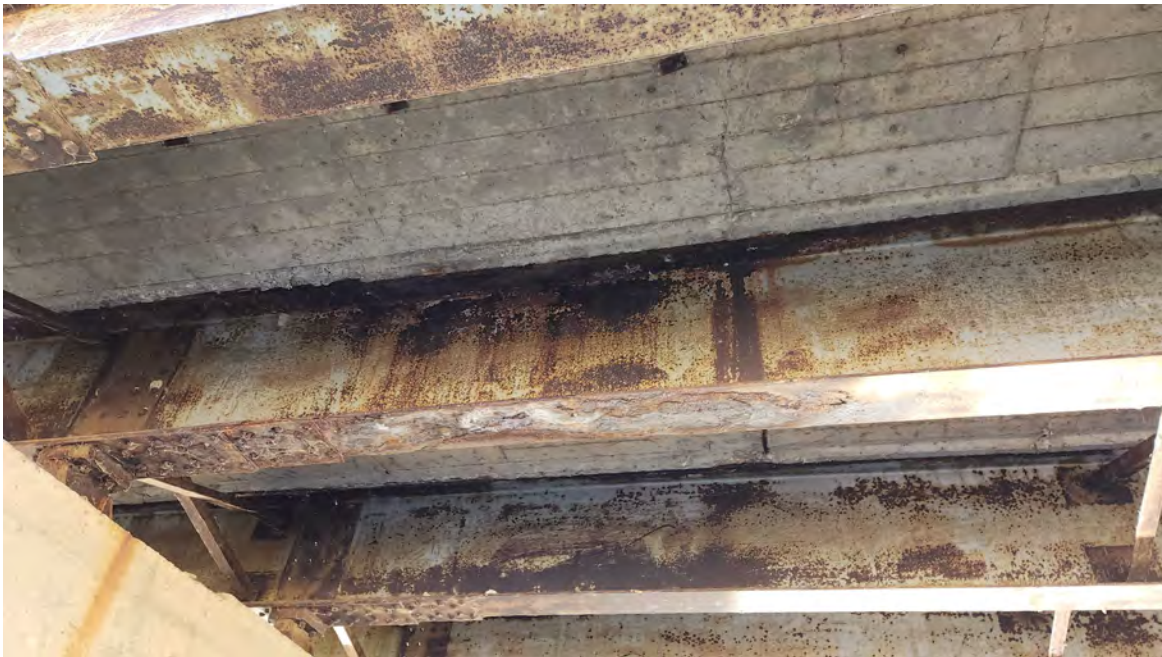
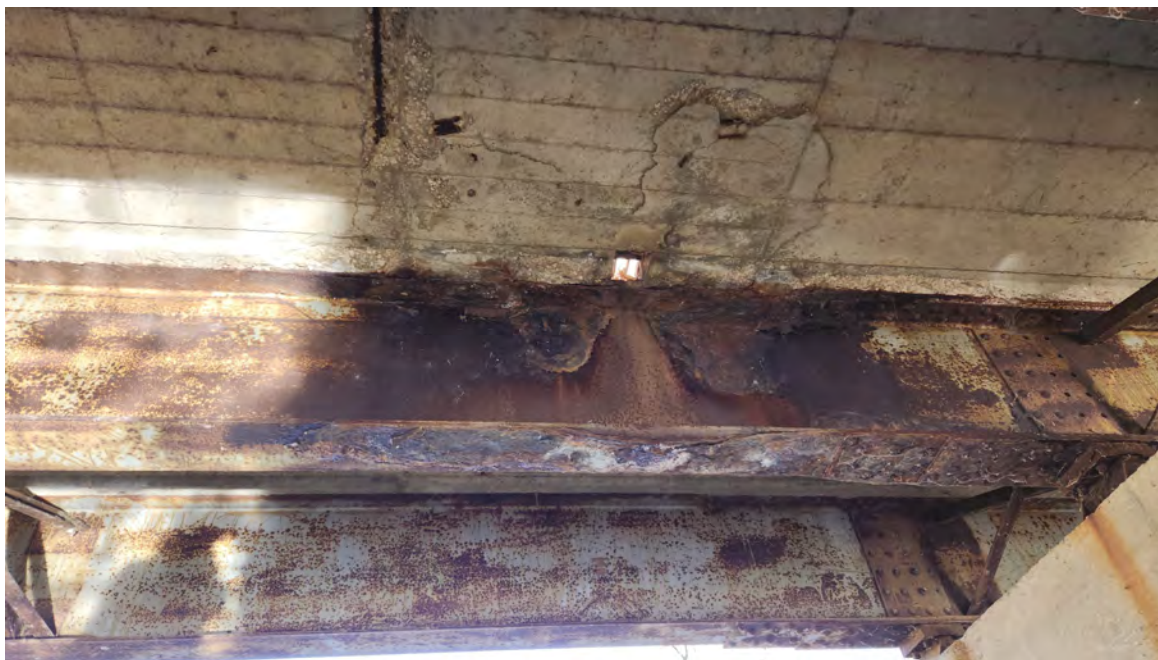
- Span 2 Beam 2 near rear scupper has an approximate section loss of 50% of top flange, 30% of web, 30% of bottom flange for a length of 8 feet.
- Span 2 Beam 2 near fwd scupper has an approximate section loss of 50% of top flange, 25% of web, 25% of bottom flange for a length of 8 feet.
- Span 2 Beam 6 near rear scupper has an approximate section loss of 50% of top flange, 50% of web, 50% of bottom flange for a length of 9 feet. **There is a 3" diameter hole in the web within this area.**
- Span 2 Beam 6 near fwd scupper has an approximate section loss of 50% of top flange, 50% of web, 50% of bottom flange for a length of 9 feet. **There is a 1 foot area with 90% section loss of bottom flange at end of moment plates.**

Description 8758948_Span 2 Beam 2 Fwd_Corrosion (2)

Description 8758948_Span 2 Beam 2 Fwd_Corrosion

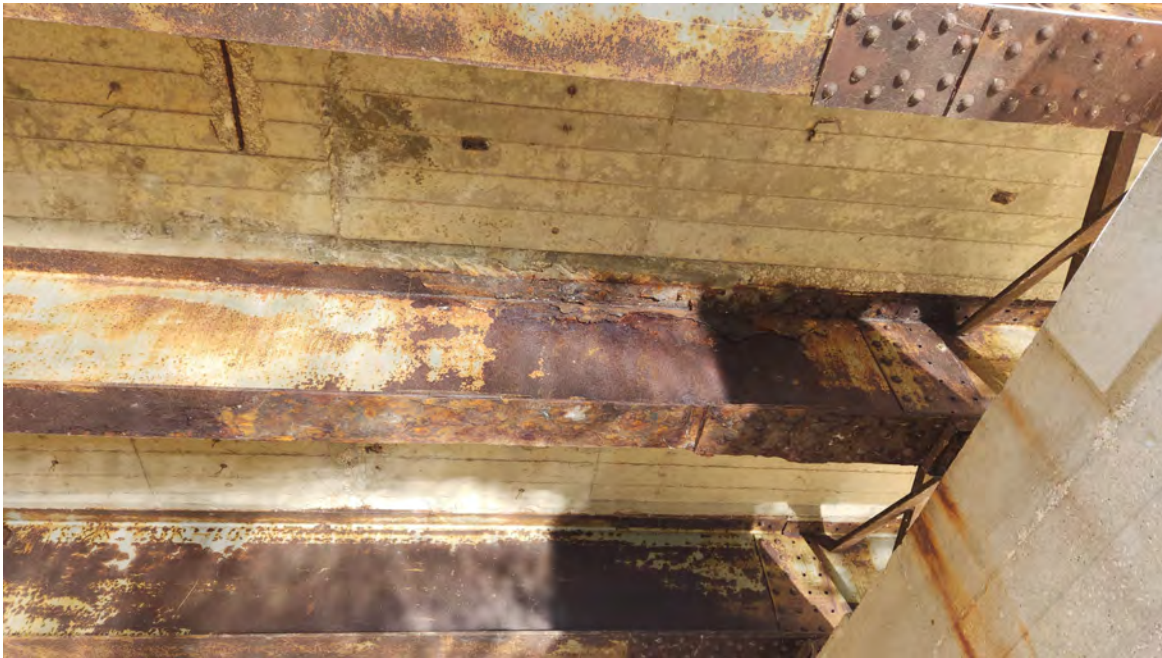
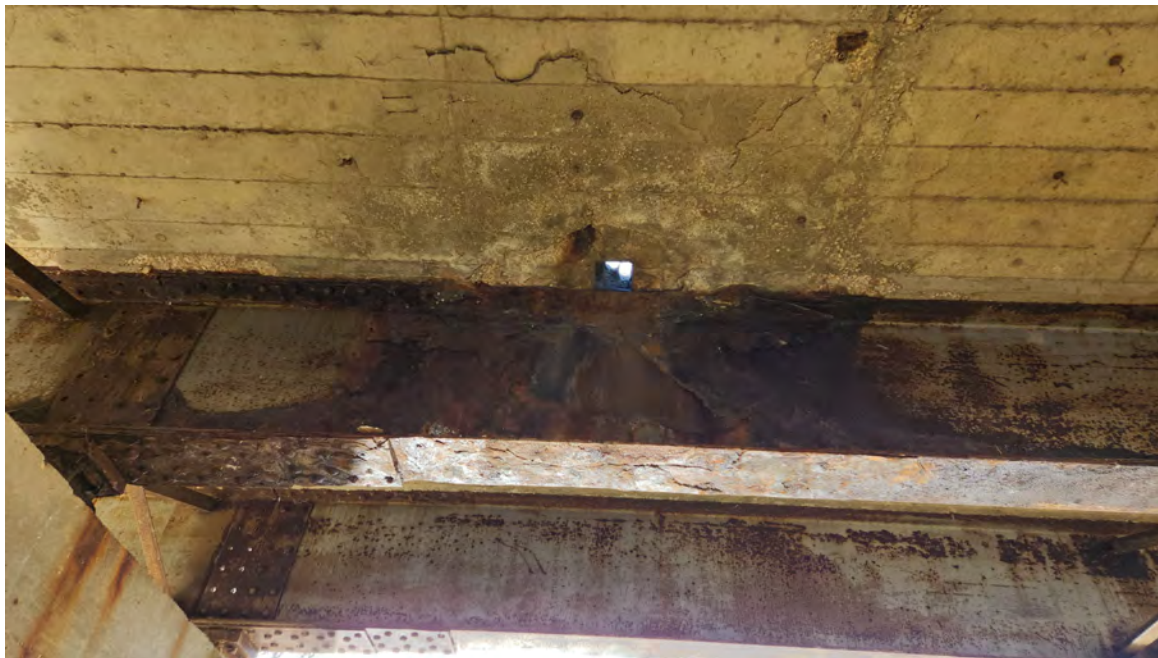
Description 8758948_Span 2 Beam 6 Fwd_Corrosion (2)

Description 8758948_Span 2 Beam 6 Fwd_Corrosion

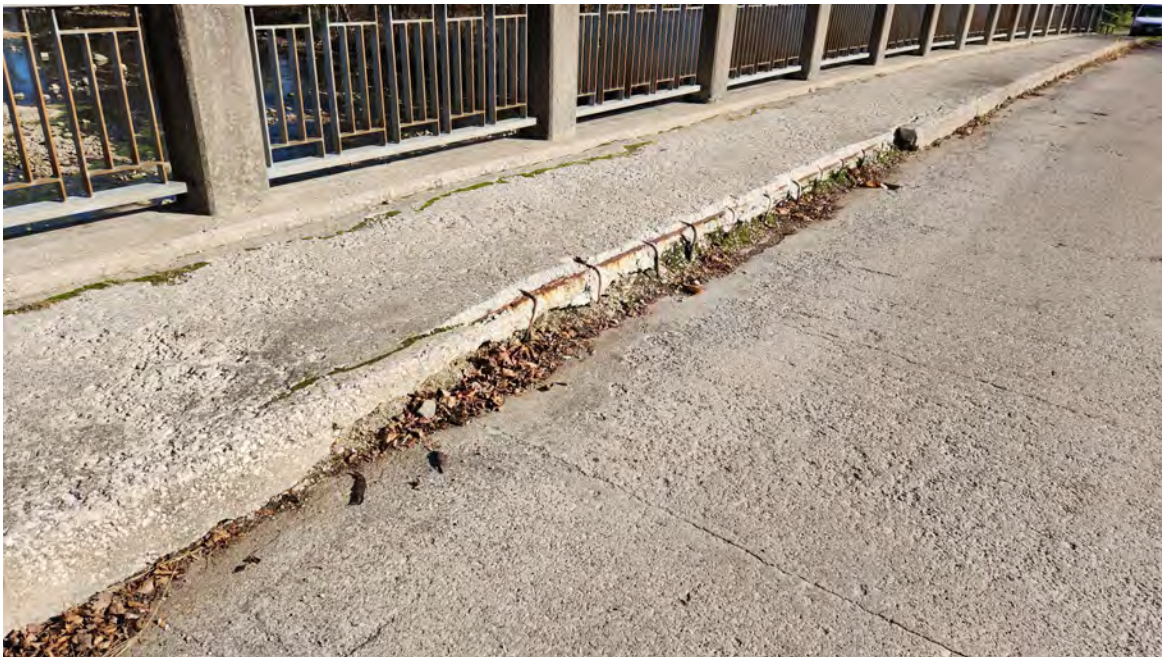
Description 8758948_North Curb_Spall

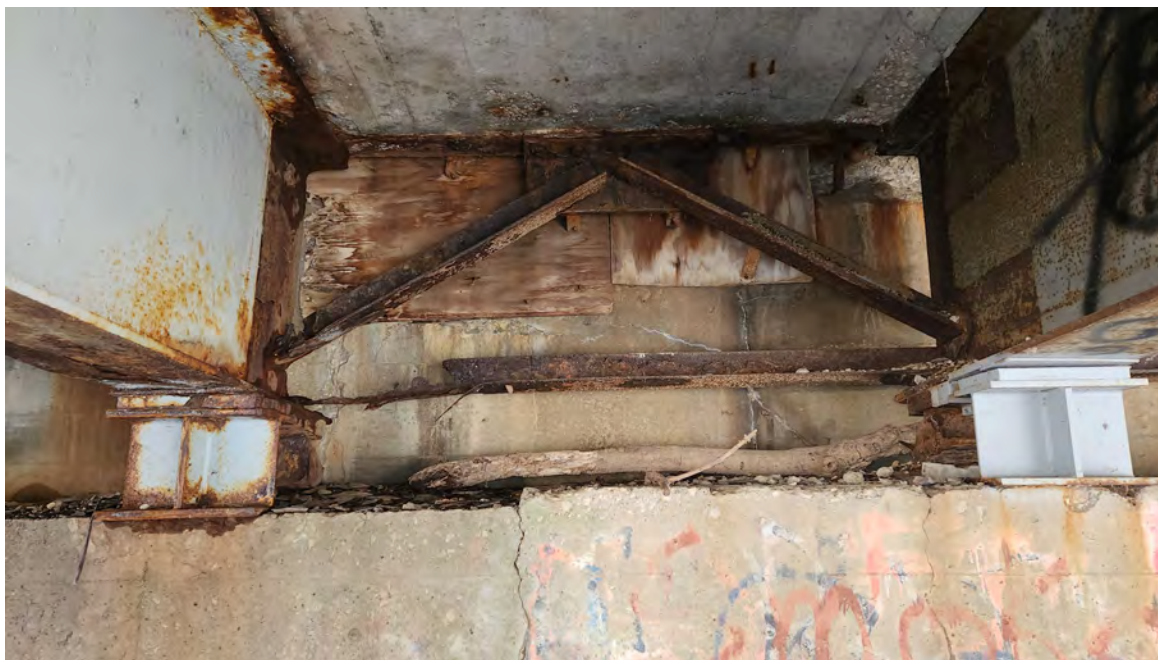
- The north side of both abutments have an abandoned gas line into the backwall.
- Somehow drainage is seeping through the abutment where the pipe was dumping water onto the bearings of beam 1 and causing deterioration.
- Both backwalls have cracking and areas of delamination.
- The forward has a large spall(4" deep)in bays 2 & 3 with steel exposed.
- Top of the rear backwall has cracks and spalling.
- Honeycombing in face of rear backwall.

Description 8758948_FA Bay 2_Backwall Repair

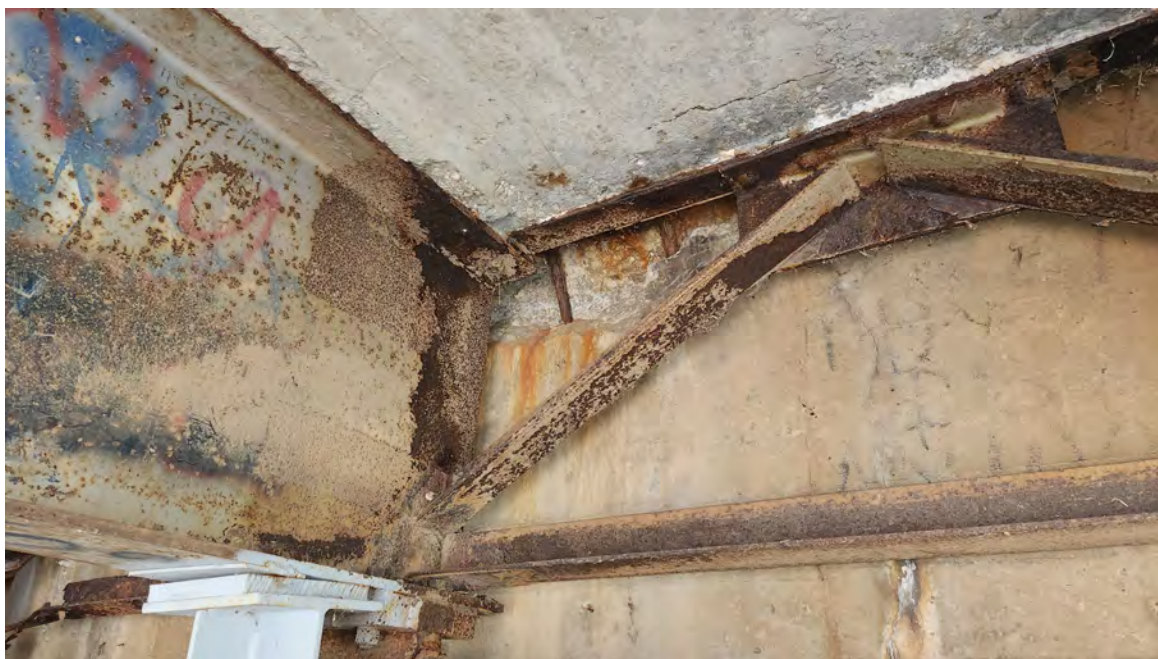
Description 8758948_FA Bay 3_Backwall Spall
