Inspector: Hess,Derek
Inspection Date: 11/09/2022

Structure Number: 8758948
Facility Carried: BRIDGE STREET

Bridge Inspection Report

WOO-C463A-0001 (8758948)

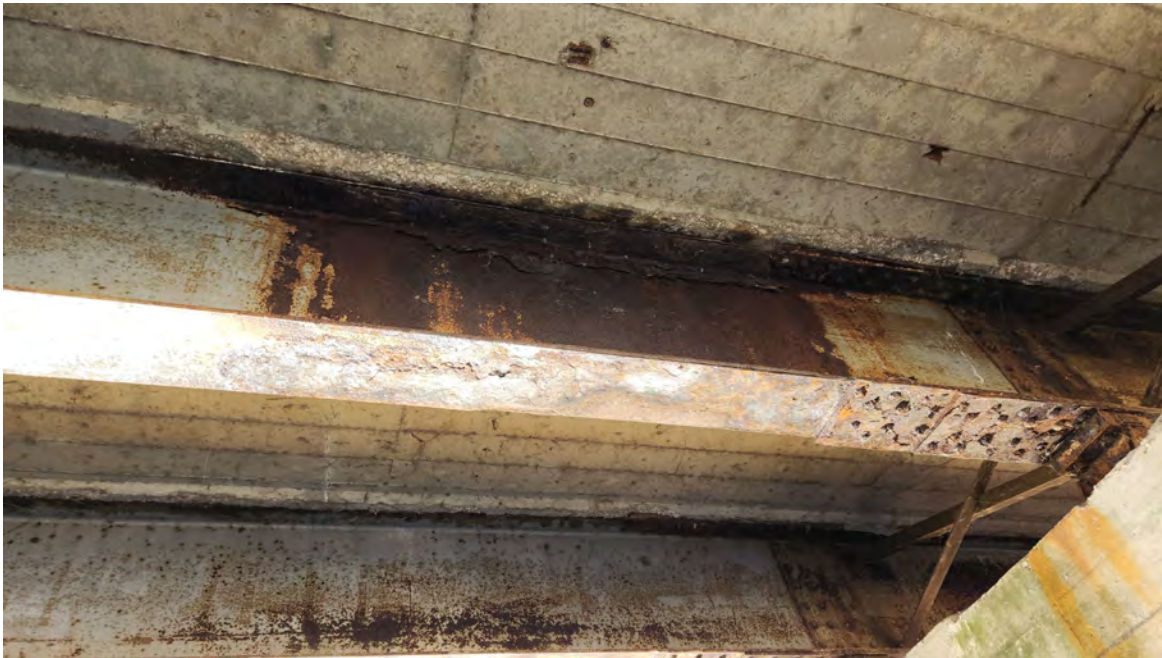
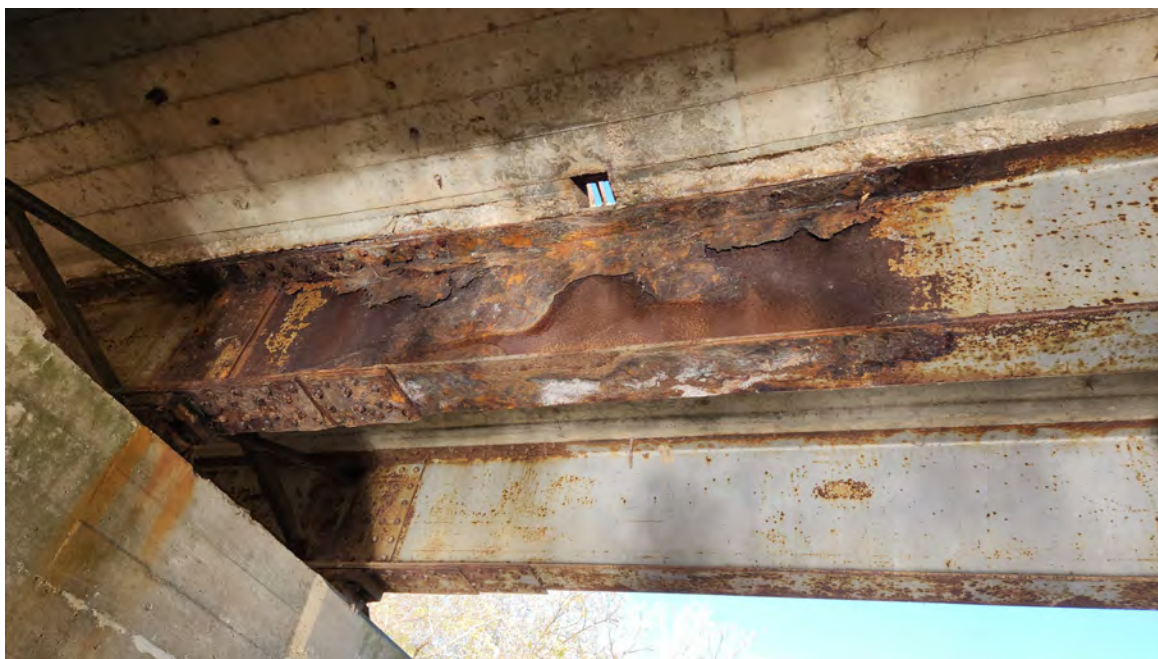
- Span 2 Beam 2 near rear scupper has an approximate section loss of 50% of top flange, 30% of web, 30% of bottom flange for a length of 8 feet.
- Span 2 Beam 2 near fwd scupper has an approximate section loss of 50% of top flange, 25% of web, 25% of bottom flange for a length of 8 feet.
- Span 2 Beam 6 near rear scupper has an approximate section loss of 50% of top flange, 50% of web, 50% of bottom flange for a length of 9 feet. **There is a 3" diameter hole in the web within this area.**
- Span 2 Beam 6 near fwd scupper has an approximate section loss of 50% of top flange, 50% of web, 50% of bottom flange for a length of 9 feet. **There is a 1 foot area with 90% section loss of bottom flange at end of moment plates.**

Description 8758948_Span 2 Beam 2 Rear_Corrosion (2)

Description 8758948_Span 2 Beam 2 Rear_Corrosion

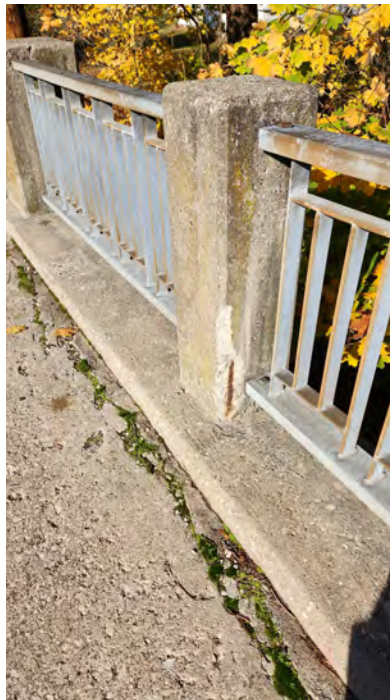
- The concrete railing posts have minor cracks and spalls with some having reinforcing exposed.
- 2nd post in the NW corner has a vertical spall with exposed rebar.

Description 8758948_Typical Railing Spall

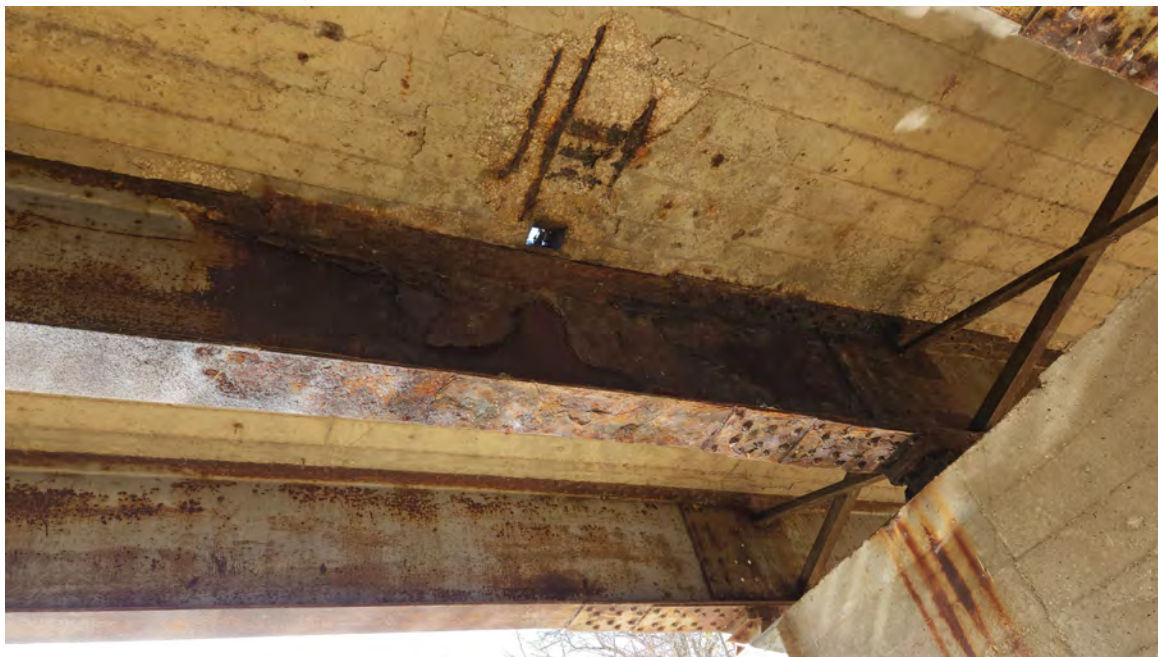
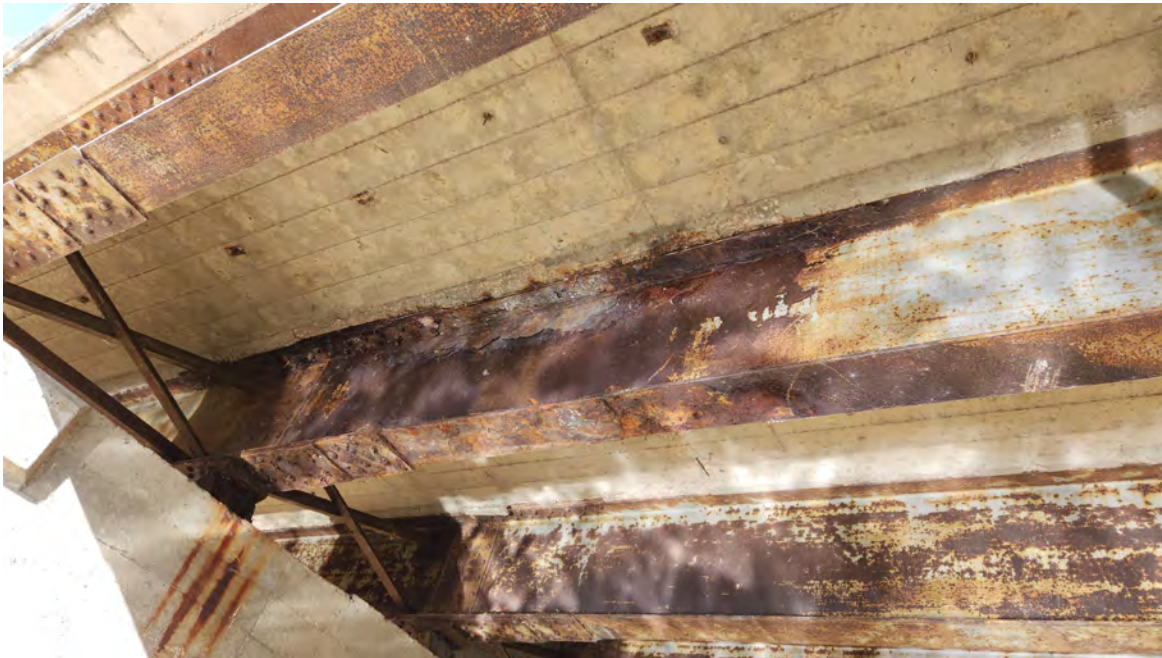
Description 8758948_Span 2 Beam 6 Rear_Corrosion (2)

Description 8758948_Span 2 Beam 6 Rear_Corrosion

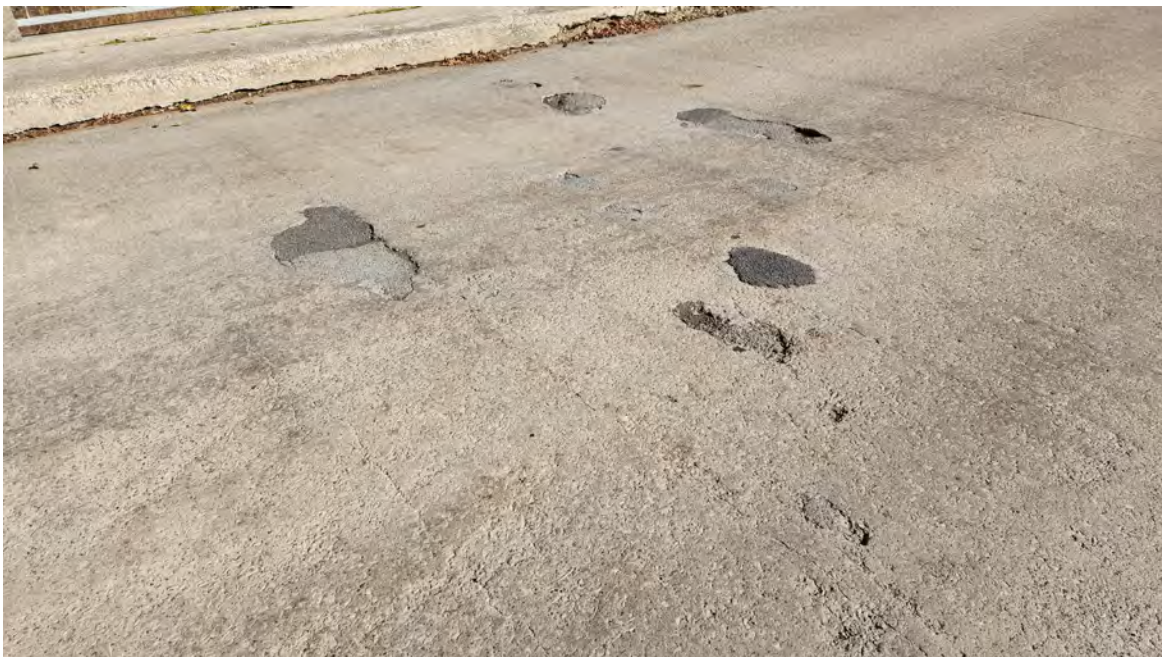
- Transverse cracking and scaling throughout.
- Span 1 has small potholes with some having been patched.
- Spot sounding has indicated approximately 25% of the wearing surface is delaminated. More prevalent in Span 1.

Description 8758948_Span 1 Patches

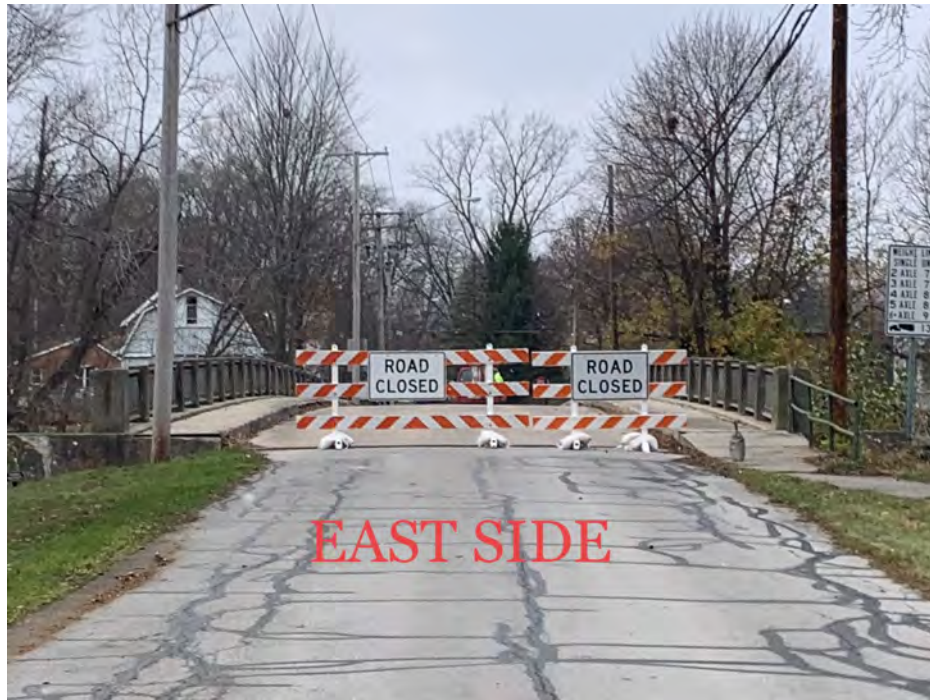
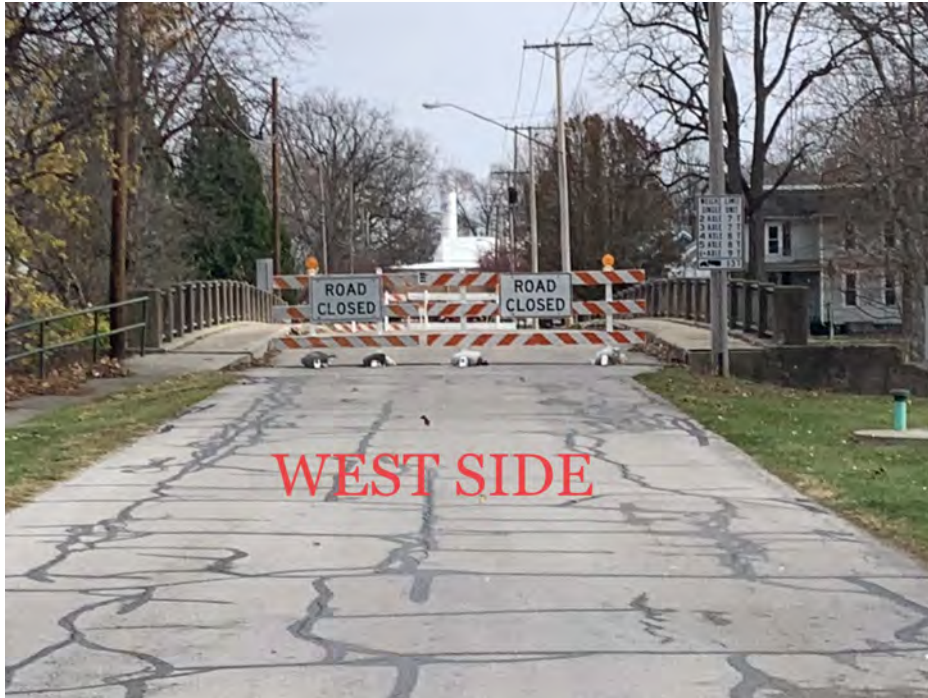
Load Posting		90: Routine Insp.	12	11/09/2022
41: Op/Post/Closed	K - Closed	92A: FCM Insp.	N	0
70: Posting	0 - More than 39.9% below legal loads	92B: Dive Insp.	N	0
70.01: Date	08/24/2018	92C: Special Insp.	Y	6
70.02: Sign Type	1- R12-H5 ("Weight Limit Single Unit", 5 trucks + Silhouette)	92D: UBIT Insp.	N	0
		92E: Drone Insp.	N	0

Description 8758948_Bridge Closure 1

Description 8758948_Bridge Closure 2

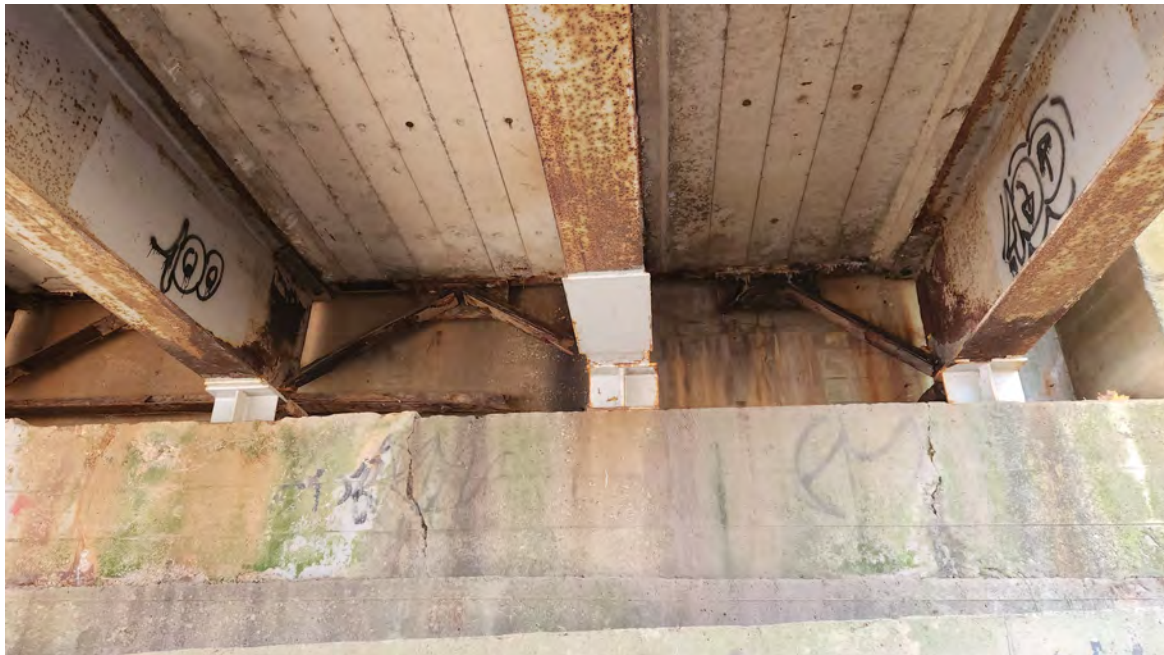
- The end cross frames of both abutments are heavily deteriorated with most having complete section loss.
- Forward abutment bays 1,2, 5 and 6 and Rear Abutment bays 1, 5, and 6 are non-functional.
- Intermediate cross frames in Bay 2 the first and last cross frame have complete section loss.
- Intermediate cross frames in Bay 6 the last cross frame has complete section loss.

Description 8758948_RA Bay 1-2_Broken X-frames

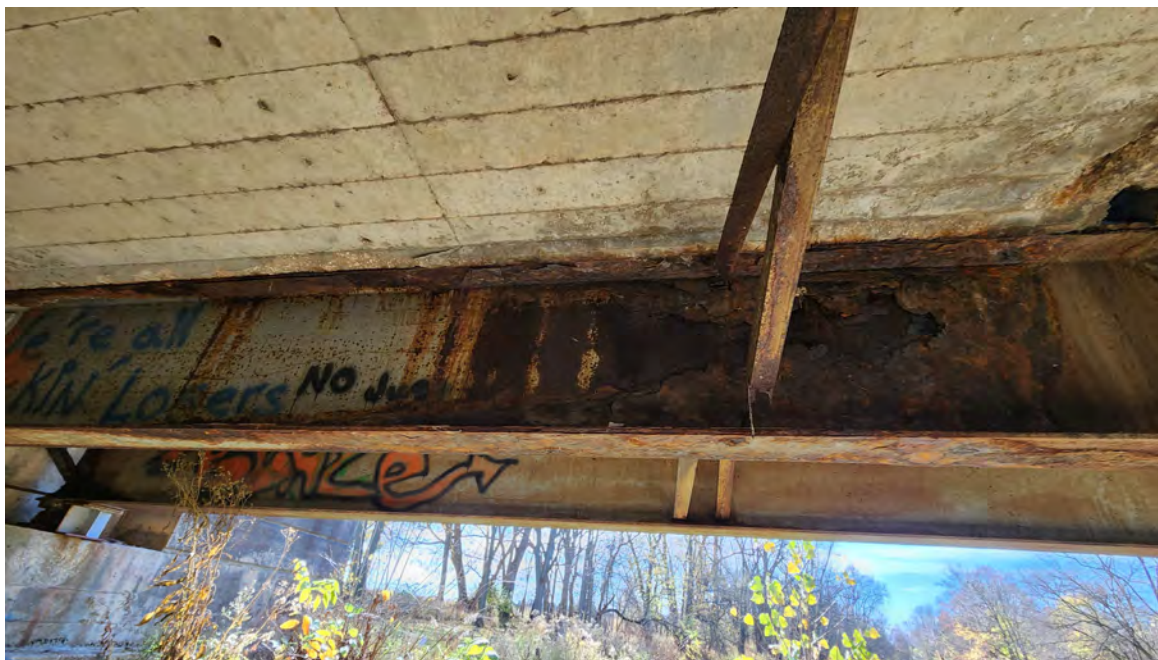
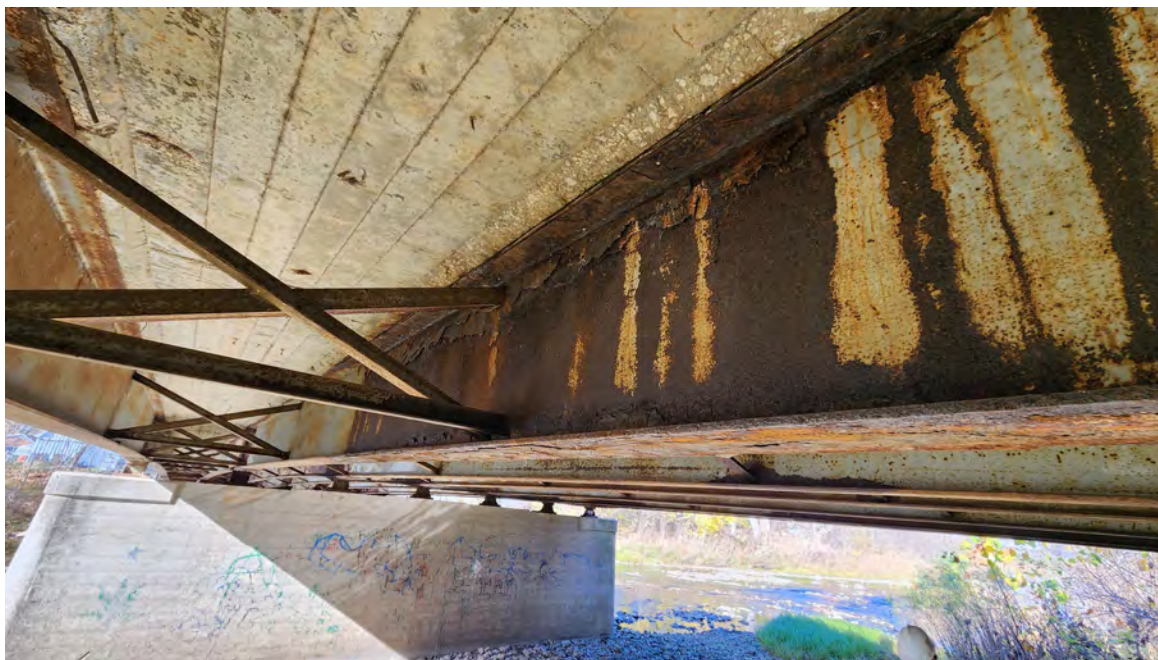
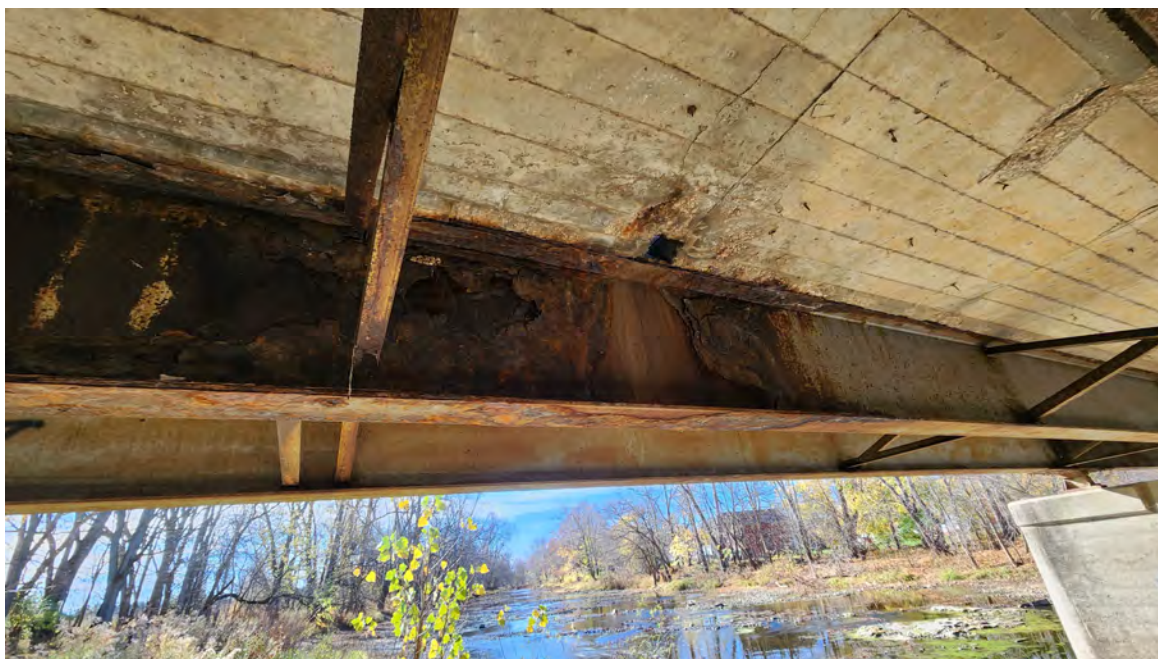
- Span 3 Beam 6 has section loss beneath scupper (Approximated at 50% of top flange, 50% of web, and 50% of bottom flange for a length of 14 feet)
-
- beams 2(hole in web in span 3 near forward scupper)and 6 have section loss under each of the scuppers. a majority of the beam ends at both abutments have corrosion holes. beam 2(plated in 2018)at the forward abutment has 2 small holes in the web over the original rocker bearing under the top flange. rear abutment: beams 2 & 6 ends have new webs and bottom flanges for +-50" and are plated at the splices(2018). forward abutment: beam 6 end has a new web and bottom flange and is plated at the splice(2018). beam 2 end is plated on each side of the web(2018). span 1 - beam 6 - 2.25" l x 3" h hole near first cross frame from abutment. span 2 - beam 6 - 8" l x 3" h hole @ 1st splice near pier 1 many rivets are missing over pier 1 and 2 for all splice plates-as built.

Description 8758948_Span 3 Beam 6_Section Loss (2)

Description 8758948_Span 3 Beam 6_Section Loss (3)

Description 8758948_Span 3 Beam 6_Section Loss

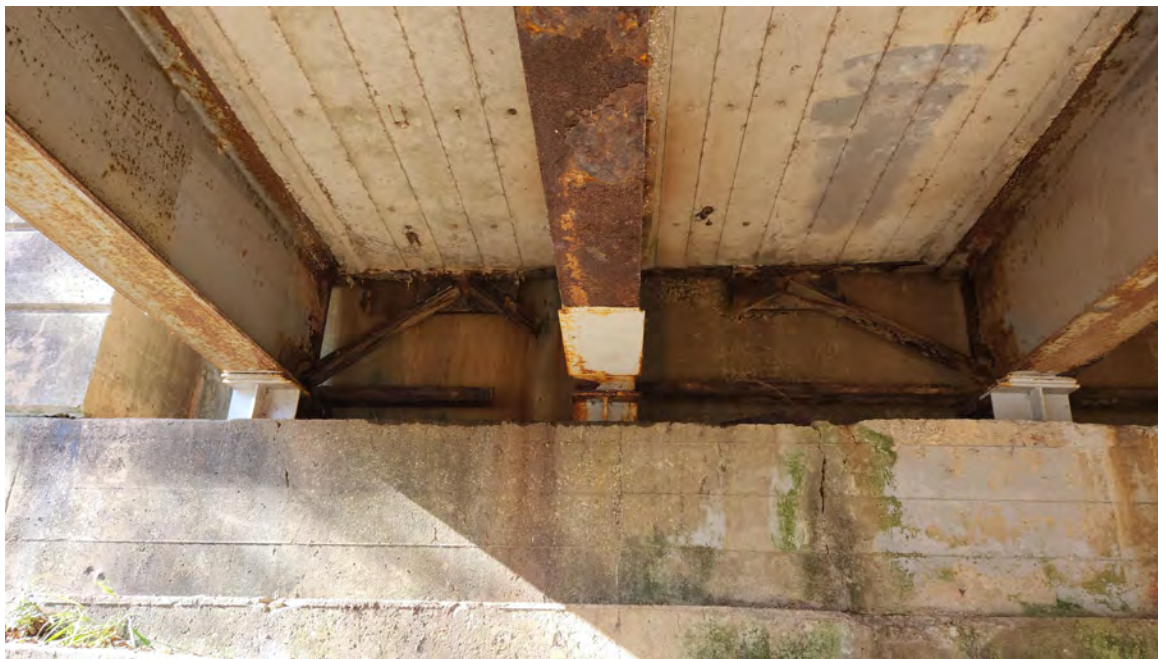
Description 8758948_RA Bay 5-6_Broken X-frames
