**REPORT OF GEOTECHNICAL EXPLORATION**  
**(FINAL)**  
**WOO-75-7.00 LANDSLIDE EXPLORATION**

PID: 120414  
WOOD COUNTY, OHIO

October 10, 2025

Stantec Consulting Services Inc.

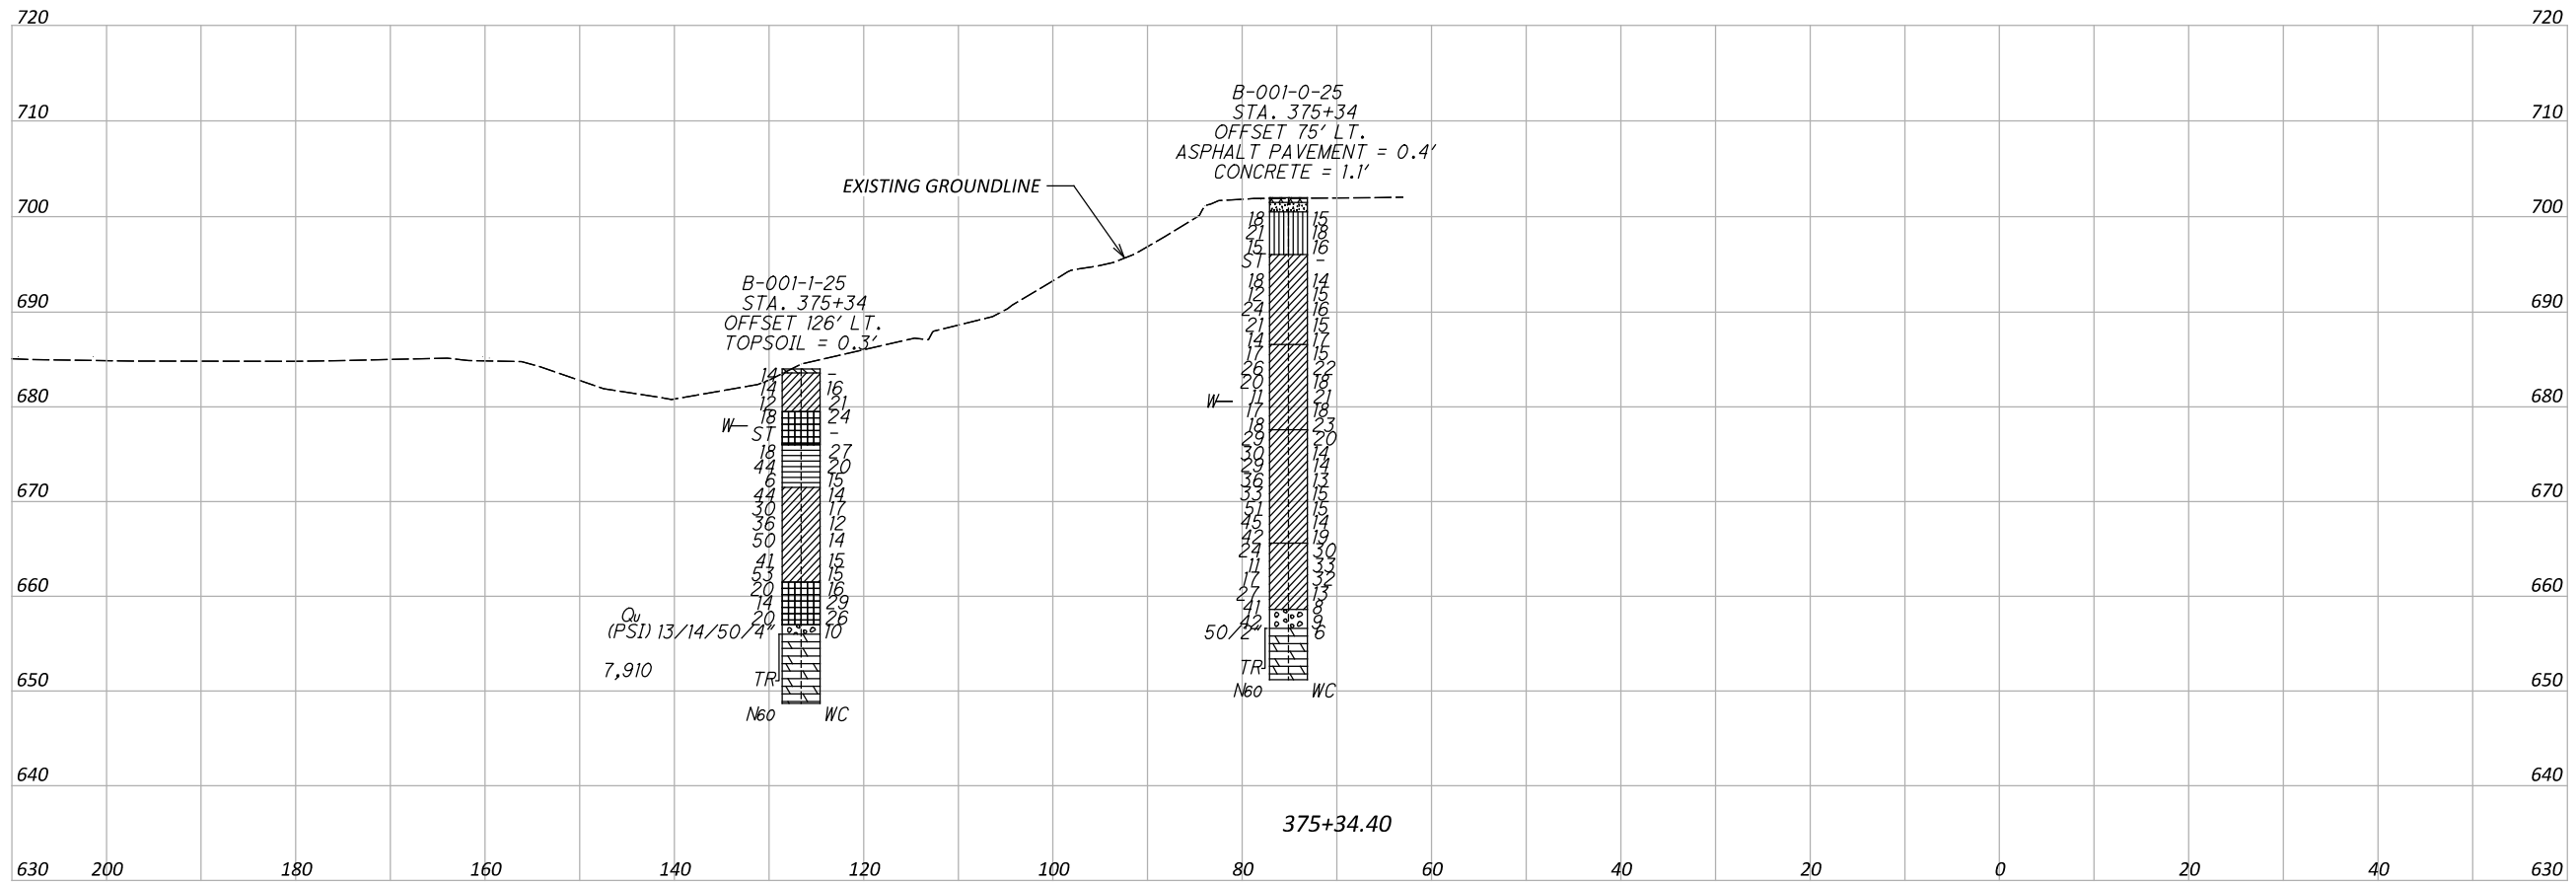
GEOTECHNICAL PROFILE - LANDSLIDE  
 CROSS SECTION STA. 375+34.40

At the conclusion of field and laboratory testing for the project, it was determined that the landslide is a shallow embankment failure most likely caused by drainage travelling down the embankment and from the nearby culvert. The recommended remediation method is special benching as outlined in Section 806 of the ODOT Geotechnical Design Manual (GDM). Recommended material properties for each soil layer encountered are summarized in Table 2. The properties were determined from laboratory testing or using estimates provided in Section 404 of the GDM. A summary of the calculations is provided in Appendix B.

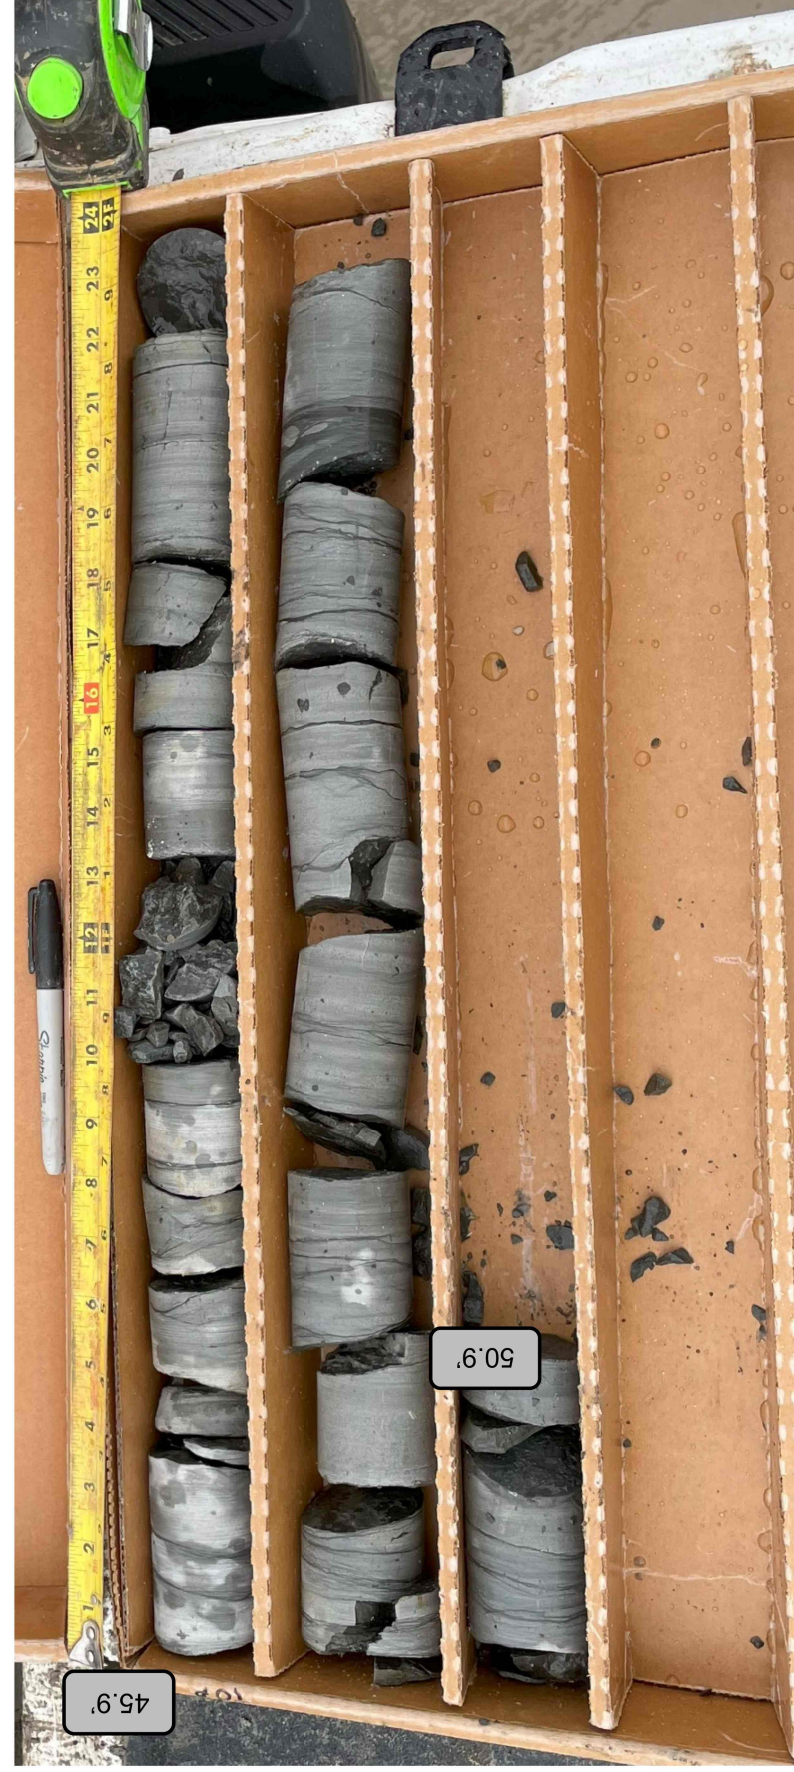
B-001-0-25

Run #:	Depth	Recovery	RQD
NQ2-1	45.9'	50.4"/60.0" 84%	0.0"/60.0" 0%
WOO-75-7.00 PID: 120414

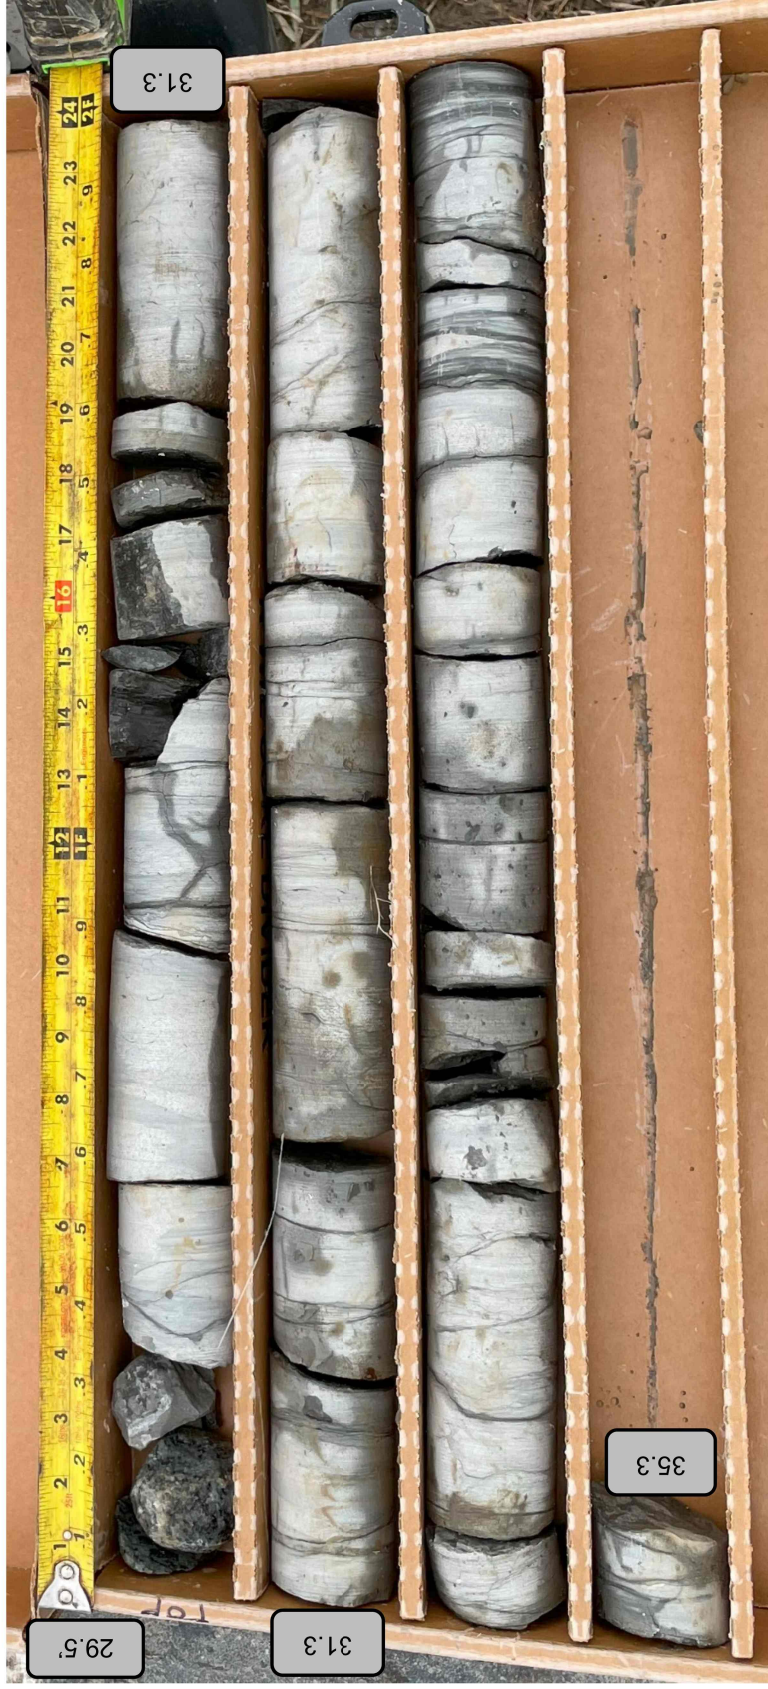
B-001-1-25

Run #:	Depth	Recovery	RQD
NQ2-1	29.5'	21.6"/21.6"	100%
NQ2-2	31.3'	48.0"/48.0"	100%
WOO-75-7.00 PID: 120414			
		4.8"/21.6"	22%
		15.6"/48.0"	33%

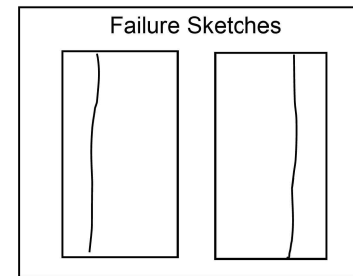
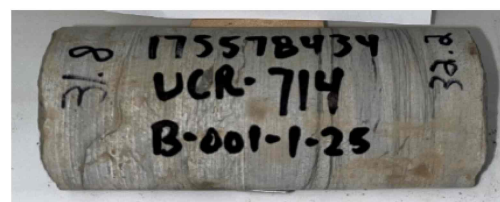
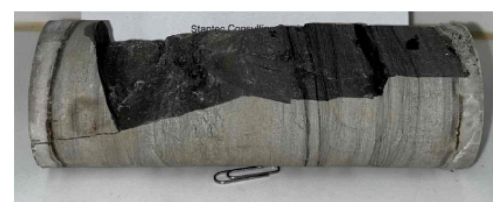
Failure Type Shear

Comments Fragile nature of specimen inhibited preparation, required capping of ends with Hydro-Stone.  
Dimensional tolerances were not confirmed.
