**Asbestos Survey of Bridge 10
(Contract Document)**

**Innerbelt Bridge
Construction Contract Group 1 (CCG1)**

FINDINGS FROM AN ASBESTOS SURVEY

CUY-90-E-10 Bridge Ramp over East 14th Street

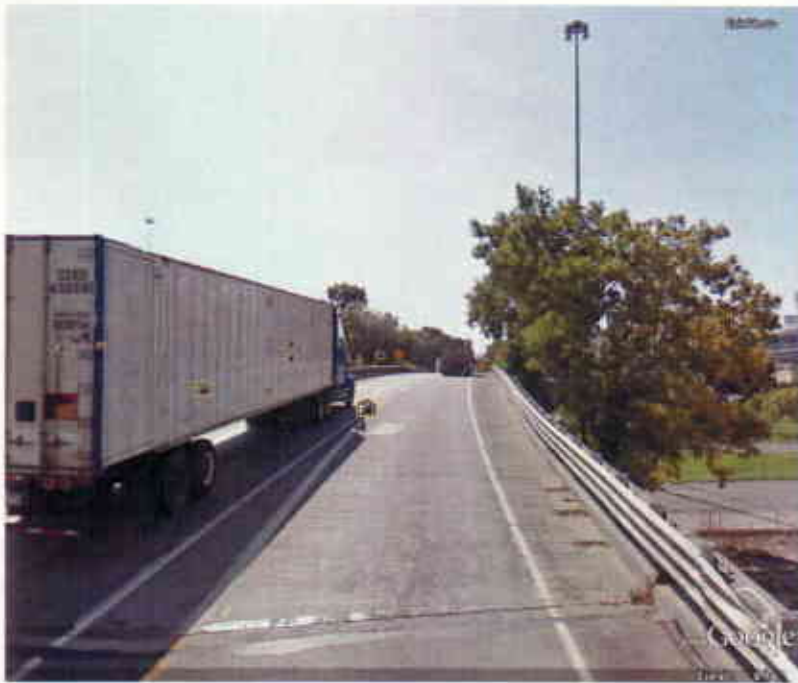
Photograph 01

View Looking West at the Top of the CUY-90 E-10 Ramp Bridge
over East 14th Street, Cleveland, Cuyahoga County, Ohio

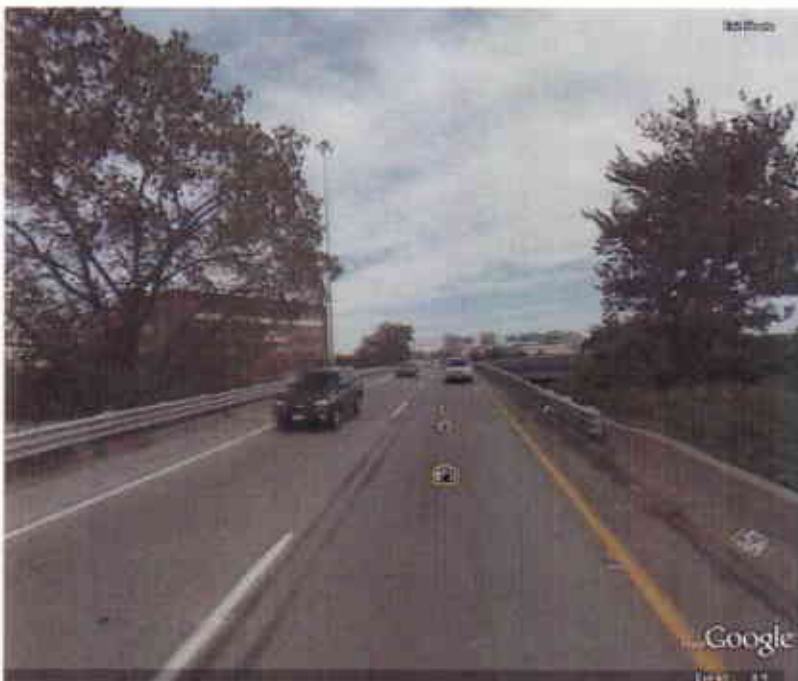
Photograph 02

View Looking East at the Top of the CUY-90 E-10 Ramp Bridge
over East 14th Street, Cleveland, Cuyahoga County, Ohio

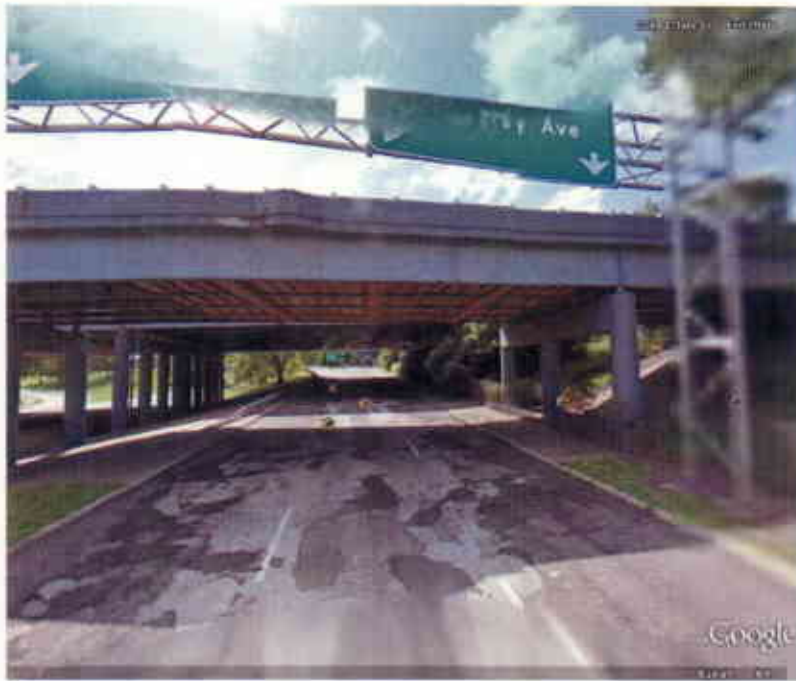
Photograph 03

View Looking South at the Northwest Side of the CUY-90 E-10 Ramp Bridge over East 14th Street, Cleveland, Cuyahoga County, Ohio

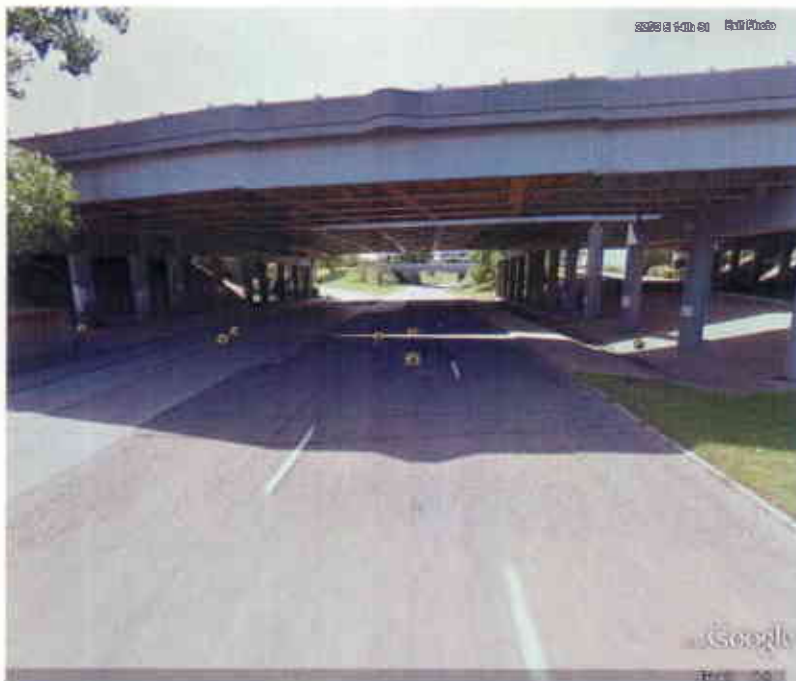
Photograph 04

View Looking South at the Northeast Side of the CUY-90 E-10 Ramp Bridge over East 14th Street, Cleveland, Cuyahoga County, Ohio

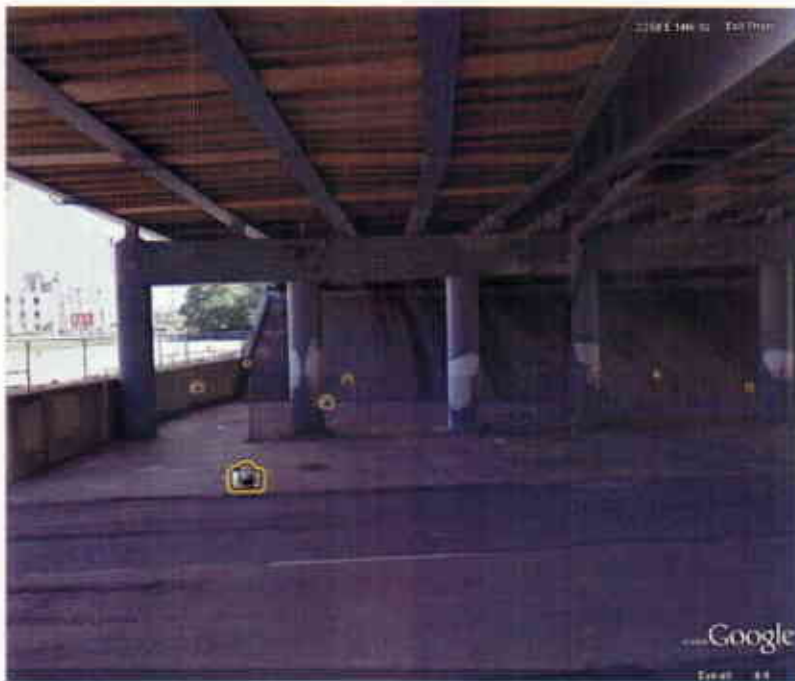
Photograph 05

View Looking East at the Underside of the East Side of the CUY-90 E-10 Ramp Bridge
over East 14th Street, Cleveland, Cuyahoga County, Ohio

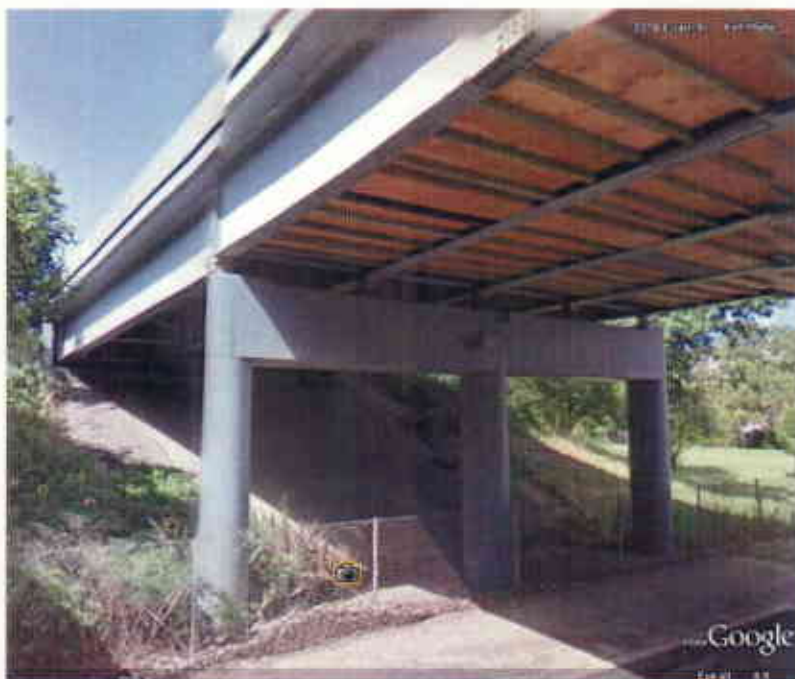
Photograph 06

View Looking West at the Underside of the West Side of the CUY-90 E-10 Ramp Bridge
over East 14th Street, Cleveland, Cuyahoga County, Ohio
