**CUY-90-14.90**

**APPENDIX PA-01**

**Pavement Core Report  
(Reference Document)**

# CUY-90-15.24 PAVEMENT CORE REPORT

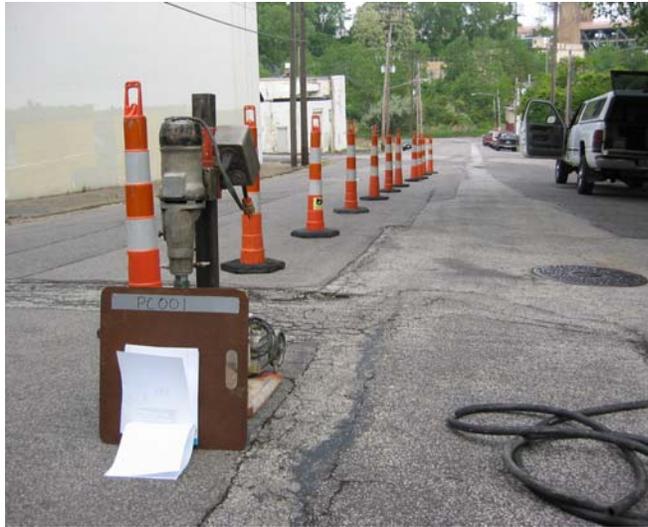
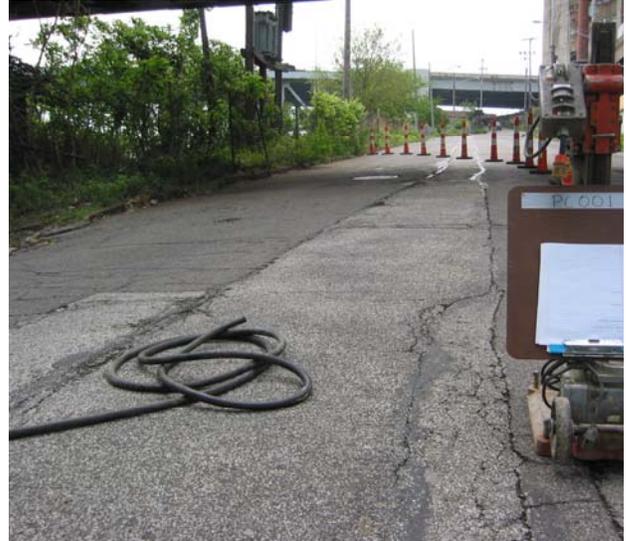
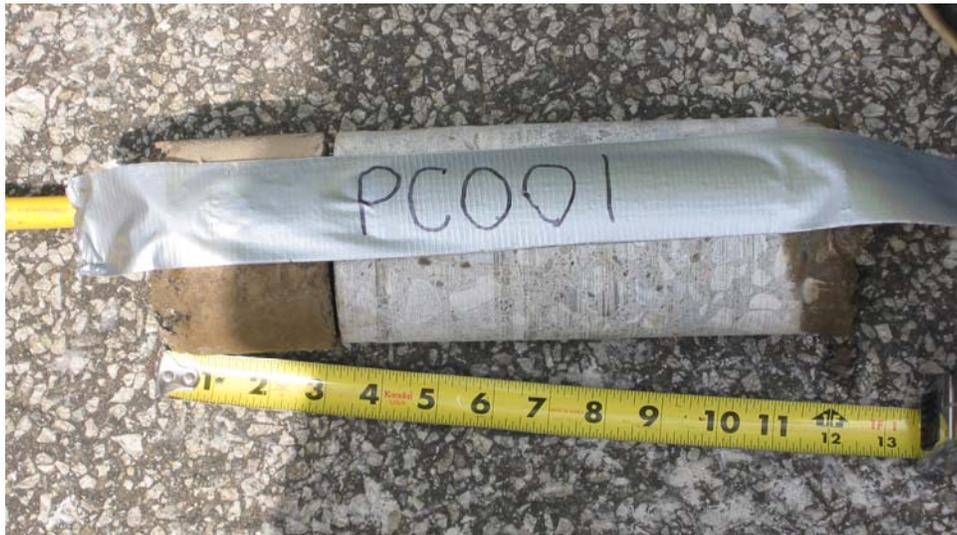
PC No. : 001  
Location: University, North of Tressel  
Latitude: 41.48592      Longitude: 81.69283

Composition: 3.5" Asphalt, 9" Concrete

Notes: Encountered 1PC of steel in asphalt. Subgrade appears to be sand. Pavement condition is poor with large cracks and small pot holes.

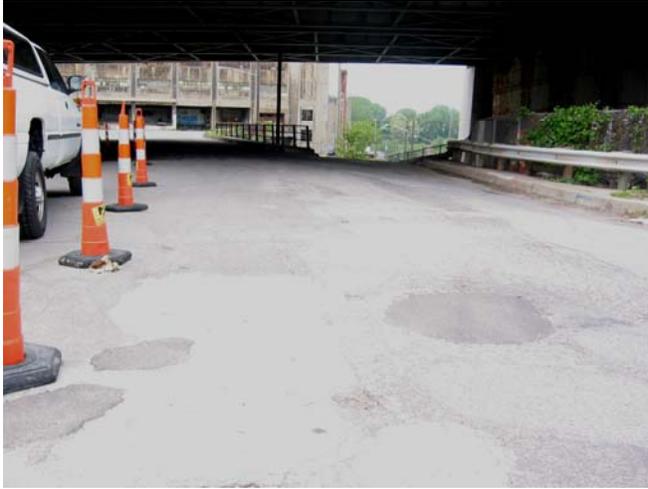
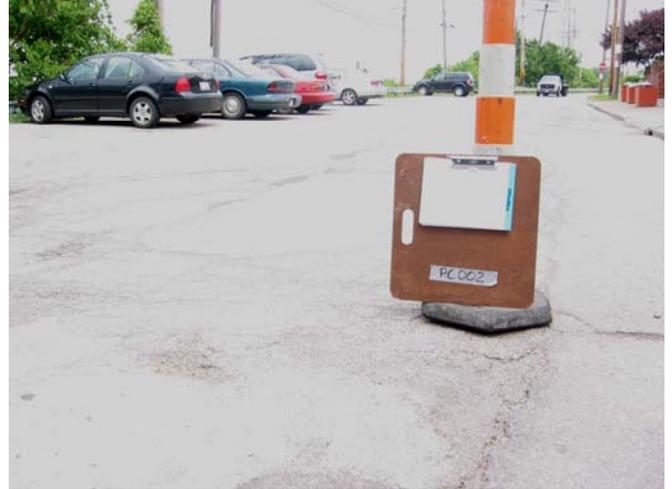
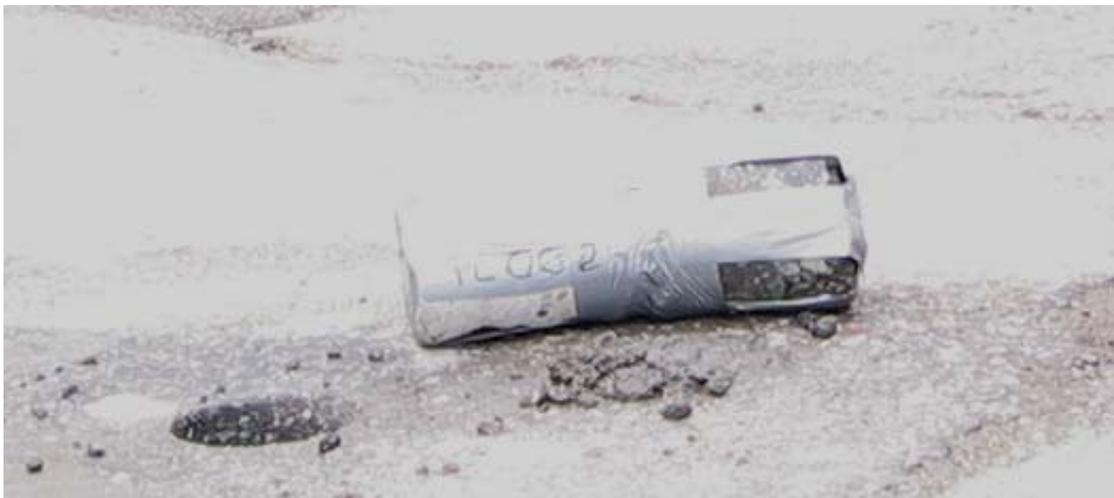
PC No. : 002  
Location: University and W. 13th  
Latitude: 41.48497

Composition: 7.5" Asphalt, 6.5" Concrete.

Notes: Subgrade soils are sand and fine gravel. Pavement condition is poor as PC 001.

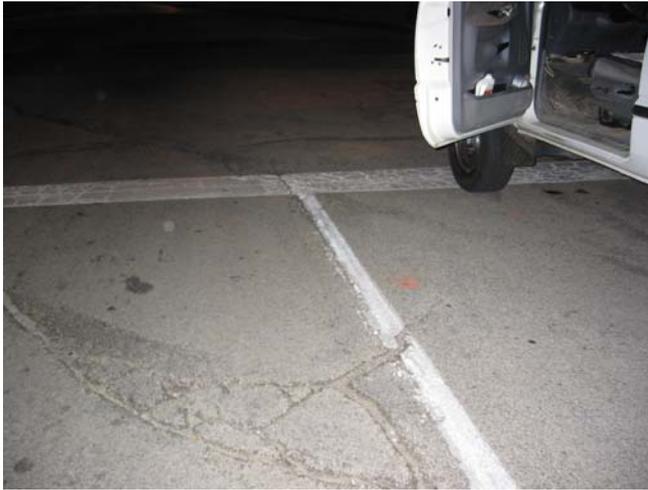
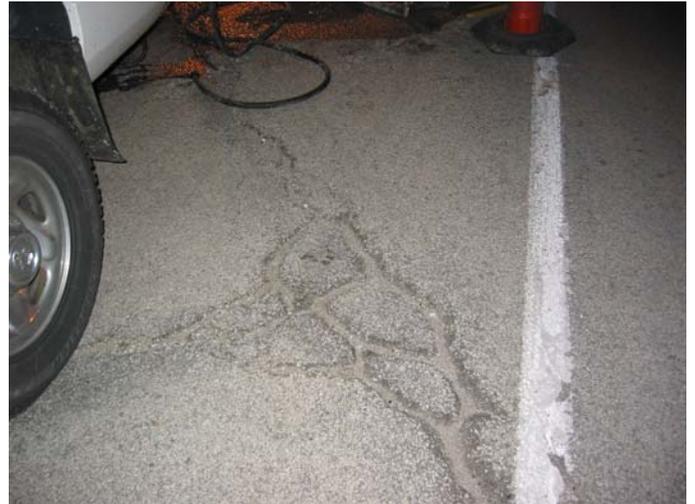
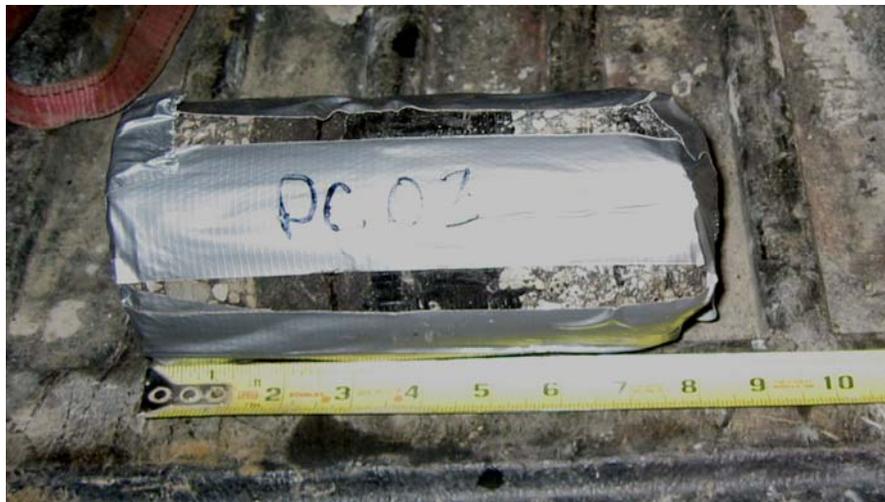
PC No. : 003

Composition: 2" Asphalt with 3.5" Bitm. Base, 11.5" Concrete (only 3" was extracted) – total recovery: 8.5"

Notes: Drilled to full depth of 17", but could not break through the concrete. Removed asphalt core and some concrete. Asphalt pavement condition is poor.

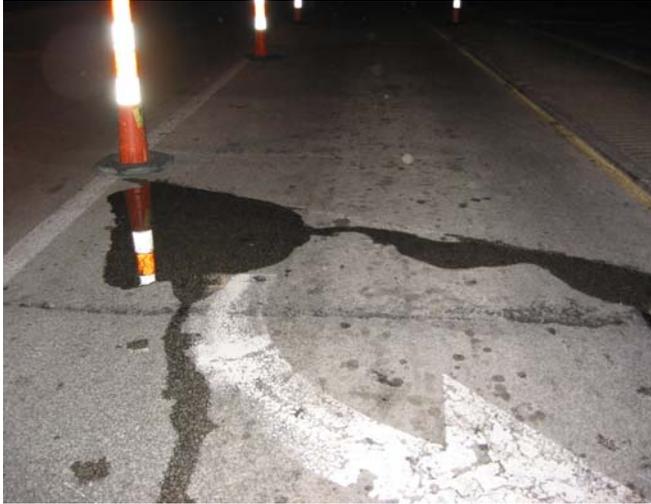
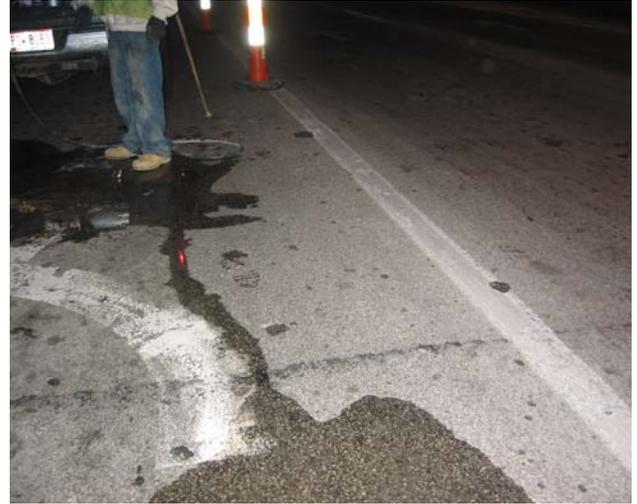
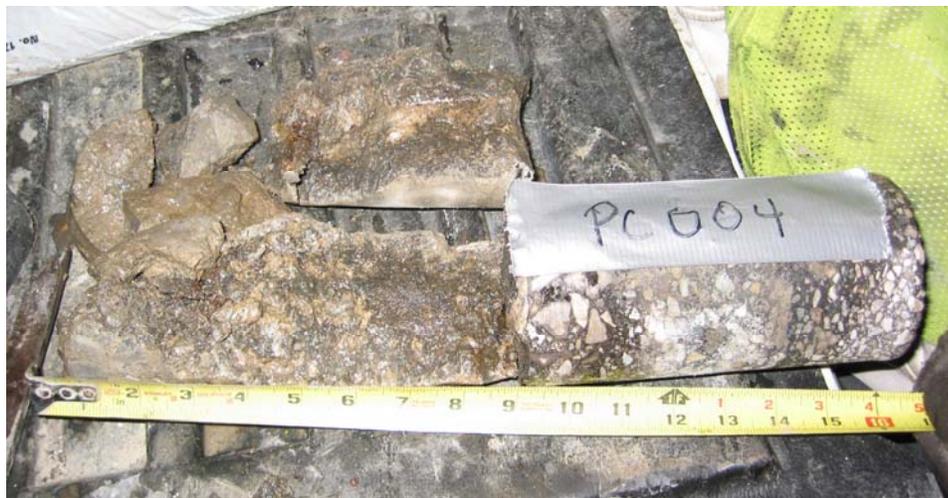
PC No. : 004

Composition: 2.5" Asphalt with 5.5" Asphalt Base, 9.0" Concrete.

Notes: Pavement condition is good.

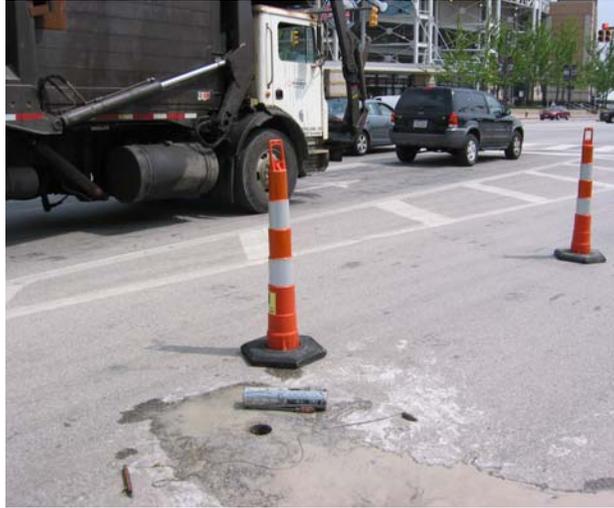
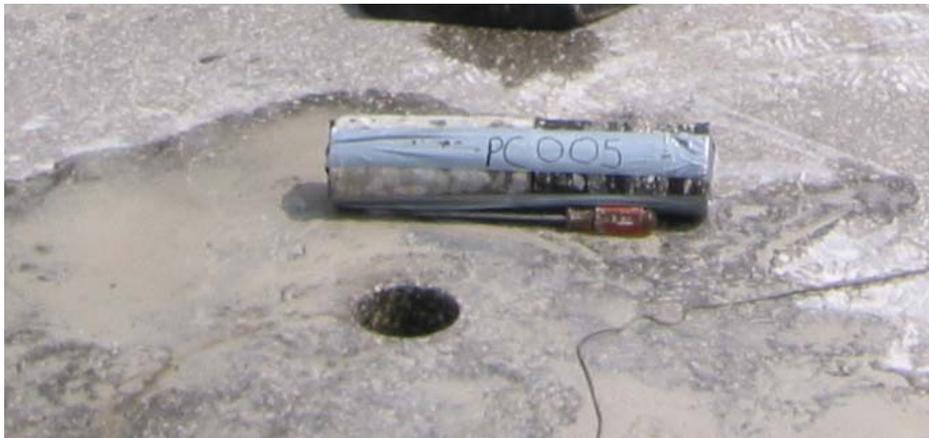
PC No. : 005

Composition: 4" Asphalt with 3.13" Asphalt Base, 8.5" Concrete

Notes: Reinforcing steel mesh in concrete. Sand and gravel base material. Pavement condition is good with some cracks near edge of shoulder.

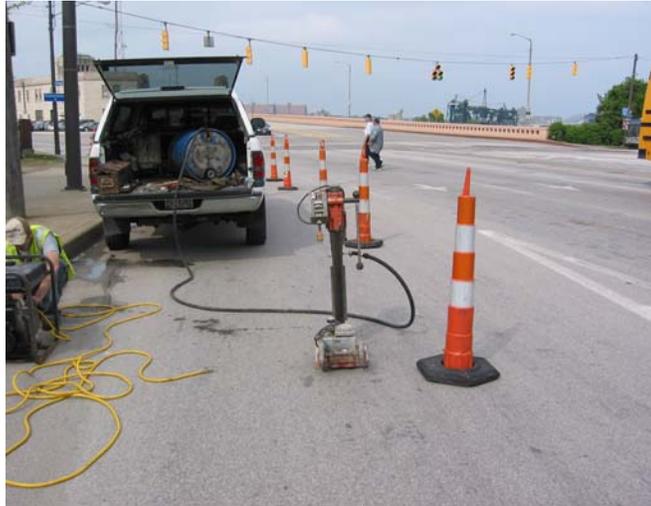
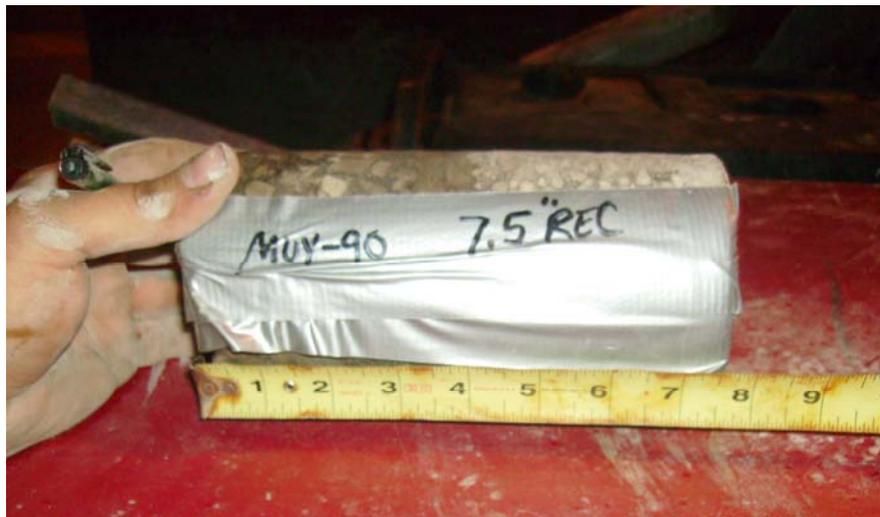
PC No. : 006

Composition: 7.5" Asphalt (3.5" surface course + 4.0" asphalt base), No concrete

Notes: Pavement condition is fair. Some small cracks, no pot holes.

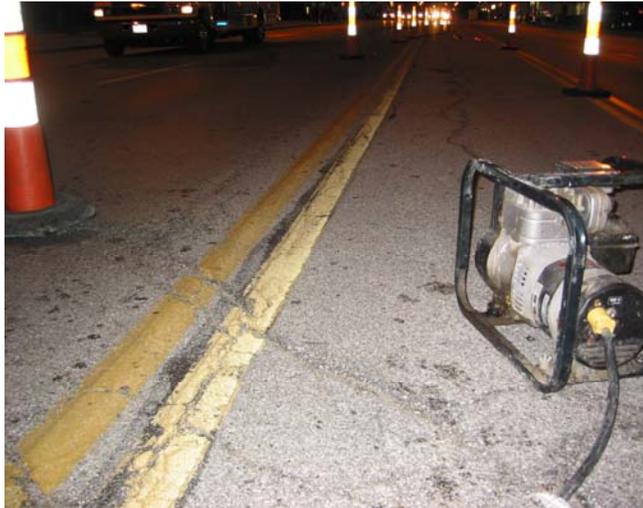
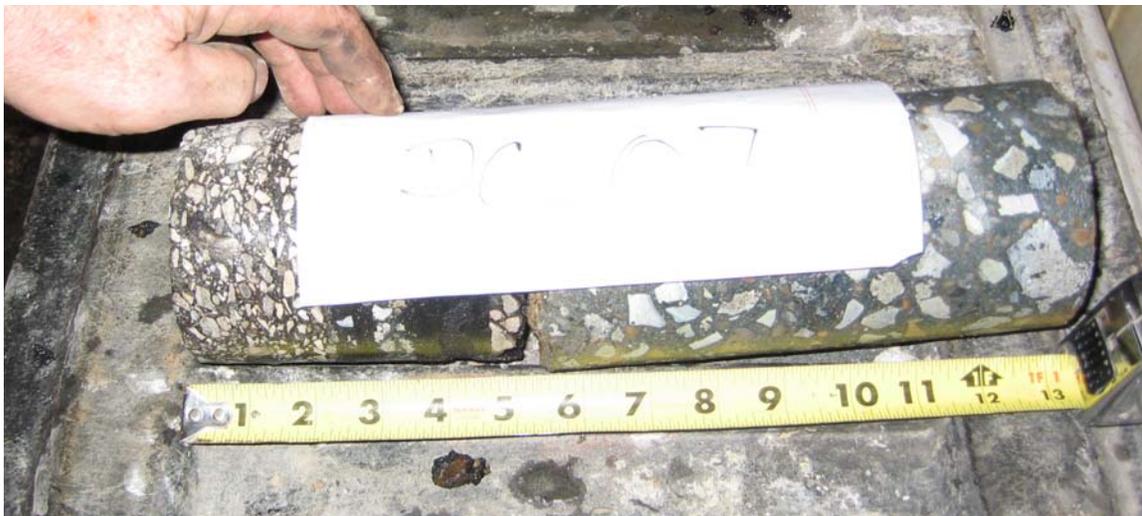
PC No. : 007

Composition: 3" Asphalt with 1" Bitm. Base, 7.75" Concrete

Notes: Pavement condition is fair to poor. Lots of large cracks. No pot holes.

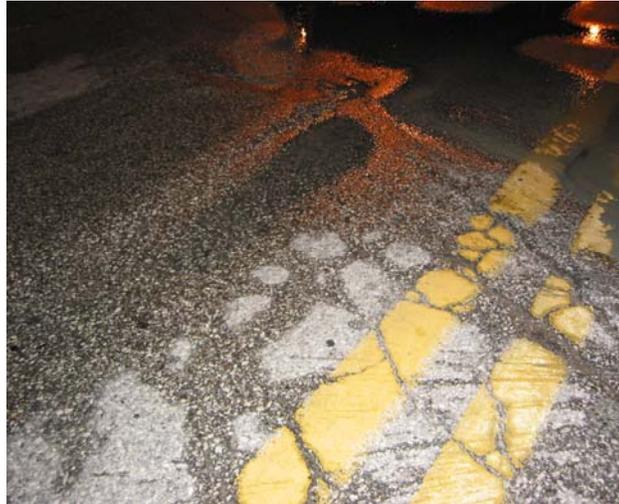
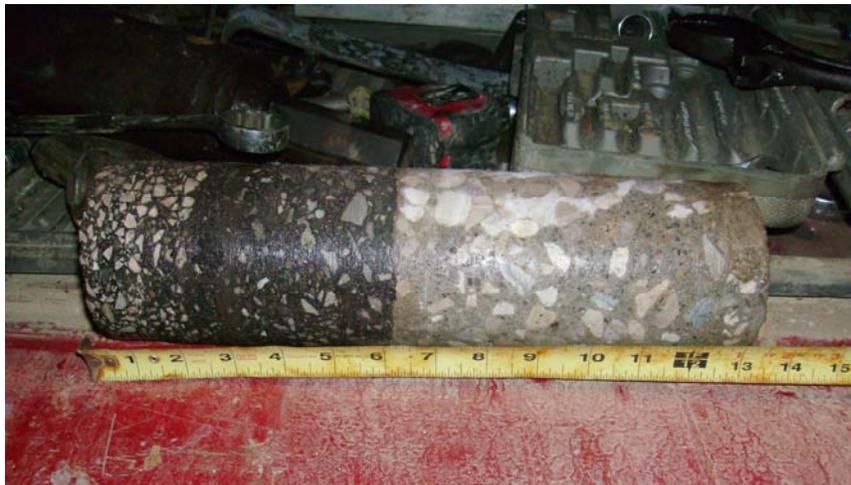
PC No. : 008

Composition: 6" Asphalt, 7.5" Concrete.

Notes: Base material is sand. Pavement condition is fair. Lots of large cracks. No pot holes.

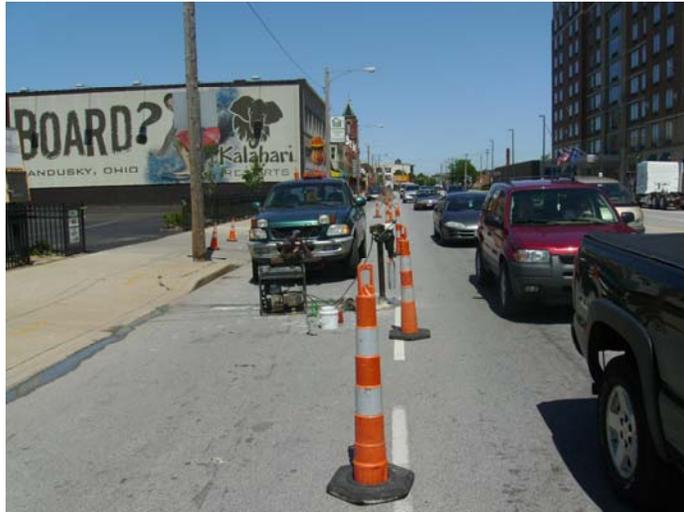
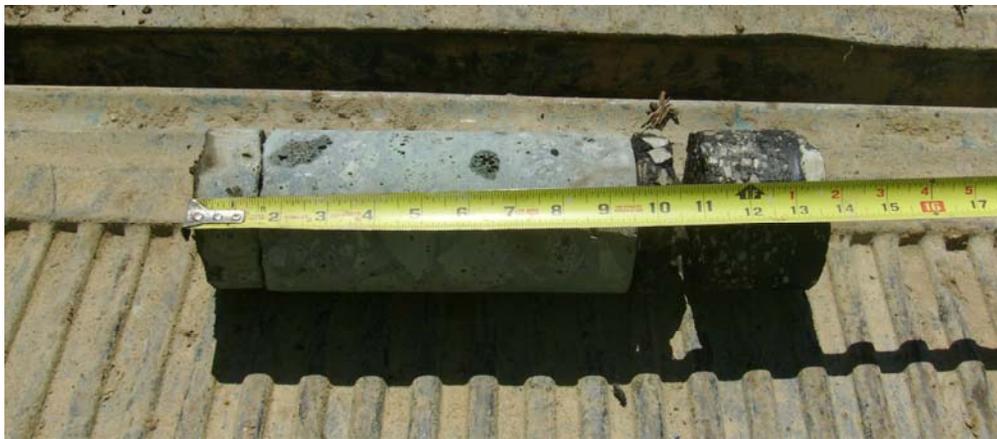
PC No. : 009

Composition: 3.5" Asphalt, 10" Concrete.

Notes: Base material is sandy gravel. Pavement condition is good with few small cracks with no pot holes.

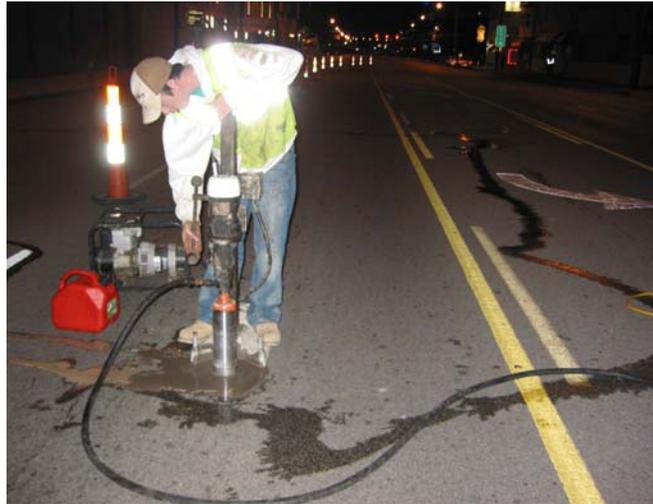
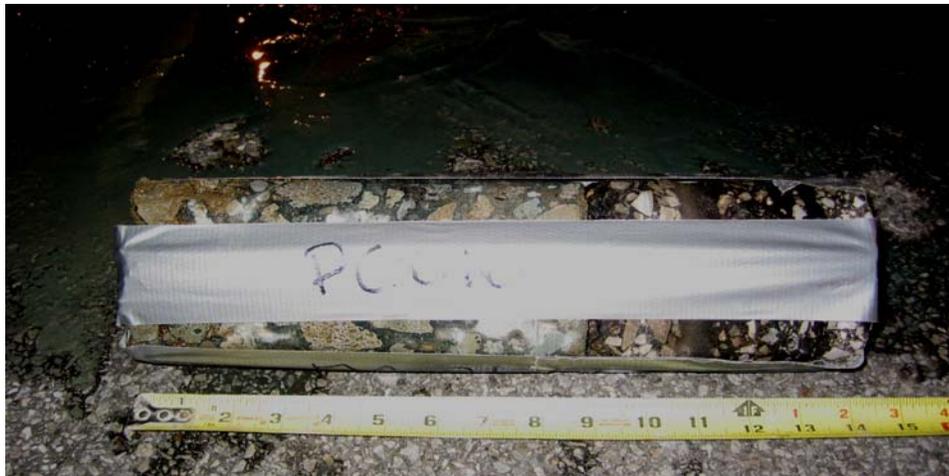
PC No. : 010

Composition: 1" Asphalt with 4.5" Asphalt Base, 9" Concrete.

Notes: 0.5" thickness of tar between 3.0" to 3.5". Pavement condition is excellent.

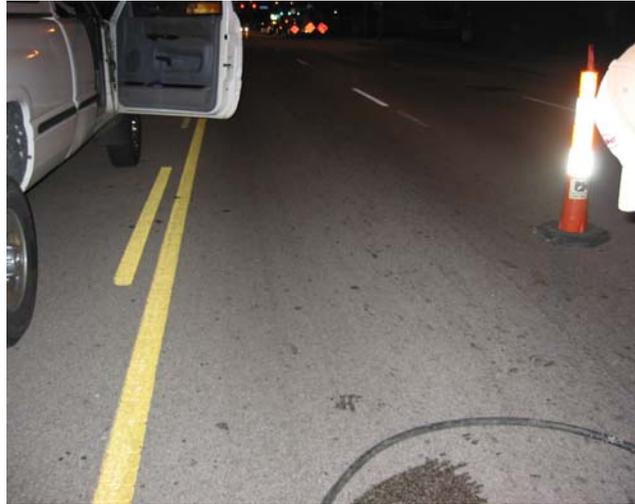
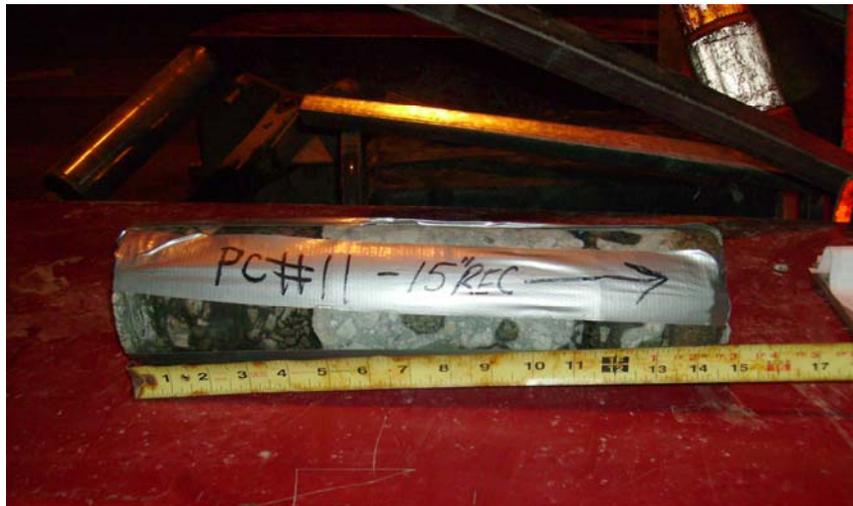
PC No. : 011

Composition: 5" Asphalt, 10" Concrete

Notes: Base material is sandy gravel. Concrete has No. 4 reinforcing steel. Pavement condition is good with some small cracks and without pot holes.

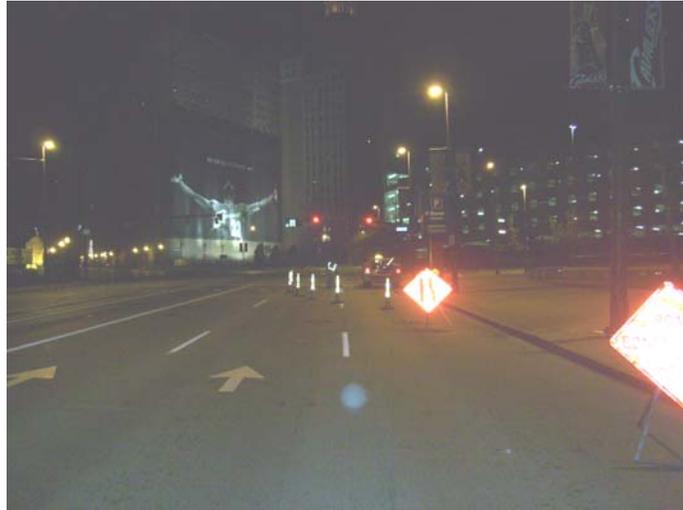
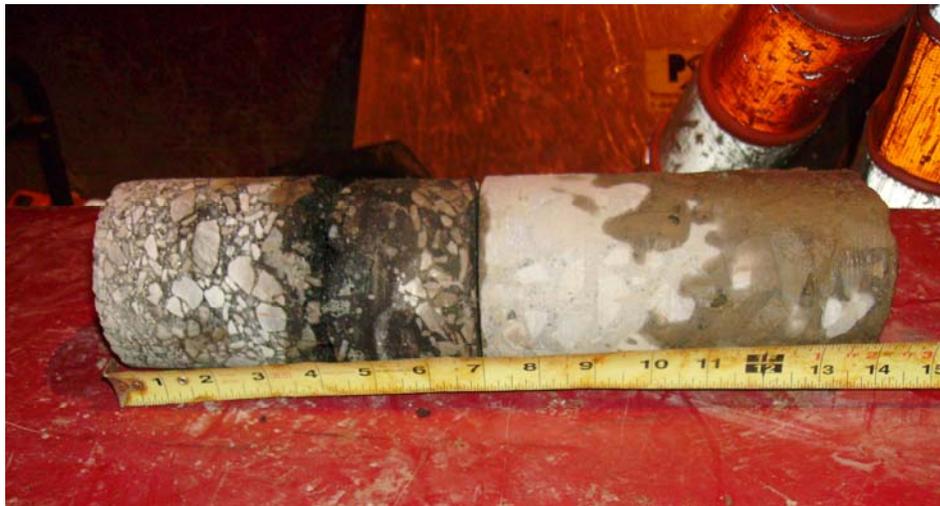
PC No. : 012

Composition: 7" Asphalt, 7" Concrete

Notes: Base material is sandy gravel. Pavement condition is good with some small cracks and without pot holes.

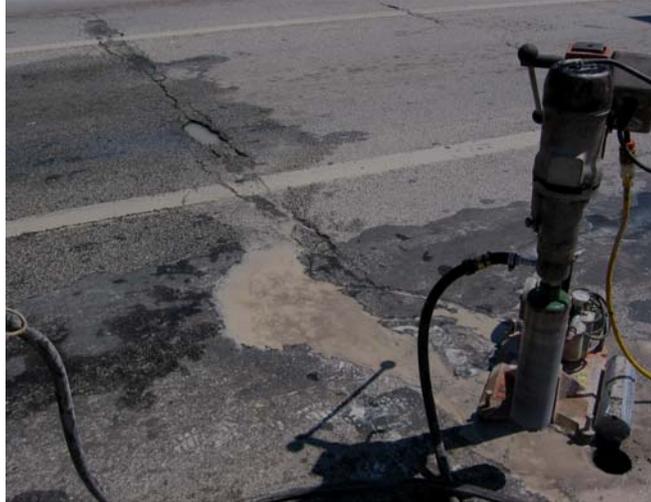
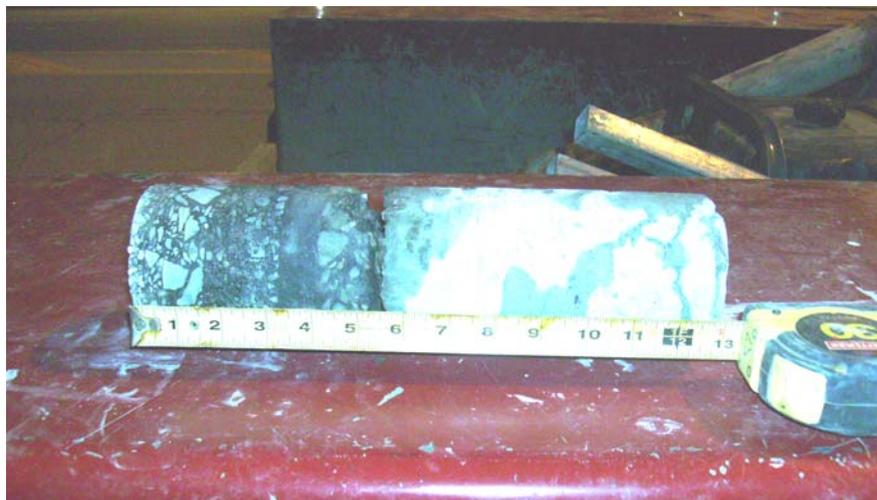
PC No. : 013

Composition: 6" Asphalt, 7" Concrete

Notes: Base material is sandy gravel. Pavement condition is poor. Small cracks with large pot hole, approximately 8" diameter and 2.5" deep along curb.

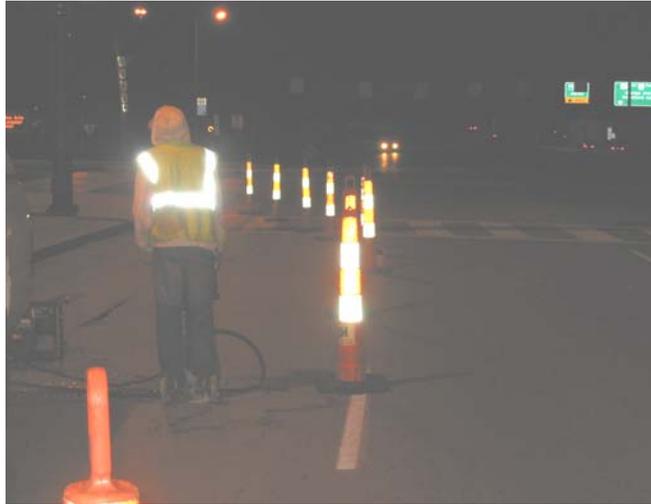
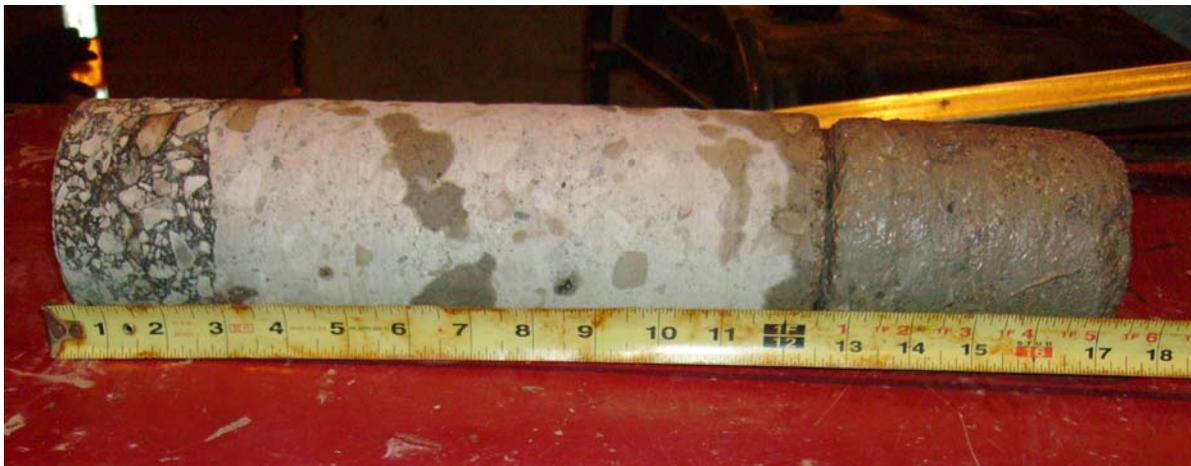
PC No. : 014

Composition: 2.5" Asphalt, 14.5" Concrete

Notes: Pavement condition is fair to good. Some small cracks and without pot holes.

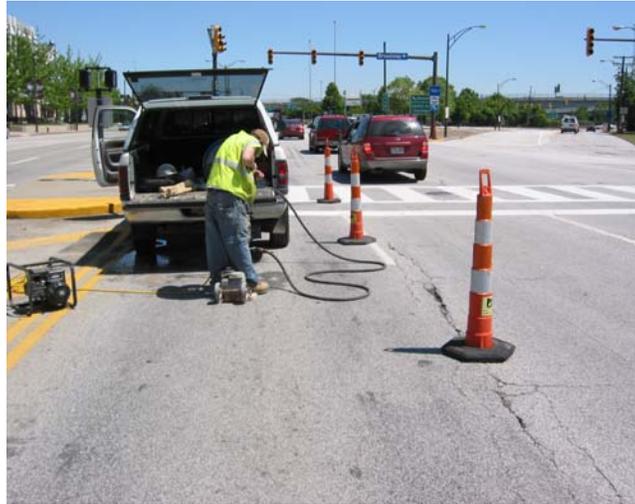
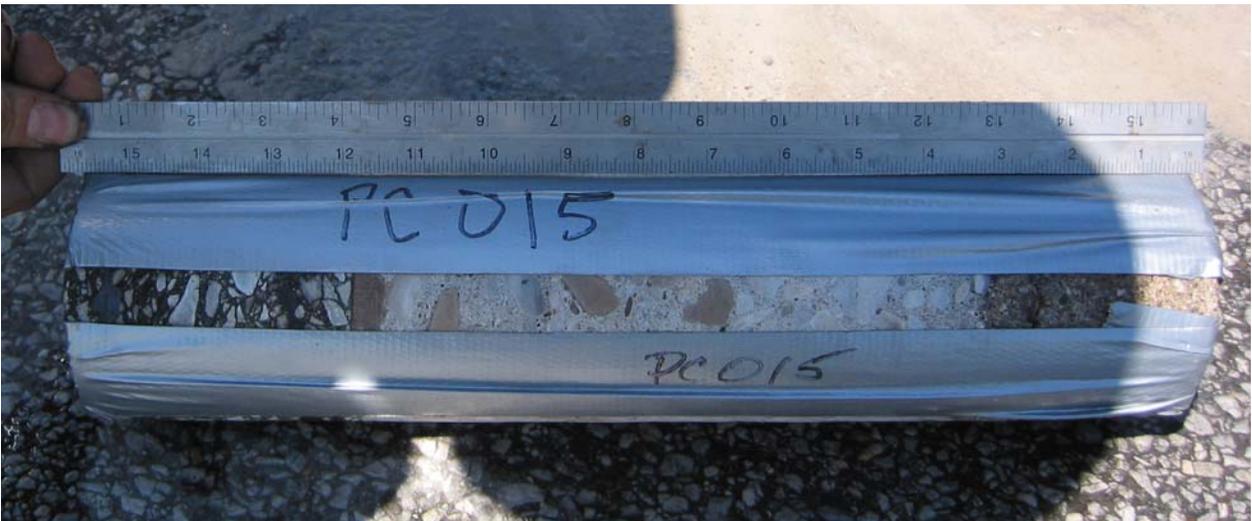
PC No. : 015

Composition: 1" Asphalt with 3" Asphalt Base, 8.75" Concrete.

Notes: 3" Interior concrete may be masonry type mortar. Subgrade is brown sandy gravel. Pavement condition is fair to good with some small cracks without pot holes.

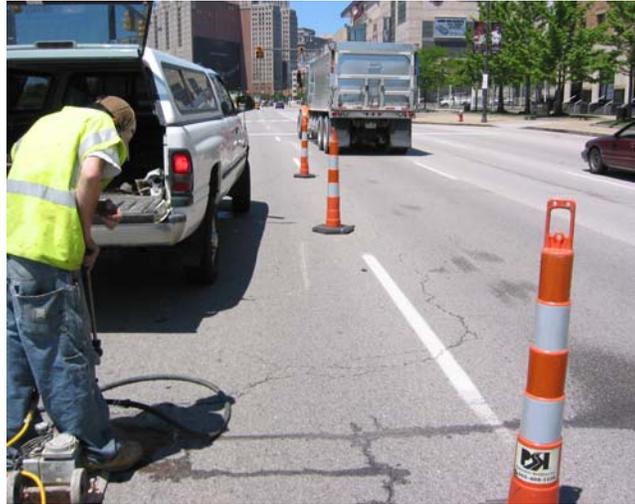
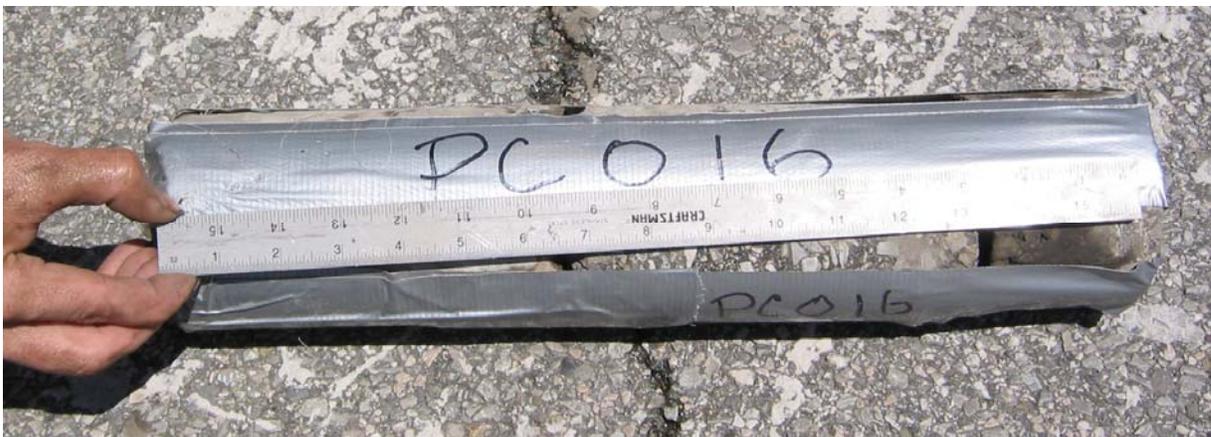
PC No. : 016

Composition: 2" Asphalt with 7.5" Asphalt Base, 7" Concrete

Notes: Pavement condition is fair to good. Some cracks.

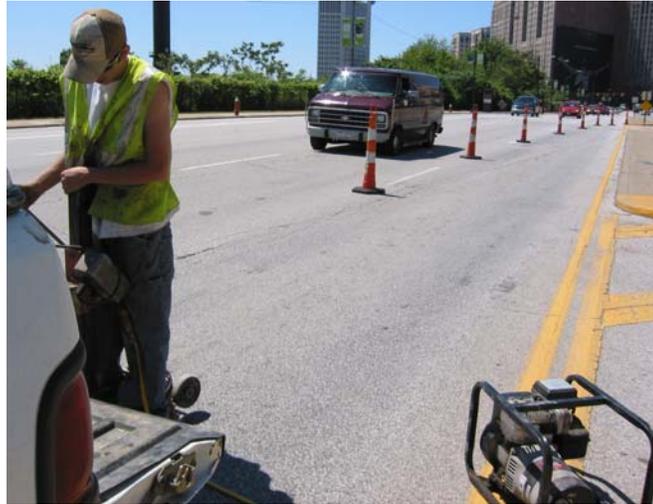
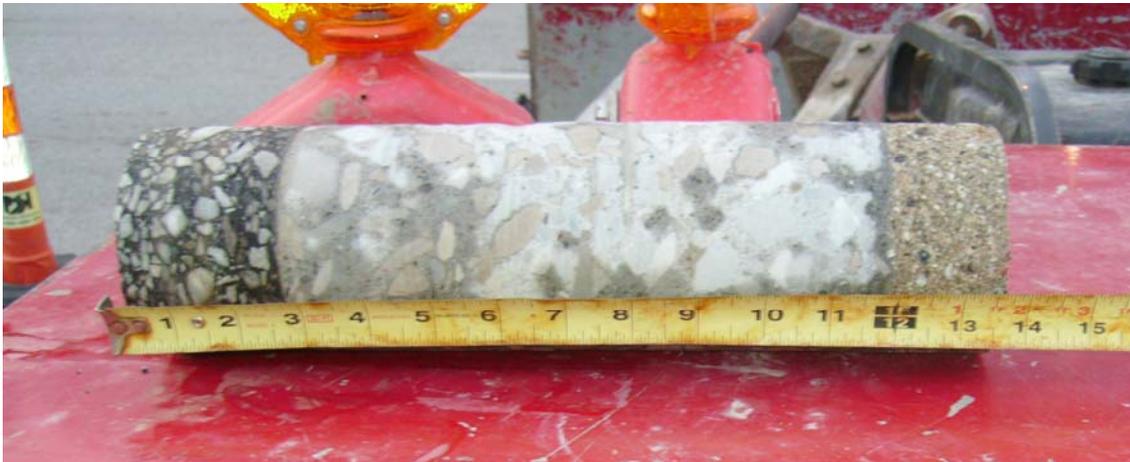
PC No. : 017

Composition: 2.5" Asphalt, 9" Concrete.

Notes: 2" interior concrete may be masonry type mortar. Pavement condition is fair to good. Some cracks.

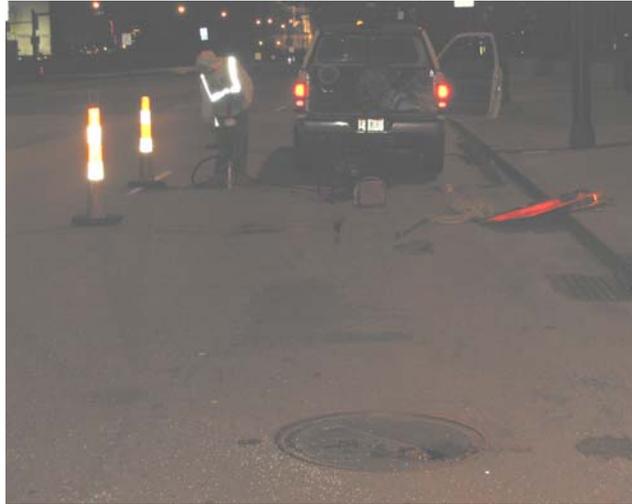
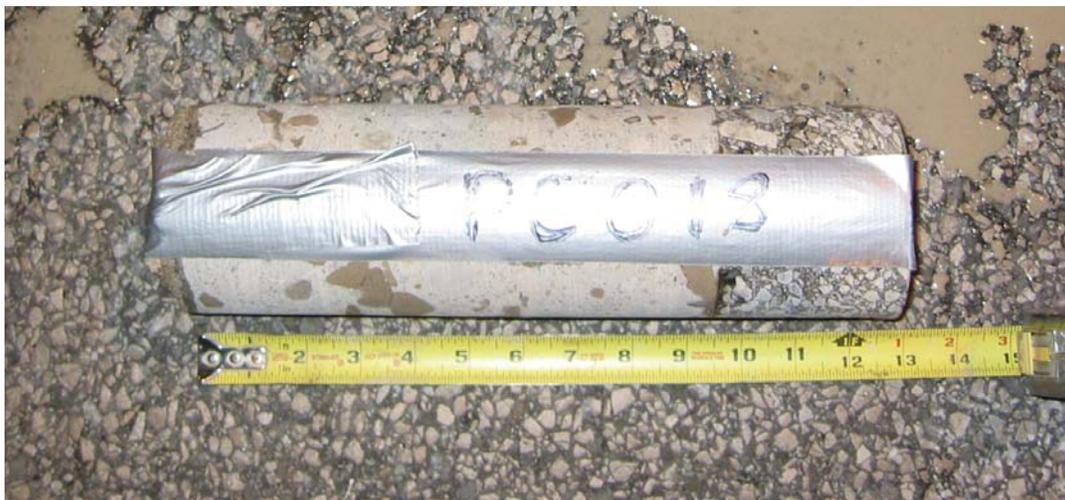
PC No. : 018

Composition: 1.5" Asphalt with 1.5" Base, 9" Concrete.

Notes: Pavement condition is fair with some cracks and small pot holes near the cracks.

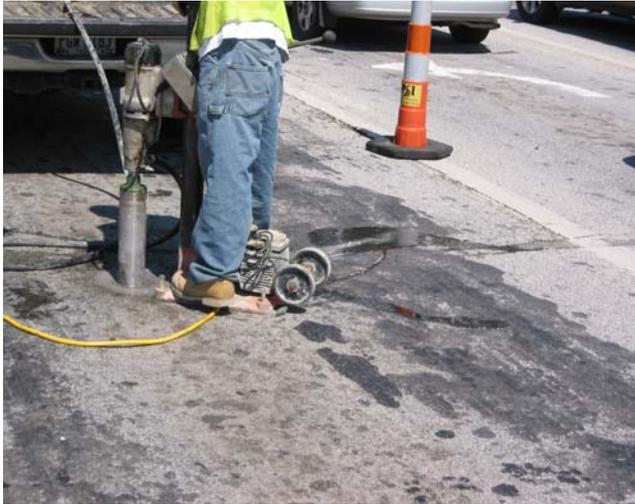
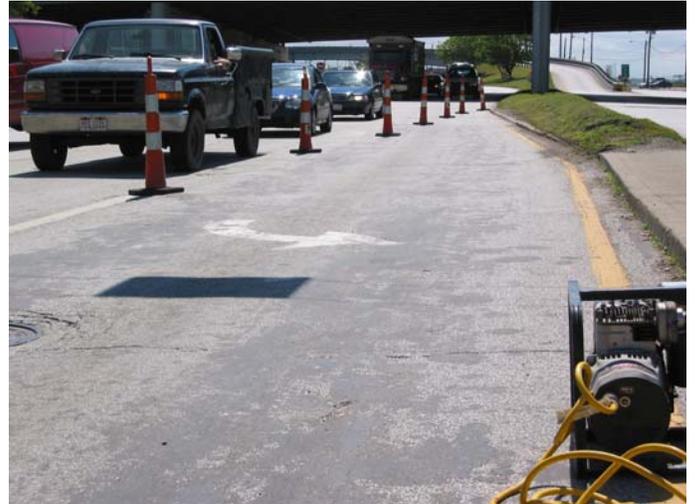
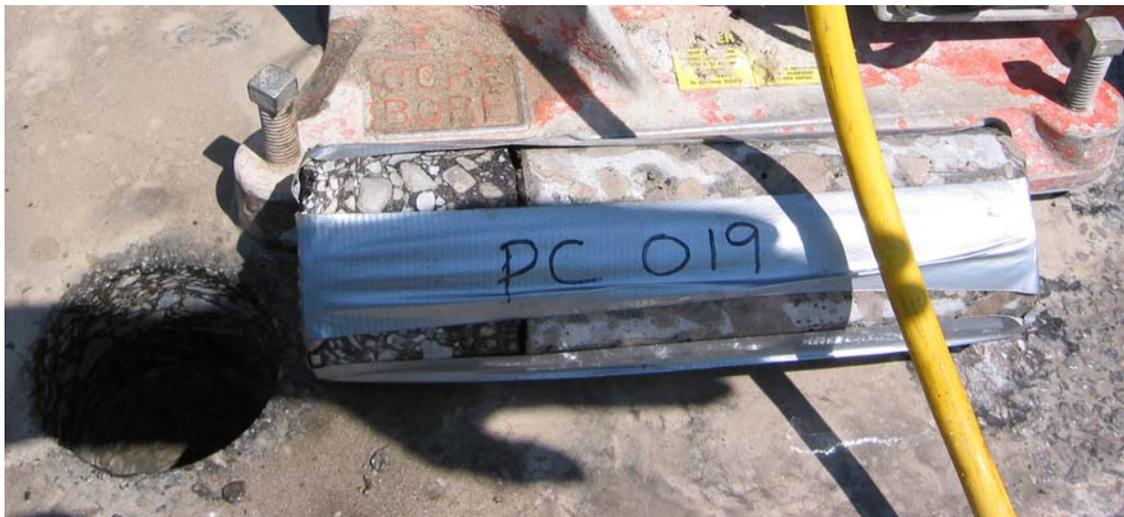
PC No. : 019

Composition: 1" Asphalt with 2.5" Asphalt Base, 8.5" Concrete

Notes: Pavement condition is fair to poor with lots of cracks, bumps, and broke pavement pieces.

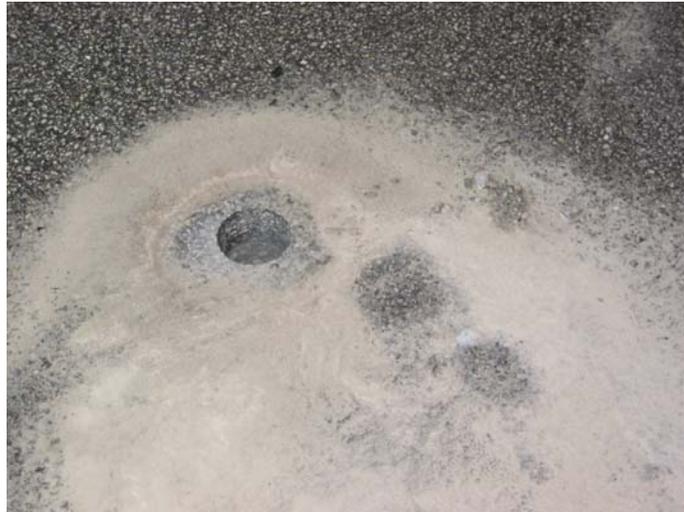
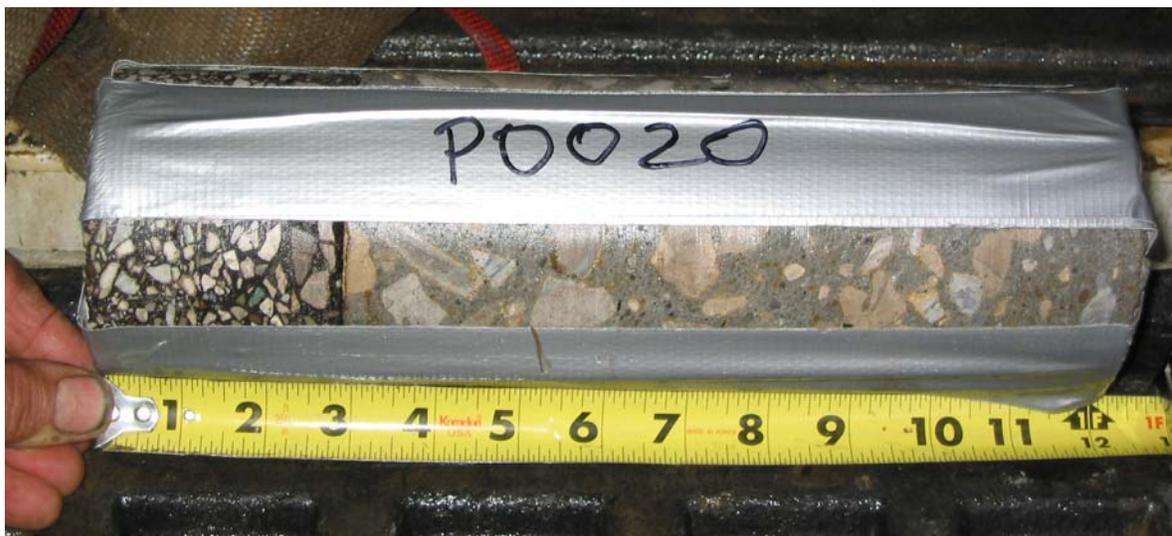
PC No. : 020

Composition: 3" Asphalt, 9.25" Concrete.

Notes: Pavement condition is good.

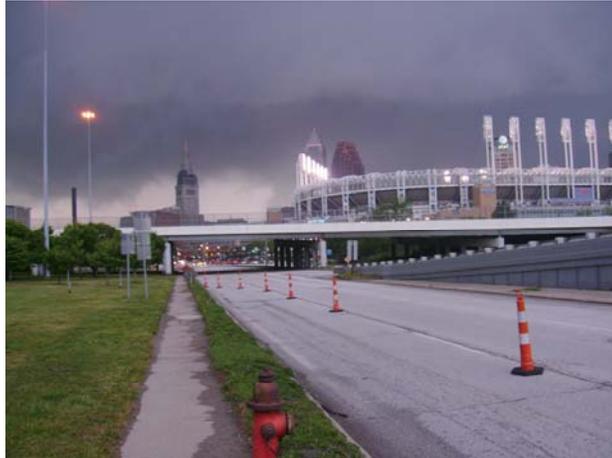
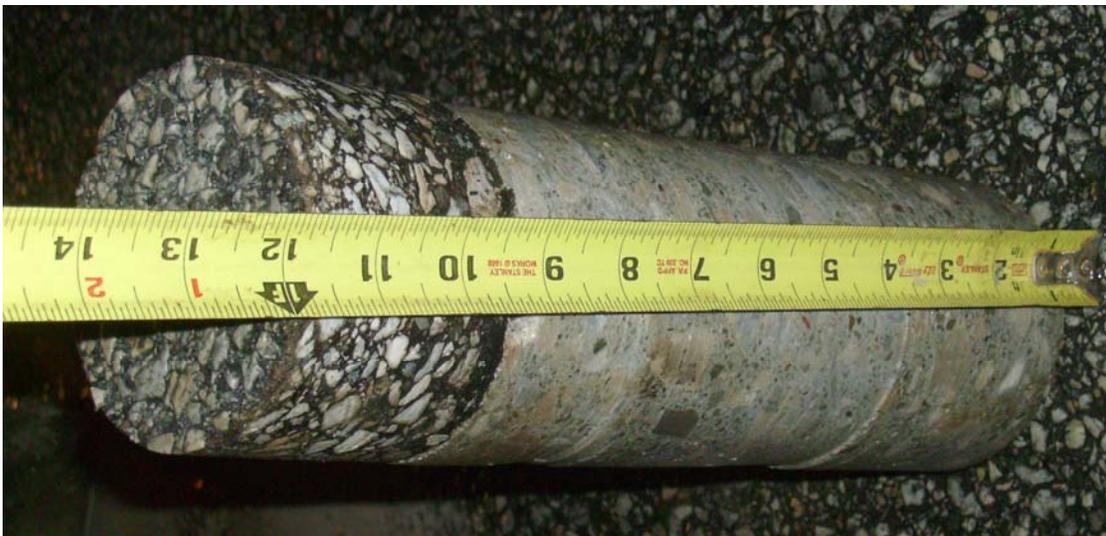
PC No. : 021

Composition: 2.75" Asphalt, 9" Concrete

Notes: Pavement condition is good with few small cracks and without no pot holes.

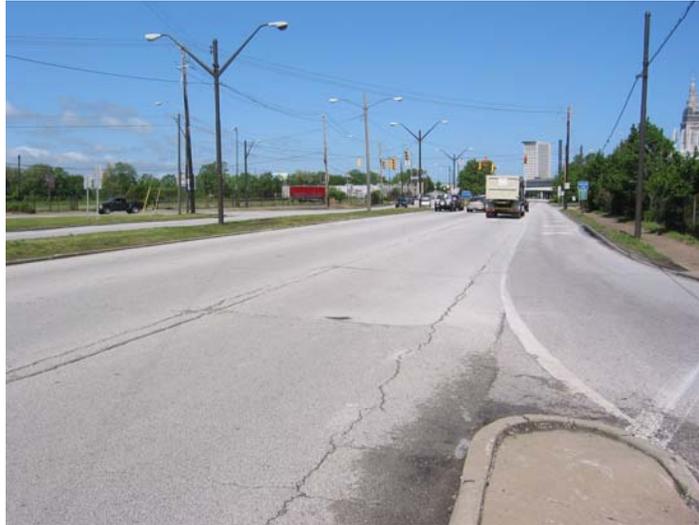
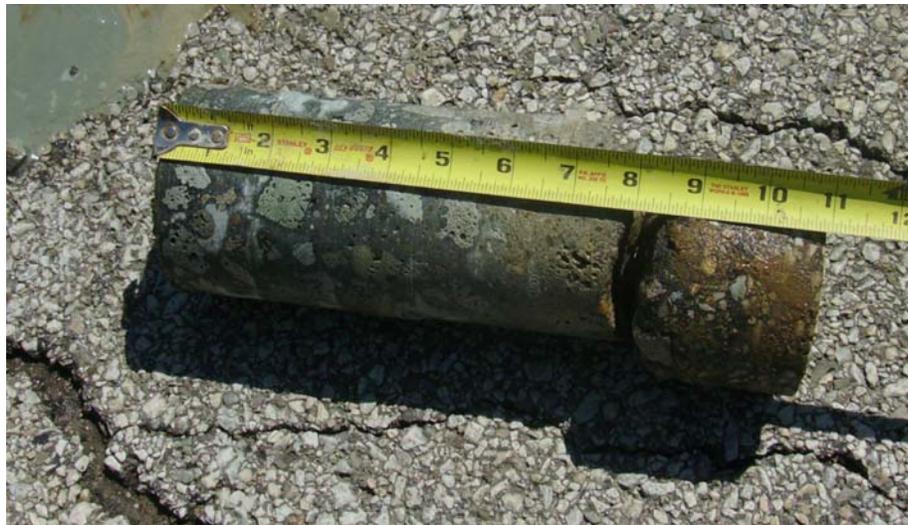
PC No. : 022

Composition: 2.5" Asphalt, 8.0" Concrete

Notes: Pavement condition is poor to fair. Lots of long cracks with small pot holes.

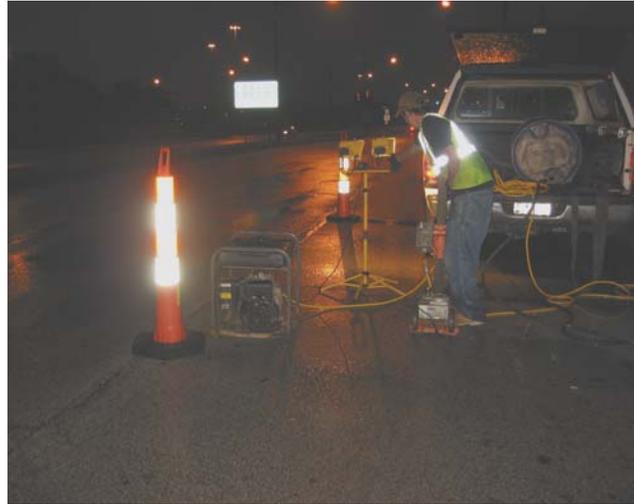
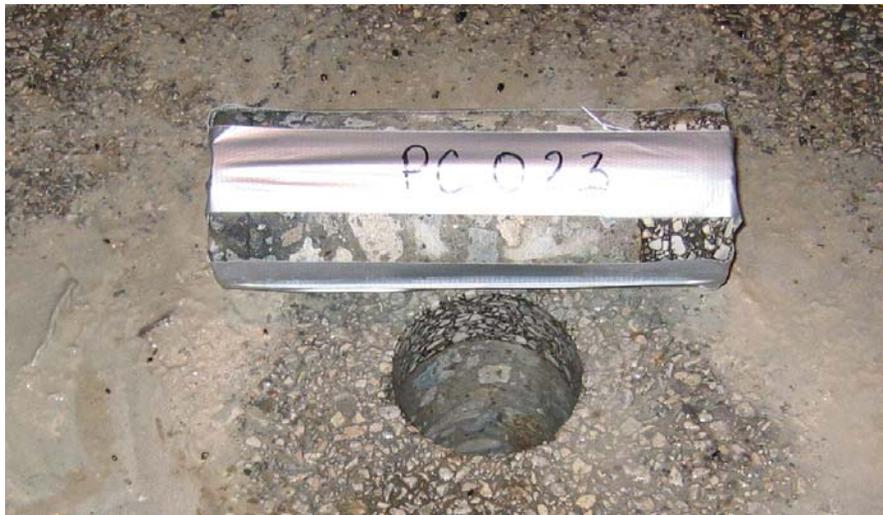
PC No. : 023

Composition: 2" Asphalt, 9" Concrete

Notes: Pavement condition is fair to good. Some cracks. No pot holes.

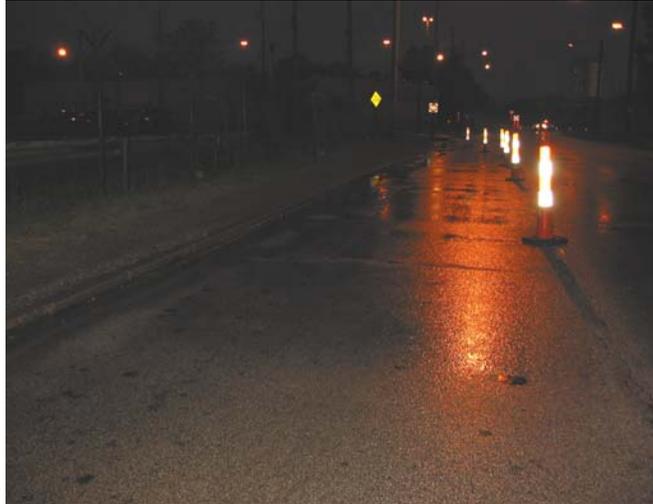
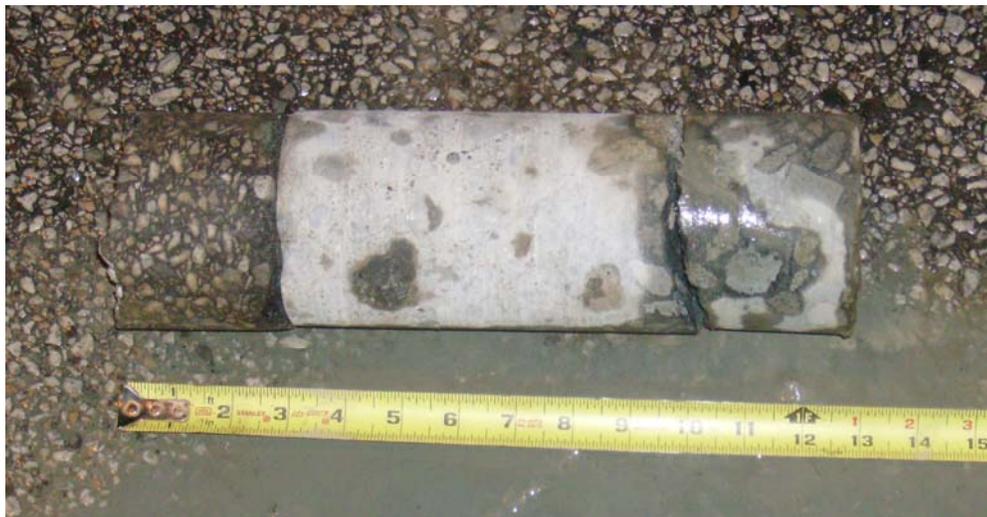
PC No. : 024

Composition: 3.5" Asphalt, 9" Concrete

Notes: Pavement condition is fair to good. Some cracks. No pot holes.
