**CUY-90-14.90**

**APPENDIX PA-01**

**Pavement Core Report  
(Reference Document)**

# CUY-90-15.24 PAVEMENT CORE REPORT

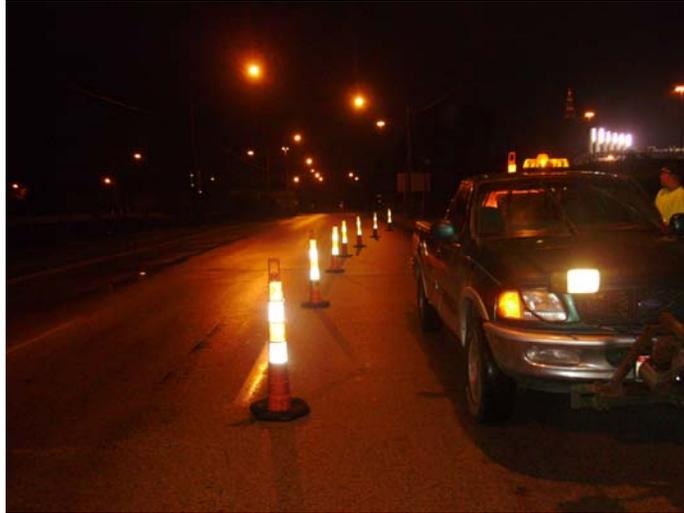
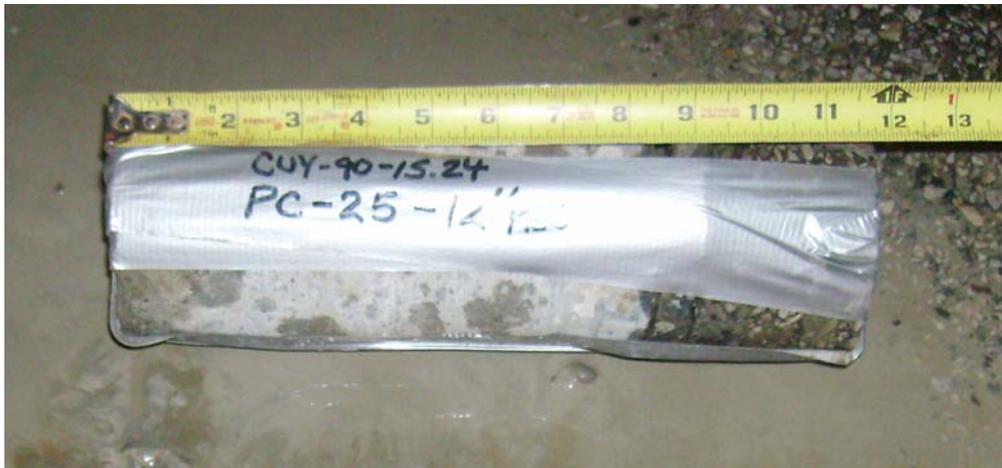
PC No. : 025

Composition: 4.0" Asphalt, 8" Concrete

Notes: Pavement condition is fair. Some cracks. No pot holes.

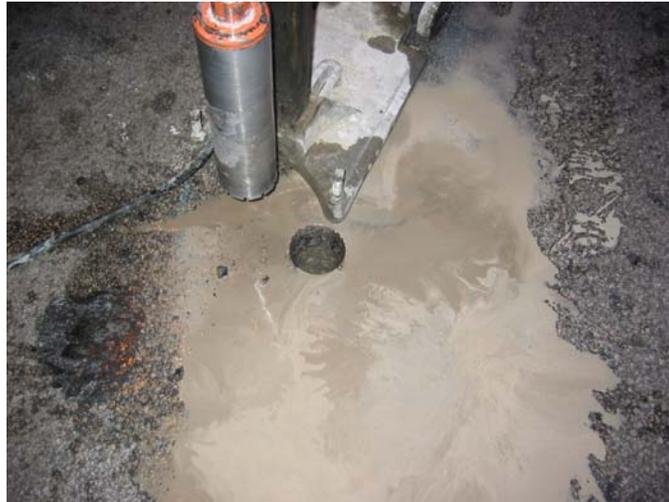
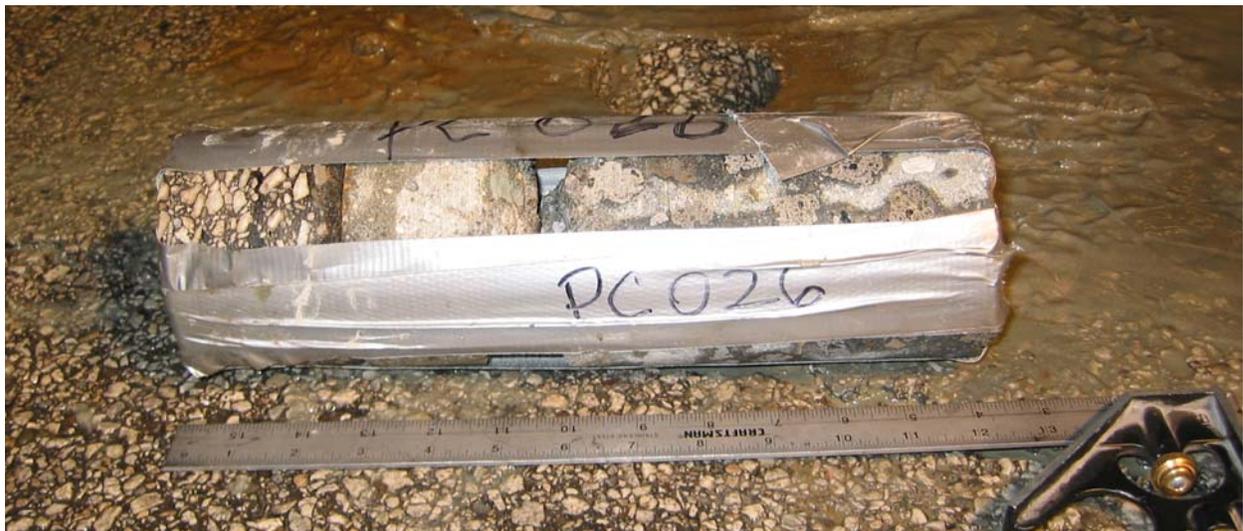
PC No. : 026

Composition: 2.5" Asphalt, 9.5" Concrete

Notes: Pavement condition is good with few cracks.

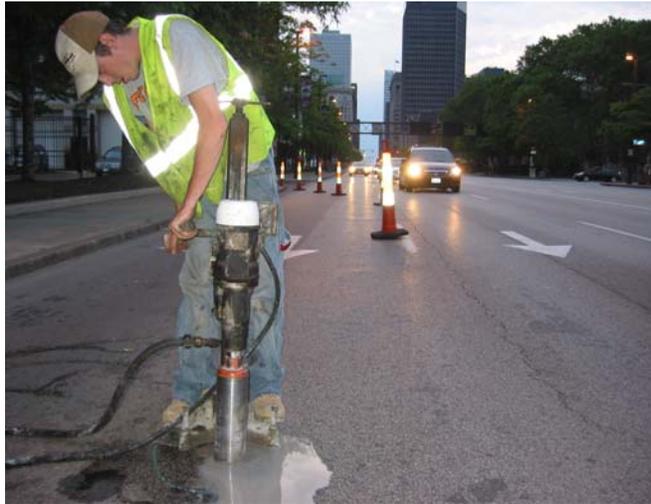
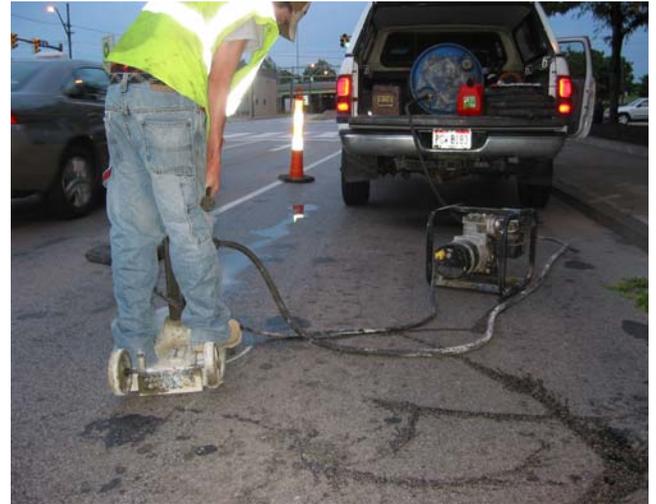
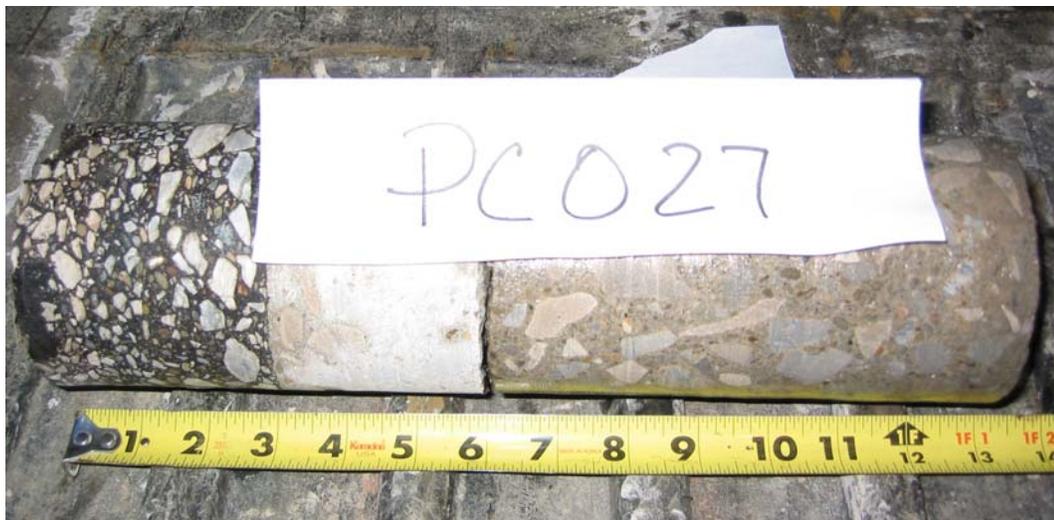
PC No. : 027

Composition: 3.5" Asphalt, 10.5" Concrete

Notes: Pavement condition is good with some cracks between lanes and joints. No pot holes.

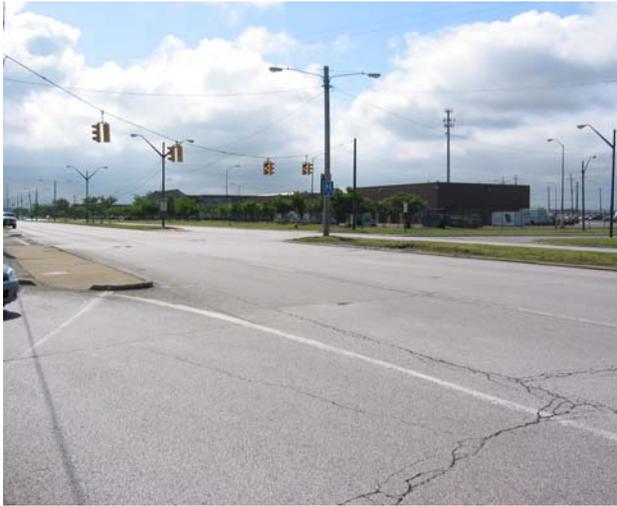
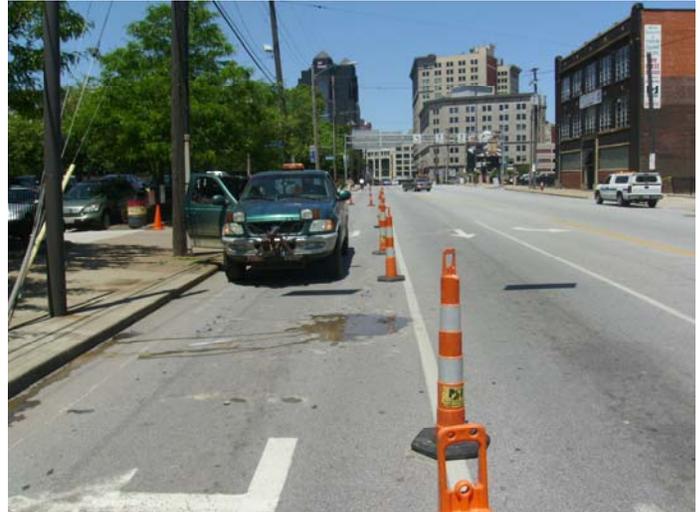
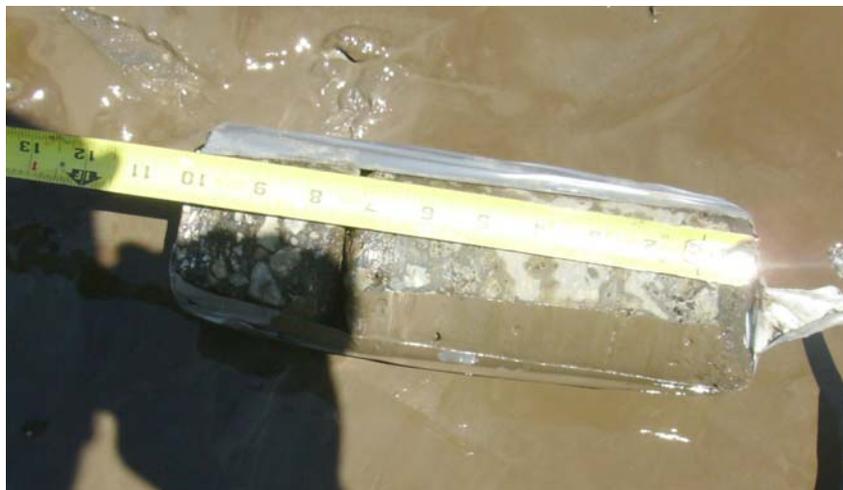
PC No. : 028

Composition: 3" Asphalt, 7" Concrete

Notes: Pavement condition is good with few small cracks and without pot holes.

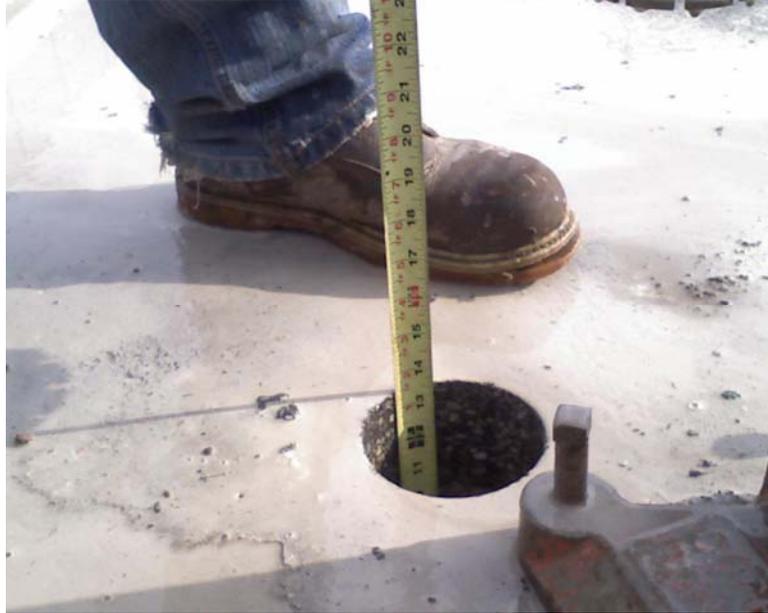
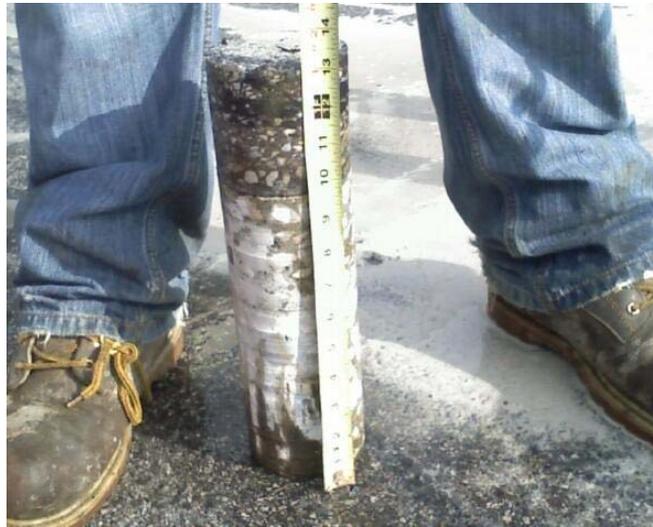
PC No. : 029  
Location: B-024-0-09  
Latitude: 41.482517

Composition: 4.0" Asphalt, 9.0" Concrete

Notes: Subgrade appears to be sand. Pavement condition is good.

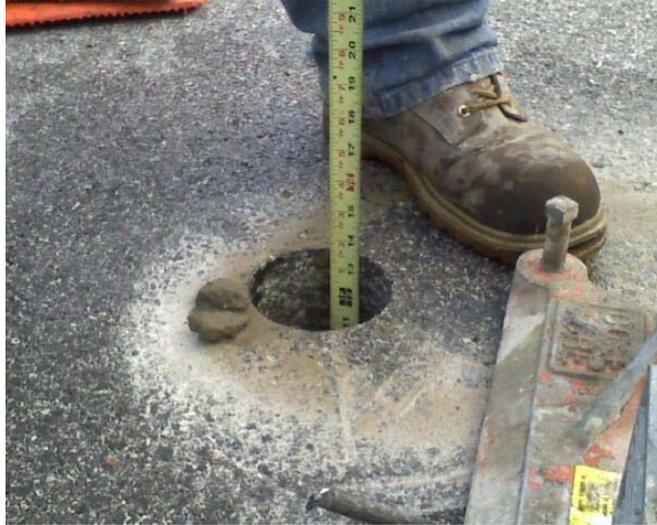
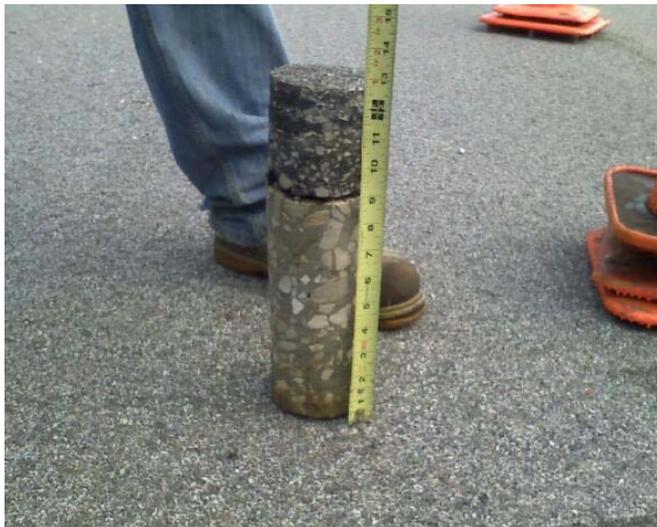
PC No. : 030  
Location: B-029-0-09  
Latitude: 41.482983

Composition: 4.0” Asphalt, 9.0” Concrete

Notes: 1.125” Rebar in concrete, Subgrade appears to be sand. Pavement condition is good.
