APPENDIX A – ANTHONY WAYNE BRIDGE ACOUSTIC EMISSION MONITORING REPORT (MISTRAS)

Anthony Wayne Bridge Acoustic Emission Monitoring Report

Location: Toledo, Ohio

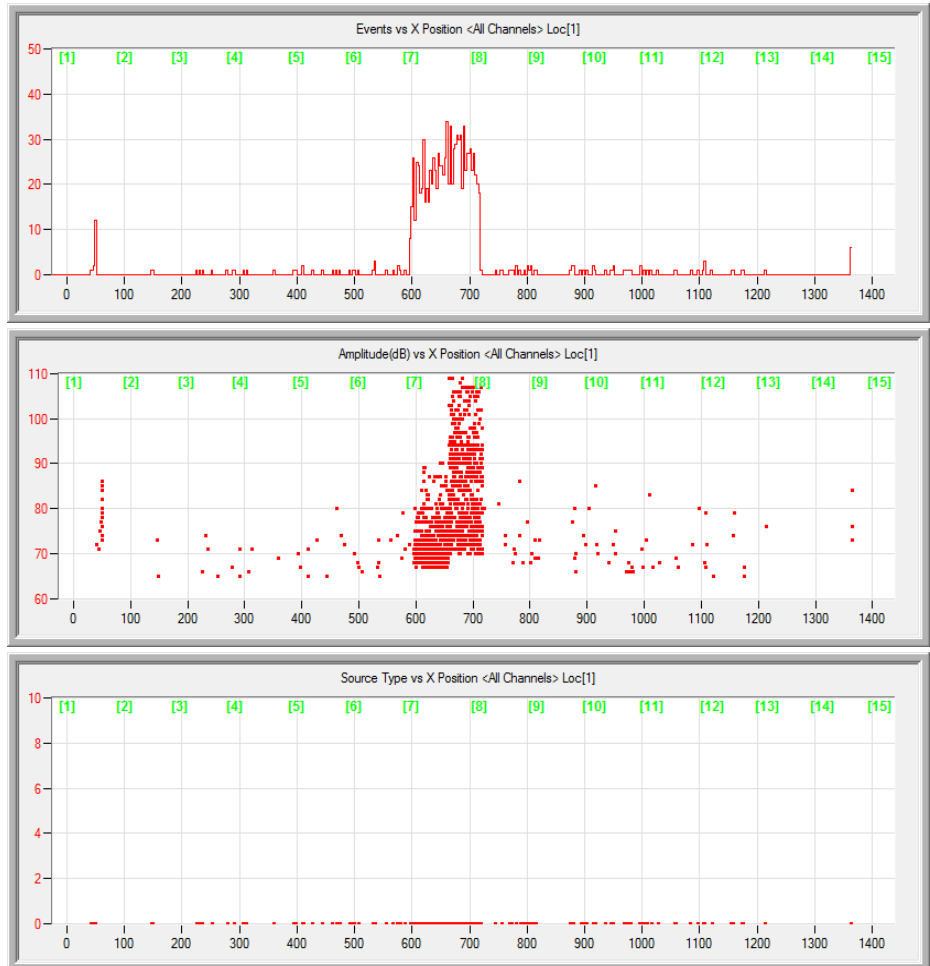
Figure 16 (South): Cum. Events vs. Pos. (top), Amp. of Events vs Pos. (middle), Source Type vs Pos. (bottom)

The graphs used for the South cable are the same as the examples of the data for the North cable as shown in Section 6.4. The data in this section covers the period from August 4, to September 6, 2011. Figure 16 shows the same plots of Cumulative Events, Amplitude of Events and Source Type of the Events vs. X Position. Similar to the North cable, the South cable shows the same clustering trend of AE events at the midspan of the main cable between sensors 7 & 8 and is approximately 3 times more active than the same section for the North cable. There are additional clusters shown at the middle of sensors 1 & 2 and 14 & 15. For the entire cable a total of 1101 events were located. Of those events, zero events reached a Source Type classification > 0 . Thus, no potential wire breaks have been observed.

A review of the remaining graphs shows that the next highest channel (after Channel 8) with AE activity is coming from Channel 3 and is several orders of magnitude higher than the surrounding channels. While only a few events were strong enough to be located in the graphs of Figure 18, the amount of activity coming from channel 3 signifies a very active source in this area of the cable. Thus, this section of the cable would be a good candidate for additional inspection. In the area of Channel 7 & 8, a review of the waveform data again shows a low frequency, continuous type waveform and indicative of a frictional noise source in the area of the sensor.

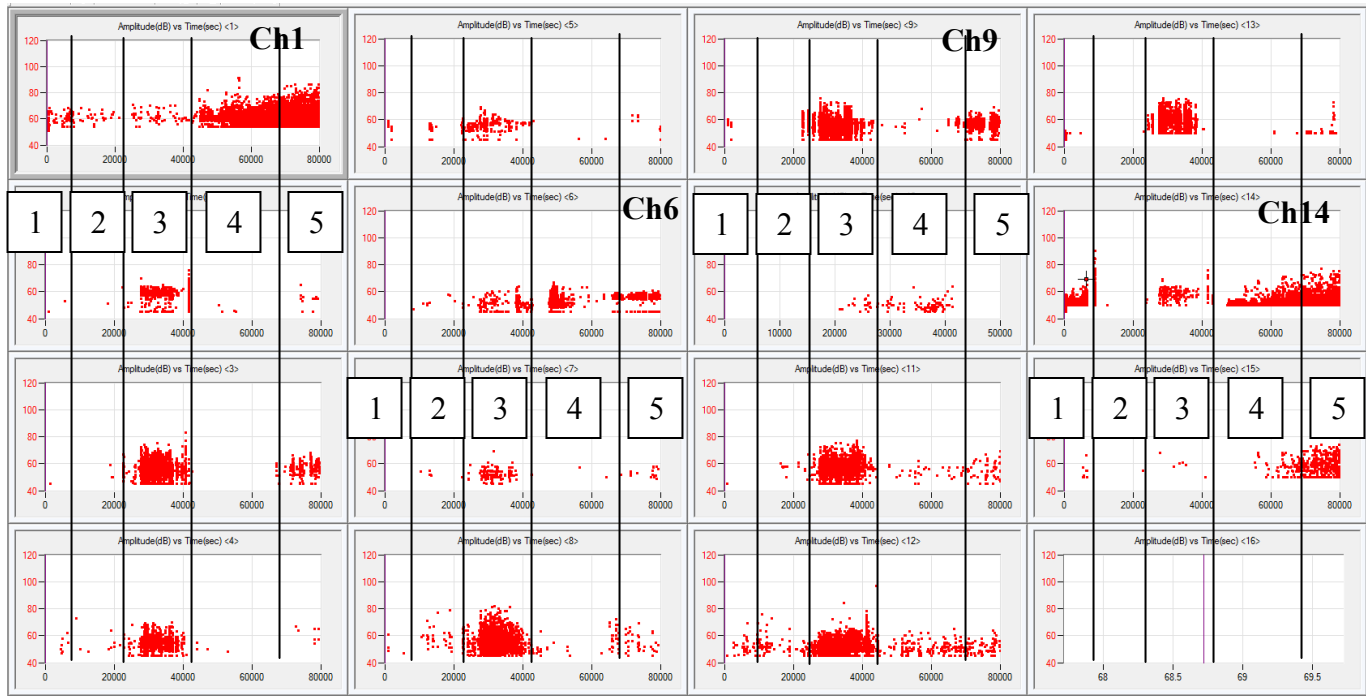
Figure 19 Channel by Channel analysis (Amplitude vs Time) - NORTH

Figure 19 shows the amplitude of each AE hit recorded, channel and time when the AE activity was recorded for the north side of the bridge. It is expected that for active corrosion, AE will be constantly recorded during this time period. As previously observed, channels 1, 9 and 15 had the highest AE hit rate. A review of this graph shows that for a majority of the period in which there was no loading on the bridge (vehicular, or wind), most of the channels are relatively quiet. For clarity, the graphs have been divided into periods that show changes external loading on the bridge. Period 1 shows activity

caused by traffic loading on the bridge. Period 2 shows the start of the shutdown of the bridge and during the time when the wind was relatively calm. Period 3 highlights the start of the period when there was a significant increase in the wind with gusts up to 21.0 mph. Period 4 shows the time when the wind decreased to around 5-6 mph (and the start of increasing relative humidity) and Period 5 shows highlights the time when there was a continuous increase in the relative humidity and start of a period of rain that lasted approximately 3.5-4 hours.

As such, at the beginning of Period 2, right after the bridge was closed to traffic, there is a significant drop in the hit rate for the majority of the channels. However, channels 1, 8, and 12 still continued to detect AE during this time period and closer inspection of the data shows a correlation for potential corrosion in the areas of these sensors. There is then a hit increase for all channels during Period 3 and the high wind loading event. While there is likely to be some AE due to corrosion during Period 3, it is masked by the increase in AE hits due increased wind loading on the bridge. Once the high winds died down in Period 4, again, the majority of the AE channels returned to very little AE activity. It was also during this period that the relative humidity began to increase from around 45% to 70% and then on to 90+% in Period 5 when a new rain event moved through the area. The exceptions at this time were channel 1, which actually began to see a significant increase in AE activity. New activity (minor) was also seen from Channel 6, 10, 11, 12 with medium increases at channels 14 and 15 moving in to Period 5. Typically in corrosion monitoring, it has been observed that corrosion will not typically activate until relative humidity levels reach at least 55% and above. Thus looking at the transition from Period 4 into Period 5, observation in the change of AE activity (minor, medium, major) is may be indicative of areas that are potentially susceptible to corrosion. Based on this transition the following changes and classifications of each channel are given as Channel 1 (major), 6 (medium), 10 (minor), 11 (minor), 12 (medium), 14 (major) and 15 (medium).

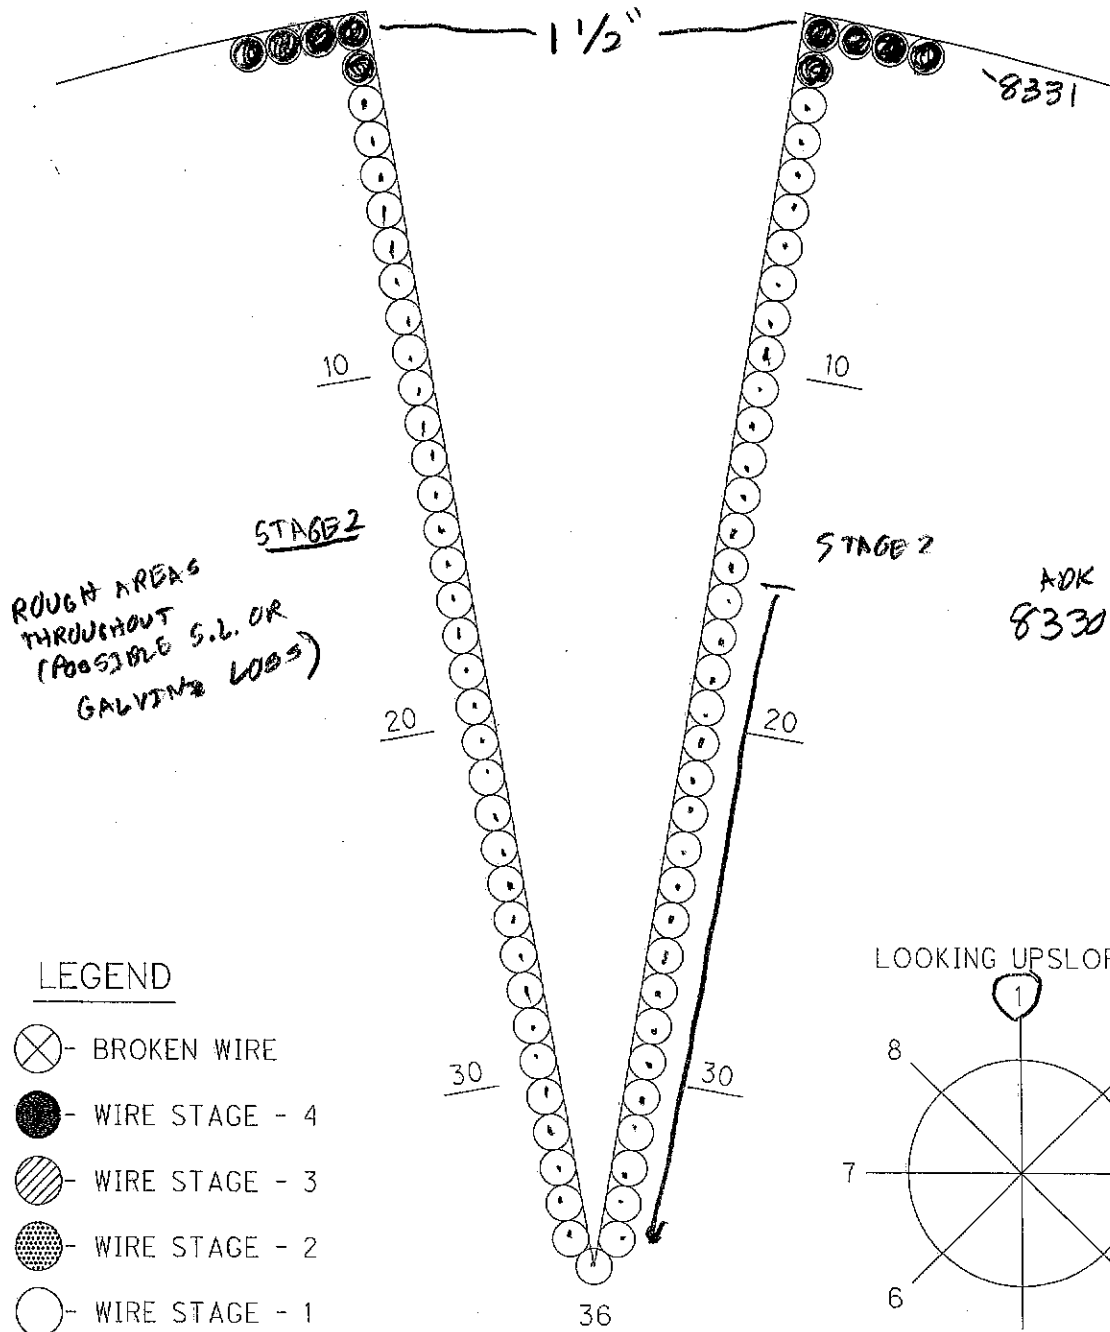
PANEL 3-4

DEPTH OF CABLE INSPECTED 6 3/4"

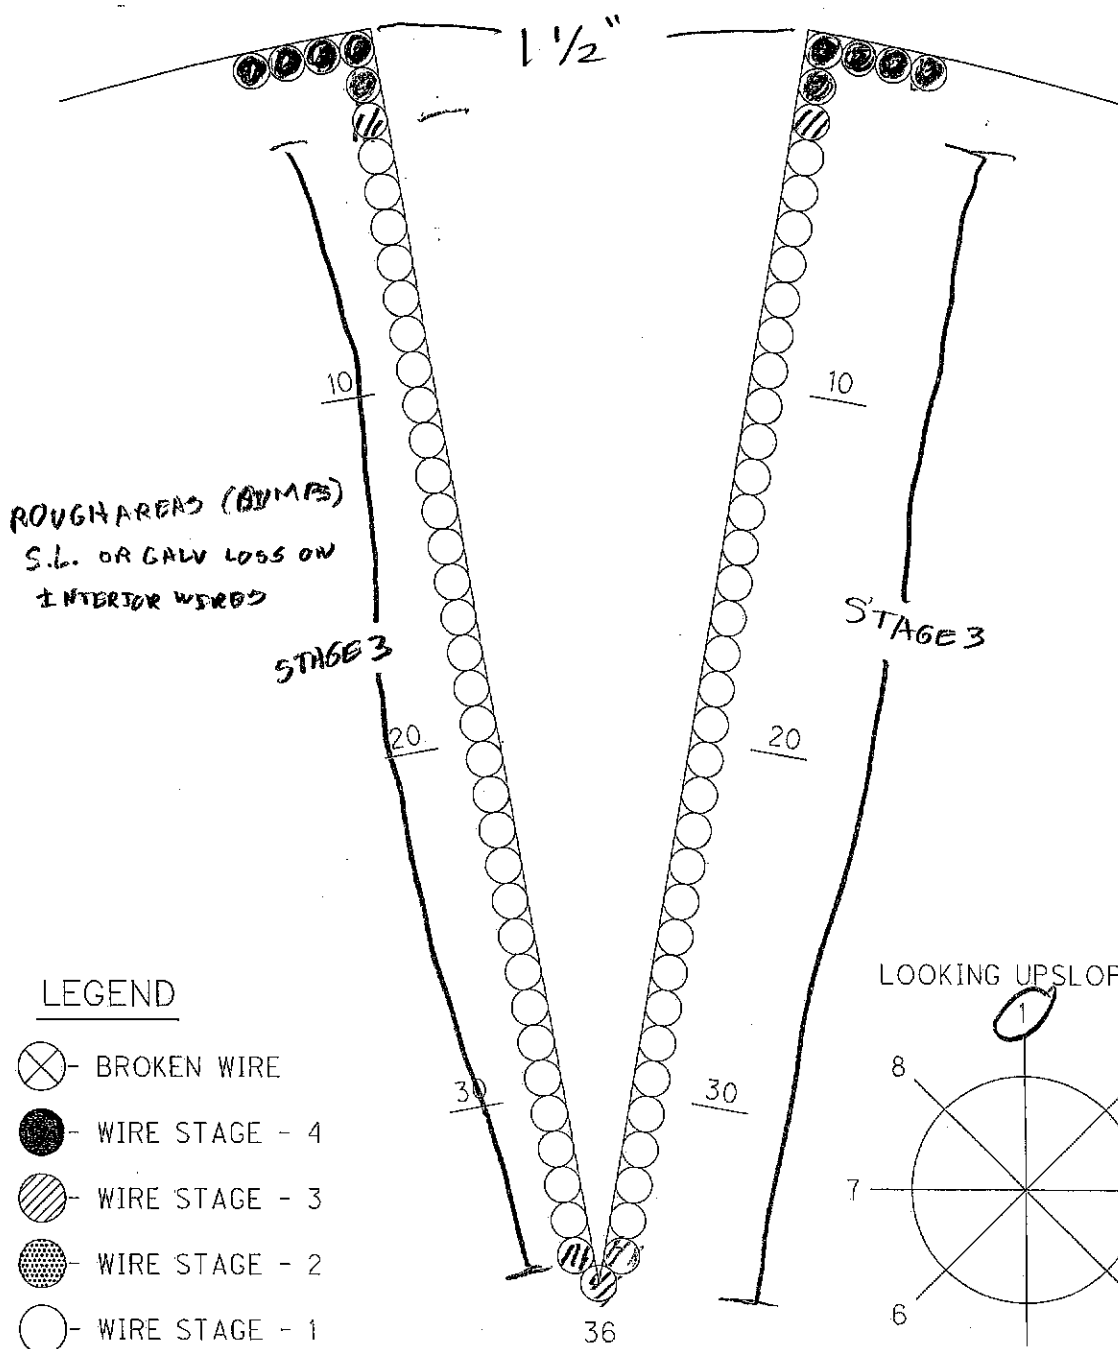
PANEL 3-4PP

DEPTH OF CABLE INSPECTED 6 5/8"

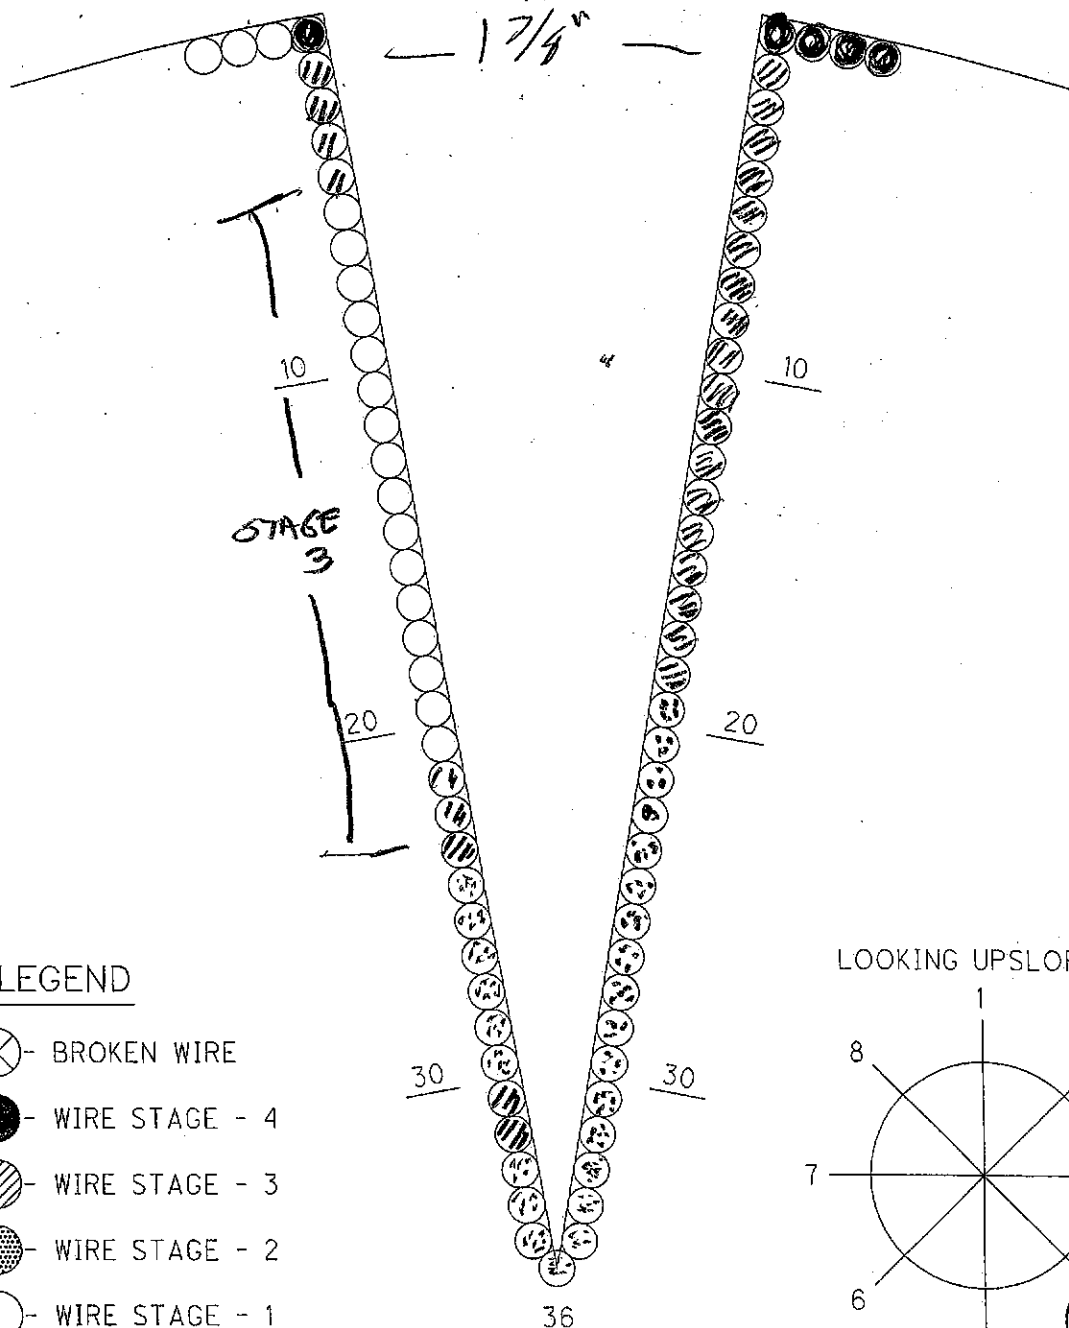
PANEL 65 B

DEPTH OF CABLE INSPECTED: 7"

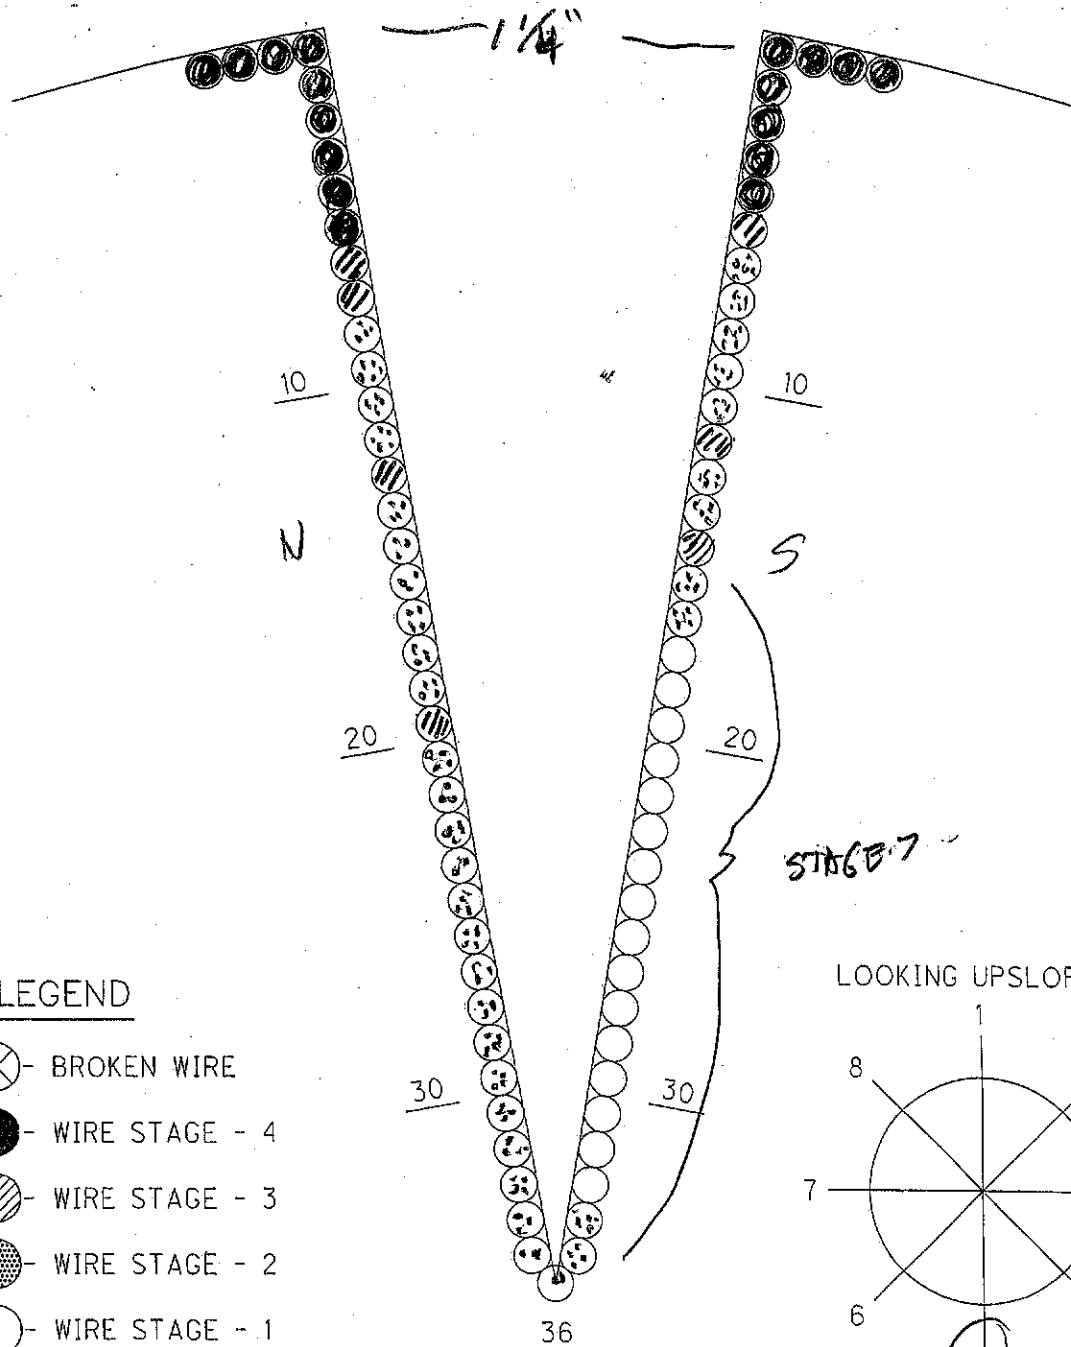
PANEL 65 EAST

DEPTH OF CABLE INSPECTED: 7 1/4"

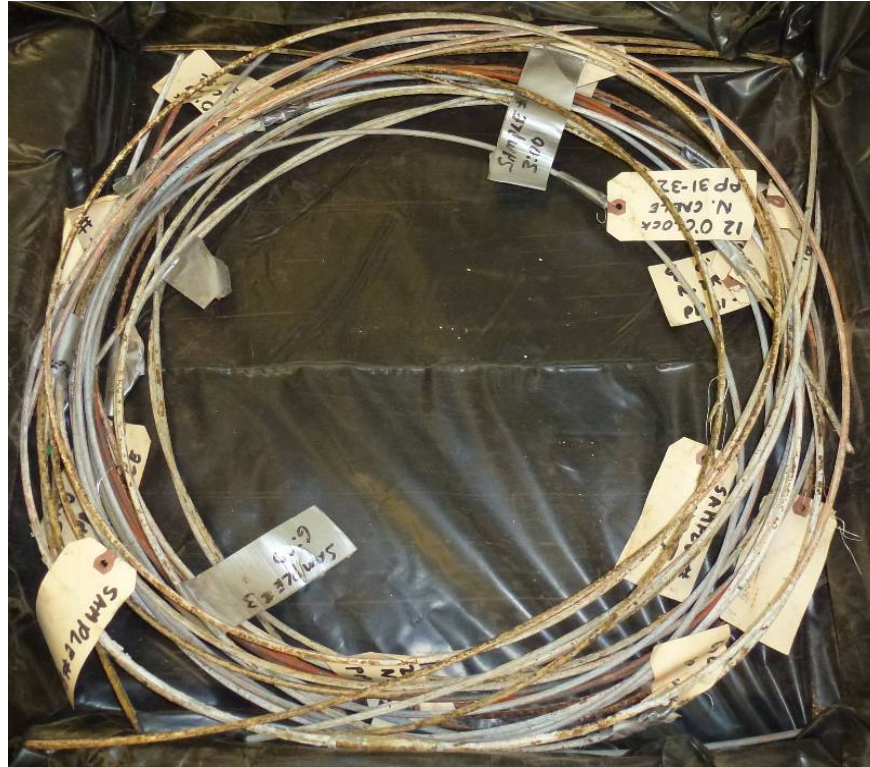
Fig. 2 Main cable wire samples in the as received condition.

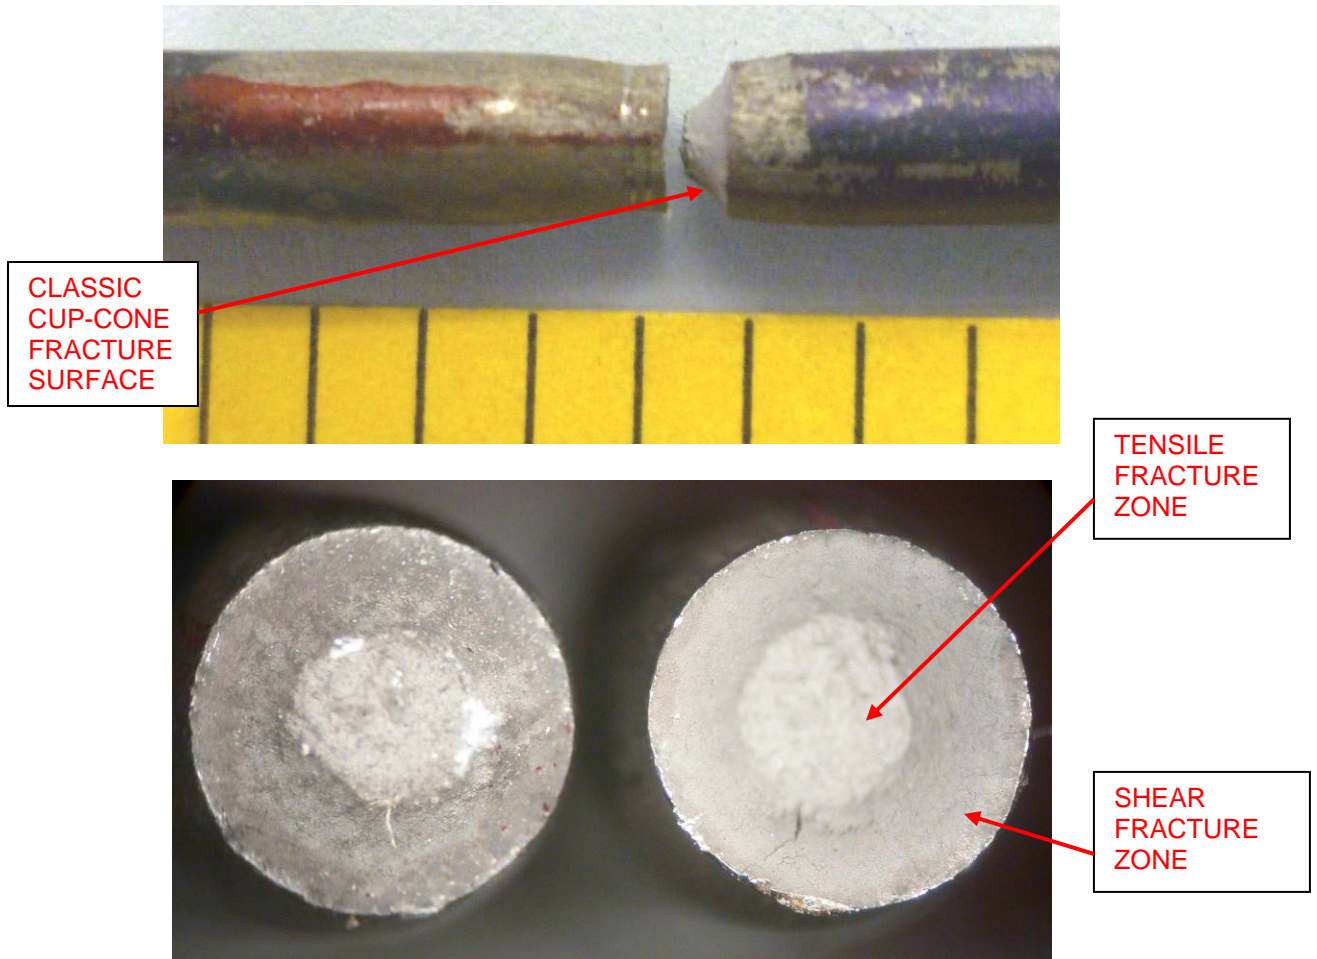
Fig. 12 Sample of classic cup-cone fracture surface with corrosion Stage 1.

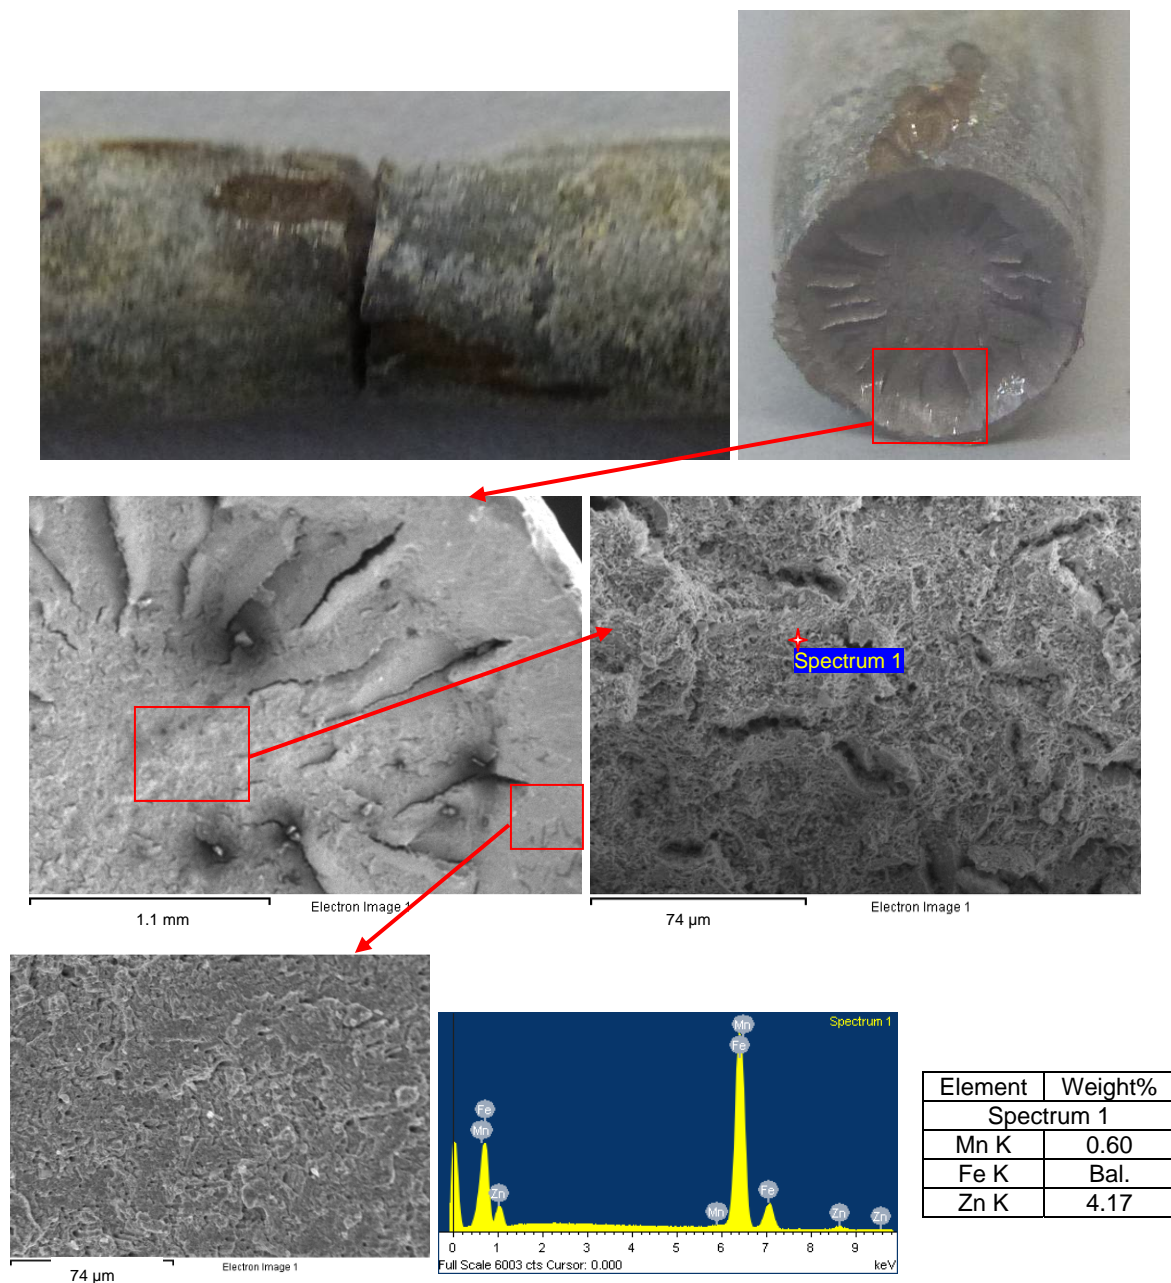
Fig. 97 Scanning electron micrograph and EDS analysis of wire 1-2 fracture surface. Zinc in fine particulate form settled on the fracture surface after spalling from the outer surface during testing.
