**THE ANTHONY WAYNE BRIDGE**

Over the Maumee River

**2013 CABLE STRENGTH EVALUATION  
REPORT**

**MODJESKI AND MASTERS, INC.**  
**CONSULTING ENGINEERS**  
**MECHANICSBURG, PENNSYLVANIA**

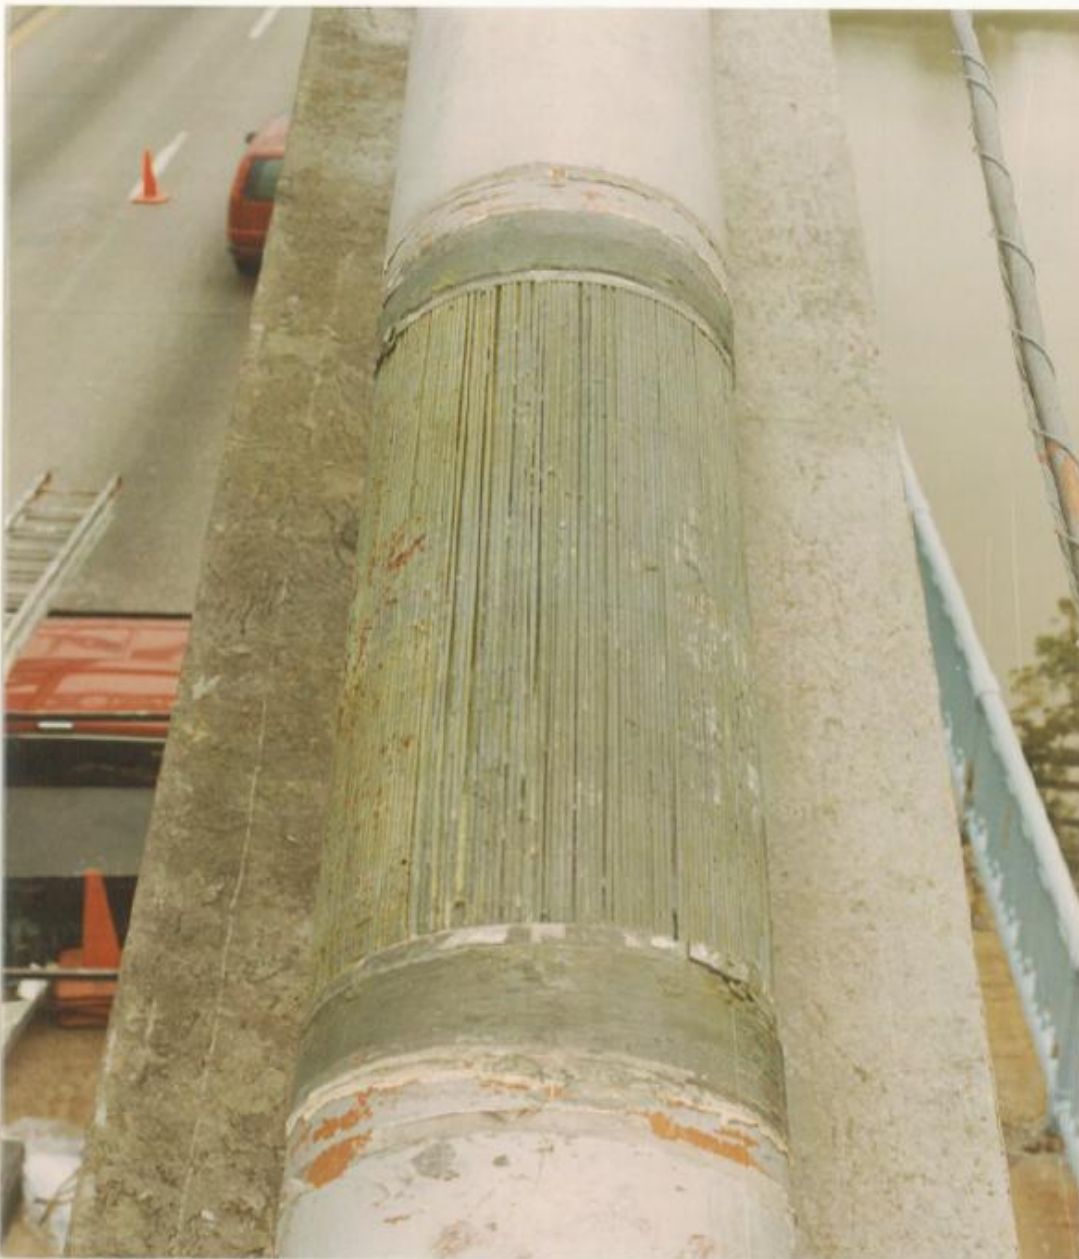
**Figure 3.1 – Cable Site D From the 1993 Inspection**

of the cable inspection and expressed a desire to open locations that contained inspection windows from previous inspections. In 1978, the wire wrapping on the cable was removed for a distance 24 in. to 36 in. at two locations on each cable in order to investigate the condition of the wires. These windows exposed the surface wires and allowed wedging to inspect the first four to five layers of the cable. The windows were reopened in 1981, 1989 and 1993. Based on the 1993 report, Field Inspection of the Suspension Components of the Anthony Wayne Bridge, prepared by Modjeski and Masters, Inc. as Subconsultants for Burgess and Niple, Limited the four windows were identified as Cable Site A, Cable Site B, Cable Site C and Cable Site D. Cable Site A was located on the north cable, east of Panel Point 65, near the low point of the side span and Cable Site B was located on the north cable between Panel Points 39 and 40, part way up the east main span. Cable Site C was located on the south cable between Panel Points 25 and 26, a short distance up the west main span and Cable Site D was located on the south cable between Panel Points 3 and 4, a short distance up the west side span. Figure 3.1 shows a photograph of Cable Site D taken during the 1993 inspection.

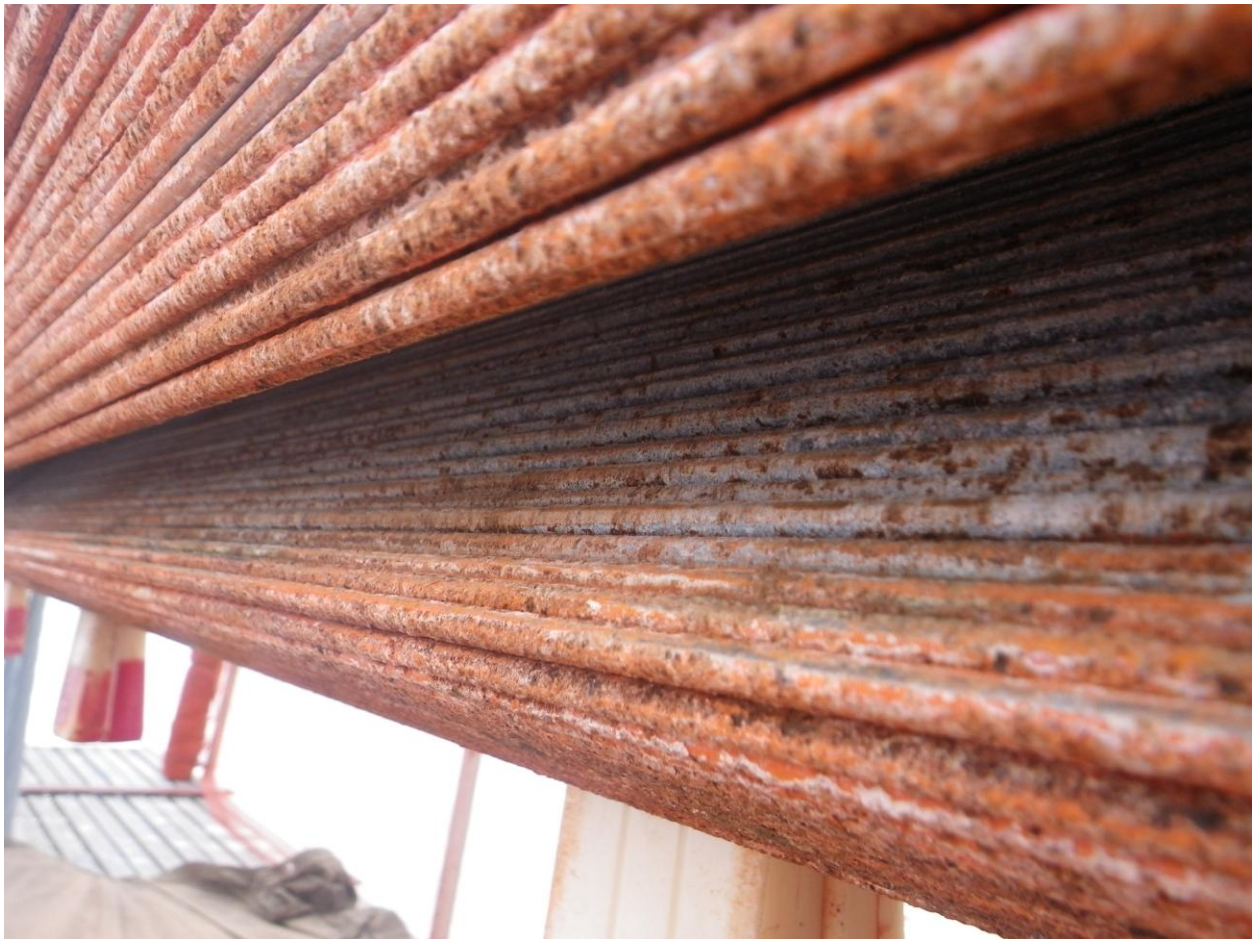
**Figure 4.12- Primary Cable Opening Location PP 3 – PP 4, South**

This was the first panel to be inspected (November 13, 2012). It is located on the south cable three panels up from the cable hold-down on the west side span. The cable was opened at six wedge lines, Locations 1 and 3 through 7. The inspection showed the wires to be in fair condition. The corrosion level is predominantly Stage 3. Stage 4 corrosion was found closer to the perimeter of the cable. No Stage 1 or Stage 2 wires were observed and no broken wires were found. The field notes indicated that some of the Stage 3 wires only had spot corrosion. Three sample wires, two Stage 3 and one Stage 4, were removed from the cable at this location. All sampled wires were repaired. Figure 4.12 shows the condition of the cable along wedge line 6.

Based on the information from the 1993 Field Inspection Report, this cable opening location should have encompassed the previous inspection window Cable Site D. During the cable opening it was determined that Cable Site D was actually located one panel below the opening location, between PP 2 –PP 3 of the south cable.

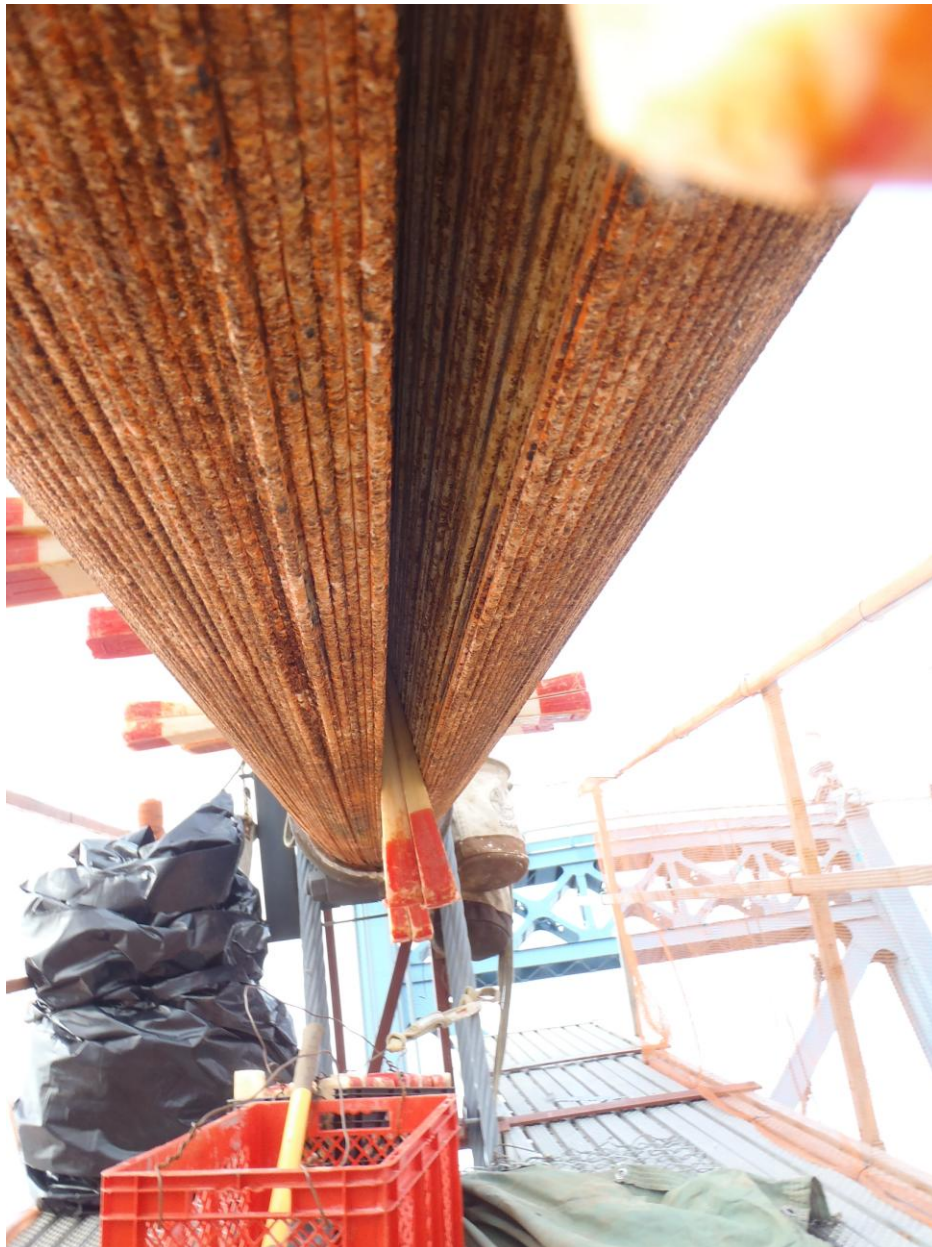
Figure 4.13- Optional Cable Opening Location PP 58 – PP 59, South

This was the second location to be inspected (November 14, 2012). It is located on the south cable approximately mid-way between the east tower and the east hold-down in the side span. Traces of water were observed to be leaking from the wire wrap on the underside of the cable when the existing neoprene wrapping system was removed. The cable was opened at seven of the eight wedge lines. The wires were found to be in poor condition, with a significant number of wires exhibiting Stage 4 corrosion. The remaining wires exhibited Stage 3 corrosion. No Stage 1 or Stage 2 wires were observed at this location. No broken wires were found, and three samples were taken: two Stage 4 and one Stage 3. All sampled wires were repaired. Figure 4.13 shows the condition of the cable along the bottom wedge line.

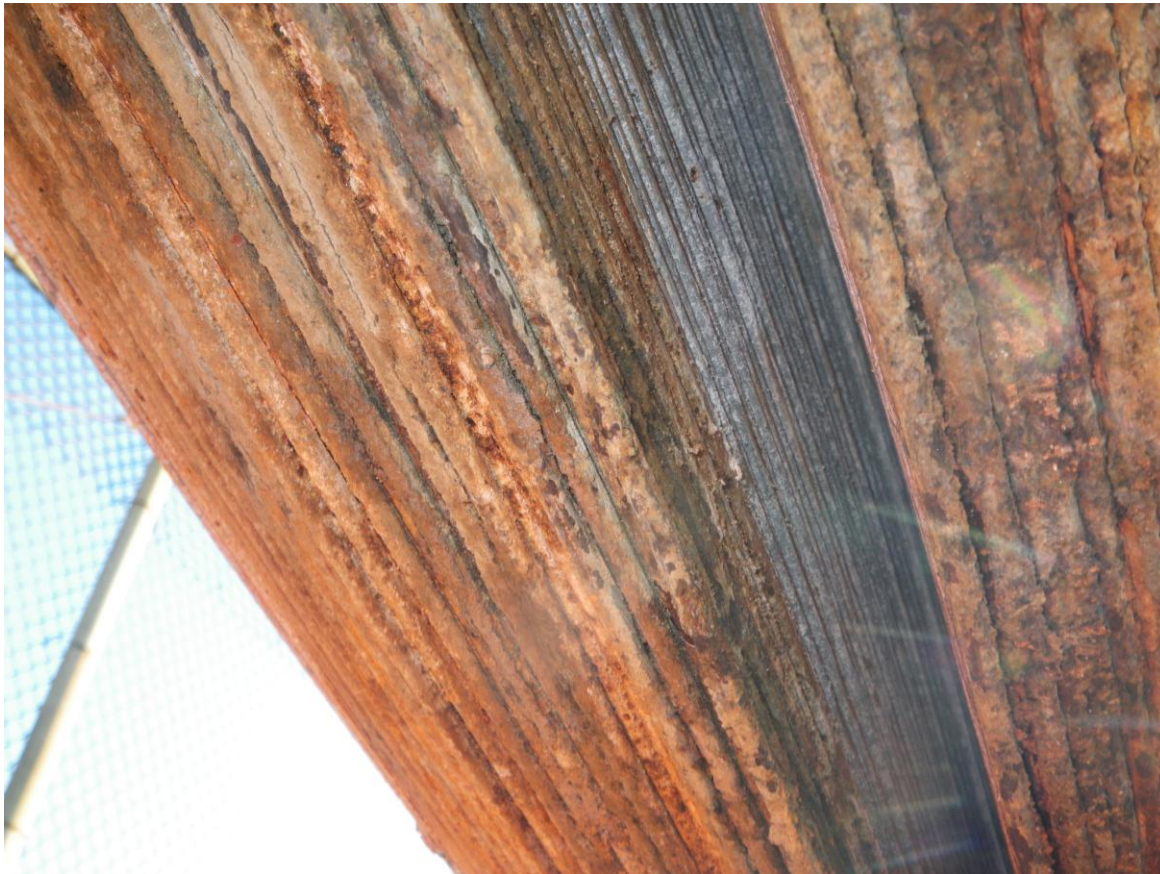
**Figure 4.14- Primary Cable Opening Location East 65, North**

This was the third panel to be inspected (November 15, 2012). It is located on the north cable in the east side span between the hold-down and the cable hood where the cable passes through the sidewalk. The cable was opened at six wedge lines. As previously mentioned, the cable was unwrapped and opened over an approximate length of 20 ft. between the cable-hold down at PP 65 and the cable sidewalk hood. The wires were found to be in better condition than the previous two locations, with roughly one-half of the wires being Stage 3. The number of Stage 4 wires was approximately one-third of the total wires and they were primarily confined to the outer layers of the cable. Three Stage 4 wire samples were removed from this location and all sampled wires were repaired. No broken wires were observed during the inspection. Figure 4.14 shows the condition of the cable along wedge line 5.

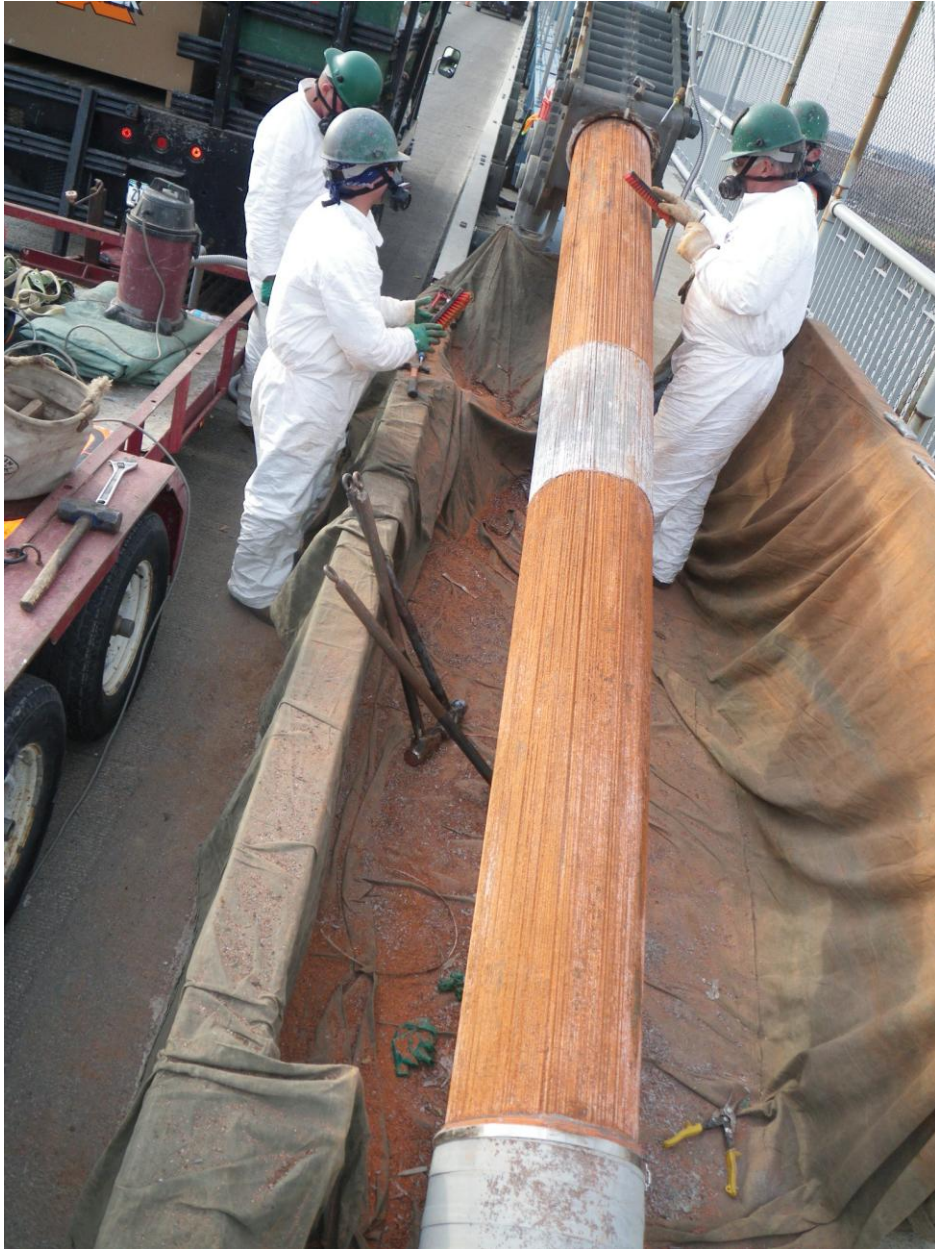
**Figure 4.15 – Cable Window from Previous Inspections**

Based on the information in the 1993 Field Inspection Report, this location was supposed to encompass Cable Site A from the previous cable inspection windows. The 1993 report indicated that after the inspection was complete, the wires were cleaned and coated with liquid zinc. The report also noted that a galvanized metal sleeve was installed over the wrapping at Window A to discourage vandalism. The daily inspection report, prepared by ARCADIS on November 15, 2012, mentions the contractor removing sheet metal from around the cable. Figure 4.15 shows a photograph of the unwrapped cable at Primary Cable Opening Location East 65, North where remnants of the liquid zinc applied to the cable window in 1993 can be seen.

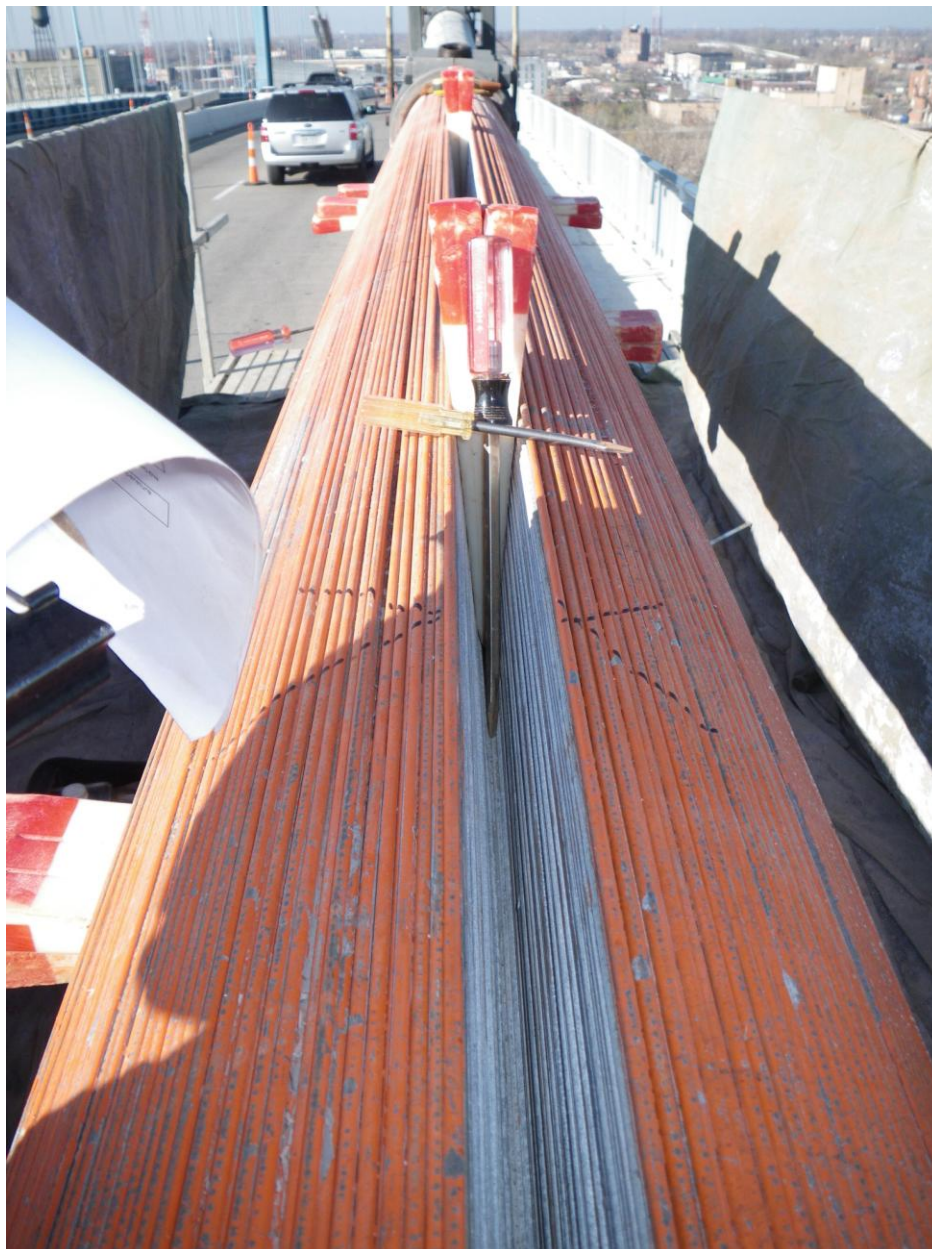
**Figure 4.16- Optional Cable Opening Location PP 31 – PP 32, North**

This was the fourth and last panel to be inspected (November 16, 2012). The cable was opened along six wedge lines. Even though this panel is located adjacent to the low point of the main span, it was by far in the best condition of all the locations that were inspected. Approximately two-thirds of the wires were Stage 2 with less than 10% of the wires observed at Stage 4. This was the only location where Stage 1 wires were observed at approximately 1% of the total. Four sample wires, one Stage 1, two Stage 2 and one Stage 3, were removed from this location. No broken wires were found at this location and all of the sampled wires were repaired. Figure 4.16 shows the condition of the cable along wedge line 1.

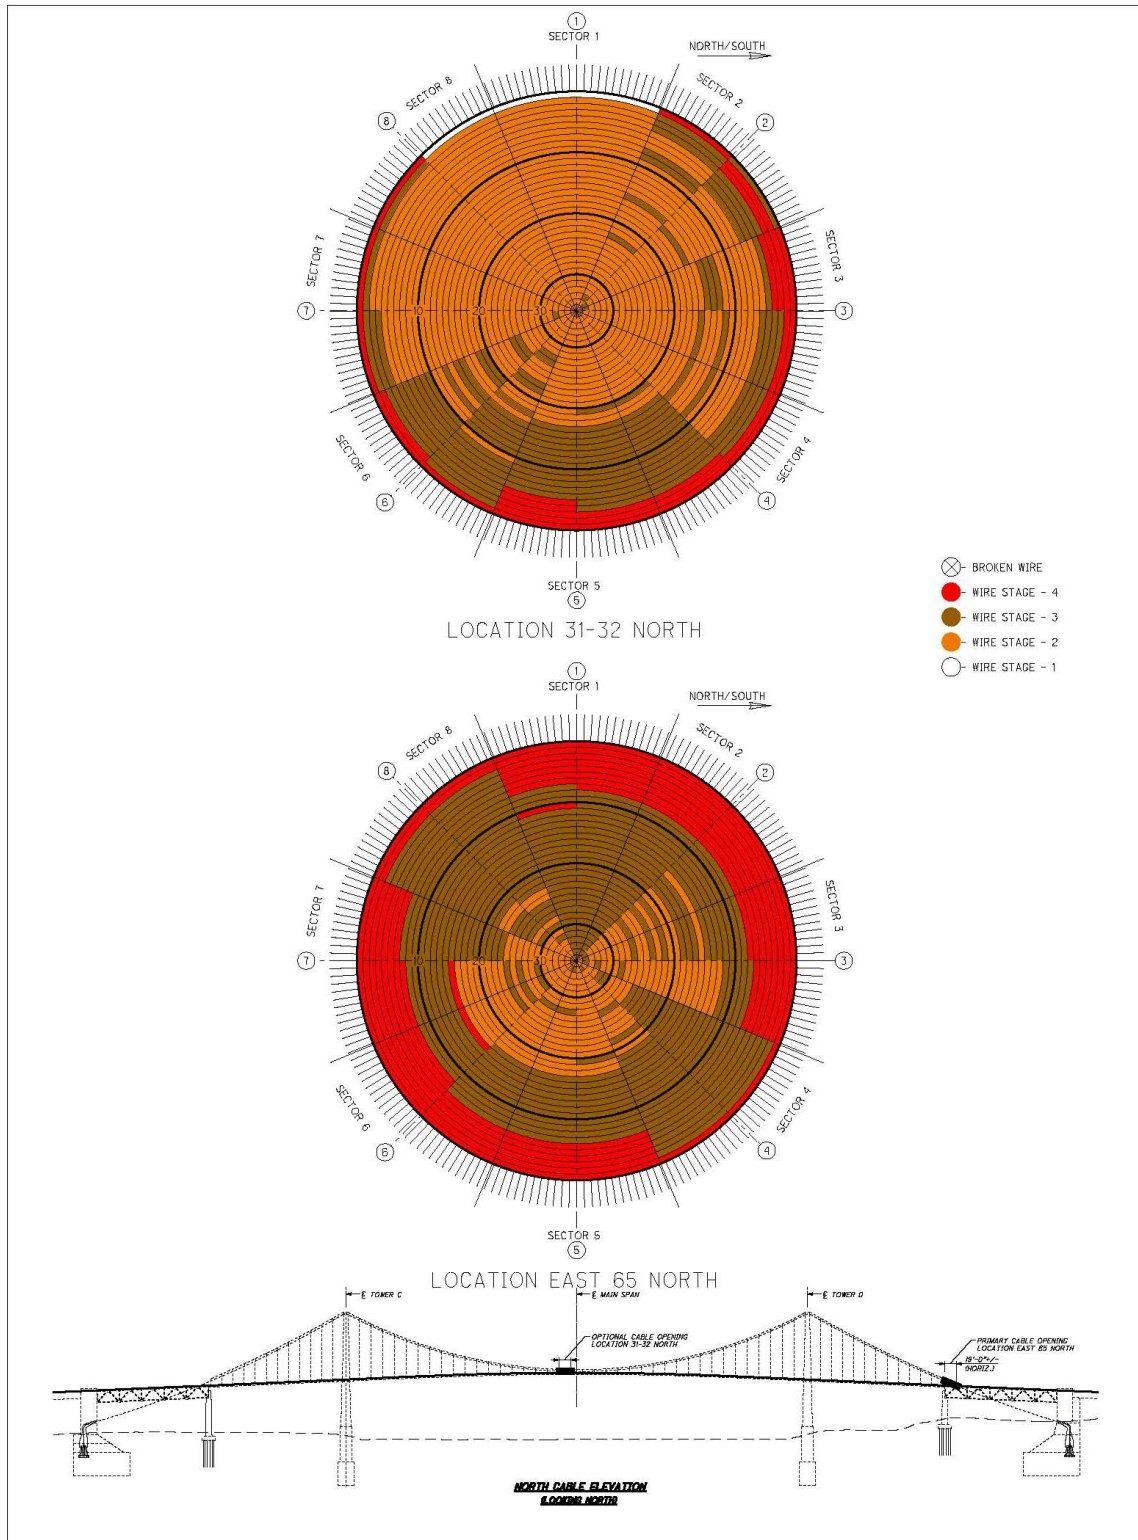
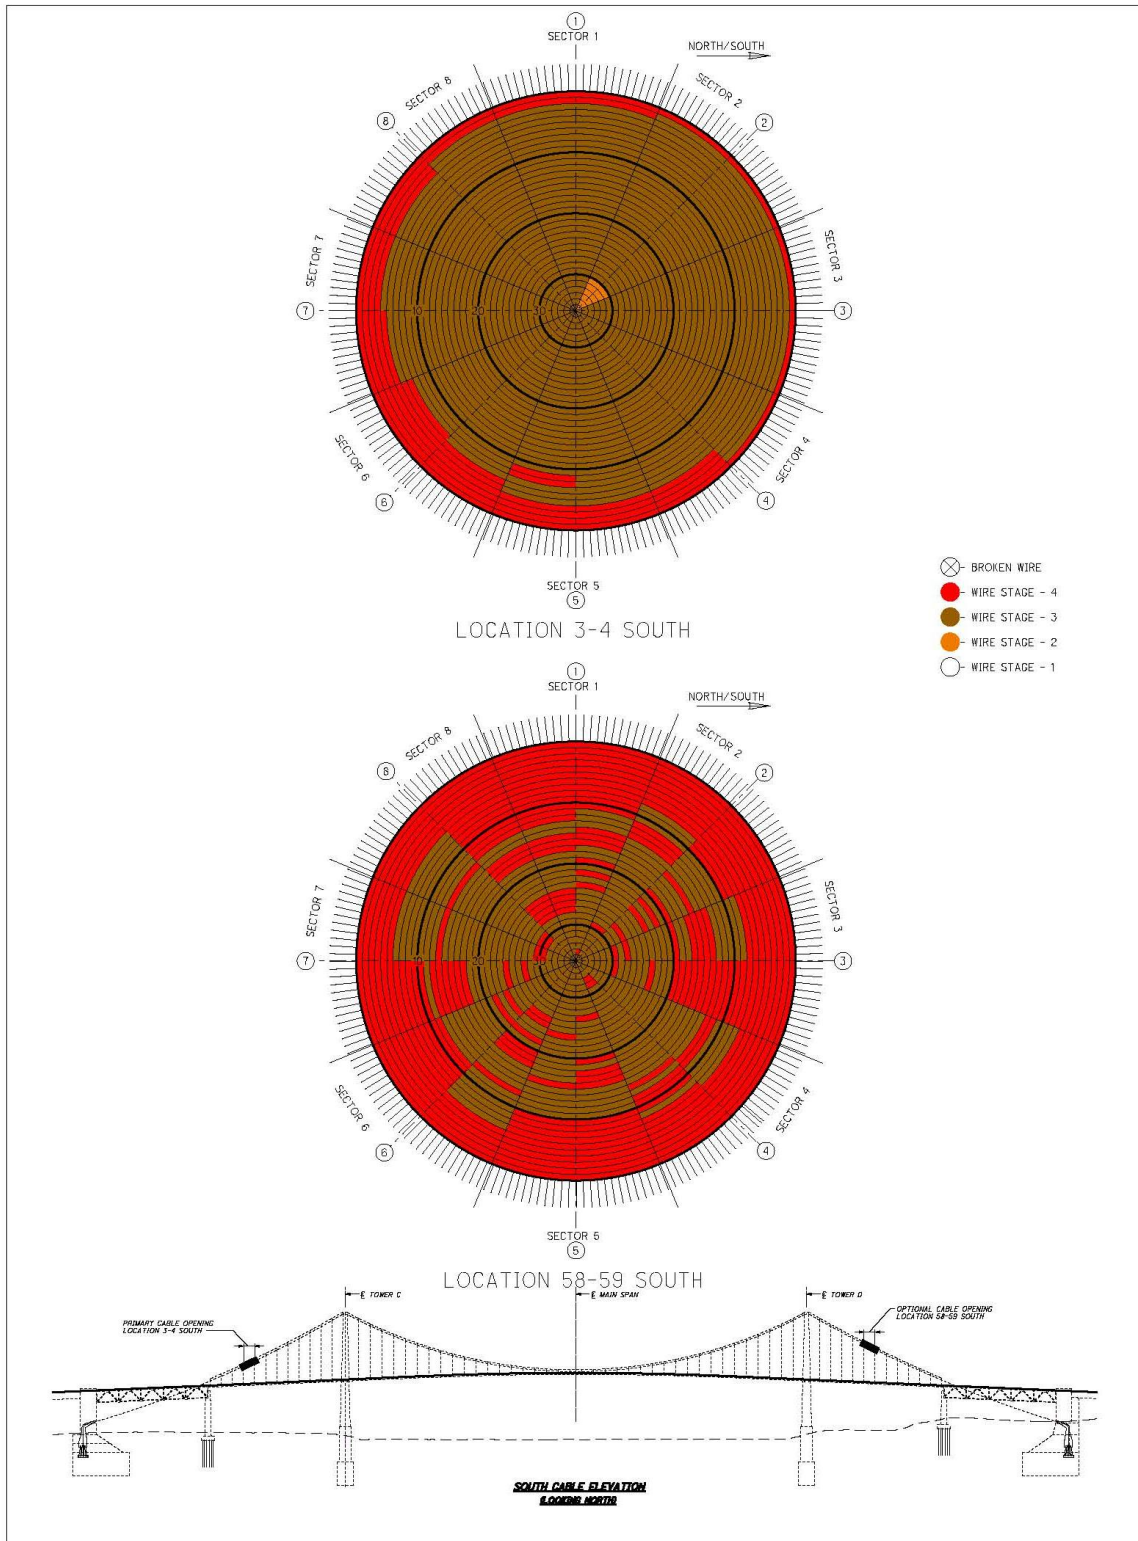
Figures 4.18 and 4.19 graphically summarize the condition of the wires for the north and south cable, respectively. Overall, the cable is in fair to poor condition at most locations. Typically, over 80% of the total wires at a given location are Stage 3 or 4, with no Stage 1 wires observed. There is, however, substantial variation in condition from one location to another. At the Optional Cable Opening Location PP 31 – PP 32, less than 10% of the wires were Stage 4 and the majority of the observed wires were Stage 2. However, this location had very few observed Stage 1 wires. No broken wires were observed at any of the locations, which is encouraging. Report 534 indicates that Stage 4 corrosion is usually accompanied by cracked and broken wires. The tensile testing revealed two Stage 4 wires with preexisting corrosion cracks. It is important to note that Report 534 recommends that a minimum of three locations along each cable be inspected during the first internal inspection. The minimum number of inspection locations is intended to increase the probability of detecting cable deterioration. This inspection did not encompass the minimum recommended number of panels and a cable band was not removed, further decreasing the probability that the worst cable condition was captured. The amount of variation between inspection locations warrants some skepticism with regard to applying the factor of safety determined herein to the entire cable. This is especially true due to the limited length of cable inspected.

**Figure 4.18 – North Cable Wire Condition**

**Figure 4.19 – South Cable Wire Condition**

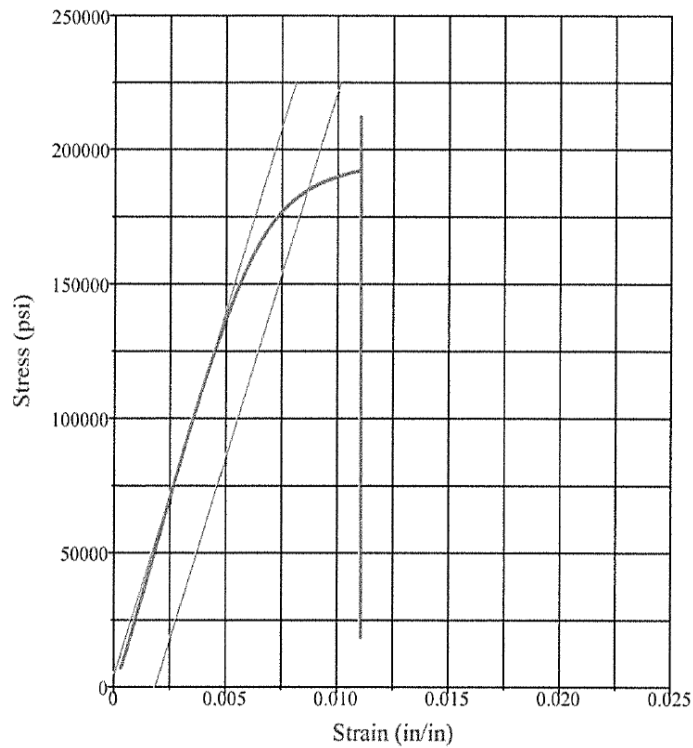
**Figure 5.4– Cracked Wire Stress-Strain Curve**

The tensile tests were also used to determine the number of specimens with pre-existing cracks. Uncracked wires fail in a ductile manner, achieving strains of about 4%. A typical stress-strain curve for an uncracked wire is shown in Figure 5.2. Their failure surface shows a reduction in the wire diameter at the failure location (necking) along with a "cup and cone" failure surface, as shown in Figure 5.3. Wires with cracks were identified by both their sudden failure at relatively low strains and their ragged failure surface, shown in Figure 5.5. Since the stress-strain curves were not generated to failure, the lower strains associated with cracked wires are not apparent in Figure 5.4. The low elongation in a 10-inch length combined with the lower ultimate tensile strength, as displayed in the information adjacent to the graphs, point to the possibility that the wire was cracked.

The presence of a crack was confirmed by microscopic analysis of the fracture surface after testing was complete.
