2020 In-Depth, Element Level Bridge Inspection Report

LUC-2-1862 **In-Depth, Element Level Bridge Inspection Report**

PID: 108045

October 2020

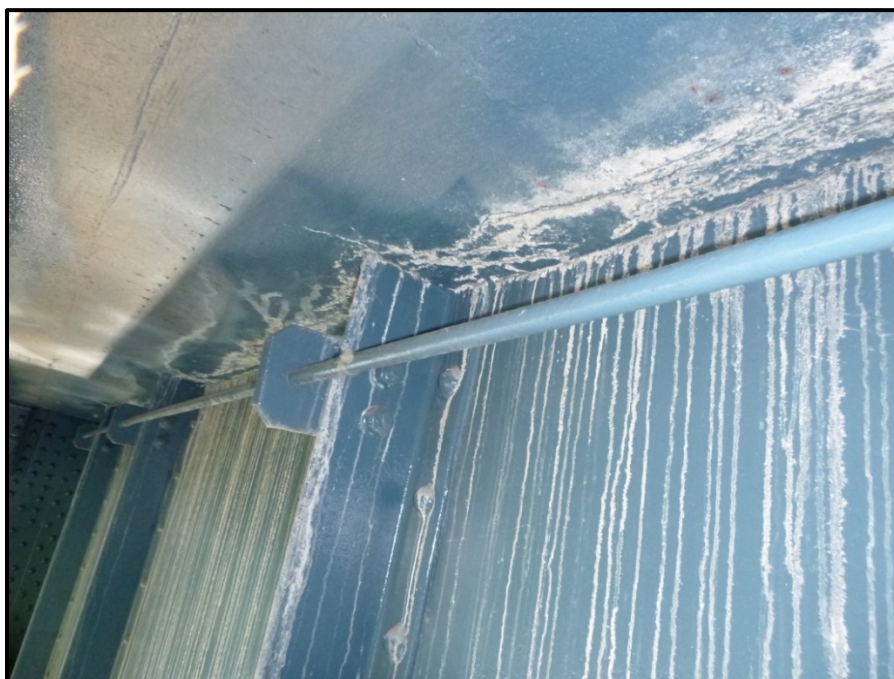
The only notable finding was the excessive efflorescence and longitudinal deck cracking at the underside of deck, at girder/deck edge interface in the suspension spans. The longitudinal deck cracks were quantified as CS3, while areas with efflorescence only were given CS2 status. Shortly after the inspection, samples of the efflorescence were sent to CTL Group to determine their mineral composition. CTL performed an x-ray diffraction test which identified the efflorescence as lithium carbonate. This identification was then verified with an inductive coupled plasma test. Once identified, Gannett Fleming contacted Vector Corrosion Technologies, the group responsible for the installation of the anodes in the deck. Vector was able to identify the source of the lithium, lithium hydroxide, the activator used during installation of the anodes. Vector does not believe the efflorescence will affect the well-being of the concrete deck, anodes, or adjacent steel girders. As for the longitudinal cracking, Gannett Fleming believes it is caused by the moderate differential movement of the deck and girder.

Photo 6 - Longitudinal Cracking & Efflorescence at Edge of Deck Underside (Typical, South Girder in Bay 15 shown)

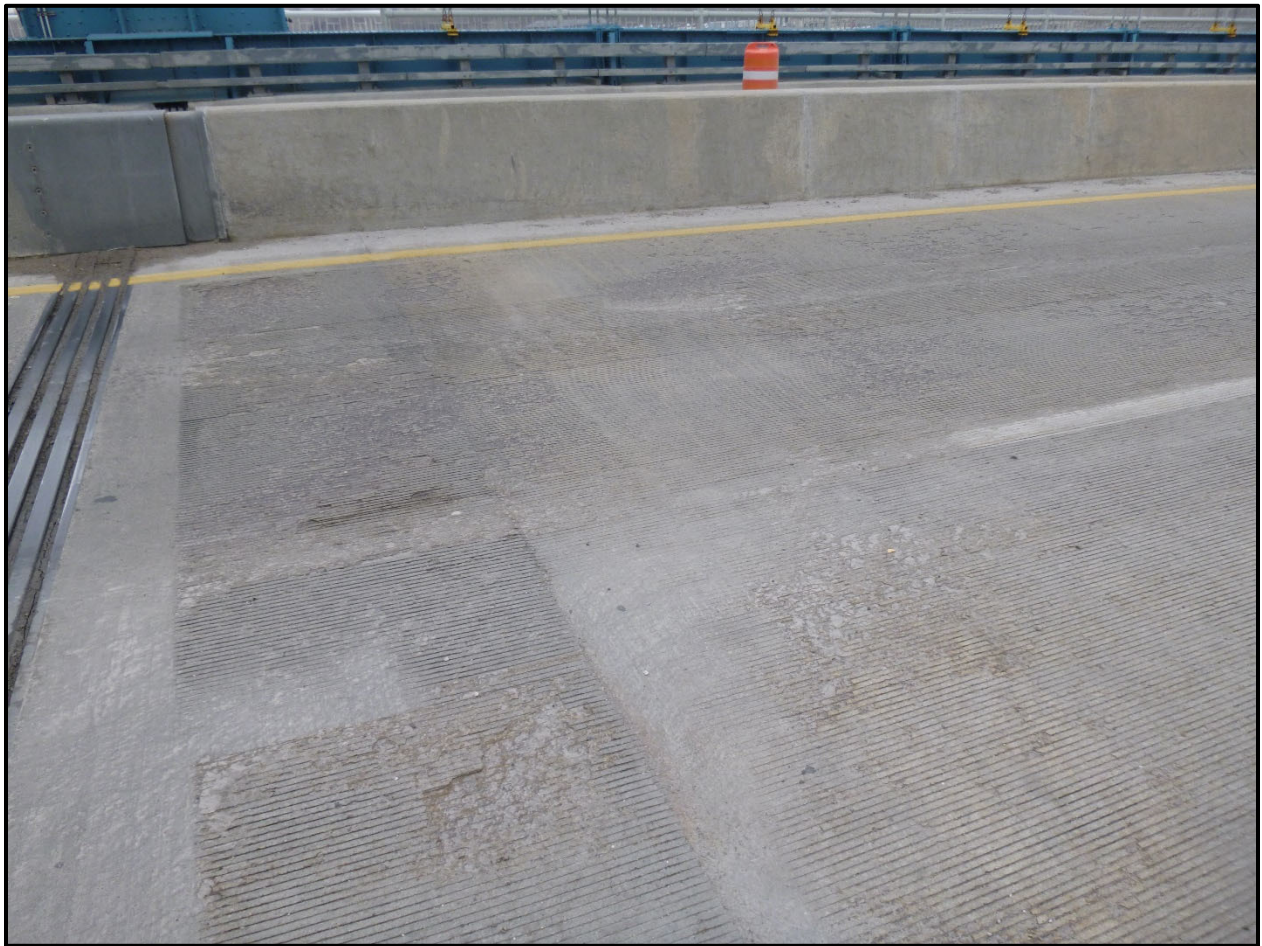
The wearing surface is in good condition with a National Bridge Inventory Rating of 7. Abrasion is present in west bound lanes near both towers and there are minor transverse cracks scattered across the bridge.

Photo 7 - Wearing Surface Abrasion

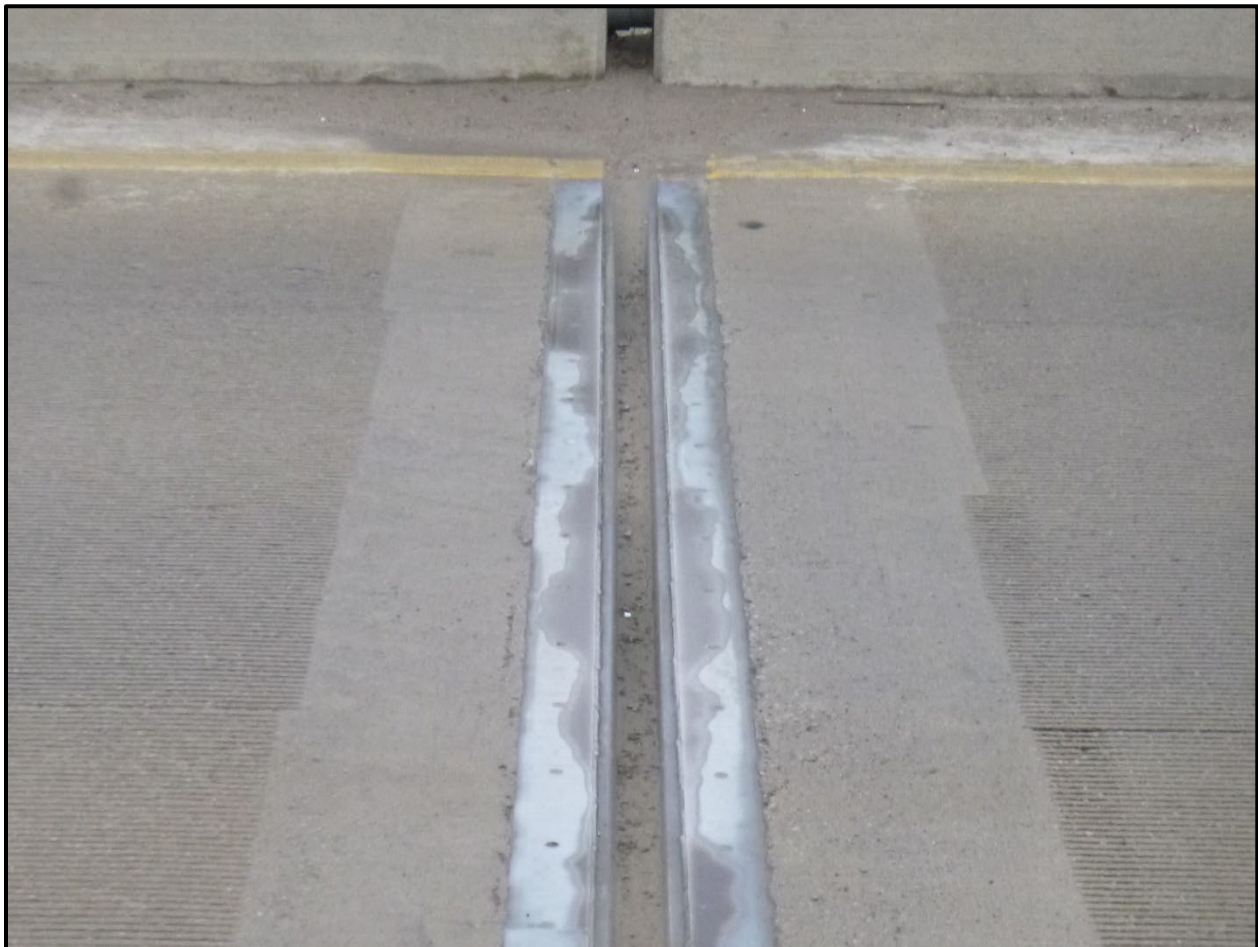
Expansion joints are in good condition with a National Bridge Inventory Rating of 7. There were no signs of leaking observed during the inspection. Modular joints are present at the towers, elastomeric strip seals are in place everywhere else. All joints are full of sediment, but movement doesn't appear to be affected.

Photo 8 - Typical Strip Seal Expansion Joint Condition

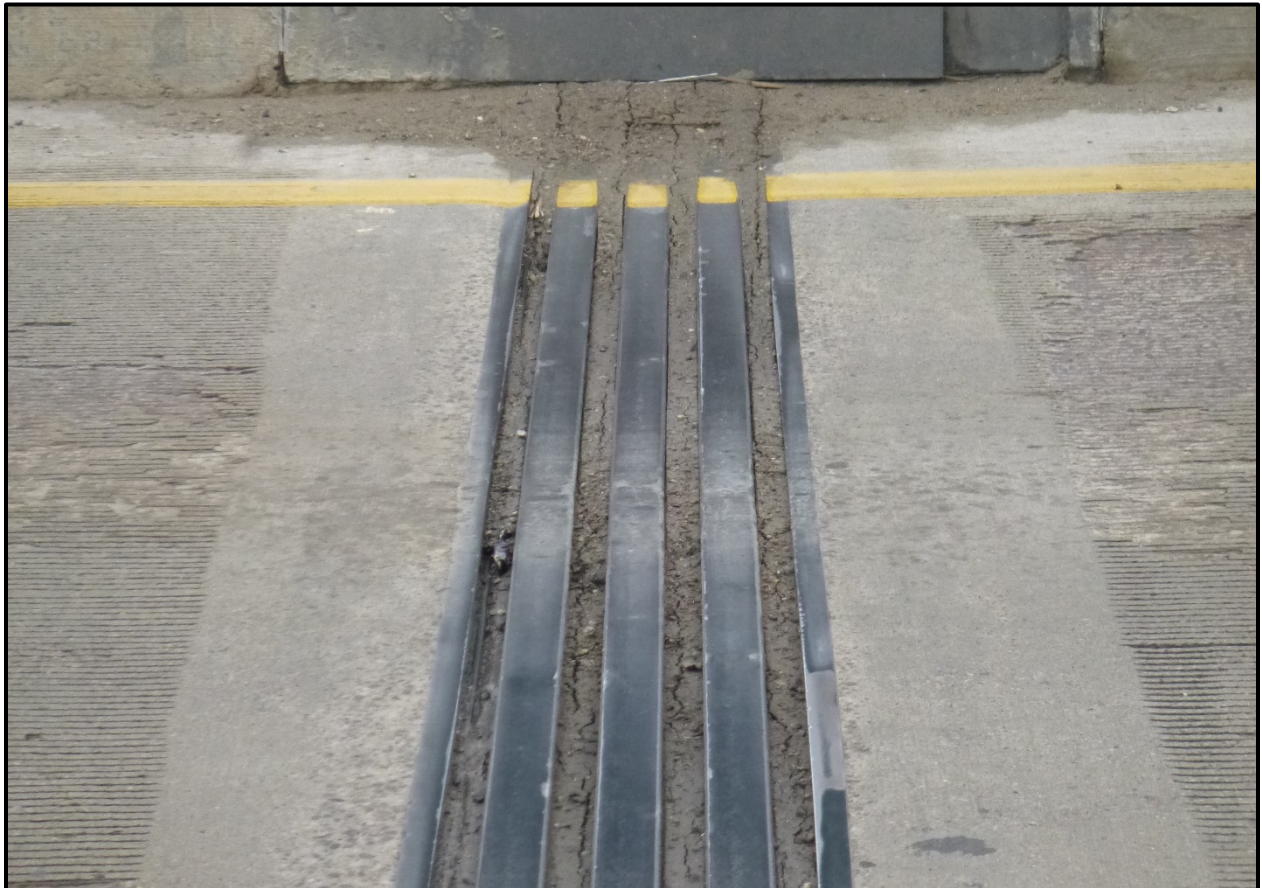
Photo 9 - Typical Modular Expansion Joint Condition

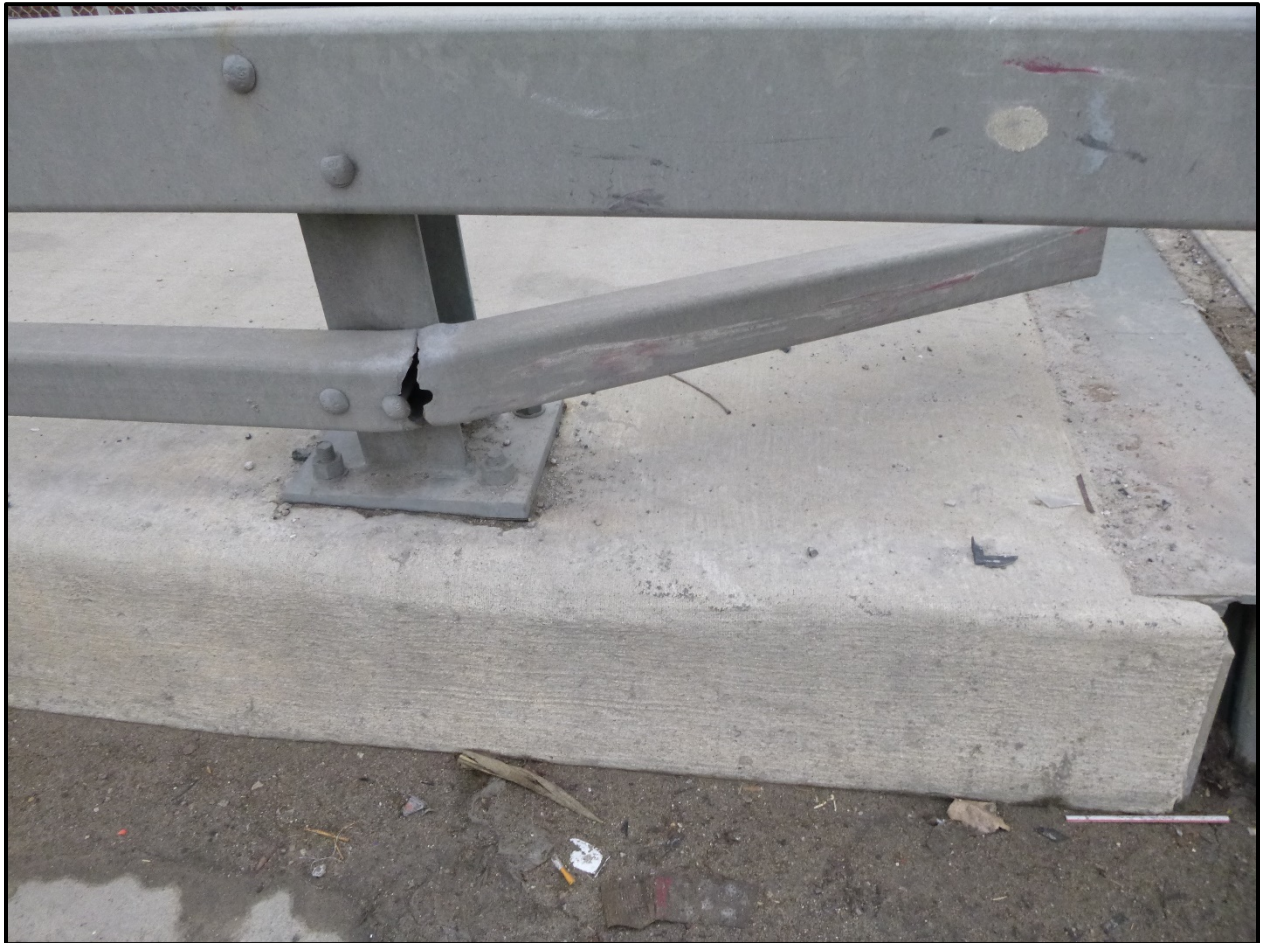
The guardrail that protects sidewalk pedestrians is in good condition. There is a missing bolt in top rail/post connection at northeast corner of bridge, Span 15E. Additionally, there is impact damage to the lower rail at first post on southwest corner of bridge.

Photo 10 – 4 feet of Impact Damage to Guardrail at First Post on Southwest Corner of Bridge

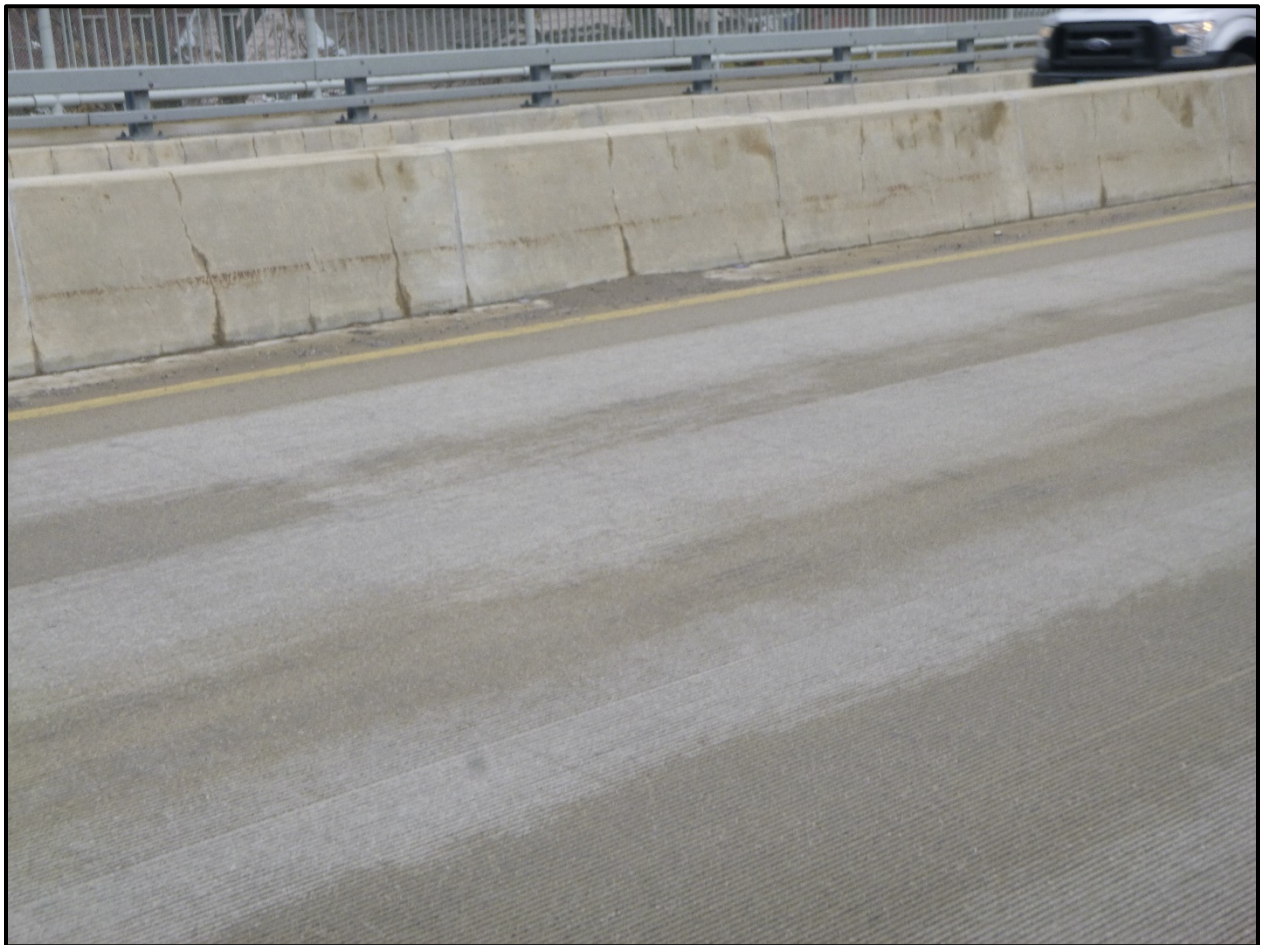
The median parapet exhibits vertical cracking at approximately 3' spacing in the approach spans. Delamination and spalling are present under both light poles that are adjacent to Tower D. It was noted during construction that the light pole anchor bolts were placed in wrong sized pattern, which resulted in the bolts being bent in order to set the poles.

Photo 11 - Typical Vertical Cracks in Median Parapet

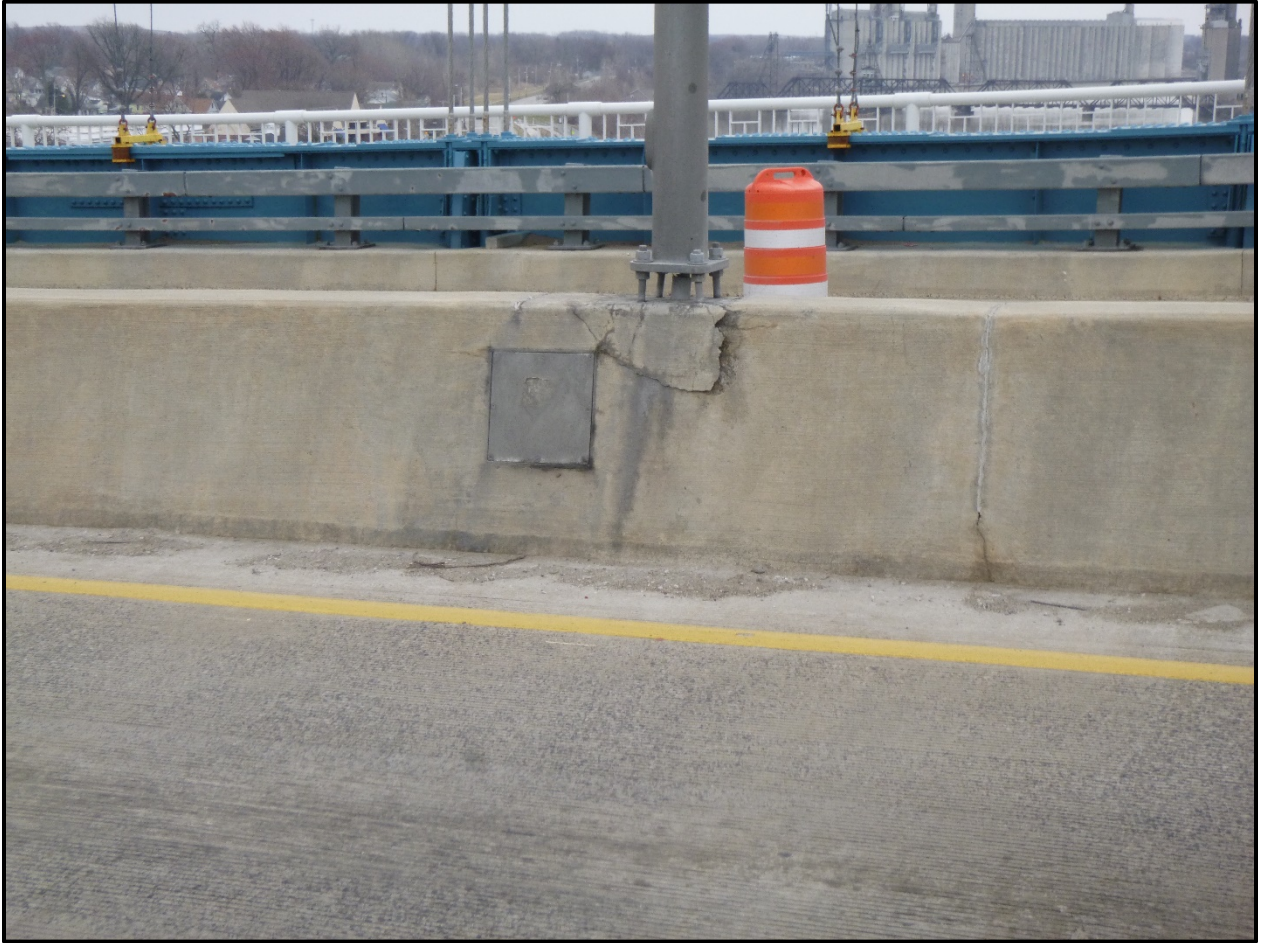
Photo 12 - Delamination and Spalling at Light Pole Adjacent to Tower D

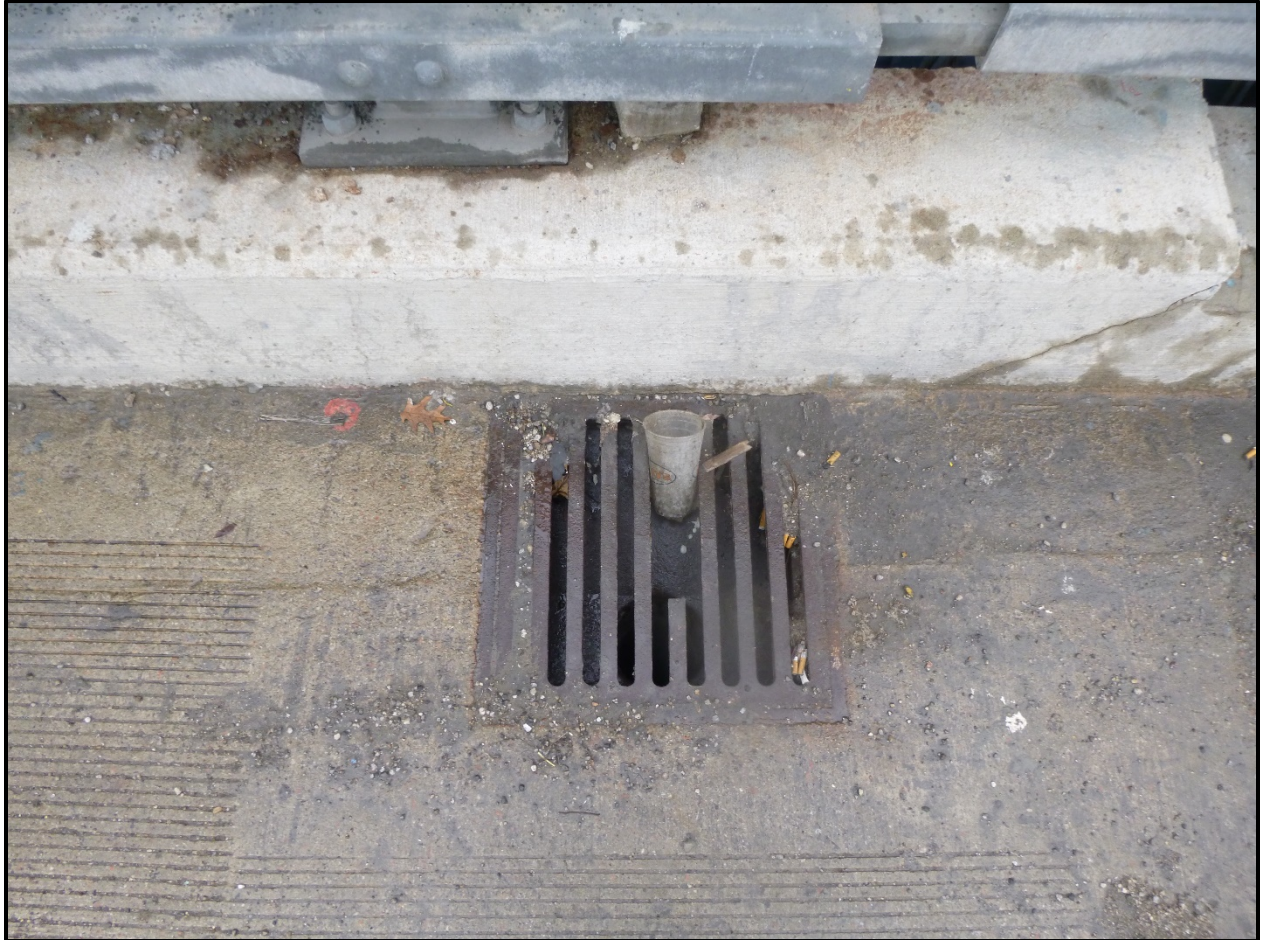
Most of the grates are partially covered in sediment/debris, but all appear to be draining. The grate along the south curb near Pier B is broken.

Photo 13 - Broken Deck Drainage Grate at South Curb near Pier B

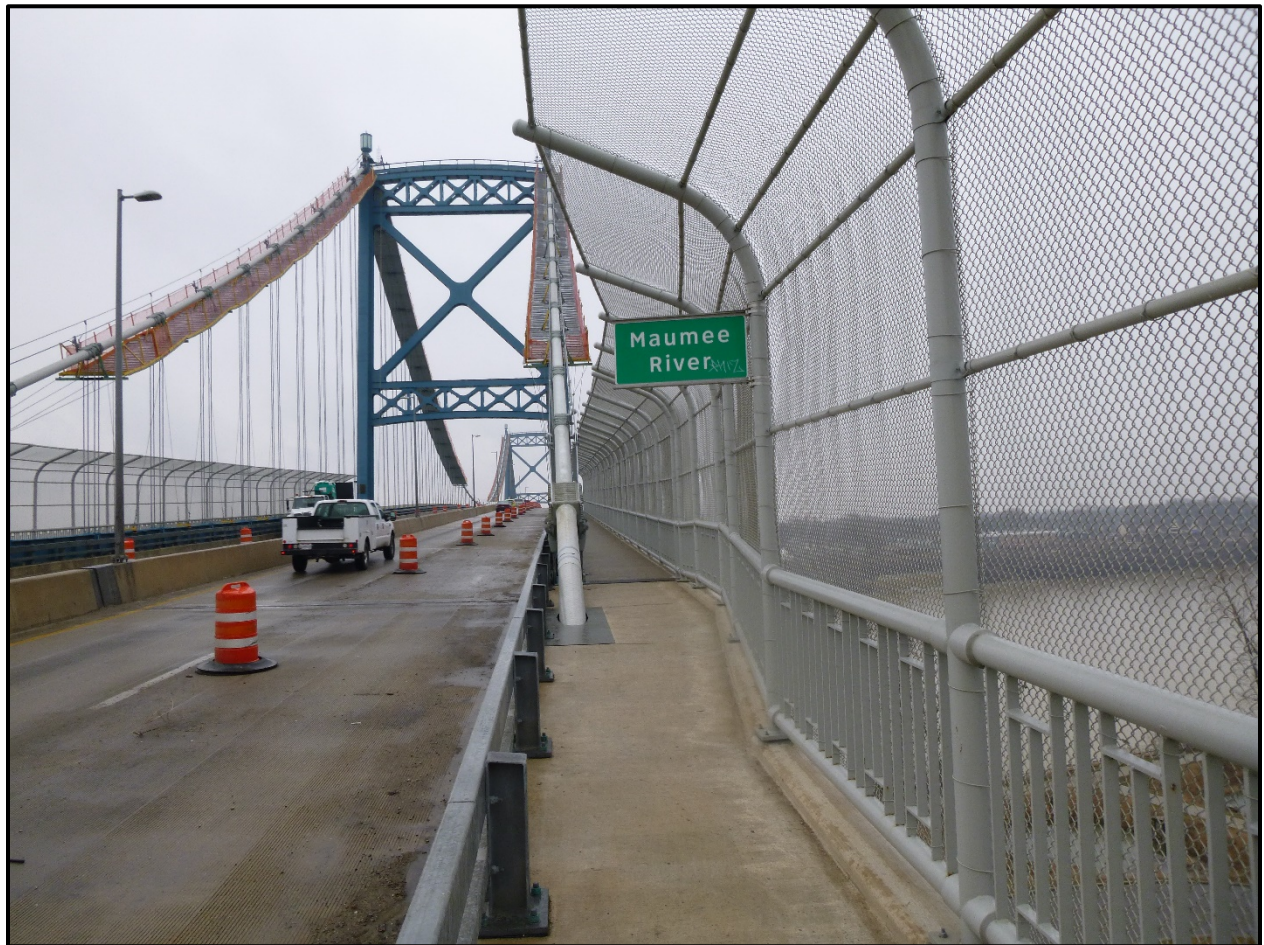
The sidewalk railing is in good condition and shows no significant signs of distress.

Photo 14 - Sidewalk Railing (Typical Condition)

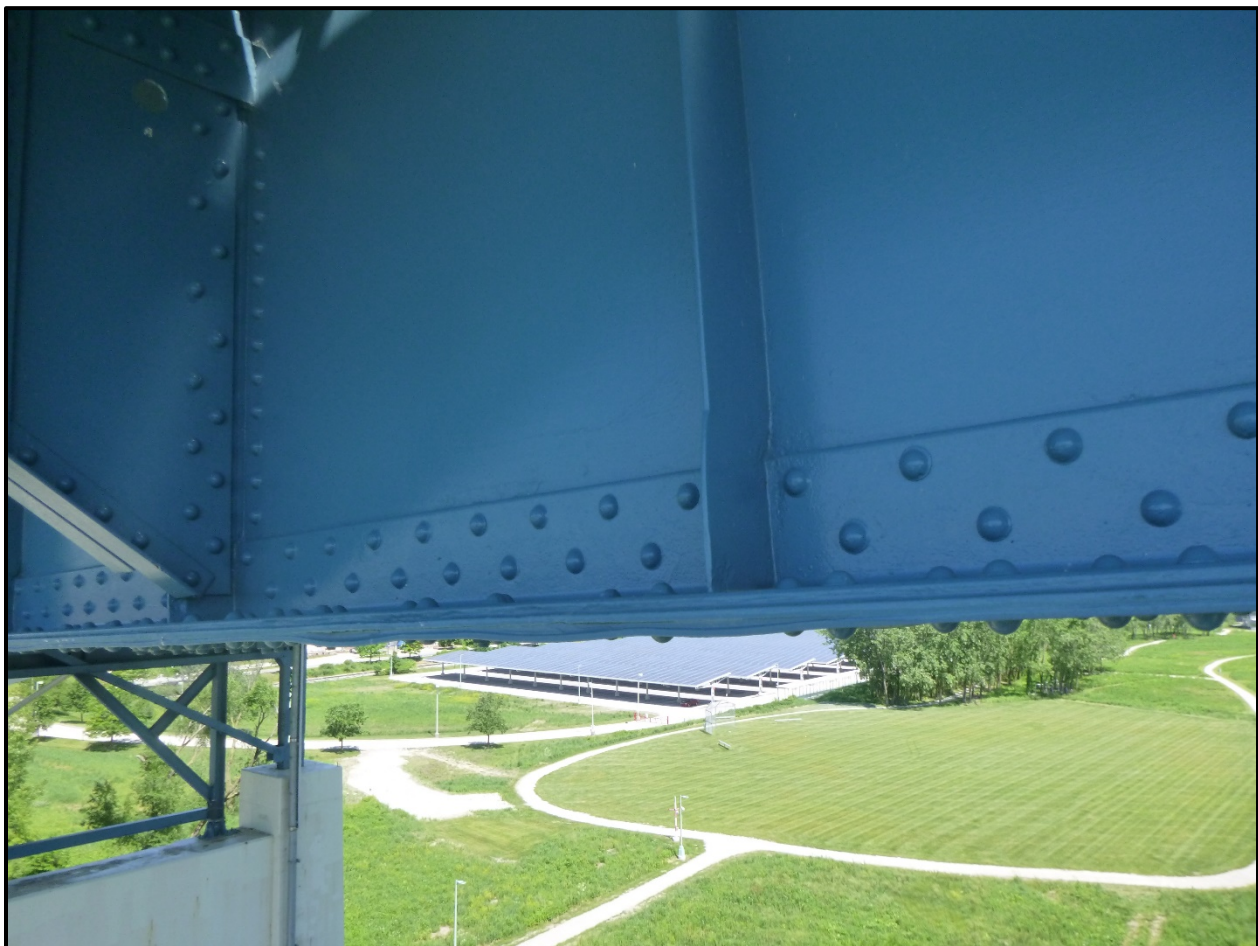
Arrested bottom flange section loss, freckled rusting, and distortion caused by pack rust were typical findings in the approach and suspension spans.

Photo 15 - Typical Pack Rust Induced Distortion of Suspension Span Girder Bottom Flange

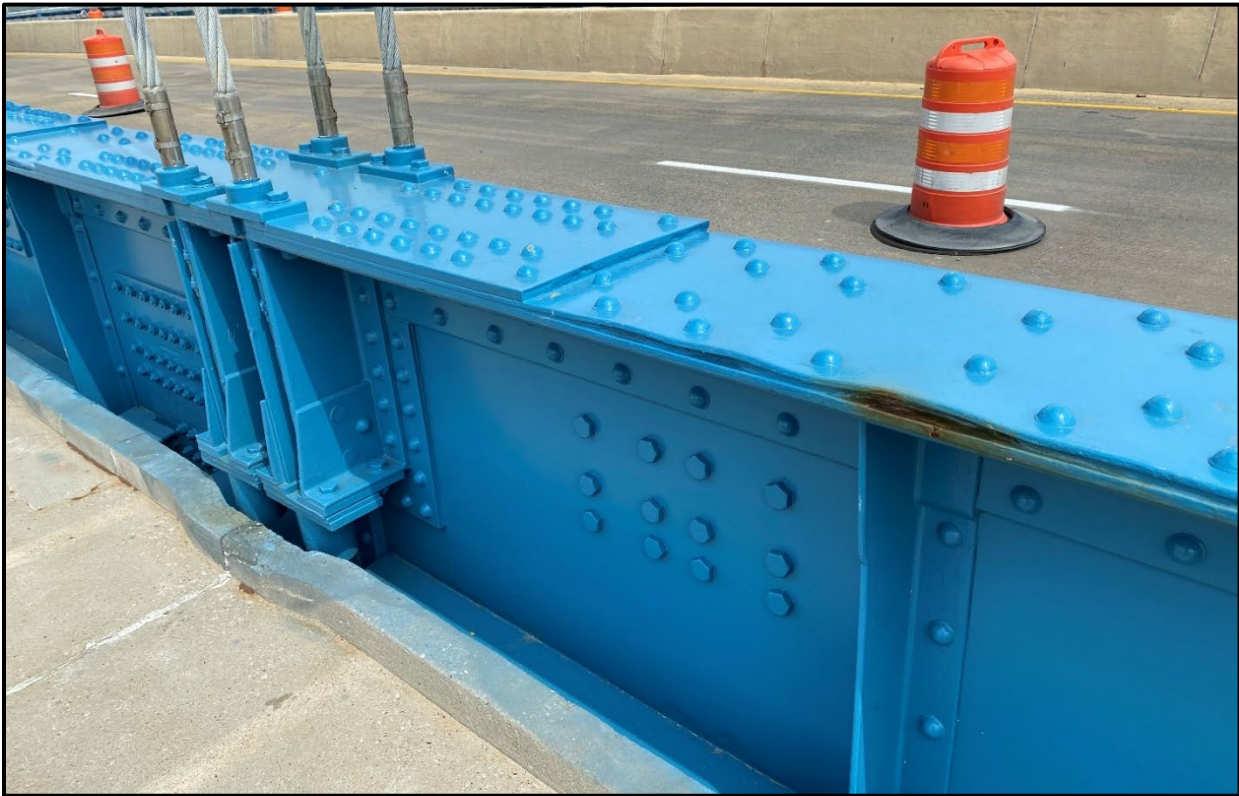
Photo 16 - Typical Condition of Top Flange/Web of Suspension Girders

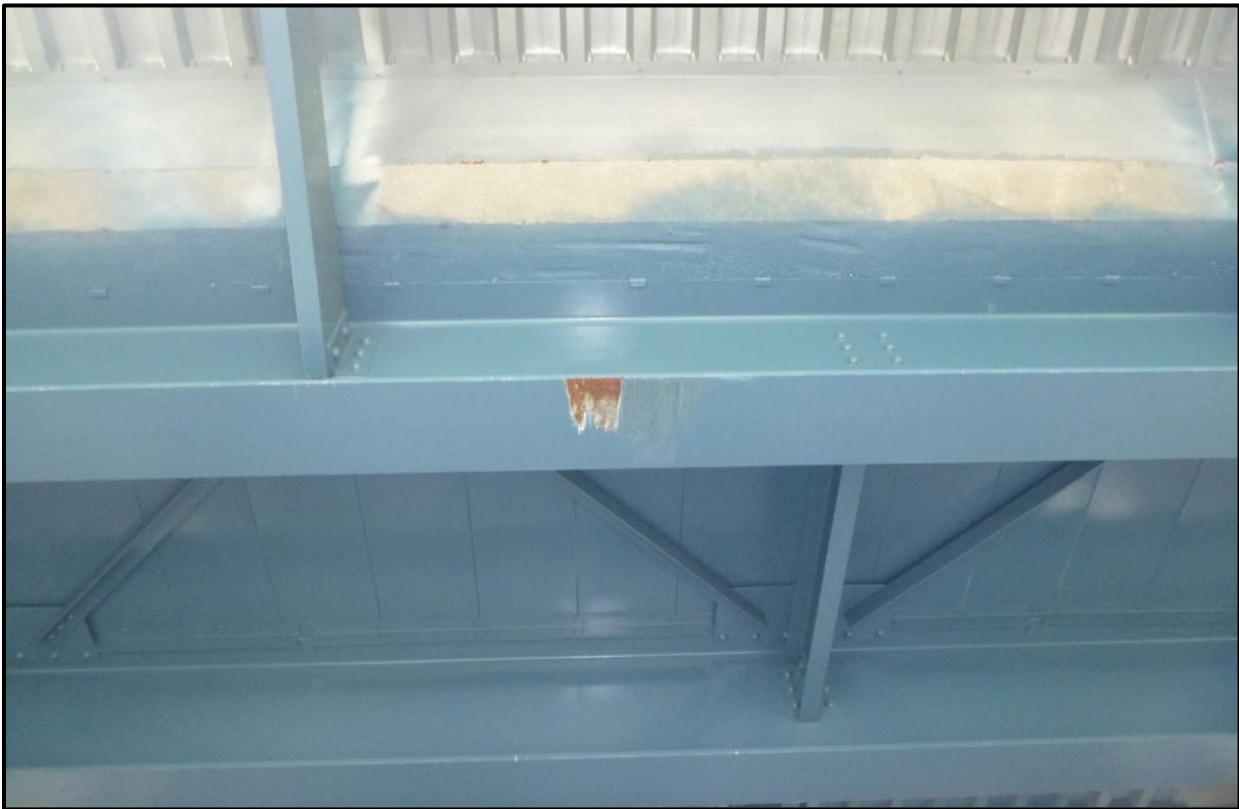
Photo 17 - Impact Damage to Bottom Flange of Beam S02 in Span 14E

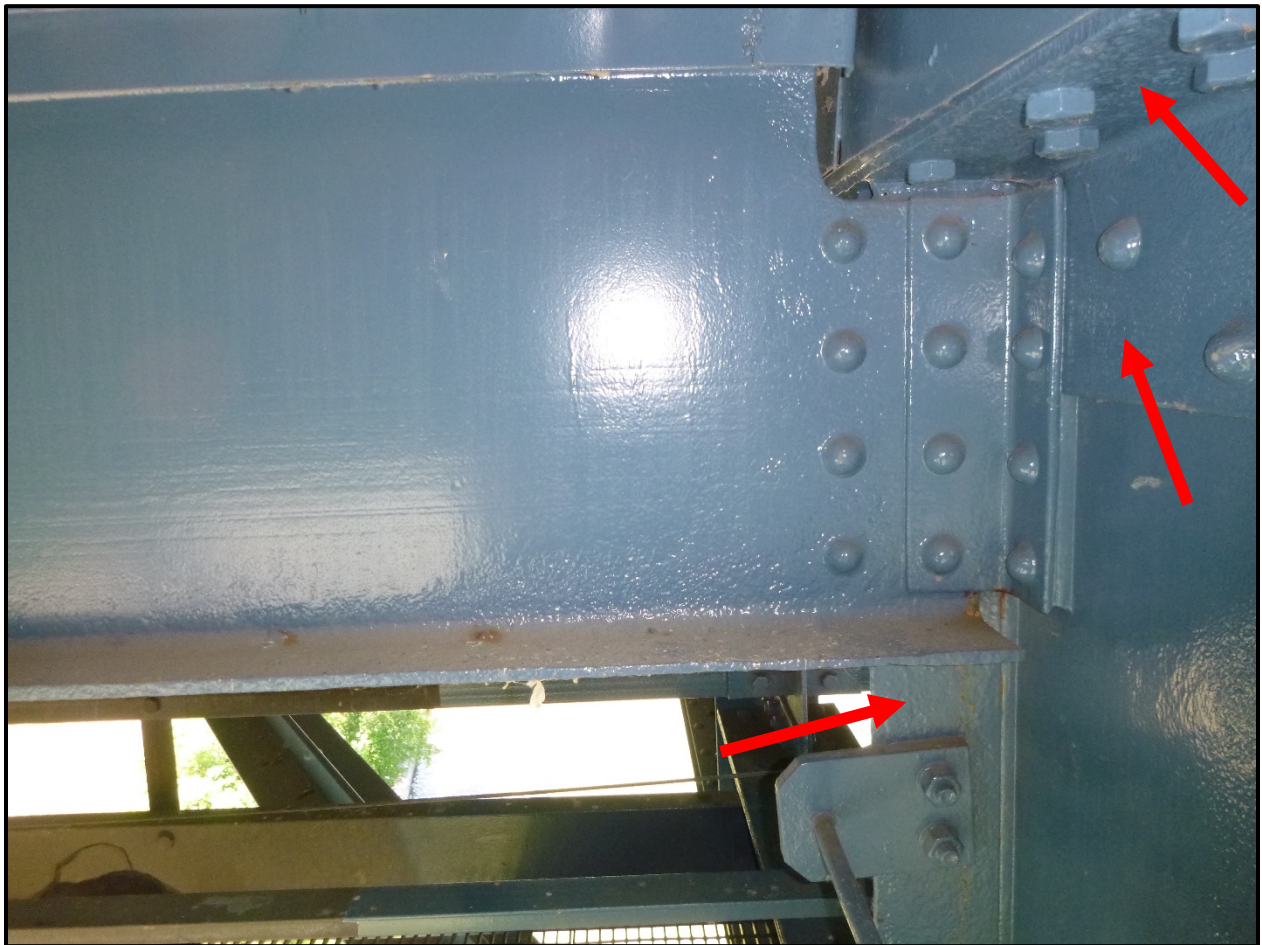
Floor beam top flange section loss greater than 1/16" was a prominent finding in the suspension spans. Other findings included freckled rusting, minor pack rust, and distortion caused by pack rust.

Photo 20 - Floor Beam Top Flange Section Loss

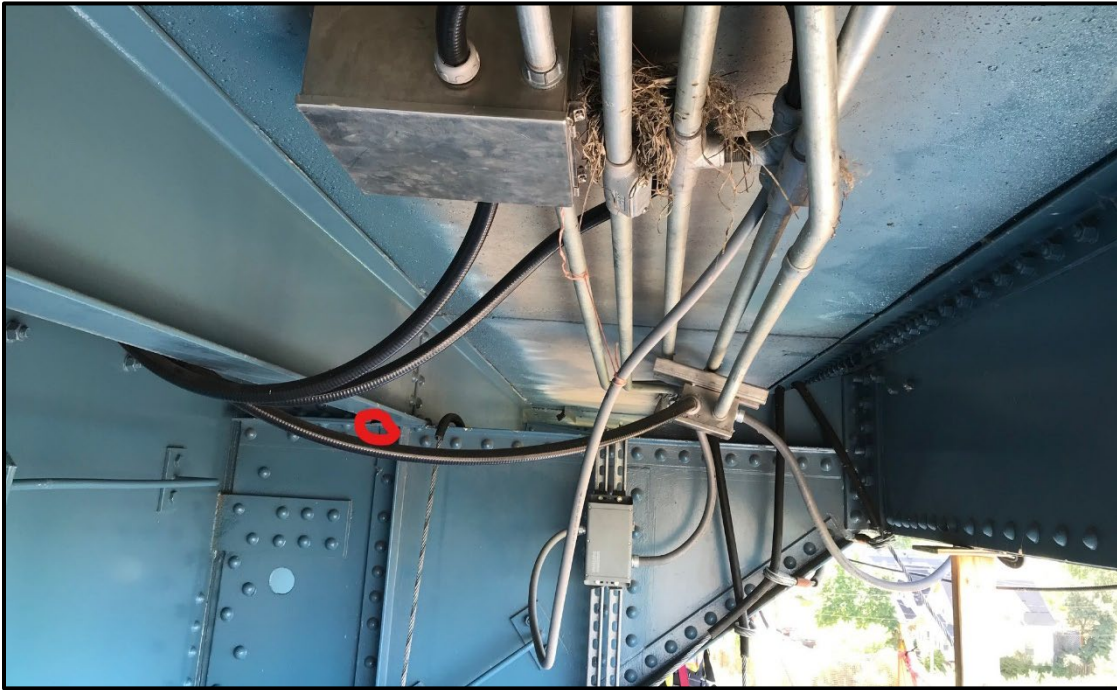
Additionally, cracks in the top flange of the floor beam cantilever at south sidewalk FB 10, 15, 16, 17, 18, 47, 50, 51 and north sidewalk FB 51 were discovered. A structural analysis of the cracked section was performed, and it was determined that the floor beams have adequate capacity for the applied loading. Gannett Fleming recommended that the onsite contractor drill out the crack and caulk and paint the affected area. These 9 cracks were deemed CS3.

Photo 21 - Location of Cracks in Floor Beam Cantilever Top Flange

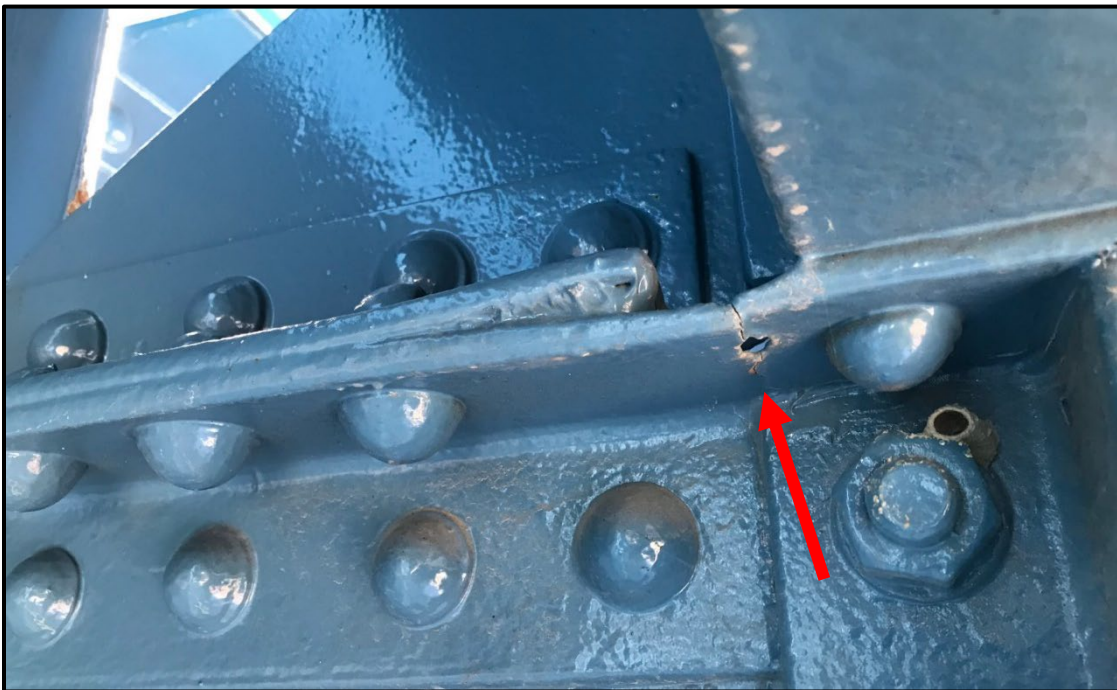
Photo 22 – Typical Crack in Floor Beam Cantilever Top Flange, FB 47 shown

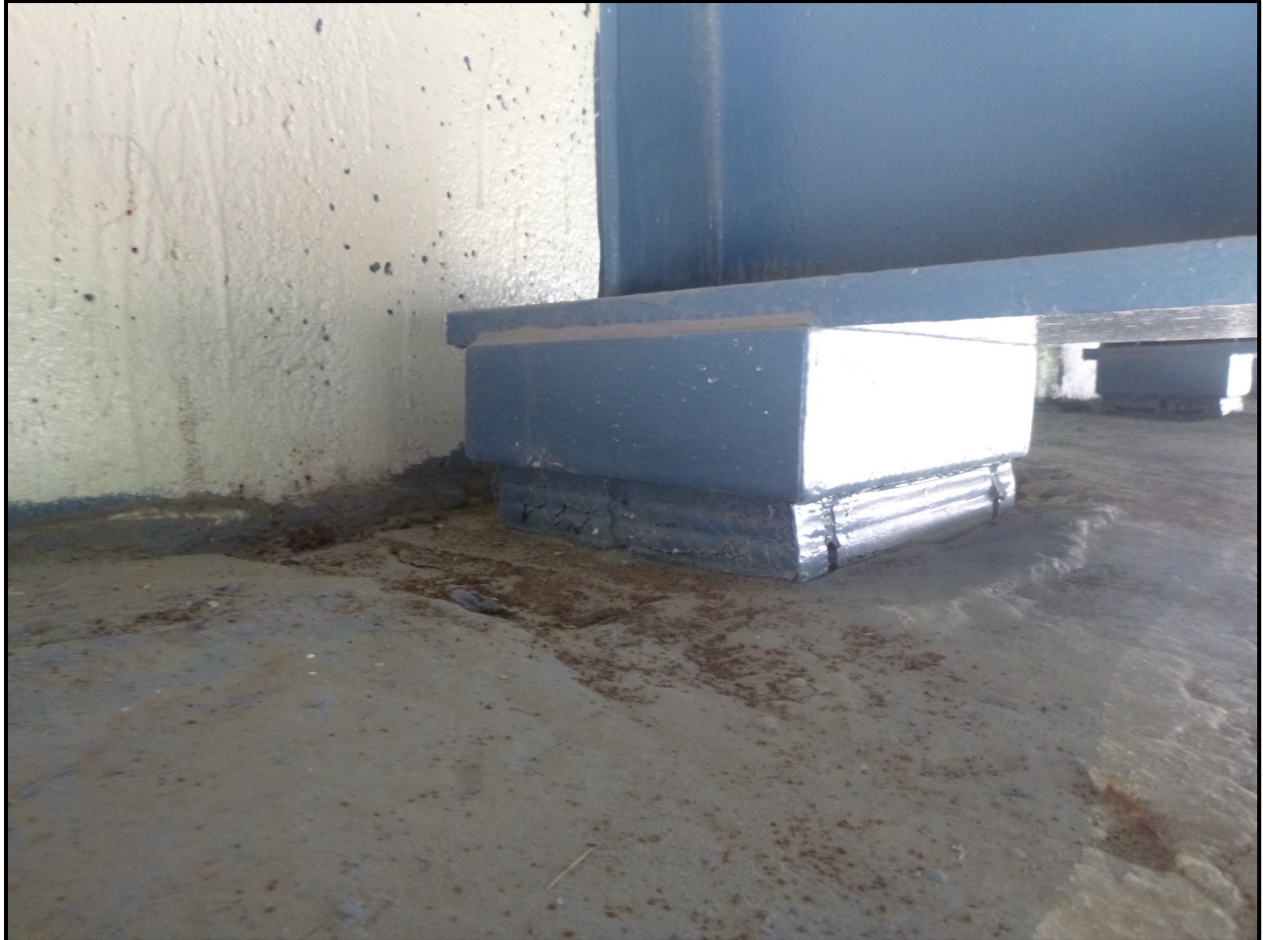
The elastomeric bearings are in good condition, with only the a few bearings at the rear abutment showing minor bulging up to 1/4".

Photo 23 - 1/4" Bulge Rear Abutment Elastomeric (S08 shown, S03 & S09 similar)

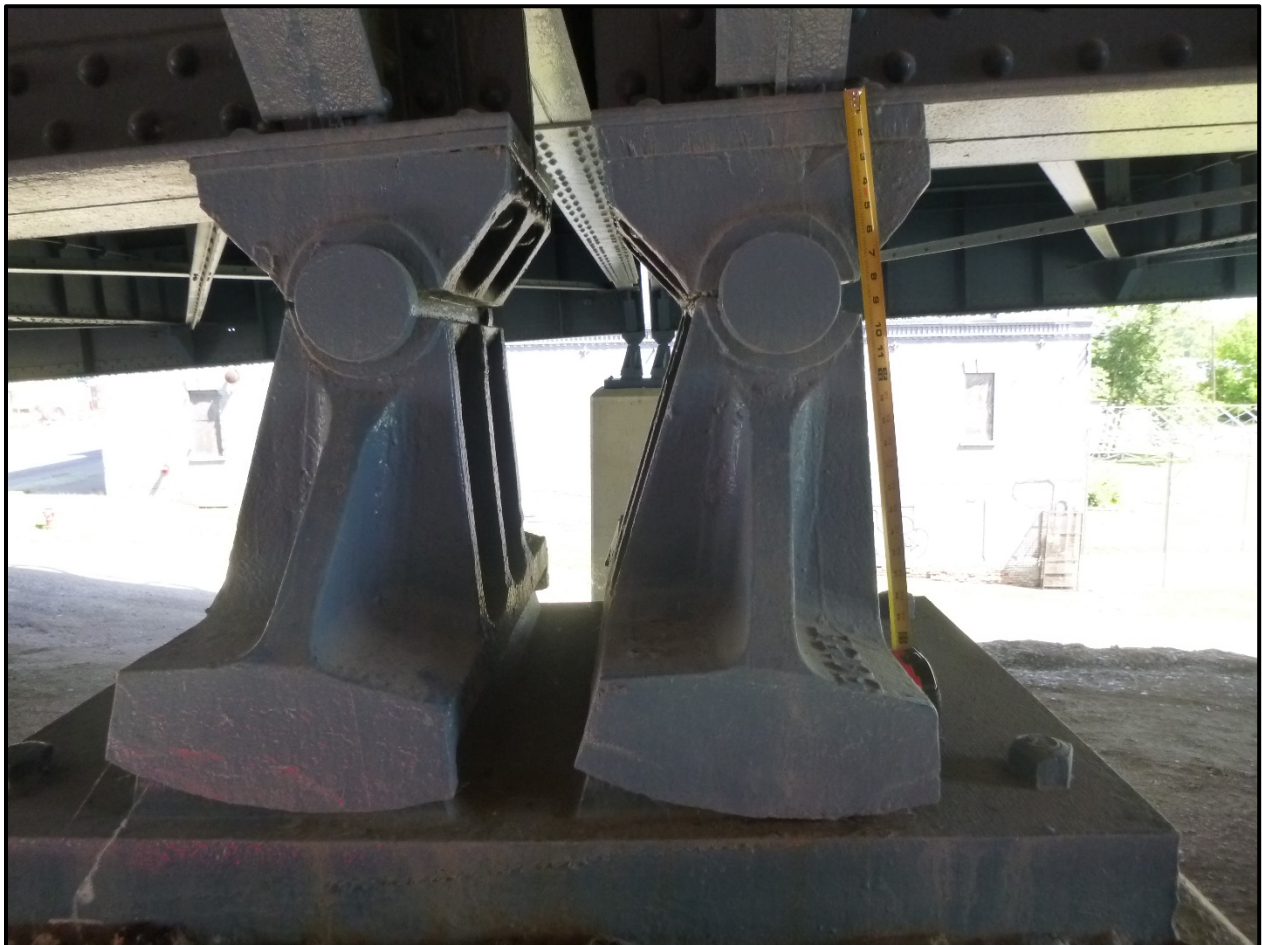
Overall, the movable bearings are in satisfactory condition. Bearings at Pier 6W are tilted 10 degrees opposite of temperature. At Pier 2W, the bearings under girder LG are touching, resulting in bottom flange girder contact and restricted movement (CS3). Pictures of the noted condition state defects are below.

Photo 24 – Bearings below Span 6W Girders at Pier 6W are Tilted approximately 10 degrees East, Opposite of Temperature (RG shown, LG similar)

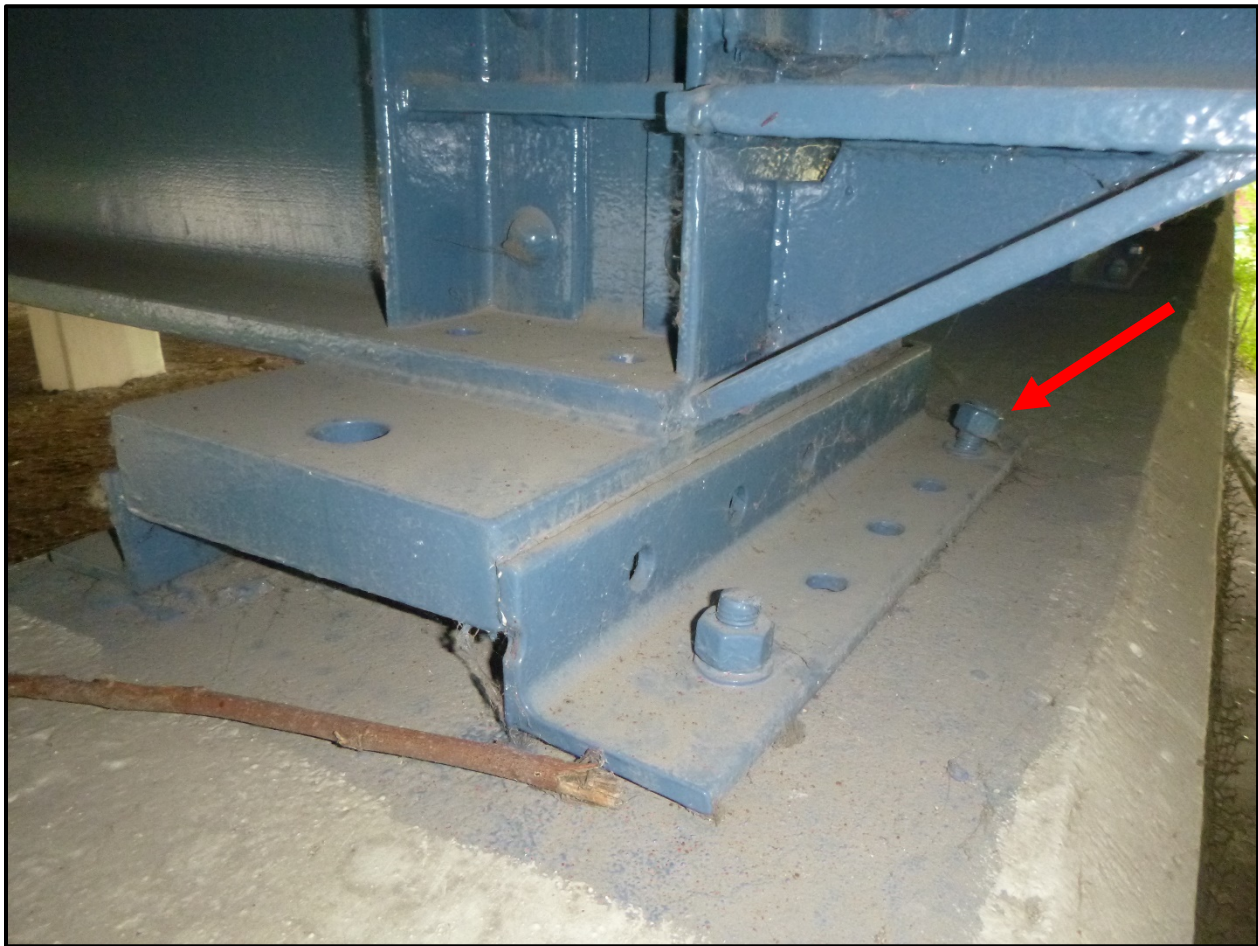
The fixed bearings are in good condition with only a minor defect at S05 on Pier 12E.

Photo 28 - Bent Anchor Rod and Loose Nut on Northeast Corner of S05 Bearing at Pier 12E

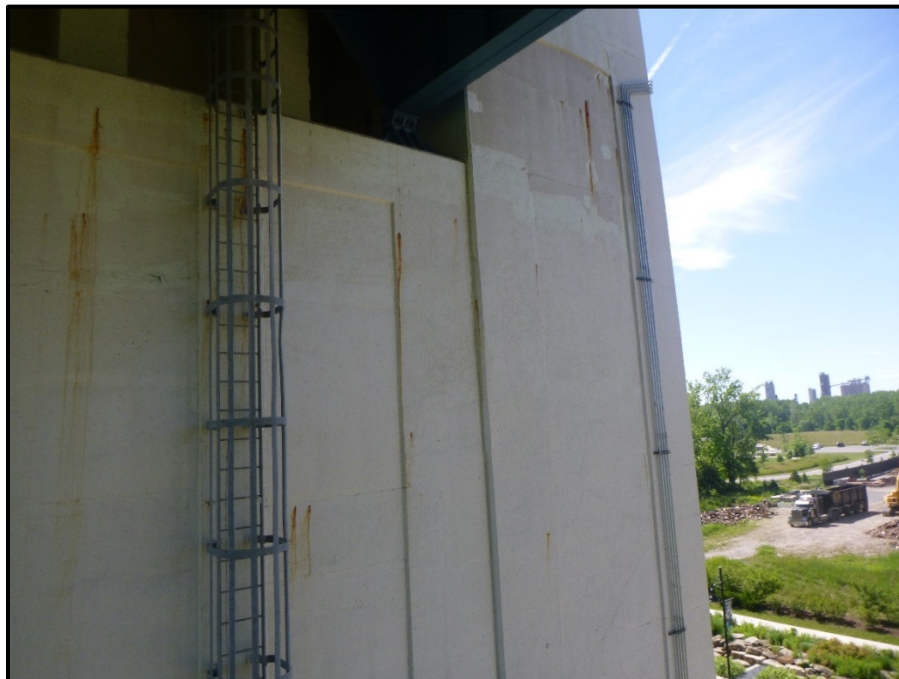
The concrete walls of the anchorage chambers are in fair condition overall. There are various minor spalls, cracks, rust staining, and efflorescence on the anchorage pier exteriors. Large spalls and unsound areas were noted throughout the interior concrete faces of all four anchorage chambers. These areas have, for the most part, been marked out for repair in the ongoing repair contract. Moisture was present inside the anchorage chambers which may accelerate deterioration of the main cable components within.

Photo 29 - Typical Rust Staining of Pier Wall (West Face of Anchorage A shown)

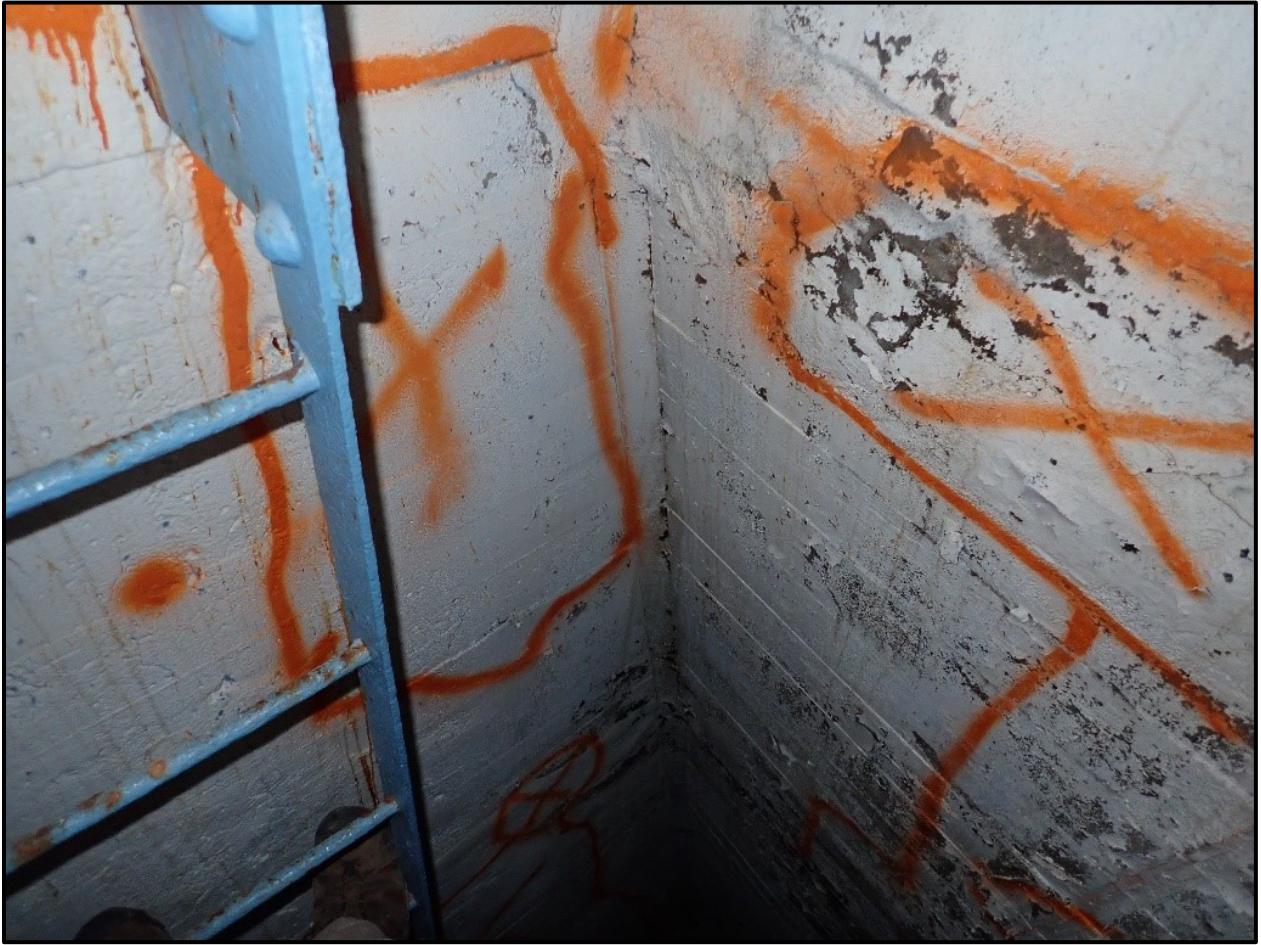
Photo 30 - Unsound Areas of Concrete Marked for Repair (Northeast Anchorage Chamber show, others similar)
