2020 In-Depth, Element Level Bridge Inspection Report

LUC-2-1862 **In-Depth, Element Level Bridge Inspection Report**

PID: 108045

October 2020

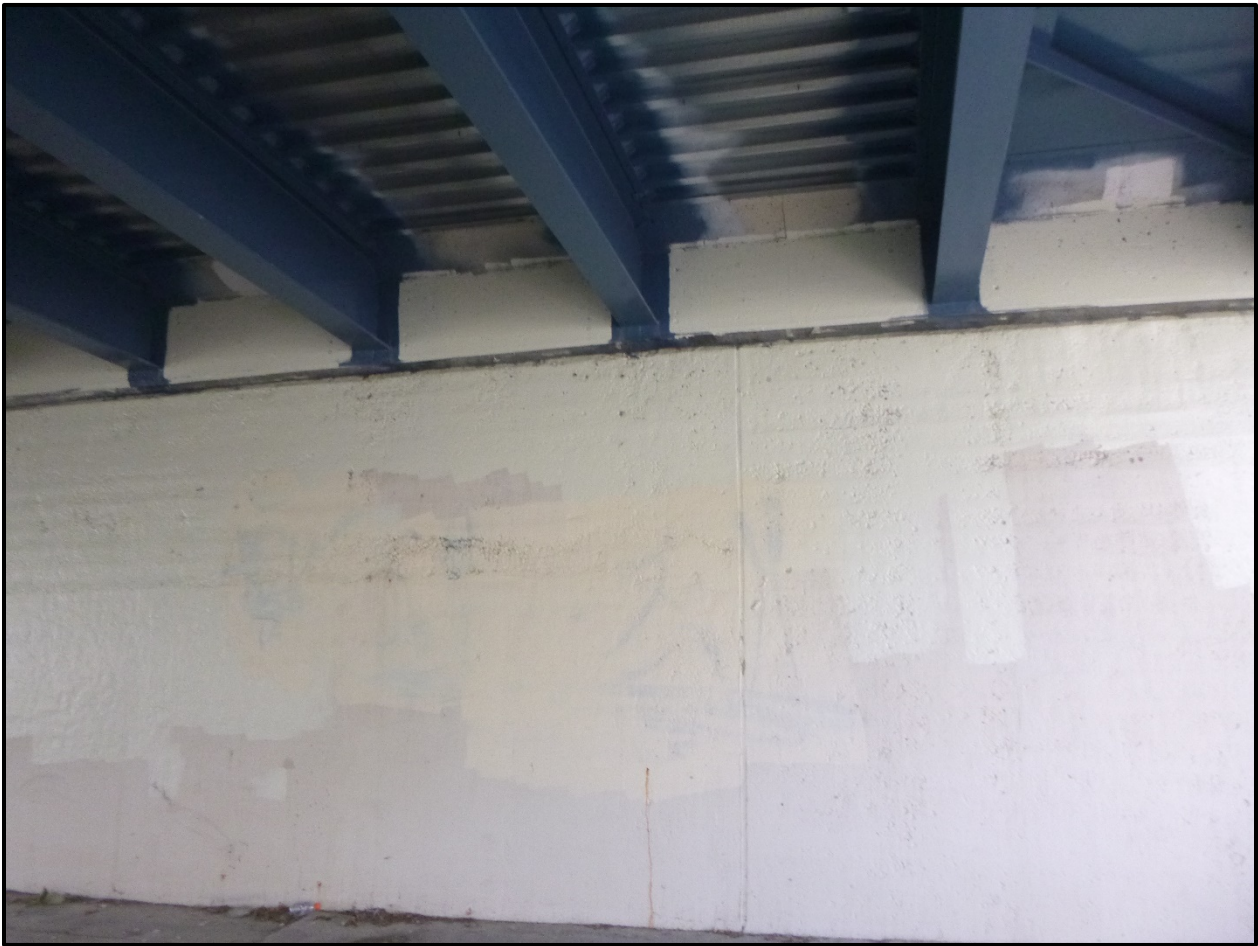
There are several minor spalls, delaminations and rust stains at the Forward Abutment.

Photo 31 - Forward Abutment Elevation

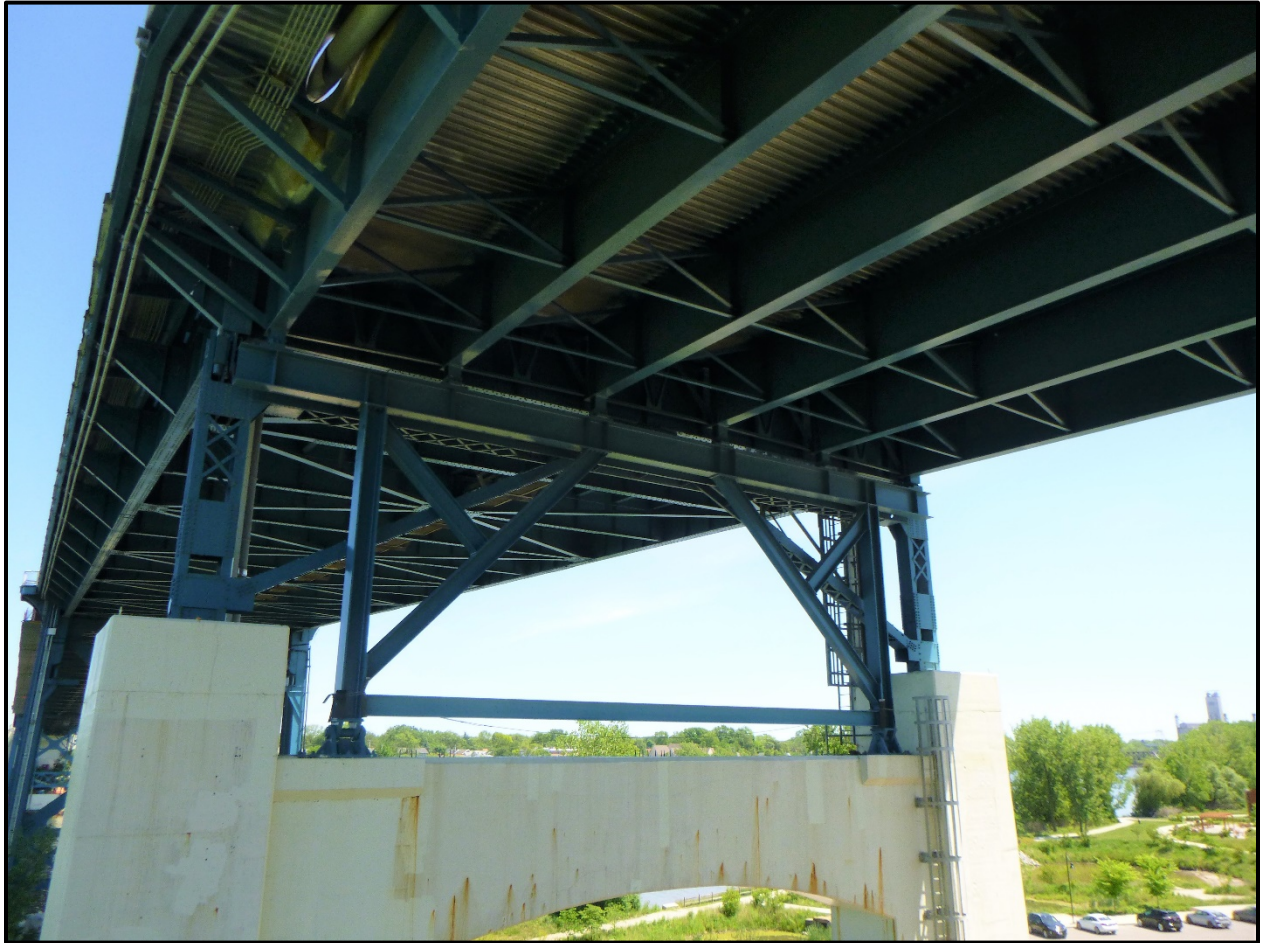
The steel frames supporting the new replacement spans are in good condition and show no signs of distress. The bearing pins at Pier E are unpainted.

Photo 32 - Steel Frame Supporting Span RW-1 @ Pier B

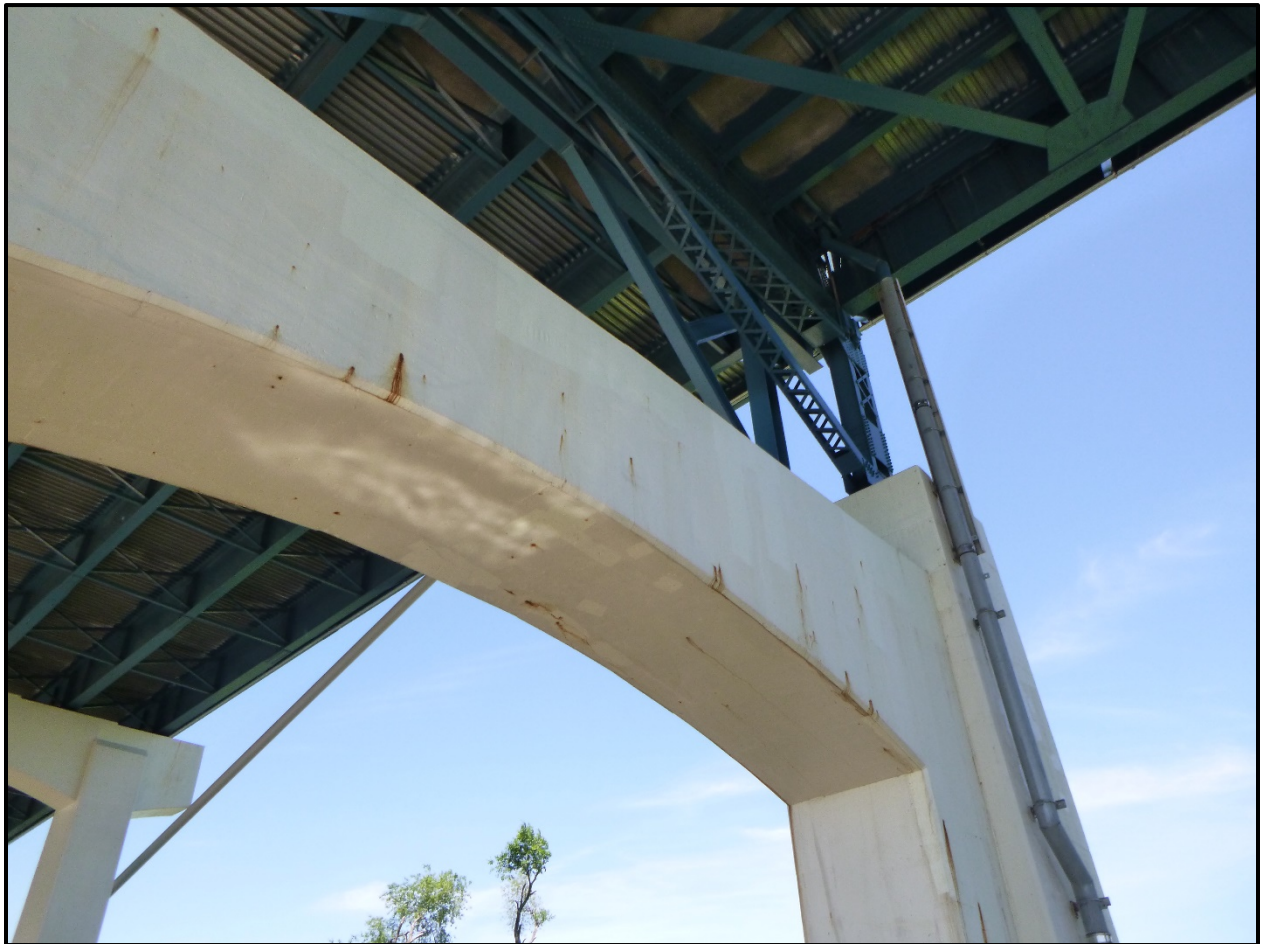
The numerous pier caps exhibit minor spalls, rust staining, cracks, and delaminations. All defects are sealed.

Photo 34 - Typical Sealed Cracks and Rust Staining of Pier Cap (Pier B shown)

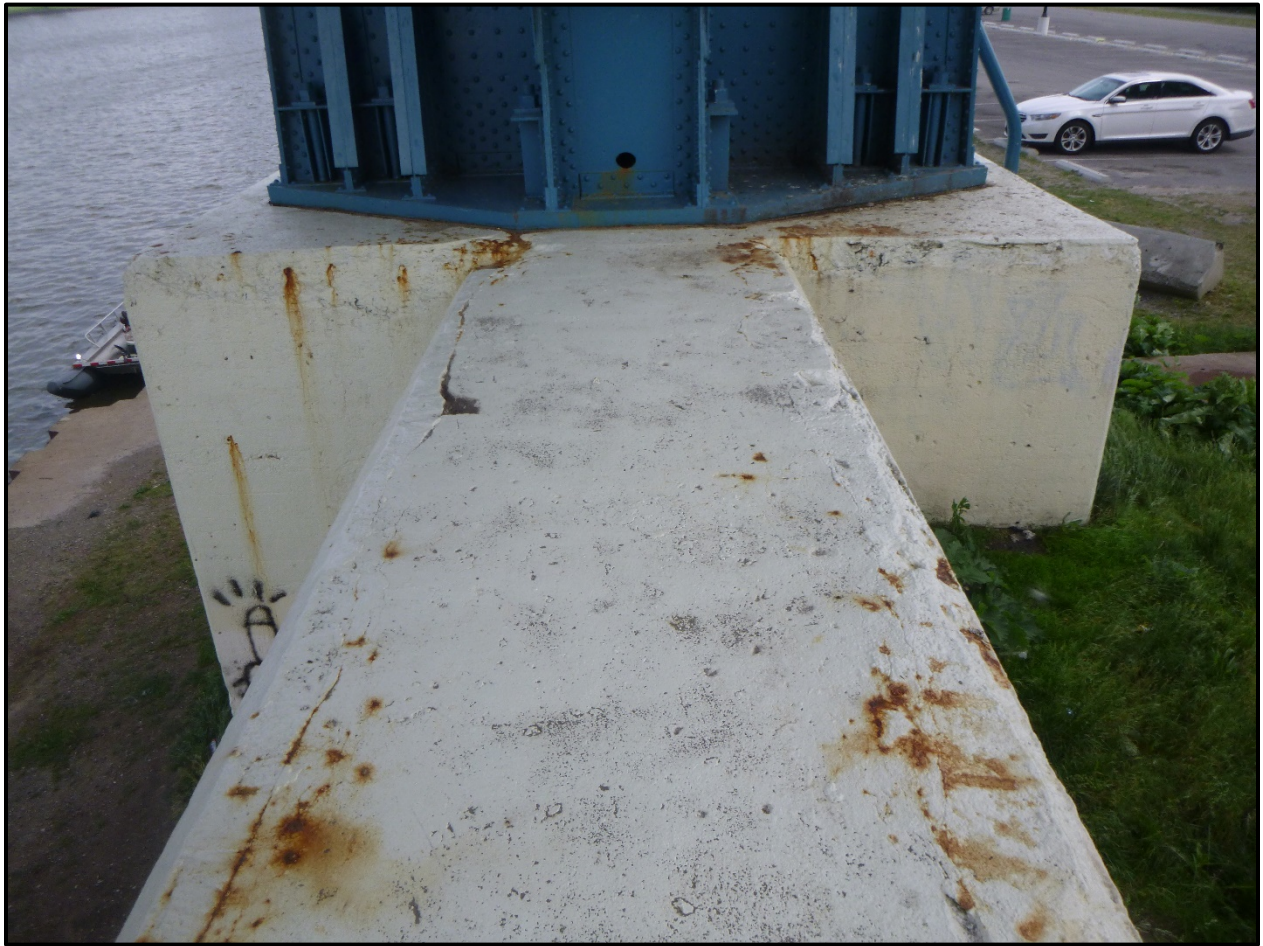
Photo 35 - Typical Condition of Partially Buried Cap Supporting Suspension Towers (Pier E shown)

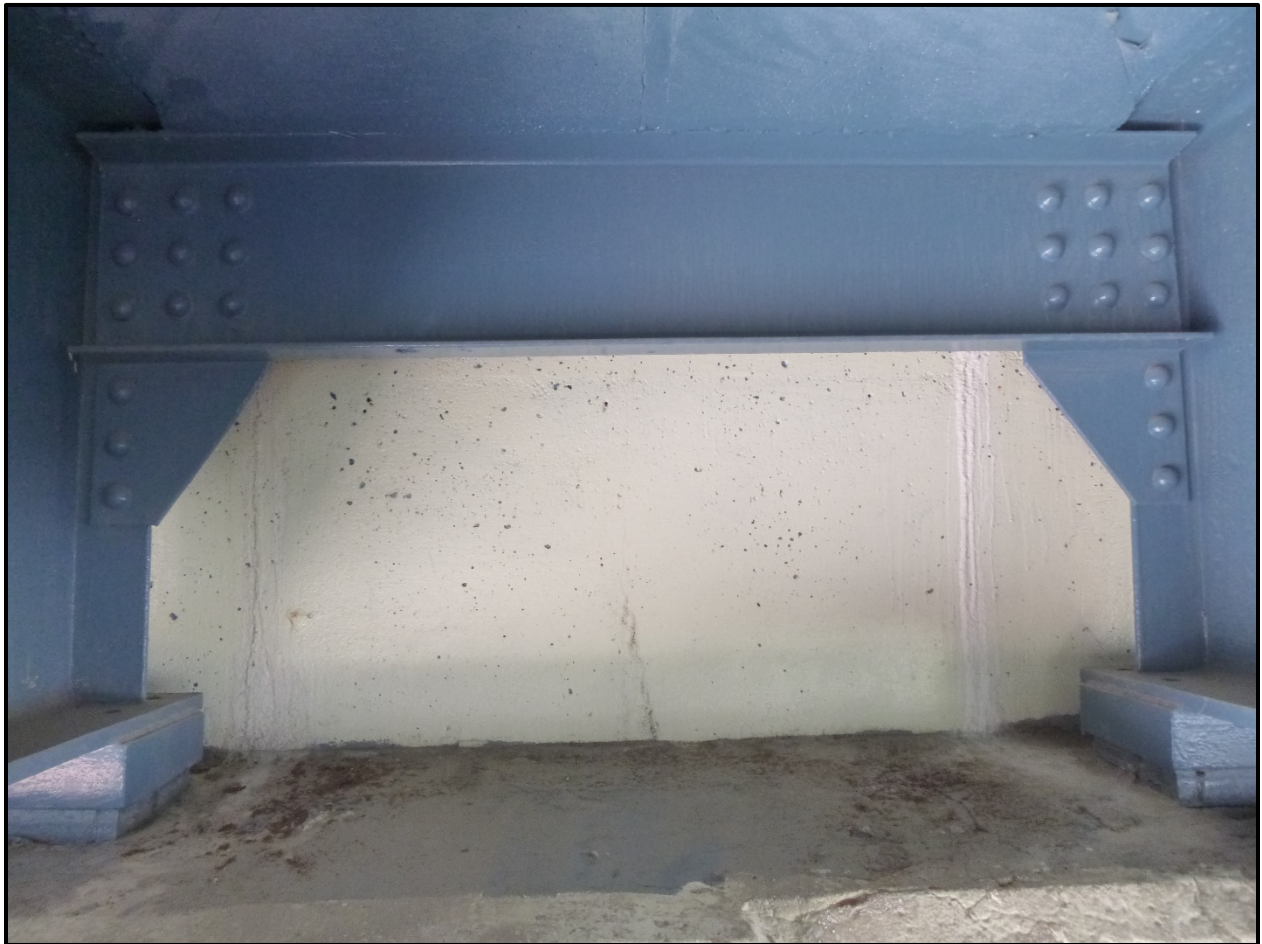
The rear abutment backwall is in good condition, with only one minor defect noted.

Photo 36 - 2' Wide Delamination between B5 & B6 at the Rear Abutment

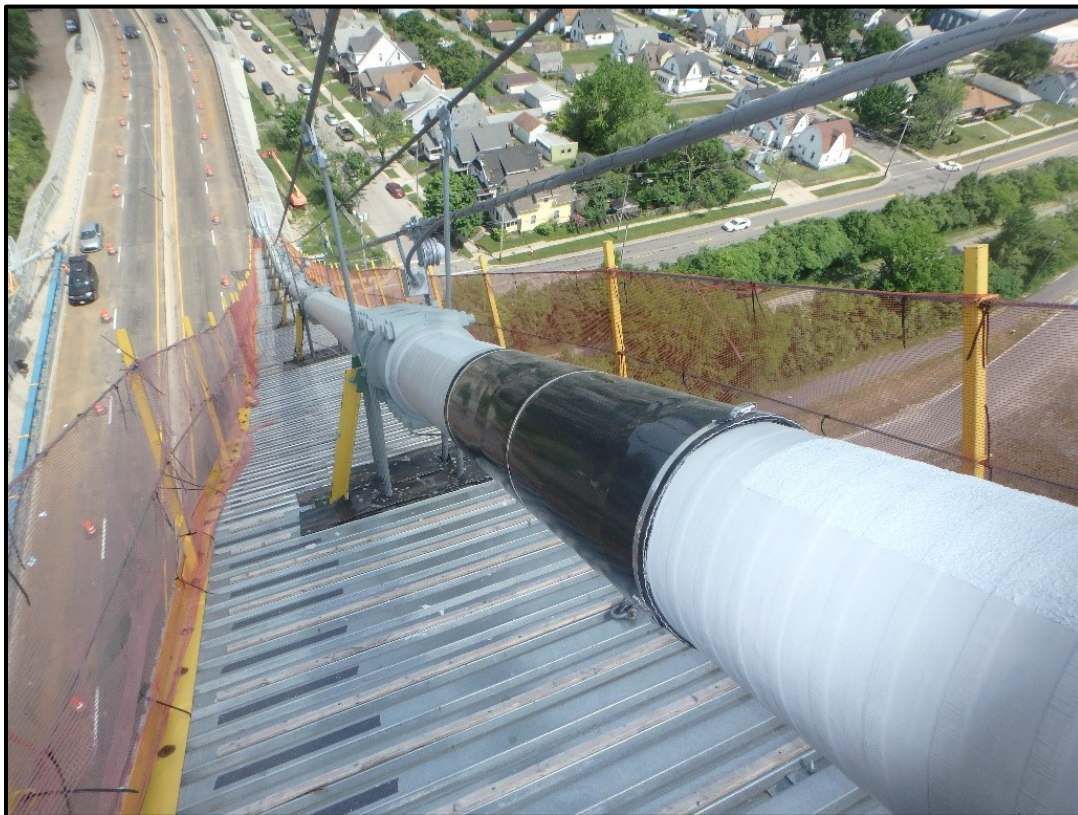
The steel main cables are in satisfactory condition overall. Noted deficiencies were limited to the East and West anchorage metalwork. Considerable moisture was present in all anchorage chambers resulting in condensation forming on the cables, strands and eyebars. Dehumidifiers are present in the chambers but are unable to maintain adequately dry conditions. The splay saddles located at the top of the anchorage pits have widespread moderate to severe corrosion, especially at the concrete interface. Areas of minor to moderate corrosion are present on several of the strands at their interface with the strand shoes. These areas serve as pockets that allow debris and moisture to collect and accelerate corrosion. Crevice corrosion up to 3/16" was noted between the eyebars and strand shoes at several locations. Section loss up to 1/4" deep was noted in some anchorage eyebars at the embedment concrete on the floor of each anchorage chamber. It was noted that water and debris accumulate in these areas as well.

Photo 37 - South Main Cable in the East Side Span. Note that a portion of the cable wrap has been removed to accommodate the dehumidification collar and the area has been temporarily covered with a clamped rubber sheet.

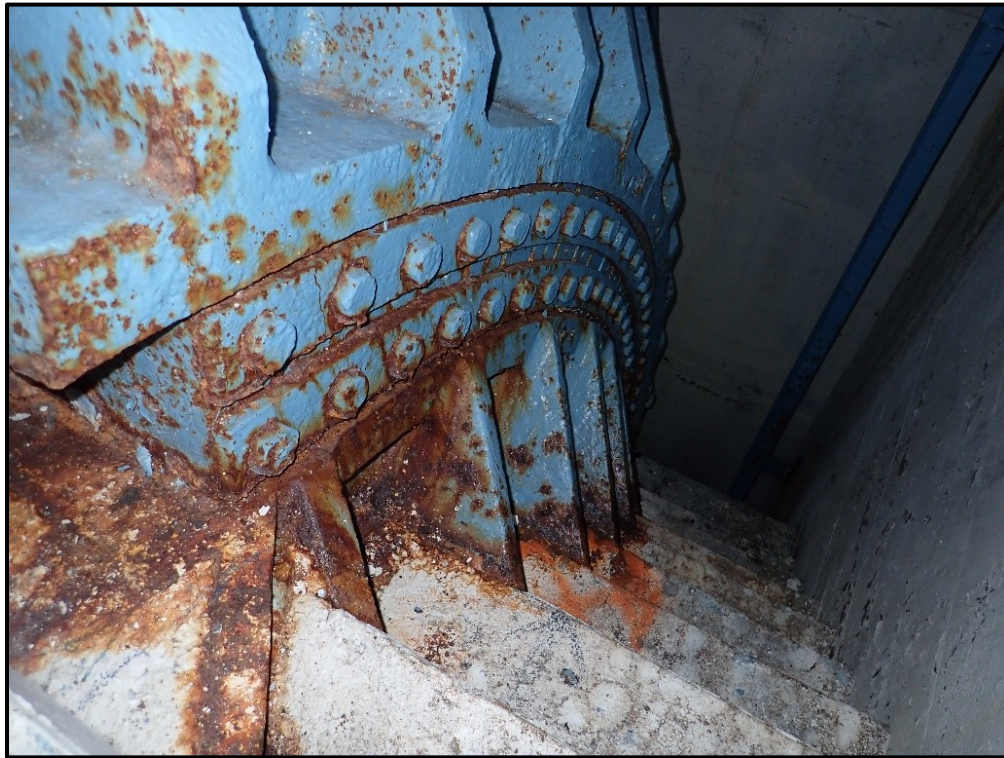
Photo 42 - Moderate to Severe Corrosion of the Splay Saddle Castings in the Northeast Anchorage

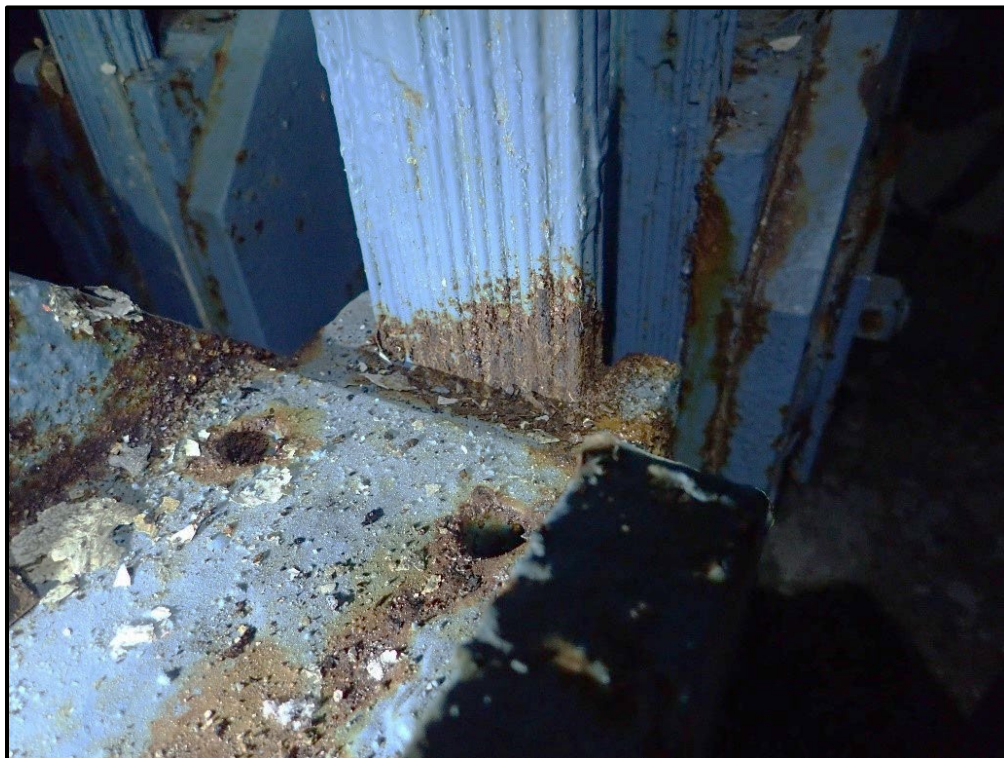
*Photo 43 - Severe Corrosion of the Main Cable Wires just above the top of the Strand Shoe.
Location - Northeast anchorage, east half of 2nd cable strand from West at 5th row of eyebar
pairs.*

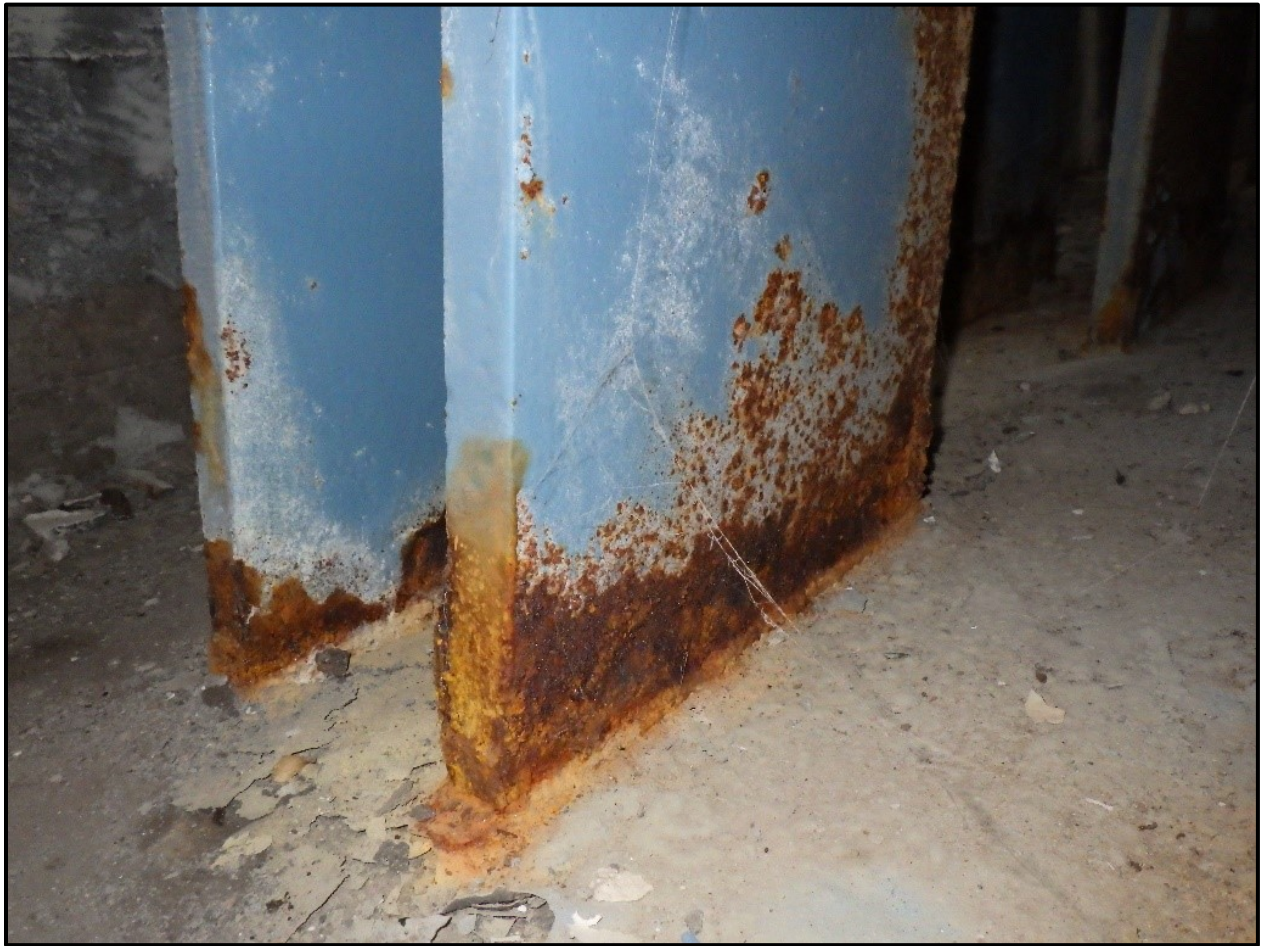
Photo 44 - Typical Corrosion and Section Loss at the Base of the Eyebars, Southeast Anchorage Chamber at Southwest Eyebars Pair Shown

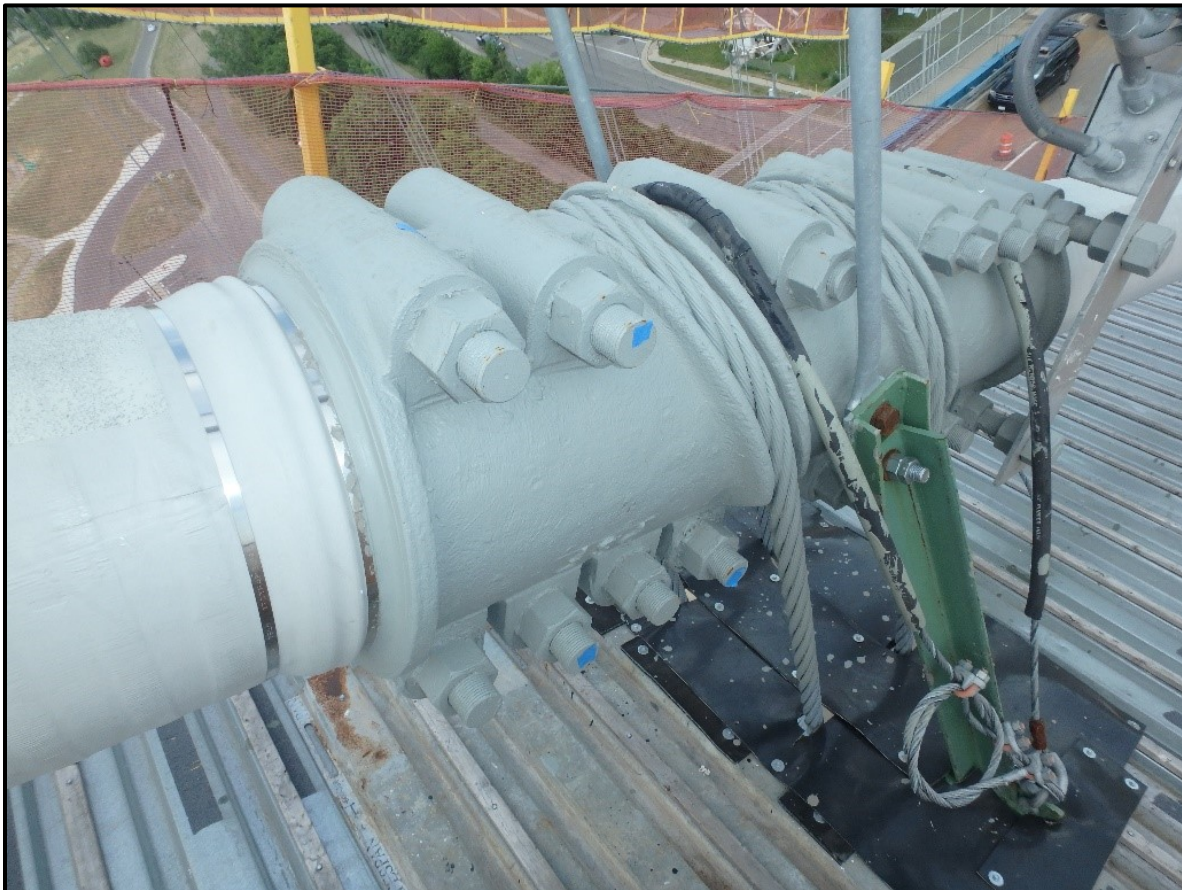
The lower ends of the hold-down suspender ropes located at the east and west ends of the side spans exhibited more significant surface corrosion and debris collection at the lower anchor block.

Photo 45 - Cable Band and Suspender Ropes of South Cable in East Side Span

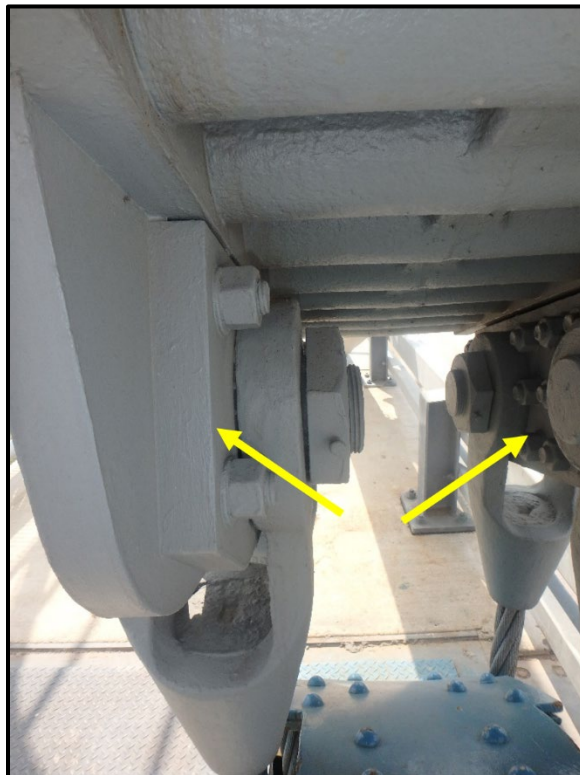
Photo 47 - West Hold-Down Ropes on South Cable. Note that the previously crack welded pin plates have been replaced with bolted plates.

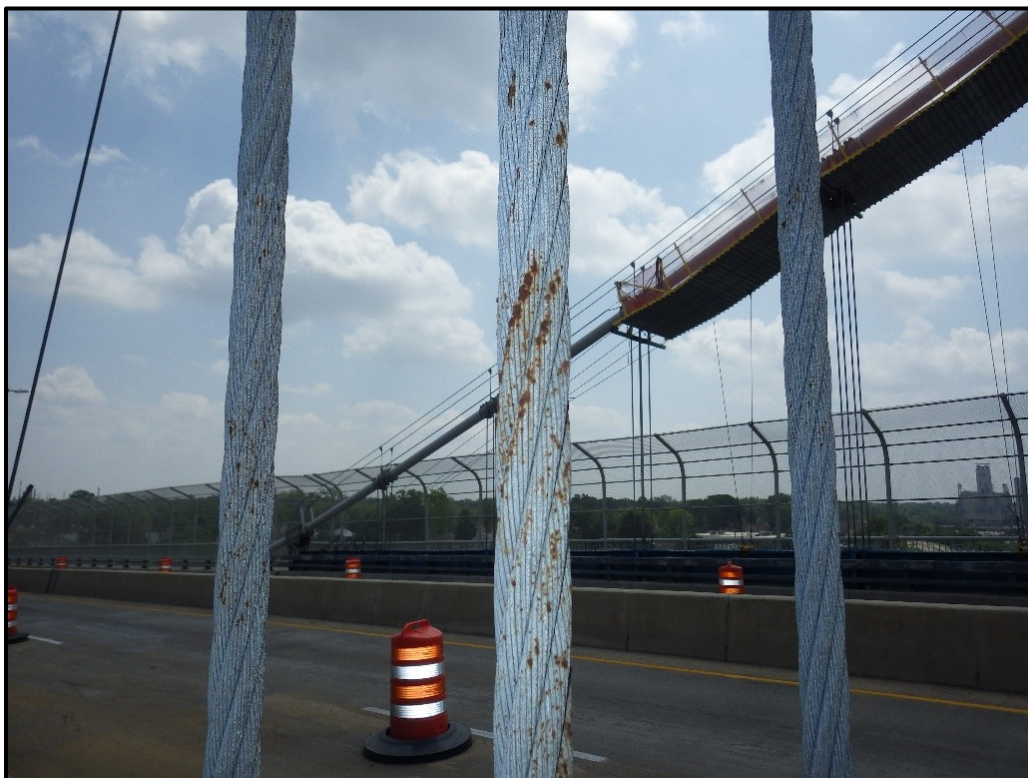
Photo 49 - Typical Suspender Ropes with Areas of Moderate Corrosion near the Roadway Level

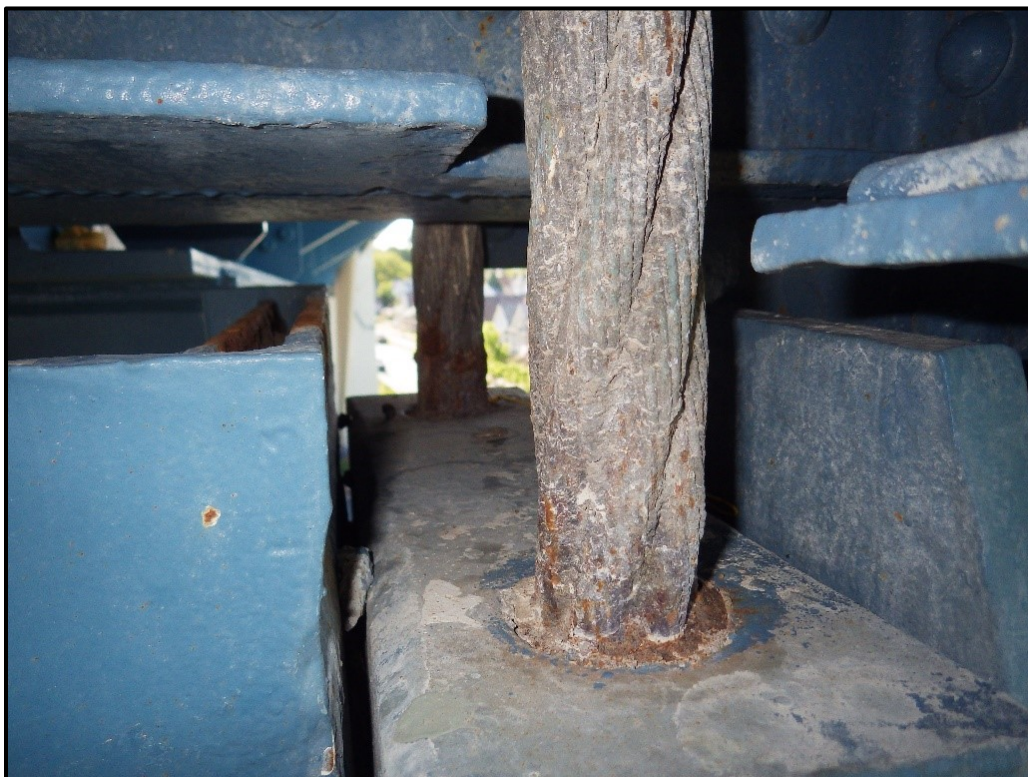
*Photo 51 - Typical Corrosion and Section Loss at the Base of the Wire Ropes at the Cable Bents.
East cable bent, south column, northwest suspender rope shown.*

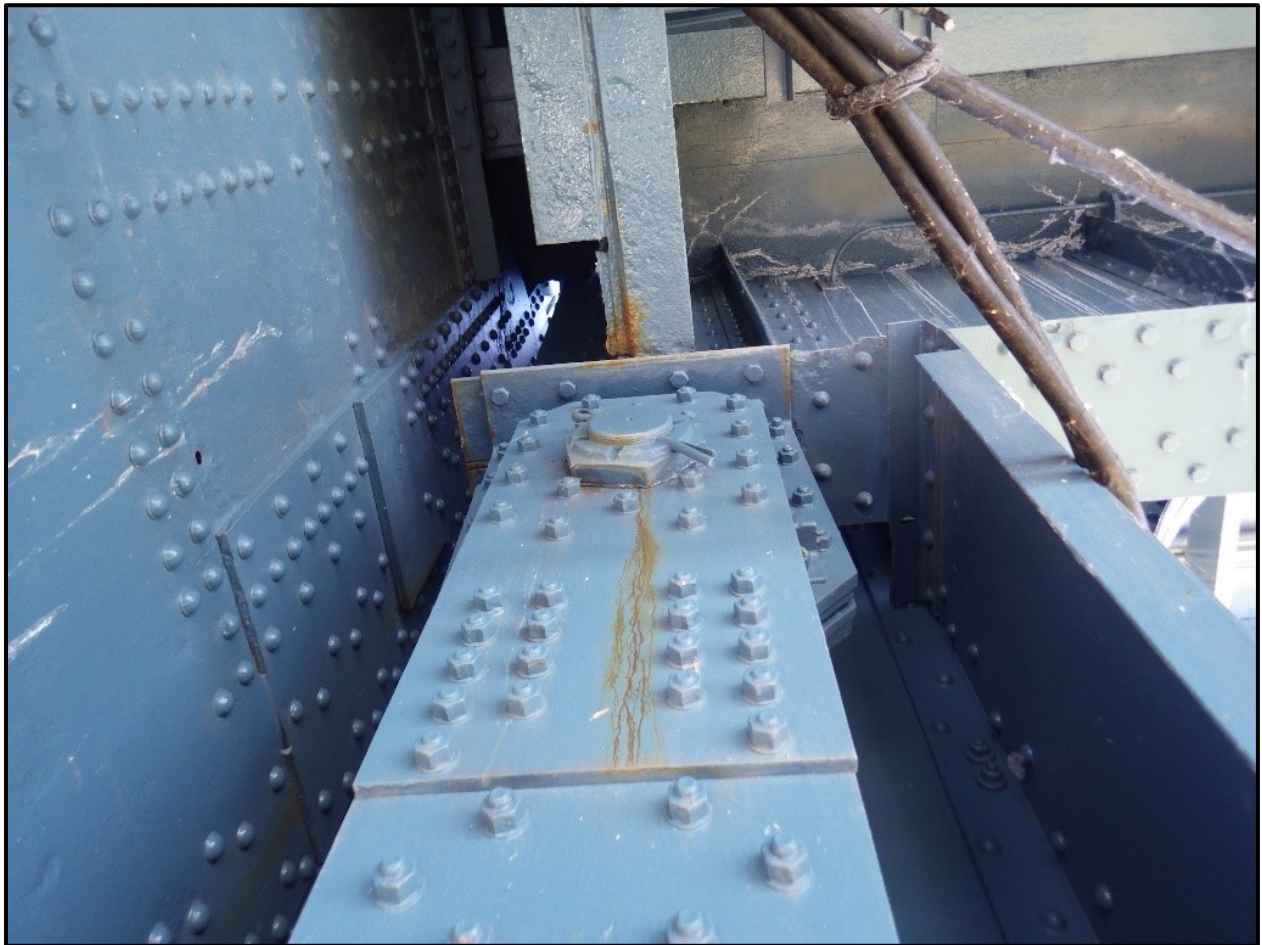
Photo 52 - Minor Corrosion Staining Emanating from the Tower D, South Leg, West Link, Top Pin

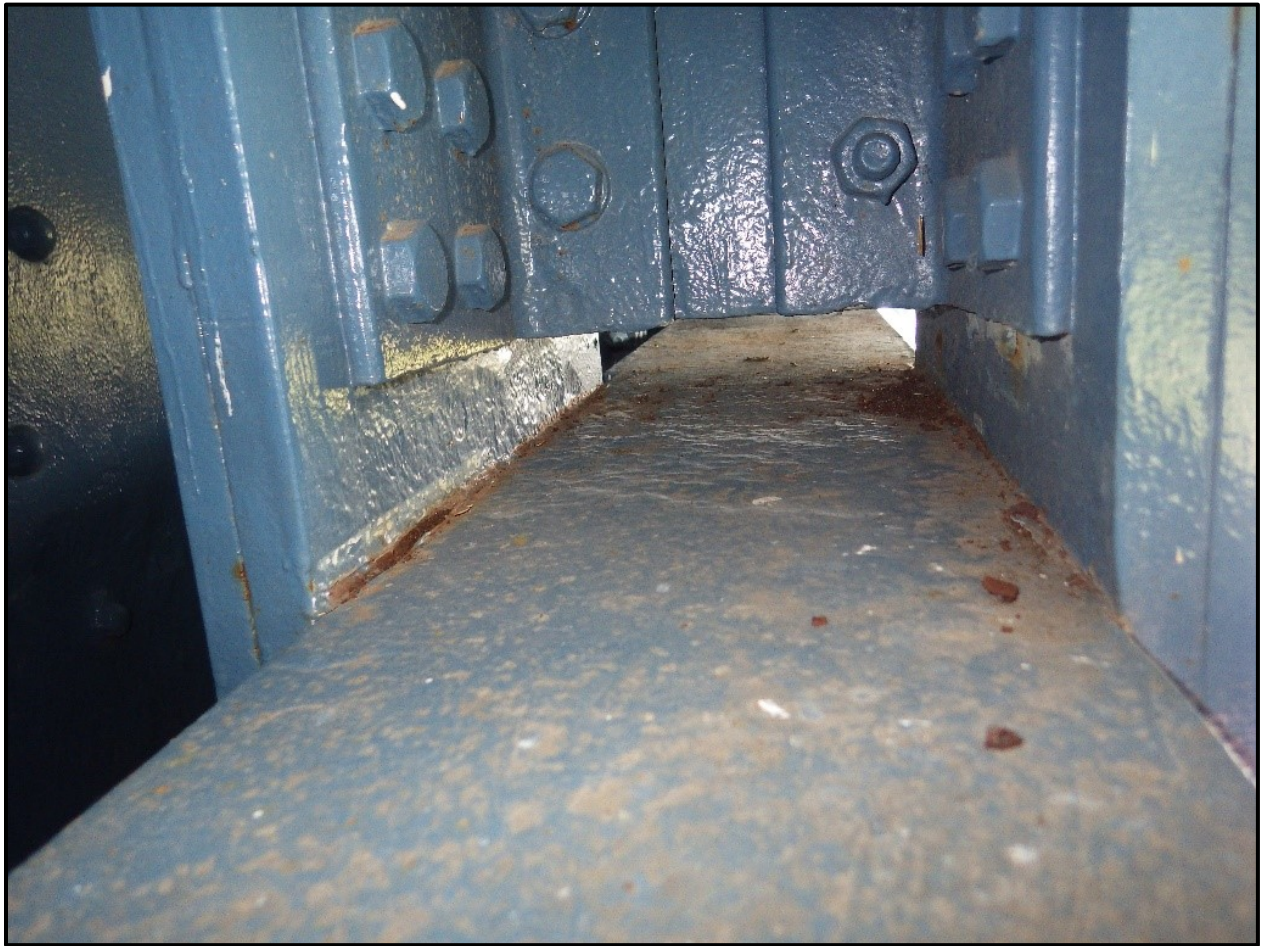
Photo 53 - Typical Hard Contact between Tower Link Plates and Tower Metalwork which Retains the Lower Pin

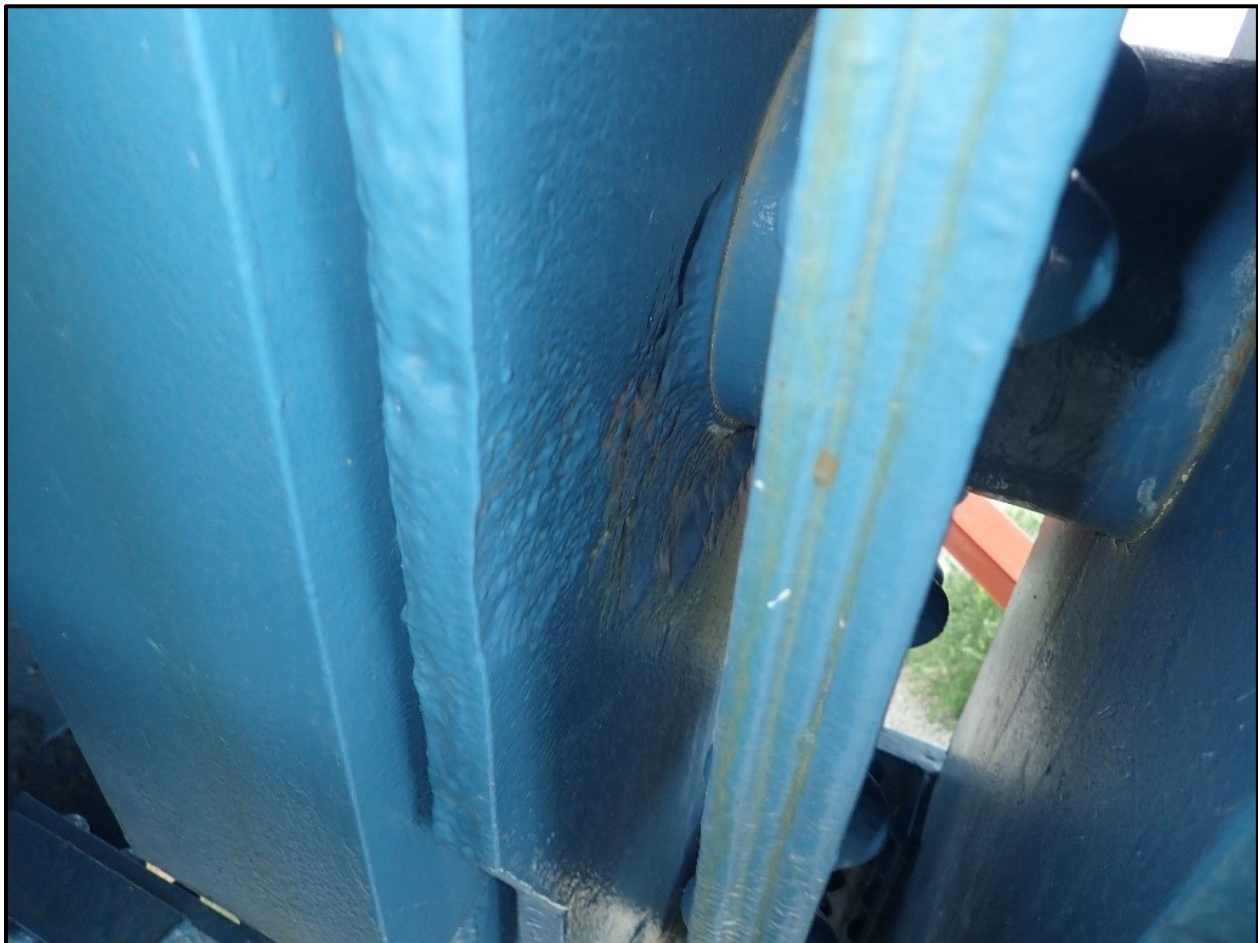
Photo 54 - 5/16" Pitting Section Loss in the East Cable Bent, North Column, Outboard Face of the Inboard Link Plate at the Top Pin

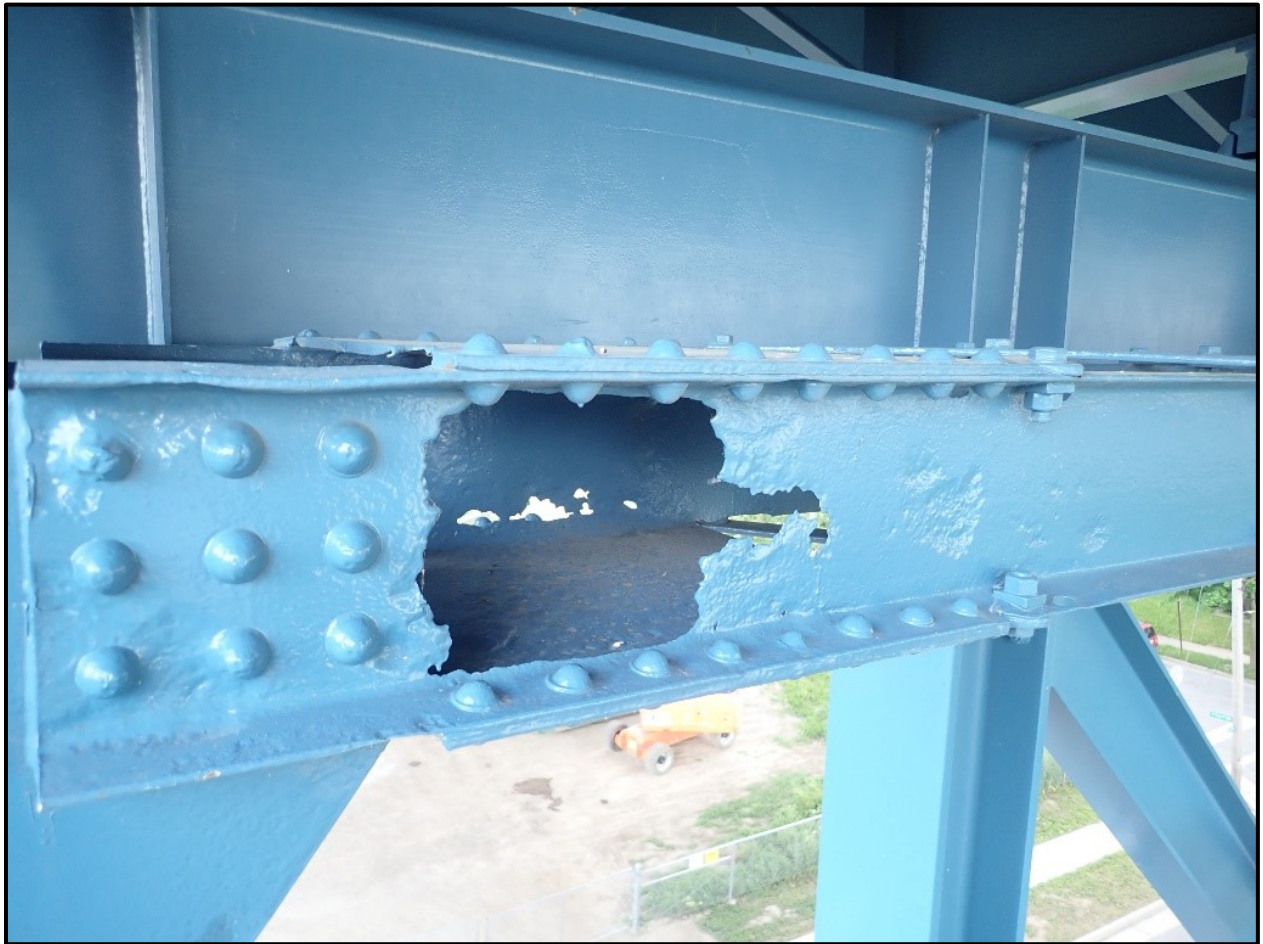
Photo 55 - Large Corrosion Hole in the West Web of the East Cable Bent Upper Strut near the North Link Column. Note corrosion holes are also present in the east web of the strut

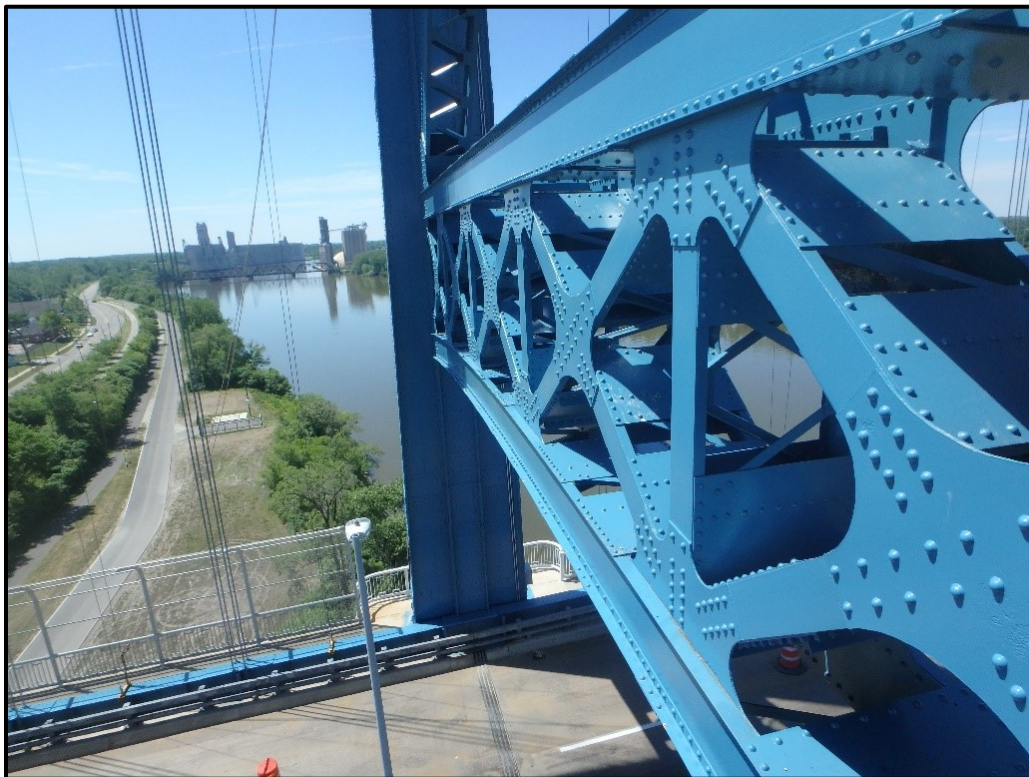
Photo 57 - Tower D Strut Above the Roadway. Note numerous repairs have been made to strut bracing members.

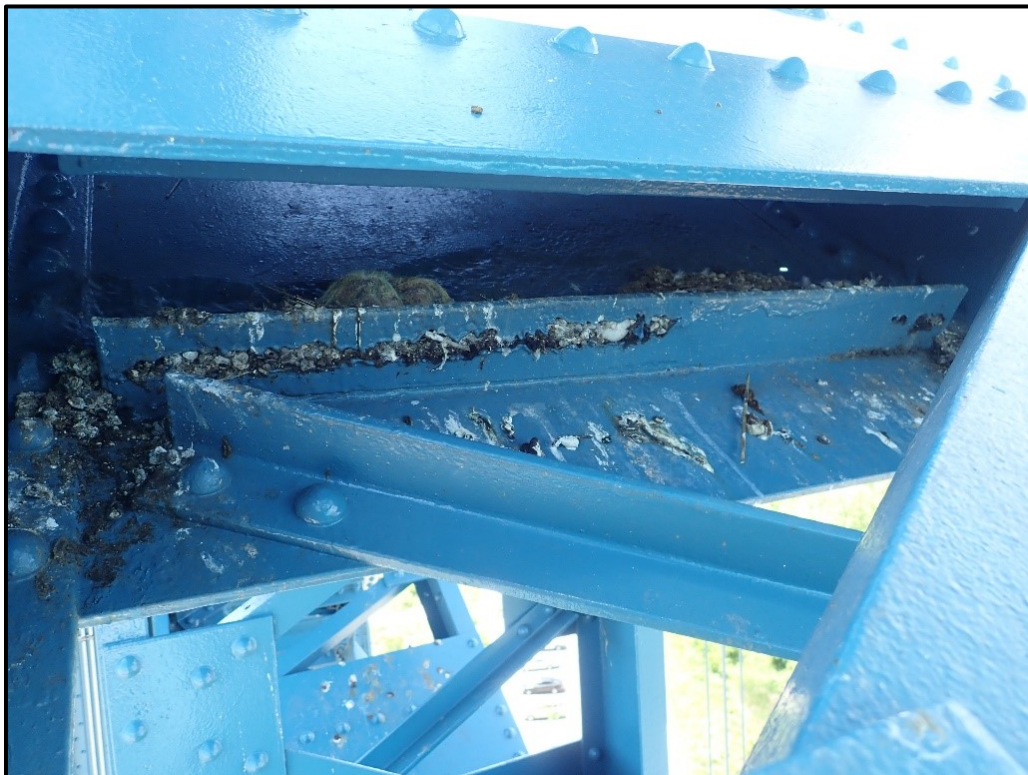
Photo 59 - Large Corrosion Hole in Stiffening Angle of Tower Bracing Batten Plate in Tower C Strut above Roadway

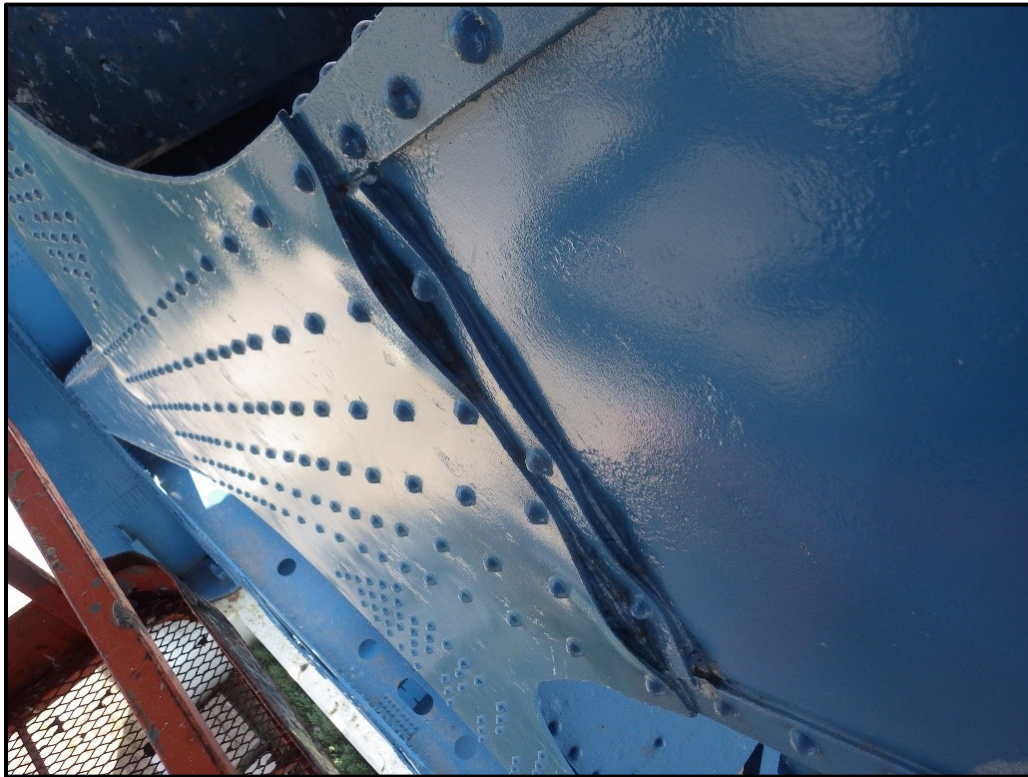
Photo 60 - The Center Gusset Plate below Roadway Level in Tower D Bracing has up to 1.5" Pack Rust Distortion between Gusset and Fill Plates

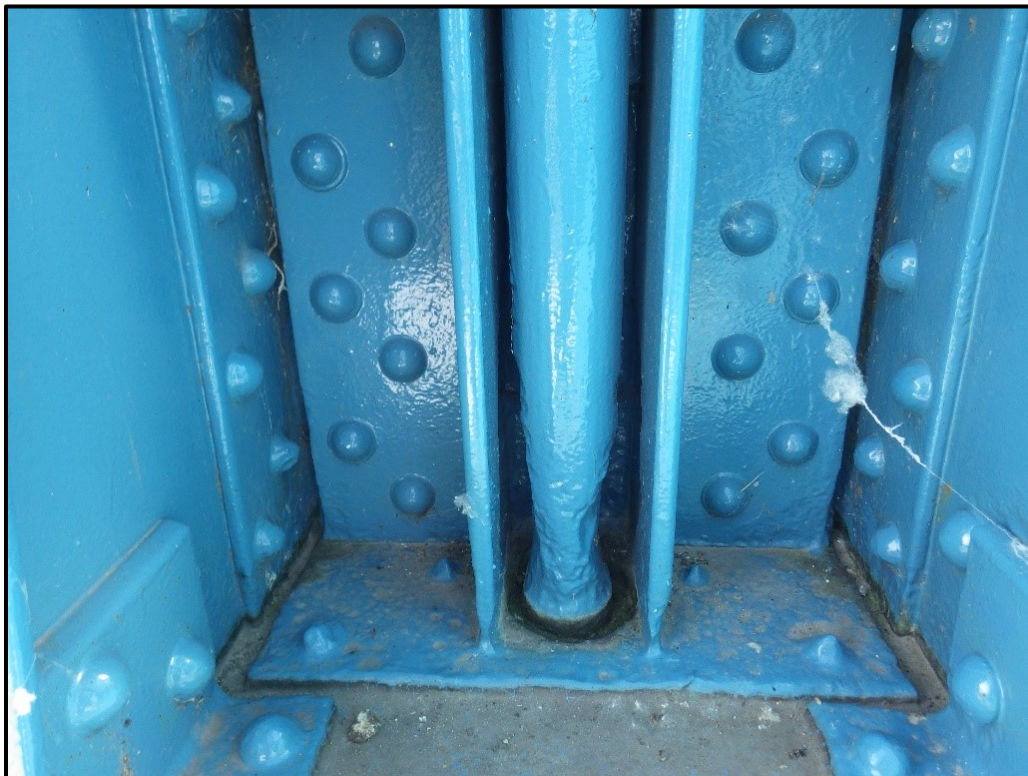
Photo 61 - Up to 40% Loss to the Anchor Bolt at the Northeast Corner of North Leg of Tower D

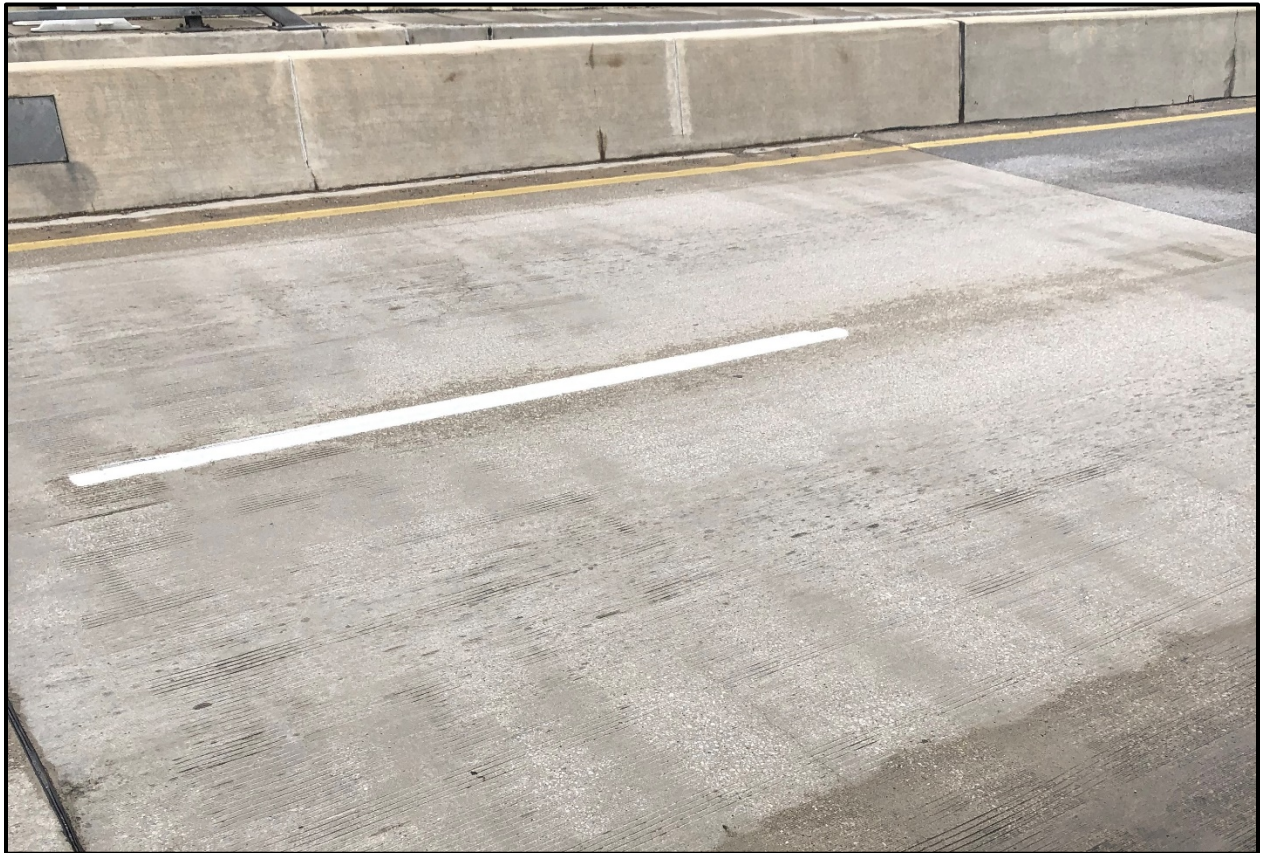
Photo 68 - Typical Approach Slab Condition (Eastbound, East Approach shown)
