2020 In-Depth, Element Level Bridge Inspection Report

LUC-2-1862 **In-Depth, Element Level Bridge Inspection Report**

PID: 108045

October 2020

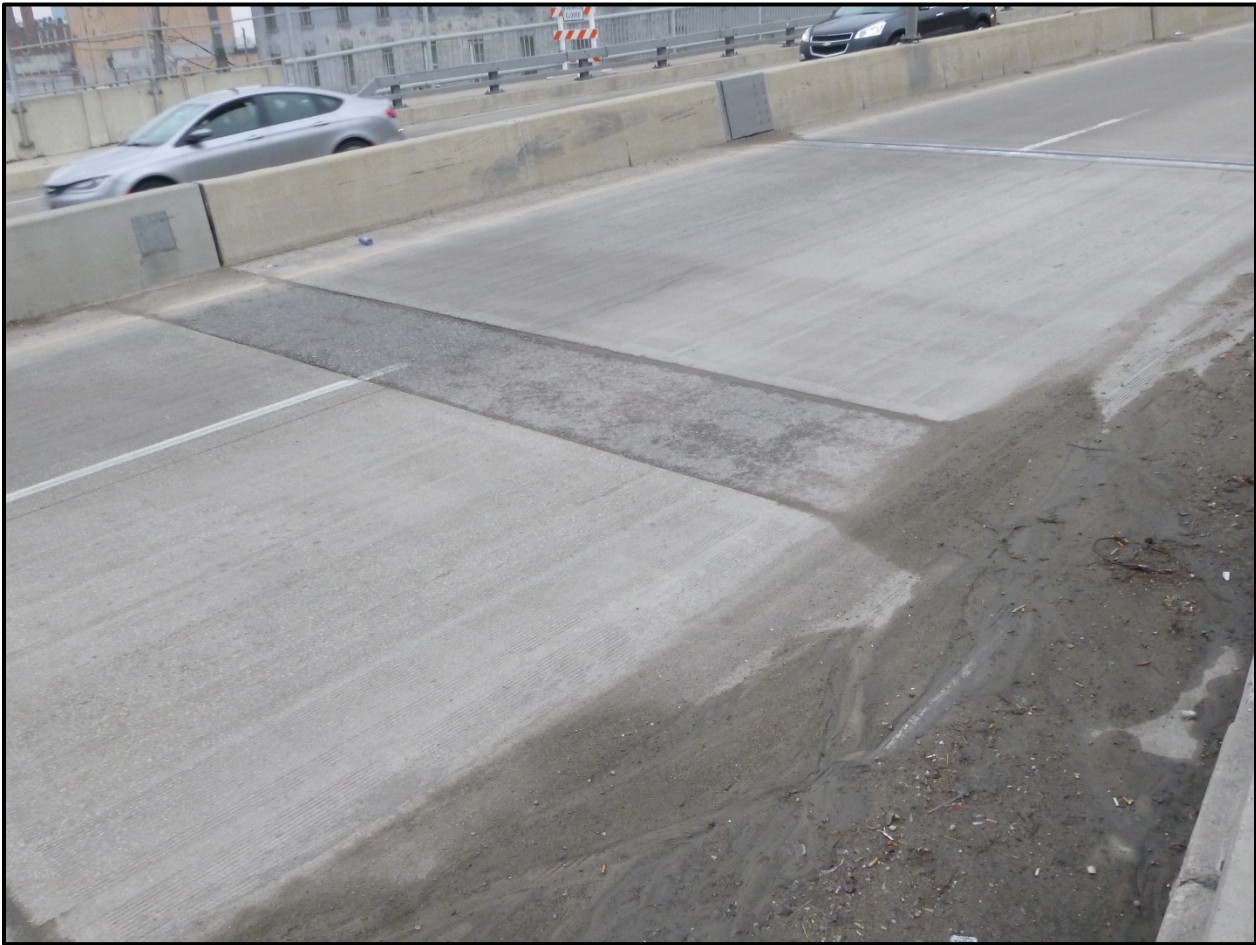
Photo 69 - Typical Approach Slab Termination Condition (Eastbound, West Approach shown)
