PHYSICAL CONDITION REPORT
2024 ROUTINE ELEMENT LEVEL AND NSTM
INSPECTION

INSPECTION MAY 2024
REPORT AUGUST 2024

ANTHONY WAYNE BRIDGE
LUC-002-1862
SFN: 4800303

Ohio Department of Transportation, District 2
317 E Poe Rd
Bowling Green, OH 43402

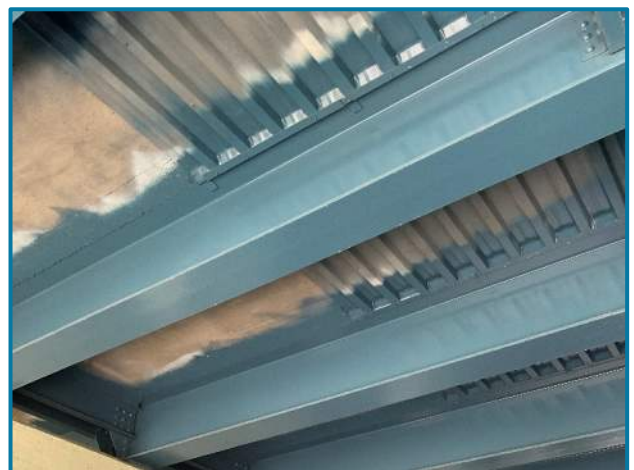
The deck is in GOOD CONDITION [7-SNBI] overall with isolated minor spalls, delaminations and moderate efflorescence in the underside of the deck (see Photo 1). The wearing surface exhibits hairline longitudinal and transverse cracks in all spans with isolated moderate abrasion/wear in the suspension spans near the towers. Both bridge railings have isolated areas of impact damage, and the median barrier has hairline transverse and longitudinal cracks, minor spalls, delaminations, and minor impact scrapes throughout. All expansion joints typically have loosely packed debris along their entire length, but no signs of water leakage.

Photo 1 – Typical condition underside of deck and stay-in-place forms (looking up and northwest between Girders 9 and 11 in Span 14E).

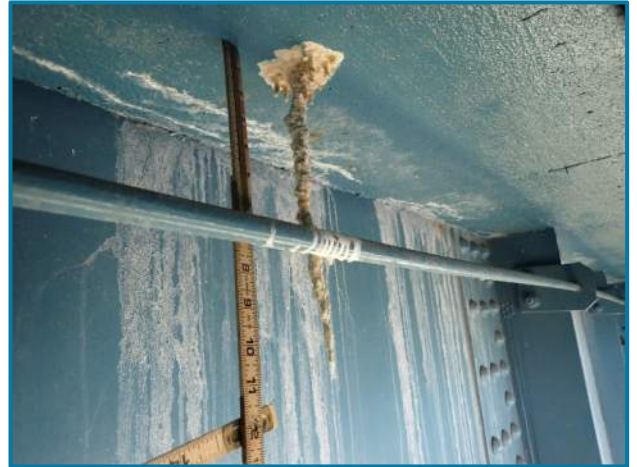
efflorescence on the deck underside with longitudinal cracking, isolated delaminations, and minor spalls along the interior face of the Left and Right Girders (see Photo 2). This deficiency is previously noted, and prior testing of the efflorescence determined the substance is lithium carbonate, which is a result of the installation materials used for the anodes in the deck. Minor efflorescence and corrosion of the stay-in-place forms is present at isolated locations in both the approach and main suspension spans (see Photo 3). Minor curb spalling and map cracking is present adjacent to assembly joints in the following locations:

Photo 2 – Typical efflorescence along girders in suspension spans and isolated location of a stalactite (looking southwest at the north face of Right Girder between Floorbeams 29 and 30 in the Main Suspension Span).

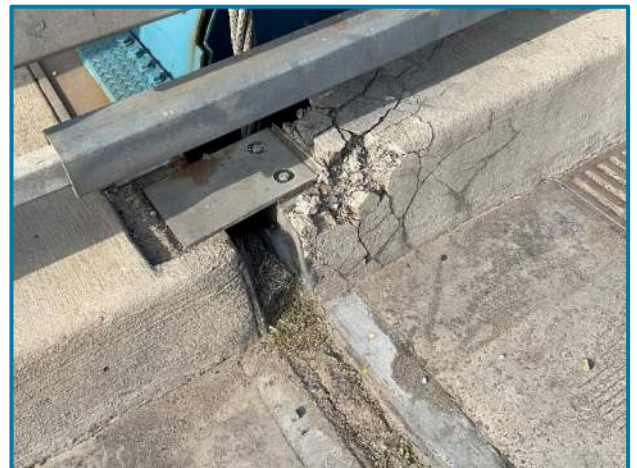
Photo 5 – 1' long by 6" wide by 1" deep curb spall with surrounding delaminated area at Pier E expansion joint, south curb (looking south).

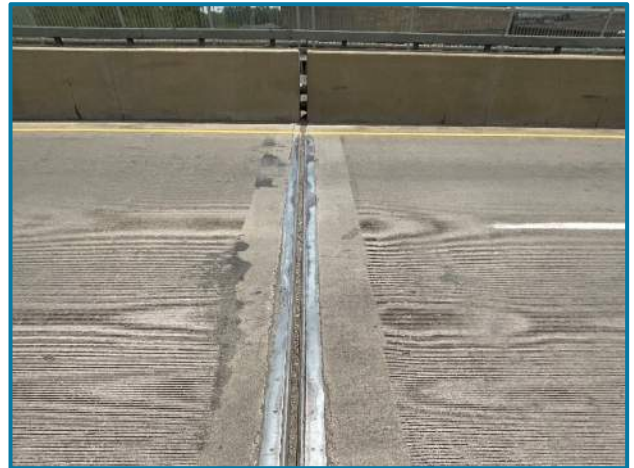
Photo 6 – Debris accumulation and minor header popouts at Pier 3W, westbound lanes (looking south).

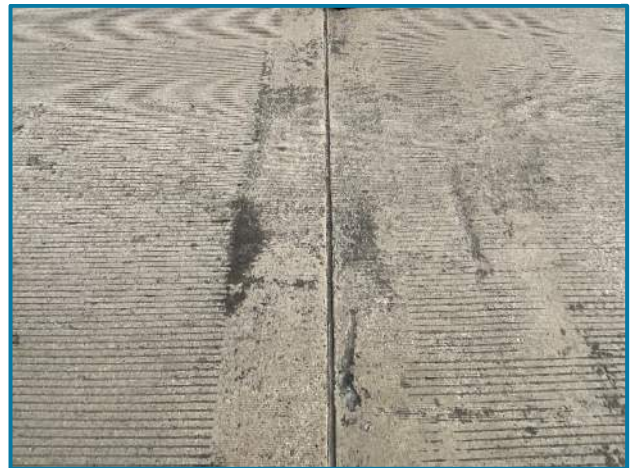
Photo 7 – Pourable strip seal at Forward Abutment, eastbound lanes (looking north).

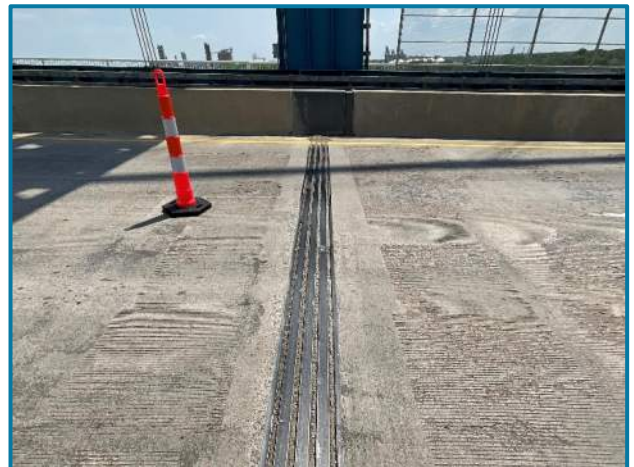
The modular expansion joints (located at Tower C and Tower D) are in good condition overall. The entire length of each joint is impacted with loosely packed debris, which does not appear to affect the overall movement of the joint (see [Photo 8](#)). No signs or indications of water leakage were noted at the time of inspection.

Photo 8 – Debris accumulated in Tower C modular expansion joint, westbound lanes (looking south).

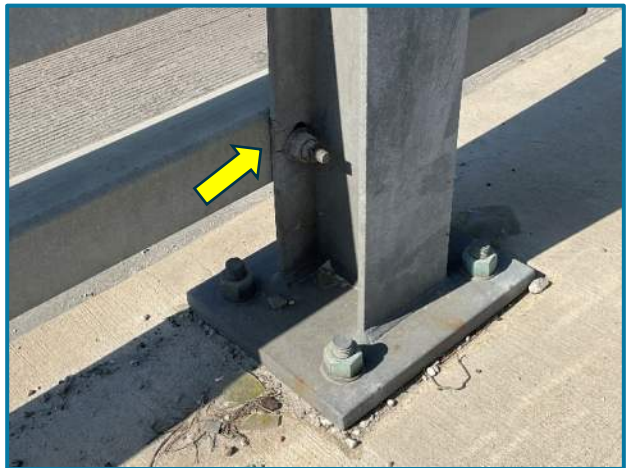
Photo 10 – Crack extending from the lower bolt hole on the east flange of the north railing post in Span 15E at Forward Abutment (looking southwest).

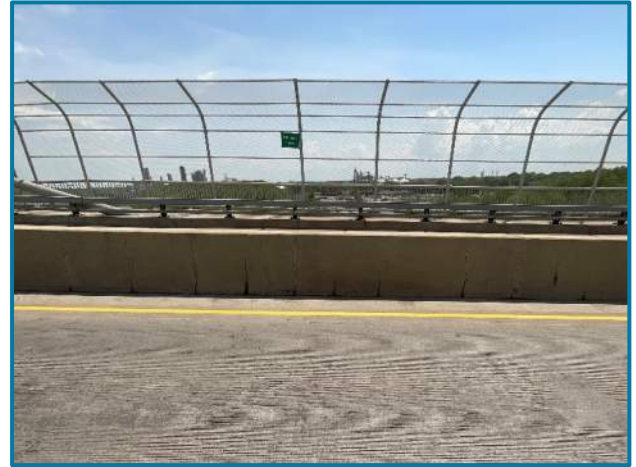
The reinforced concrete bridge railing, which includes the median barrier along the centerline of the bridge, is in satisfactory condition overall with isolated spalls, isolated minor delaminations, and longitudinal cracking at light poles (see Photo 13). Full height vertical cracks, typically at 3' spacing with light rust staining, and hairline transverse cracks are present throughout (see Photo 14).

Photo 14 – Typical cracks with rust staining at 3' spacing, (looking south at the north face in Span RW-1).

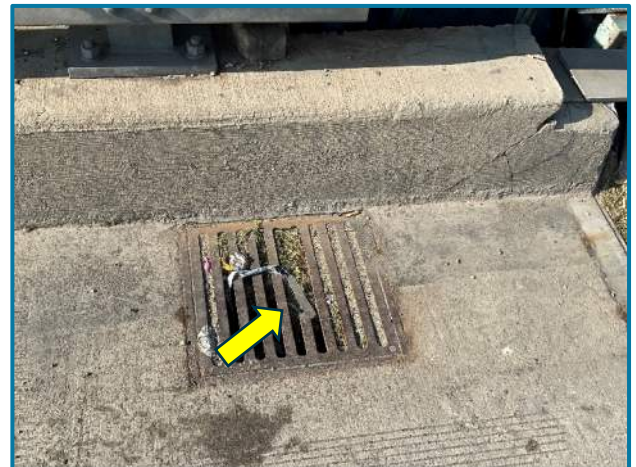
The bridge deck drainage is in satisfactory condition. The deck scuppers throughout are 25-75% clogged with debris but appear to be draining. One grate, along the south curb of the eastbound lane of the West Suspension Span near Pier B, has a broken grating bar (see Photo 15). No deficiencies were observed to the remainder of the drainage system below deck level.

Photo 15 – Broken and partially clogged drainage grate at Pier B, West Suspension Span along the south curb (looking south).

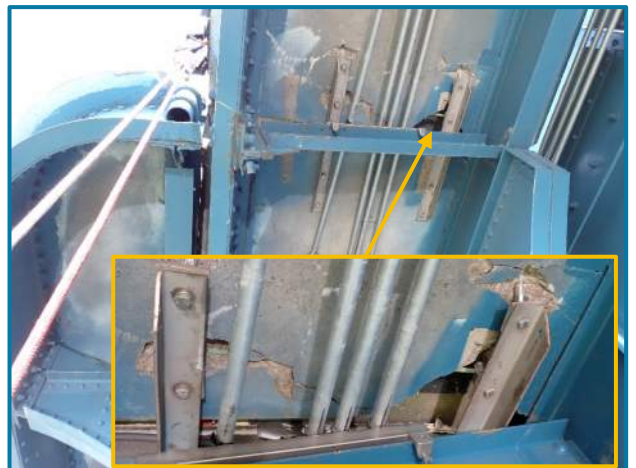
Photo 16 – Spalls with exposed reinforcement and spalls around anchors connecting the sidewalk panels together at the east side of Tower C, south sidewalk (looking west). Note several broken conduits and exposed wires.

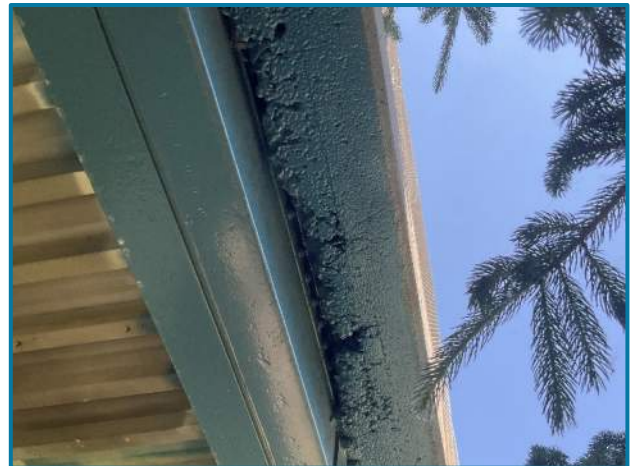
Photo 19 – Poorly consolidated concrete along Stringer 13 in Span 12E (looking east).

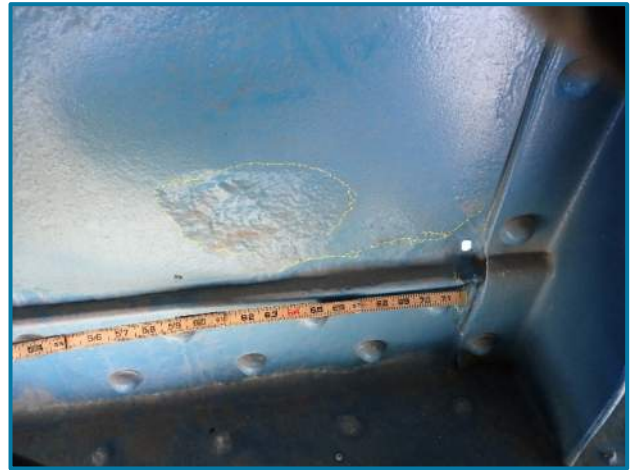
Photo 21 – 1/4" deep web pitting with 1/2" diameter corrosion hole through Right Girder in Main Suspension Span between Floorbeams 42 and 43 (looking south).

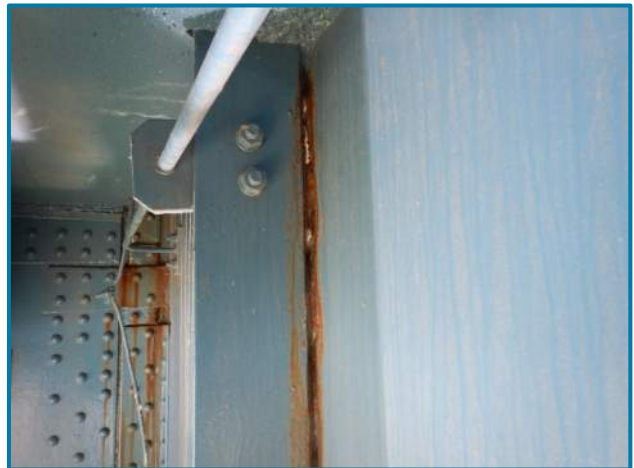
Photo 23 – Laminate corrosion to the edge of fill plate and girder web along the edge of the transverse stiffener on the Left Girder between Floorbeams 26 and 27 in the Main Suspension Span (looking west).

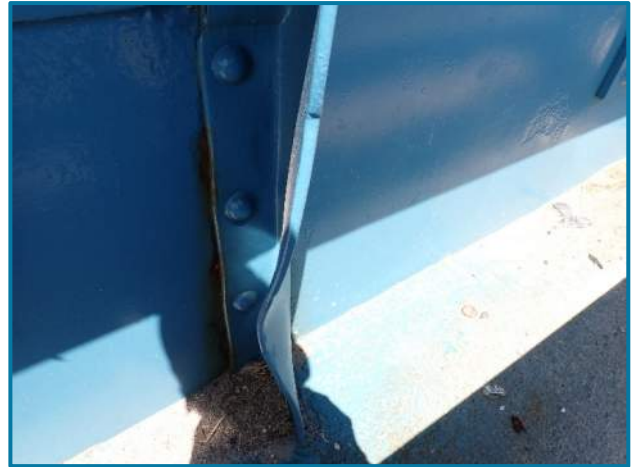
Photo 25 – Impact damage to transverse stiffener above deck of the Left Girder between Floorbeams 1 and 2 in the West Suspension Span (looking northeast).

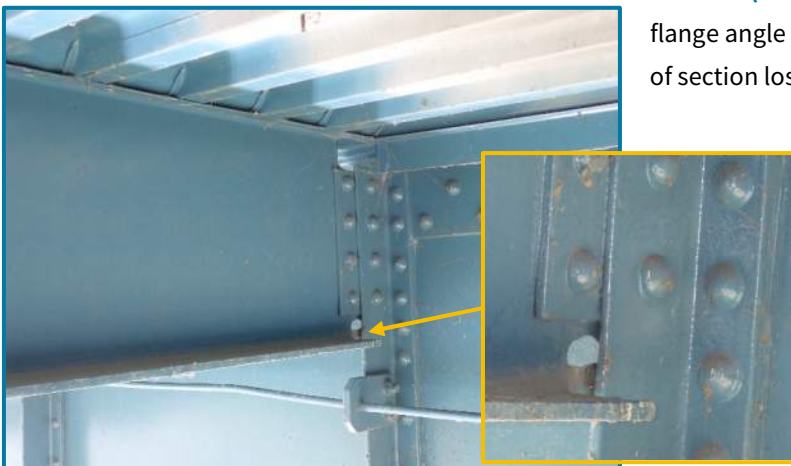
Photo 27 – 3" corrosion hole through Stringer 3 web at connection to Floorbeam 30 in Main Suspension Span (looking southwest).

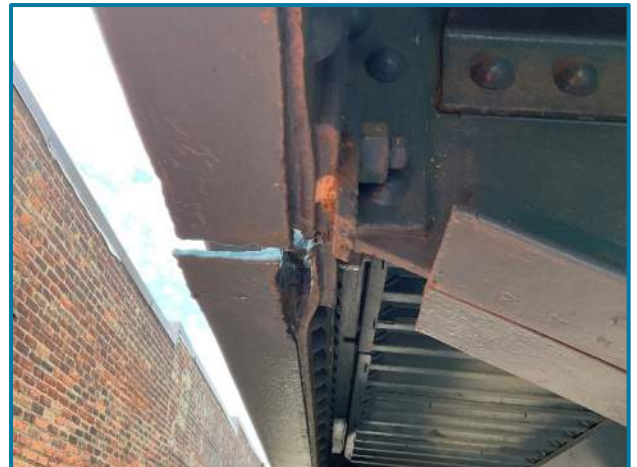
Photo 29 – Pack rust between bottom flange angle and web plate of Right Stringer 2 at Floorbeam 1 in Span 6W (looking west).

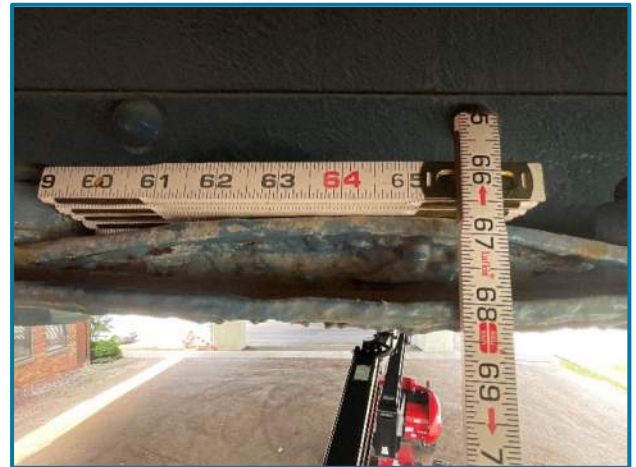
Photo 33 – Pack rust up to 1" thick along FB3 bottom flange in Span 7W at midspan (looking west).

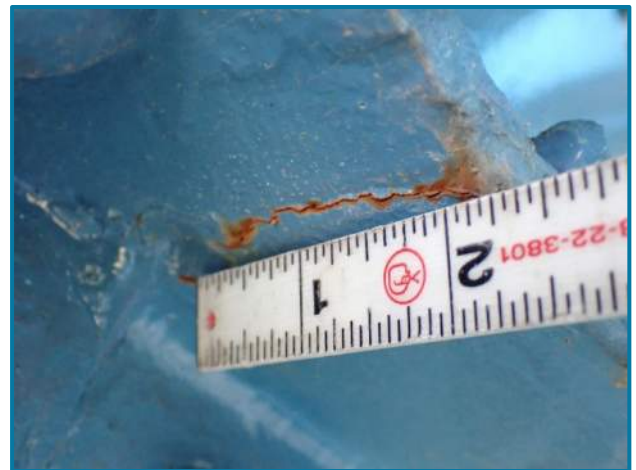
Photo 35 – Cantilever sidealk bracket at Floorbeam 51, top flange with 1 3/4" long crack between Left Stringer 1 and Left Girder in Main Suspension Span (looking southwest). Note the arrest hole filled with caulk.

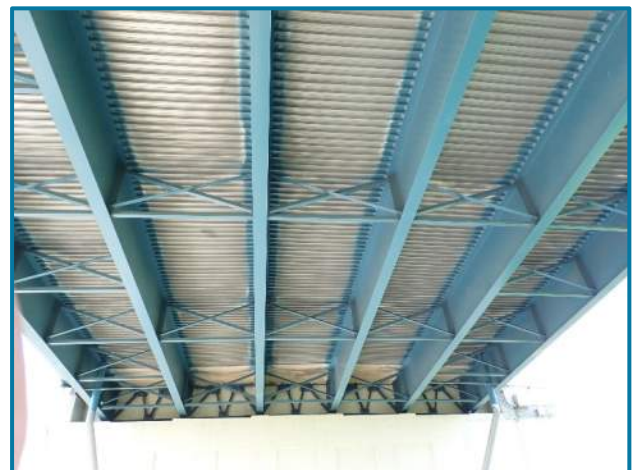
The steel protective coating is in good condition. As part of the 2016-2017 rehabilitation, all structural steel components were cleaned and painted (see Photo 36). Isolated instances of peeling paint, paint failure and light chalking are typical at areas of reactivated laminate corrosion.

Photo 36 – Typical condition of steel protective coating, Span RW-2 (looking west).

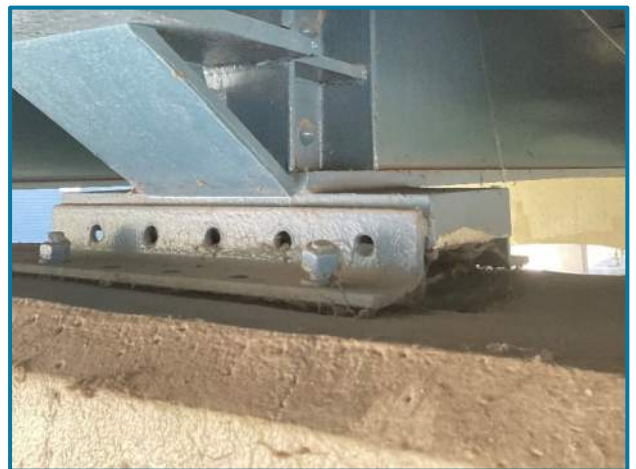
Photo 38 – Backed off northeast anchor rod nut of Beam 11 at Pier 12E (looking southwest).

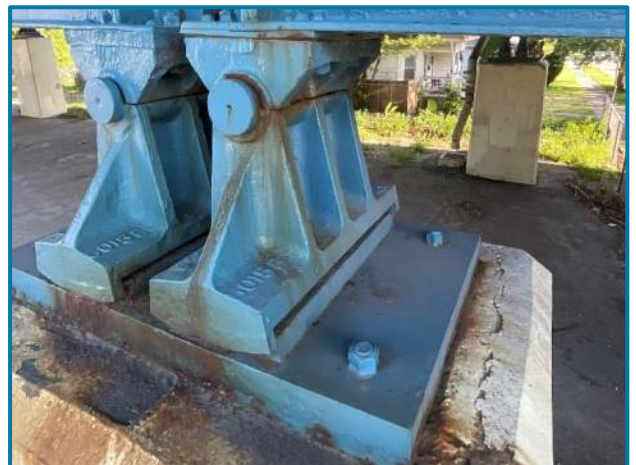
Photo 40 – Right Girder rocker bearing at Pier 6E (looking north).

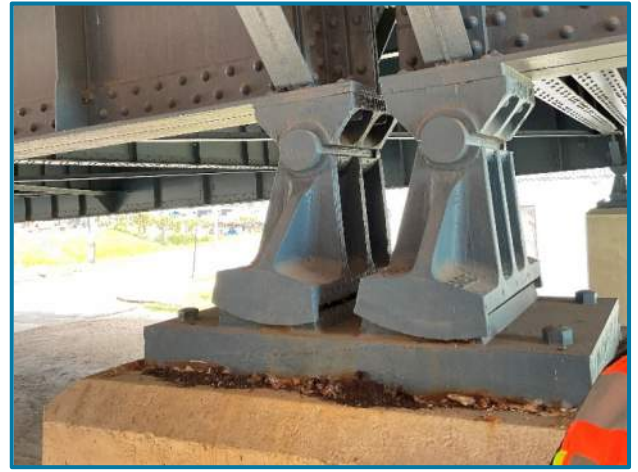
Photo 42 – Right Girder rocker bearing tilted up to 10° to the east at Pier 6W (looking northwest).

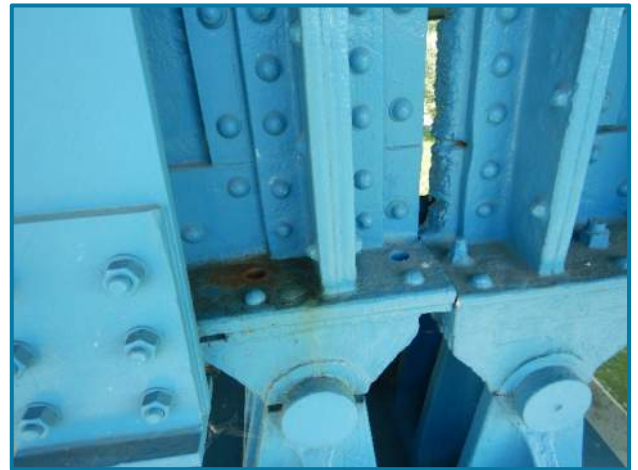
the rocker bearing sole plate and Left Girder bottom flange are missing (see Photo 43). The bottom flange of the Left Girder between adjacent Spans 3W and 2W is in contact above Pier 2W.

Photo 43 – 4 of 8 missing connectors at Left Girder rocker bearing sole plate, Pier 2W (looking south).

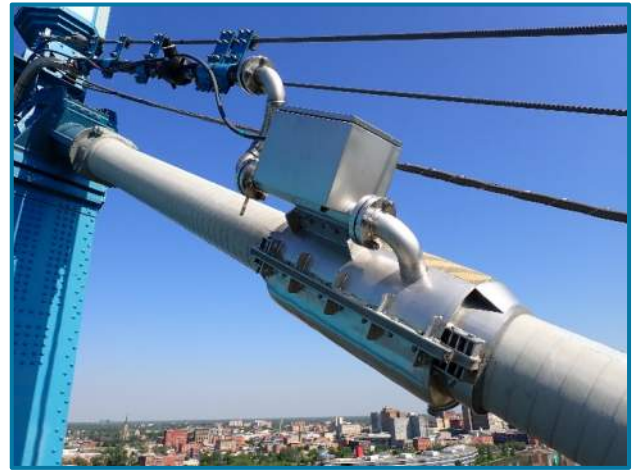
Photo 46 – Dehumidification system at North Cable east of Tower D (looking northwest).

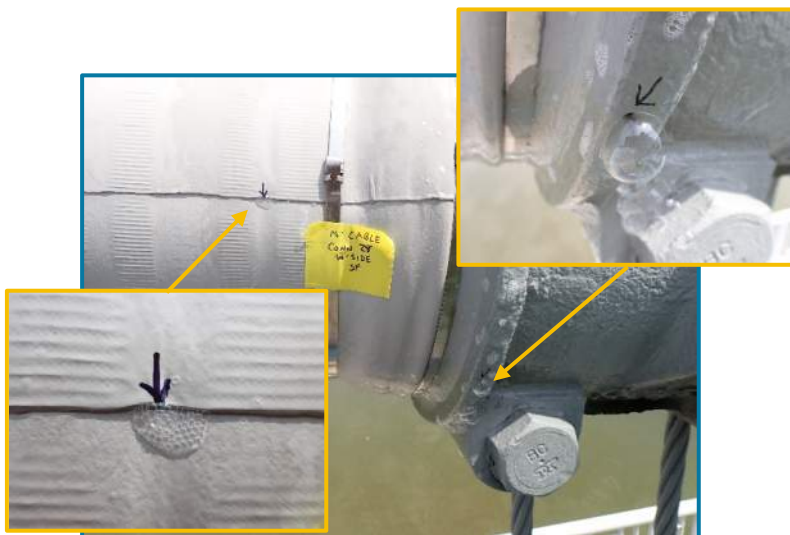
Photo 47 – Minor leaks in the cable wrap and at an open hole in the suspender collar of the North Cable at Suspender Cable 28 (looking north).

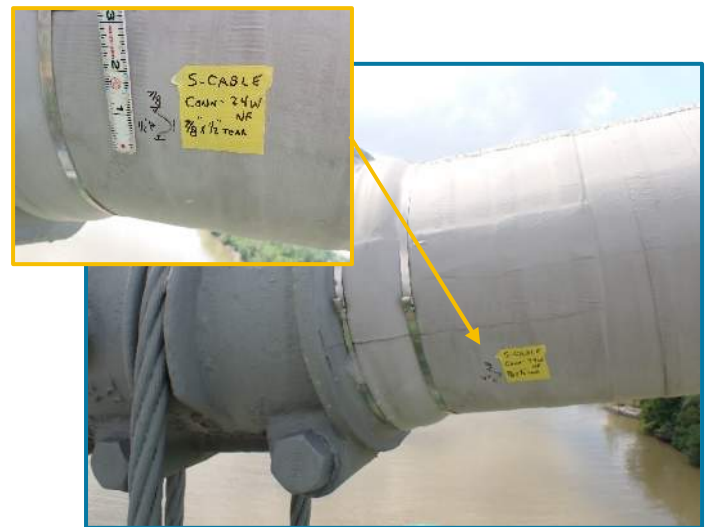
Photo 48 – Gouge in South Cable wrap at Suspender Cable 24 (looking south). Note there were not leaks associated with this gouge.

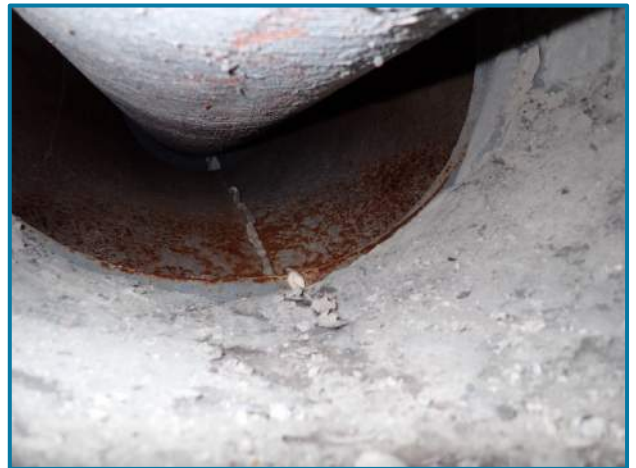
Photo 52 – Surface corrosion of North Cable sleeve at entrance into Anchorage F (looking west).

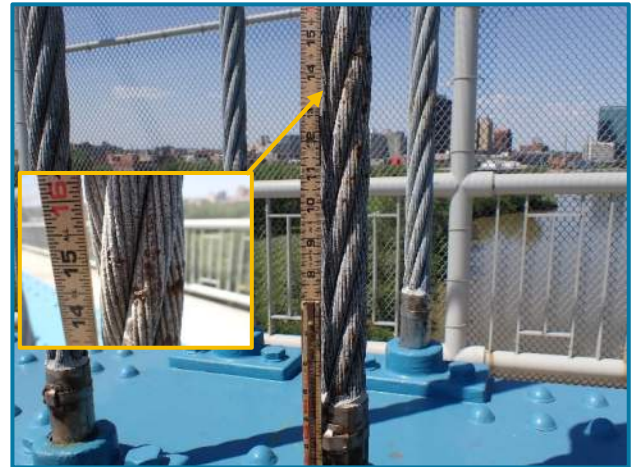
Photo 56 – Minor surface corrosion on North Suspender Cable 10 in the splash zone (looking northwest).

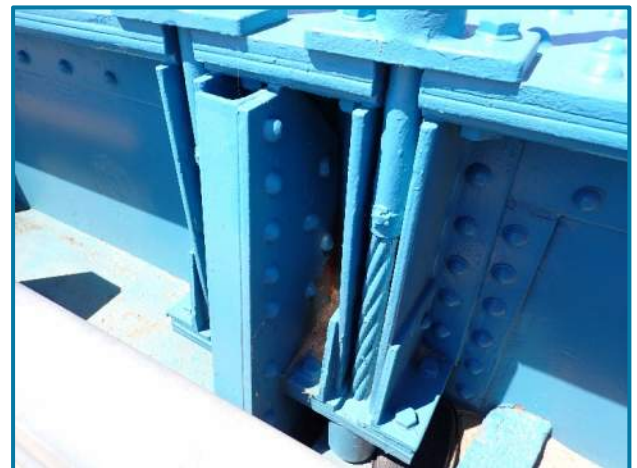
Photo 57 – Accumulation of roadway debris between the stiffeners at deck level at the North Suspender Cable 5 at Left Girder (looking northwest)

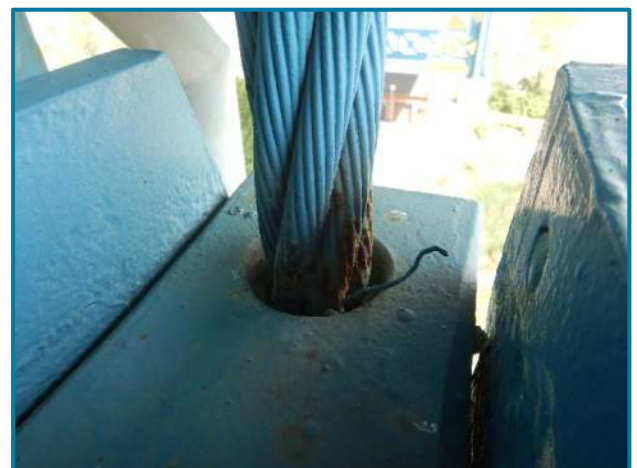
Photo 59 – Broken wire at southeast suspender cable of South Suspender Cable 0 (looking east).

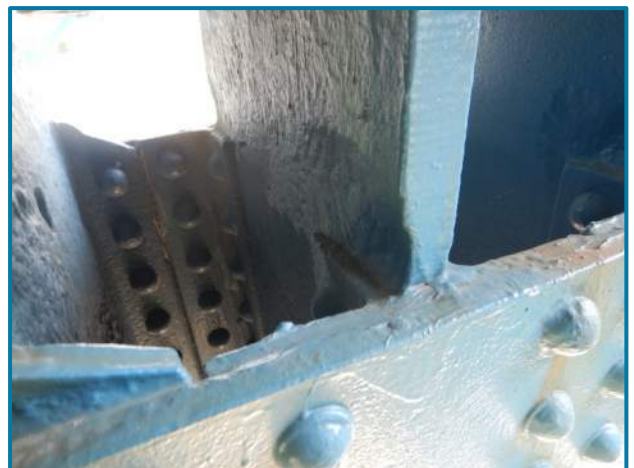
Photo 62 – 1/8" deep pitting of south link plate of the south column at Pier B (looking northwest).

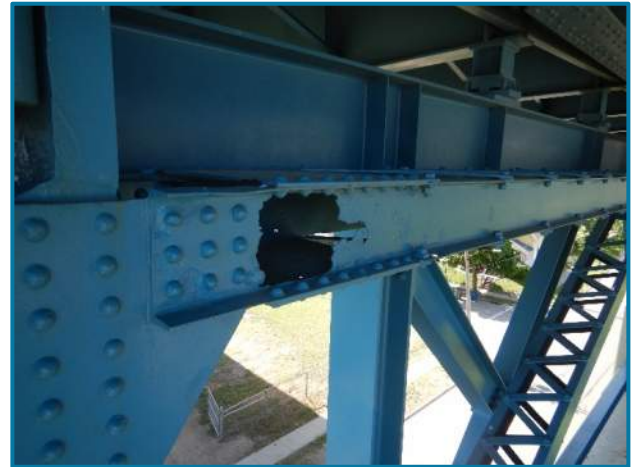
Photo 65 – Numerous corrosion holes through the upper strut at Pier E near the north column (looking southeast).

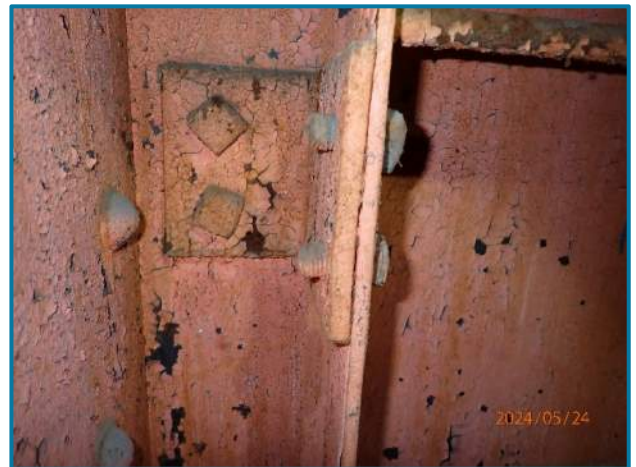
Photo 69 – Missing nuts at ladder connection and typical paint condition of the easternmost cell of Tower D in the south leg (looking southeast).

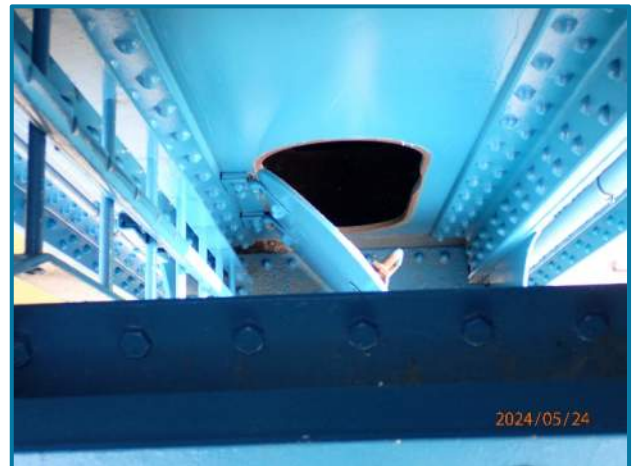
Photo 71 – Unsecured upper access hatch at the north leg of Tower D (looking north).

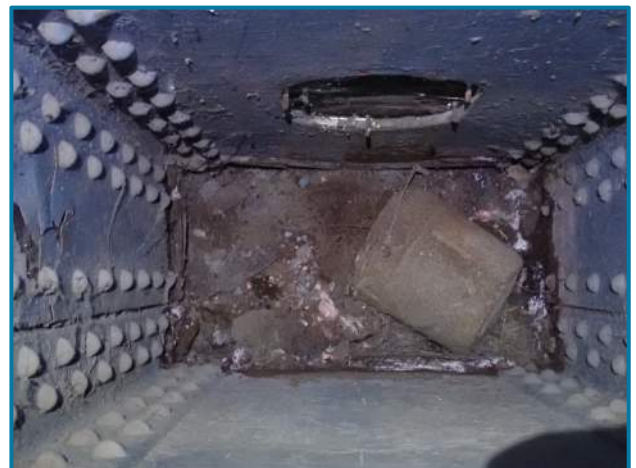
Photo 73 – Debris and laminate corrosion in the center cell of Tower D at the north leg base (looking east/down).

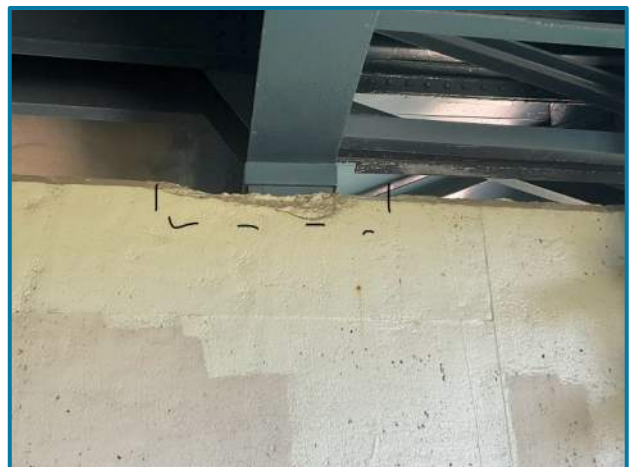
Photo 80 – 2' wide by 6" high by 3" deep spall on the west face of the Pier 11E cap under Beam 11 (looking east).

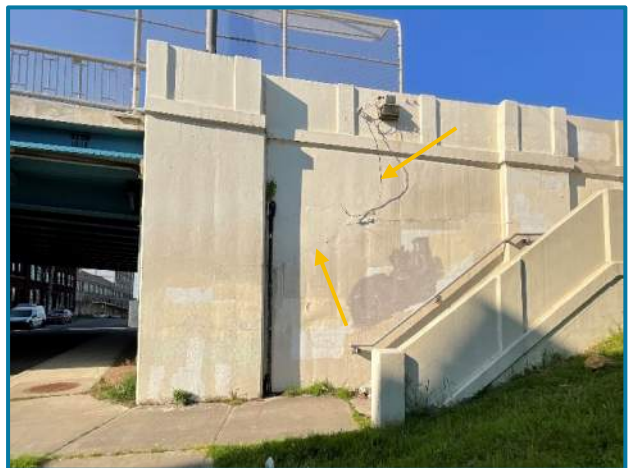
Photo 82 – 40'L horizontal crack and disconnected staircase light at the Rear Abutment North Retaining Wall (looking south).

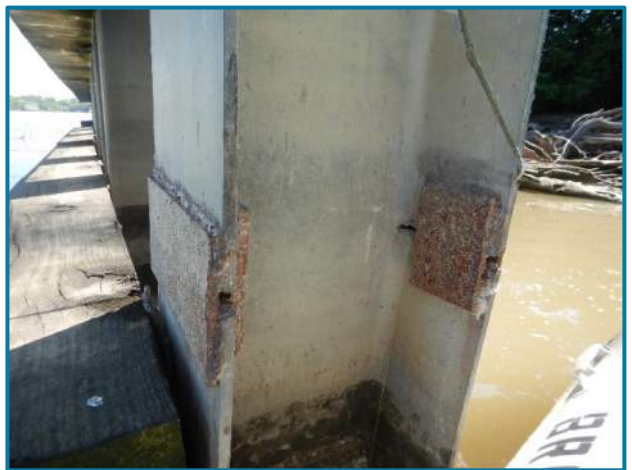
Photo 84 – Poor quality at northernmost pile at Tower C pier protection (looking south).

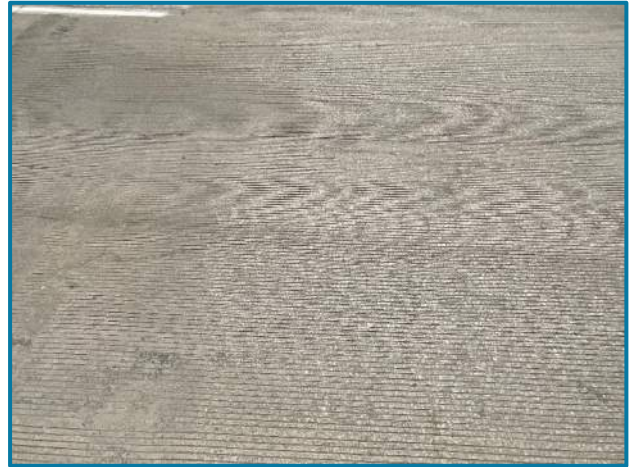
Photo 88 – Typical widespread map cracking in the Rear Approach Slab, westbound lanes (looking south).

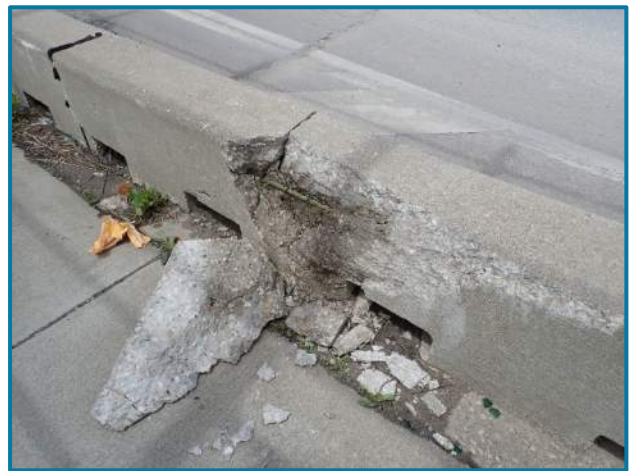
Photo 89 – Rear Approach guardrail with 4' long by 2' high by 6" deep spall with exposed reinforcement (looking north).

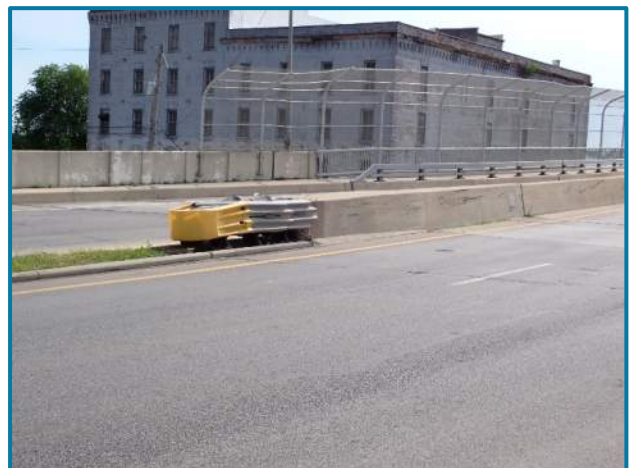
Photo 90 – Impact damage to attenuator at the west end of the Rear Approach median barrier (looking northeast).

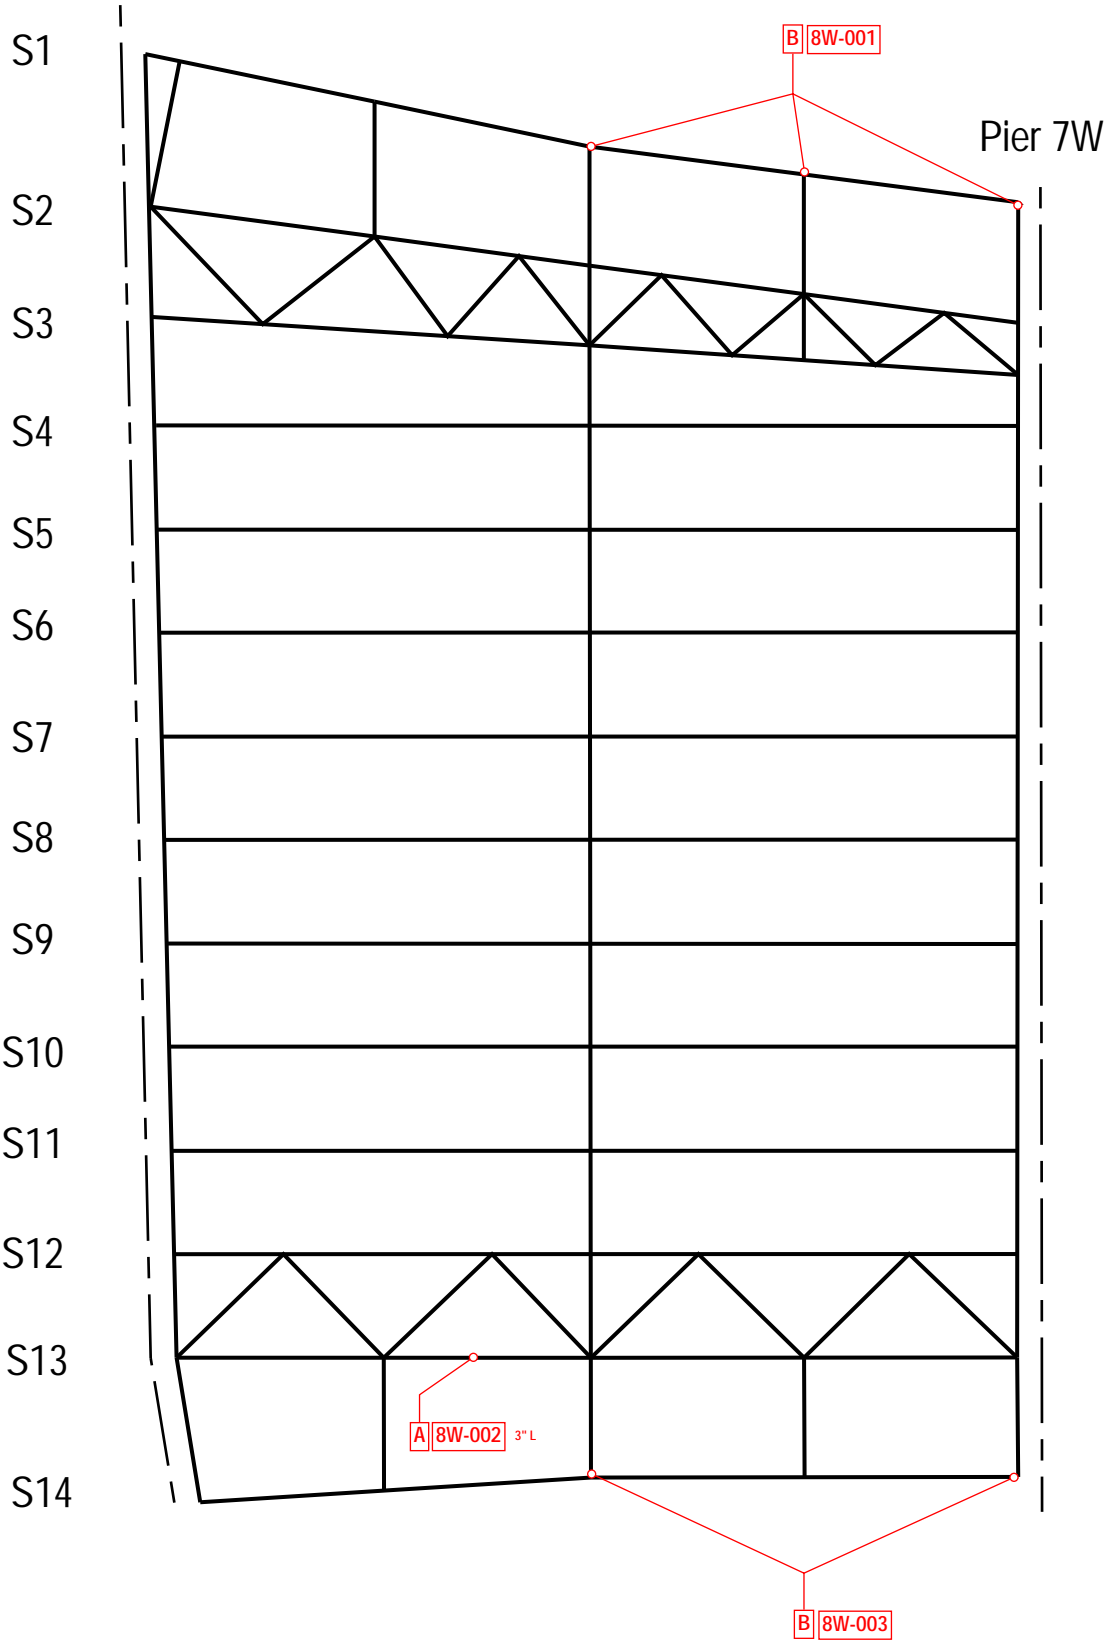
Rear Abutment

A: Floorbeam - up to 100% section loss of top flange at sidewalk overhang
B: Floorbeam - Painted over section loss of top flange at sidewalk overhang
C: Floorbeam - Typical, pack rust between bottom angle/cover plate
D: Stringer - Typical, pack rust between bottom angle/web of fascia stringers
E: Stringer - Typical, painted over section loss of fascia stringers at connection
F: Deck - minor hauch spalling

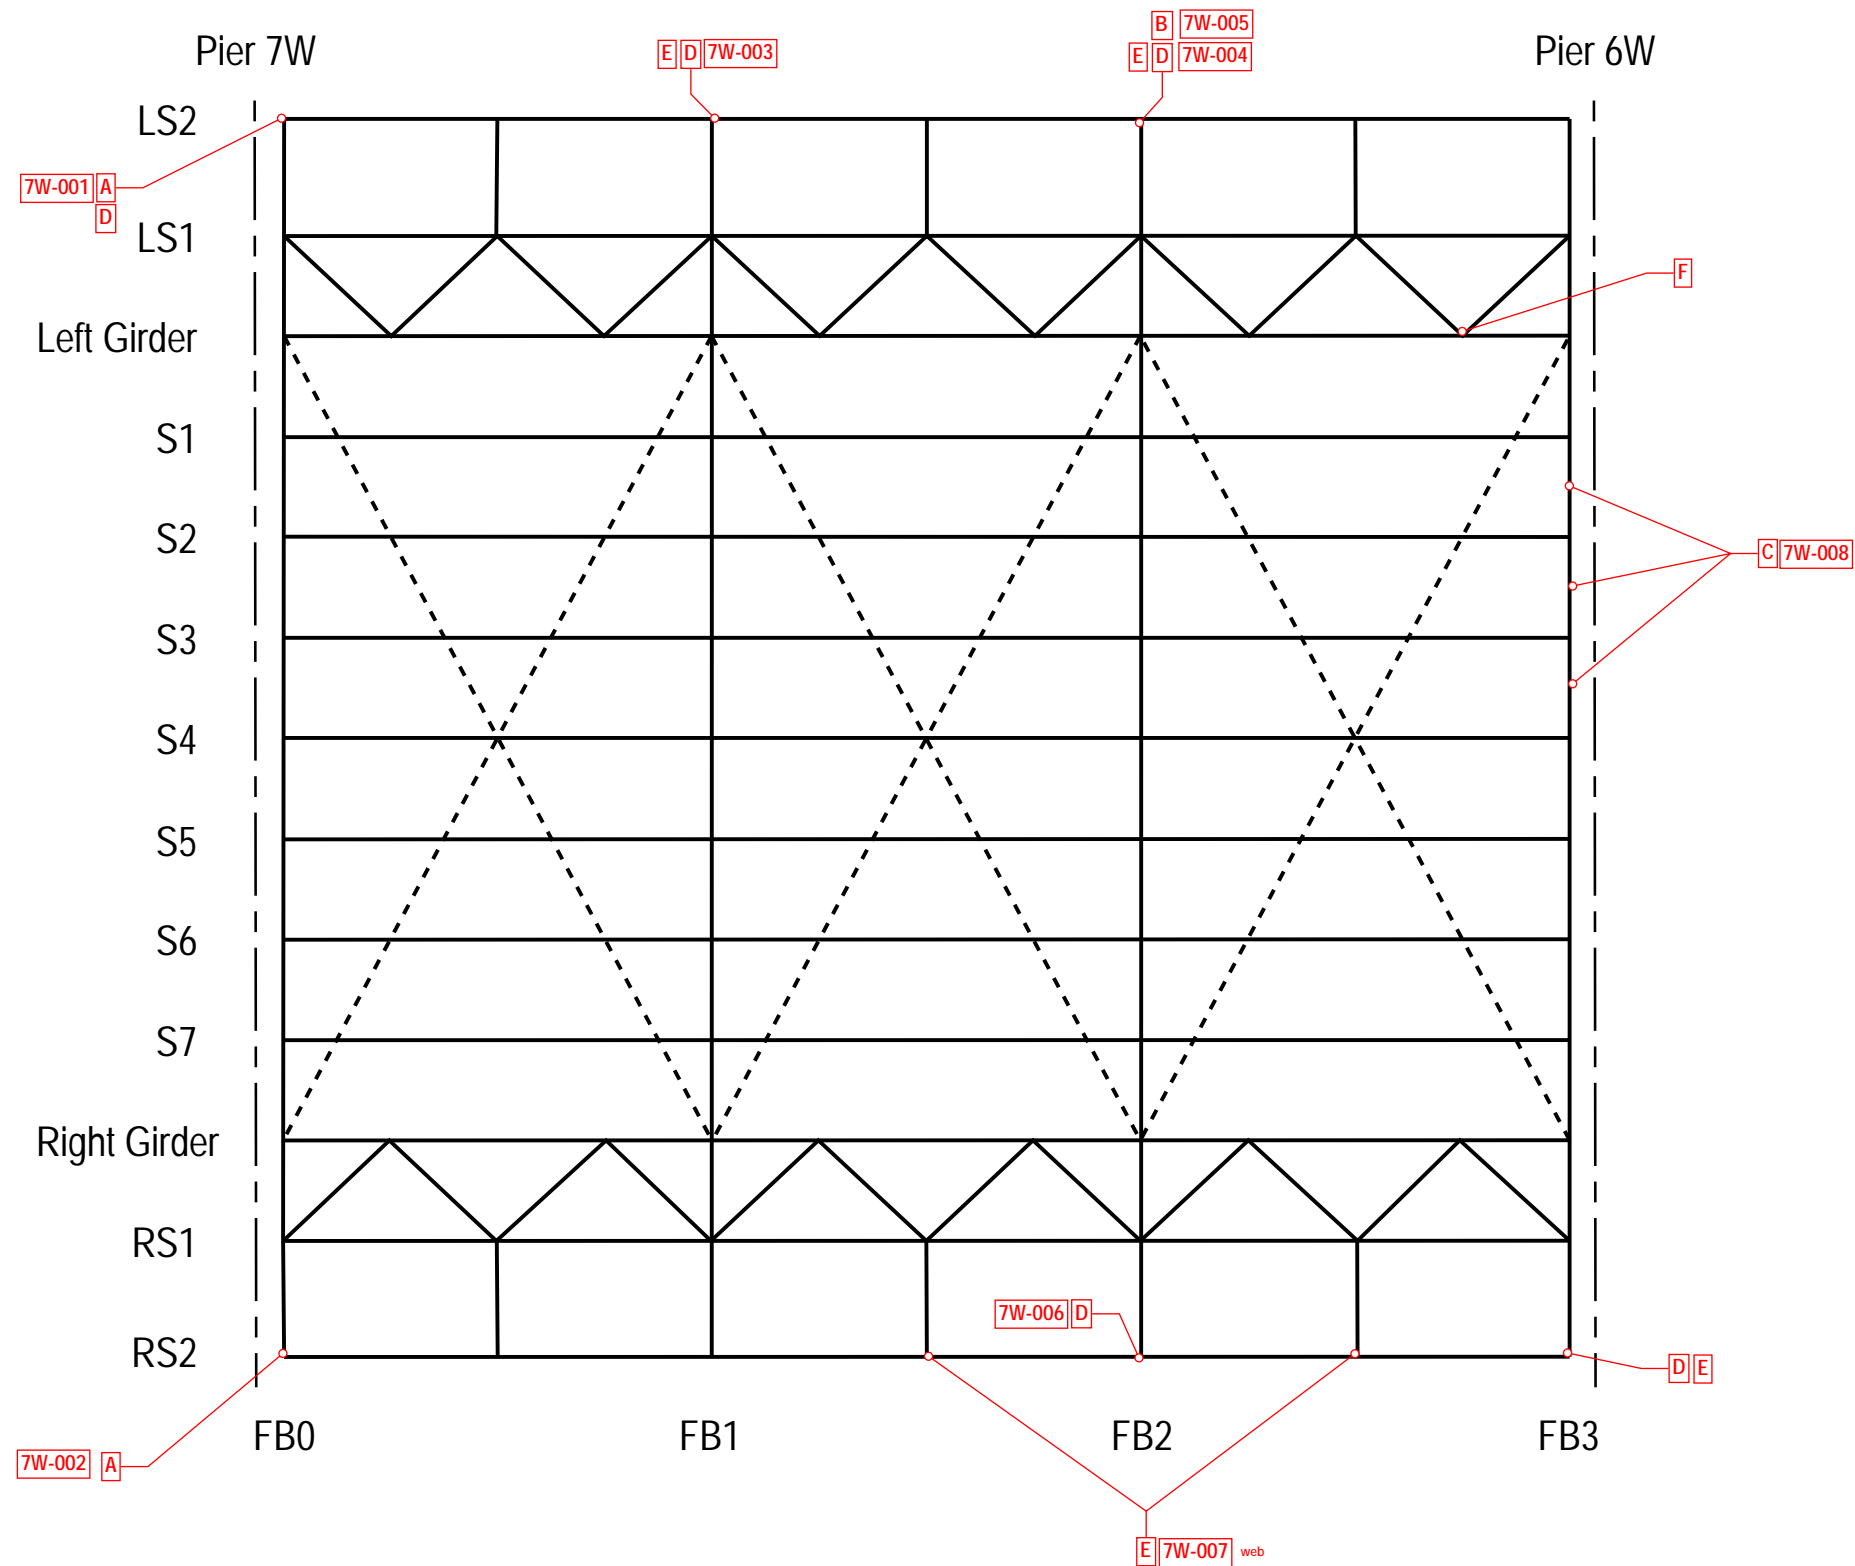
A: Bearing - all bearings at Pier 6 tilted 10° degrees to the east
B: Lateral Brace - typical granular and bird debris on connection plate
C: Stringer - 3 of 4 bolts missing on stiffener angle
D: Stringer - Typical, pack rust between bottom angle/web of fascia stringers
E: Stringer - Typical, painted over section loss of fascia stringers at connection

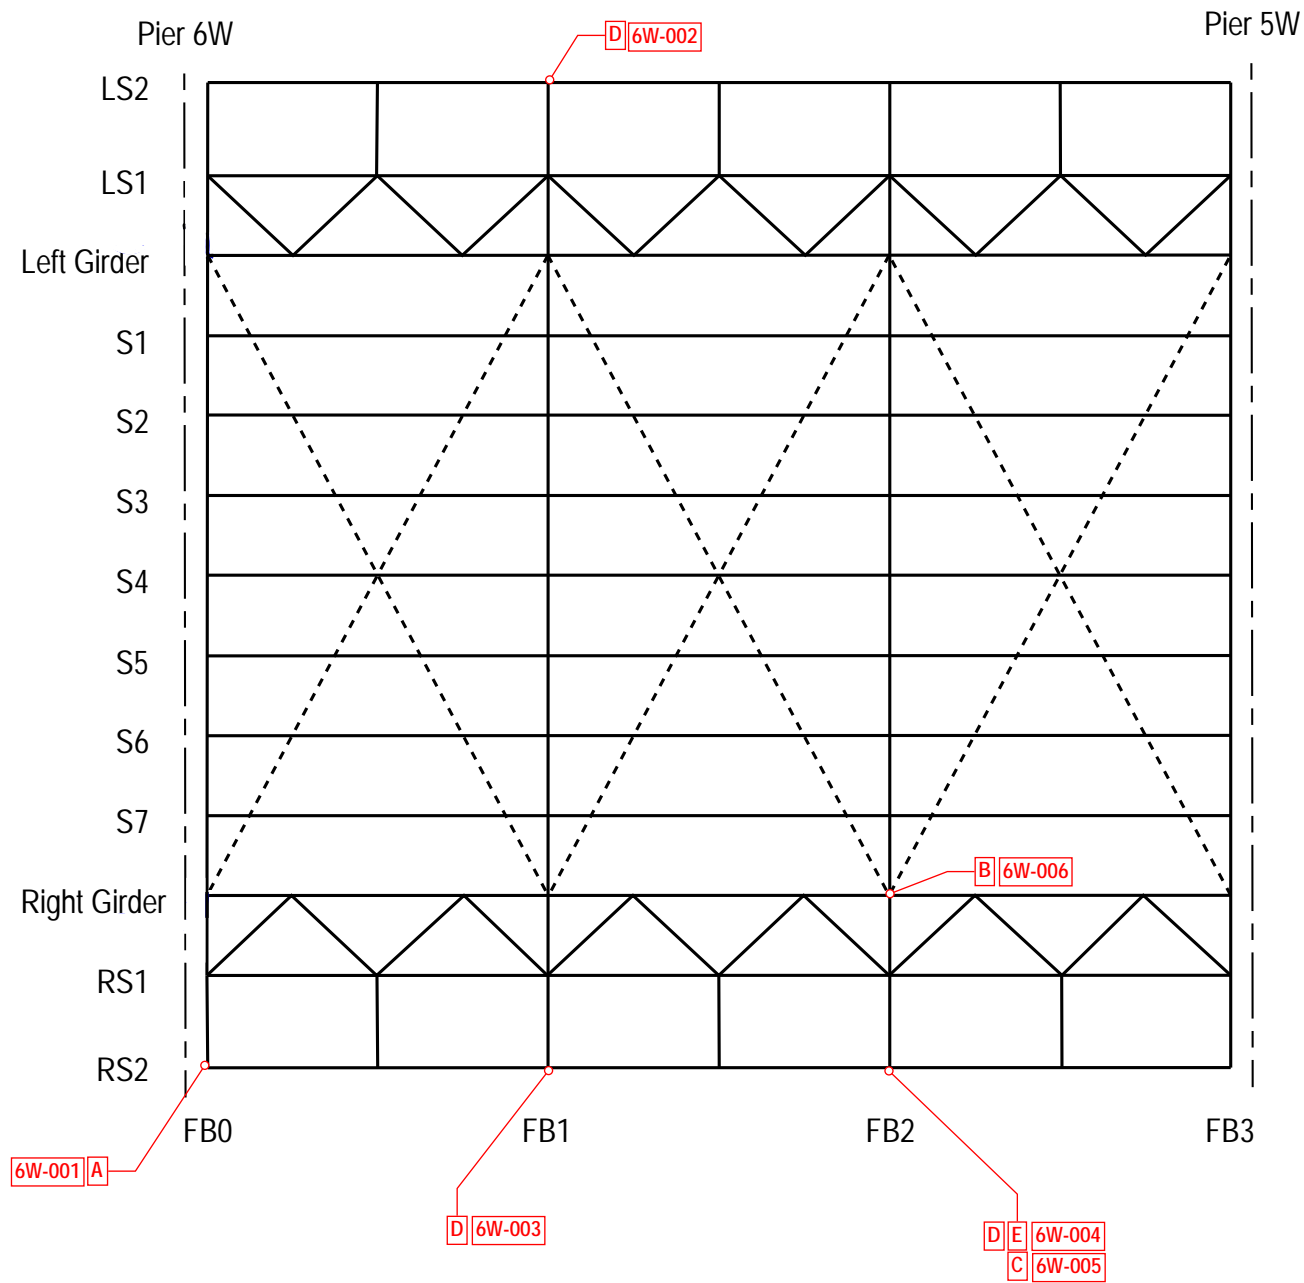
A: Floorbeam - up to 100% section loss of ____ flange at sidewalk overhang
B: Floorbeam - Painted over pitting throughout web
C: Floorbeam - Minor bowing to web
D: Stringer - Typical, pack rust between bottom angle/web of fascia stringers
E: Stringer - Typical, painted over section loss of fascia stringers
F: Girder - abandoned fillet welds on web
G: Girder - typical bird nesting debris on bottom flange, ____ side of floorbeam
H: Floorbeam - stiffeners flame cut 12" from bottom flange
