PHYSICAL CONDITION REPORT
2024 ROUTINE ELEMENT LEVEL AND NSTM
INSPECTION

INSPECTION MAY 2024
REPORT AUGUST 2024

ANTHONY WAYNE BRIDGE
LUC-002-1862
SFN: 4800303

Ohio Department of Transportation, District 2
317 E Poe Rd
Bowling Green, OH 43402

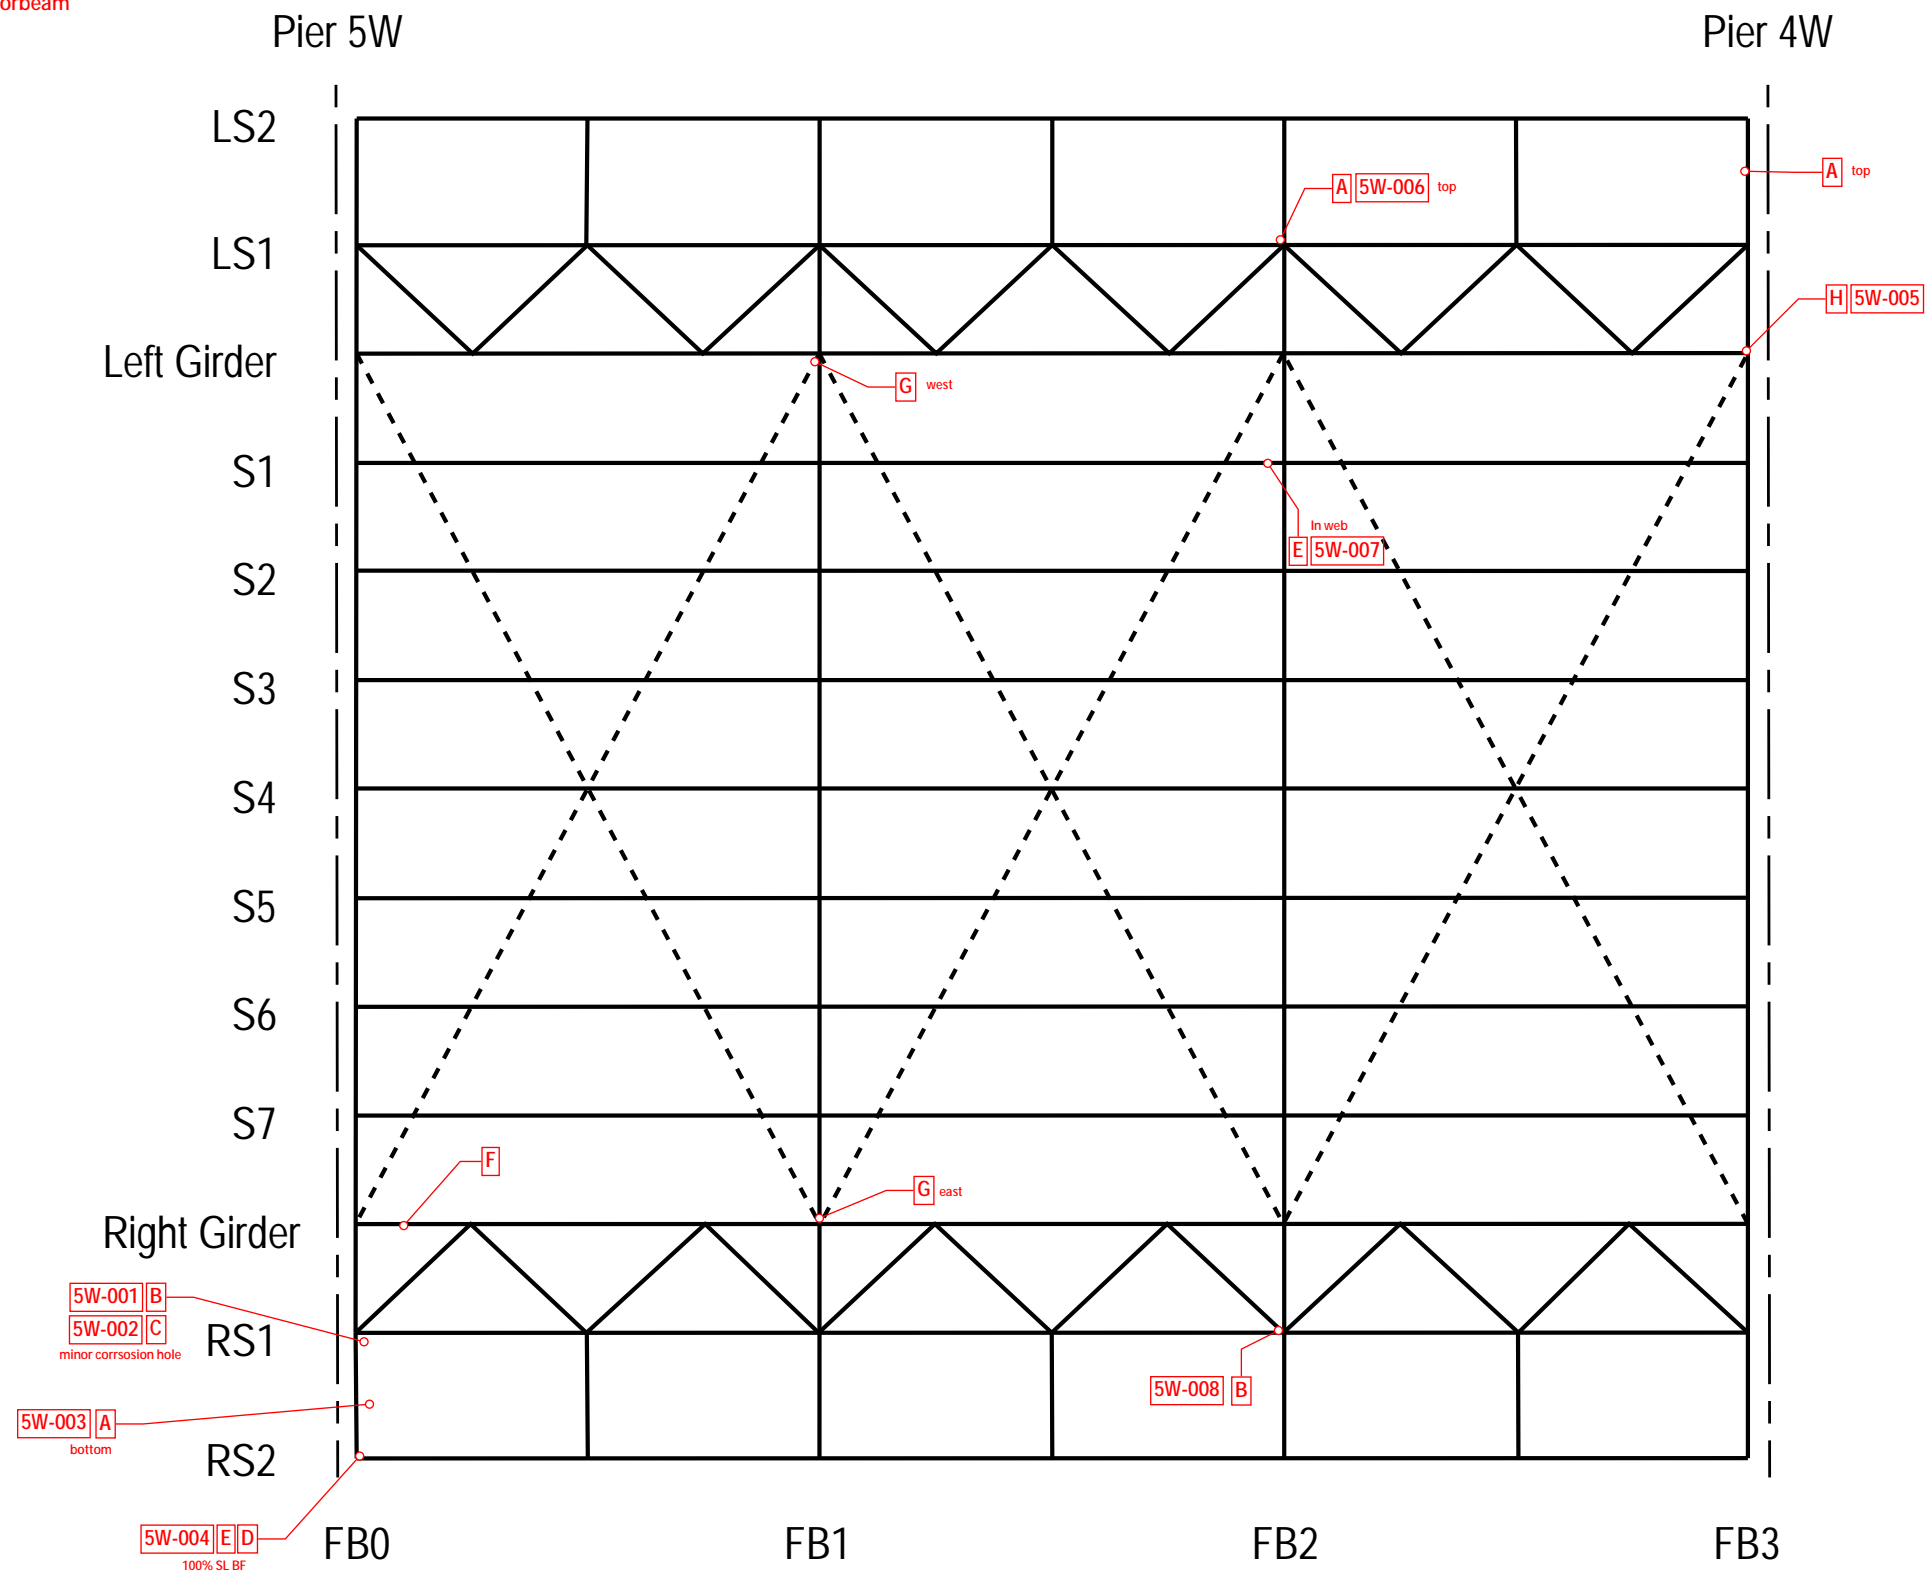
A: Stringer - up to 1/2" thick pack rust between the sidewalk cantilever bracket connection causing wave in bottom of C-channel (typical)
B: Stringer - missing bolt at the bottom of utility hanger connection
C: Floorbeam - bottom flange coped (13" length) at either end between girders
D: Floorbeam - transverse weld in the top flange between LS1 and LS2
E: Bearings - up to 50% section loss to anchor rod
F: Floorbeam - typical painted over section loss with caulking at stiffener base
G: Floorbeam - up to 100% section loss in top flange

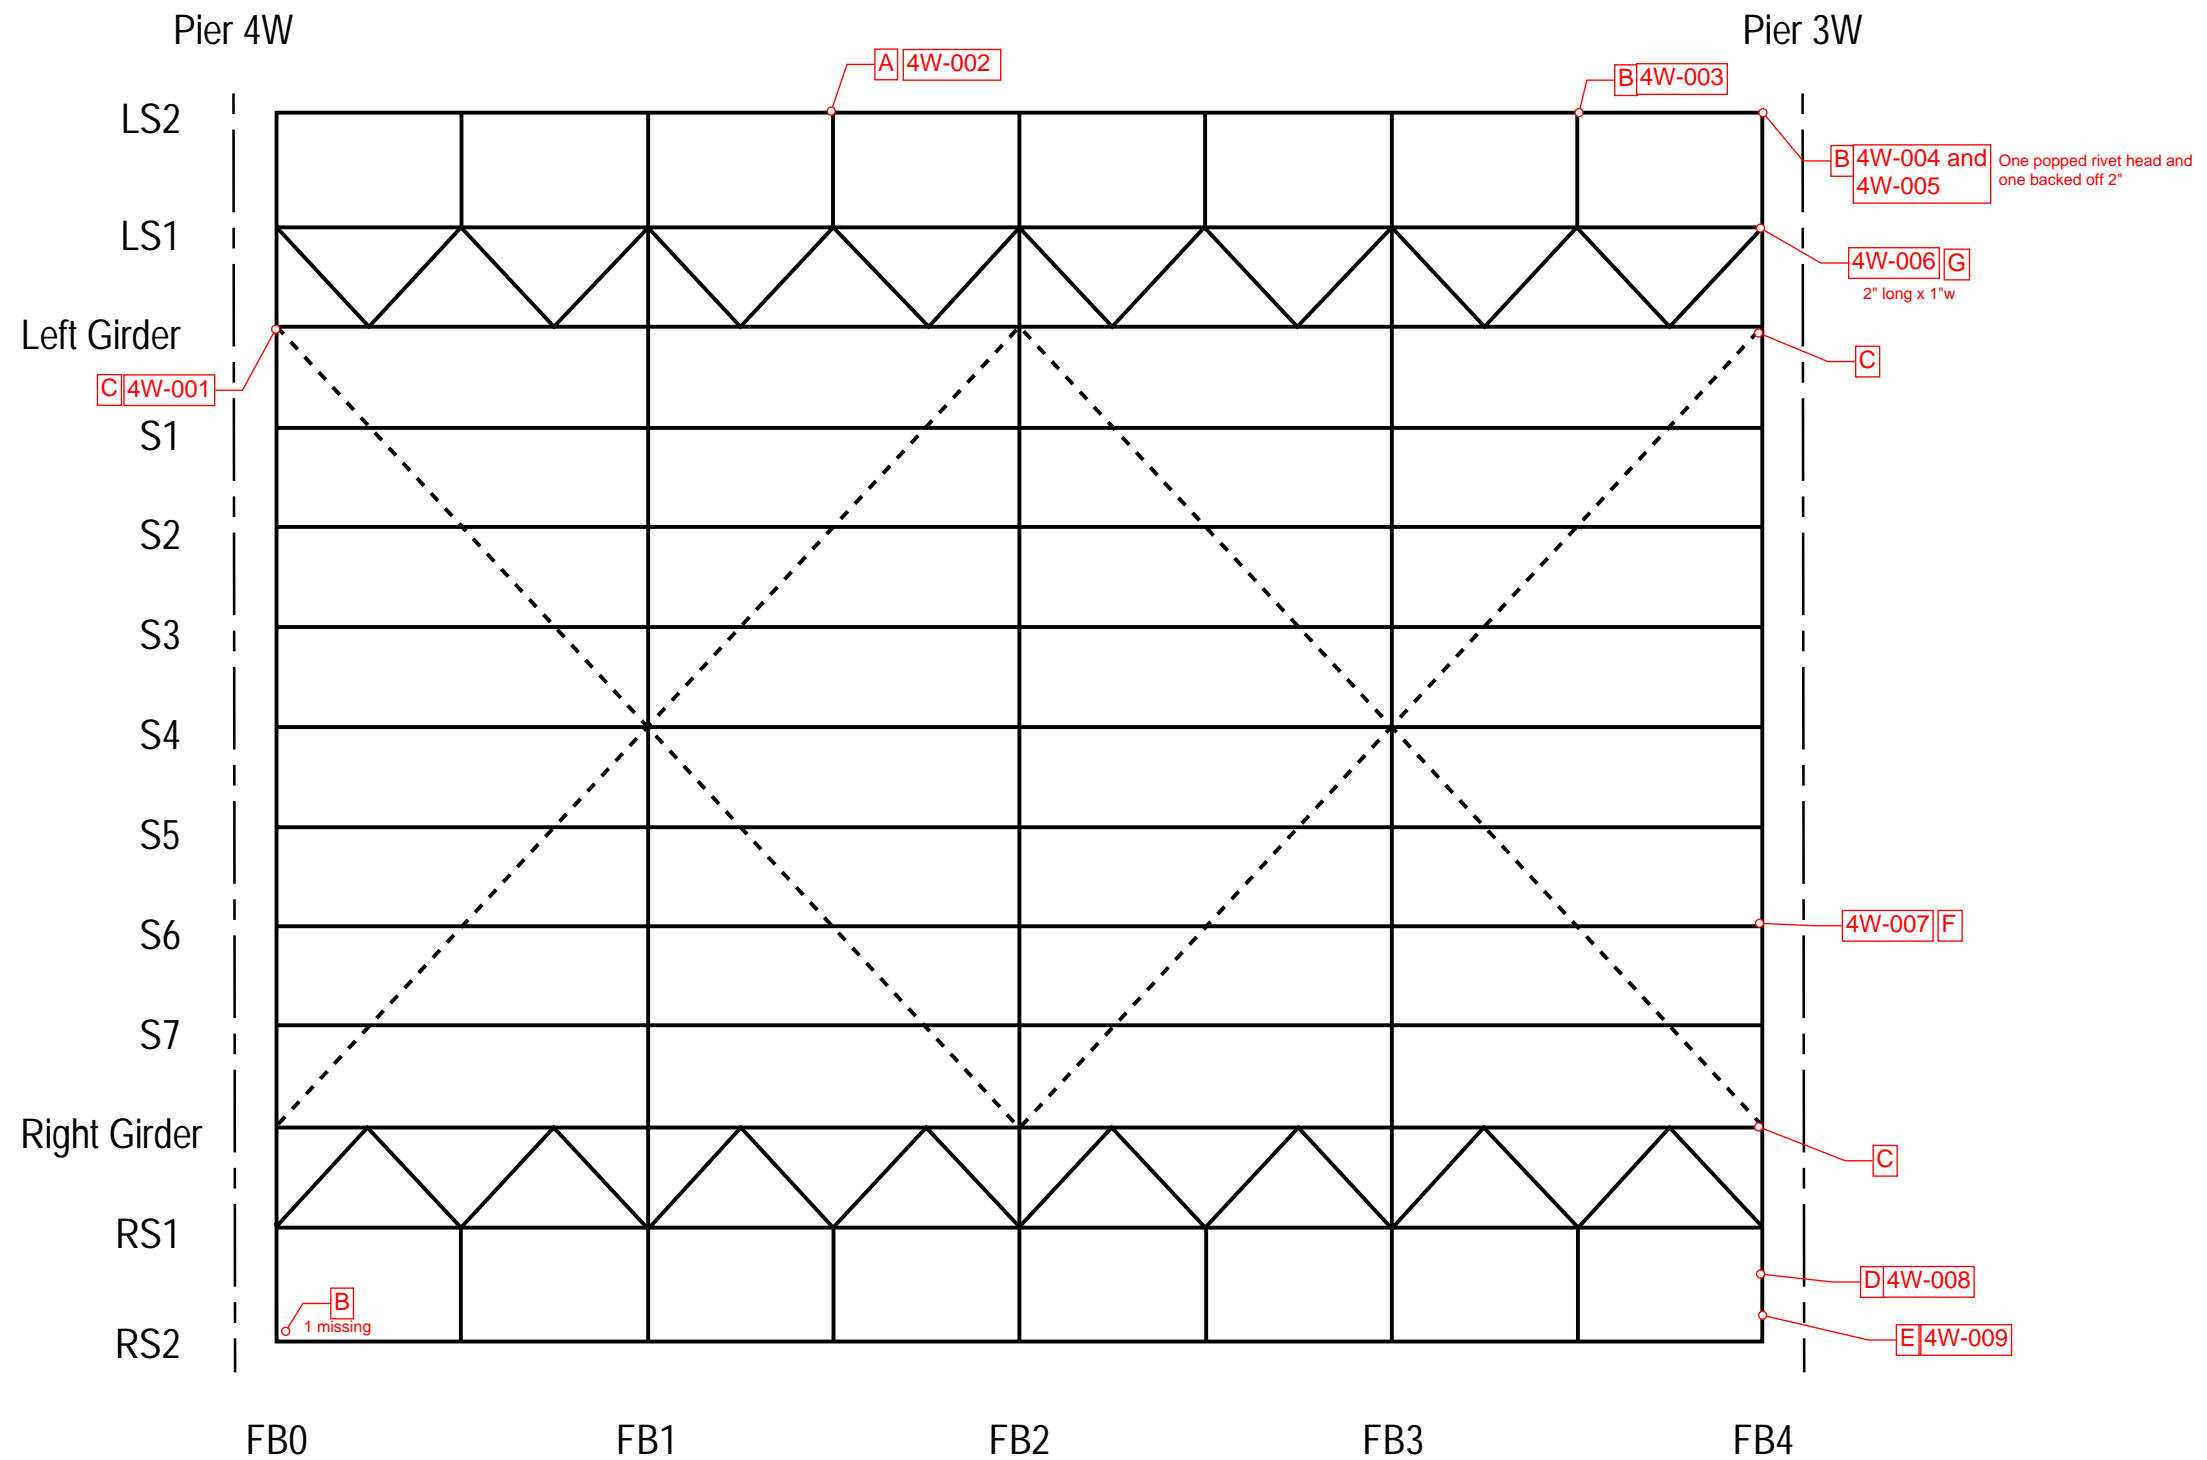
A: Stringer - up to 1/2" thick pack rust between the sidewalk cantilever bracket connection causing wave in bottom of C-channel (typical). Scattered areas on exterior angle with 100% loss x FH of vertical leg
B: Floorbeam - stiffeners flame cut 12" from bottom flange
C: Floorbeam - transverse weld in the top flange between RS1 and RS2
D: Floorbeam - top flange with up to 100% section
E: Floorbeam - top flange repair plate at top with 3 tab plates on underside.
F: Floorbeam - section loss up to 100% throughout flanges and stiffeners

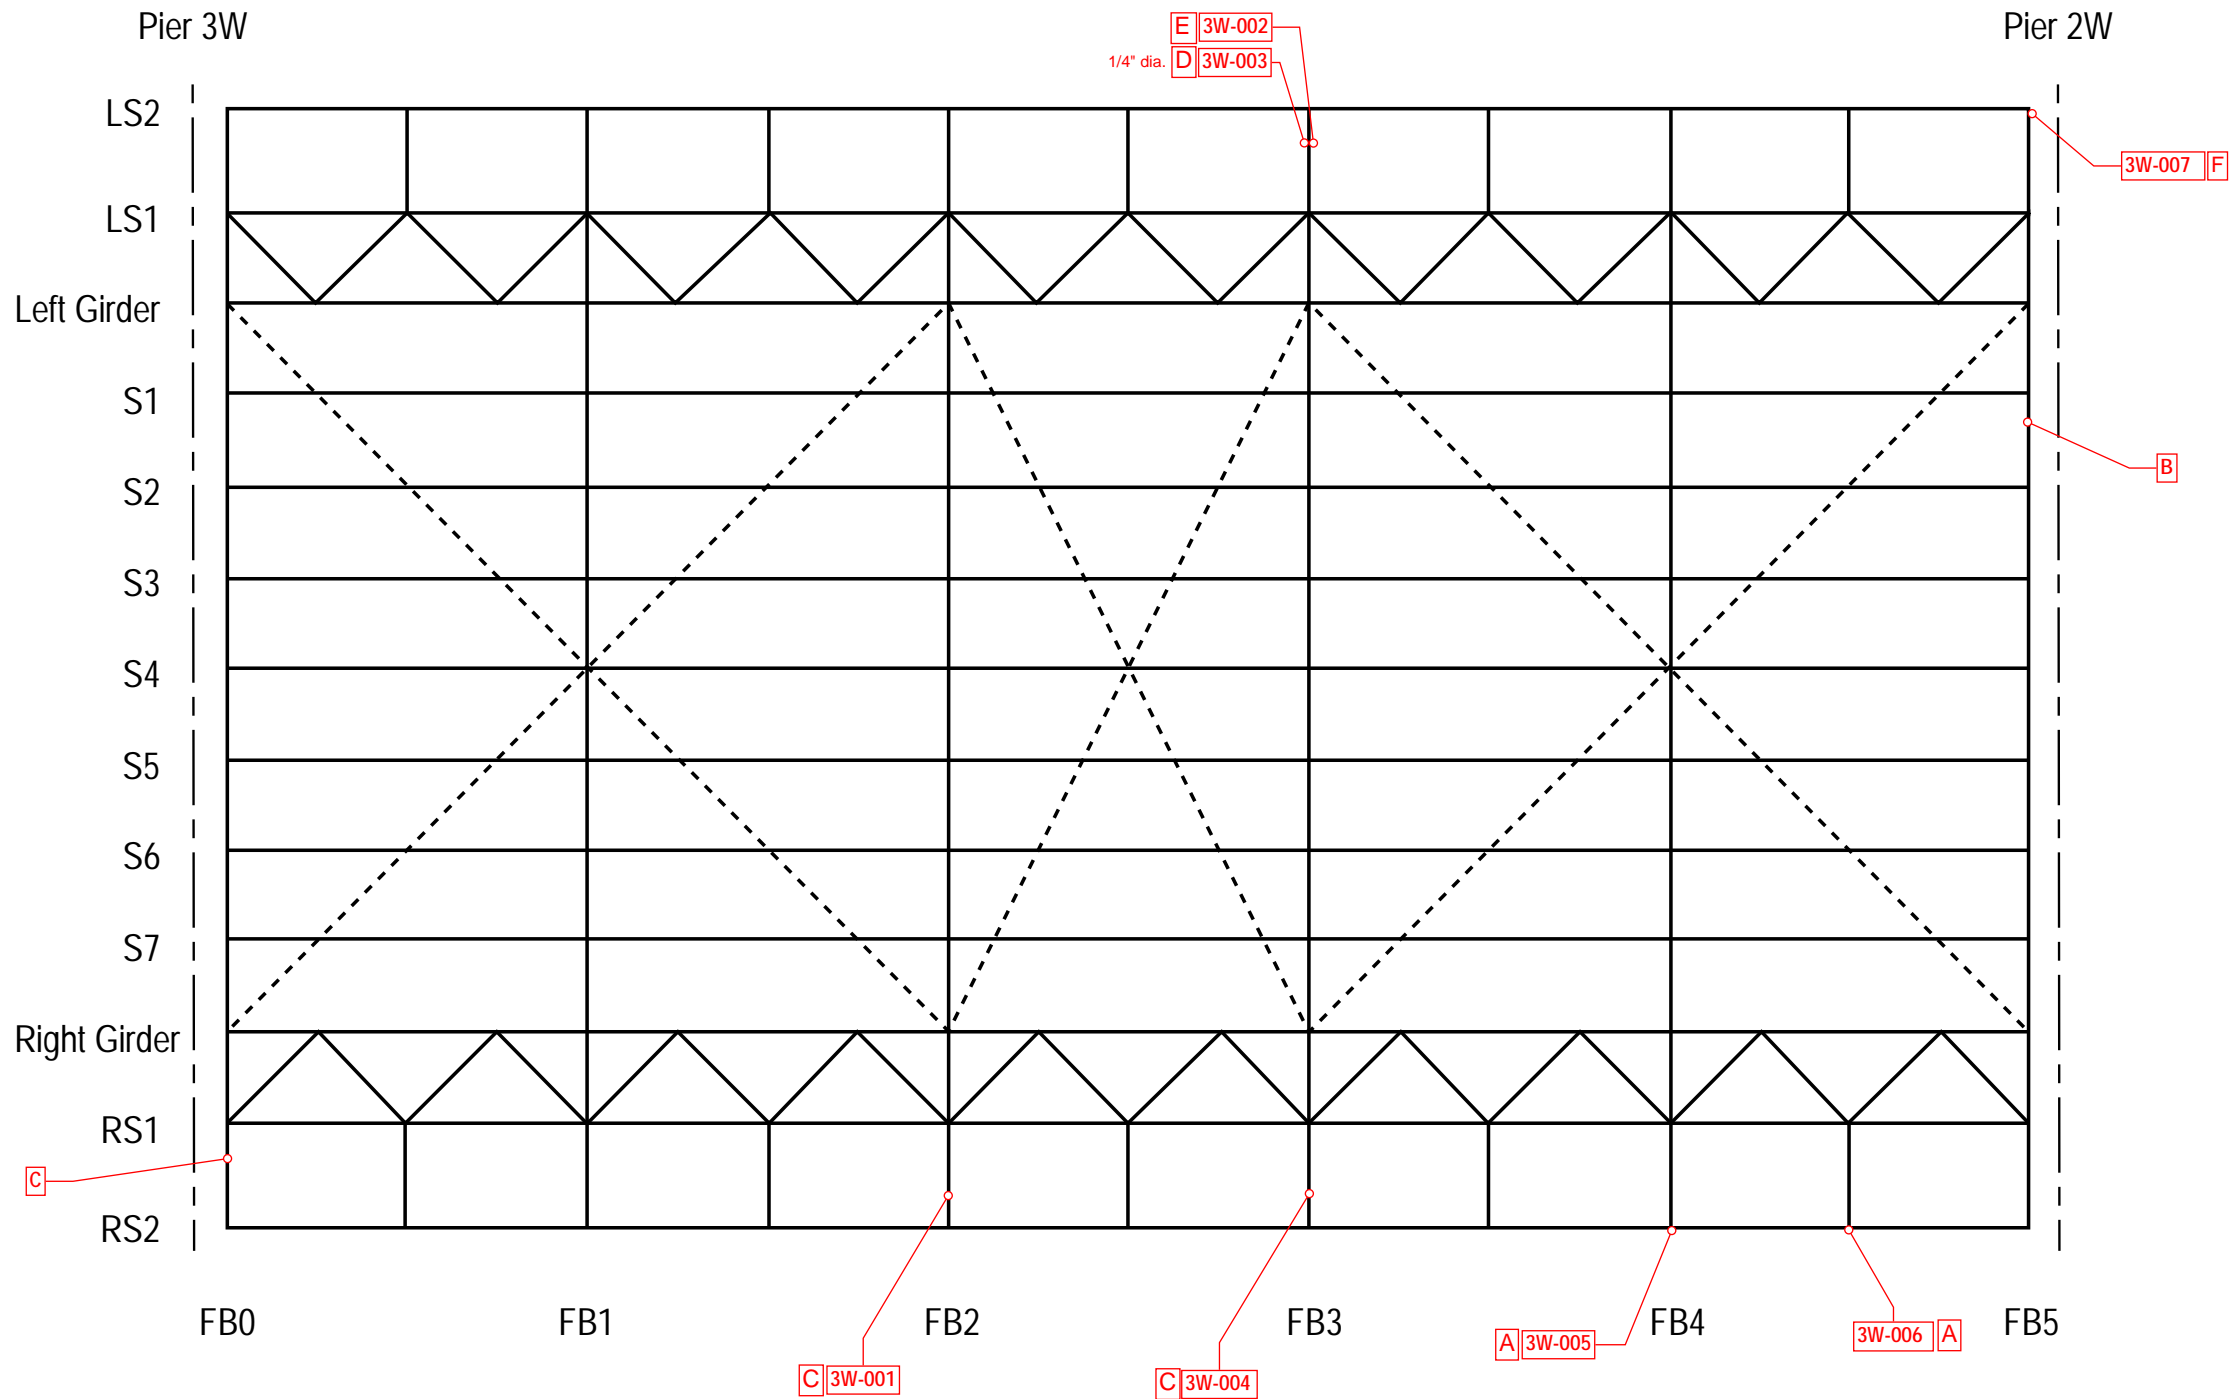
A: Stringer - up to 1/2" thick pack rust between the sidewalk cantilever bracket connection causing wave in bottom of C-channel (typical)
B: Floorbeam - bottom flange coped (13" length) at either end between girders
C: Floorbeam - stiffeners flame cut 12" from bottom flange
D: Stringer - bottom flange with 100% section loss
E: Floorbeam overhang - three popped rivet heads in top flange, underside

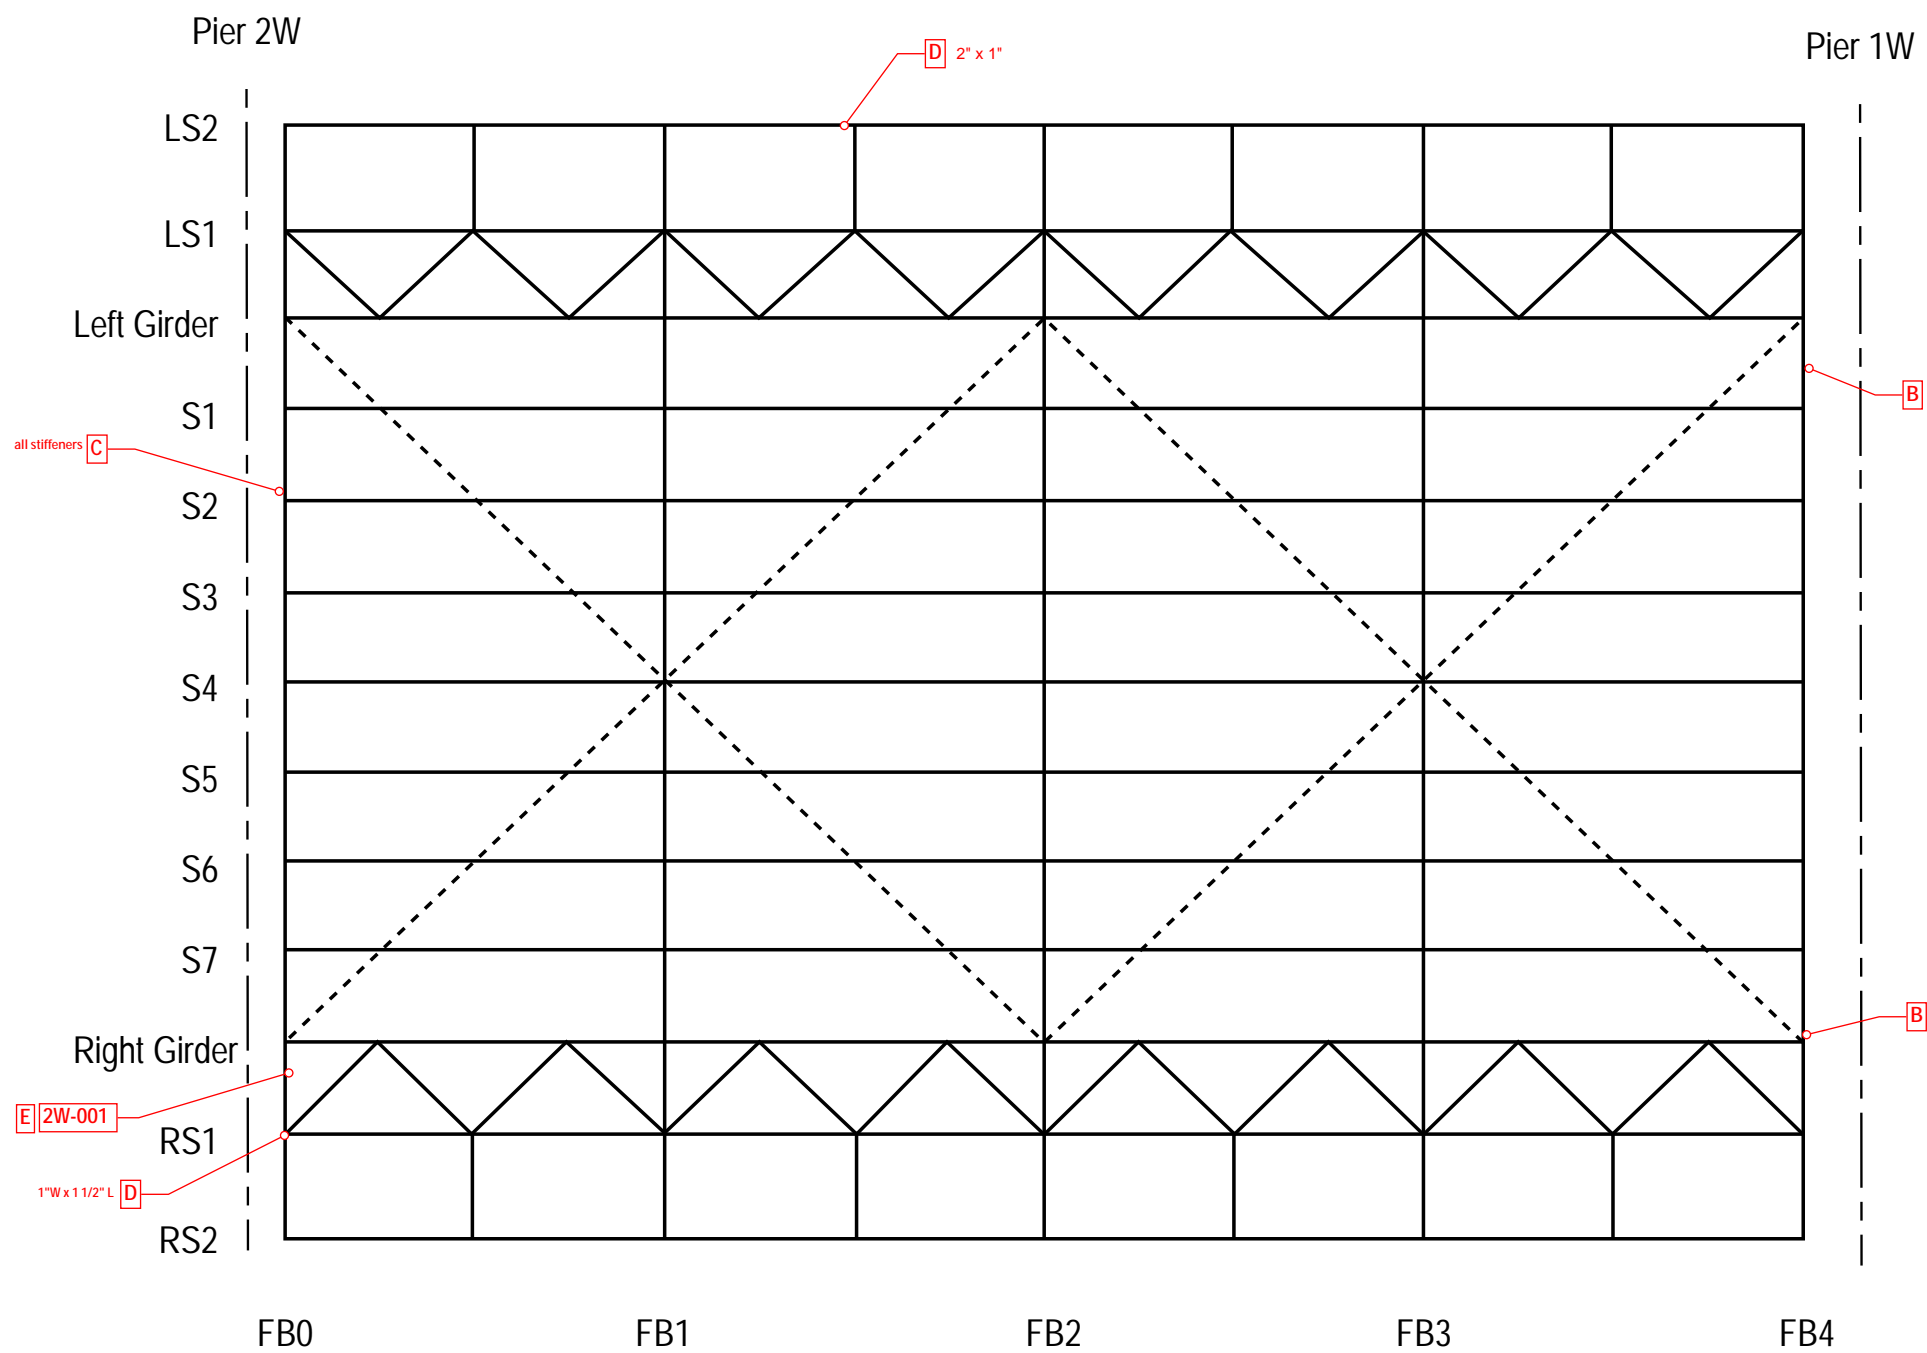
A: Stringer - up to 1/2" thick pack rust between the sidewalk cantilever bracket connection causing wave in bottom of C-channel (typical)
B: Floorbeam - up to 1/2" thick pack rust between bottom flange and cover plate
C: Lateral bracing - distorted and twisted up to 2' long
D: Floorbeam - cantilever bracket bottom flange with areas of 100% SL (typical)

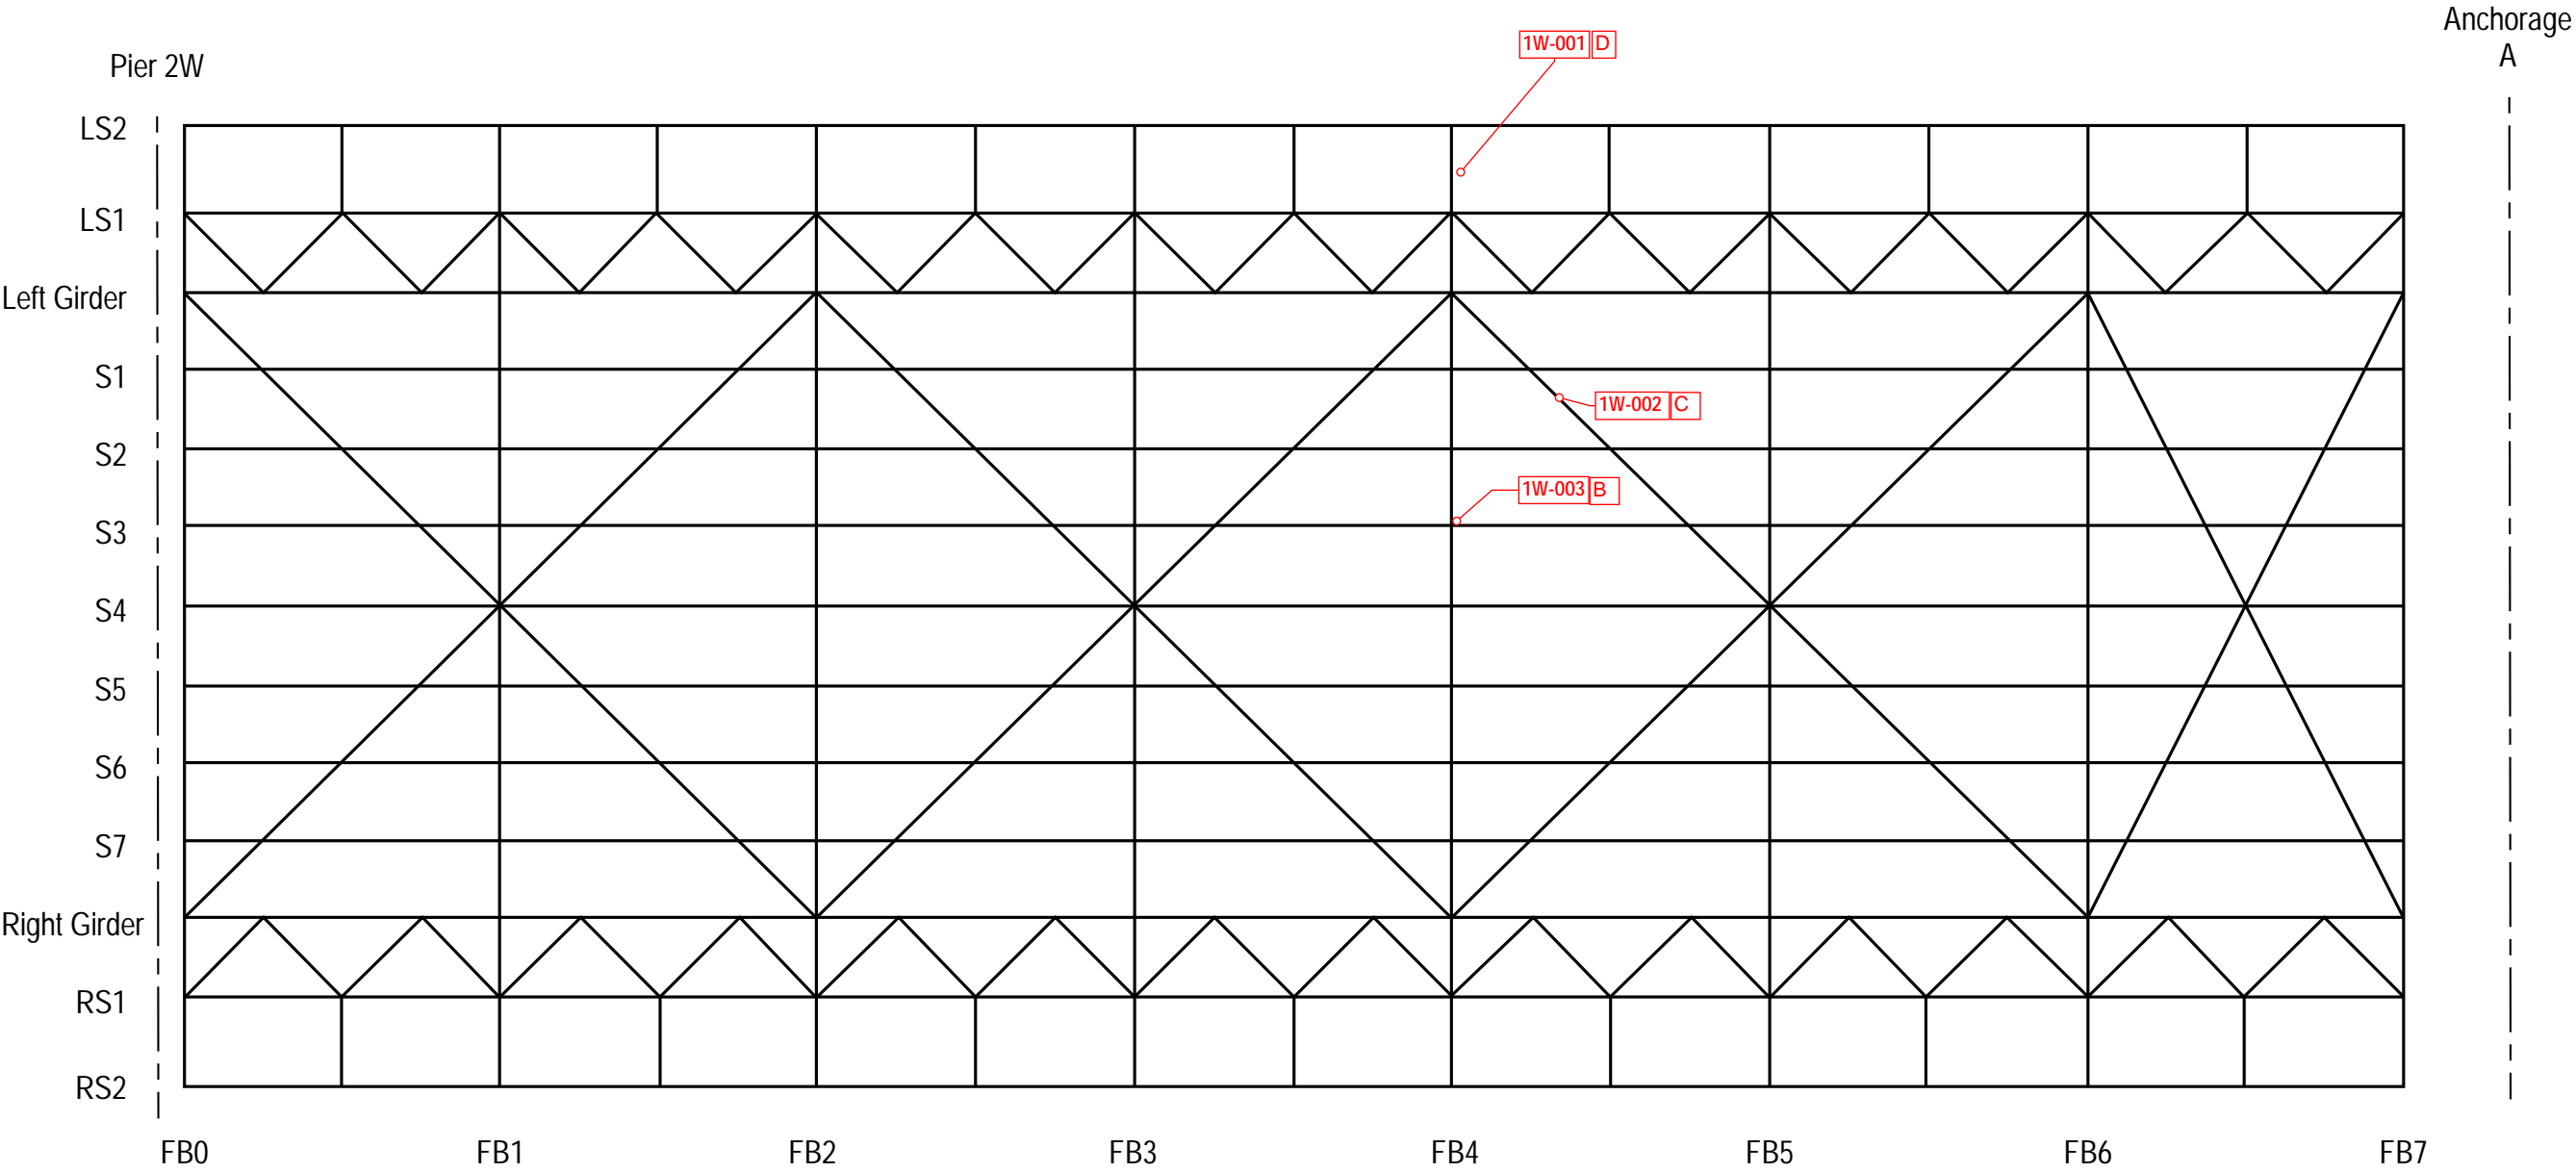
A. Bearing - loss of bearing area
B. Bearing - bearing plate missing, masonry plate slanted down towards east face of pedestal
C. Bearing - anchor bolts with up to 50% section loss throughout

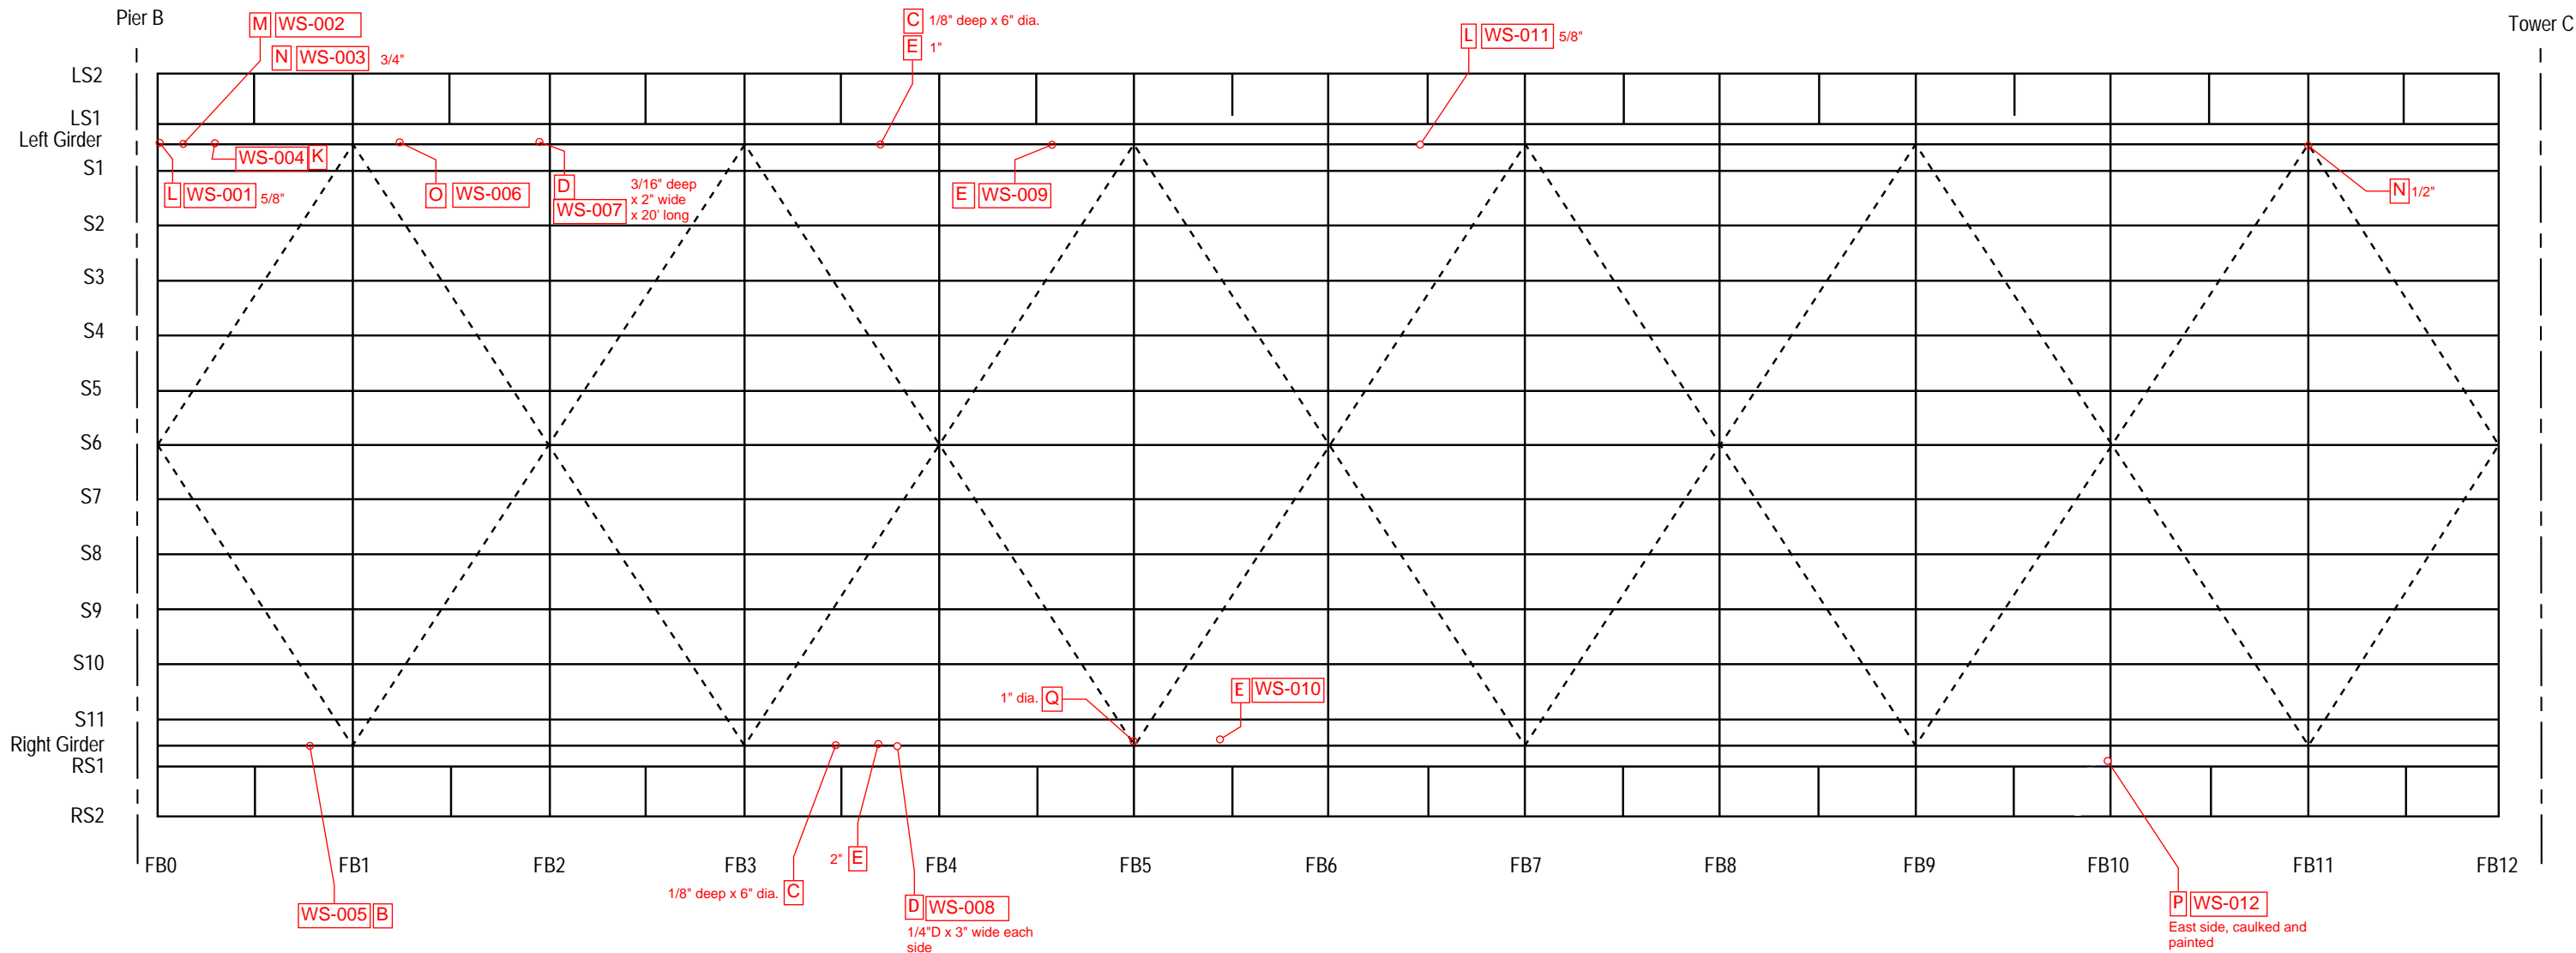
- L: Deck - abandoned steel cable protruding through
- M: Lower Lateral Brace - typ. bolted repair
- N: Edge Girder - two open holes in web between FB 20 and transverse stiffener
- O: Lower Lateral Brace - area of 100% section loss to center connection plate
- P: Stringer - 1/16" deep pitting to web
- Q: Stringer - stray angles welded longitudinally along bottom flange
- R: Floorbeam - sidewalk cantilever top flange crack
- S: Edge Girder - Pack rust between the top flange plates

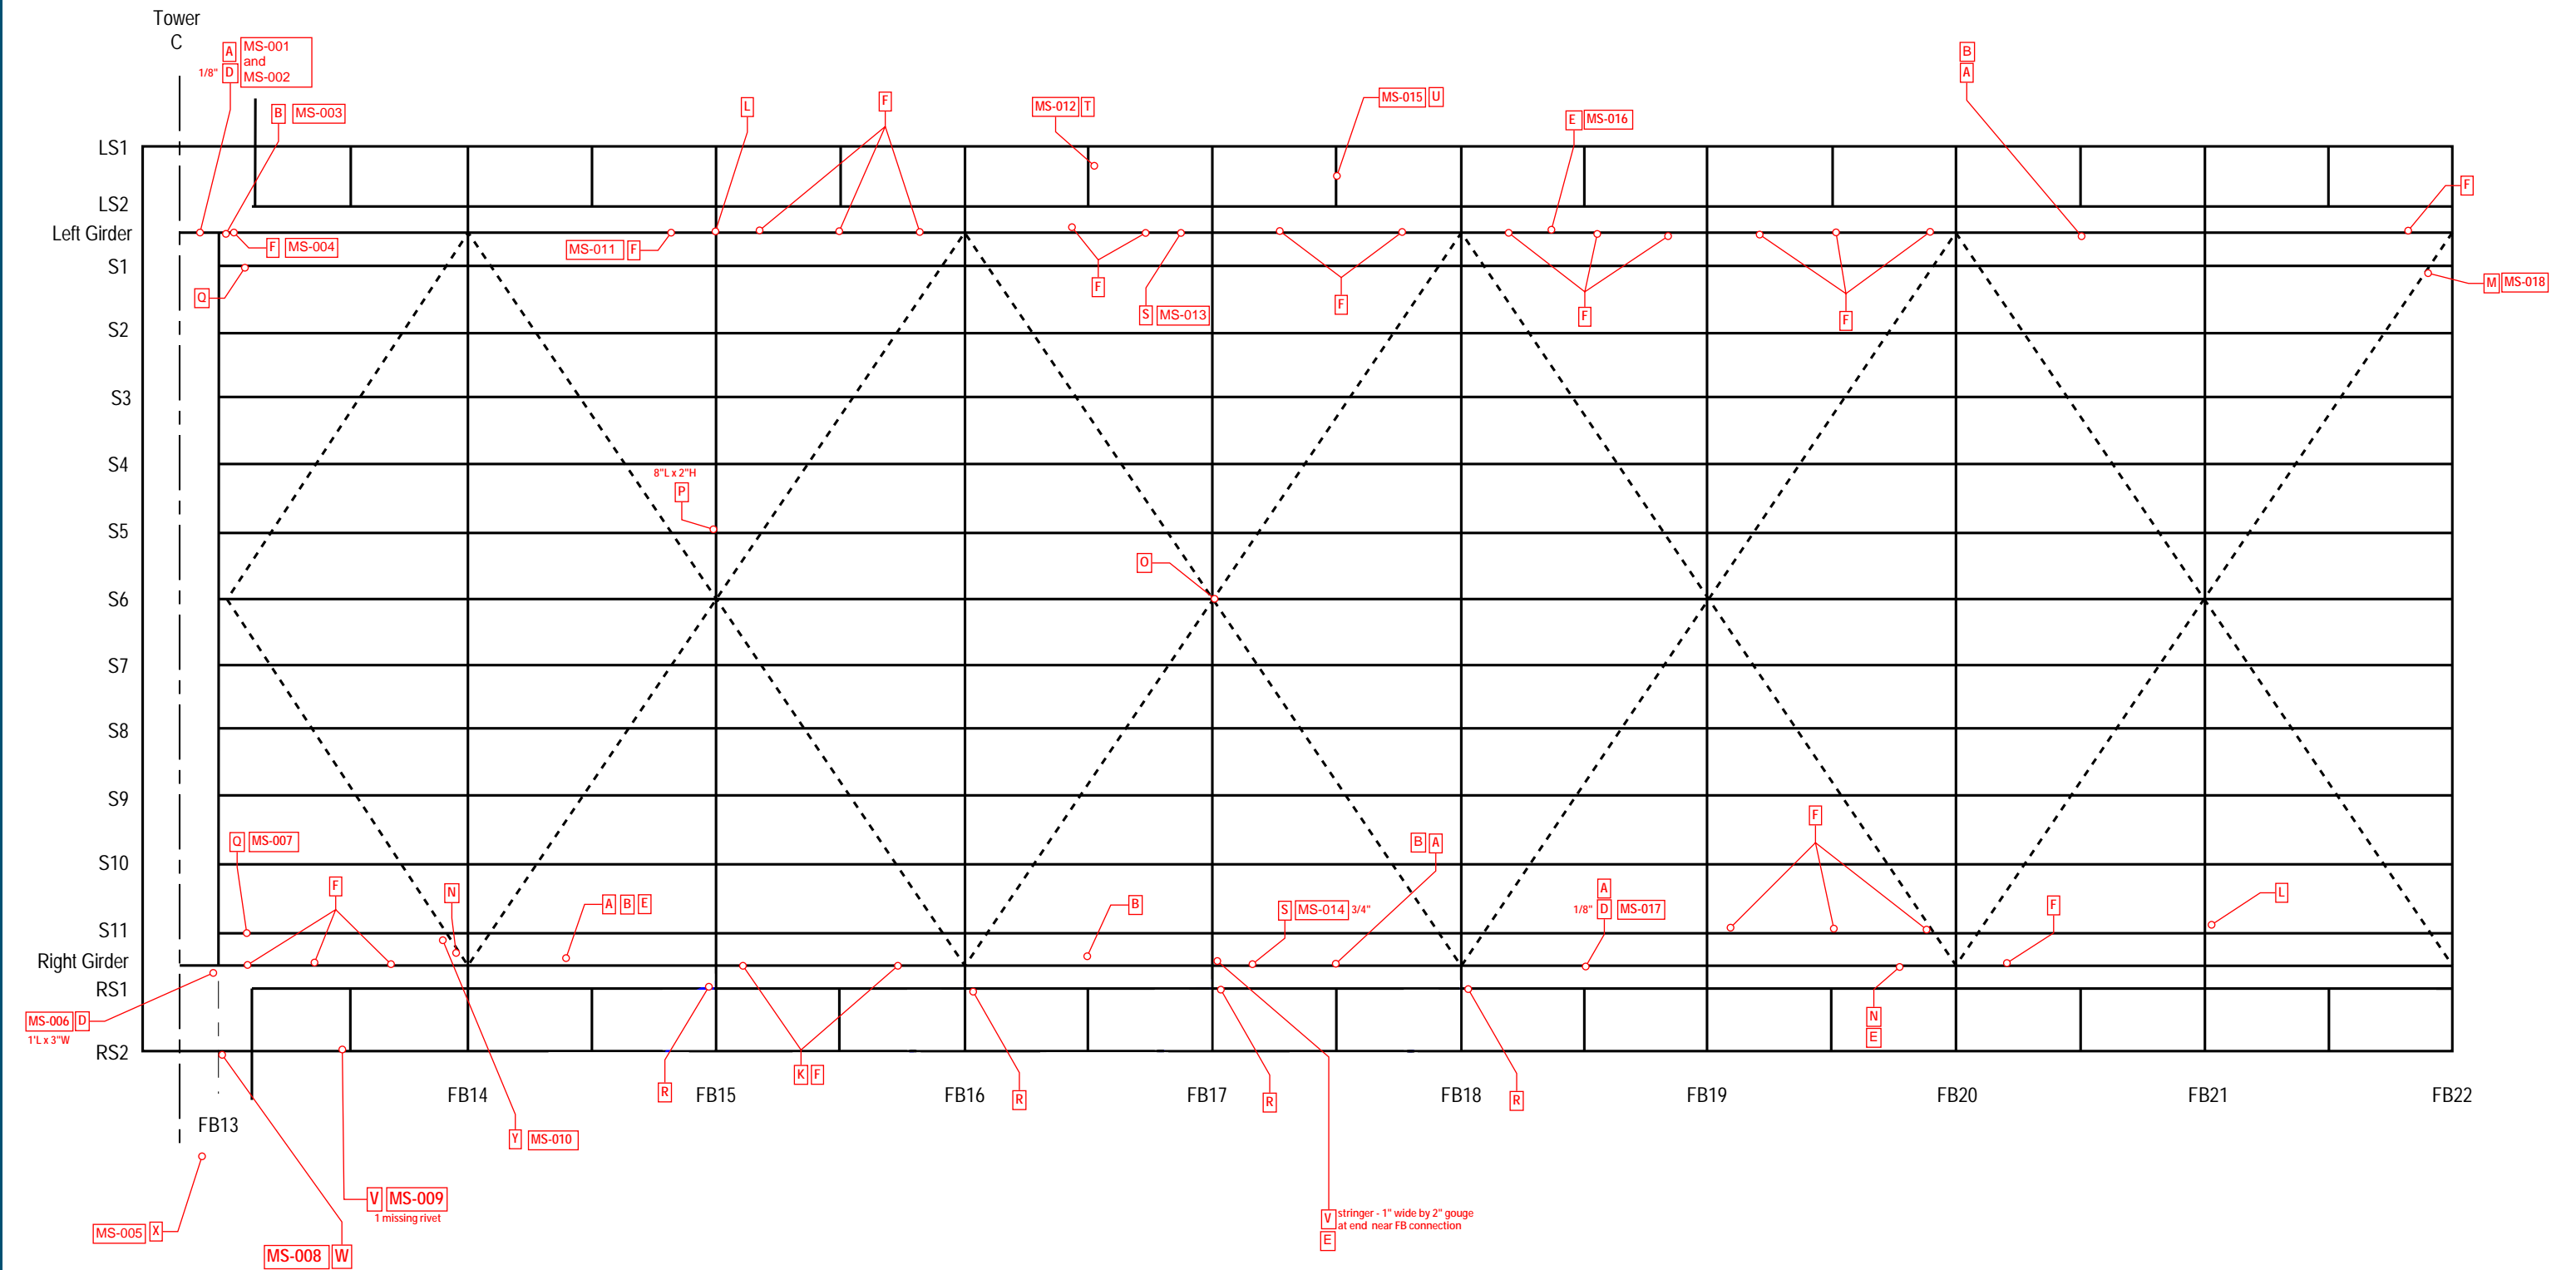
- A: Edge Girder - typical rivet heads with up to 100% section loss on the bottom flange
- B: Edge Girder - typical pitting 1/16" to 1/8" deep throughout
