PHYSICAL CONDITION REPORT
2024 ROUTINE ELEMENT LEVEL AND NSTM
INSPECTION

INSPECTION MAY 2024
REPORT AUGUST 2024

ANTHONY WAYNE BRIDGE
LUC-002-1862
SFN: 4800303

Ohio Department of Transportation, District 2
317 E Poe Rd
Bowling Green, OH 43402

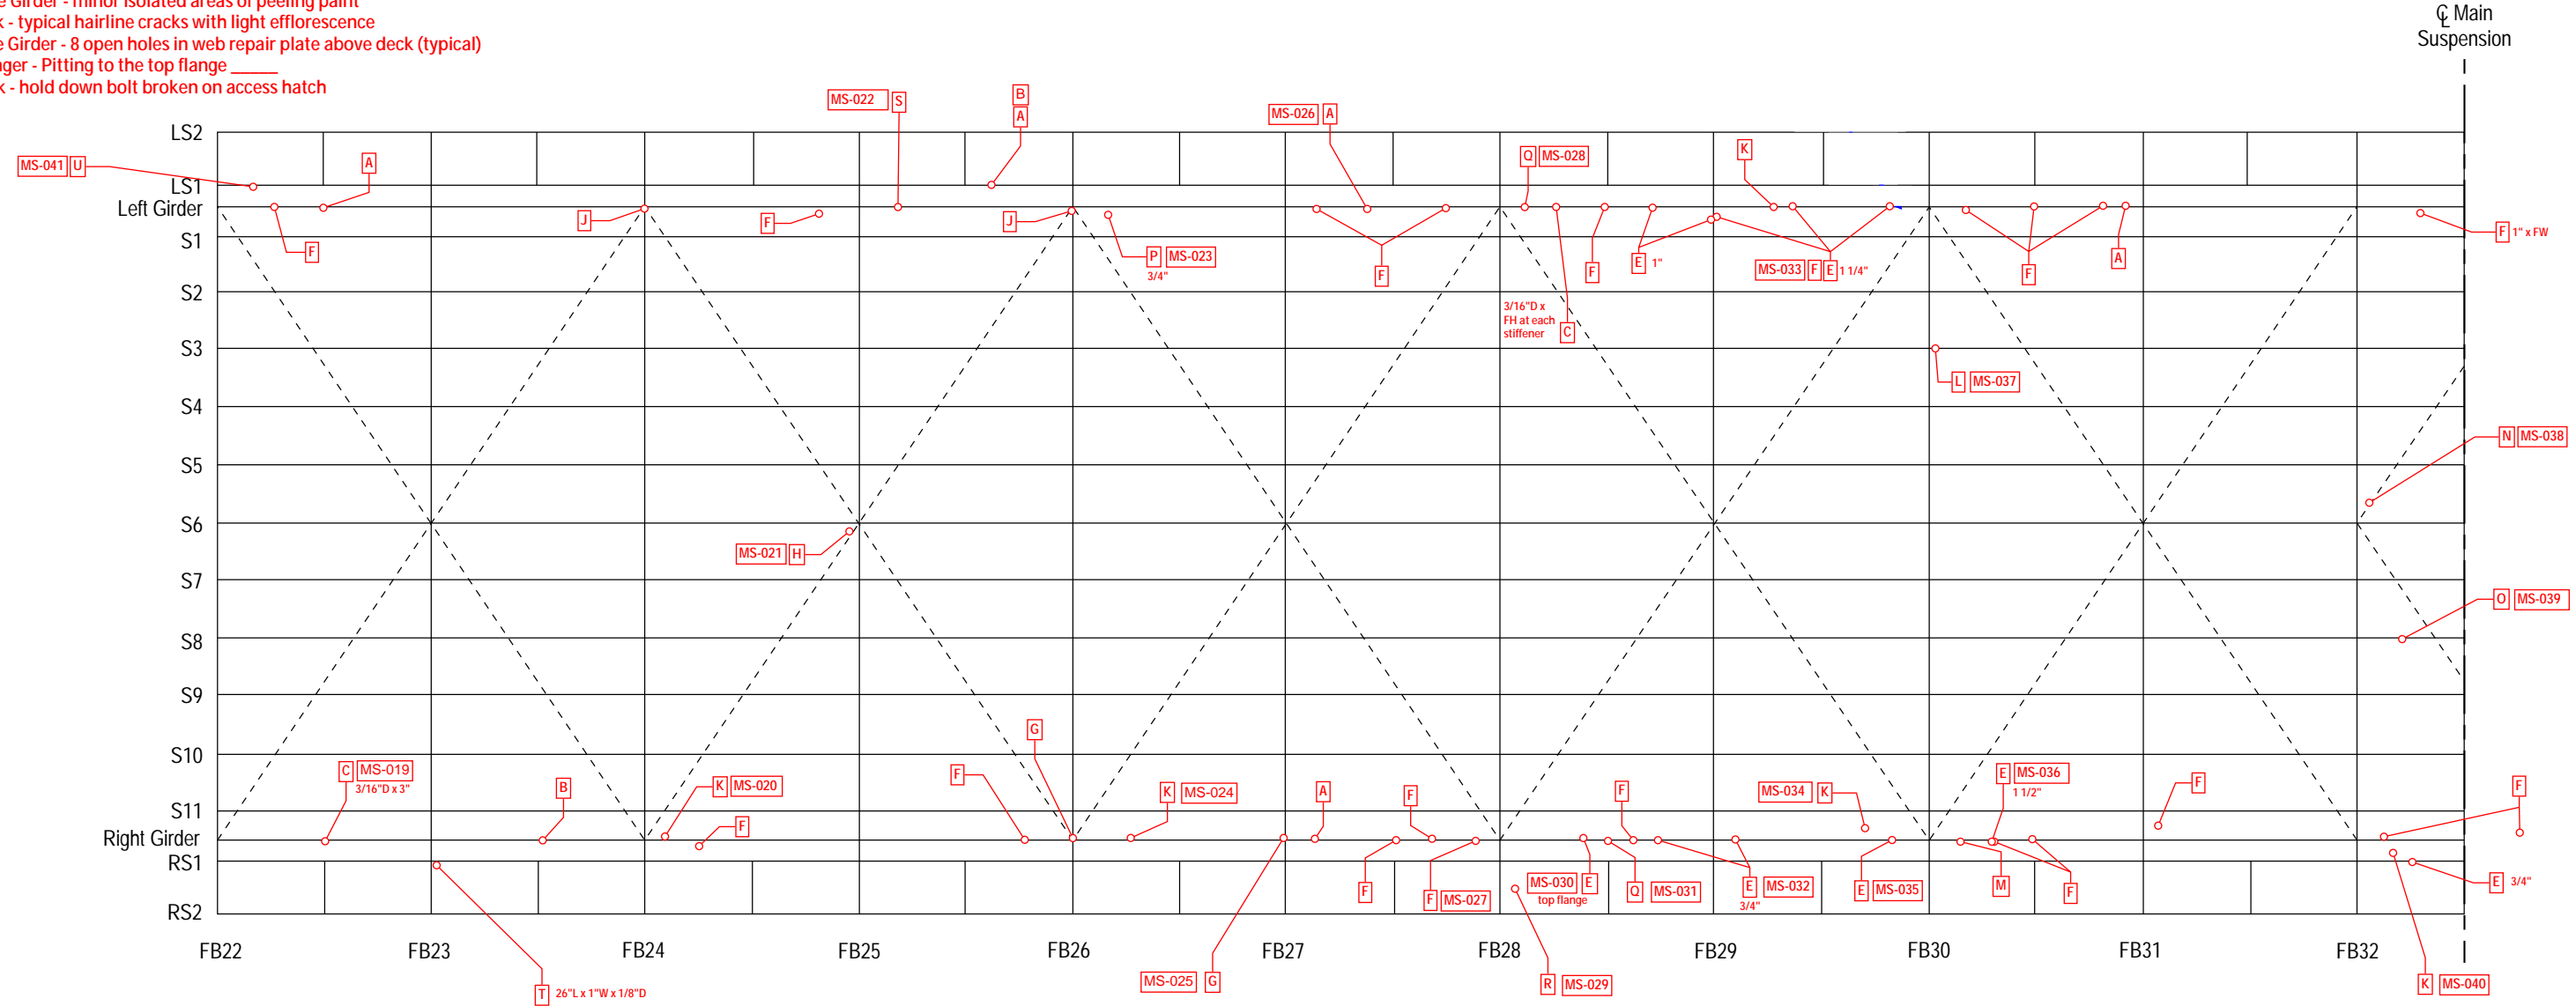
A: Edge Girder - typical rivet heads with up to 100% section loss on the bottom flange
B: Edge Girder - typical pitting 1/16" to 1/8" deep throughout
C: Edge Girder - Pitting to the web _____
D: Edge Girder - Pitting to the bottom flange _____
E: Edge Girder - Pack rust between the bottom flange plates
F: Edge Girder - Advanced section loss/100% section loss to transverse stiffener
G: Floorbeam Kneebrace - 100% section loss to outstanding leg of angle
H: Lower Lateral Brace - typical granular and bird debris on connection plate
J: Lower Lateral Brace - Pack rust between connection plate and lateral bracing member
K: Deck - typical efflo staining on girder web
L: Lower Lateral Brace: Pack rust between angles (web)
M: Stringers: Pitting to the web and flanges ____"
N: Handrail - ____'L x ____'H offset
O: 3/8" drilled hole in girder web
P: Lower Lateral Brace - Packrust between connection plate and edge girder

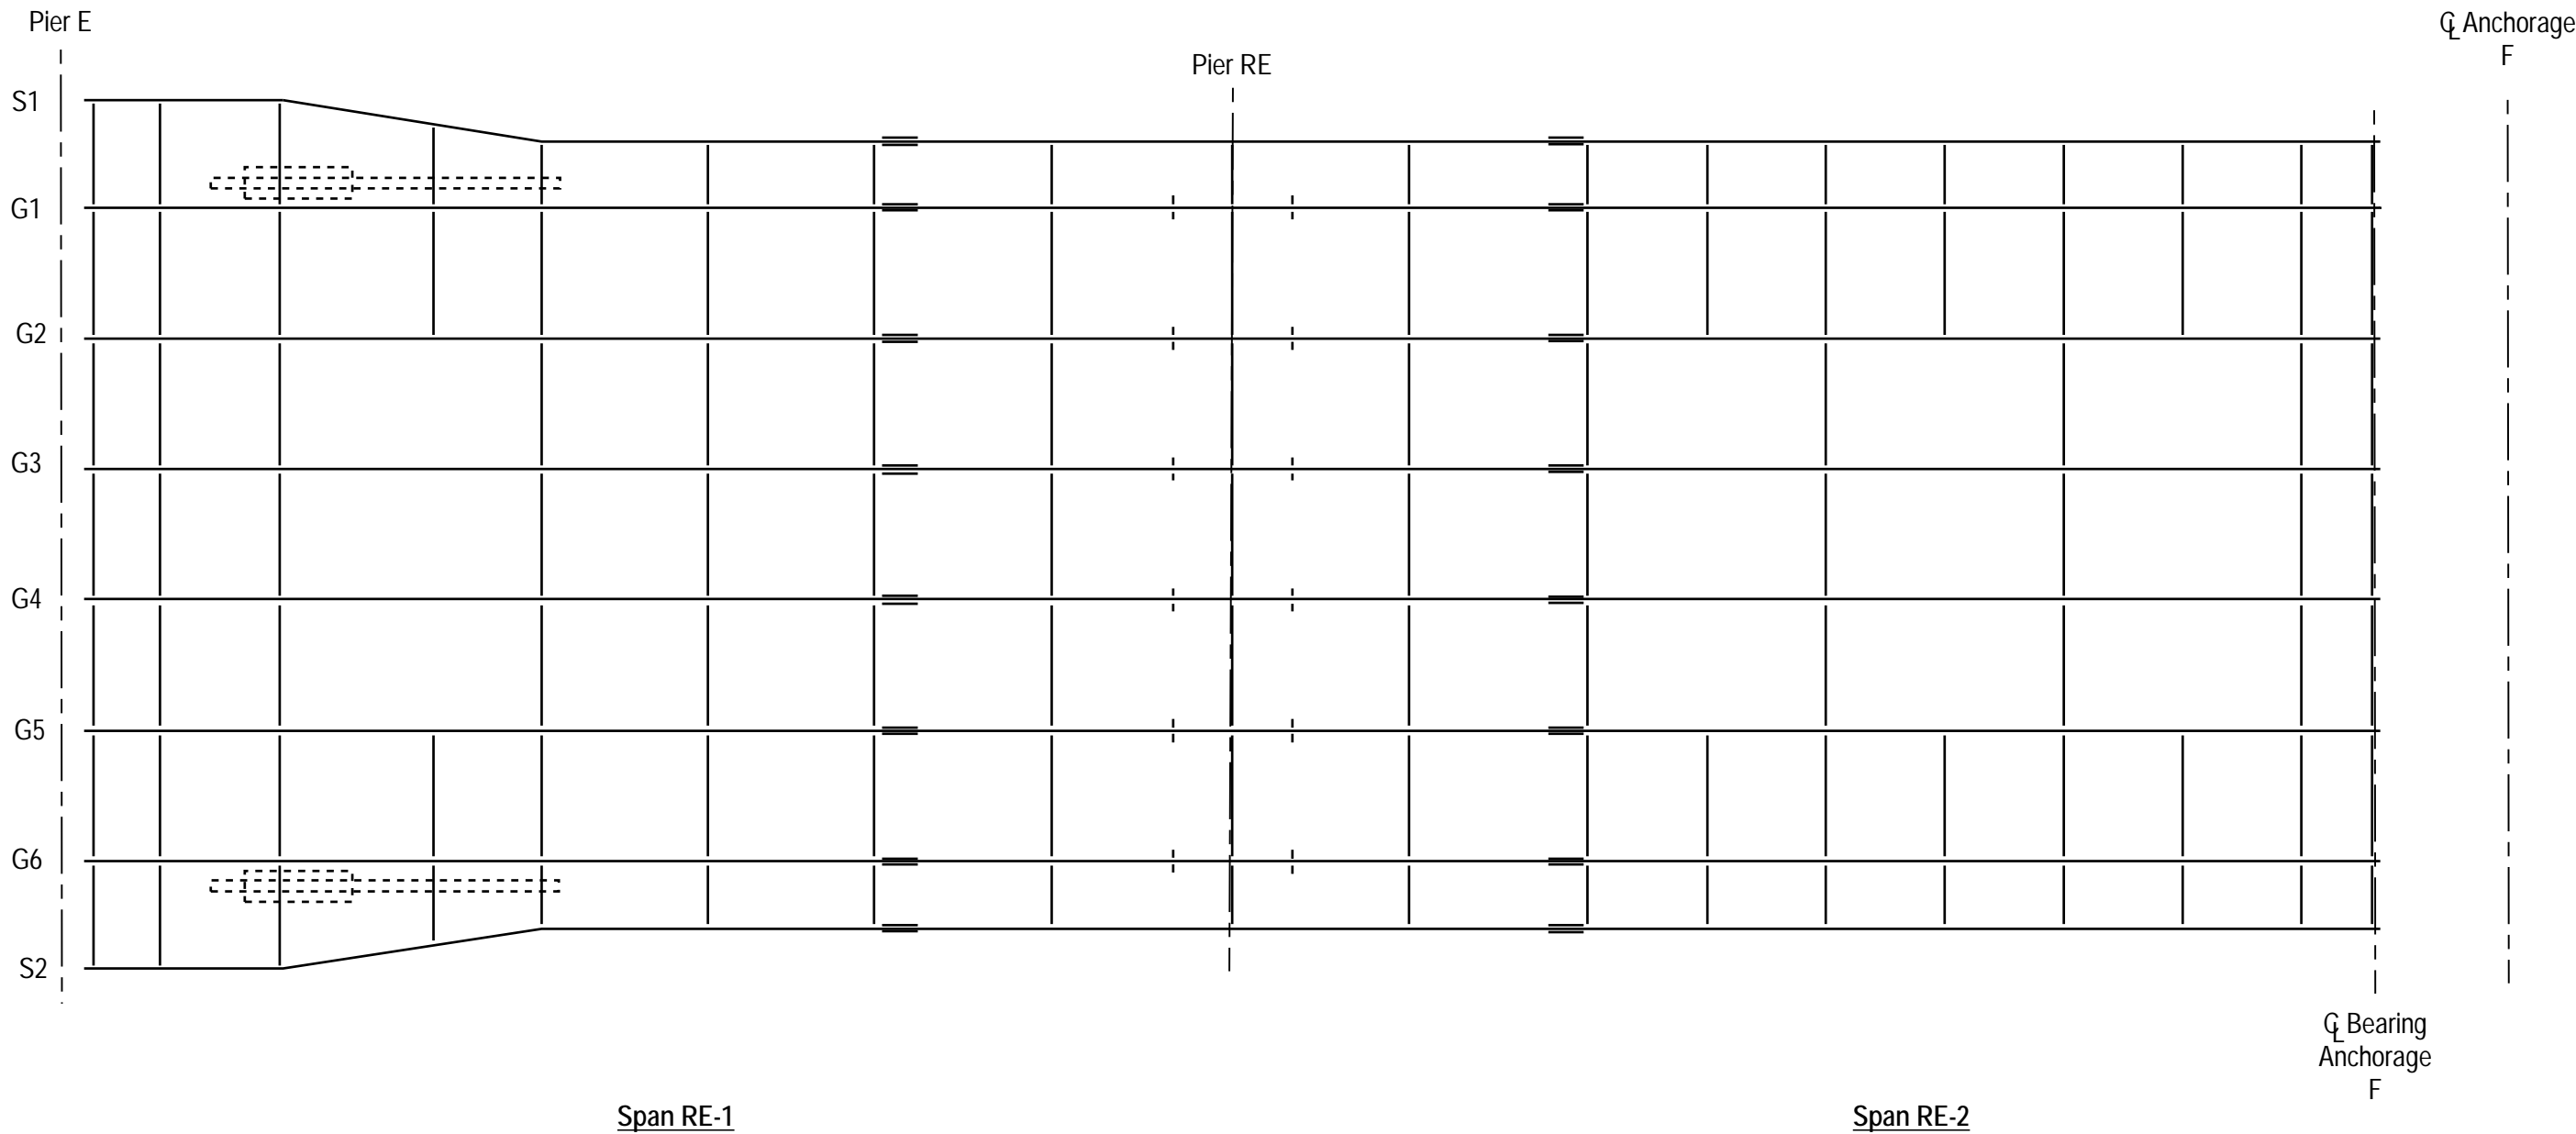
- A. Bearing - Minor corrosion of masonry plate
- B. Floorbeam - Minor distortion to bottom angles of knee brace at Left Girder and painted over pack rust
- C. Floorbeam - Minor active corrosion to ____ flange
- D. Stringer - Minor active corrosion to ____ flange
- E. Floorbeam - Painted over 100% section loss to transverse stiffener
- F. Lateral Bracing - Painted over minor pack rust/deformation to lateral bracing connection plate
- G. Stringer - Painted over areas of corrosion, pack rust between bottom angle/web of fascia stringers (typical)

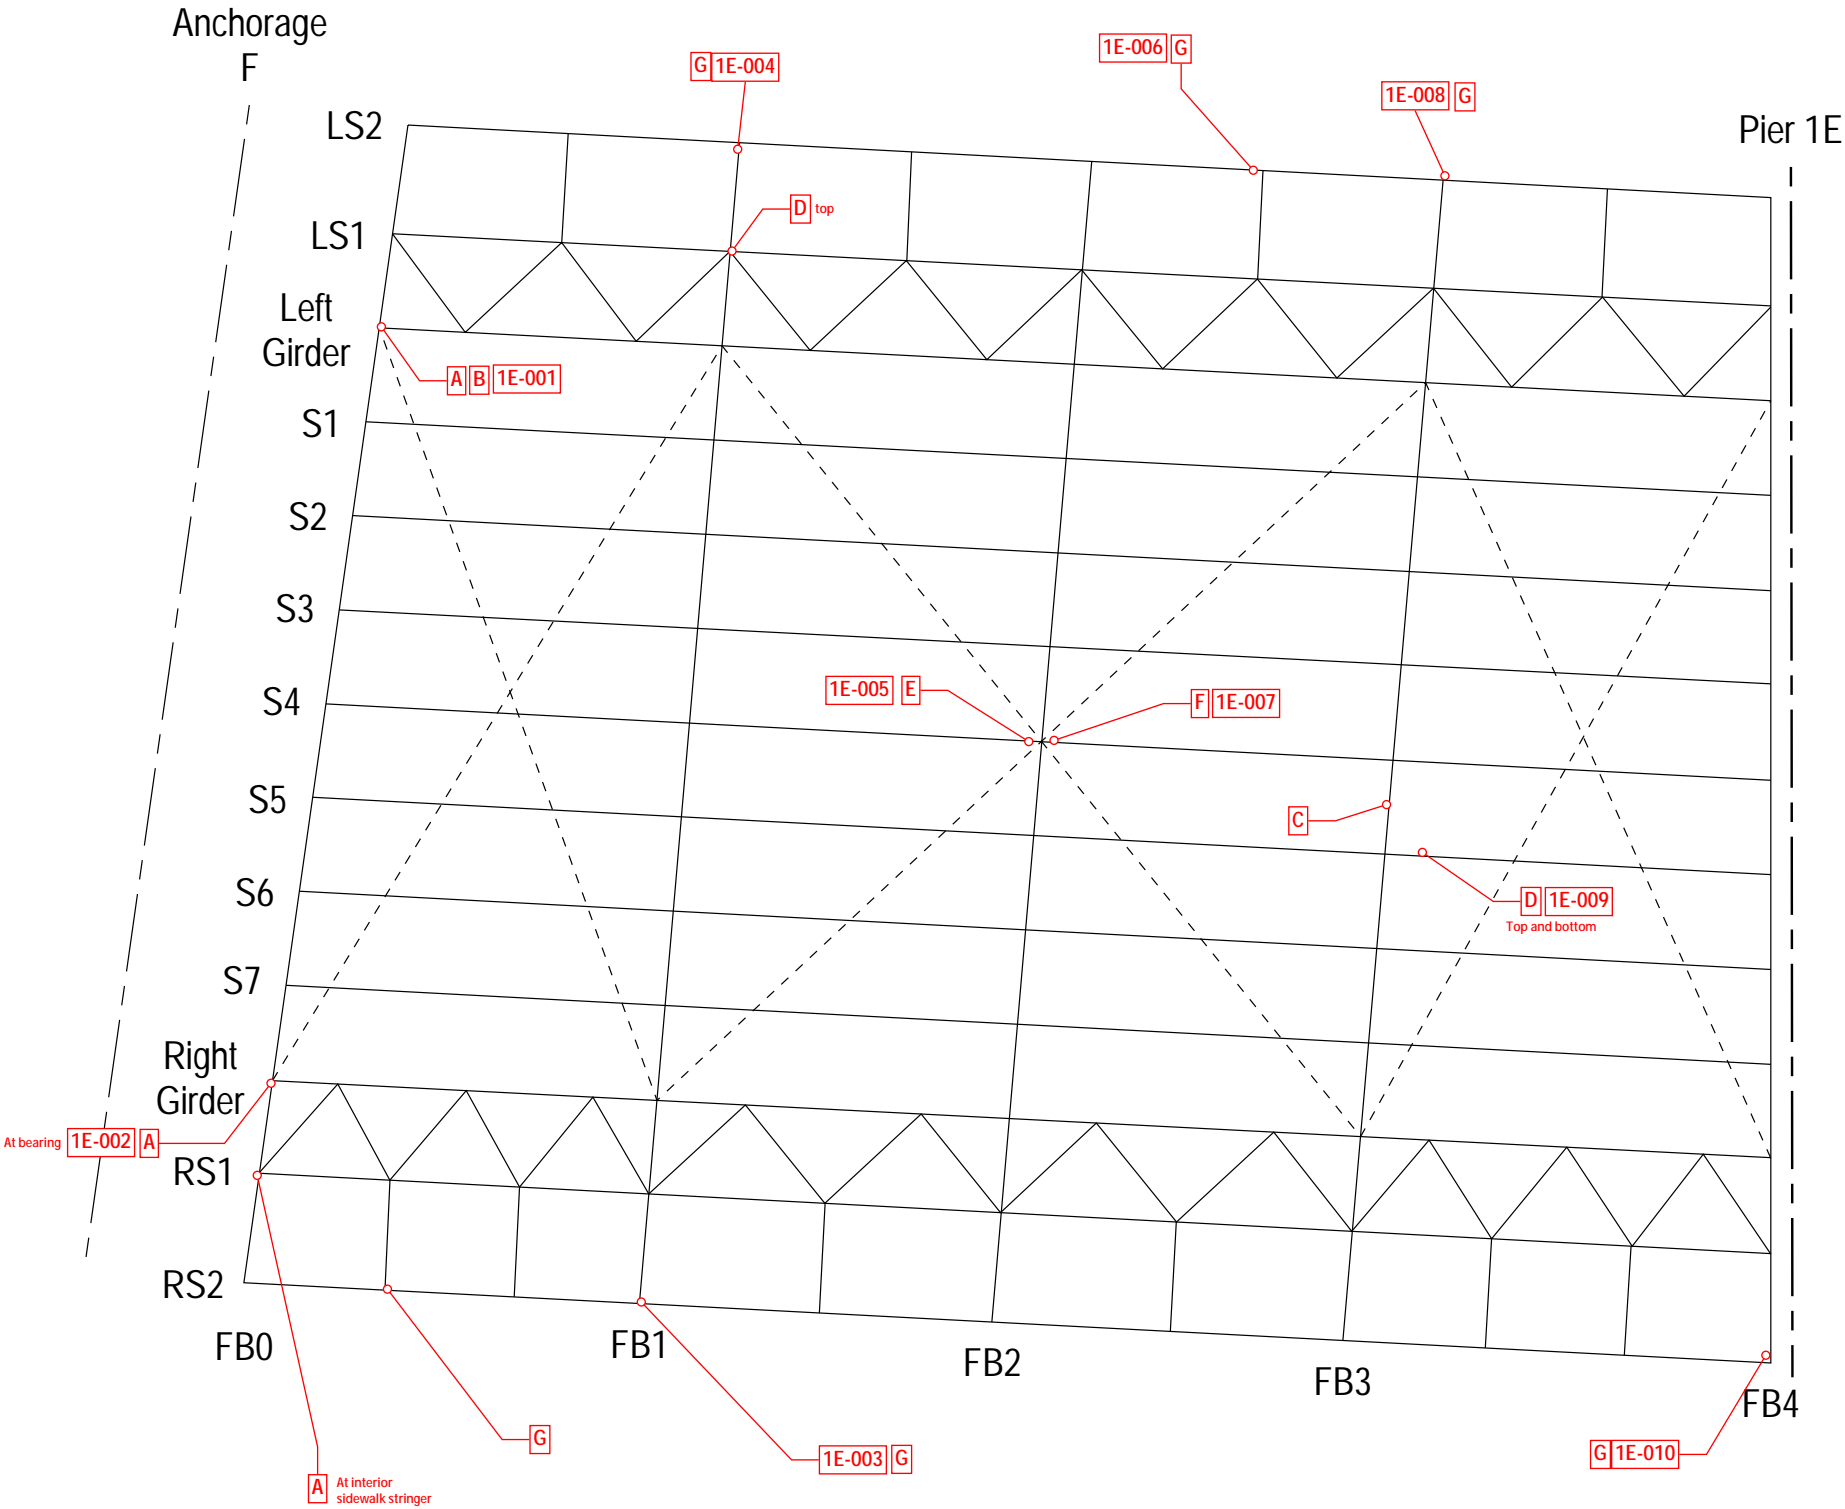
- A. Floorbeam - Minor active corrosion between knee brace angles at overhang
- B. Lateral Bracing - Minor bowing of connection plate due to painted over pack rust
- C. Stringer - Minor painted over pack rust at stringer connection to floorbeam stiffener
- D. Floorbeam - ____ painted over perforation of ____
- E. Floorbeam - Up to 100% section loss of majority of transverse stiffeners along bottom flange
- F. Stringer - Painted over areas of corrosion, pack rust between bottom angle/web of fascia stringers (typical)

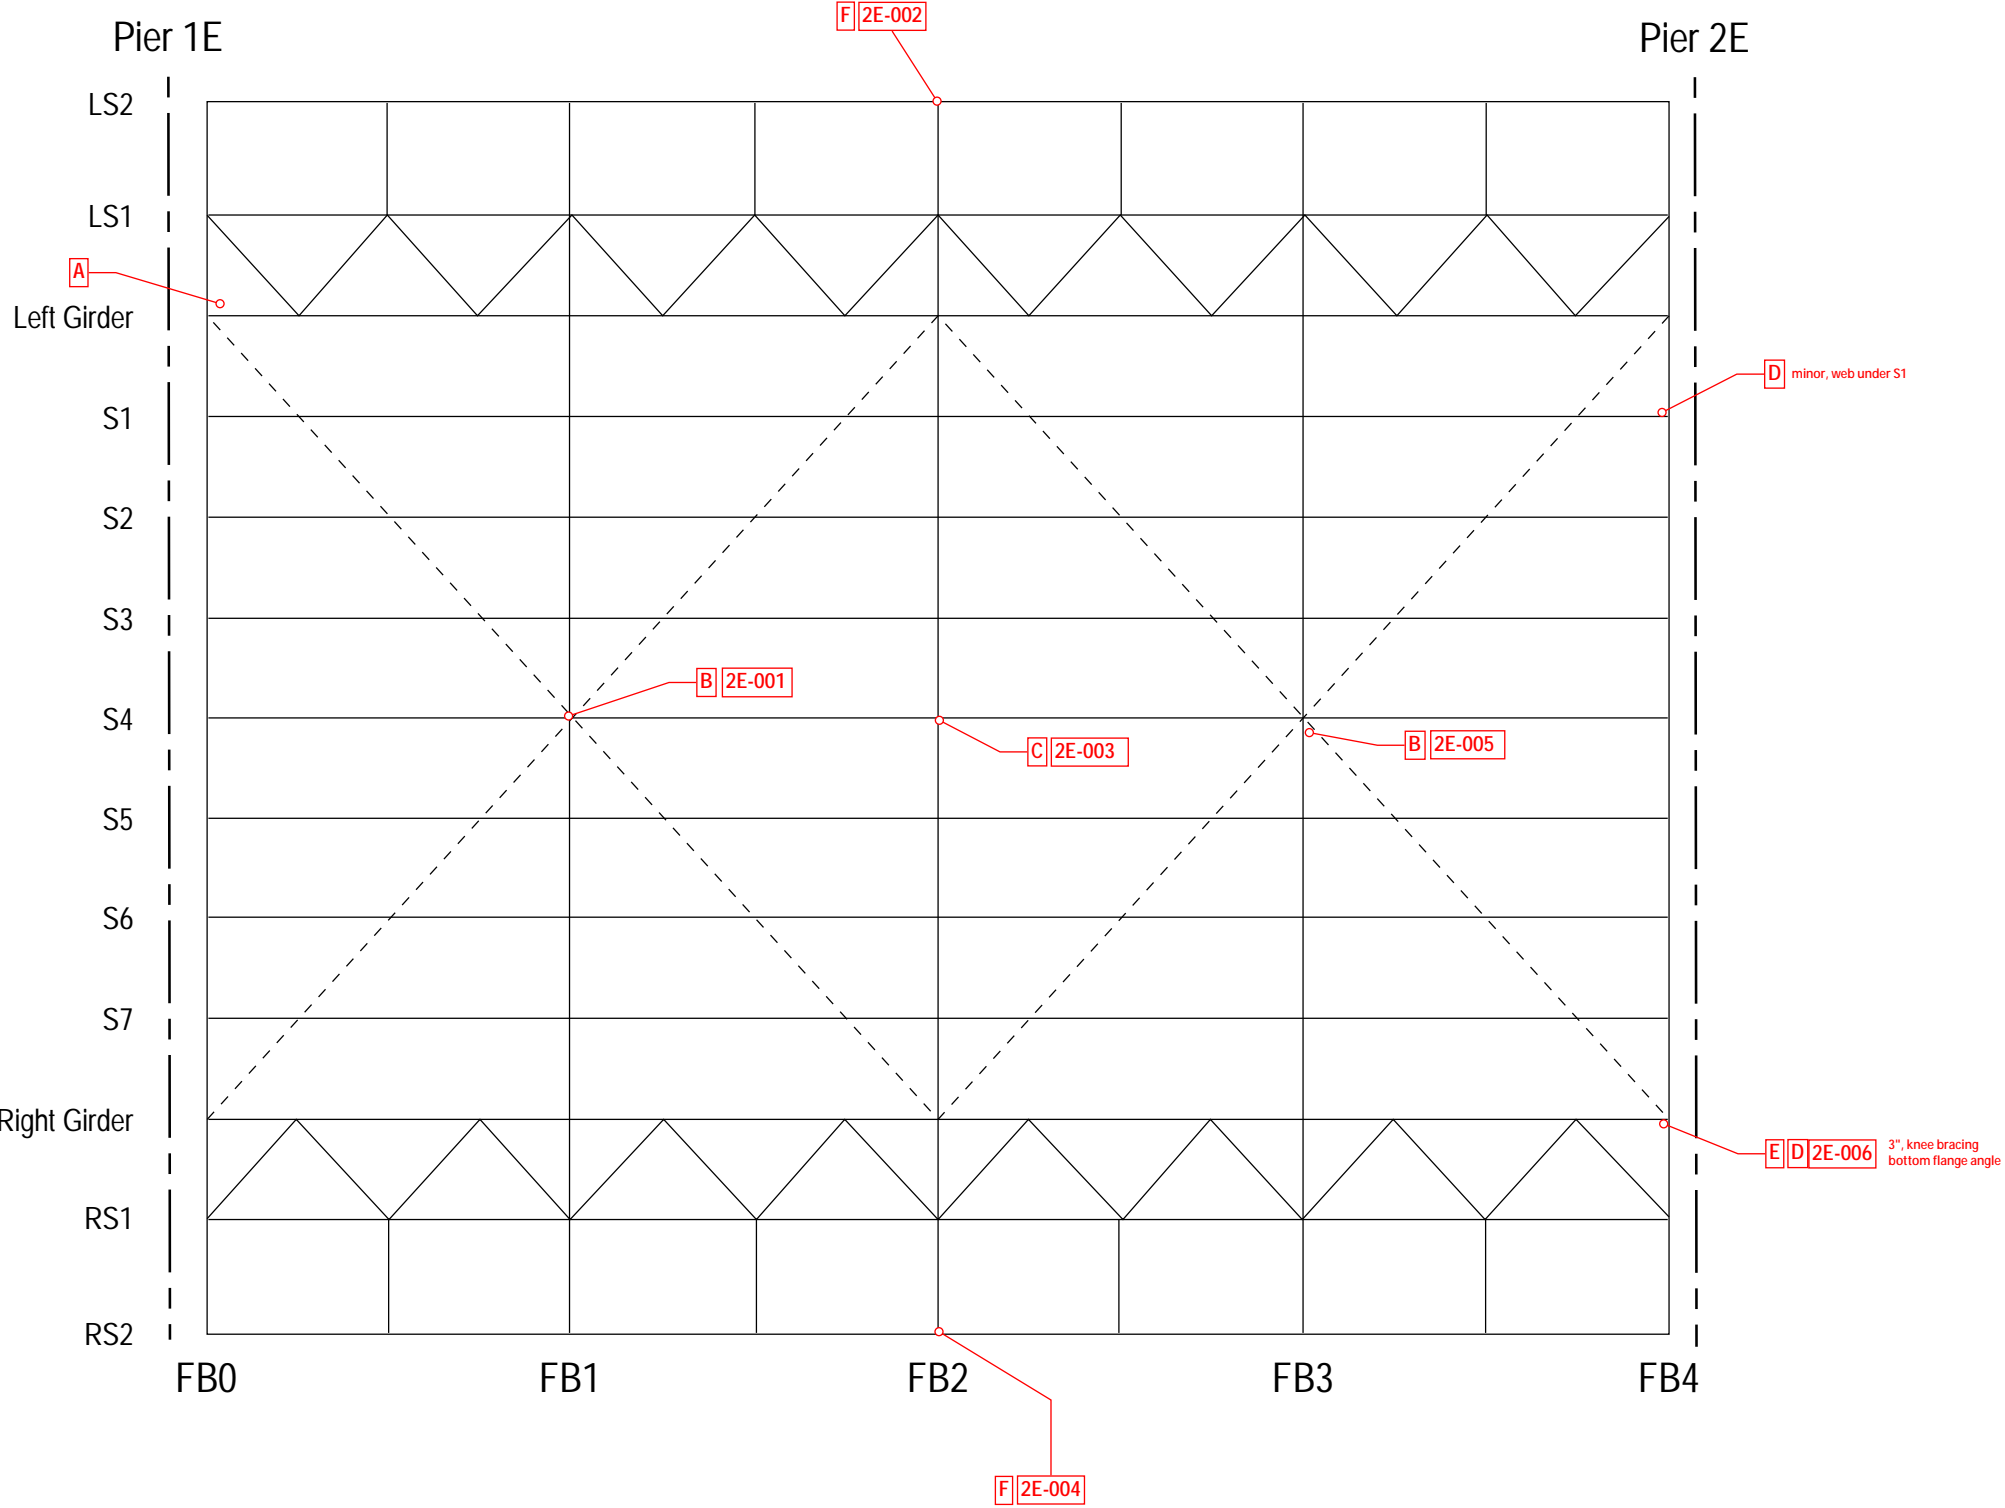
- A. Stringer - Minor painted over pack rust at stringer connection to floorbeam stiffener
- B. Deck - Minor corrosion and efflorescence of deck pan flashing at ____
- C. Floorbeam - Painted over pack rust between bottom flange angles and cover plate causing minor distortion along bottom flange
- D. Floorbeam - Up to 100% section loss of majority of transverse stiffeners along bottom flange
- E. Floorbeam - Painted over area of 100% section loss to bottom flange angle of kneebrace at overhang
- F. Lateral Bracing - Minor bowing of connection plate due to painted over pack rust
- G. Floorbeam - Minor impact damage to transverse stiffener
- H. Stringer - Painted over areas of corrosion, pack rust between bottom angle/web of fascia stringers (typical)

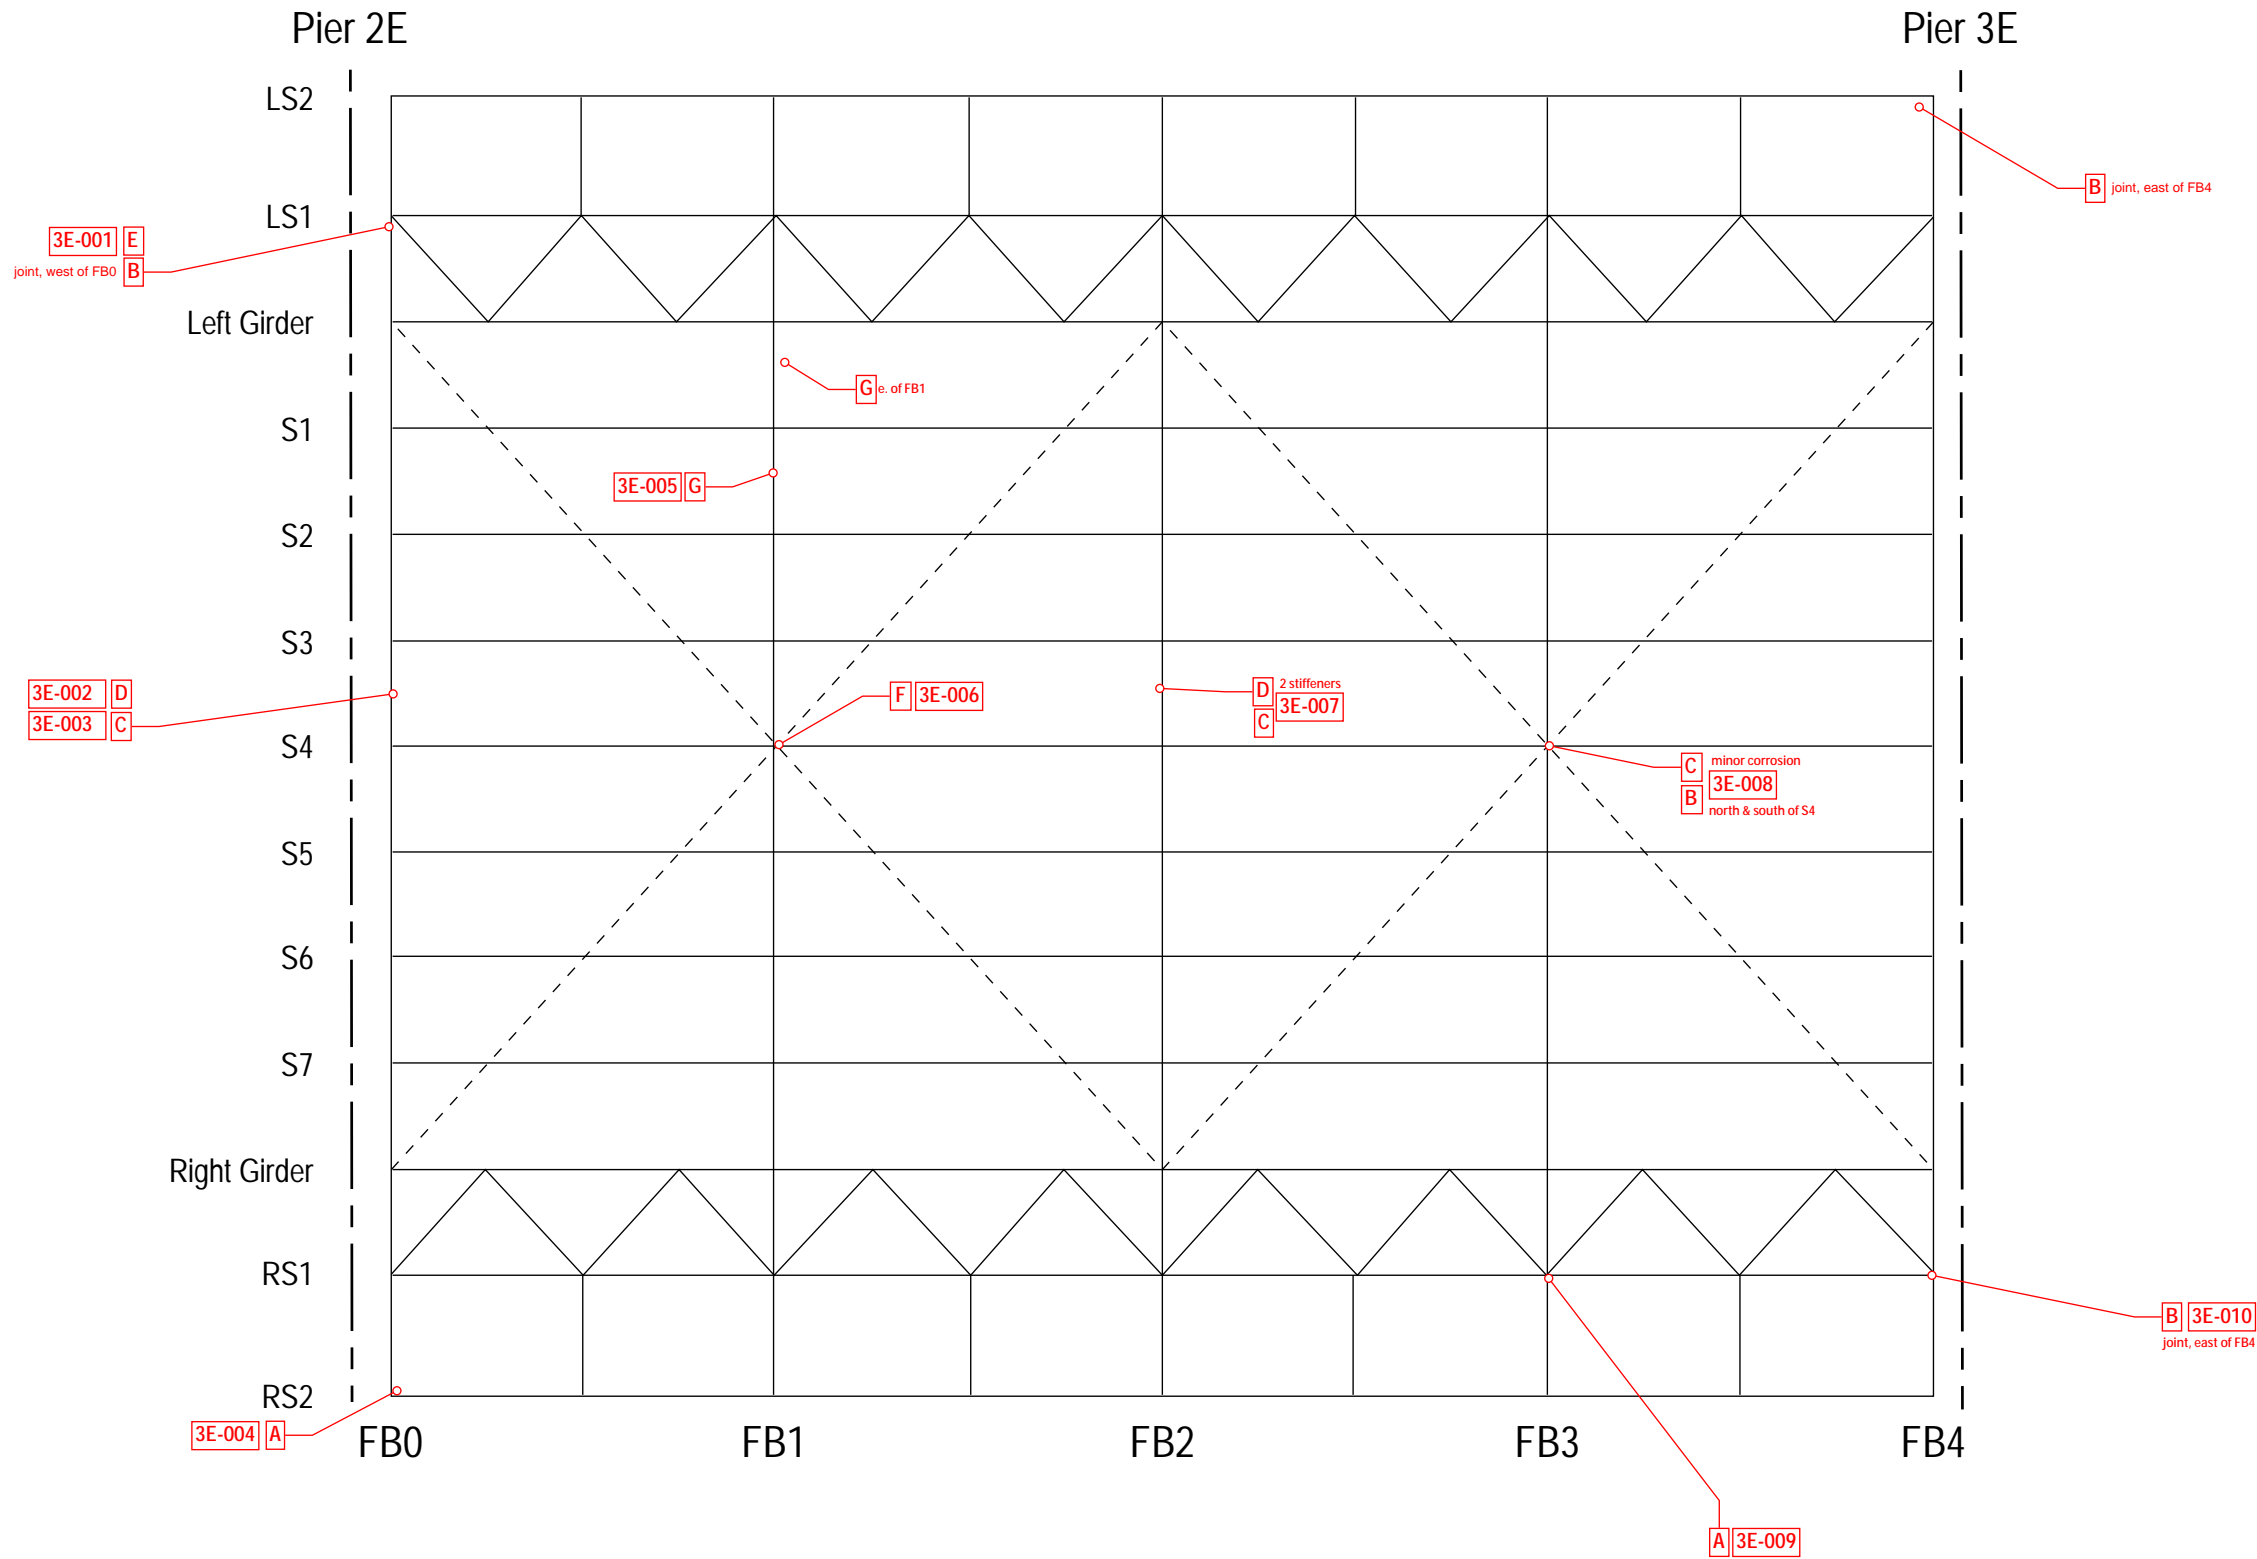
- A. Stringer - Painted over areas of corrosion, pack rust between bottom angle/web of fascia stringers (typical)
- B. Floorbeam - Painted over areas of pitting with up to 100% section loss of top flange/transverse stiffeners and active corrosion of deck pan flashing at joints
- C. Lateral Bracing - Minor bowing of connection plate due to painted over pack rust
- D. Stringer - Painted over areas of pitting with up to 100% section loss to web
- E. Floorbeam - Painted over pack rust between bottom flange angles and cover plate with minor distortion along bottom flange. Painting over pitting of bottom flange and transverse stiffeners, one with 100% section loss. Very minor areas of corrosion to the top flange
- F. Stringer - Minor painted over pack rust at stringer connection to floorbeam stiffener

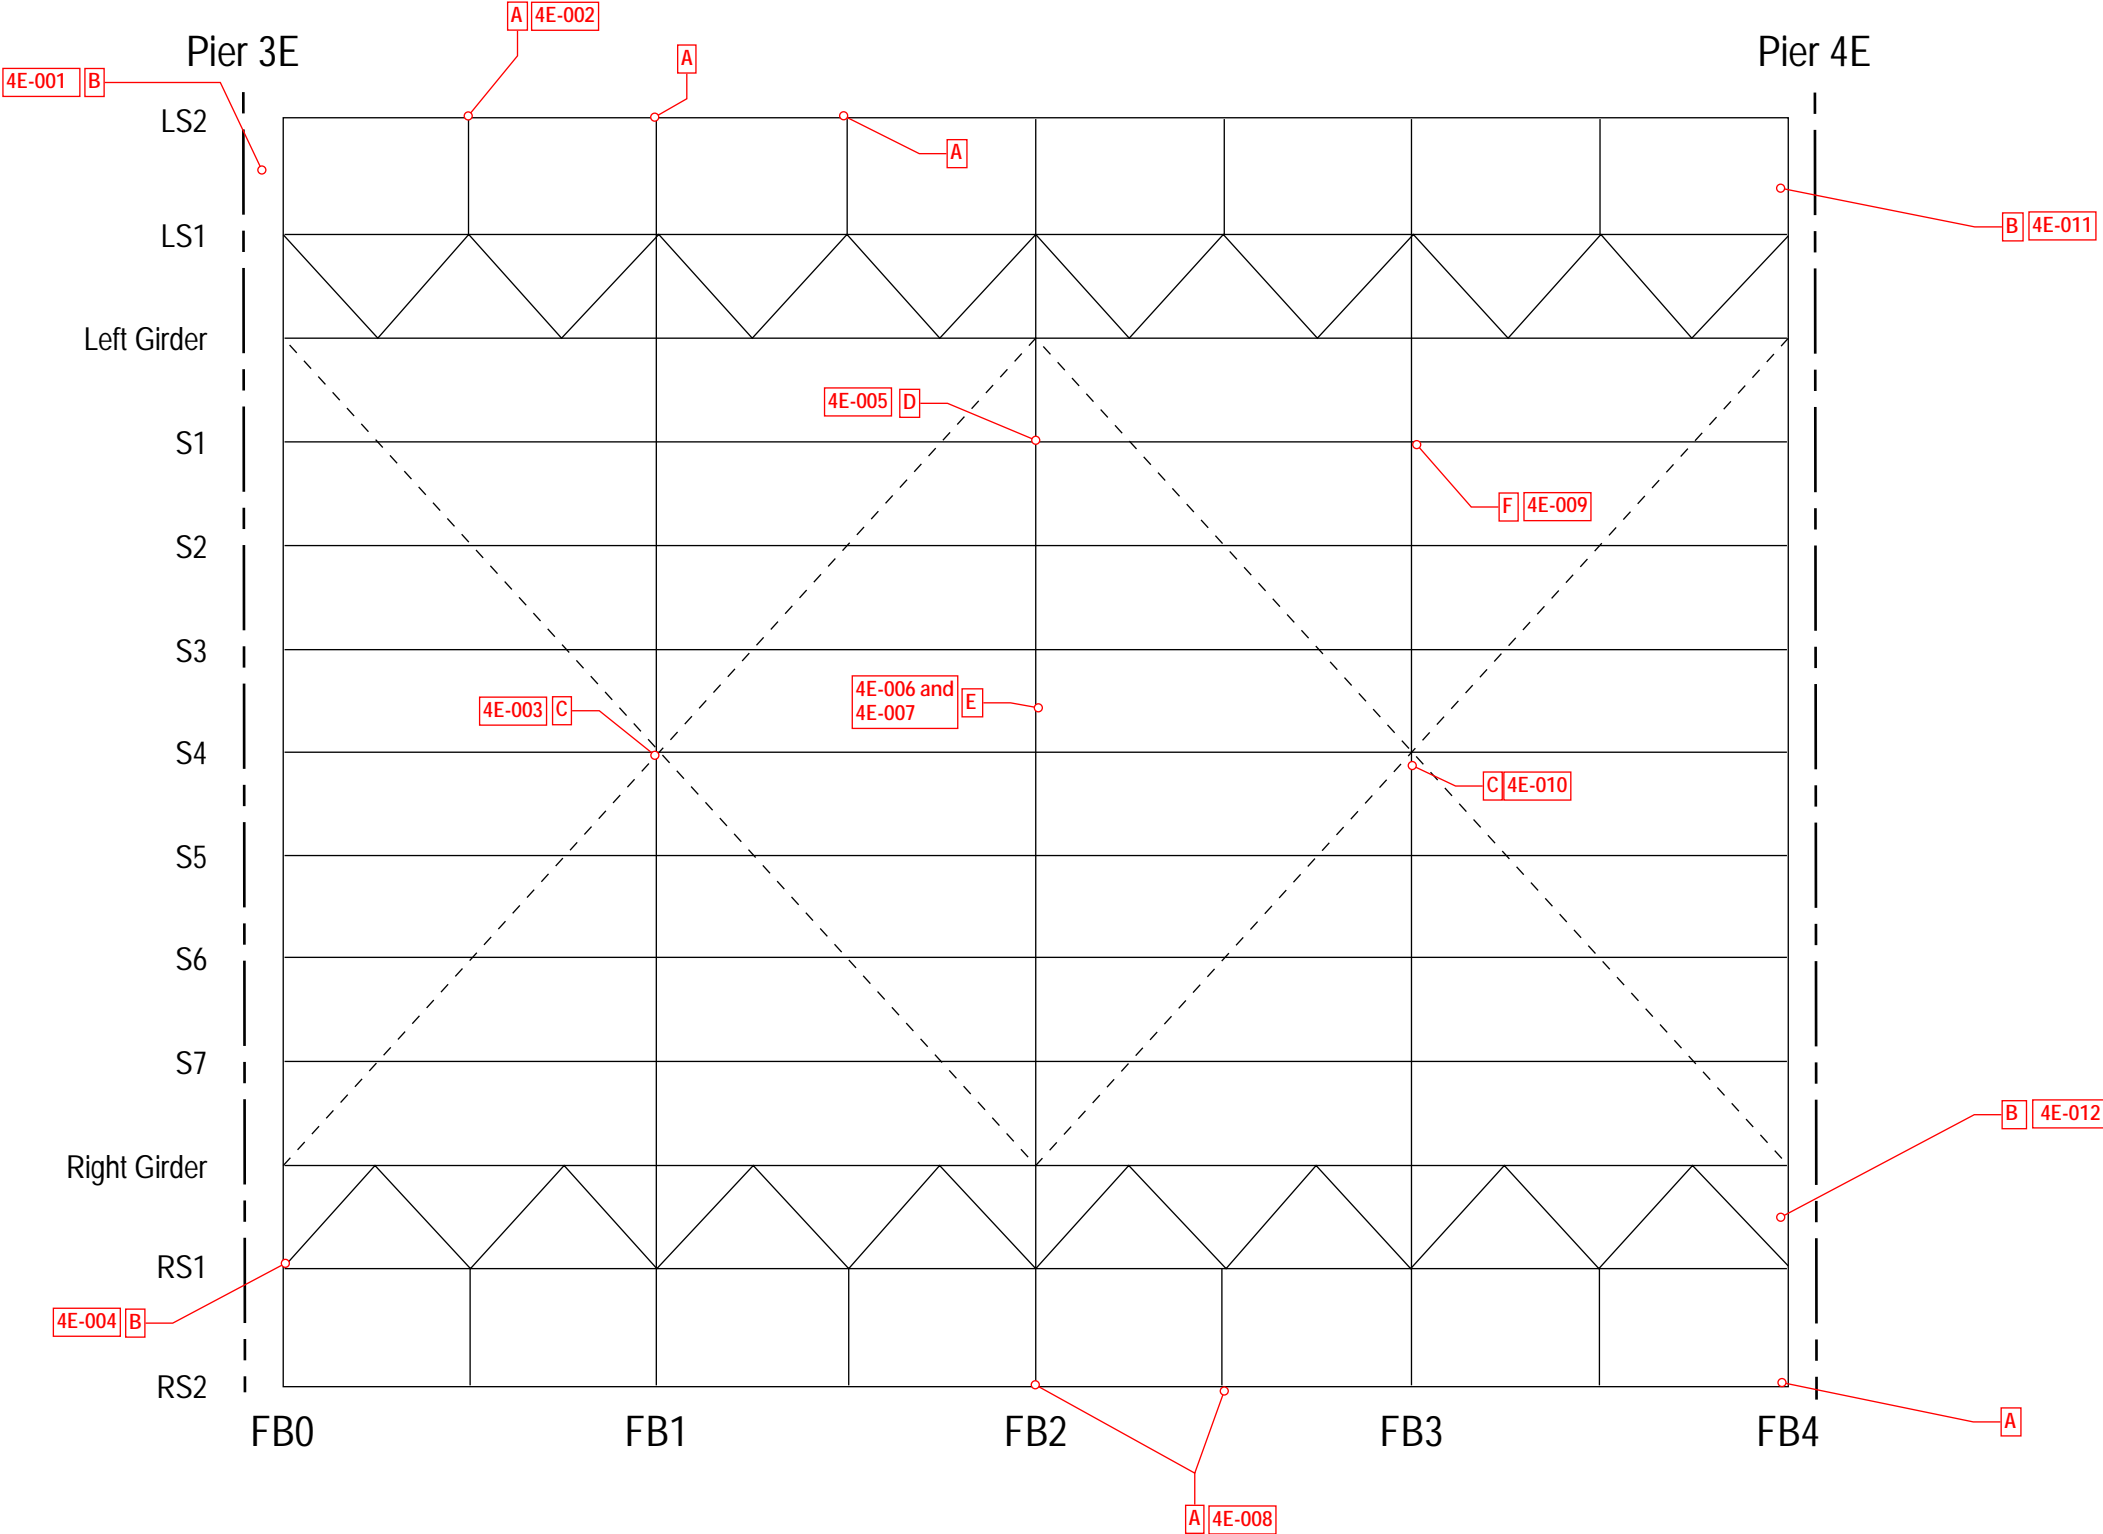
- A. Stringer - Painted over areas of corrosion up to 100% section loss and pack rust between bottom angle/web of fascia stringers (typical)
- B. Floorbeam - Painted over areas of pitting with up to 100% section loss of top flange/transverse stiffeners and active corrosion of deck pan flashing at joints
- C. Lateral Bracing - Minor bowing of connection plate due to painted over pack rust
- D. Stringer - 1 1/2' long by 4" high unpainted web with exposed primer
- E. Floorbeam - Painted over pack rust between bottom flange angles and cover plate causing minor distortion along bottom flange
- F. Stringer - Minor painted over active corrosion of top flange with light deck efflorescence
- G. Bearing - Minor corrosion of masonry plate

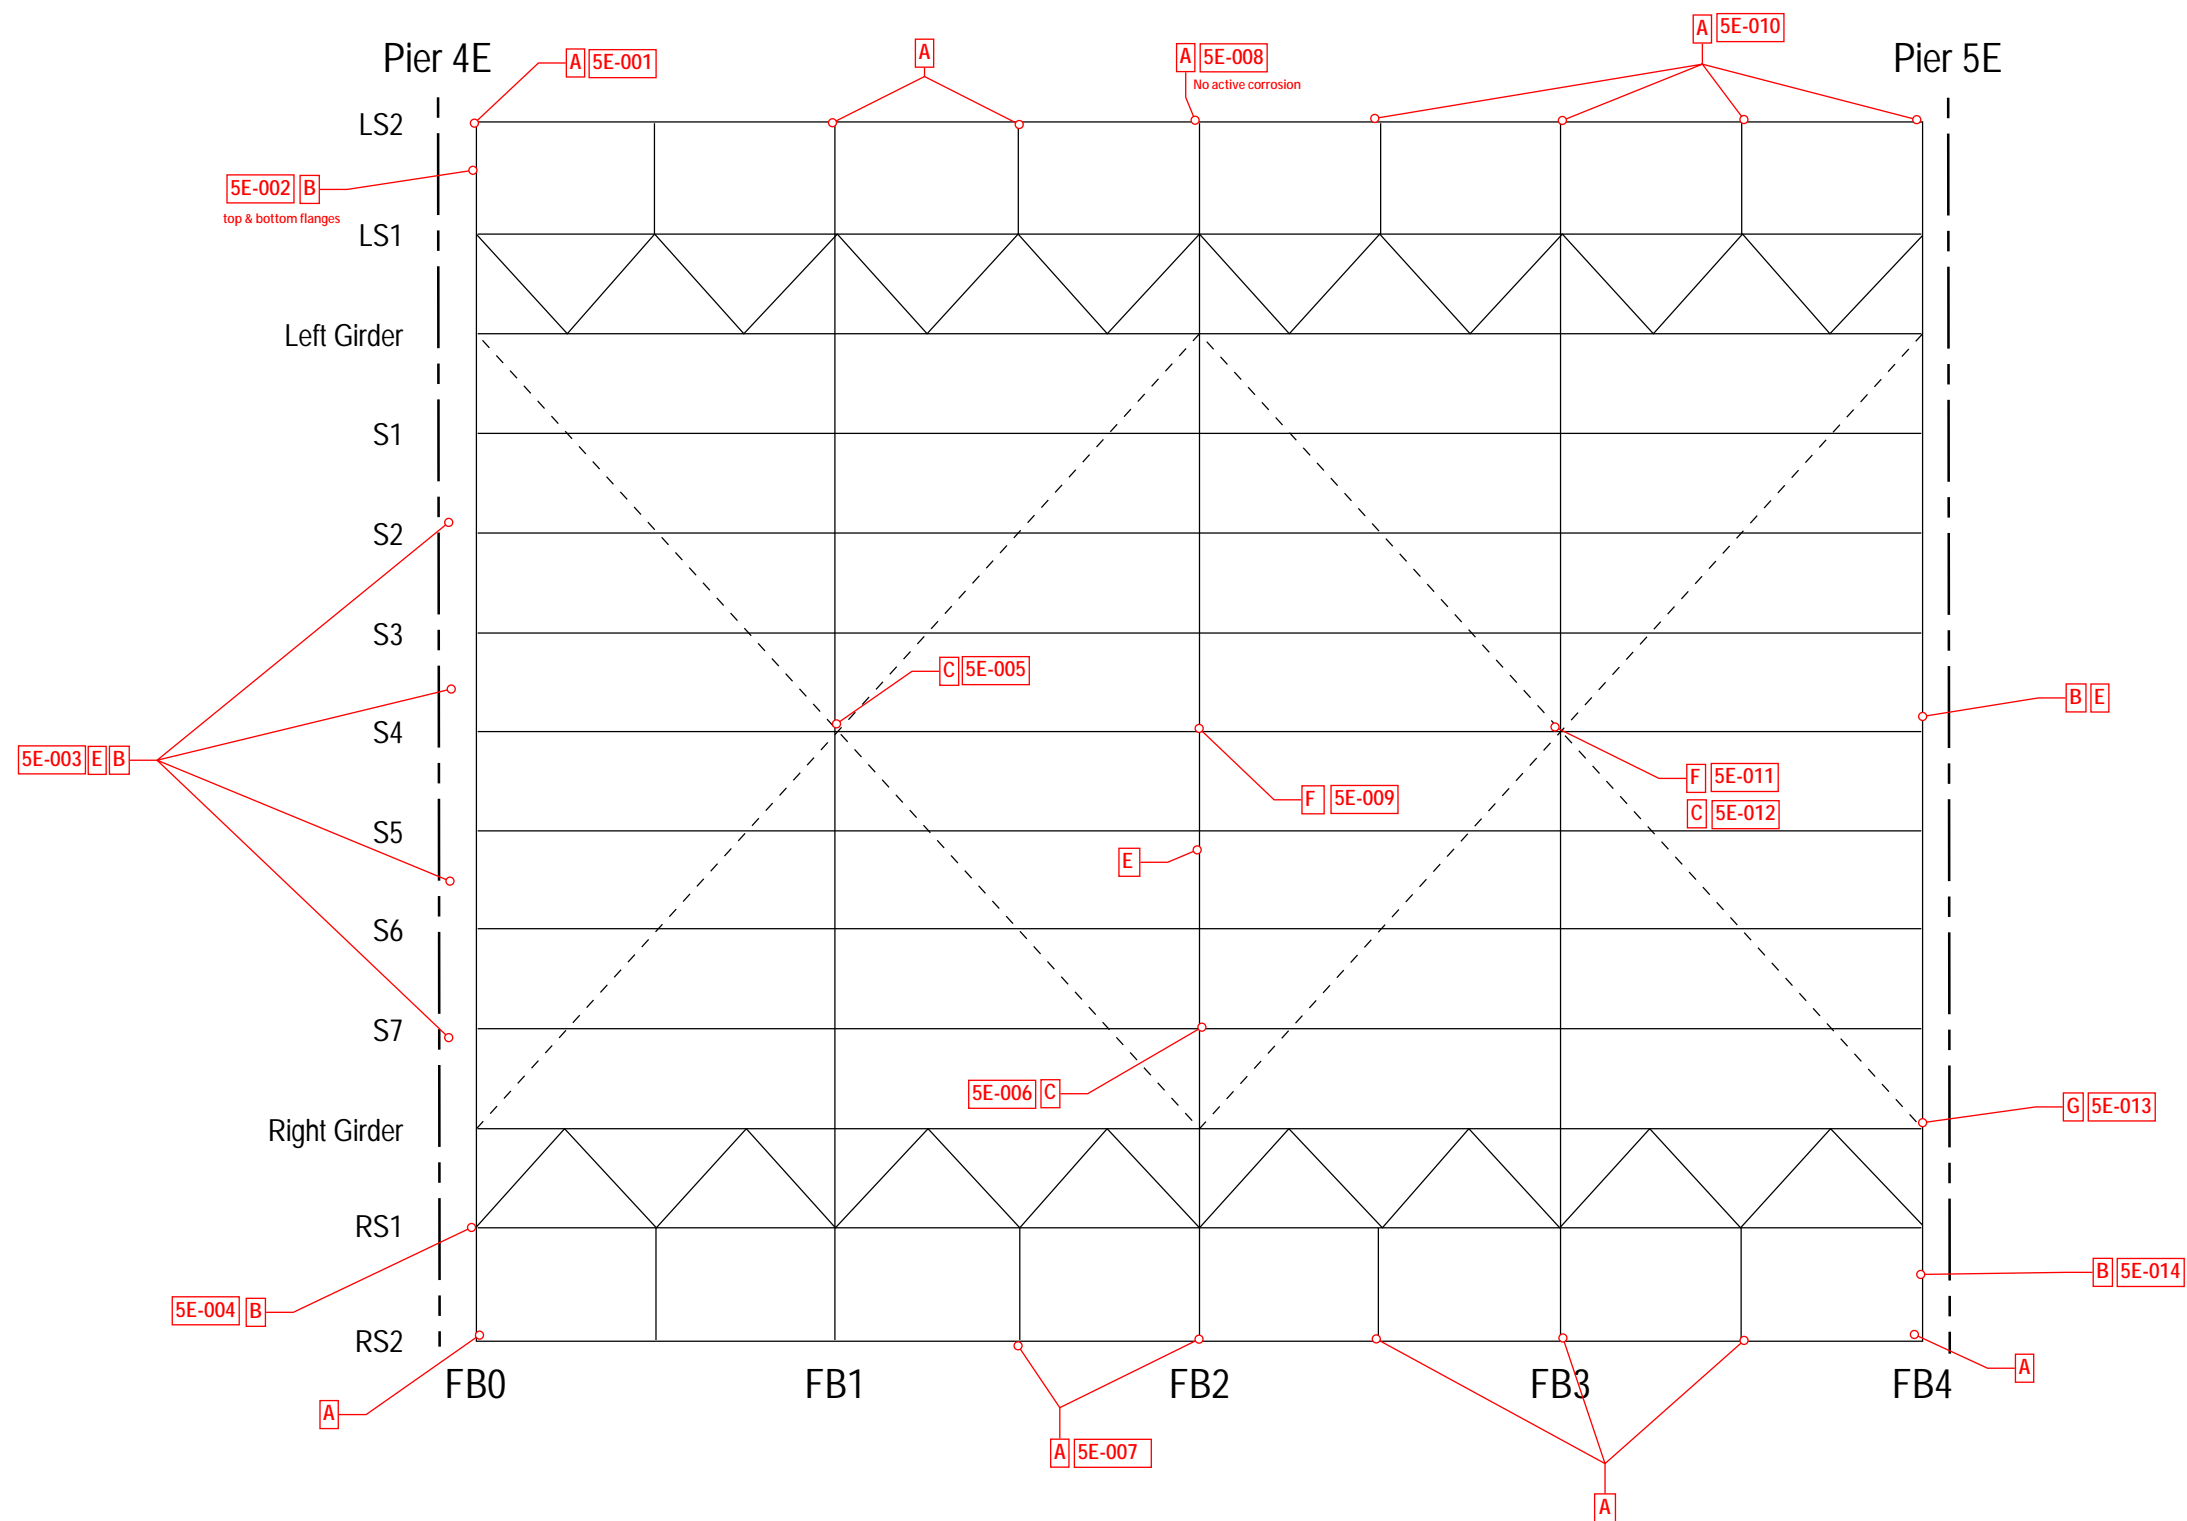
- A. Floorbeam - Painted over areas of pitting with up to 100% section loss of top flange/transverse stiffeners and active corrosion of deck pan flashing at joints
- B. Stringer - Painted over areas of corrosion up to 100% section loss and pack rust between bottom angle/web of fascia stringers (typical)
- C. Lateral Bracing - Minor bowing of connection plate due to painted over pack rust
- D. Lateral Bracing - Minor impact damage
- E. Floorbeam - Painted over pack rust between bottom flange angles and cover plate causing minor distortion along bottom flange
- F. Floorbeam - Painted over section loss up to 100% of ____
- G. Floorbeam - Minor impact damage
