PHYSICAL CONDITION REPORT
2024 ROUTINE ELEMENT LEVEL AND NSTM
INSPECTION

INSPECTION MAY 2024
REPORT AUGUST 2024

ANTHONY WAYNE BRIDGE
LUC-002-1862
SFN: 4800303

Ohio Department of Transportation, District 2
317 E Poe Rd
Bowling Green, OH 43402

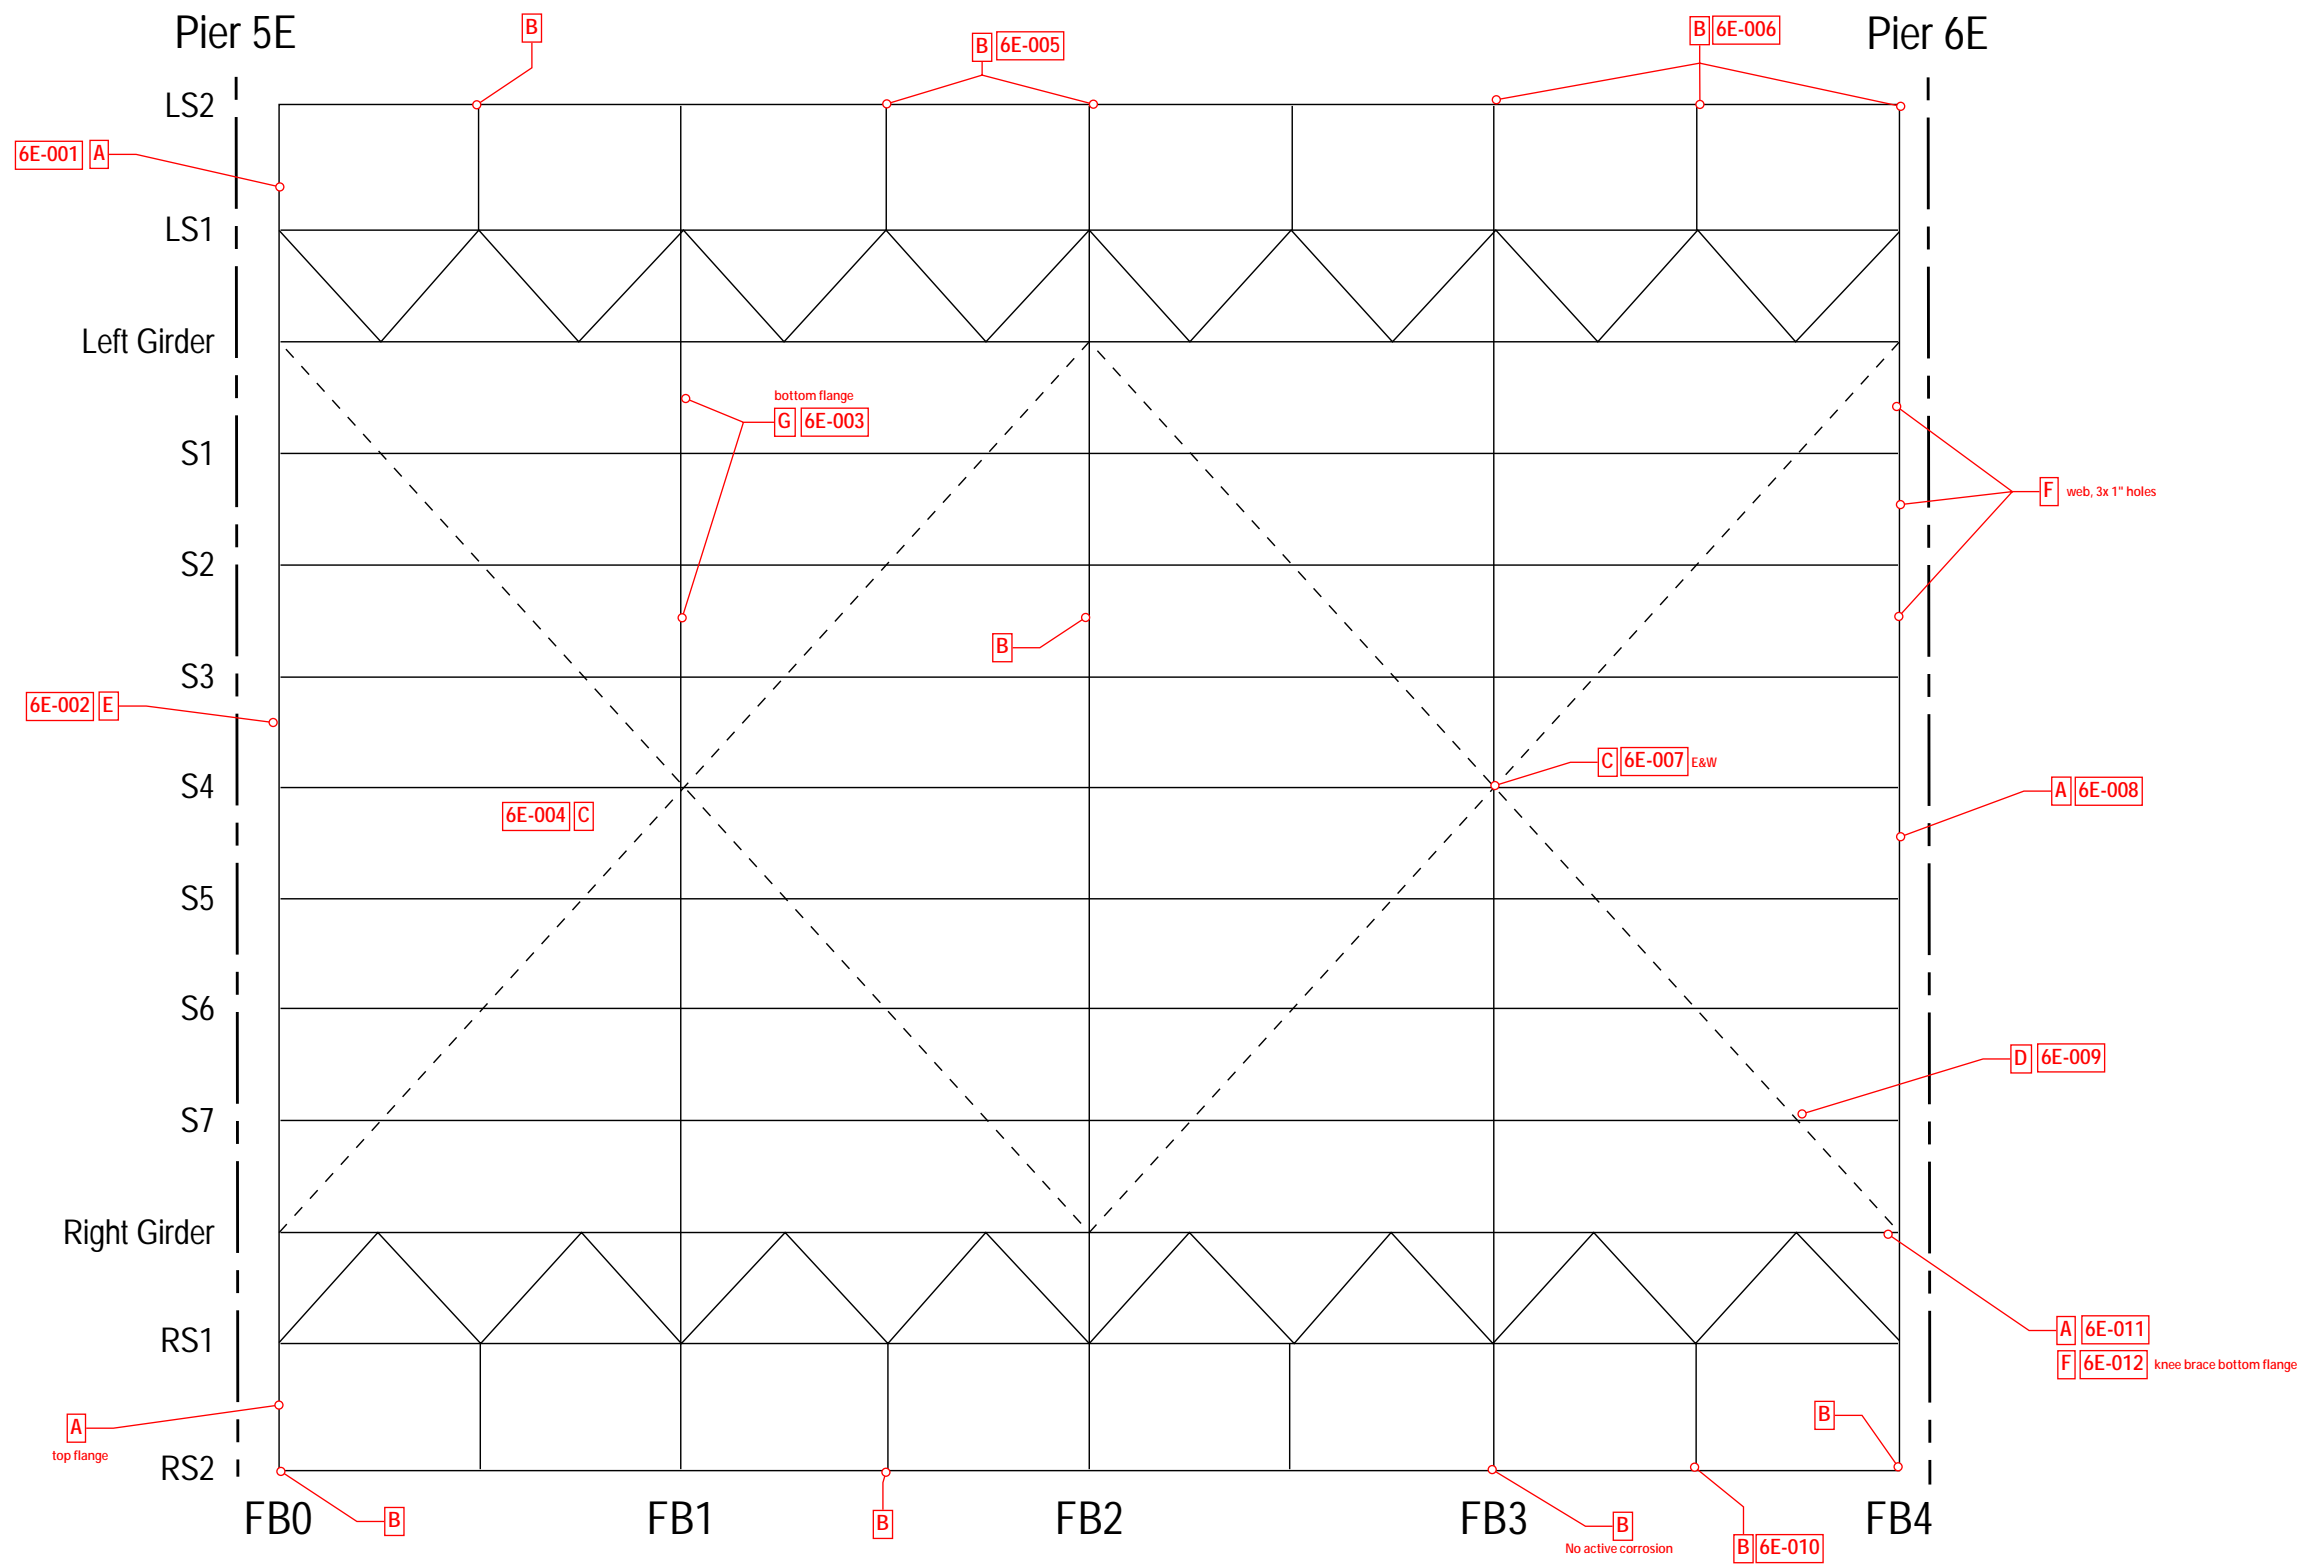
- A. Bearing - Corrosion between masonry plate/rocker assembly and minor pack rust between sole plate/rocker assembly
- B. Stringer - Painted over areas of corrosion up to 100% section loss and pack rust between bottom angle/web of fascia stringers (typical)
- C. Girder - Minor painted over section loss to ____
- D. Floorbeam - Painted over section loss to ____
- E. Floorbeam - Up to 100% section loss of majority of transverse stiffeners along bottom flange
- F. General - broken underpass light

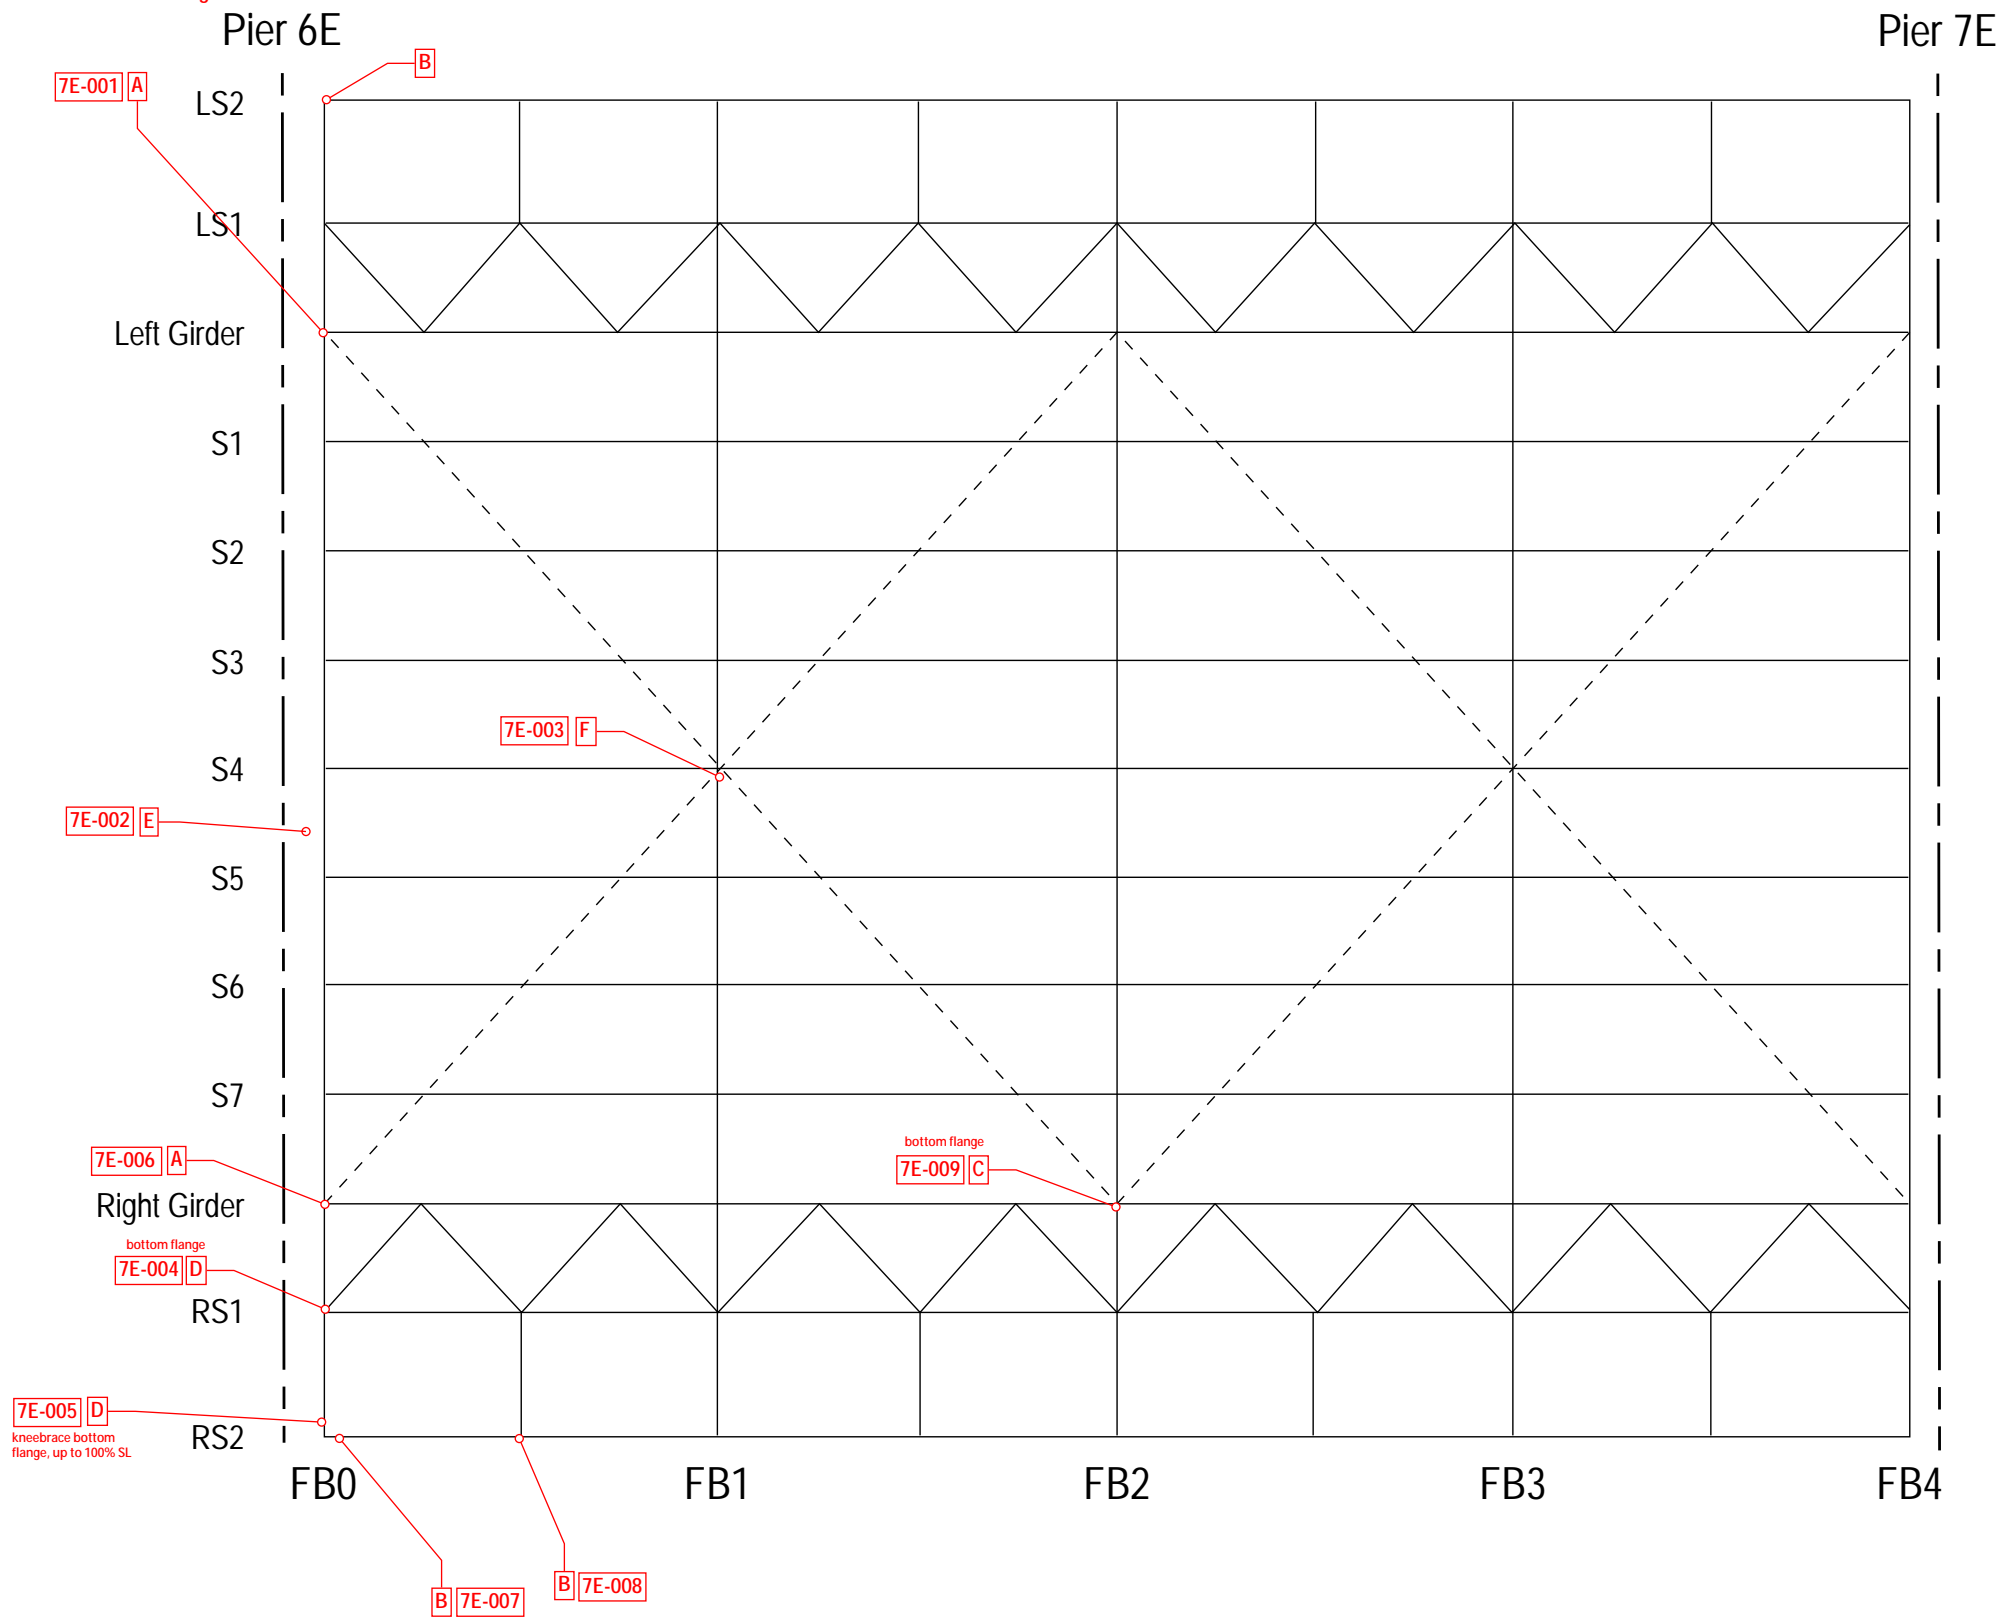
- A. Stringer - Painted over areas of corrosion with up to 100% section loss and pack rust between bottom angle/web of fascia stringers (typical)
- B. Stringer - Minor active top flange corrosion (typical)
- C. Stringer - Minor impact scrapes on bottom flange
- D. Stringer - Minor painted over pitting throughout stringer, focused along bottom flange and at stringer ends and bearing stiffeners

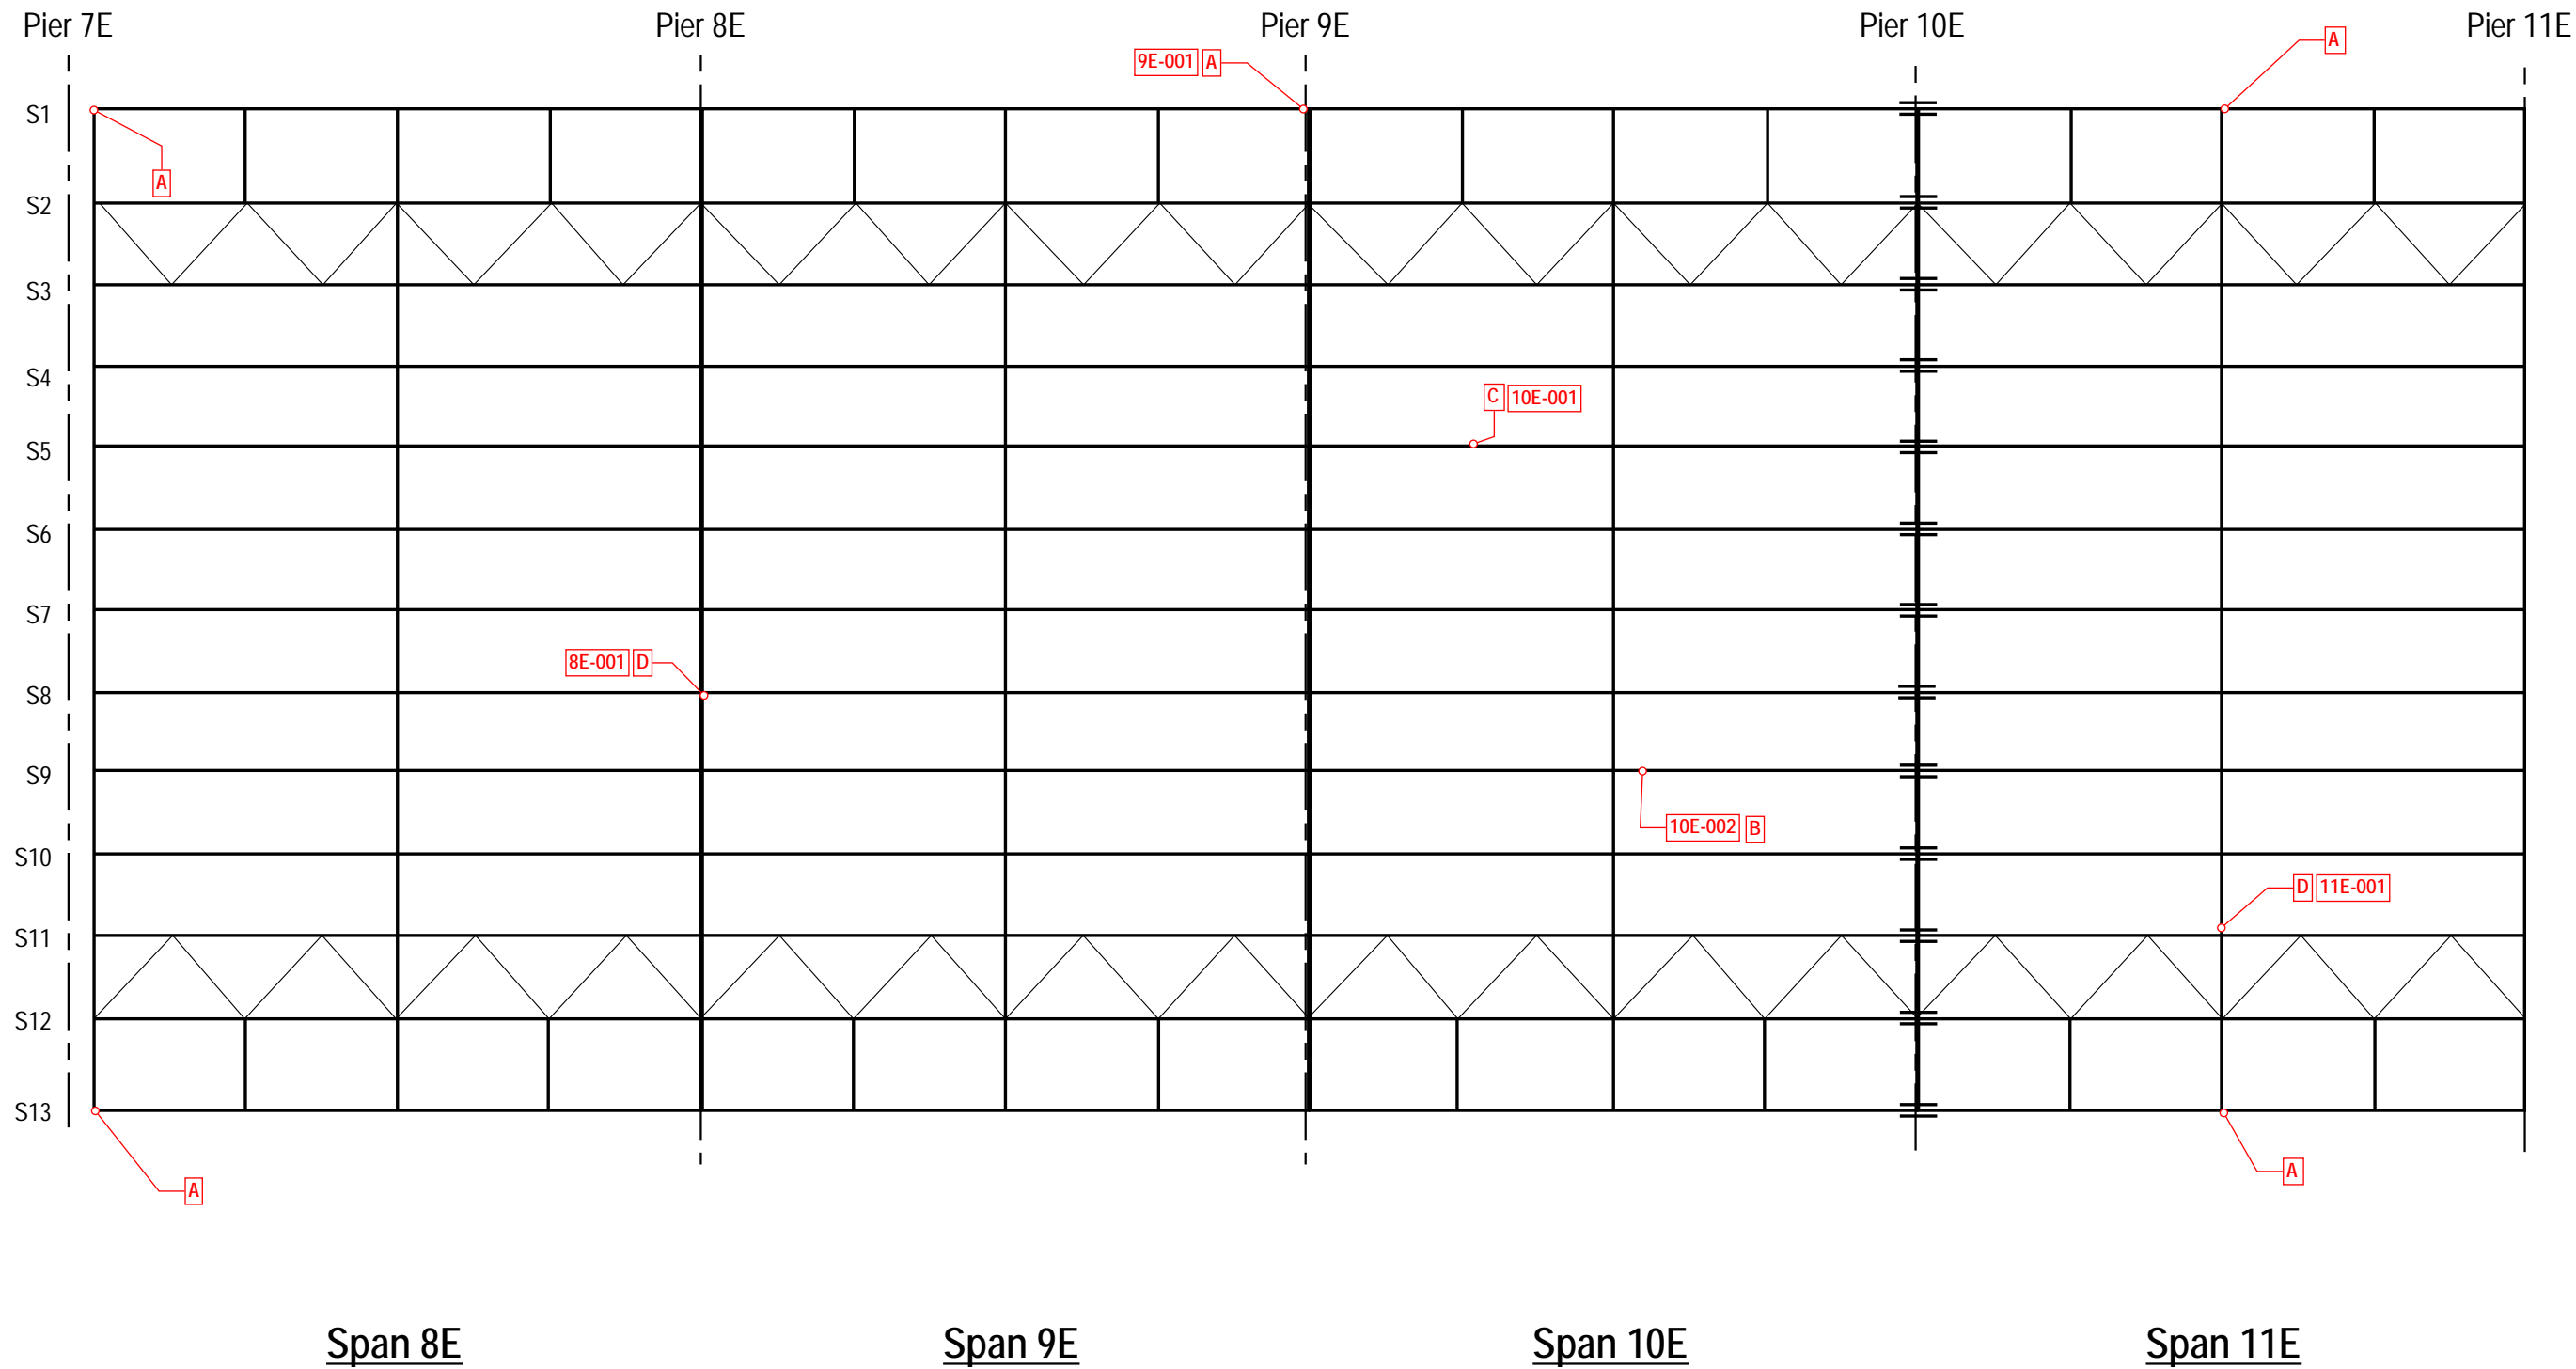
- A. Stringer - Painted over areas of corrosion with up to 100% section loss and pack rust between bottom angle/web of fascia stringers (typical)
- B. Stringer - Minor painted over pitting throughout stringer (typical)
- C. Stringer - Minor impact scrapes on bottom flange
- D. General - broken underpass light
