2022 PHYSICAL CONDITION INSPECTION REPORT

ERI-6-2893

State Route 6 over the Vermilion River

Ohio Department of Transportation

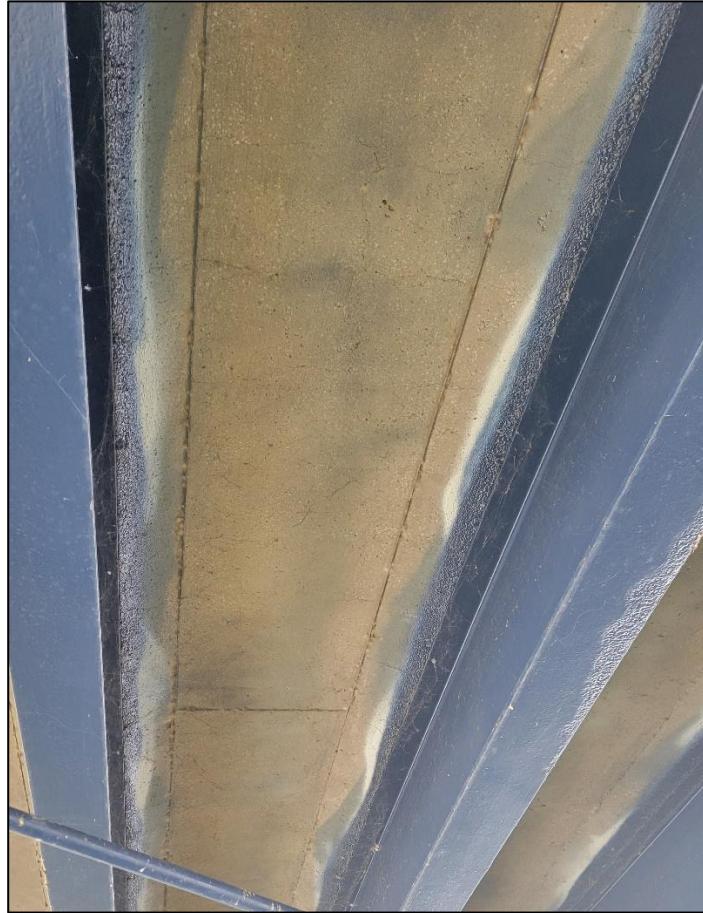
The floor is in **fair** condition. The floor has typical hairline map cracking (see Picture 1). There are cracks with efflorescence in Panels 1 and 5 through 9, and cracks with moisture in Panels 6 and 7 (see Appendix E for more information).

Picture 1: Typical hairline map cracking in deck.

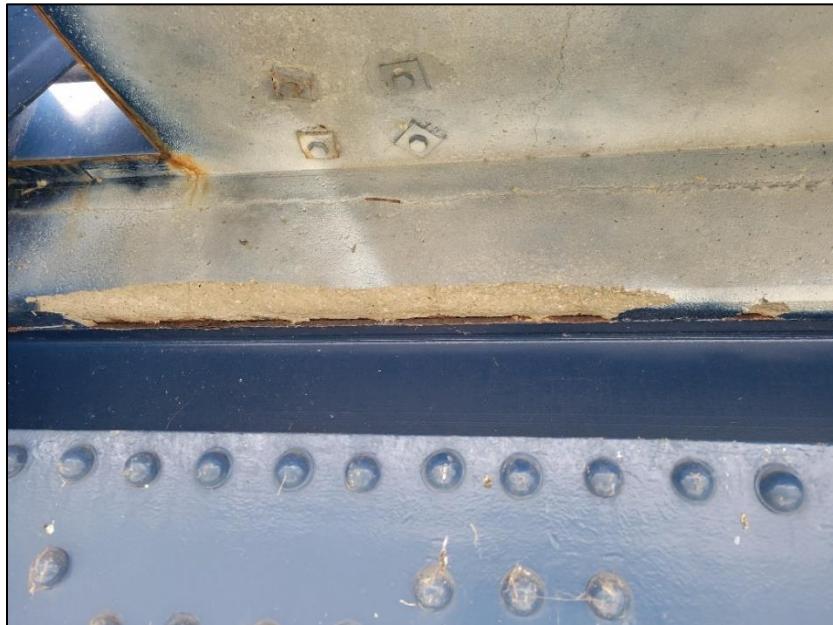
The edge of floor is in **poor** condition. There are spalls and delaminations for more than 200 feet of the 992 ft of deck edge (>20% spalled) (see Picture 2). For a more detailed layout of the deck edge deterioration see Appendix C. In 2021, a large spall fell from the deck edge and landed on a boat parked below. WPG closely inspected the entire length of the deck edges and found additional delaminations. The spalls and delaminations are due to the way the deck reinforcing was framed, no end rebar was used based on standard practice of the time. This has been known to cause spalling along the edges, especially in more aquatic applications. WPG took special care to look at the entire deck edge and safely remove any existing delaminations during this inspection to minimize future risk of falling concrete in the river or anyone using the recreational waterway beneath the structure (see Pictures 3 & 4).

Picture 2: Spalls on south edge of deck in Panel 1.

- Continue to monitor the deck edge closely for potential spalls.
- Consider cleaning and clearing underside of bridge of pigeon debris and nests.

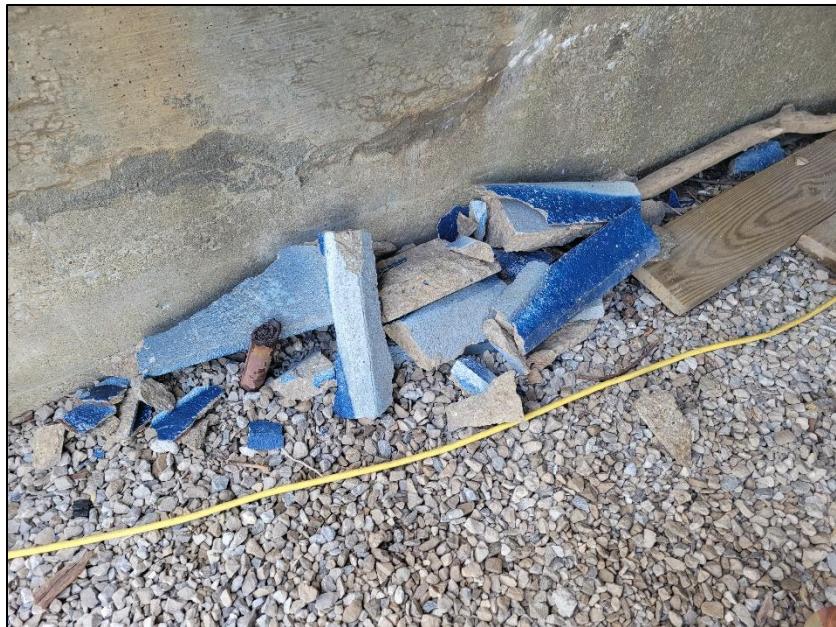
Picture 3: A portion of the spalls safely removed.

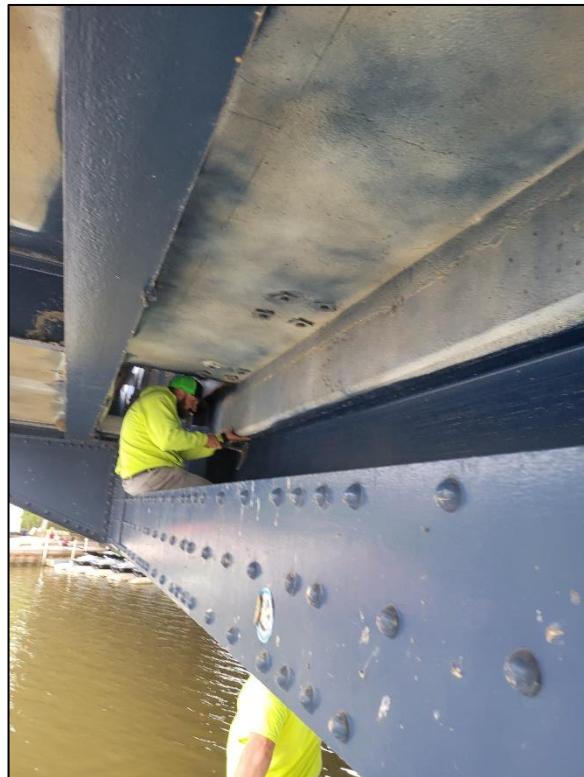
Picture 4: Safely removing delaminations on deck edge.

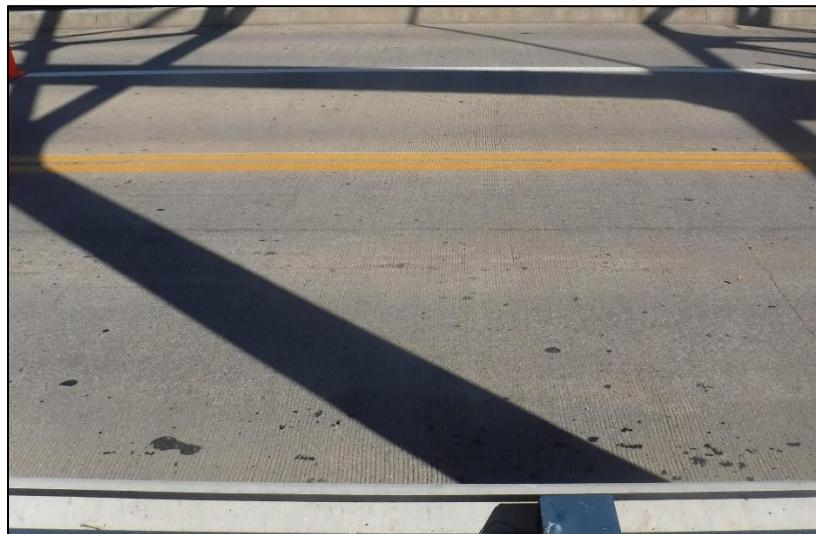
There are a few small spalls and pop-outs in the westbound and turn lanes near the east end of the bridge. There were no delaminated areas found by sounding the deck. There are typical transverse cracks all along the deck (see Picture 5). Transverse cracks that are over the floorbeams are up to 0.03" wide. There are two longitudinal hairline cracks down the westbound lane that may be located above stringers. The westbound lane has deformations in the wearing surface that may be due to original construction. Typically, the grooves in the wearing surface are worn smooth in the wheel lines.

Picture 5: Looking north (near mid panel) at hairline cracks in wearing surface.

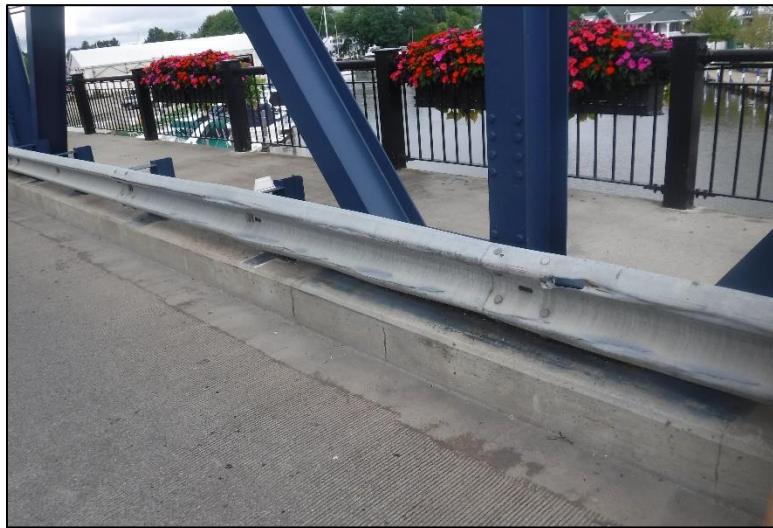
Curbs - The concrete curbs have minor cracks and spalls. There are typical cracks in the curbs next to the verticals, diagonals and guardrail posts (see Picture 6). There is a spall in the curb in Panel 6 of the north truss that has a hole 2" deep. The hole appears to be from original construction.

Picture 6: Looking northwest at north sidewalk near L4.

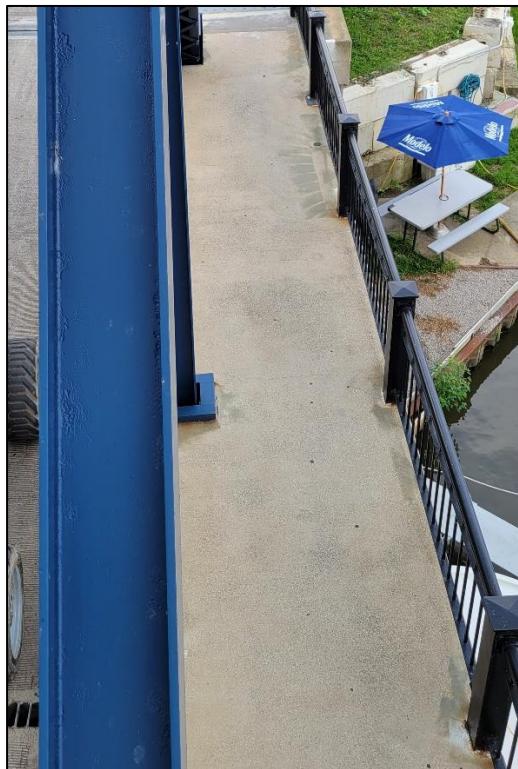
Sidewalk - The concrete sidewalks have minor spalls and typical minor hairline cracks originating from the pedestrian rail posts, guardrail posts and truss members (see Picture 7).

Picture 7: Looking west at north sidewalk near L1.

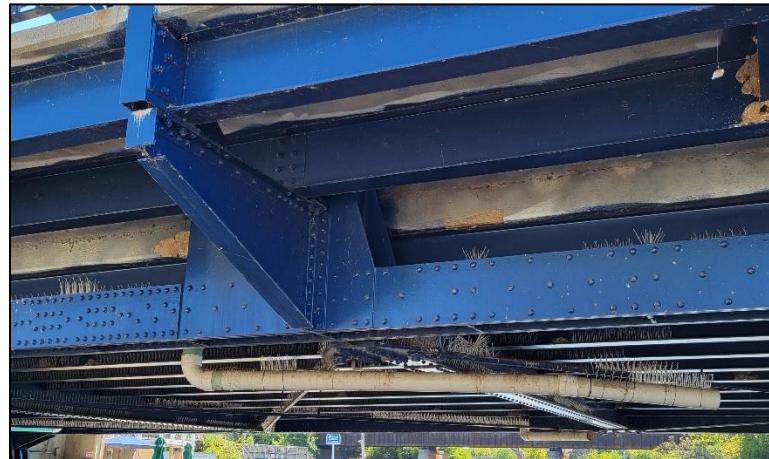
Sidewalk Stringers and Diaphragms - The sidewalk stringers are in good condition (see Picture 8) with minor section loss at the connections to the cantilever brackets. The fascia stringer of the north sidewalk at L6 has a small hole in the bottom flange. There are a few small localized areas with active rust at the ends of the fascia sidewalk stringers between the bearing and abutment backwall. There are holes in the end of the fascia sidewalk stringer web between the bearing and rear abutment backwall on south sidewalk. There is a hole in the end of the fascia sidewalk stringer web on south sidewalk in Panel 8 at L7. The diaphragms are in good condition.

Picture 8: Typical sidewalk stringer condition.

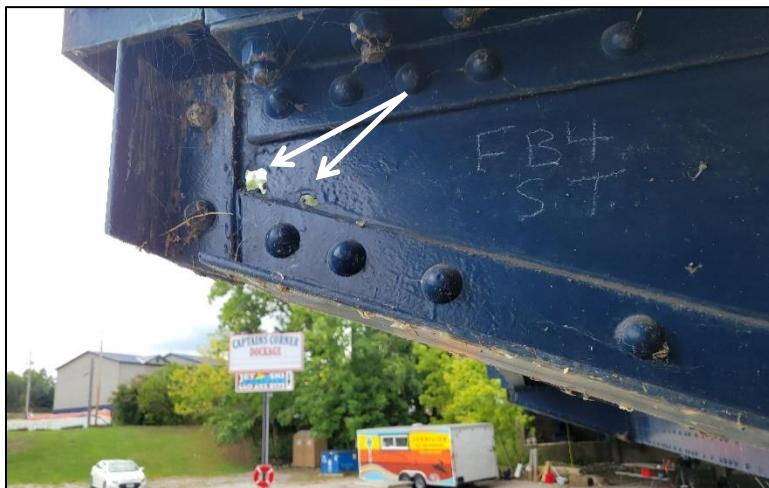
Picture 9: Looking west at hole in web of south cantilever bracket at L4.

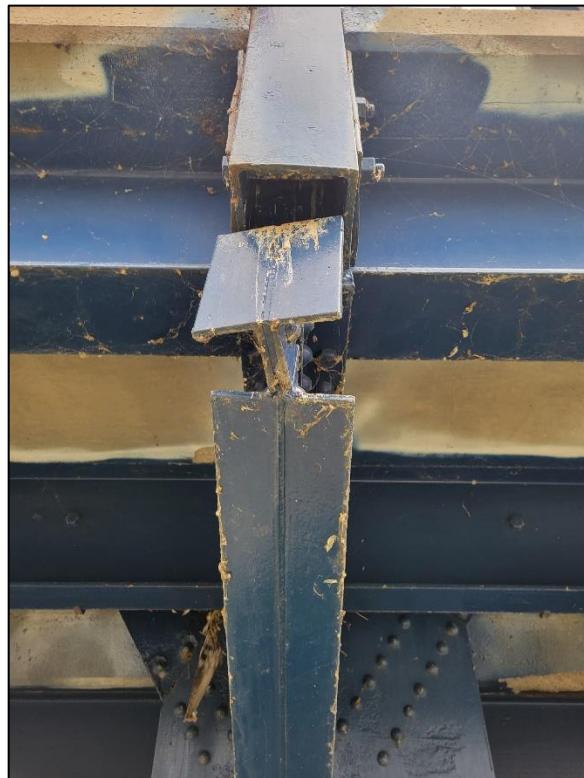
Sidewalk Cantilever Brackets - The sidewalk cantilever brackets are typically in good condition. There is some minor section loss in the webs at the connections to the trusses. The north cantilever bracket at L3 has a small hole in the web. The south cantilever bracket at L4 has three small holes in the web (see Picture 9). The south cantilever bracket at L5 has two small holes in the web. The south cantilever bracket at L6 has impact damage and a small hole in the web (see Picture 10). The sidewalk south cantilever at L9 has pack rust and minor active rust at the bottom of the connection angle at the bearing. Three of the sidewalk cantilever brackets have bent ends where boats have impacted the structure (see Picture 11).

Picture 11: Bent south cantilever bracket.

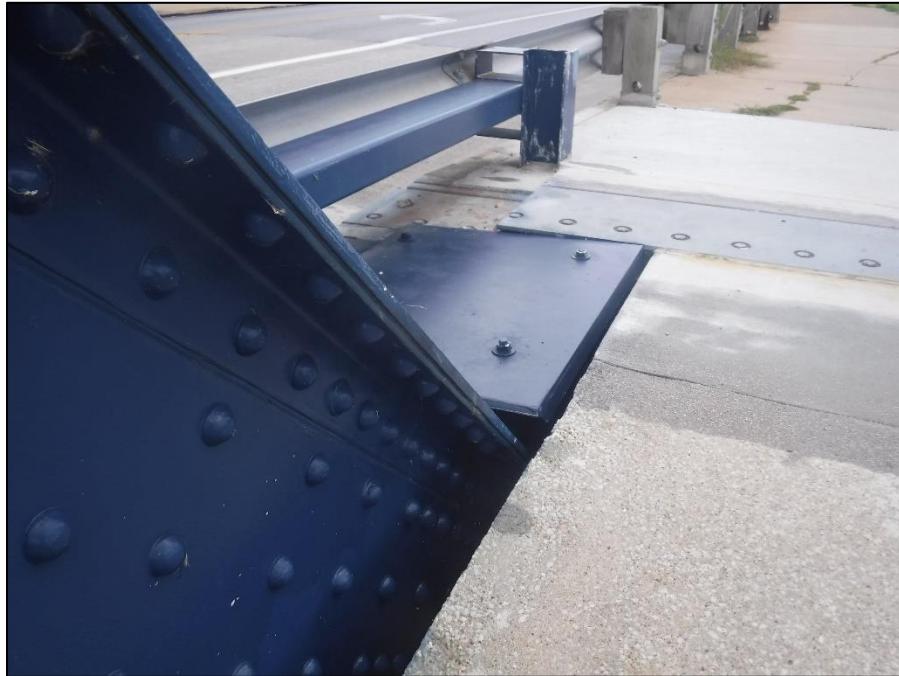
Truss Member Cover Plates - Steel cover plates at the sidewalk level protect the truss members at each lower chord panel point. The cover plates have minor active rust at the bottom next to the sidewalk. The cover plates at L3 of the north truss, L6 of the north truss and L3 of the south truss are loose. There is ponding next to the cover plate at L6 of the north truss. The cover plate at L0 of the north truss is $\frac{1}{4}$ " higher than the adjacent sidewalk (see Picture 12).

Picture 12: Minor misalignment of plates at L0 on north truss.

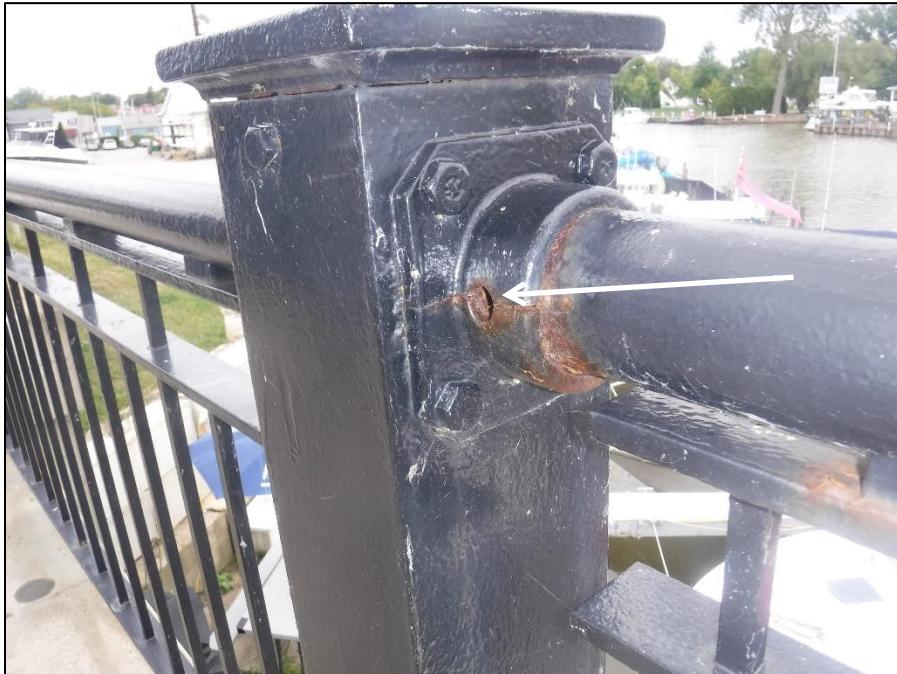
The bolt is missing from the connection at the top rail and post (see Picture 13) at 3 locations on the south pedestrian railing and 10 locations on the north pedestrian railing.

Picture 13: Missing bolt in connection plate.

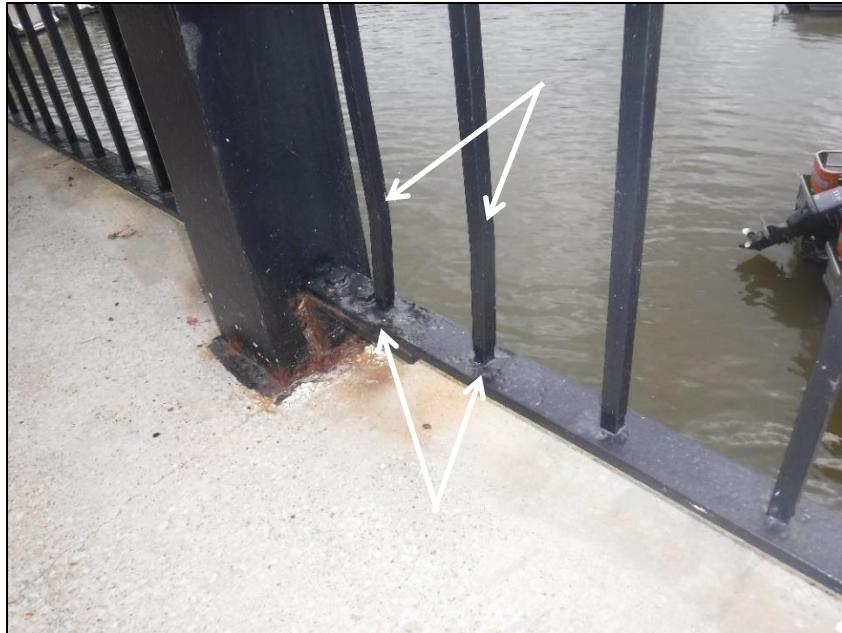
The top rail connection plate to the post is cracked or broken at 8 locations on the south pedestrian railing and 3 locations on the north pedestrian railing. There are 15 bent vertical rails on the south pedestrian railing and 13 bent vertical rails on the north pedestrian railing (see Picture 14). Many of the vertical rails have section loss at the bottom connection (see Picture 14). The south pedestrian railing section loss is worse (up to 50% section loss).

Picture 14: Bent vertical rails on pedestrian railing and section loss at bottom vertical rails.

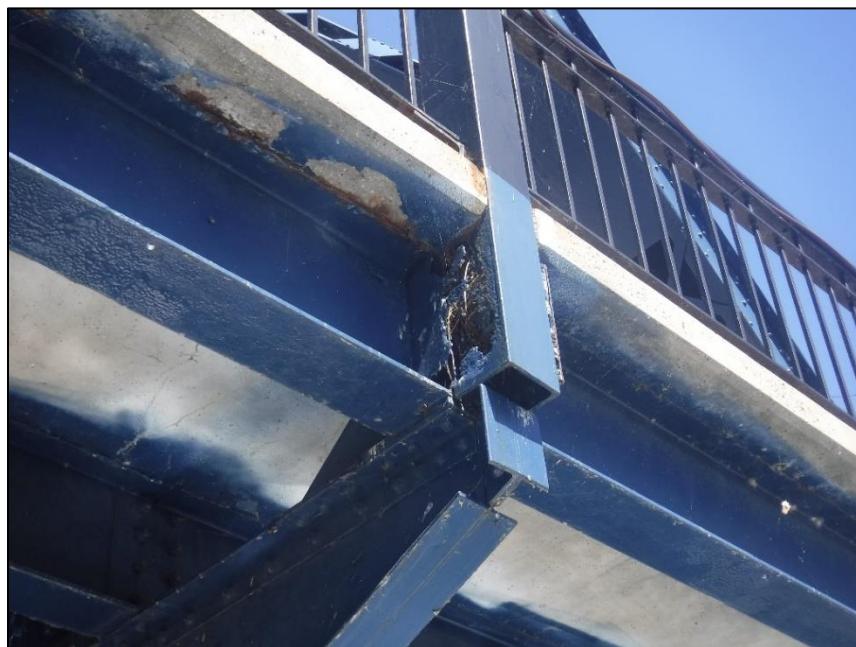
Picture 15: South truss L8 pedestrian post connection to stringer on west side.

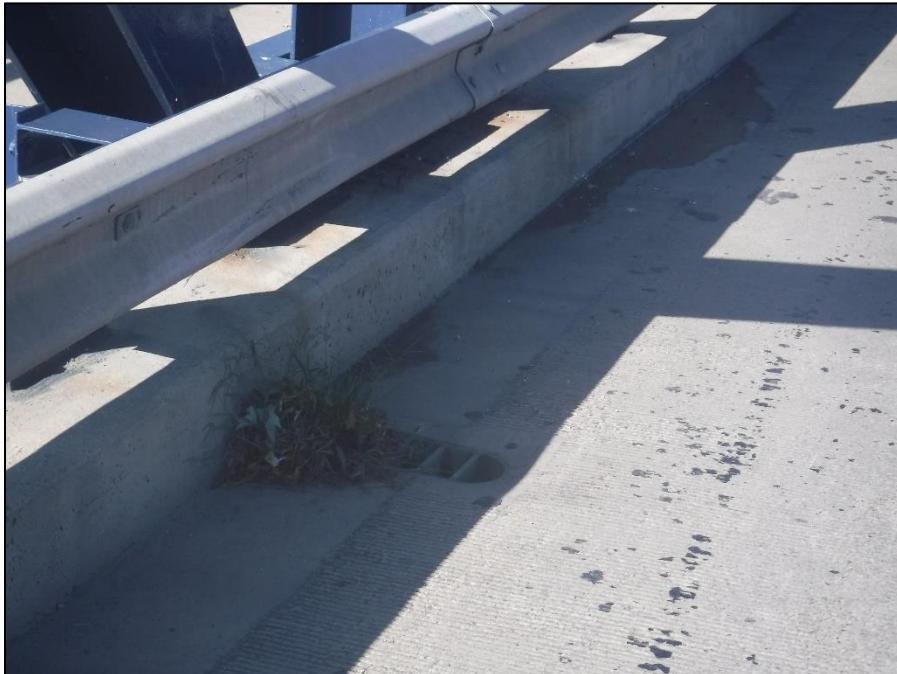
The drainage system is in **fair** condition. The roadway surface is crowned. Scuppers collect the water run-off and deposit it below deck through downspouts. There are 6 scuppers along each curb. Six of the 12 scuppers are partially plugged (approximate blockage for 30% of area). There is minor ponding and debris along the curbs (see Picture 16).

Picture 16: Evidence of ponding along south curb near L8 and partially blocked scupper.

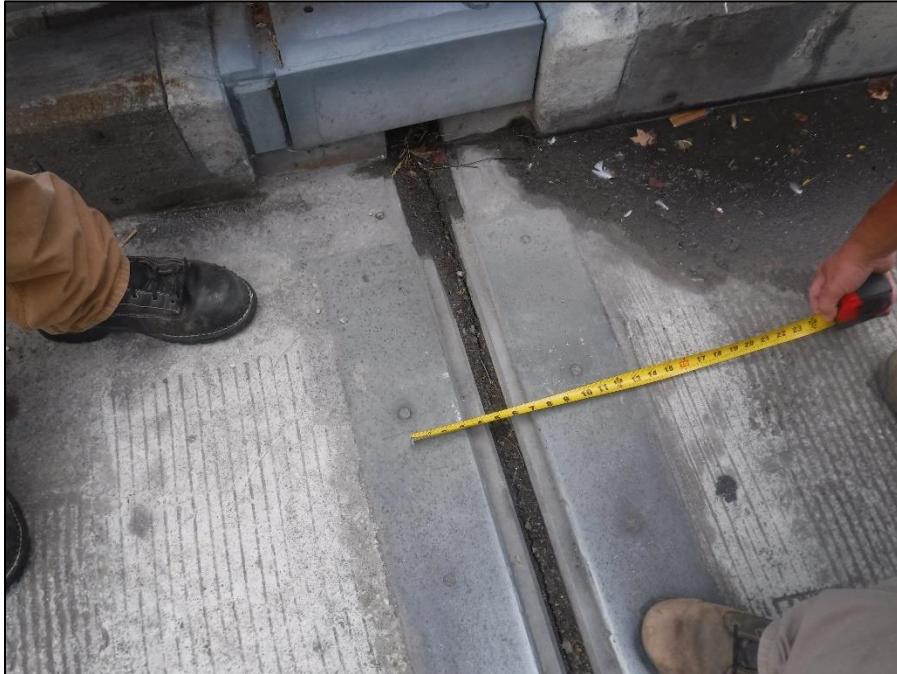
Expansion Joint - The roadway expansion joint is located at the rear abutment. The joint opening was measured to be: 1-3/8" between the steel plates at both curbs at 80 degrees (see Picture 17).

Picture 17: Expansion joint opening at rear abutment at north curb.

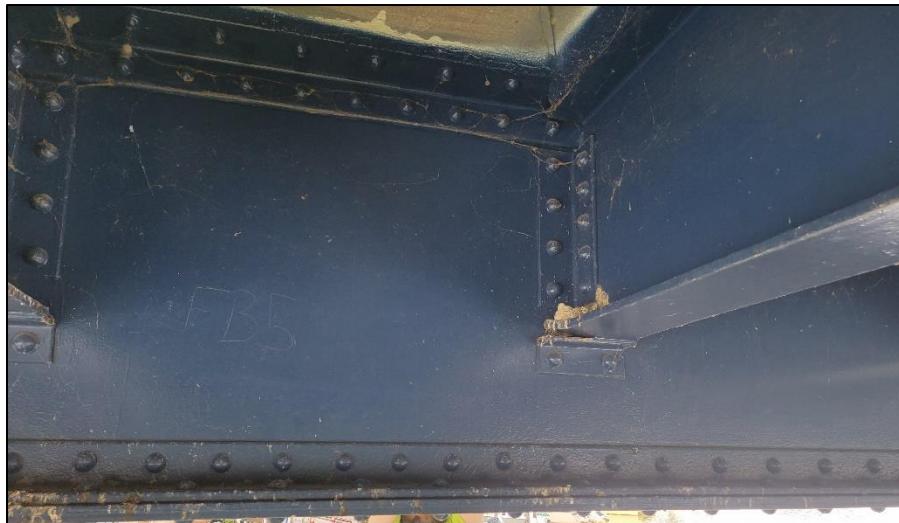
Picture 19: Typical bent stringer connection and support angle.

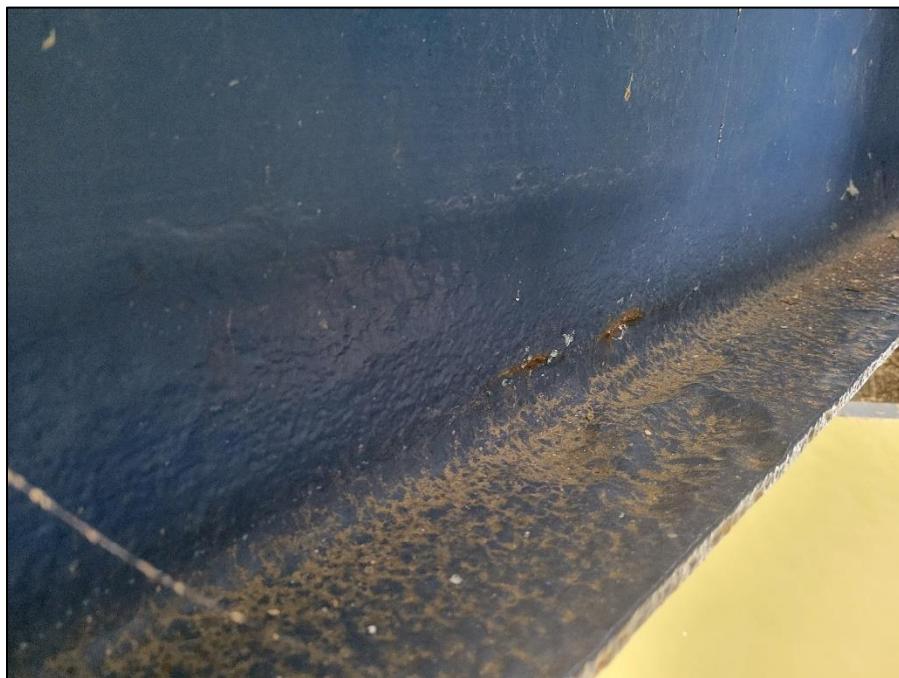
The stringers are in **good** condition with only minor corrosion. The stringers are simple span rolled sections connected to the floorbeam webs with riveted angles. There are a few small localized areas with active rust. The active rust is located at a few stringer bottom flanges at the floorbeams, and along the top flanges of Stringer 10 near the rear abutment and Stringer 1 near the forward abutment. There is pitting in stringer webs and the top of the bottom flanges with a maximum of 15% section loss. Approximately 5 stringer bottom flanges are bent at the floorbeam connections (see Picture 19). One stringer top flange is bent at the floorbeam connection. One stringer has dings in the bottom flange. These minor deficiencies are most likely from original construction. About 4 stringers have small holes in the bottom flange at the floorbeam connection and one stringer has small holes in the web at the floorbeam connection (see Picture 20).

Picture 20: Looking south at Stringer 1 on the east side of Floorbeam 6.

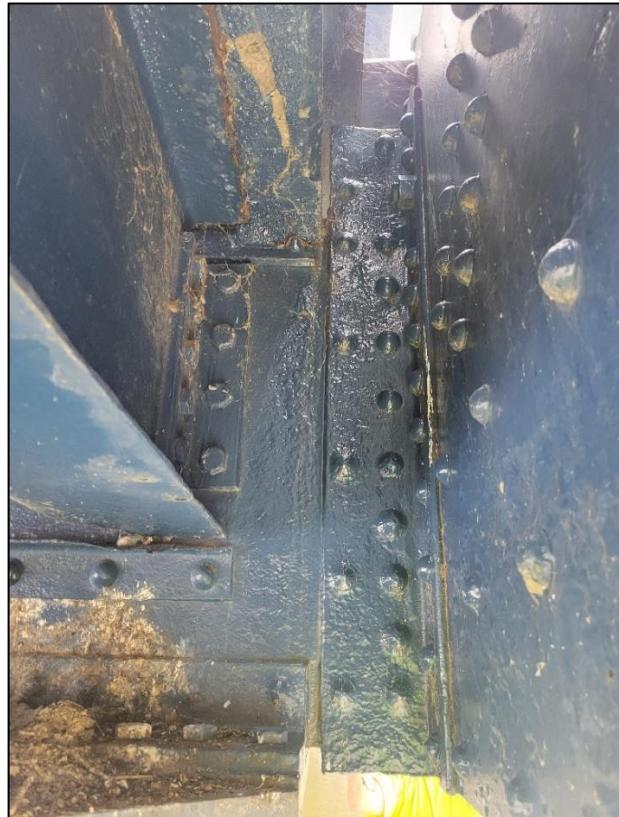
Approximately 23 stringers are not seated on the support angles. The stringer and floorbeam connections were rated in 2015, and found that the support angles are not needed to safely carry loads. The support angles were likely installed to temporarily support the stringers while the web connections were made. There are approximately 15 stringer support angles that are bent and have section loss (see Picture 21). There are pigeons and swallows nesting on the bridge. Pigeon spikes have been installed on the stringer bottom flanges (see Picture 22) over the boats docked at each side of the channel, but this has not fully deterred birds from nesting.

Picture 21: Floorbeam 5 truss connection plate; also, the stringer is not seated on the seat angle.

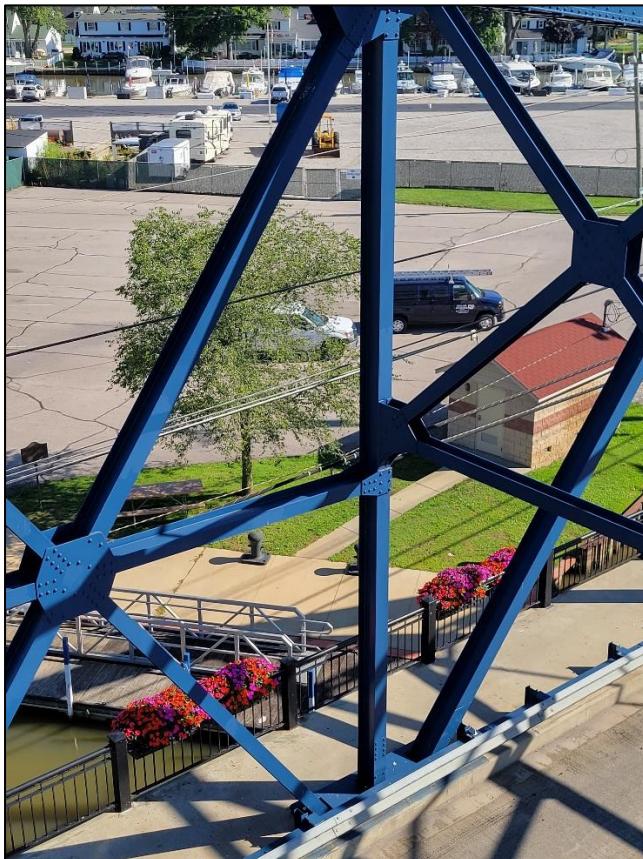
The verticals are rolled steel sections. The truss verticals are in **fair** condition having minor section loss (see Picture 24) and pitting in areas outside of the splash zone. There is pitting on the end verticals at the original end portal connection locations. The end portals were raised to increase vertical clearance in 1986. There is pitting at locations of the original pipe rail connections located above the deep beam guardrail. The truss verticals have pitting with section loss (approximately 10% of web area) in the splash zone (see Picture 25). Plates have been added to the bottom of the vertical webs at L2U2 of the south truss, L8U8 of the north truss, and L8U8 of the south truss. Vertical L6U6 on the north truss has a hole on the south side of the web in the splash zone. The vertical connections to floorbeams have minor section loss and pack rust.

Picture 24: Looking northeast at L5U5 of north truss.

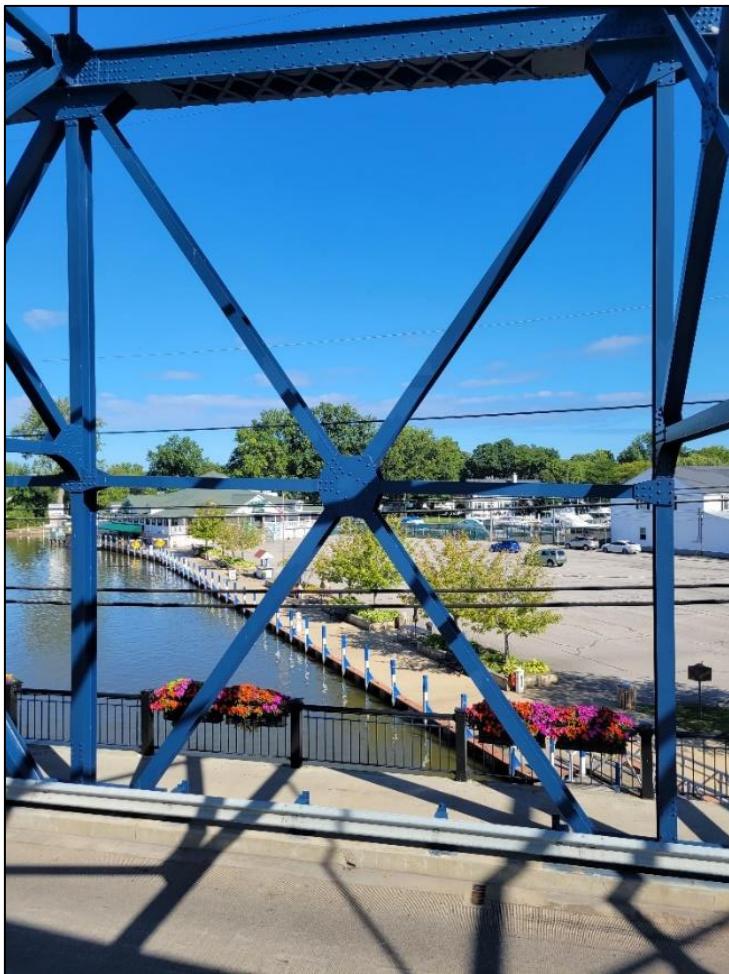
Truss Diagonals - The truss diagonals are in **fair** condition. The diagonals are rolled steel sections (see Picture 26). The truss diagonals and their connections have minor section loss and pitting in areas outside of the splash zone. There is pitting at locations of the original pipe rail connections located above the deep beam guardrail. The truss diagonals have pitting with section loss (approximately 10% of web area) in the splash zone (see Picture 27). There are holes and deep pitting in the webs of L3U4 of the south truss, L4U5 of the south truss, and L6U5 of the north truss. L6U7 of the south truss and L7U8 of the south truss have section loss and holes in the web at the bottom of the diagonal. Plates have been added to the bottom of the diagonal webs at L3U2 of the south truss, L5U4 of the south truss, and L6U5 of the south truss. The fill plates between the diagonals and the lower chord gusset plates have section loss with minor active rust, some of the fill plates are bent, and rivets are not engaged at some locations. U4L5 of the north truss has minor misalignment of flanges (see Picture 28).

Picture 26: Typical X-diagonal (Panel 6 of north truss).

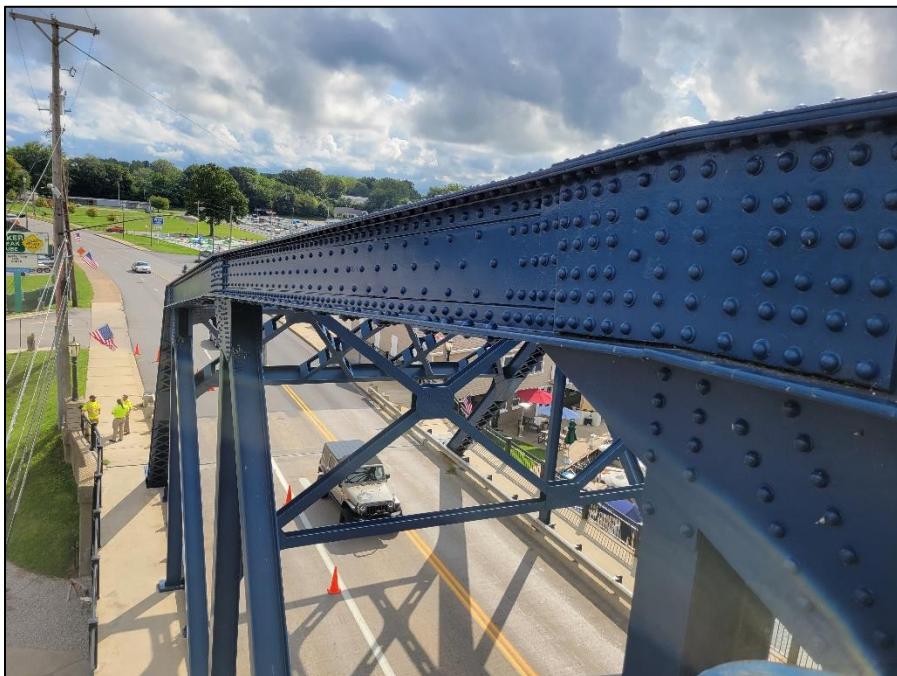
The truss upper chords are in **fair** condition. The upper chords are built-up riveted members made of plates and angles (see Picture 29). The upper chord members have minor pitting in the webs. There is minor pitting and section loss at the connections to the portals and sway bracing. There are dents from original construction in the top flange of the upper chord at U1U2 of the north truss (see Picture 30), U3U4 of the south truss, U5U6 of the north truss, U6U7 of the south truss, U7U8 of the south truss, and U8U9 of the south truss. There is active rust at a small hole in the web of U6U7 of the south truss. The upper chord has several bent lacing bars. The bottom flanges of U2 of the south truss and U5 of the north truss have $\frac{1}{4}$ " offset from original construction.

Picture 29: U6 of the north truss looking east.

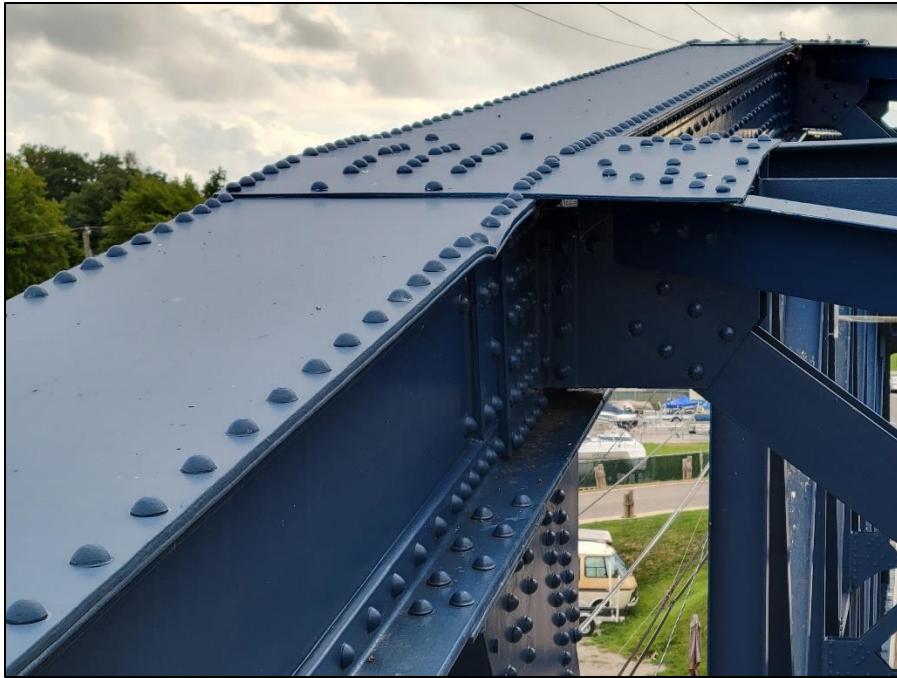
Picture 30: Dent in the top flange of U1U2 of the north truss.

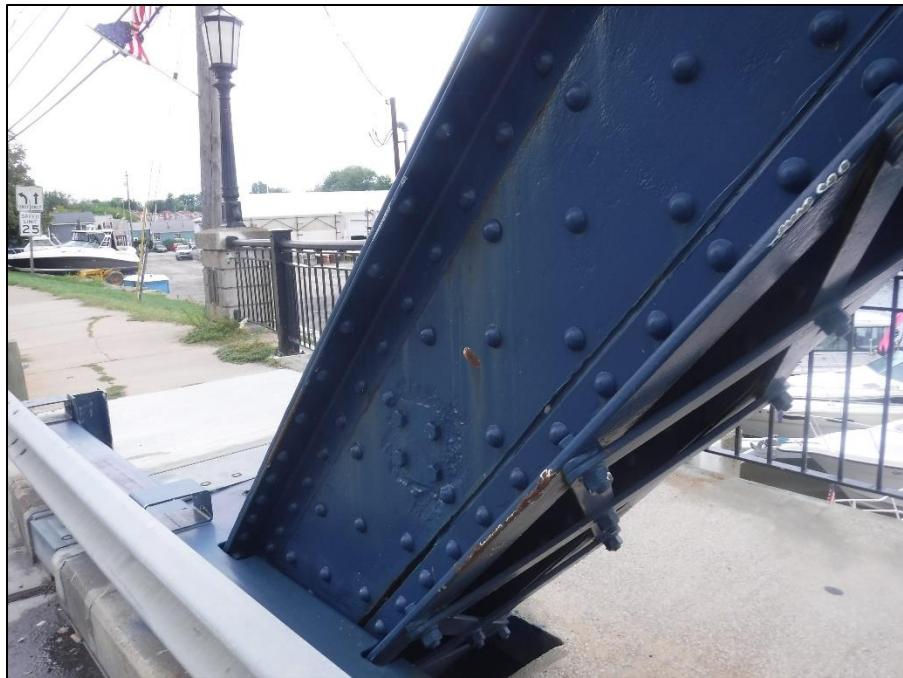
End Posts - The end posts are built-up riveted members made of plates and angles. The end posts have minor section loss, pitting and pack rust in the splash zone and a few other localized areas. There is pitting at locations of the original pipe rail connections located above the deep beam guardrail (see Picture 31). The end posts have minor active rust at the web to flange connections. The batten plates near the lower chord have section loss with holes at L0U1 of the north truss and L9U8 of the south truss. Several lacing bars at each end post are bent. Some of the angles at the bottom of the end posts are bent due to pack rust. There are sections of the upper flange where the sign connections bolts are rusting through the plate (see Picture 32).

Picture 31: Looking at L0U1 of the north truss.

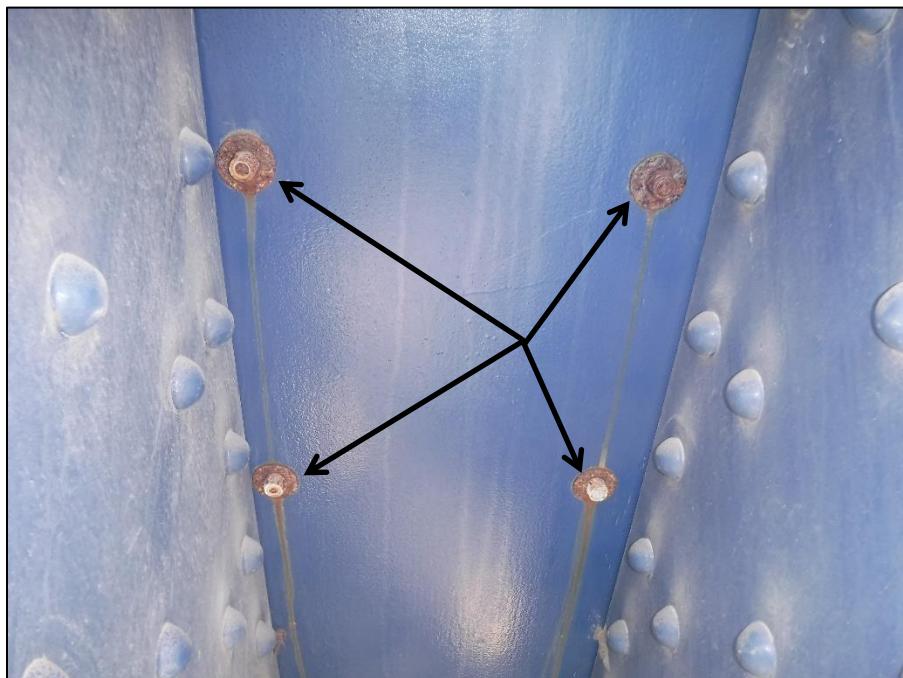
Picture 32: Rusted sign connection bolts inside end post.

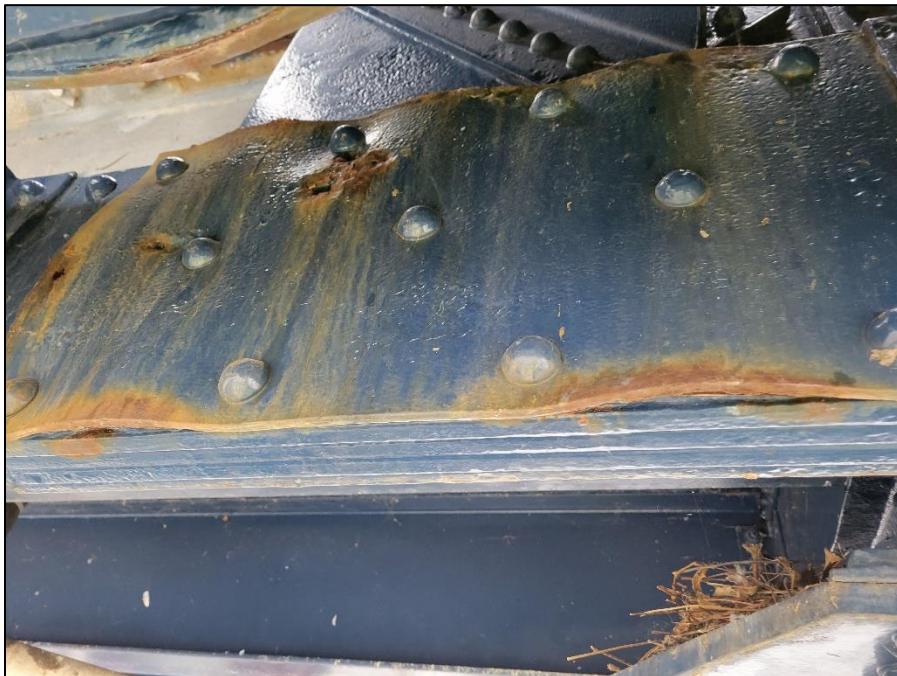
Lower chord members L3L4 and L5L6 are made up of 4 plates on each side - three 15"x³/₄" plates and one 15"x⁵/₁₆" plate. Lower chord member L4L5 are made up of 4 plates on each side - three 15"x³/₄" and one 15"x¹/₂" plate. The thinner plates are on the insides of the member. There are holes in the inner lower chord web plates on L2L3 of the north truss, L3L4 of the south truss, L4L5 of the north truss, L5L6 of the north truss, and L6L7 of the south truss. Similarly the exterior plates near the gusset plate connections are thinner and have reactivated pack rust (see Picture 33).

Picture 33: Holes in north inside plate of L5L6 at L6 of south truss.

- The addition of stiffening angles to the lower edge of U1 and U8.
- Blast and paint lower chord members and gusset plates to arrest active corrosion and pack rust.
- Reinforce sheet piling along river on west side and regrade back to abutment.

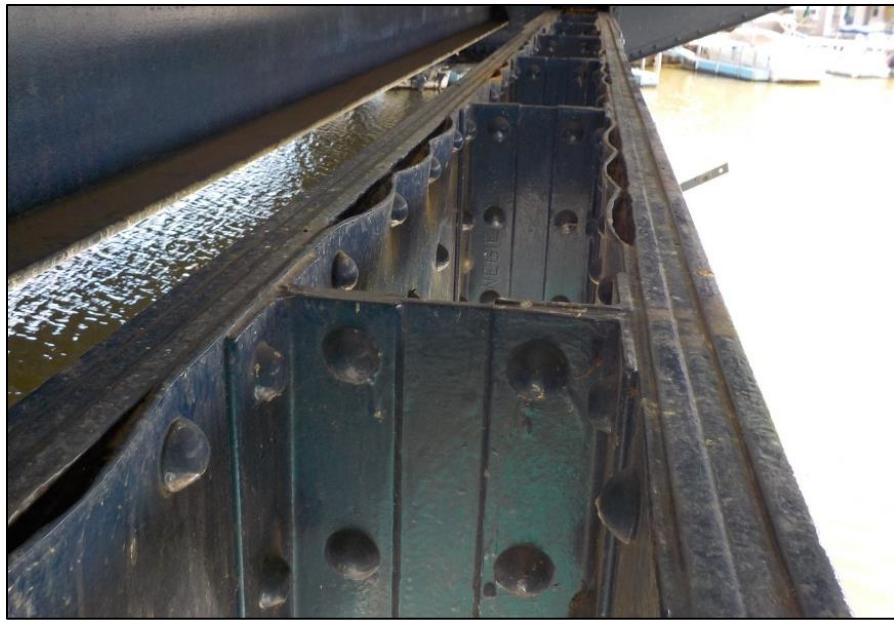
The lower chord is wavy from pack rust at L2L3 of the north truss, L3L4 of the north truss, L3L4 of the south truss (see Picture 34), L4L5 of the north truss, L5L6 of the north truss, and L5L6 of the south truss due to the thin plates on the insides of the member. Several of the diaphragm angles have pack rust causing bulges in the angles and have minor active rust. There is a hole in the diaphragm at L7 of the north truss.

Picture 34: Pack rust in between plates of L3L4 of the south truss.

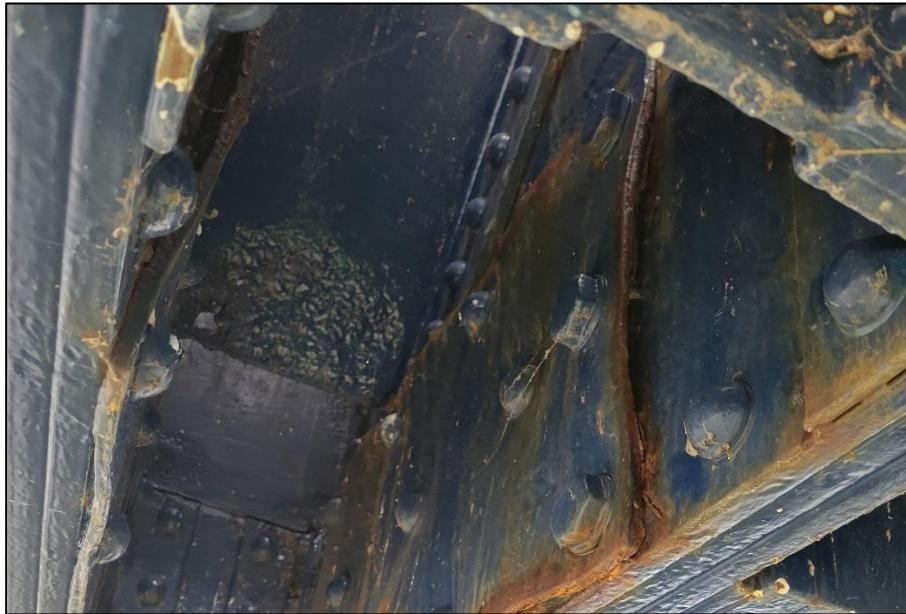
The General Appraisal of this bridge is a **5**, meaning that it is in **fair** condition. This rating is governed by the bowing in the gusset plates and the leaning abutments. The gusset plate rating includes bowing due to pack rust and misalignment.

Picture 36: Pack Rust Bowing at L4 South Truss Inside Gusset Plate

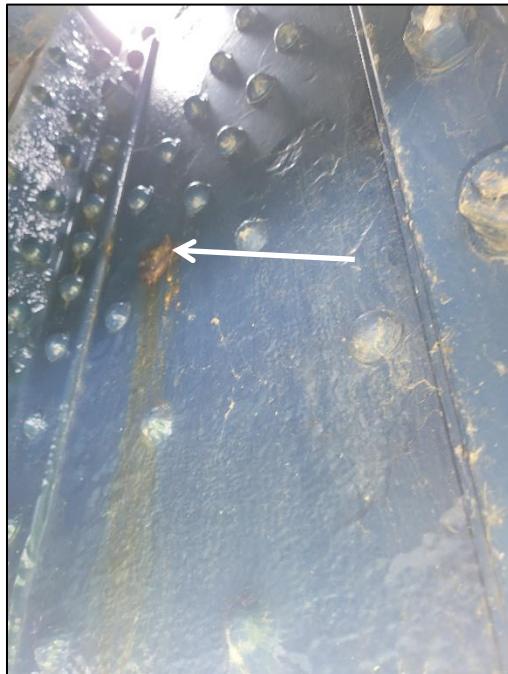
There is a hole on the inside gusset plates of L5 and L6 of the south truss on the east side of the floorbeam connection (see Picture 37). There are 2 holes on inside gusset plate of L4 of the south truss on the west side of the floorbeam connection.

Picture 37: Looking at a rust hole through the inside gusset plate of L6 of the south truss.

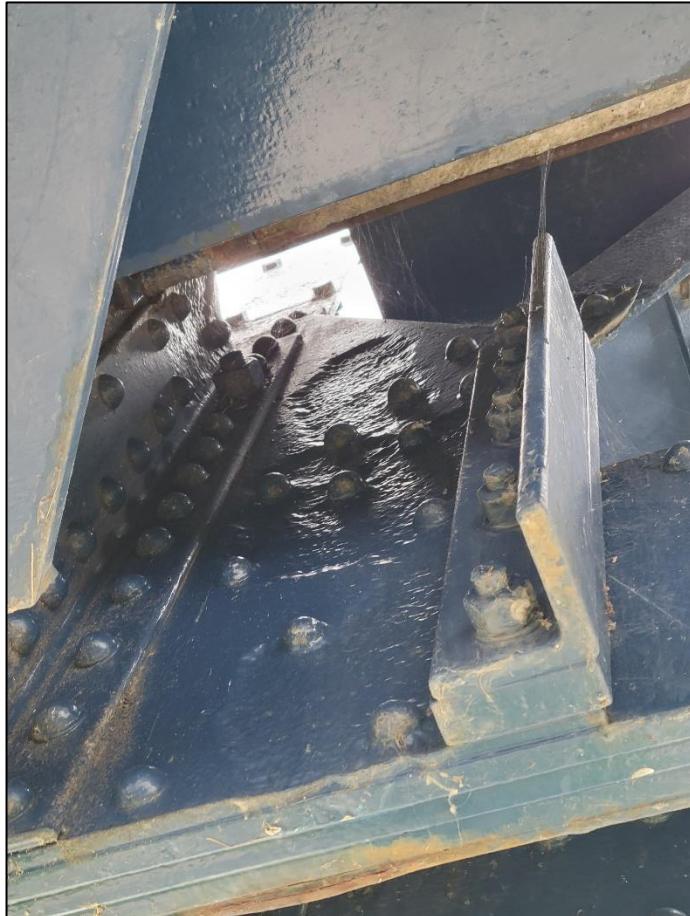
There is deep pitting of the inside gusset plates at L4 (see Picture 38), L5, and L6 of the south truss and up to 50% previous section loss over 30-50% of the plate area. The inside gusset plate at L2 of the south truss has pitting and about 20% section loss. All other gusset plates have minor pitting and less than 15% section loss.

Picture 38: Looking at outside gusset plate of L4 of the south truss.

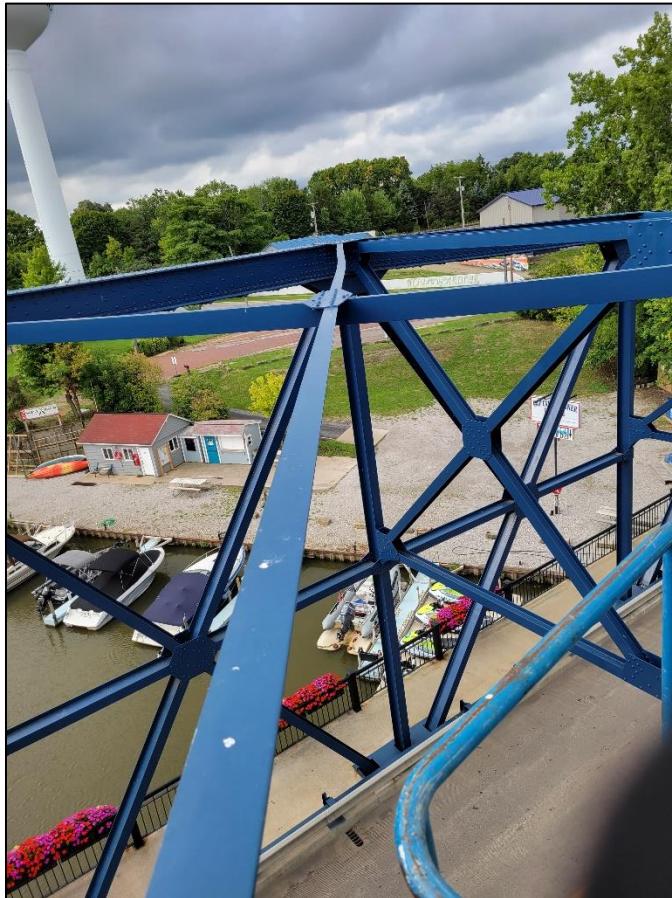
The lateral bracing is rated in **good** condition. The upper lateral bracing has minor deformation in the connection plates due to pack rust. The pack rust at the connection plates has been removed but not caulked in some areas. The members from U3 of the north truss to U4 of the south truss are bowed (see Picture 39).

Picture 39: Looking at upper lateral bracing from U3N to U4S.

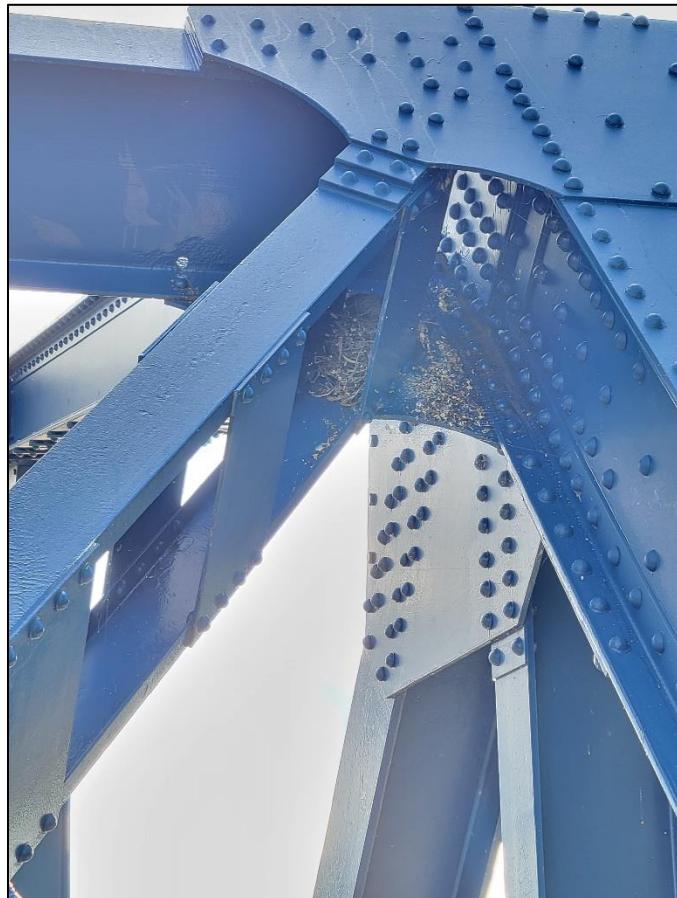
Picture 40: Pigeon presence on portal at U1 of the south truss.

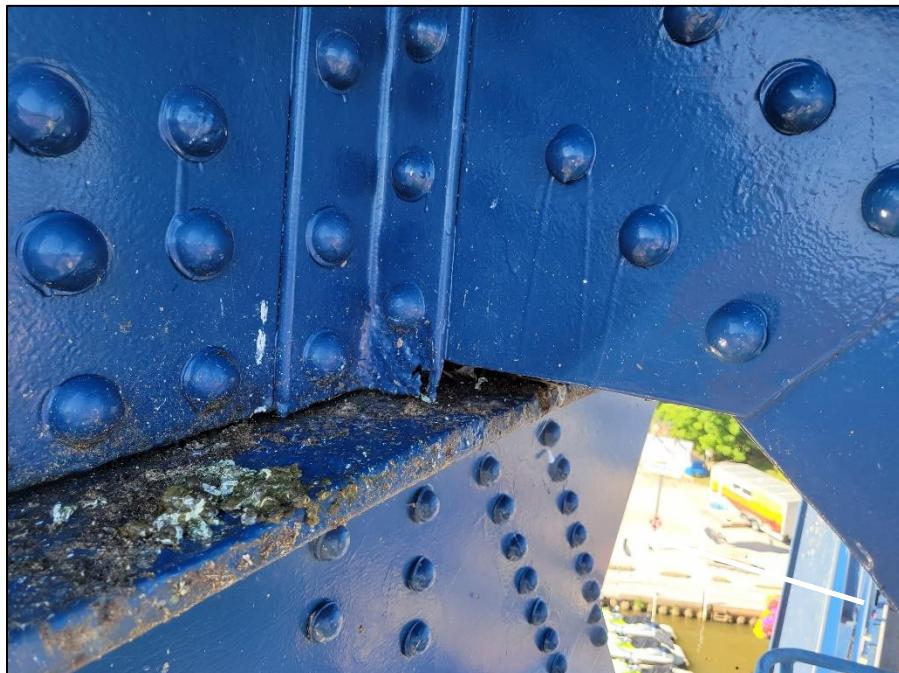
Picture 41: Looking west at sway brace connection to U6 of the south truss.

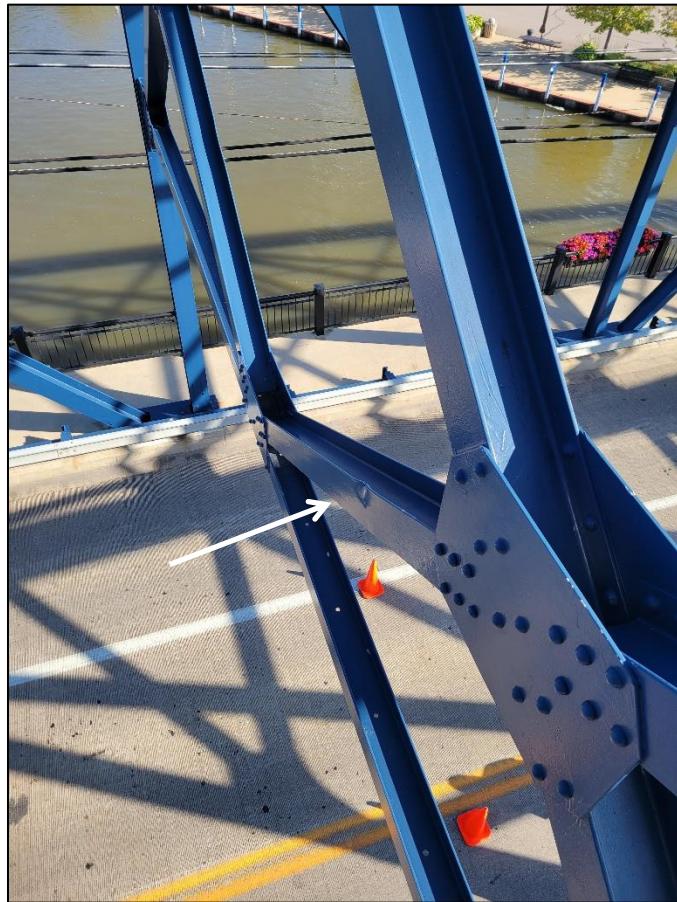
Picture 42: Dent in flange of lower diagonal sway bracing at PP5.
