2022 PHYSICAL CONDITION INSPECTION REPORT

ERI-6-2893

State Route 6 over the Vermilion River

Ohio Department of Transportation

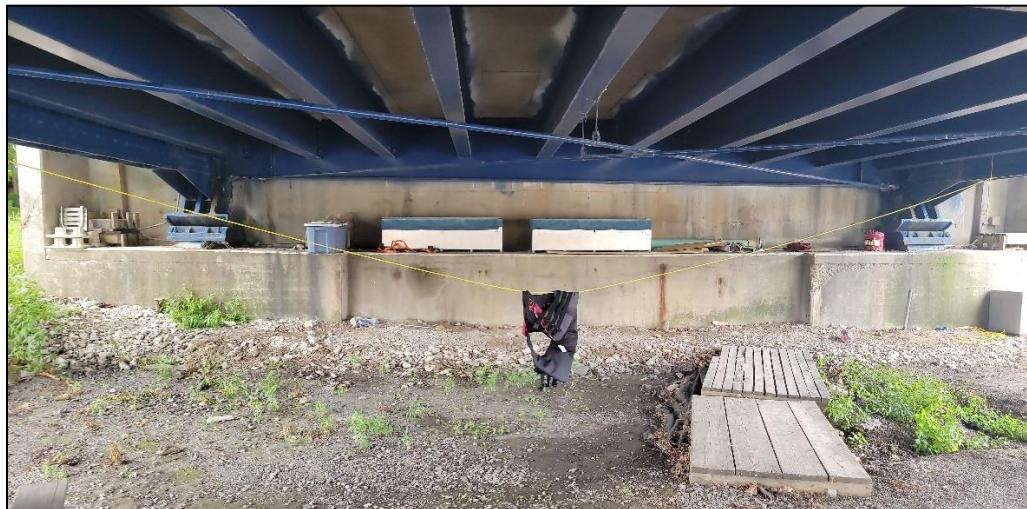
The rear abutment is leaning $\frac{3}{8}$ " away from the river for every 4 feet vertical. The rear abutment breastwall has delaminations, minor spalls, cracks, and efflorescence (see Picture 48). The rear abutment breastwall has 15.0 square feet of spalls and delaminations.

Picture 48: Rear abutment.

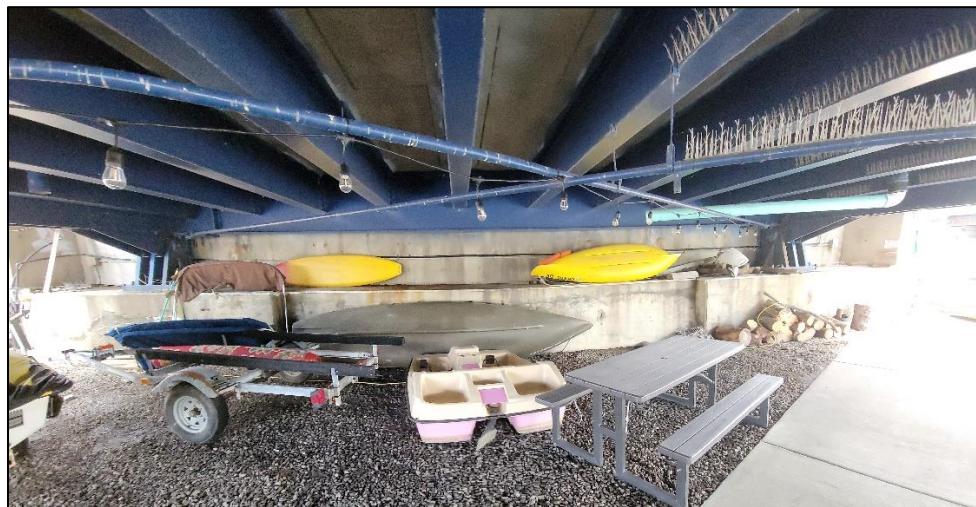
The forward abutment is leaning $\frac{3}{8}$ " towards the river for every 4 feet vertical. The forward abutment breastwall has cracks, efflorescence and spalls with exposed reinforcing steel (see Picture 49). The forward abutment breastwall has 30.5 square feet of delamination.

Picture 49: Forward abutment.

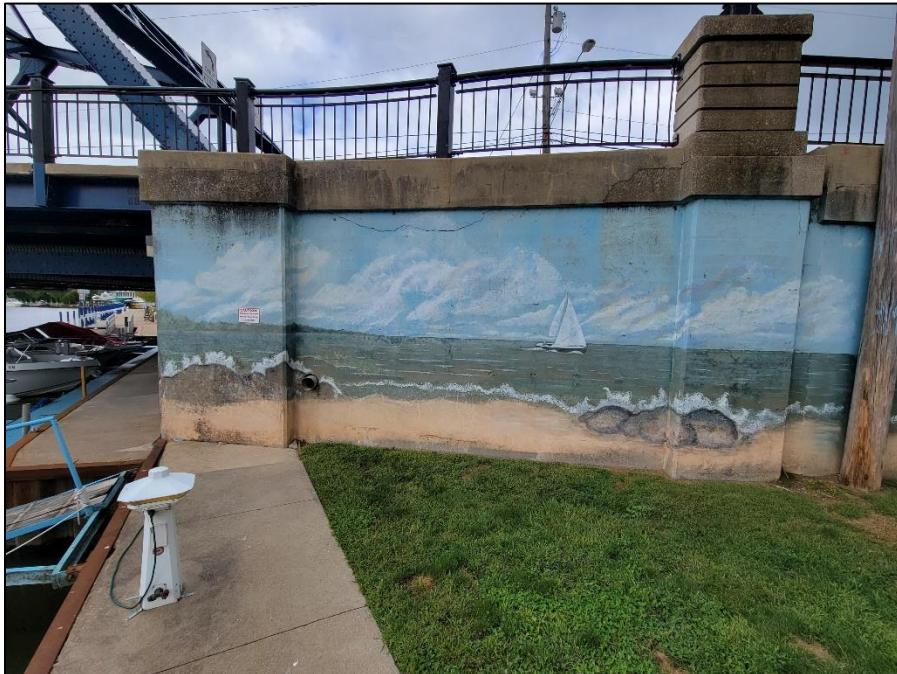
The wingwalls are in **fair** condition. The approach sidewalks at all corners have settled. This may be caused by the loss of fill from behind the wingwalls. There are a few spalls with exposed reinforcing on the backs of the southwest wingwall next to the seat. The southwest wingwall has 1.75 square feet of delamination. The southeast wingwall has a mural (See Picture 50). The southeast wingwall has map cracking, a few small delaminations and one long crack at the top. The seal in the joint between the southeast wingwall and the retaining wall to the east has deteriorated and is mostly gone. The northeast and northwest wingwalls have minor cracks (see Picture 51).

Picture 50: Southeast wingwall.

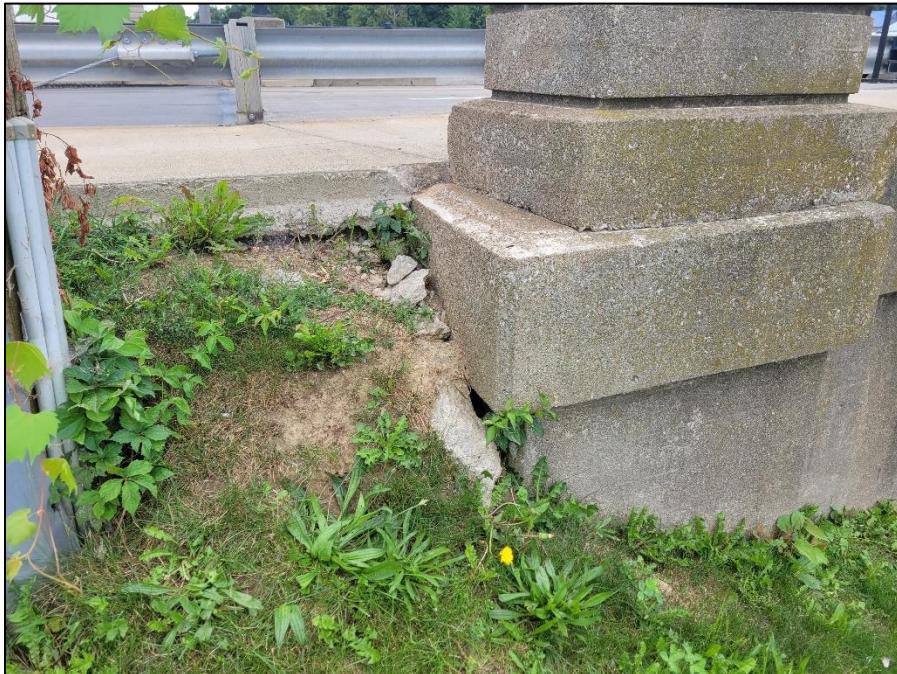
Picture 57: Erosion at northeast embankment is beneath sidewalk.

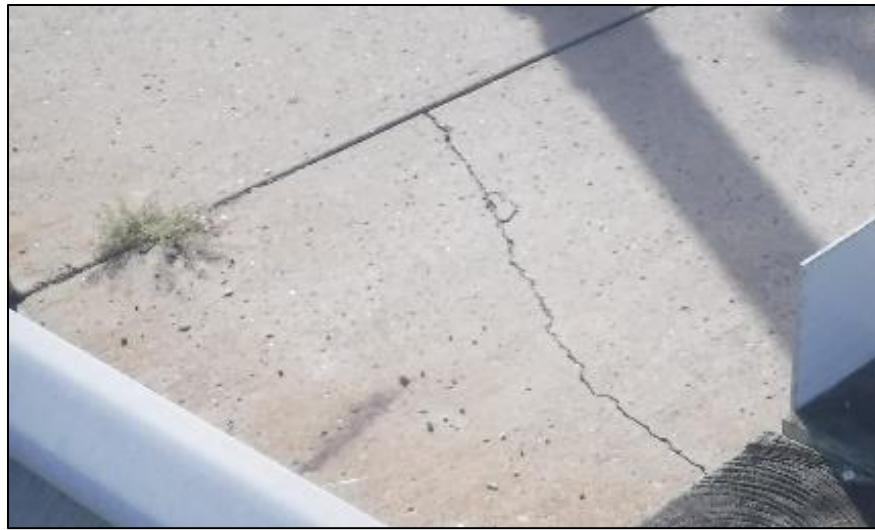
Picture 58: Approach sidewalk cracked at southwest corner.

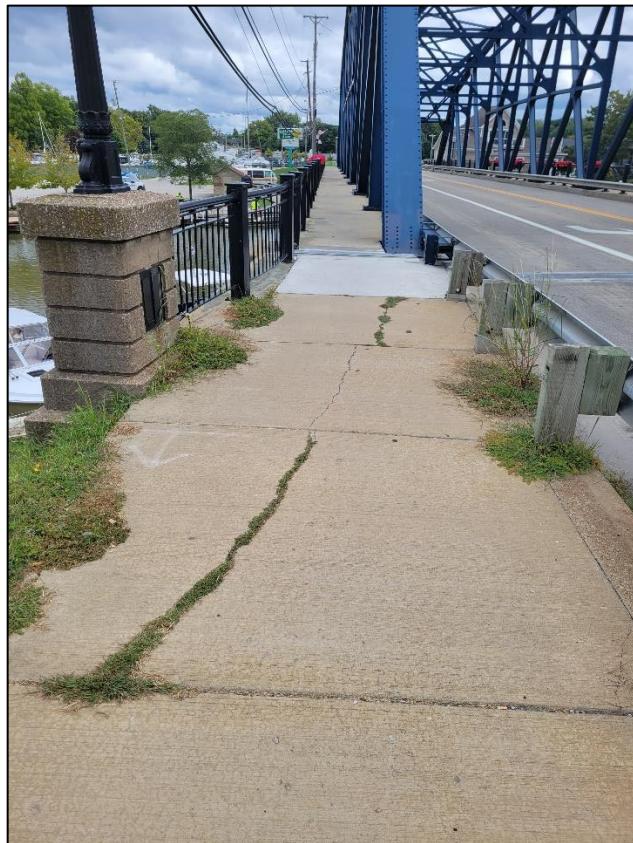
Picture 59: Northwest approach sidewalk cracked.

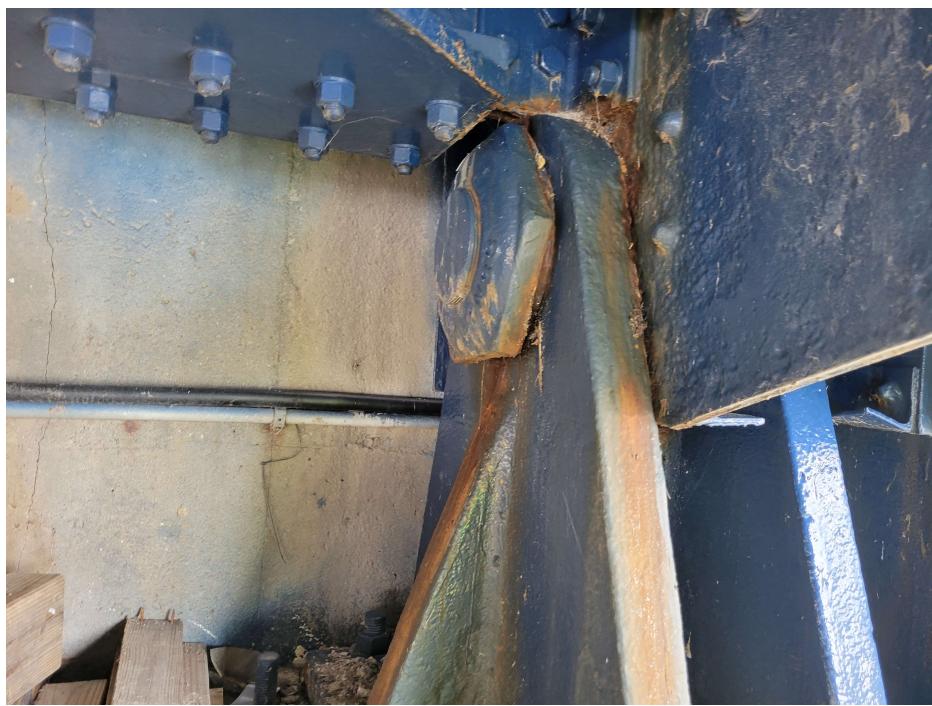
PHOTO 2

Description SE Bolster rust around pin bolt
