2024 UPDATE TO THE
2022 PHYSICAL CONDITION INSPECTION REPORT

ERI-6-2893

U.S. Route 6 over the Vermilion River

Ohio Department of Transportation

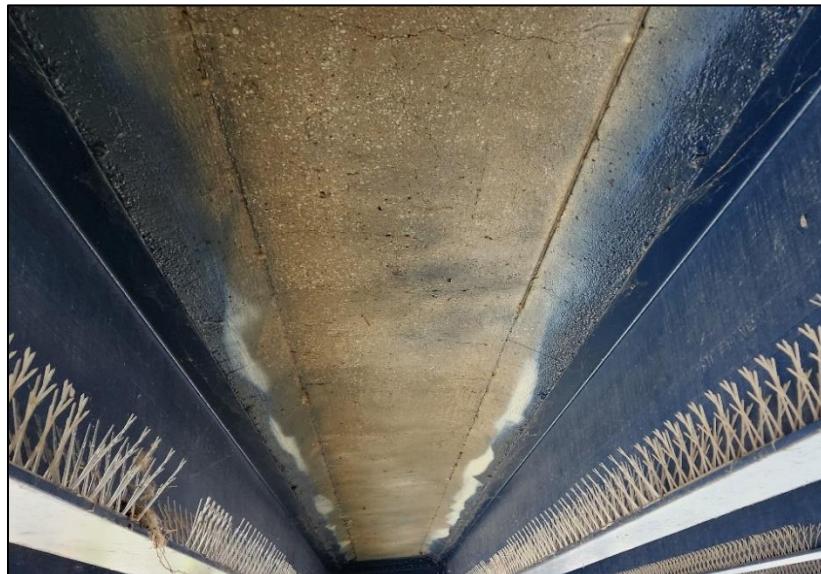
The floor is in **satisfactory** condition. The floor has typical **medium cracks (between 0.012" and 0.030" width)** and **moderate pattern map cracking (between 1' and 3' spacing)** (see Pictures 1 & 2). There are cracks with efflorescence in Panels 1 and 5 through 9, and cracks with moisture in Panels 6 and 7 (see Appendix E for more information).

Picture 1: Typical map cracking in deck.

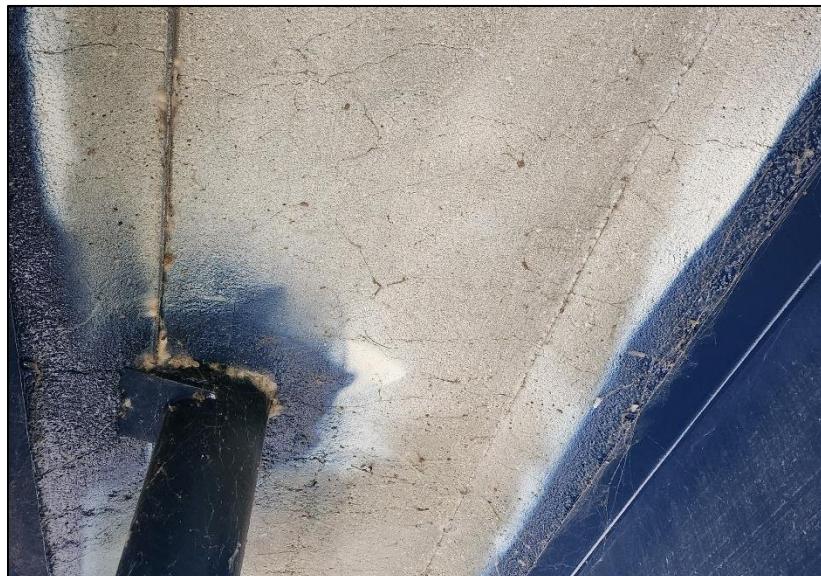
Picture 2: Typical map cracking around drainage pipe.

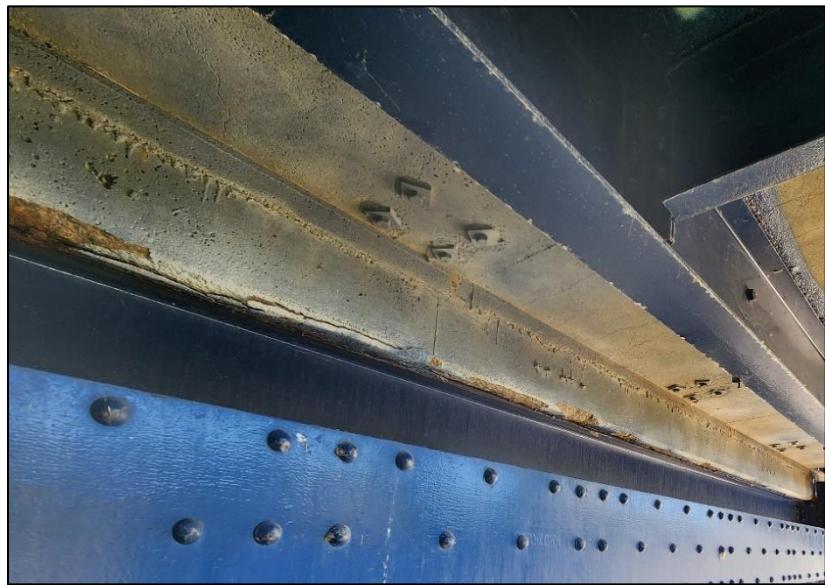
The edge of floor is in **fair** condition. There are spalls and delaminations for more than 200 feet of the 992 ft of deck edge (>20% spalled) (see Picture 3). For a more detailed layout of the deck edge deterioration see Appendix C. In 2021, a large spall fell from the deck edge and landed on a boat parked below. MSG closely inspected the entire length of the deck edges. The spalls and delaminations are due to the way the deck reinforcing was framed, no end rebar was used based on standard practice of the time. This has been known to cause spalling along the edges, especially in more aquatic applications. MSG took special care to look at the entire deck edge and safely remove any existing delaminations during this inspection to minimize future risk of falling concrete in the river or anyone using the recreational waterway beneath the structure (see Picture 3).

Picture 3: Spalls on south edge of deck in Panel 1.

- Continue to monitor the deck edge closely for potential spalls.
- Consider cleaning and clearing underside of bridge of pigeon debris and nests.

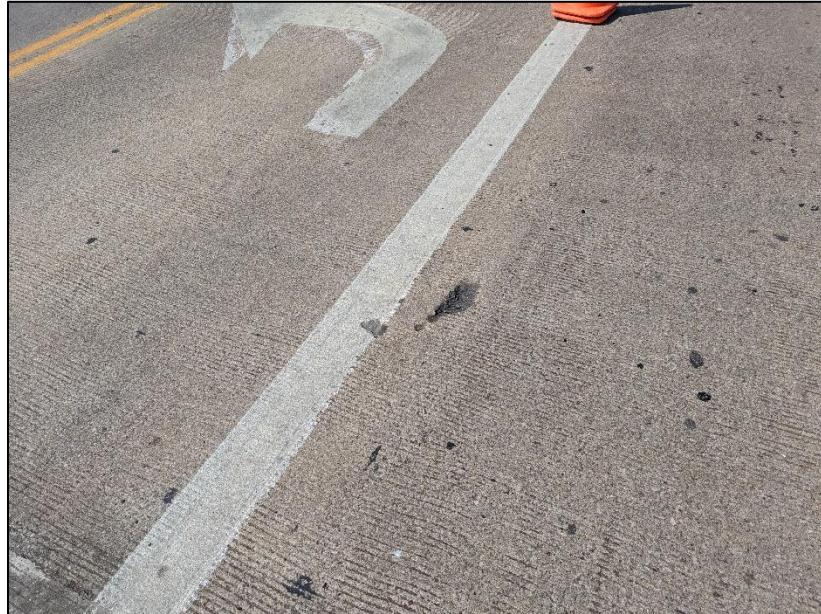
There are two small spalls and pop-outs in the westbound and turn lanes near the east end of the bridge (see Picture 4). There were no delaminated areas found by sounding the deck. There are typical transverse cracks all along the deck (see Picture 5). Transverse cracks that are over the floorbeams are up to 0.030" wide. There are longitudinal cracks lane that may be located above stringers. The westbound lane has deformations in the wearing surface that may be due to original construction. Typically, the grooves in the wearing surface are worn (the wheel lines are worn smooth).

Picture 4: Small spall in wearing surface at east end.

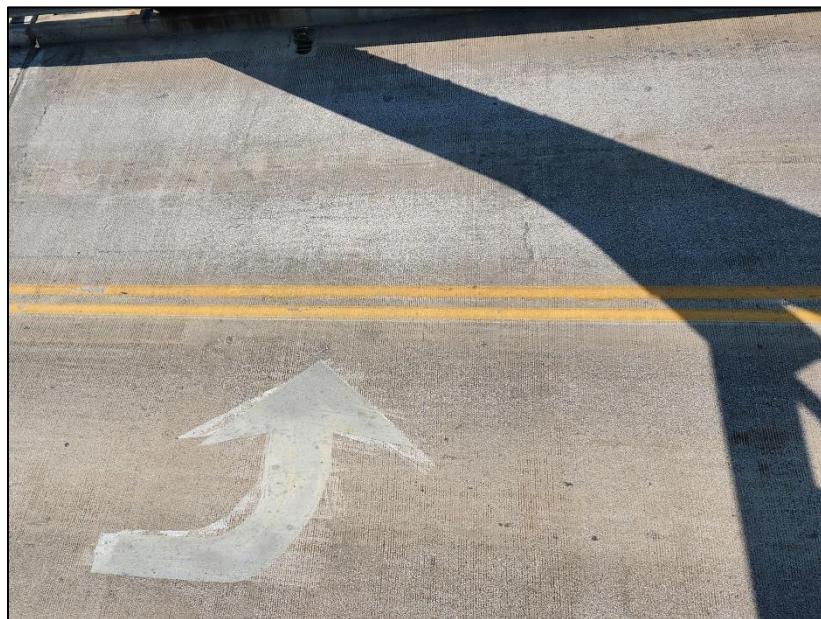
Picture 5: Typical wearing surface at east end.

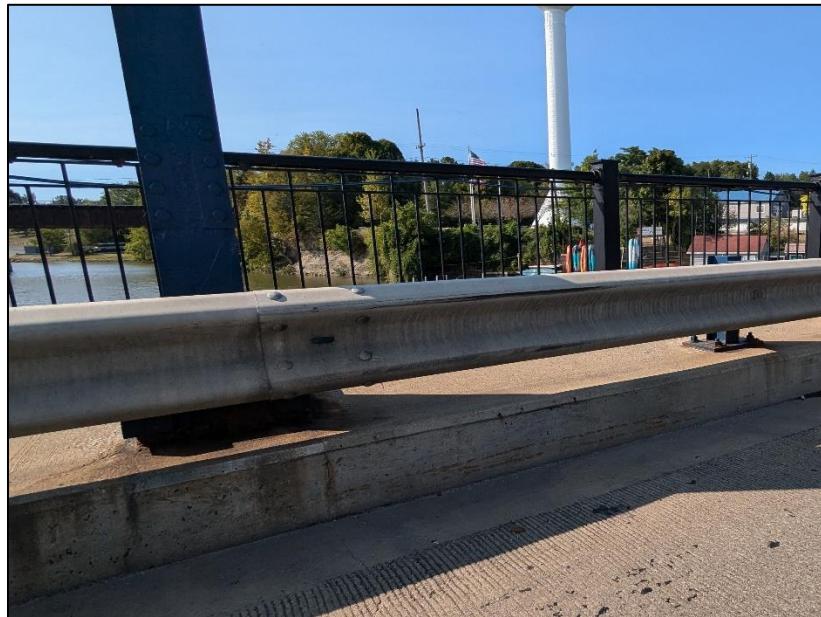
Curbs - The concrete curbs have minor cracks and spalls. There are typical cracks in the curbs next to the verticals, diagonals and guardrail posts (see Picture 6). There is a spall in the curb in Panel 6 of the north truss that has a hole 2" deep. The hole appears to be from original construction.

Picture 6: Looking southwest at south sidewalk near L8.

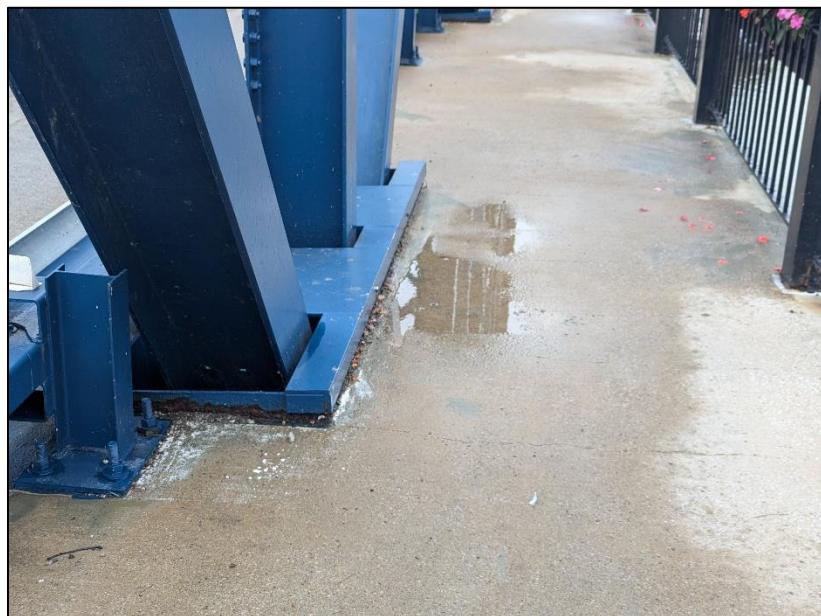
Sidewalk - The concrete sidewalks have a few spalls and typical transverse cracks originating from the pedestrian rail posts, guardrail posts and truss members (see Picture 7).

Picture 7: Looking west at north sidewalk near L1.

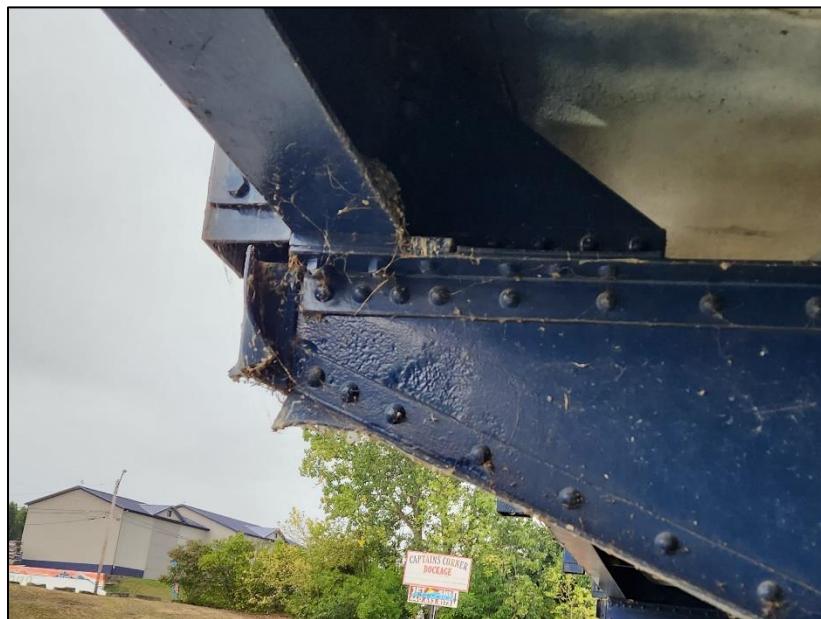
Sidewalk Cantilever Brackets - The sidewalk cantilever brackets are typically in good condition. There is some minor section loss in the webs at the connections to the trusses. The north cantilever bracket at L3 has a small hole in the web. The south cantilever bracket at L4 has three small holes in the web (see Picture 9). The south cantilever bracket at L5 has two small holes in the web. The south cantilever bracket at L6 has impact damage and a small hole in the web (see Picture 10). The sidewalk south cantilever at L9 has pack rust and minor active rust at the bottom of the connection angle at the bearing. Three of the sidewalk cantilever brackets have bent ends where boats have impacted the structure (see Picture 11).

Picture 11: Bent south cantilever bracket.

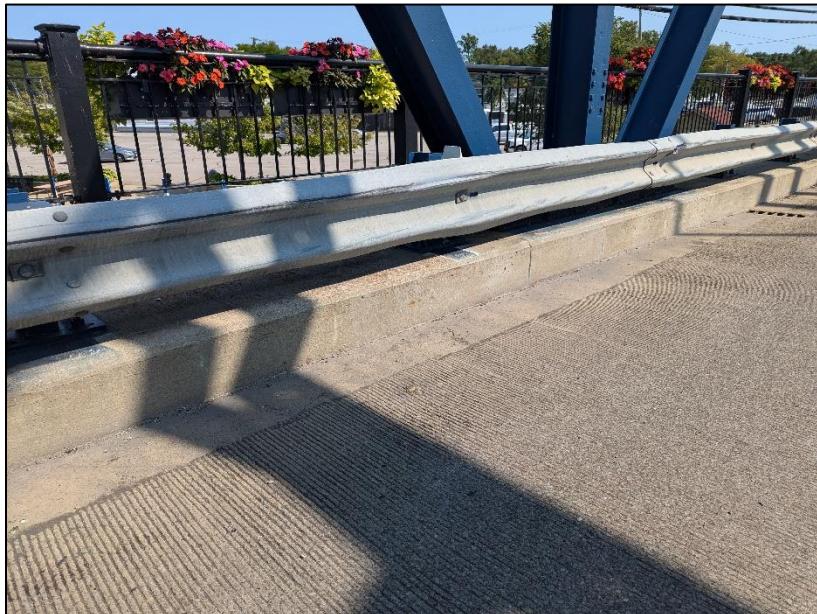
Deep Beam Rail and Posts - The roadway railings consist of deep beam rail with steel posts and are in **satisfactory** condition. The steel posts are anchored into the concrete sidewalks. The guardrail has minor scratches and rub marks with paint transfer for a majority of both north and south rails. There is impact damage with a hole in the railing at L4 on the north railing (see Picture 12) and at L7 on the south railing. The reflectors have broken off the steel tubes in Panel 1 of the north truss, Panel 3 of the south truss, and Panel 9 of the north truss. There is minor active rust at the steel tube connections and base plate anchor bolts. There are minor surface rust spots appearing on the top of the steel tube railing.

Picture 12: North railing at L4.

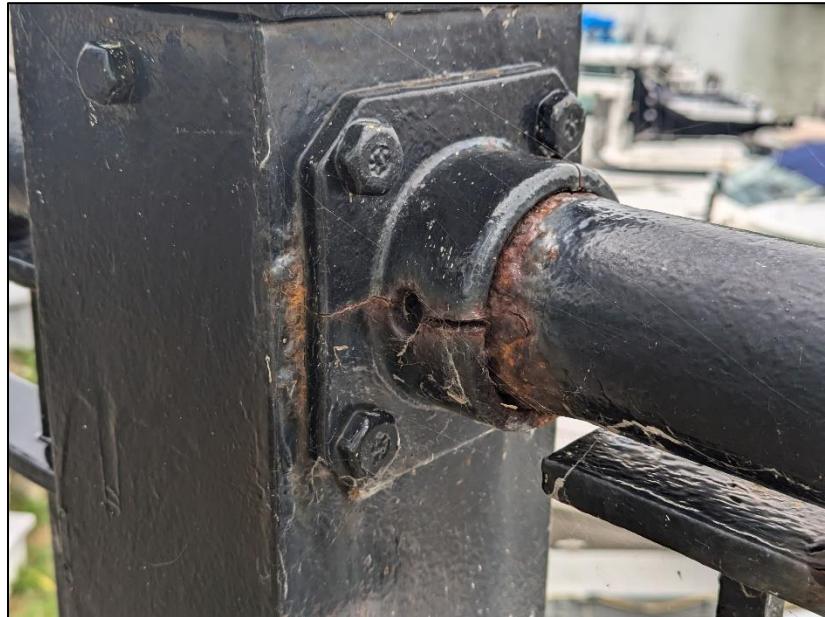
The bolt is missing from the connection at the top rail and post (see Picture 13) at 3 locations on the south pedestrian railing and 10 locations on the north pedestrian railing.

Picture 13: Broken connection plate.

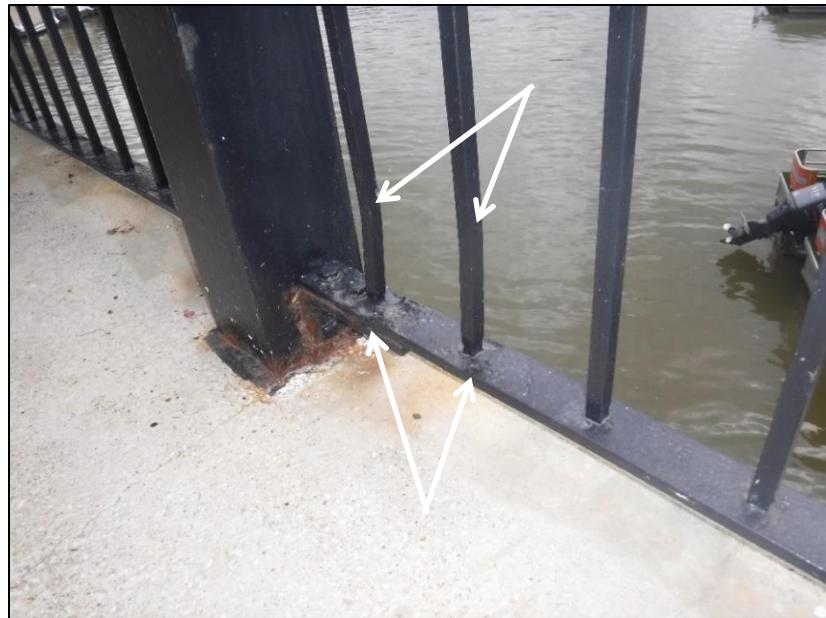
The top rail connection plate to the post is cracked or broken at 8 locations on the south pedestrian railing and 3 locations on the north pedestrian railing. There are 15 bent vertical rails on the south pedestrian railing and 13 bent vertical rails on the north pedestrian railing (see Picture 14). Many of the vertical rails have section loss at the bottom connection (see Picture 14). The south pedestrian railing section loss is worse (up to 50% section loss).

Picture 14: Bent vertical rails on pedestrian railing and section loss at bottom vertical rails.

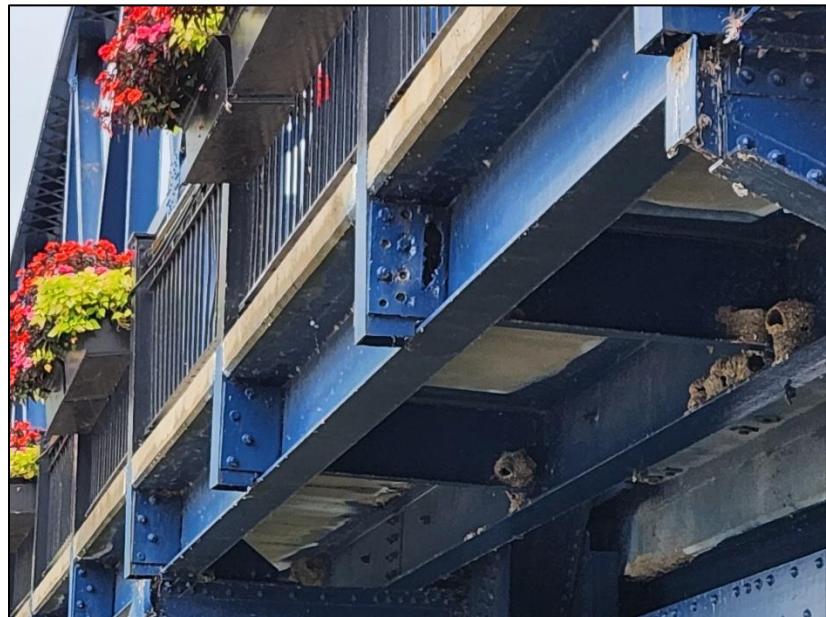
Picture 15: Hole in south truss pedestrian post connection between L6 and L7.

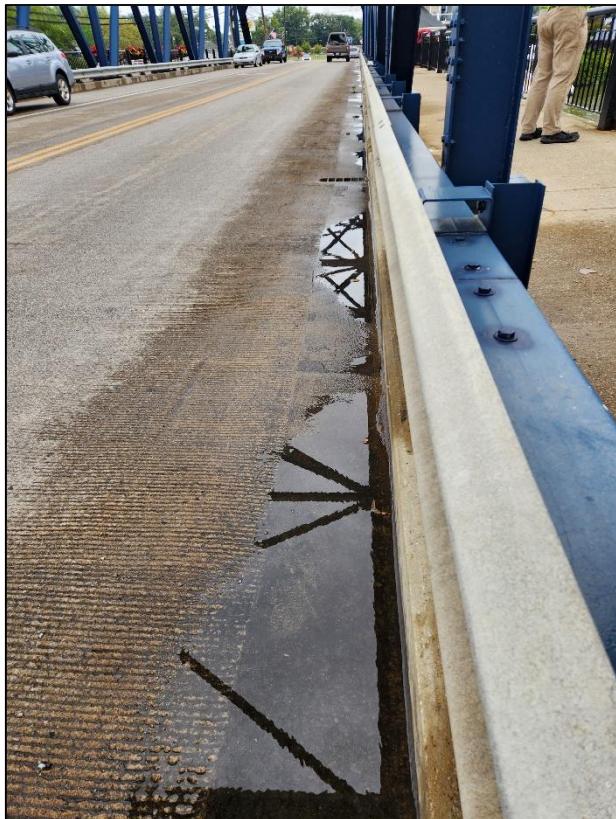
The drainage system is in **satisfactory** condition. The roadway surface is crowned. Scuppers collect the water run-off and deposit it below deck through downspouts. There are 6 scuppers along each curb. The scupper near L7S is fully blocked and allows very little water through when compared to the other scuppers. Eight of the remaining 11 scuppers are partially plugged (approximate blockage for 30% of area). There is ponding and debris along the curbs (see Picture 16).

Picture 16: Ponding along south curb.

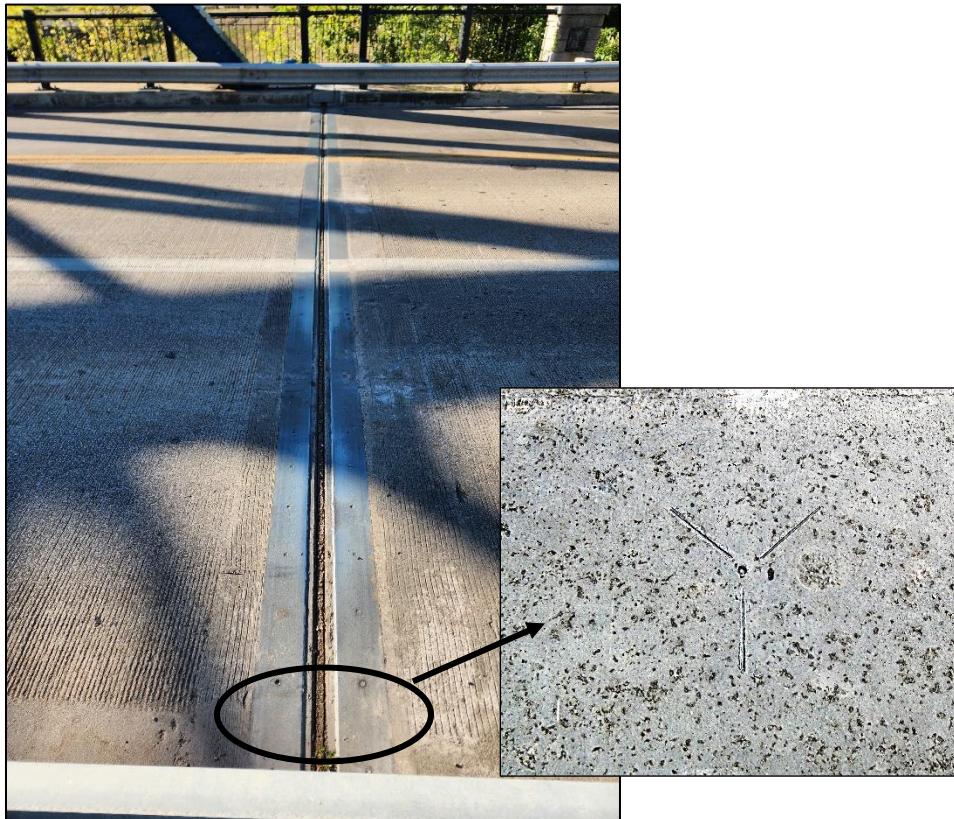
Strip Seal Expansion Joint - The roadway expansion joint is located at the rear abutment. The joint opening was measured to be: 9-11/16" at the south and 9-7/8" at the north. Measurements were taken at 72 degrees using the crow's feet marks added in 2022 for consistent measurements (see Picture 17) . The joint has loose debris in the seal for the full length. Crows feet are located approximately 1.5ft from both curbs.

Picture 17: Rear expansion joint.

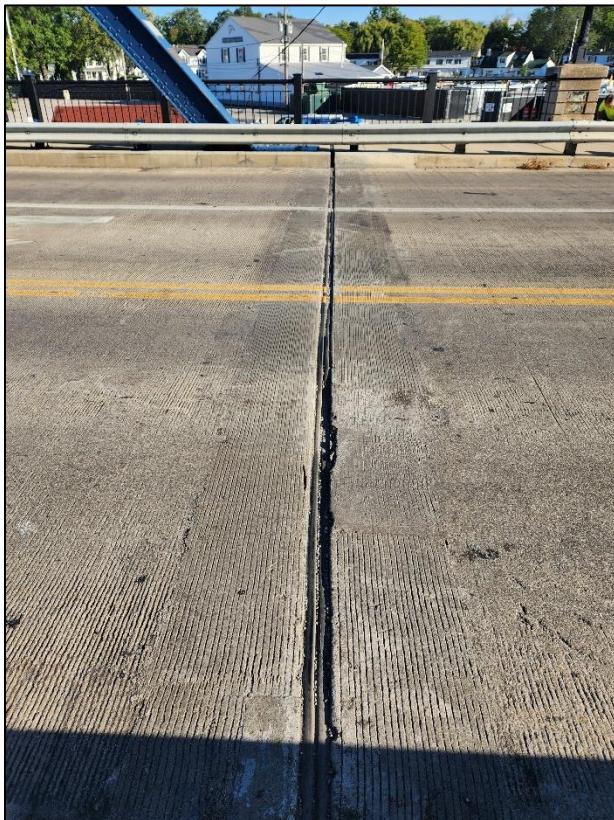
Compression Joint Seal - A compression seal is located between the deck at forward abutment and the forward approach slab. The joint has loose debris in the seal for the full length and there are some spalls in the concrete along the joint (see Picture 18).

Picture 18: Forward compression seal.

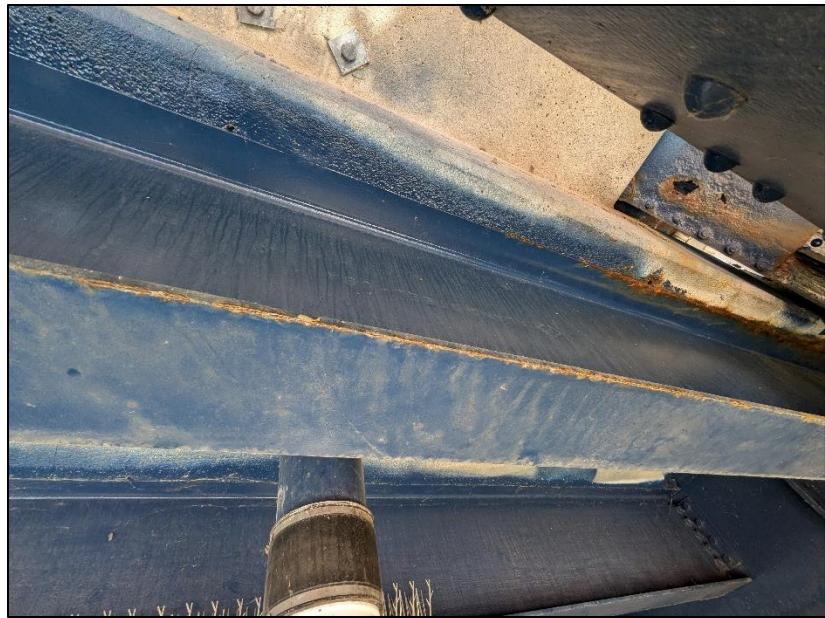
The stringers are in **satisfactory** condition with only minor corrosion. The stringers are simple span rolled sections connected to the floorbeam webs with riveted angles. There are a few small localized areas with active rust. The active rust is located at a few stringer bottom flanges at the floorbeams, and along the top flanges of Stringers 1 and 10 near the abutments(see Picture 19). There is pitting in stringer webs and bottom flanges with a maximum of 15% section loss. Approximately 5 stringer bottom flanges are bent at the floorbeam connections (see Picture 20). One stringer top flange is bent at the floorbeam connection. One stringer has dings in the bottom flange. These minor deficiencies are most likely from original construction. About 4 stringers have small holes in the bottom flange at the floorbeam connection and one stringer has small holes in the web at the floorbeam connection.

Picture 19: Rust along top and bottom flanges of Stringer 10 near The forward abutment.

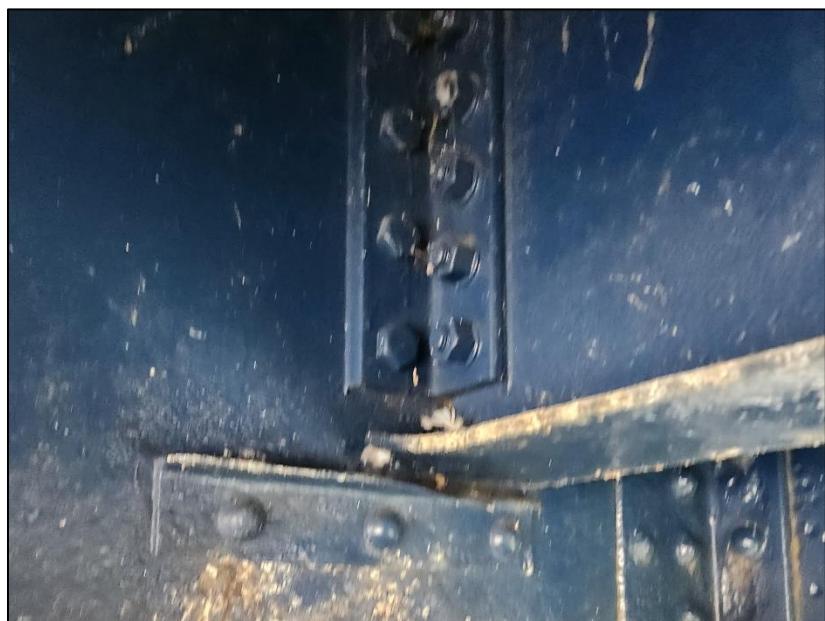
Picture 20: Typical bent stringer bottom flange.

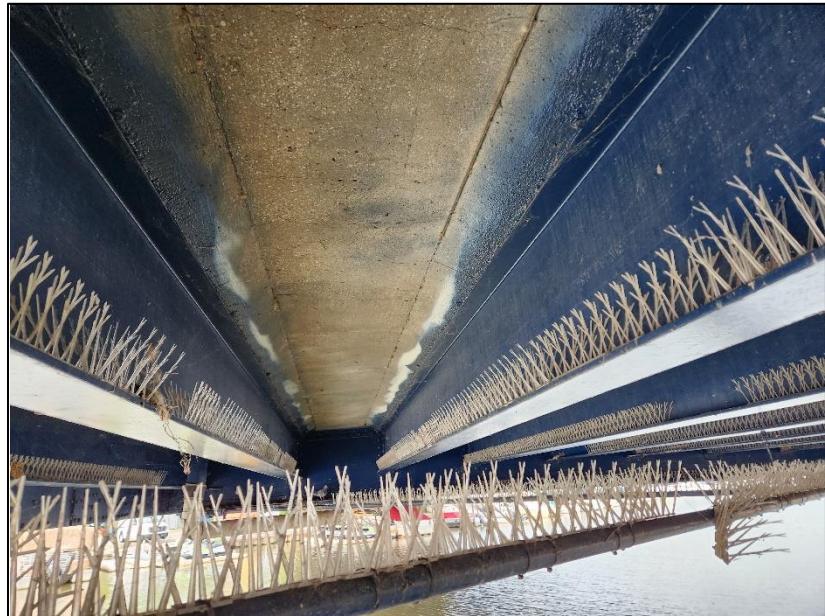
Approximately 23 stringers are not seated on the support angles. The stringer and floorbeam connections were rated in 2015, and found that the support angles are not needed to safely carry loads. The support angles were likely installed to temporarily support the stringers while the web connections were made. There are approximately 15 stringer support angles that are bent and have section loss (see Picture 20). There are pigeons and swallows nesting on the bridge. Pigeon spikes have been installed on the stringer bottom flanges (see Picture 21) over the boats docked at each side of the channel, but this has not fully deterred birds from nesting.

Picture 21: Pigeon spikes on floor system of Panel 8.

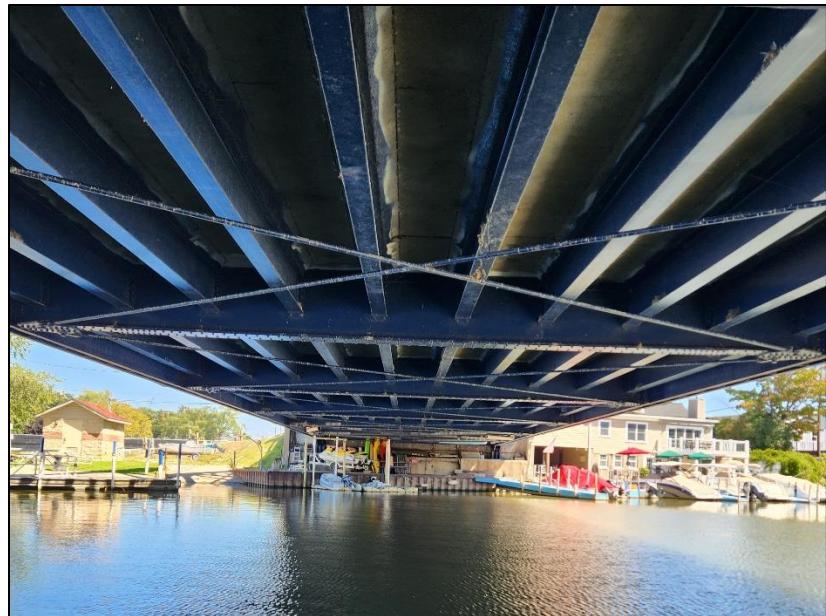
The floorbeams and the floorbeam connections are in **fair** condition. The floorbeams span between the north and south truss verticals. The interior floorbeams (1-8) are built-up riveted steel members from original construction (see Picture 22). The end floorbeams (0 and 9) are built-up welded steel members installed in 1986. The floorbeam connections to the verticals are riveted angles. There is some minor active rust at the floorbeam connections. There is some pitting and section loss (up to 20%) in the floorbeams and the floorbeam connections near the verticals (see Picture 23). A few of the connection angles are bent due to pack rust. A few connection angles have small holes. Two floorbeams have holes in the bottom flange near the connection to the lower lateral bracing. There is one location with holes in the fill plate between the vertical and the gusset plate at the top two rivets of the floorbeam connection to the vertical. The top two rivets are not engaged. One location has a hole in the floorbeam web at the top two rivet connections to vertical. The condition of the floorbeam web between the connection angles could not be determined.

Picture 22: Typical floor system layout.

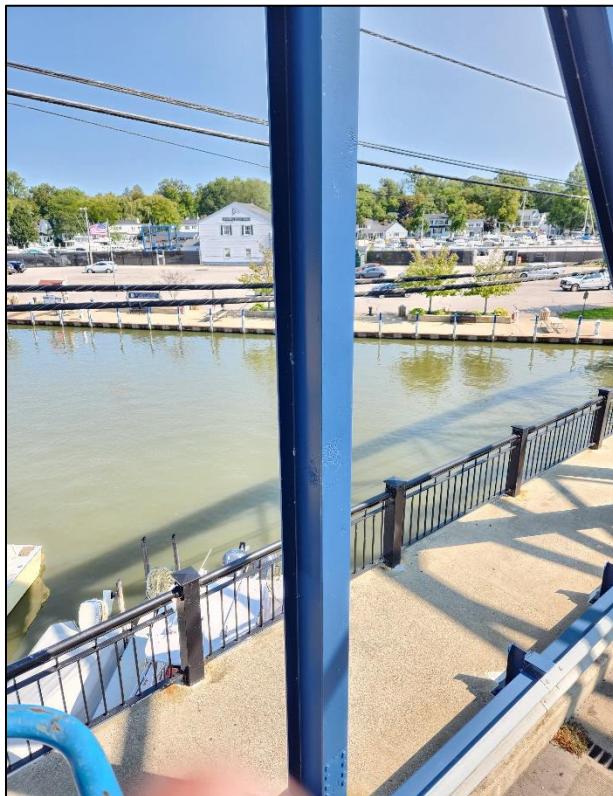
The verticals are rolled steel sections. The truss verticals are in **fair** condition having minor section loss (see Picture 24) and pitting in areas outside of the splash zone. There is pitting on the end verticals at the original end portal connection locations. The end portals were raised to increase vertical clearance in 1986. There is pitting at locations of the original pipe rail connections located above the deep beam guardrail. The truss verticals have pitting with section loss (approximately 10% of web area) in the splash zone (see Picture 25). Plates have been added to the bottom of the vertical webs at L2U2 of the south truss, L8U8 of the north truss, and L8U8 of the south truss. Vertical L6U6 on the north truss has a hole on the south side of the web in the splash zone. The vertical connections to floorbeams have minor section loss and pack rust.

Picture 24: Looking northeast at L1U1 of north truss.

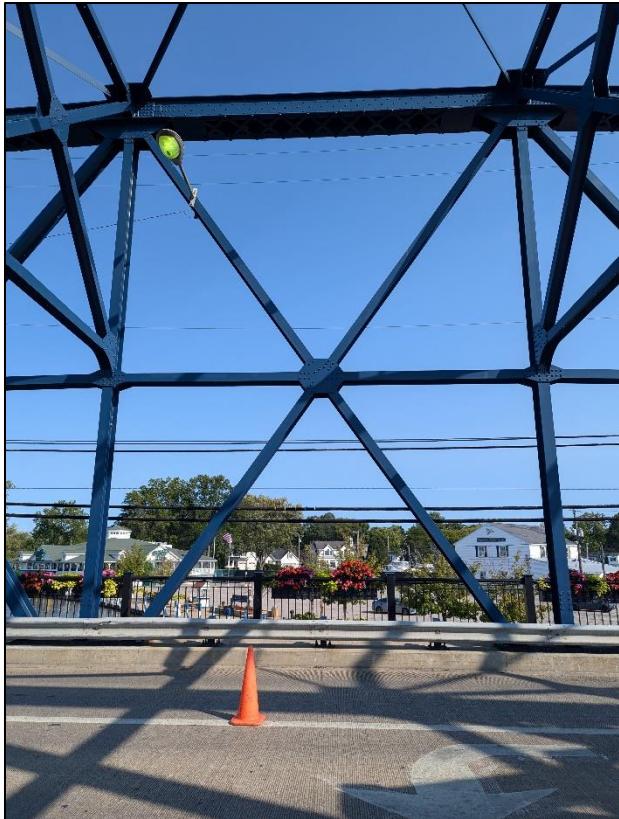
The truss diagonals are in **fair** condition. The diagonals are rolled steel sections (see Picture 26). The truss diagonals and their connections have minor section loss and pitting in areas outside of the splash zone. There is pitting at locations of the original pipe rail connections located above the deep beam guardrail. The truss diagonals have pitting with section loss (approximately 10% of web area) in the splash zone (see Picture 27). There are holes and deep pitting in the webs of L3U4 of the south truss, L4U5 of the south truss, and L6U5 of the north truss. L6U7 of the south truss and L7U8 of the south truss have section loss and holes in the web at the bottom of the diagonal. Plates have been added to the bottom of the diagonal webs at L3U2 of the south truss, L5U4 of the south truss, and L6U5 of the south truss. The fill plates between the diagonals and the lower chord gusset plates have section loss with minor active rust, some of the fill plates are bent, and rivets are not engaged at some locations. U4L5 of the north truss has minor misalignment of flanges (see Picture 28).

Picture 26: Typical X-diagonal (Panel 6 of north truss).

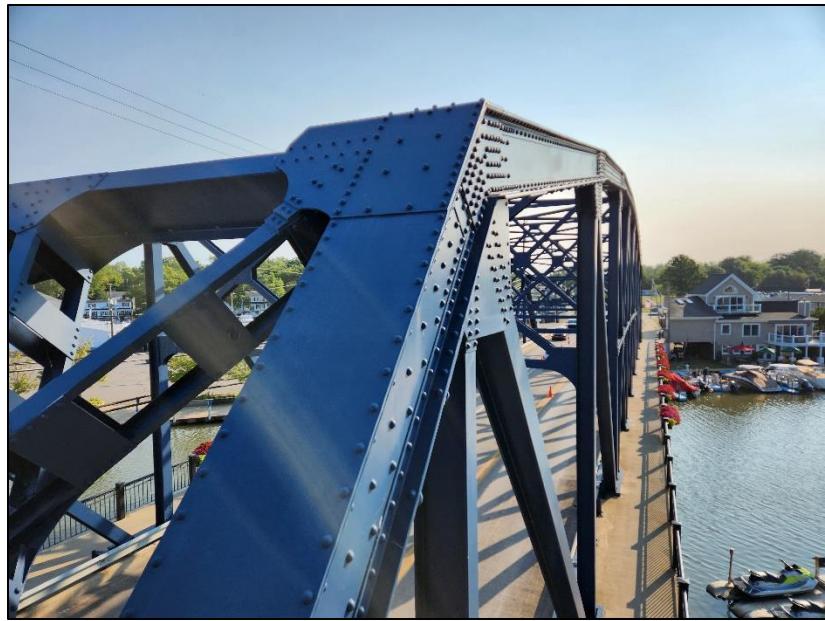
The truss upper chords are in **fair** condition. The upper chords are built-up riveted members made of plates and angles (see Picture 29). The upper chord members have minor pitting in the webs. There is minor pitting and section loss at the connections to the portals and sway bracing. There are dents from original construction in the top flange of the upper chord at U1U2 of the north truss (see Picture 30), U3U4 of the south truss, U5U6 of the north truss, U6U7 of the south truss, U7U8 of the south truss, and U8U9 of the south truss. There is active rust at a small hole in the web of U6U7 of the south truss. The upper chord has several bent lacing bars. The bottom flanges of U2 of the south truss and U5 of the north truss have $\frac{1}{4}$ " offset from original construction.

Picture 29: U1 of the south truss looking east.

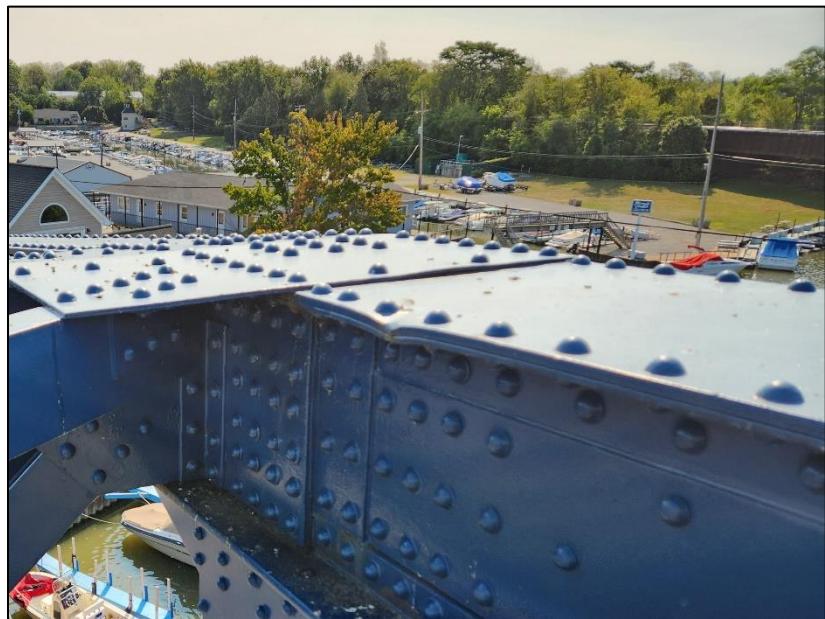
Picture 30: Dent in the top flange of U5U6 of the south truss.

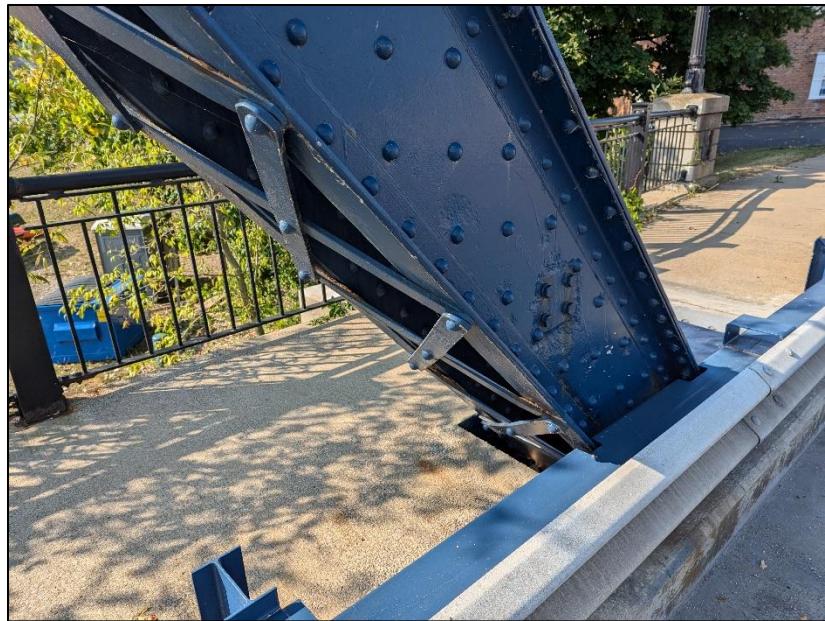
End Posts - The end posts are built-up riveted members made of plates and angles. The end posts have minor section loss, pitting and pack rust in the splash zone and a few other localized areas. There is pitting at locations of the original pipe rail connections located above the deep beam guardrail (see Picture 31). The end posts have minor active rust at the web to flange connections. The batten plates near the lower chord have section loss with holes at L0U1 of the north truss and L9U8 of the south truss. Several lacing bars at each end post are bent. Some of the angles at the bottom of the end posts are bent due to pack rust. There are sections of the upper flange where the sign connections bolts are rusting through the plate (see Picture 32).

Picture 31: Looking at L0U1 of the south truss.

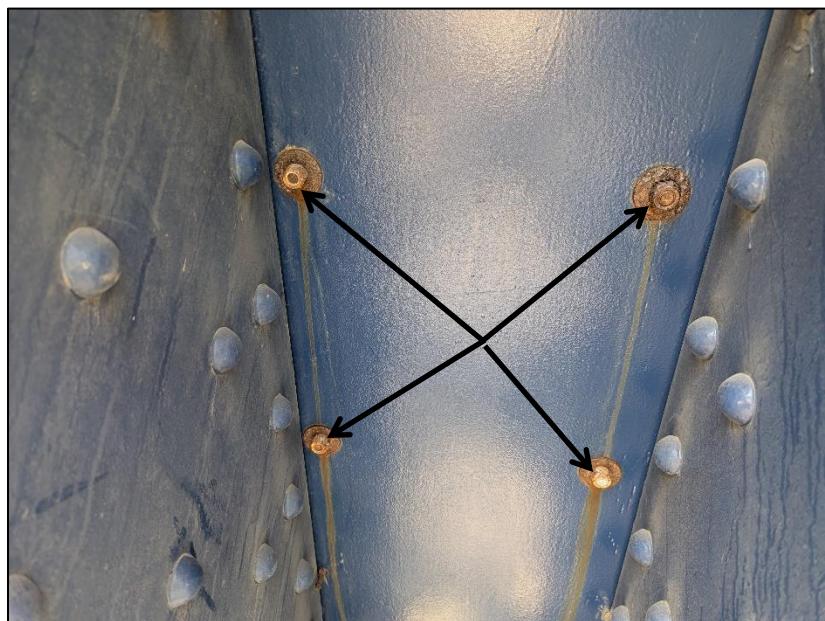
Picture 32: Rusted sign connection bolts inside end post.

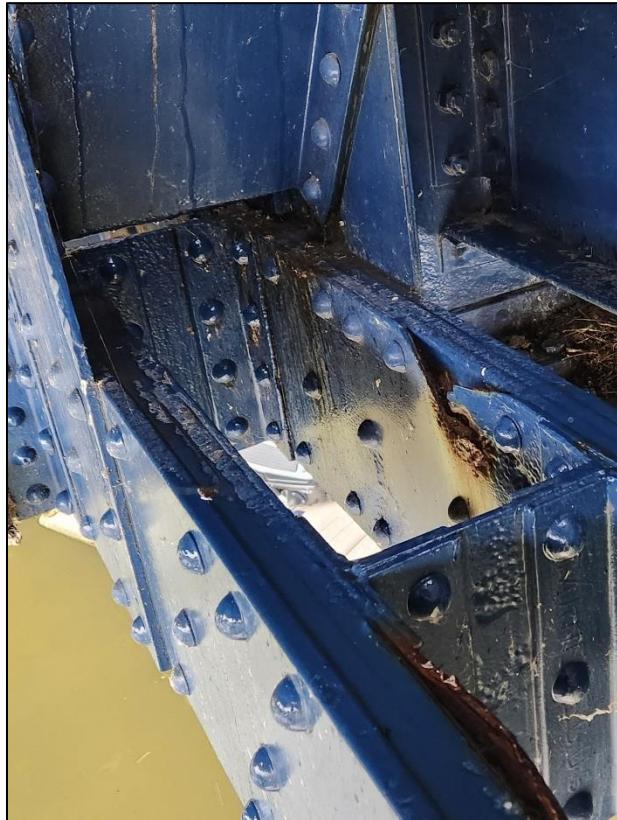
Lower chord members L3L4 and L5L6 are made up of 4 plates on each side - three 15"x³/₄" plates and one 15"x⁵/₁₆" plate. Lower chord member L4L5 are made up of 4 plates on each side - three 15"x³/₄" and one 15"x¹/₂" plate. The thinner plates are on the insides of the member. There are holes in the inner lower chord web plates on L2L3 of the north truss, L3L4 of the south truss (see Picture 33), L4L5 of the north truss, L5L6 of the north truss, and L6L7 of the south truss. Similarly the exterior plates near the gusset plate connections are thinner and have reactivated pack rust.

Picture 33: Hole in north inside plate of L3L4 at L3 of south truss.

- The addition of stiffening angles to the lower edge of U1 and U8.
- Blast and paint lower chord members and gusset plates to arrest active corrosion and pack rust.
- Reinforce sheet piling along river on west side and regrade back to abutment.

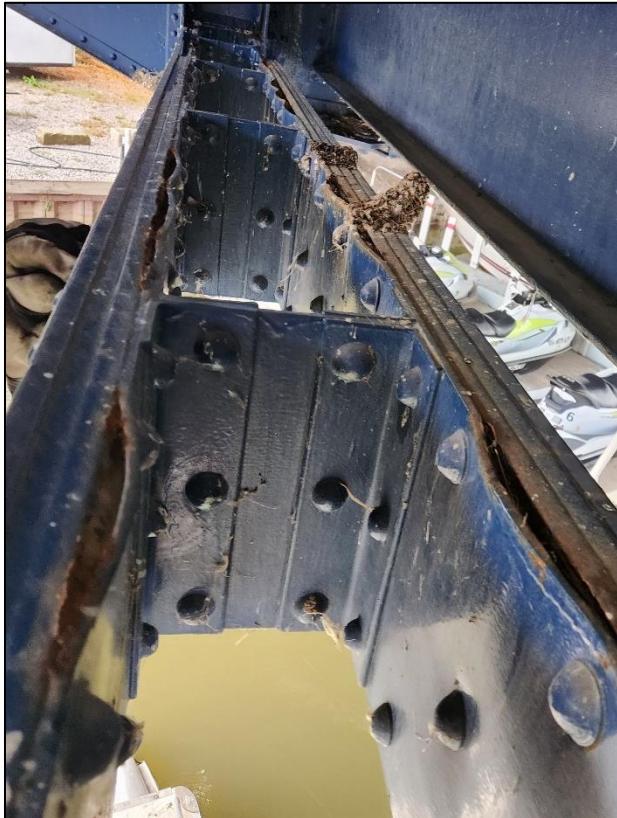
The lower chord is wavy from pack rust at L2L3 of the north truss, L3L4 of the north truss, L3L4 of the south truss (see Picture 34), L4L5 of the north truss, L5L6 of the north truss, and L5L6 of the south truss due to the thin plates on the insides of the member. Several of the diaphragm angles have pack rust causing bulges in the angles and have minor active rust. There is a hole in the diaphragm at L7 of the north truss.

Picture 34: Pack rust in between plates of L3L4 of the south truss.

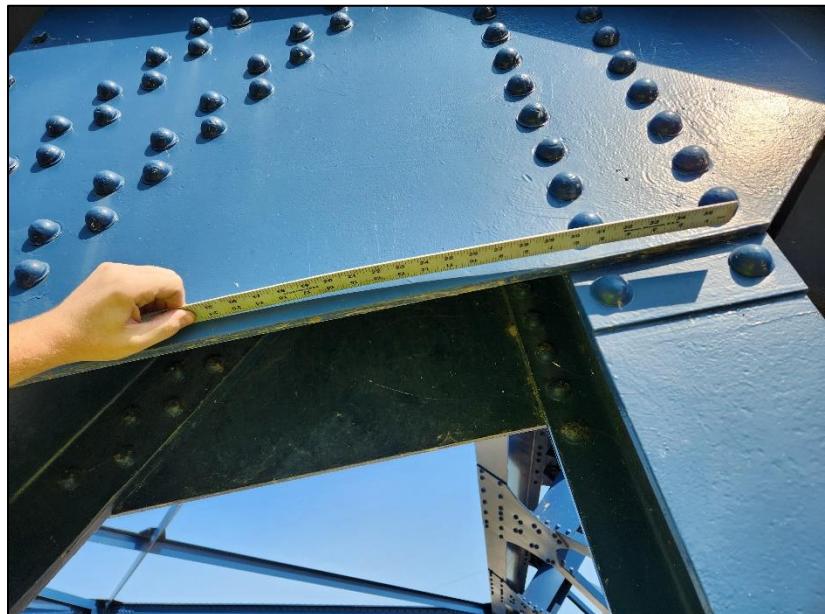
Bowing due to member misalignment were found by placing a straight edge along the free edge from where the gusset plate and members meet and measuring the maximum offset of the gusset plate (see Picture 35). The size of the pack rust bows were found by measuring the gap created by pack rust between the gusset plate and member (or the fill plate if between the member and gusset plate) (see Picture 36).

Picture 35: Misalignment bow of U8 south truss outside gusset plate.

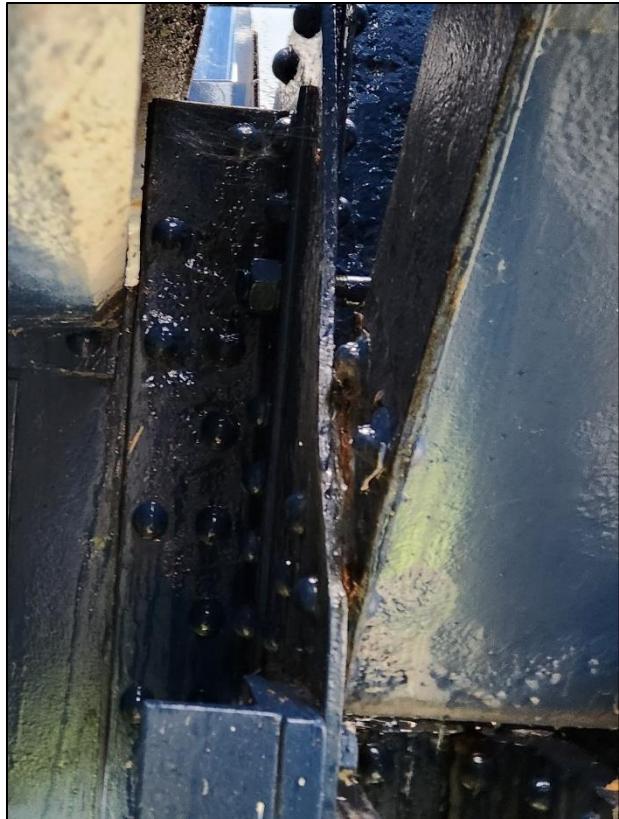
The outside gusset plates at L1 and L8 of the north truss, and both inside and outside gusset plates of U7 of the north truss and U8 of the south truss, are the only gusset plates that have slight bows due to misalignment. The remaining gusset plates listed in the table above have bows due to pack rust.

Picture 36: Pack rust bowing of L5 south truss inside gusset plate.

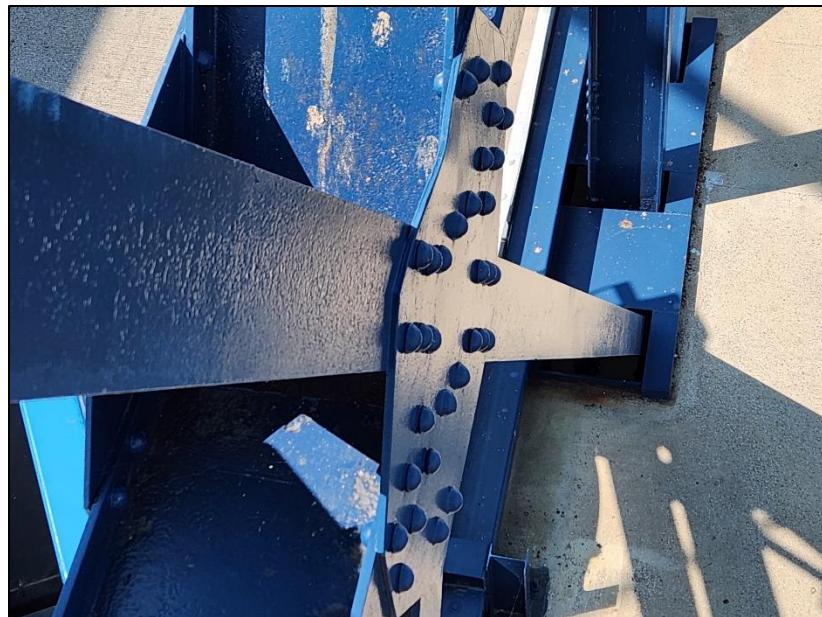
There is an approximate $\frac{3}{8}$ " bow on the top edge of the outside gusset plate at M4.5 of the north truss, which connects the center of diagonals L4U5 and L5U4 (see Picture 37).

Picture 37: Bowing of M4.5 north truss inside gusset plate.

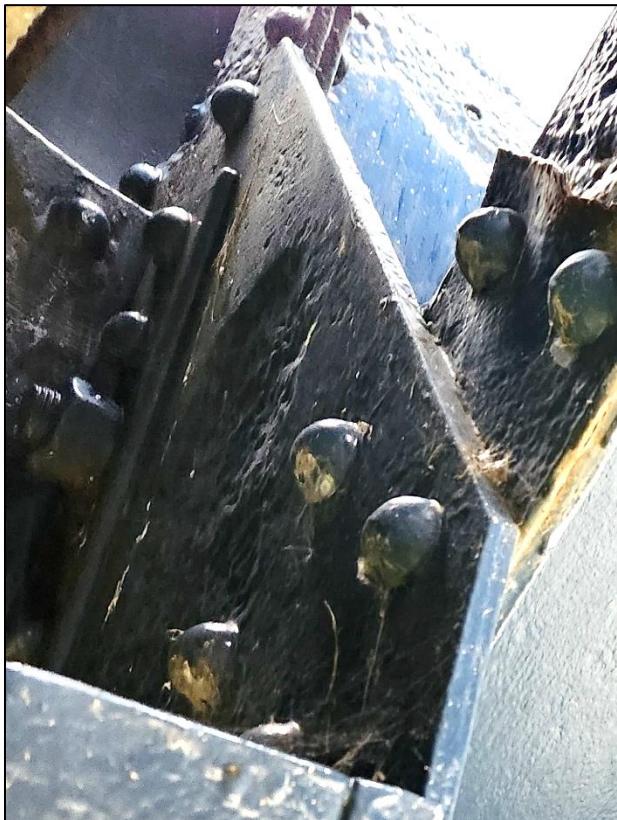
There is deep pitting of the inside gusset plates at L4 (see Picture 38), L5, and L6 of the south truss and up to 50% previous section loss over 30-50% of the plate area. The inside gusset plate at L2 of the south truss has pitting and about 20% section loss. All other gusset plates have minor pitting and less than 15% section loss.

Picture 38: Deep pitting on inside gusset plate of L6 of the south truss.

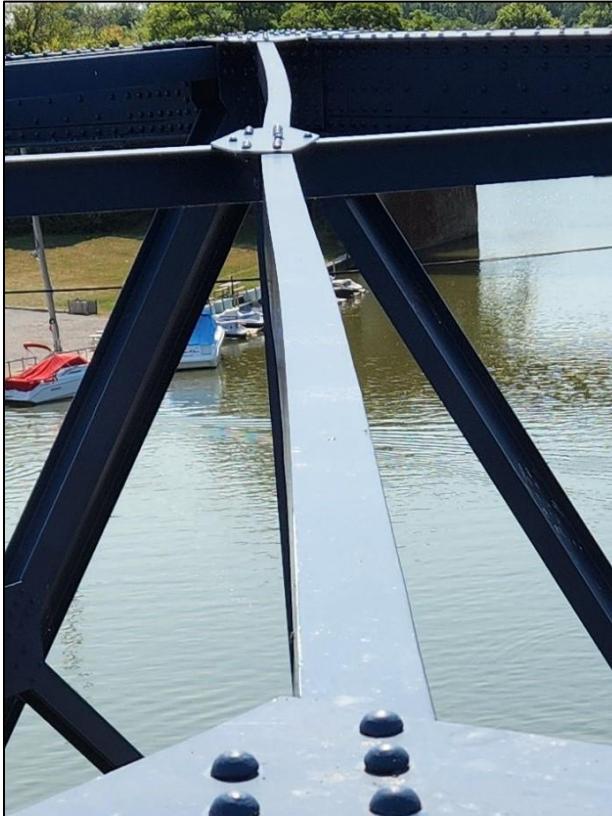
The lateral bracing is rated in **good** condition. The upper lateral bracing has minor deformation in the connection plates due to pack rust. The pack rust at the connection plates has been removed but not caulked in some areas. The members from U3 of the north truss to U4 of the south truss and from U4 of the south truss to U5 of the north truss are bowed (see Picture 39).

Picture 39: Looking at upper lateral bracing from U3N to U4S.

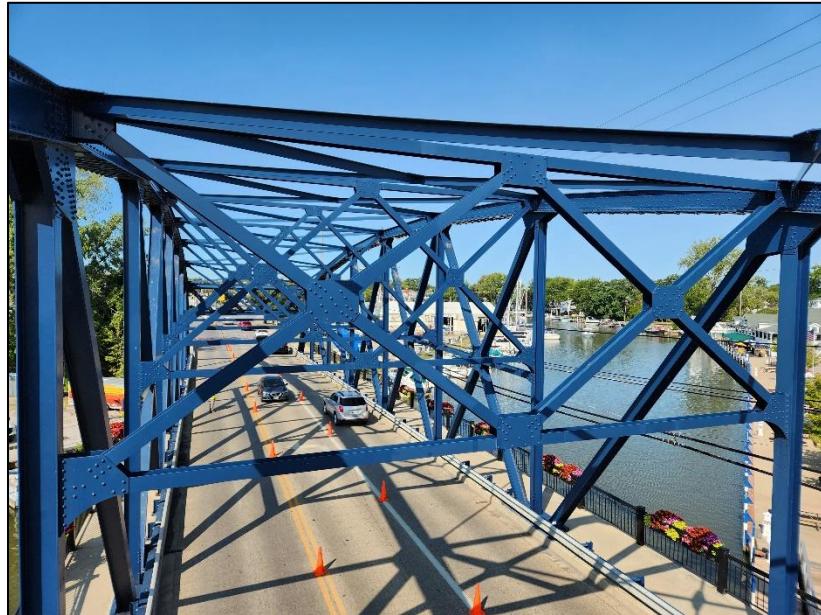
The sway bracing is in **fair** condition. The portals have minor pitting and minor section loss at connections. The sway bracing has minor pitting and section loss. Approximately 15 sway brace connection plates have minor deformation due to pack rust.

Picture 40: Sway bracing at PP7.

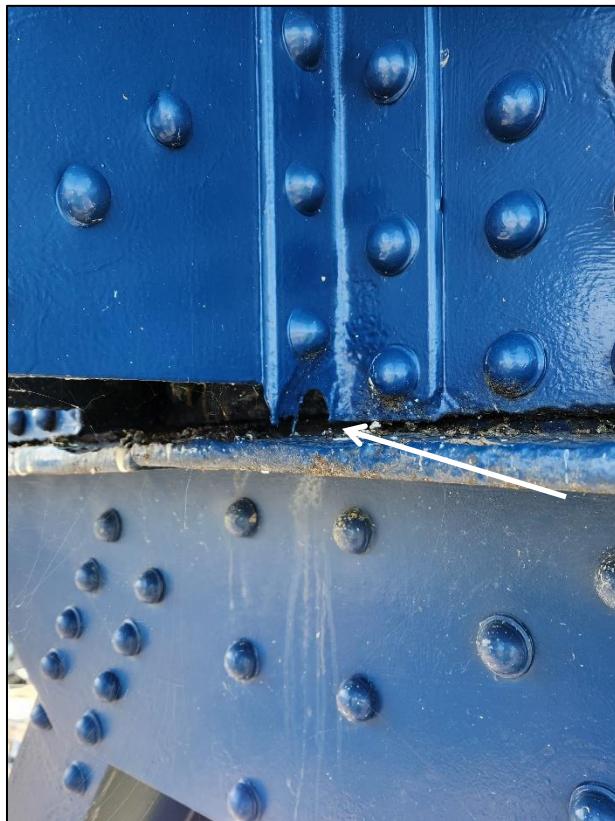
Picture 42: Looking west at sway brace connection to U5 of the south truss.

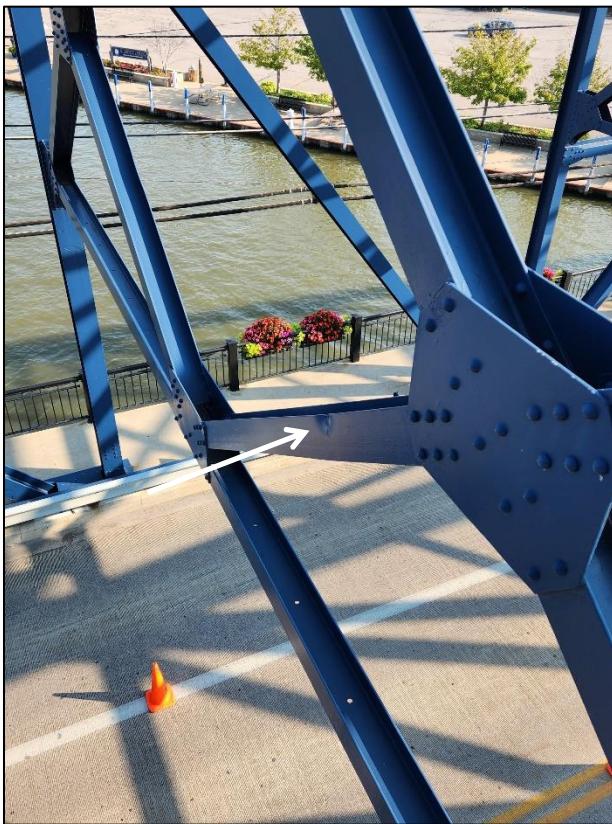
Picture 43: Dent in flange of lower diagonal sway bracing at PP5.
