2024 UPDATE TO THE
2022 PHYSICAL CONDITION INSPECTION REPORT

ERI-6-2893

U.S. Route 6 over the Vermilion River

Ohio Department of Transportation

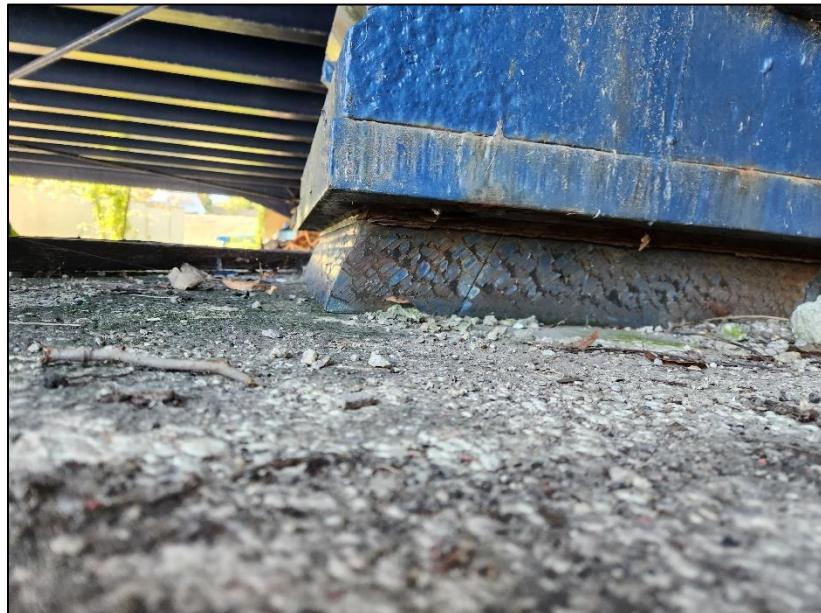
Picture 44: North elastomeric bearing on rear abutment.

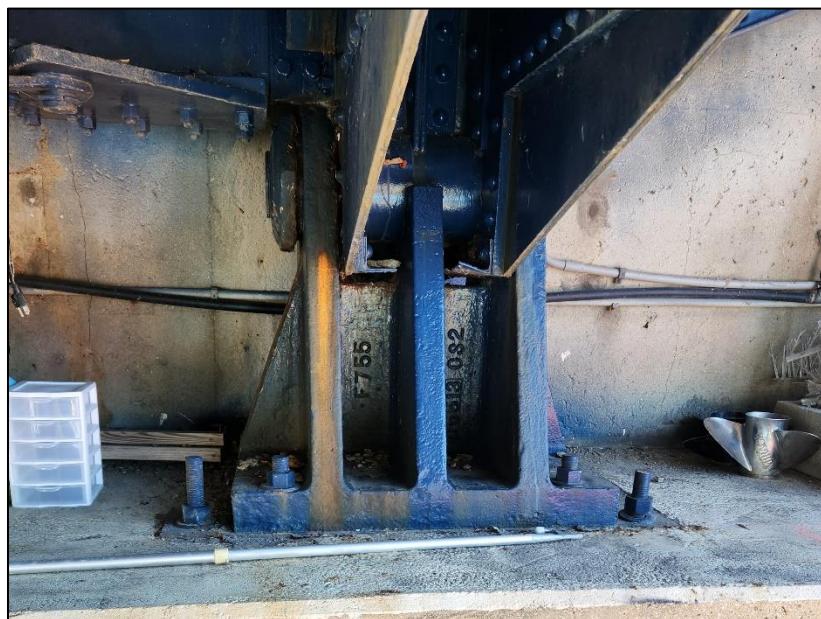
Picture 46: South bearing (bolster) on forward abutment.

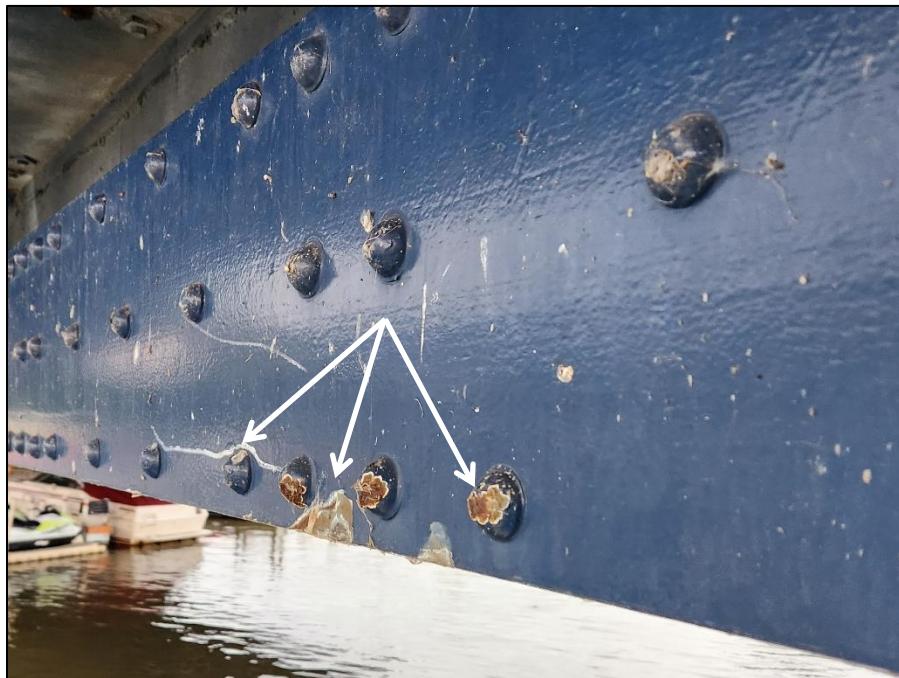
There is chipped paint or minor scrapes in the paint is typical on both the diagonals and verticals from roadway and sidewalk impacts, and on the lower chord due to minor impacts from boats (see Picture 47). There are chips and dings in the paint at L0U1 of the north truss, L6U7 of the north truss, L9U8 of the north truss, deep beam railing bolt in Panel 4, the pedestrian railing, the sway brace at Panel Point 2 and the lower gusset plate connection to the north truss.

Picture 47: Looking at south face of L5L6 of the south truss.

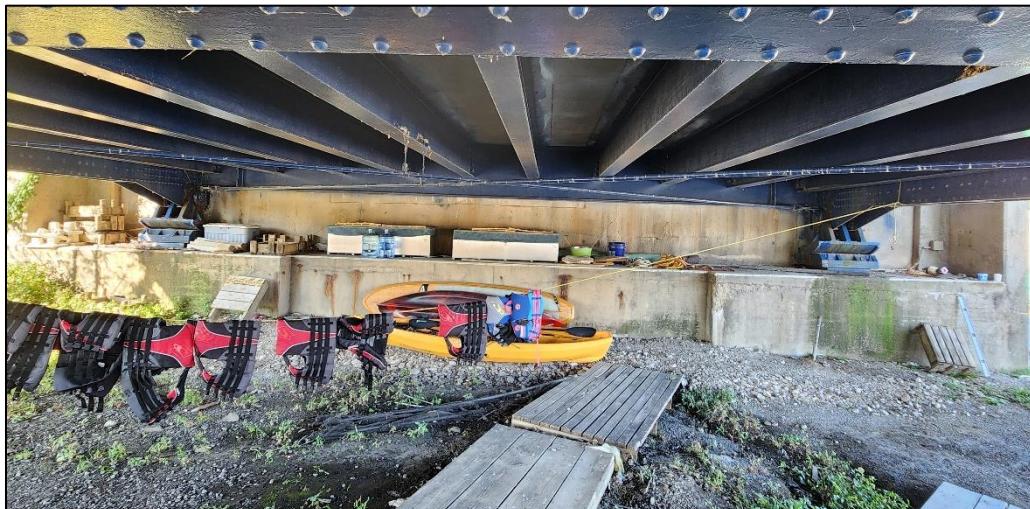
The rear abutment is leaning $\frac{3}{8}$ " away from the river for every 4 feet vertical. The rear abutment breastwall has delaminations, minor spalls, cracks, and efflorescence (see Picture 48). The rear abutment breastwall has 15.0 square feet of spalls and delaminations.

Picture 48: Rear abutment.

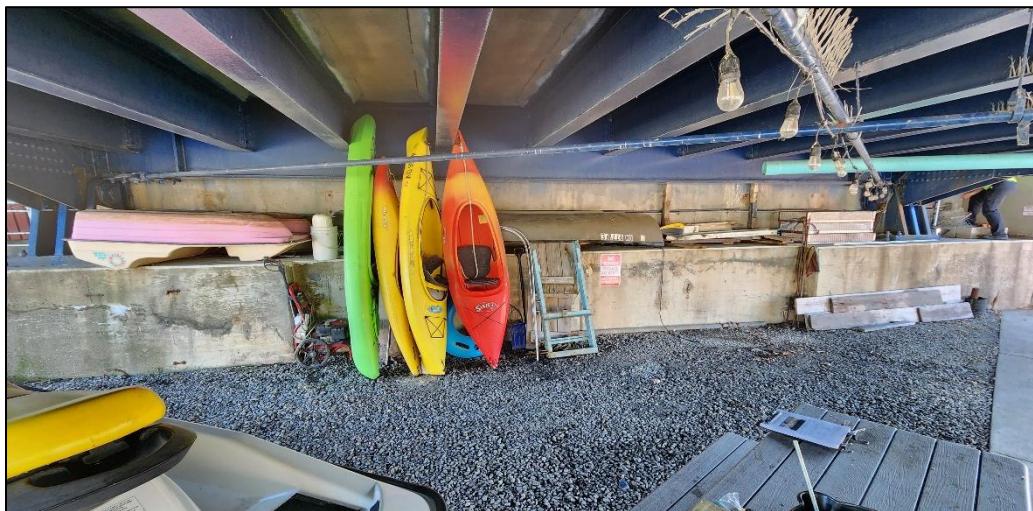
The forward abutment is leaning $\frac{3}{8}$ " towards the river for every 4 feet vertical. The forward abutment breastwall has cracks, efflorescence and spalls with exposed reinforcing steel (see Picture 49). The forward abutment breastwall has 30.5 square feet of delamination.

Picture 49: Forward abutment.

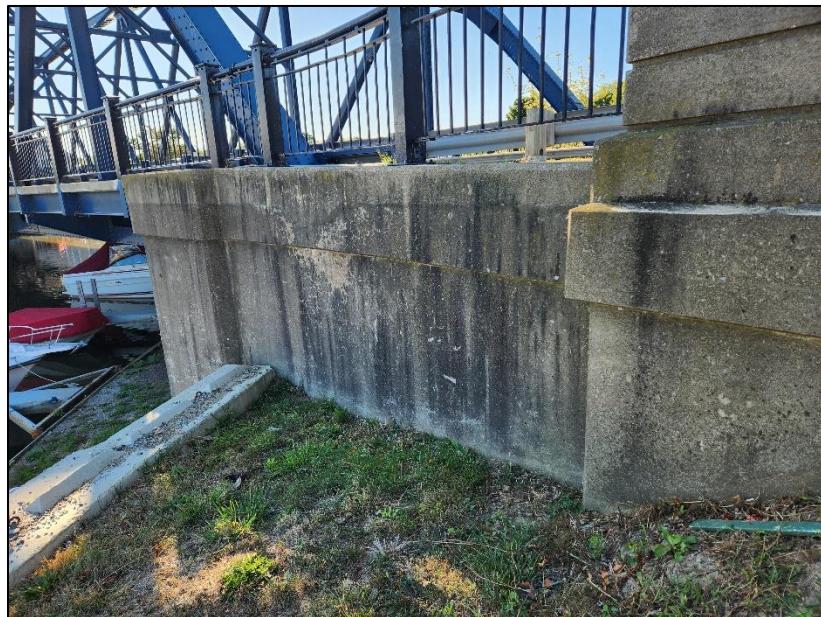
The wingwalls are in **fair** condition. The approach sidewalks at all corners have settled. This may be caused by the loss of fill from behind the wingwalls. There are a few spalls with exposed reinforcing on the backs of the southwest wingwall next to the seat. The southwest wingwall has 1.75 square feet of delamination. The southeast wingwall has a mural; it exhibits map cracking, a few small delaminations and one long crack at the top. The seal in the joint between the southeast wingwall and the retaining wall to the east has deteriorated and is mostly gone. The northwest (see Picture 50) and northeast (see Picture 51) wingwalls have minor cracks.

Picture 50: Northwest wingwall.

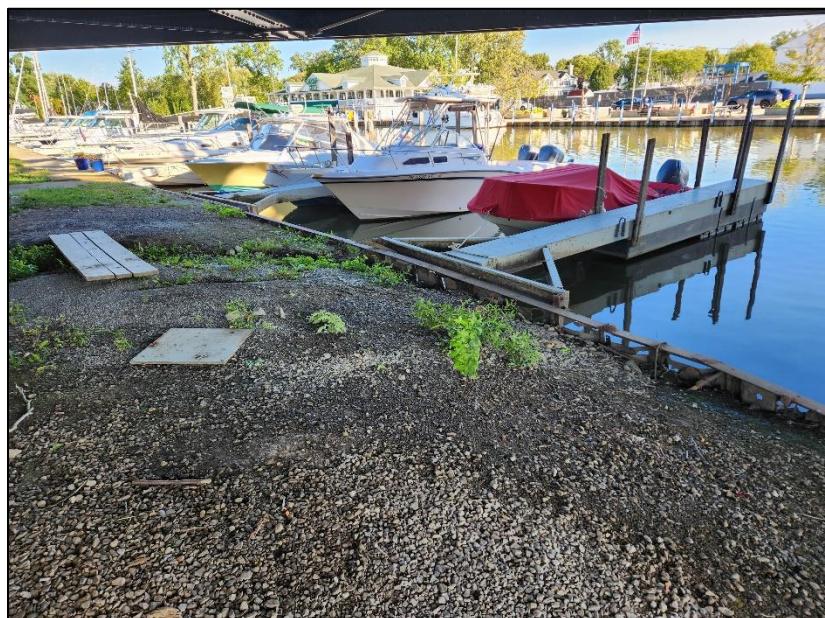
Slope protection for this bridge is in **good** condition. The rear abutment slope has crushed aggregate slope protection and vegetation. Sheet piling retains the soil in front of the rear abutment. There are several deep ruts leading to the sheet piling. The forward abutment slope has crushed aggregate slope protection and concrete sidewalks. Sheet piling retains the soil in front of the forward abutment all of the slope protection measures on the forward end of the structure is in good condition.

Picture 52: Looking east at rear abutment slope protection.

- The addition of stiffening angles to the lower edge of U1 and U8.
- Blast and paint lower chord members and gusset plates to arrest active corrosion and pack rust.
- Reinforce sheet piling along river on west side and regrade back to abutment.

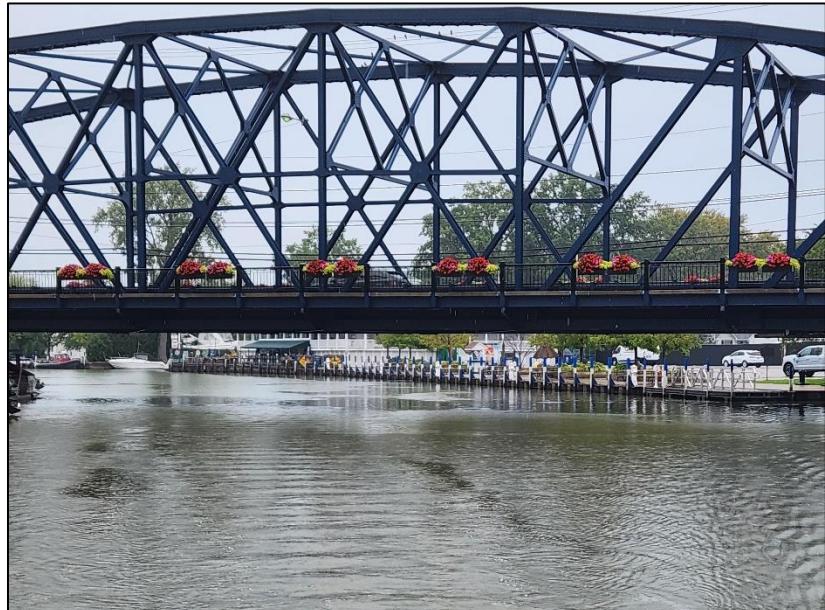
The alignment of the Vermilion River is **good**. No deficiencies are noted.

Picture 53: Looking downstream (north).

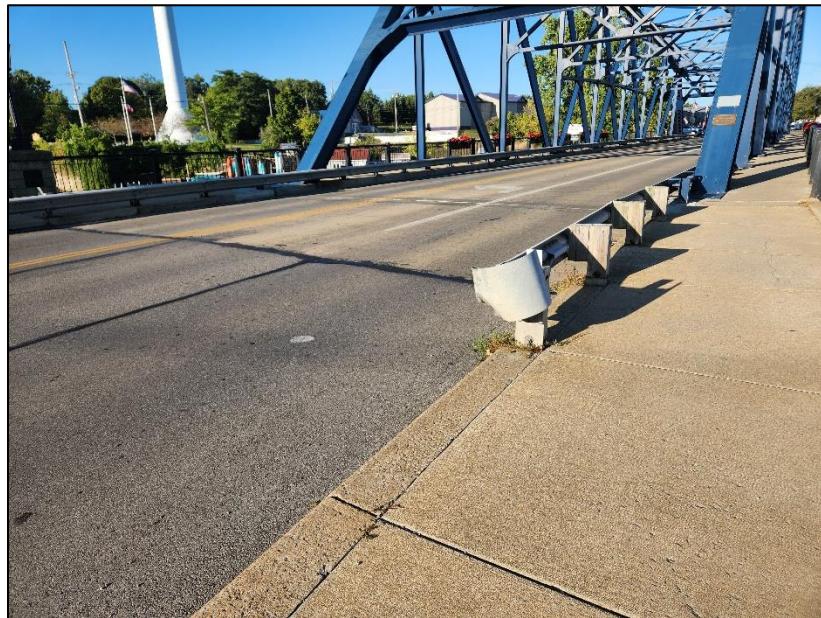
The approach pavement has a concrete base with a layer of brick and an asphalt overlay. The approach pavement is rated **good**. Both approach wearing surfaces were replaced **between 2021 and 2022** (see Picture 55).

Picture 55: Looking southwest at forward approach.

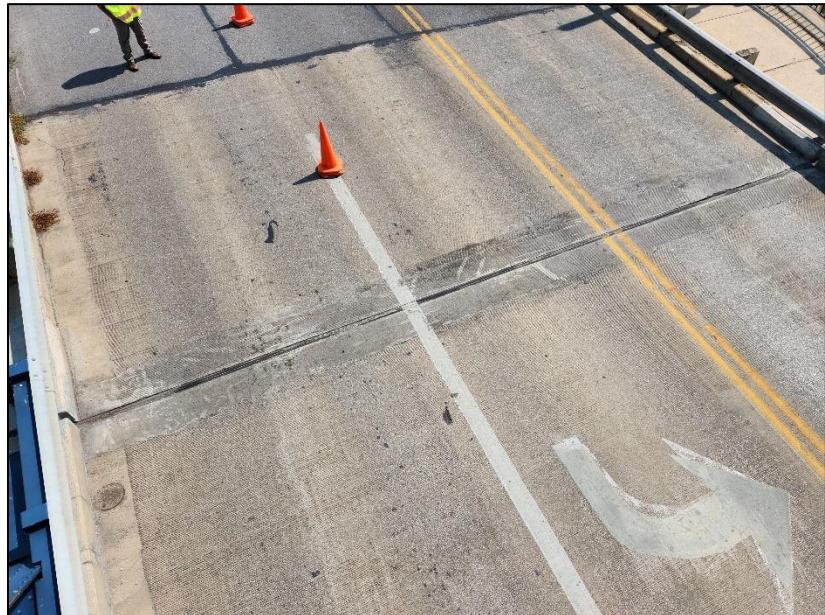
The reinforced concrete approach slabs are in **good** condition. The approach slabs are 20'-0" long, 13" thick reinforced concrete (see Picture 56). The approach slabs have a few small potholes, a 12 square foot patch was added in 2021 to repair a delamination in the eastbound lane on the rear approach slab. A portion of the approach slab along both deck joints were replaced during the 2021 joint rehab to fix many small spalls along the joints.

Picture 56: Forward approach slab.

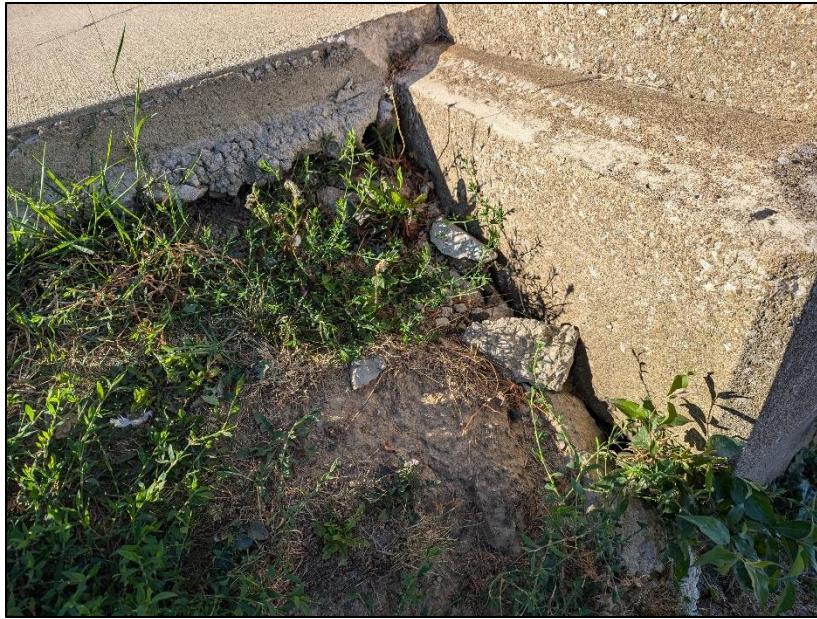
Picture 57: Erosion at northeast embankment is beneath sidewalk.

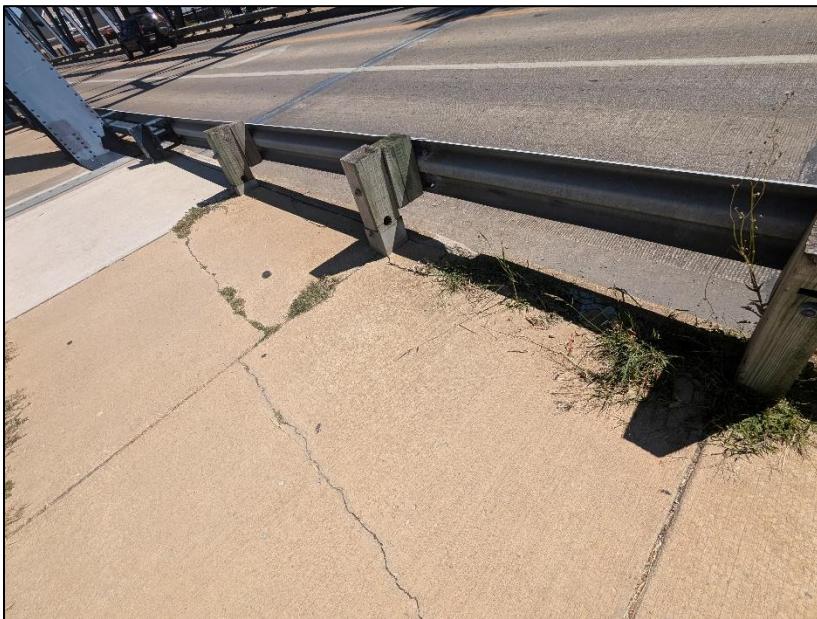
Picture 58: Approach sidewalk cracked at northwest corner.

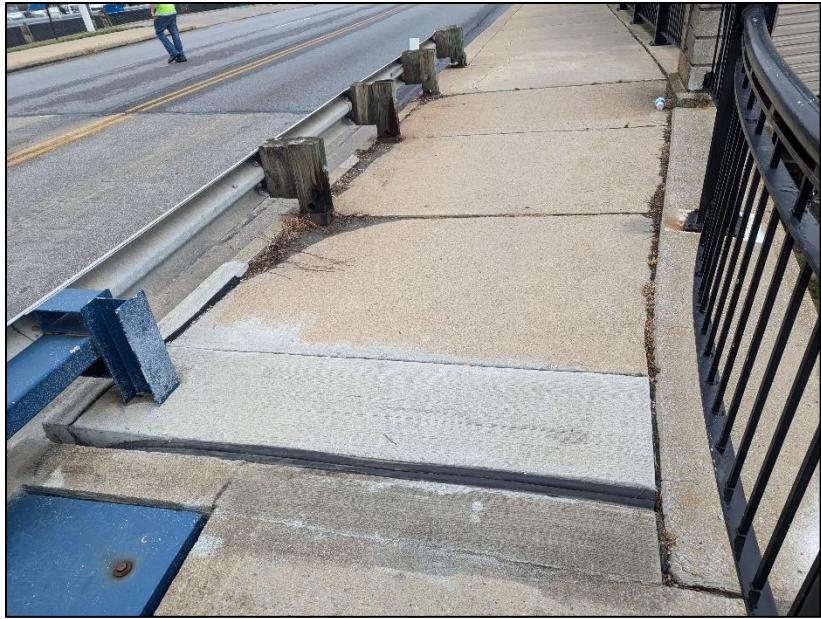
Picture 59: Southeast approach sidewalk settled.

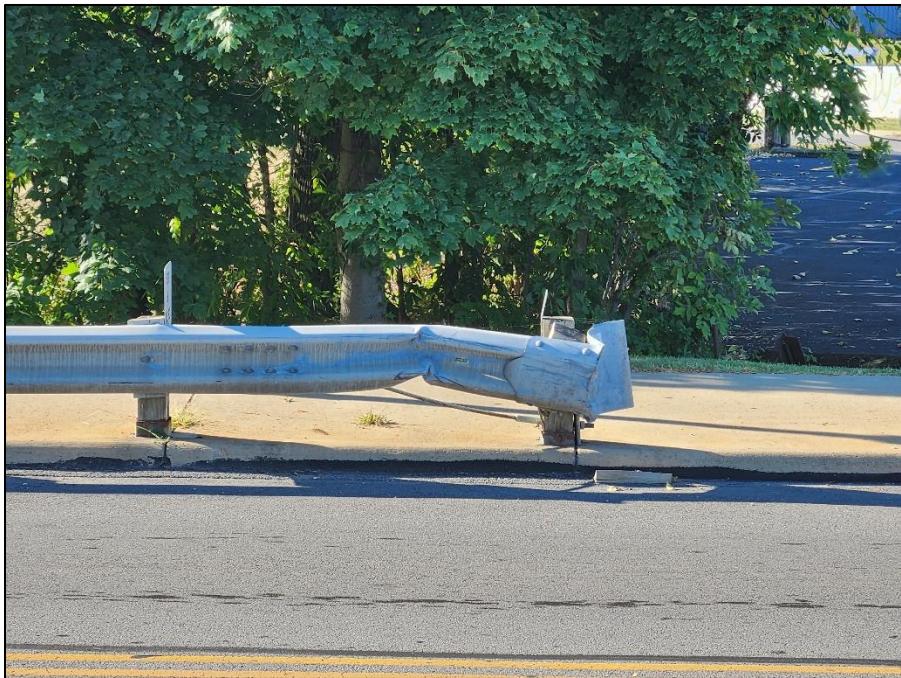
Picture 60: Impact damage at southwest corner.

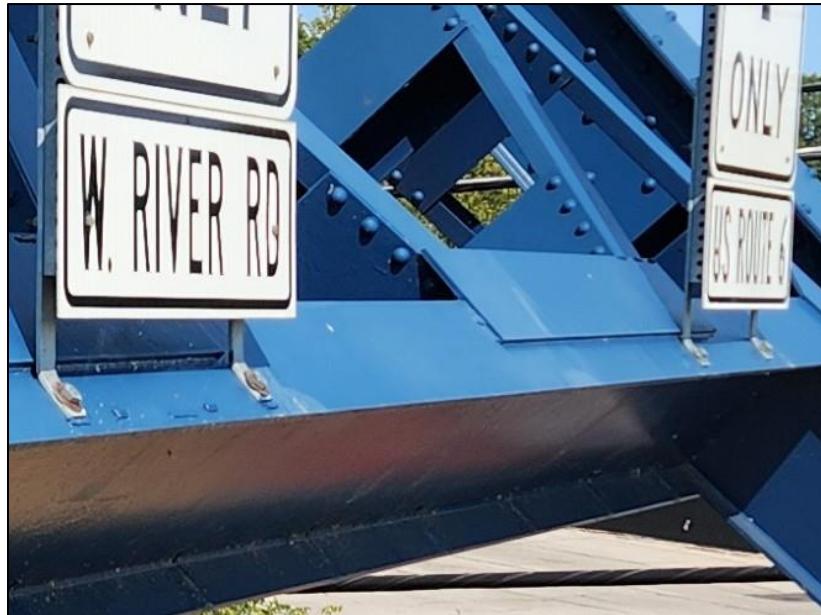
Picture 62: Lane sign support on east portal.

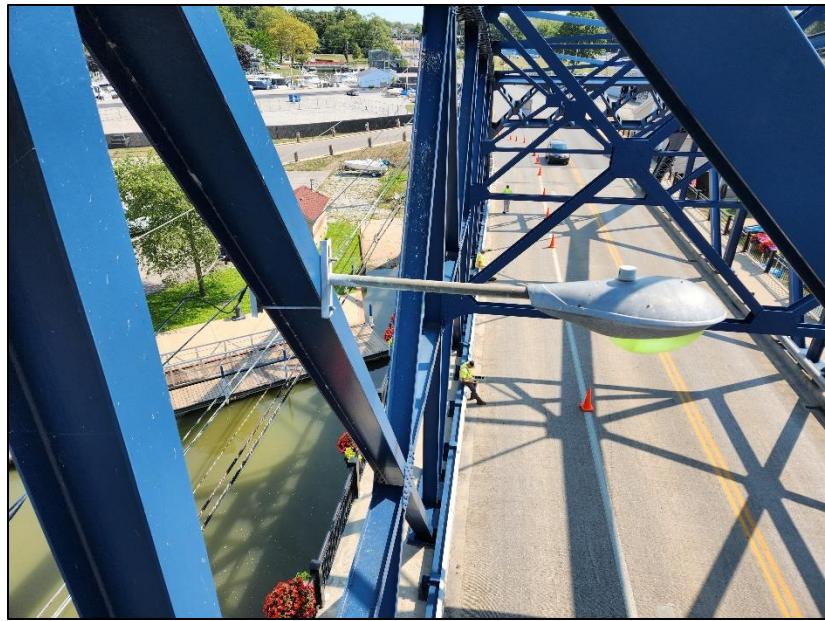
Picture 63: Looking east at light at L5U4 of the north truss.

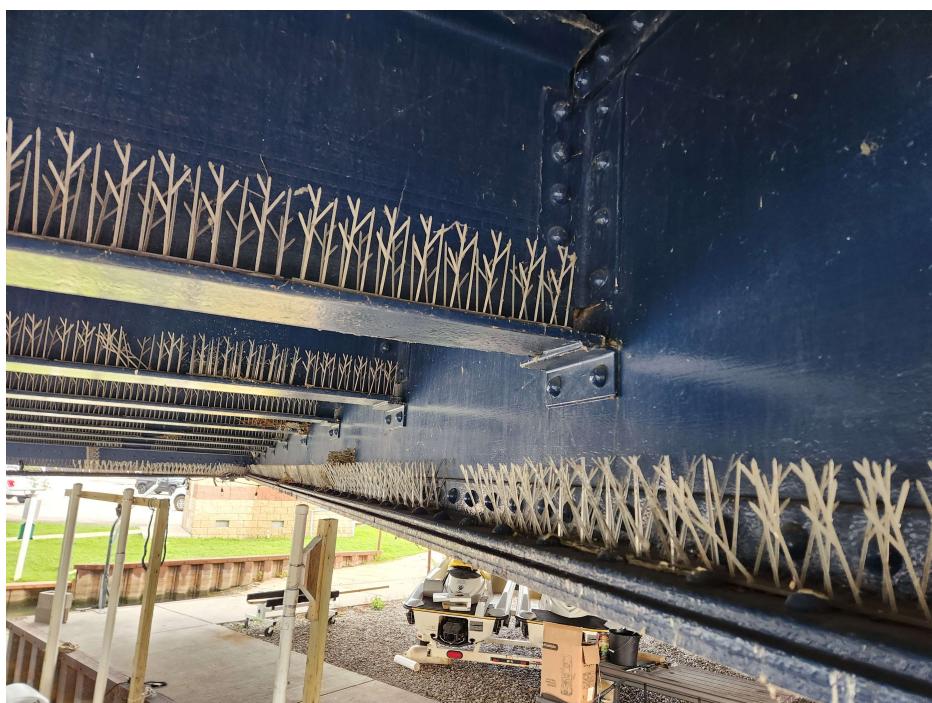
PHOTO 1

Description Stringer 10 Near FA rust on top flange
