2020 IN-DEPTH & FRACTURE CRITICAL BRIDGE INSPECTION REPORT

ERI-6-2884

SFN: 2202344

Vermilion, Ohio

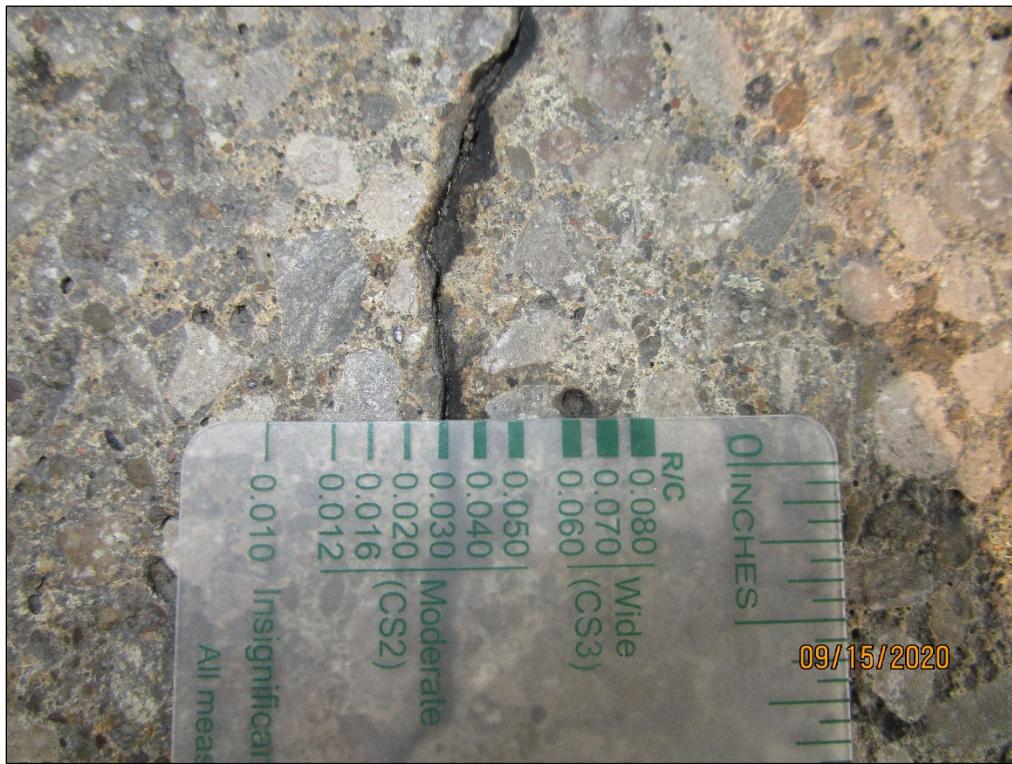
The Reinforced Concrete Deck, replaced in 1986, is in *SATISFACTORY* condition. Transverse and longitudinal cracks were found throughout the top surface. Crack widths were classified as hairline width, generally measuring up to 0.03" wide (**Photo 2**). The pattern of transverse cracks closely matches the floorbeams below with some additional partial length transverse cracks between the floorbeams. A 3' L x 3' W delamination and a 1' L x 1' W spall (**Photo 3**) was found in the center lane near the forward abutment. The longitudinal cracking on the top of the deck is scattered throughout and does not appear to be related to the stringer framing below. Deck findings including transverse cracks in the sidewalks are shown on the Deck Location Plan in **Appendix B**. At the bottom of the deck there are isolated transverse and longitudinal hairline cracks scattered throughout. There are various hairline cracks with leakage and efflorescence (**Photo 4**). There are also minor spalls and delaminations at various haunches (**Photo 5**). There is a spall approximately 6'-0" long with one exposed reinforcing bar on the underside at the rear abutment (**Photo 6**).

PHOTO 2 - TRANSVERSE CRACK IN DECK, 0.030" WIDE

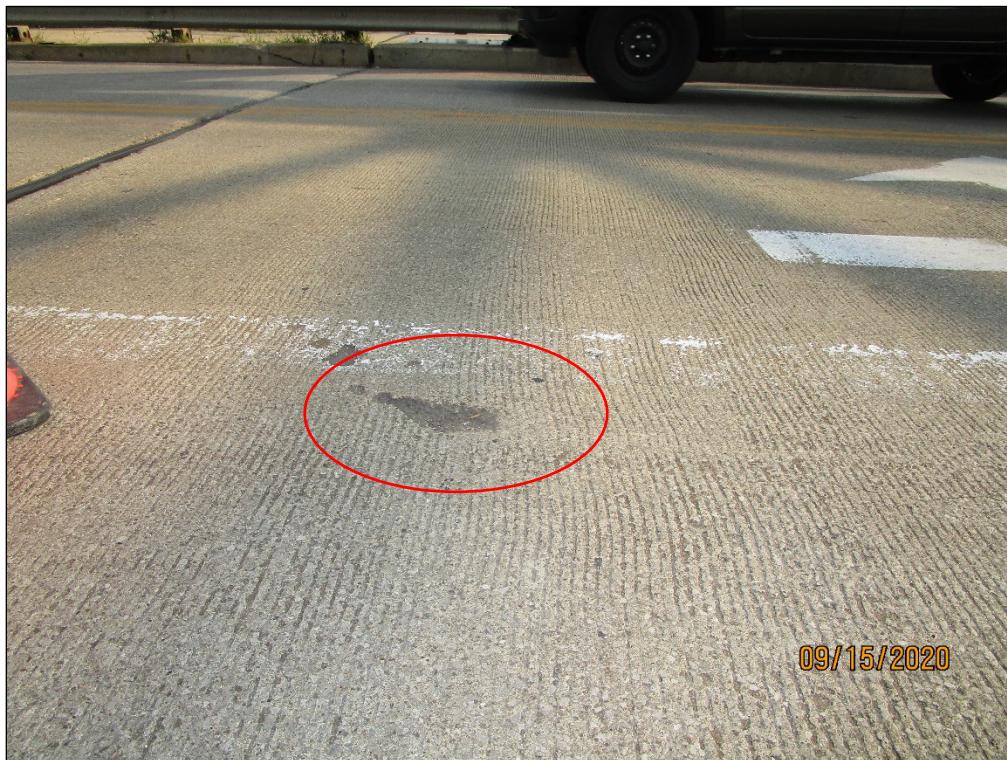
PHOTO 3 – 1'X1' SPALL IN DECK, CENTER LANE, FORWARD ABUTMENT

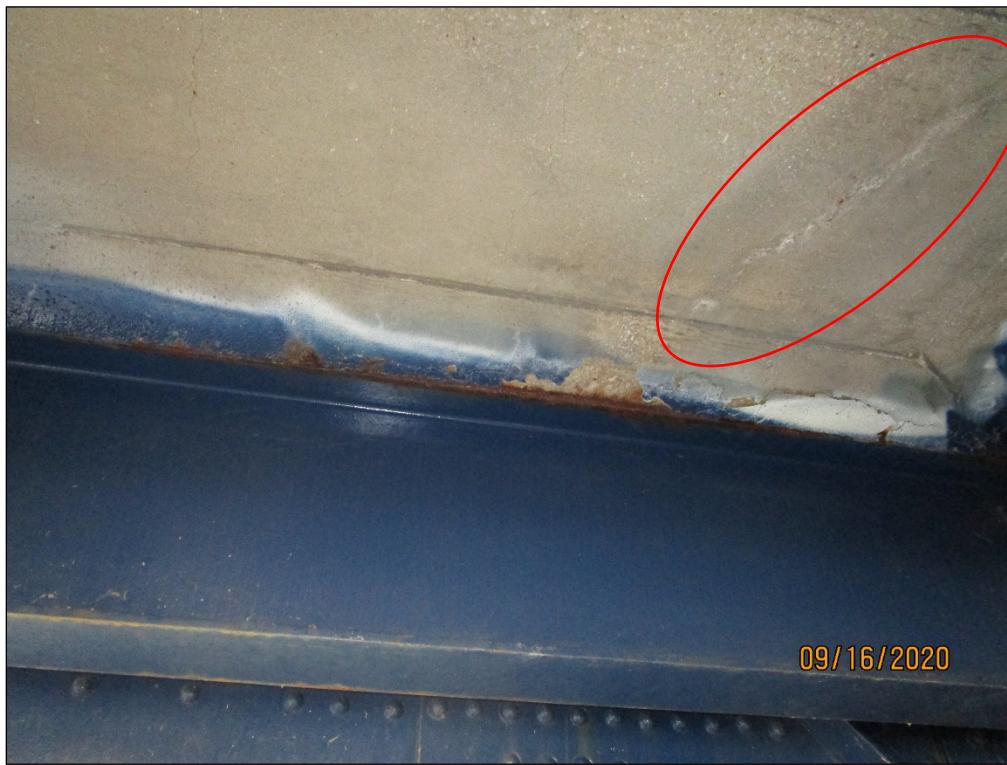
PHOTO 4 – HAUNCH SPALL AND TRANSVERSE CRACK WITH EFFLORESCENCE, STRINGER 1, FLOORBEAM 9

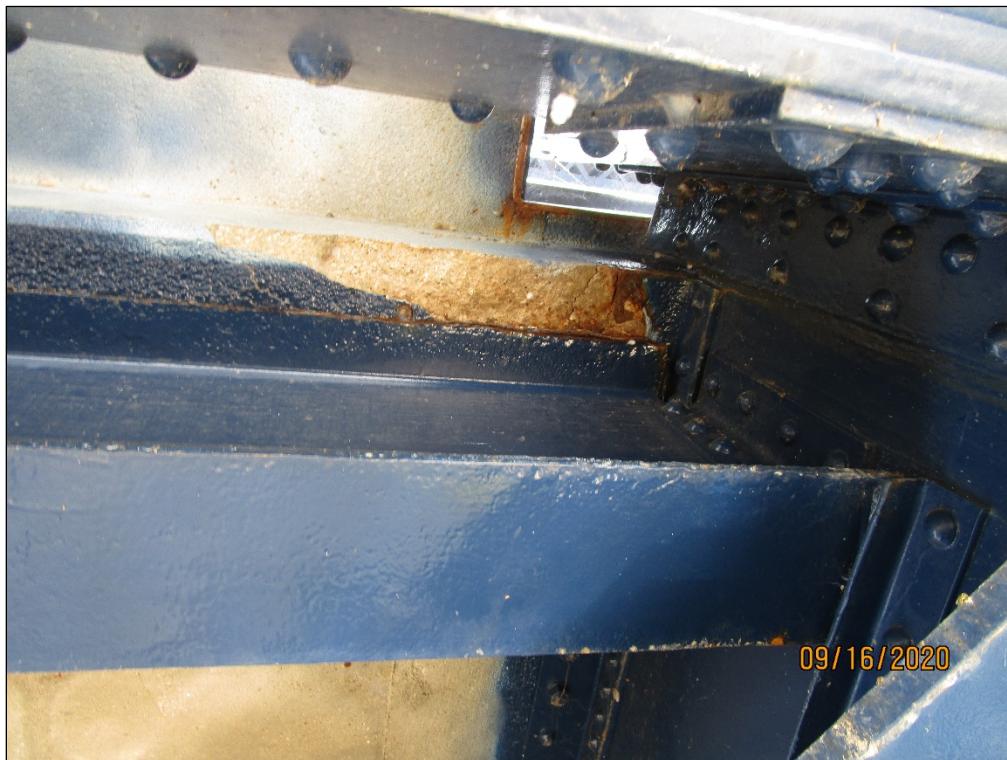
PHOTO 5 – HAUNCH SPALL, STRINGER 10, BETWEEN FLOORBEAMS 7 & 8

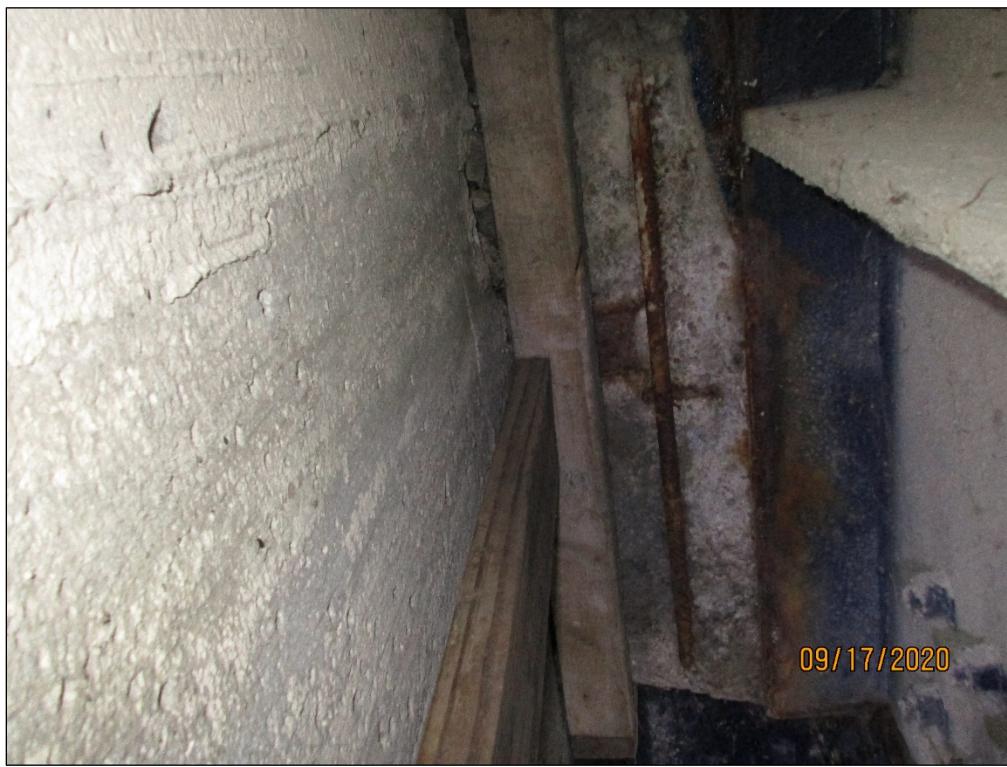
PHOTO 6 – SPALL ON UNDERSIDE OF DECK NEAR REAR ABUTMENT, FLOORBEAM 0

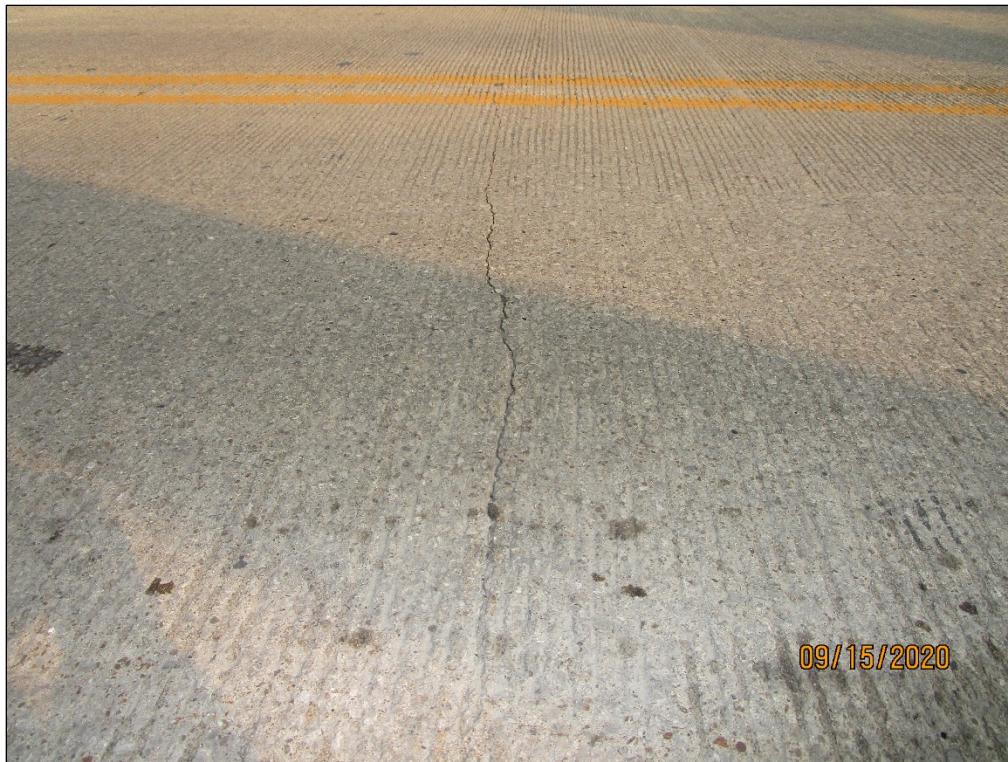
The Wearing Surface is in **SATISFACTORY** condition, or a **6** on the NBIS condition rating guidelines. There is a grid pattern of transverse and longitudinal cracking present. There has been an increase in hairline transverse cracks since the 2018 inspection. The wearing surface skid-resistance grooves are noticeably worn along the wheel paths, especially along the eastbound lane and the westbound left turn lane (**Photo 7**). The wearing surface skid-resistance grooves are also filled with sealer. There are small spalls along the length of the expansion joints (**Photo 8**).

PHOTO 7 – TYPICAL WEAR OF SKID-RESISTANCE GROOVES IN WHEEL PATH AND TRANSVERSE CRACK

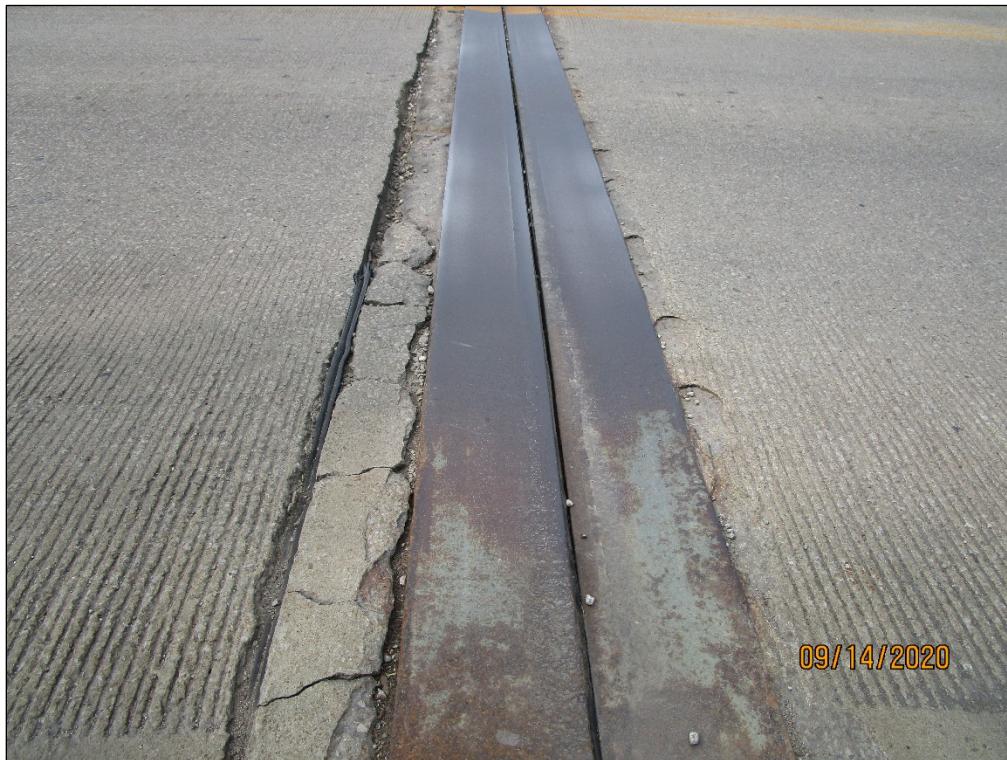
PHOTO 8 – SMALL SPALLS IN DECK ALONG EXPANSION JOINT, REAR ABUTMENT

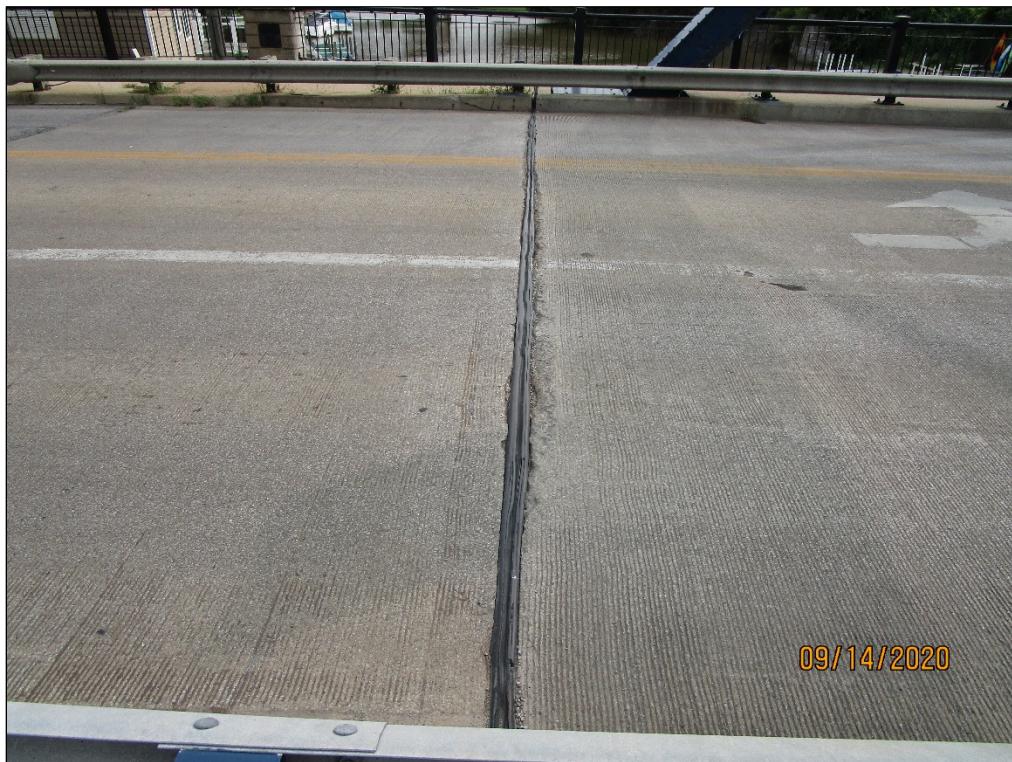
The Expansion Joints are in **POOR** condition, or a **4** on the NBIS condition rating guidelines. The expansion joint at the Rear Abutment measures $\frac{3}{8}$ " between the steel retainers, comparable to the 2016 and 2018 measurement (**Photo 8**). This joint is completely closed with no deficiencies noted in the armor. The Forward Abutment compression seal is torn for the entire length with spalls along the bridge deck side (**Photo 9**).

PHOTO 9 – TORN COMPRESSION SEAL WITH DECK SPALLS, FORWARD ABUTMENT

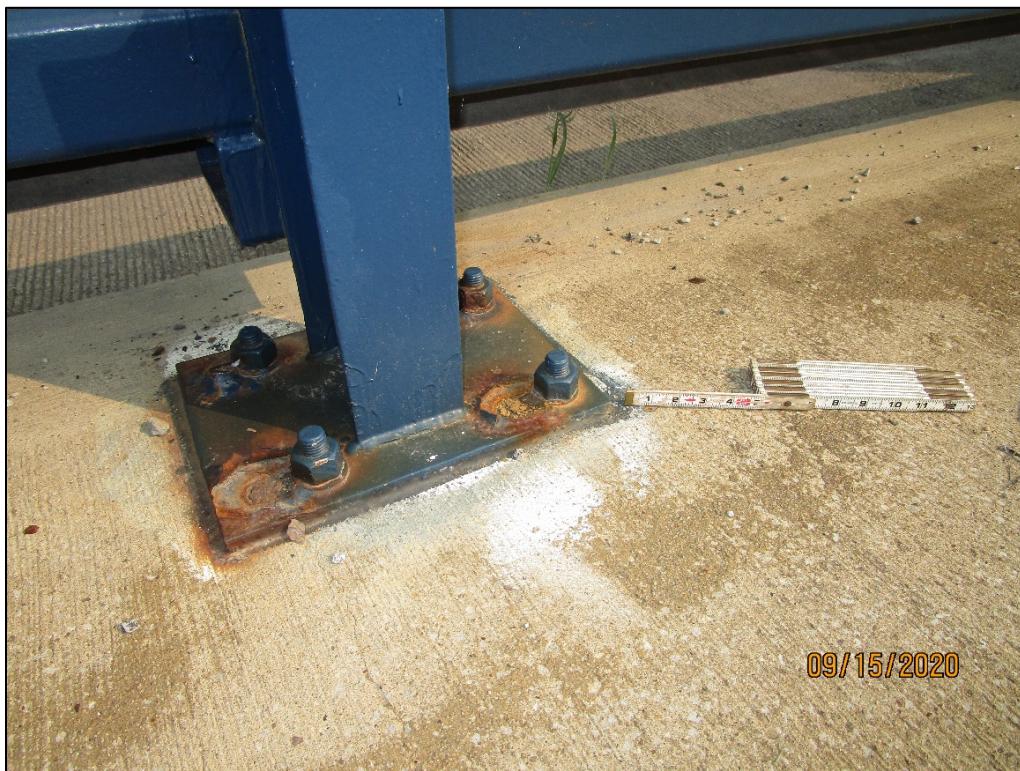
The Bridge Railing is in *GOOD* condition. The DBR railing posts have areas of light corrosion on the bases (**Photo 10**). Five of the rail mounted reflectors are broken (**Photo 11**). Section loss with a perforation was found on the backside of the tubular steel backup (**Photo 12**). There is minor impact damage to the south guardrail (**Photo 13**). The pedestrian hand railing consists of steel posts supporting panels with top and bottom railing with pickets and has scattered deficiencies throughout. Ten of the brackets that attach the railing panels to the posts are cracked. Moisture has entered the posts under the caps (tightened during in the 2012 rehabilitation project), partially filling the posts. Five approach railing posts have vertical cracks along the section seams due to the trapped water freezing inside the post (**Photo 14**). The railing post connection assemblies below the sidewalk deck have advanced section loss in areas, however these connections are believed to be redundant as the posts are structurally encased in the sidewalk deck. Painted over section loss is present on the bottom of the pickets in isolated areas. Chipped paint is also present in isolated areas with some active corrosion.

PHOTO 10 – CORROSION TO RAIL POST BASE PLATE

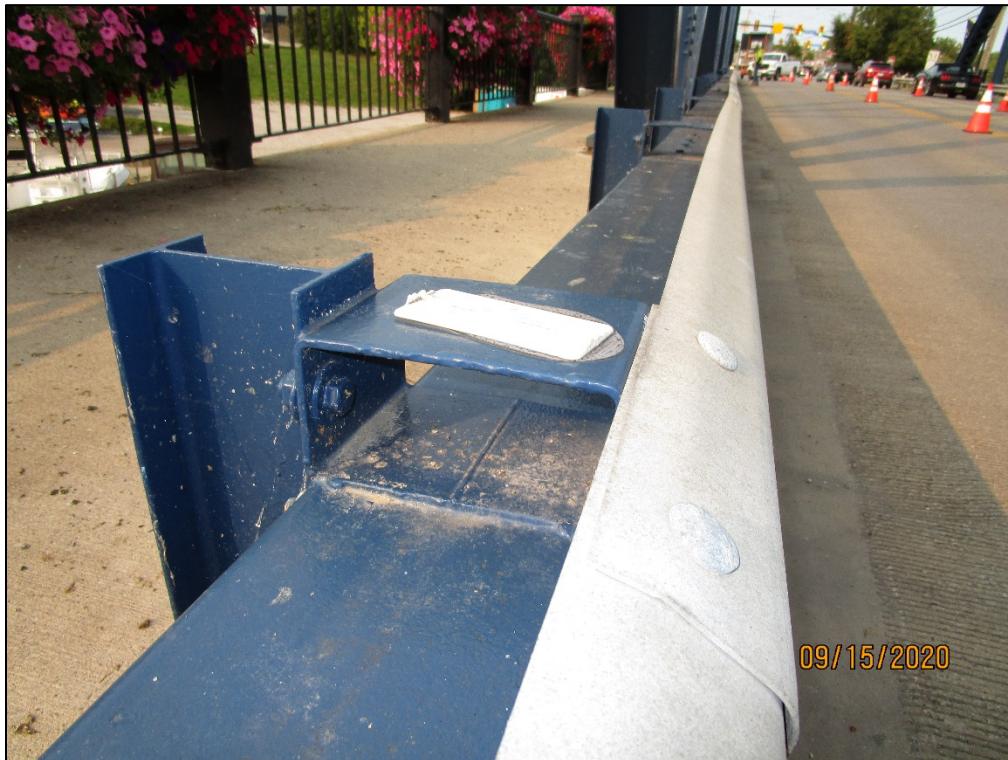
PHOTO 11 – BROKEN REFLECTOR

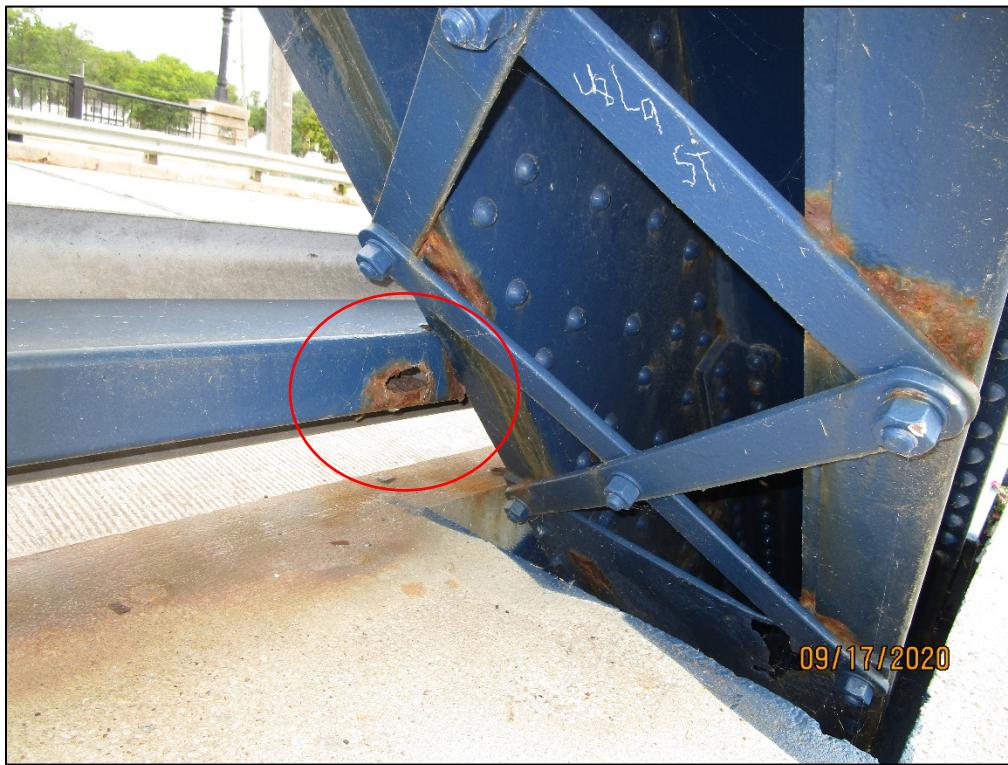
PHOTO 12 – ACTIVE CORROSION WITH PERFORATION ON BACKSIDE OF STEEL BACKUP, SOUTH TRUSS NEAR L9.

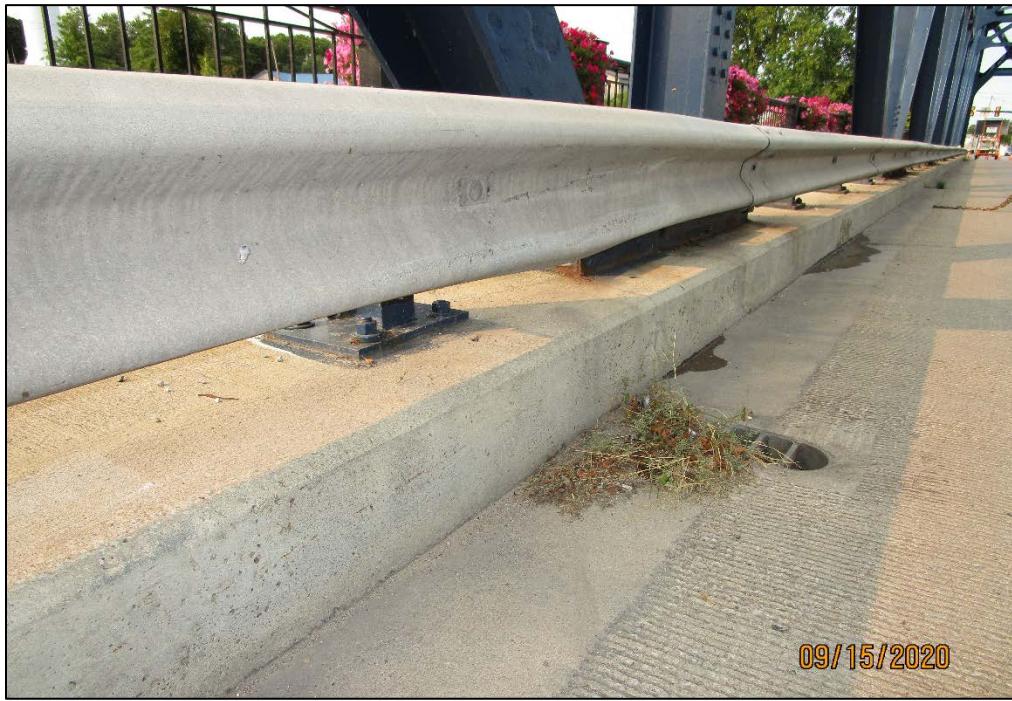
PHOTO 13 – IMPACT DAMAGE TO GUARDRAIL, SOUTH FACE

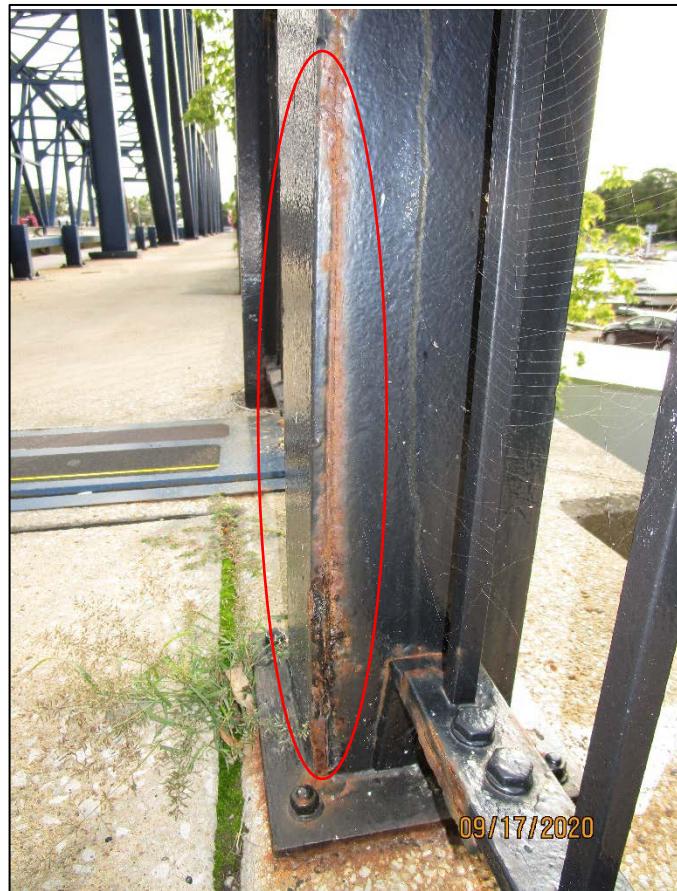
PHOTO 14 – VERTICAL CRACK IN SIDEWALK RAILING POST, SOUTHWEST APPROACH

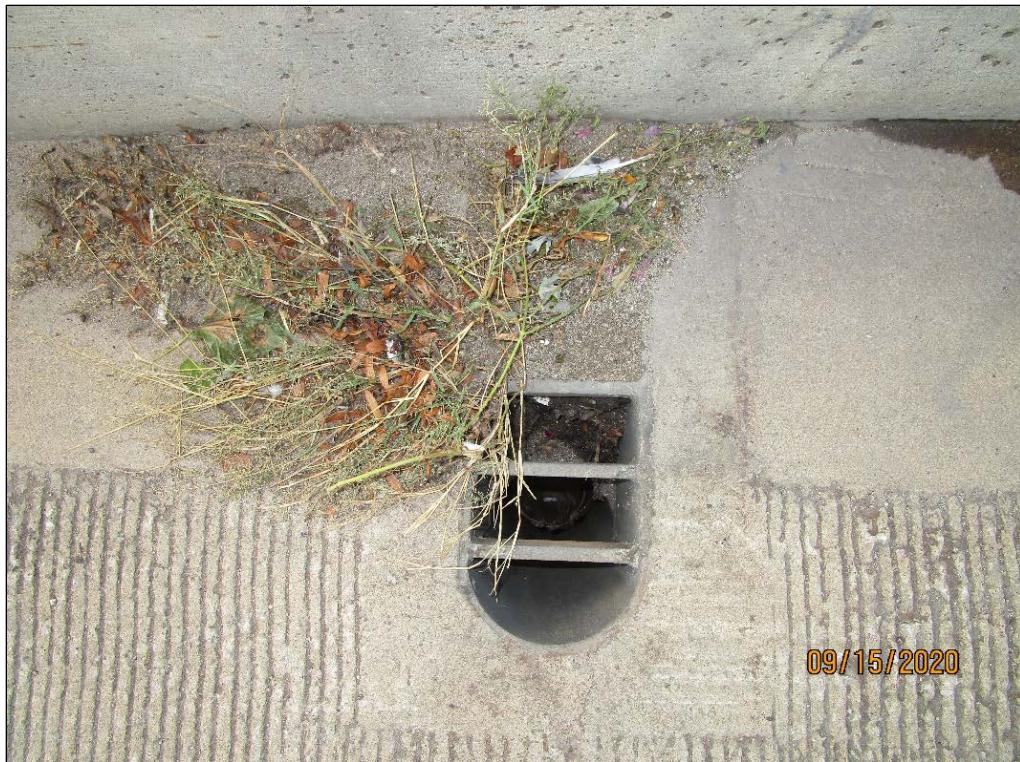
Drainage is in *GOOD* condition. Minor debris within and around the scupper was observed on the north curb (**Photo 15**). All drainpipe entrances are open and allow water to flow through. The plastic drainpipe at the northeast corner has been shortened since the 2018 inspection, it is possible that the cracked coupling broke and the pipe extension was removed since the previous inspection (**Photo 16**). Areas with minor ponding and debris are present along the south curb near the Rear Abutment (**Photos 13 & 17**).

PHOTO 15 – TYPICAL SCUPPER WITH PARTLY CLOGGED INLET AND DEBRIS

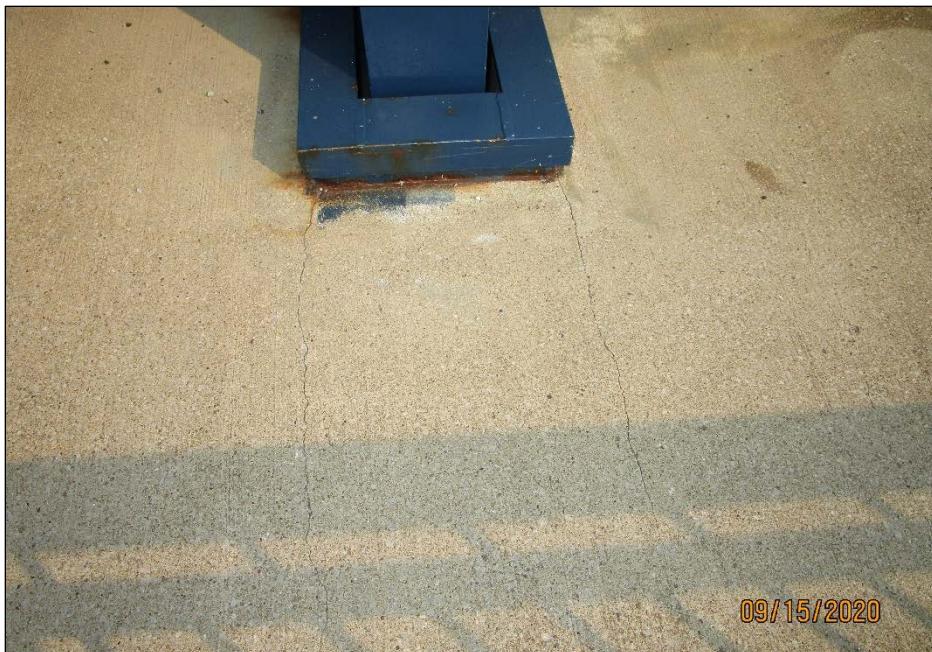
The curbs and sidewalks are in *GOOD* condition. Typical hairline transverse cracking exists on the sidewalks between the railing posts and the blockouts in the deck for the truss (**Photo 18**). Where truss members pass through the sidewalk deck, several steel covers are loose with others having isolated active corrosion. The curb on the southeast corner is spalled and delaminated near the joint seal (**Photo 19**). See the Deck Location Plan in **Appendix B** for crack locations.

PHOTO 18 – TYPICAL TRANSVERSE HAIRLINE CRACKS ON SIDEWALK NEAR TRUSS BLOCKOUT

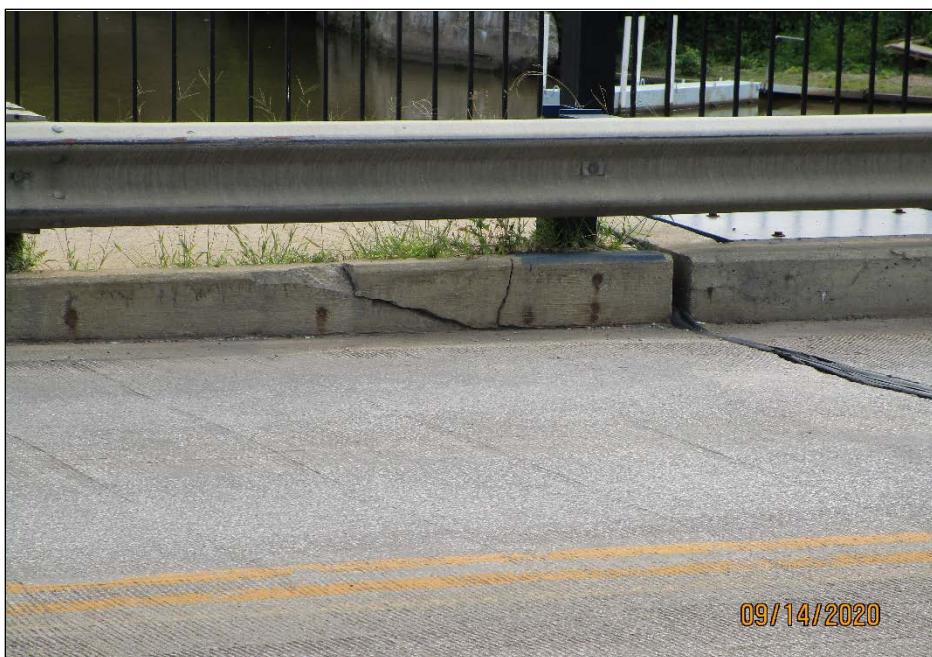
PHOTO 19 – SPALL AND DELAMINATED CURB ON SOUTHEAST CORNER

- Patch deteriorated curbs.

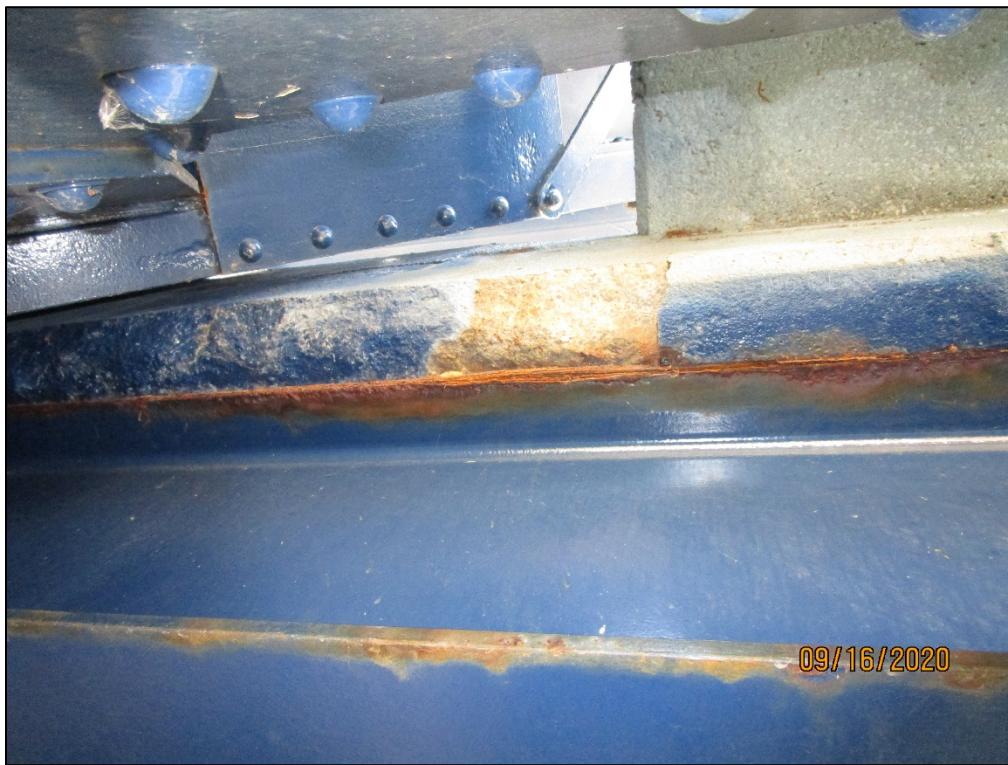
The stringers are in *GOOD* condition with no major deficiencies. The exterior stringers under the roadway deck have active corrosion on the top of the top flange at the abutments (Photo 20). Pitting up to $3/16$ " deep is present in isolated areas on the bottom flange and webs of the roadway stringers (Photos 21 & 22). A few bent bottom flanges are present at stringer to floorbeam connections (Photo 23). The stringers supporting the sidewalks have scattered pitting with some isolated perforations (Photo 24).

PHOTO 20 – ACTIVE CORROSION TO INSIDE EDGE OF EXTERIOR STRINGER TOP FLANGE, STRINGER 1, PANEL 9

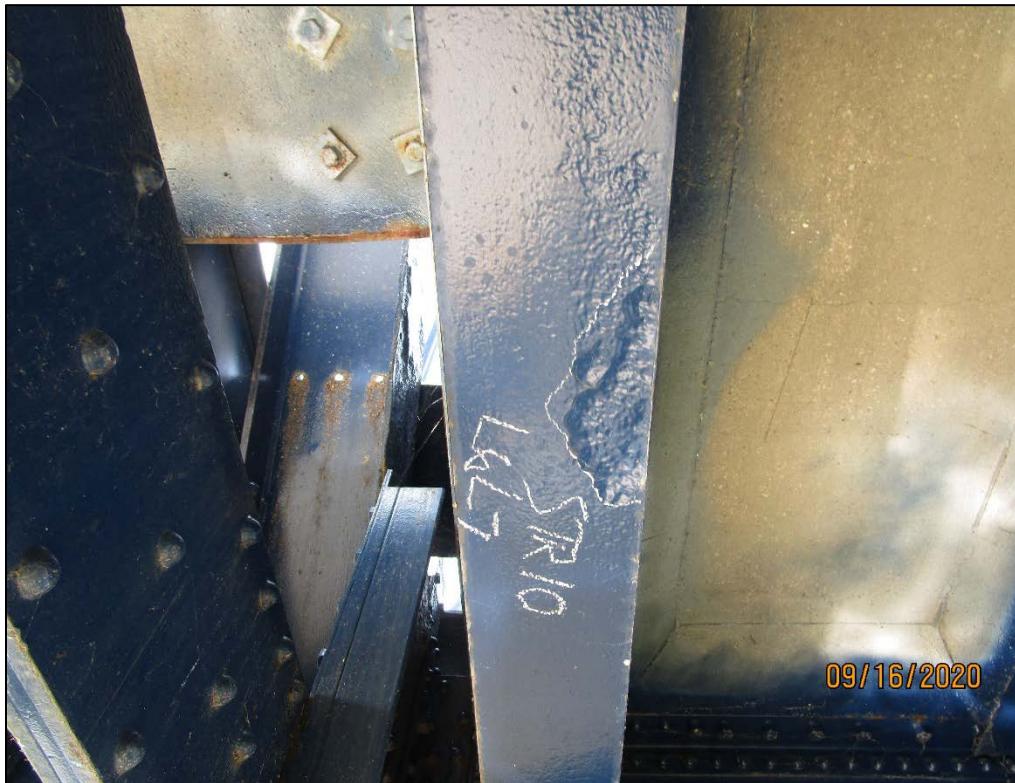
PHOTO 21 – BOTTOM FLANGE OF STRINGER WITH PITTING, STRINGER 10, PANEL 7

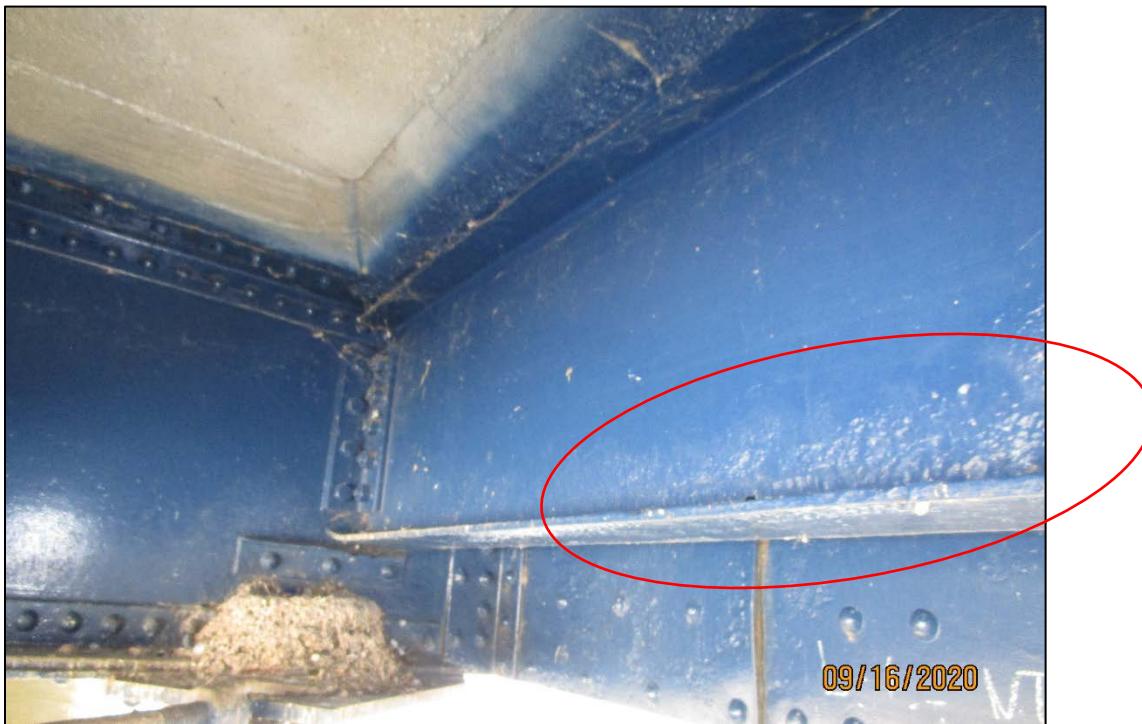
PHOTO 22 – BOTTOM FLANGE AND WEB PAINTED OVER PITTING, STRINGER 1, PANEL 7

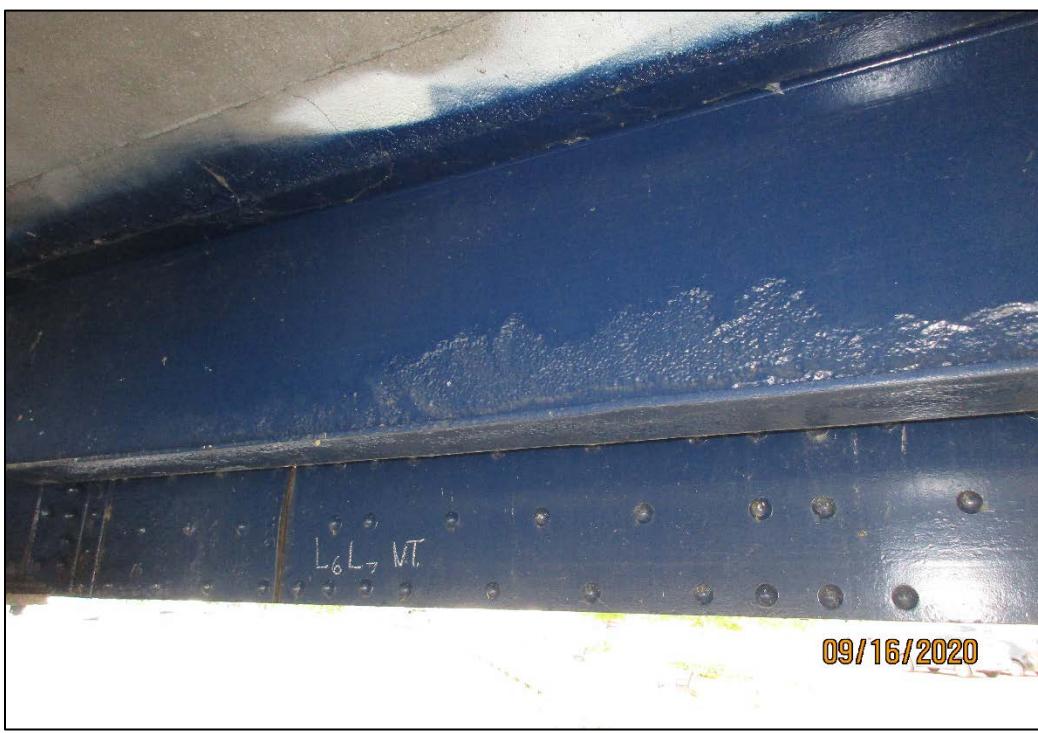
PHOTO 24 – PAINTED OVER PITTING ON SIDEWALK STRINGER, NORTH SIDE, PANEL 7

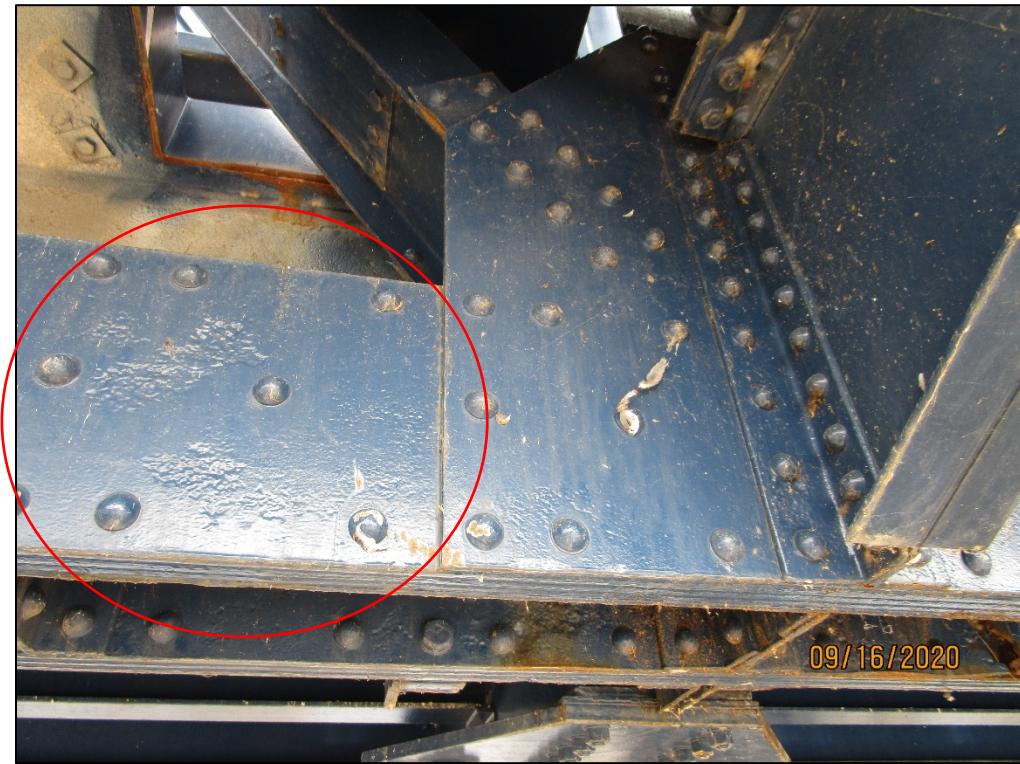
The lower chord has painted over pitting and loss of section is typical on the exposed web plates (**Photo 25**). Pack rust between the built-up plates is present from L₂ through L₇ with several locations now exhibiting active corrosion (**Photo 26**). This pack rust in the middle five panels occurs here and not at the end panels because the interior plates are $\frac{3}{8}$ -inch thick, much less than the $\frac{5}{8}$ -inch thickness threshold to prevent pack rust formation. In isolated areas the pack rust and associated section loss has become advanced and created perforations, with the estimated maximum section loss approximately 8%. (**Photo 27**).

PHOTO 25 – TYPICAL LOWER CHORD PAINTED OVER PITTING

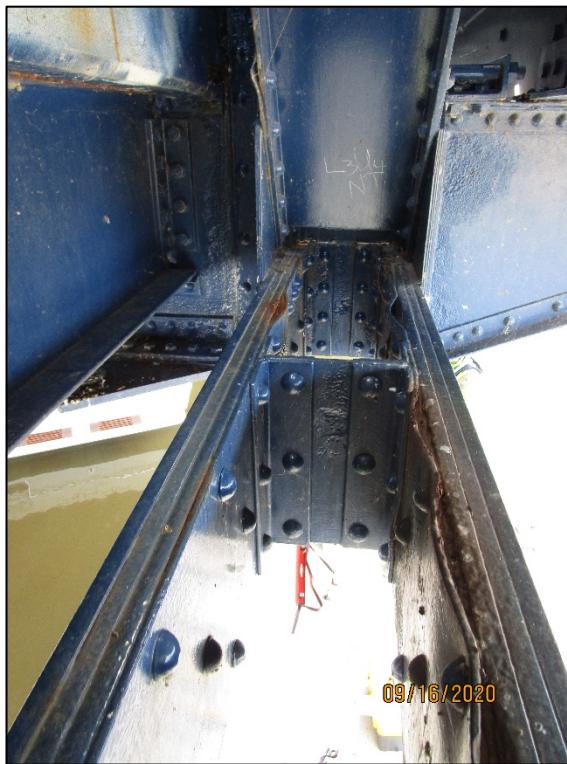
PHOTO 26 – LOWER CHORD, ACTIVE PACK RUST > $\frac{1}{2}$ ", PANEL 4, NORTH TRUSS

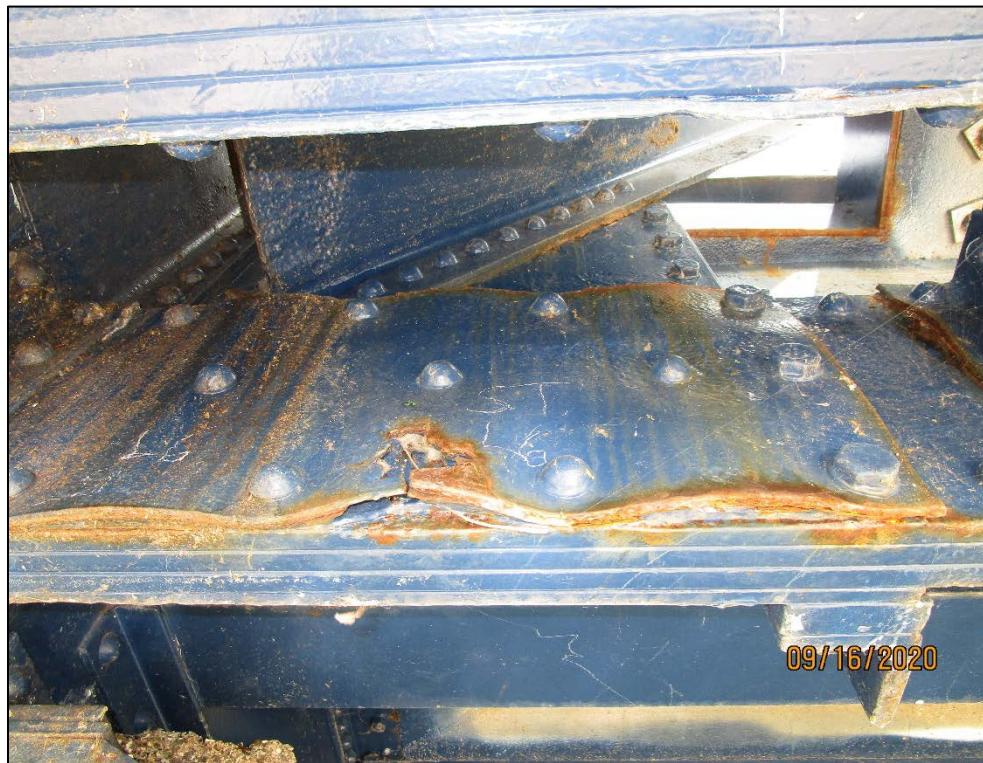
PHOTO 27 – LOWER CHORD WEB PLATE PERFORATION, L6, SOUTH TRUSS

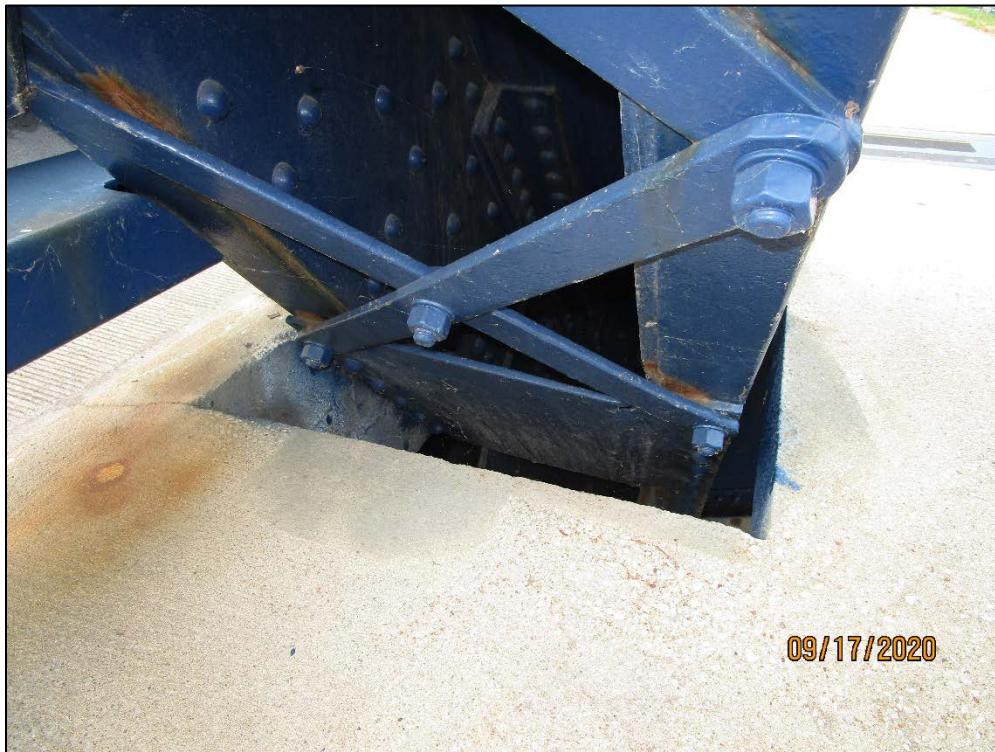
The Upper Chord exhibits typical painted over pitting on the bottom flange angles gussets (Photo 28). Minor arrested pitting is also present to the web plates in isolated areas. The top flange plate and angle are dented in isolated areas, likely due handling during transportation or erection (Photo 29). The top chord and end post diagonals have up to five pairs of bent lacing bars (Photo 30). See Table 3 for bent lacing bar summary. The end posts have minor pitting in the splash zone with some active corrosion (Photo 31).

PHOTO 31 – TYPICAL ACTIVE CORROSION TO END POST IN SPLASH ZONE, SOUTH TRUSS

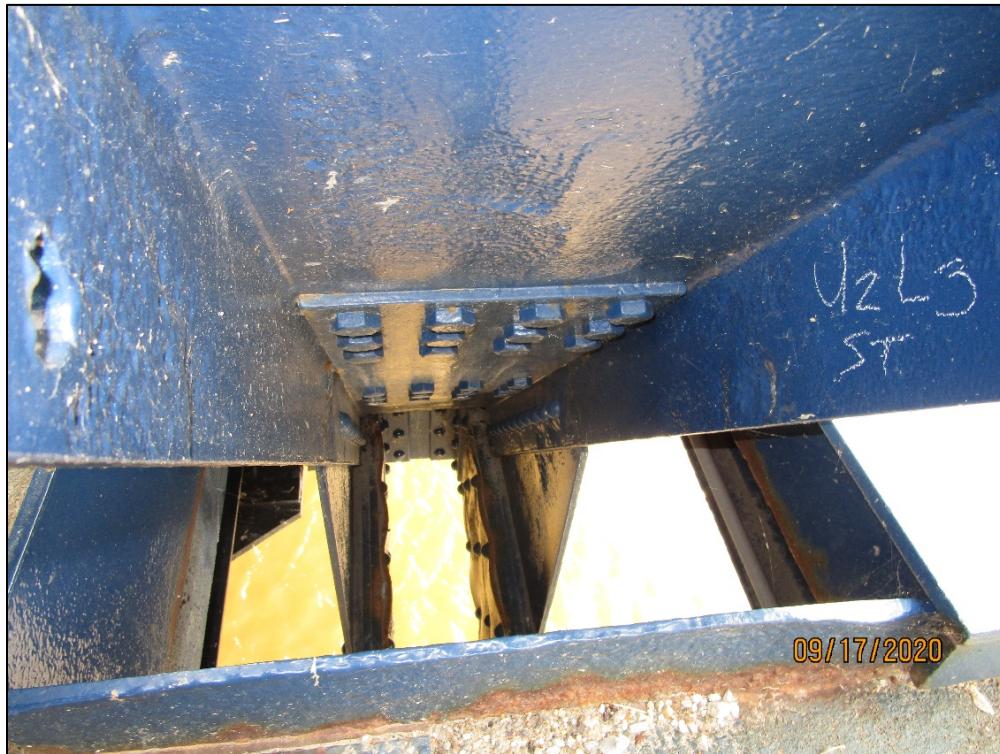
The diagonals exhibit typical painted over pitting and section loss, advanced in areas. This is most common at the web and flanges in the splash zone (Photos 32 & 33). Fill plates have section loss, up to 100% in areas, and pack rust between the flanges and the lower gussets. Some pack rust is reactivating. Various flanges are wavy for up to 12" (Photo 34). There is bird droppings and nest debris on various diagonals (Photo 35).

PHOTO 32 – PAINTED OVER PITTING WITH PERFORATION, U2L3, SOUTH TRUSS

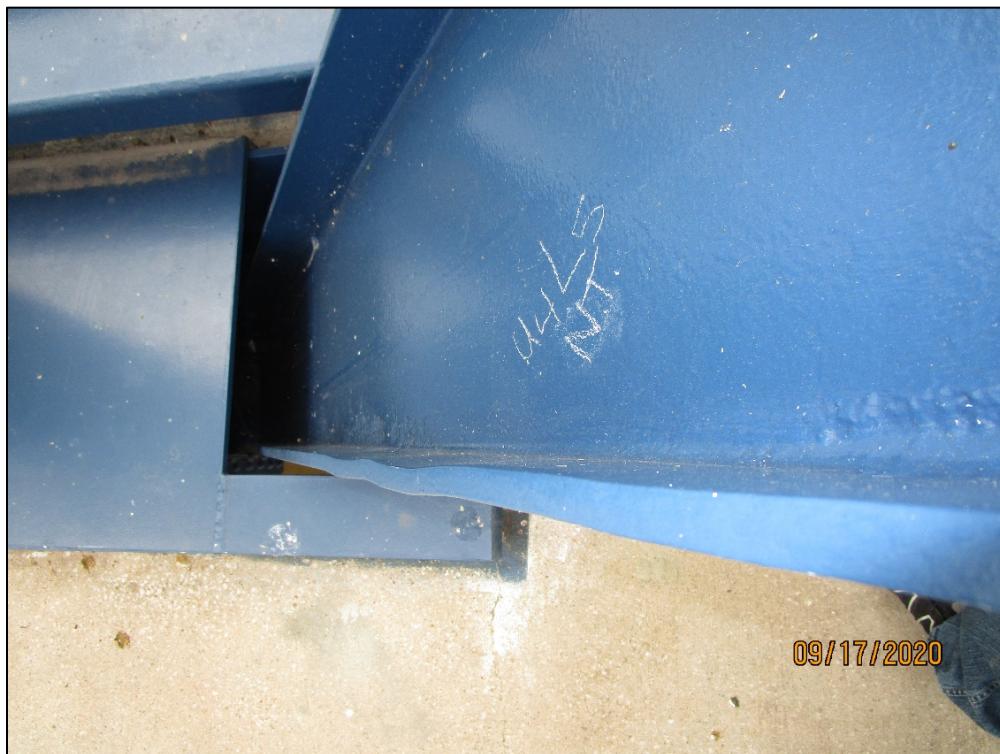
PHOTO 34 – WAVY DIAGONAL FLANGE, U4L5, NORTH TRUSS

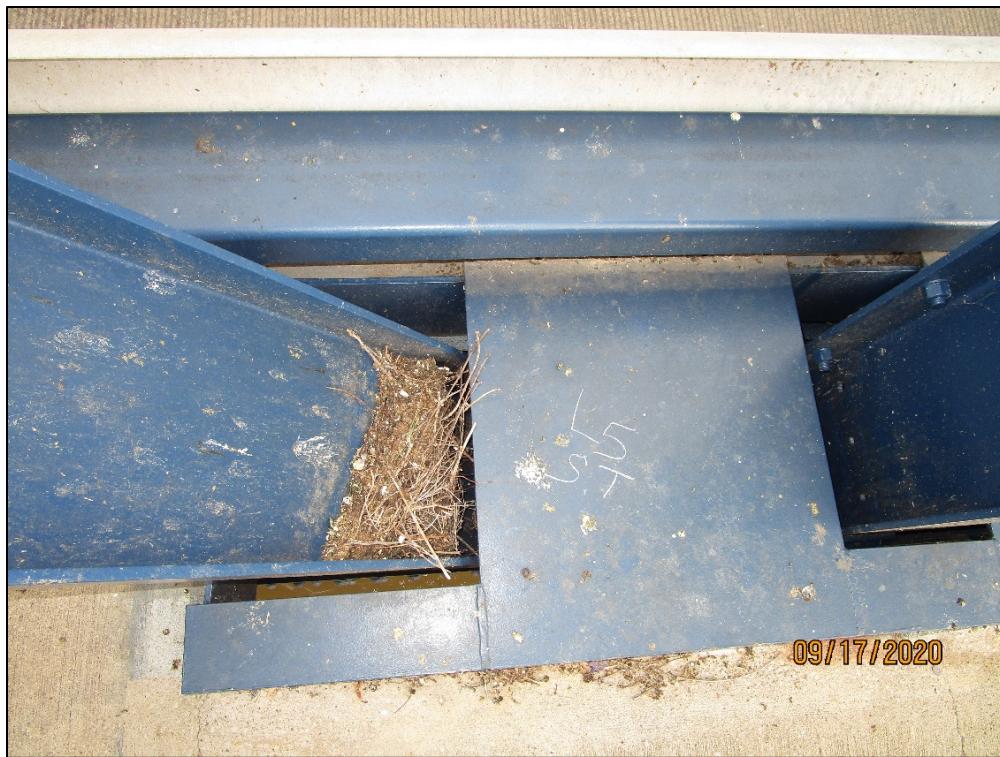
PHOTO 35 – TYPICAL BIRD DROPPINGS AND DEBRIS, L5, SOUTH TRUSS

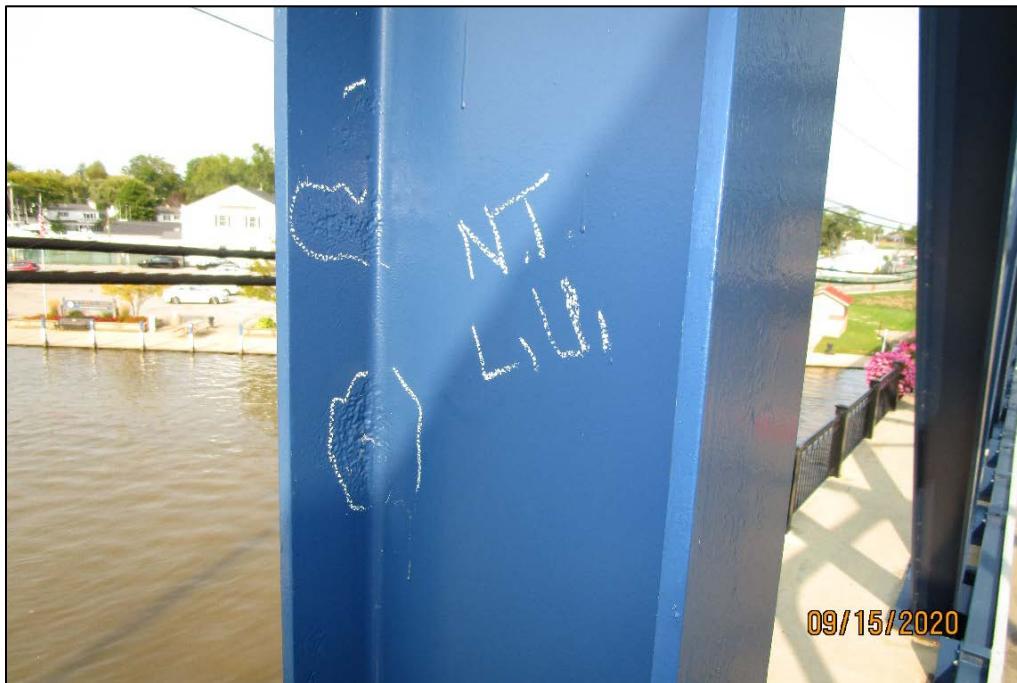
Verticals exhibit typical painted over pitting at the lower vertical ends in the splash zone (Photo 36 & 37). Perforations were found in the web of L₆U₆ North. These were in similar condition to the 2018 inspection. Repairs were made to several verticals with advanced section loss.

PHOTO 36 – PAINTED OVER PITTING, L1U1, NORTH TRUSS
