2020 IN-DEPTH & FRACTURE CRITICAL BRIDGE INSPECTION REPORT

ERI-6-2884

SFN: 2202344

Vermilion, Ohio

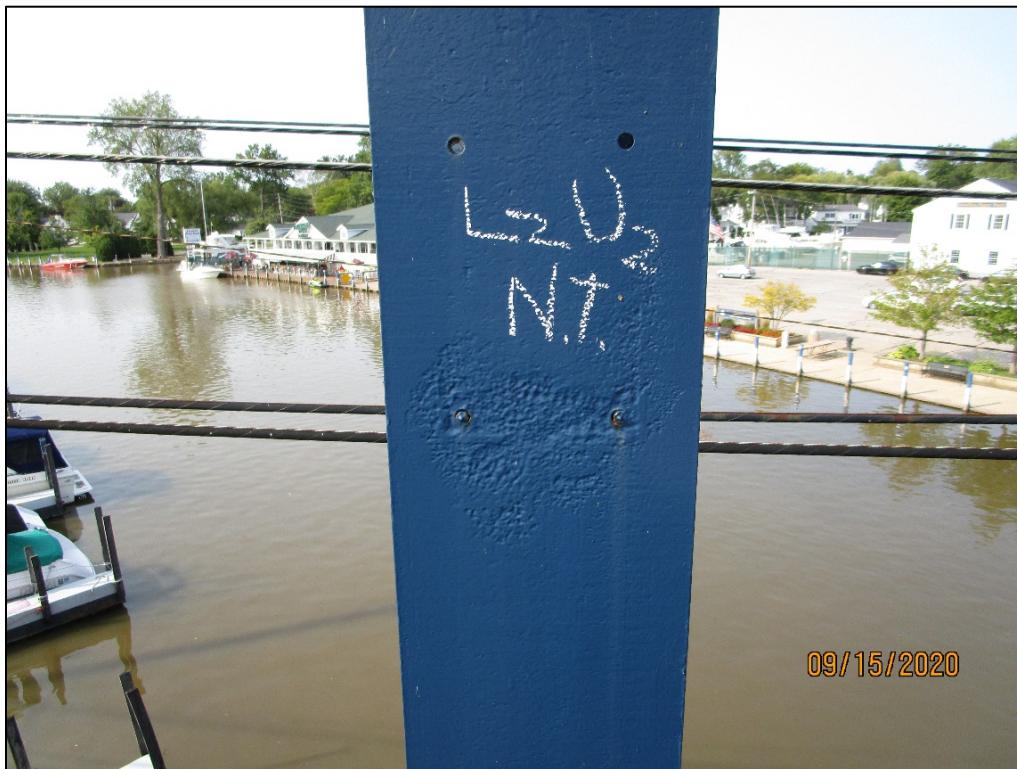
Verticals exhibit typical painted over pitting at the lower vertical ends in the splash zone (Photo 36 & 37). Perforations were found in the web of L₆U₆ North. These were in similar condition to the 2018 inspection. Repairs were made to several verticals with advanced section loss.

PHOTO 37 – HOLES AND PAINTED OVER PITTING, L2U2, NORTH TRUSS

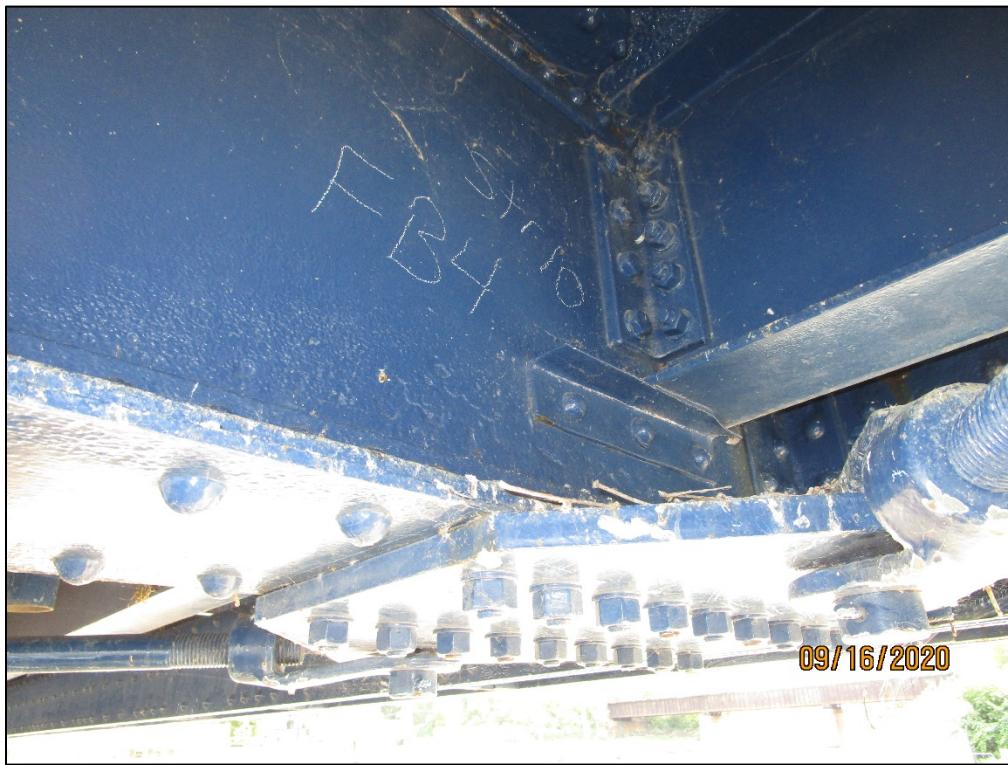
The floorbeams are in *GOOD* condition. Painted over pitting on the web and top and bottom flanges is typical at the floorbeam ends adjacent to the lower gusset plate connections (**Photos 38, 39, & 40**). Pack rust behind floorbeam connection angles is also reactivating. Pinhole perforations are present in the bottom flanges of Floorbeams 2 and 5, both adjacent to the north lower lateral gusset plates. The cantilever floorbeam extensions supporting the sidewalks also have painted over pitting with isolated perforations (**Photos 41 & 42**). Floorbeam 0 at the rear abutment has active corrosion along the top flange where the deck is spalled (**Photo 6**).

PHOTO 38 – TYPICAL PAINTED OVER PITTING, FLOORBEAM 4, SOUTH END

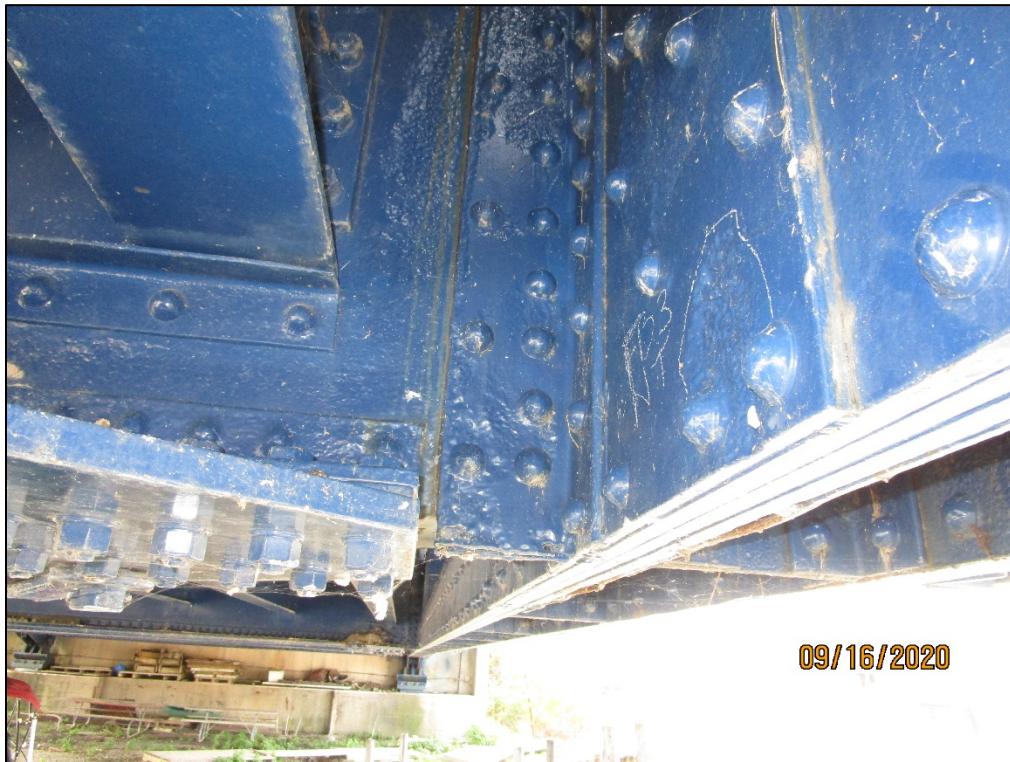
PHOTO 39 – ACTIVE CORROSION AT FLOORBEAM END & GUSSET, FLOORBEAM 3, NORTH END

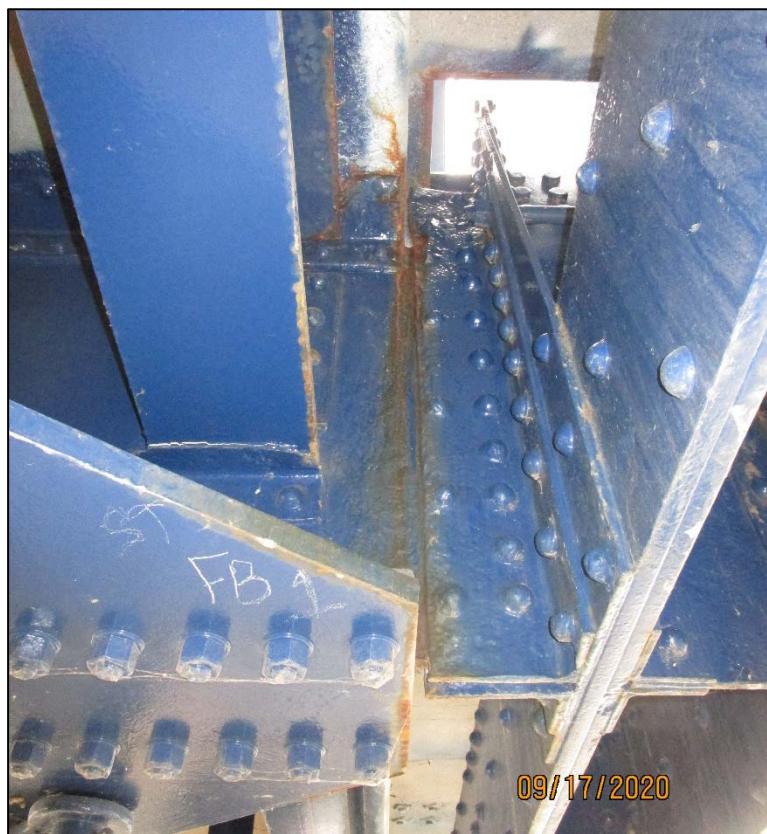
PHOTO 40 – ACTIVE CORROSION AT FLOORBEAM END, FLOORBEAM 1, SOUTH TRUSS

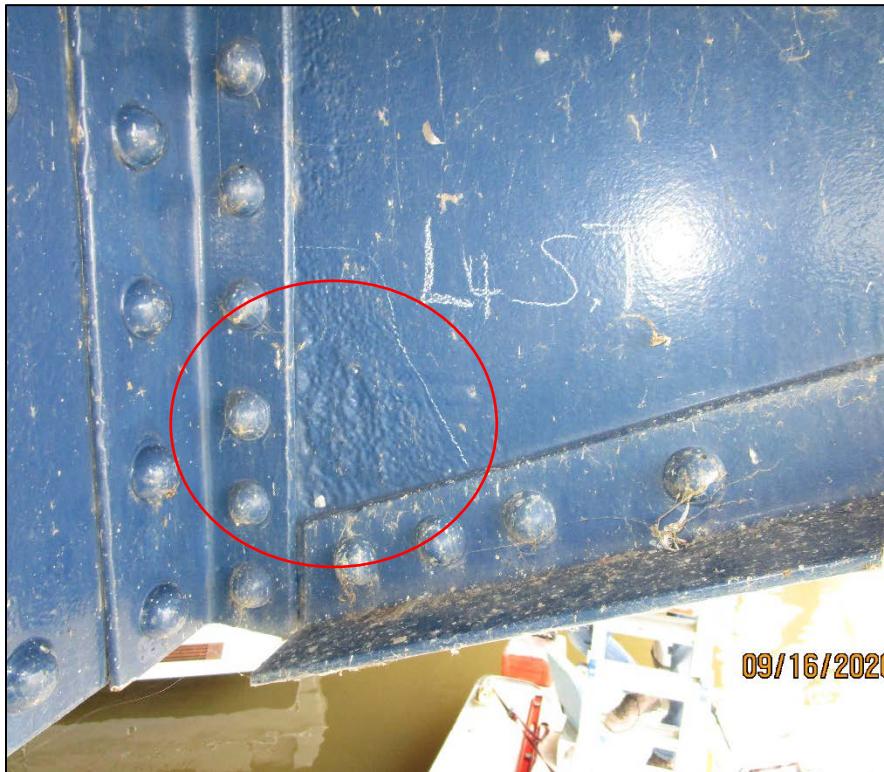
PHOTO 41 – PAINTED OVER PITTING WITH PINHOLE, FLOORBEAM 4 SIDEWALK CANTILEVER, SOUTH TRUSS

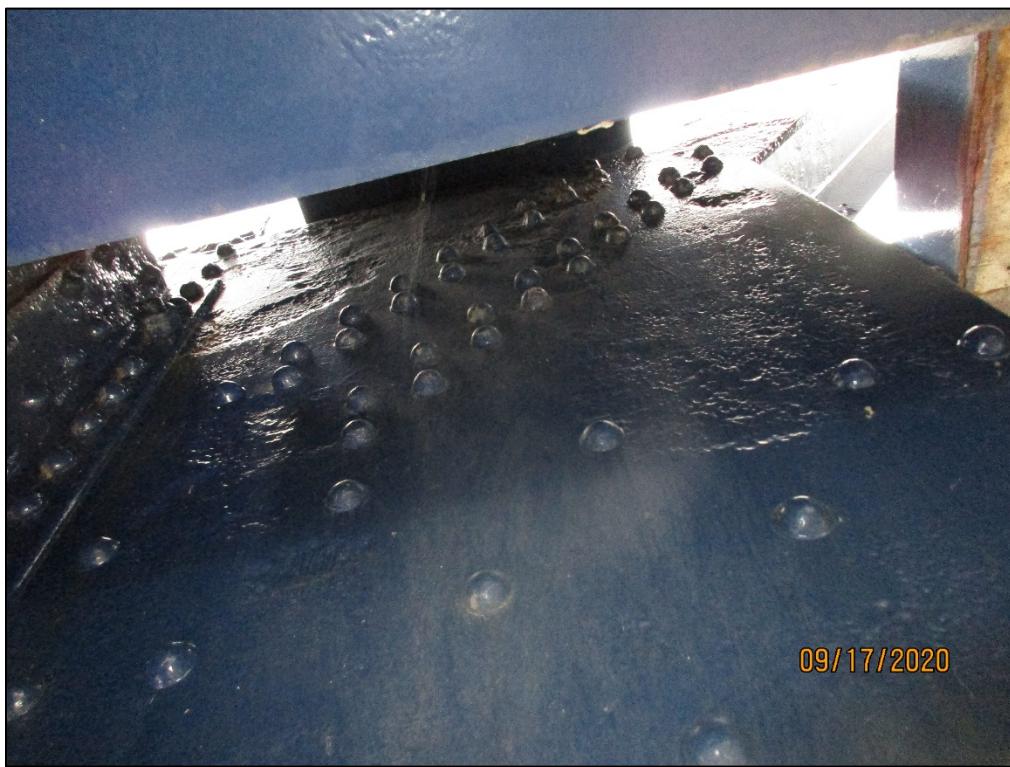
PHOTO 43 – TYPICAL PAINTED OVER PITTING

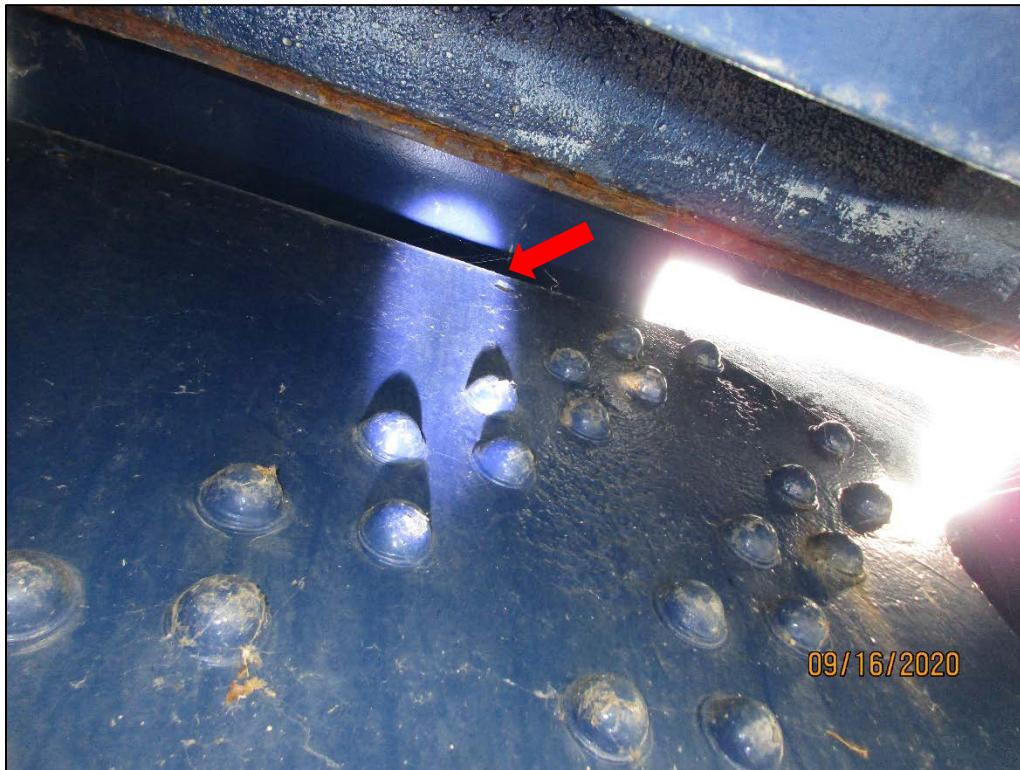
PHOTO 44 – PAINTED OVER PITTING AND PERFORATION, L2, INSIDE GUSSET, NORTH TRUSS

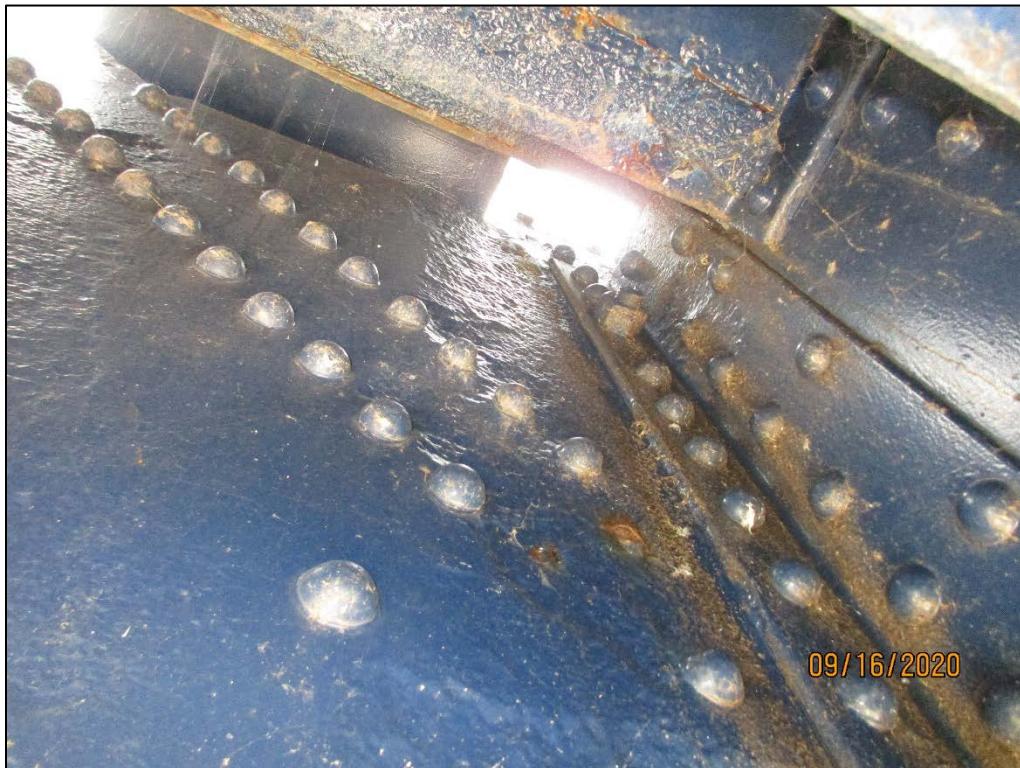
PHOTO 45 – PAINTED OVER PITTING, L6, INSIDE GUSSET, SOUTH TRUSS

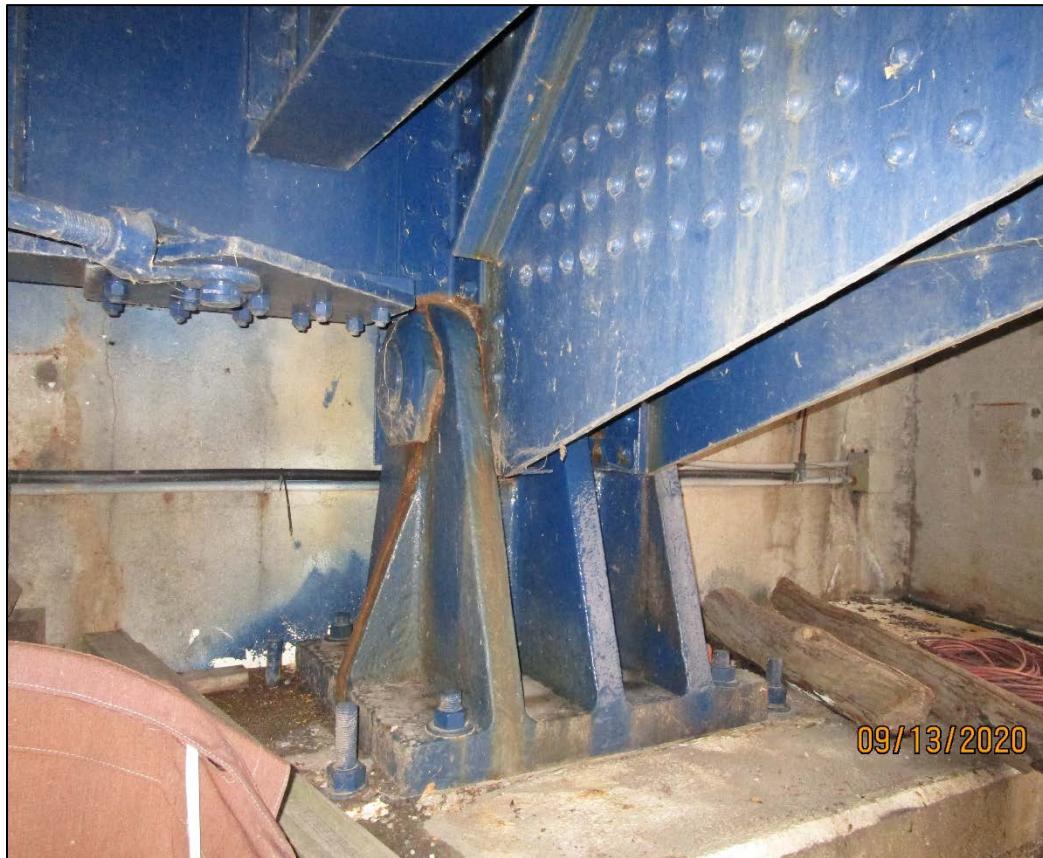
Bearings are in FAIR condition. Minor pitting is typical on the bearings. The fixed bearings at the forward abutment have active corrosion around the pins and pin nuts (Photo 46). Several anchor bolt nuts are not seated. (Note: This is not considered to be a problem.) At the rear abutment, the north rocker is tilted toward the backwall 16° degrees and the south rocker is tilted toward the backwall 13° degrees (Photo 47). Also, the north and south elastomeric bearing pads are deformed $1\frac{3}{16}$ " and $1\frac{5}{16}$ " respectively toward the backwall (Photo 48). There is a $2\frac{3}{8}$ " gap between the rear abutment backwall and truss at the north bearing (Photo 49) and a $2\frac{3}{4}$ " gap at the south bearing. It was 65 degrees during the measurements.

PHOTO 46 – FIXED BEARING AT FORWARD ABUTMENT, SOUTH TRUSS

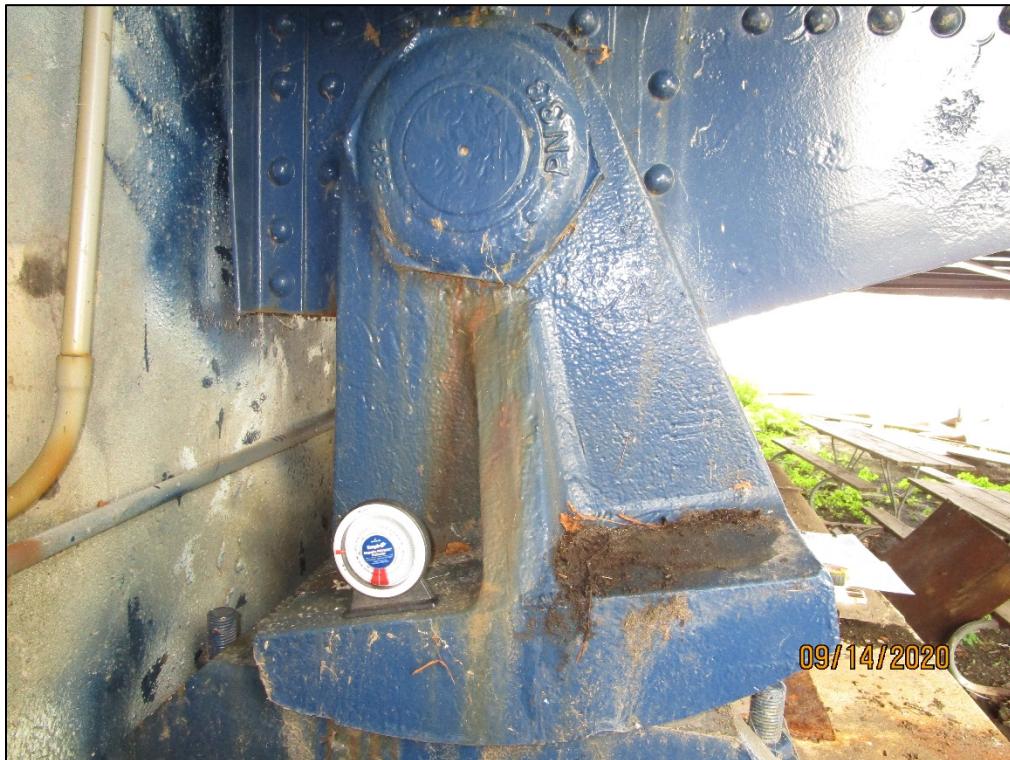
PHOTO 47 – ROCKER BEARING WITH ACTIVE CORROSION, REAR ABUTMENT, SOUTH TRUSS

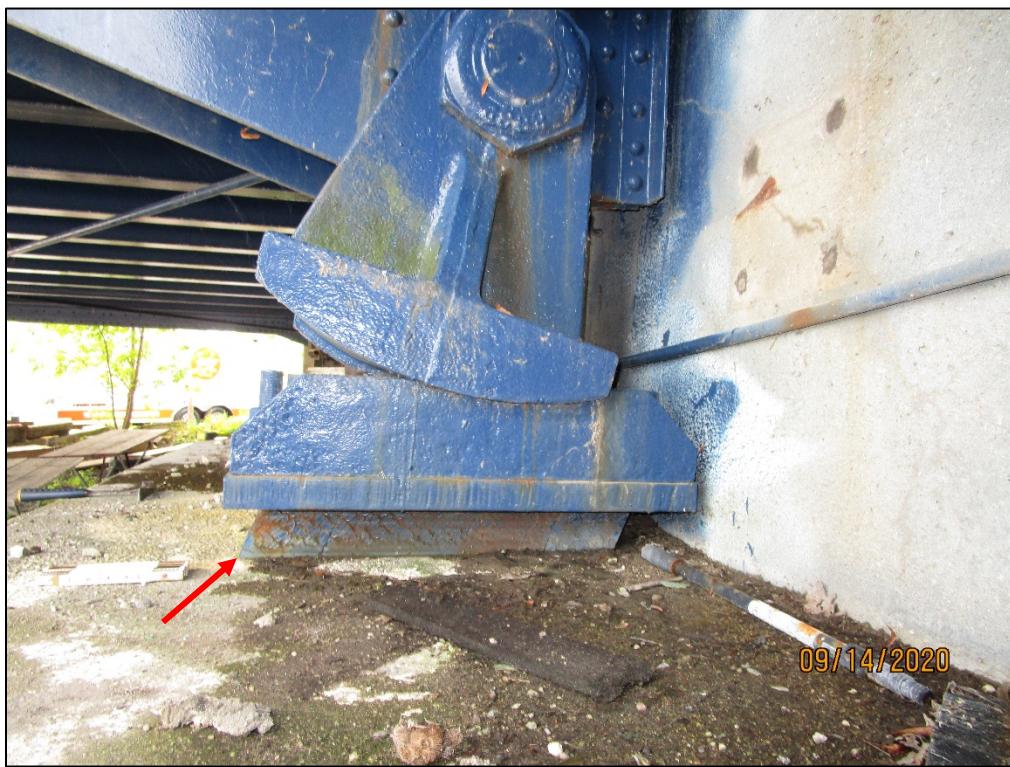
PHOTO 48 – DEFORMED ELASTOMERIC BEARING, REAR ABUTMENT, NORTH TRUSS

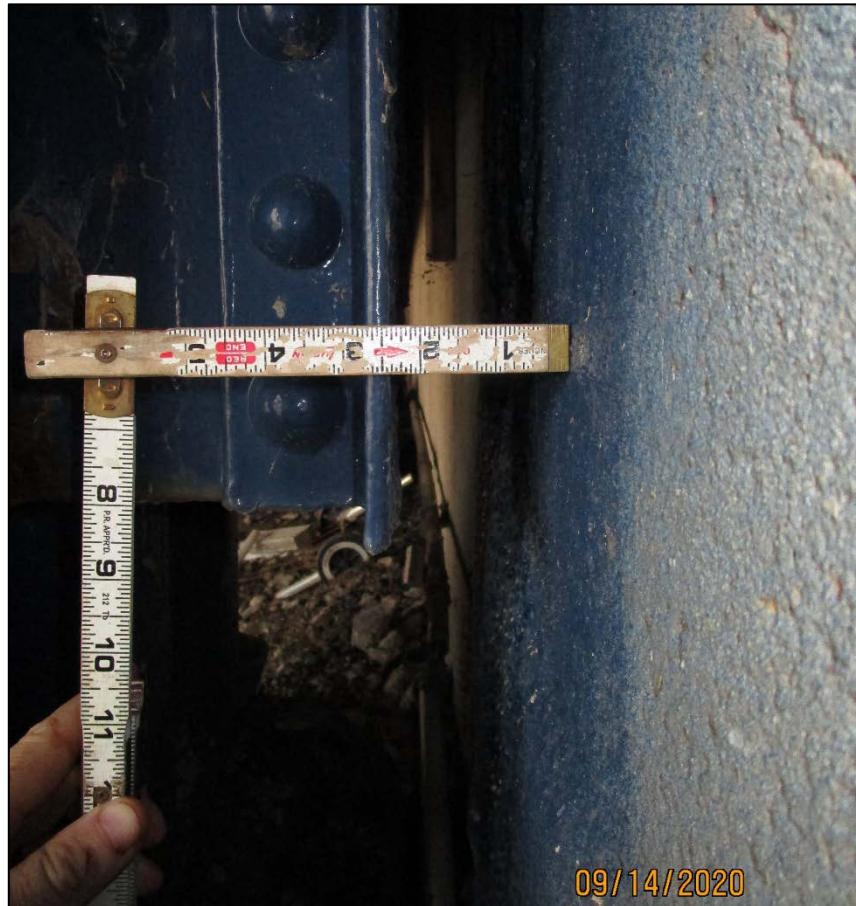
PHOTO 49 – 2 3/8" GAP FROM REAR ABUTMENT BACKWALL AND TRUSS

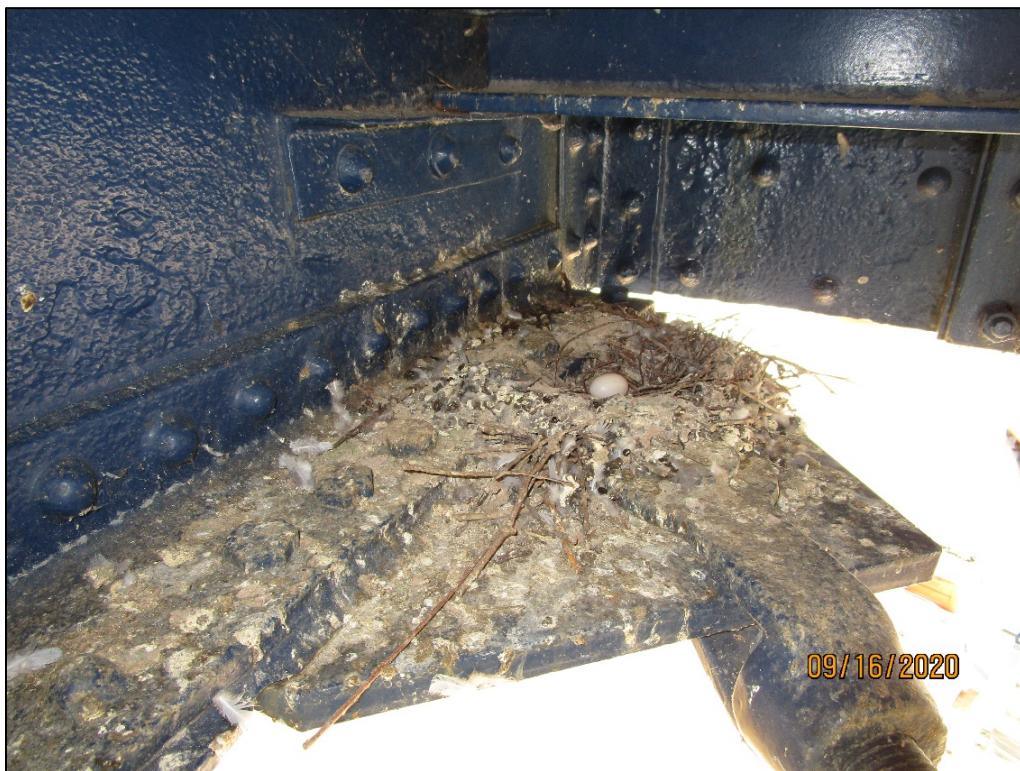
The paint system is in **Good** condition and is rated as a **7** on the modified protective coating rating system. Scattered areas of active corrosion exist throughout with isolated locations of re-activating pack rust, especially at the bearing gussets. Local protective coating failure is also present on the unpainted exterior deck stringer tops adjacent to edge spalls. Chipped paint is present on the truss end posts. Excessive pigeon droppings are present inside the upper chord, diagonals, and on the lower lateral bracing gussets (**Photos 50 & 51**).

PHOTO 50 – TYPICAL PIGEON DROPPINGS ON LOWER LATERAL BRACING

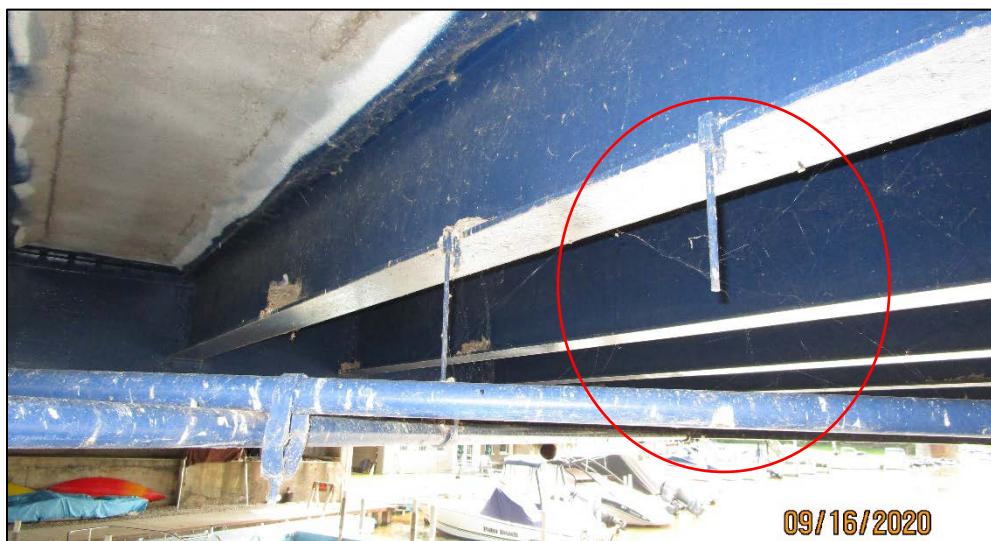
The lateral bracing is in *GOOD* condition. The lower lateral bracing ties and gusset plates have been replaced and are in good condition. Minor deficiencies to the lower lateral bracing members are a slightly bent rod in Panel 7 and a broken hanger in Panel 9 (**Photo 52**).

PHOTO 52 – BROKEN HANGER, PANEL 9

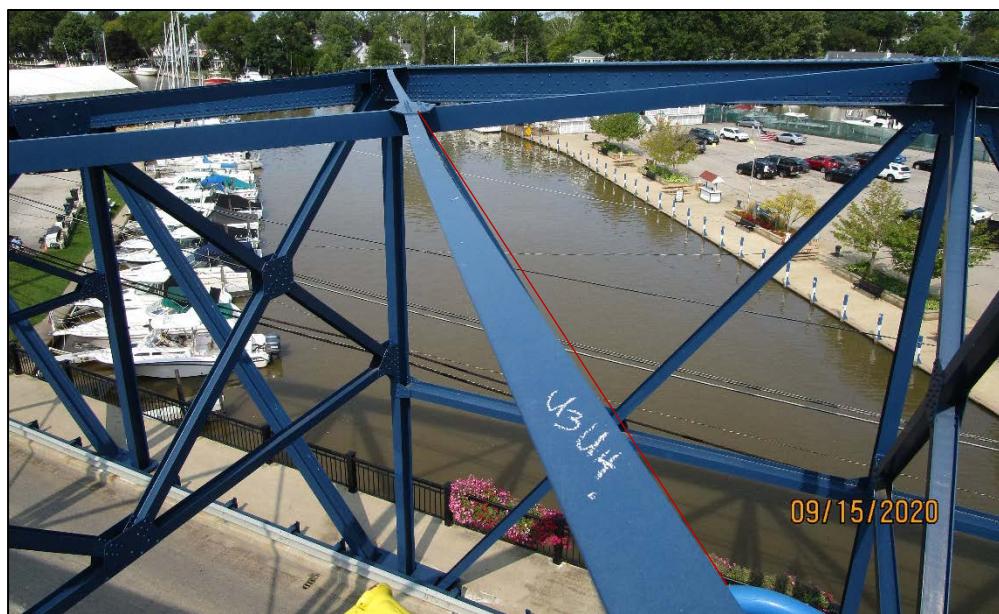
The upper later bracing also is in *GOOD* condition. The angles that form upper lateral bracing members are sagging due to self-weight but appear to be functioning as designed (**Photo 53**).

PHOTO 53 – TYPICAL UPPER LATERAL BRACING SAG

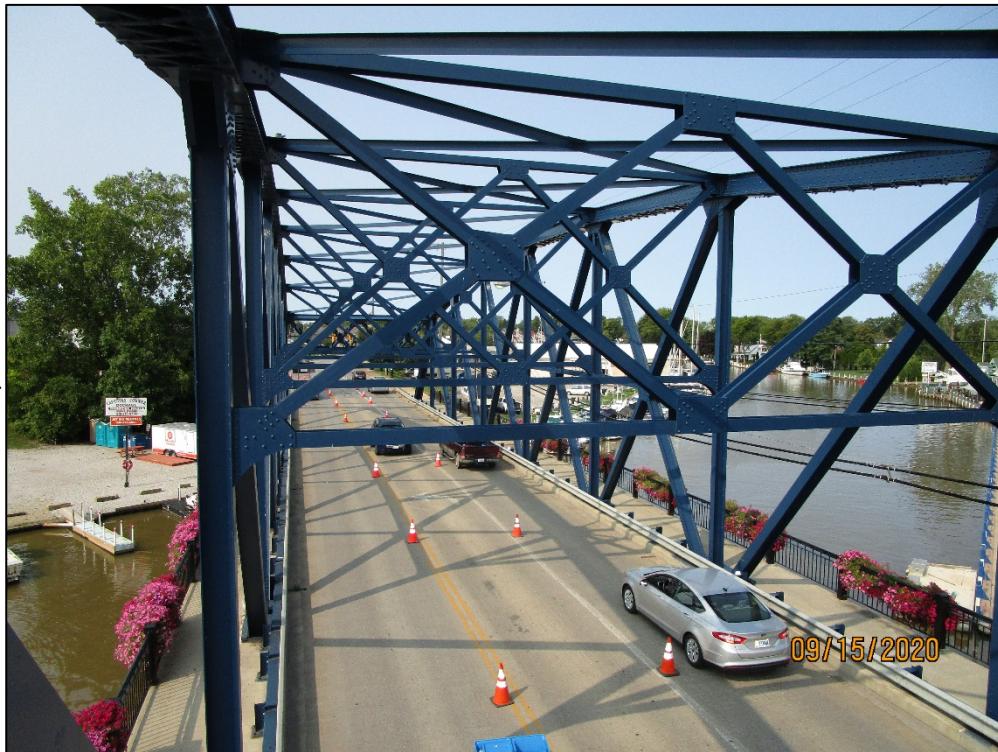
The sway bracing is in *SATISFACTORY* condition (**Photo 54**). Typical deficiencies throughout the sway bracing includes arrested pitting of the connection angles connecting to the gussets with isolated perforations. There is impact damage to the sway bracing at panel point 2 (**Photo 55**). Minor deficiencies to the sway bracing include scattered pitting and dented flanges of the struts and diagonals as well as pack rust at the top and bottom connection plates in the portals.

PHOTO 54 – SWAY BRACING, LOOKING WEST

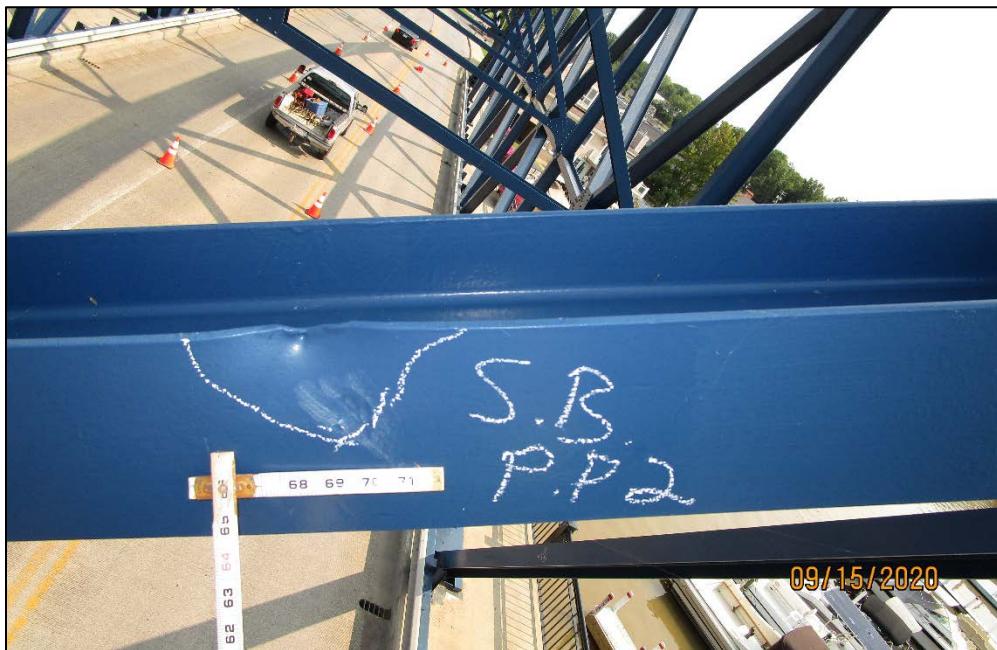
PHOTO 55 – IMPACT DAMAGE TO FLANGE, PANEL POINT 2

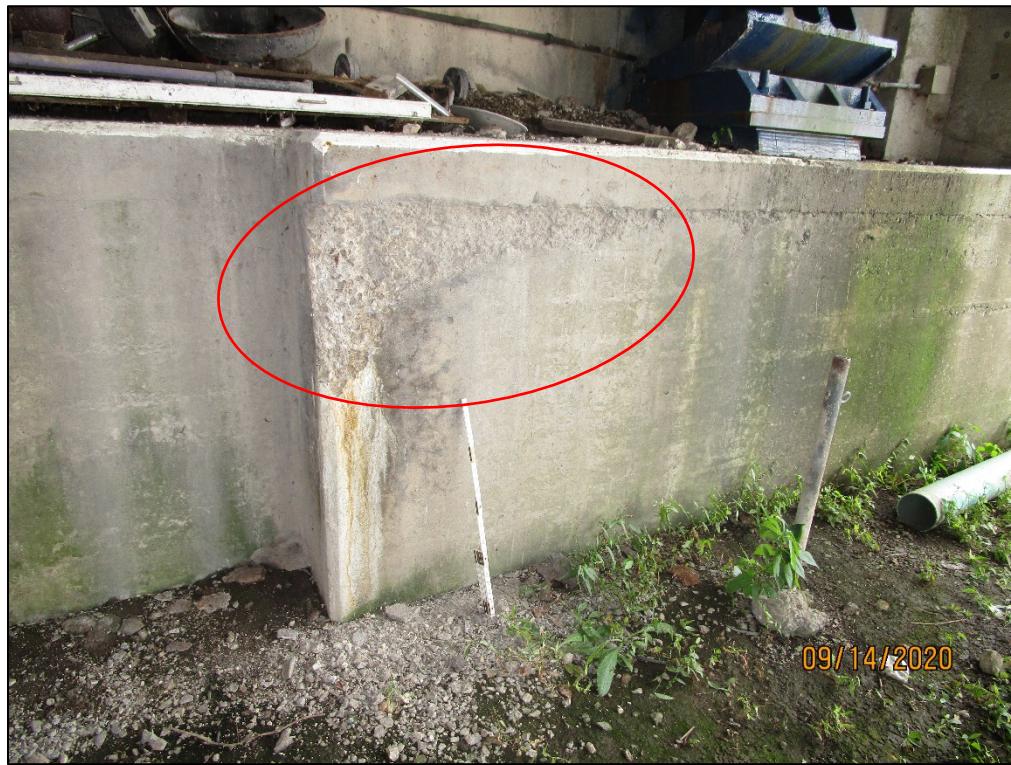
The Abutments are in *FAIR* condition. The Rear Abutment has isolated areas of minor spalling with a single reinforcing bar exposed and delaminations (Photo 56). The Forward Abutment also has several areas of delaminations and spalls and cracks with efflorescence (Photos 57 & 58). The 2016 In-Depth inspection documented that the Rear Abutment was leaning $\frac{3}{4}$ " over 4 feet to the north and leaning away from the river $\frac{3}{8}$ " horizontally per four feet vertically. It has been noted on previous inspection reports that these observations likely are attributed to formwork and finishing variations, however continued observation during future inspections is warranted.

PHOTO 56 – SPALL WITH EFFLORESCENCE, REAR ABUTMENT

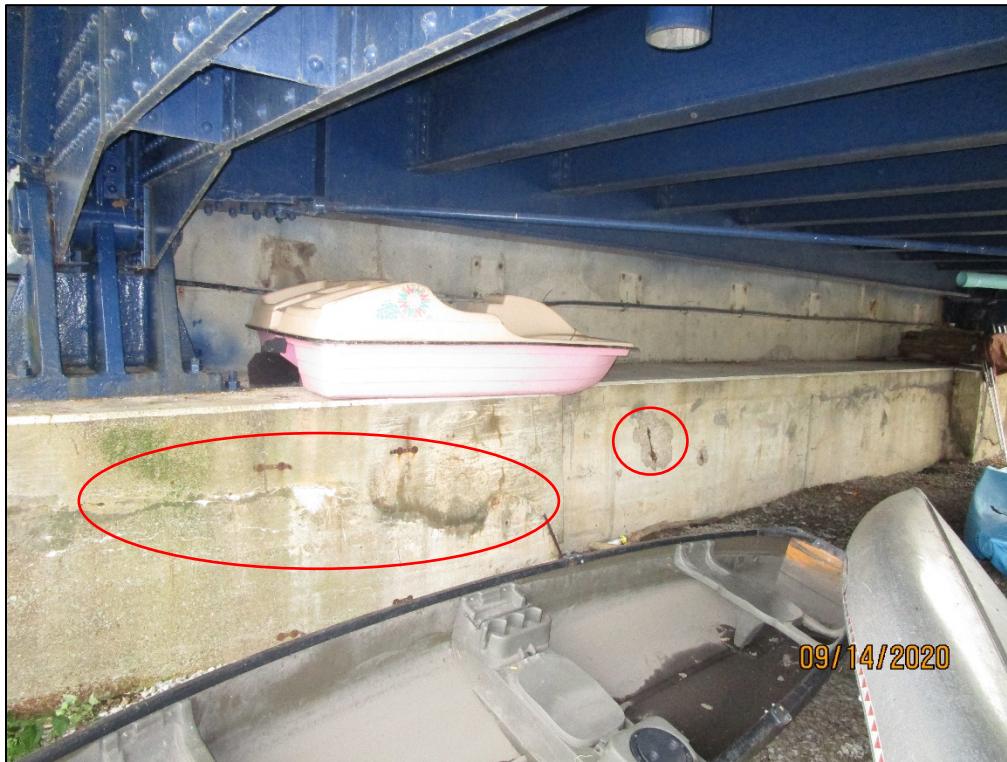
PHOTO 56 – PATCHED JOINT WITH EFFLORESCENCE AND SPALL WITH EXPOSED REINFORCING, FORWARD ABUTMENT

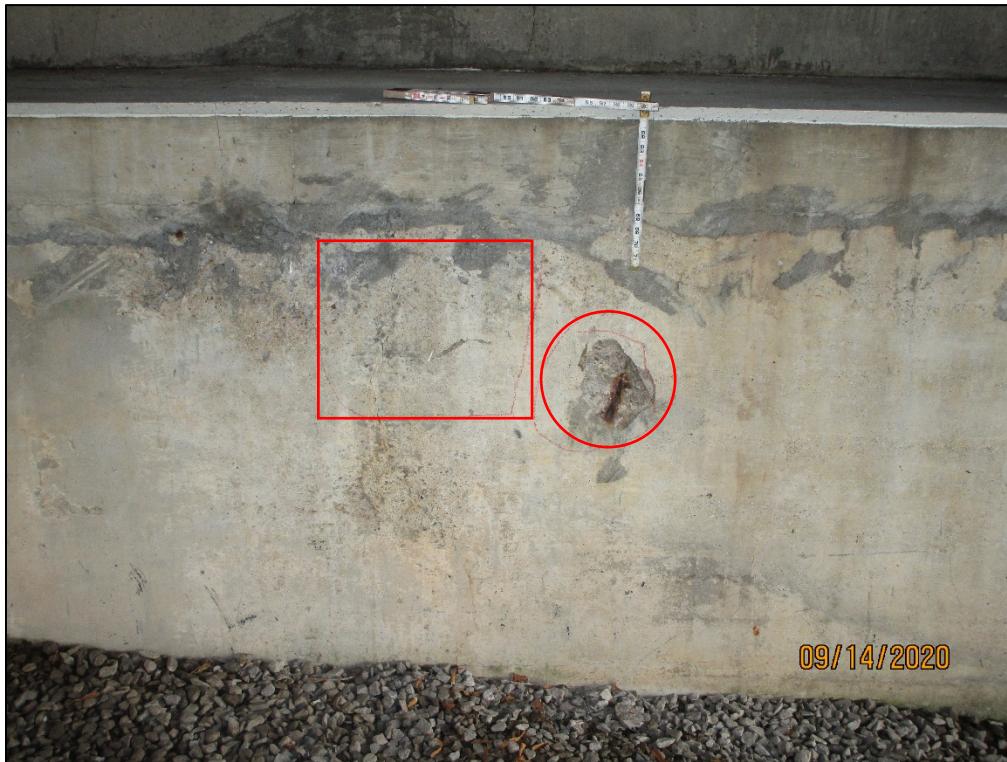
PHOTO 58 – DELAMINATION AND SPALL WITH EXPOSED REINFORCING, FORWARD ABUTMENT

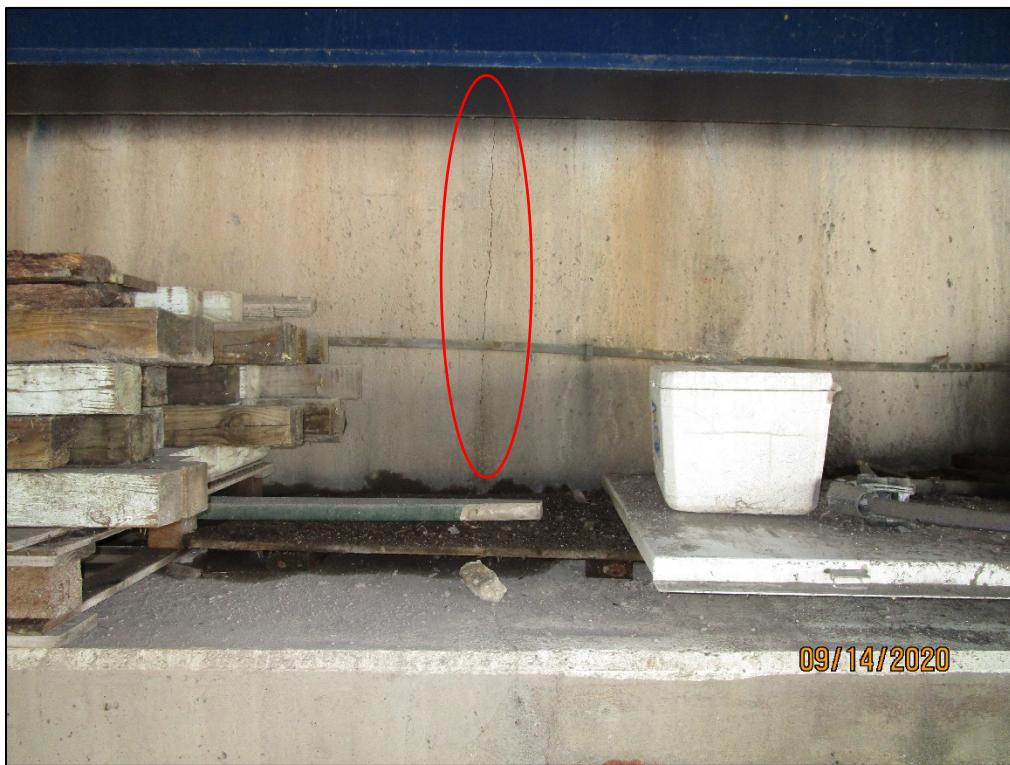
The backwalls are in *GOOD* condition. Both backwalls have scattered hairline map cracking with isolated delaminated areas at the tops of the backwalls. There is one vertical CS3 crack on the rear abutment near the middle (**Photo 59**).

PHOTO 59 – VERTICAL CRACK NEAR MIDDLE OF REAR ABUTMENT

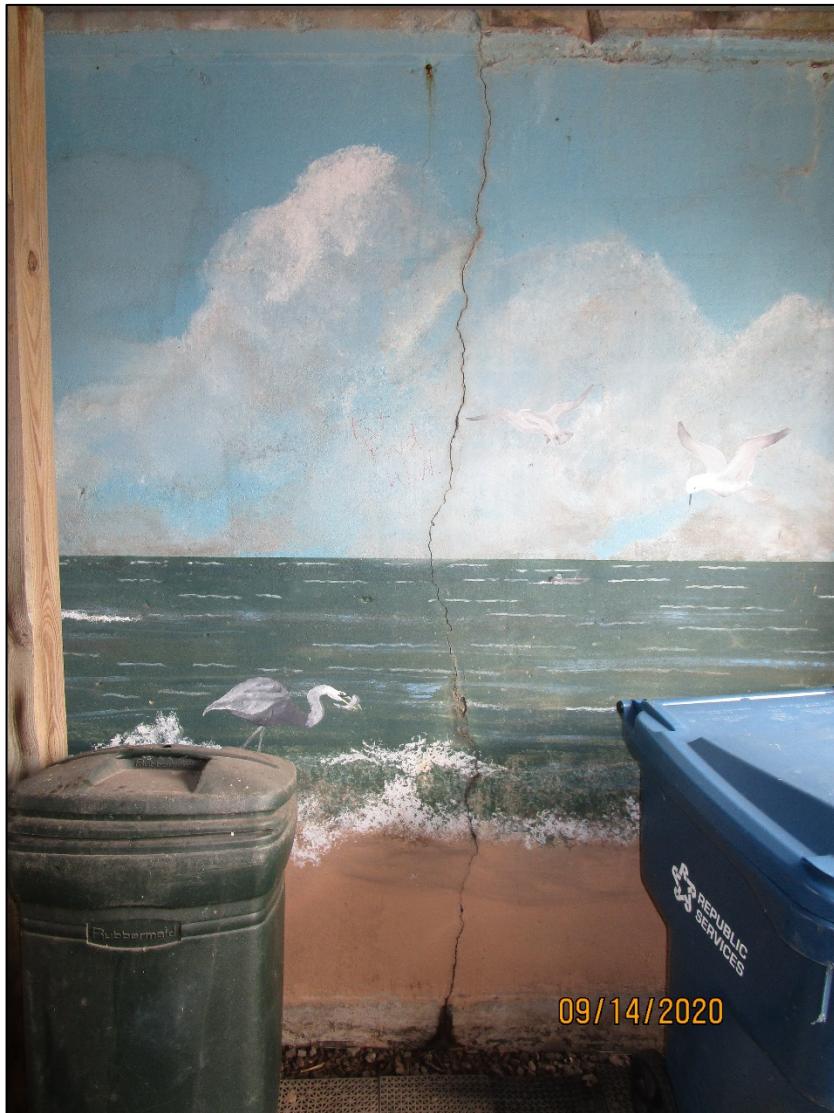
PHOTO 60 – CS3 VERTICAL CRACK ON SOUTHEAST WINGWALL

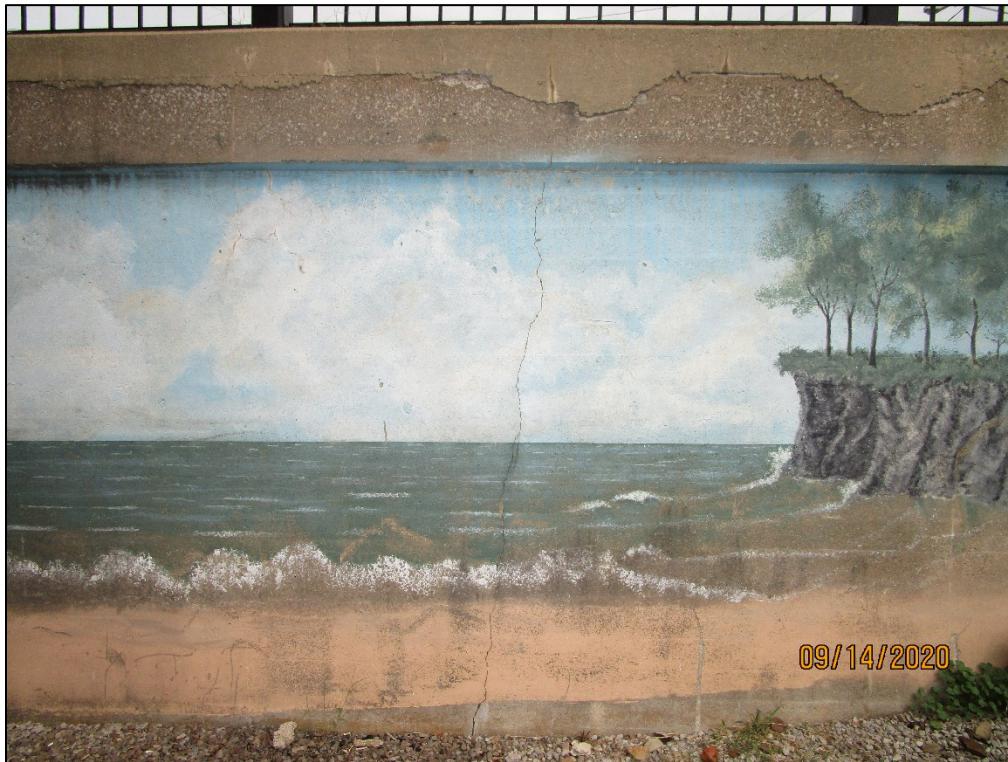
PHOTO 61 – CS3 VERTICAL CRACK ON SOUTHEAST WINGWALL

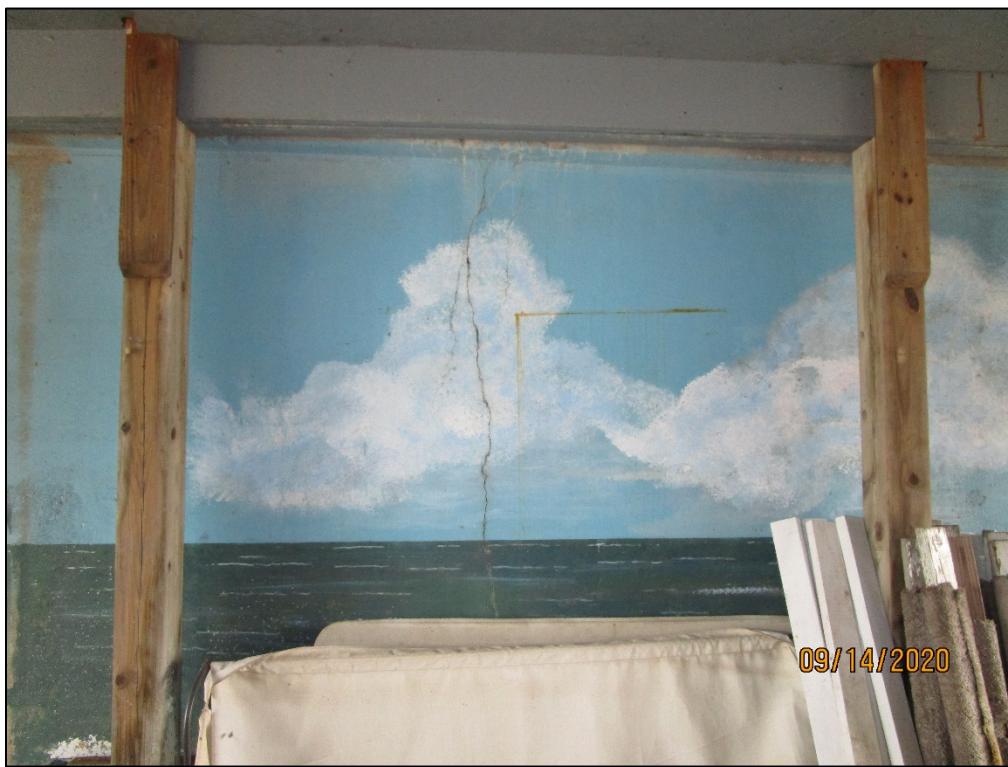
PHOTO 62 – CS3 VERTICAL CRACK ON SOUTHEAST WINGWALL

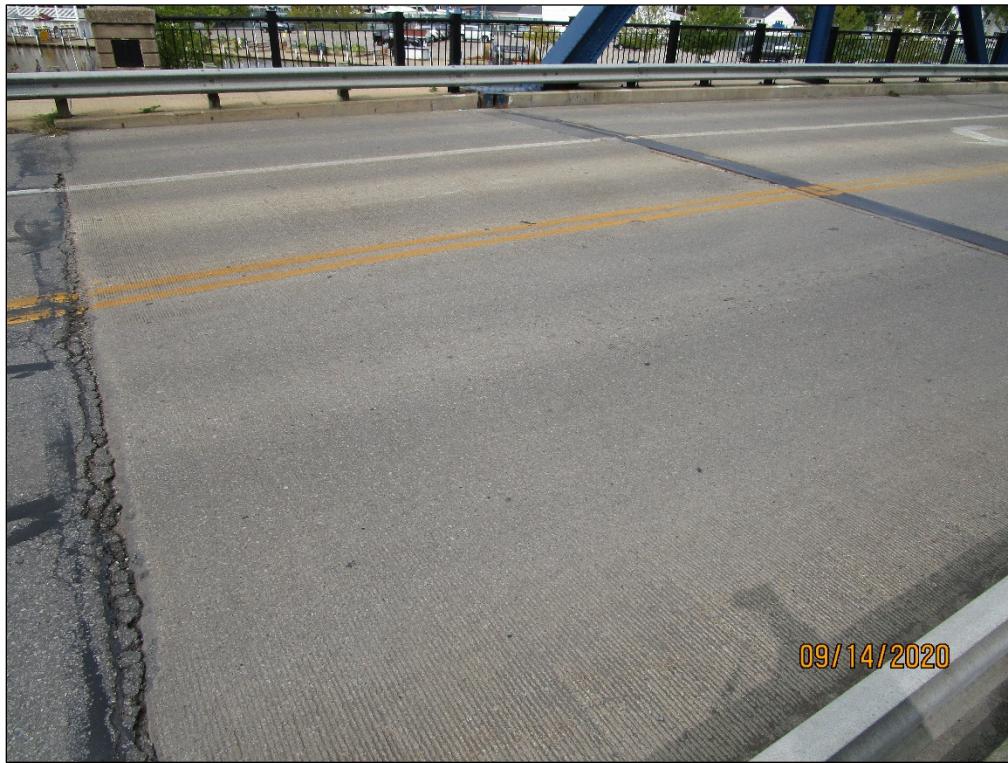
The approach slabs are in *GOOD* condition. Both approach slabs have minor corner spalling along the compression seal joints. The west approach slab has a failed compression seal (**Photos 63 & 64**) and minor cracking, spalls and delaminations on the north curb. The rear approach slab is raised slightly in relation to the deck, expansion joint and backwall creating a small bump. The east approach slab is in good condition with a spall and delamination on the south curb (**Photo 65**).

PHOTO 63 – REAR APPROACH SLAB (LOOKING NORTH)

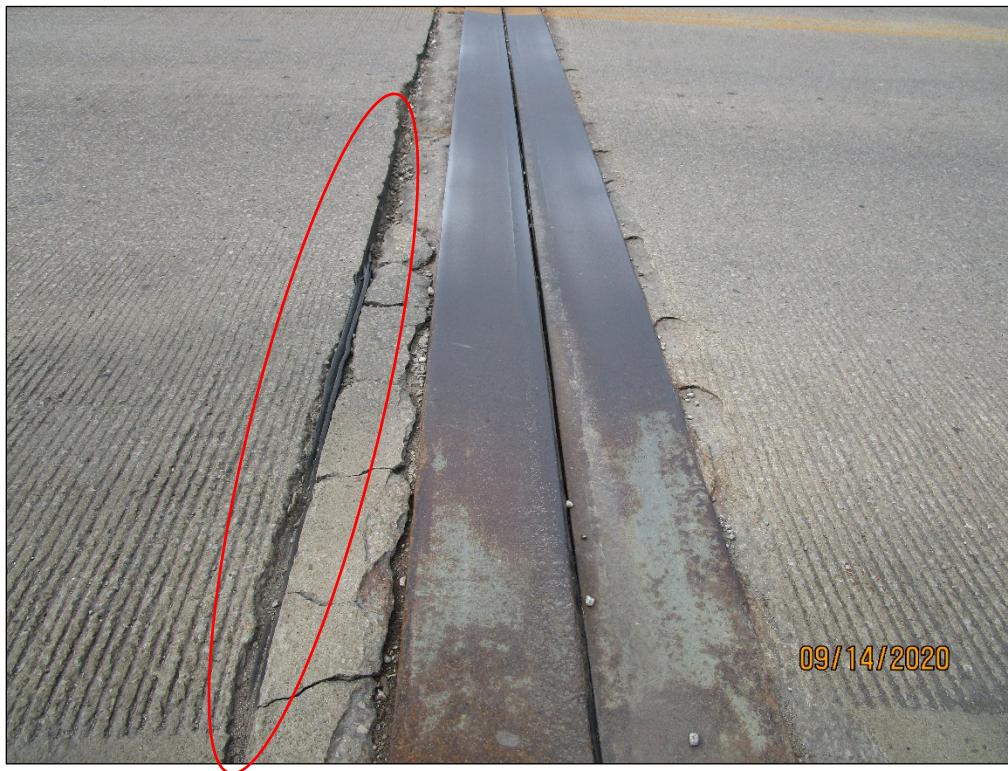
PHOTO 64 – REAR APPROACH SLAB WITH FAILED COMPRESSION SEAL AND SPALLS

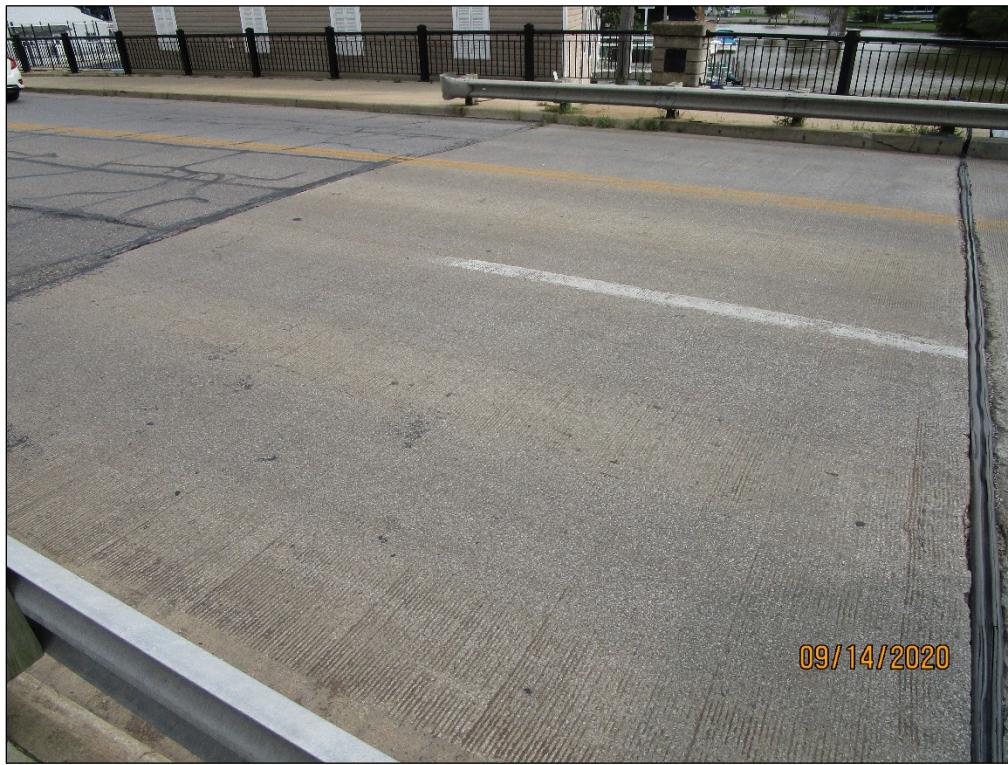
PHOTO 65 – FORWARD APPROACH SLAB (LOOKING SOUTH)

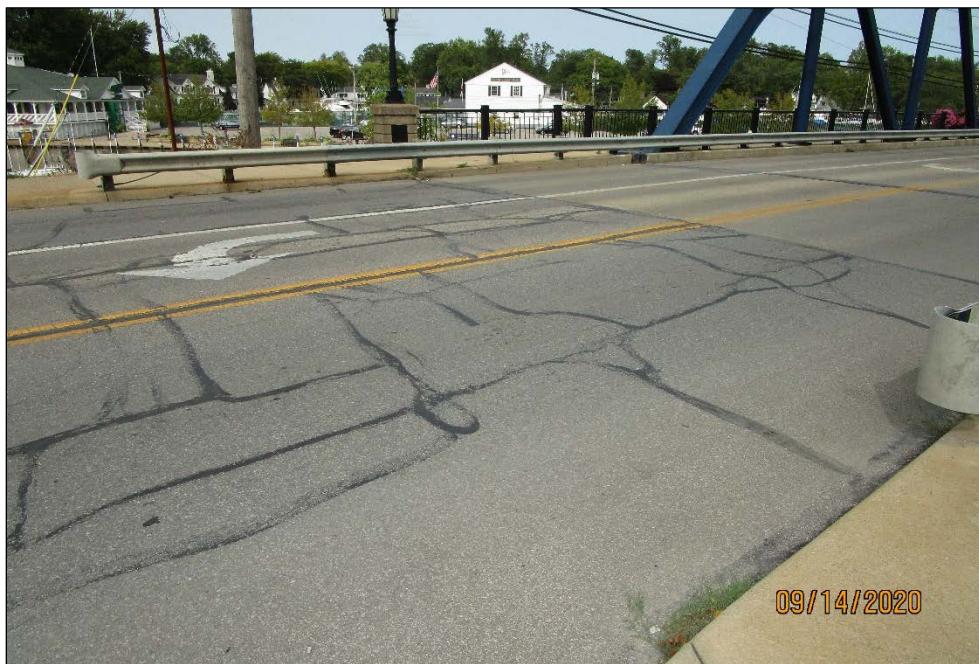
The asphalt approach pavement is in *FAIR* condition. Both approaches have sealed cracks throughout (Photos 66 & 67). The west approach has a small bump between the pavement and the approach slab and a deteriorating pothole patch, 14" wide x 15" long, in the right westbound lane at the approach slab. The east approach has a pothole, 12" wide x 6" long x 1" deep, in the right westbound lane at the approach slab and a small 3" wide x 3' long x 1" deep pothole in the left wheel path in the right westbound lane.

PHOTO 66 - WEST APPROACH WEARING SURFACE
