2020 IN-DEPTH & FRACTURE CRITICAL BRIDGE INSPECTION REPORT

ERI-6-2884

SFN: 2202344

Vermilion, Ohio

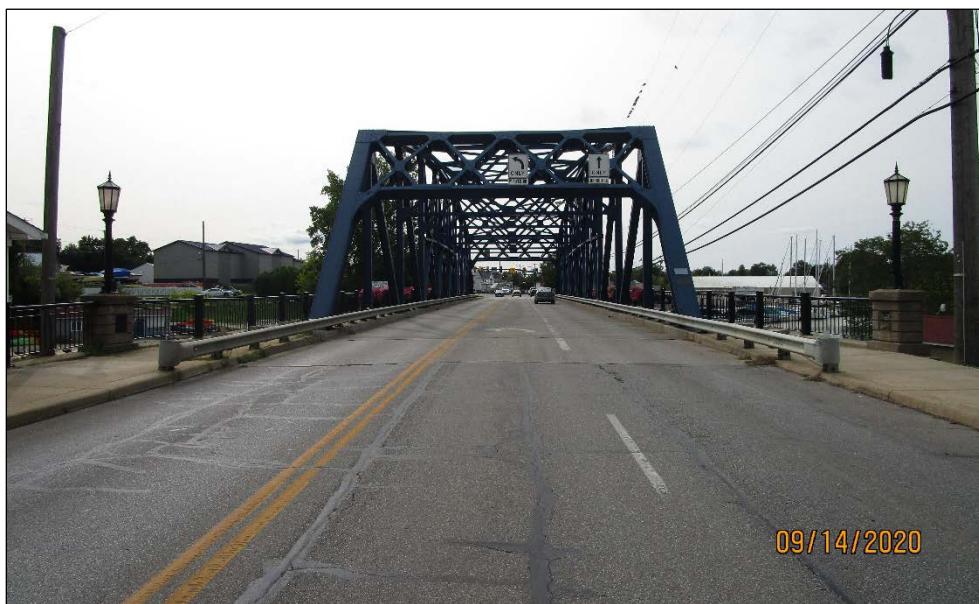
The asphalt approach pavement is in *FAIR* condition. Both approaches have sealed cracks throughout (Photos 66 & 67). The west approach has a small bump between the pavement and the approach slab and a deteriorating pothole patch, 14" wide x 15" long, in the right westbound lane at the approach slab. The east approach has a pothole, 12" wide x 6" long x 1" deep, in the right westbound lane at the approach slab and a small 3" wide x 3' long x 1" deep pothole in the left wheel path in the right westbound lane.

PHOTO 67 - EAST APPROACH WEARING SURFACE

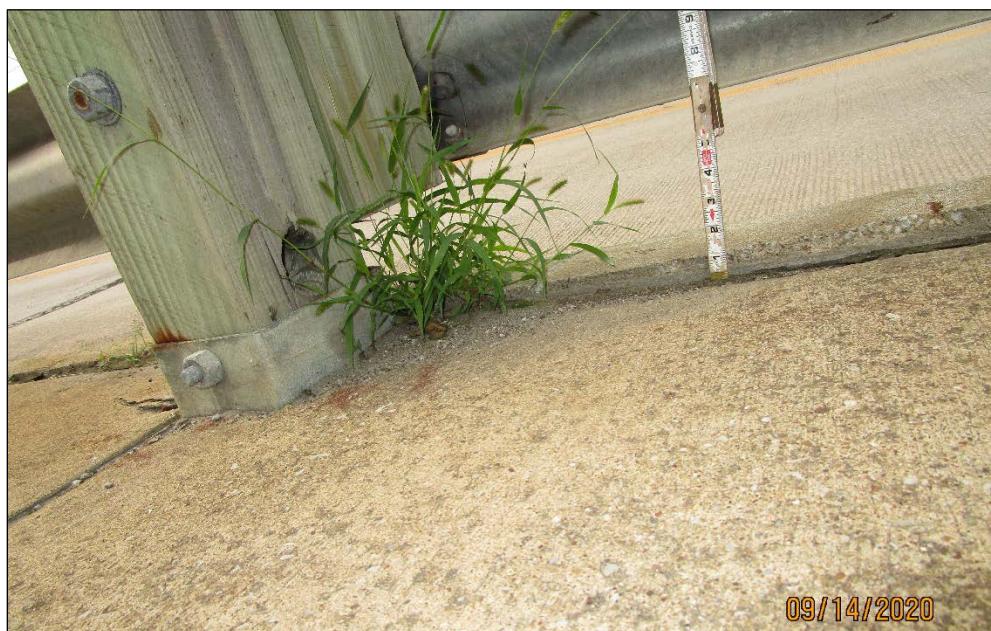
The approach embankments are well vegetated and in *FAIR* condition. The northeast and northwest sidewalks have minor settlement with longitudinal cracking and diagonal cracks around posts (**Photo 68**). The northeast sidewalk has a small area of undermining at the face of the wingwall. The southeast sidewalk has minor settlement with vegetation growth between sidewalk and curb and 21" of undermining (**Photo 69**).

PHOTO 68 – SIDEWALK SETTLEMENT AT NORTHWEST APPROACH

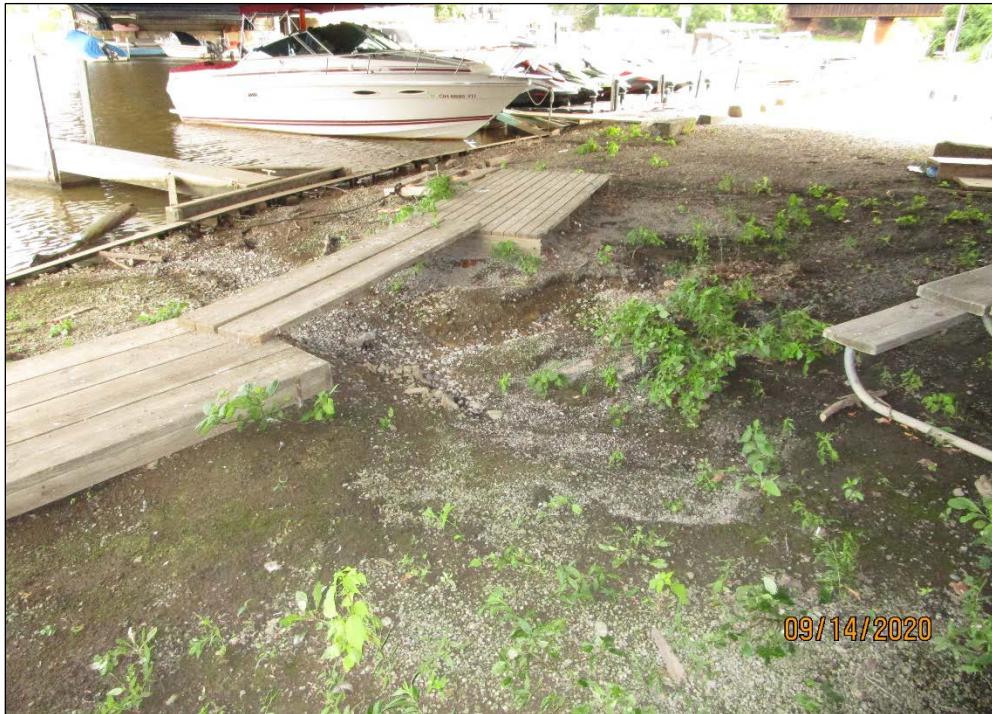
Bank Protection is in **FA/R** condition. An erosion gully is present running from the sheet pile wall to the Rear Abutment (**Photo 71**).

PHOTO 71 – EROSION IN FRONT OF REAR ABUTMENT
