**OHIO DEPARTMENT OF TRANSPORTATION
2018 IN-DEPTH BRIDGE INSPECTION REPORT**

**LIBERTY AVENUE OVER VERMILION RIVER
BRIDGE No. ERI-6-2284**

SFN: 2202344

2018 In-Depth Bridge Inspection Report

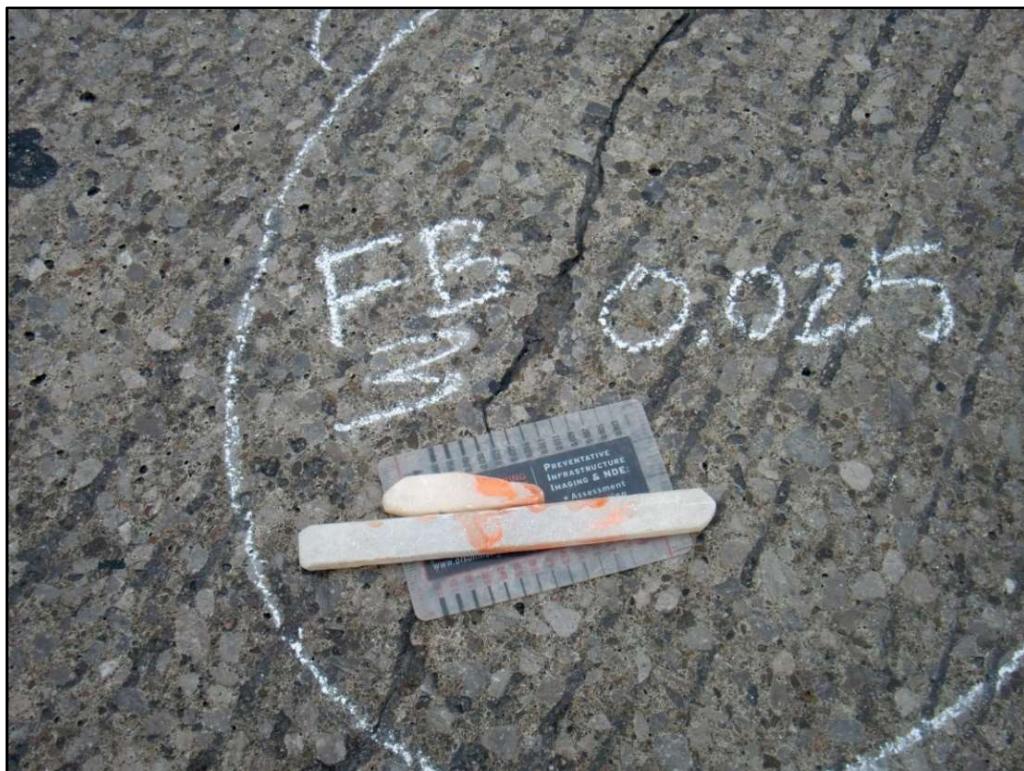
The reinforced concrete deck, replaced in 1986, is in ***Satisfactory*** condition. Transverse and longitudinal cracks were found throughout the top surface. Crack widths were classified as hairline width, generally measuring up to 0.025" wide (**Photo 4**). The pattern of transverse cracks closely matches the floorbeams below with some additional partial length transverse cracks between the floorbeams. A 3' long, 3' wide delamination was found in the center lane near the forward abutment. The longitudinal cracking on the top of the deck is scattered throughout and does not appear to be related to the stringer framing below. Deck findings are shown on the Deck Location Plan in **Appendix B**. On the bottom of the floor, isolated transverse and longitudinal hairline cracks were scattered throughout. Occasionally cracks were found with leakage and efflorescence (**Photo 5**).

Photo 4 – 0.025" Wide Transverse Crack in Deck, Near Floorbeam 3

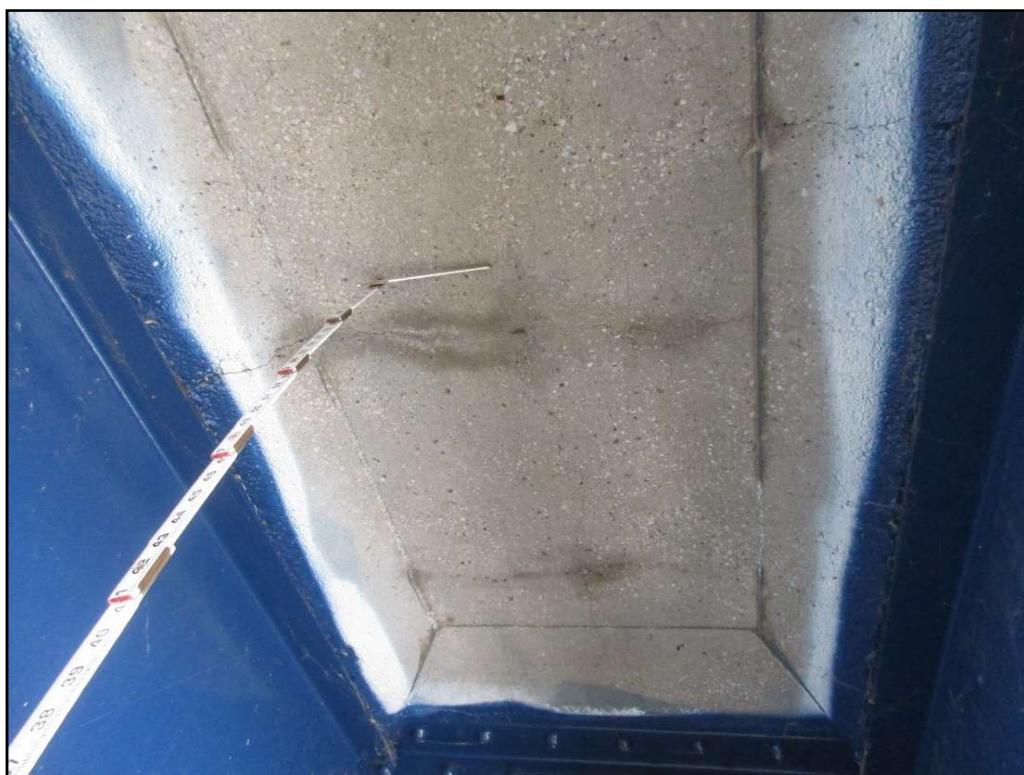
Photo 5 – Typical Transverse Crack in Underside of Deck with Efflorescence

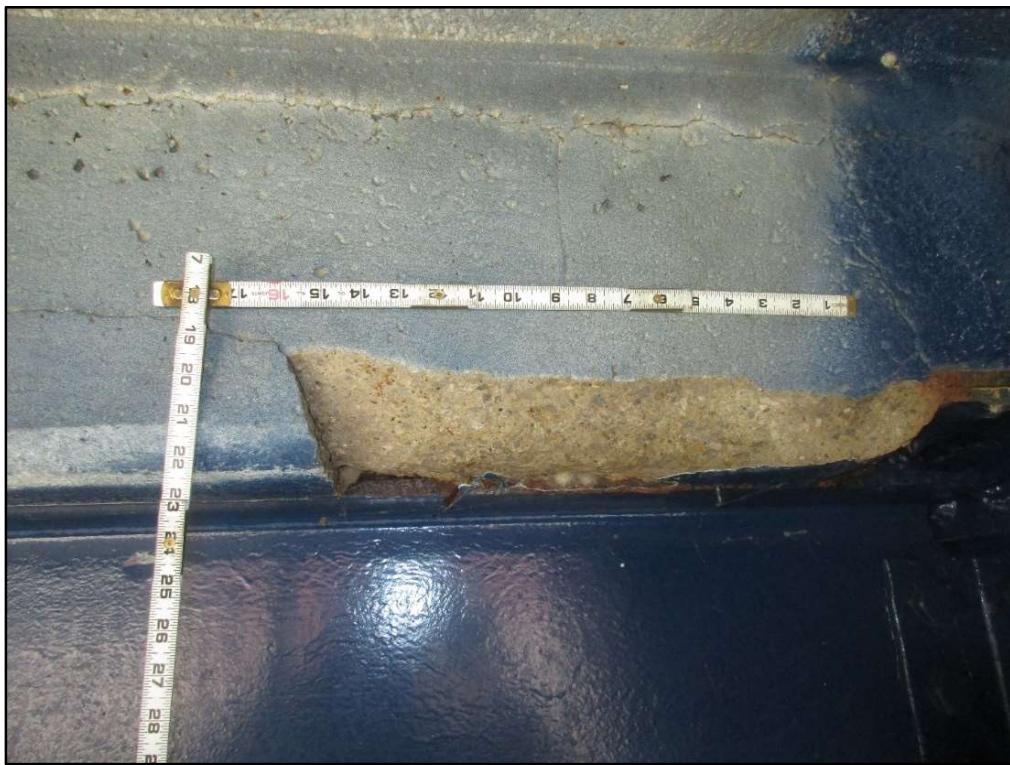
The edge of the deck is in **Good** condition. For inventory purposes, the edge of the sidewalk deck and edge of roadway deck are counted once per side. Isolated spalls and delaminations are present on the edge of the roadway deck (**Photo 6**).

Photo 6 – Typical Corner Spall and Delamination, Edge of Roadway Deck

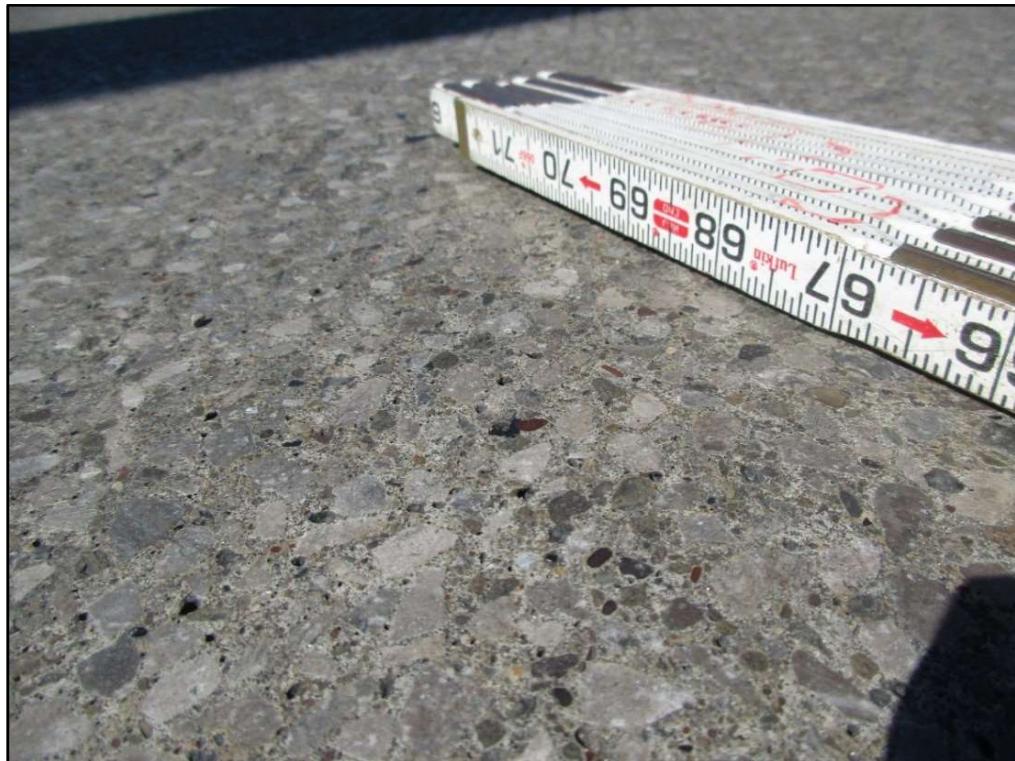
The concrete wearing surface is in **Good** condition with a grid pattern of transverse and longitudinal cracking is present. See *Floor* commentary for discussion on deck cracking. The wearing surface skid-resistance grooves are noticeably worn along the wheel paths, especially along the eastbound lane and the westbound left turn lane (**Photos 7**). The wearing surface skid-resistance grooves are also filled with sealer (**Photo 8**).

Photo 7 – Common Wear of Skid-Resistance Grooves

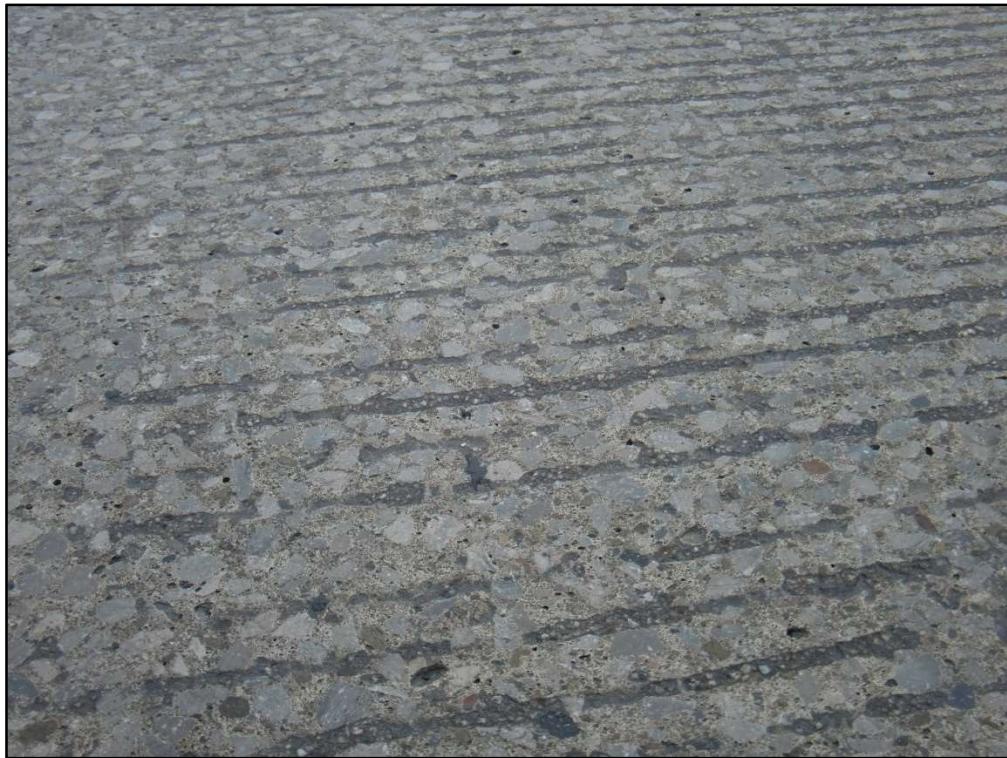
Photo 8 – Deck Sealer Within Skid-Resistance Grooves

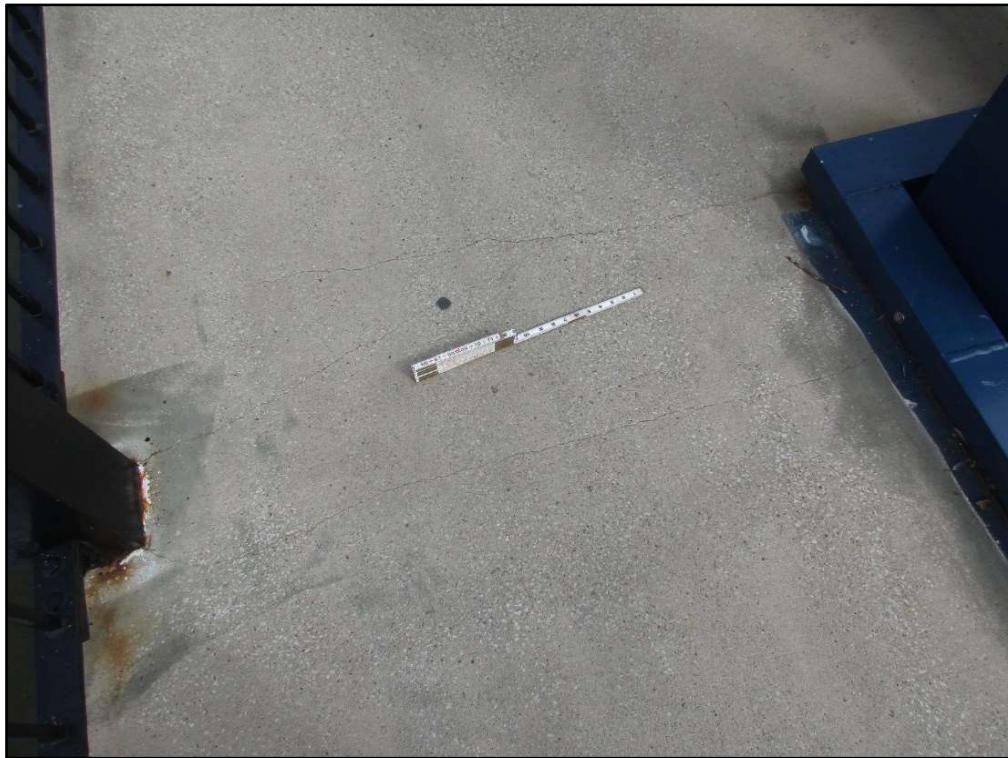
The curbs and sidewalks are in **Good** condition. Typical hairline transverse cracking exists on the sidewalks between the railing posts and the blockouts in the deck for the truss (Photo 9). Where truss members pass through the sidewalk deck, several steel covers are loose with others having isolated active corrosion.

Photo 9 – Typical Transverse Cracking in Sidewalk

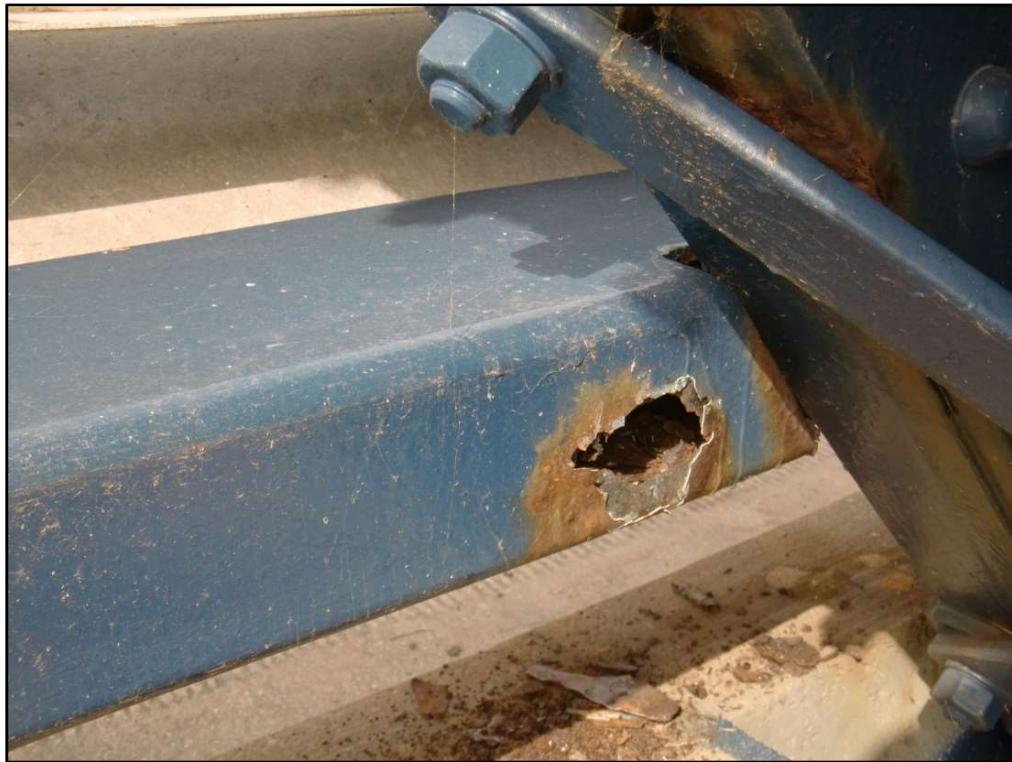
The railings are in **Good** condition. The DBR railing posts have areas of light corrosion on the bases. Five of the rail mounted reflectors are broken. Section loss with a perforation was found on the backside of the tubular steel backup (**Photo 10**). The pedestrian hand railing consists of steel posts supporting panels with top and bottom railing with pickets and has scattered deficiencies throughout. Ten of the brackets that attach the railing panels to the posts are cracked (**Photo 11**). Moisture has entered the posts under the caps (tightened during in the 2012 rehabilitation project), partially filling the posts. Five approach railing posts have vertical cracks along the section seams due to the trapped water freezing inside the post (**Photo 12**). The railing post connection assemblies below the sidewalk deck have advanced section loss in areas (**Photo 13**), however these connections are believed to be redundant as the posts are structurally encased in the sidewalk deck. Section loss is present on the bottom of the pickets in isolated areas. Chipped paint is also present in isolated areas.

**Photo 10 – Active Corrosion with Perforation, Railing Tubular Steel Backup,
near L9 South**

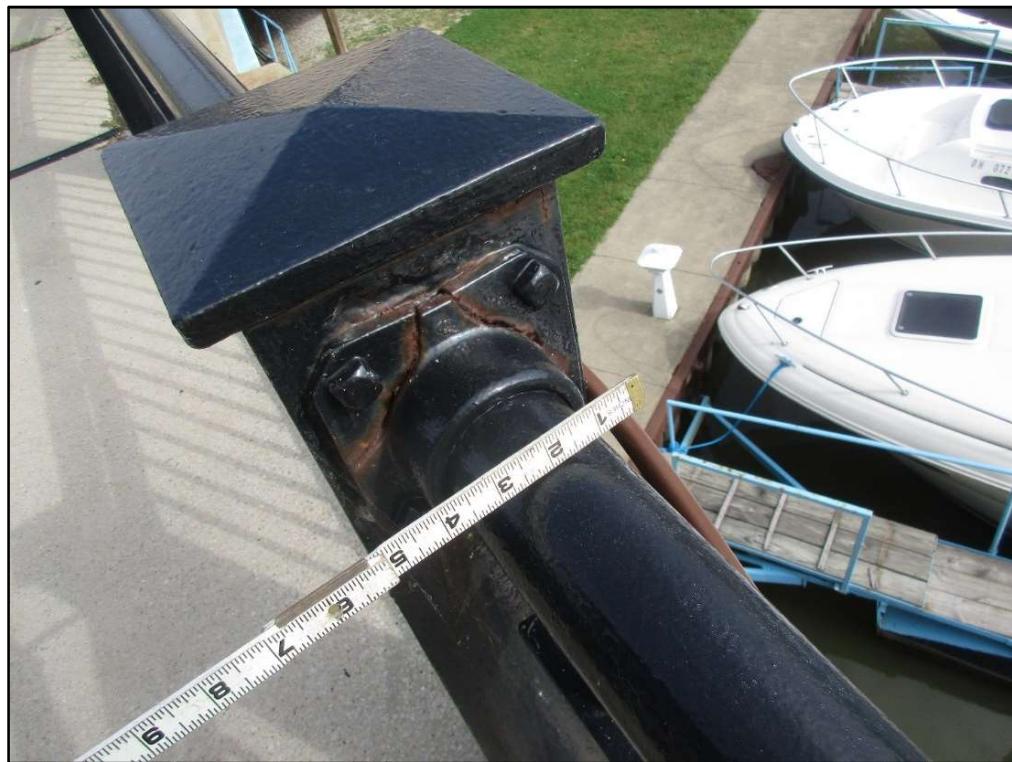
Photo 11 – Typical Cracked Railing Bracket, South Rail

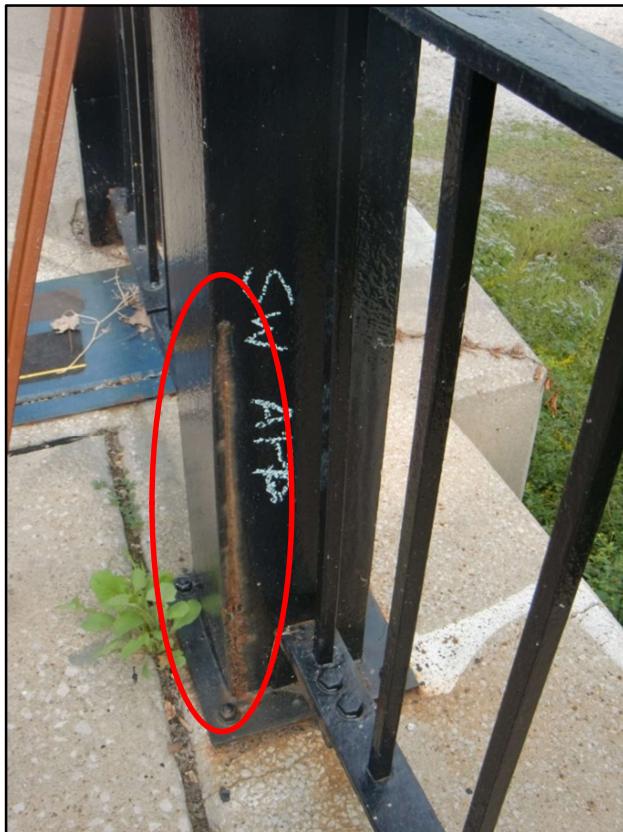
**Photo 12 – Vertical Crack in Railing Post
(Circled), Southwest Approach**

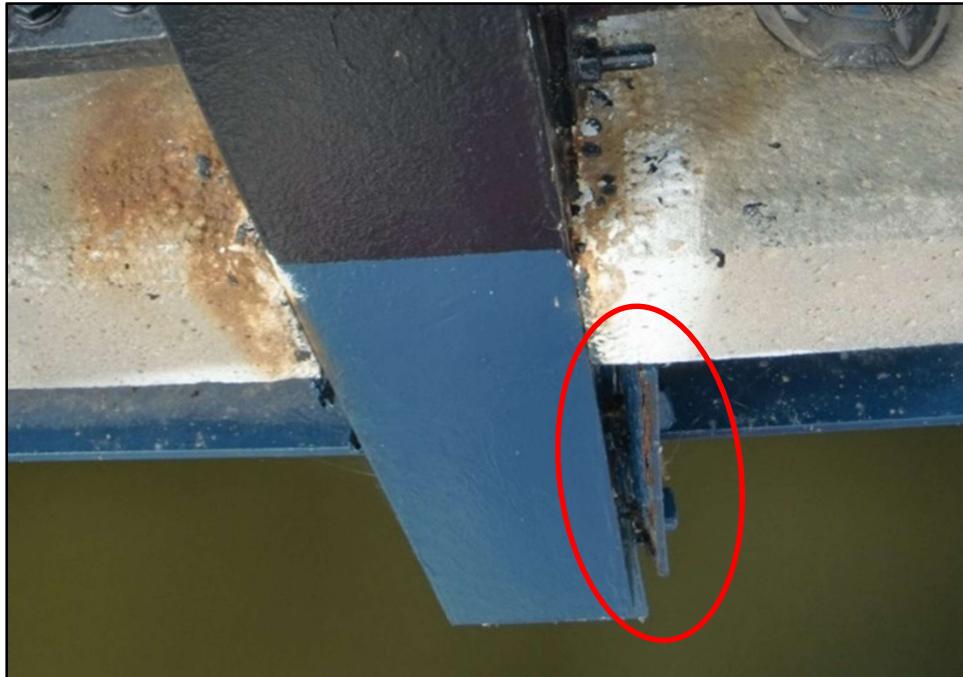
**Photo 13 – Advanced Section Loss to Abandoned Railing
Post Connection Assembly (Circled)**

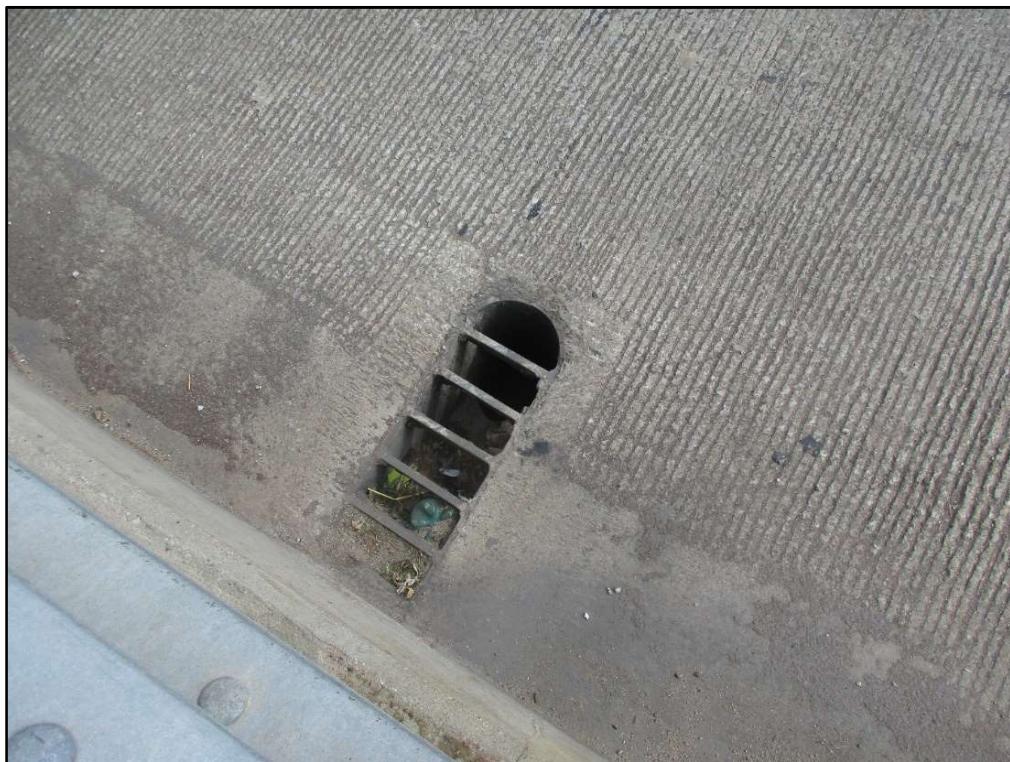
The drainage is in **Good** condition. No clogs or debris within the drain pipes were observed. Some debris is present within one north curb scupper collector (**Photo 14**), however all drain pipes entrances are open. The plastic drain pipe at the northeast corner has a cracked coupling (**Photo 15**). Areas with minor ponding and debris are present along the south curb near the Rear Abutment (**Photo 16**).

Photo 14 – Partly Clogged Scupper Inlet, North Curb

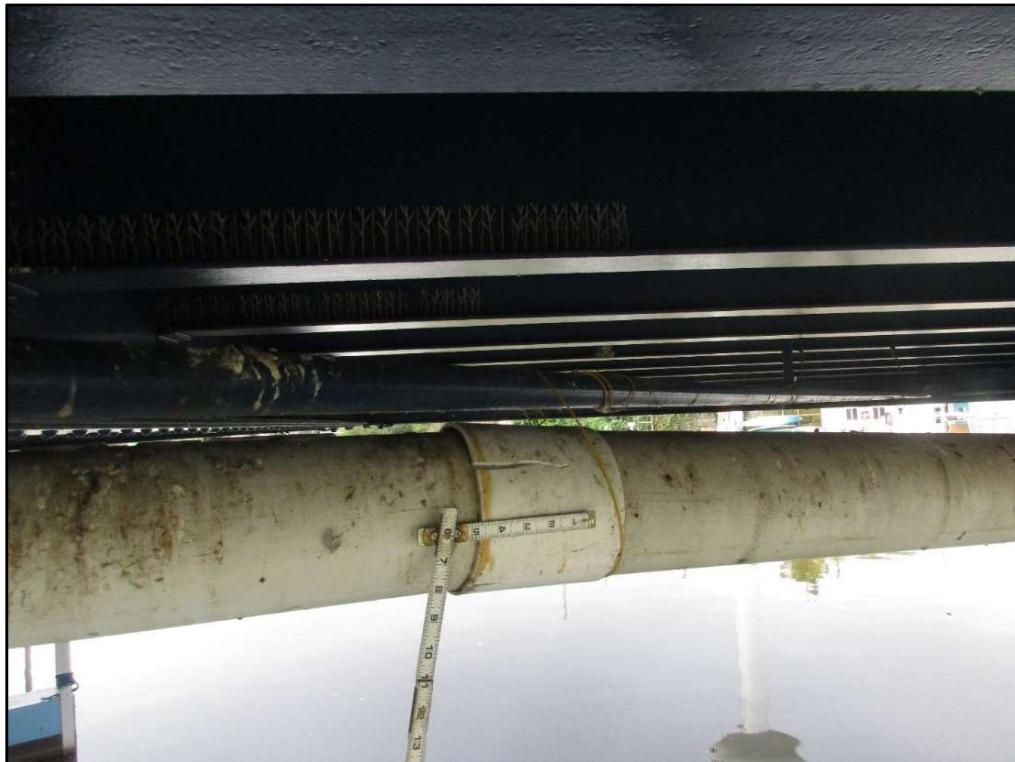
Photo 15 – Cracked Drain Pipe Coupling, Northeast Corner

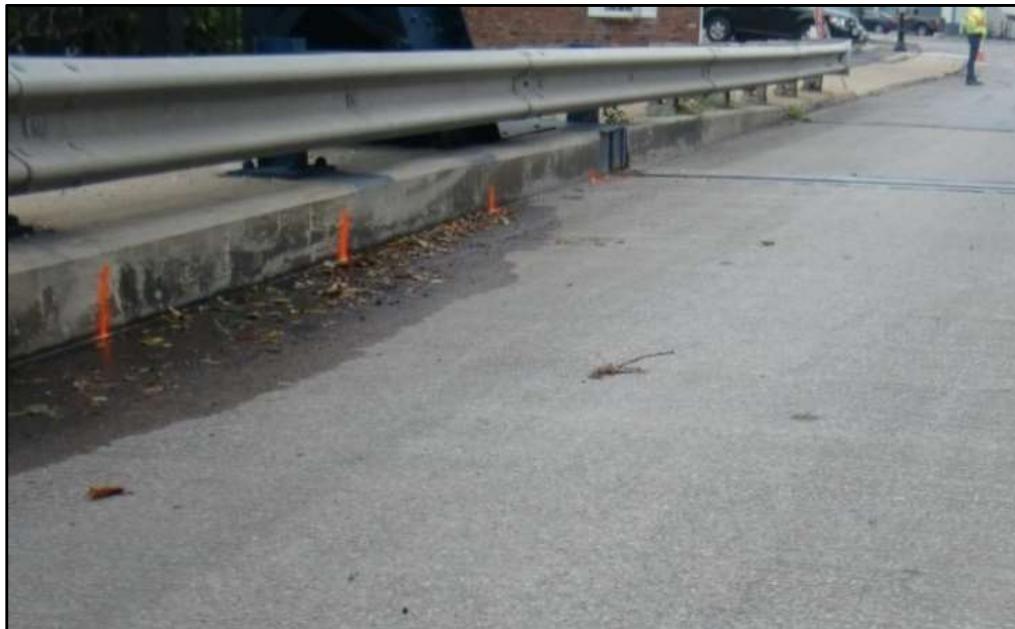
Photo 16 – Minor Ponding & Debris Along Edge of Deck, Southwest Curb

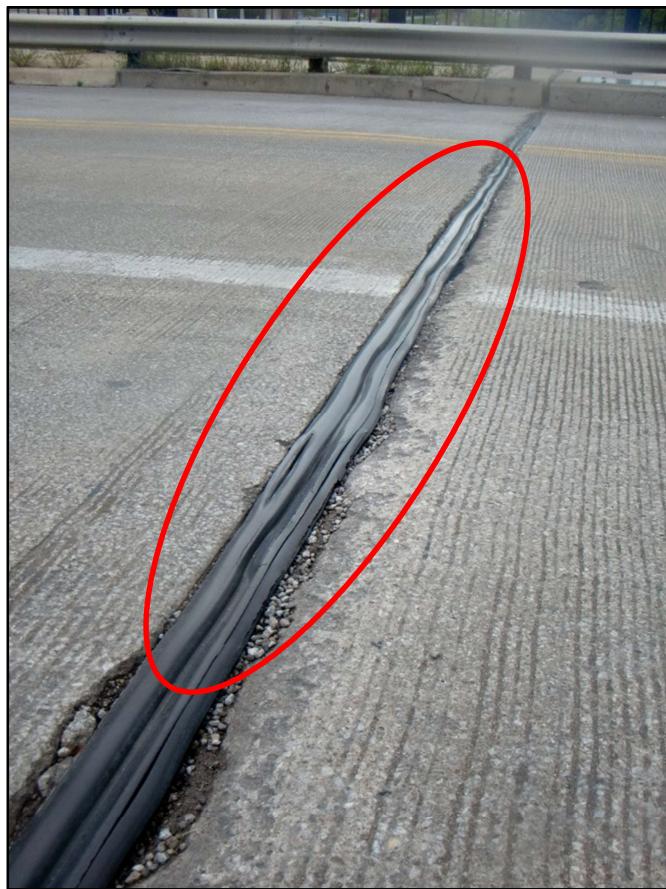
The expansion joints are in **Poor** condition. The expansion joint at the Rear Abutment measures $\frac{3}{8}$ " between the steel retainers, comparable to the 2016 measurement. No deficiencies were noted in the armor. The compression seal between the approach slab and the backwall at the rear abutment is described in the approach slab section. The Forward Abutment compression seal is torn for the entire length (**Photo 17**).

**Photo 17 – Torn Compression Seal Joint,
Forward Abutment**

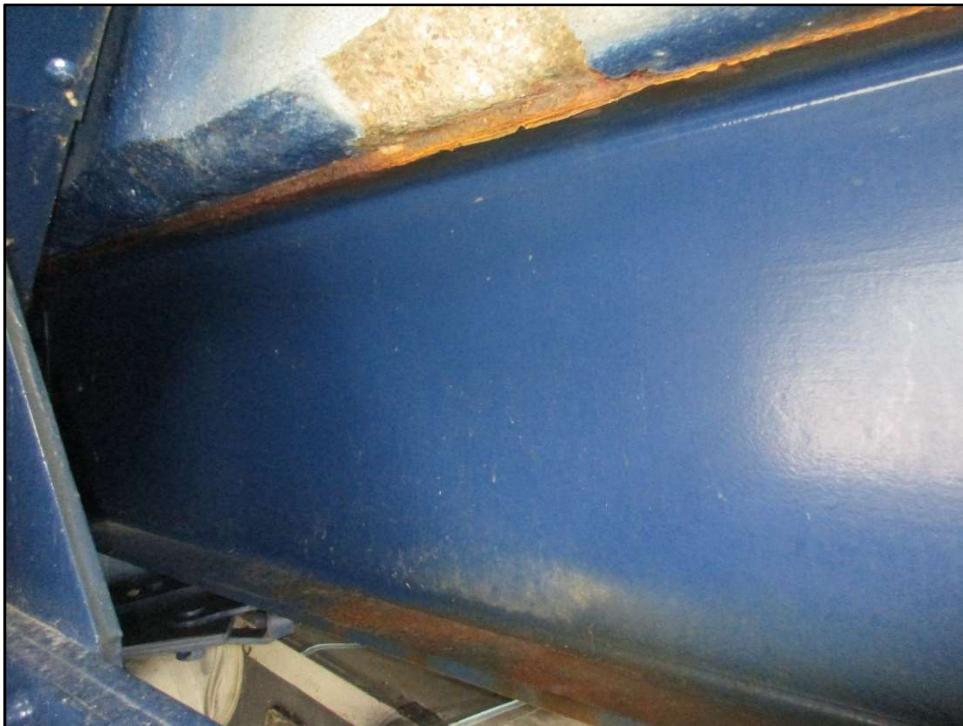
The stringers are in **Good** condition. The exterior stringers under the roadway deck have active corrosion on the top of the top flange at the abutments (**Photo 18**). Pitting up to $3/16$ " deep is present in isolated areas on the bottom flange of the roadway stringers (**Photos 19 and 20**). A few bent bottom flanges are present at stringer to floorbeam connections. The stringers supporting the sidewalks have scattered pitting with some isolated perforations (**Photo 21**).

Photo 18 – Top Flange Active Corrosion, Stringer 1, Panel 9

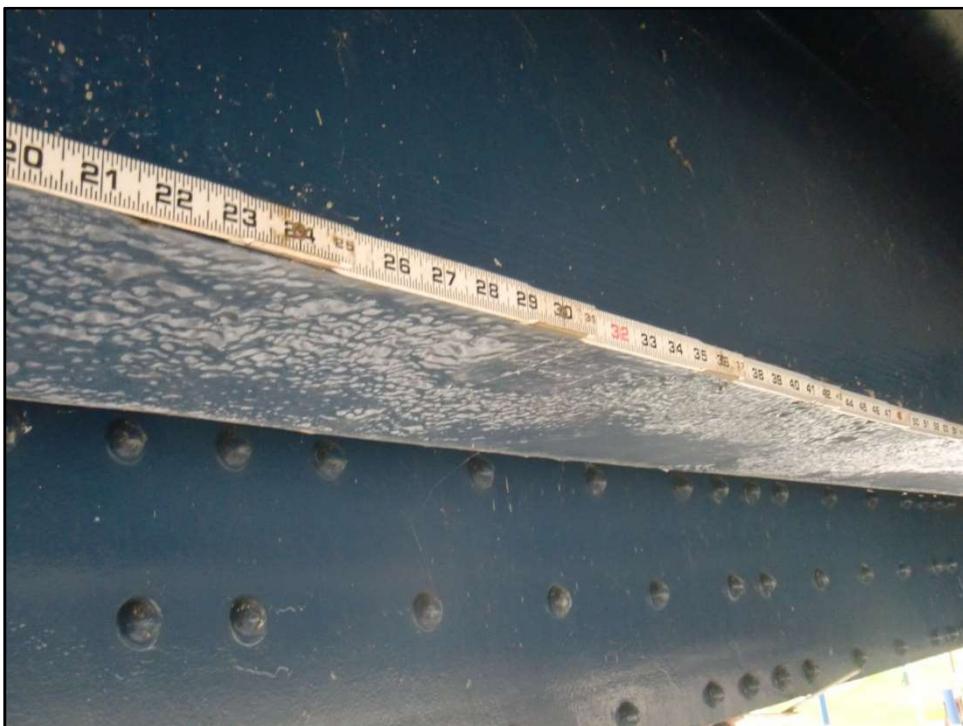
Photo 19 – Bottom Flange Pitting, Stringer 1, Panel 5

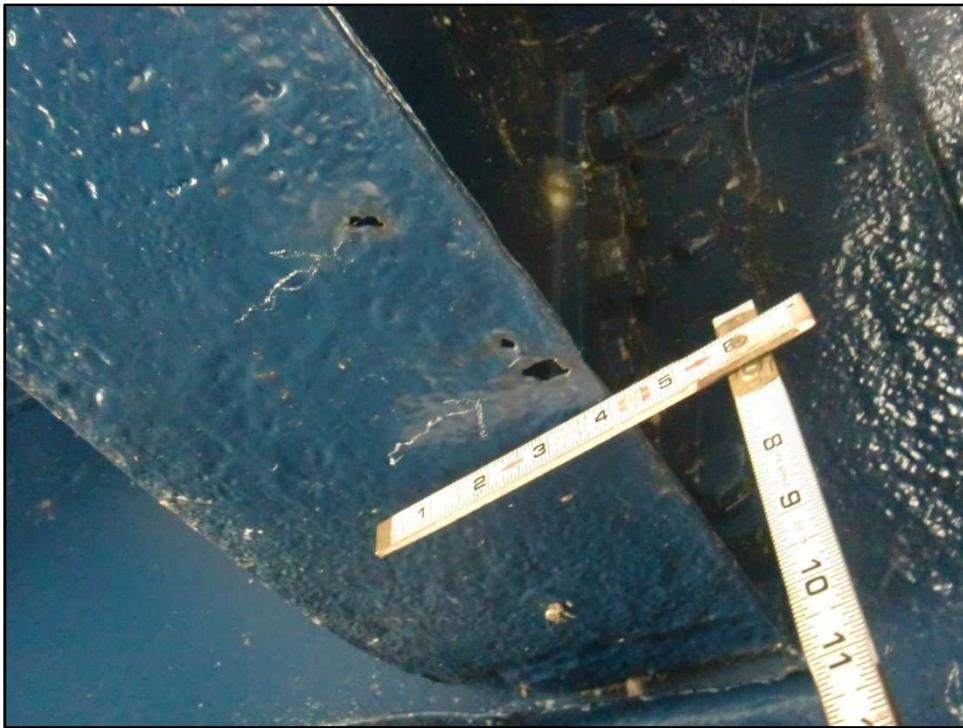
Photo 20 – Bottom Flange Pitting with Perforations, Stringer 1, Panel 7

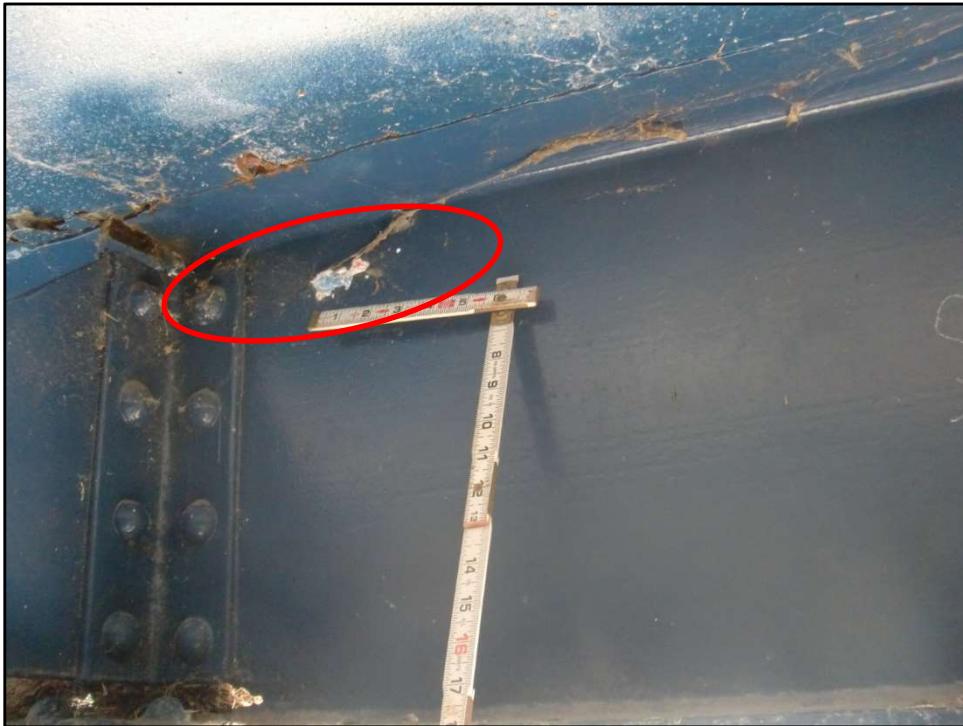
Photo 21 – Typical Web Perforations (Circled), Exterior Sidewalk Stinger

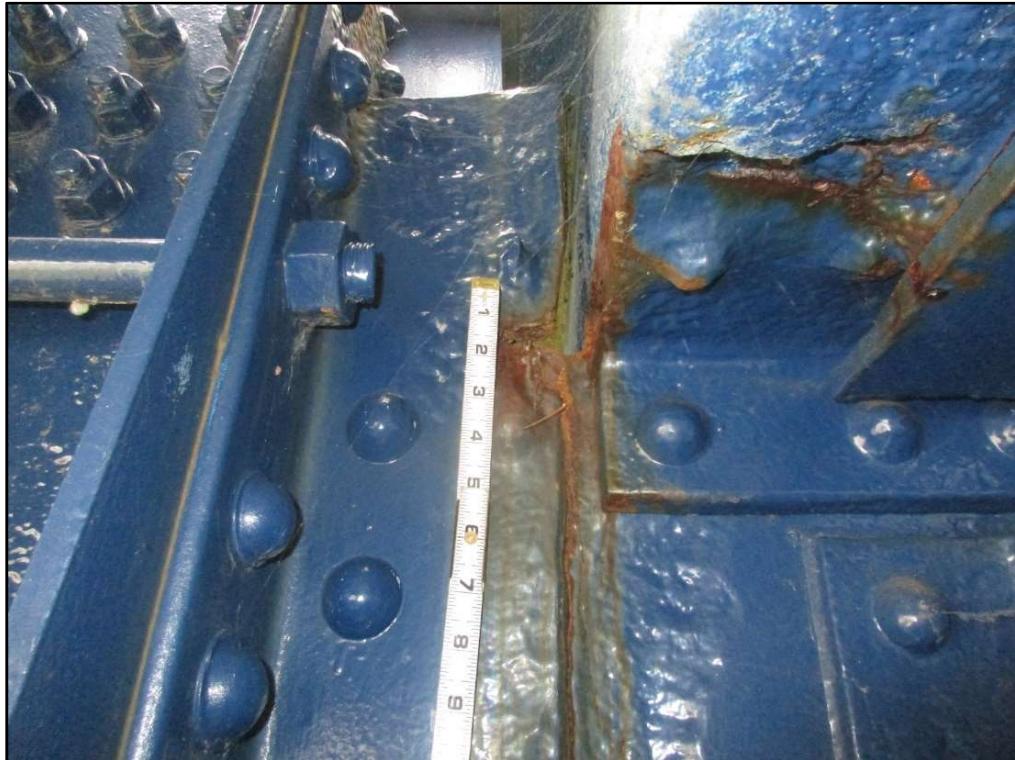
Photo 22 – Pitting with Edge Hole in Connection Angle, Floorbeam 1 at L1 South

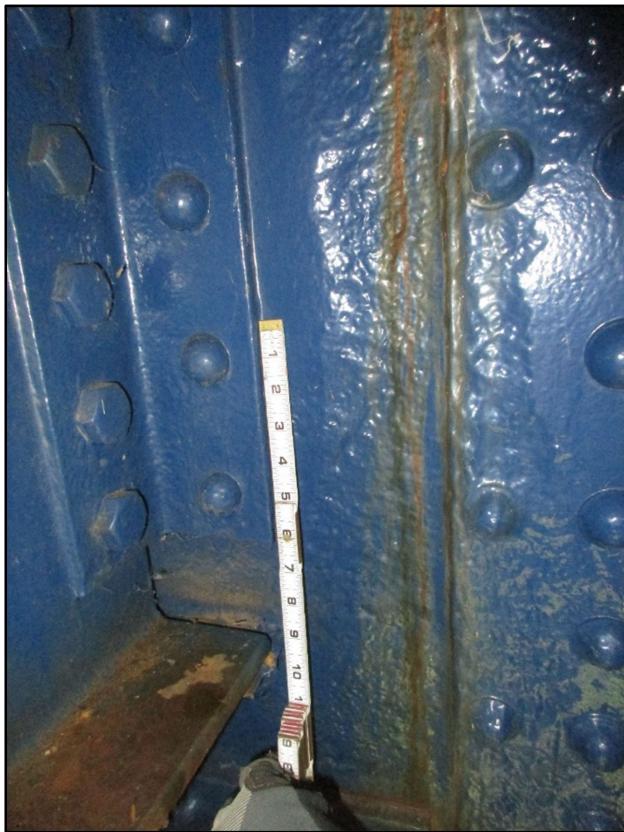
**Photo 23 – Pitting to Web,
Floorbeam 1 at L₁ South**

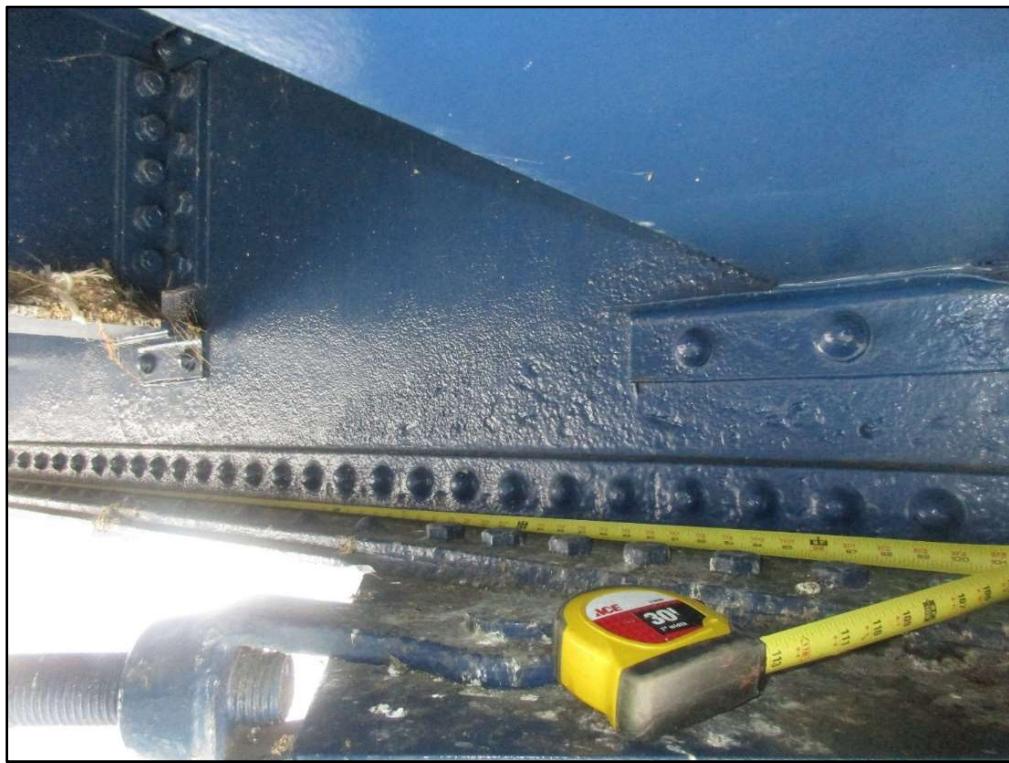
Photo 24 – Typical Pitting to Floorbeam End & Bottom Flange Angle, Near Truss Connection

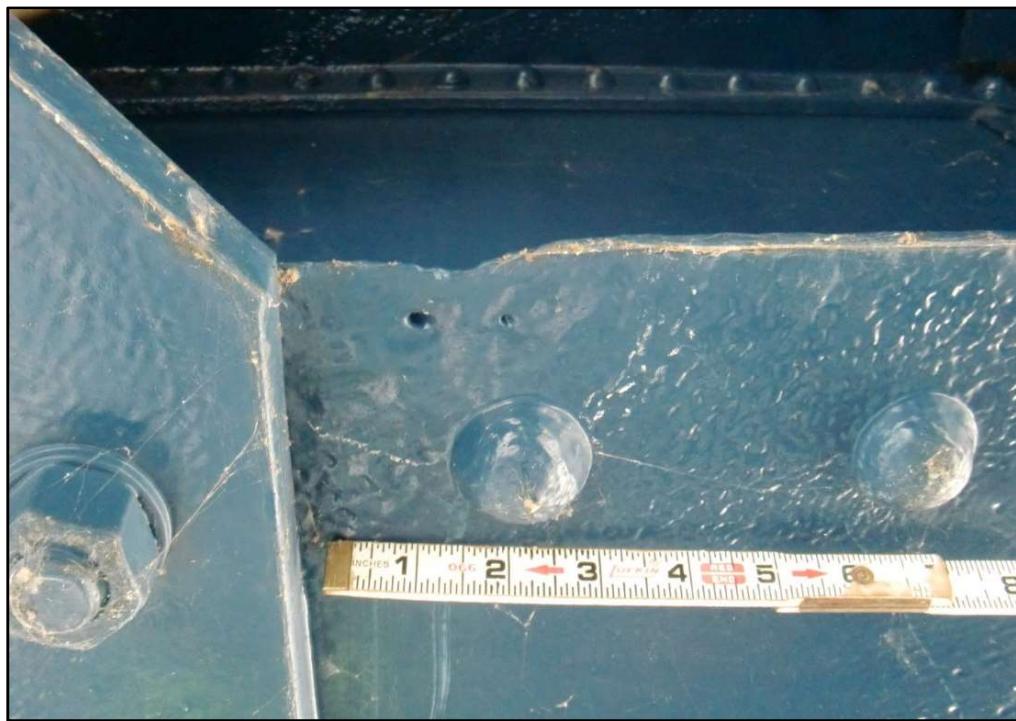
**Photo 25 – Pitting with Pinholes to Bottom Flange, Floorbeam 5
at North Lower Lateral Brace Connection Plate**

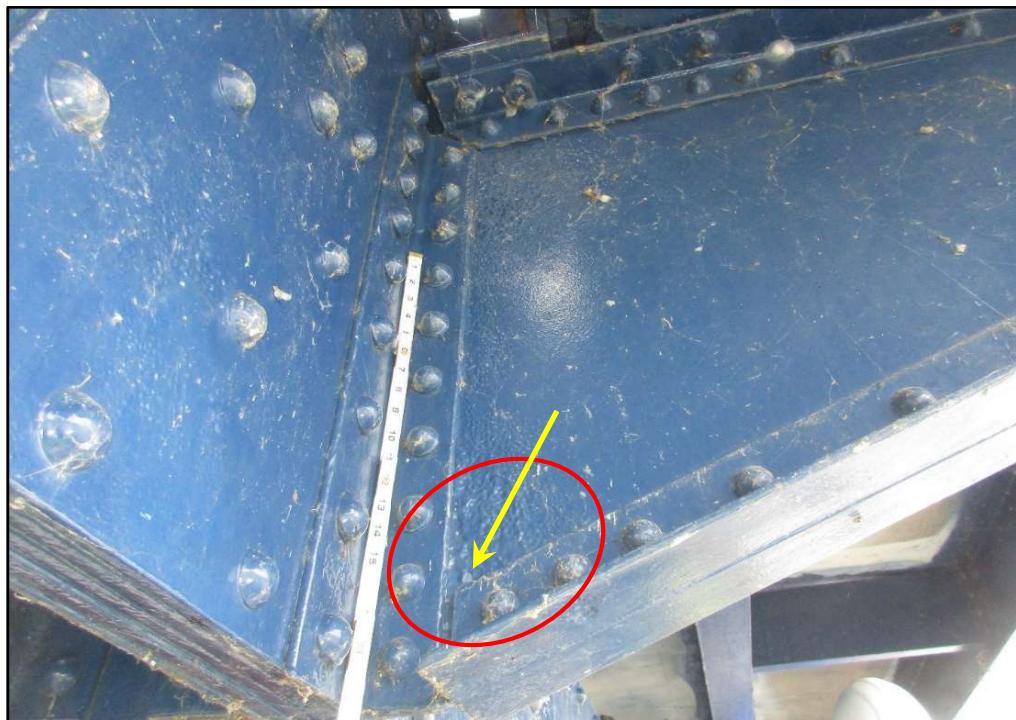
The floor beams are in **Good** condition. Arrested pitting on the web and top and bottom flanges is typical at the floorbeams ends adjacent to the lower gusset plate connections (**Photos 22, 23 & 24**). Pack rust behind floorbeam connection angles is also reactivating. Perforations are present in the bottom flanges of Floorbeams 2 and 5, both adjacent to the north lower lateral gusset plates (**Photo 25**). The cantilever floorbeam extensions supporting the sidewalks also have arrested pitting with isolated perforations (**Photo 26**).

**Photo 26 – Web Pitting (Circled) with Perforation (at Arrow),
Floorbeam Sidewalk Cantilever End, L5 North**

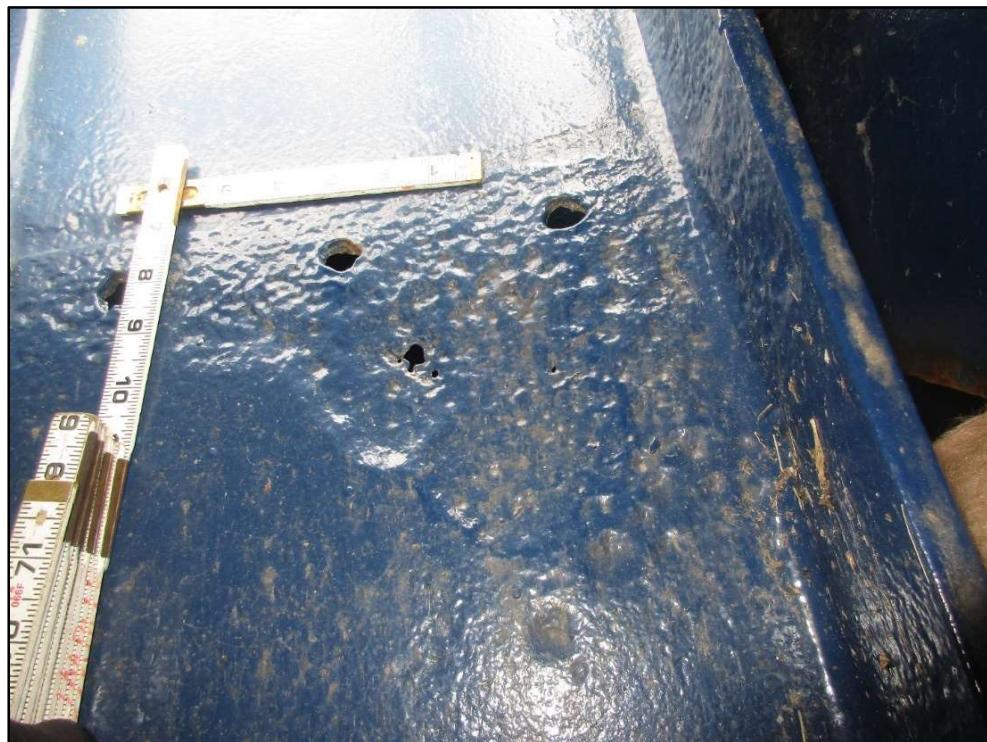
The top chord is in **Fair** condition. Arrested pitting is typical at the lower vertical ends in the splash zone. Perforations were found in the web of L₆U₆ North (**Photo 27**). Repairs were made to several verticals with advanced section loss.

Photo 27 – Web Pitting & Perforations, L₆U₆ North

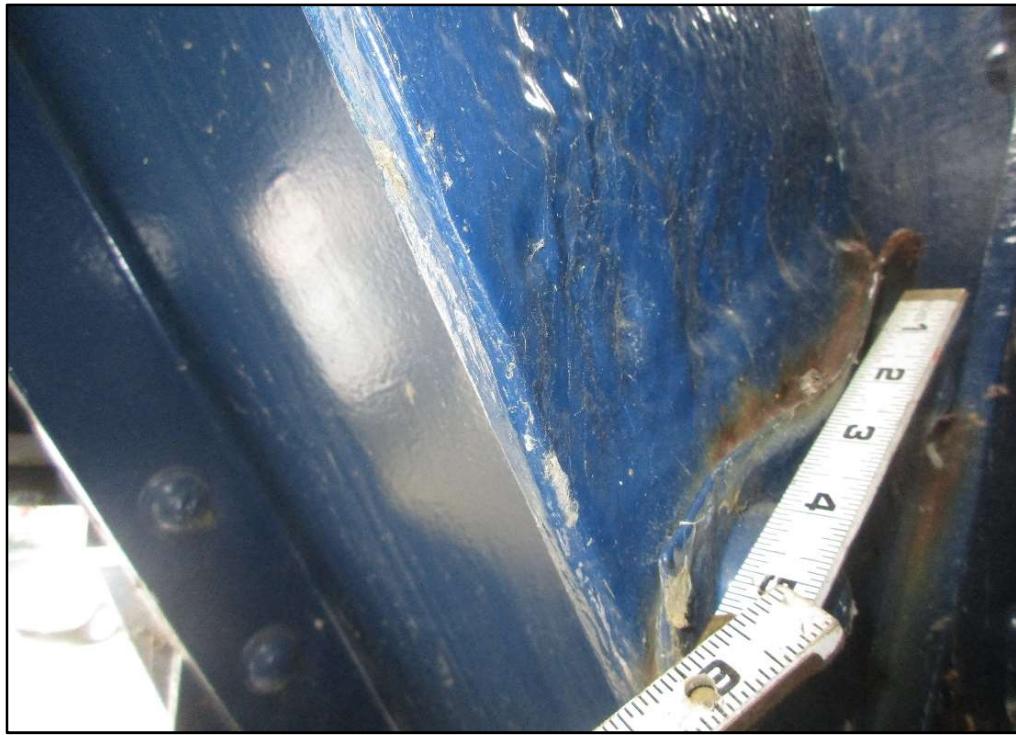
The diagonals are in **Fair** condition. Arrested pitting and section loss, advanced in areas, is typical to the web and flanges in the splash zone (**Photos 28 & 29**). Fill plates have section loss, up to 100% in areas, and pack rust between the flanges and the lower gussets. Some pack rust is reactivating. Repairs were made to several verticals with advanced section loss in the splash zone.

Photo 28 – Section Loss to Flanges with Pack Rust Behind Fill Plate, L₃U₄ South at L3S

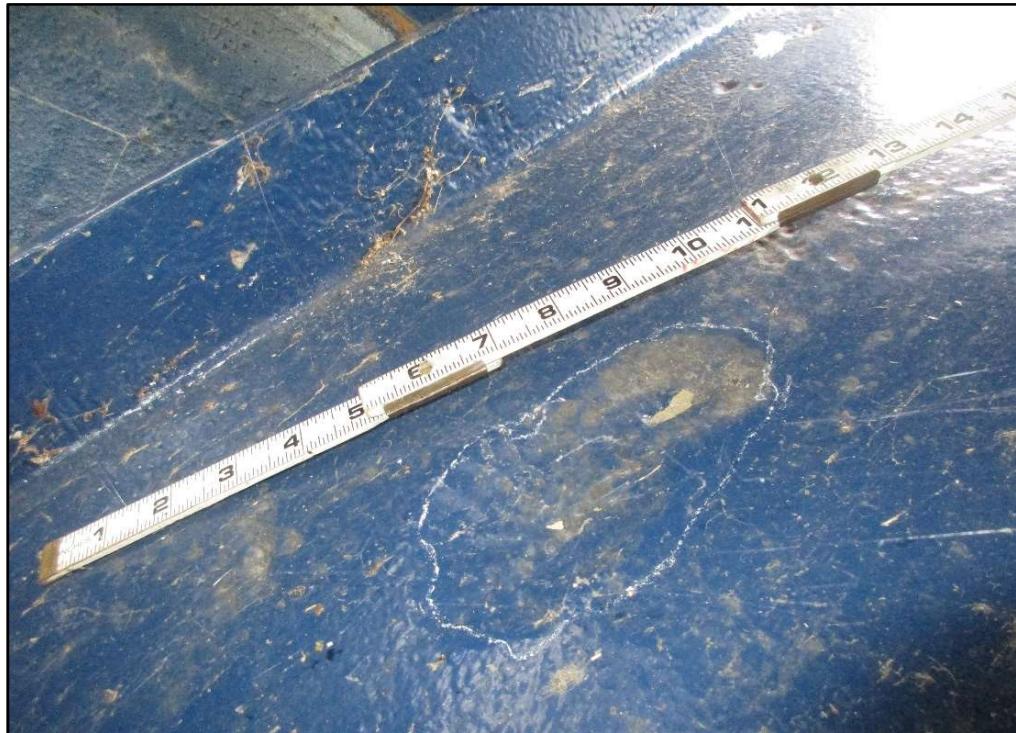
Photo 29 – Web Pitting with Perforation, U₅L₆ North, Near L₆ North

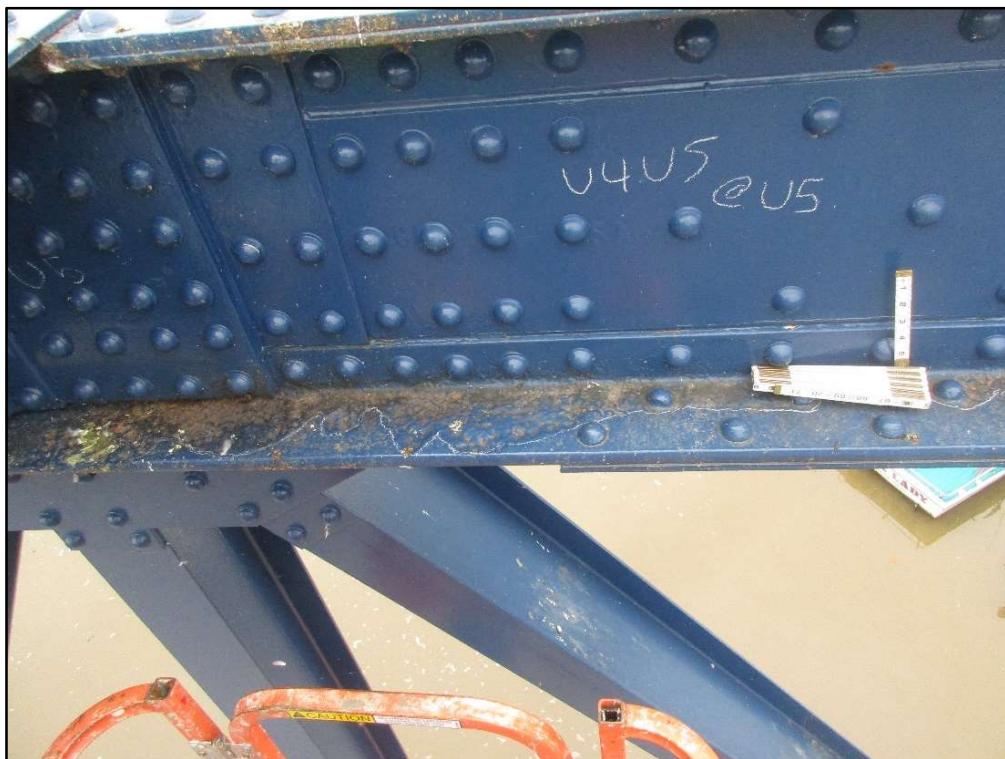
The upper chord is in **Fair** condition. Arrested pitting is typical on the bottom flange angles gussets (**Photo 30**). Minor arrested pitting is also present to the web plates in isolated areas. The top flange plate and angle are dented in isolated areas, likely due handling during transportation or erection (**Photo 31**). The top chord and end post diagonals have up to five pairs of bent lacing bars (**Photo 32**). The end posts have minor pitting in the splash zone (**Table 3**).

Photo 30 – Pitting to Bottom Flange Angle, U4U5 South

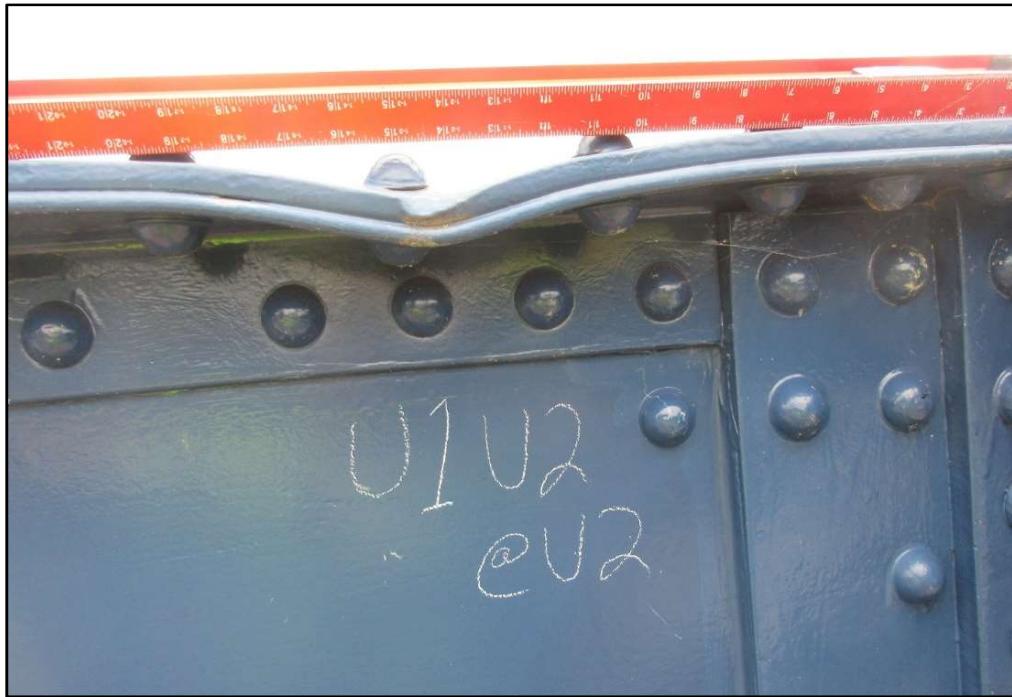
Photo 31 – Dented Top Flange Plate and Angle, U₁U₂ North
