**OHIO DEPARTMENT OF TRANSPORTATION
2018 IN-DEPTH BRIDGE INSPECTION REPORT**

**LIBERTY AVENUE OVER VERMILION RIVER
BRIDGE No. ERI-6-2284**

SFN: 2202344

2018 In-Depth Bridge Inspection Report

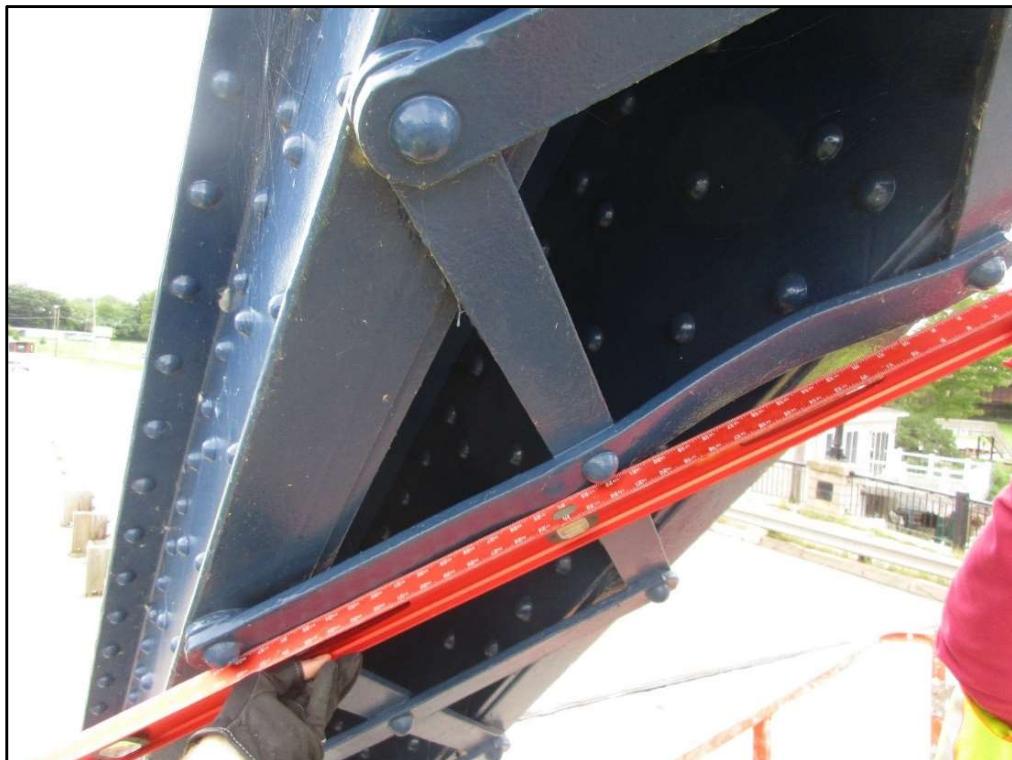
Photo 32 – Typical Bent Lacing Bar, U₈L₉ North

Panel	No. of Bent Lacing Bars	
	North Truss	South Truss
L ₀ U ₁	2	0
U ₁ U ₂	2	1
U ₂ U ₃	3	0
U ₃ U ₄	5	4
U ₄ U ₅	3	4
U ₅ U ₆	5	6
U ₆ U ₇	6	4
U ₇ U ₈	2	0
U ₈ L ₉	6	0
Total	34	19

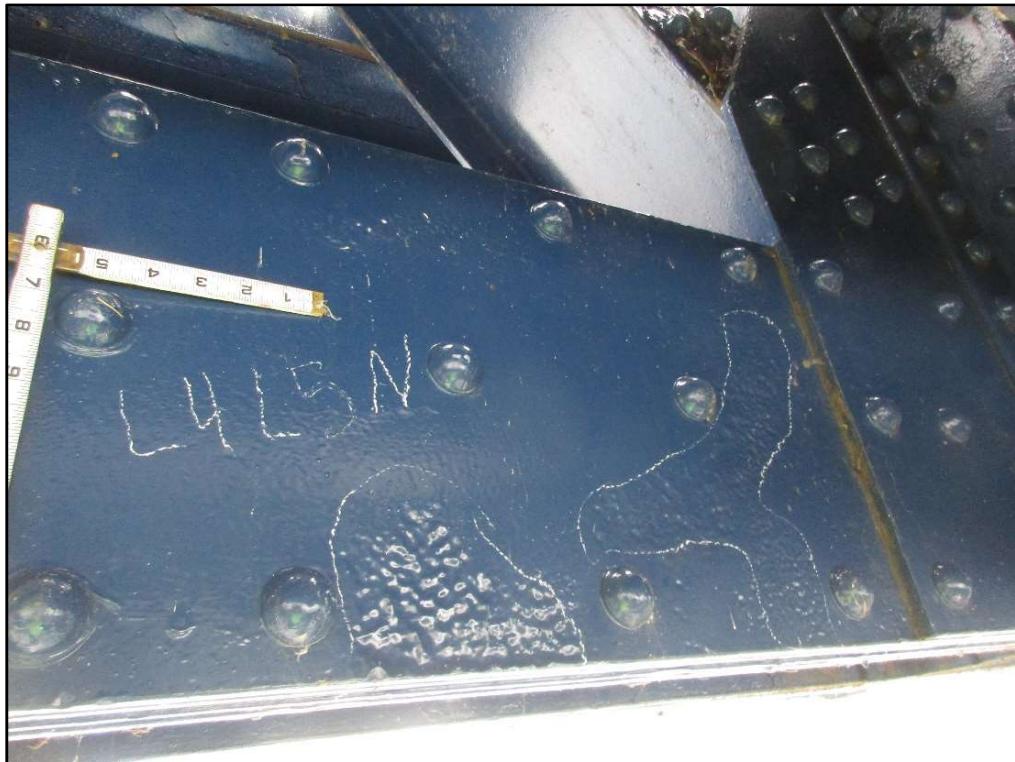
The lower chord is in **Fair** condition. Arrested pitting and loss of section is typical on the exposed web plates (**Photo 33**). Pack rust between the built-up plates is present from L₂ through L₇ with several locations now exhibiting active corrosion (**Photo 34**). This pack rust in the middle five panels occurs here and not at the end panels because the interior plates are $\frac{3}{8}$ -inch thick, much less than the $\frac{5}{8}$ -inch thickness threshold to prevent pack rust formation. In isolated areas the pack rust and associated section loss has become advanced and created perforations, with the estimated maximum section loss approximately 8%. (**Photo 35**).

Photo 33 – Typical Lower Chord Pitting

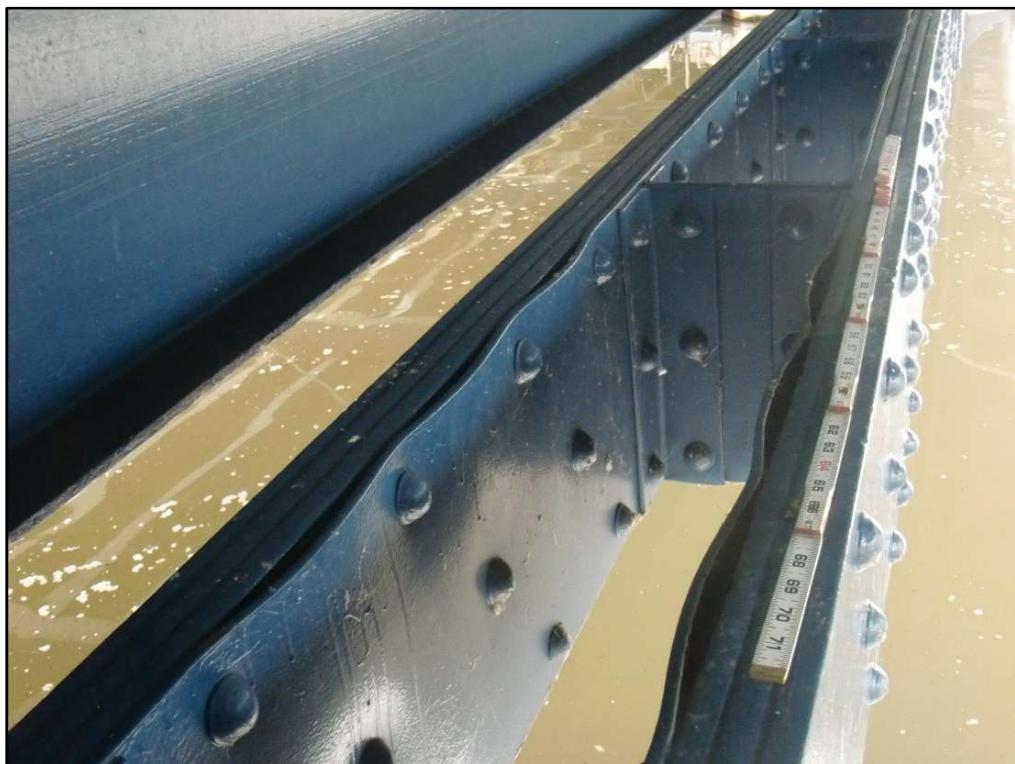
Photo 34 – Typical Lower Chord Pack Rust, L₂ to L₇

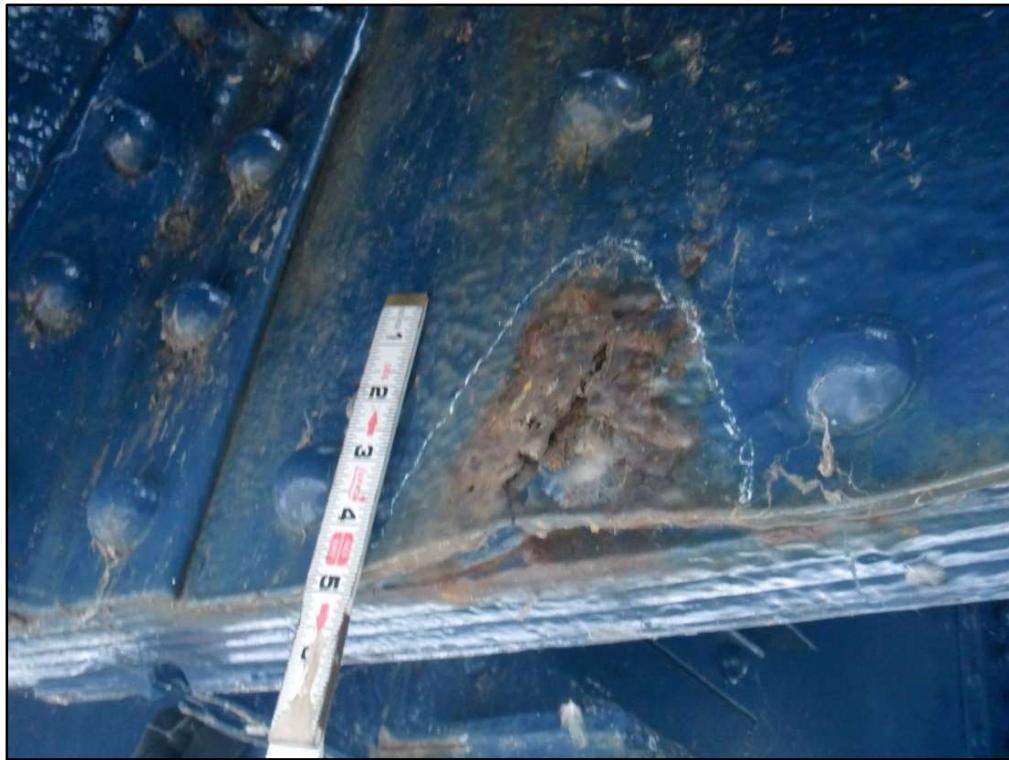
Photo 35 – Lower Chord Web Plate Perforation, L₂L₃ North

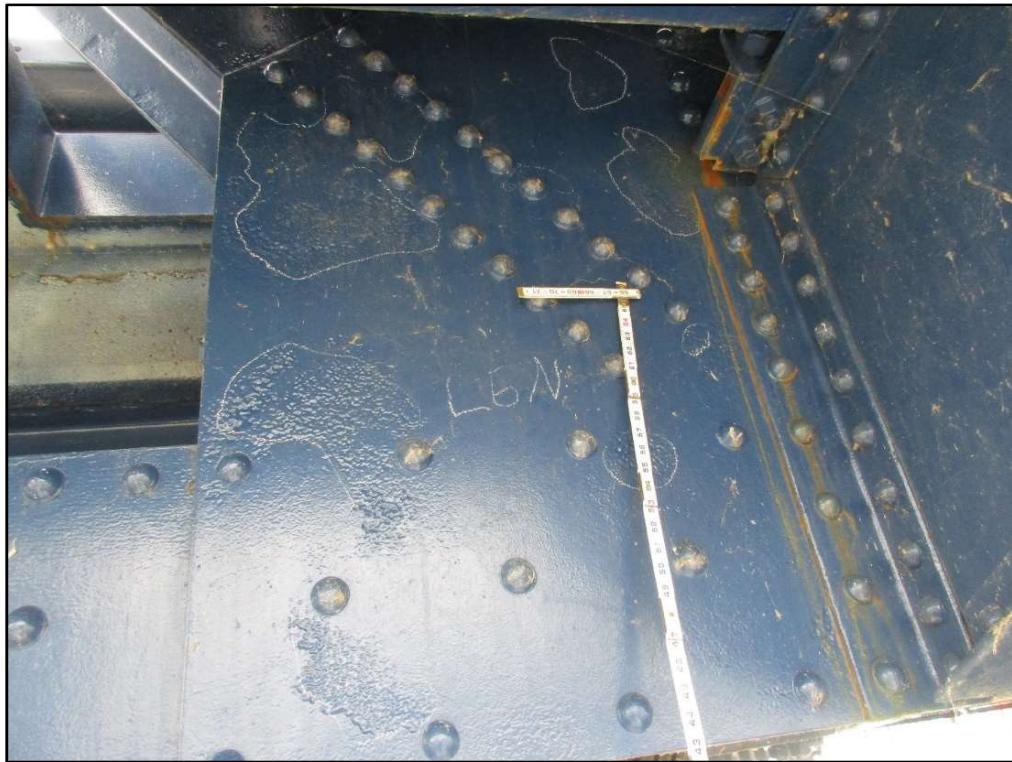
Photo 36 – Typical Scattered Minor Pitting, L6 North Exterior Gusset Plate

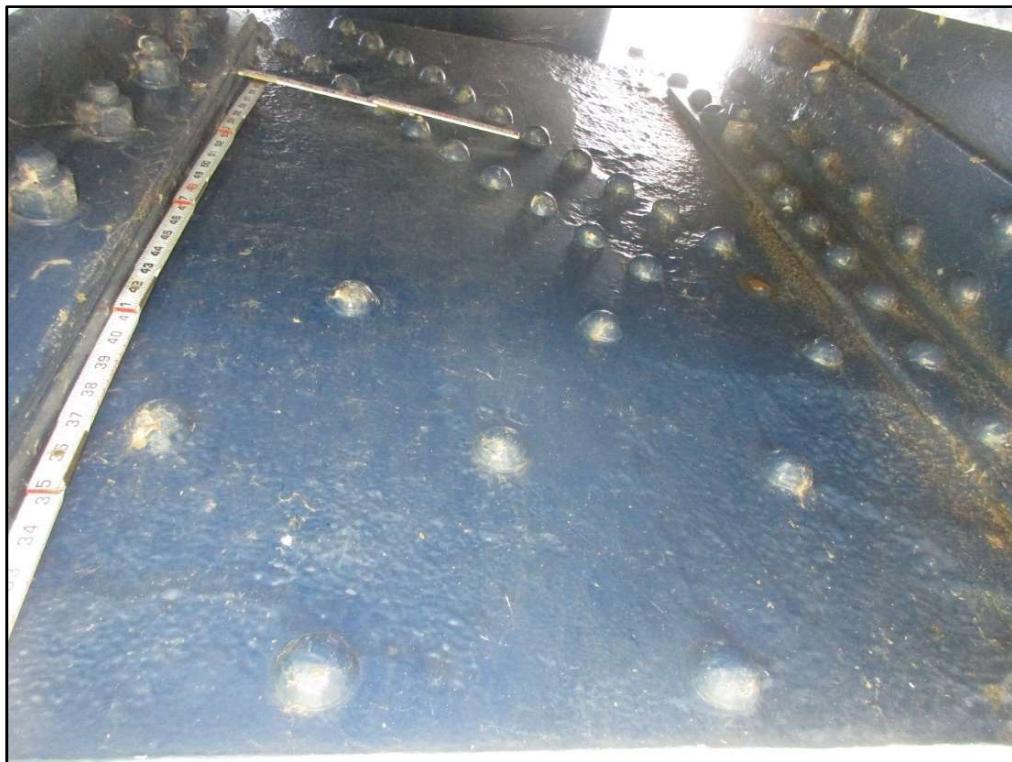
Photo 37 – Pitting with Perforations, L6 South Interior Gusset Plate

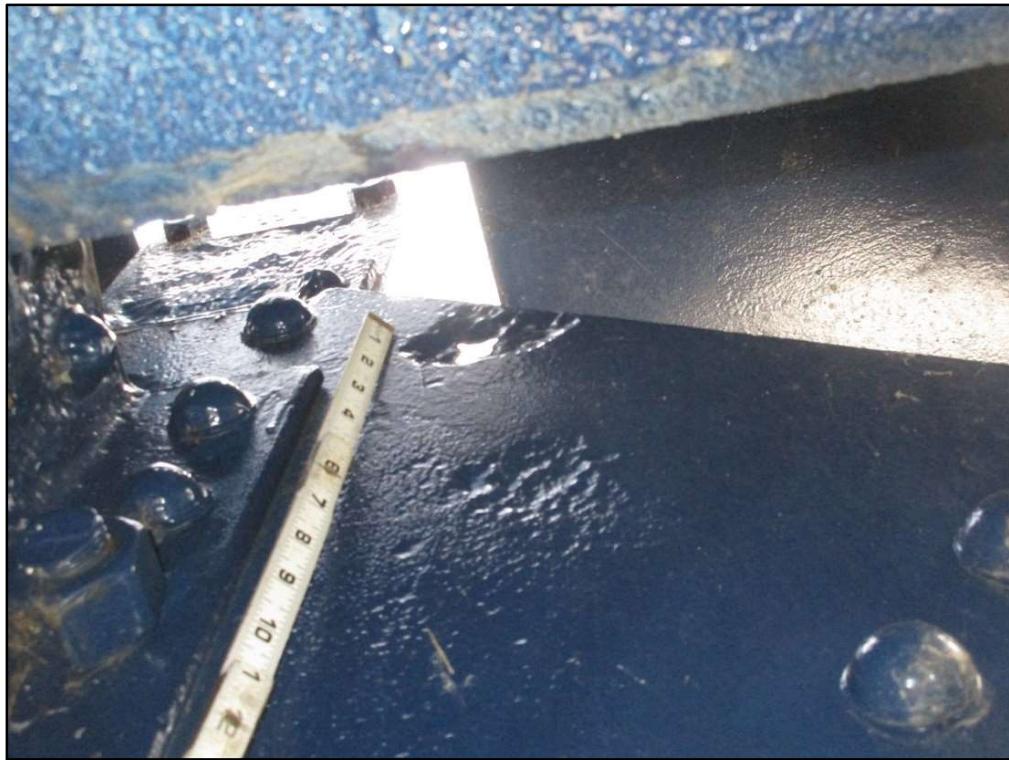
Photo 38 – Perforation at Top of Interior Gusset Plate, L4 South

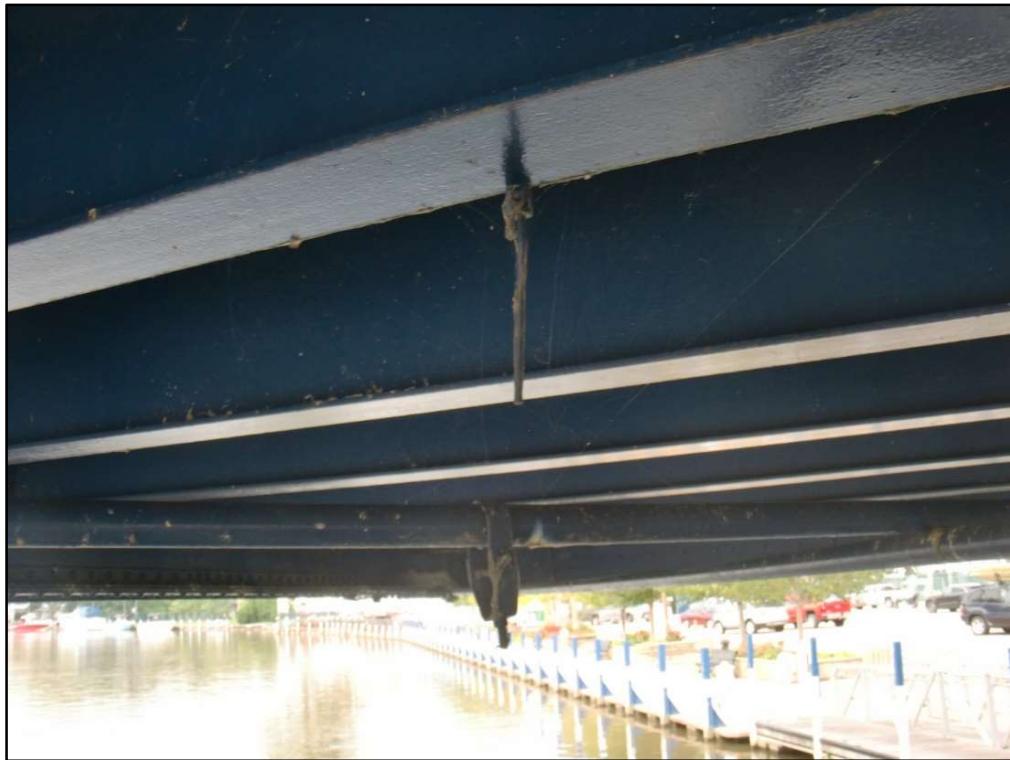
The lower lateral bracing is in **Good** condition. The lower lateral bracing ties and gusset plates have been replaced and are in good condition. Minor deficiencies to the lower lateral bracing members are a slightly bent rod in Panel 7 and a broken hanger in Panel 9 (**Photo 39**).

Photo 39 – Broken Lower Lateral Bracing Rod Hanger, Panel 7

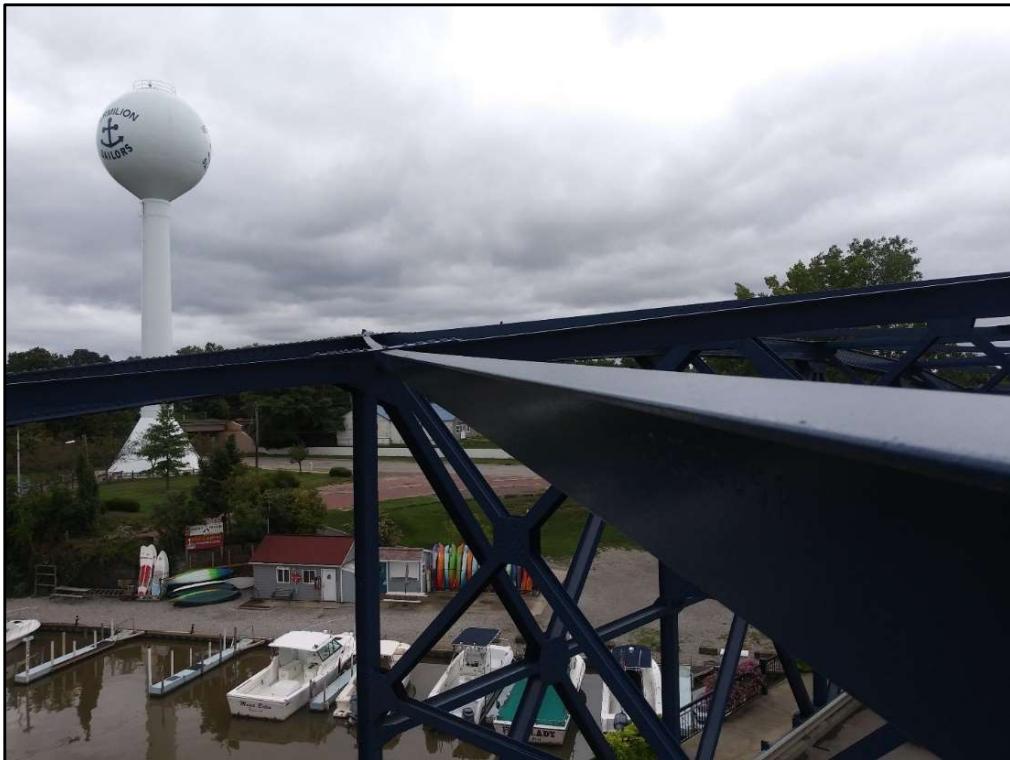
The upper later bracing also is in **Good** condition. The angles that form upper lateral bracing members are sagging due to self weight but appear to be functioning as designed (**Photo 40**).

Photo 40 – Typical Upper Lateral Bracing Sag

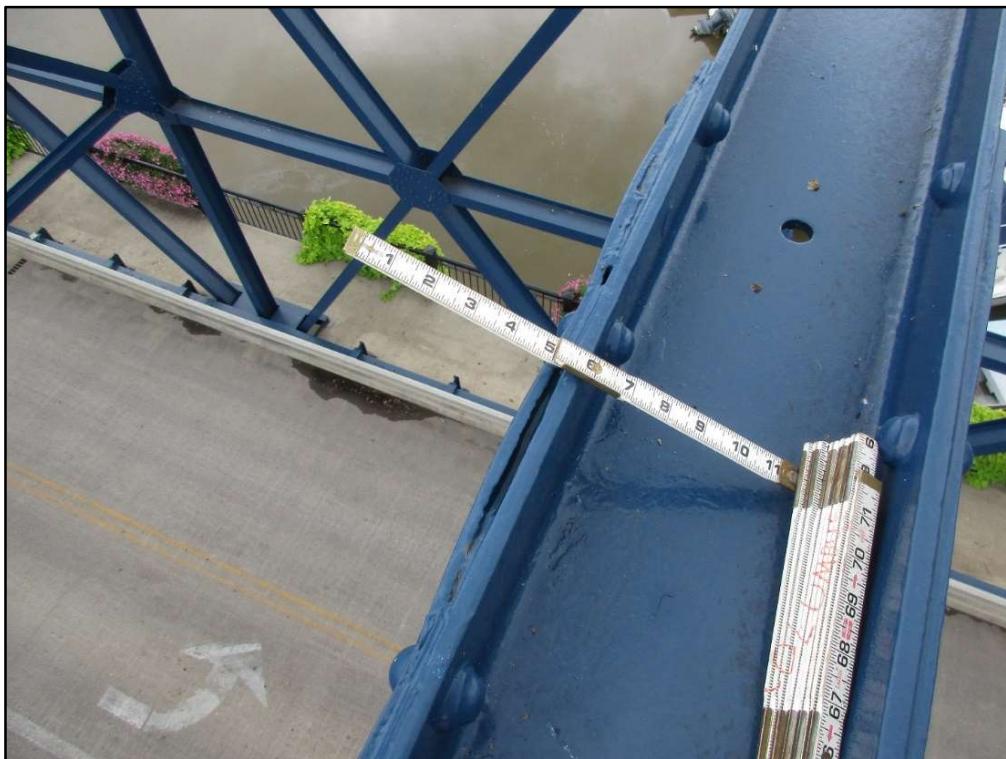
The sway bracing is in **Fair** condition. Typical deficiencies throughout the sway bracing includes arrested pitting of the connection angles connecting to the gussets with isolated perforations (**Photo 41**). Minor deficiencies to the sway bracing include scattered pitting and dented flanges of the struts and diagonals as well as pack rust at the top and bottom connection plates in the portals (**Photo 42**).

Photo 41 – Typical Pack Rust Behind Sway Bracing Gusset

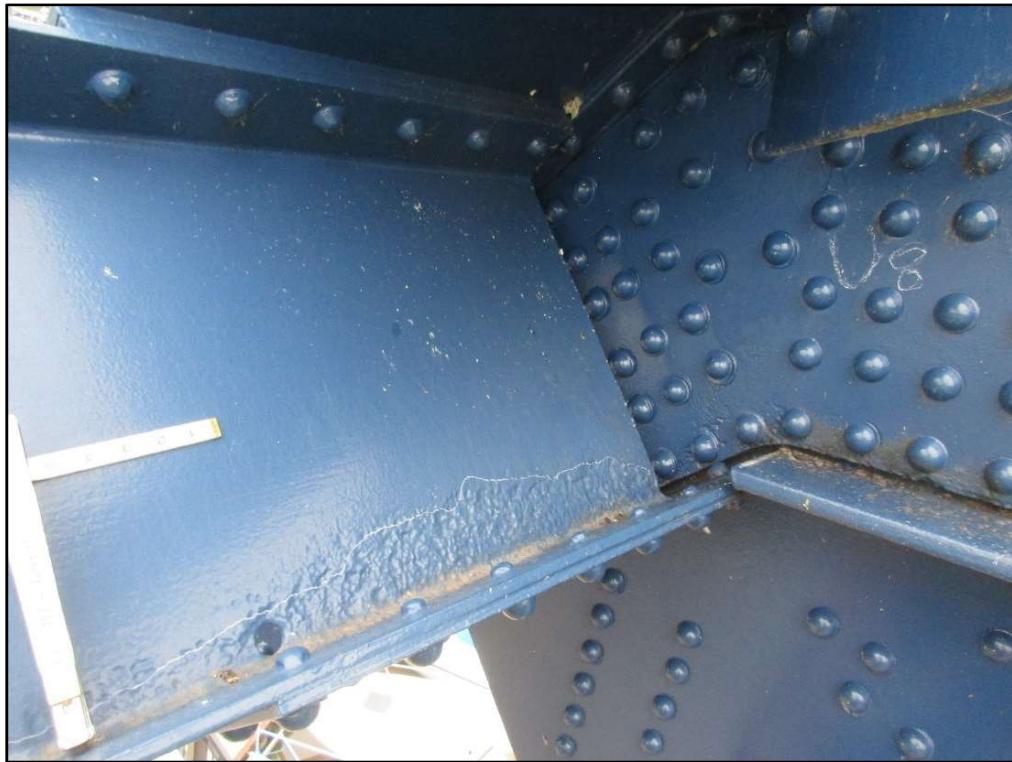
Photo 42 – Minor Web Pitting, East Portal

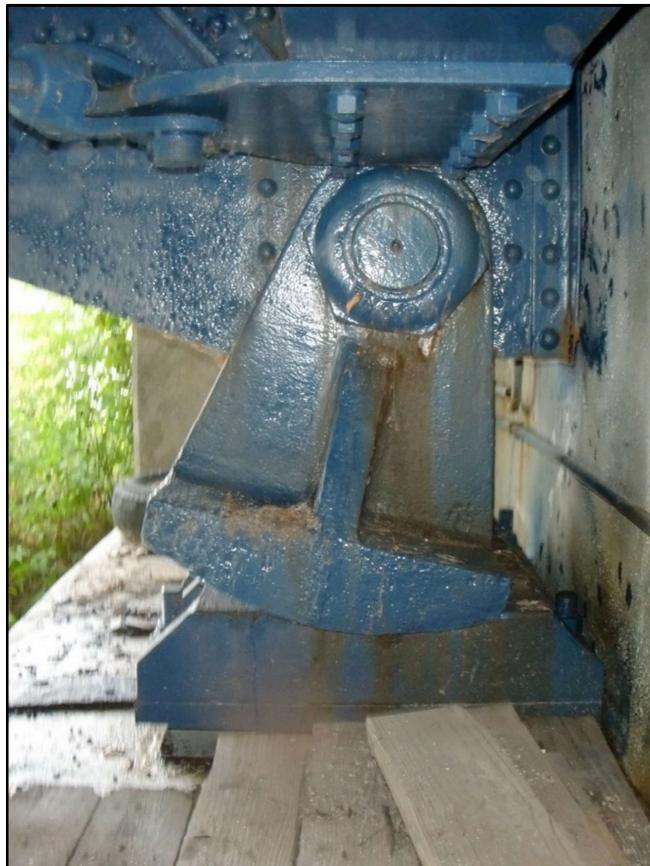
The bearings are in **Fair** condition. Minor pitting is typical on the bearings. The fixed bearings at the forward abutment have active corrosion around the pins and pin nuts. Several anchor bolt nuts are not seated. (Note: This is not considered to be a problem.) At the rear abutment, the north rocker is tilted toward the backwall 16° degrees and the south rocker is tilted toward the backwall 14° degrees (**Photo 43**). Also, the north and south elastomeric bearing pads are deformed 1" and $1\frac{1}{16}$ " respectively toward the backwall. This over-expansion as measured at 70° F, and is similar to that observed at 20° F in January 2018.

Photo 43 – Expanded Rocker Bearing,
Lo South at 75° F

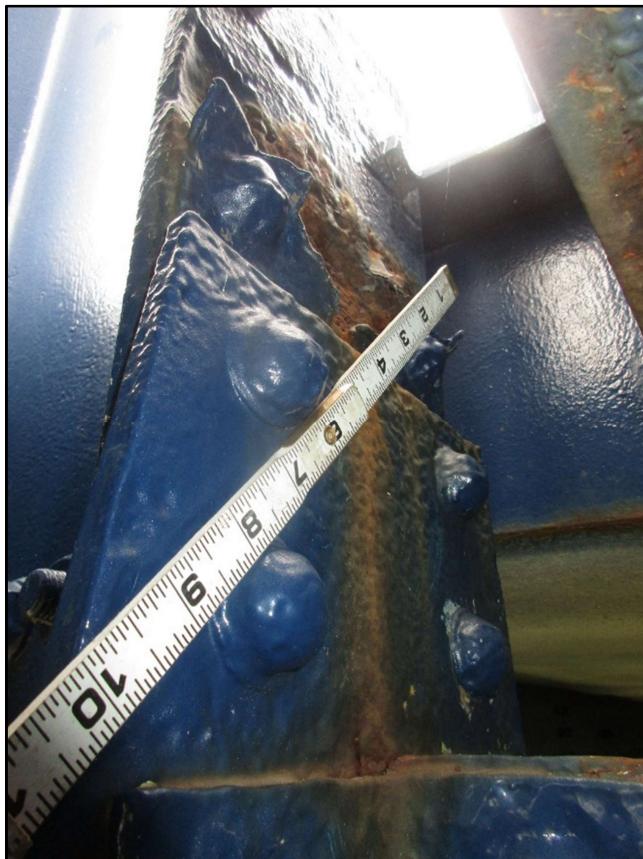
The paint system is in **Good** condition and is rated as a **7** on the modified protective coating rating system. Scattered areas of active corrosion exist throughout with isolated locations of re-activating pack rust, especially at the bearing gussets (Photo 44). Local protective coating failure is also present on the unpainted exterior deck stringer tops adjacent to edge spalls. Chipped paint is present on the truss end posts. Excessive pigeon manure is present inside the upper chord and on the lower lateral bracing gussets (Photo 45).

Photo 44 – Common Local Protective Coating System Failure & Reactivating Pack Rust Failure, Bearing Gusset Plates

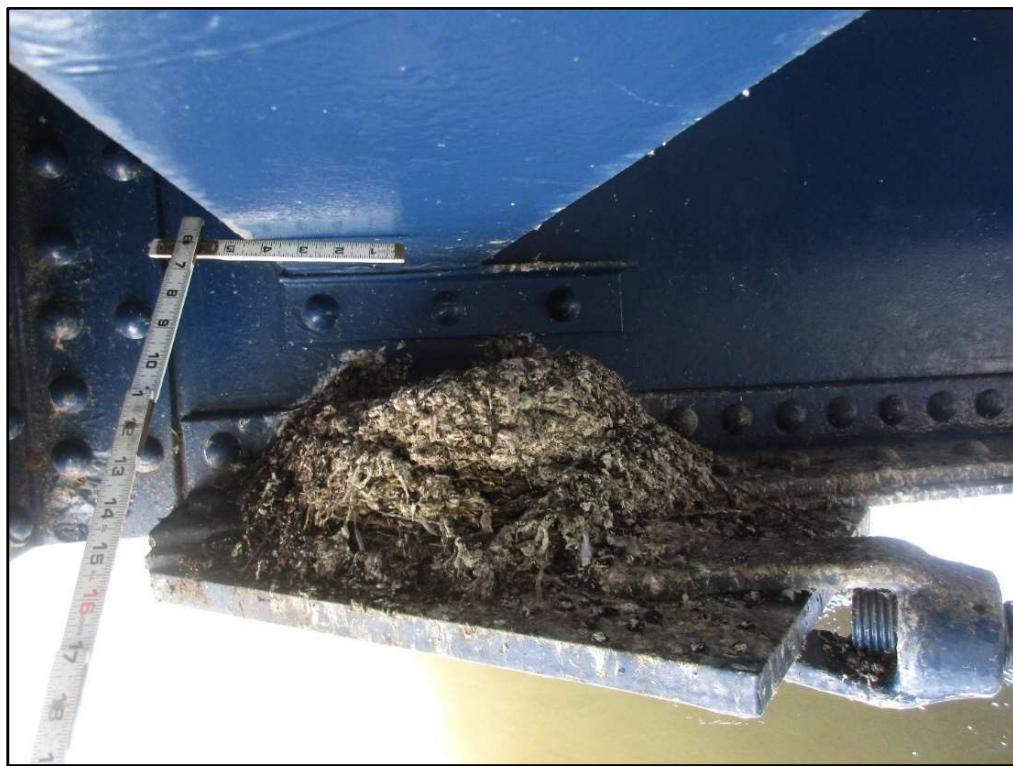
Photo 45 – Typical Pigeon Manure Pile, Lower Lateral Bracing Gusset Plate

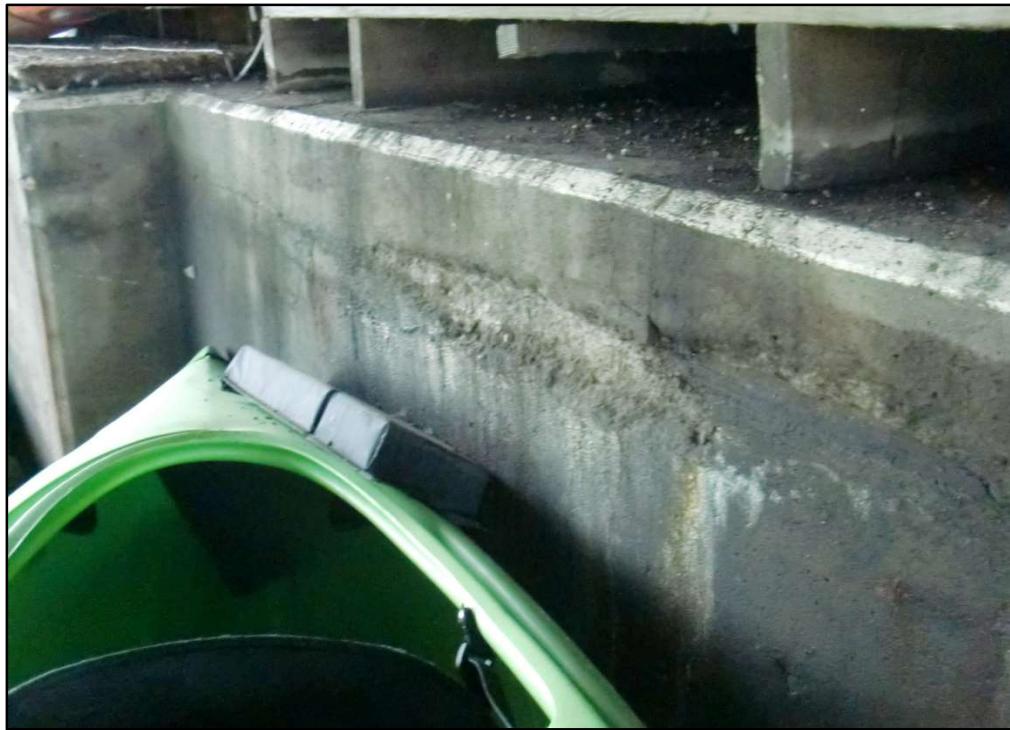
The abutments are in **Fair** condition. The Rear Abutment has isolated areas of minor popouts along edges of patches and scaling patches (**Photo 46**). The Forward Abutment also has several areas of delaminations (**Photo 47**). The 2016 In-Depth inspection documented that the Rear Abutment was leaning $\frac{3}{4}$ " over 4 feet to the north and leaning away from the river $\frac{3}{8}$ " horizontally per four feet vertically. These observations likely are attributed to formwork and finishing variations, however continued observation during this and future inspections is warranted.

Photo 46 – Scaling Below New Abutment Seat, Rear Abutment

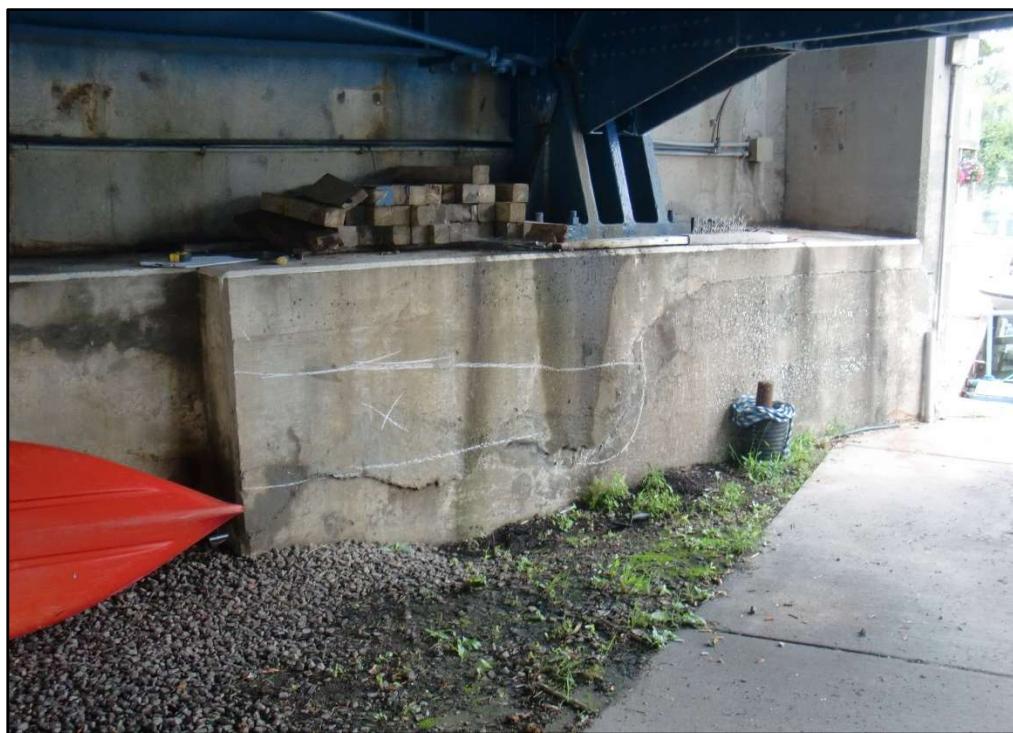
Photo 47 – Delamination Below New Abutment Seat, Forward Abutment

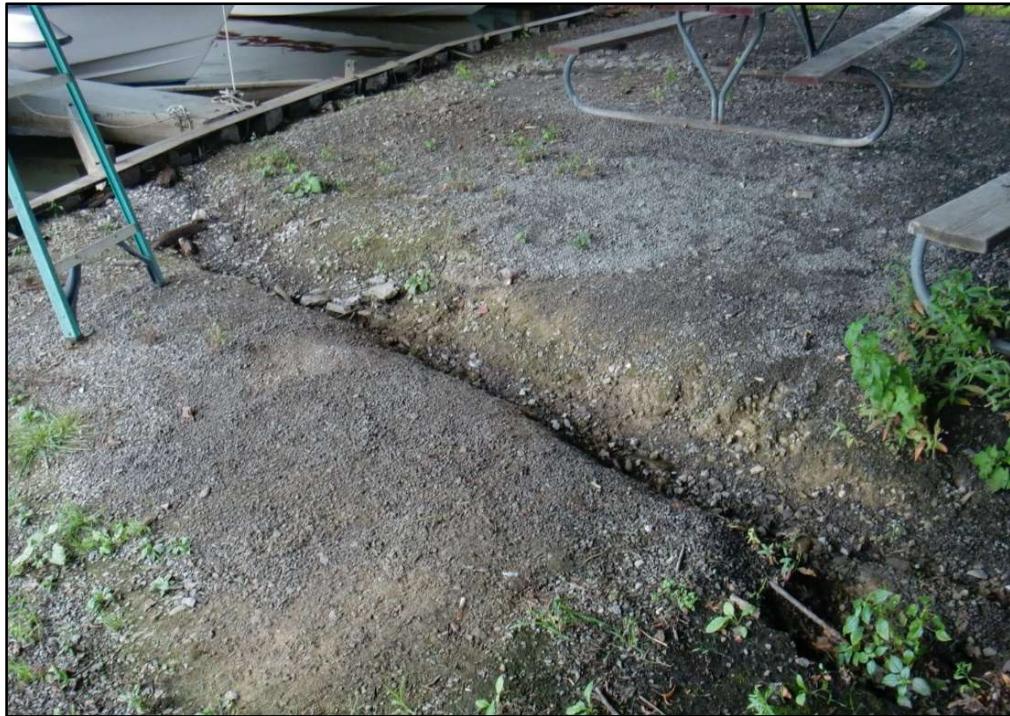
The slope protection is in **Fair** condition. An erosion gully is present running from the abutment wall to the slope protection at the Rear Abutment (**Photo 48**).

Photo 48 – Erosion Gully, Rear Abutment

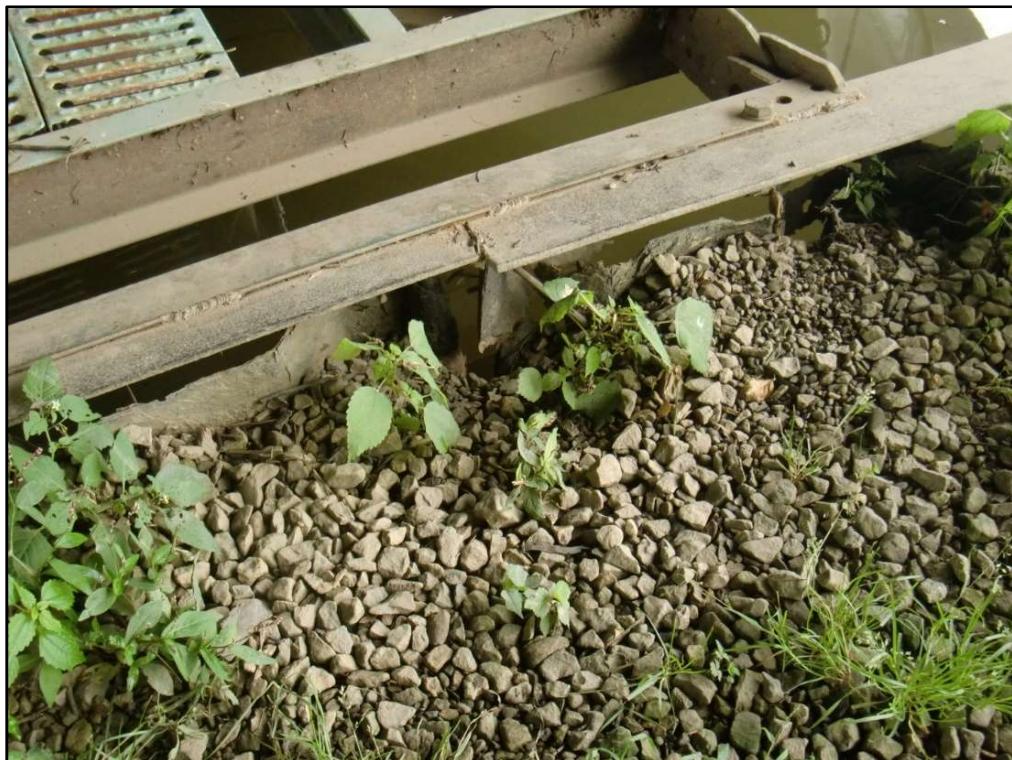
Photo 49 – Hole in Sheet Pile Wall, Rear Abutment

The channel protection consists of sheet pile walls along both banks and is in **Good** condition. Both walls are leaning inward very slightly. A 6" long hole is present at the top of the Rear Abutment sheet pile (**Photo 49**).

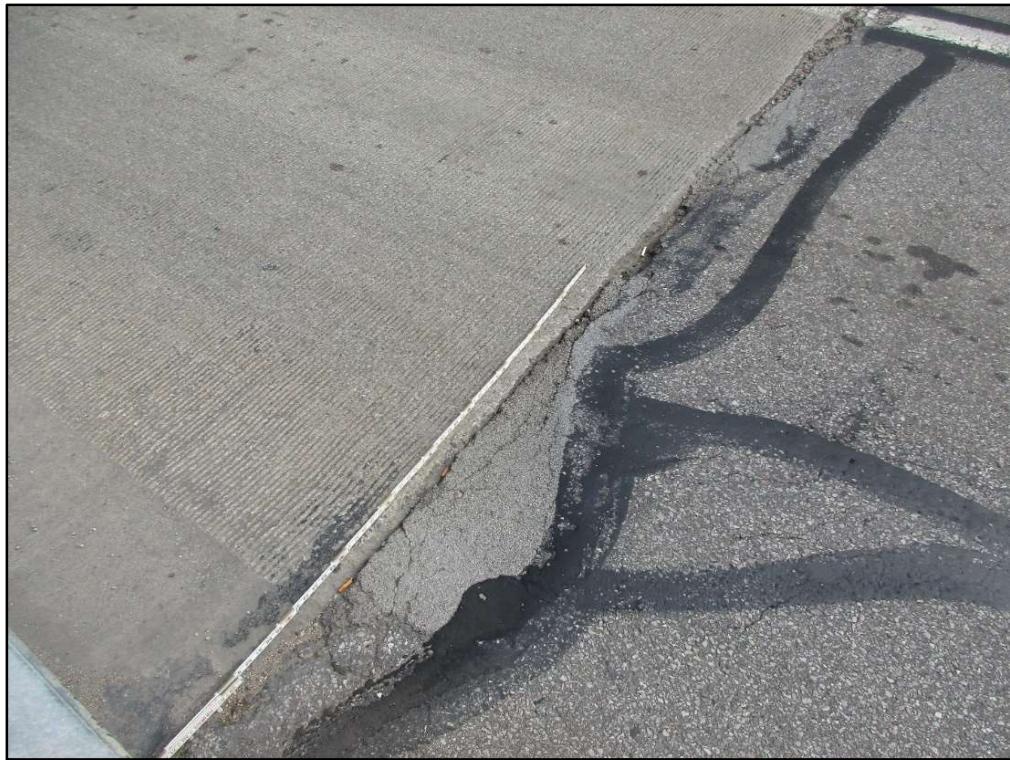
The approach pavement is in ***Fair*** condition. Both approaches have sealed cracks throughout. The West Approach has a small bump between the pavement and the approach slab and a deteriorating pothole patch, 14' wide x 15" long, in the right westbound lane at the approach slab (**Photo 50**). The East Approach has a pothole, 12" wide x 6" long x 3" deep, in the right westbound lane at the approach slab (**Photo 51**).

Photo 50 – Deteriorating Approach Wearing Surface Patch, West Approach

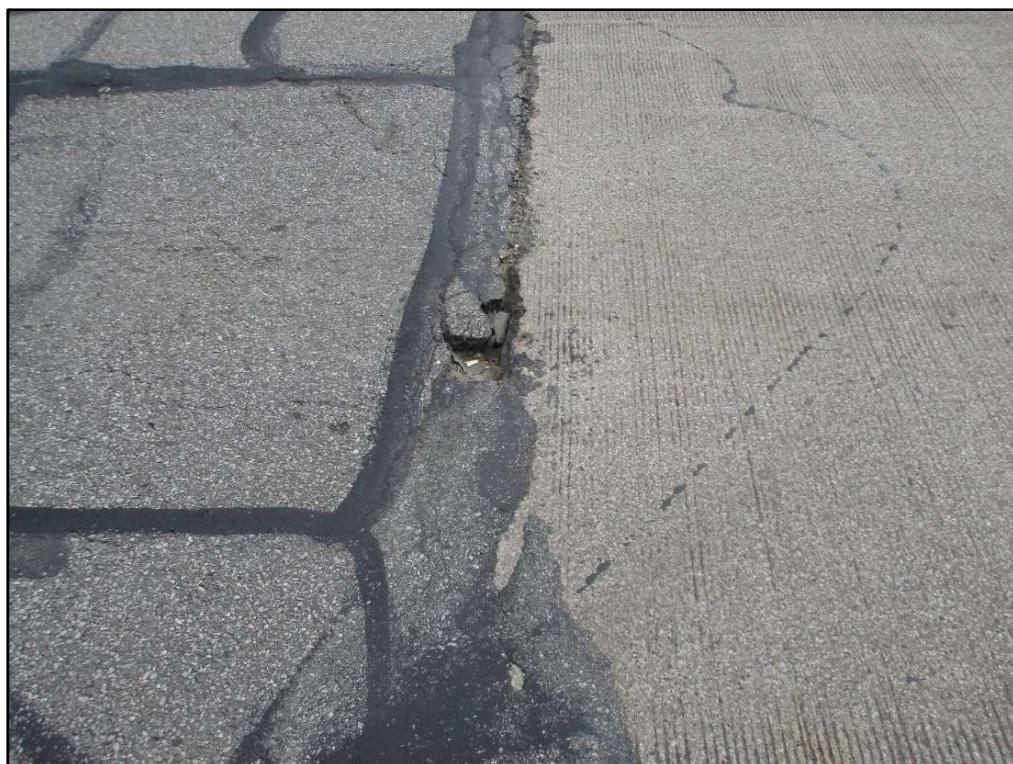
Photo 51 –East Approach Pothole

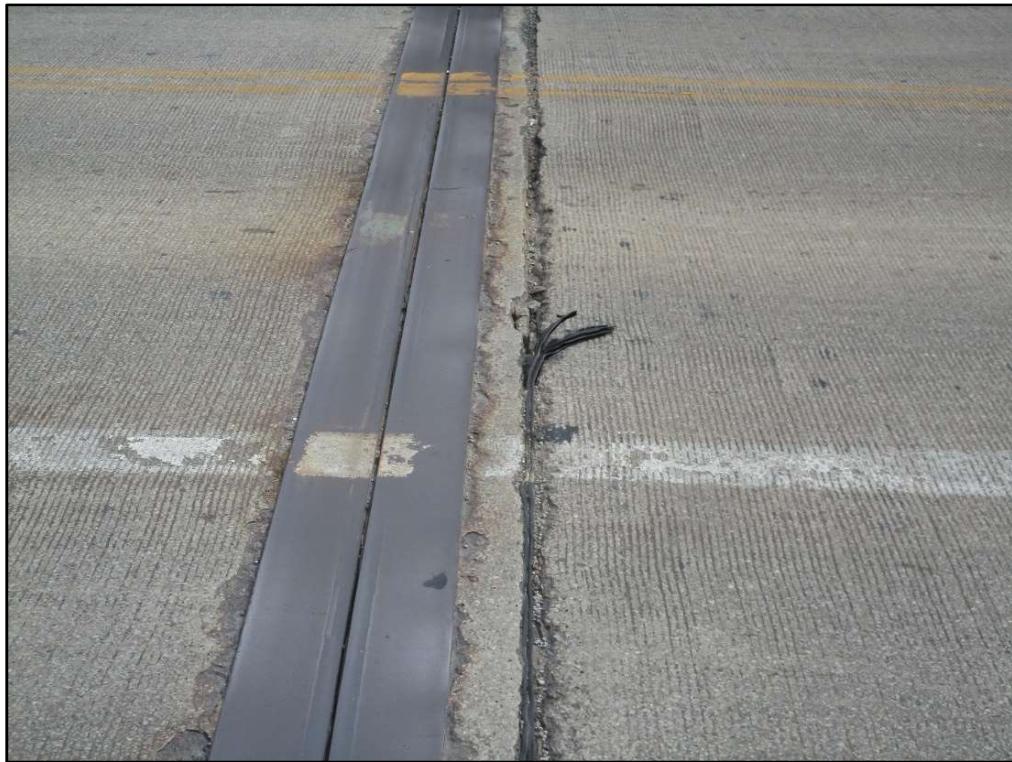
Photo 52 – Torn Compression Seal, Rear Approach

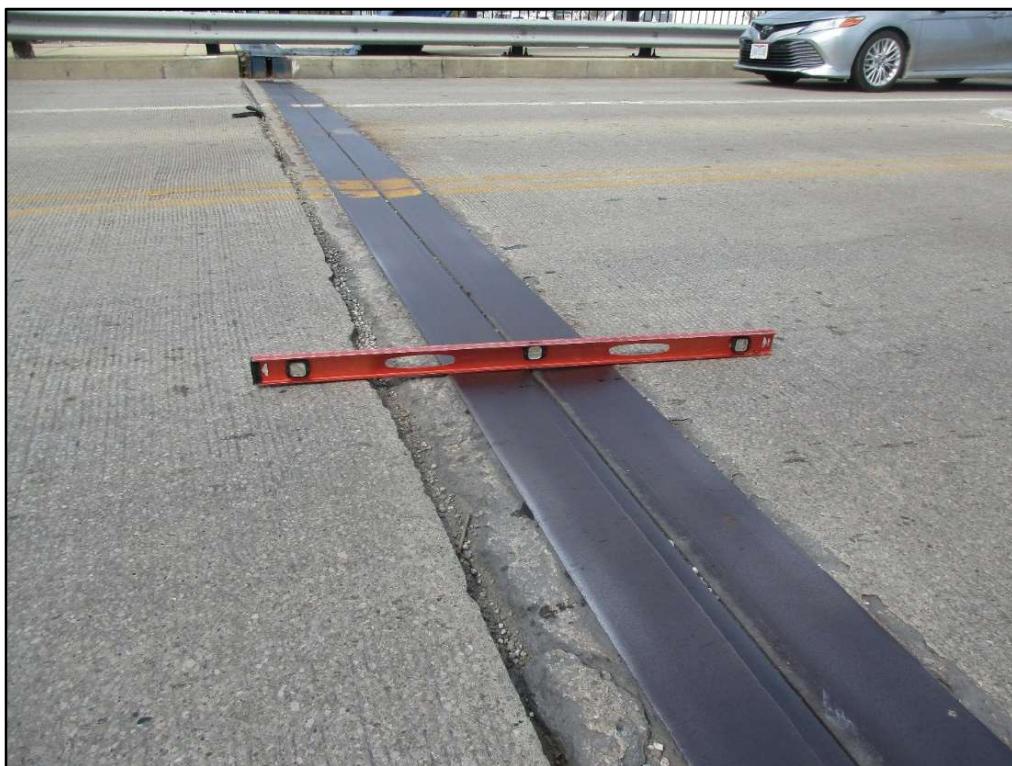
Photo 53 – Uneven Approach-to-Floor Transition, Rear Approach

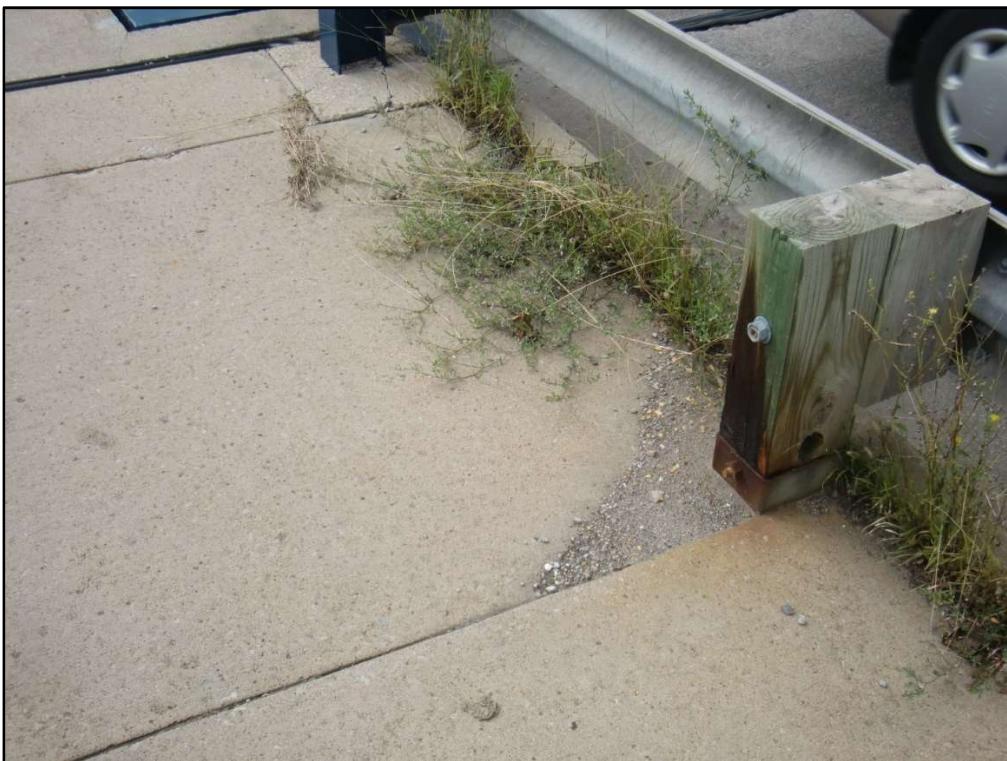
Photo 54 – Typical Approach Sidewalk Settlement (Northwest Approach Sidewalk shown)

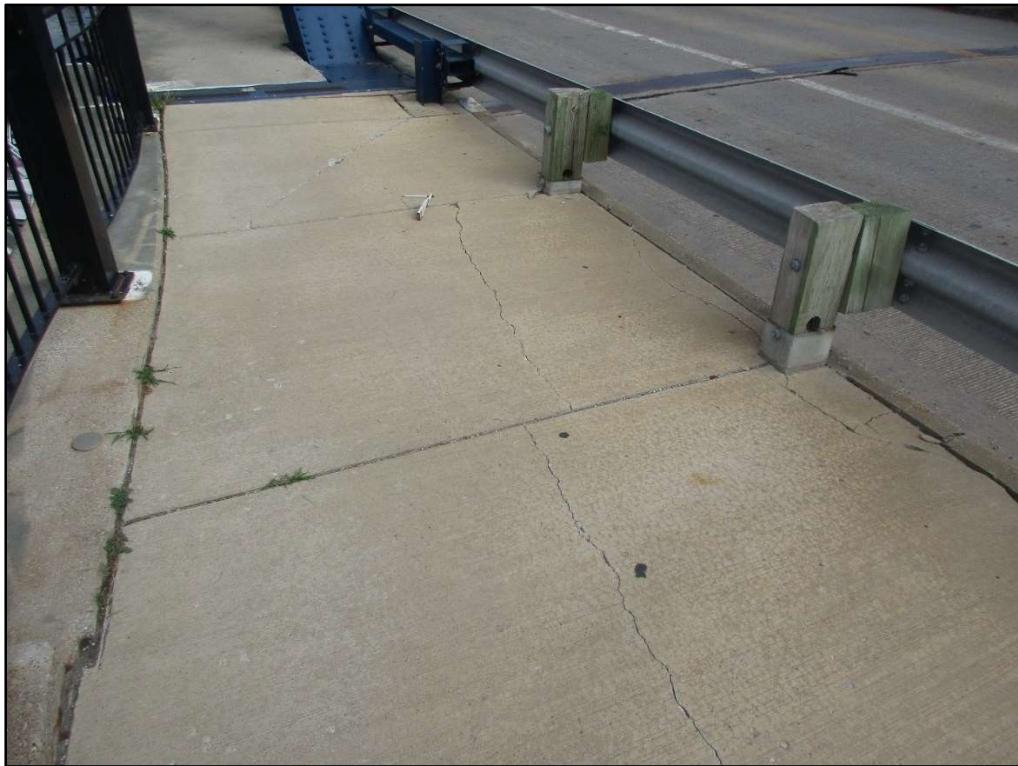
Photo 55 – Settlement & Vegetation, Southeast Approach Sidewalk

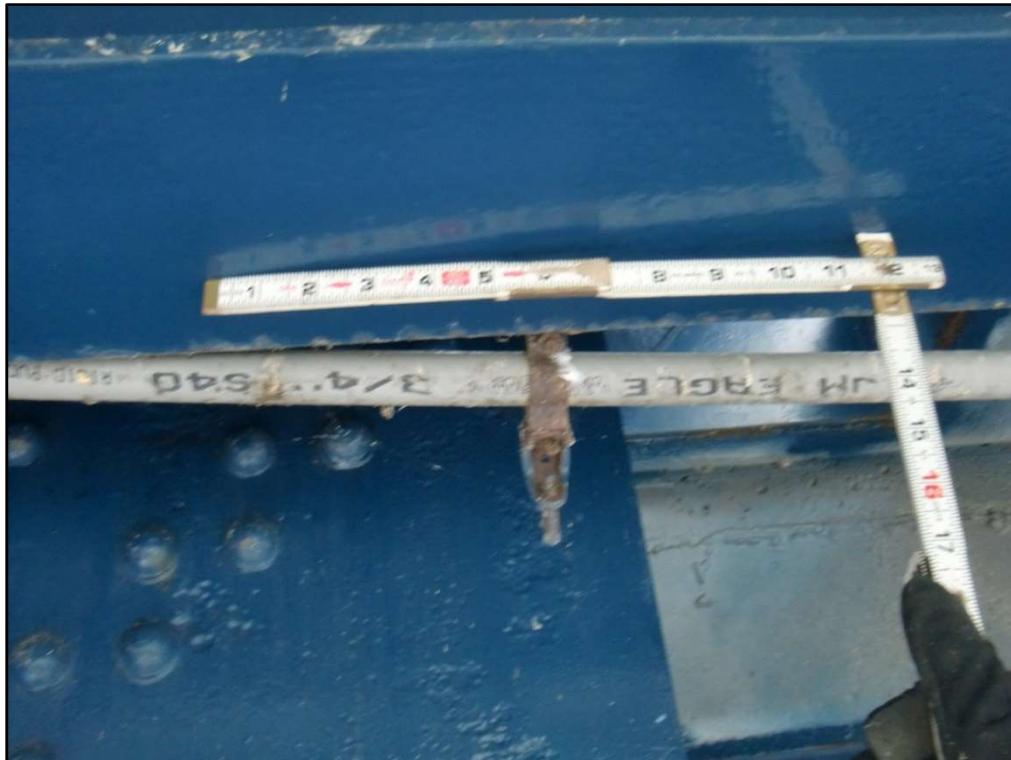
Photo 56 – Broken Electrical Conduit & Hanger

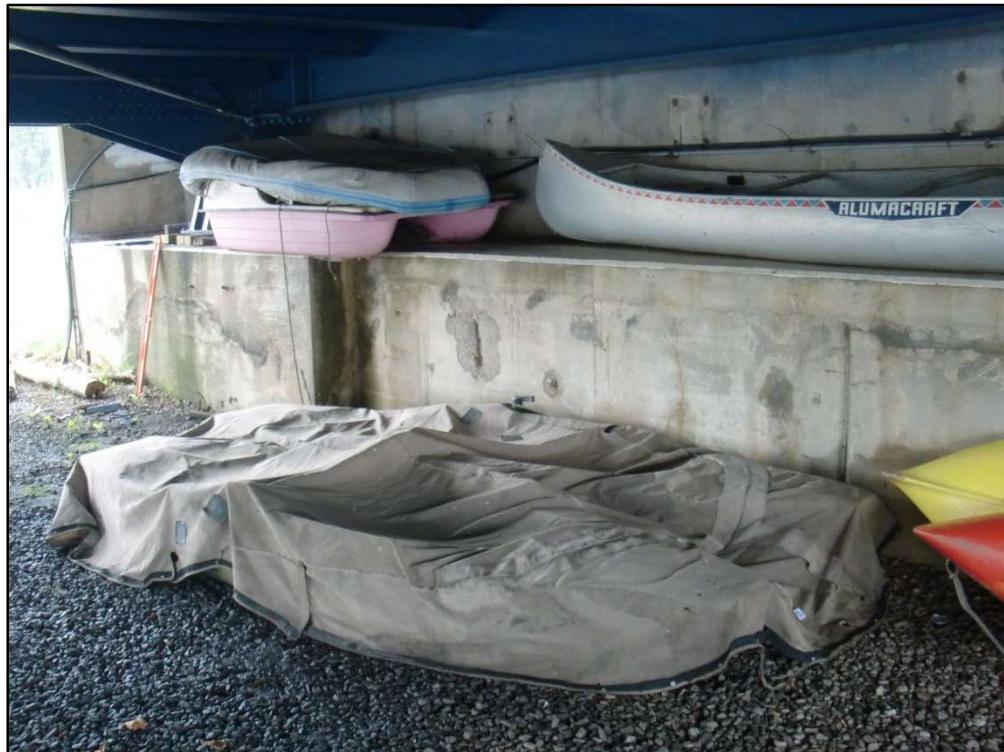
Private docks are below the structure along both shorelines of the Vermilion River. Small Watercraft is being stored along both abutment barrels and on top of both abutment seats (**Photo 57**). At the Rear Abutment, flammable containers and charcoal grills are being stored on the abutment seat and near the truss superstructure (**Photo 58**).

Photo 57 – Private Watercraft Stored on Forward Abutment Seat

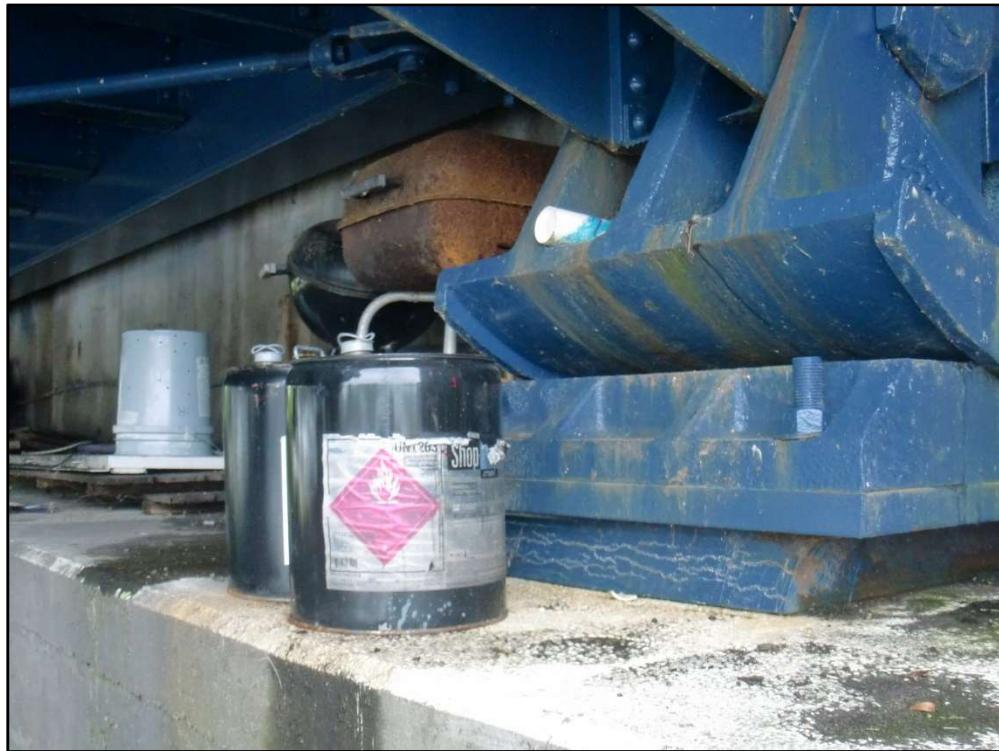
Photo 58 – Flammable Material & Charcoal Grills Stored on Rear Abutment Seat
