Inspection Date: 09/12/2024

Facility Carried: SR 93

Ohio Bridge Inspection Summary Report

STA-00093-0434 (7604831)

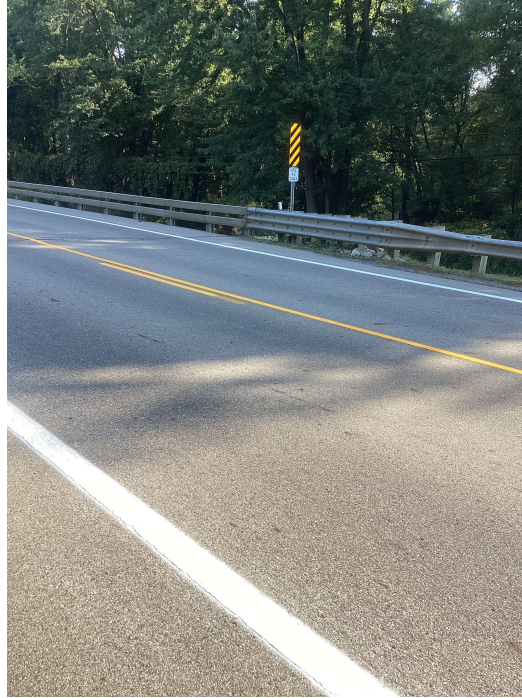
PHOTO 3

321-Reinforced Concrete Approach Slab	3 - Mod.	1200	sq. ft.	1128	72	0	0
Paved over, new asphalt 2020. CS2: - D-Cracking full width at expansion joints.							
330-Metal Bridge Railing	3 - Mod.	306	ft.	306	0	0	0
815-Drainage	3 - Mod.	2	each	2	0	0	0
830-Abutment Backwall	3 - Mod.	72	ft.	48	12	12	0
CS2: - Vertical cracks <1/16" with saturation and effl. at both backwalls. - Horizontal crack <1/16" forward abutment bay #3 approx. 4lf. CS3: - Spalls >1" with concrete deterioration at top of backwall at forward abutment bay #1, approx. 4' long. Bay #2 approx 4' long. Bay #3 approx. 2' long. - Spalls >1" with concrete deterioration at top of backwall at right rear, approx. 2' long.

Description Rear approach

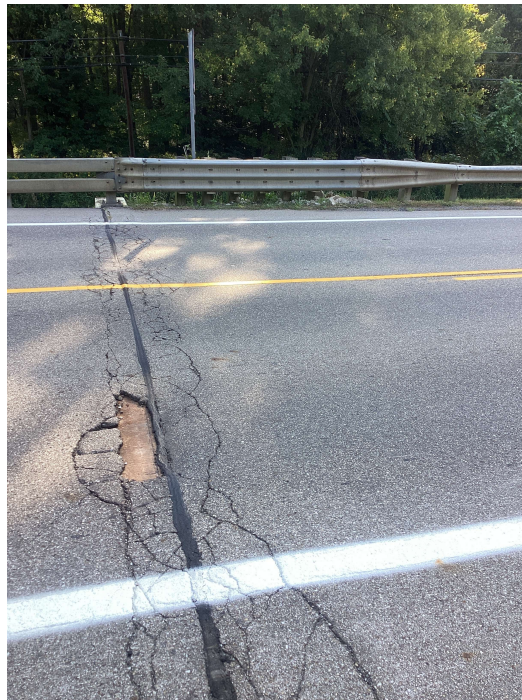
PHOTO 4

New asphalt 2020. CS2: - D-cracking full width at expansion joints. CS3: - Pothole over expansion joint at rear left, approx. 4' long. - Pothole over expansion joint at forward left and center, approx. 6' long.							
107-Steel Open Girder/Beam	3 - Mod.	765	ft.	750	15	0	0
CS2: - Minor section loss at abutments at web/bottom flange joint, has been painted over. - Beam ends within 1" of backwall at rear abutment. Appears beams ends at forward abutment trimmed 2020.							
515-Steel Protective Coating		8524	sq. ft.	8324	186	14	0
CS2: - Areas of rust and rust staining along top flanges throughout from saturated deck. - Rust and rust staining at beam ends. CS3: - Peeling along top top flange beam 1 span 1 approx. 14sf							
205-Reinforced Concrete Column	3 - Mod.	3	each	3	0	0	0
Scaling, has been sealed over.							
215-Reinforced Concrete Abutment	3 - Mod.	72	ft.	64	4	4	0
Patched and sealed 2020. CS2: - Isolated vertical cracks <1/16" approx. 2 ea. CS3: - Map cracking <1/16" at patched area at forward bay 3, 4lf.

Description Rear joint

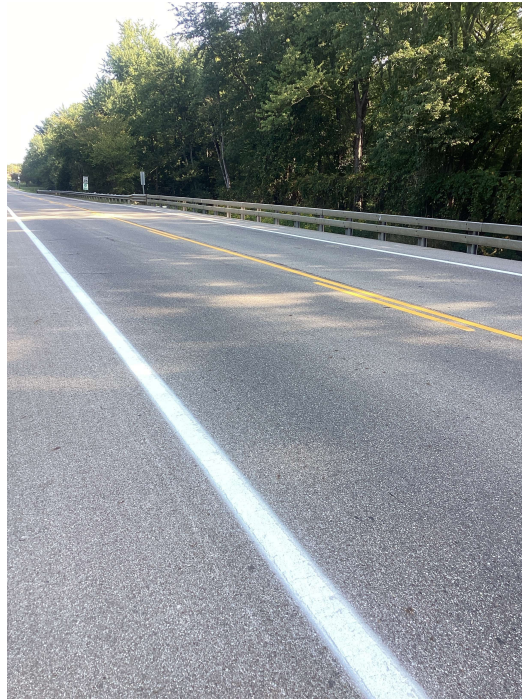
PHOTO 5

Description Wearing surface

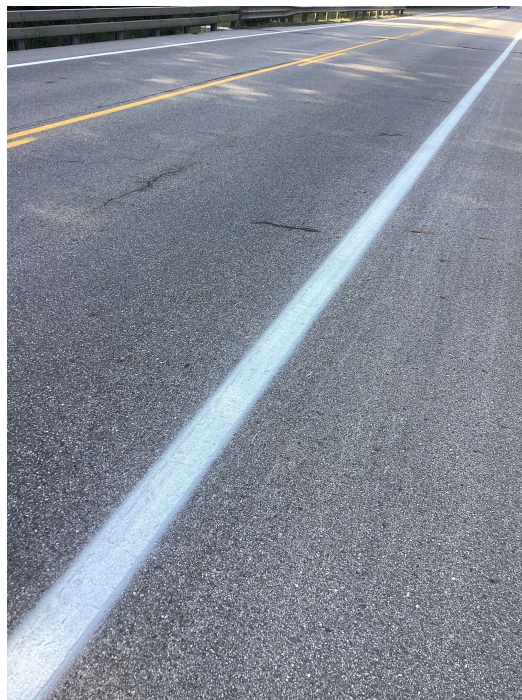
PHOTO 6

Description Wearing surface

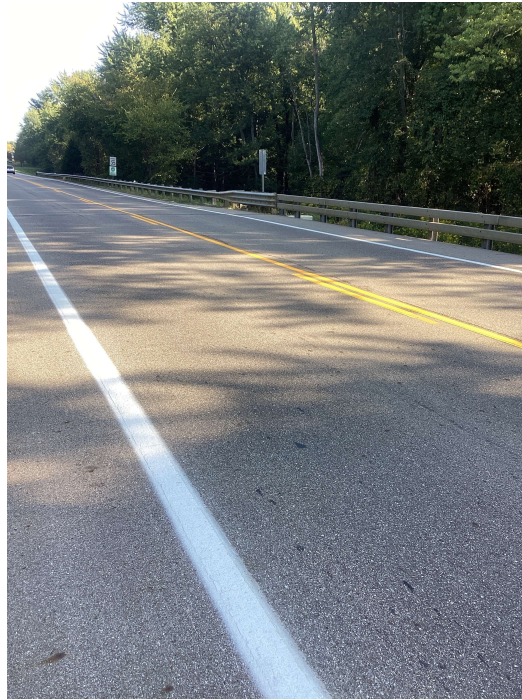
PHOTO 7

Description Wearing surface

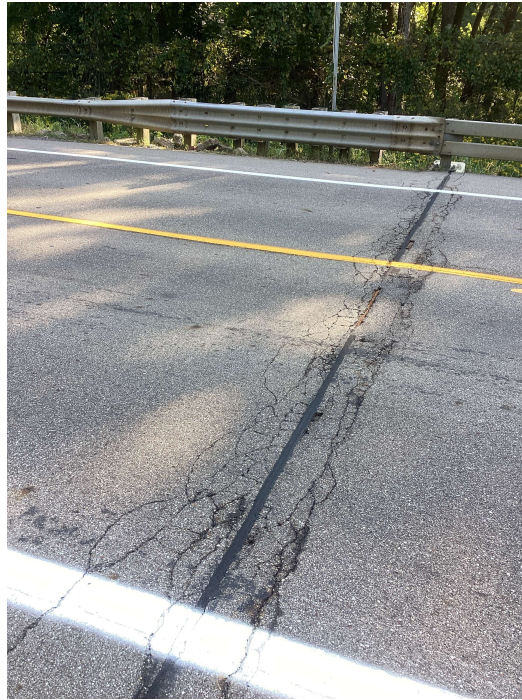
PHOTO 9

Description Forward joint

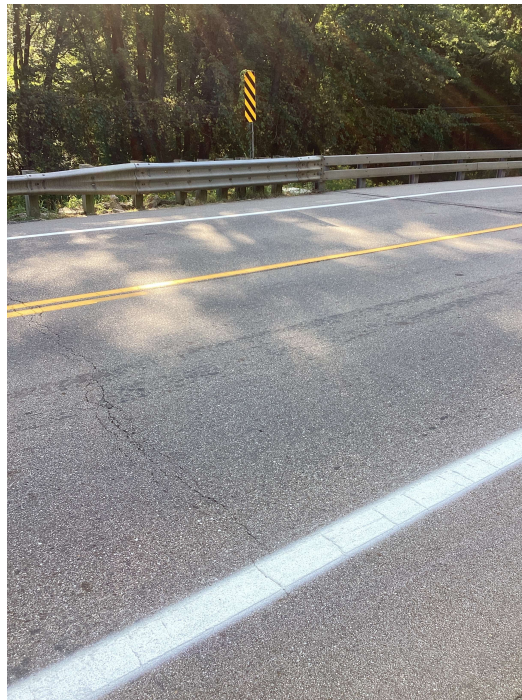
PHOTO 10

Description Forward approach

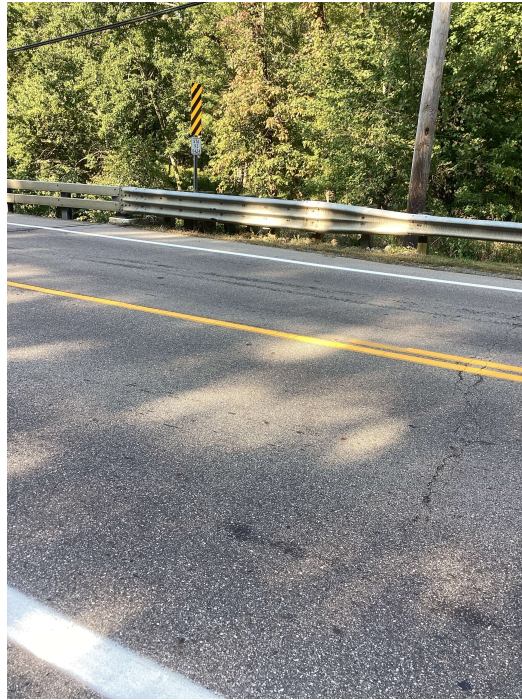
PHOTO 11

Description Forward approach

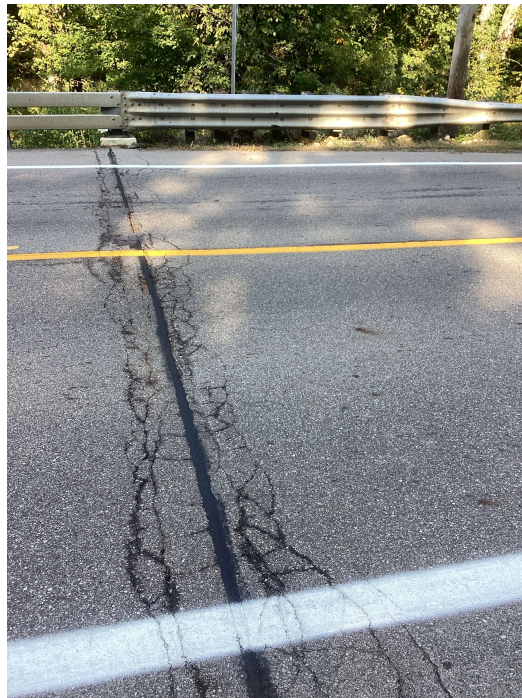
PHOTO 12

Description Forward joint

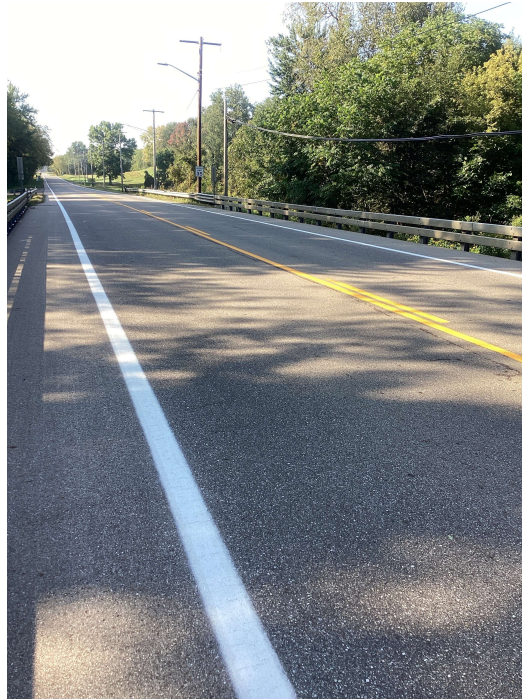
PHOTO 13

Description Wearing surface

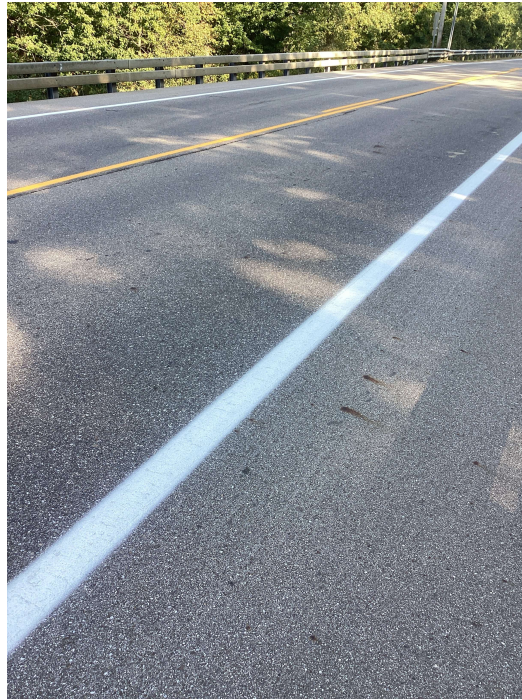
PHOTO 15

Description Wearing surface

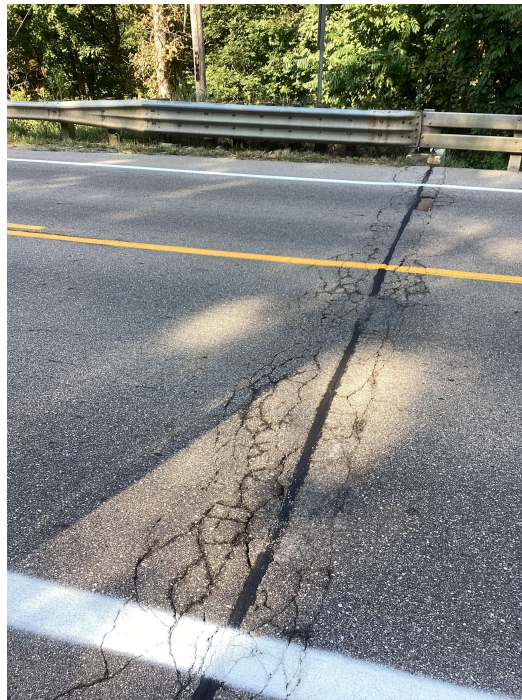
PHOTO 16

Description Rear joint

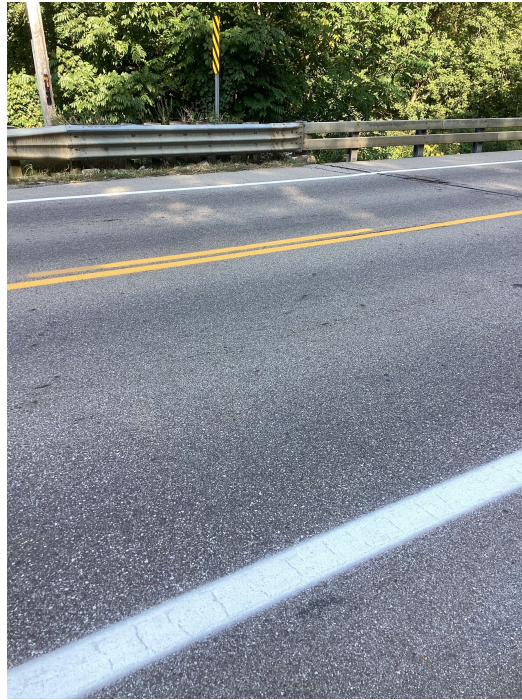
PHOTO 17

Description Rear approach

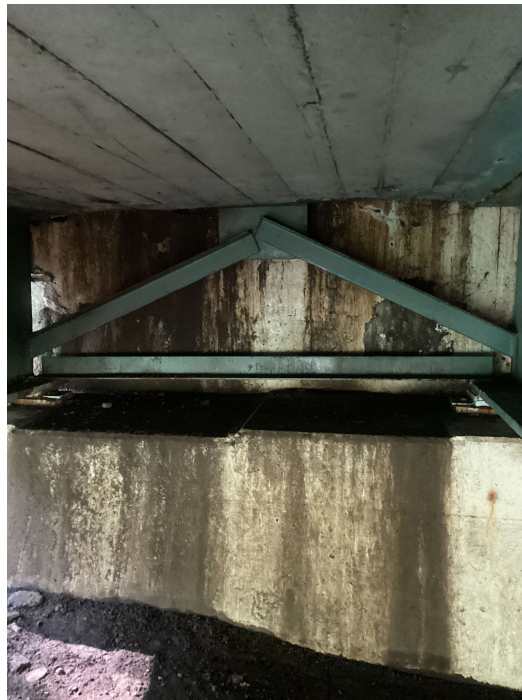
PHOTO 20

Description Rear abutment bay 4

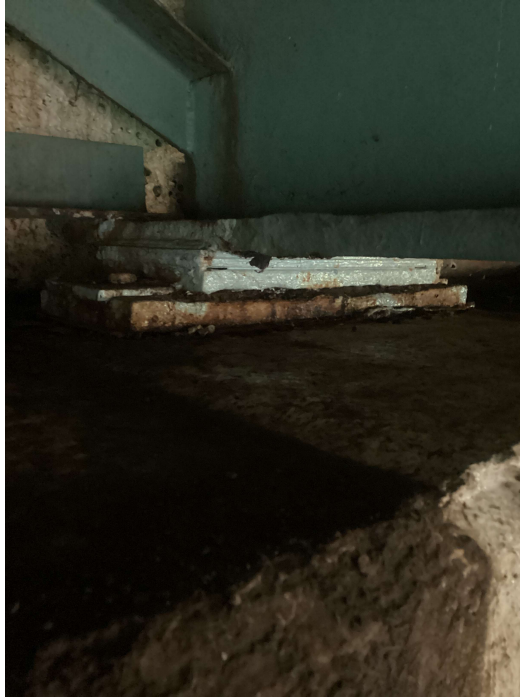
PHOTO 21

Description Rear abutment bm4

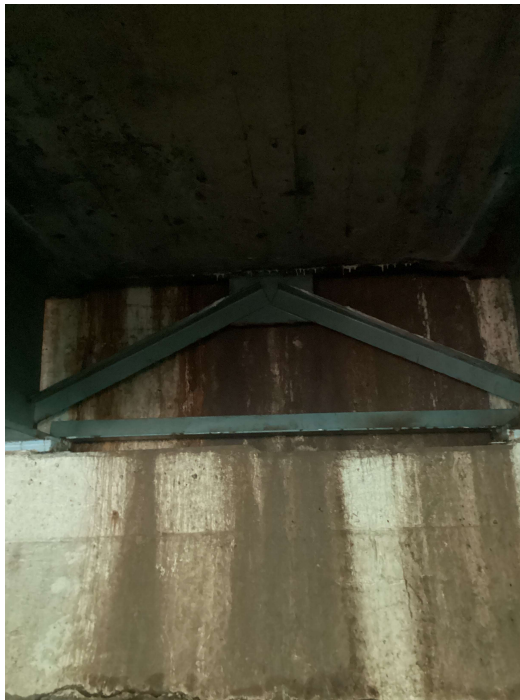
PHOTO 22

Description Rear abutment bay 2

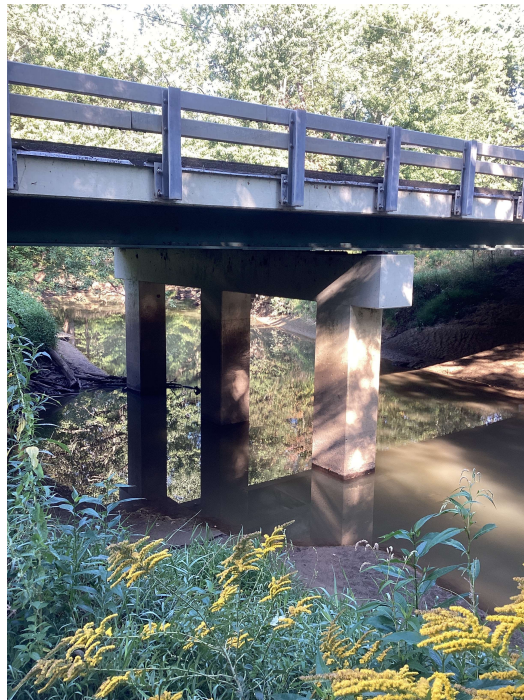
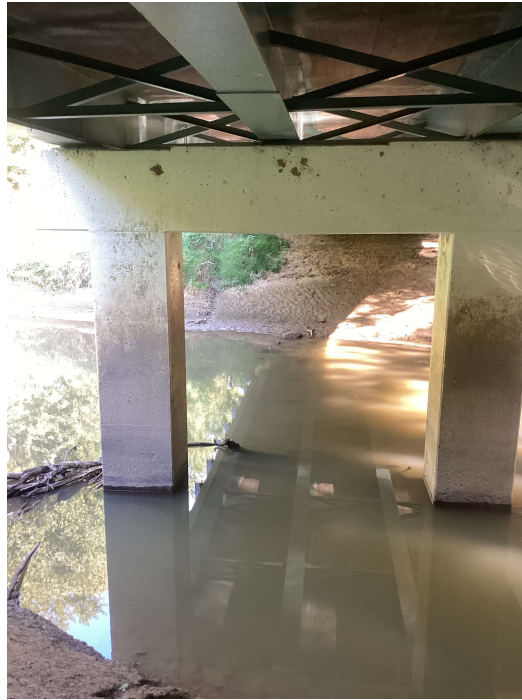
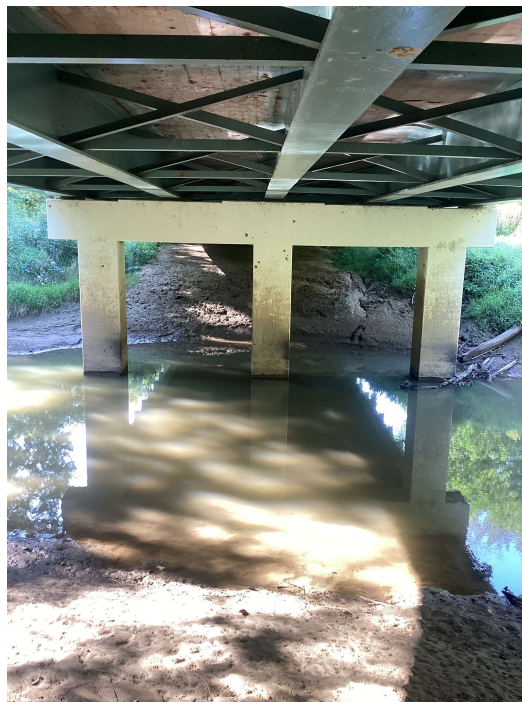
Environment	Total Quantity	Units	Condition State 1	Condition State 2	Condition State 3	Condition State 4
234-Reinforced Concrete Pier Cap	3 - Mod.	36	ft.	33	3	0	0
Sealed 2008. CS2: - Vertical cracks <1/16".							
305-Assembly Joint without Seal	3 - Mod.	72	ft.	0	0	72	0
Paved over 2020. Area over joint, approx. 1" wide, has been slot-cut and filled with crack seal. CS3: - D-Cracking with potholes and pavement deterioration on both sides of expansion joint. - Leaking evident at both joints. 2019 comments: Expansion joints cleaned out 2017. Asphalt around expansion joints is cracked and broken up. Both joints are making a banging noise. Plow damage at forward center, riser on deck side is torn.							
311-Movable Bearing	3 - Mod.	15	each	5	10	0	0
Abutment bearings refurbished 2020. CS2: - Light rust and deterioration at abutment bearings. 2019 comments: Bearings at forward abutment are over extended. Welds connecting top bearing plates to bottom flanges at forward abutment are cracked. One broken weld at bearing plate/bottom flange connection at rear abutment. Rust with moderate deterioration to bearings at forward abutment. Light rust and deterioration at rear abutment. All bearings were painted 2008.

PHOTO 28
Description Pier 1

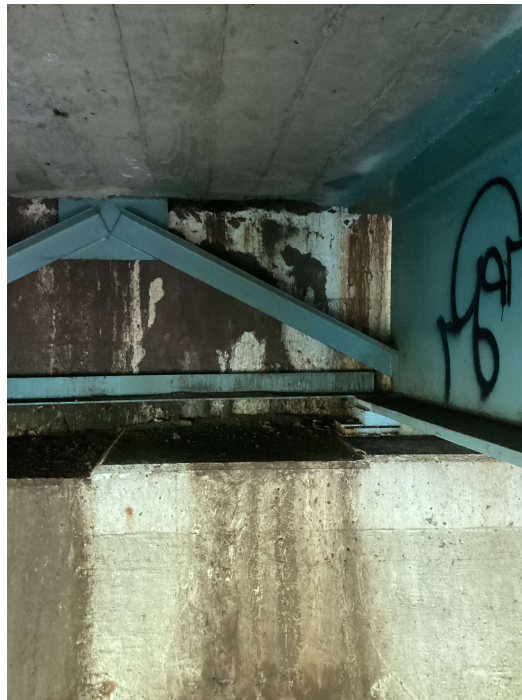
PHOTO 36

Description Forward abutment bay 1

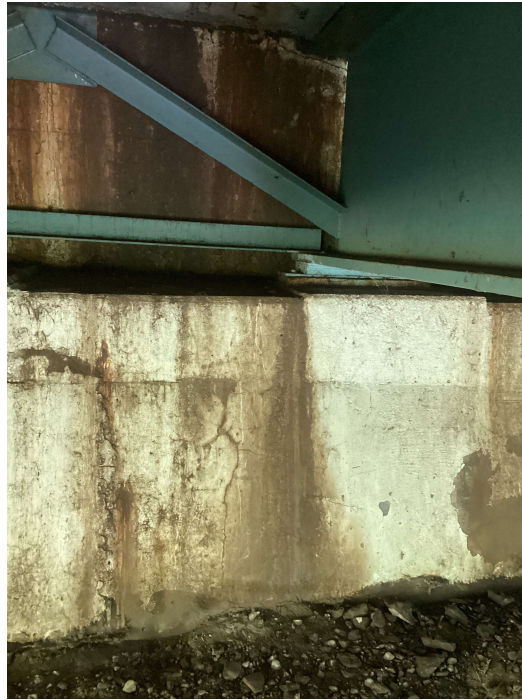
PHOTO 37

Description Forward abutment bay 3
