# UNDERWATER BRIDGE INSPECTION REPORT

BRIDGE NO. GUE-70-2192

STRUCTURE NO. 3002071

I-70 OVER

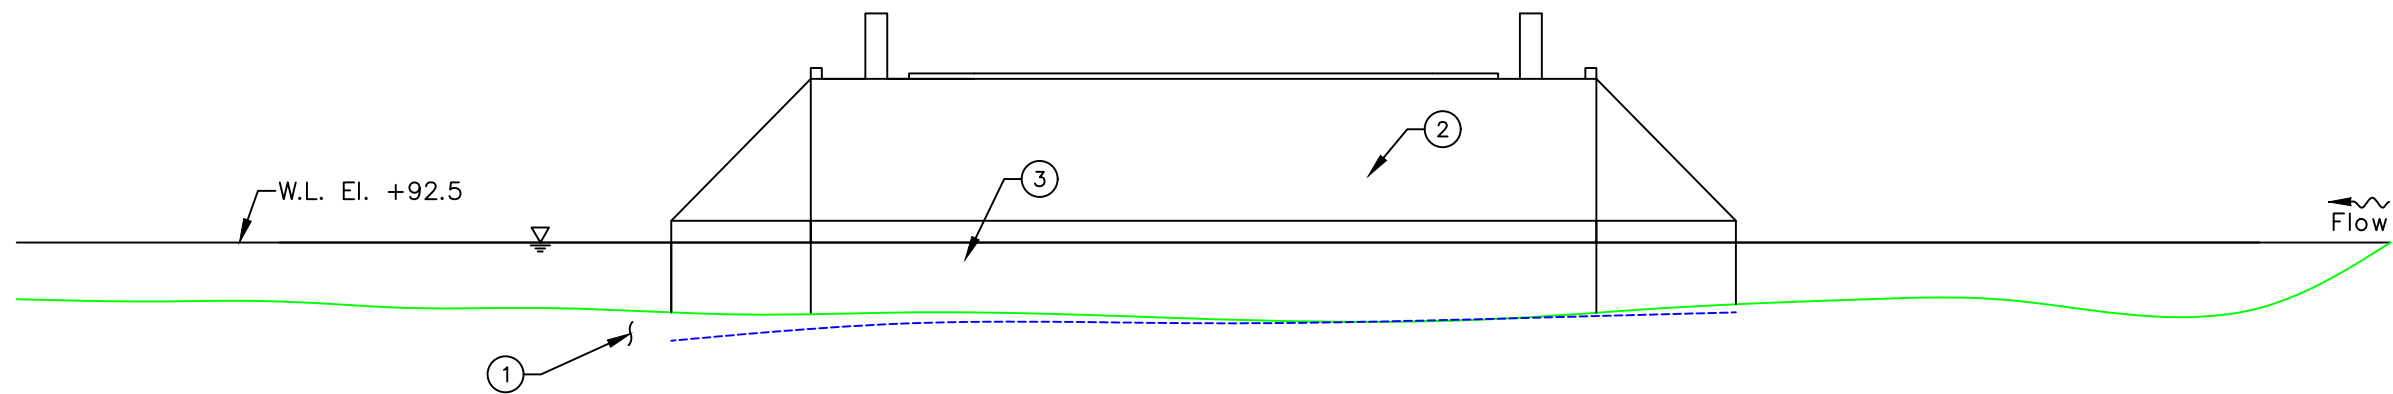
**I-70 OVER HIGHWAY DITCH  
STRUCTURE NO. 3002071  
INSPECTION FINDINGS  
GUERNSEY COUNTY, OHIO**

- ① Channel bottom consisted of soft silt with up to 24 in of probe rod penetration.
- ② Vertical joints experienced moderate corrosion with up to  $\frac{3}{16}$  in of section loss.
- ③ Steel condition underwater consisted of light surface corrosion with up to  $\frac{1}{32}$  in section loss.

- Monitor steel section loss.

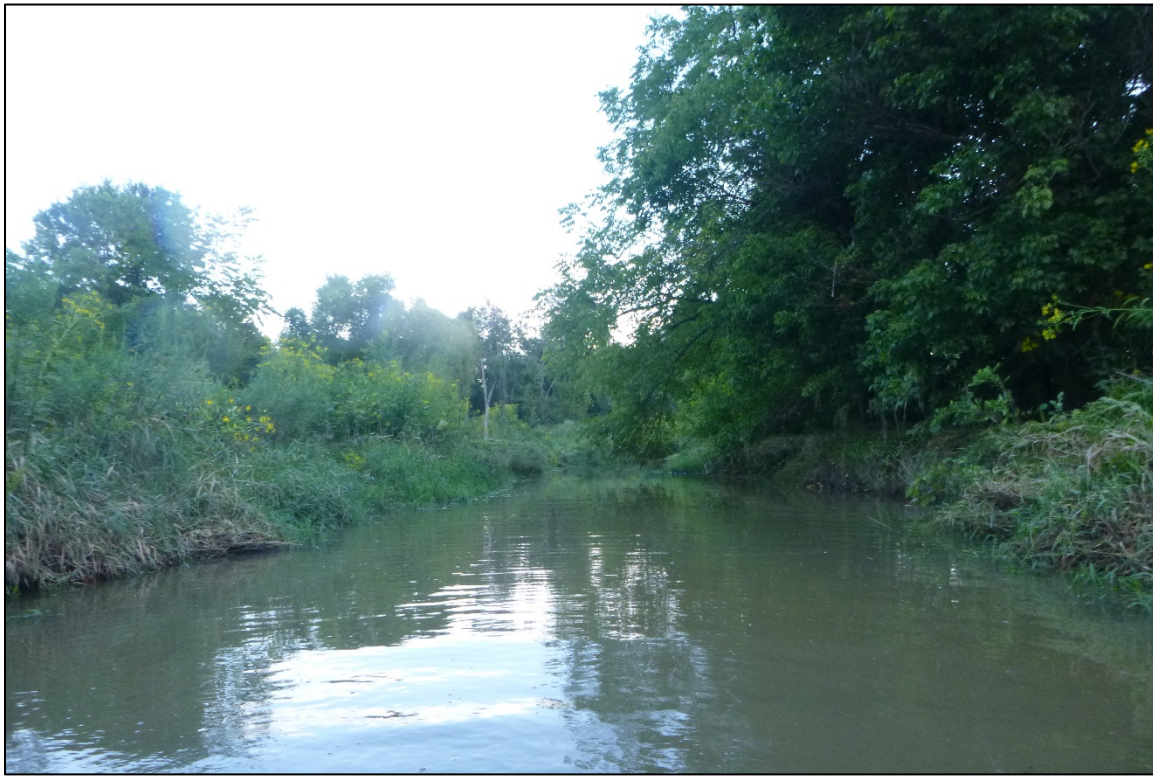
At the time of the inspection, the waterline of Structure No. 3002071 was located approximately 7.5 ft below the top of invert at the inlet of the culvert, which corresponds to an assumed waterline elevation of 92.5 ft. During the inspection, the waterway was flowing at approximately 1 ft per second. The culvert skew was consistent with the channel alignment and does not require attention at this time. The north and south shorelines consisted of mildly to moderately vegetated mild slopes with minor erosion. Refer to Photographs 3 through 6 in Exhibit 2 for views of the shorelines near the structure.

Photograph No. 3: View of the Downstream Channel of the Structure, Looking South.

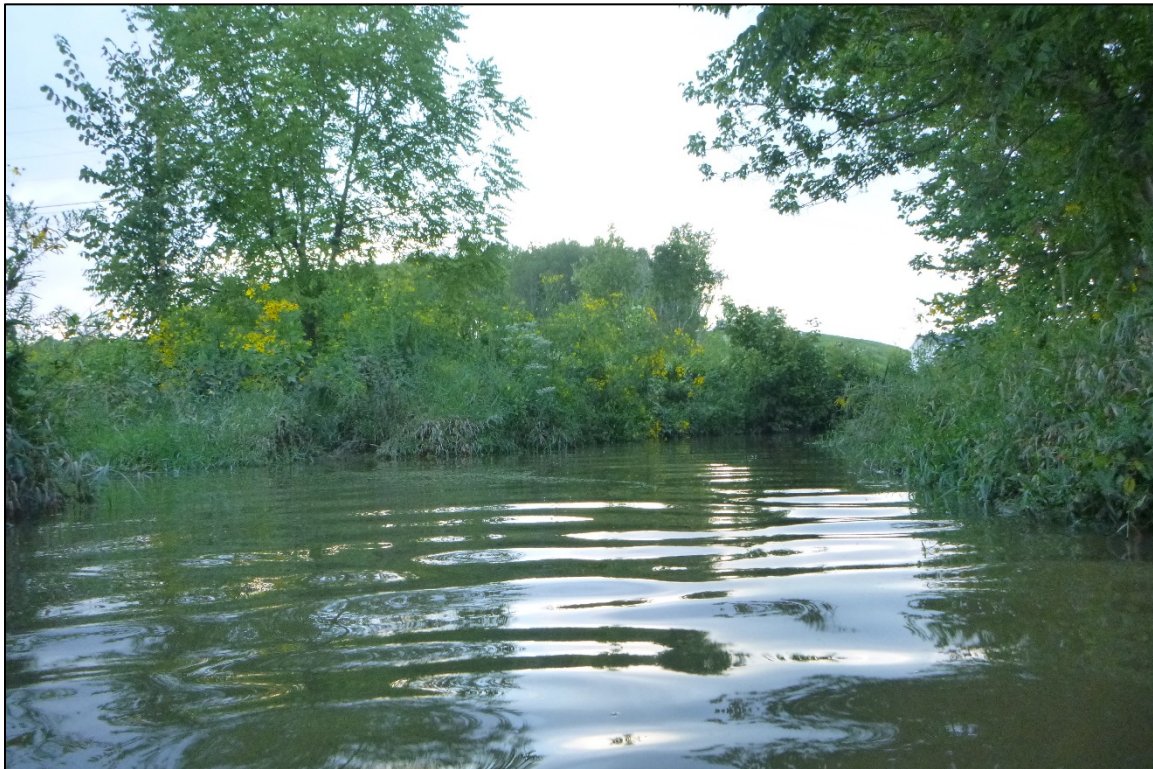
Photograph No. 4: View of the Upstream Channel of the Structure, Looking North.

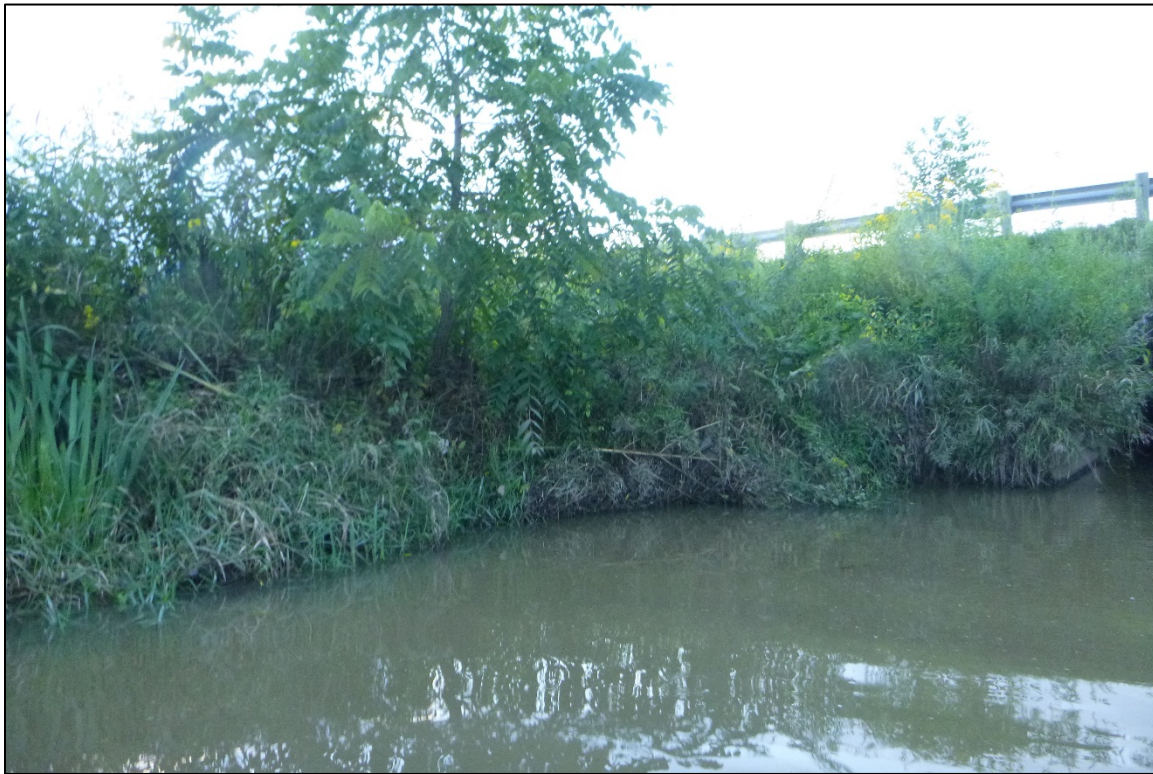
Photograph No. 5: View of the West Embankment looking Downstream of the Structure, Looking Northwest.

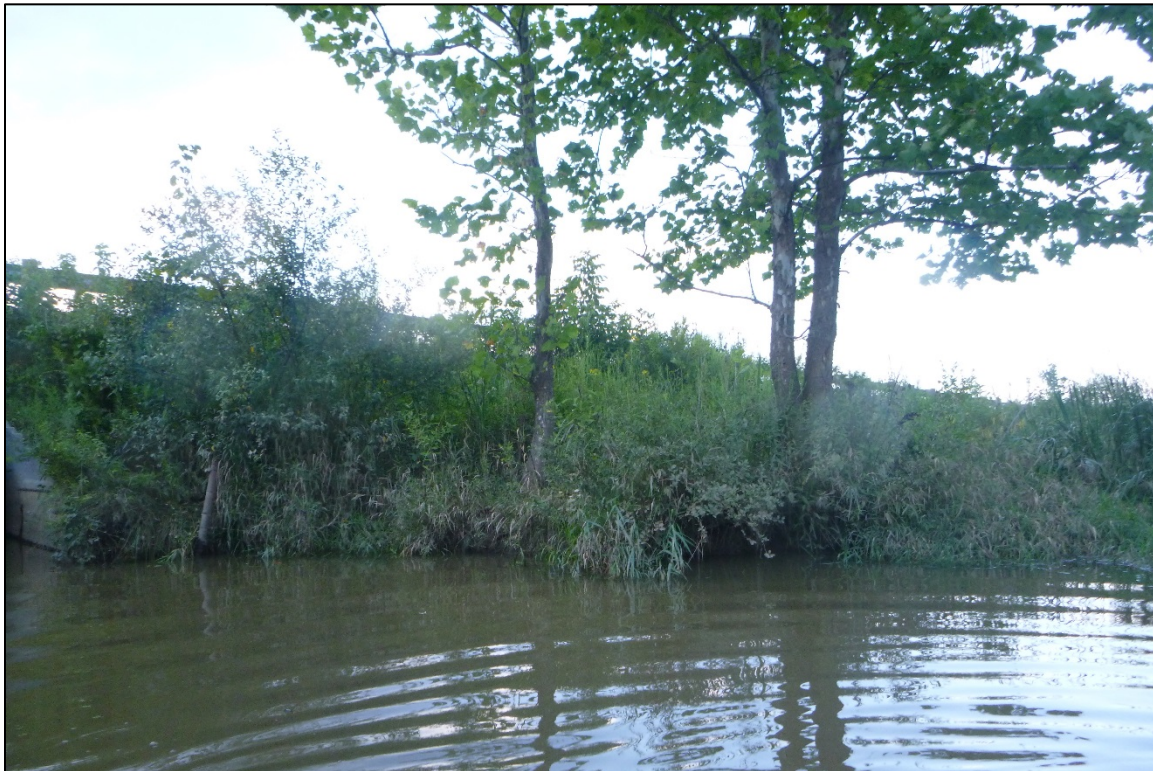
Photograph No. 6: View of the East Embankment looking Downstream of the Structure, Looking Northeast.

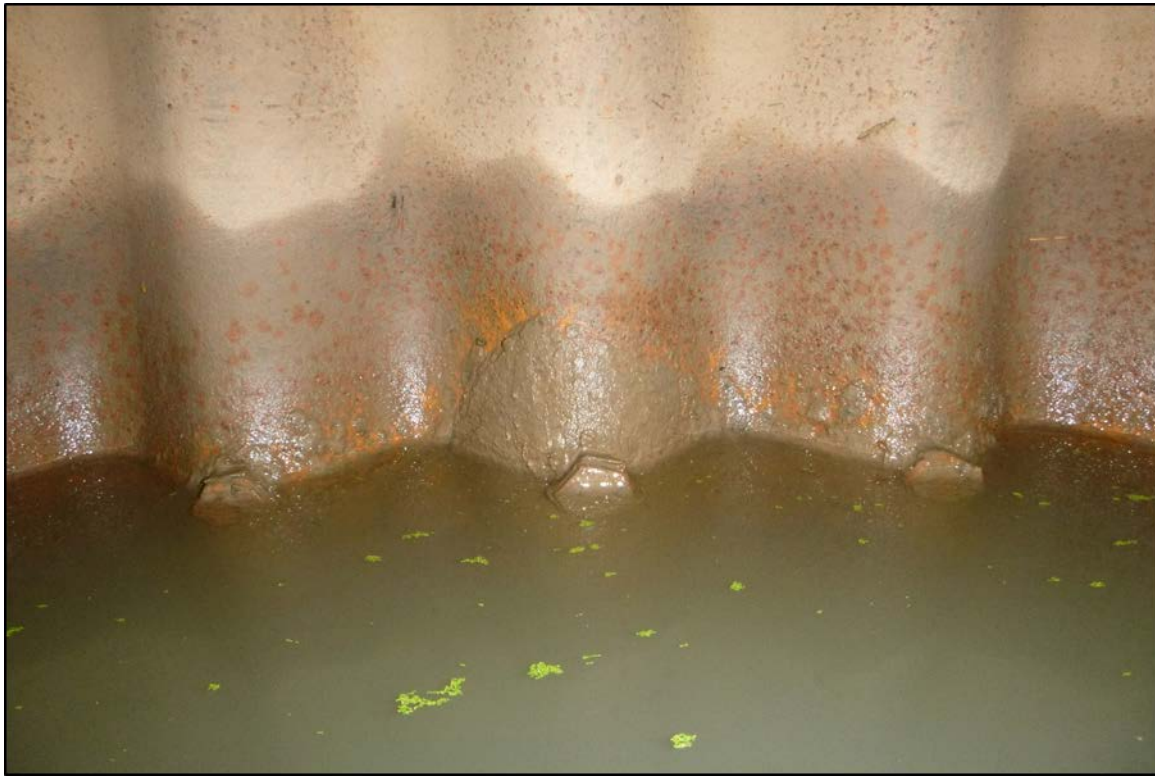
The channel bottom material around the culvert consisted of soft silt with approximately 24 in probe rod penetration. The submerged portions of the culvert exhibited light scaling up to 1/32 in deep and vertical joints exhibited moderate corrosion with up to 3/16 in section loss. Refer to Figure 4 in Exhibit 1 for detailed inspection notes. Refer to Photographs 9 through 10 in Exhibit 2 for views of the typical Steel condition at the waterline.

Photograph No. 9: View of the Typical Steel at the Waterline of the Structure, Looking West.

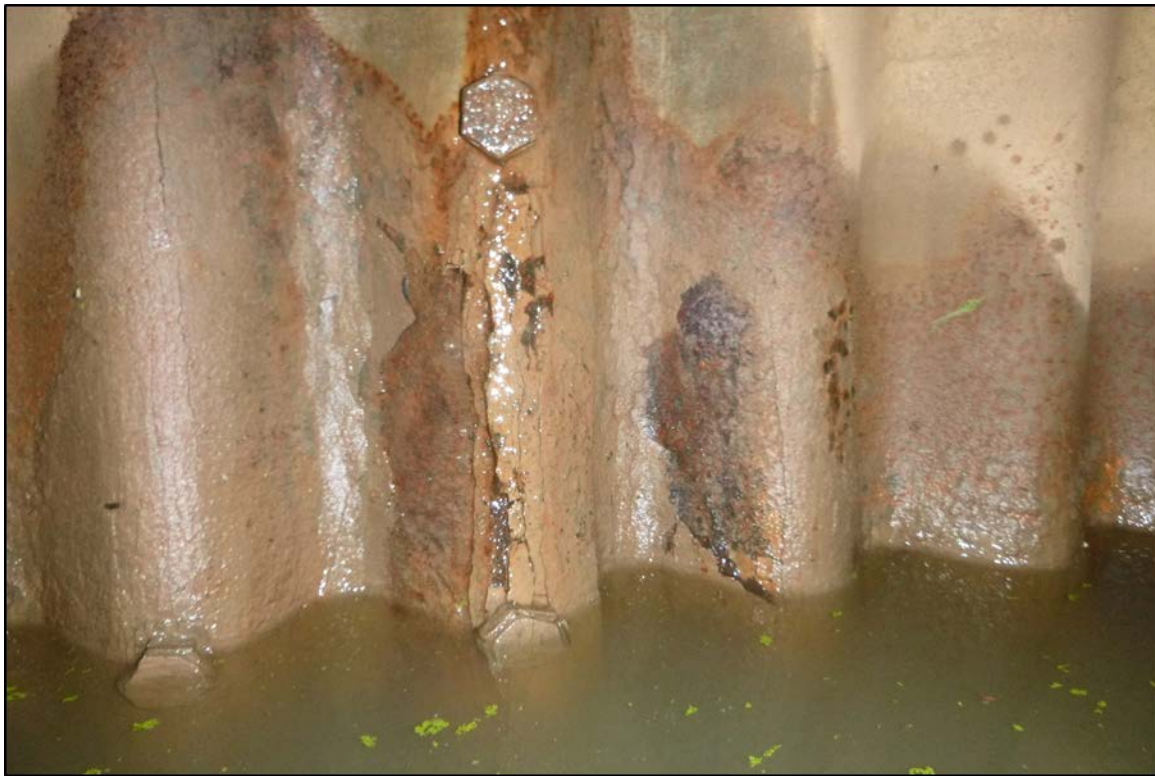
Photograph No. 10: View of the Typical Corrosion on the Vertical Joints of the Structure, Looking West.
