Inspector: Osting,Matthew
 Inspection Date: 01/18/2025

Structure Number: 2500817
 Facility Carried: HIGH STREET

Ohio Bridge Inspection Summary Report

FRA-0023D-0441 (2500817)

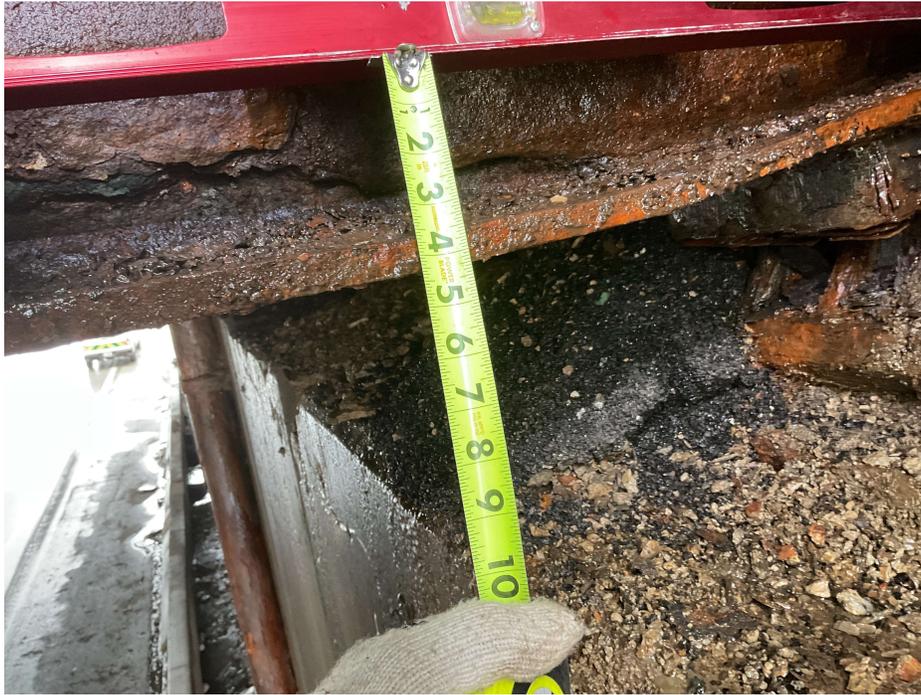
PHOTO 1

Description 2025 rear B1 deflection

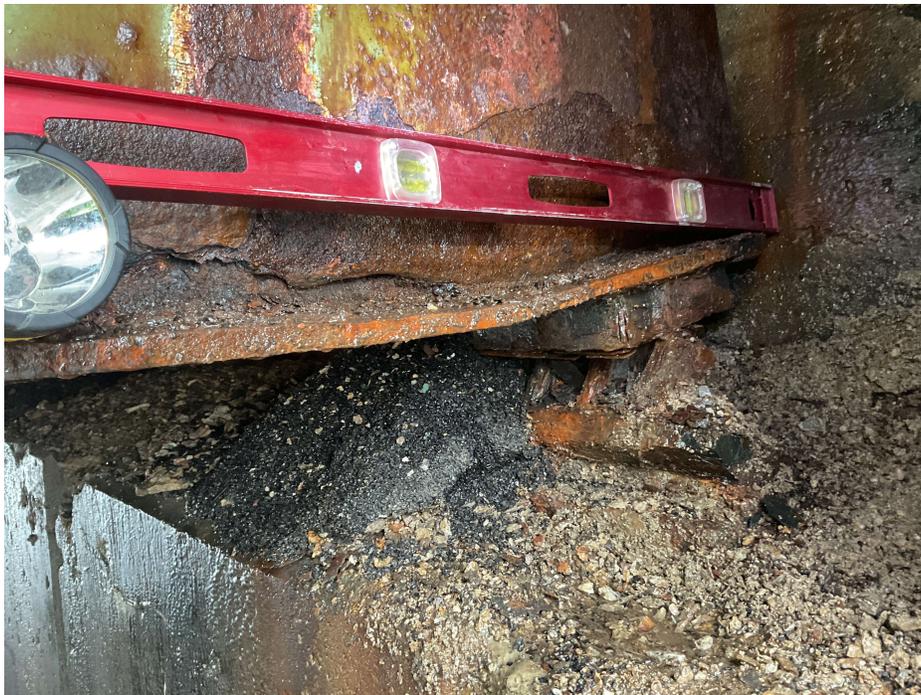
PHOTO 2

Description 2025 B1 rear

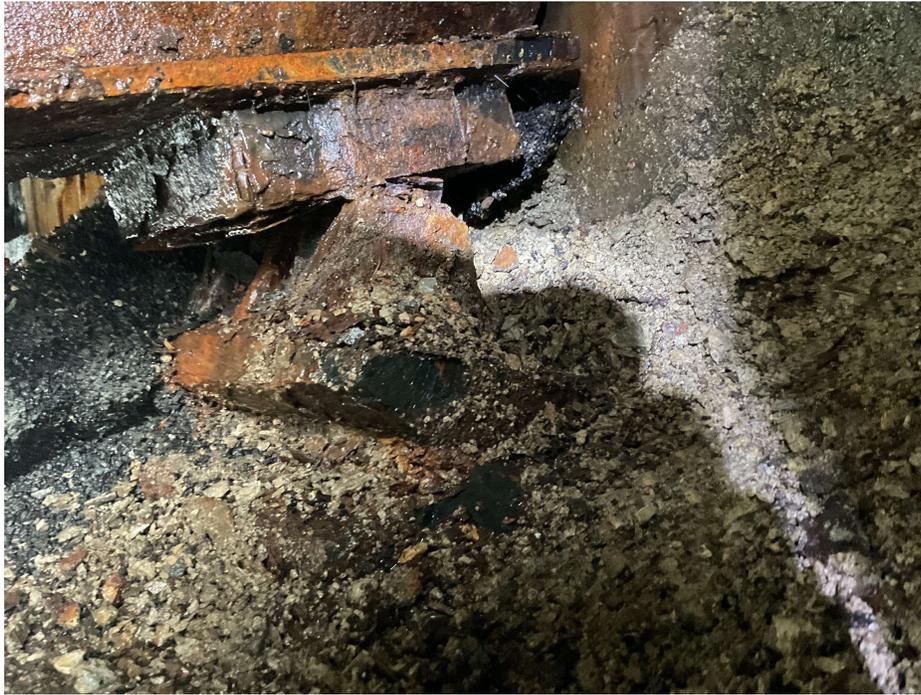
PHOTO 3

Description 2025 bearing 1 rear

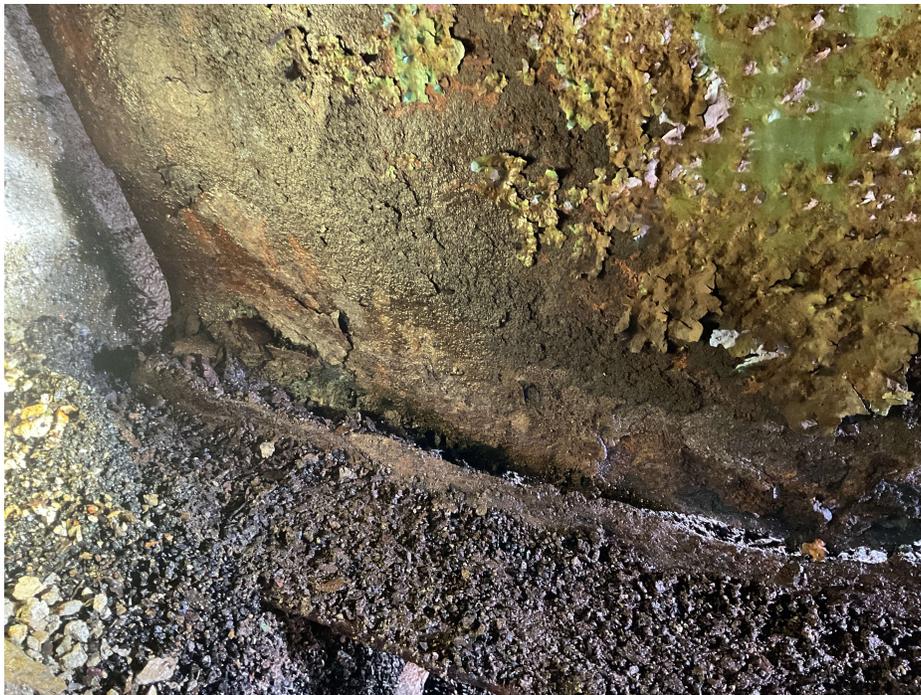
PHOTO 4

Description 2025 rear B1 thru hole at bottom of web

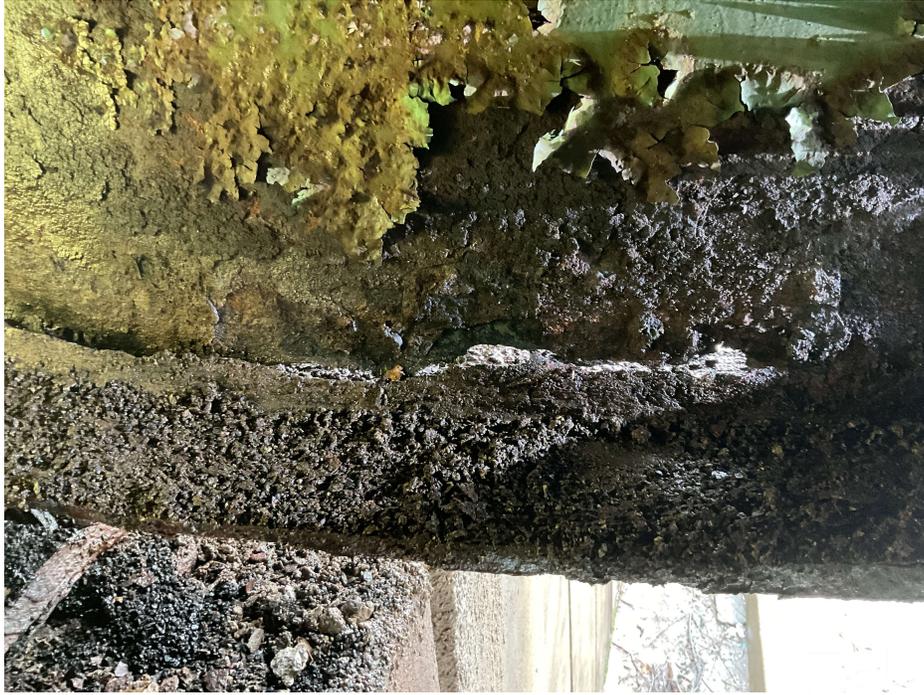
PHOTO 5

Description 2025 rear beam 1 thru hole

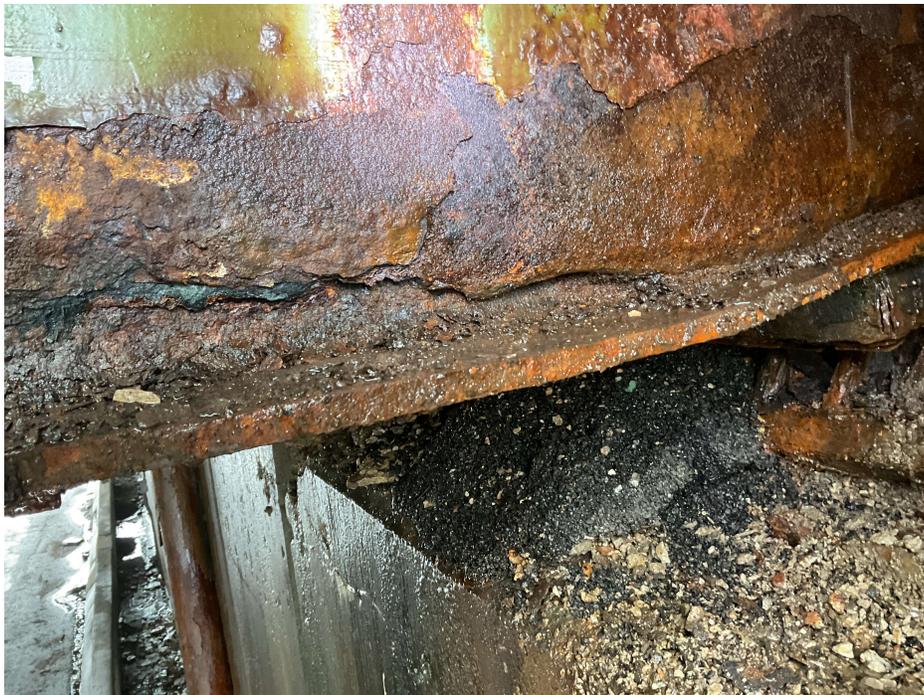
PHOTO 6

Description 2025 B1 crushing

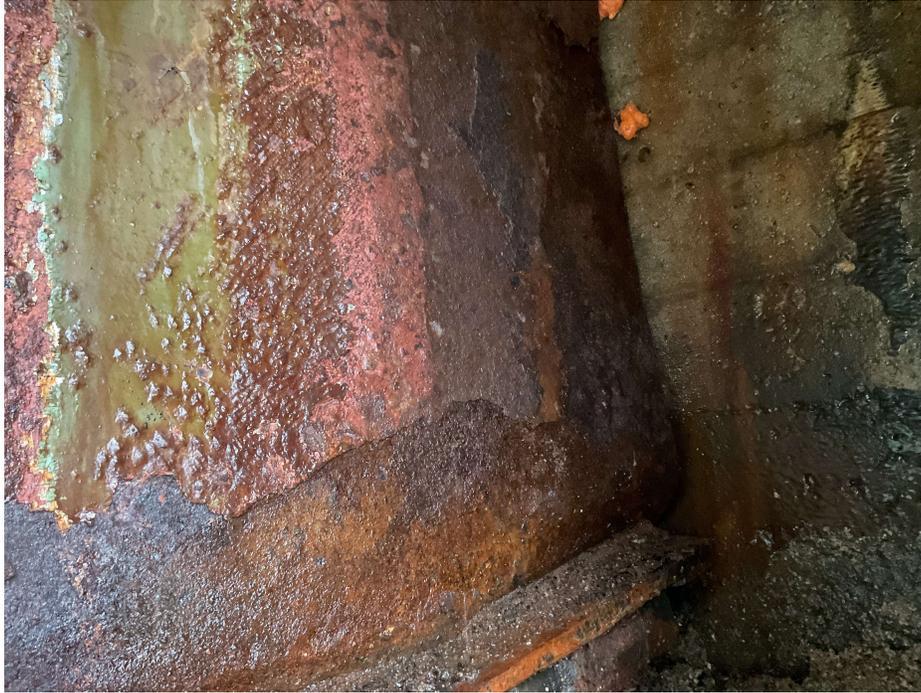
PHOTO 7

Description 2025 rear b1 web crushing at beam

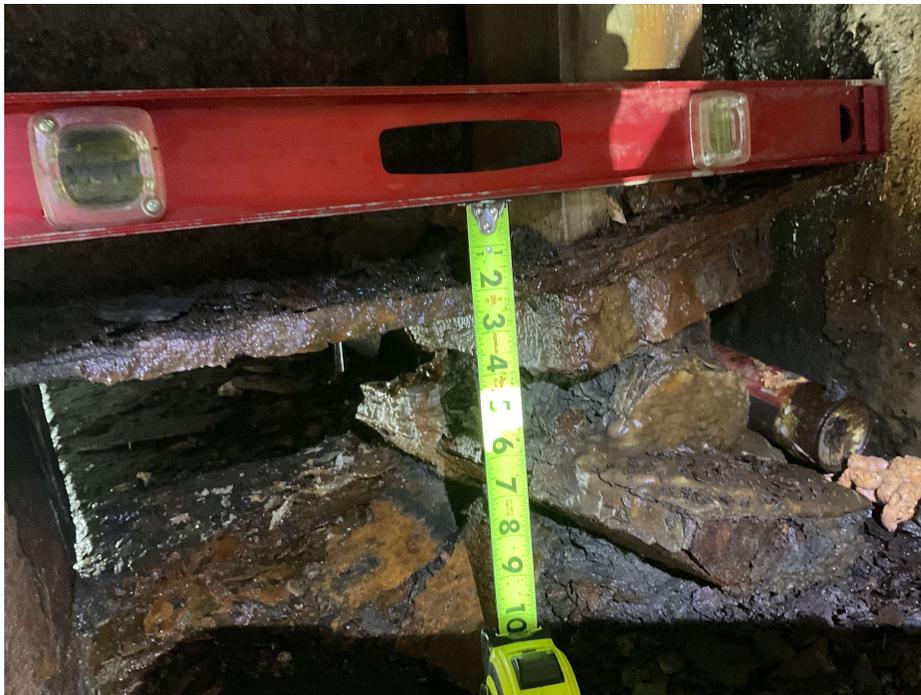
PHOTO 8

Description 2025* beam 2, has a 2" deflection 16" out from back wall.
g..

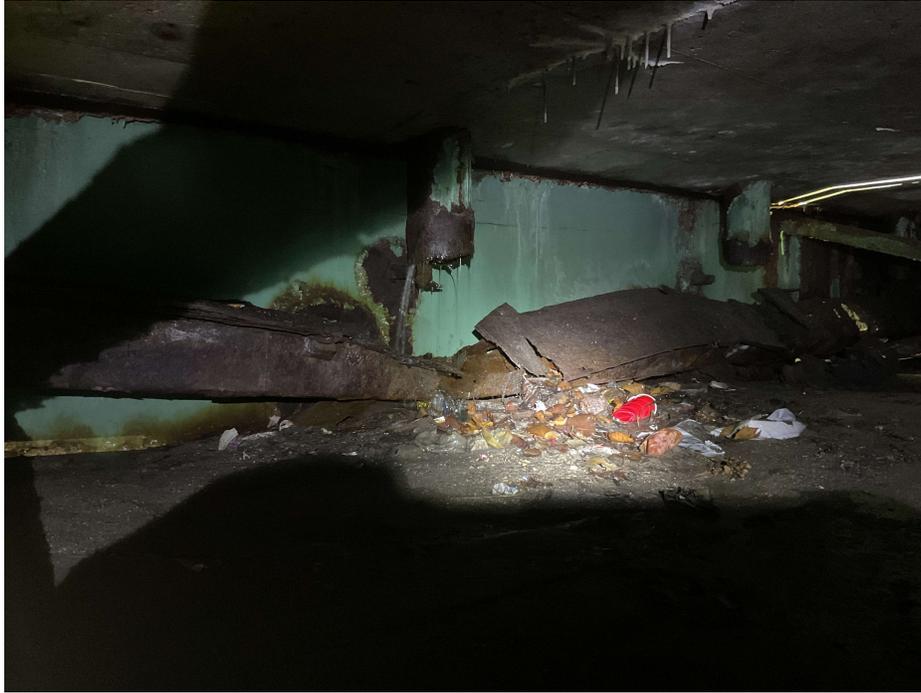
PHOTO 9

LG.DRAIN PIPES RUSTED THRU,CORROSION FLAKING OFF OVER TRAFFIC/PLUGGED**NEEDS REMOVED OVER EB OFF RAMP TO 3RD.ST. **ALL SCUPPERS PLUGGED

Description 2025 bay 2/scupper failed

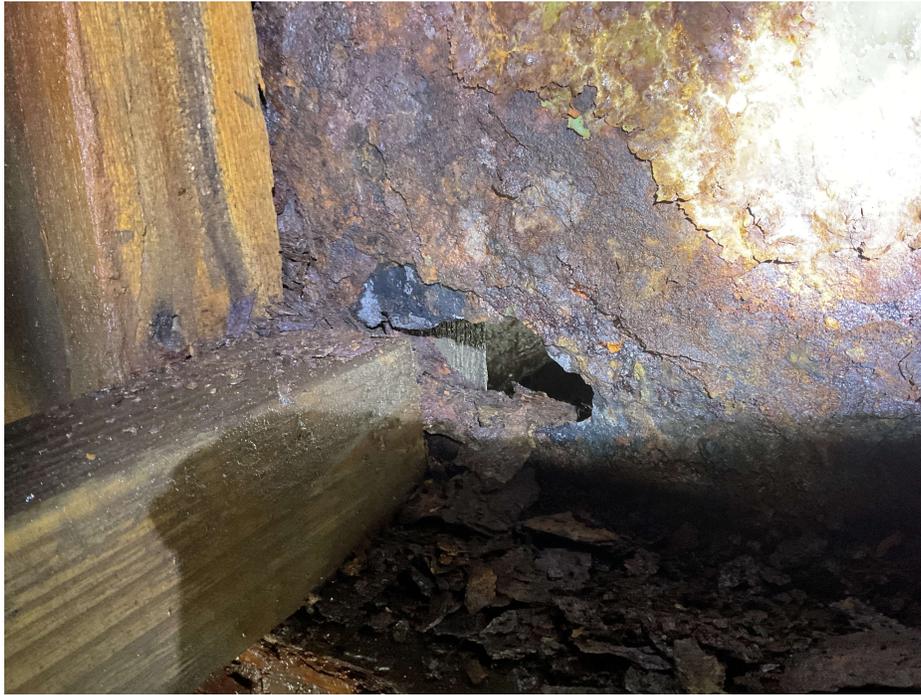
PHOTO 11

RT.FWD., RUSTED,CORROSION,PAC RUST,HEAVY SECTION LOSS W/THRU HOLES AT DECK ENDS.,BEAM 11 RUSTED W/SECTION LOSS FULL LENGTH.

Description 2025 rear beam 11 thru hole
