Structure Number: 5902827
 Facility Carried: SR 288

MRW-00288-0050 _(5902827)

Feature Inters: FLAT RUN

Bridge Inspection Report

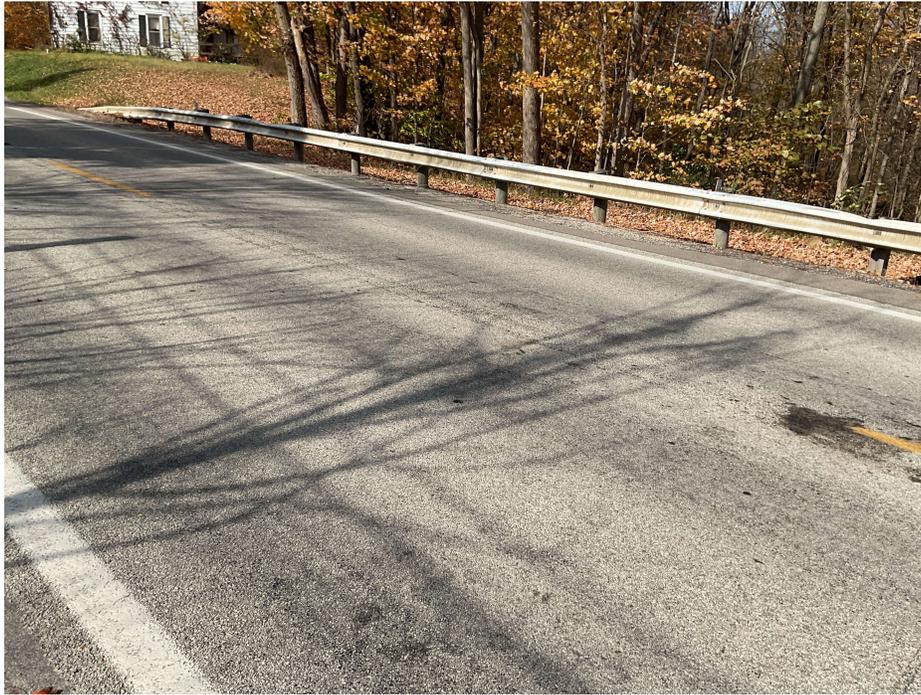
PHOTO 1

Description Rear Approach

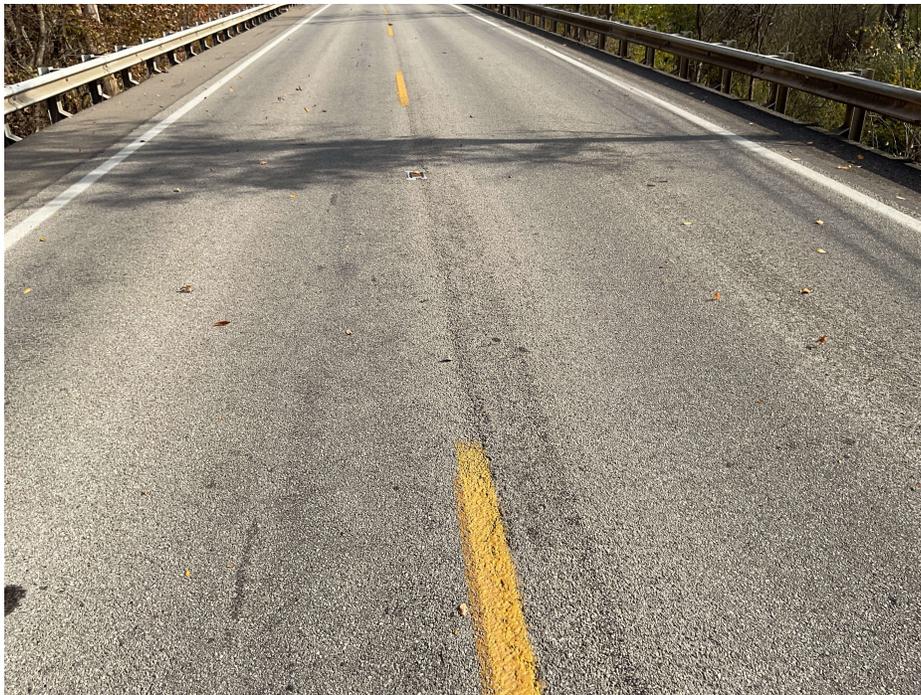
PHOTO 2

Description Wearing Surface

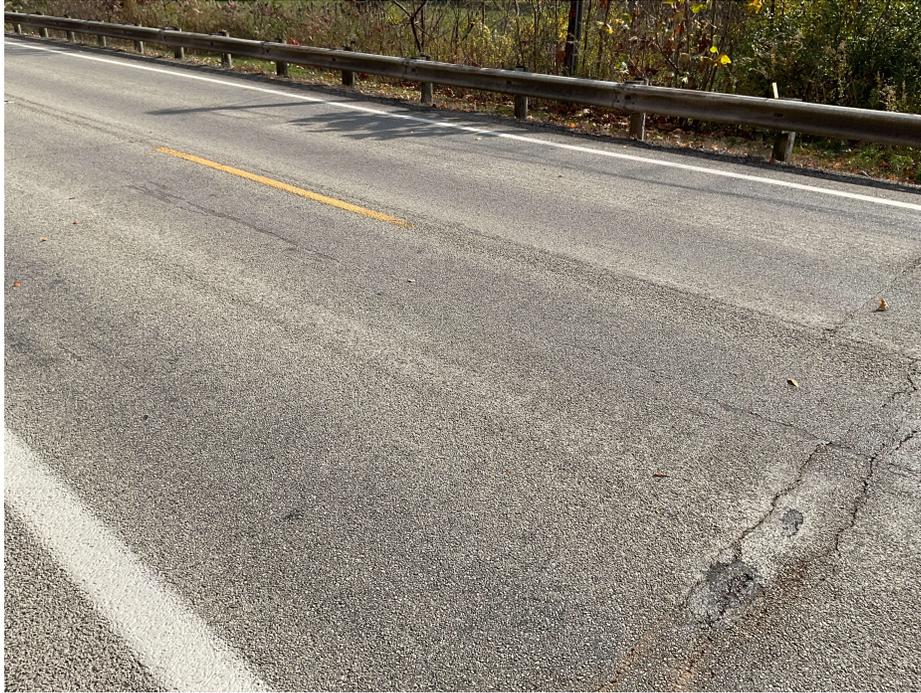
PHOTO 3

Description Fwd Approach

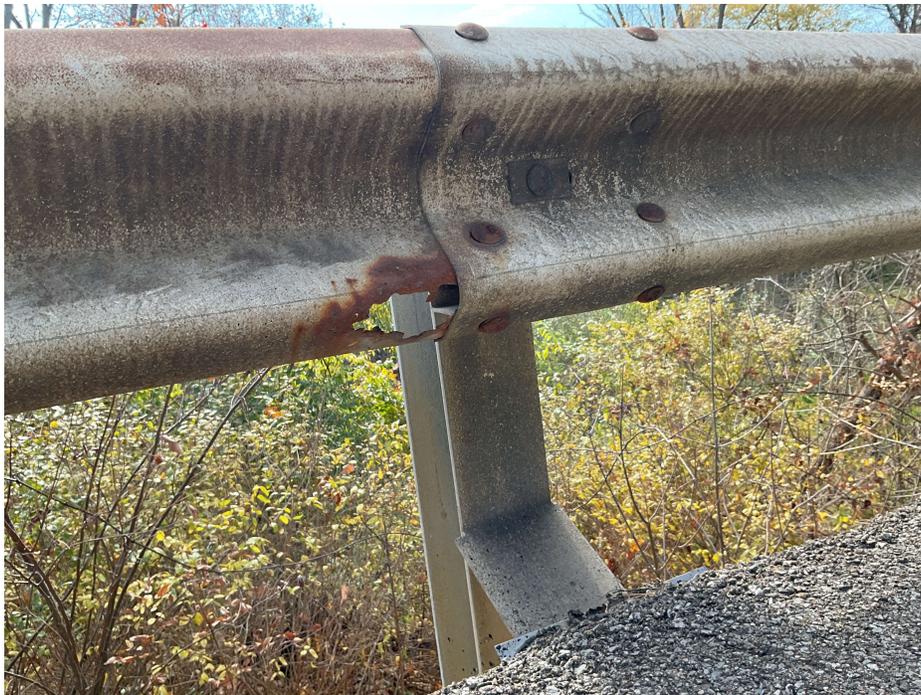
PHOTO 4

2022- chip sealed. 2024 CS2 Fwd & Rear - trans & longitudinal cracks 21 SF (Fwd-15 SF)(Rear-6 SF)							
330-Metal Bridge Railing	3 - Mod.	293	ft.	228	0	65	0
2024 CS3 LT & RT (lower portion of panels) - rusted w/ various thru holes 65'							
815-Drainage	3 - Mod.	2	each	2	0	0	0
830-Abutment Backwall	3 - Mod.	64	ft.	38	26	0	0
2024 CS2 Fwd & Rear - open trans cracks in asphalt over backwall 16' Fwd bays 4&5 saturated, horizontal cracks with efflorescence and areas of unsound concrete 10'

Description RT railing (typical rust w/ thru holes)

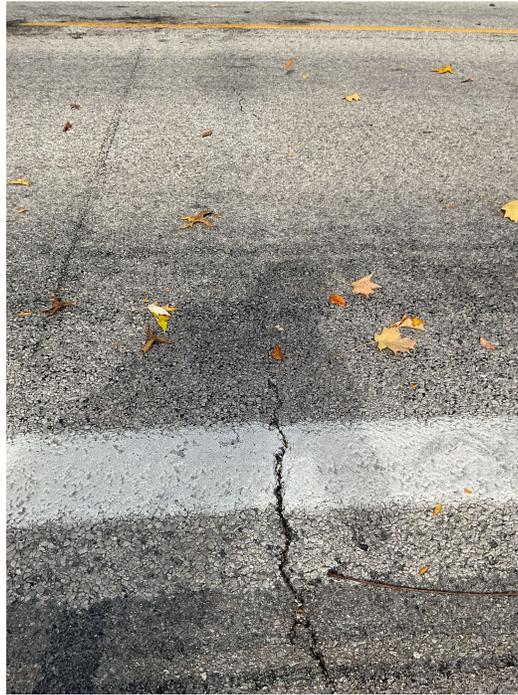
PHOTO 5

Description Wearing Surface (Rear RT)

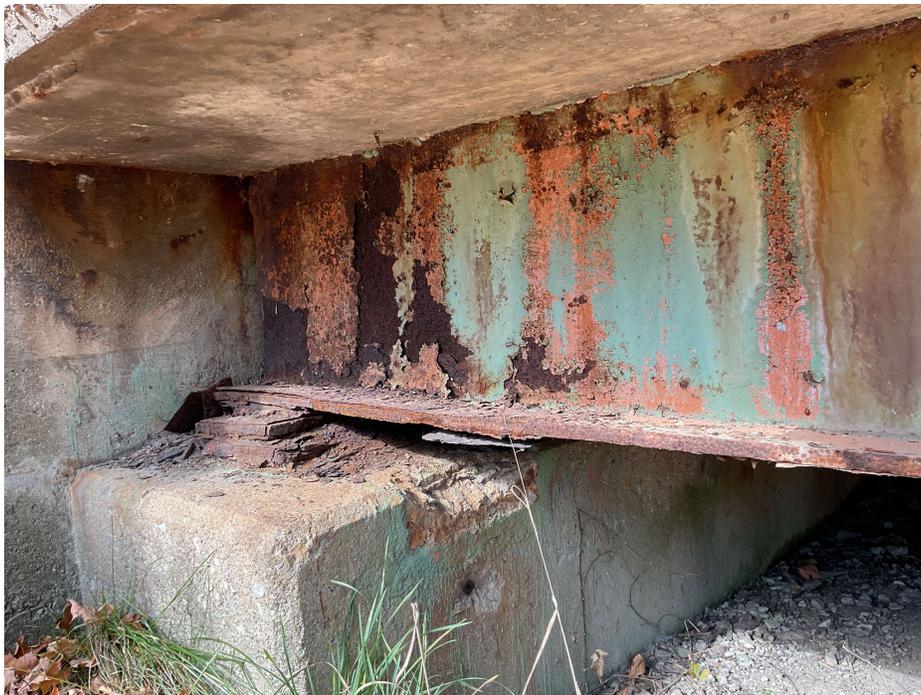
PHOTO 6

Description B6 @ Rear Abut

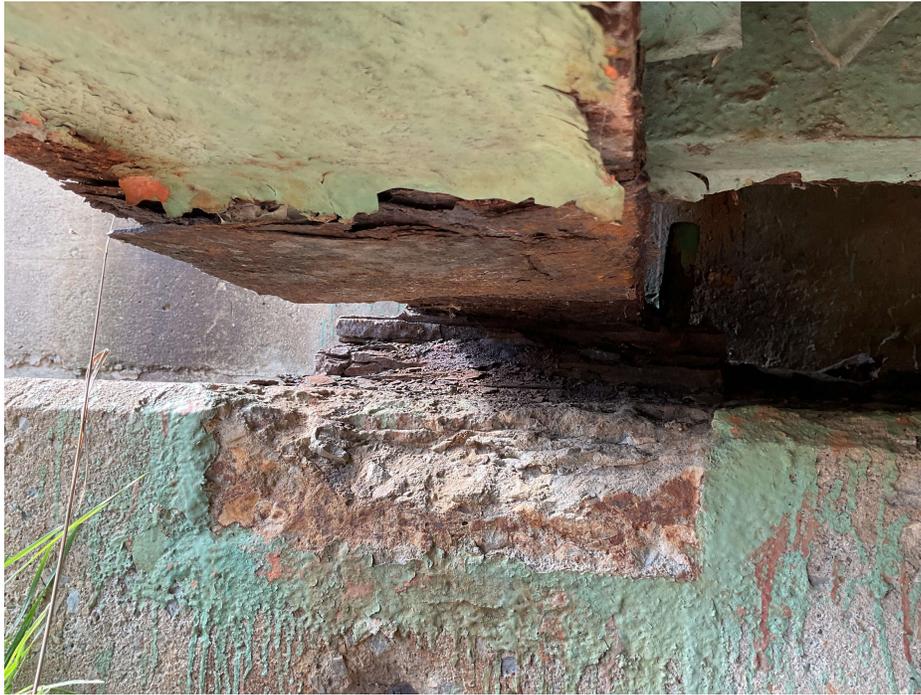
PHOTO 7

Description Rear Abut bearing 6

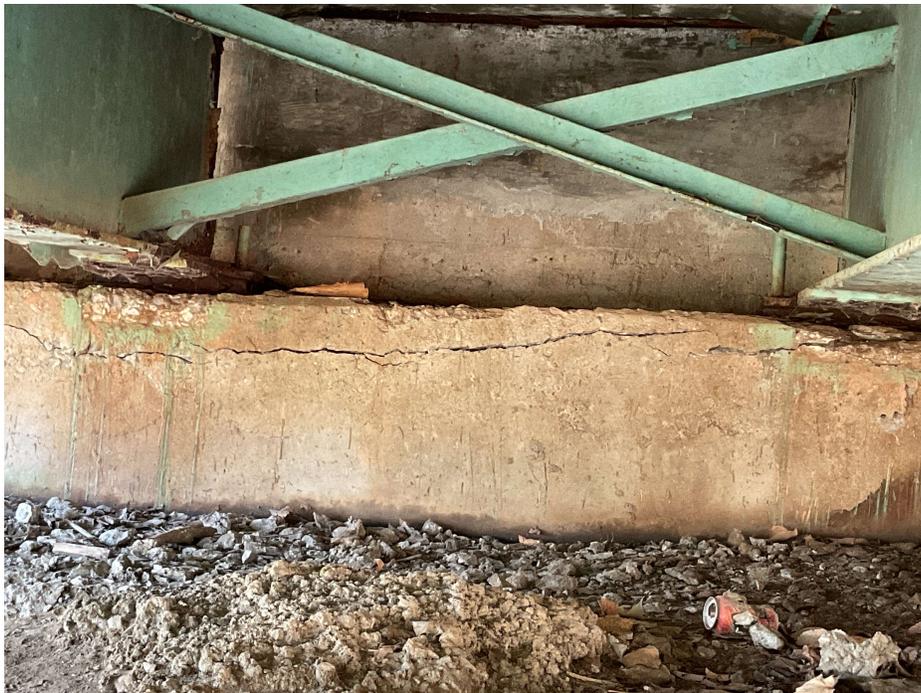
PHOTO 8

Description Rear Abut bay 4

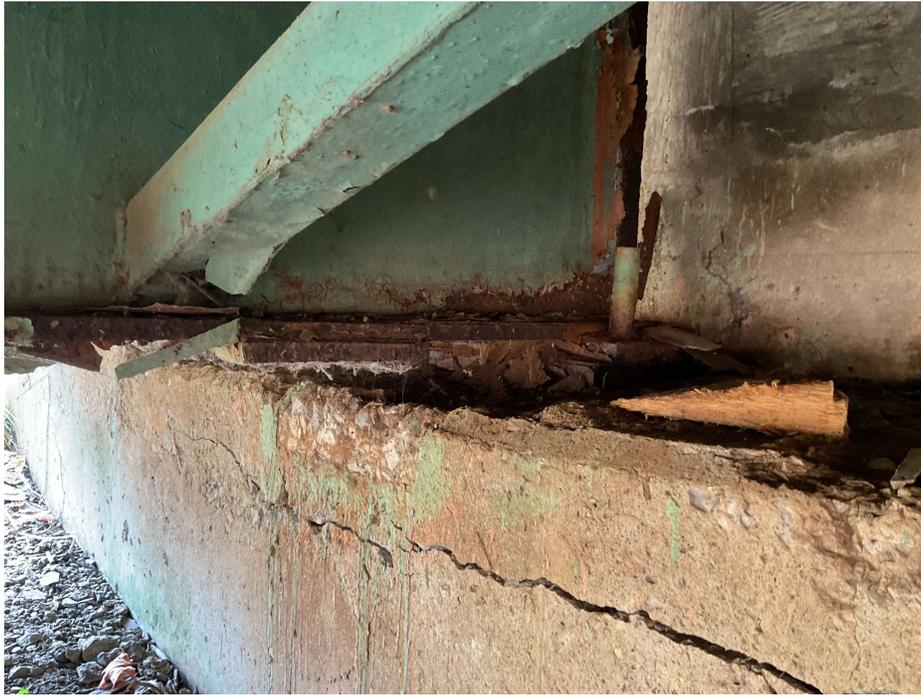
PHOTO 9

107-Steel Open Girder/Beam	3 - Mod.	879	ft.	703	159	5	12
2024 *Negative camber in all beams CS2 All Spans (near top & bottom flanges) - light rust w/ minor section loss 159' (Span 1-64')(Span 2-40')(Span 3-55') CS3 Span 1 B5 (at Rear abut) - heavy rust and corrosion with moderate section loss 5' CS4 Span 1 B1 & B6 (@ Rear Abut) - pack rusted w/ heavy section loss / bottom flange beginning to distort & sag 8' (B6-4')(B1-4') Span 3 B1 (@ Fwd Abut) - heavy rust w/ moderate section loss / bottom flange distorted & sagging, approx 50% section loss to bottom flange 4'							
515-Steel Protective Coating		7208	sq. ft.	0	3708	3000	500
2024 CS2- Chalking thin throughout CS3- Peeling, flaking throughout, worse at bottom flanges and low web area. CS4- PC has failed at bottom flanges, web, and beam ends throughout.							
205-Reinforced Concrete Column	3 - Mod.	6	each	6	0	0	0
215-Reinforced Concrete Abutment	3 - Mod.	64	ft.	12	52	0	0

Description Span 1 B5 @ Rear Abut

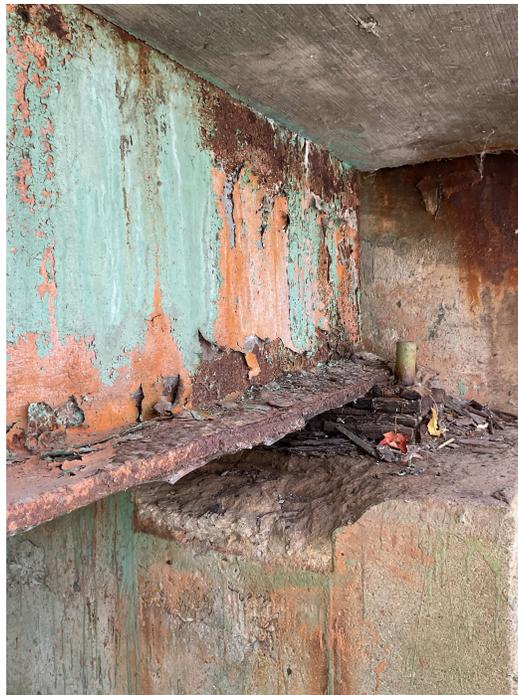
PHOTO 10

Description Span 1 B1 @ Rear Abut

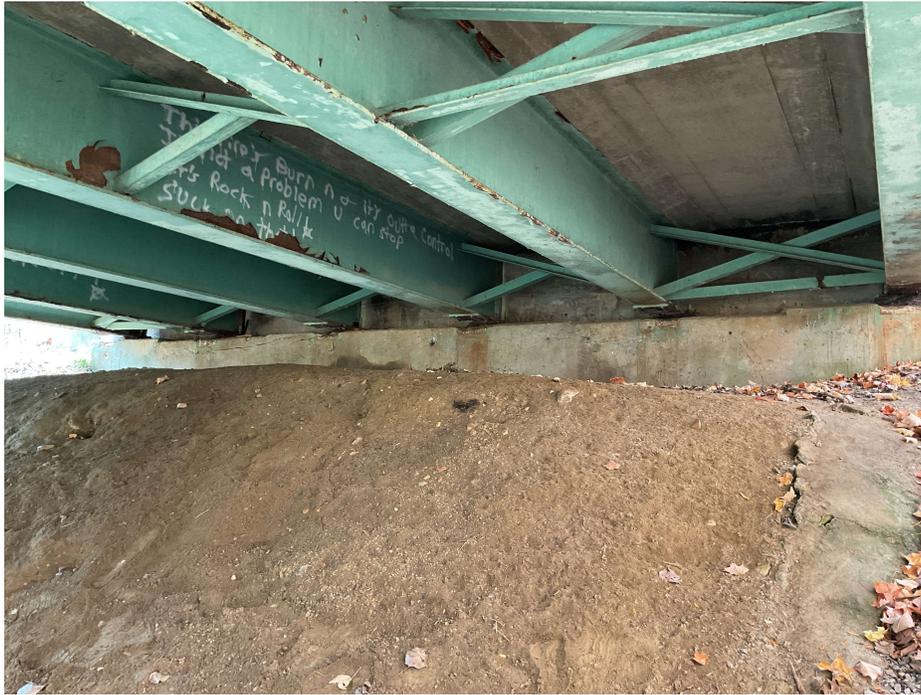
PHOTO 11

2024 CS2 Rear- small spalls under B1-6, open horizontal cracks & scaling t/o 30' Fwd- small spalls under B1-6, horizontal cracks with some minor delams & scaling 22'

Description Rear Abut

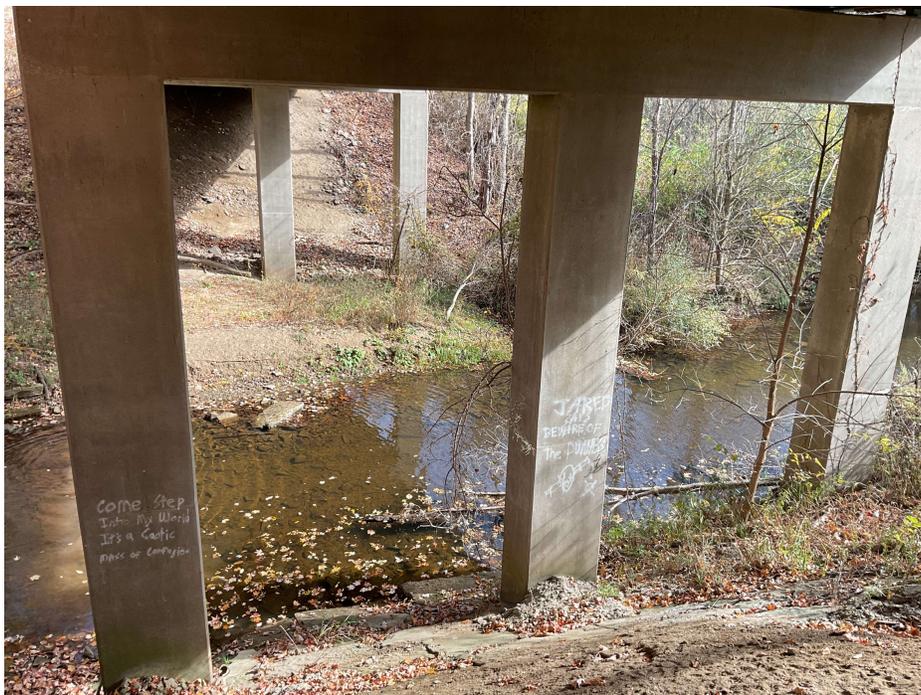
PHOTO 12

Description PS1

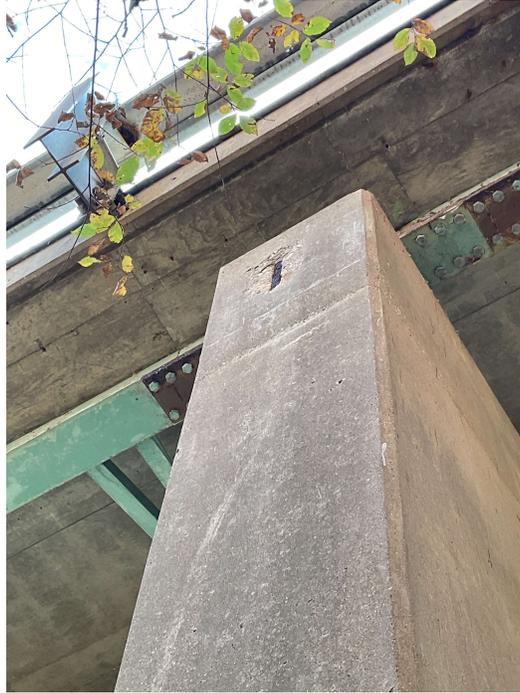
PHOTO 13

Environment	Total Quantity	Units	Condition State 1	Condition State 2	Condition State 3	Condition State 4
234-Reinforced Concrete Pier Cap	3 - Mod.	64	ft.	60	2	2	0
2024 CS2 PS2 Rt corner - delam 1' PS2 Lt top - small spall 1' CS3 PS1 LT & RT (outside face) - spall with exposed rebar with section loss 2'							
302-Compression Joint Seal	3 - Mod.	64	ft.	0	0	0	64
2024 CS4 Fwd & Rear - paved over, closed & no longer functional 64'							
311-Movable Bearing	3 - Mod.	18	each	5	1	6	6
2024 CS2 PS2 bearing # 5 - rust initiated (1) CS3 Fwd & Rear abuts bearings - pack rusted, all bearing seats Fwd&Rear are spalled (6) CS4 Rear Abut bearings (1,5,6) - heavy rust w/ section loss & rust debris impacting function ability (3) Fwd Abut bearings (1,2,6) - heavy rust w/ section loss & rust debris impacting function ability (3)							
313-Fixed Bearing	3 - Mod.	6	each	6	0	0	0
321-Reinforced Concrete Approach Slab	3 - Mod.	1600	sq. ft.	1579	21	0	0

Description PS1 cap LT end

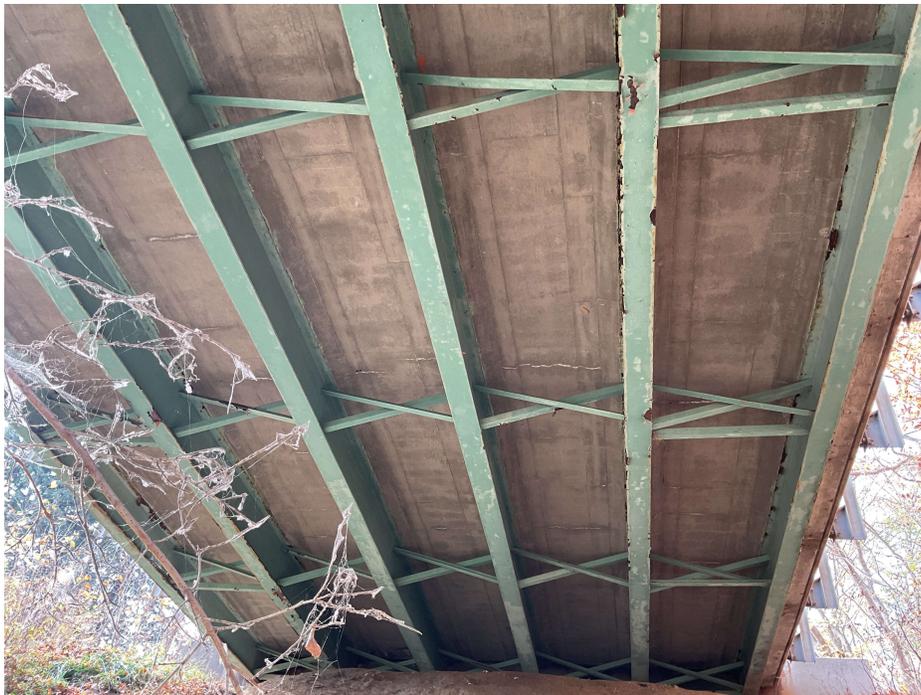
PHOTO 14

Environment	Total Quantity	Units	Condition State 1	Condition State 2	Condition State 3	Condition State 4
12-Reinforced Concrete Deck	3 - Mod.	4688	sq. ft.	4070	549	69	0
2024 CS2 Span 1 - Transverse cracks with efflorescence throughout as well as several small delams and haunch spalls and saturated areas under GR anchors Lt&Rt. Rear corner spalled, saturated with efflorescence 85 SF Span 2 - transverse cracks with efflorescence throughout, 2x2 delam Fwd of mid span, saturated under GR anchors Lt&Rt 314 SF Span 3 - transverse cracks with efflorescence throughout, delam in bay3 and saturated under GR anchors, small spall Fwd LT corner, 150 SF CS3 Span 1 bay 3 (near PS1) - spall w/ exposed rebar w/ section loss 3 SF Span3 LT corner - spalled off 2 SF Fwd & Rear deck end -areas heavily saturated w/ efflor 64 SF							
510-Wearing Surfaces		4688	sq. ft.	4461	227	0	0
2022- chip sealed 2024 CS2 Near c/l - longitudinal cracks 146 SF Fwd & Rear (over jnts) & LT & RT shoulders - trans cracks 81 SF

Description Span 1

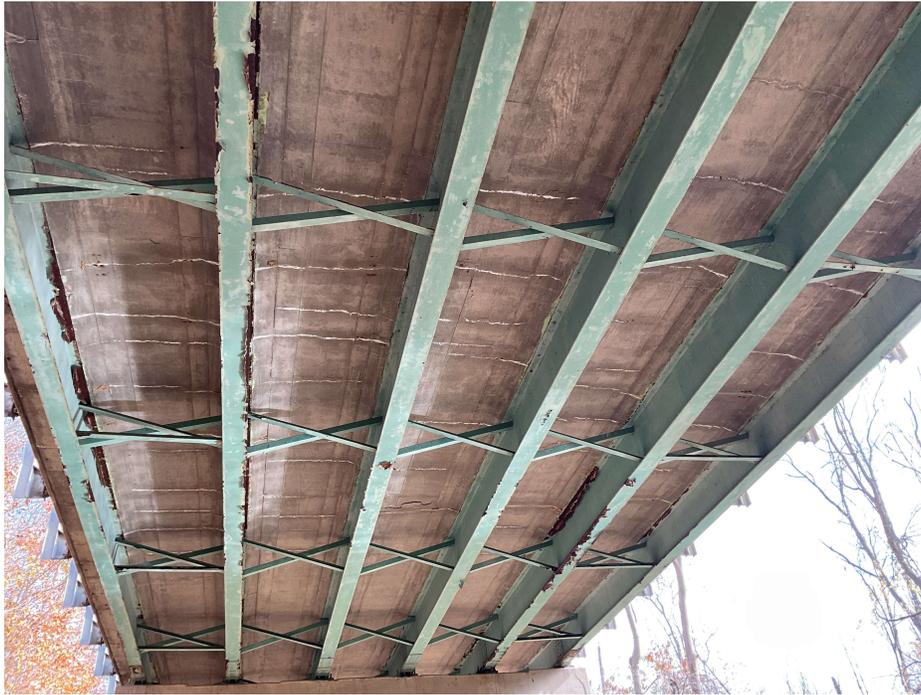
PHOTO 15

Description Span 2

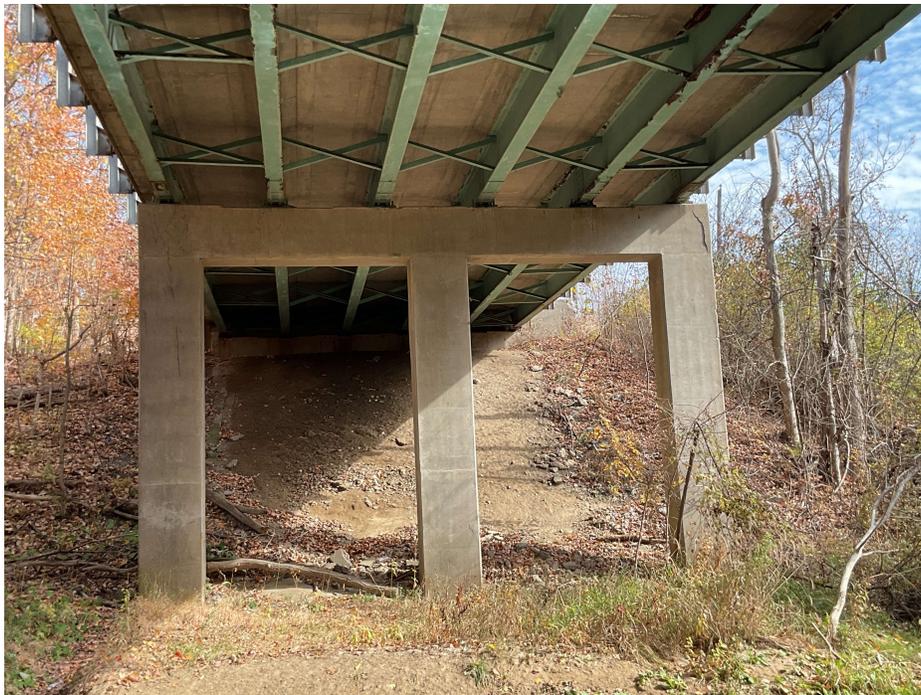
PHOTO 16

Description PS2

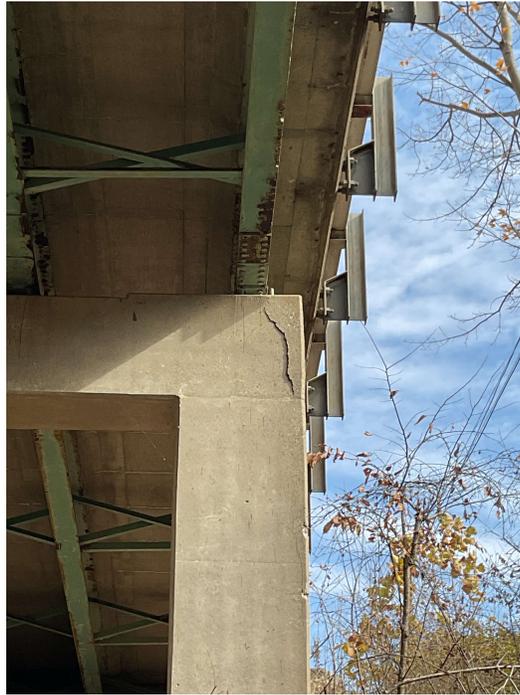
PHOTO 19
Description PS2 cap RT

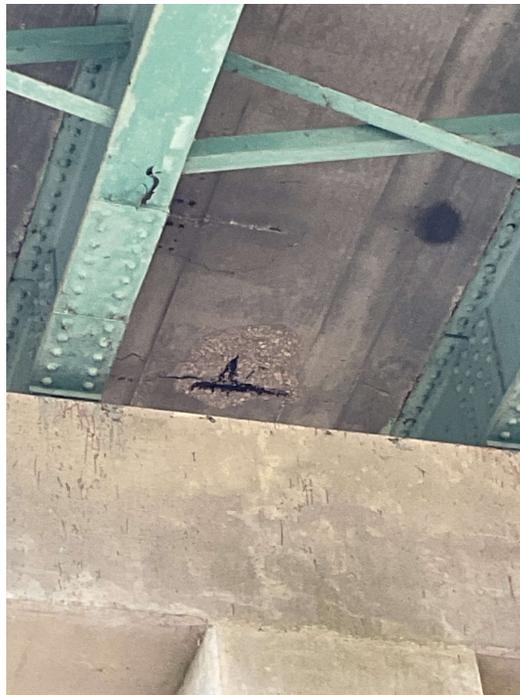
PHOTO 20
Description Span 1 bay 3 (near PS1)

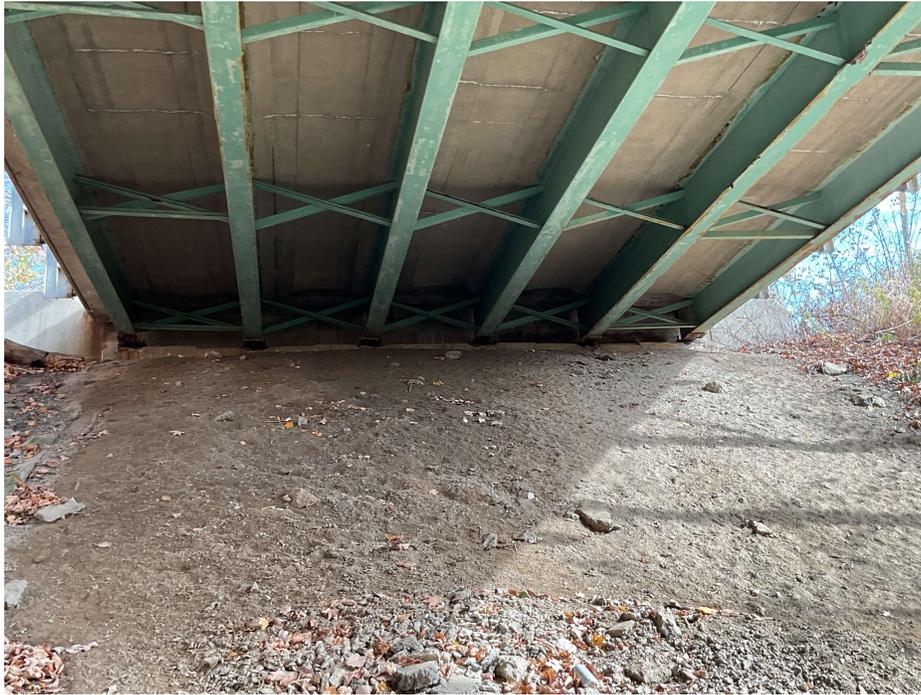
PHOTO 21

Description Fwd Abut

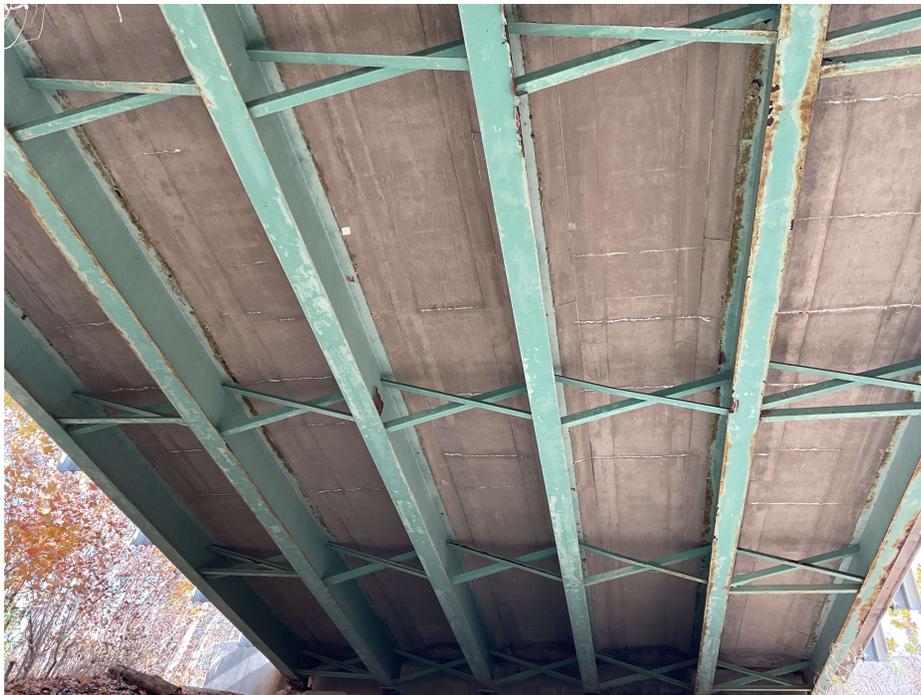
PHOTO 22

Description Span 3

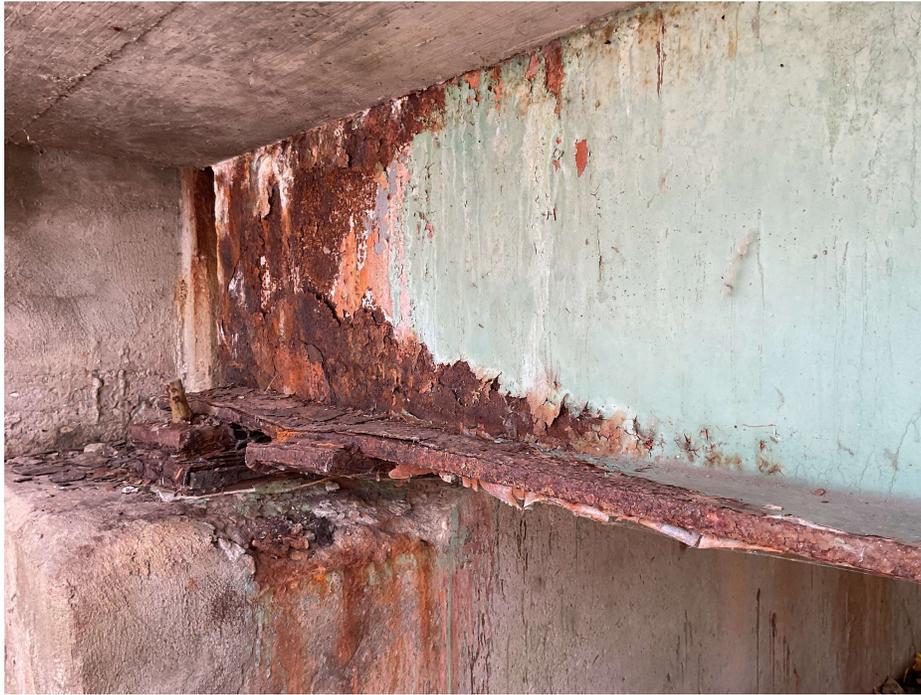
PHOTO 23

Description Span 3 B1 @ Fwd Abut

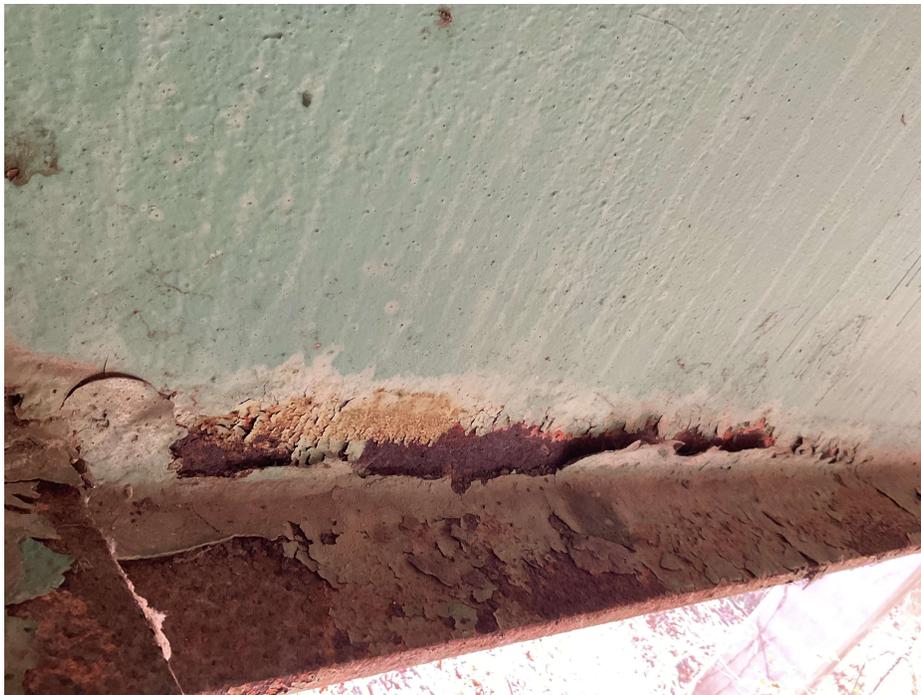
PHOTO 24

Description Typical rust t/o

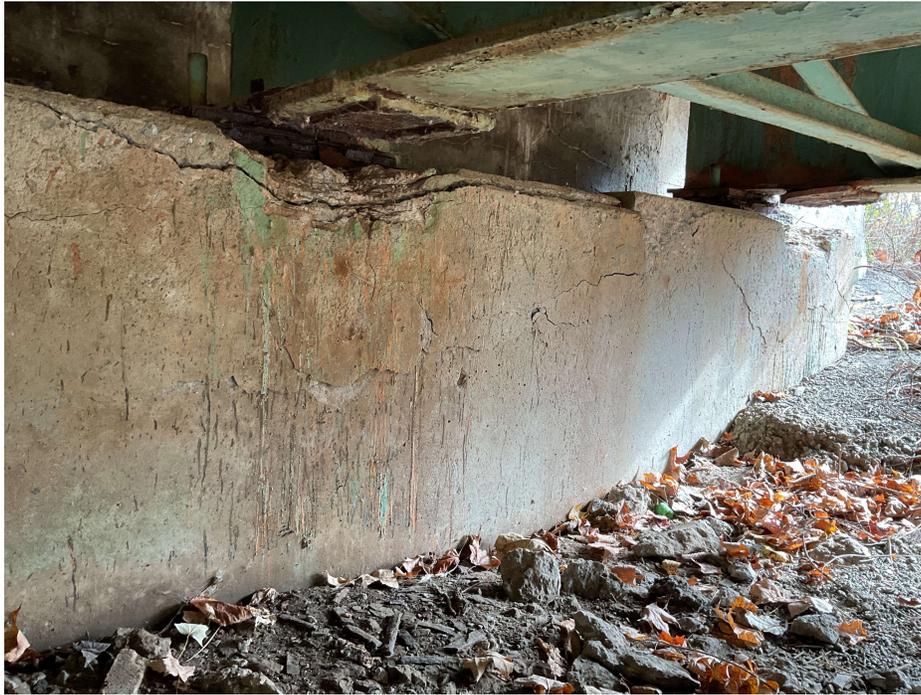
PHOTO 25

Description Fwd Abut RT

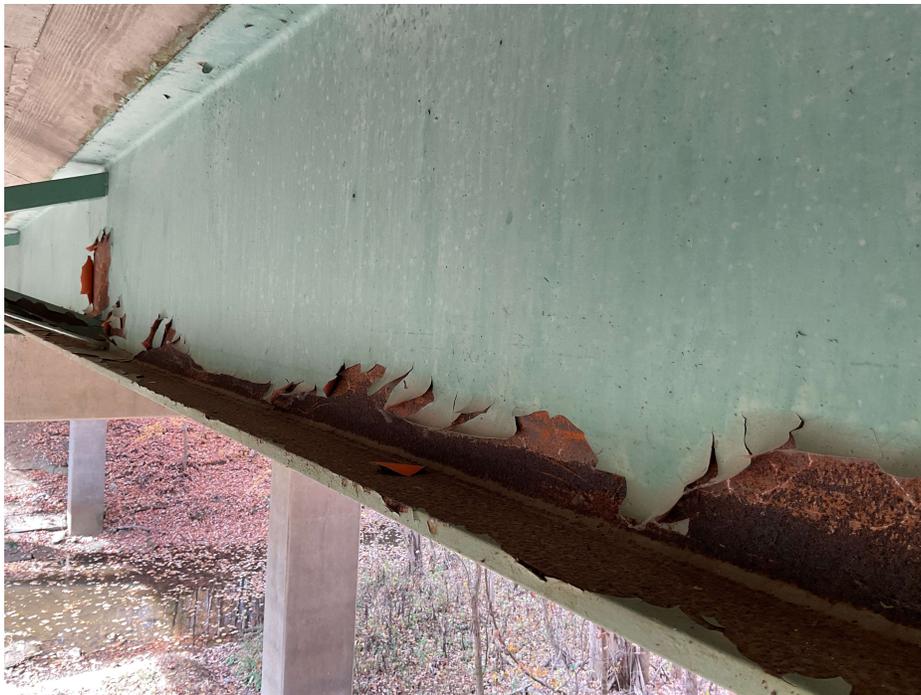
PHOTO 26

Description Span 3 B3

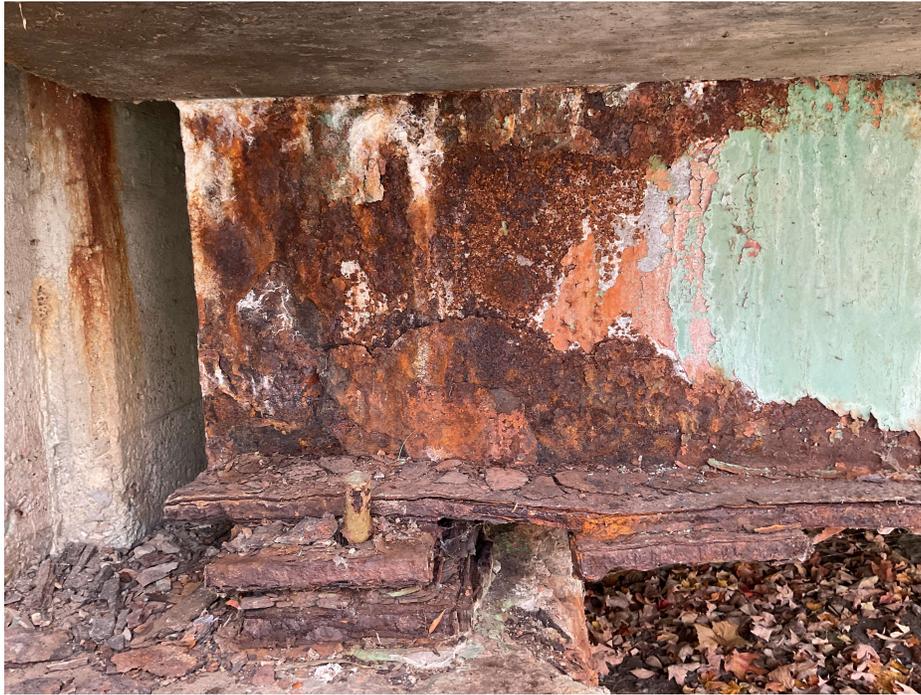
PHOTO 27

Description Span 3 B1 @ Fwd Abut

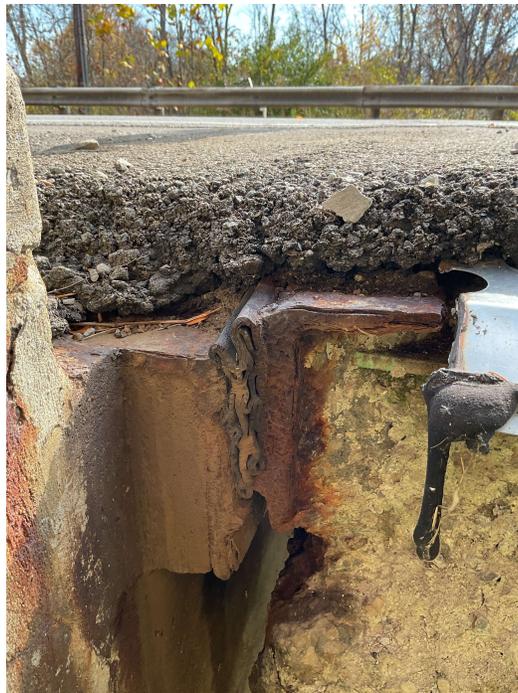
PHOTO 28

Description Fwd Joint
