## Ohio Bridge Inspection Summary Report

**FRA-00071-1703R (2507595)**

### Bridge Inspection Report

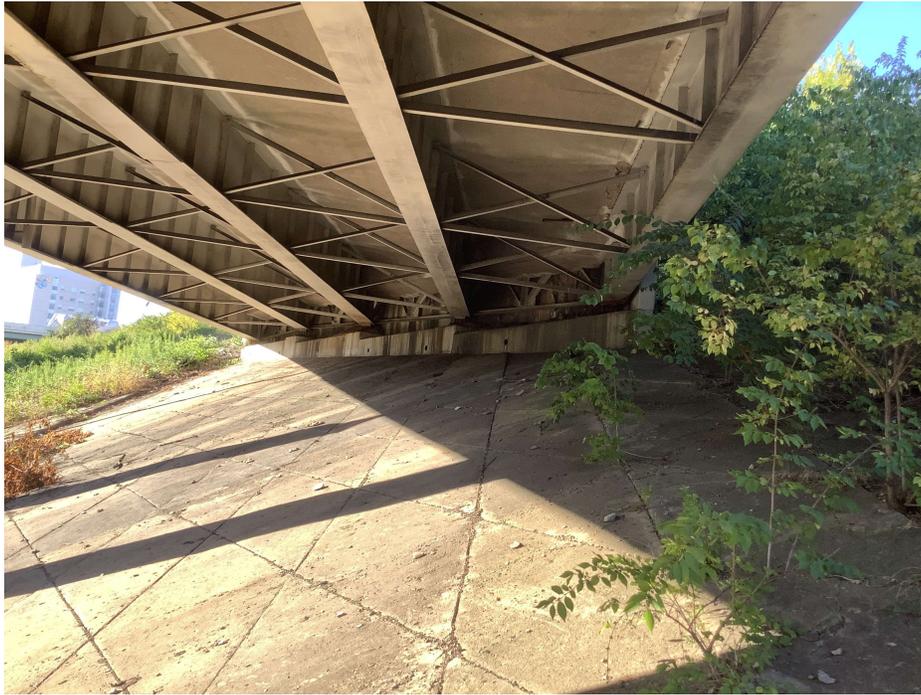
PHOTO 1

Description Rear Abut

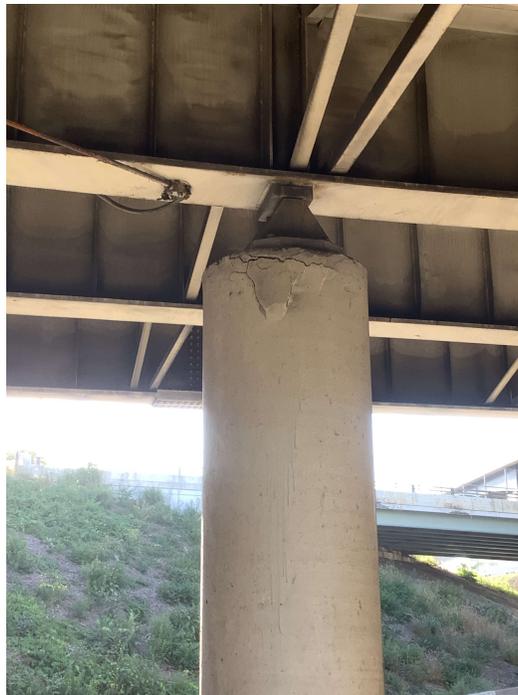
PHOTO 2

Description PS1 col. 3

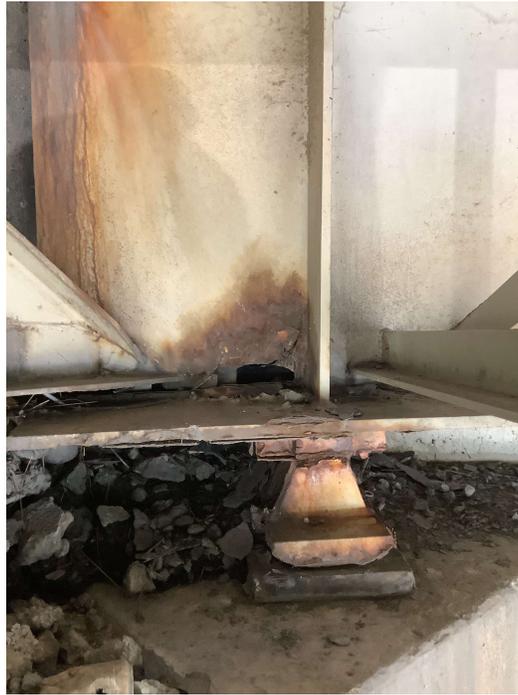
PHOTO 3

Description B1 @ Rear Abut

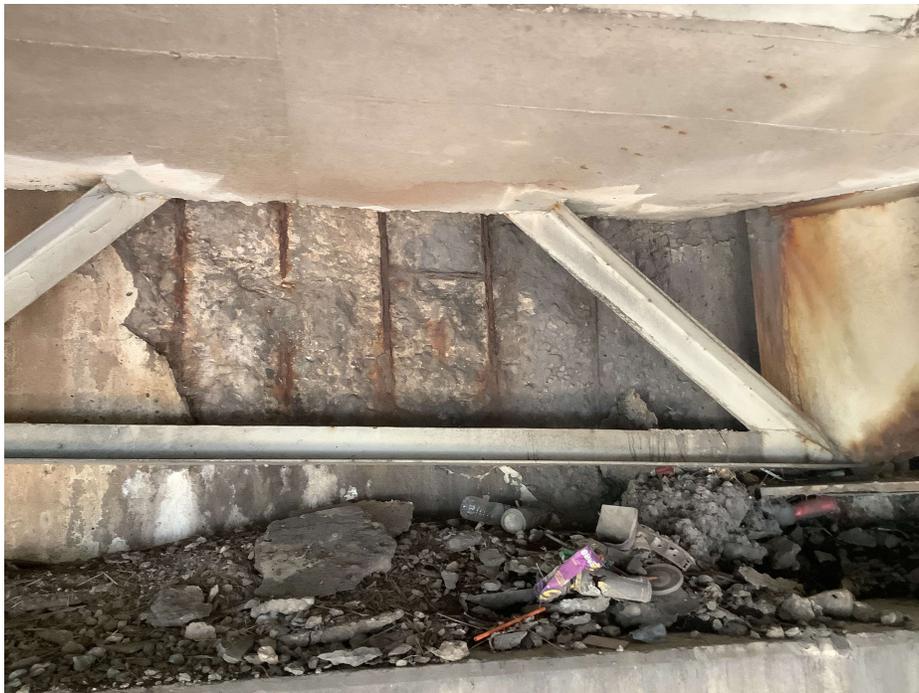
PHOTO 4

Substructures are in fair condition, heavy spalling with exposed rebar in backwalls.

Description Rear backwall bay 1

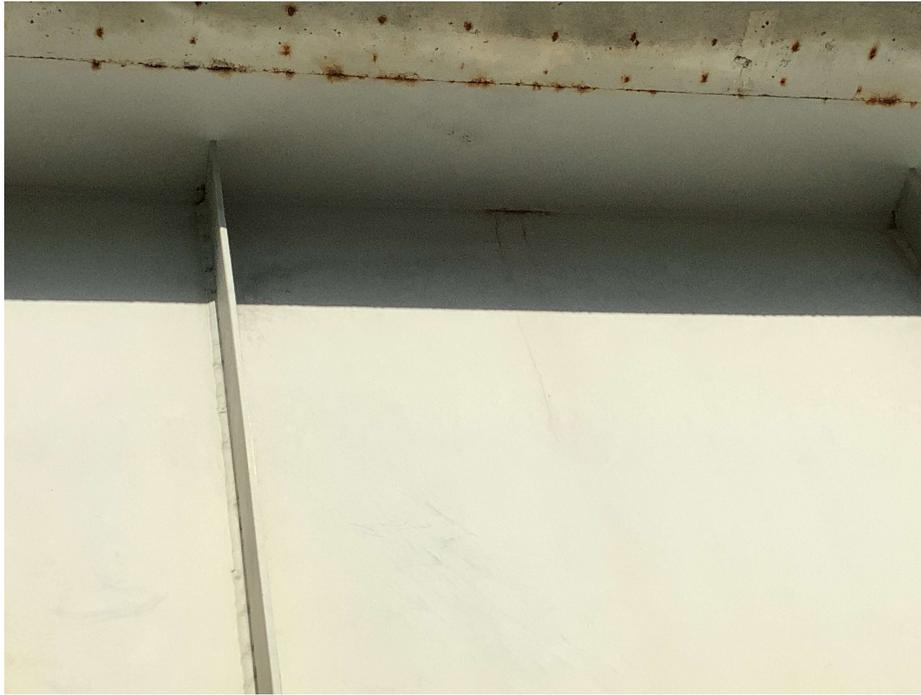
PHOTO 5

Description Span 1 B5

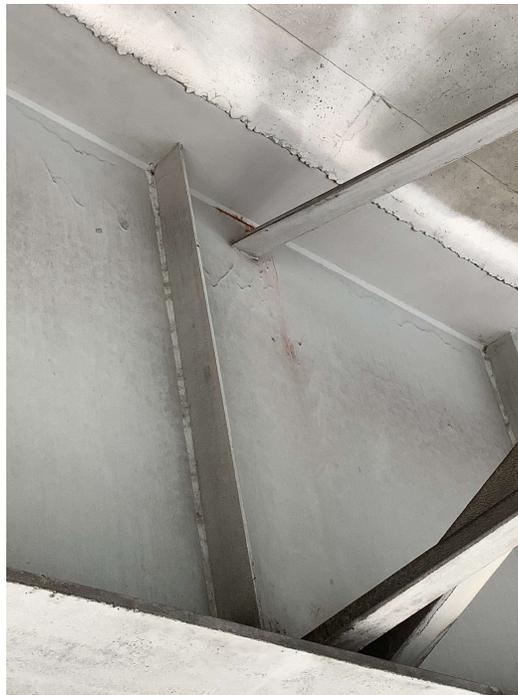
PHOTO 6

Description Span 1 B3

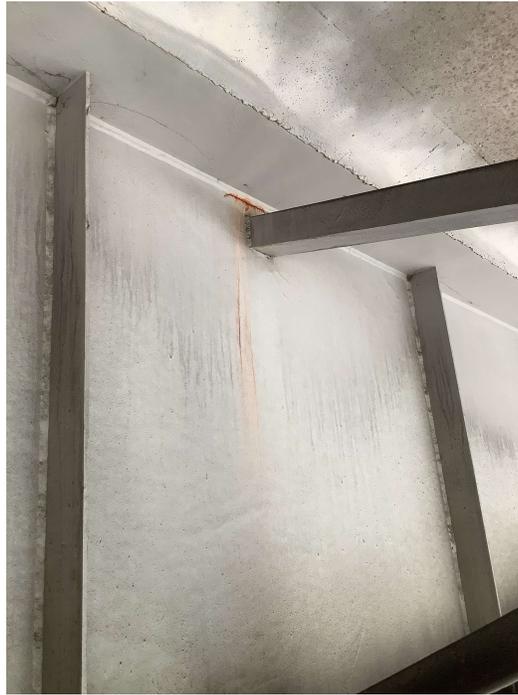
PHOTO 7

Description Span 1 B2

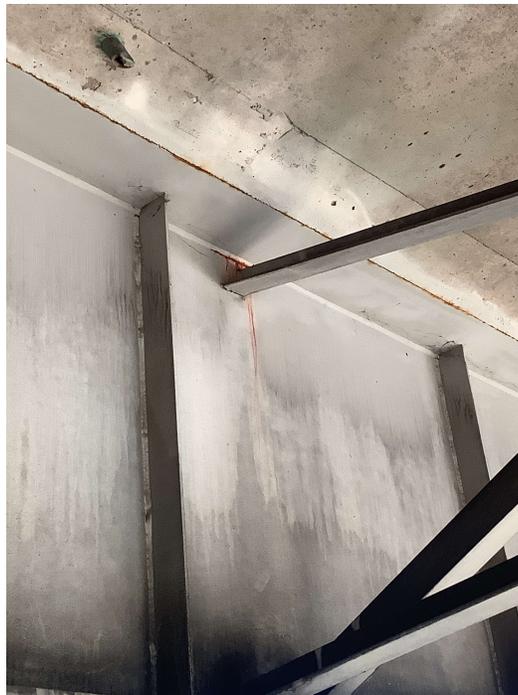
PHOTO 8

Description Span 1 B1

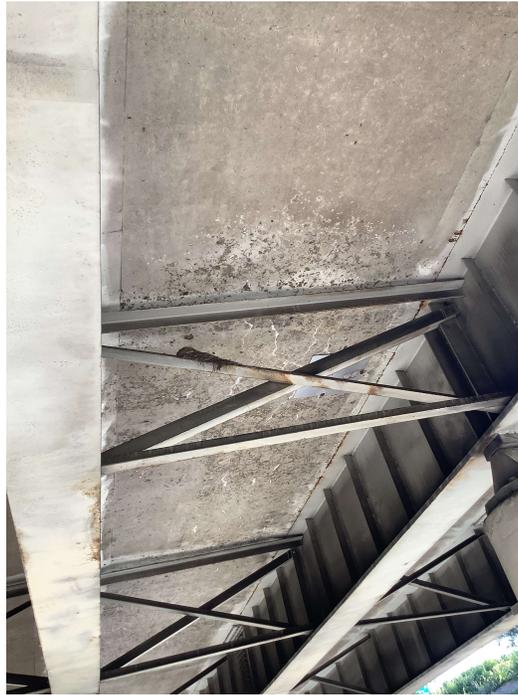
PHOTO 9

Description Bay 3 @ PS1

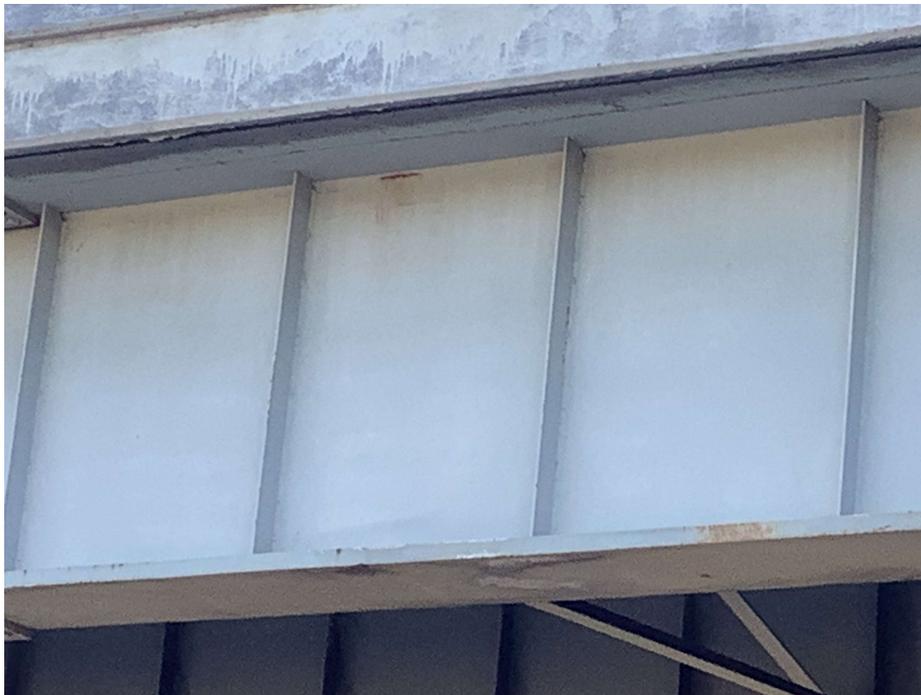
PHOTO 10

Description Span 2 B1 (near middle of span)

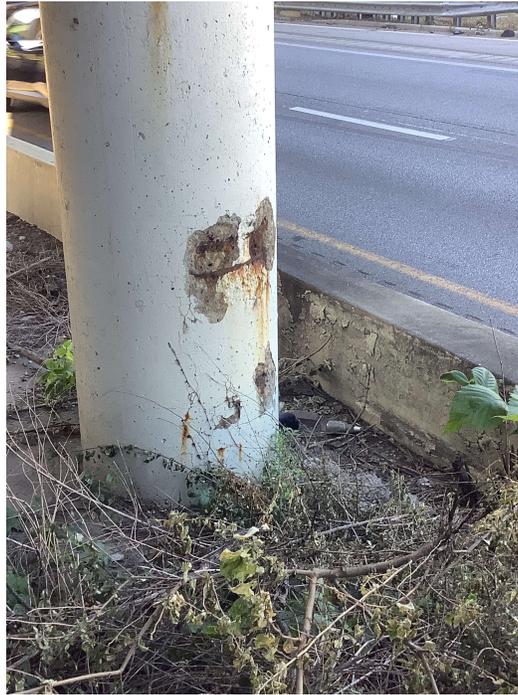
PHOTO 11

Description PS2 col. 1

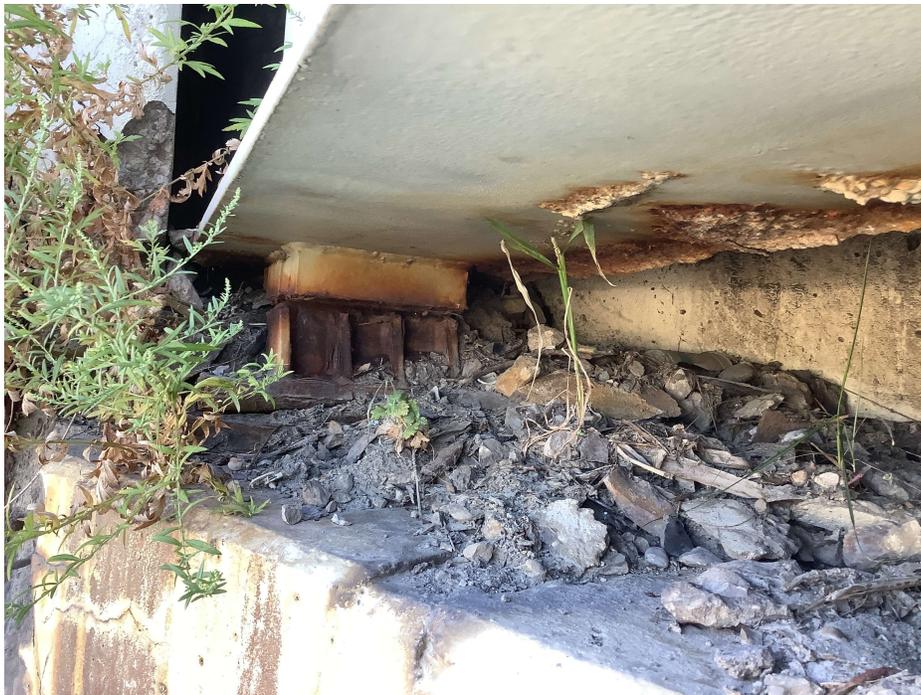
PHOTO 12

Environment	Total Quantity	Units	Condition State 1	Condition State 2	Condition State 3	Condition State 4
	CS2: Moderate rust at forward abutment bearings (3 EA). CS3: Heavy rust and debris at rear abutment and forward abutment bearings (7 EA). 2022 CS2 Rear bearings 2&4 - minor rust initiating CS3 Rear bearings 1,3,5 & Fwd. bearings 1,5- heavy rust and debris restricting movement 2023 same as 2022						
<b>313-Fixed Bearing</b>	3 - Mod.	5	each	5	0	0	0
<b>321-Reinforced Concrete Approach Slab</b>	3 - Mod.	2250	sq. ft.	2230	0	20	0
	CS3: Small hole in top left corner of rear approach slab (1sf). Hole should be filled to stop water pouring onto abutment. 2022 - Same as previous inspection 2023 same as						
<b>331-Reinforced Concrete Bridge Railing</b>	3 - Mod.	495	ft.	435	57	3	0
	CS2: Vertical cracking and vehicle scrape damage throughout (50ft). 2022 - Same as previous inspection CS3 Fwd. LT top - spall w/ exposed rebar w/ section loss 3' 2023 same as 2022

Description Fwd Abut bearing #1

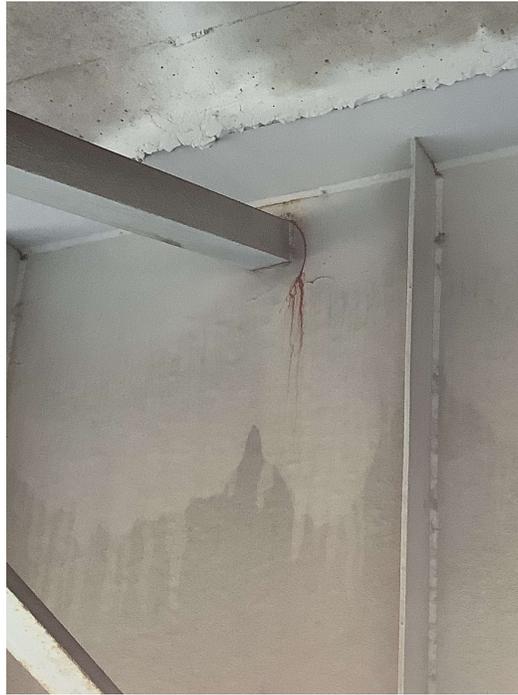
PHOTO 13

Description Span 3 B1 (2 cross members toward Rear from Fwd Abut)

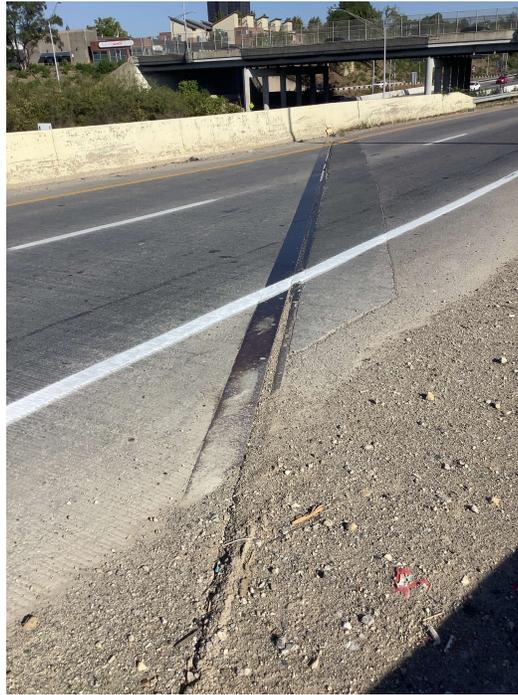
PHOTO 15  
Description Fwd Joint

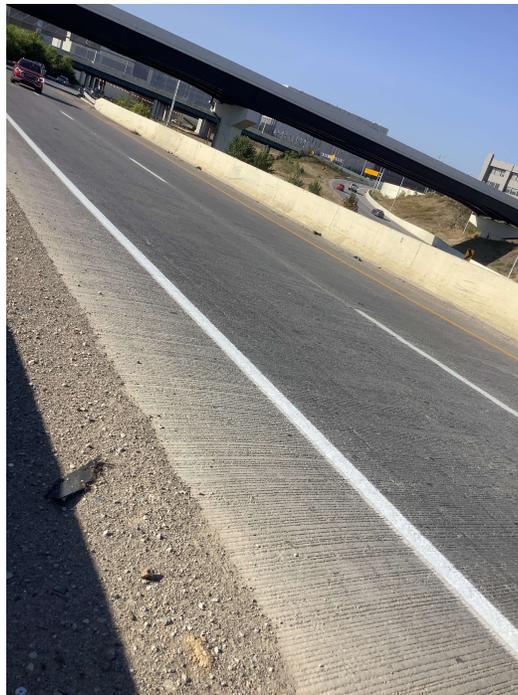
Overlay is in good condition, one broken and cracked area.

PHOTO 16  
Description Wearing Surface

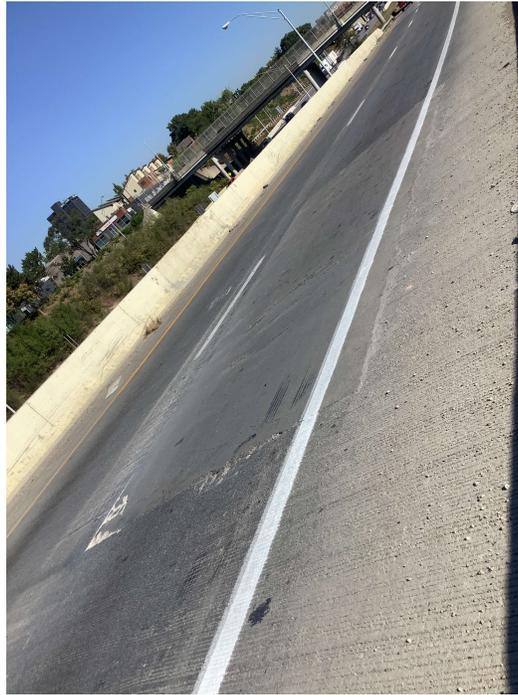
PHOTO 17

Description WS - large patched area

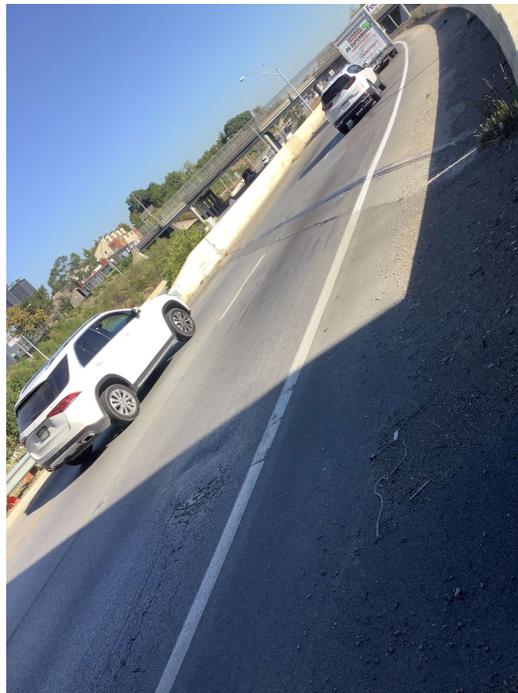
PHOTO 18

Approach slab is not visible due to AC overlay.

Hole in top of left rear approach slab allows water onto beam seat.

Description Rear Approach

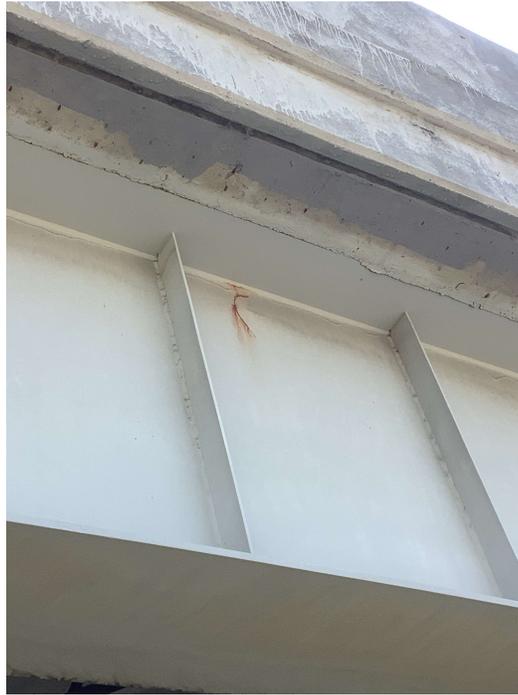
PHOTO 19

Description Span 3 B1 (2nd cross frame back from Fwd Abut)

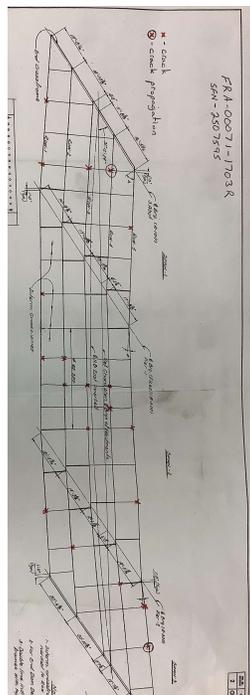
PHOTO 20

Description Sketch of crack locations
