Wasson Armleider Shared Use Path- General Structures Scope (PID 113603)

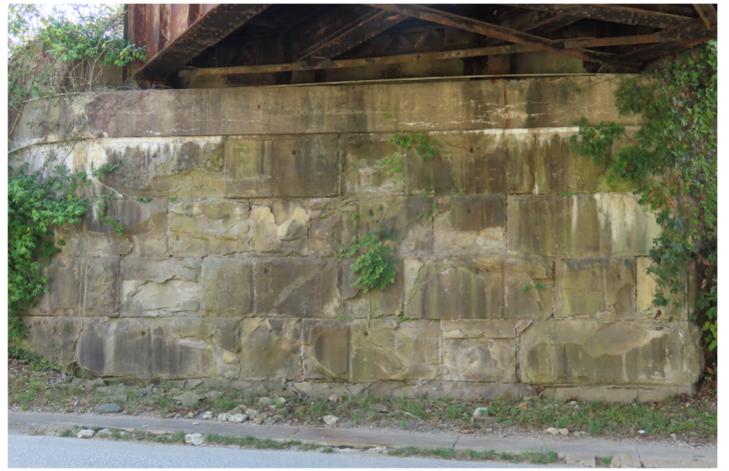
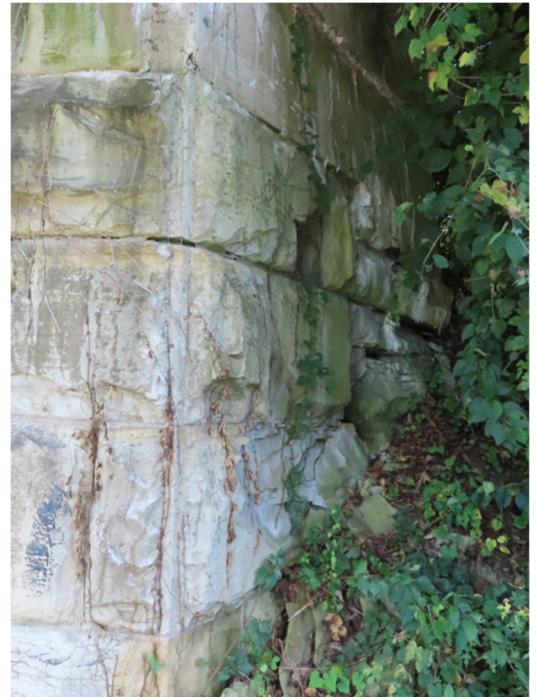
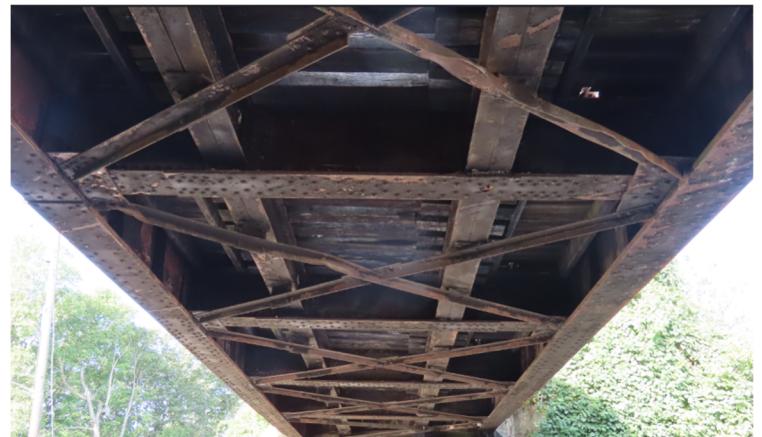
Bridge #5: Wooster Rd over Railroad

No need for structural repairs were found.

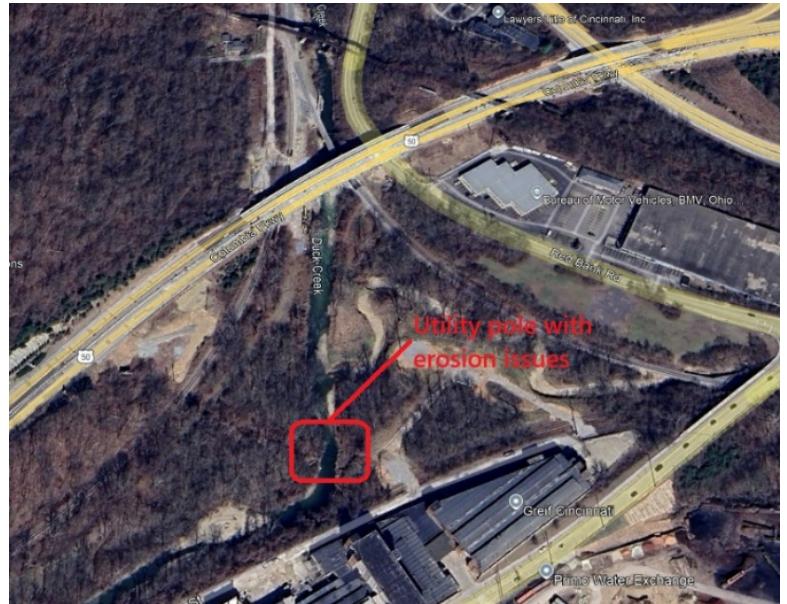
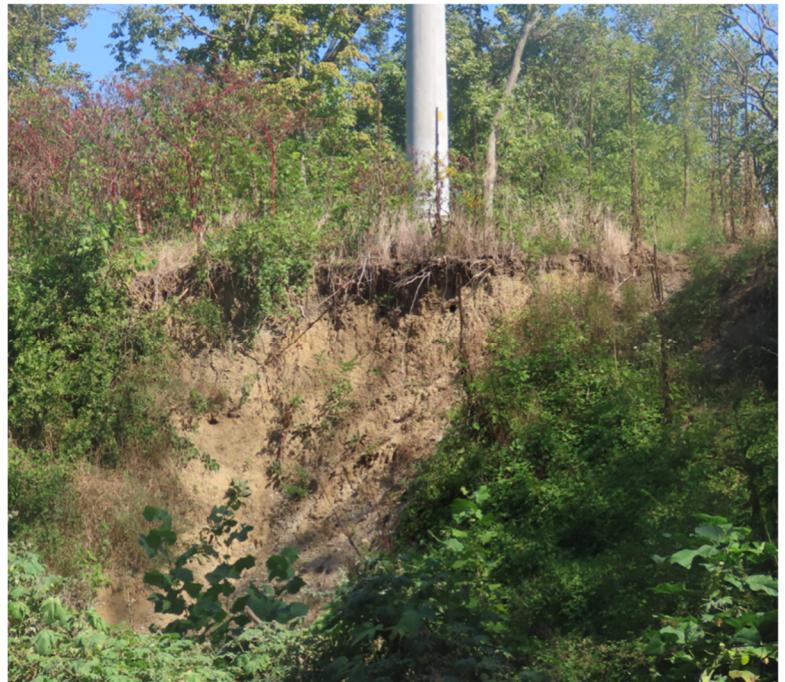
Utility pole with erosion issues
