ODOT District 8
2023 Fracture Critical and In-Depth
Element Level Inspection Report

December 3, 2023

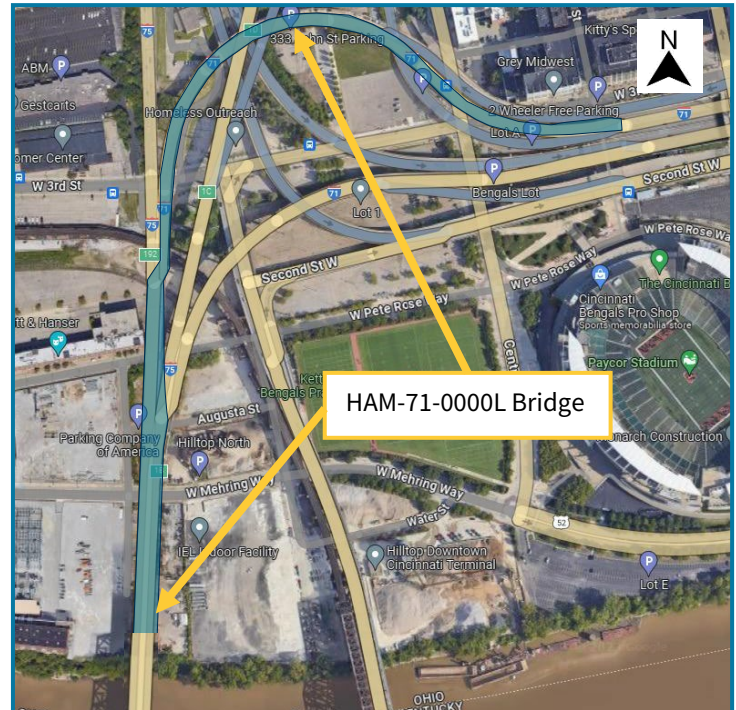
The FWW superstructure consists of welded steel plate girders and rolled beams. Spans 1 through 4 are made up of five rolled steel beams that run continuously through the Fracture Critical steel pier cap at Pier 2 by end plates that are welded to the beams and bolted to the steel pier cap. There are welded stiffener plates within the steel pier cap that transfer the forces across the pier cap at

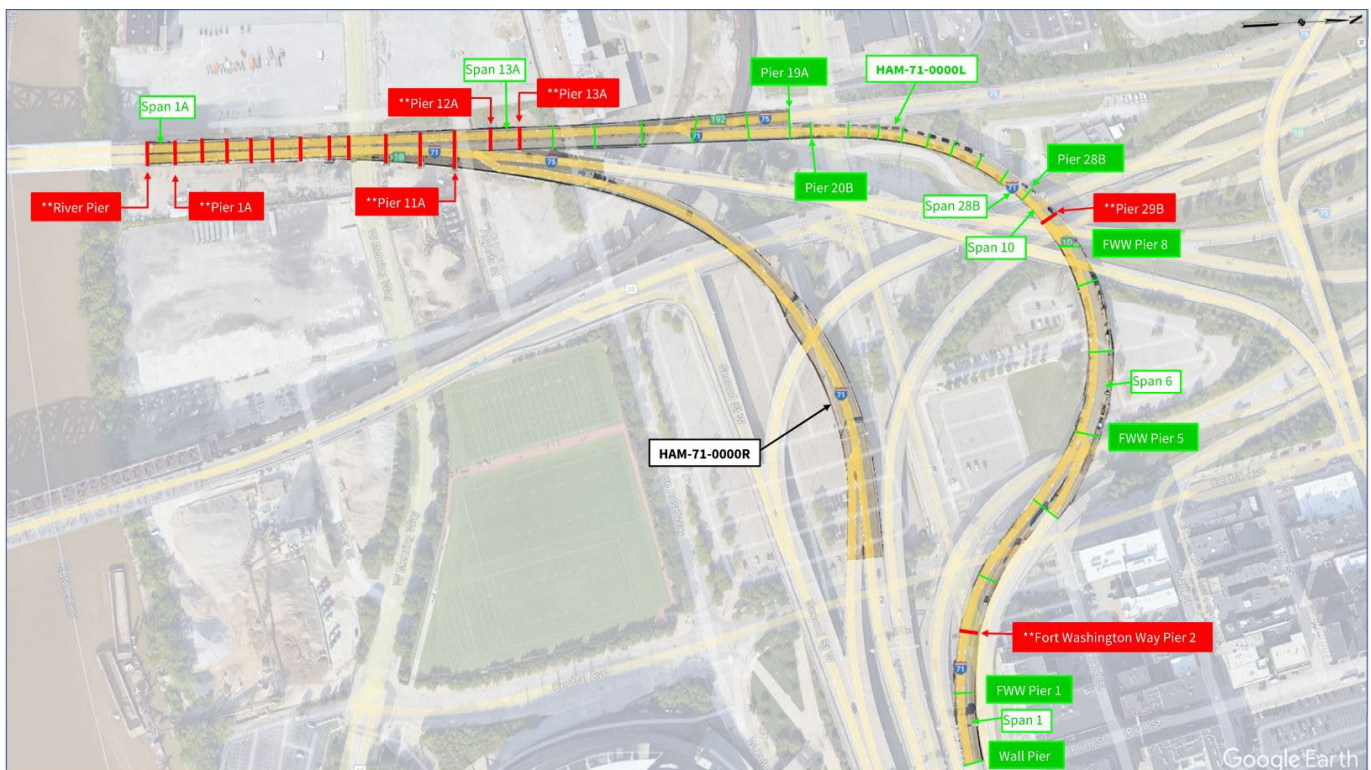
Figure 1 – Overall Location Map and Bridge Nomenclature

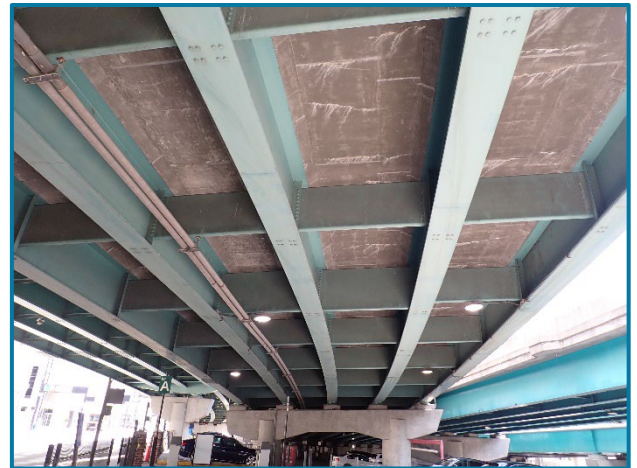
Photo 1 – Typical underside of deck with transverse cracking and efflorescence throughout (looking northeast in Span 2 (FWW)).

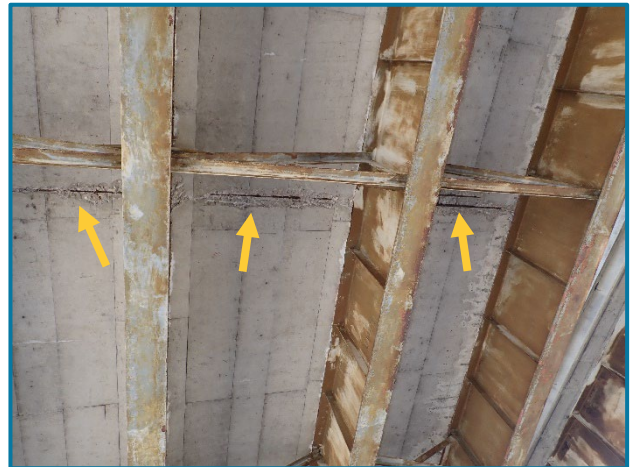
Photo 2 – Full width underside of deck spall at midspan of Span 21B (looking up and south).

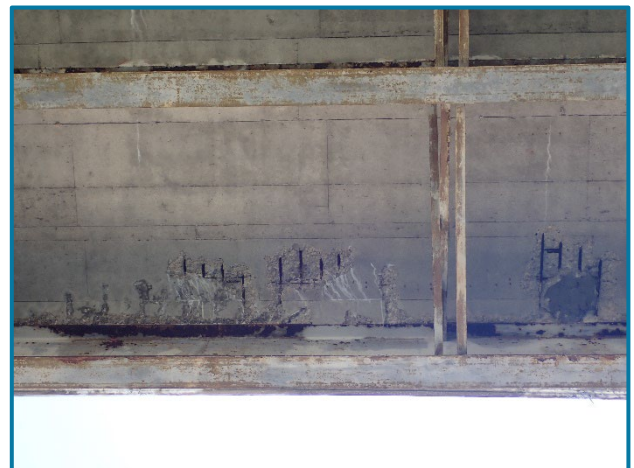
Photo 3 – Four spalls with exposed reinforcement in the underside of the deck between Girders D and E in Span 26B (looking up and west).

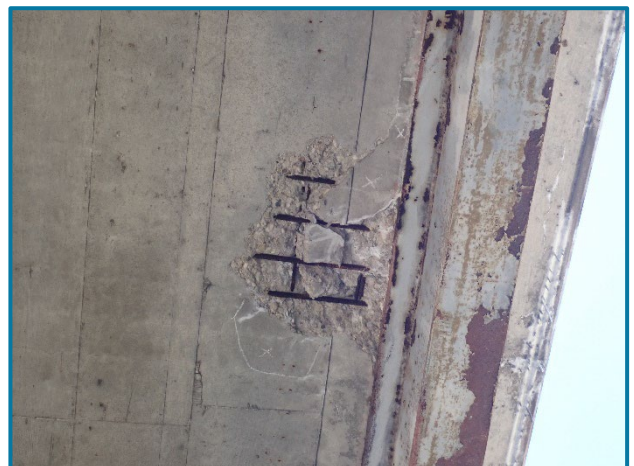
Photo 4 – Underside of deck spall between Girders D and E in Span 27B (looking up).

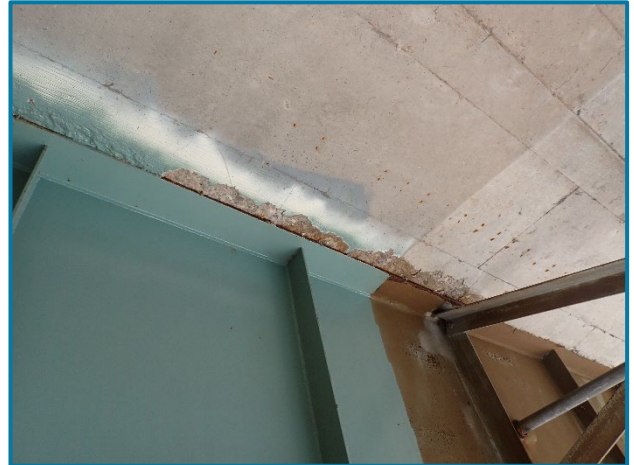
Photo 5 – Typical haunch spalls along the top flange of Girder A in Span 20B (looking northwest).

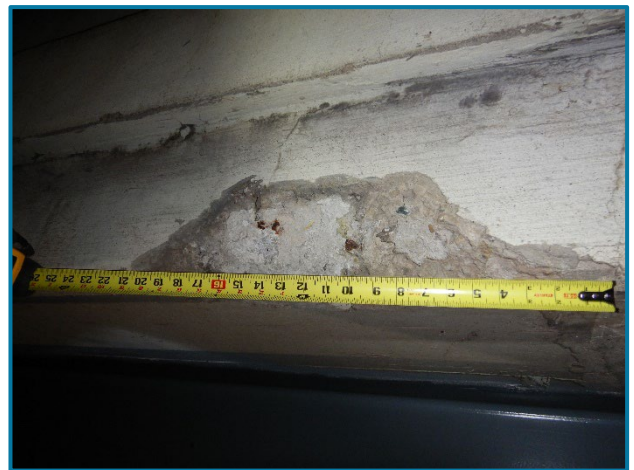
Photo 6 – 21" long by 12" wide by 1" deep spall on the east face of the east overhang near midspan of Span 1A (looking west).

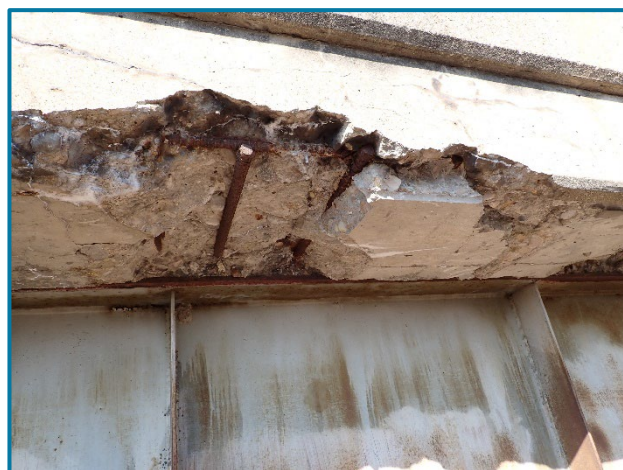
Photo 7 – East overhang spall with exposed reinforcement near Pier 19A in Span 20B (looking west).

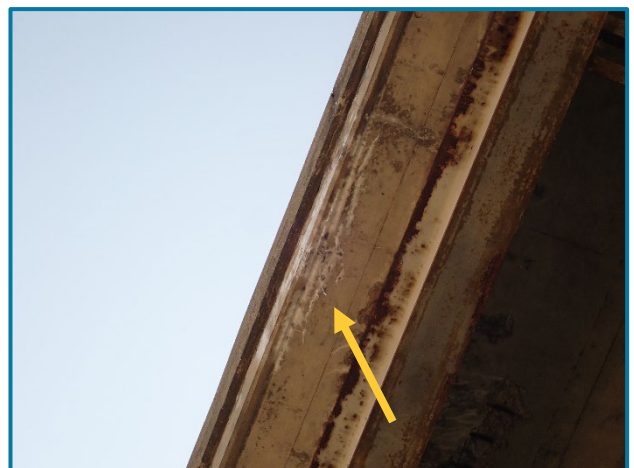
Photo 8 – Heavy cracking and efflorescence throughout the bottom edge of the east overhang in Span 26B (looking up and south).

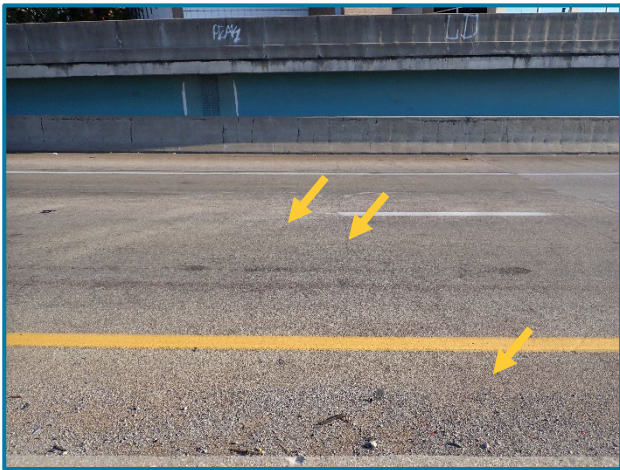
Photo 9 – Typical wearing surface with hairline transverse cracks throughout (looking northwest in Span 3 (FWW) at Pier 2 (FWW)).

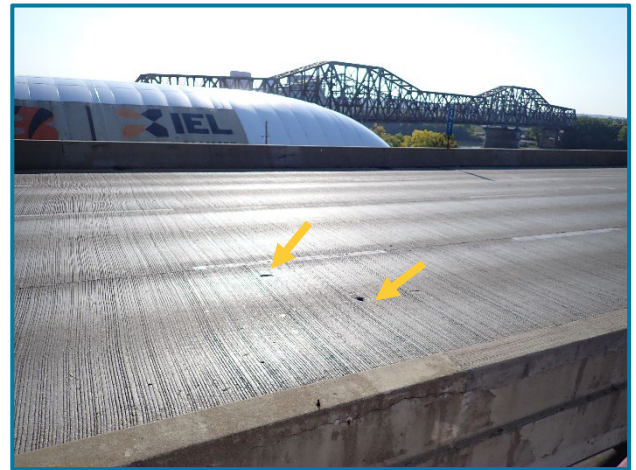
Photo 10 – Typical shallow pop-out spalls in the wearing surface in Span 3A (looking east).

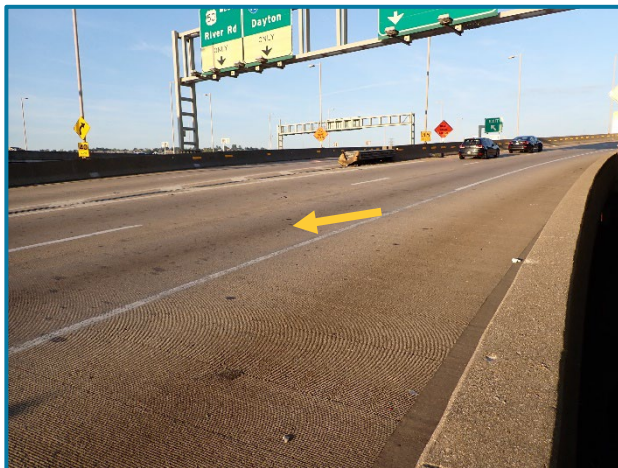
Photo 11 – Typical high friction treatment worn away in the travel lanes but present in the shoulders (looking southwest in Span 1 (FWW)).

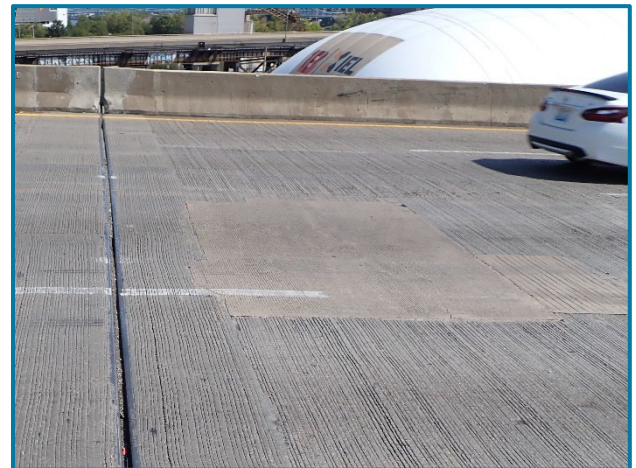
Photo 12 – Typical concrete patches near the expansion joint at Pier 8A (looking east).

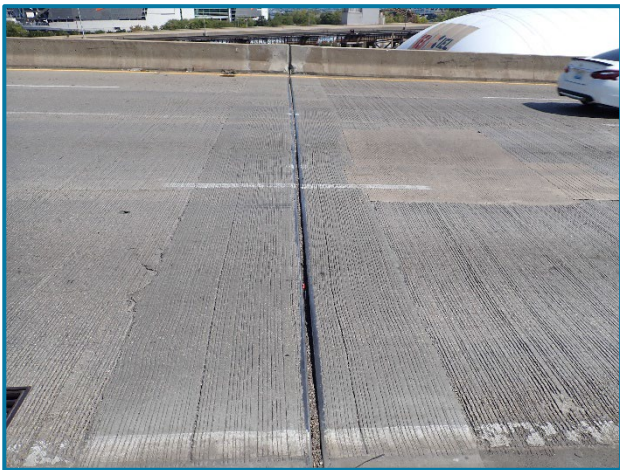
Photo 13 – Typical expansion joint at Pier 8A (looking east).

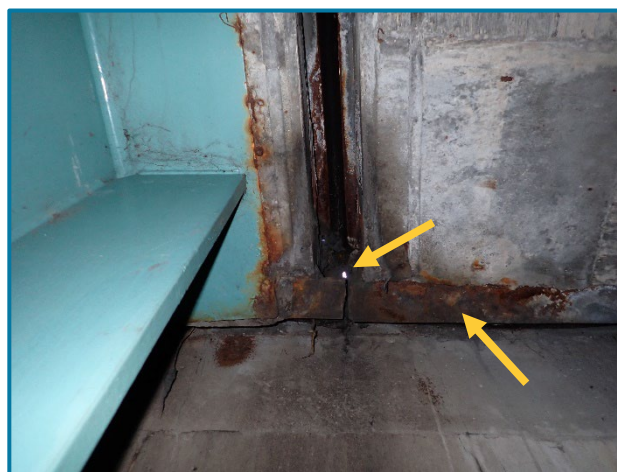
Photo 15 – Daylight shining through tears in the strip seal material between HAM-71-0000L and HAM-50-2091L (looking north). Note the rust and water staining to the underside of deck surrounding the torn strip seal.

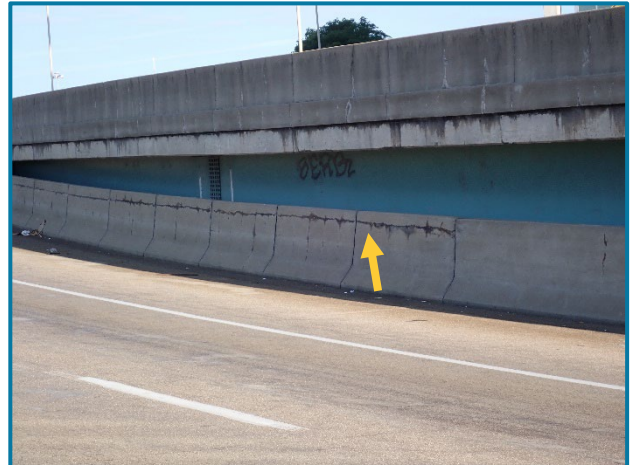
Photo 16 – Typical longitudinal cracking on the interior face of the concrete railing (looking northwest in Span 3 (FWW)).

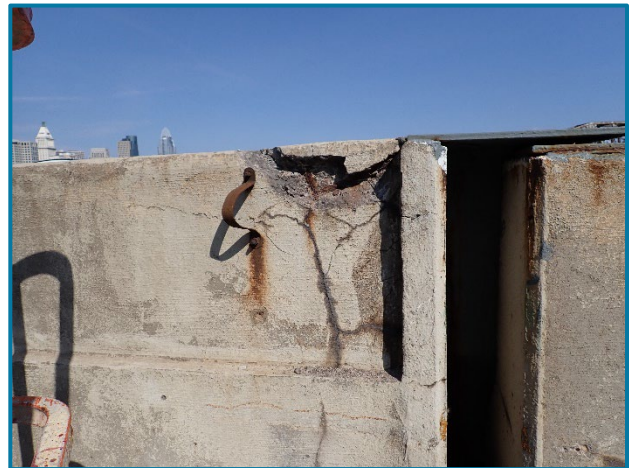
Photo 17 – Spall with exposed reinforcement at the top edge of the west railing at the River Pier (looking east).

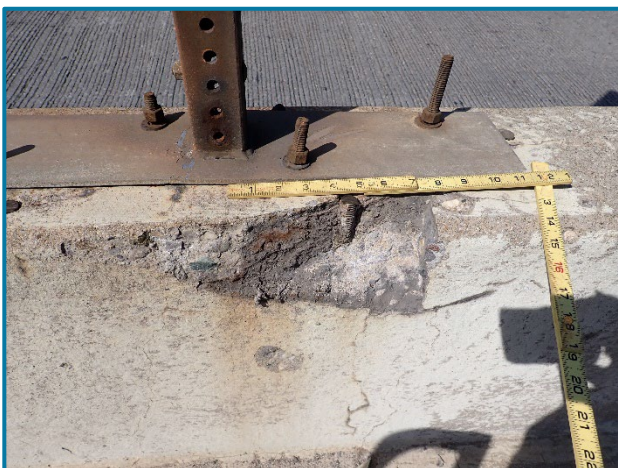
Photo 18 – Spall with exposed reinforcement at the top edge of the east railing at the base of a sign connection (looking west).

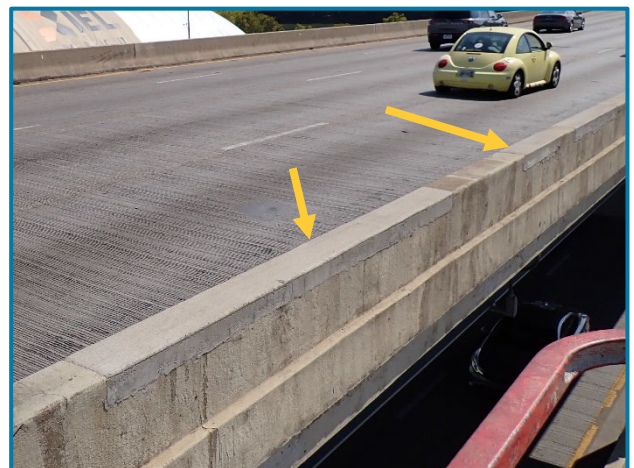
Photo 19 – Typical concrete patches at the top of the railing (looking southeast at the west railing in Span 7A).

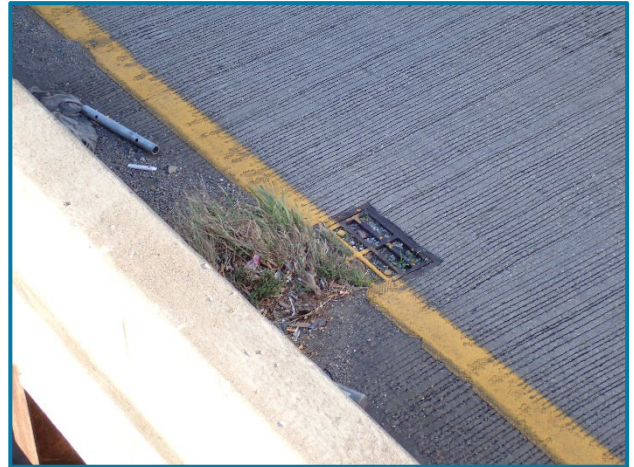
Photo 20 – Typical clogged scupper (looking south in Span 17A near Pier 16A).

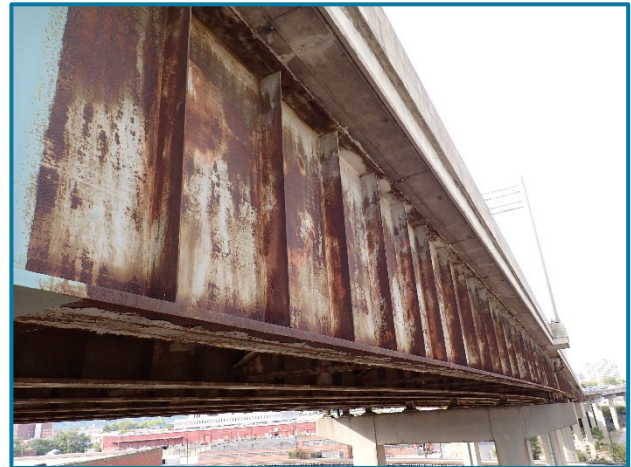
Photo 24 – Active corrosion throughout the east fascia girder in Span 16A (looking northwest).

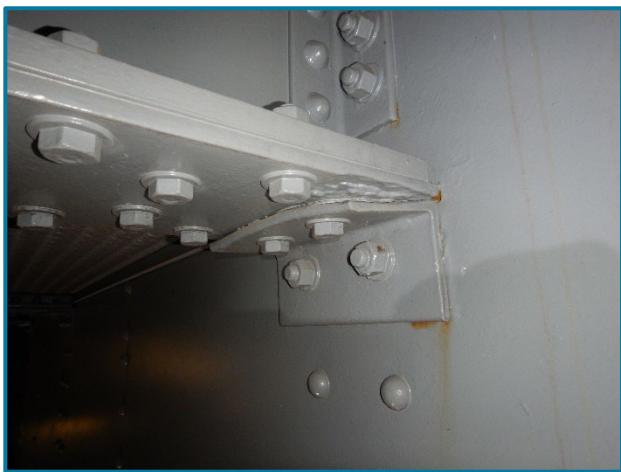
Photo 25 – Typical painted over pack rust between the girder bottom flange and seat angle at the girder to pier cap connection (looking south at Girder A on the north side of the River Pier Cap).

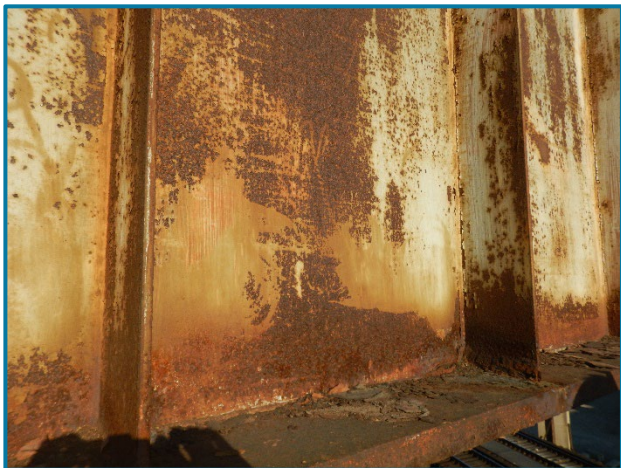
Photo 26 – Section loss throughout bottom flange and web on the east face of Girder H in Span 18A (looking northwest).

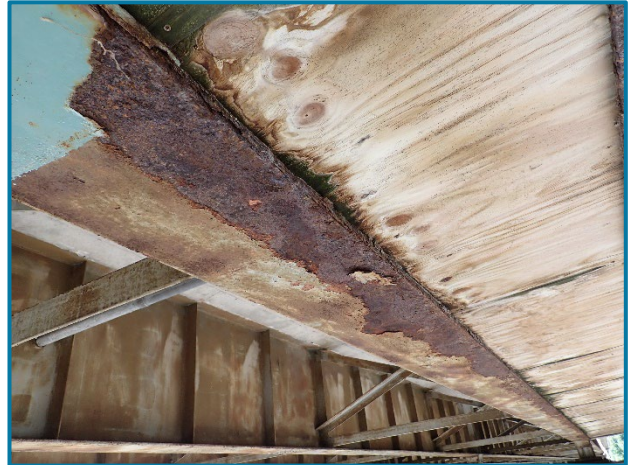
Photo 27 – Laminate corrosion with up to 1/8" deep section loss to the underside of the bottom flange of Girder A in Span 20A (looking southeast).

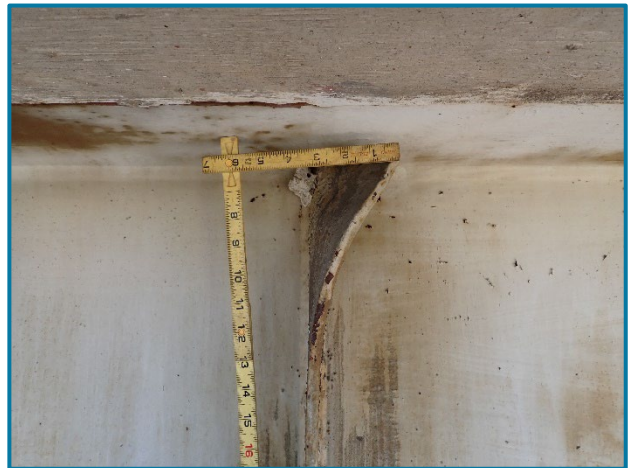
Photo 28 – Bent stiffener near the top flange on the east side of Girder E near Pier 21B in Span 22B (looking west).

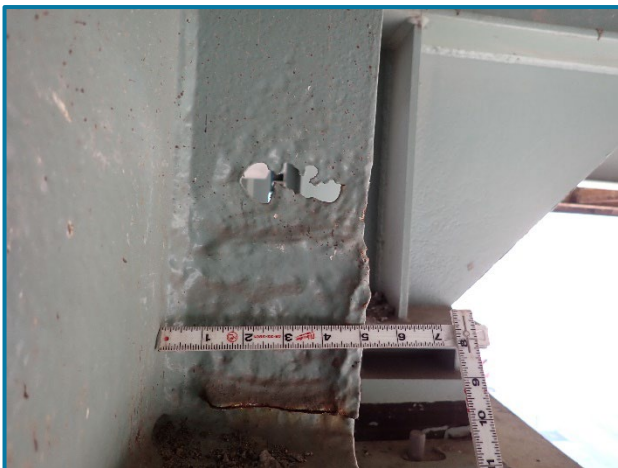
Photo 29 – Painted over corrosion hole in the web behind the bearing stiffener of Girder D at Pier 19B (looking west).

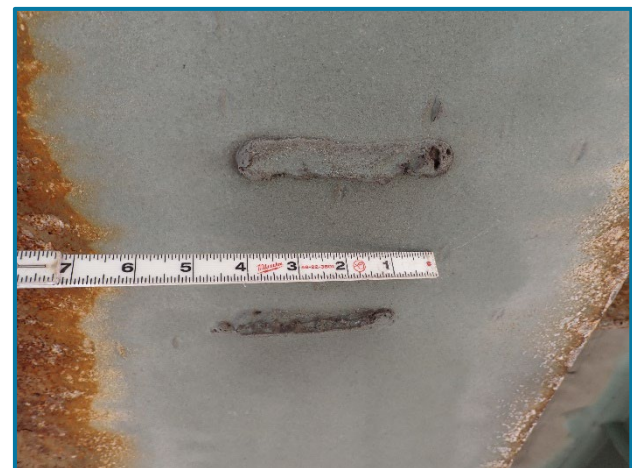
Photo 30 – Fatigue-prone welds on the underside of the girder bottom flange in Span 15A (looking south at Girder F).

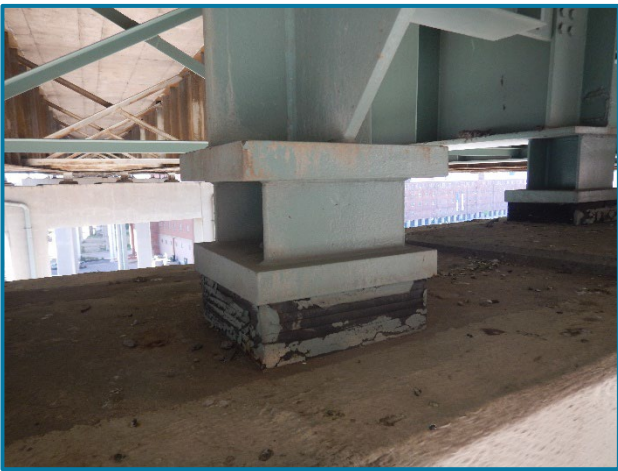
Photo 31 – Typical elastomeric bearing (looking southwest at the Girder D bearing at Pier 19A).

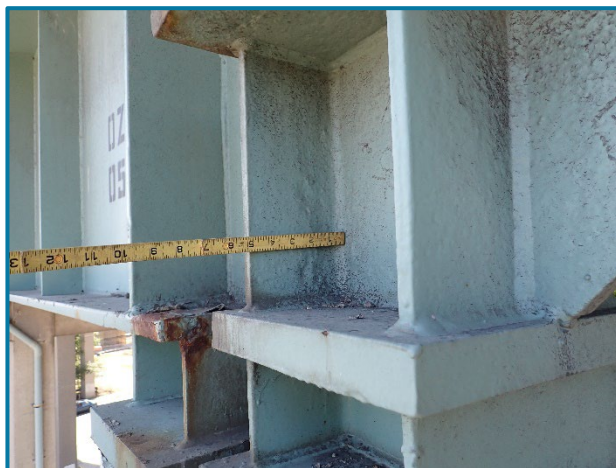
Photo 33 – Typical painted over pitting throughout the elastomeric bearing assembly (looking southwest at the Girder E bearing at Pier 23B). Note the corrosion on the south bearing.

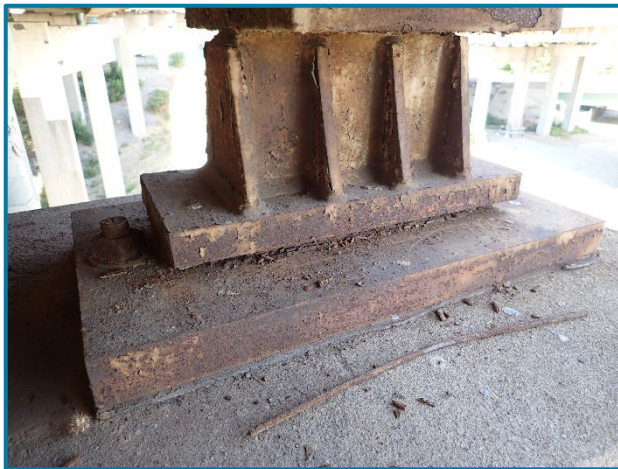
Photo 34 – 1/4" thick pack rust between the masonry plate and rocker bearing of Girder E at Pier 22B (looking north).

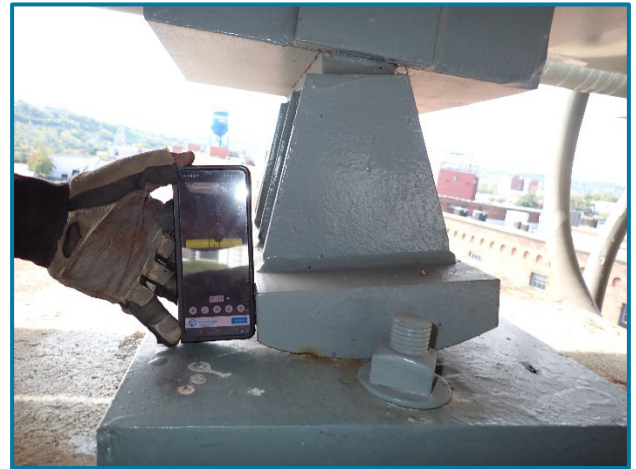
Photo 35 – Girder A bearing at Pier 14A contracted 7° to the south at Pier 14A (looking west).

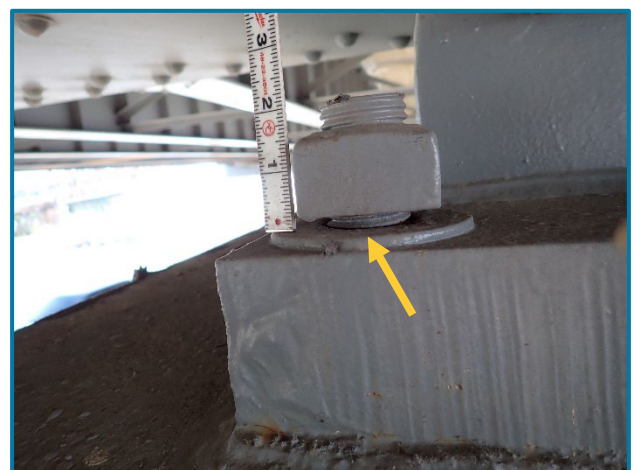
Photo 37 – Loose anchor bolt nut at the Girder B bearing of Pier 13A (looking southeast).

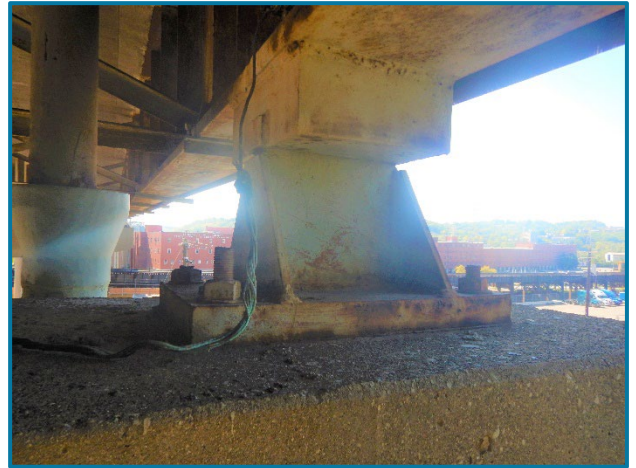
Photo 38 – Typical surface corrosion throughout fixed bearings (looking southwest at Girder A bearing at Pier 21B).

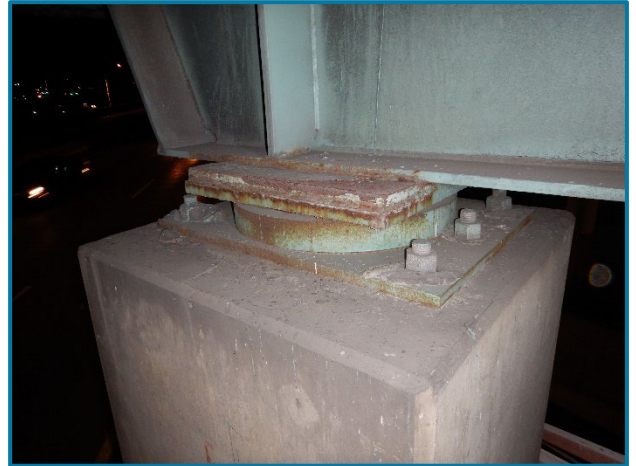
Photo 39 – Corrosion throughout the bearing at Girder 6 of Pier 29B (looking southeast).

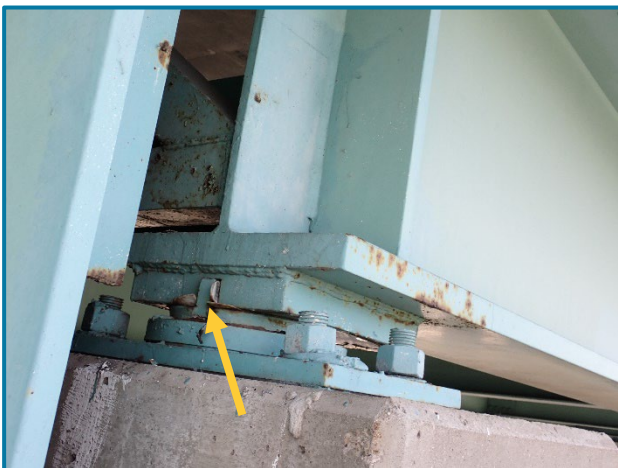
Photo 40 – Teflon pad extruded from the Girder 6 bearing at Pier 7 (looking southwest).

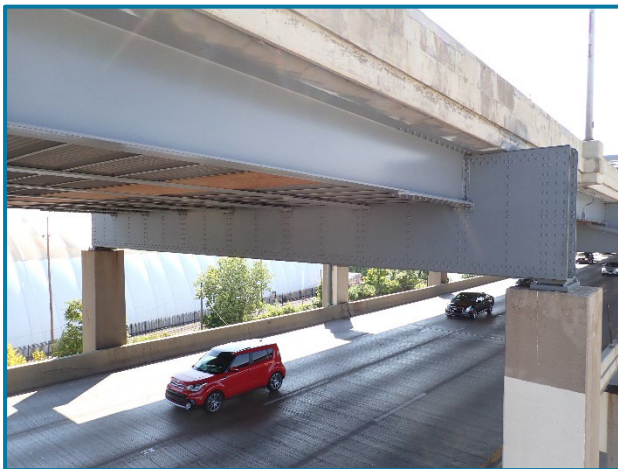
Photo 42 – Typical protective coating system condition in Spans 1A-14A (looking southeast towards Pier Cap 5A).

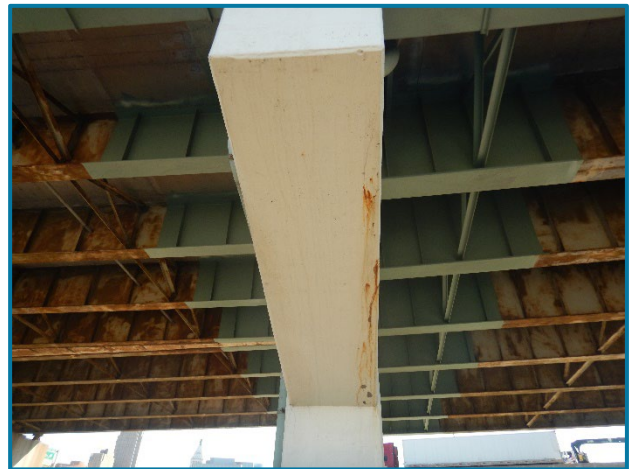
Photo 43 – End 10' of steel members at Pier 19A expansion joint painted during 2017 rehabilitation (looking east).

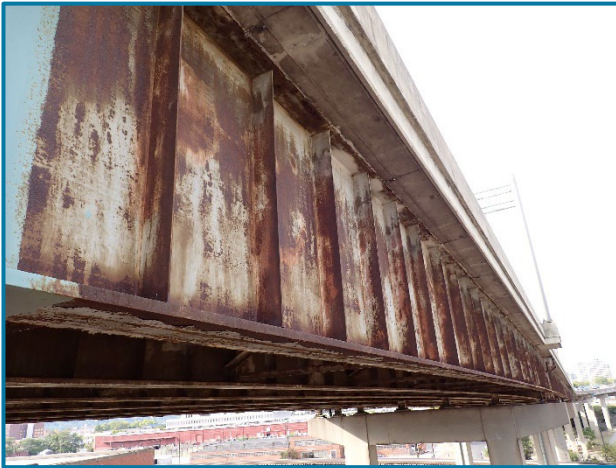
Photo 44 – Typical surface corrosion throughout Spans 15A-28B (looking northwest at Girder H in Span 16A).

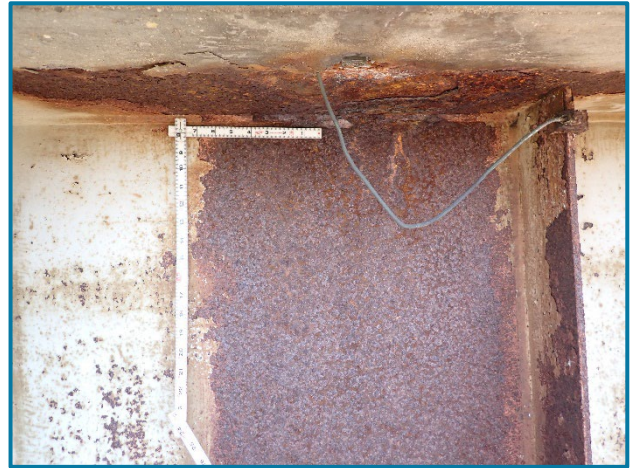
Photo 45 – Typical failed paint on the exterior face of the fascia girder with areas of measurable section loss (looking east at the west face of Girder A in Span 23B).

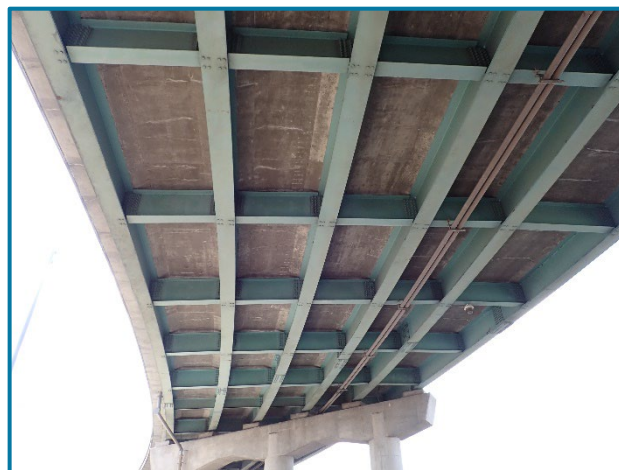
Photo 46 – Typical paint condition in the FWW spans (looking west in Span 8).

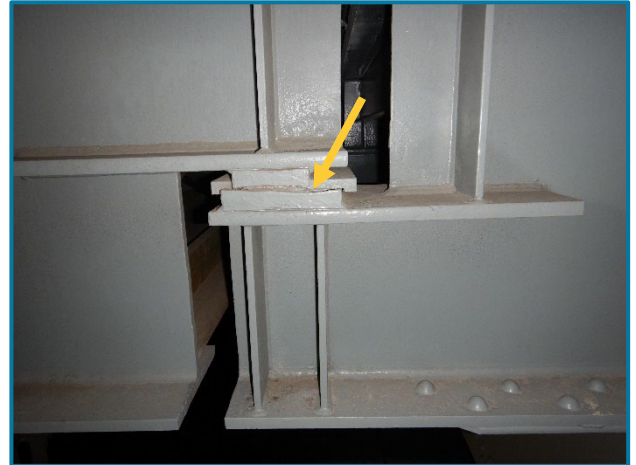
Photo 47 – Typical area of section loss painted over on the bearing plates near Pier 4A (looking west).

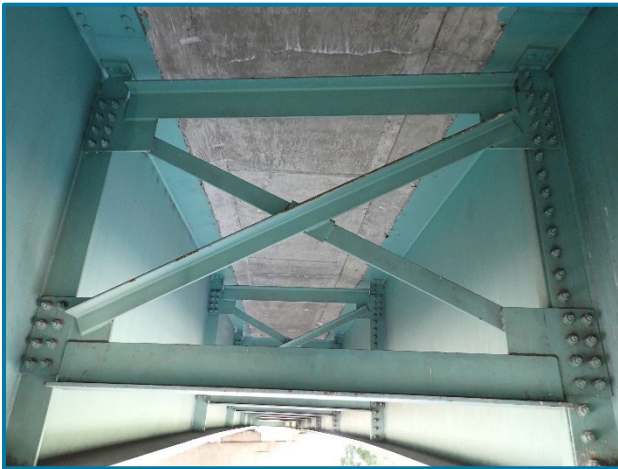
Photo 48 – Typical crossframe with minor surface corrosion in Span 5 (FWW) between Beams 9 and 10 (looking south).

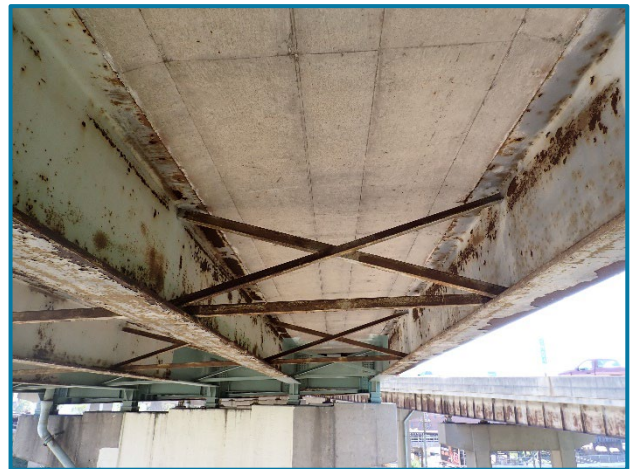
Photo 49 – Typical crossframes with minor surface corrosion in the original spans (looking south in Span 24B between Girders A and B).

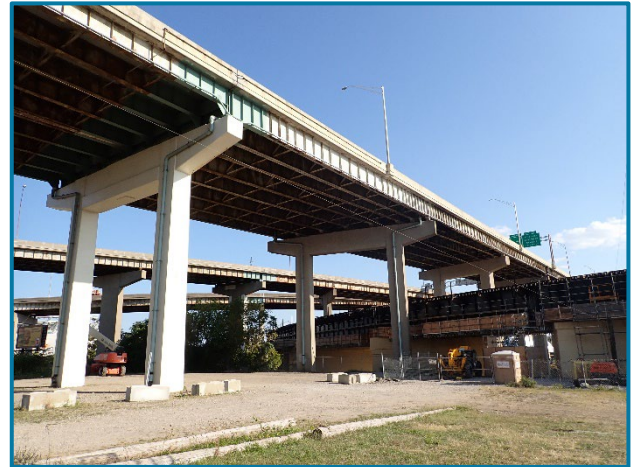
Photo 50 – Typical concrete piers in the original spans with FRP wrapping throughout (looking southeast at Piers 17A-19A).

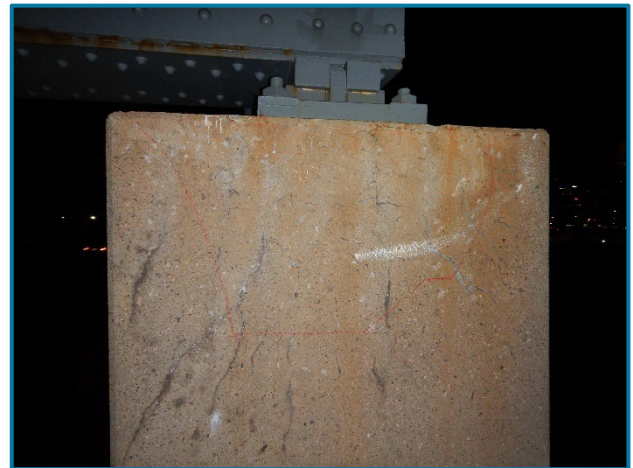
Photo 51 – Typical delamination and hairline cracking throughout the concrete column (looking north at Column 2 of Pier 8A).

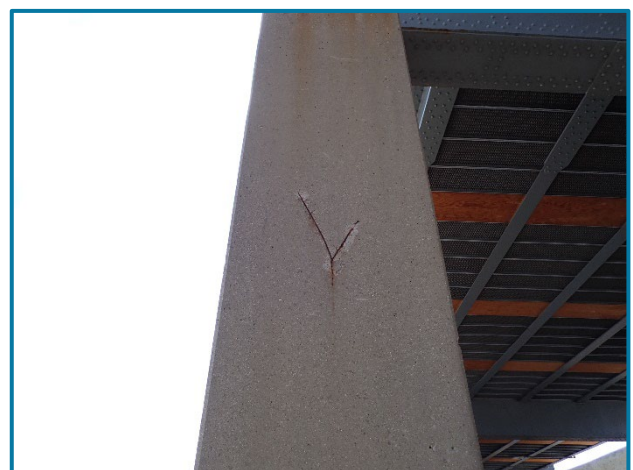
Photo 52 – Typical shallow spall with exposed reinforcement wire ties due to lack of cover (looking south at the north face of Column 1 at Pier 5A).

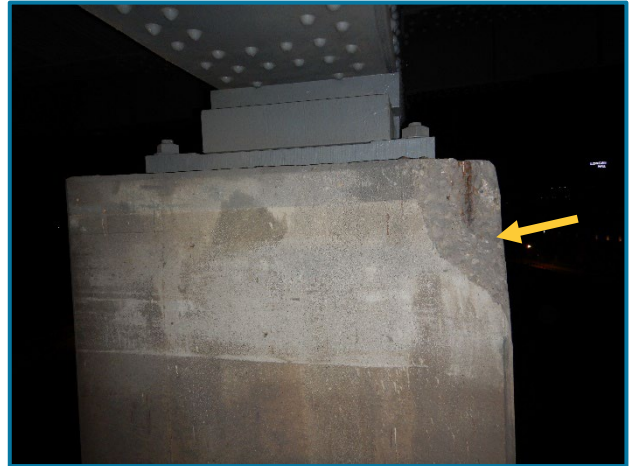
Photo 53 – Spall with exposed reinforcement at the top northeast corner of Column 2 at Pier 11A (looking north).

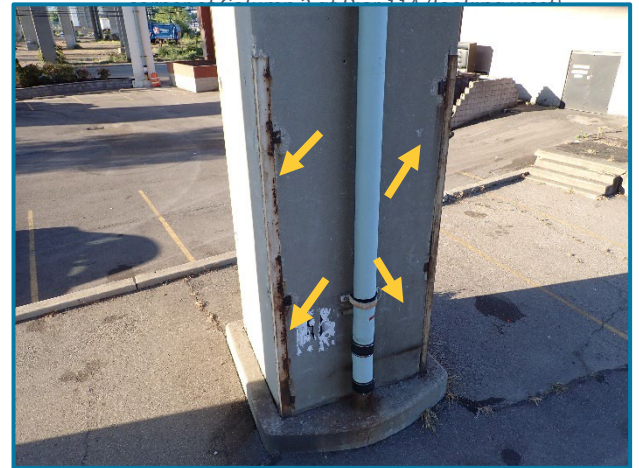
Photo 54 – Spalls at the corners of the existing protection brackets at Pier 16A (looking south at the north face of Column 1).

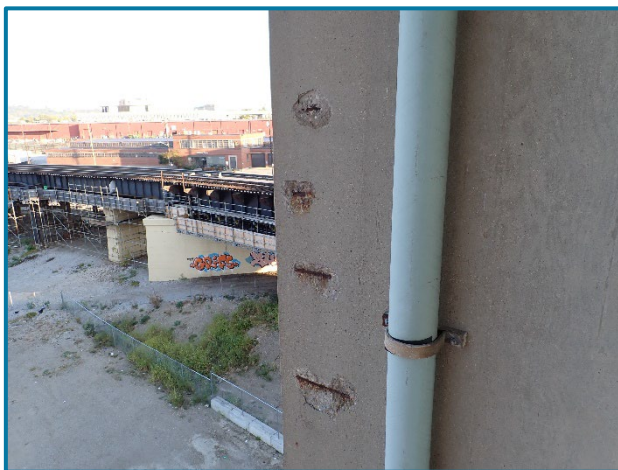
Photo 55 – Spalls with exposed reinforcement on the south face of Column 1 at Pier 17A (looking northwest).

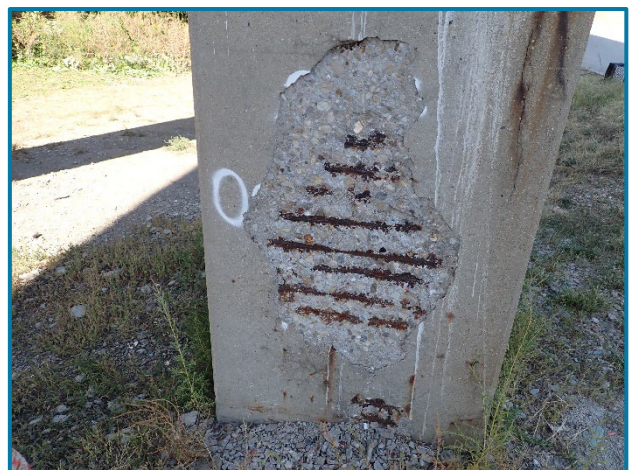
Photo 56 – Spall with exposed reinforcement on the south face of Column 2 at Pier 23B (looking north at the base).

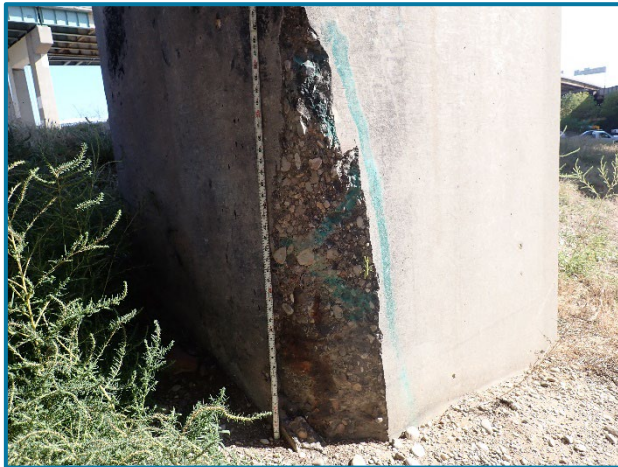
Photo 57 – Spall with exposed reinforcement at the northwest corner of Column 2 at Pier 24B (looking southeast).

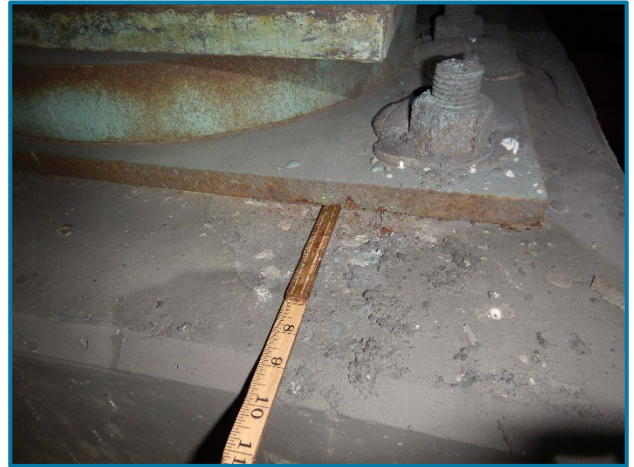
Photo 58 – Spall at the east bearing masonry plate of Pier Cap 29B (looking north).

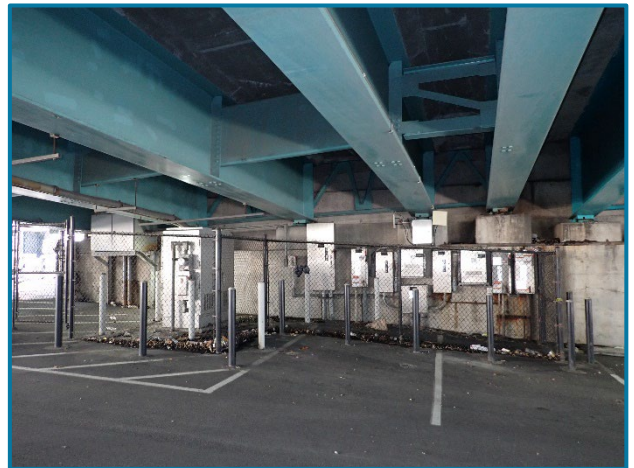
Photo 59 – Utilities fenced in at the Wall Pier (looking north).

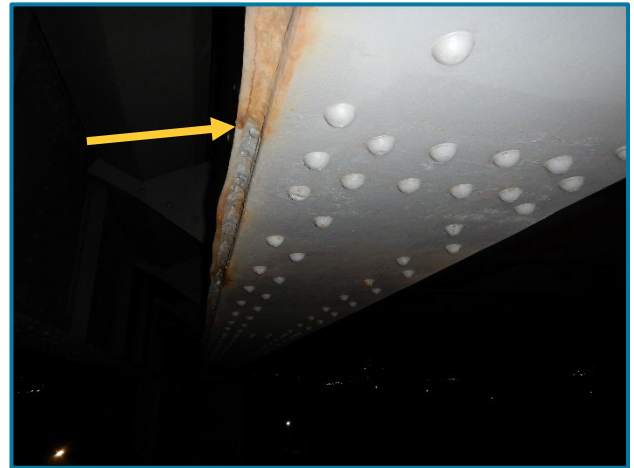
Photo 60 – Pack rust between the south web plate and bottom flange angles on the exterior of the River Pier Cap (looking west).

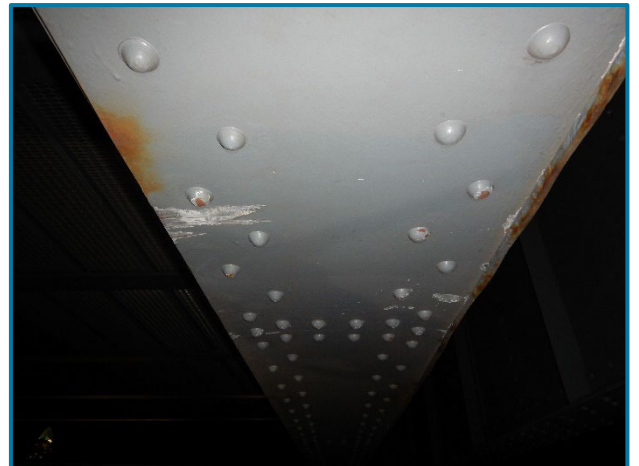
Photo 61 – Minor scrape on the underside of the River Pier Cap bottom flange between Girders B and C (looking east).

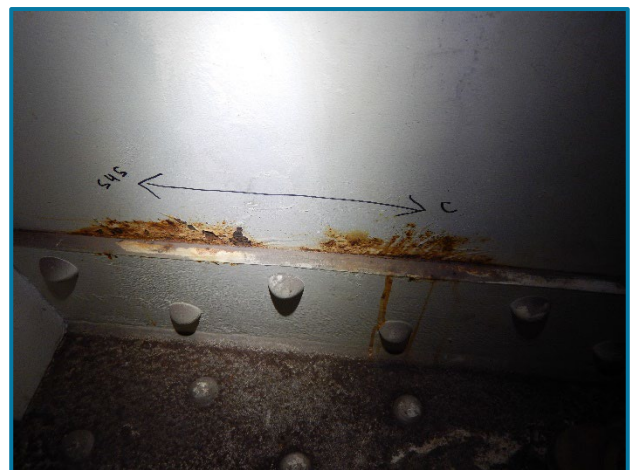
Photo 62 – Active corrosion along the bottom flange angle at the north web plate between Girders C and D inside the River Pier Cap (looking north).

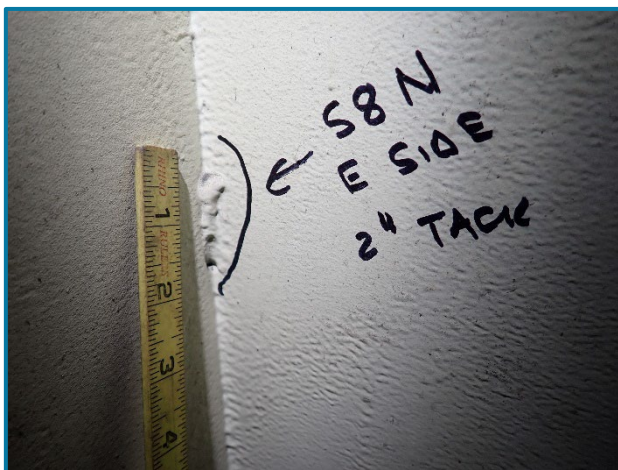
Photo 63 – Typical tack weld between the interior transverse stiffener and web plate (looking northwest inside of the River Pier Cap).

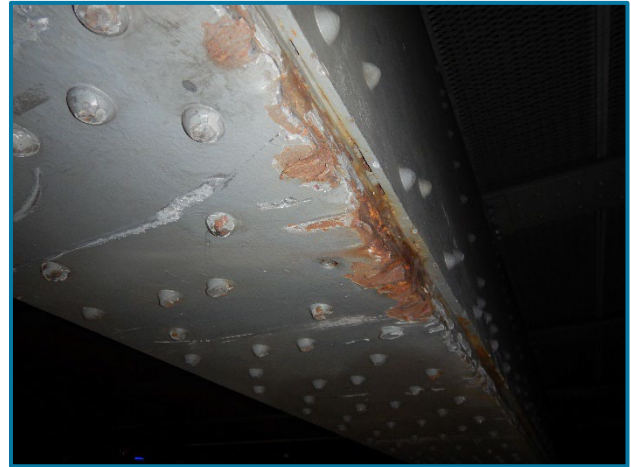
Photo 65 – Section loss at the base of the Girder C stiffening diaphragm at Pier Cap 1A (looking east).

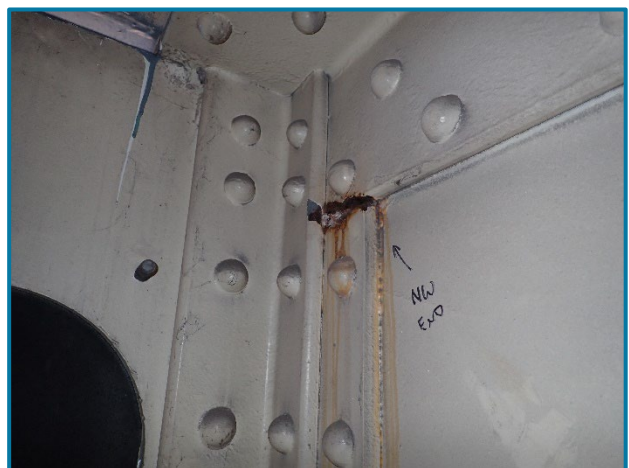
Photo 67 – Active corrosion along the interface between the north vertical web angle and top flange angle at the west end of Pier Cap 1A (looking northwest).

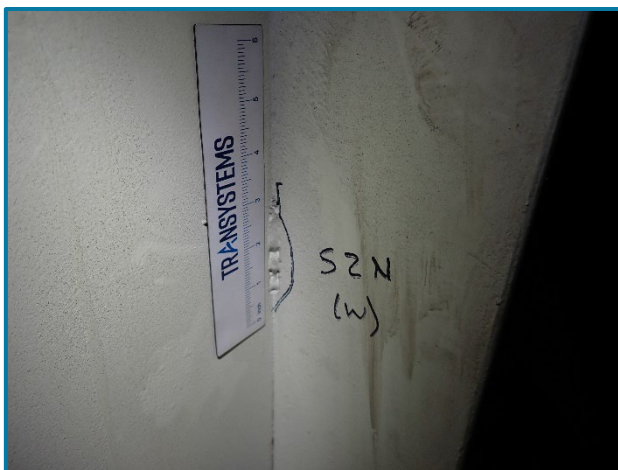
Photo 68 – Typical tack weld to the transverse stiffeners on the interior of Pier Cap 1A (looking northeast).

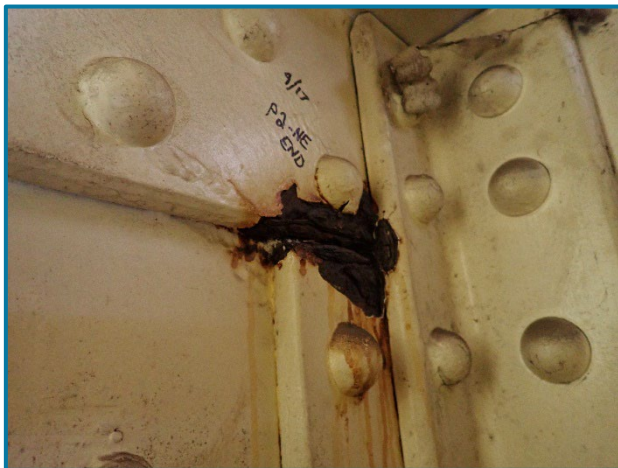
Photo 71 – Active laminate corrosion and section loss at the top corner of the north web plate, vertical angle, and top flange angle at the east end of Pier Cap 2A (looking northeast).

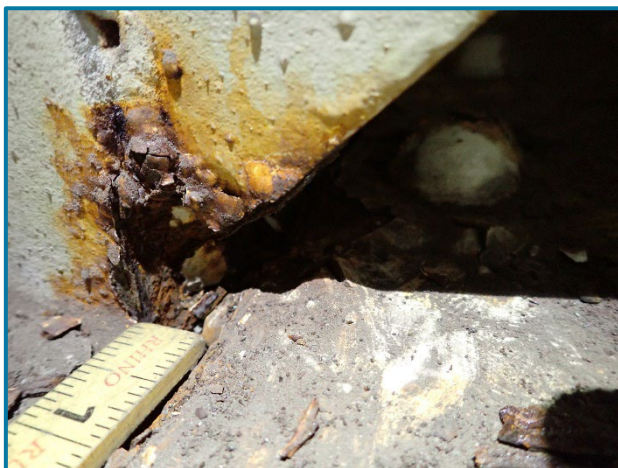
Photo 72 – Section loss at the base of the Girder G stiffening diaphragm on the interior of Pier Cap 2A (looking east).

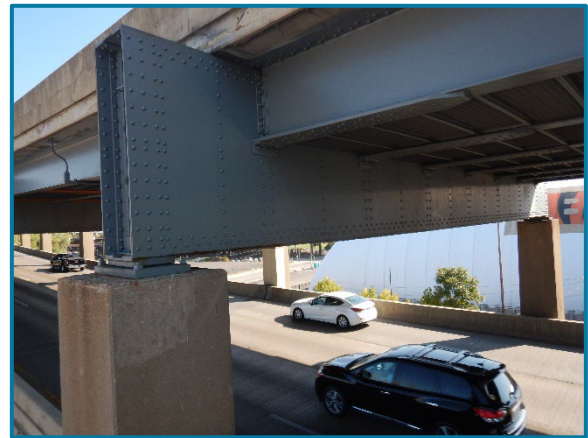
Photo 75 – Pier Cap 3A north elevation (looking southwest).

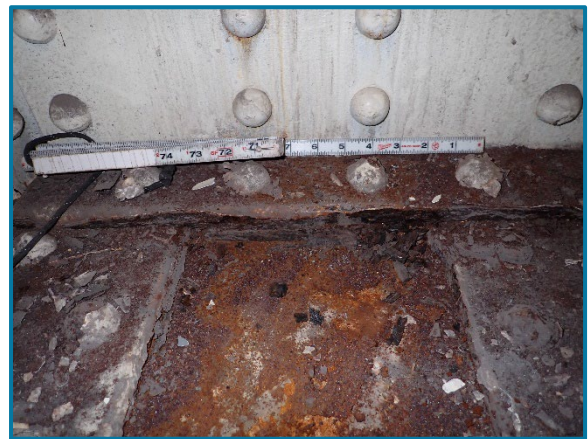
Photo 76 – Active corrosion along the bottom flange plate and bottom flange angle in the interior of Pier Cap 3A (looking east).

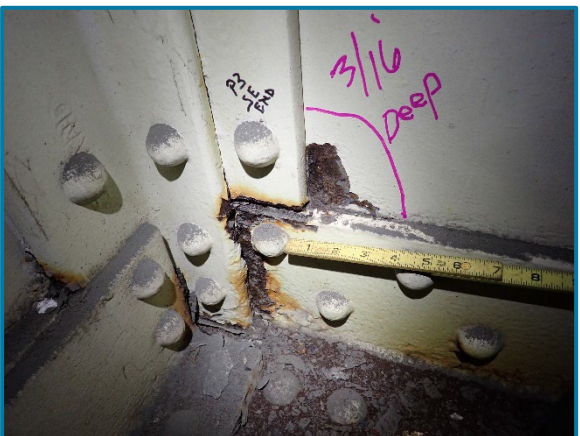
Photo 77 – 3/16" deep pitting in the south web plate and the south bottom flange angle at the east end of Pier Cap 3A (looking southeast).

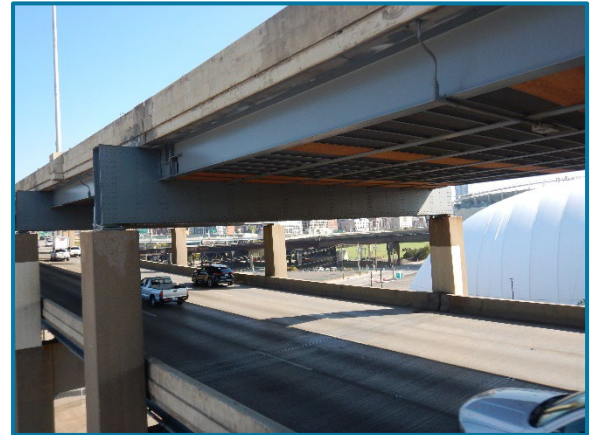
Photo 80 – Pier Cap 4A south elevation (looking northeast).

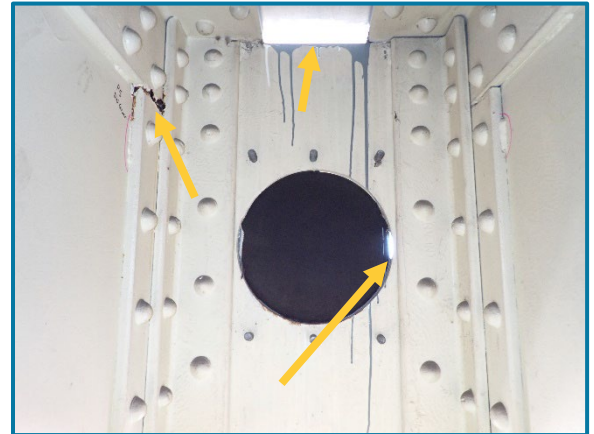
Photo 85 – Pier Cap 5A west end (looking west). Note the gaps in the access plates and corrosion along the south top flange angle.
