ODOT District 8
2023 Fracture Critical and In-Depth
Element Level Inspection Report

December 3, 2023

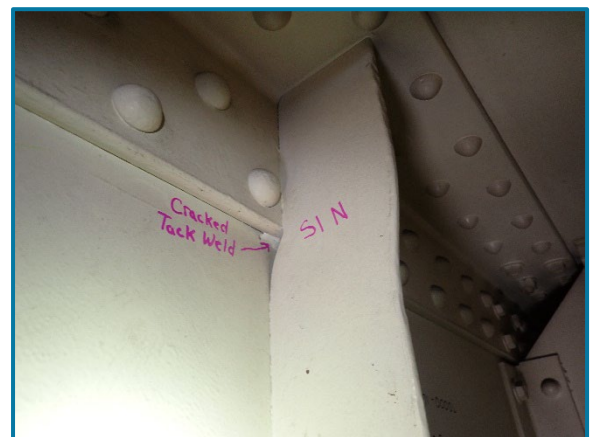
Photo 86 – Pier Cap 5A west end (looking west). Note the gaps in the access plates and corrosion along the south top flange angle.

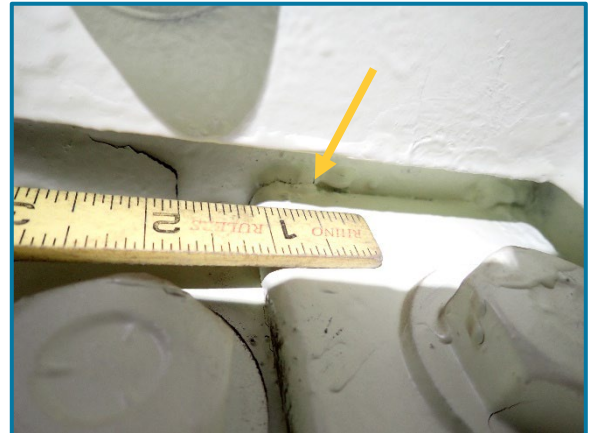
Photo 87 – Cracked tack weld between Girder E bottom flange and diaphragm connection angle (looking southwest at the south web plate of Pier Cap 5A).

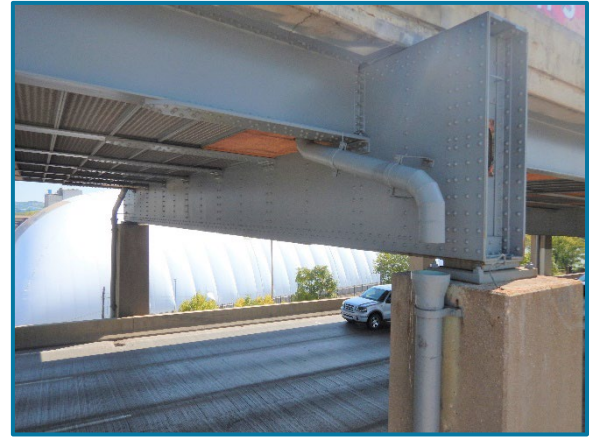
Photo 90 – Pier Cap 6A north elevation (looking southeast).

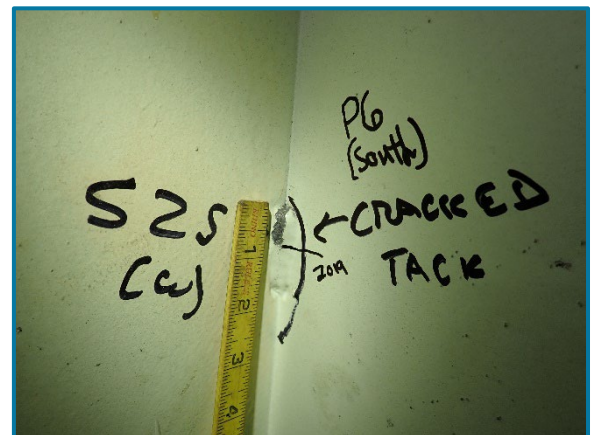
Photo 92 – Cracked tack weld at the second intermediate stiffener between the south web near midheight (looking southeast).

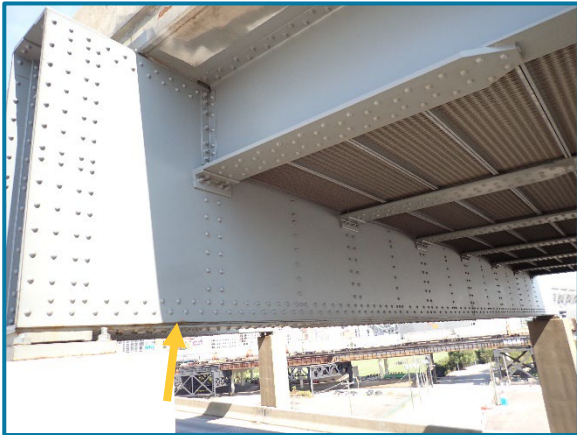
Photo 95 – Pack rust between the south web plate and the bottom flange angle with reactivating rust (looking northeast at the south face of Pier Cap 7A).

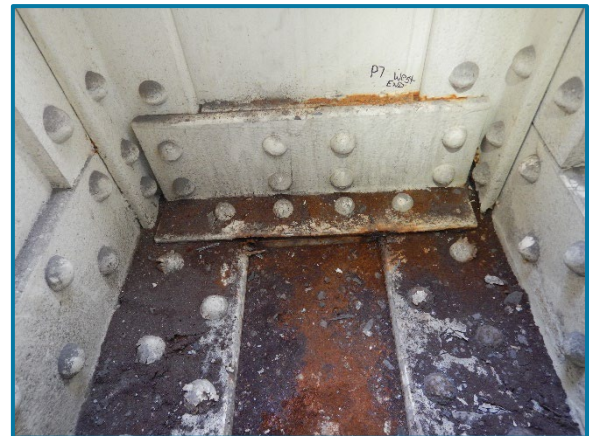
Photo 96 – Corrosion throughout the bottom flange plate and angles at the west end of Pier Cap 7A (looking down and west).

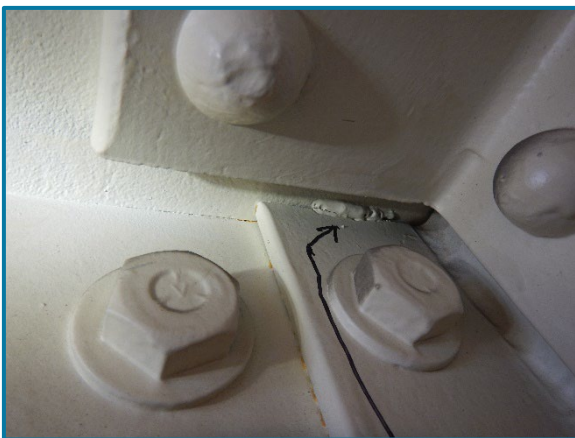
Photo 97 – Cracked tack weld between the north web plate and stiffening diaphragm of Girder A inside of Pier Cap 7A (looking northeast).

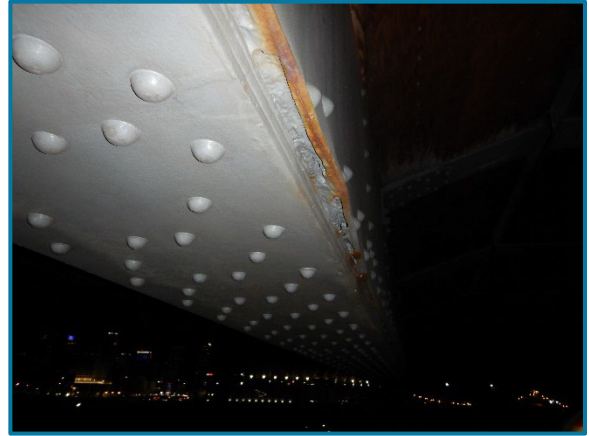
Photo 100 – Pack rust between the south web plate and south bottom flange angle (looking west below Girder C at the underside of Pier Cap 8A).

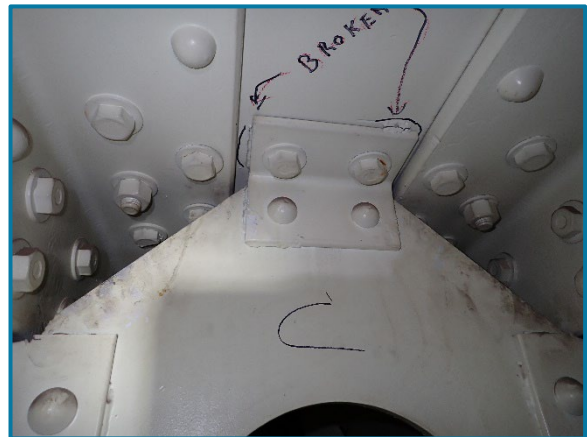
Photo 101 – Typical cracked tack welds along the Girder C diaphragm connection angle to top flange plate (looking east inside of Pier Cap 8A).

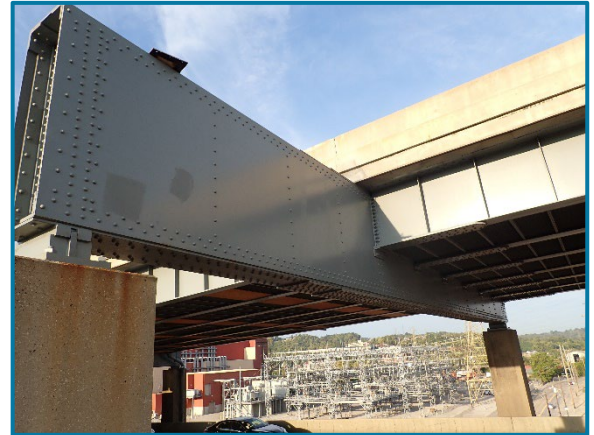
Photo 104 – Pier Cap 9A north elevation (looking southwest).

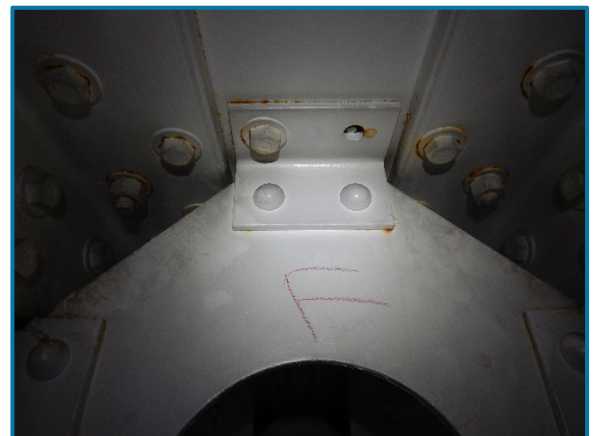
Photo 106 – Missing bolt in the east horizontal angle leg at the top flange connection of Girder F diaphragm (looking west on the inside of Pier Cap 9A).

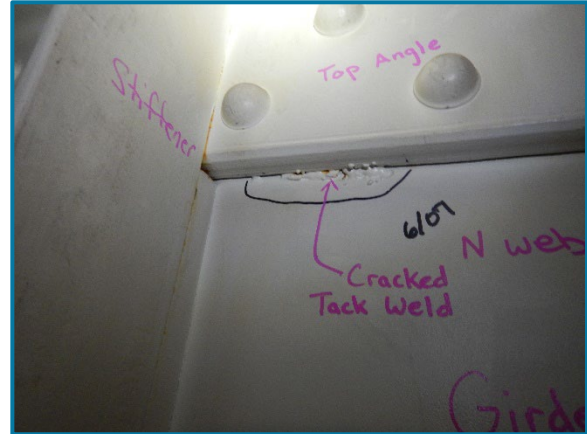
The cracks do not propagate into the base metal.

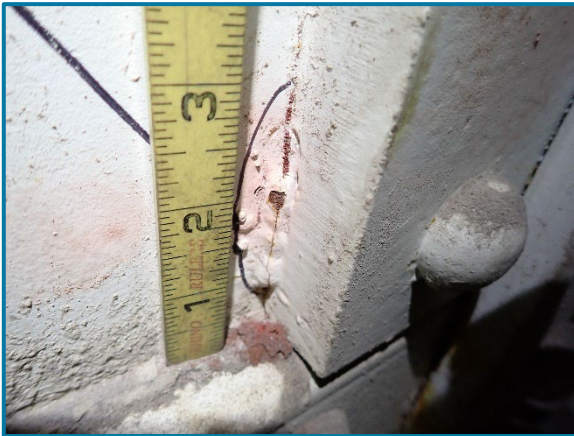
Photo 108 – Cracked tack weld between the east edge of the west bearing diaphragm fill plate and south web plate (looking southwest inside of Pier Cap 9A).

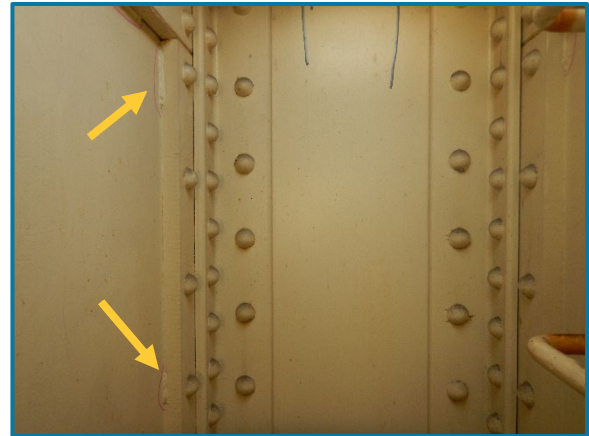
Photo 109 – 2"-3" tack welds at east end bearing fill plate (looking east inside of Pier Cap 9A).

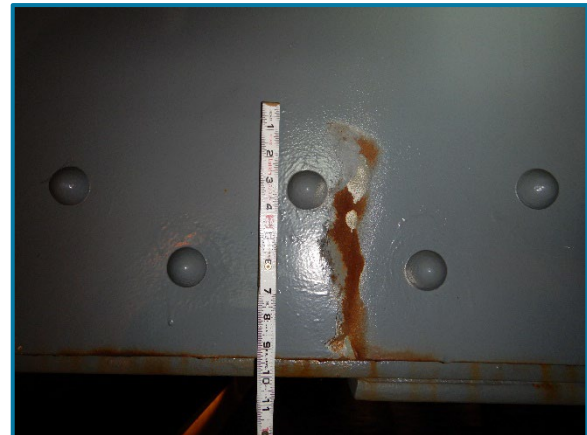
Photo 110 – Scrape on the north face of the north web plate of Pier Cap 10A east of the splice plate (looking south).

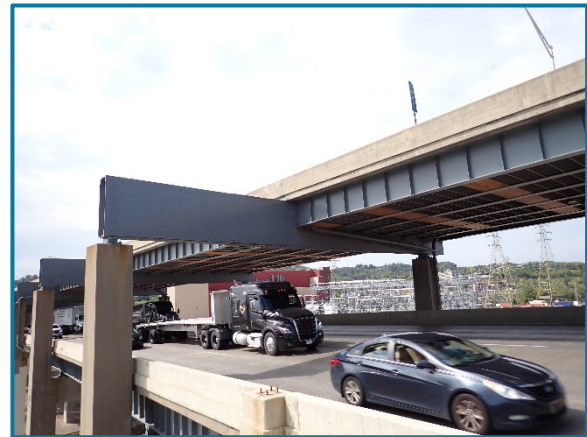
Photo 111 – Pier Cap 10A north elevation (looking southwest).

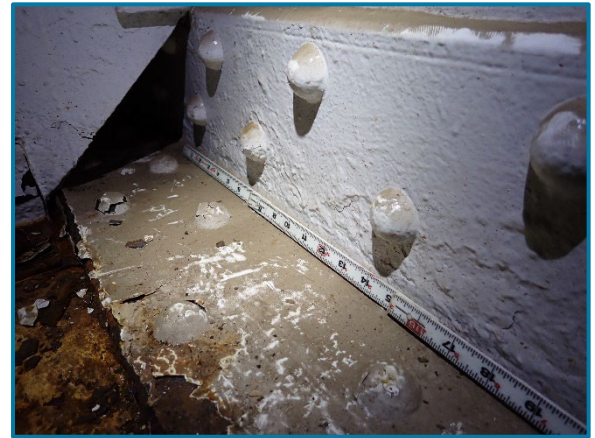
Photo 112 – Painted over pitting along the bottom flange connection angle and bottom flange plate of Pier Cap 10A (looking southeast near midspan).

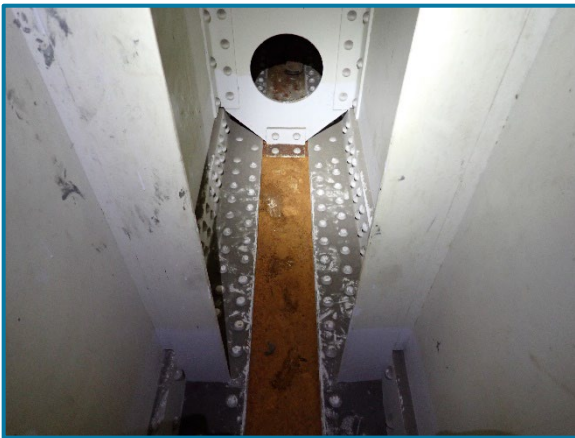
Photo 116 – Granular debris throughout the interior of Pier Cap 11A (looking west near east end).

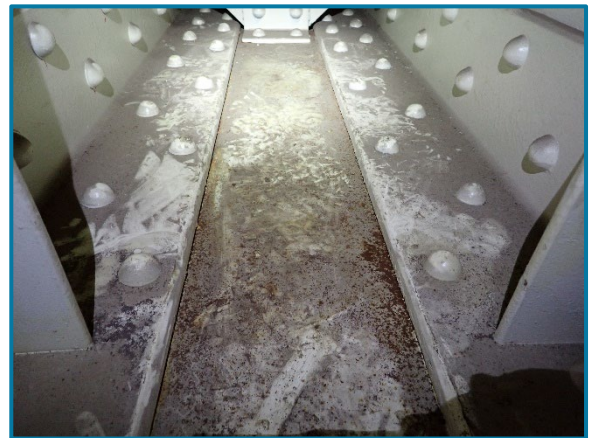
Photo 119 – Typical granular debris throughout the bottom of the interior of Pier Cap 12A (looking east near the west end of the cap).

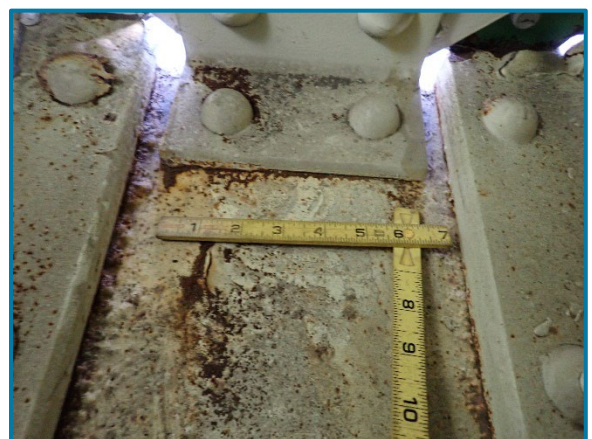
Photo 120 – Typical active corrosion and pitting throughout the bottom flange plate at the west end (looking west inside of Pier Cap 12A).

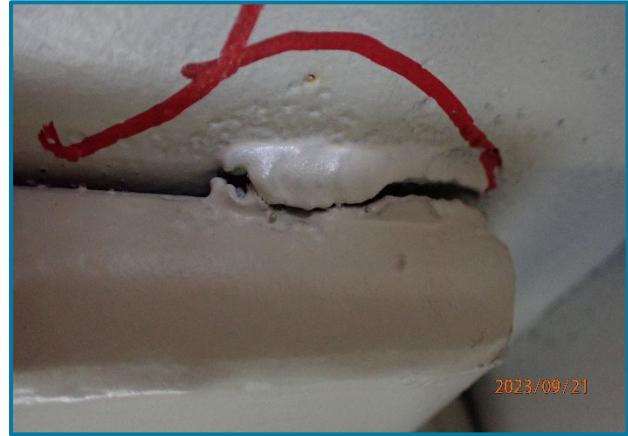
Photo 121 - Typical tack welds between the top angle and girder diaphragms (looking east near the top of Girder B inside of Pier Cap 12A).

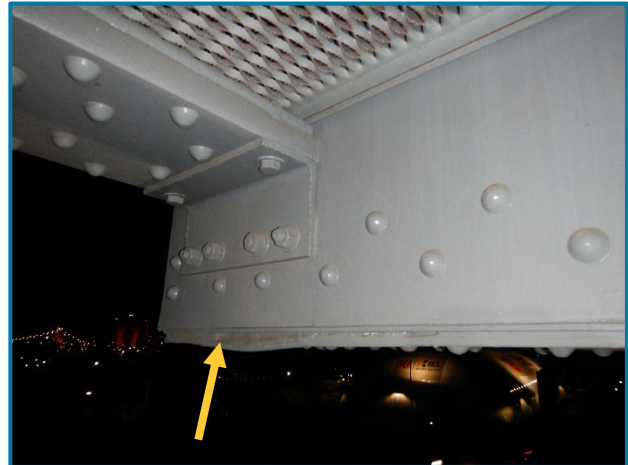
Photo 123 – Pack rust between the bottom flange plate and north bottom angle below Girder G at Pier Cap 13A (looking southeast).

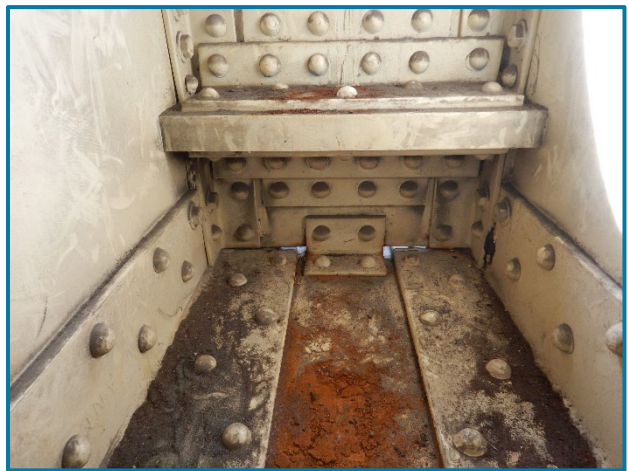
Photo 124 – Typical granular debris and dust throughout the bottom of the Pier Cap 13A interior (looking east near the west end of the cap).

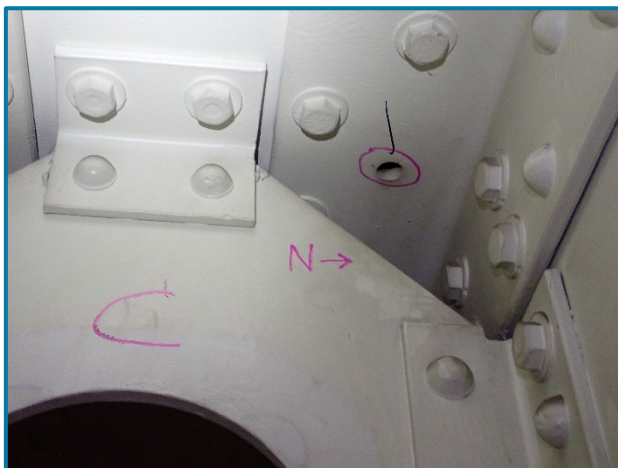
Photo 125 – Missing bolt at the connection between the north top flange angle and north web plate at Girder C (looking west inside of Pier Cap 13A).

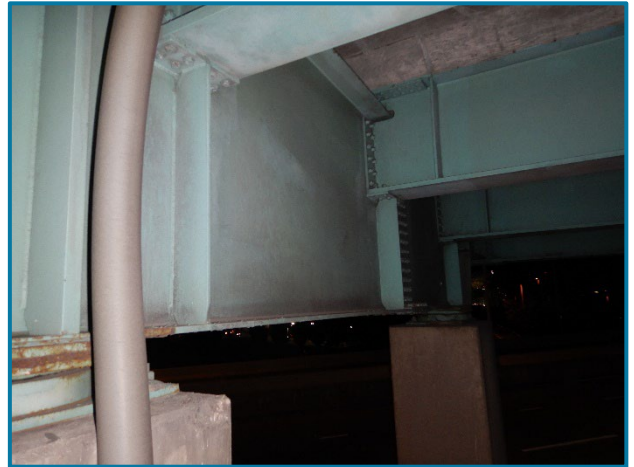
Photo 128 – Pier 29B south face at the west end (looking east).

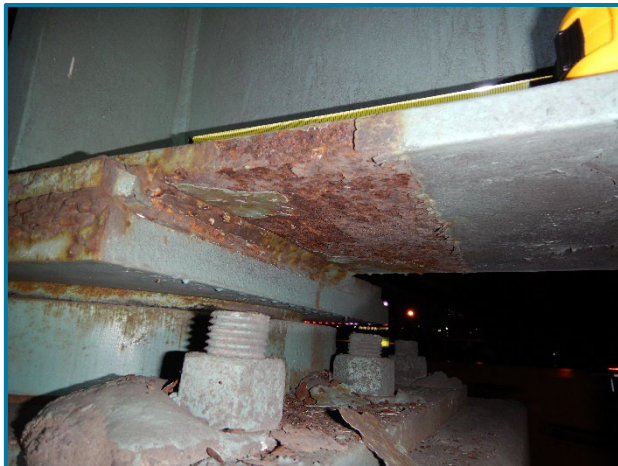
Photo 129 – Active rust with peeling paint on the Pier 29B bottom flange at the north bearing (looking northeast).

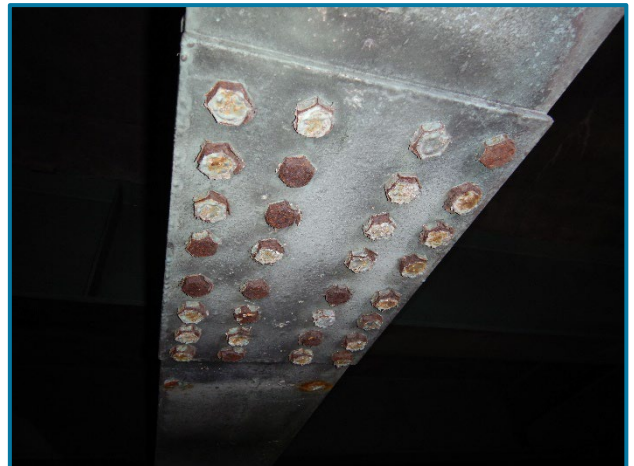
Photo 130 – Surface corrosion throughout the bolts in the bottom flange splice plate of Pier 29B (looking east).

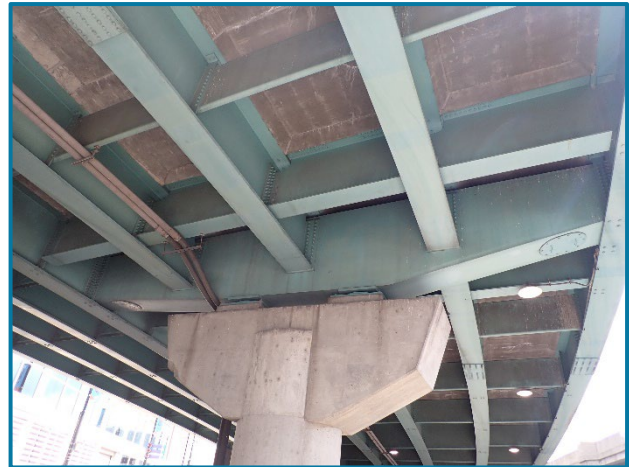
Photo 131 – Pier 2 (FWW) south elevation (looking north).

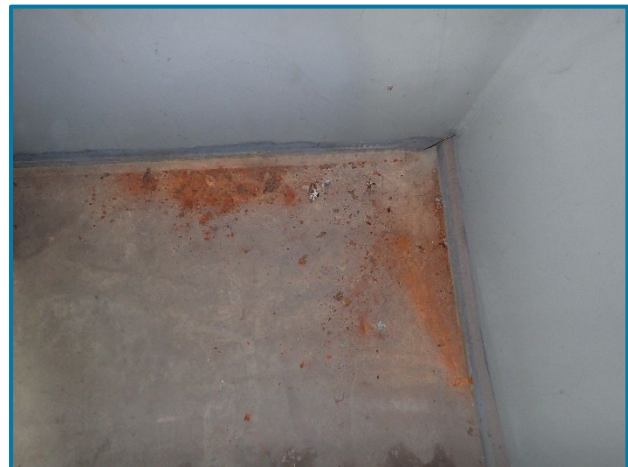
Photo 132 – Area of minor surface corrosion on the bottom flange plate near the east bearing on the interior of Pier 2 (FWW) (looking north).

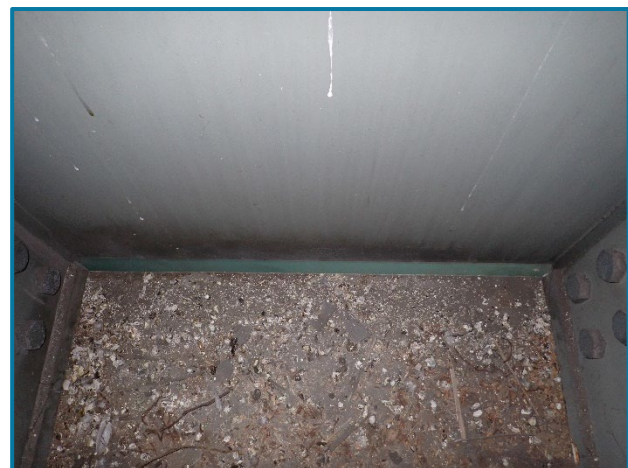
Photo 133 – Gap between bottom flange plate and web plate on the interior of Pier 2 (FWW) at the west end (looking west). Note the bird debris throughout the surface of the bottom flange plate.

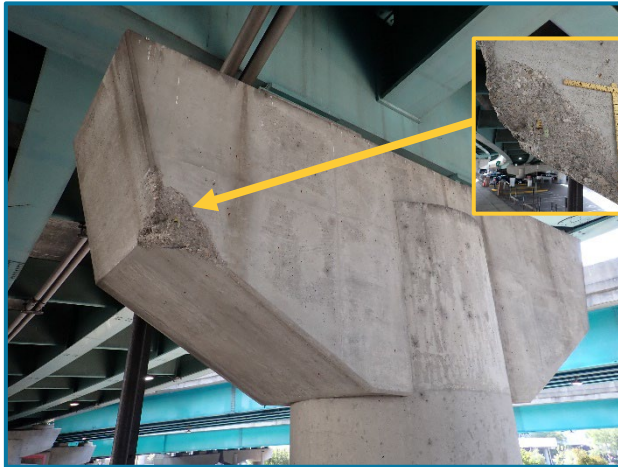
Photo 134 – 2' wide by 2' high by 4" deep corner spall with exposed reinforcement on the west face of Pier Cap 2 (FWW) (looking southeast).

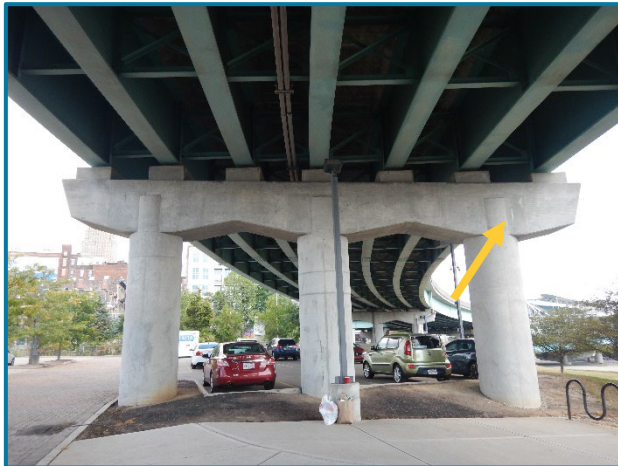
Photo 135 – Typical hairline cracks with minor efflorescence throughout the west face of Pier Cap 6 (FWW) (looking east).

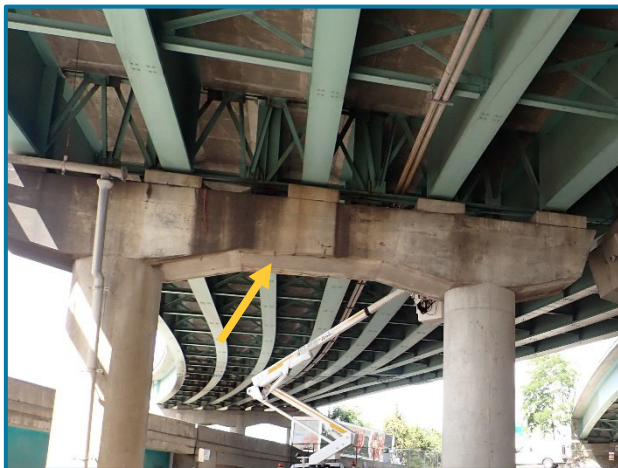
Photo 136 – Flexural cracks between the pier columns at Pier 4 (FWW) (looking west).

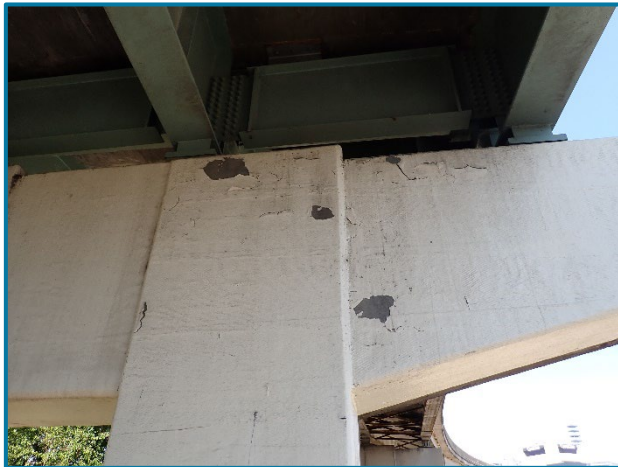
Photo 137 – Typical FRP wrapping with isolated areas of peeling/failing protective coating (looking north at the south face of Pier 23B).

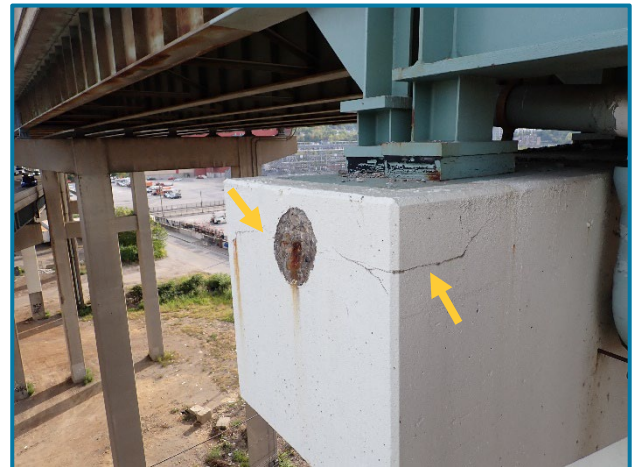
Photo 138 – 1' diameter by 1" deep spall on the east face of Pier Cap 15A (looking southwest). Note the longitudinal cracks extending from spall.

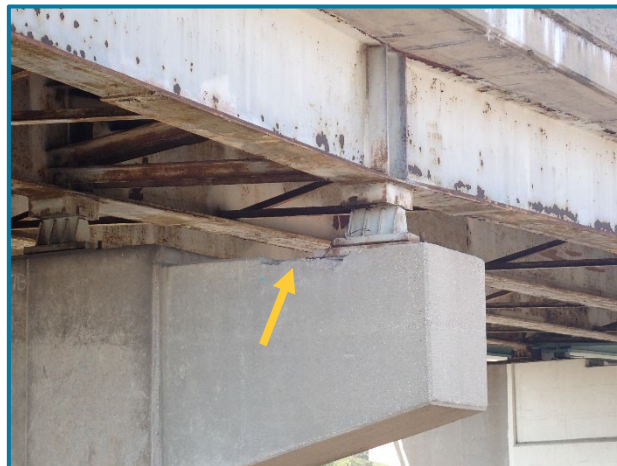
Photo 139 – 2' long by 1' wide by 3" deep spall extending onto the south face of Pier Cap 27B (looking north).

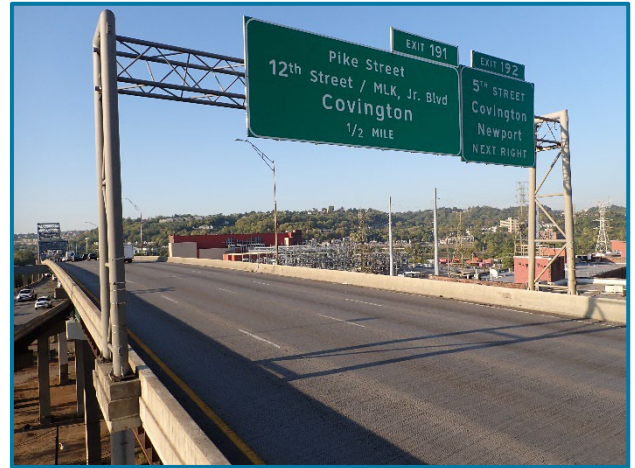
Photo 140 – Exit signs mounted in Span 16A (looking southwest).

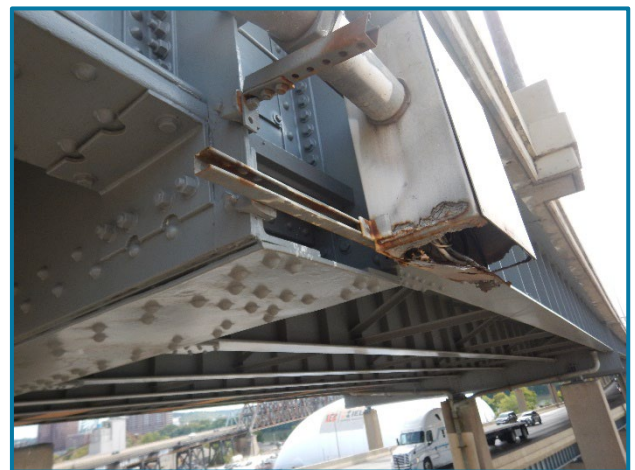
Photo 141 – 100% section loss throughout the utility junction box at the west access hatch at Pier 13A (looking southeast).

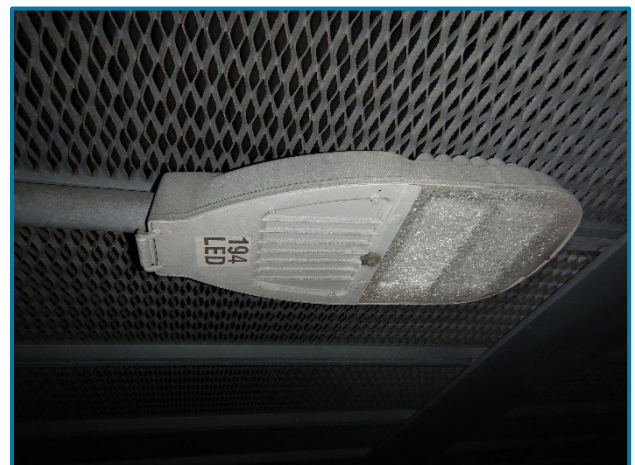
Photo 142 – Roadway light with shattered lens between Girders B and C at midspan in Span 11A (looking north).

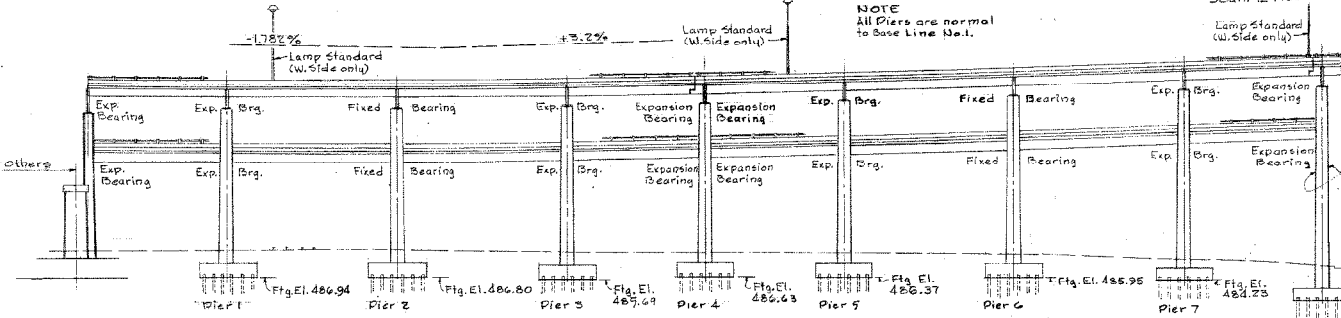
ALIGNMENT NOTE:
 The spiral curves shown on the Site Plan are shown replaced by compound circular curves, in order to facilitate the layout and construction of the bridge. The alignment of the compound curves does not depart more than 0.10 ft. at any point from the alignment of the spirals they replace.

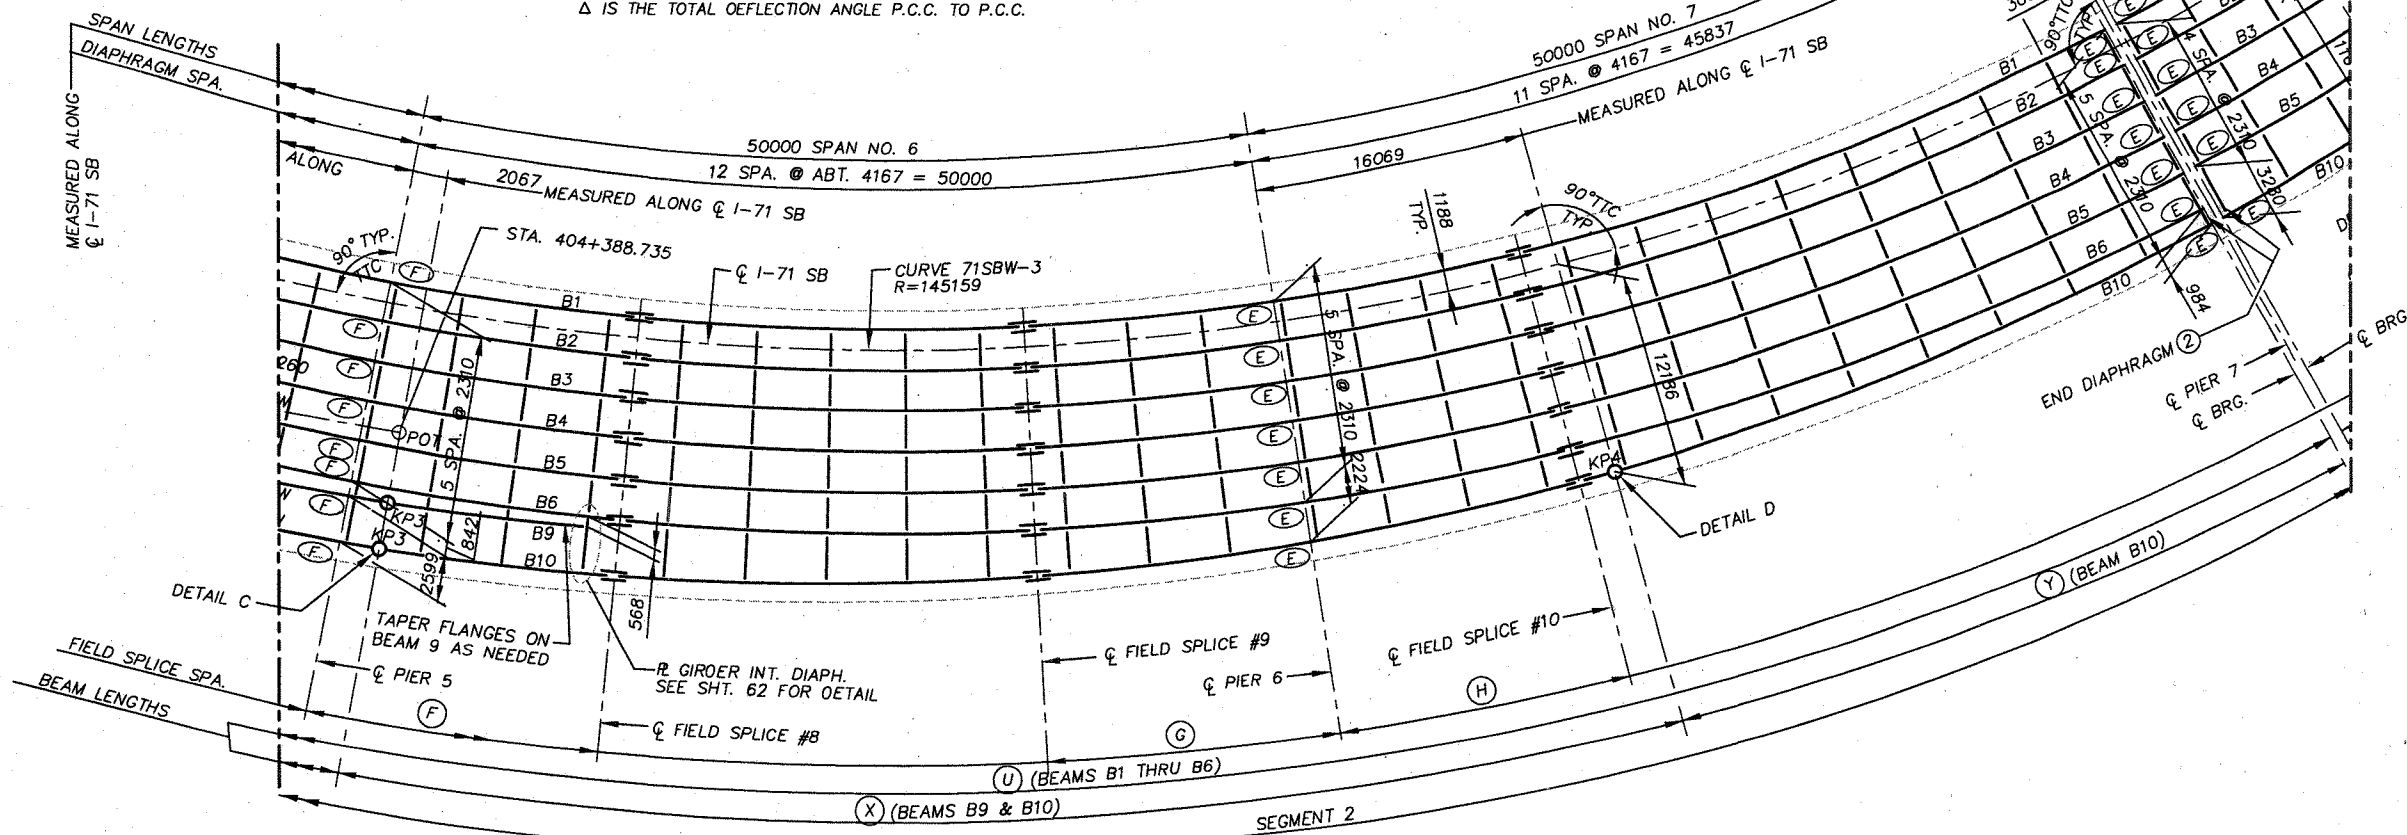
Δ IS THE TOTAL DEFECTION ANGLE P.C.C. TO P.C.C.

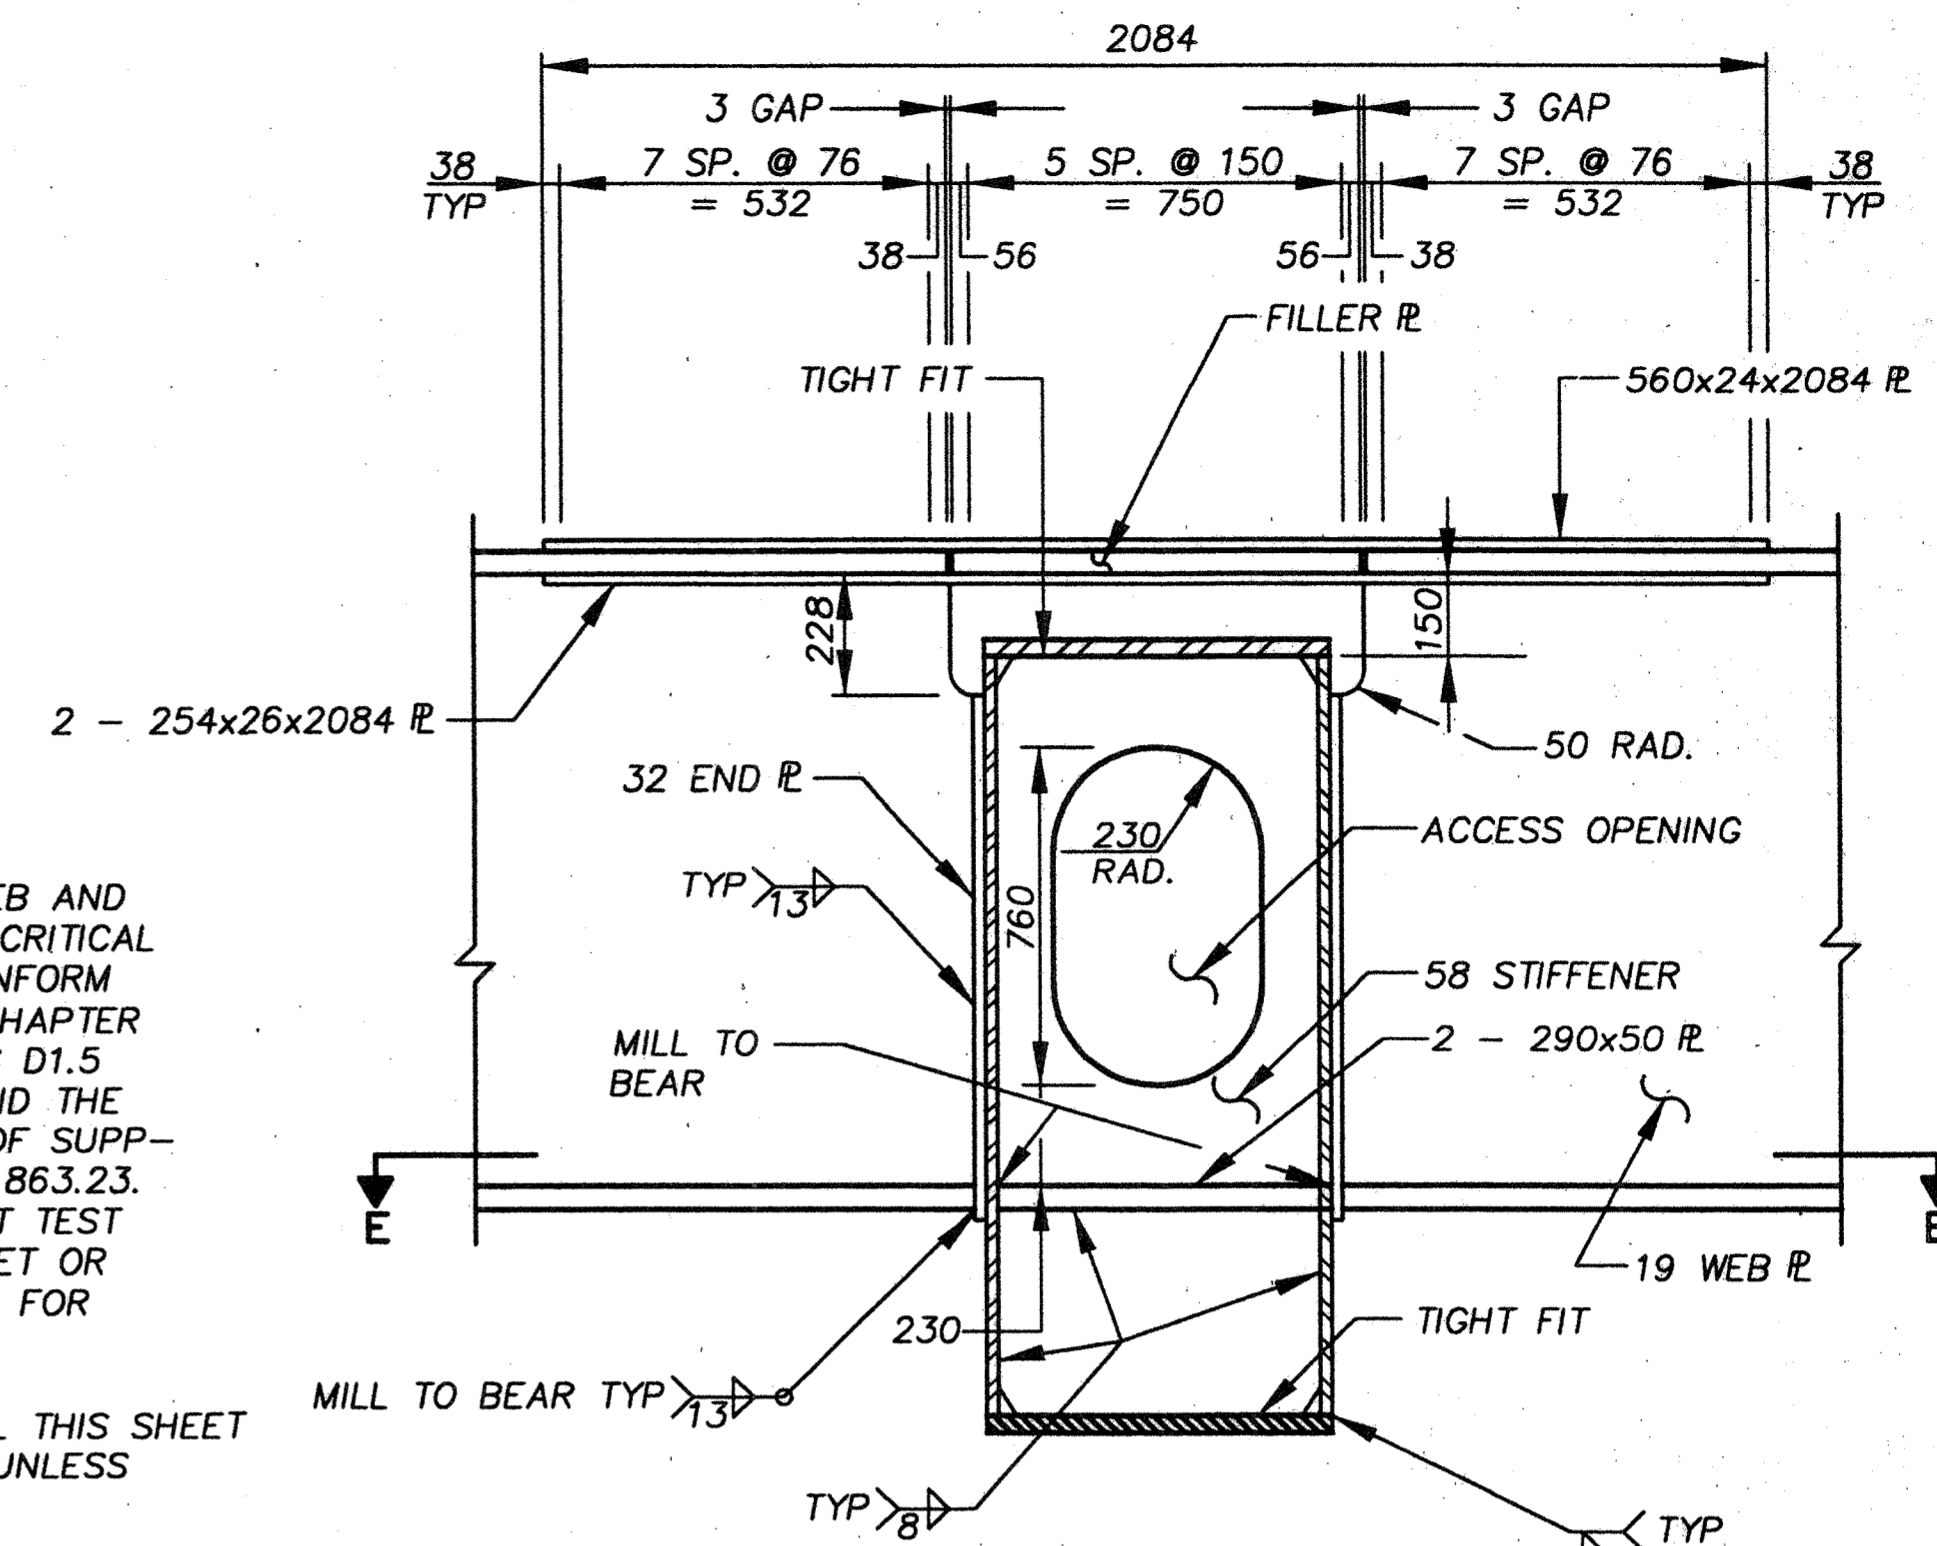
- NOTES:
1. INTEGRAL PIER CAP WEB AND FLANGES ARE FRACTURE CRITICAL MEMBERS AND SHALL CONFORM TO THE PROVISIONS OF CHAPTER 12 OF ANSI/AASHTO/AWS D1.5 BRIDGE WELDING CODE AND THE WELDING REQUIREMENTS OF SUPPLEMENTAL SPECIFICATION 863.23. CHARPY V-NOTCH IMPACT TEST REQUIREMENTS SHALL MEET OR EXCEED THE FCM VALUES FOR ZONE 2.
 2. ALL STRUCTURAL STEEL THIS SHEET SHALL BE A572M GR345 UNLESS OTHERWISE NOTED.
 3. INTERIOR SURFACES OF BOX SHALL BE PRIME PAINTED PRIOR TO WELDING OF FINAL BOX FLANGE.

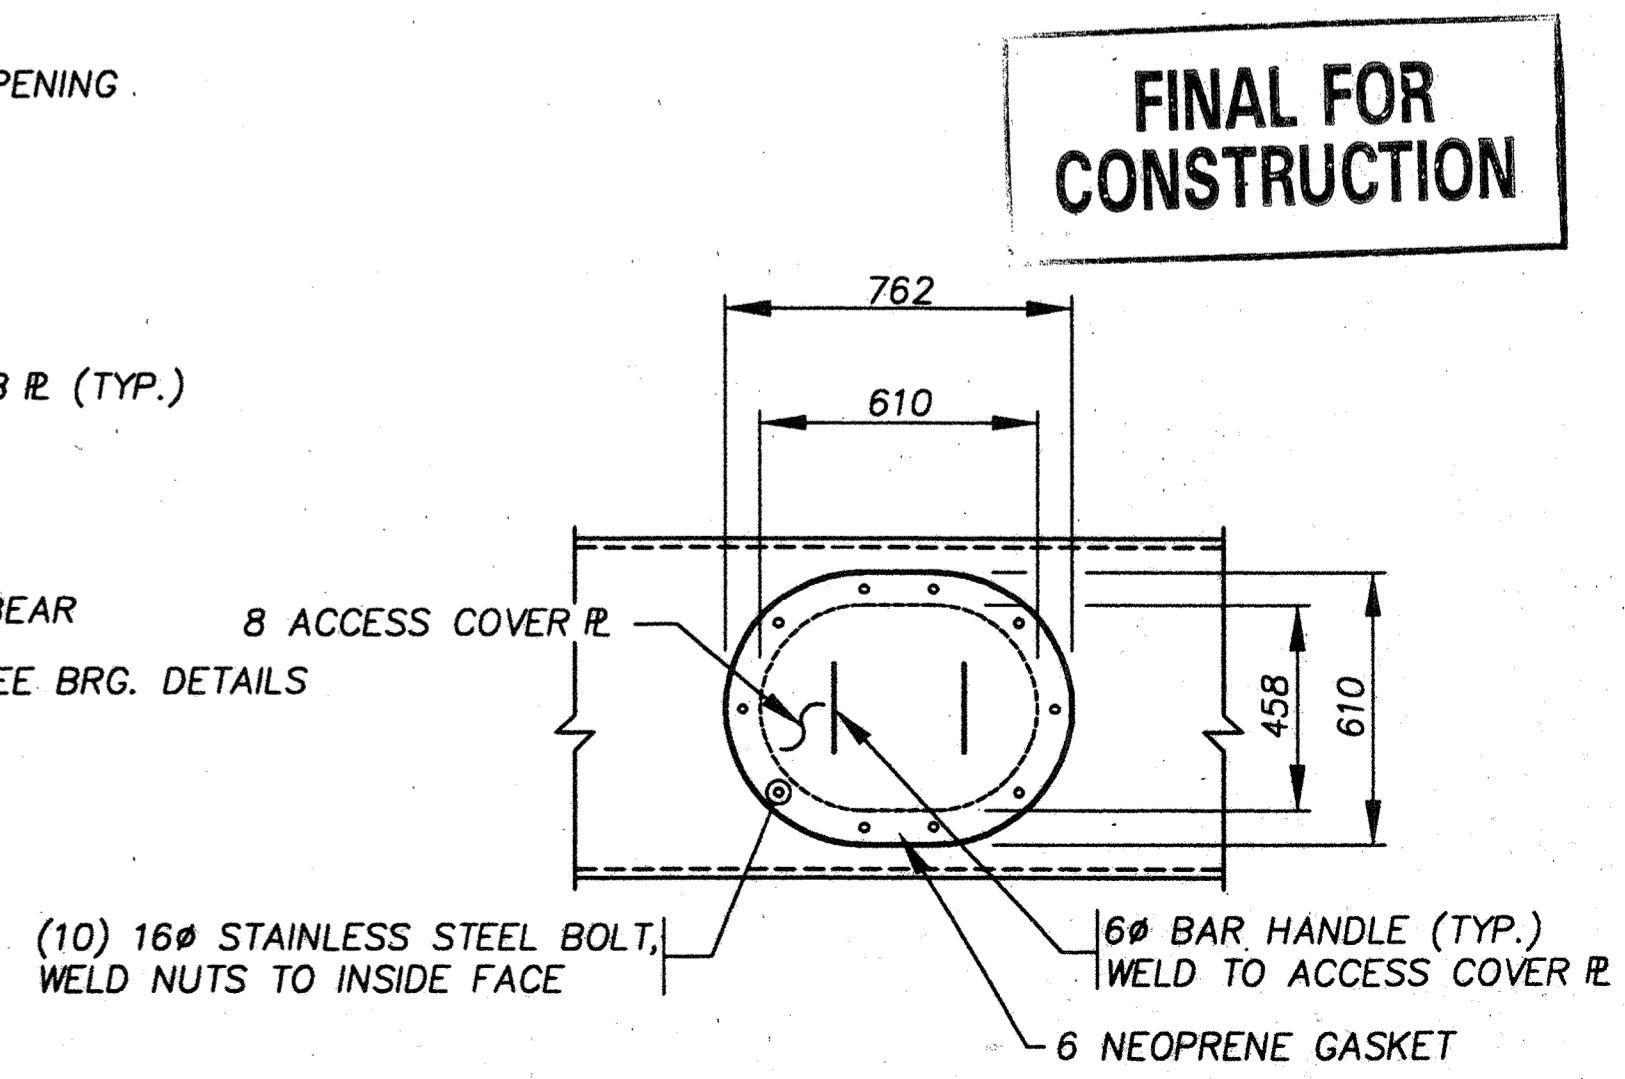
INSPECTION ACCESS COVER

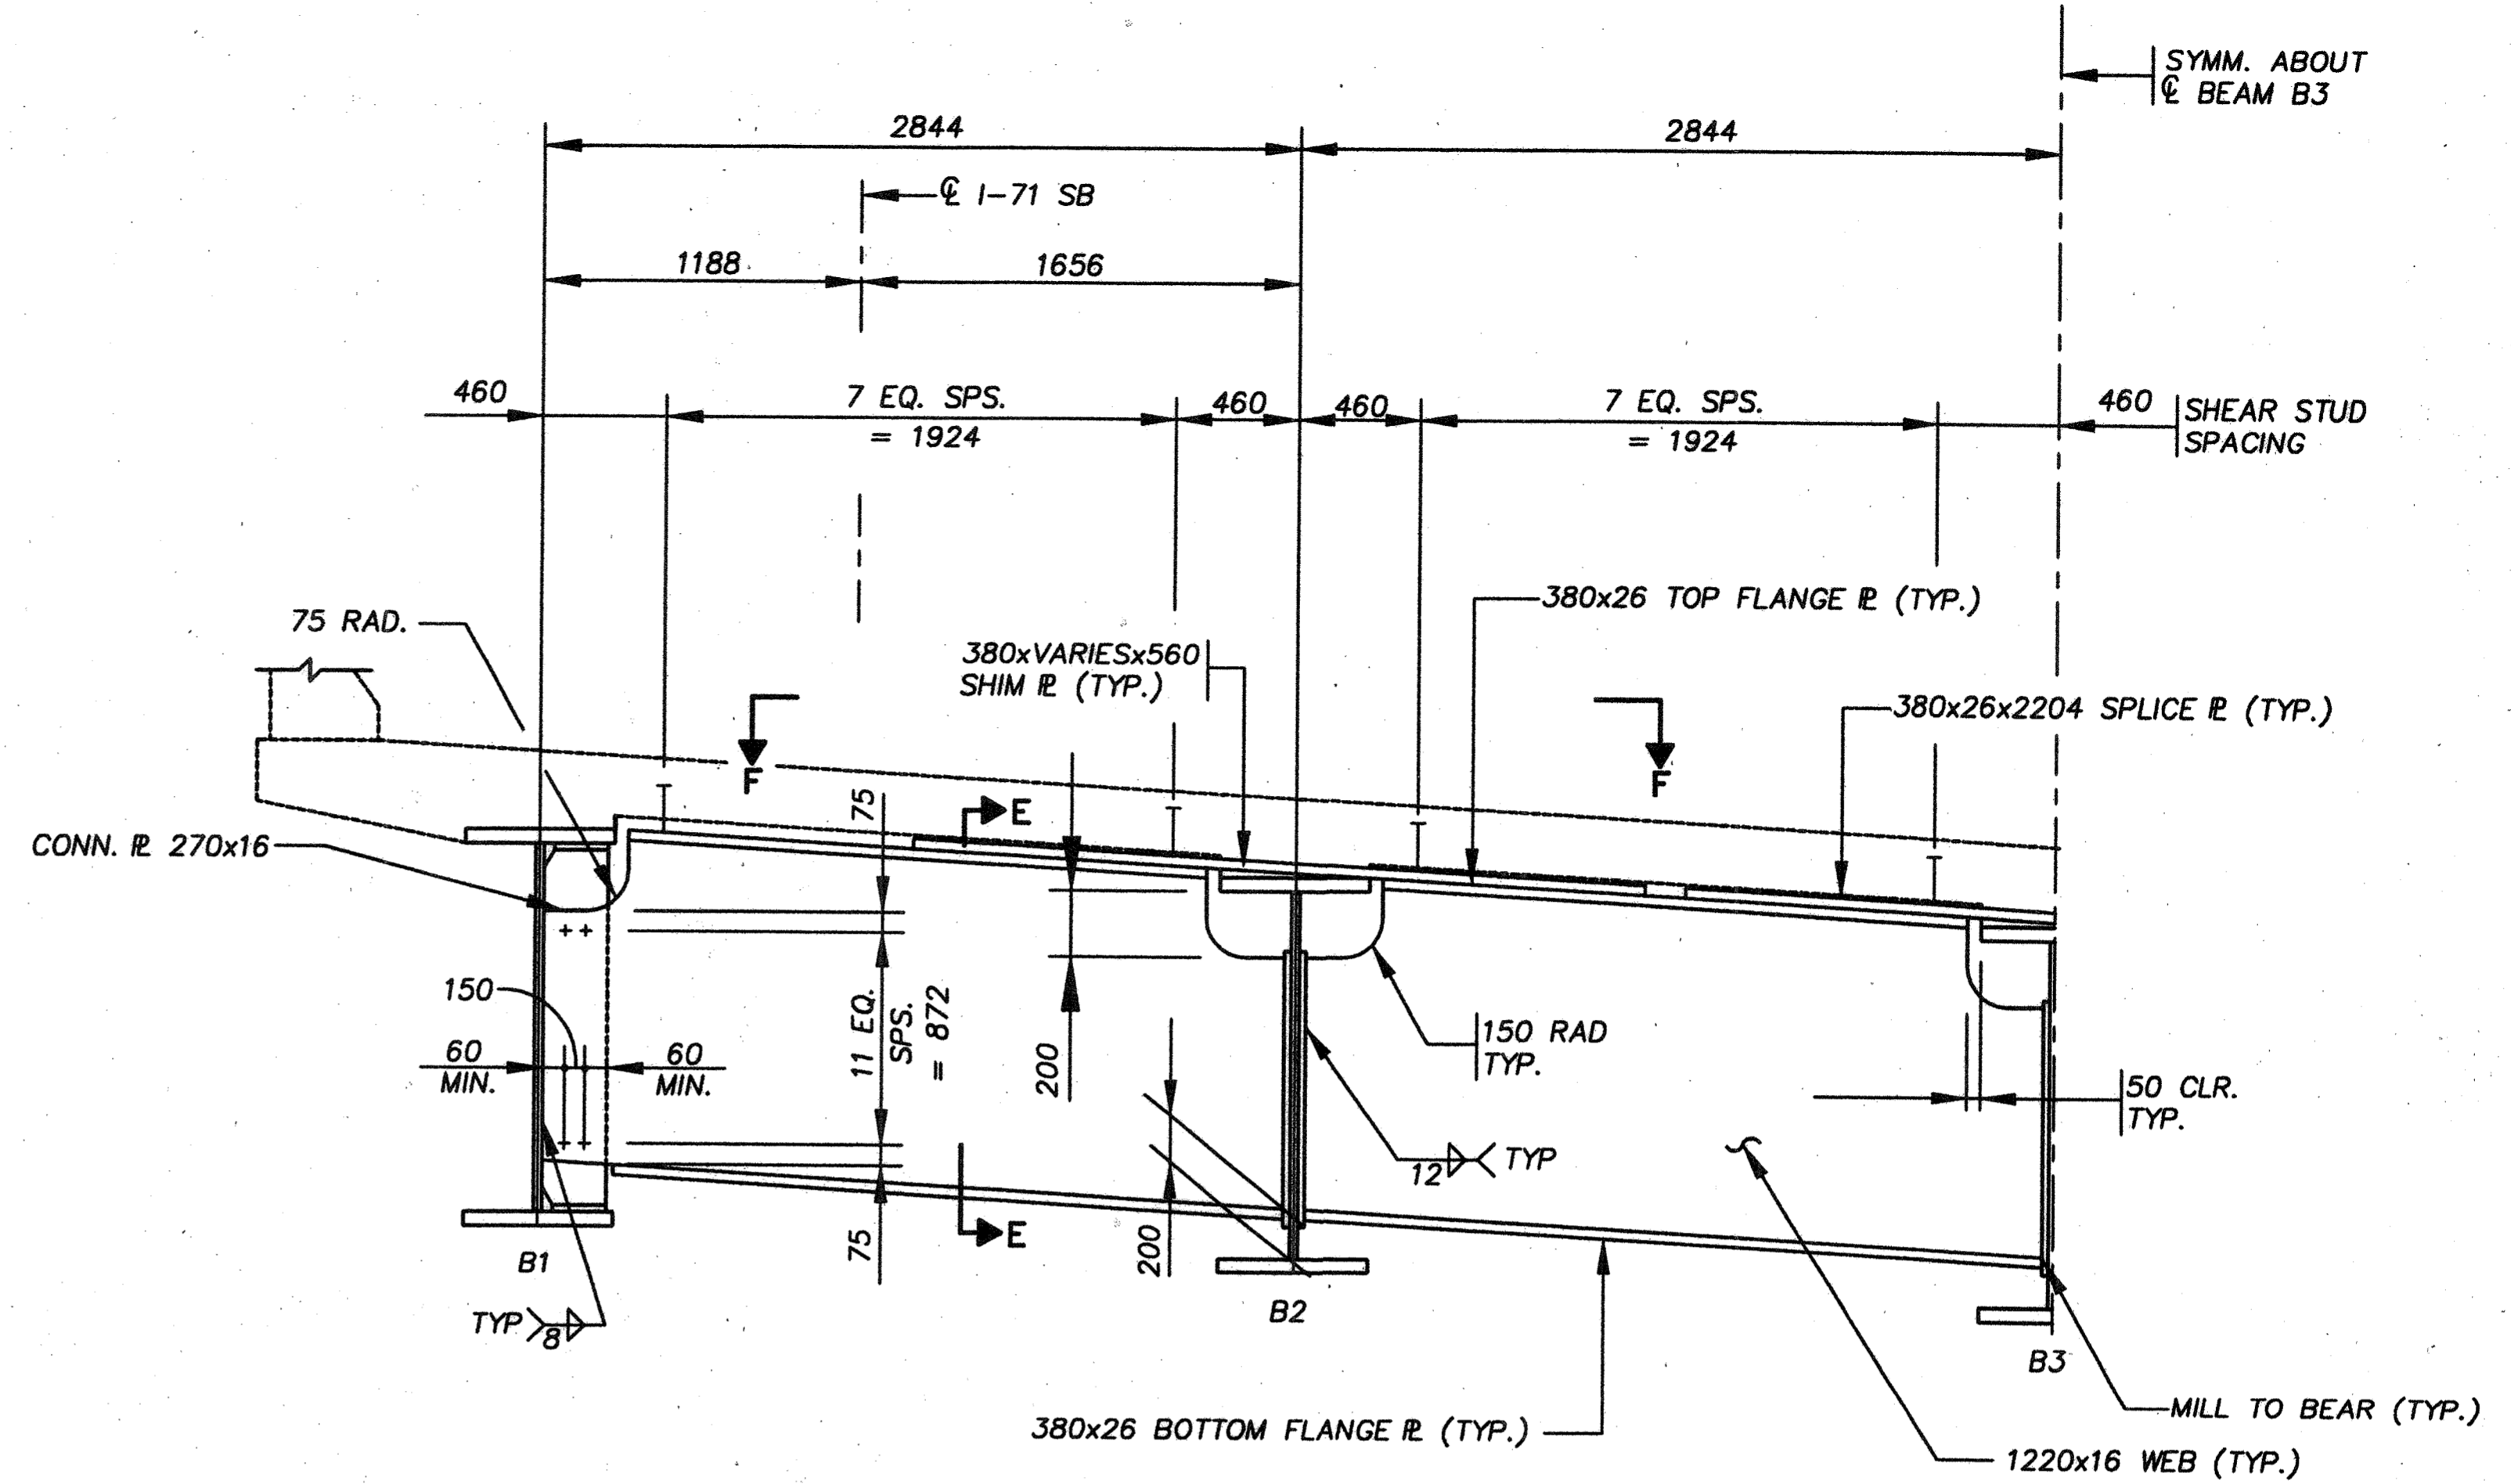
REDUNDANT LOAD PATH DIAPHRAGM
