2024 ROUTINE INSPECTION REPORT
BRIDGE NO: HAM-75-0022L, SFN 3102791
VAR-DISTRICT 8 Bridge Inspections
Brent Spence Approach Bridges

Cincinnati, Ohio

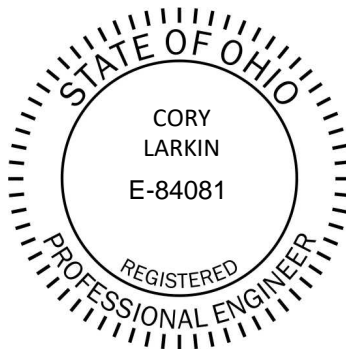
Michael Baker
INTERNATIONAL

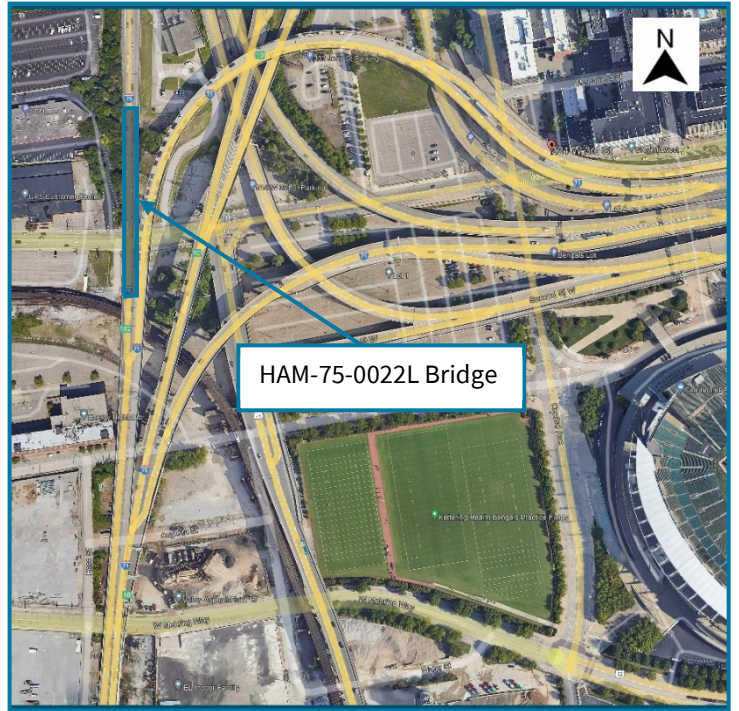
The nomenclature for this bridge follows the convention set in the design plans with spans, substructure units, and crossframes labeled from south to north and girders labeled from west to east. The substructure units are numbered from Pier 19A to Abutment A, spans are numbered from Span 20A to Span 25A, and girders are labeled from A to E (see [Figure 1](#)).

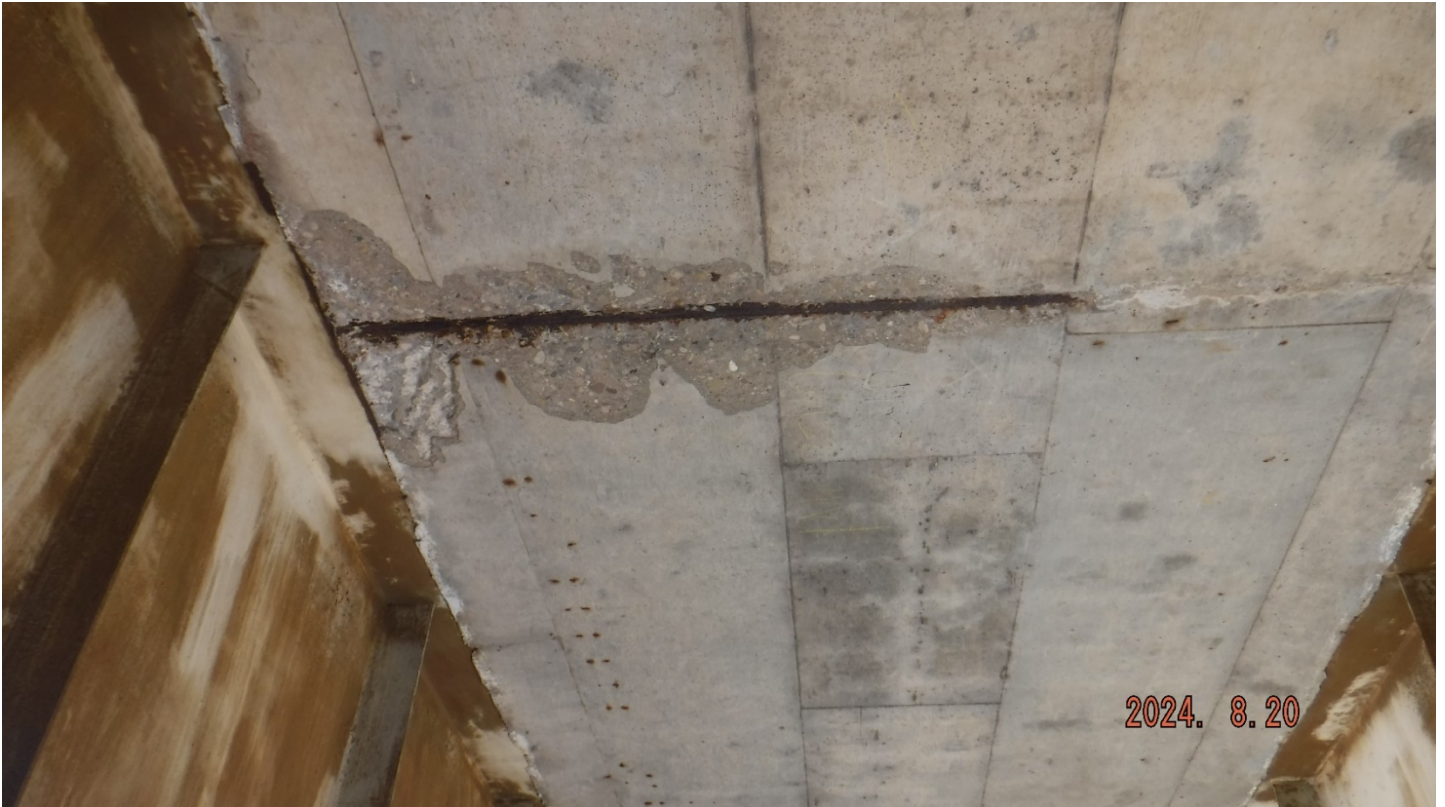
PHOTO 1. DECK SPAN 21 BAY 1, 2SQFT SPALL WITH EXPOSED REINFORCEMENT AT 2 LOCATIONS

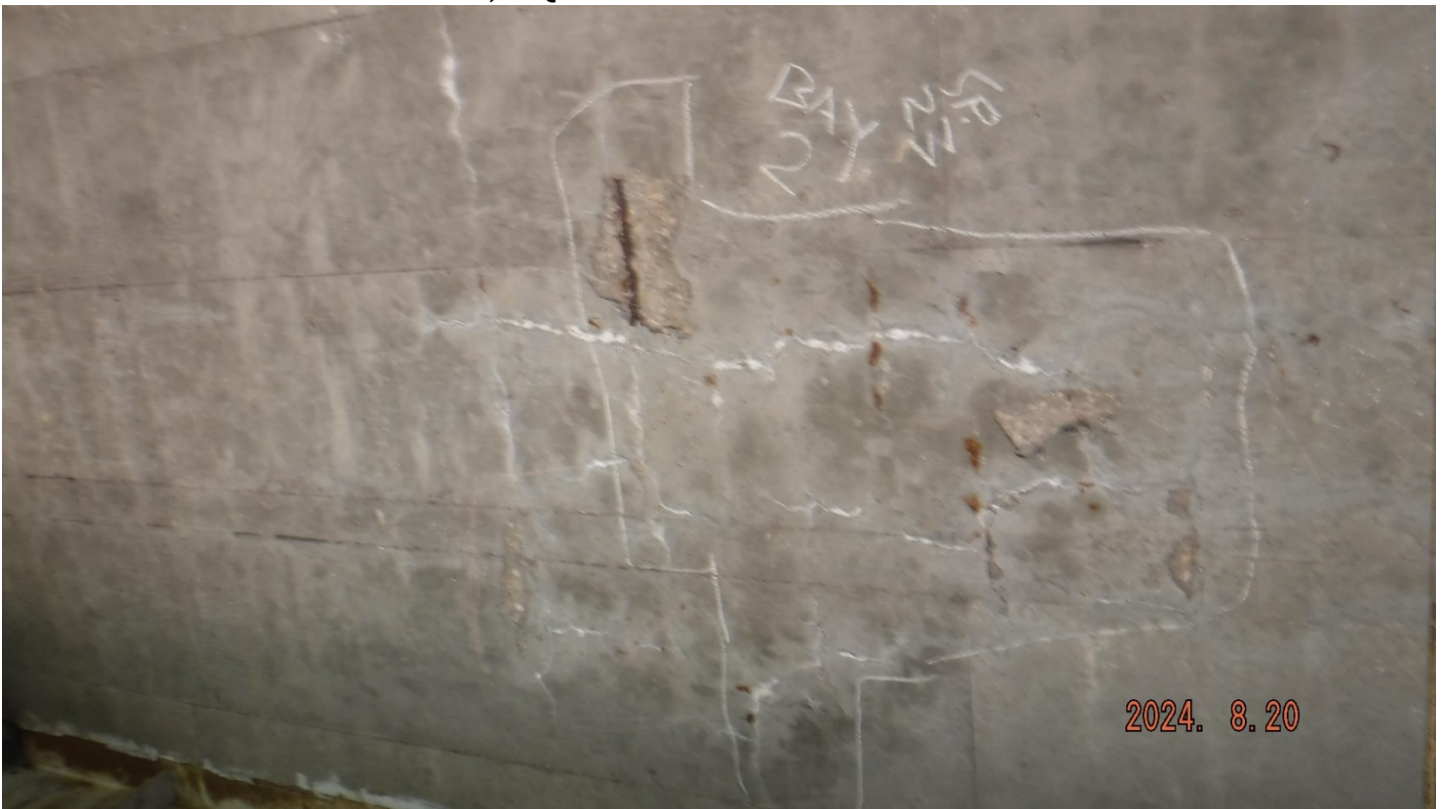
PHOTO 2. DECK SPAN 23A BAY 2, 8'LX8'WX1" DEEP AREA OF DELAMINATION AND 2' SPALL WITH EXPOSED REINFORCEMENT

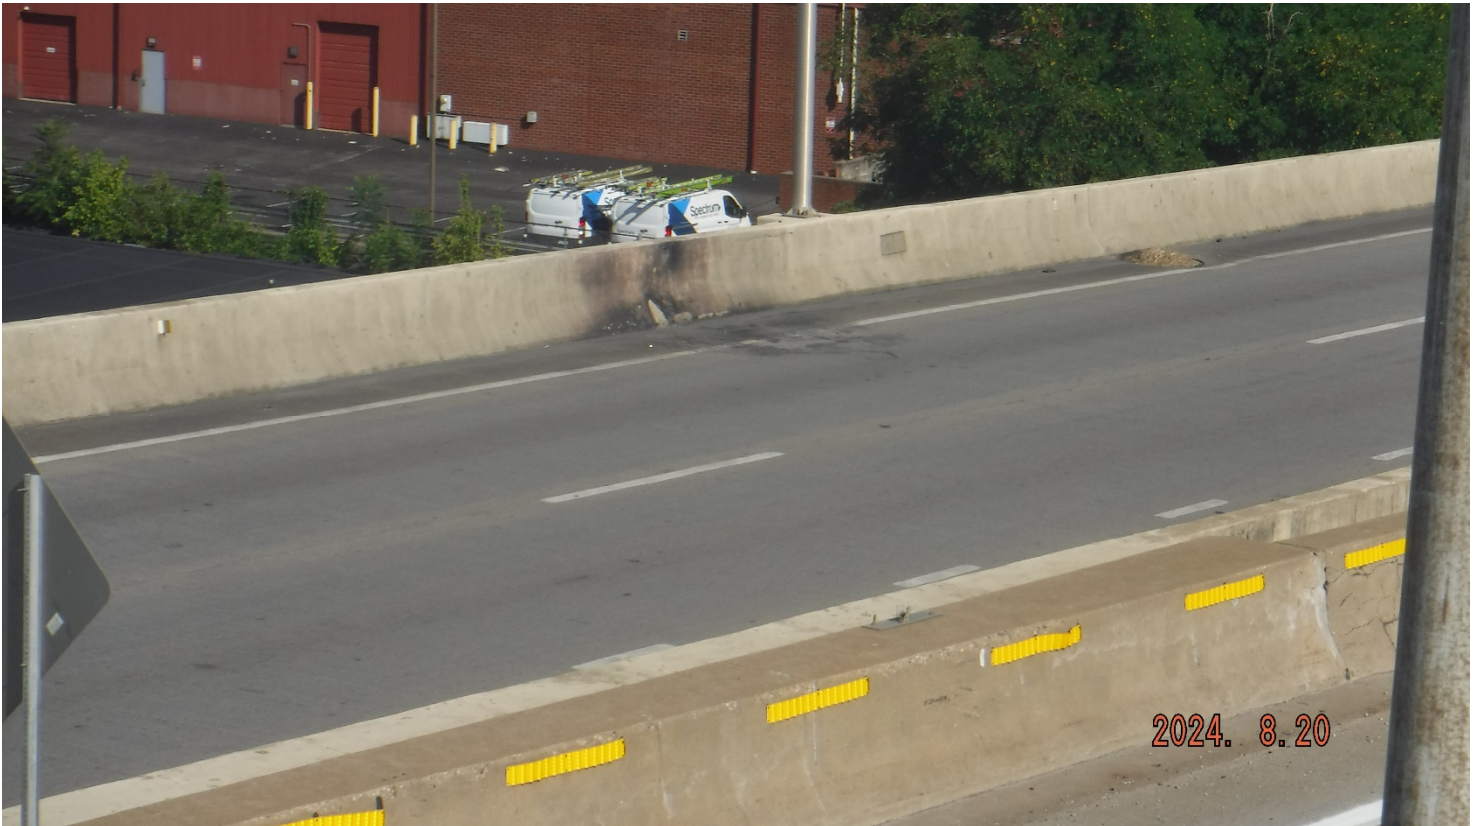
PHOTO 3. WEARING SURFACE SPAN 21, FIRE DAMAGE OR CHEMICAL IN RIGHT LANE SHOULDER

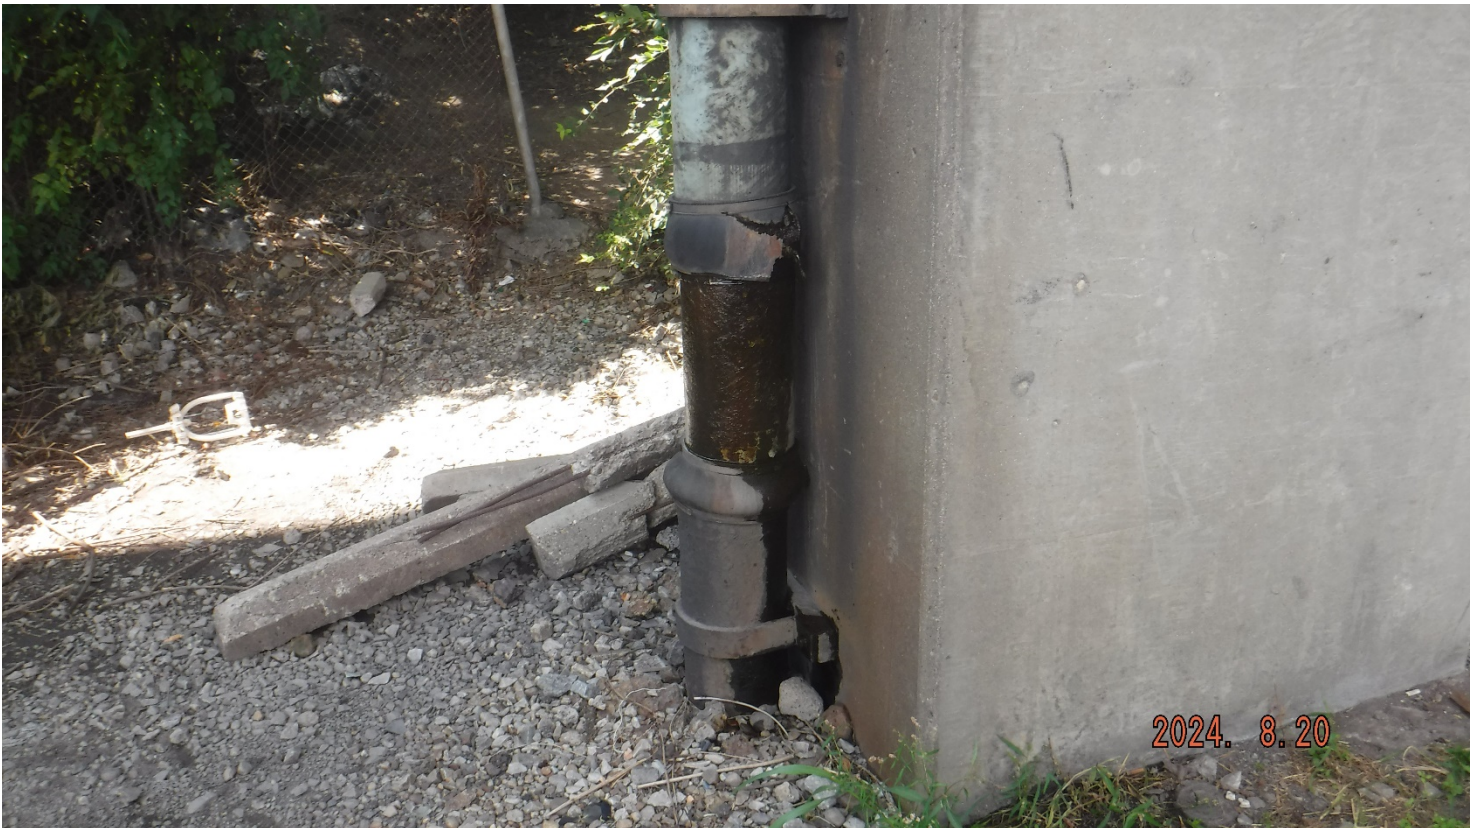
PHOTO 4. DRAINAGE PIER 23A COLUMN 1, CRACKED AND LEAKING GASKET IN THE DRAINAGE PIPE

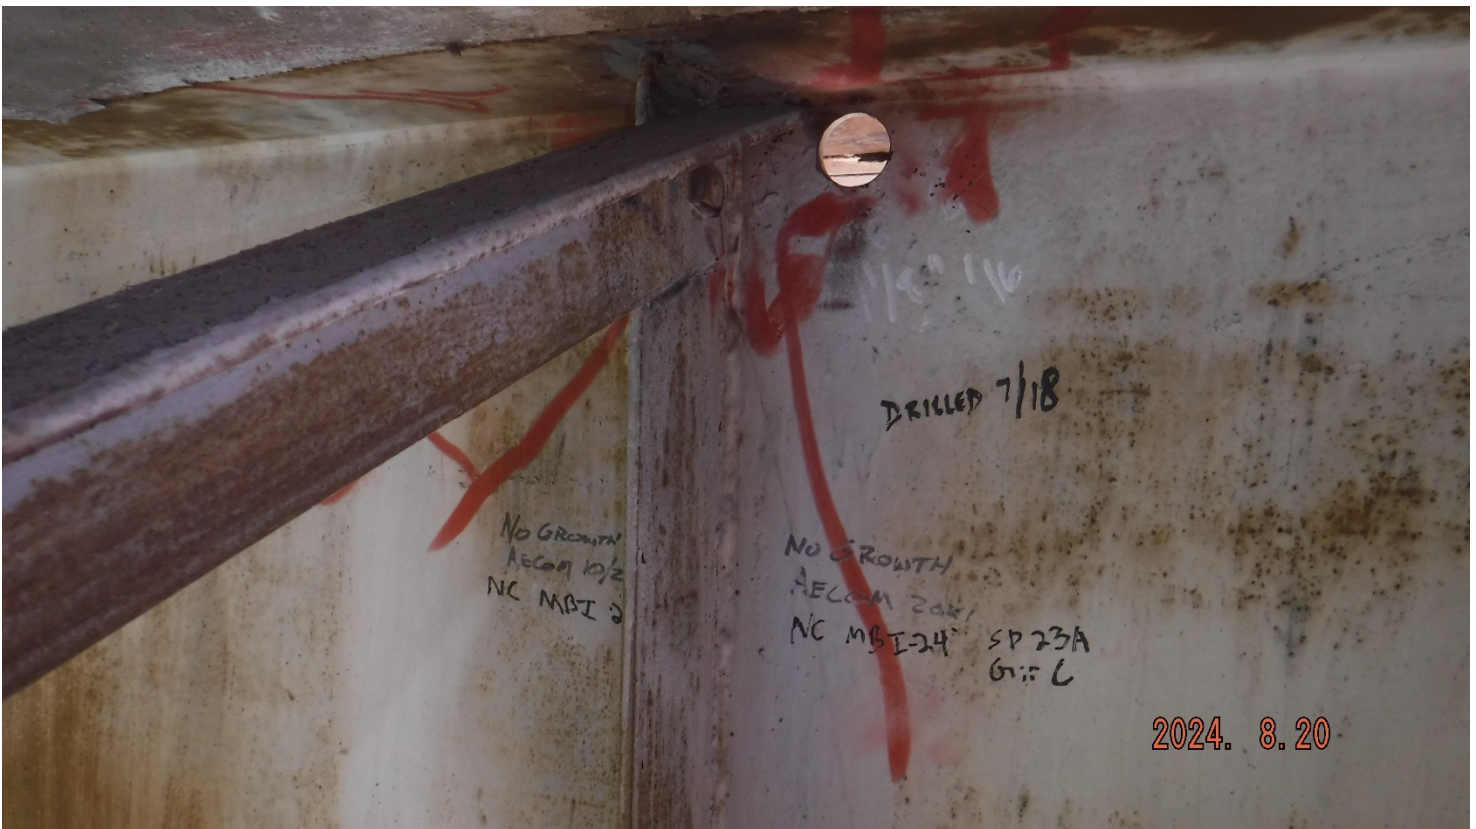
PHOTO 5. GIRDER 23A GIRDER C, MULTIPLE CRACKS IN WEB AND TRANSVERSE STIFFENER WELDS. ALL CRACKS REPAIRED WITH ARREST HOLES AND NO INDICATION OF CONTINUED PROPAGATION

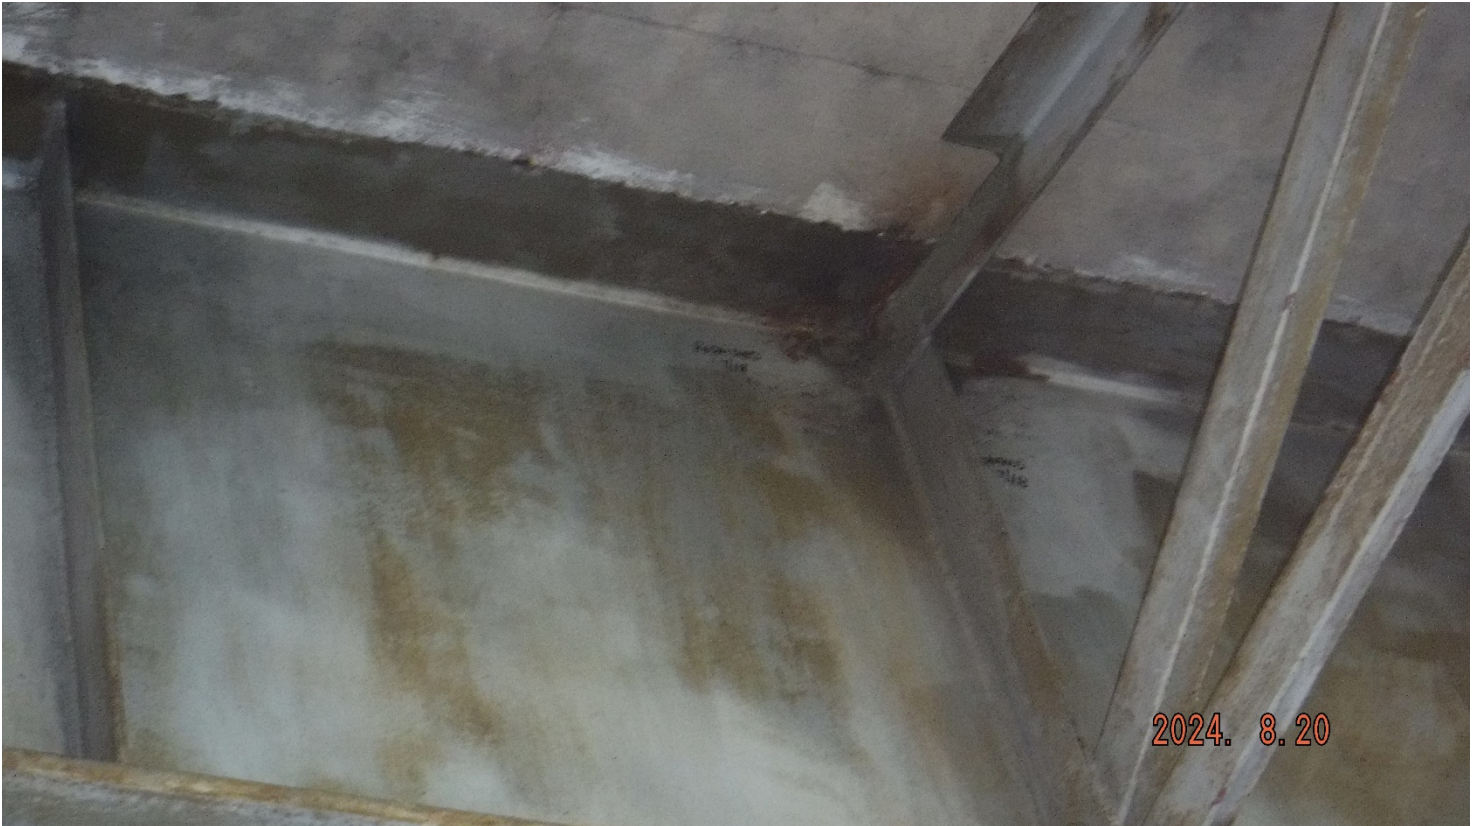
PHOTO 6. GIRDER 25A GIRDER C, MULTIPLE CRACKS IN WEB AND TRANSVERSE STIFFENER WELDS. ALL CRACKS REPAIRED WITH ARREST HOLES AND NO INDICATION OF CONTINUED PROPAGATION

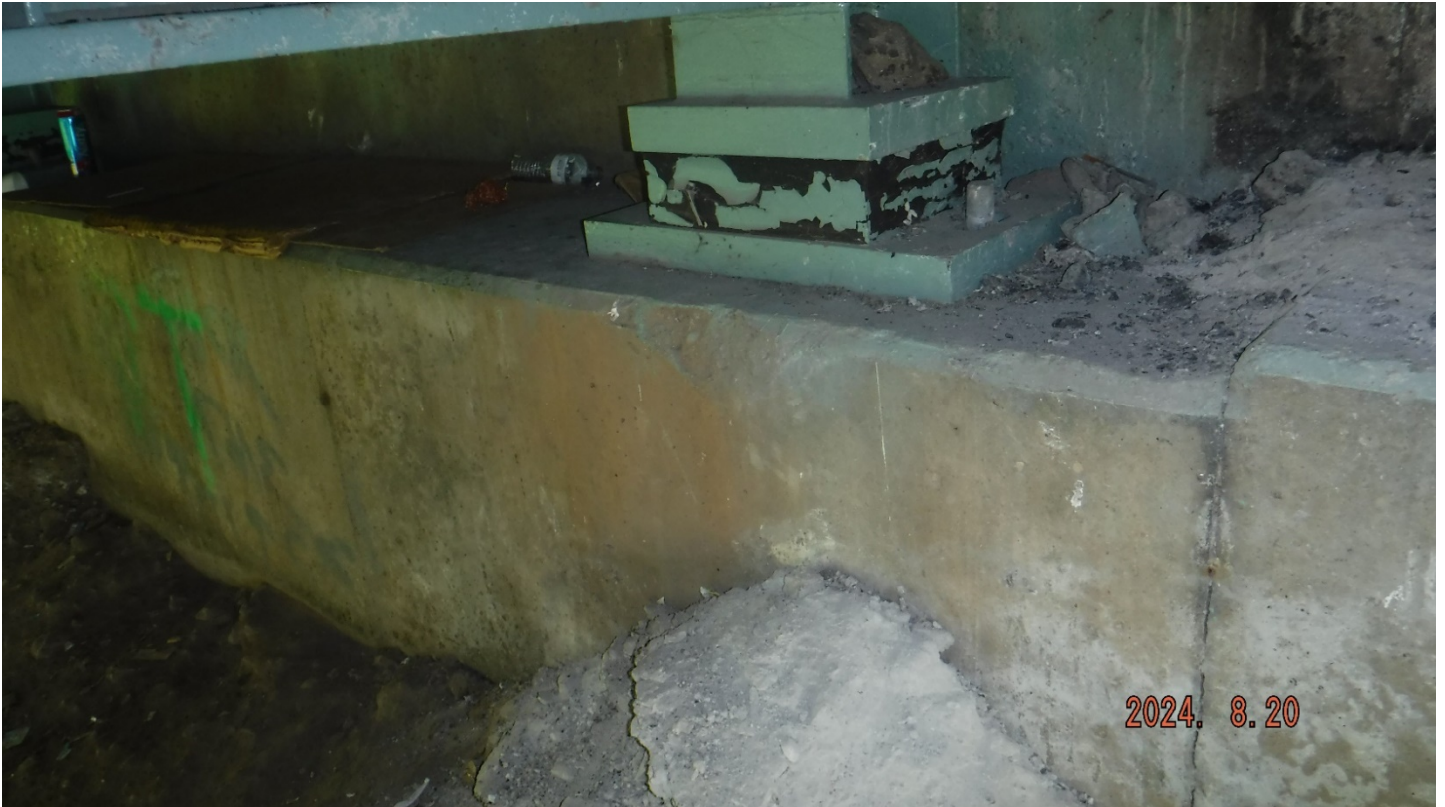
PHOTO 7. ELASTOMERIC BEARING C ABUTMENT, 12" L X 6" W X 1" DEEP SPALL BELOW BEARING GIRDER C

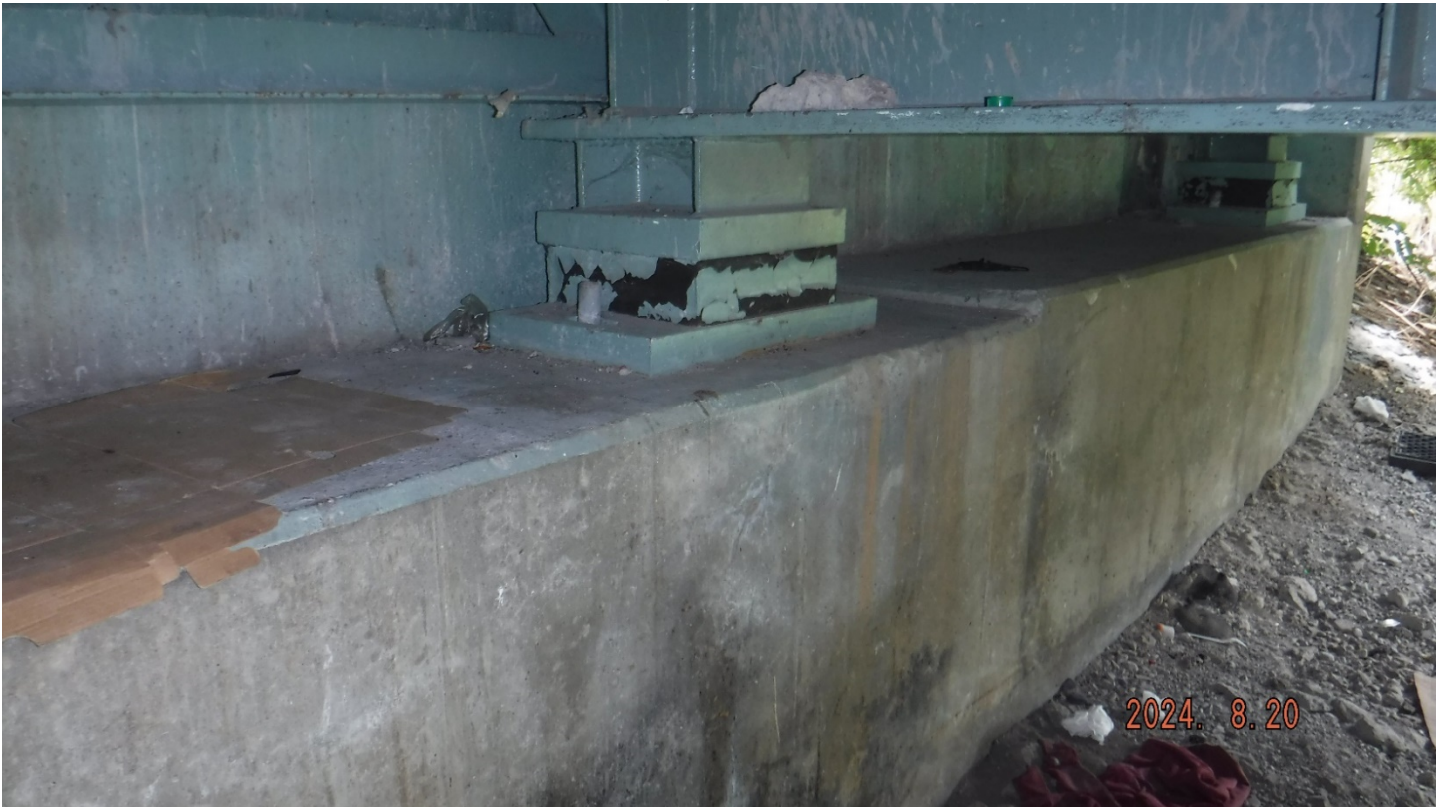
PHOTO 8. ELASTOMERIC BEARING D ABUTMENT, 4" L X 2" W X 1" DEEP SPALL BELOW THE BEARING OF GIRDER D

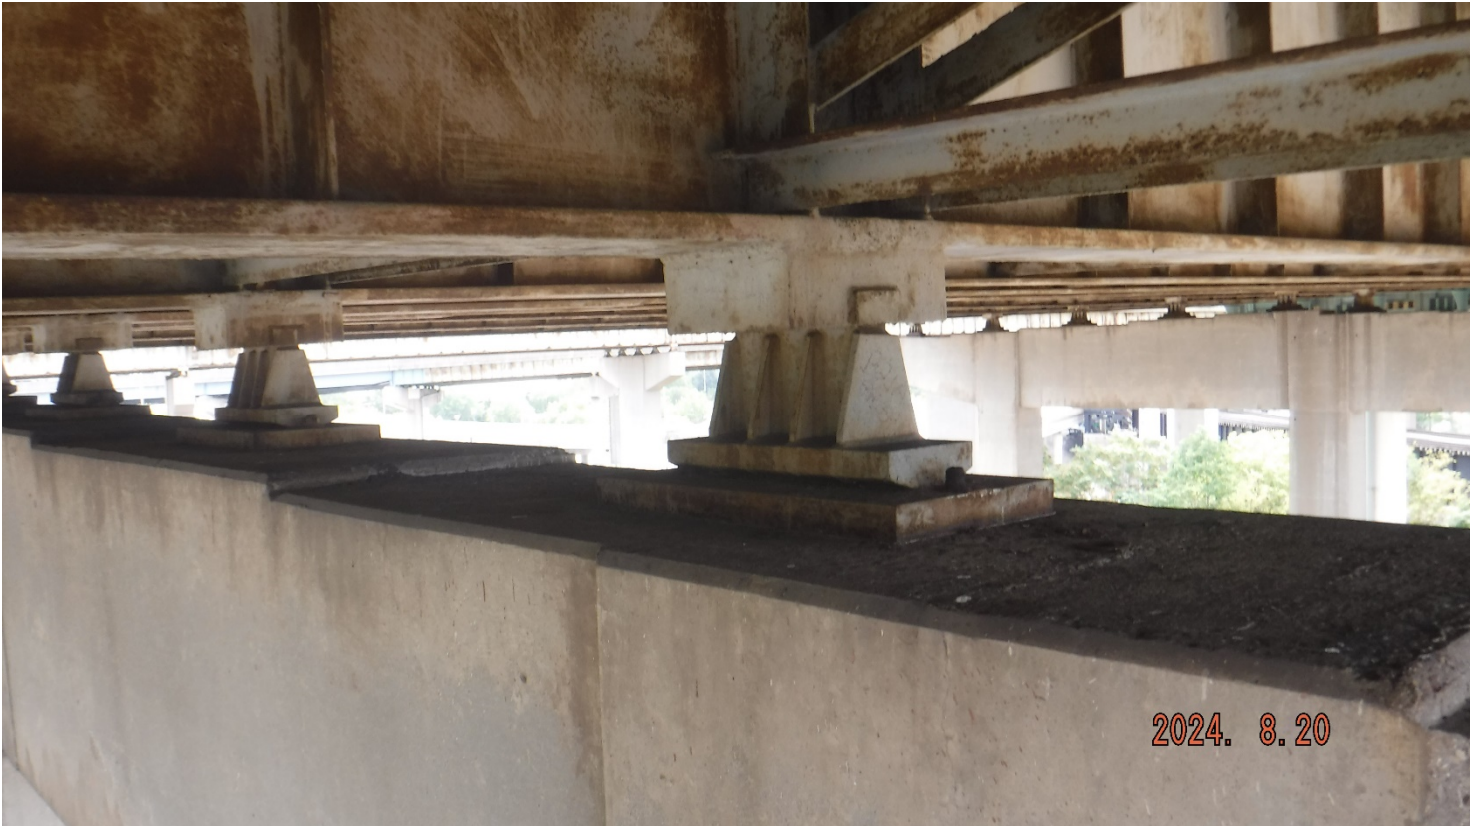
PHOTO 9. MOVABLE BEARING B PIER 21A MOVABLE, MISSING NUT ON BOLT

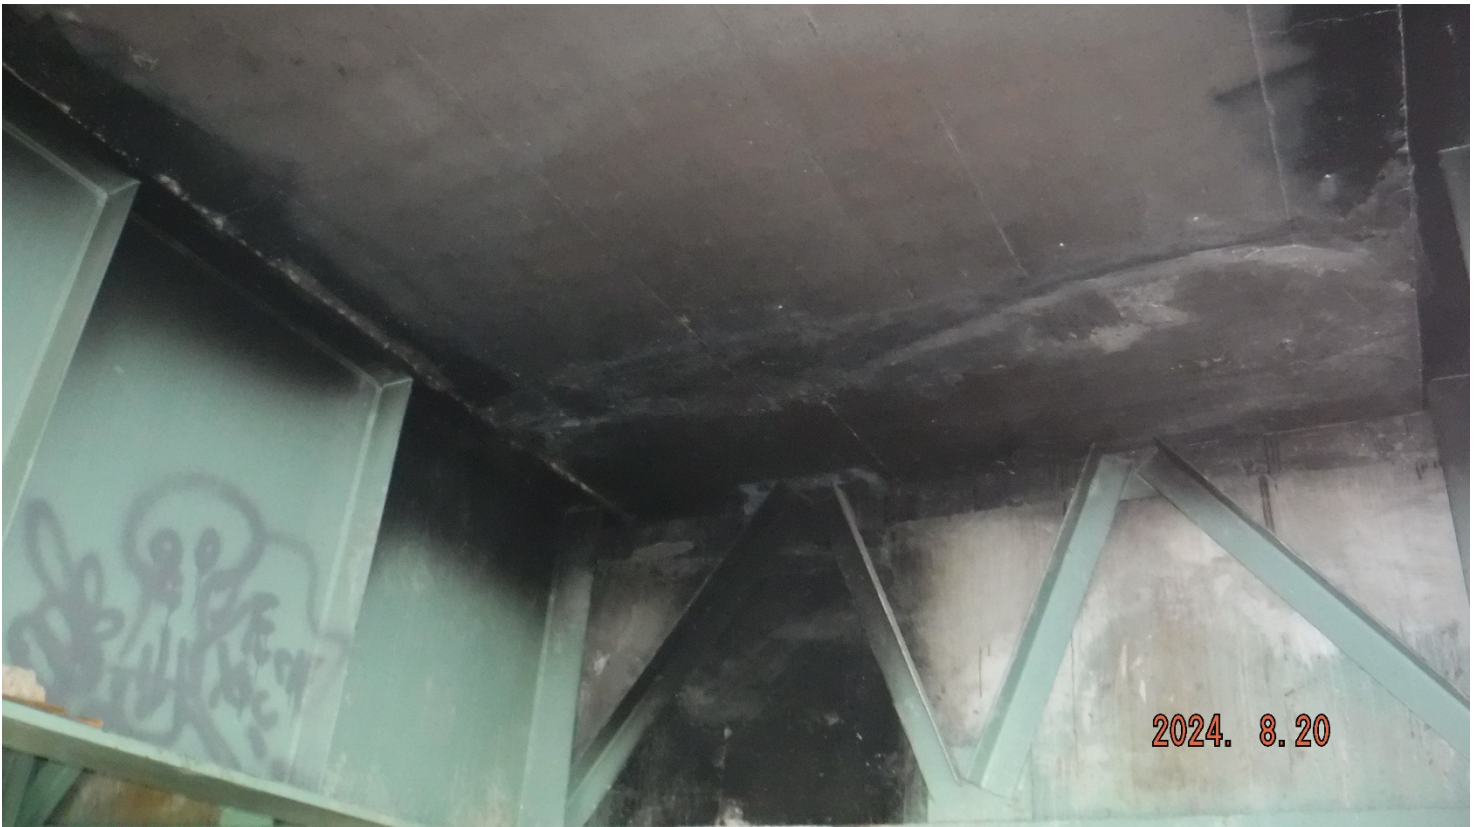
PHOTO 10. BACKWALL BAY 3, FIRE DAMAGE WITH HAIRLINE CRACKING THROUGHOUT BACKWALL

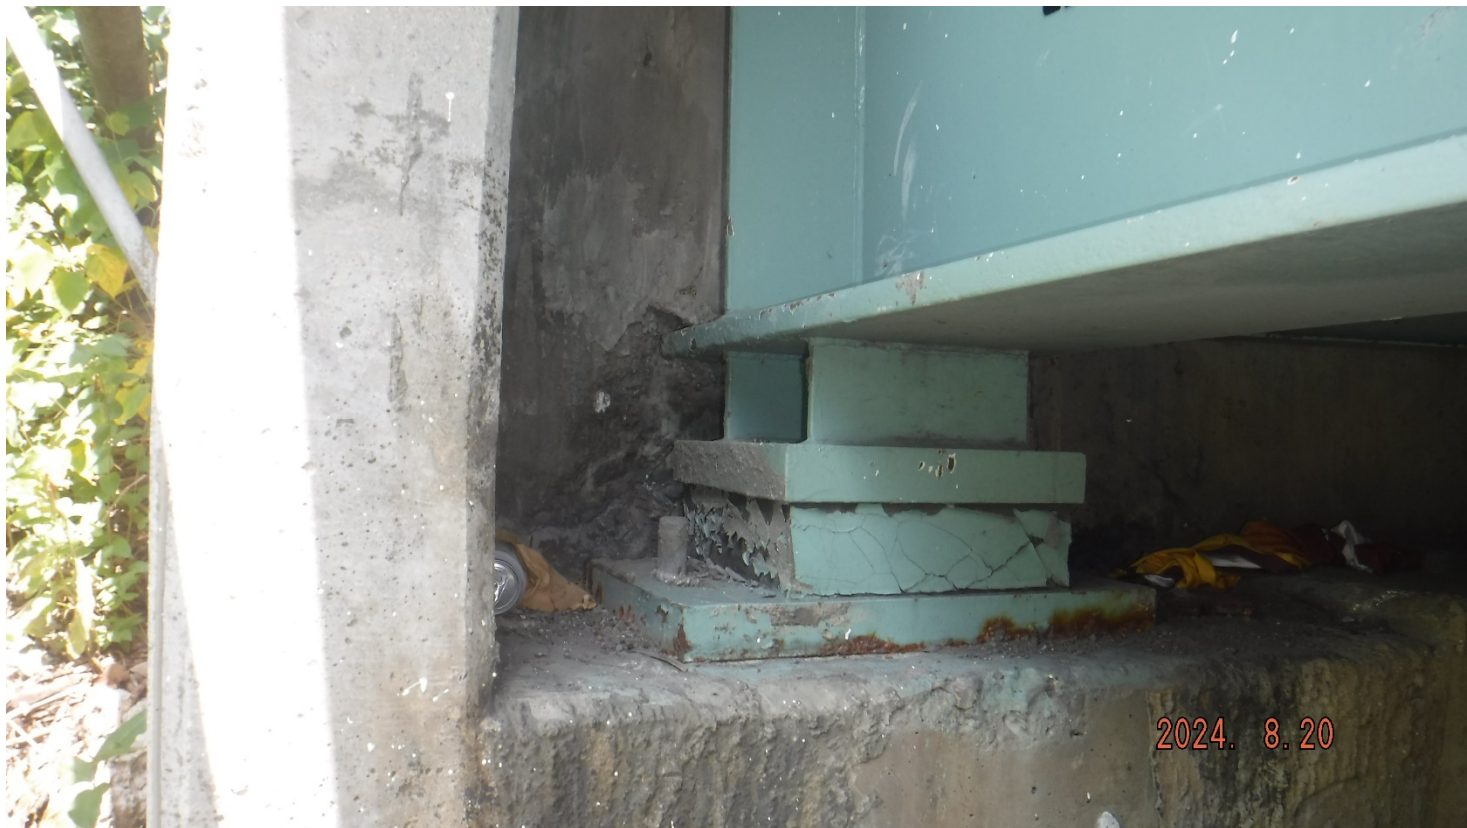
PHOTO 11. BACKWALL GIRDER A, 2" DIAMETER X 1' DEEP SPALL BEHIND BEARING
