ODOT District 8  
2024 Fracture Critical and In-Depth  
Element Level Inspection Report

October 2024

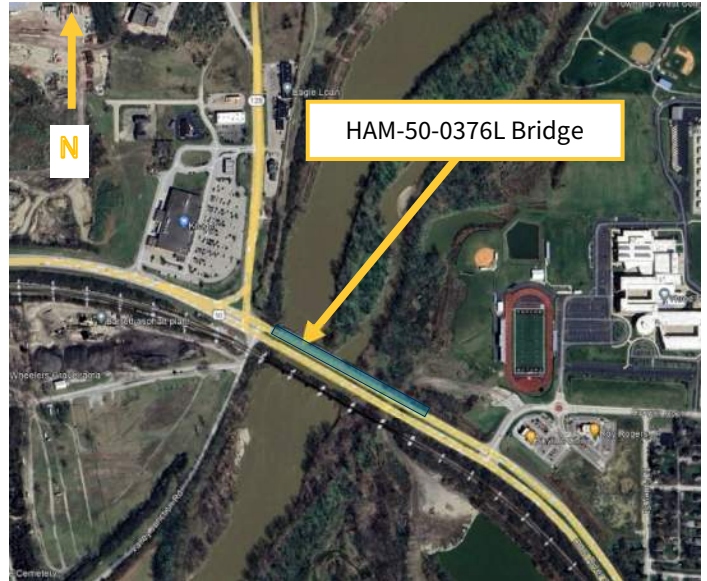
Figure 1 - Location Map

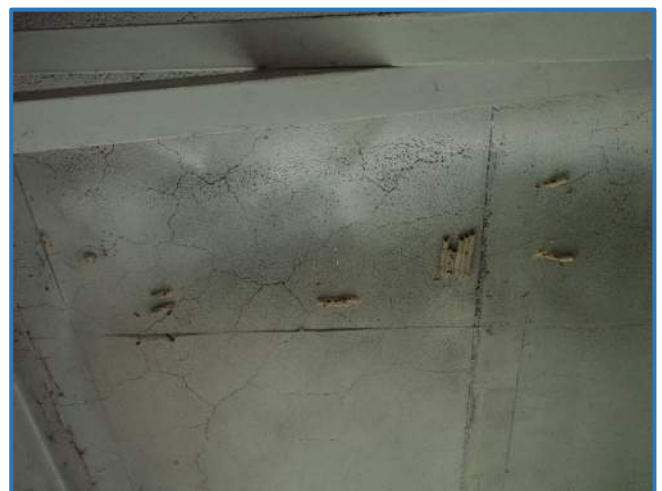
Photo 1 - Typical map cracking in underside deck. Shown Span 4, Bay 3, near Floorbeam 8

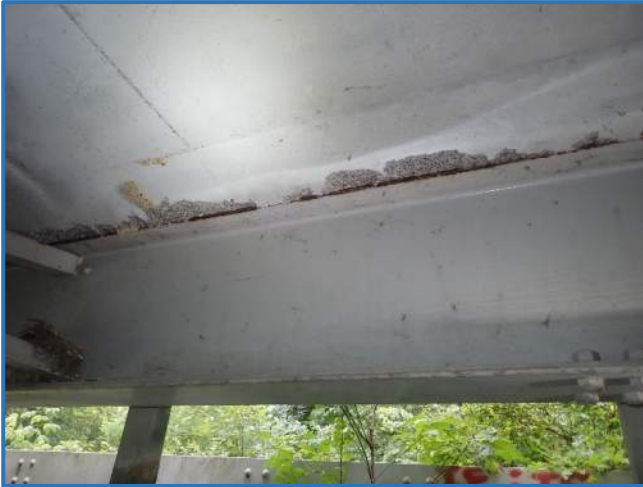
Photo 2 - Typical haunch spall. Shown 15' long by 6" high by 0.5" deep in Span 4, top of Stringer 1, looking north

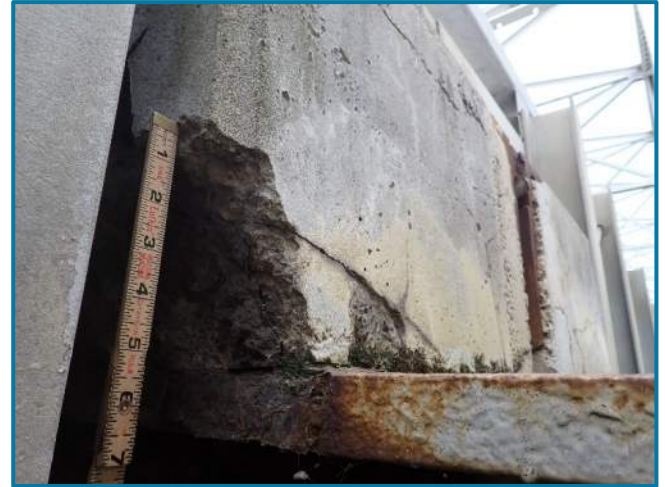
Photo 3 - 6" by 6" by 6" spall on edge of deck on north end, above FBO, in Span 3

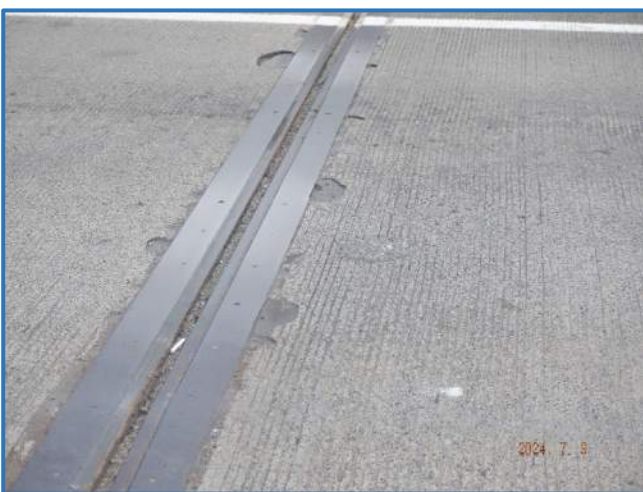
Photo 4 - Spalling along Pier 2 joint

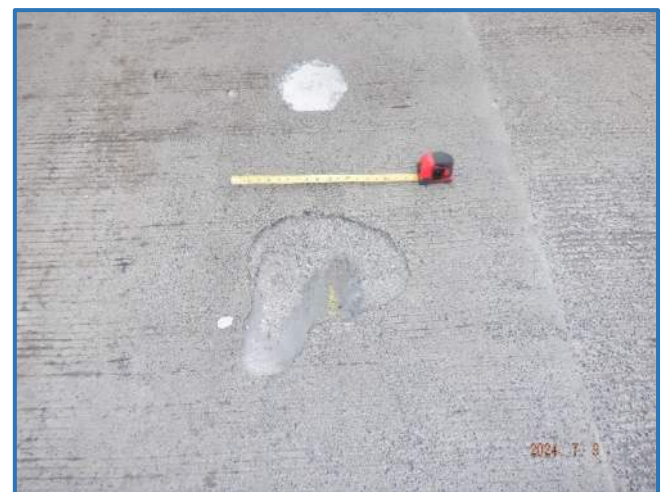
Photo 5 - Spalls in wearing surface on Span 3, left lane, between Panel Points 2 and 3

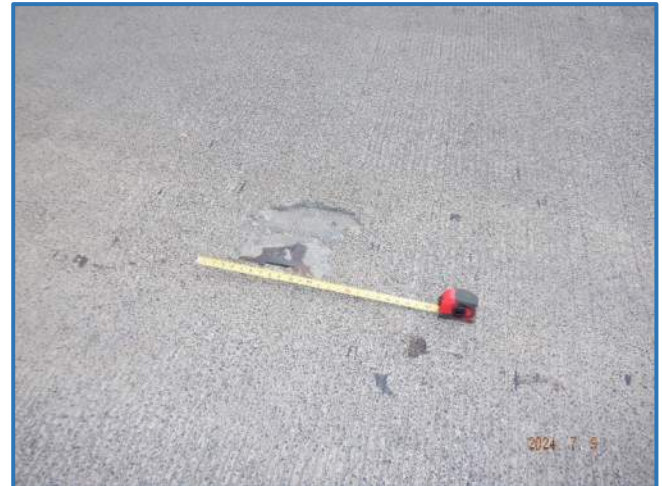
Photo 6 - Spall in Span 1, east side of span

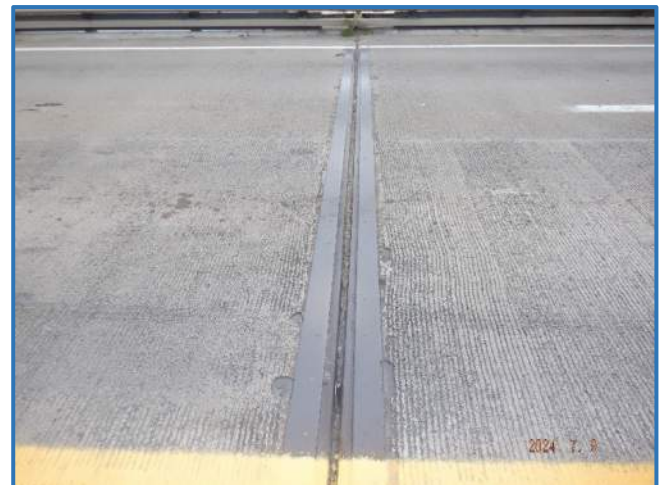
Photo 7 - Typical expansion joint with debris and surface corrosion. Shown is Pier 2 joint, looking north

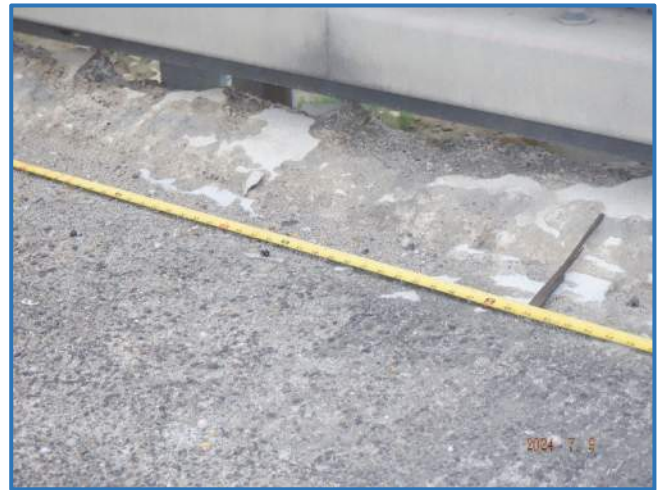
Photo 8 - Spalling of left lane curb in Span 2, between Panel Points 5 and 6

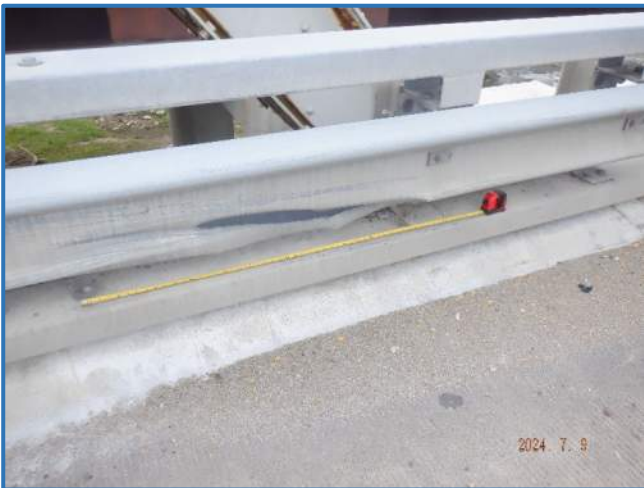
Photo 9 - Impact damage to metal railing, showing Span 3, south railing, between Panel Points 0 and 1

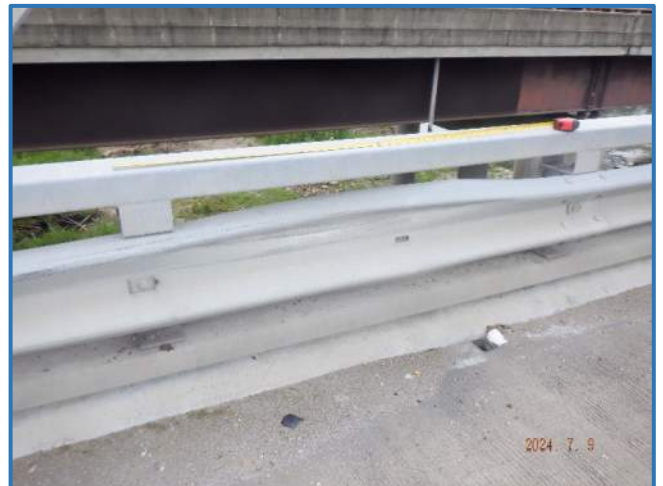
Photo 10 - Impact damage to metal railing, showing Span 3, south railing, between Panel Points 1 and 2

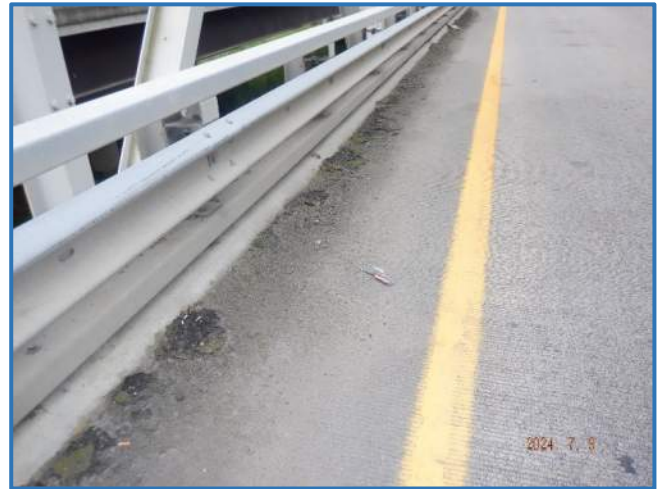
Photo 11 - Typical debris accumulation along edge of bridge deck, shown Span 4, south lane

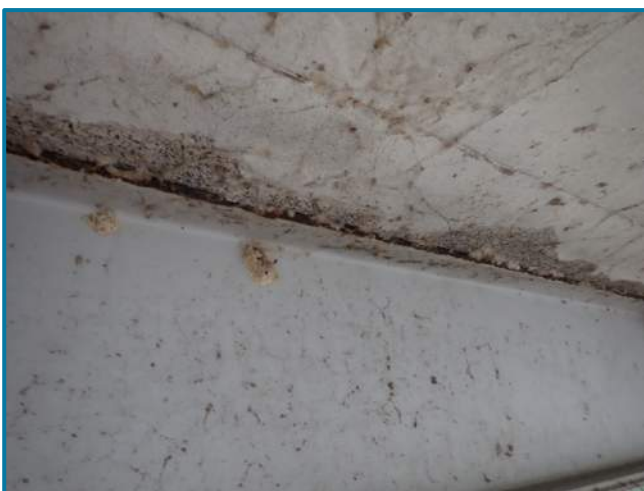
Photo 12 - Typical haunch spalling along outside stringers with surface corrosion along top flange. Shown Span 2, Stringer 1, looking northeast

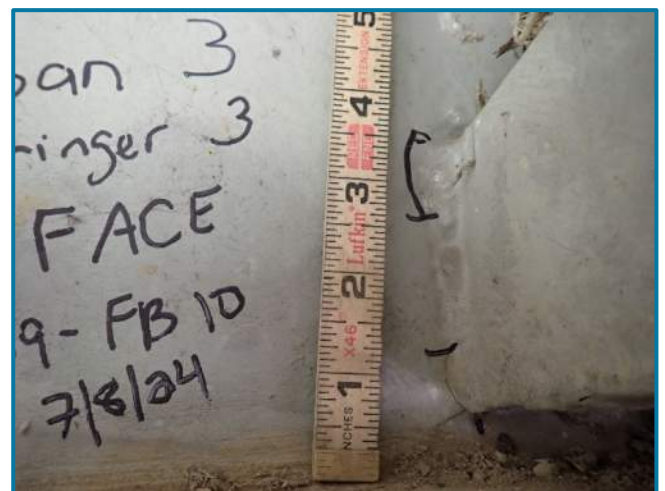
Photo 13 - Crack in weld for 2/3 of length on Stringer 3 connection to diaphragm between Floorbeam 9 and 10, looking north

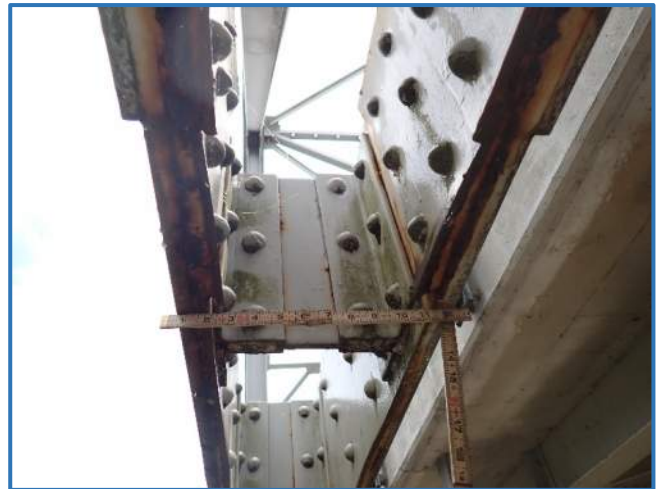
*Photo 14 - 1/2" pack rust in lower chord plates in Span 2, North Truss, member L7L8, looking east*

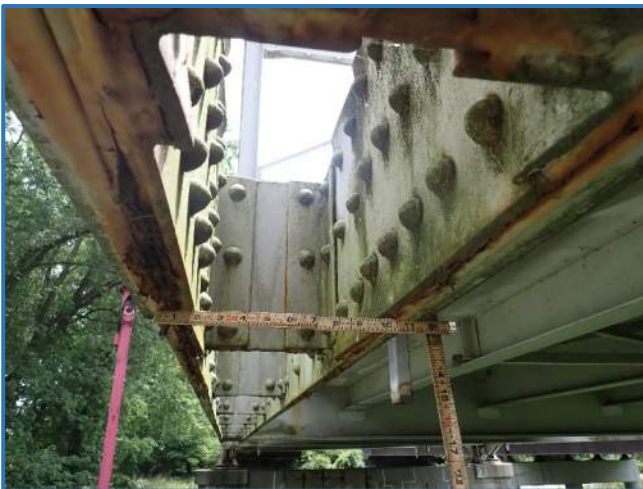
*Photo 15 - 3/4" pack rust in lower chord plates in Span 3, North Truss, member L7L8, looking east*

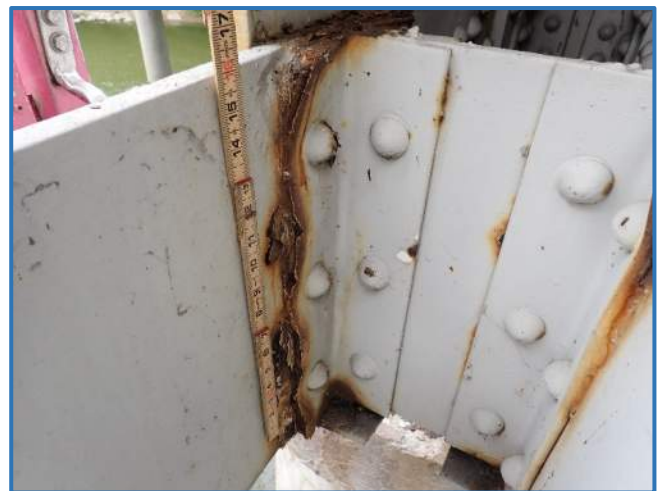
*Photo 16 - 3/4" pack rust between lower chord and diaphragm, Span 2, South Truss, member L0L1*

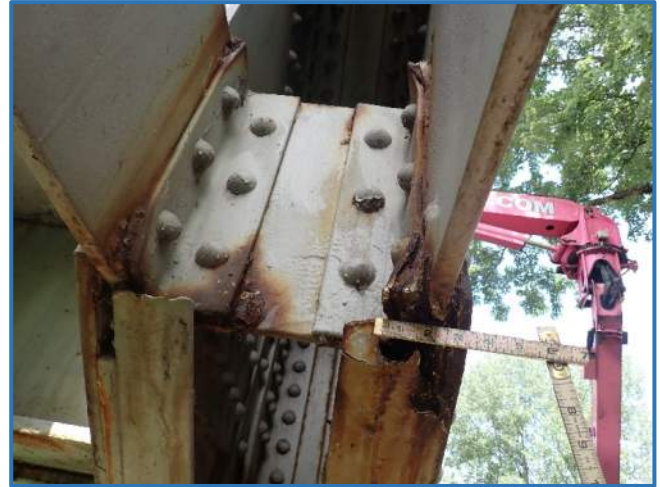
Photo 17 - Bowing in lower chord northeast diaphragm angle due to pack rust, 1 1/2" over 4", Span 4, North Truss, member L0L1

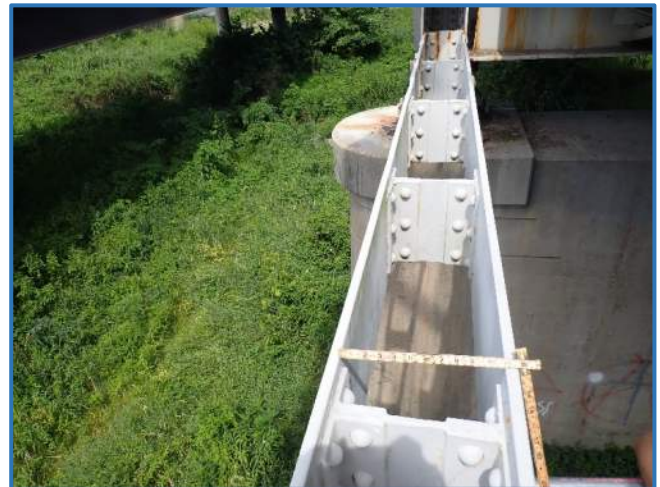
Photo 18 - Inconsistent diaphragm dimensions; Member L0L1, South Truss, Span 4 shown

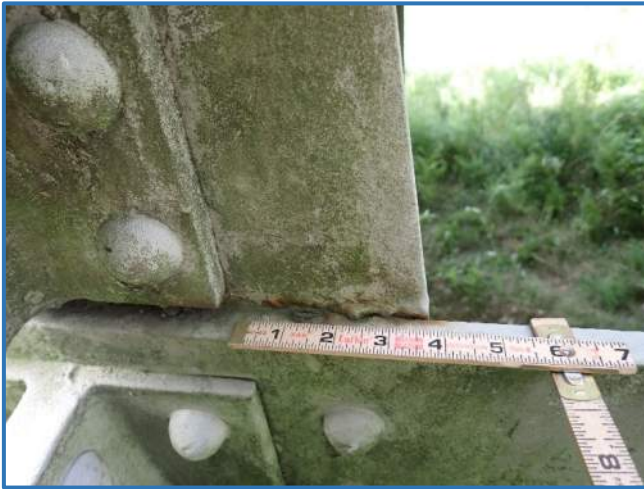
Photo 20 - Broken tack weld between lower chord and gusset plates, Span 4, North Truss, at Panel Point 1, looking south

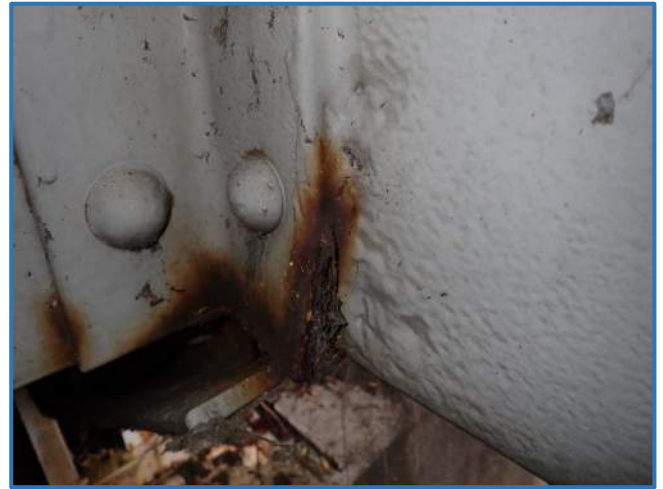
Photo 21 - Area of 2" wide by 4" high x 3/16" deep pitting on the south face of north web plate in Span 1, North Truss, between Panel Point 0 and 1, looking west

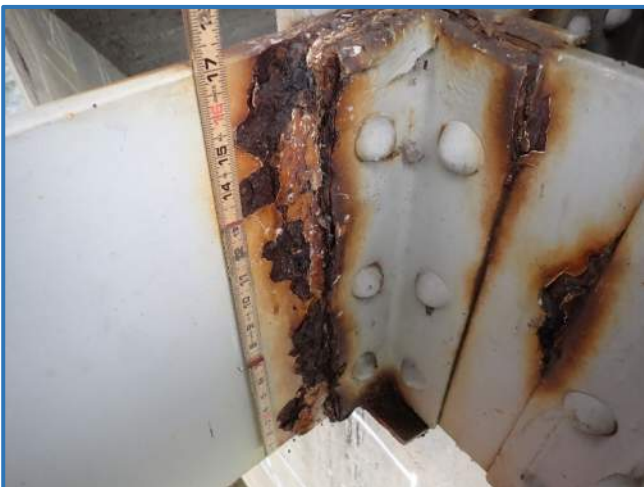
Photo 24 - Active laminar corrosion throughout the connection, Span 2, North Truss, at Panel Point 0, looking west

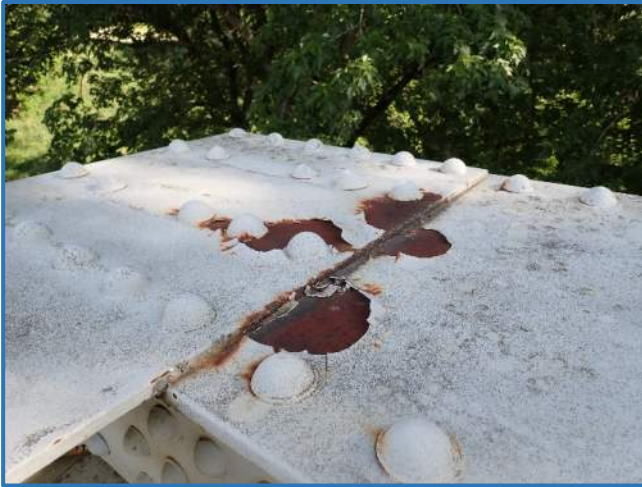
*Photo 25 - Typical paint spot failure on top of upper chord, with active corrosion. Shown Span 4, North Truss, east of U1, looking northwest*

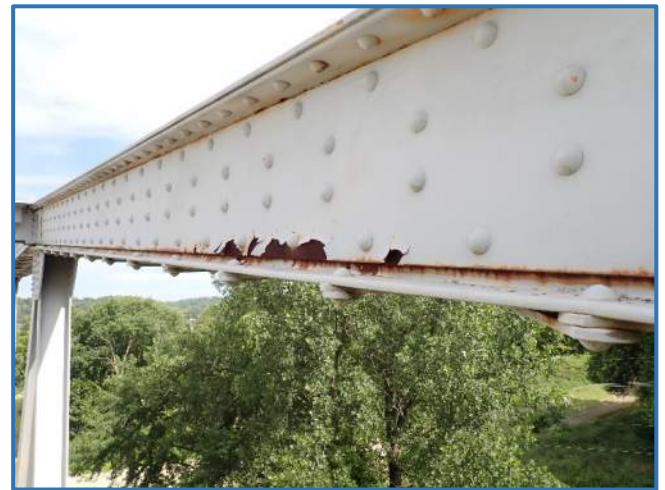
*Photo 26 - Reactivated corrosion between the channel and web plate in Span 3, North Truss, member U7U8, looking northwest*

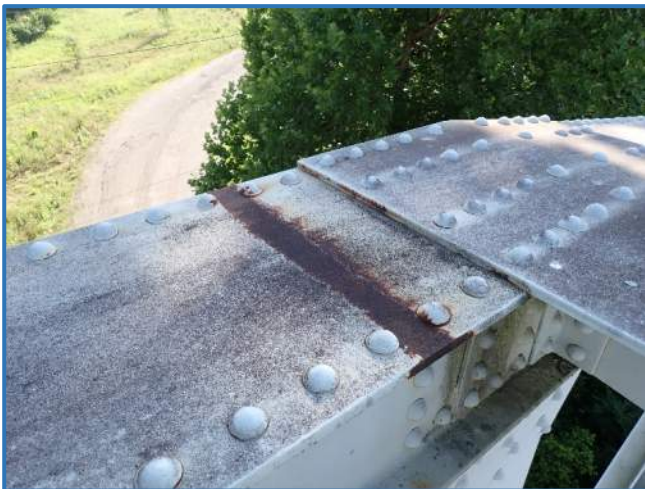
*Photo 27 - 6" long by 4" wide paint failure in Span 4, North Truss, member U5U6, looking northeast*

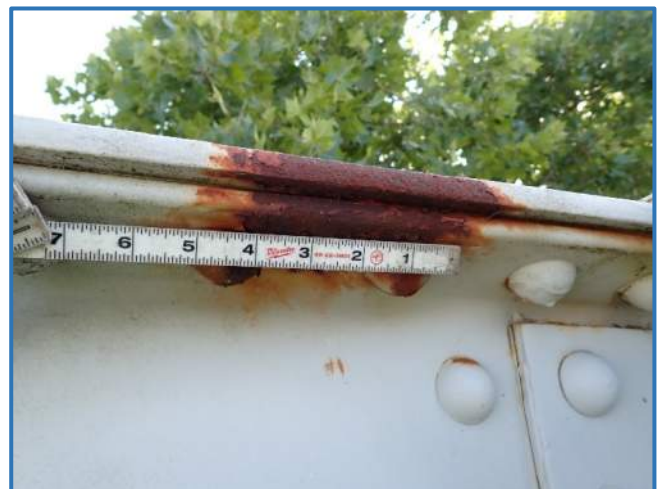
*Photo 28 - 6" long by 4" wide paint failure in Span 4, North Truss, member U6U7, looking north*

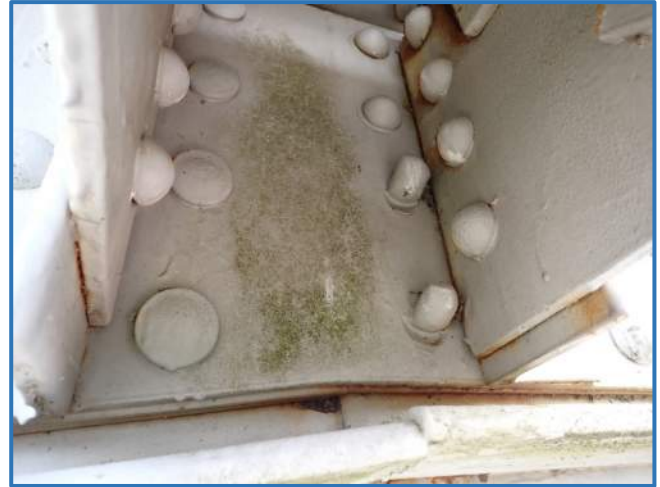
*Photo 29 – Typical improperly installed rivet heads in stiffener plate, Span 3, North Truss, at Panel Point 3*

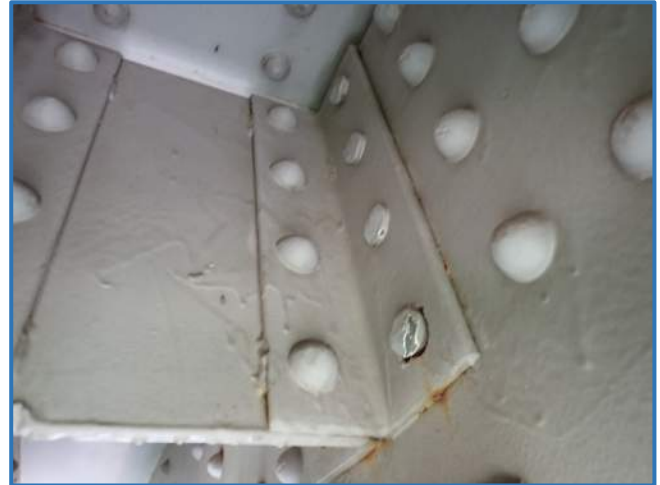
*Photo 30 - Typical missing rivet heads on south diaphragm clip angle, Span 3, North Truss, at Panel Point 4, looking southeast*

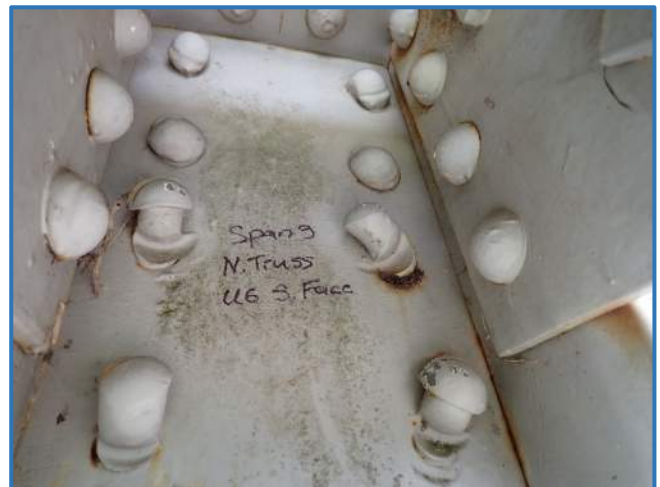
*Photo 31 – Improperly installed rivets in stiffener plate, Span 3, North Truss, at Panel Point 6, looking north*

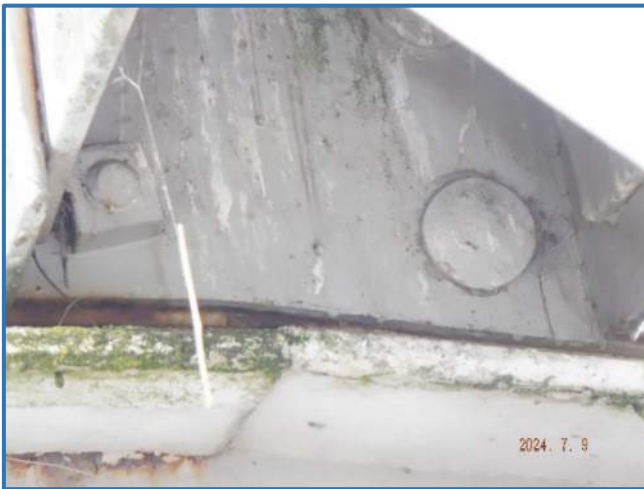
Photo 32 - Bolt with square nut and flattened rivet head on upper chord stiffener plate, Span 2, South Truss, at Panel Point 3, looking south

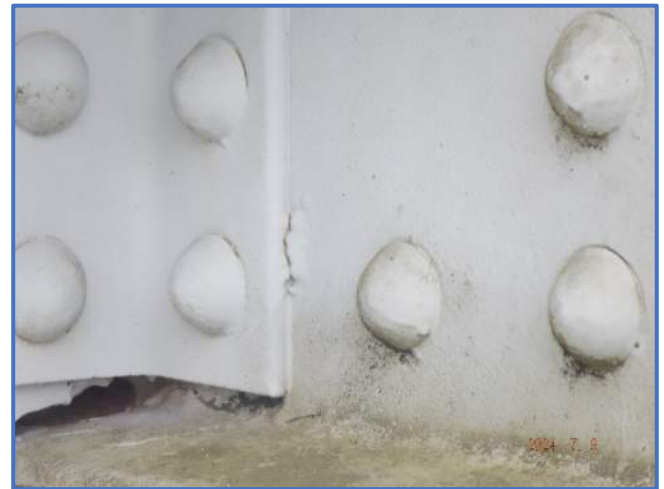
Photo 33 - Crack in tack weld between upper chord and sway bracing connection plate in Span 4, South Truss, at Panel Point 4, looking southeast

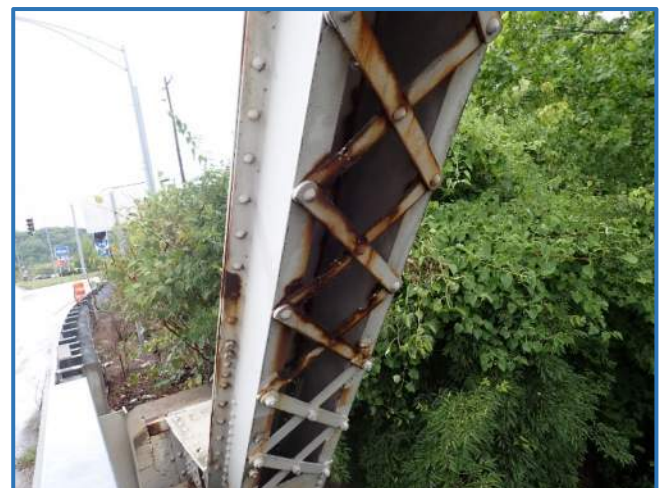
Photo 34 - Typical lacing bars with up to 100% section loss. Shown is the end post in Span 1, North Truss, between Panel Points 0 and 1, looking northwest

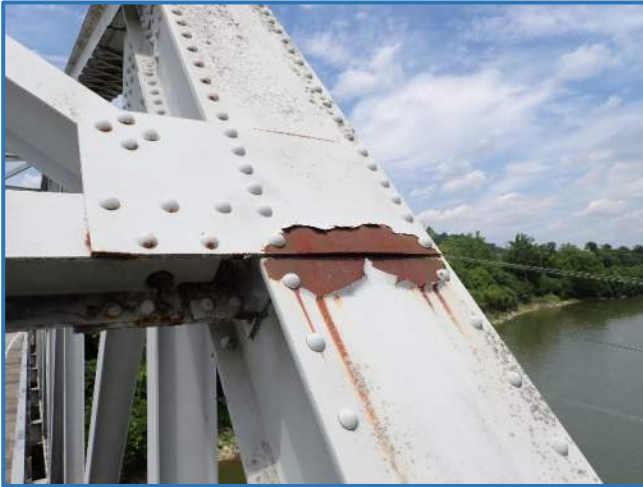
Photo 35 - Paint failure with surface corrosion on top face of end post in Span 1, North Truss, between Panel Points 7 and 8, looking west

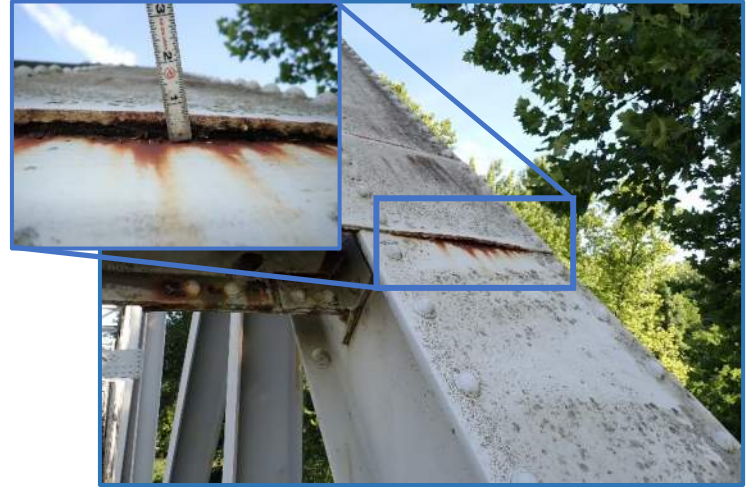
Photo 36 - 1/2" pack rust between portal bracing connection plate and edge post in Span 4, North Truss, on U7L8, looking west

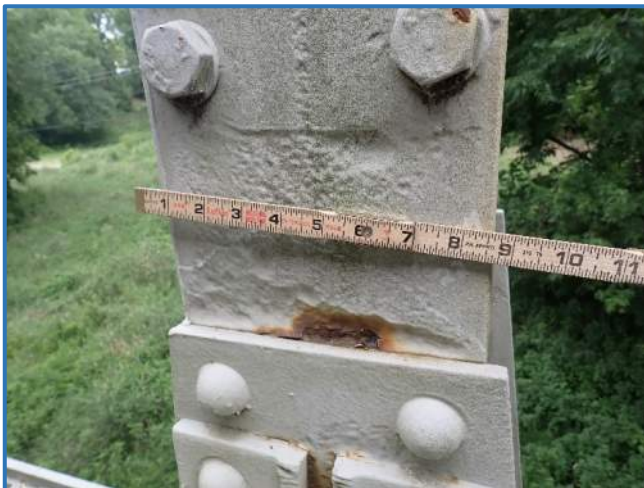
Photo 37 - Pitting with active corrosion and section loss (2" high by 6" wide by 3/8" deep) on vertical just above lower chord connection in Span 3, North Truss, at Panel Point 9, looking west

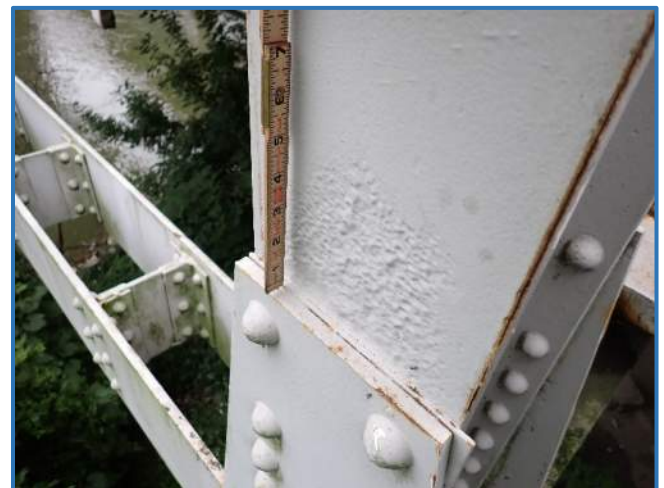
Photo 38 - Painted over pitting up to 3/16" deep on vertical just above lower chord connection, Span 1, North Truss, at Panel Point 1, looking northwest

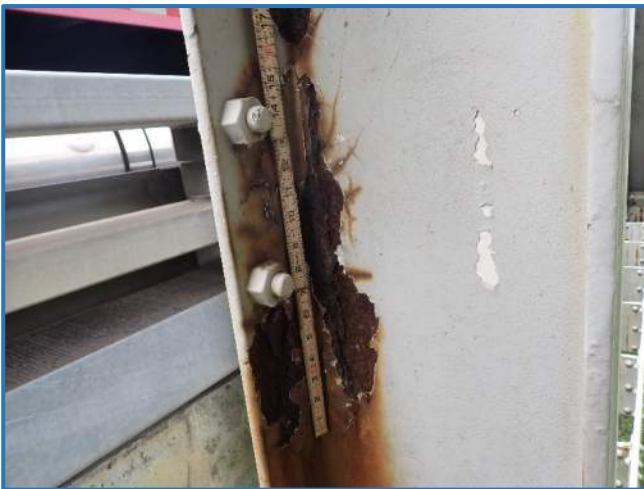
Photo 39 - Laminar corrosion on flange and web of vertical member in Span 3, North Truss, at Panel Point 9, looking west

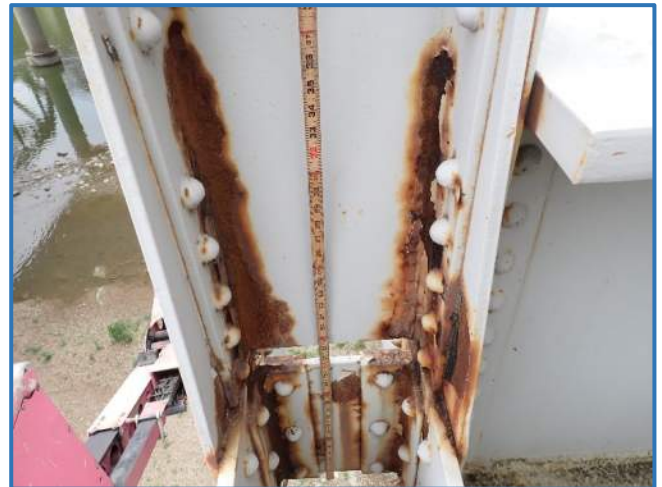
Photo 40 - Active corrosion with section loss along flanges and web of vertical member in Span 2, South Truss, at Panel Point 9, looking west

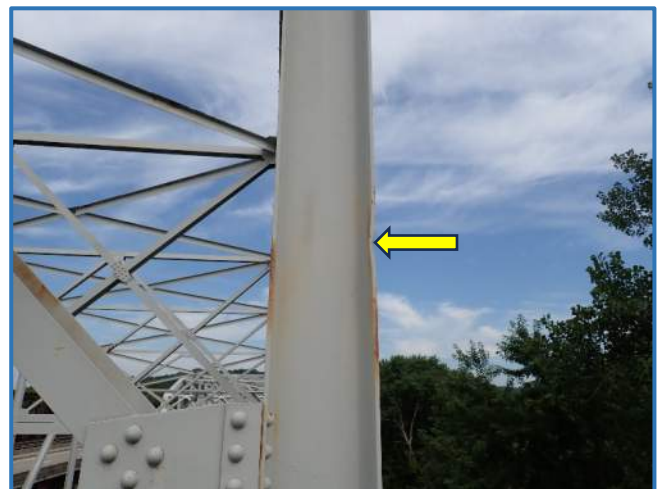
Photo 41 - Impact damage to north flange in Span 3, North Truss, at Panel Point 6, looking west

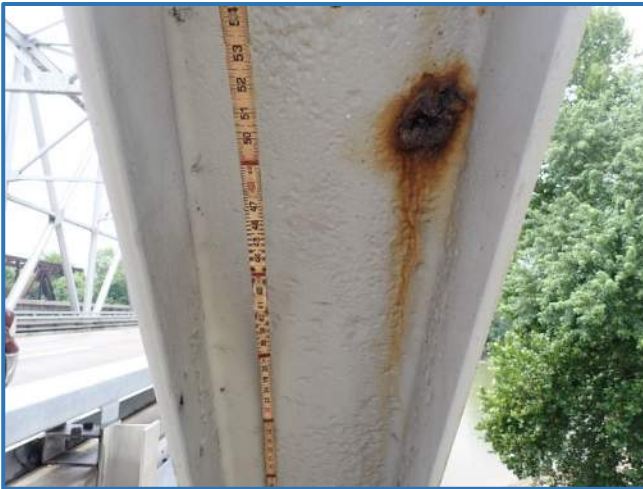
Photo 42 - Pitting on underside of web in Span 2, North Truss, member L8U9, looking west

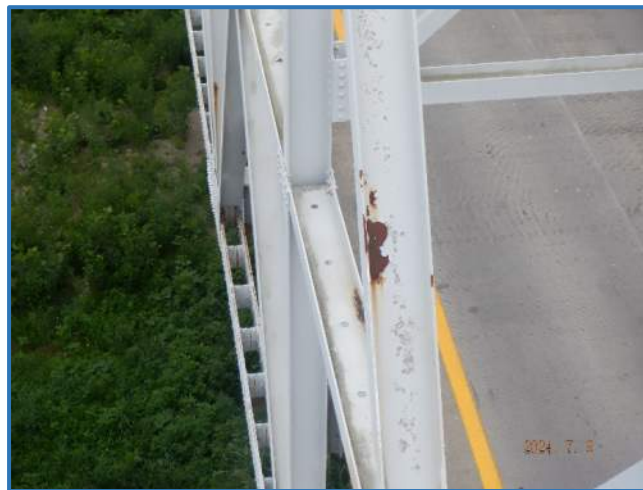
Photo 44 - Paint failure with active corrosion on web of diagonal in Span 3, South Truss, member U5L6, looking west

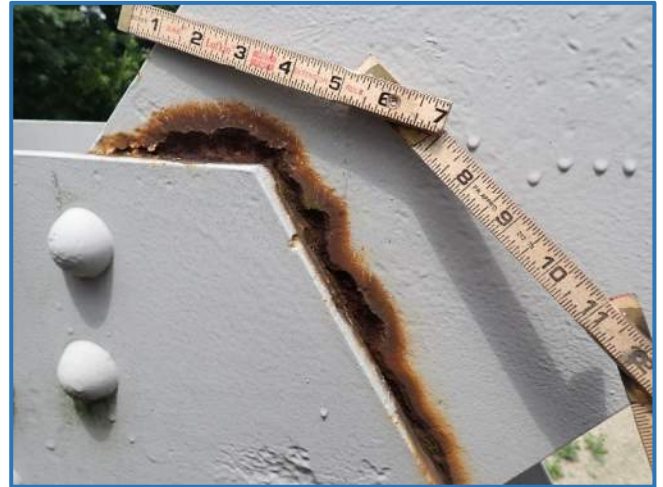
*Photo 45 - 3/16" deep section loss along lower gusset plate on south face of diagonal in Span 2, North Truss, at Panel Point 8, looking north*

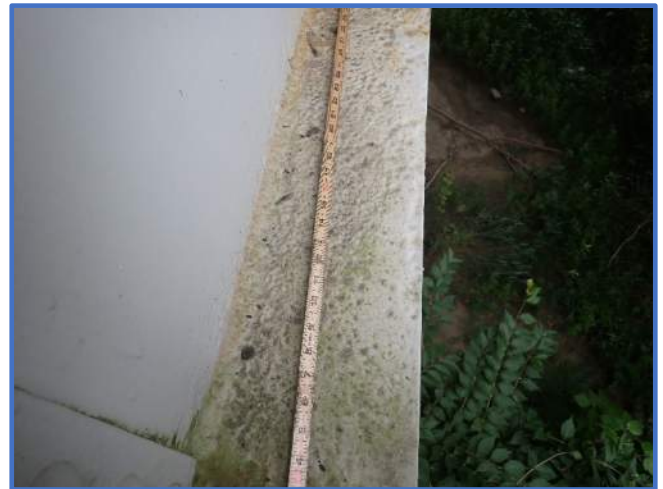
Photo 46 - Typical pitting on top face of bottom flange. Shown is 3.5' long by 1/16" deep pitting on Floorbeam 1, south end, Span 1, looking north

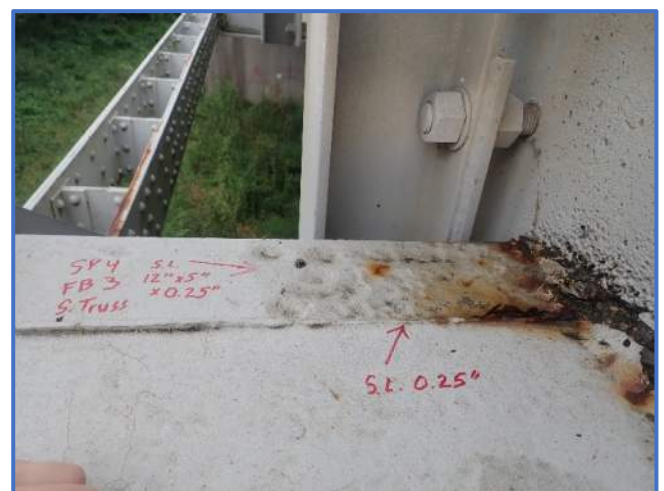
Photo 49 - Pitting with section loss along the top of top flange, at south end of Floorbeam 1, Span 4, looking west

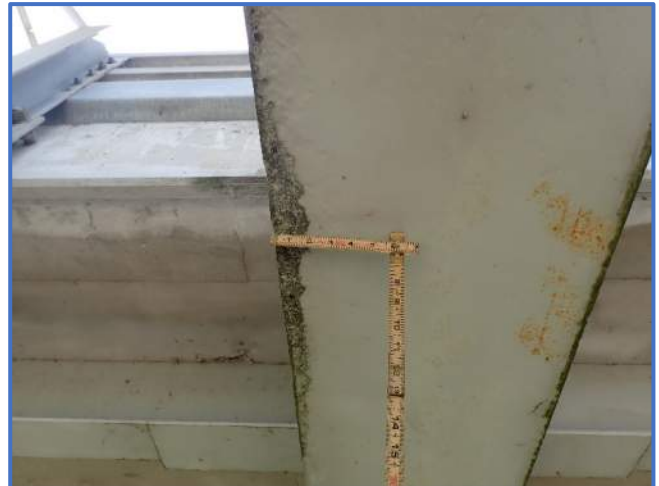
Photo 50 - Pitting along underside of Floorbeam 1, Span 3, looking south

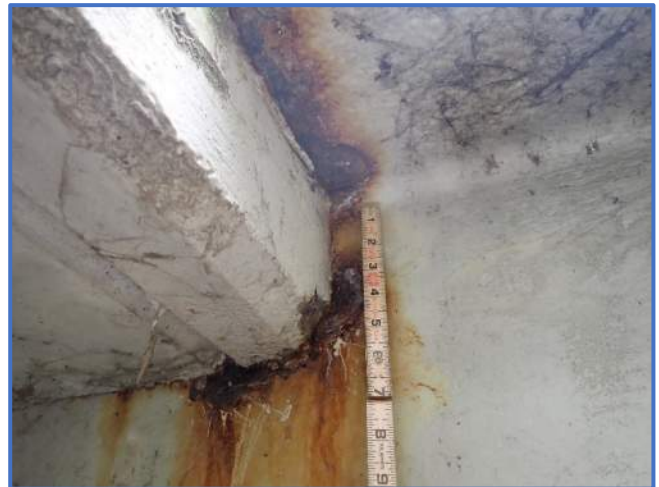
Photo 51 - Corrosion at deck and Floorbeam top flange interface. Shown Span 3, Floorbeam 8, north end, looking west

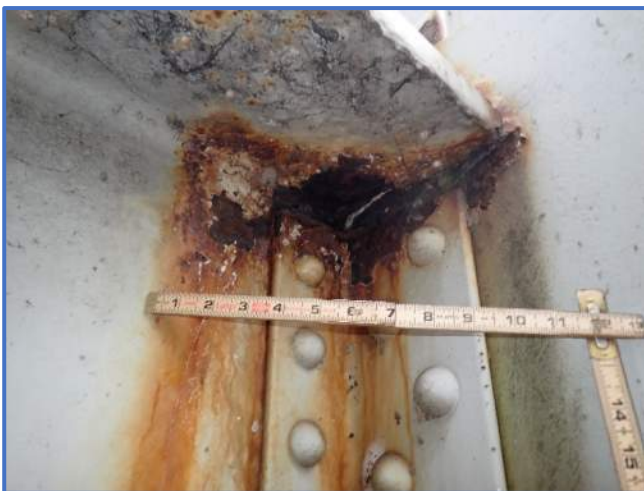
Photo 52 - Corrosion along top flange and clip angle in Span 1, Floorbeam 6 west face, north end, looking north

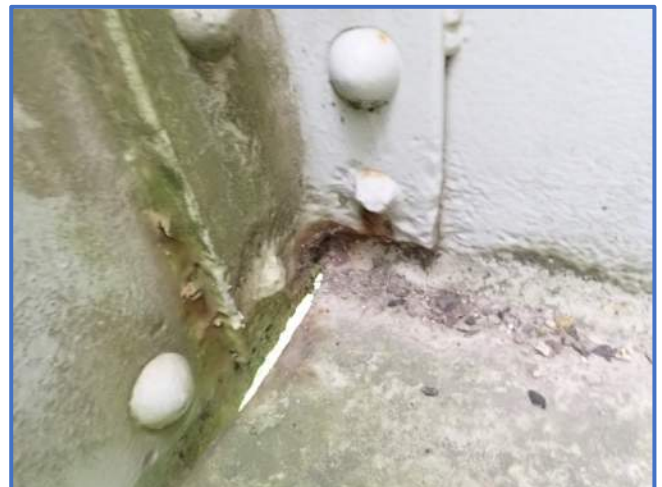
Photo 53 - Up to 50% section loss in rivet heads in Span 3, Floorbeam 4, gusset plate clip angle connection, south end, looking west

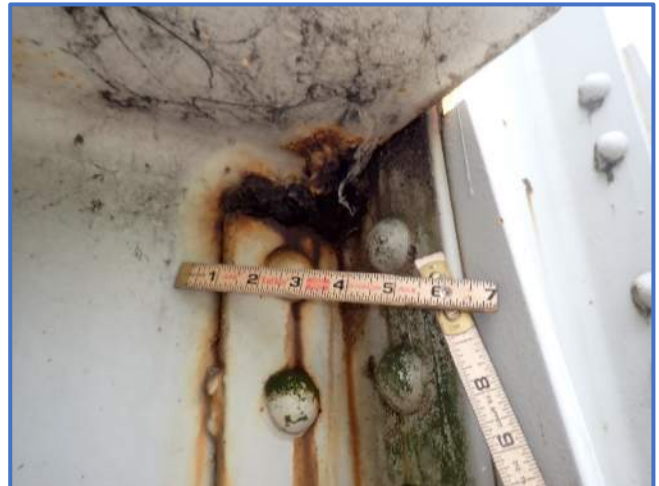
*Photo 54 – Corrosion along top flange and clip angle in Span 2, Floorbeam 9 west face, north end, looking west. Note tack weld at clip angle to floorbeam web connection.*

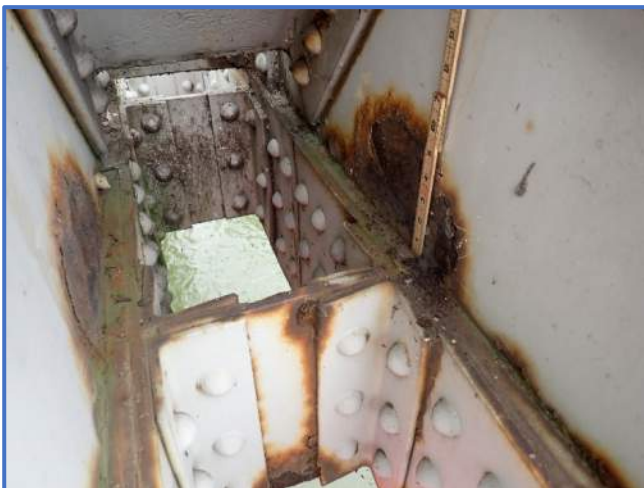
*Photo 55 - Laminar corrosion with section loss on interior lower gusset plate. Span 2, North Truss, Panel Point 6, 3" long by 3" wide by 1/8" deep, looking west*

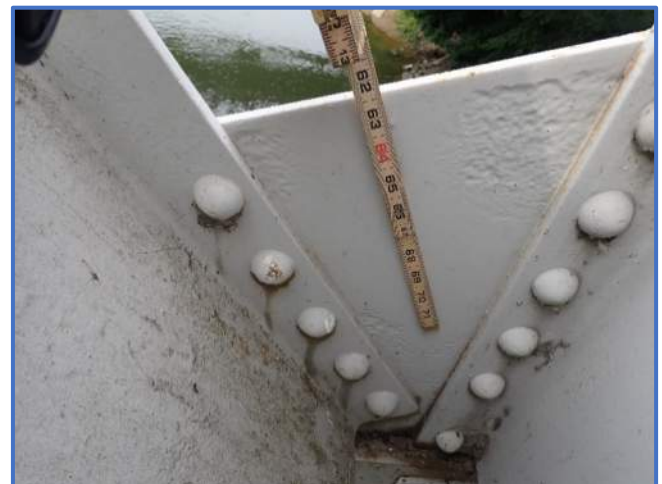
*Photo 56 - Typical coated pitting on interior gusset plate. Shown Span 1, South Truss, at Panel Point 4, looking south*

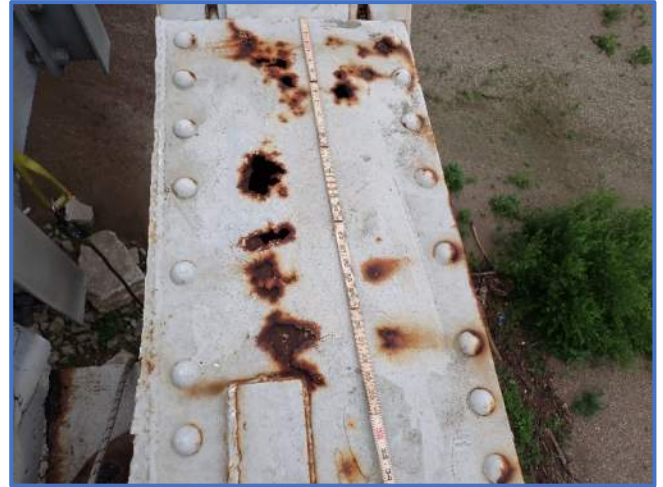
*Photo 58 - Corrosion holes with 100% section loss on top cover plate in Span 2, North Truss, at Panel Point 10, looking west*

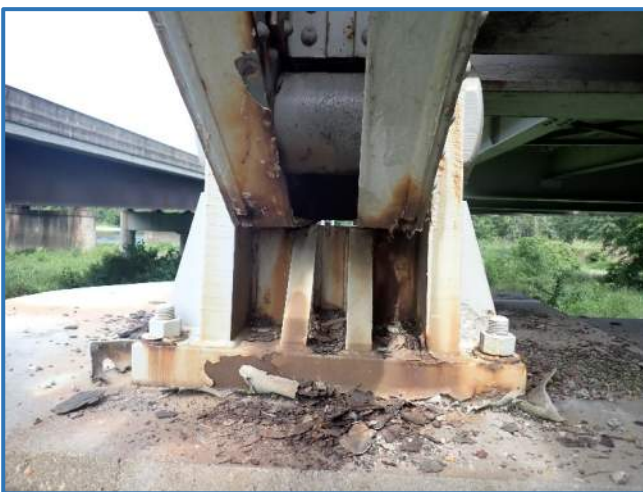
*Photo 59 - Typical corrosion and section loss on bearings. Shown is Span 3, movable bearing on Pier 4, looking east*

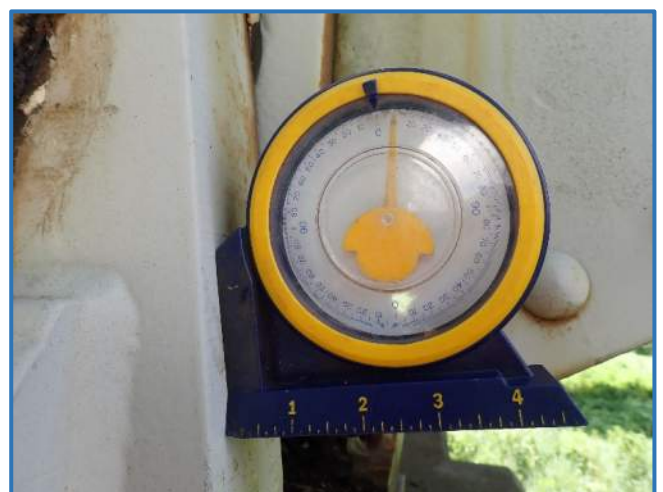
*Photo 60 - 9-degree tilt of bearing in Span 3, north bearing on Pier 4, looking south*

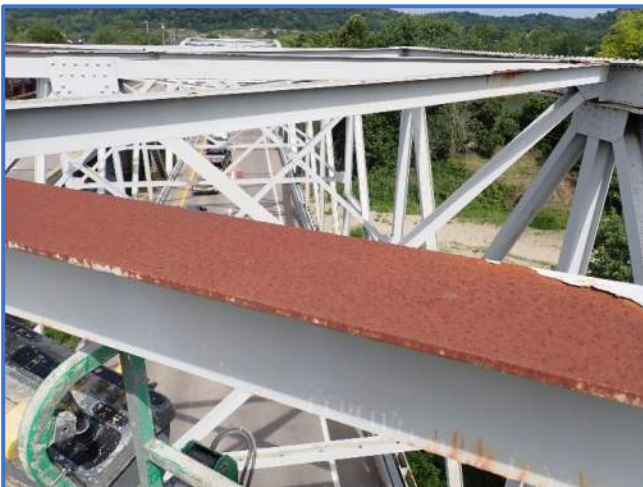
Photo 63 - Upper lateral bracing paint failure with surface corrosion. Shown is worst case in Span 3, North Truss, between Panel Points 5 and 6, looking southeast

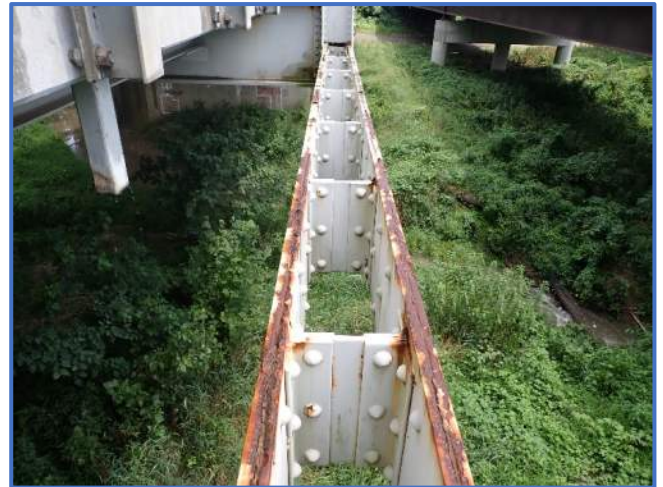
Photo 64 - Typical protective coating condition on lower chord. Shown is Span 3, South Truss, between Panel Points 6 and 7, looking east

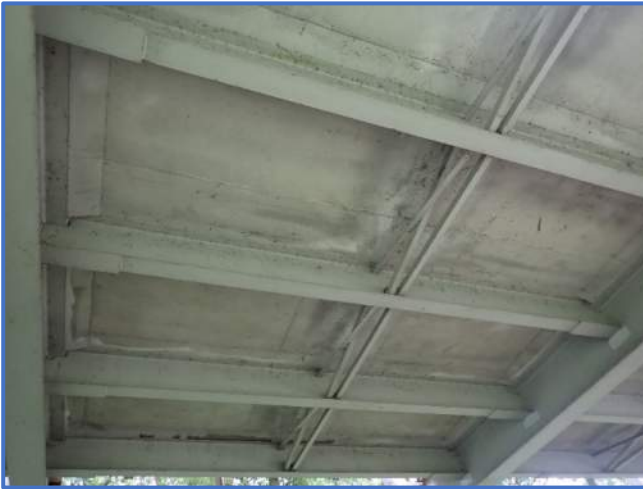
Photo 65 - Typical protective coating condition of floorbeam and stringers. Shown in Span 4

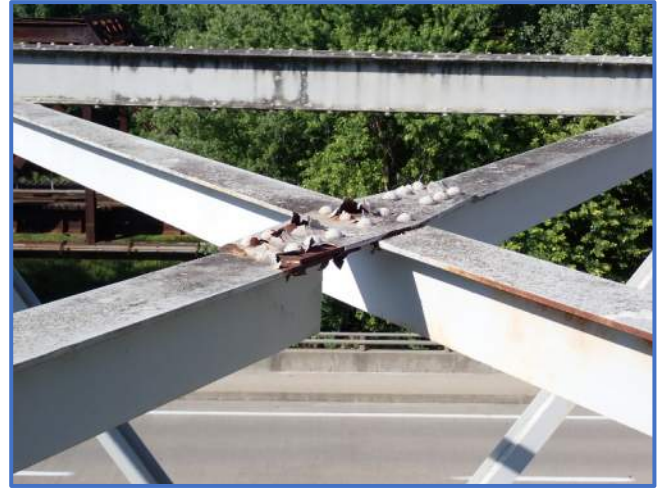
Photo 66 - Typical paint failure of top of upper lateral bracing connection plate with surface corrosion. Shown in Span 4, between Panel Points 3 and 4, looking south

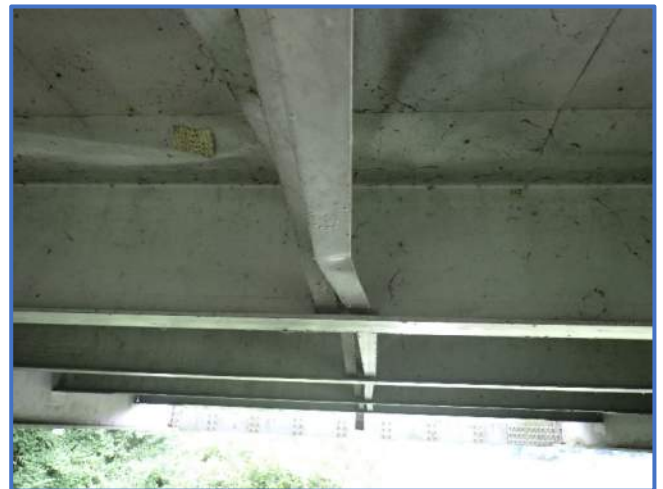
Photo 67 - Deformed diaphragm in Span 1 at Floorbeam 2, looking north

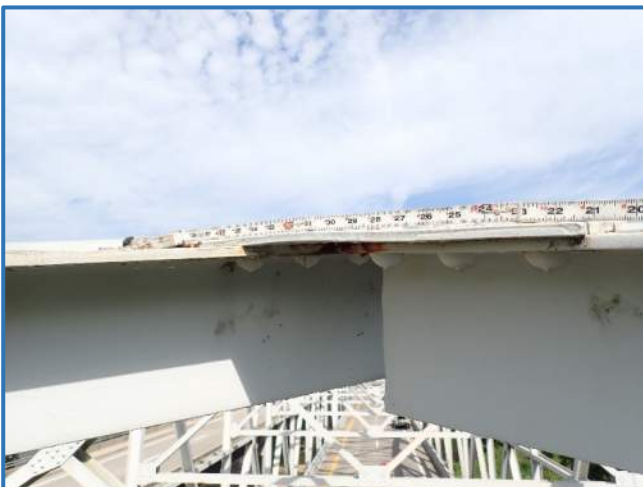
Photo 68 - Bowing in upper lateral bracing connection plate in Span 3, between Panel Points 8 and 9, looking west

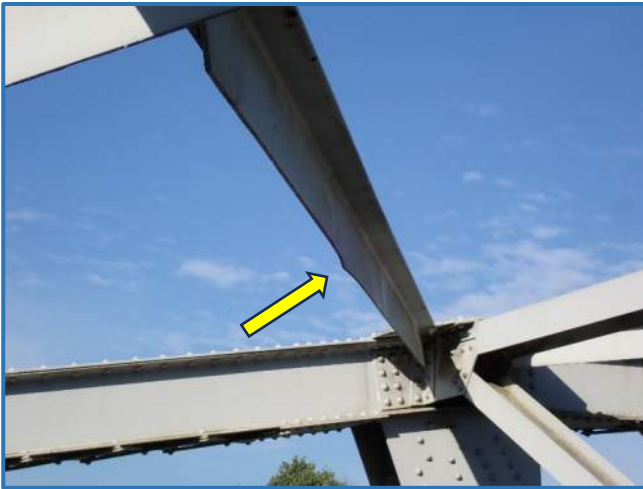
Photo 69 - Bowing in bottom leg of upper lateral bracing in Span 4, between Panel Points 6 and 7, looking south

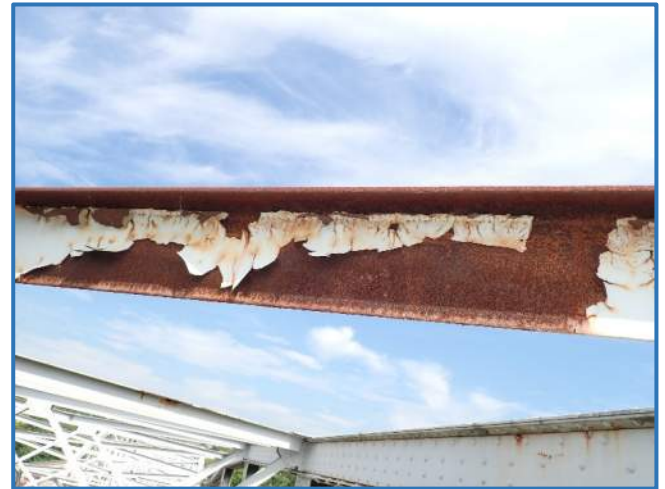
Photo 70 - Paint failure with surface corrosion on upper lateral brace in Span 3, between Panel Points 5 and 6, looking northwest

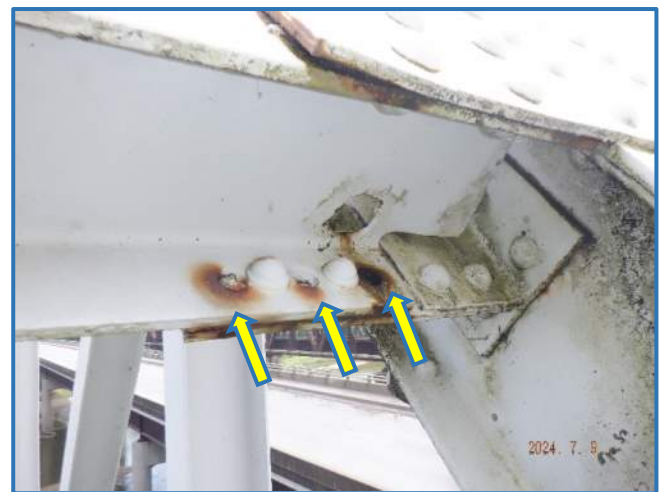
Photo 71 - Misdrilled holes on lower sway brace in portal frame in Span 1, at Panel Point 1, at South Truss connection, looking east

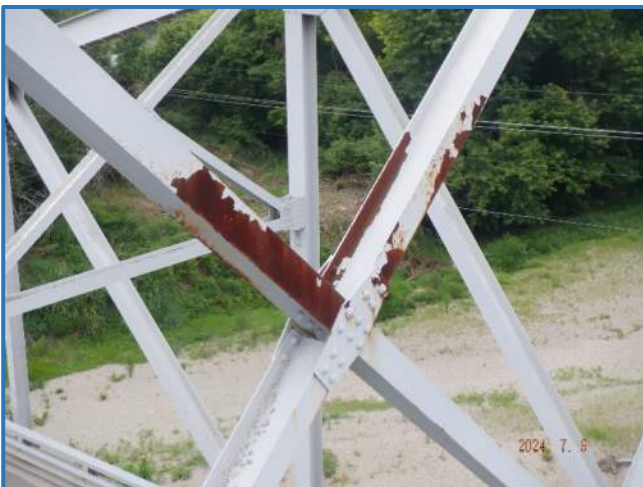
Photo 72 - Surface corrosion on diagonal sway braces in Span 3, at Panel Point 3, looking west

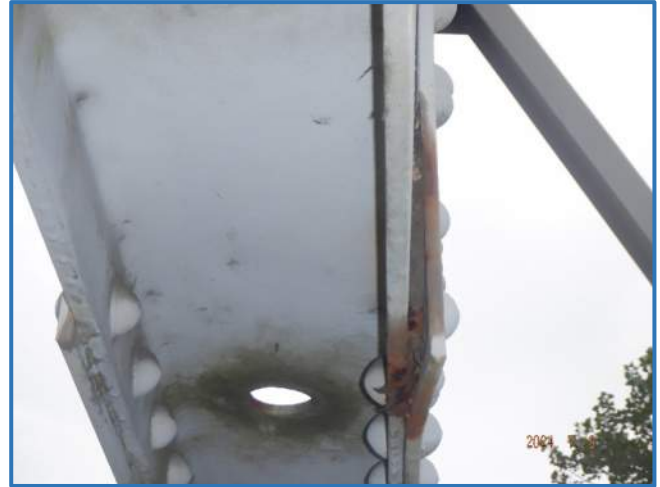
*Photo 73 - Bowing of lower sway bracing connection plate due to pack rust in Span 3 at Panel Point 4, looking north*
