ODOT District 8  
2024 Fracture Critical and In-Depth  
Element Level Inspection Report

October 2024

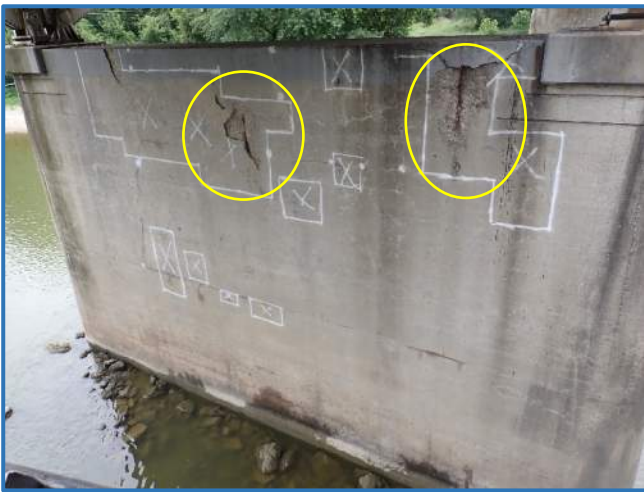
Photo 74 - Large spalls at top of west face of Pier 2

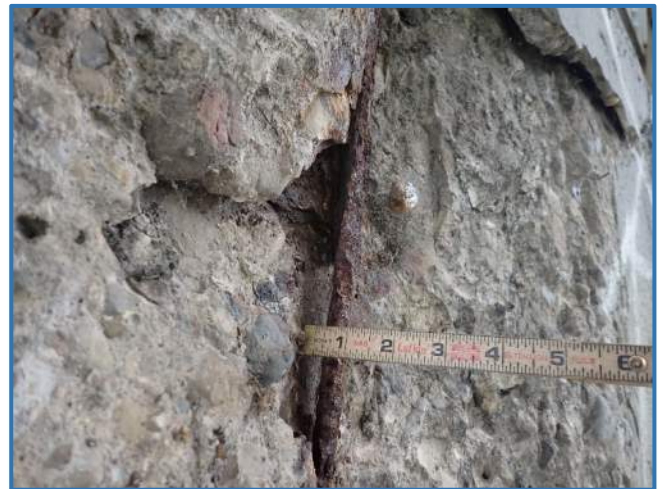
Photo 75 - Spall in west face of Pier 2 with exposed debonded rebar under Stringer 5

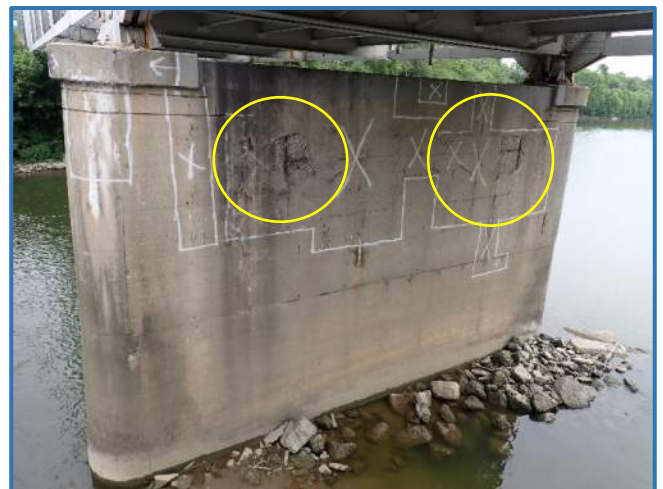
Photo 76 - Large spalls at top of east face of Pier 2

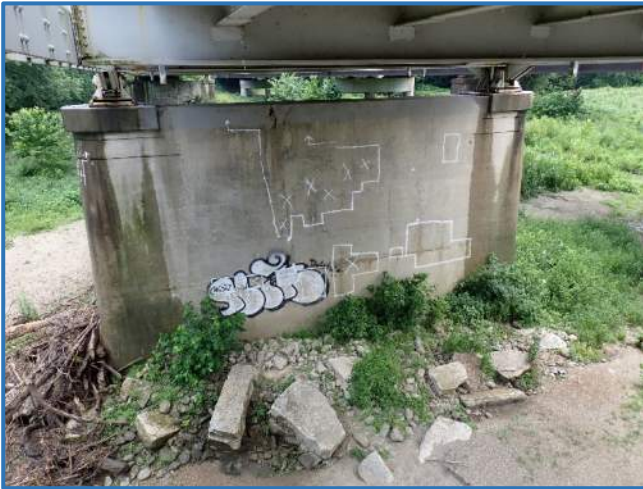
Photo 77 - Large delaminated area at the top of west face of Pier 3

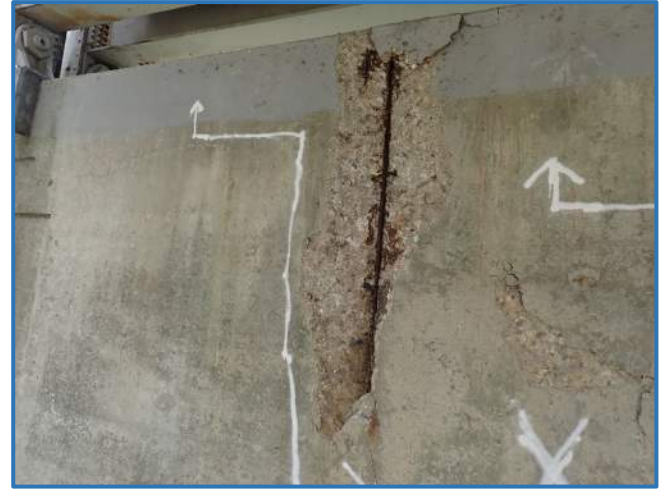
Photo 78 - Spall in west face of Pier 3 under Stringer 2, with exposed rebar with section loss

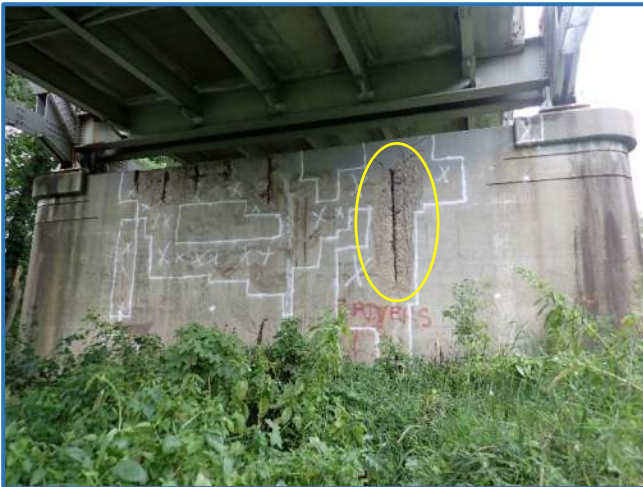
Photo 80 - Large spall under Stringer 4 on West face of Pier 4

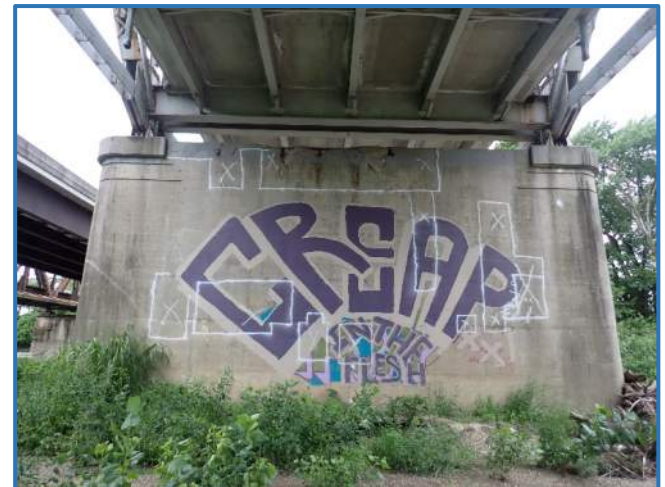
Photo 79 - Widespread delaminated areas and spalls on east face of Pier 3

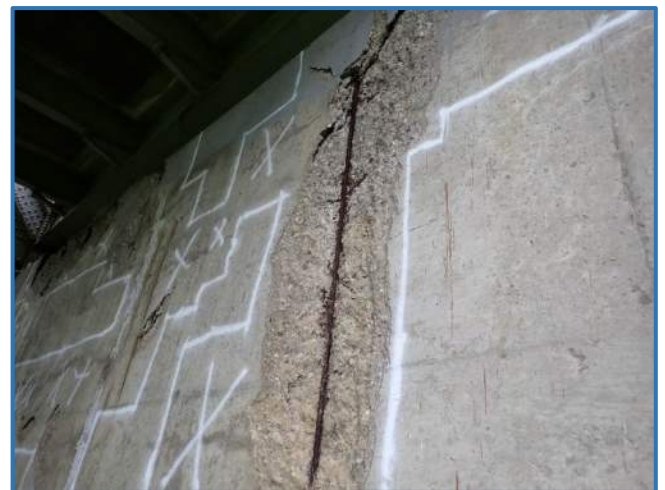
Photo 81 - Spall in west face of Pier 4, under Stringer 4 with exposed, debonded rebar

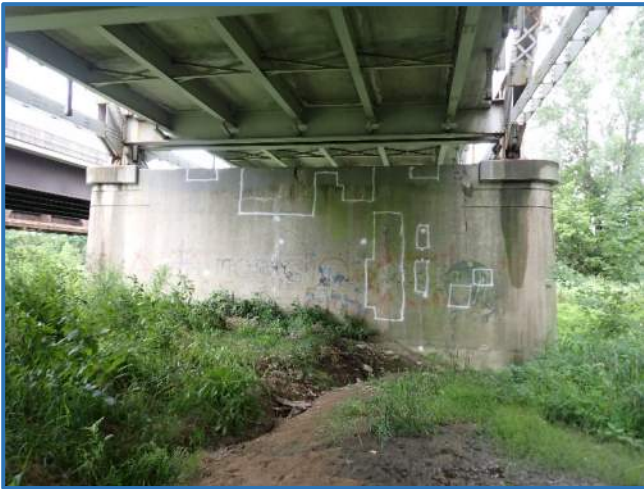
Photo 82 - East face of Pier 4

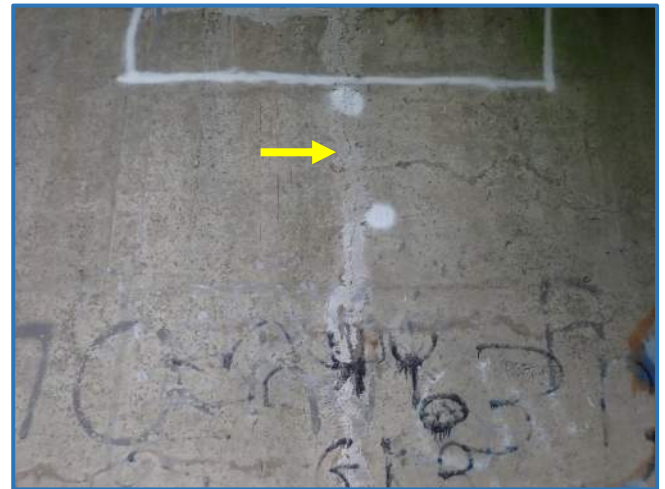
Photo 83 - Crack up to 1/8" wide by full width under Stringer 4 on west face of Pier 4, previously sealed

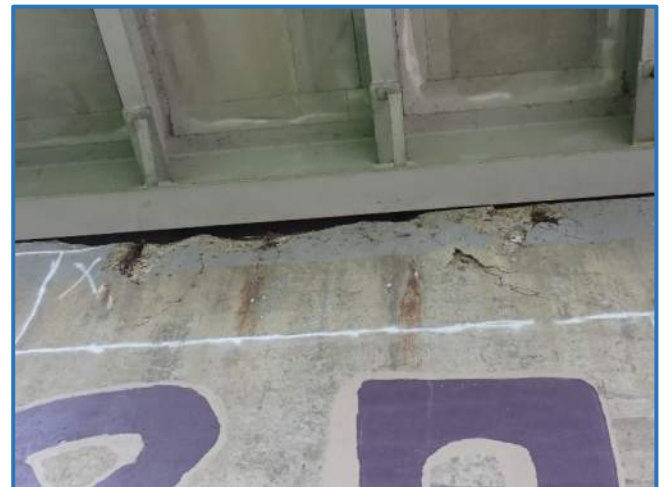
Photo 84 - Spall in top of Pier 3 east face between Stringers 2 and 4, with exposed rebar

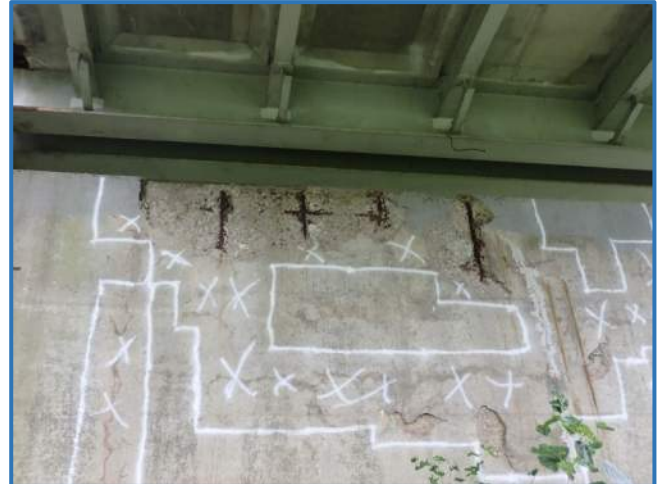
Photo 85 - Spall in Pier 4 west face pier cap, with vertical and transverse rebar exposed

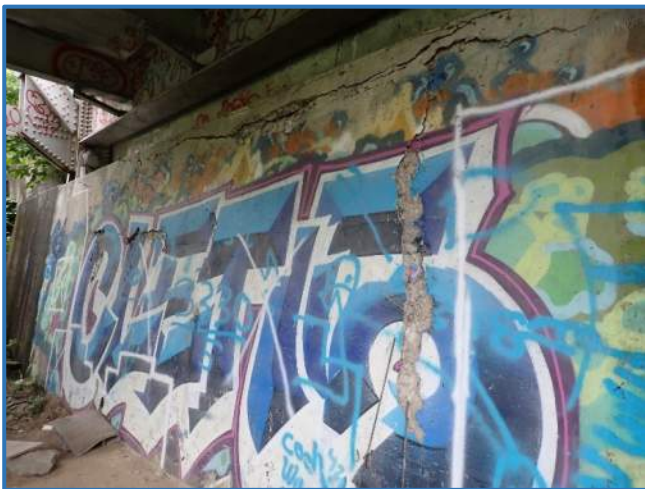
Photo 86 - Rear abutment with cracking and delaminations

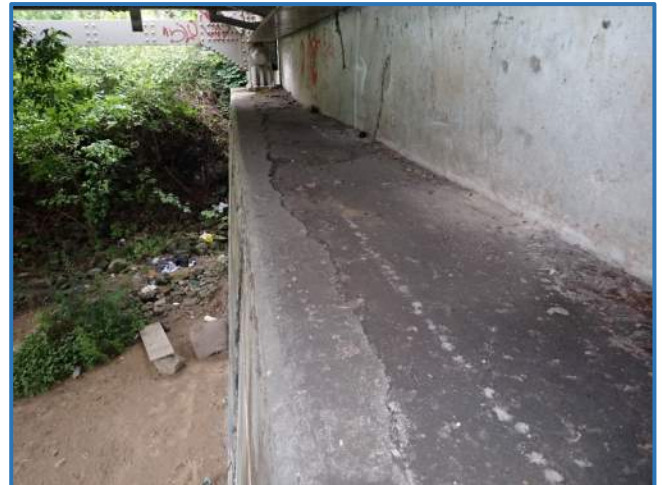
Photo 87 - Bearing seat of rear abutment with delaminations, looking south

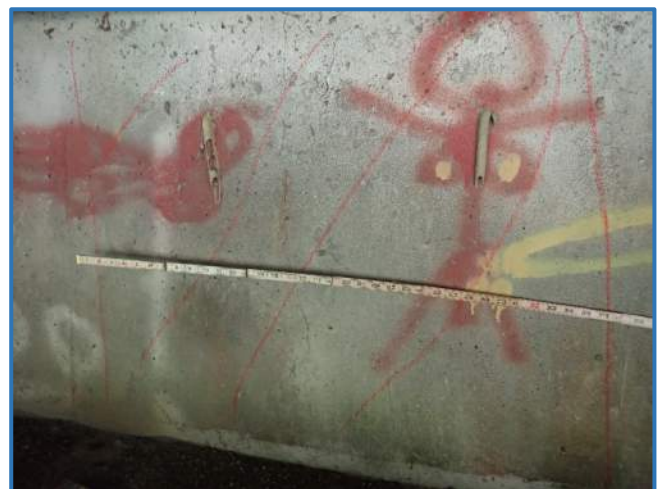
Photo 88 - Delaminated area along backwall of forward abutment

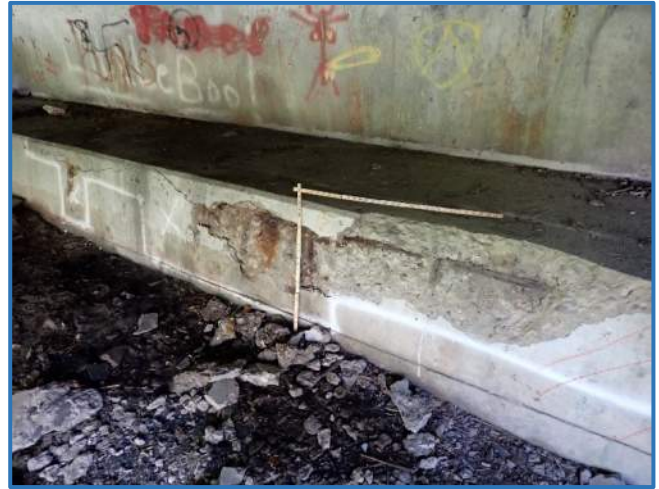
Photo 89 - Delamination and spalling with exposed rebar along bearing seat of forward abutment, looking southeast

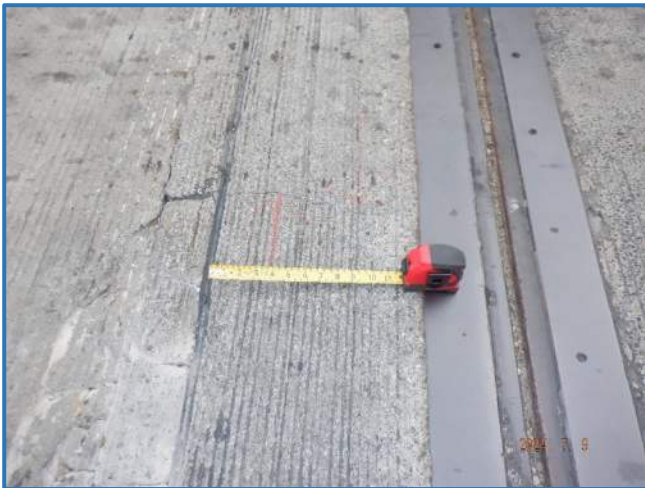
Photo 90 - Longitudinal crack in top of header of rear abutment, looking north

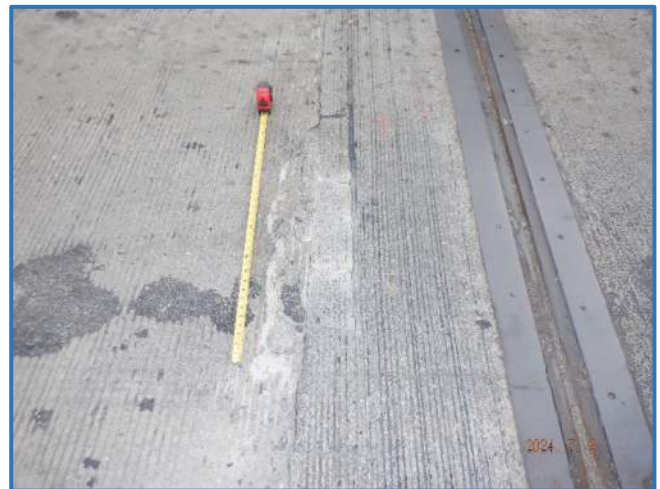
Photo 91 - Spalling in west approach slab, just west of rear abutment, looking north

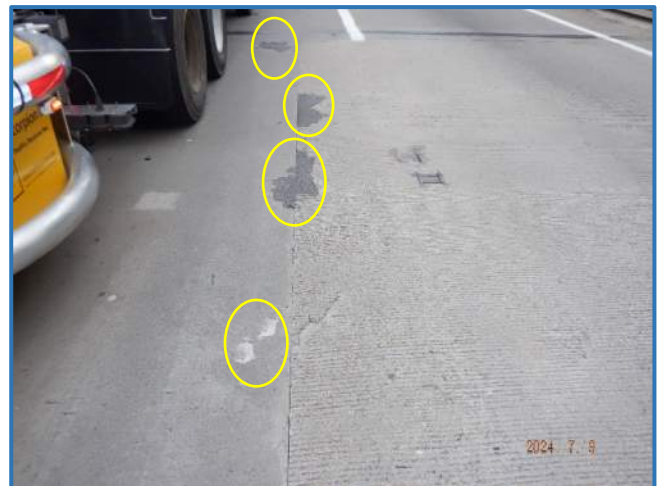
Photo 92 - Spalling in the east approach along center of road, looking west

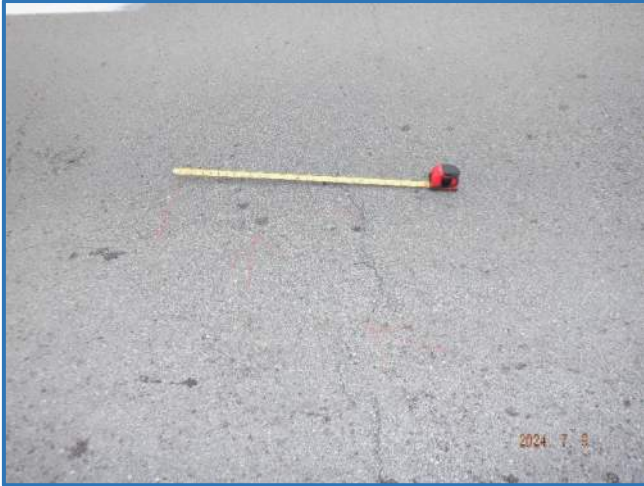
*Photo 93 - Longitudinal cracks up to 1/8" wide in east approach pavement, looking north*

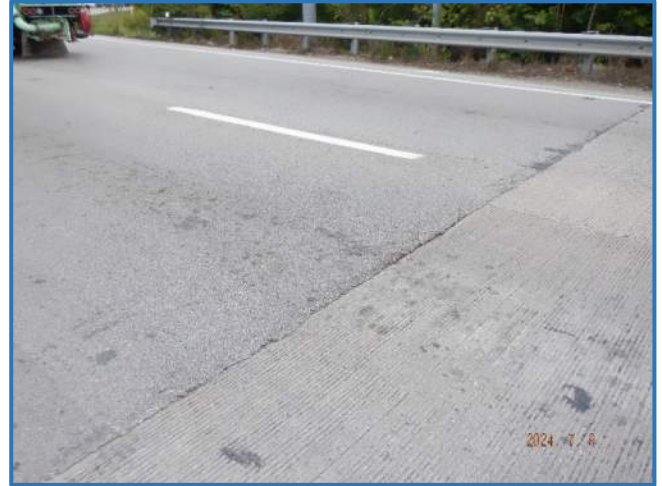
*Photo 94 - Map cracking in west approach pavement, looking northwest*

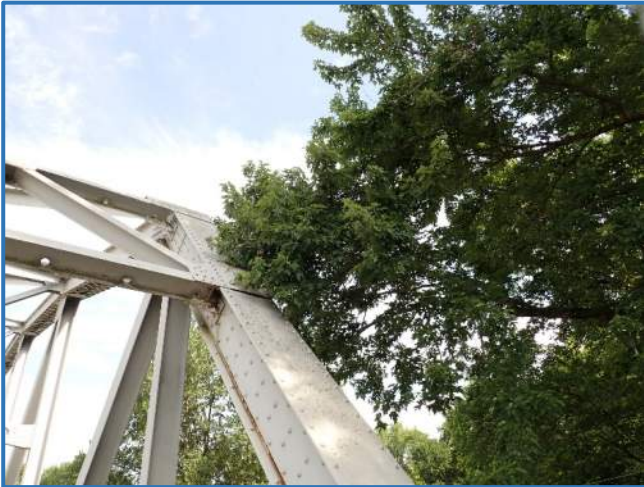
*Photo 95 - Tree encroaching on end post in Span 3, North Truss, between Panel Points 9 and 10, looking northwest*

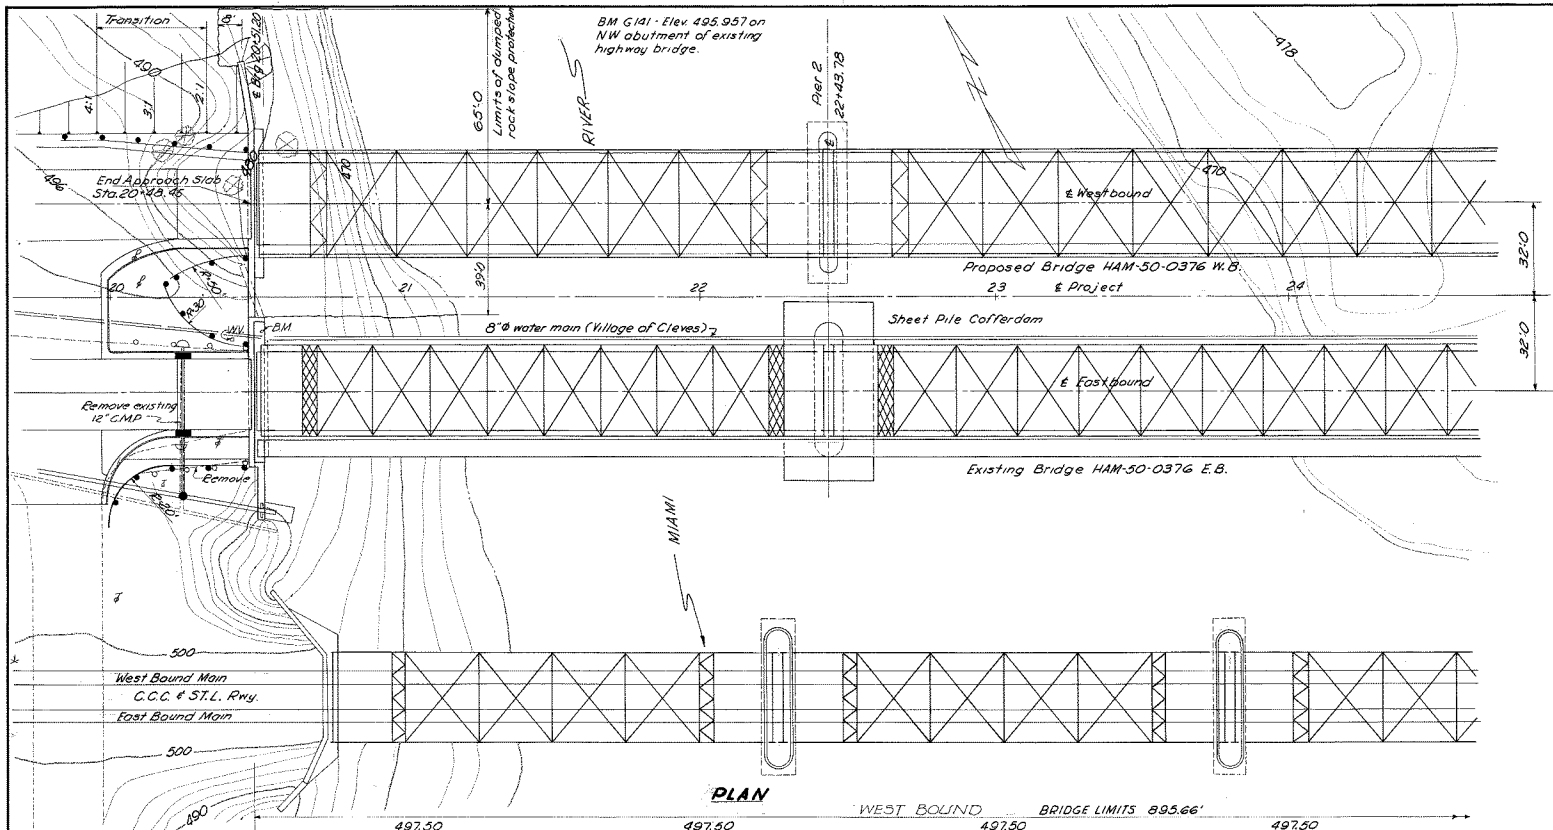
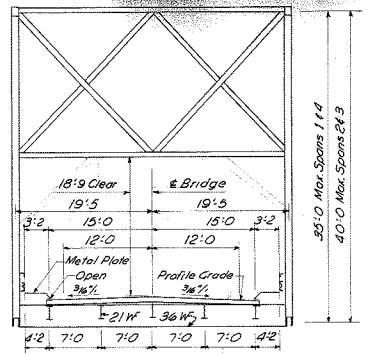
**EXISTING BRIDGE DATA**

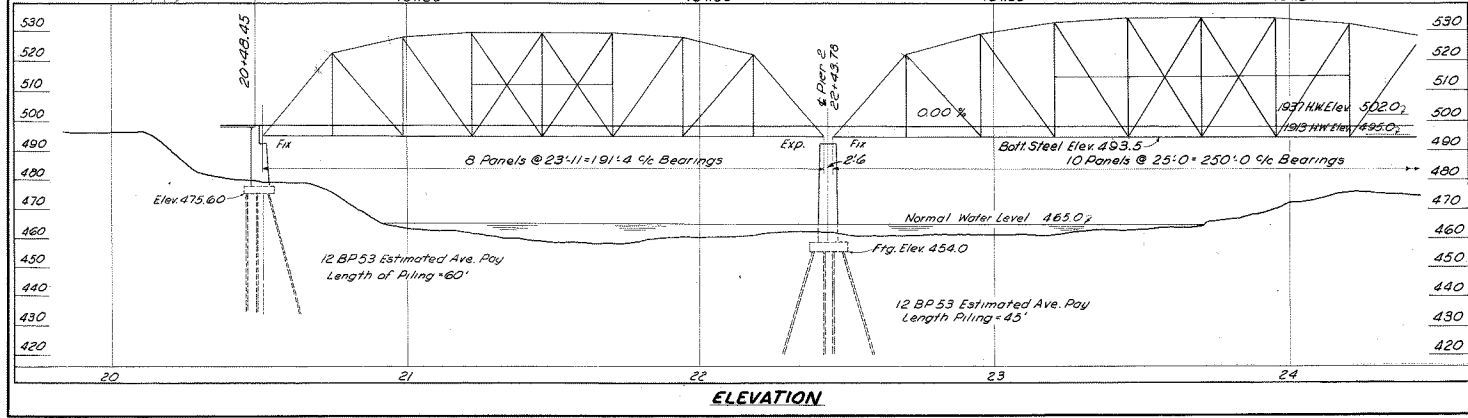
Foundation design and foundation quantities are based on a study of rod soundings and soil sampling soundings made at the site. This sounding information may be inspected in the office of the Bureau of Bridges in Columbus, or in an abridged form in the Division office, but the State assumes no responsibility for the accuracy thereof.

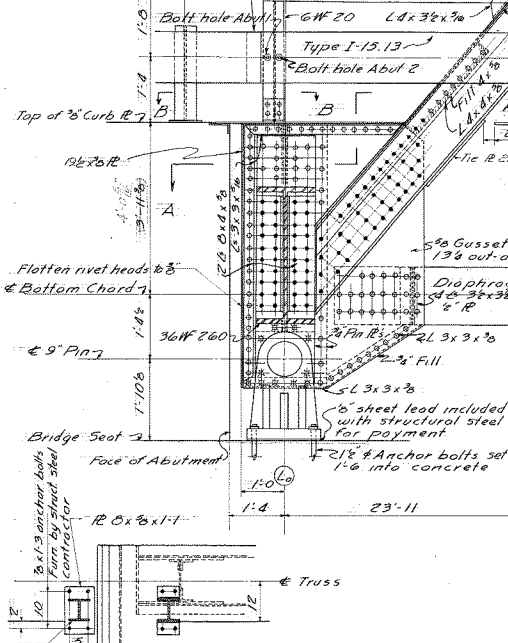
**Note:**  
 All rivets 5/8" unless noted

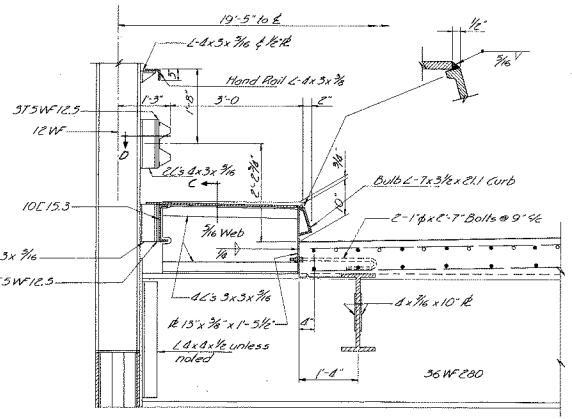
**SECTION AT FLOOR BEAM**

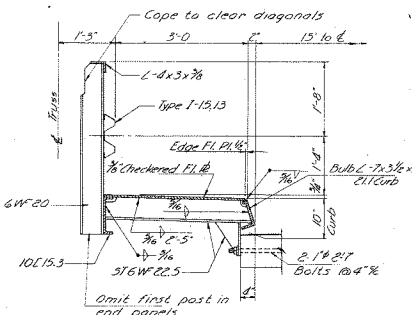
**INTERMEDIATE RAILING AND CURB SUPPORT**
