ODOT District 8
2024 In-Depth & NSTM Inspection Report

INSPECTION July/Aug 2024
REPORT Sept 2024

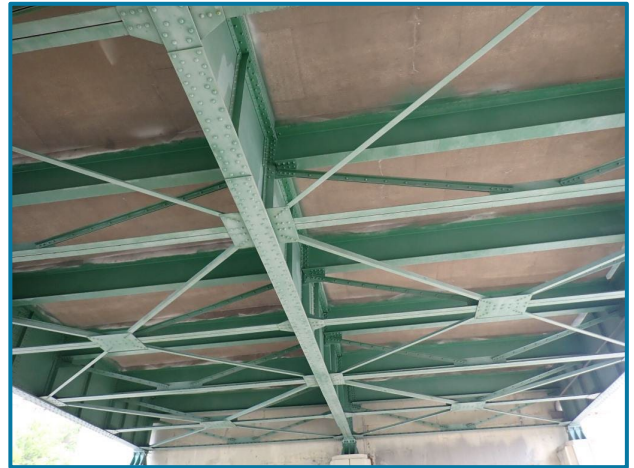
Photo 1 – Typical condition of the deck underside (looking up and east in Span 17).

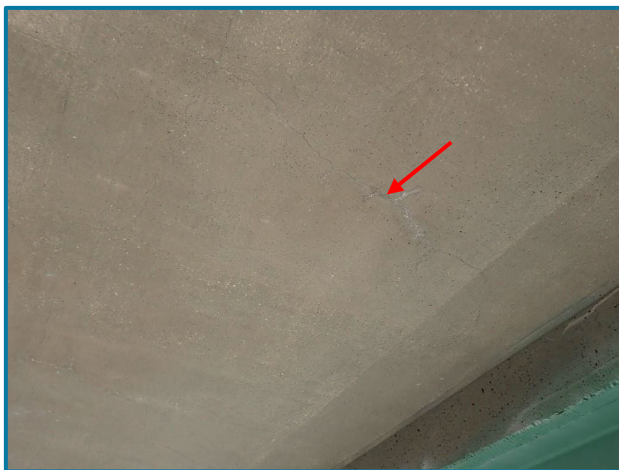
Photo 2 – Typical hairline longitudinal cracks in the deck between the floorbeams (Span 10 shown).

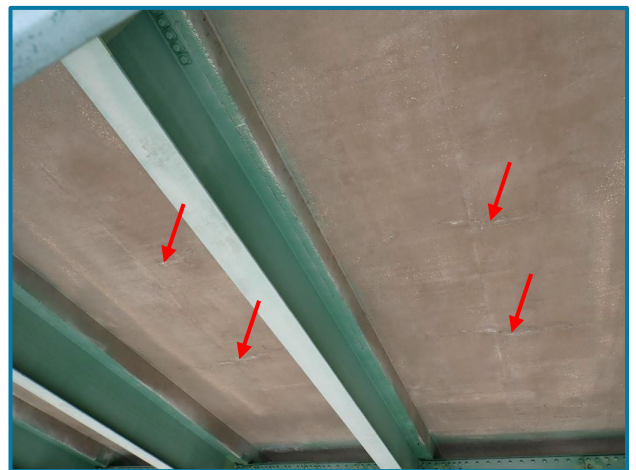
Photo 3 – Longitudinal cracking with efflorescence in the deck between floorbeams (Span 9 shown).

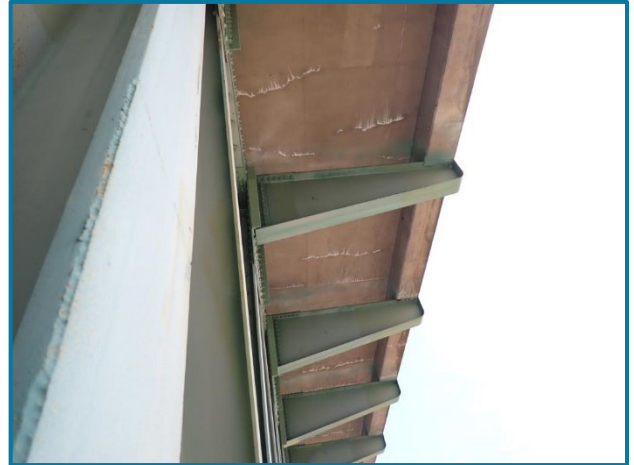
Photo 4 – Transverse cracking with efflorescence in the deck overhang (Span 9 shown).

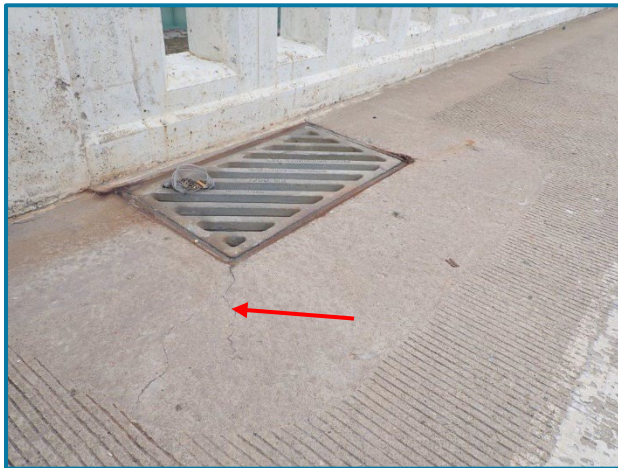
Photo 5 – Moderate to wide cracks propagating from the scupper grate corner (near Pier 10).

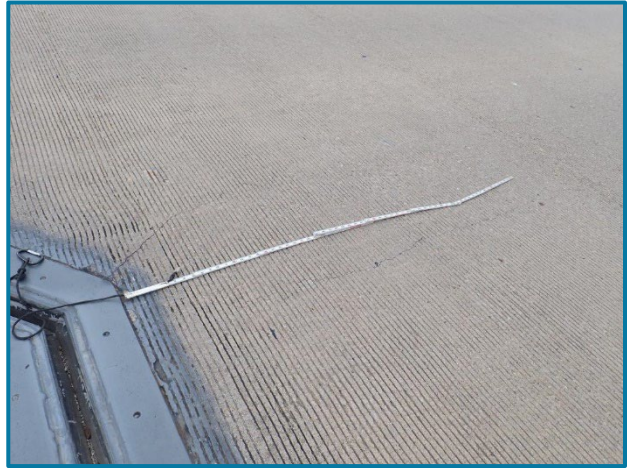
Photo 6 – Moderate to wide cracks near where the expansion joint armor bends (near Pier 10).

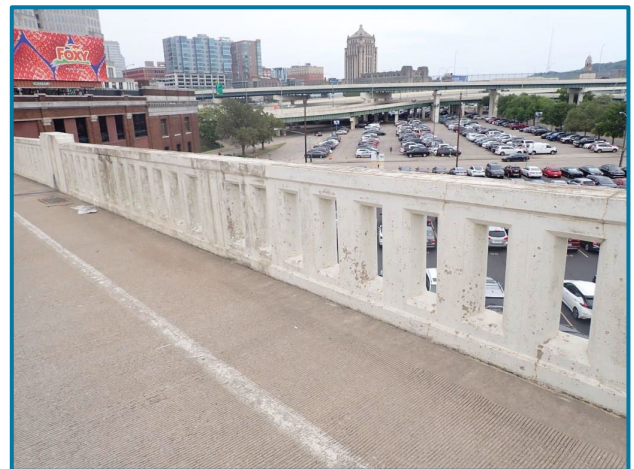
Photo 7 – Bridge railing (looking northwest).

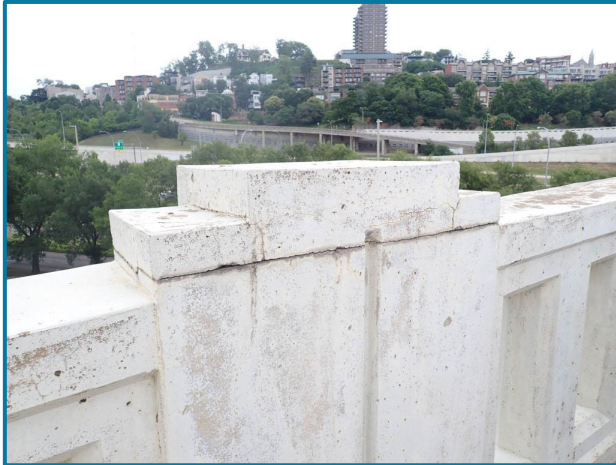
Photo 8 – Crack with delamination at the decorative post cap (looking southwest).

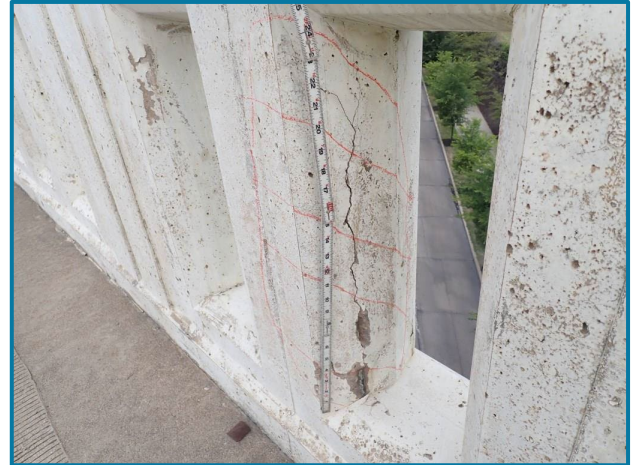
Photo 9 – 2' H x 1' W delamination with a crack in the north railing stem (looking southeast).

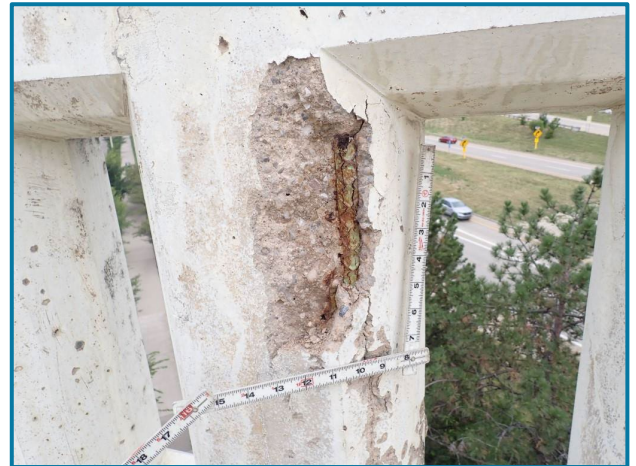
Photo 10 – Spall with exposed rebar in the railing stem (looking northwest at north railing).

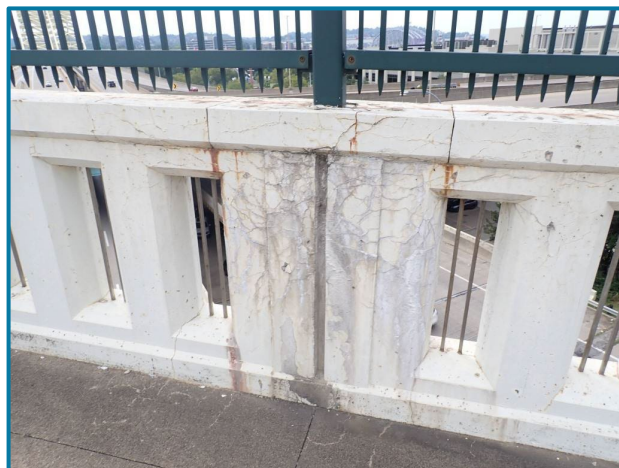
Photo 11 – Map cracking with efflorescence (possible ASR) in the concrete railing (looking south at the south railing).

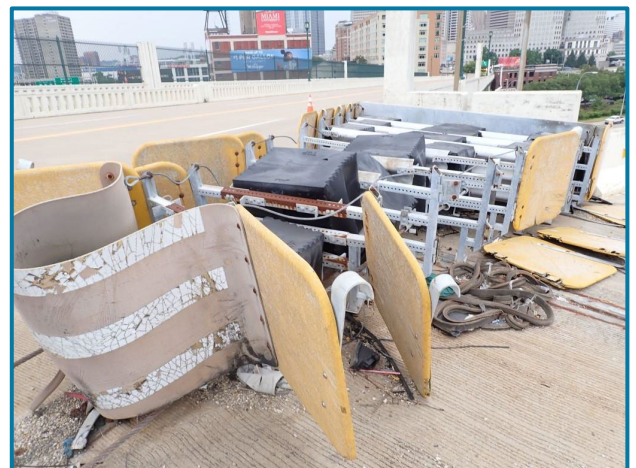
Photo 12 – Damaged crash attenuator with hanging panels, deployed cushions, and loose cables (looking west).

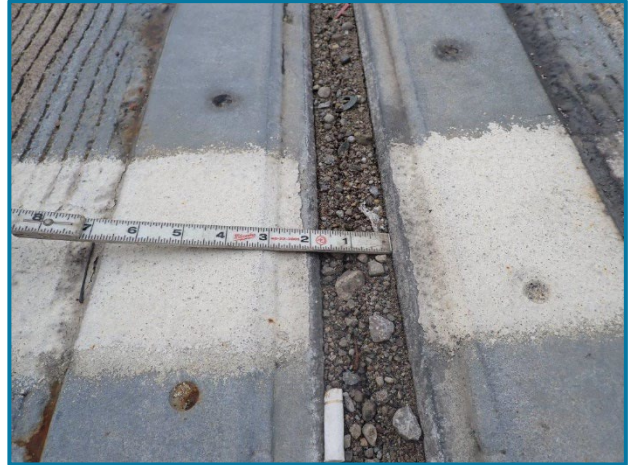
Photo 13 – Debris accumulation in the deck joint (Pier 4 shown, looking south).

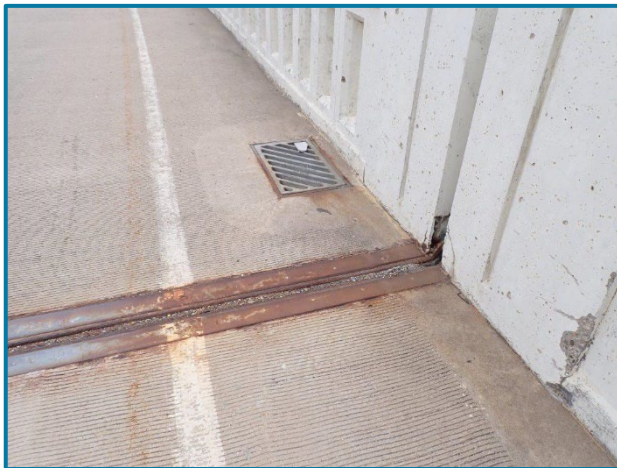
Photo 14 – Surface corrosion to the deck joint armour in the shoulder (Pier 16 shown, looking east).

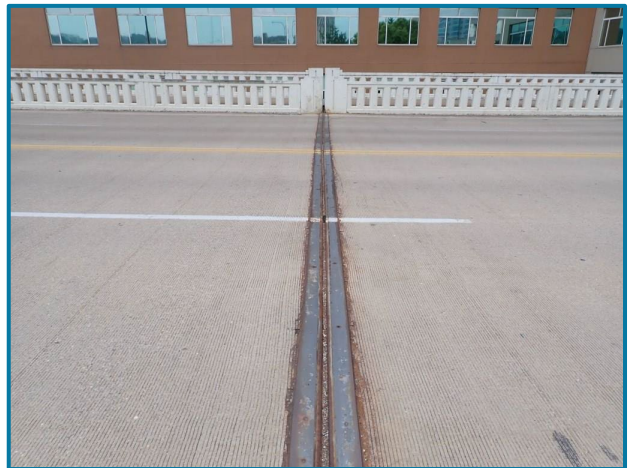
Photo 15 – Surface corrosion to the full length of the deck joint armor (Pier 2 shown, looking south).

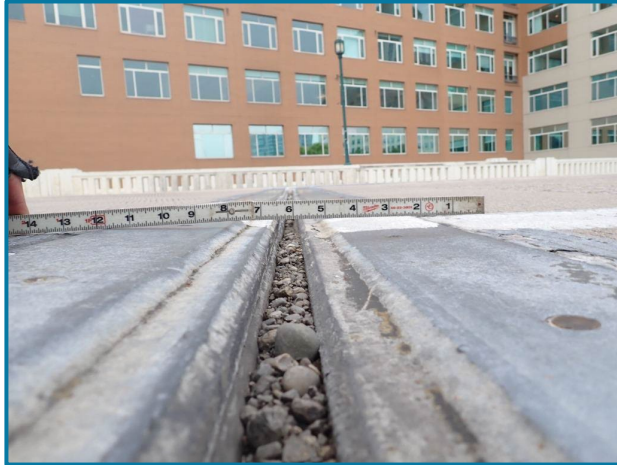
Photo 16 – 1/2" vertical offset in the deck joint (Pier 3 shown, looking south).

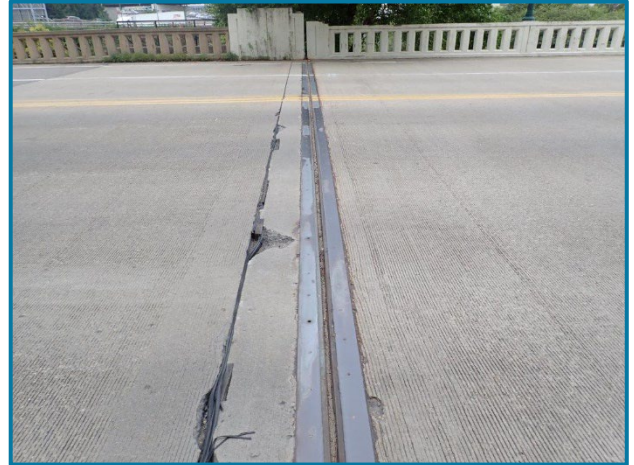
Photo 17 – Spalls in the joint header with damaged construction joint material (Abutment 1 shown, looking north).

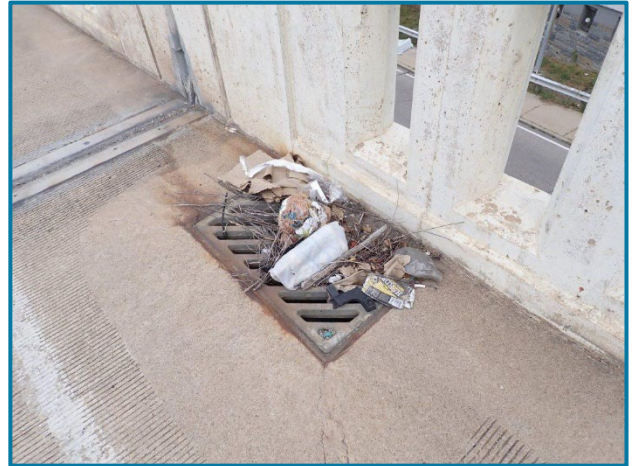
Photo 18 – Debris/Trash build-up at isolated deck scuppers (Pier 17 shown, looking north).

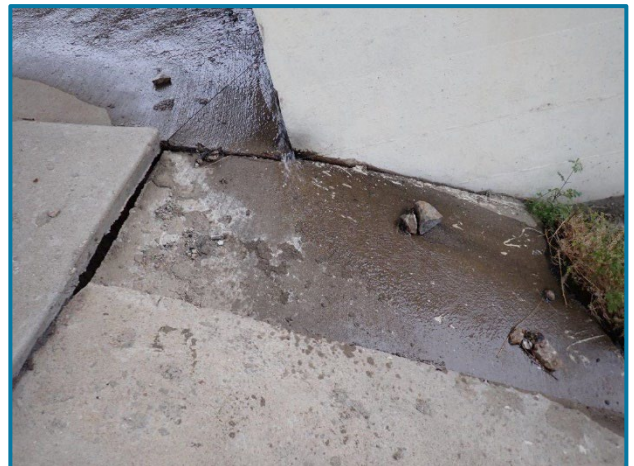
Photo 20 – Slope protection is broken and undermined (Pier 11 shown, looking south).

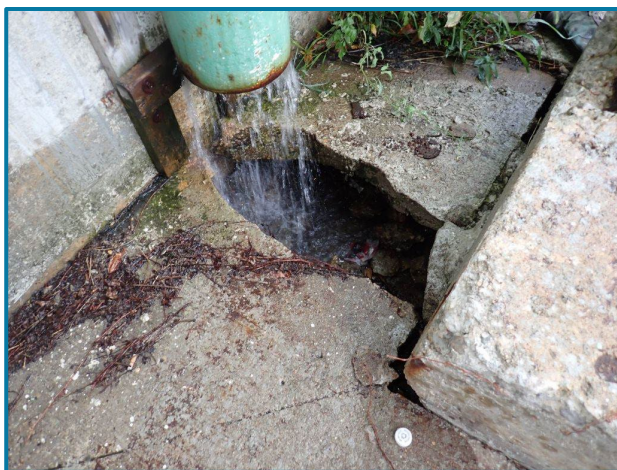
Photo 21 – Broken slope protection with a void underneath drainpipe (Pier 12 shown, looking northeast).

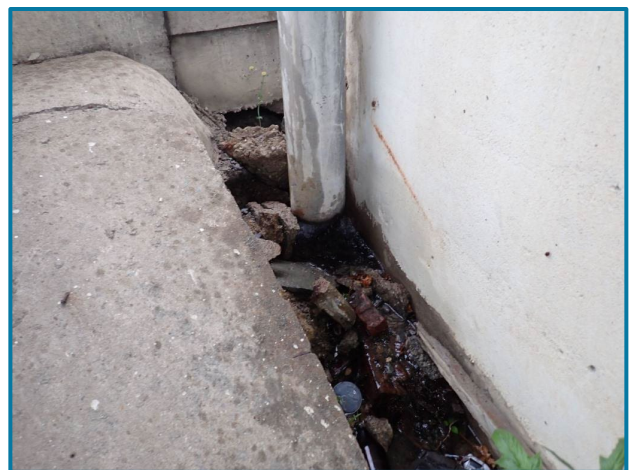
Photo 22 – Slope protection and adjacent approach slab are undermined (Pier 13 shown, looking west).

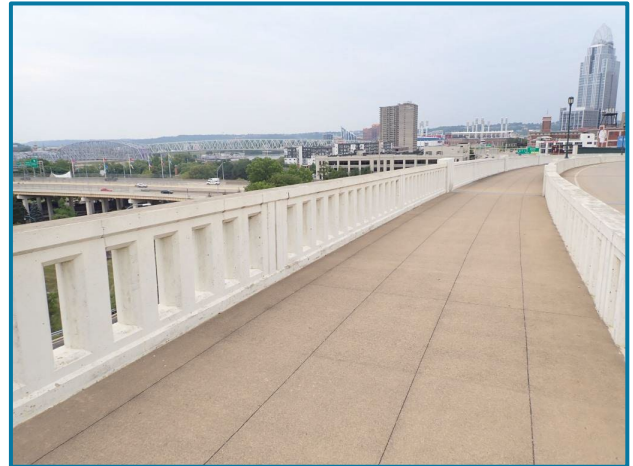
Photo 23 – Pedestrian sidewalk on the south side of the bridge (looking west).

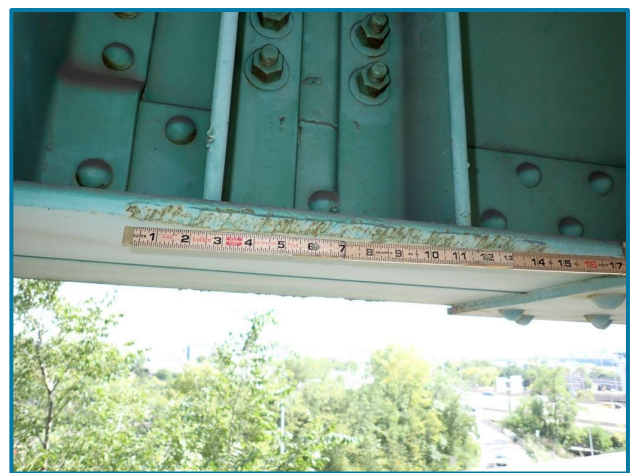
Photo 26 – 1'-2" torch cut bottom flange (Span 14 shown, looking south).

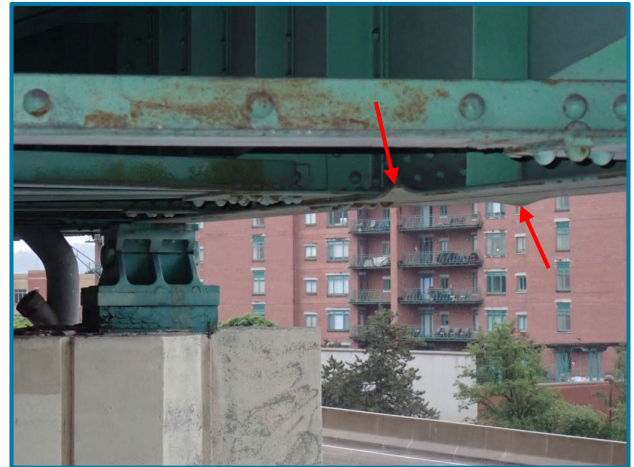
Photo 27 – Bent bottom flange (Span 12 shown, looking southeast).

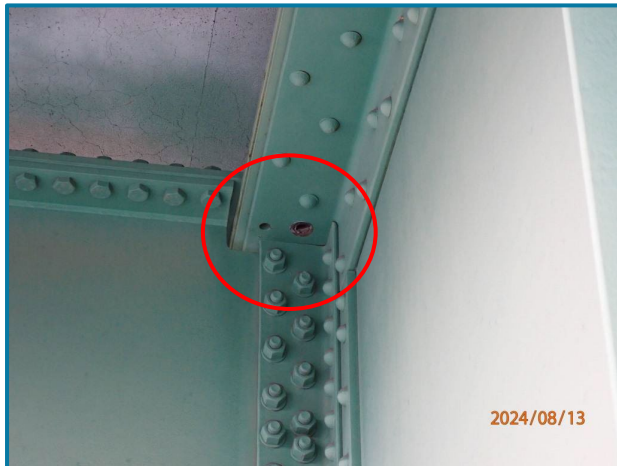
Photo 28 – Blind hole and missing rivet (Span 3 shown, looking east).

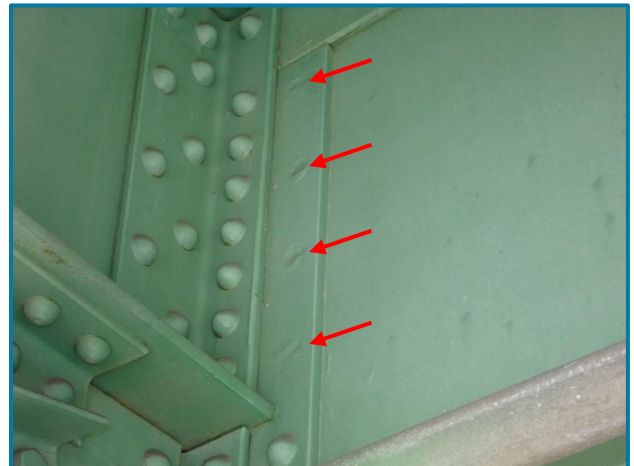
Photo 29 – South Girder near FB 6 has 4 plug welds (Span 16 shown, looking southeast).

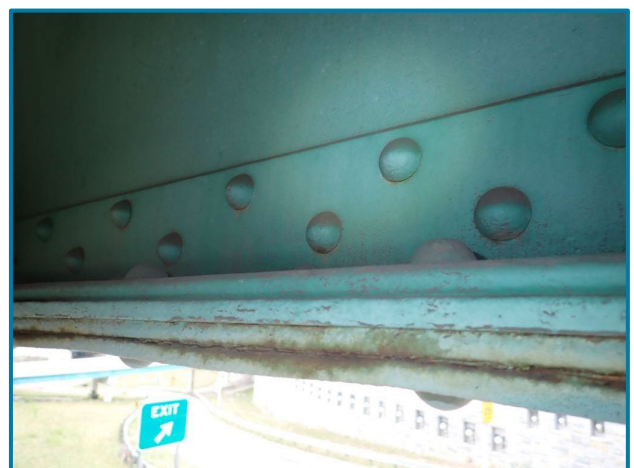
Photo 31 – 1/16" pack rust between the bottom flange cover plates (Span 16 shown, looking northwest).

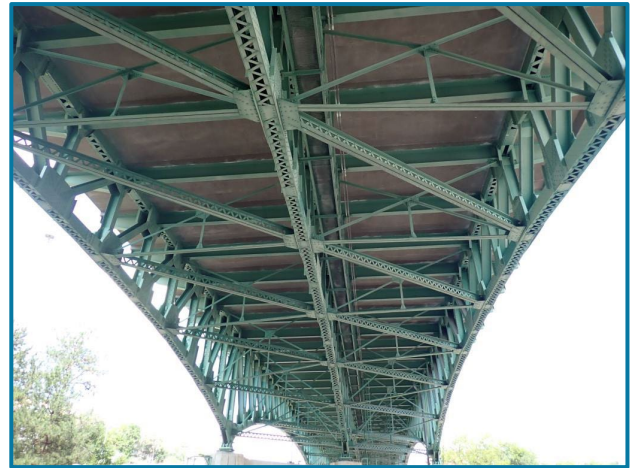
Photo 32 – Steel truss has three truss lines (Span 6 shown, looking east).

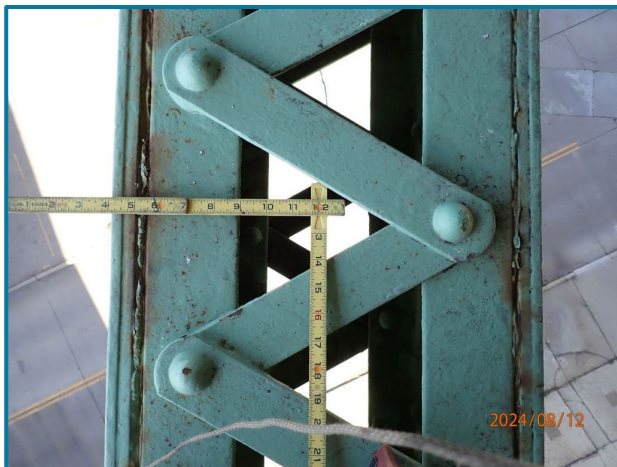
Photo 33 – 1/2” pack rust between the web and flange components (L6L7 of the South Truss, Span 10).

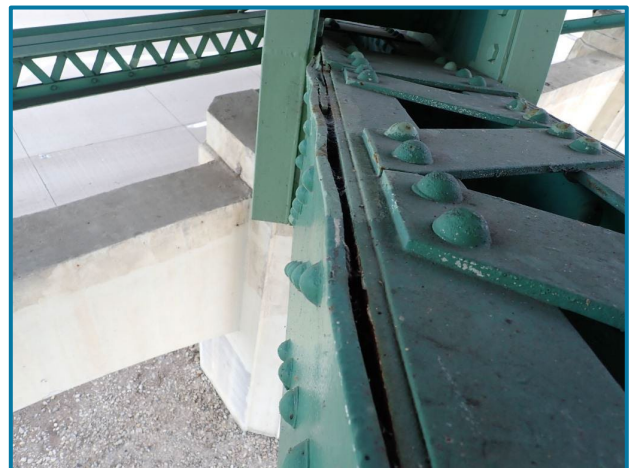
Photo 34 – Pack rust causing warping of the web plate (L28L29 of the Center Truss, Span 8, looking east).

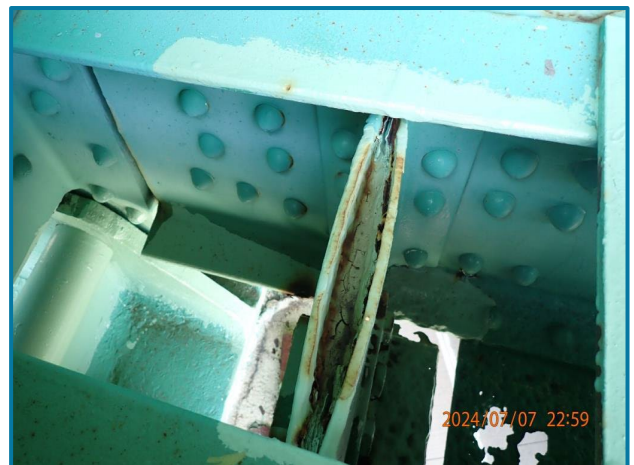
Photo 35 – Pack rust up to 1-1/2” wide at the internal stiffeners (L43L44 of the North Truss, Span 9).

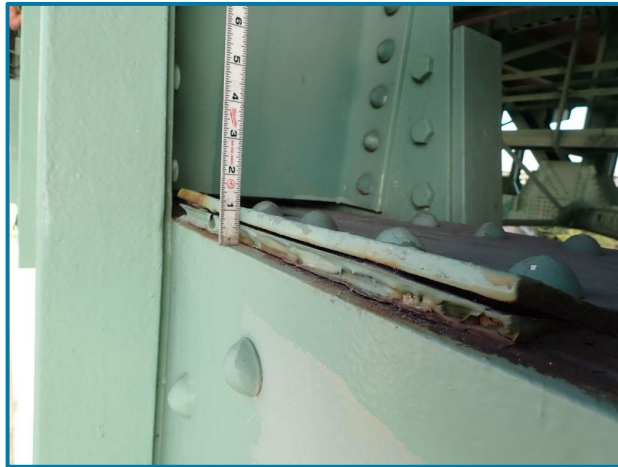
Photo 36 – Pack rust prying up the lower chord batten plate (L5L6 of the South Truss, Span 7).

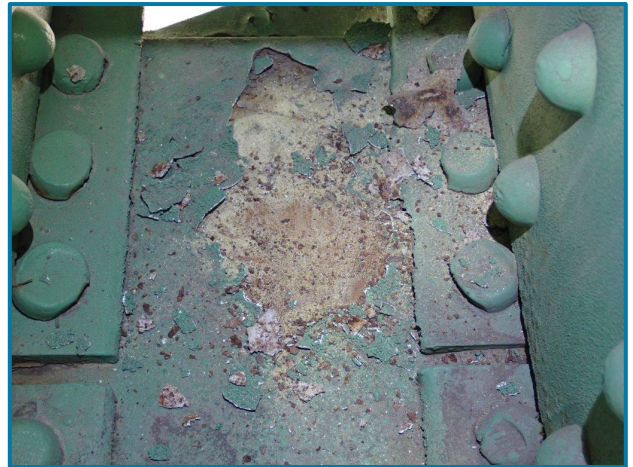
Photo 37 – Peeled paint with exposed bare metal and surface corrosion (L38 of the Center Truss, Span 9).

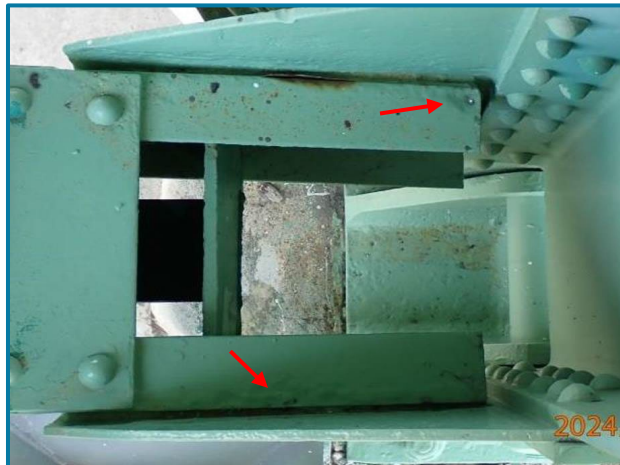
Photo 38 – 3/16” deep section loss to the top flange (L19L20 of the South Truss, Span 6).

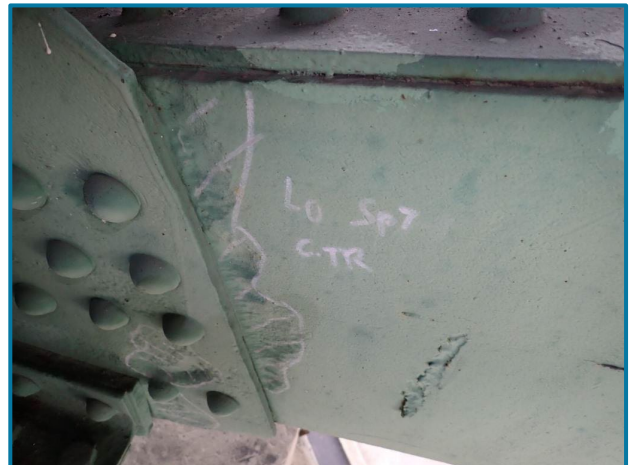
Photo 39 – 3/16” deep section loss to the lower chord adjacent to the gusset plate (L0L1 of the Center Truss, Span 7).

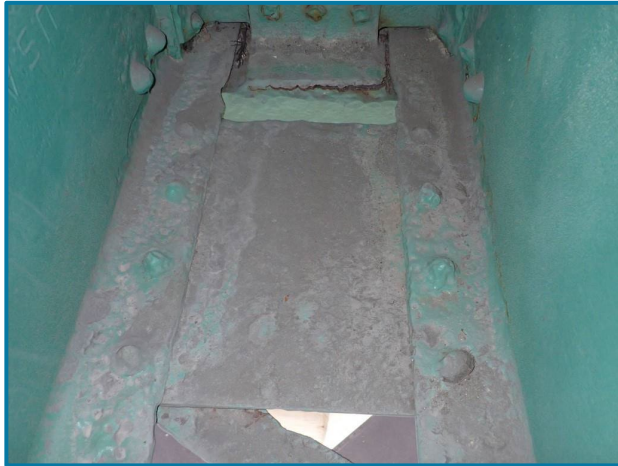
Photo 40 – Up to 50% section loss to the rivet heads inside the lower chord (L0L1 of the Center Truss, Span 7).

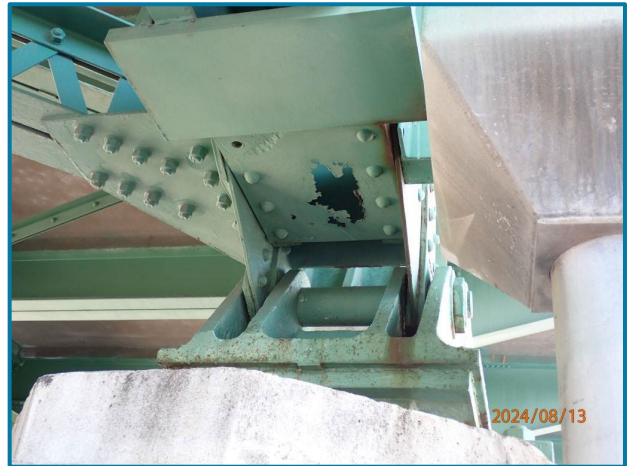
Photo 41 – 10” H x 6” W corrosion hole in the lower batten plate at the bearing (L0 of the North Truss, Span 5).

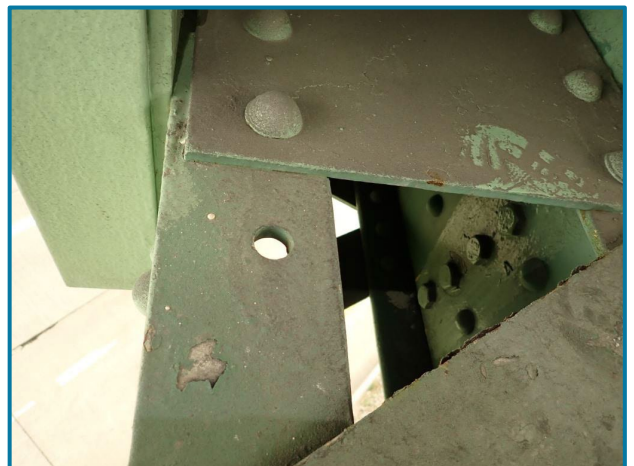
Photo 42 – Blind hole in the lower chord top flange near (L27L28 of the Center Truss, Span 8).

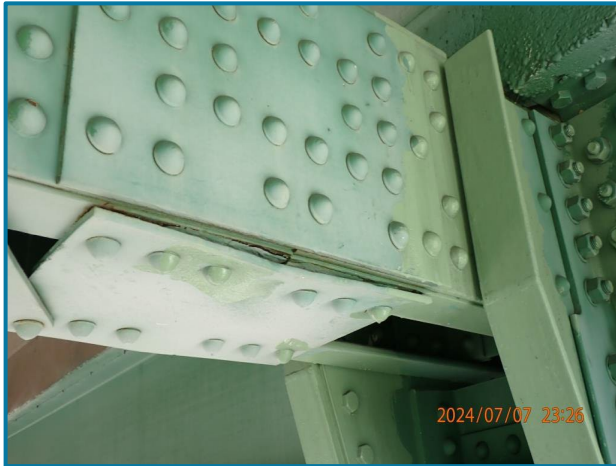
Photo 44 – 3/4" pack rust at the bottom batten plate (U42U43 of the North Truss, Span 9).

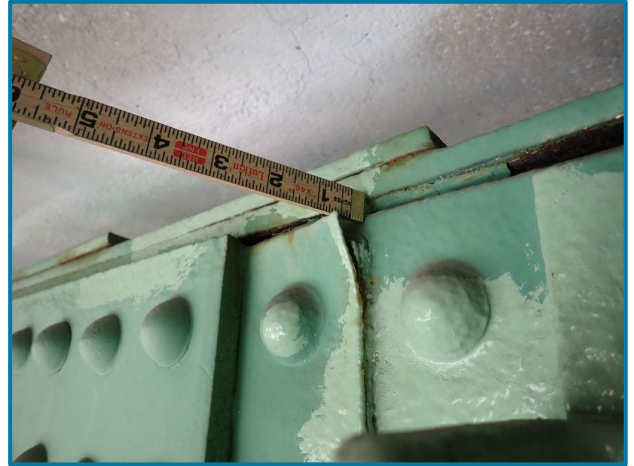
Photo 45 – Pack rust at the top splice plate and distortion at the fill plate (U12U13 of the Center Truss, Span 6).

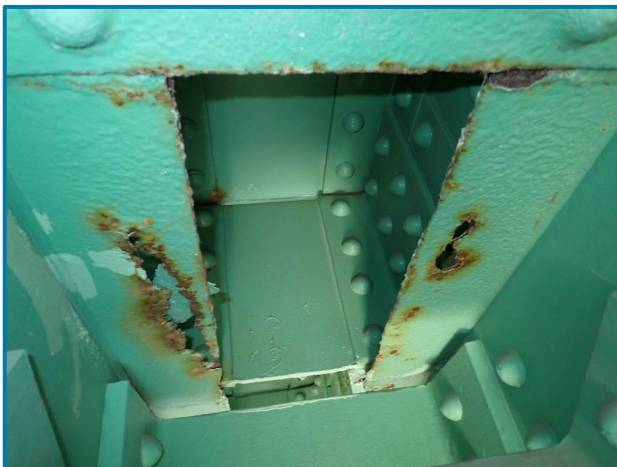
Photo 46 – Corrosion holes, pitting, and active corrosion to the bottom flanges (U0 of the Center Truss, Span 10).

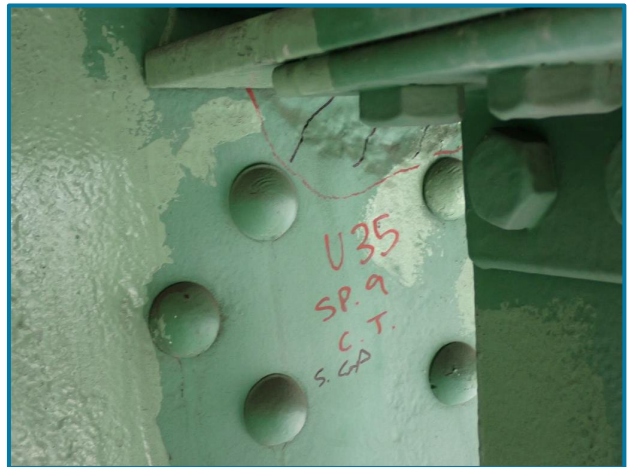
Photo 47 – 6" L x 2" H x 1/8" D pitting underneath the floorbeam connection (U35 of the Center Truss, Span 9).

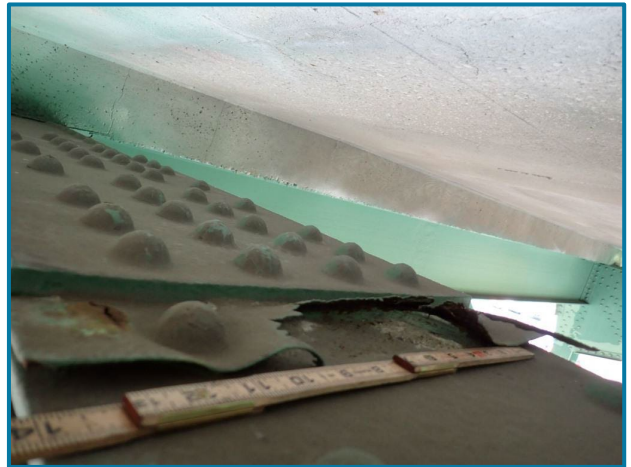
Photo 48 – 8" L x 2" W area of 100% section loss to the fill plate (U9U10 of the Center Truss, Span 6).

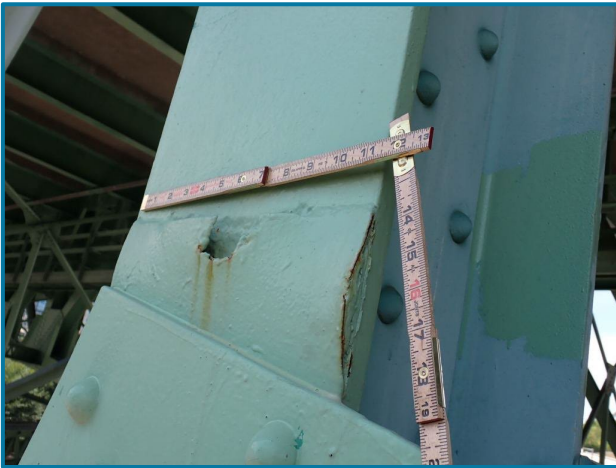
Photo 51 – 9/16” pack rust at the fill plate causing distortion to the plate (U13L13 of the South Truss, Span 7).

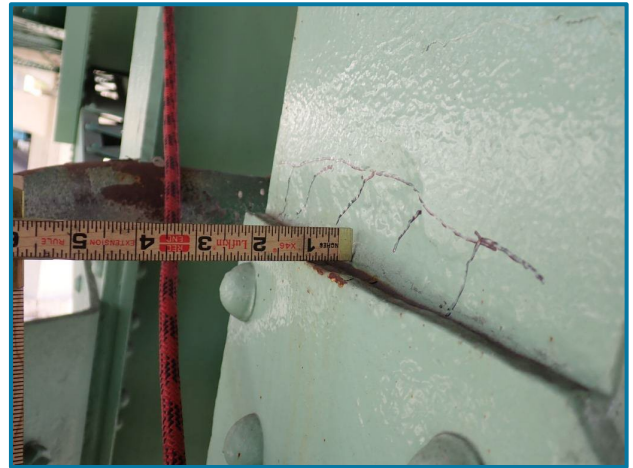
Photo 52 – 1/8” section loss across the flange width at the lower gusset plate (U44L44 of the Center Truss, Span 9).

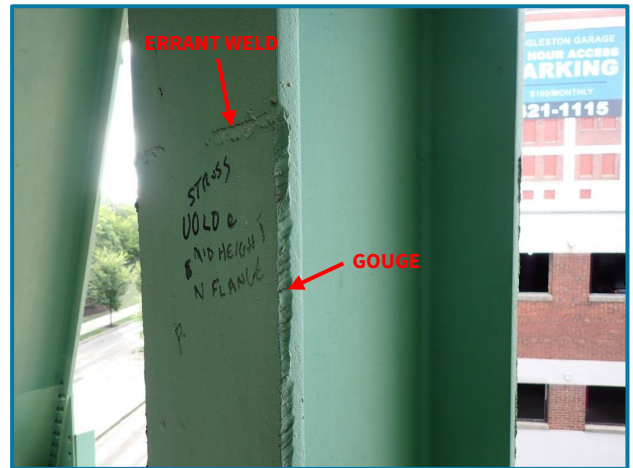
Photo 54 – Errant weld attached to the vertical flange (U0L0 of the South Truss, Span 7).

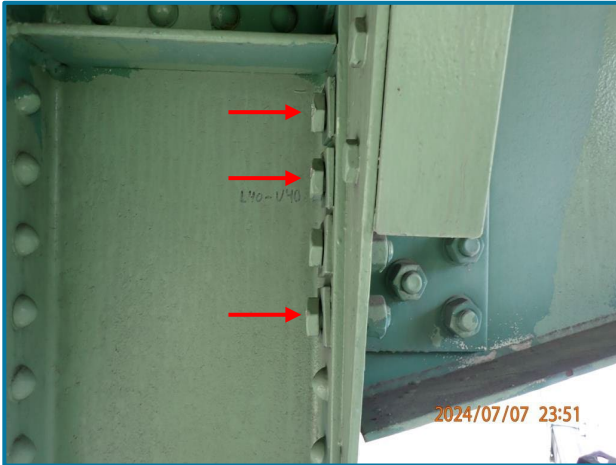
Photo 55 – Three bolts not properly snug (U40 of the North Truss, Span 9).

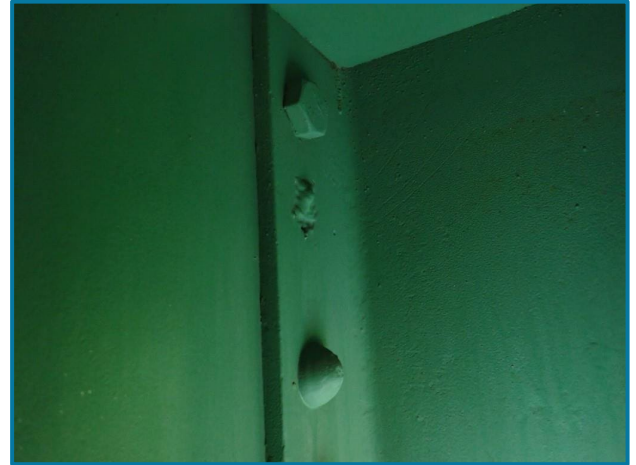
Photo 56 – Rivet head has been torch cut off (U20 of the North Truss, Span 11).

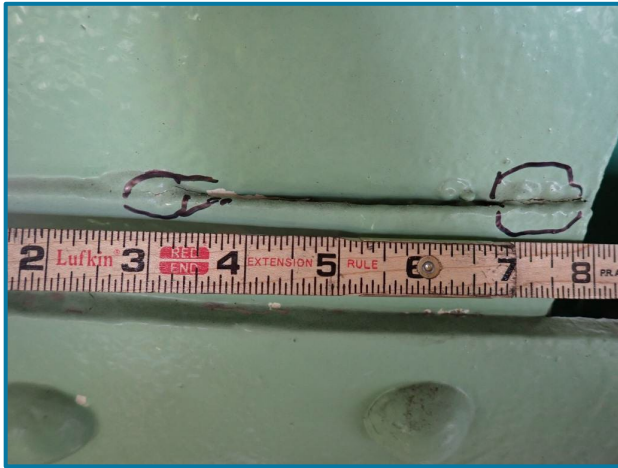
Photo 57 – 1” crack and broken weld at the fill plate welds to the vertical (U13L13 of the Center Truss, Span 6).

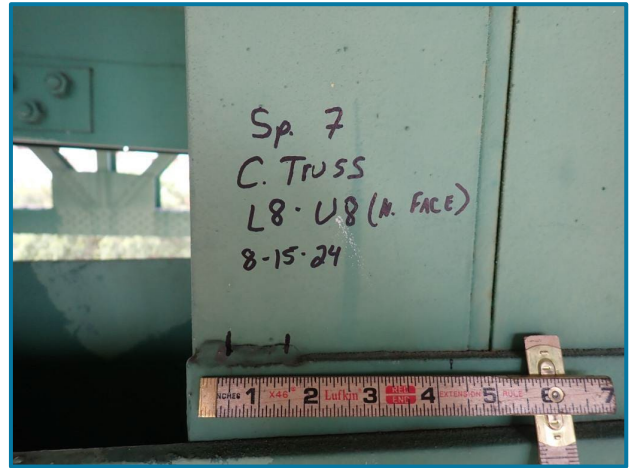
Photo 58 – 1” crack in the fill plate weld to the vertical (U8L8 of the Center Truss, Span 7).

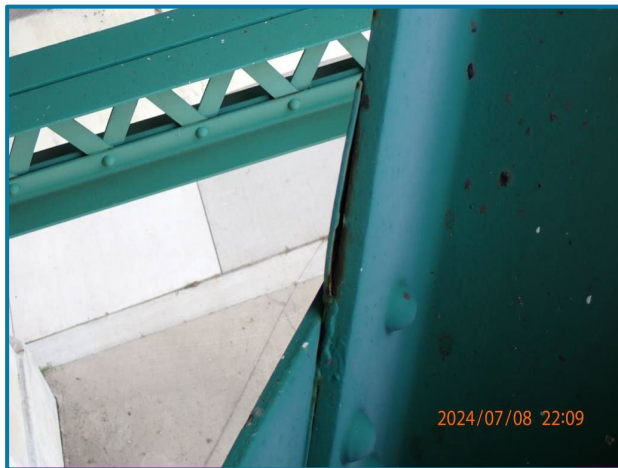
Photo 59 – 1/8” pack rust at the fill plate causing distortion to the plate (U16L17 of the North Truss, Span 8).

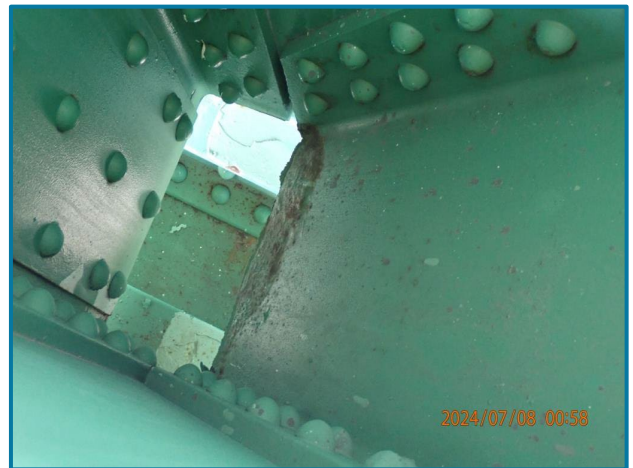
Photo 60 – Surface corrosion at the diagonal end with pack rust forming (U32L33 of the North Truss, Span 9).

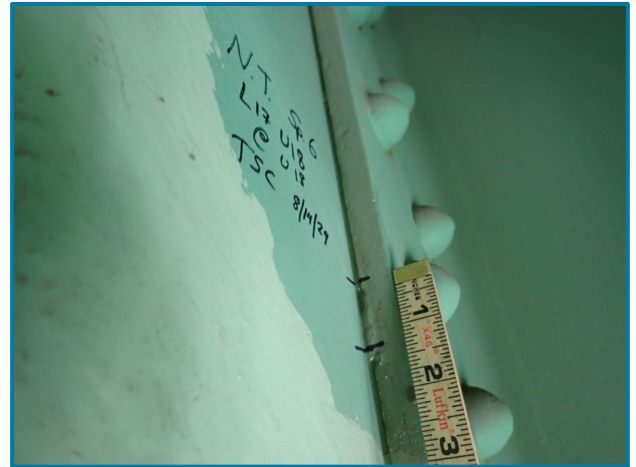
Photo 61 – 1-1/2" long cracked tack weld (L17U18 of the North Truss, Span 6).

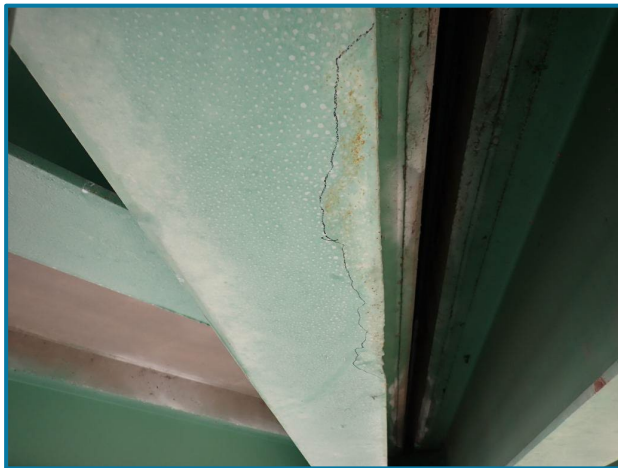
Photo 62 – 2' L x 3" W area of light surface corrosion to the bottom flange (Span 6 over Pier 7).

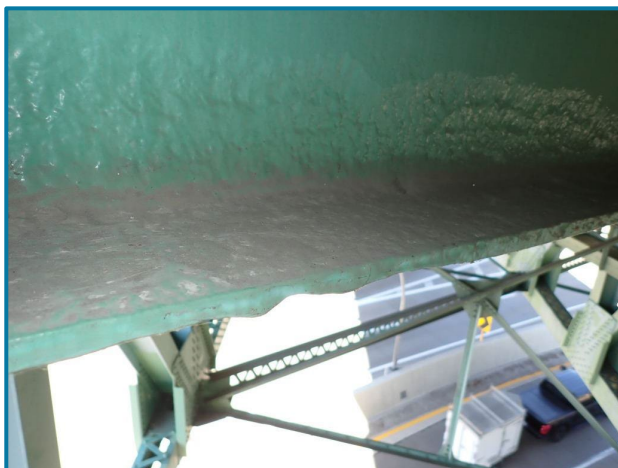
Photo 63 – 1/8" section loss across the bottom flange and lower web (over Pier 10 looking west).

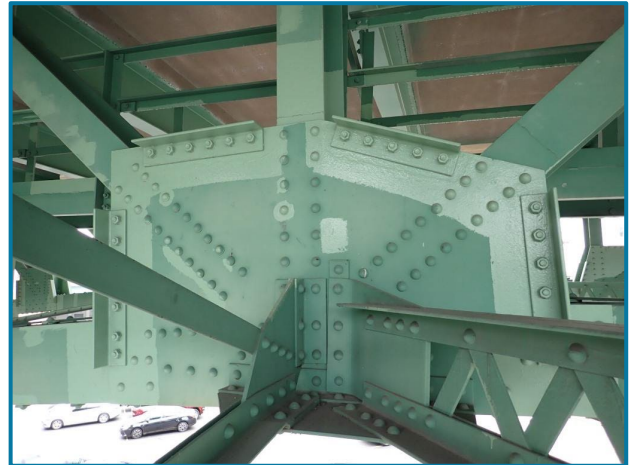
Photo 65 – Rehabilitation work to stiffen the gusset plates that were bowed (looking west).

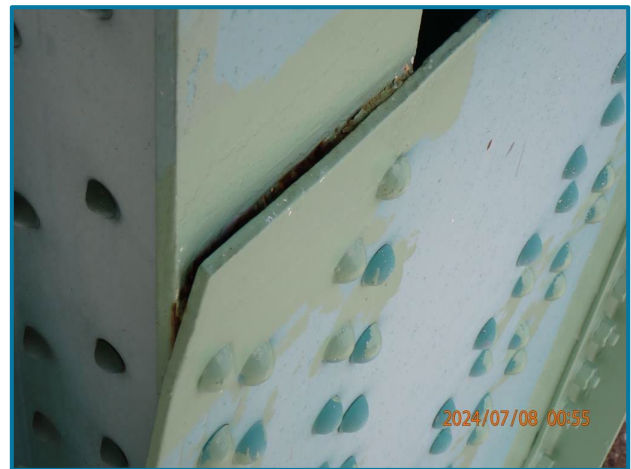
Photo 67 – Typical pack rust at the gusset plate causing distortion (L33, North Truss, Span 9).

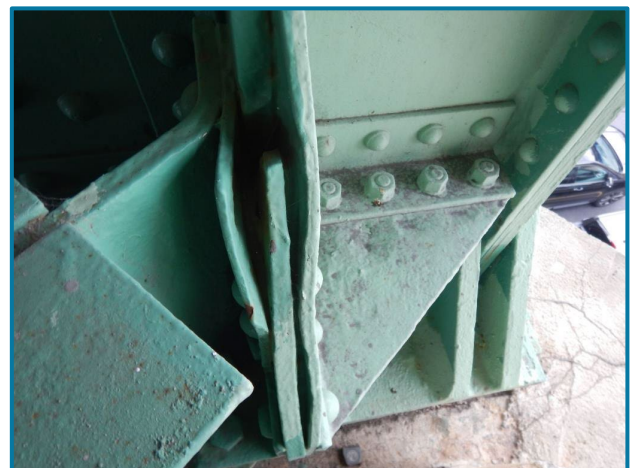
Photo 68 – 1" pack rust between the lower lateral bracing fill plate and the gusset plate (L0, South Truss, Span 5).

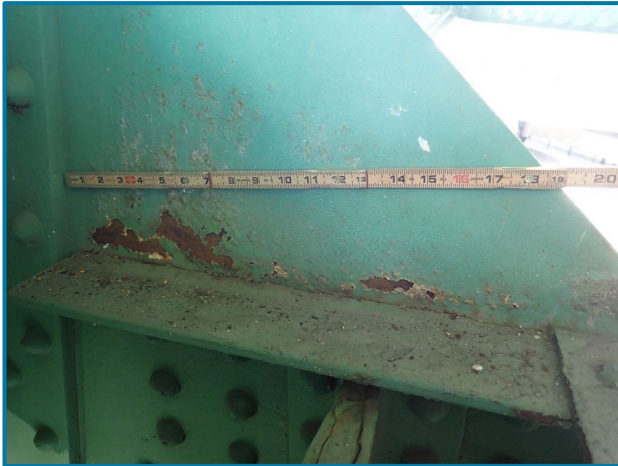
Photo 69 – Failed protective coating system with surface corrosion (L44, Center Truss, Span 9).

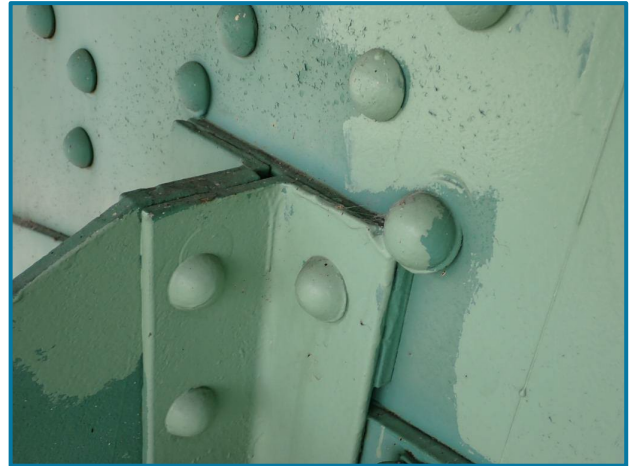
Photo 70 – Rivet deformation due to conflict with the sway bracing connection (L28, Center Truss, Span 8).

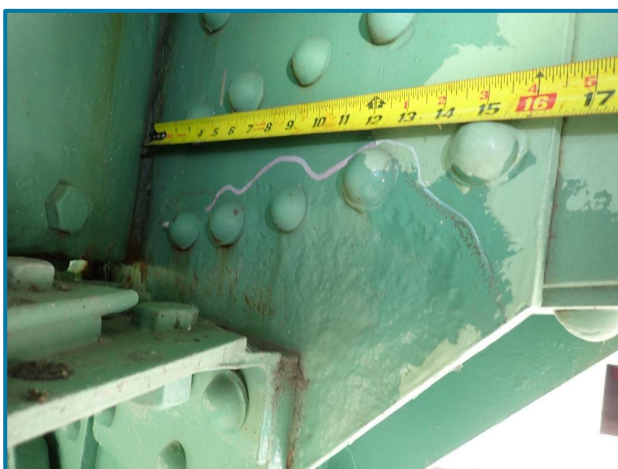
Photo 71 – 2'-4" L x 6" H x 3/16" D painted over pitting adjacent to the bearing (L20, South Truss, Span 6).

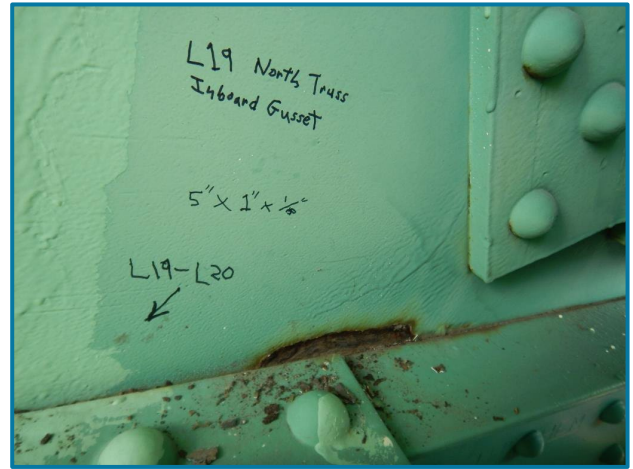
Photo 74 – 1/8” pitting with active corrosion (L19, North Truss, Span 6).

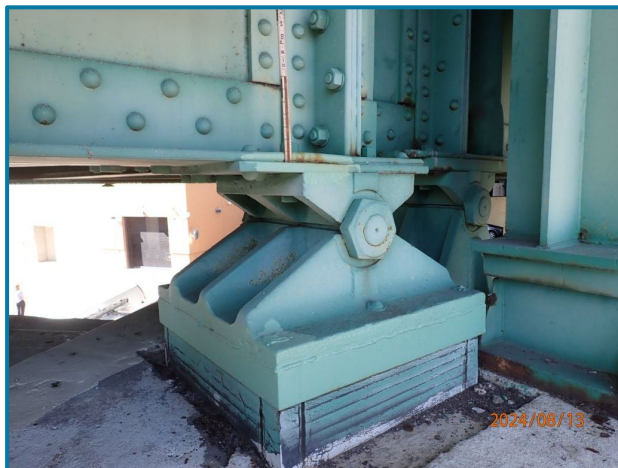
Photo 75 – 3/16” pack rust between the lower chord and the bearing (North Truss, Span 4, looking southwest).

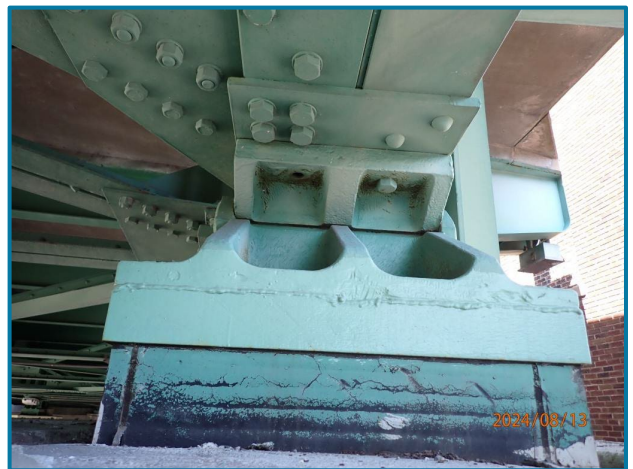
Photo 76 – Missing bolt attaching the sole plate to the girder (North Girder, Floorbeam 0, Span 4, looking west).

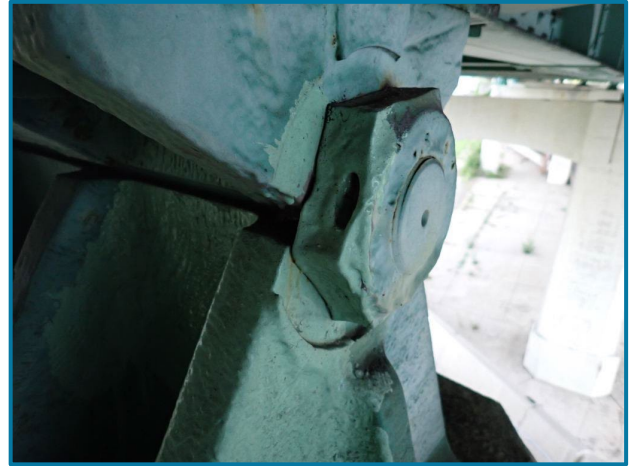
Photo 77 – Gouge in the pin nut with painted over pitting (Pier 12, Center Girder, Span 12, looking southwest).

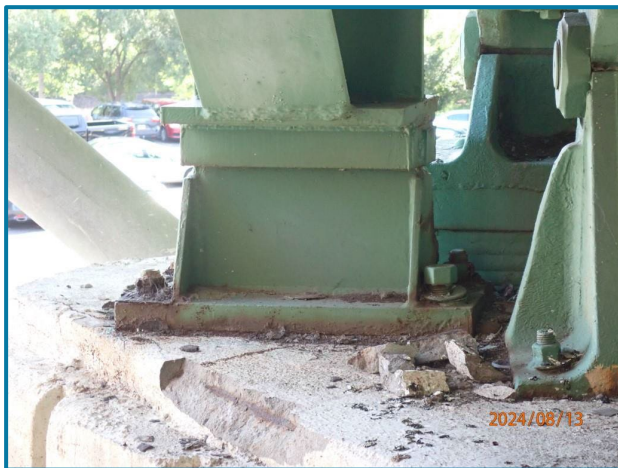
Photo 78 – 1 loose anchor nut and 2 with 30% section loss (Pier 4, North Girder, Span 3, looking east).

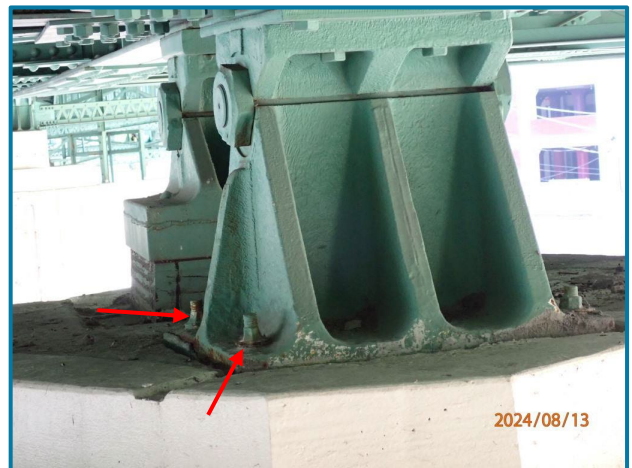
Photo 79 – Up to 40% section loss to the anchor nuts (Pier 4, Center Girder, Span 3, looking southeast).

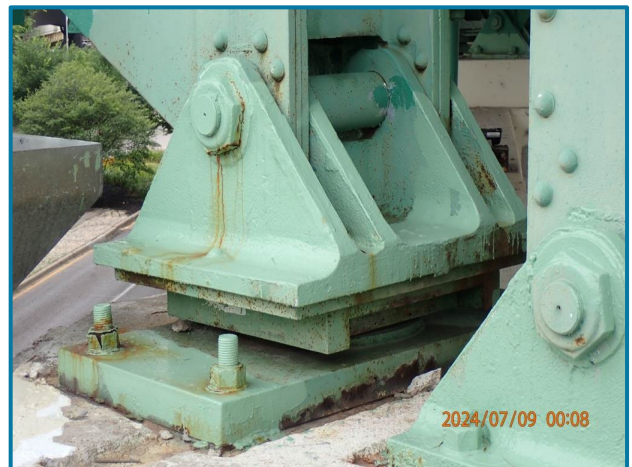
Photo 80 – Surface corrosion and rust staining to the bearing (L14, North Truss, Pier 8, looking southeast).

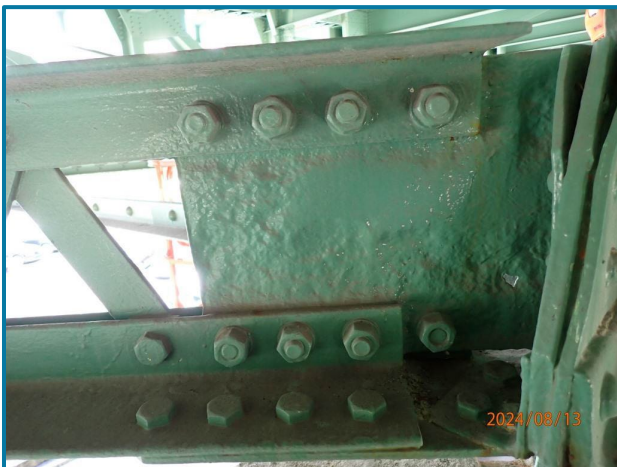
Photo 81 – Painted over pitting up to 3/16" (L0, Center Truss, Span 5, looking northeast).

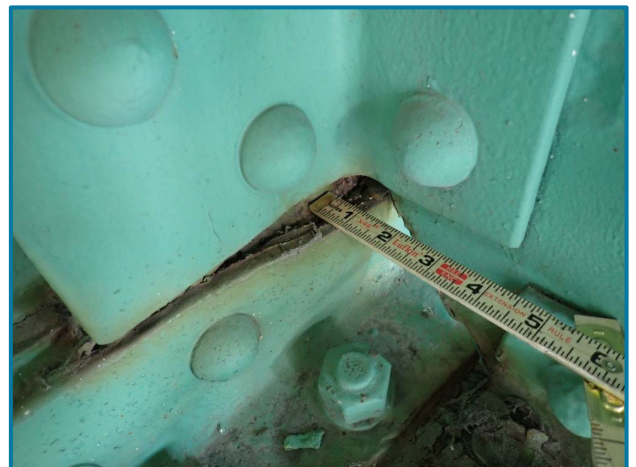
Photo 82 – 3/4" pack rust at the bottom strut flange angle (L20, North Truss, Span 6, looking northwest).

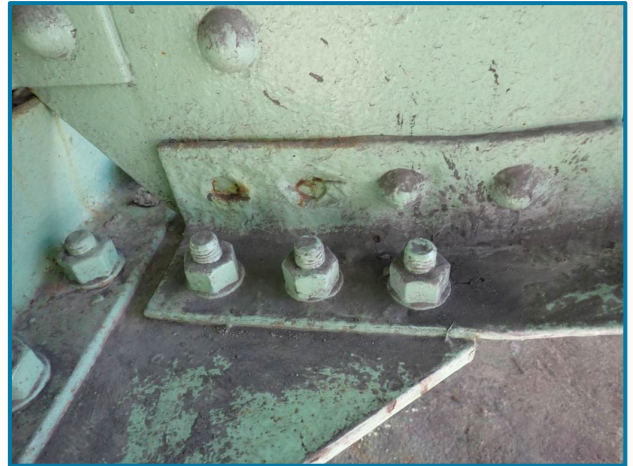
Photo 83 – 2 sheared off rivet heads at the sway bracing bottom strut (L0, Center Truss, Span 10, looking west).

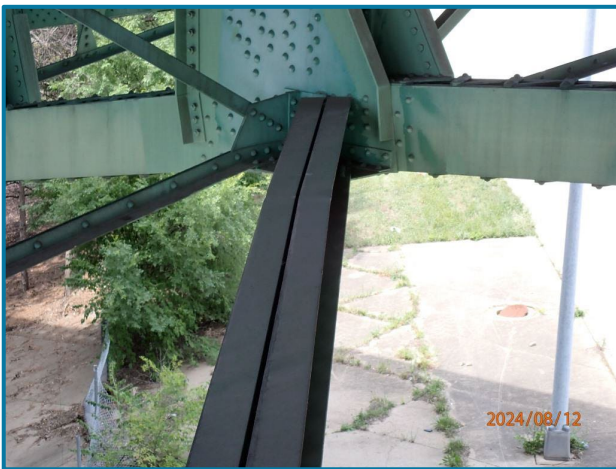
Photo 84 – Impact damage to the lower lateral bracing (6' south of L18, Center Truss, Span 8, looking north).
